**WEAR BEHAVIOUR AND MICROSTRUCTURAL
CHARACTERIZATION OF WORN SURFACES AND
WEAR DEBRIS OF A HIGH PURITY Al AND AN Al-Si
ALLOY AND AN Al-Si/SiC_p COMPOSITE SLIDING
AGAINST AN M2 STEEL**

XIANYAO LI

DOCTOR OF PHILOSOPHY

Metallurgical Science Laboratory
Department of Mechanical and Industrial Engineering
Winnipeg, Manitoba

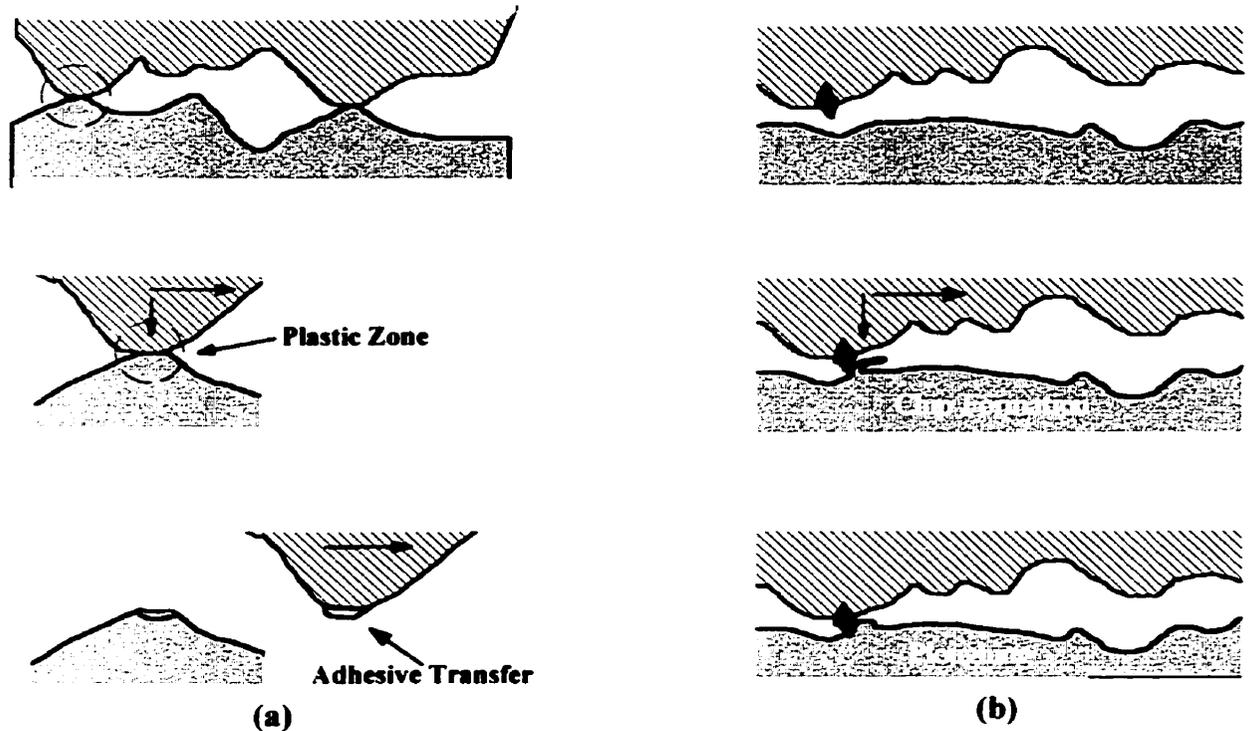
Fig. 2. 4 (a) Schematic illustration of the classical adhesion mechanism of sliding wear.
 (b) Schematic illustration of adhesive mechanism of sliding wear, showing two possible modes of interaction between a hard asperity (an embedded abrasive particle) and a second surface.

The abrasive wear is usually involved with a third body such as an embedded abrasive particle between the contacting surface or hard protuberances that are forced against and move along the sliding surface. Several mechanisms can be responsible for the surface damage, including plowing, cutting, microcracking, microfatigue and wedge formation[37] during abrasive wear. Fig. 2.4 (b) shows two possible modes of the damage caused by abrasive wear.

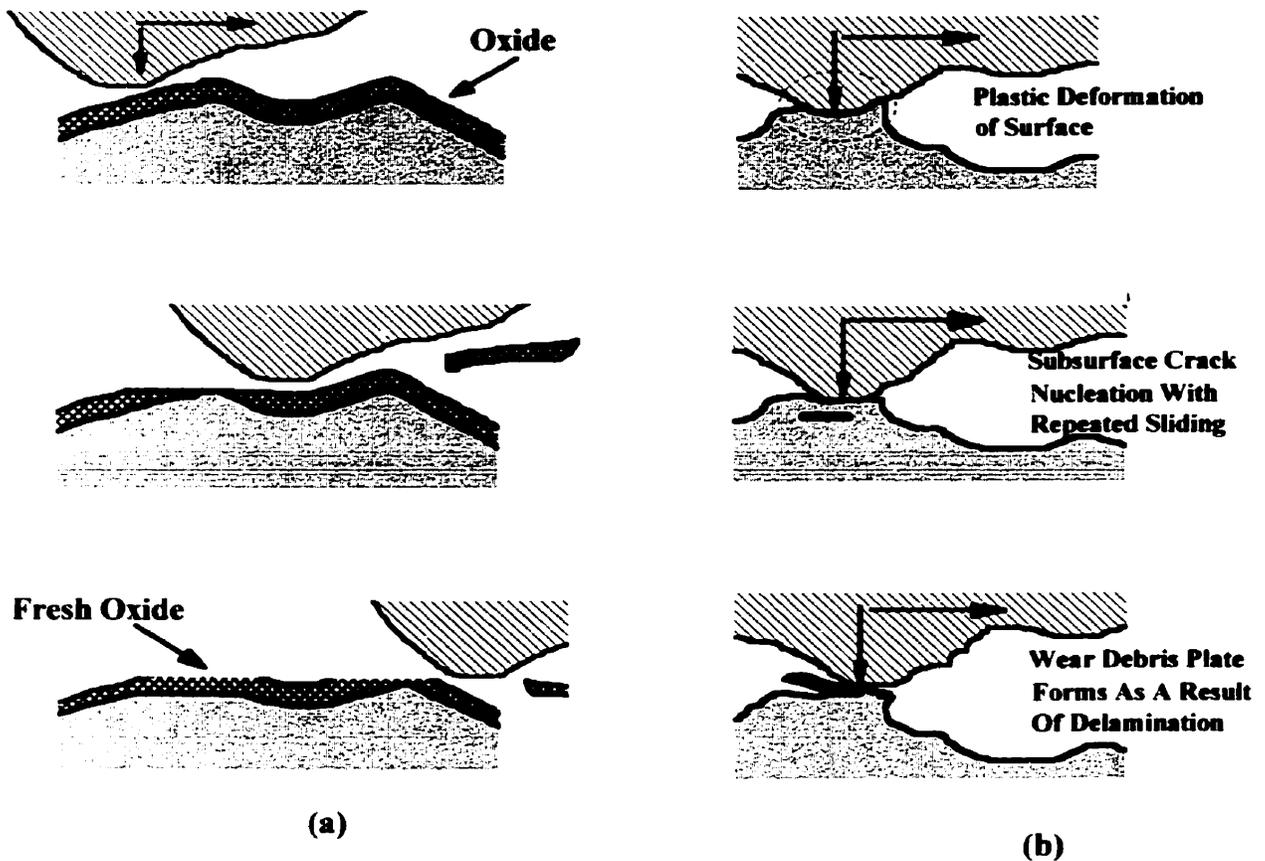
Fig. 2. 5 (a) Schematic illustration of a possible oxidation wear in which a surface oxide film is formed and detached under the sliding conditions.
 (b) Schematic illustration of delamination wear showing various stages involved, such as plastic deformation, subsurface crack nucleation and the eventual delamination.

In a sliding motion, most of the work done against friction is turned into heat resulting in a temperature rise on the surface. Oxidation may be observed in the sliding surface, and a possible mechanism of oxidation wear may result from the repeated formation and removal of a surface oxide film, as demonstrated in Fig. 2.5 (a). Quinn [40] has developed an oxidation theory of mild wear for dry sliding of steels, in which a film of oxide is formed on a sliding asperity and the oxide will be removed when it reaches to a critical thickness and becomes mechanically unstable. It is believed that in many cases tribological oxidation could reduce the wear rate compared to the running in wear stage [40]. This theory is valid only for the case where oxidation is the dominant mechanism, such as at a very high load and a high sliding speed.

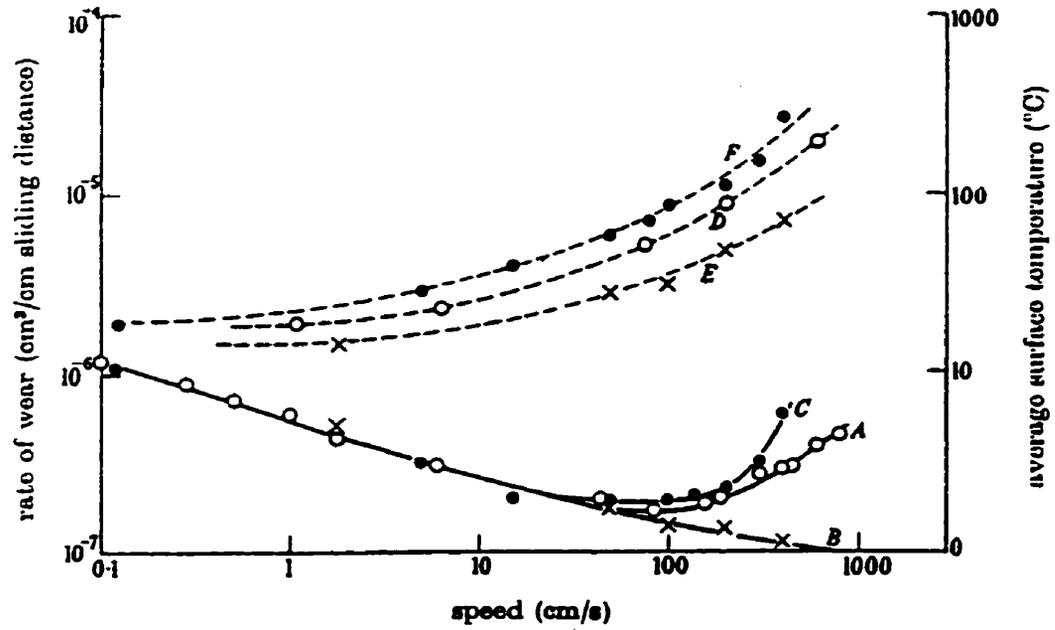
Fig. 2.7

- Fig. 2.6** The wear mechanisms map for a steel sliding pair using a pin-on-disk configuration.
- Fig. 2.7** Variation of wear rate and surface temperature with speed for thermally insulated and cooled pins. The solid line, wear rate; the dash line, surface temperature. Line A and line D, metal pin-holder; line B and line E, water-cooled pin-holder; line C and line F, thermally insulated pin-holder. After[49].

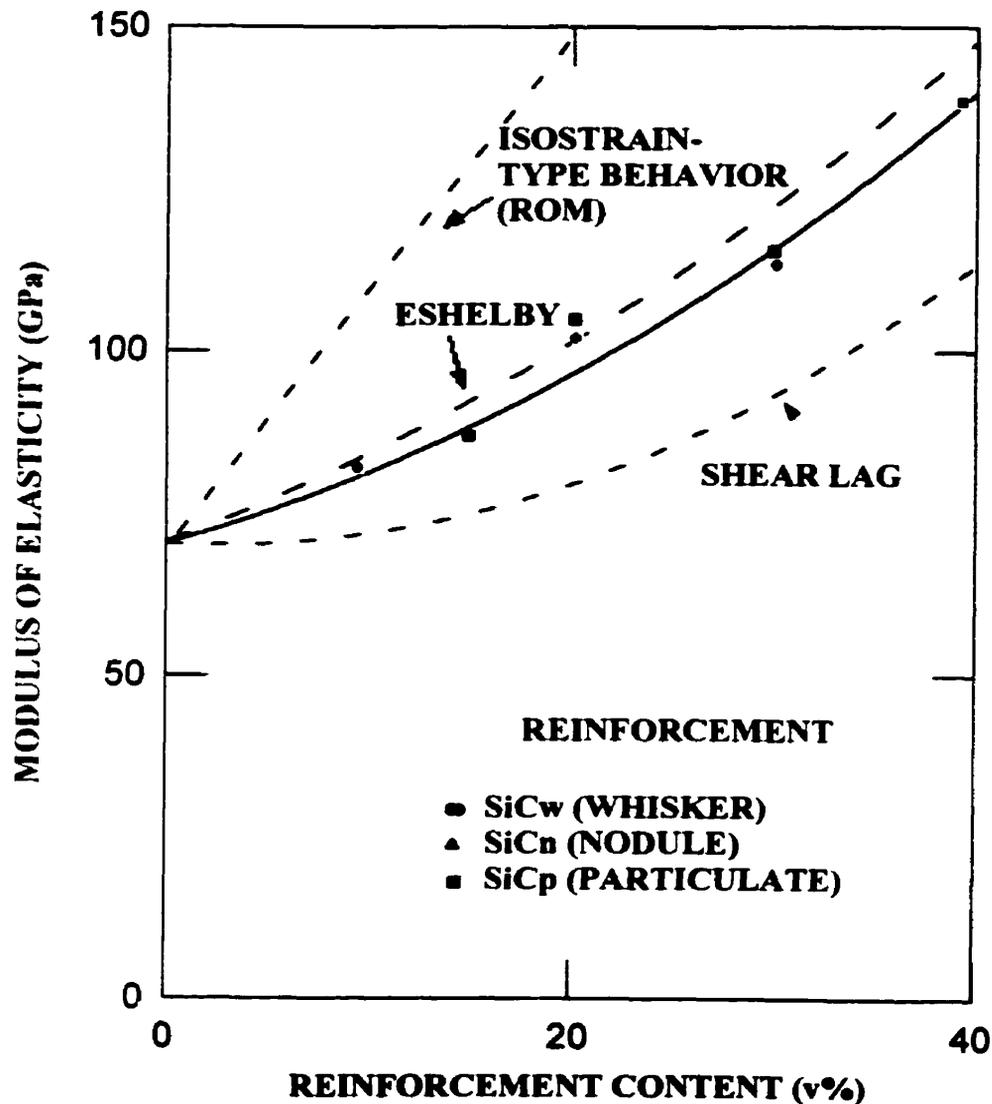
Fig. 2.14 Effect of reinforcement content on modulus of elasticity of SiC/6061 Al composites. After [82].

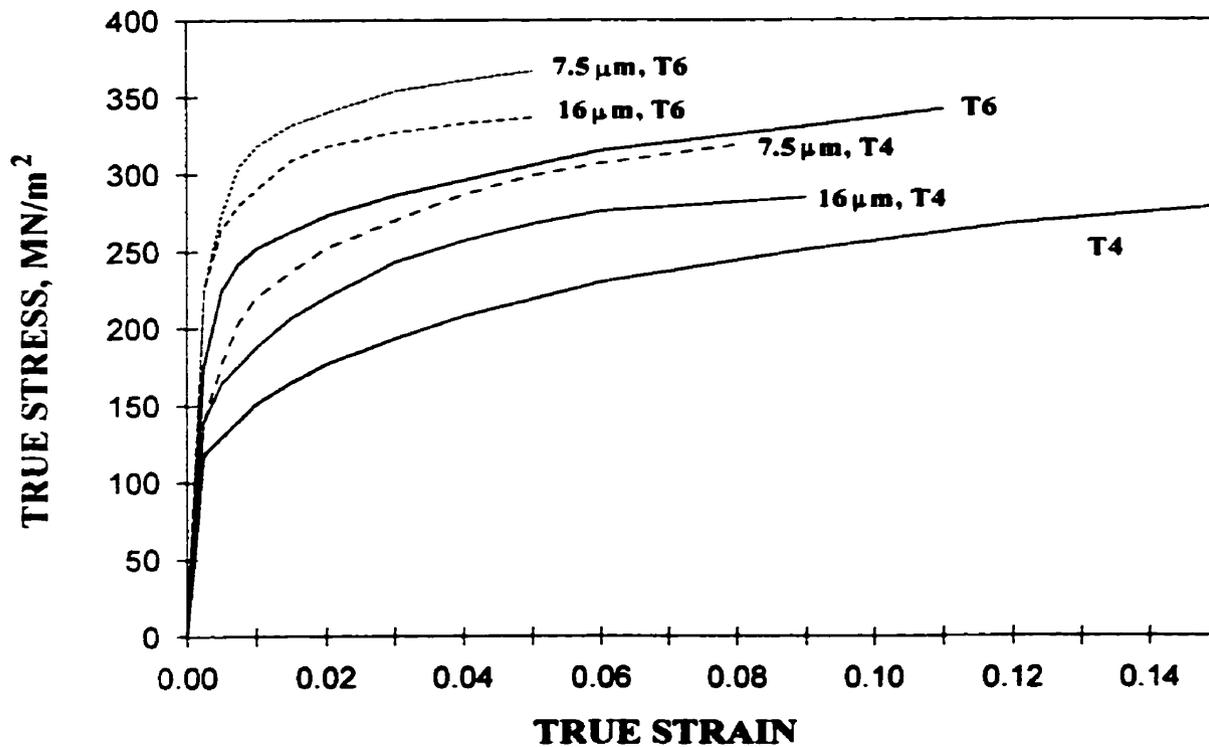
Fig. 2.15 Stress-strain curves for extruded A356(AI-Si) and A356(AI-Si)/SiCp composite with different particles sizes and tempers. After [81]

shows the comparison of stress-strain curves of the unreinforced material and the composites. It can be seen that the work hardening rate at low strains is higher in the composites. It implies that work hardening in the composites is extremely rapid at low strains. After strains of about 3% the stress-strain curves of the composite and the

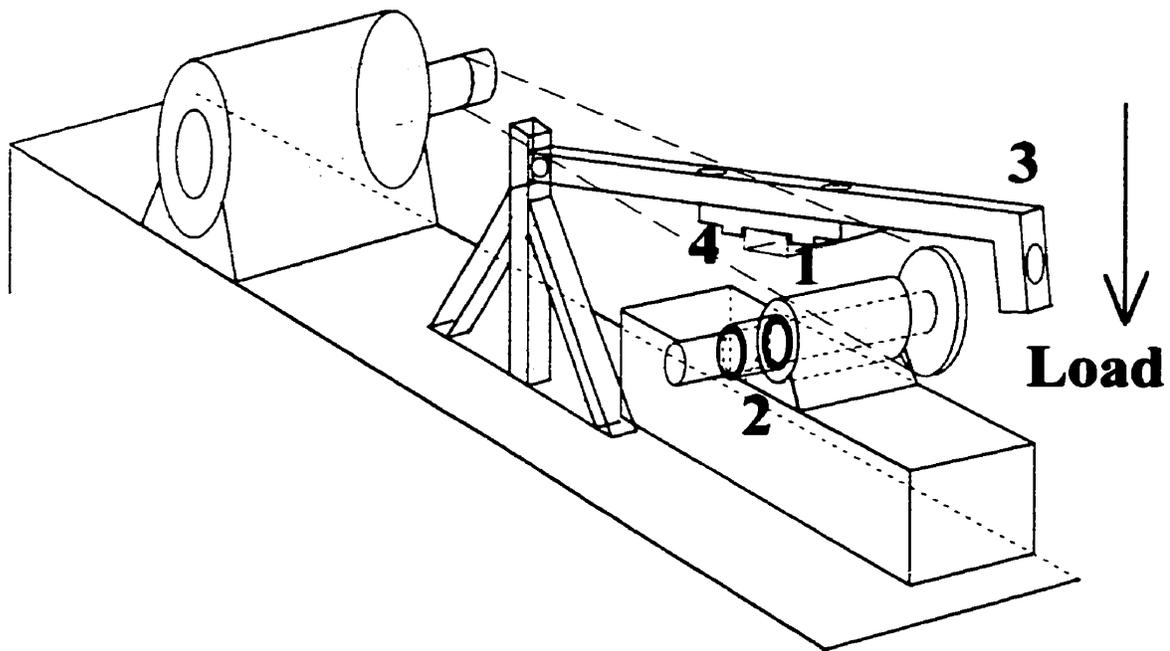
Fig. 4.1 Schematic illustration of Block-on Ring wear tester. (1) Specimen Block; (2) Test Ring; (3) Load Arm; and (4) Block Holder.

The Al alloy and Al MMC specimens were used as rectangular blocks of 9 x 9 x 9 (mm³), and slid against a tempered M2 tool steel ring with an outer diameter of 35 mm and width of 10 mm. The hardness of the M2 steel ring was 60-64 HRC, and the nominal composition of the M2 tool steel is shown in Table 4.3. The counterpart steel ring was polished to 1 μm *in-situ* by using the same wear tester in a manner that special steel blocks attached with sand papers of different grits and polishing clothes were sliding against the steel rings immersed in a coolant.

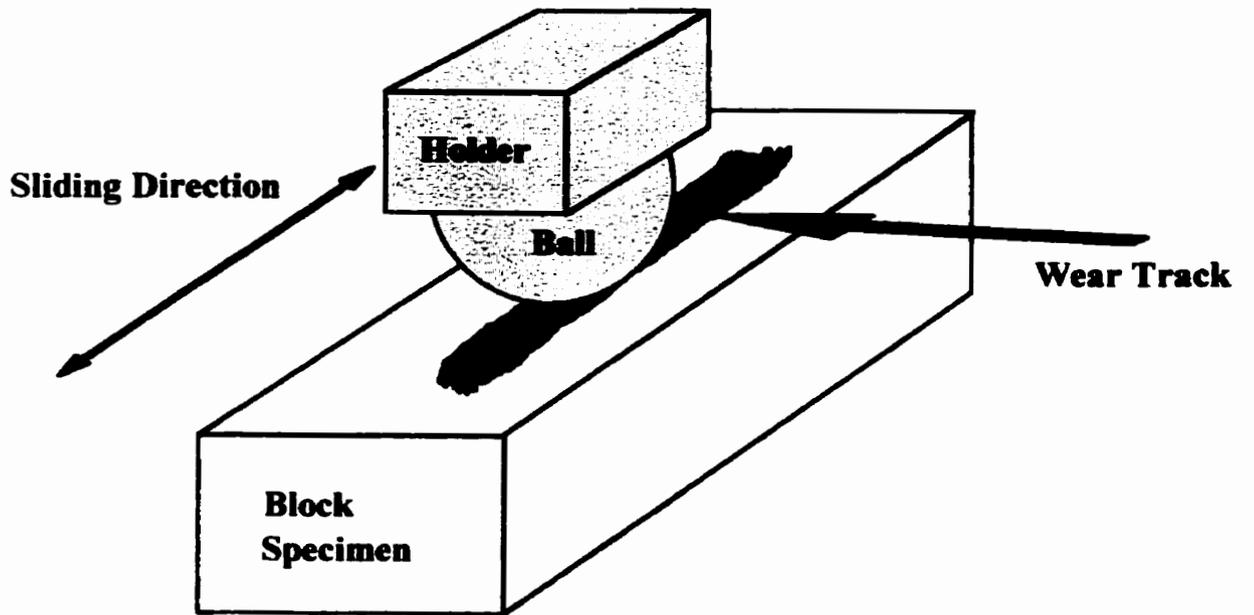
Fig. 4.3 Schematic illustration of Ball-on Block wear test.

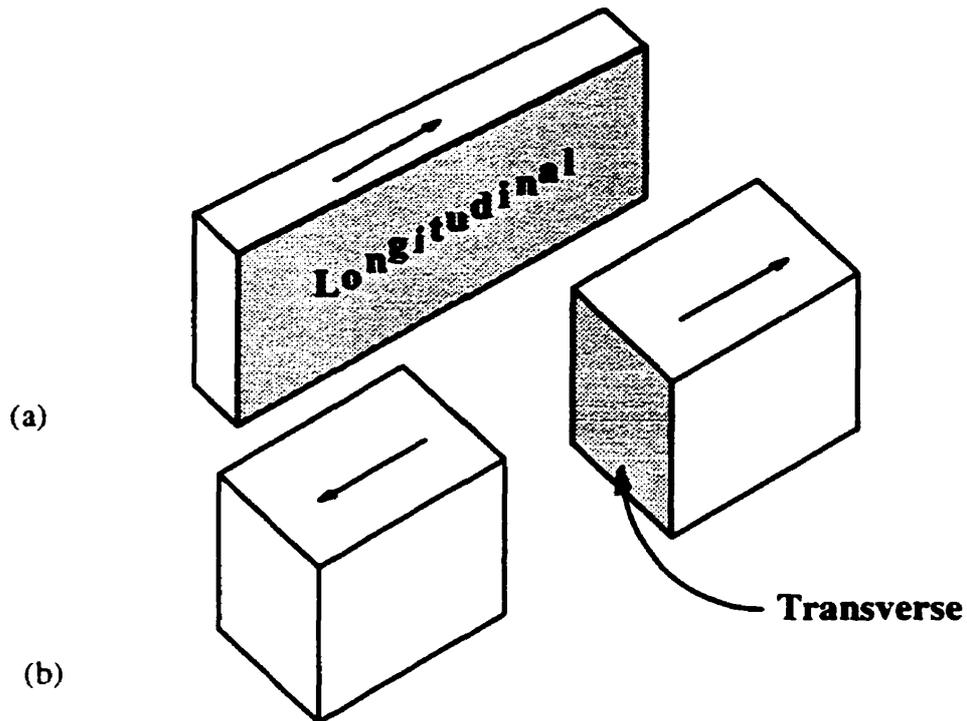
Fig. 4.4 Schematic illustration of two kinds of cross-sections. (a) Unidirectional sliding wear; and (b) Reciprocal sliding wear.

Two half blocks from the wear specimens were polished down to 0.25 μm , and the polished sides were joined, face to face, tightly together using a small bolt. The joint sample was then polished in such a way that the side to be polished, was perpendicular to the joint surfaces. The joint sample was then ready for wear test with the polished side being slid against the steel and the joint surfaces being either parallel (longitudinal) or perpendicular (transverse) to the sliding direction. During the wear test, the joint surfaces near the wearing contacts would friction weld and be displaced. After the test, the joined blocks were simply broken apart, and worn surfaces were also broken into two parts. Thus, fracture cross-sections of the worn surfaces were produced. These fracture cross-sections were expected to provide some unique information compared to those obtained from the Method 1. As well, no any contamination on the fracture cross-sections was present since the fractured cross-sections were put into SEM for observation immediately after being fractured.

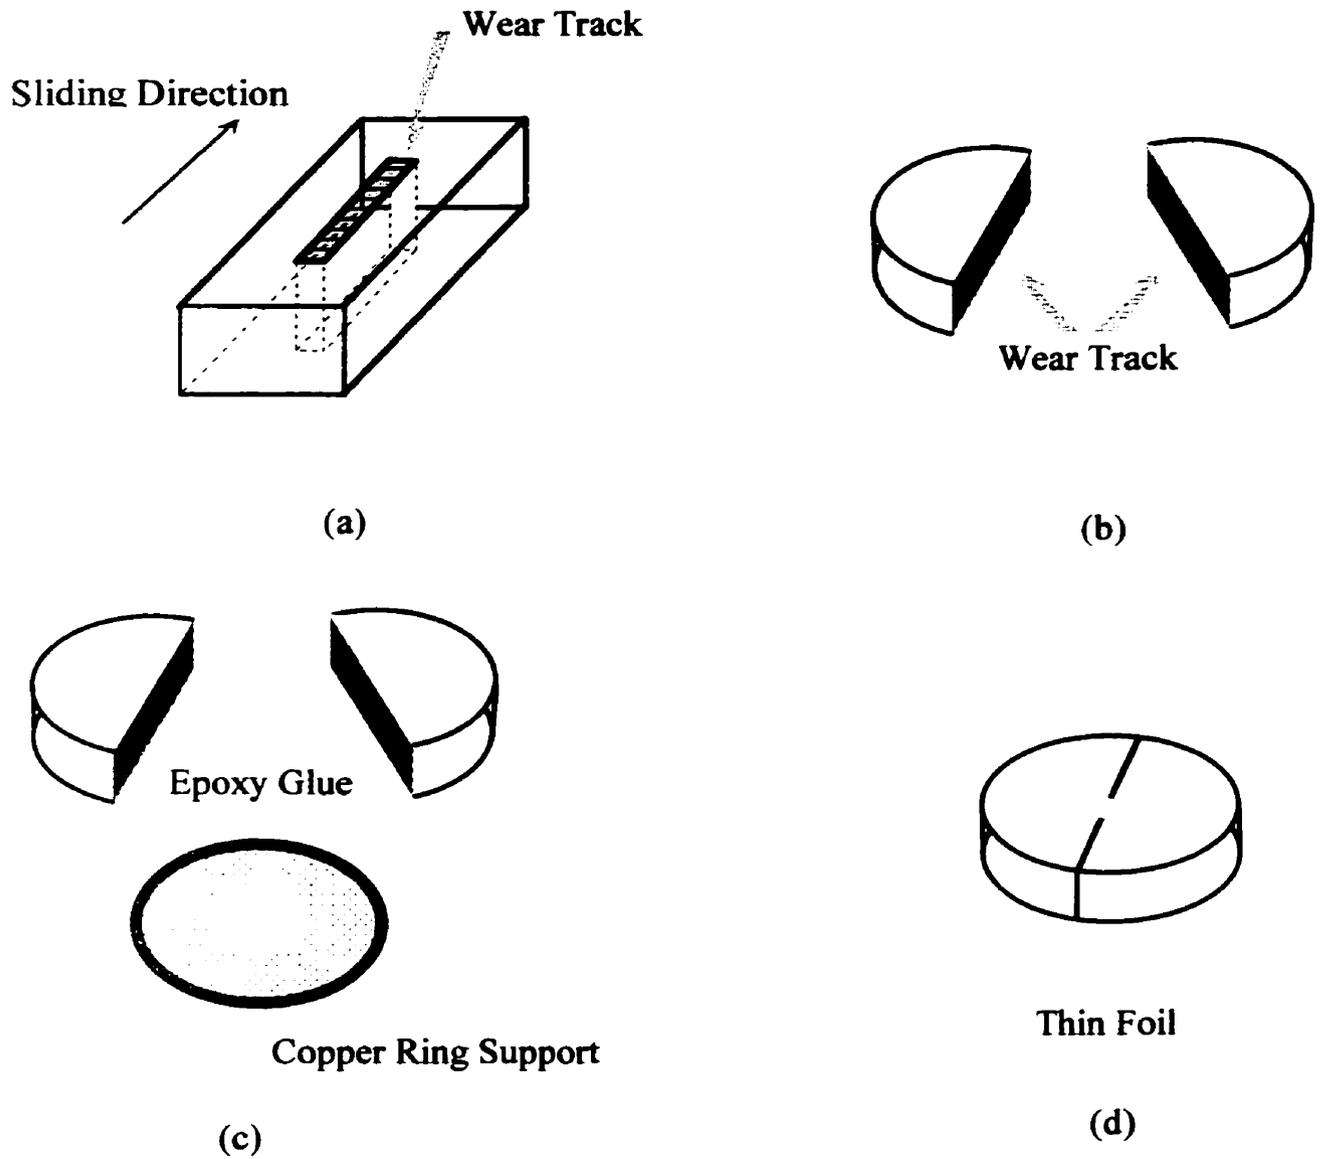
Fig. 4.5 Schematic illustration of preparation of TEM thin foils of longitudinal cross section of worn surface. (a) A longitudinal cross section is cut from a specimen; (b) and (c) Two pieces of the sections is put together with epoxy and supported by a Cu ring of 3 mm; (d) The thin foil.

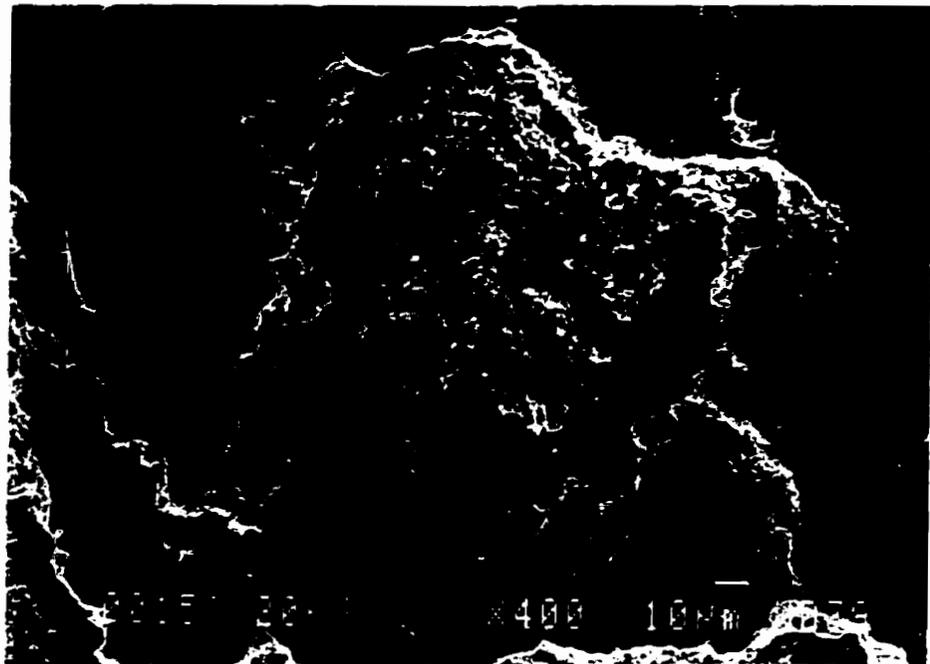
Fig. 5.15 A crater region with sharp edges in the worn surface of the Al-Si alloy at a load of 7 kg, an indicative of adhesive wear.

Fracture in the subsurface below the worn surface was also noted. In the bottom of a crater shown in Fig. 5.14, it is evident that extensive cracking occurred in the subsurface as a result of severe deformation and heavy strains caused by the sliding wear. Fig. 5.15 shows a crater with very sharp edges, from which debris very likely had detached by adhesion. In a montage micrograph shown in Fig. 5.16, it was noted that in area A, the bottom of the crater seemed to be very flat with extensive cracks, and no particles similar to those in Fig. 5.10 were present. Furthermore, Flake B as marked in Fig. 5.16, did not show direct evidence of being detached from adjacent areas, and there were gaps between Flakes B and C and the subsurface below Flake B. It suggests that Flake B might be displaced during the sliding motion, and Flake C might be smeared on the former in a subsequent event.

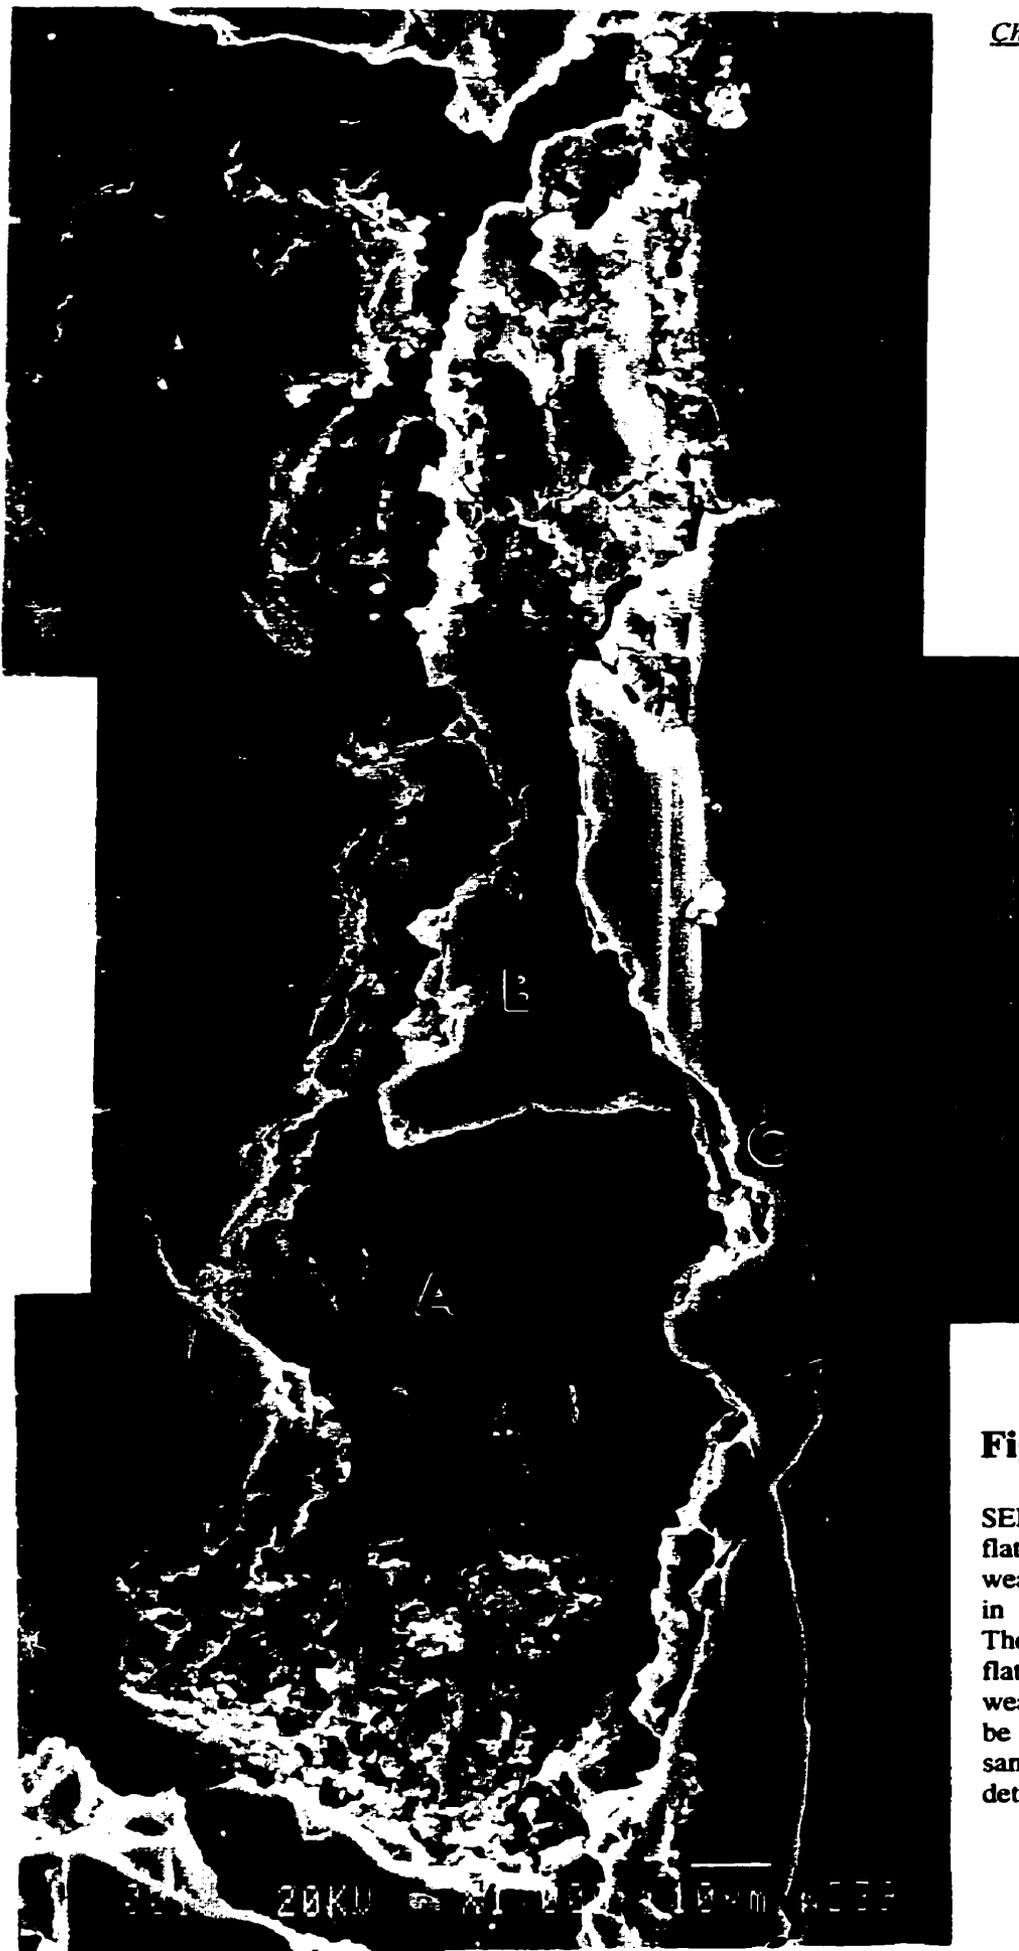
Fig. 5.16

SEM Micrograph of a flat crater area (A) and wear flakes (B) and (C) in the worn surface. The formation of the flat crater area and the wear flakes might not be occurring at the same time. See text for details.

During the wear process, loose debris were detached from the worn surface, and some of debris were compacted into the surface again. This can be confirmed by the observation as shown in Fig. 5. 16. In the smooth region, some of flakes were found to be

comprised of small particles embedded in the large flakes (smooth region A), as shown in Fig. 5.16. This feature can be observed more clearly on the worn surface of HP Al at a load of 3 kg, as shown Fig. 5.17. The worn surface was comprised mainly of small fragments or agglomerates with a size of 2 μm . It is likely that the cracks, either perpendicular or parallel to the sliding direction, occurred at the boundaries or interfaces of the small fragments. It was noted that these segments consisted of a large amount of Fe.

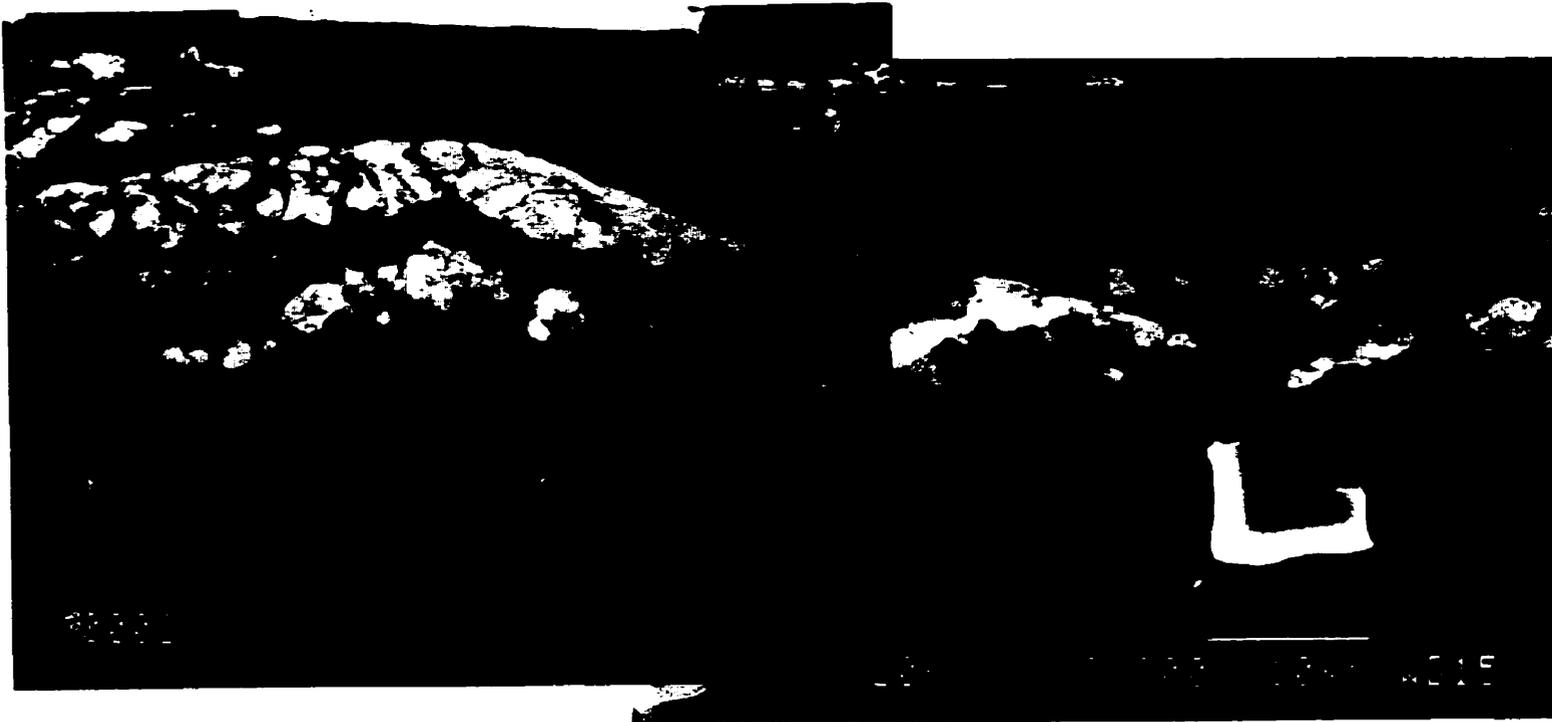
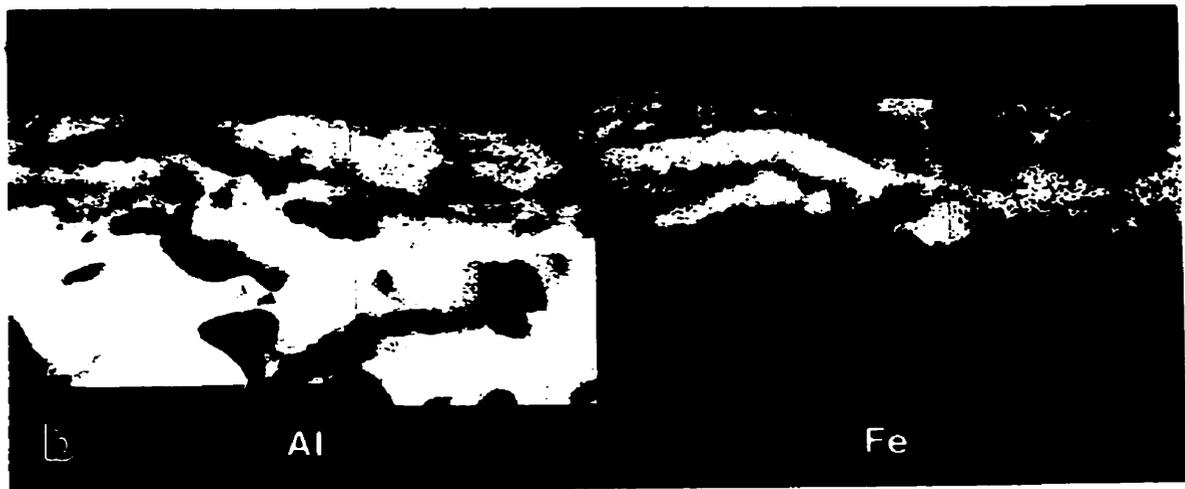
Fig. 5. 29 A sandwich structure of the MML in a longitudinal cross section of the worn surface of the Al/SiC composite at a load of 10 kg, in which sublayers either rich in Fe or Al alternatively exist. SEM micrograph, and (b) X-ray mapping of worn surface showing Fe and Al distributions in the MML.

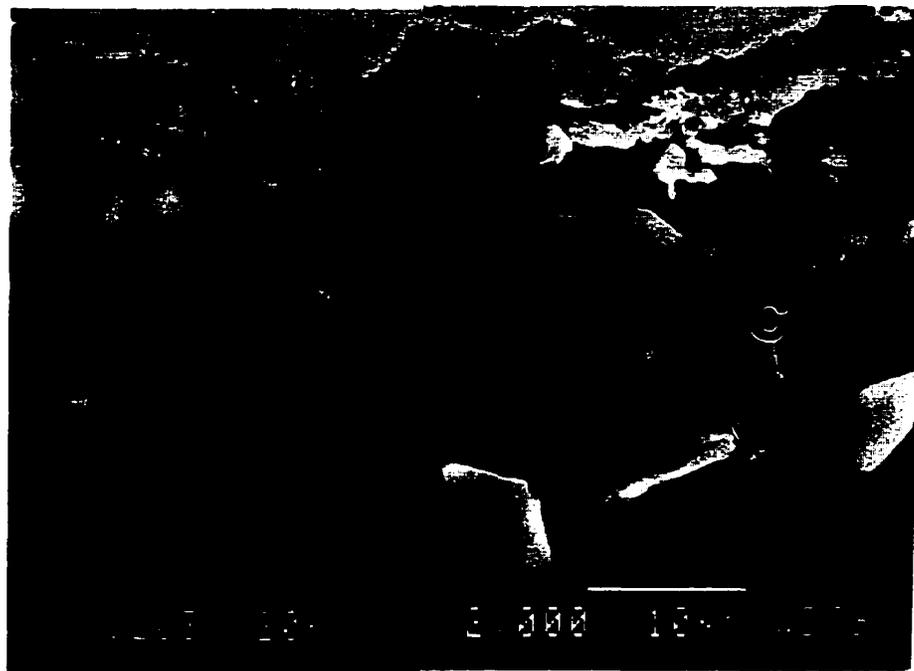
Fig. 5. 34 Fracture and fragmentation of SiC particles in the subsurface of the worn surface of the Al-Si/SiC composite at a load of 7 kg. (a) Cracking perpendicular and parallel to the sliding direction in the particle A and B, respectively; (b) Transparticle cracking of SiC. Particle C was broken into three parts as indicated by the arrow.

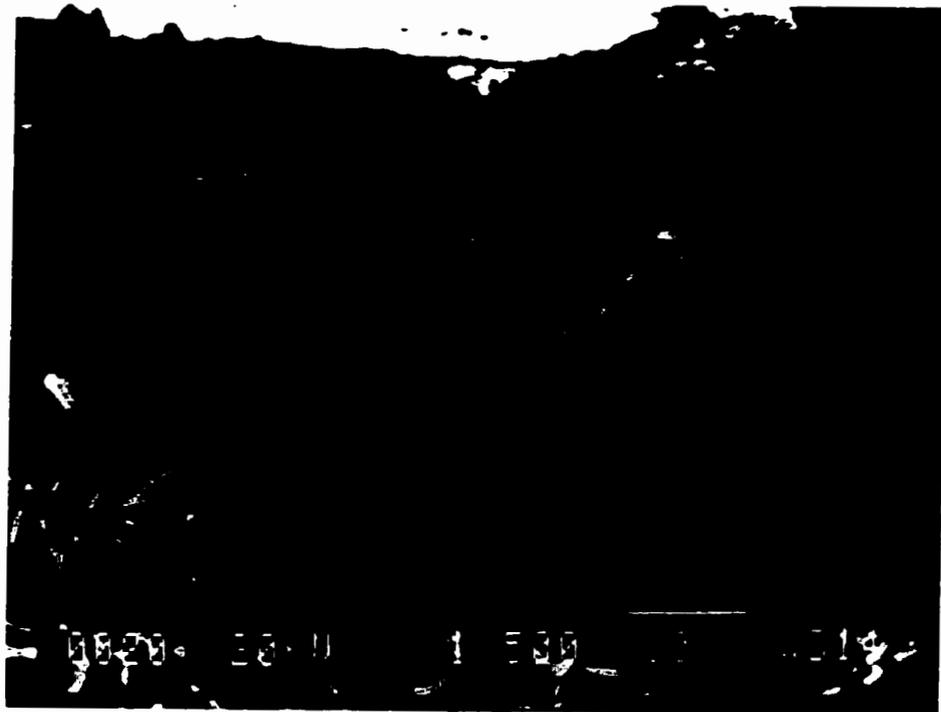
Fig. 5. 37 Fracture and fragmentation of eutectic Si particles in a transverse cross section of the worn surface of the Al-Si/SiC composite at a load of 7 kg. (a) Secondary electron image; and (b) backscattering electron image.

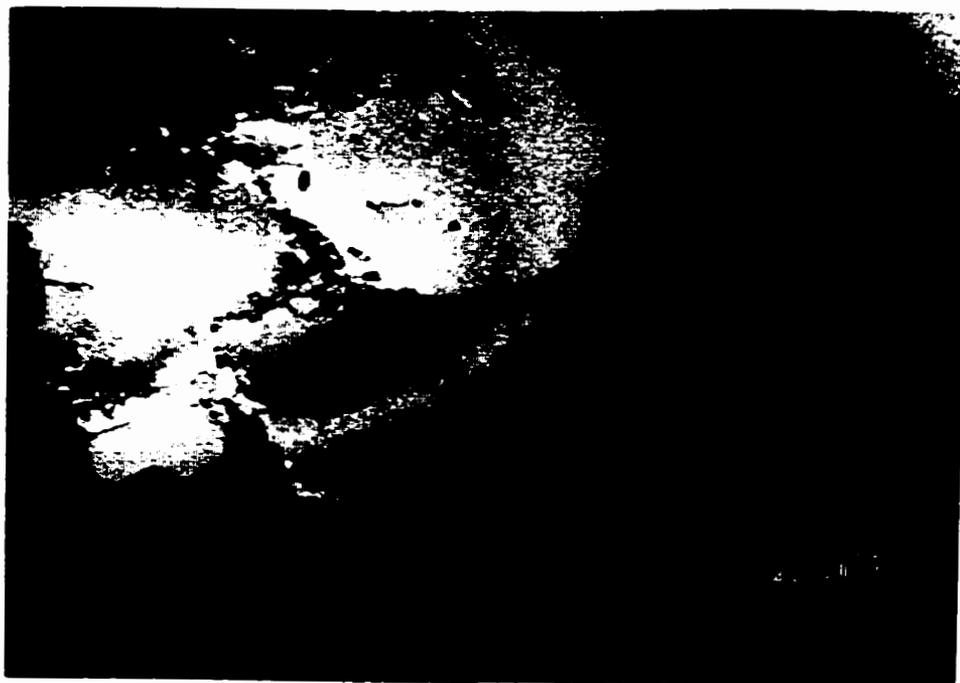
Fig. 5. 42 (a) and (b) Microstructures of the worn surface of the HP Al at a depth of about 50-300 μm , showing reduction of dislocation inside the cells, and presence of thick walls of cells. Sliding load: 5 kg.

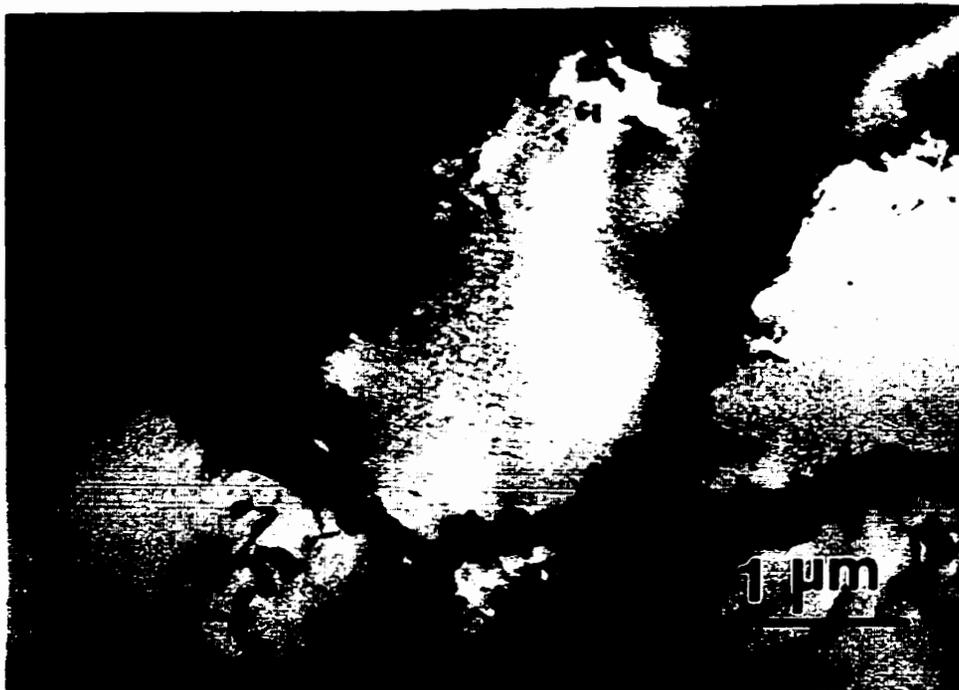
Fig. 5. 43 Cell structures in the worn surface of the HP Al at a depth about 100 μm from the top surface.

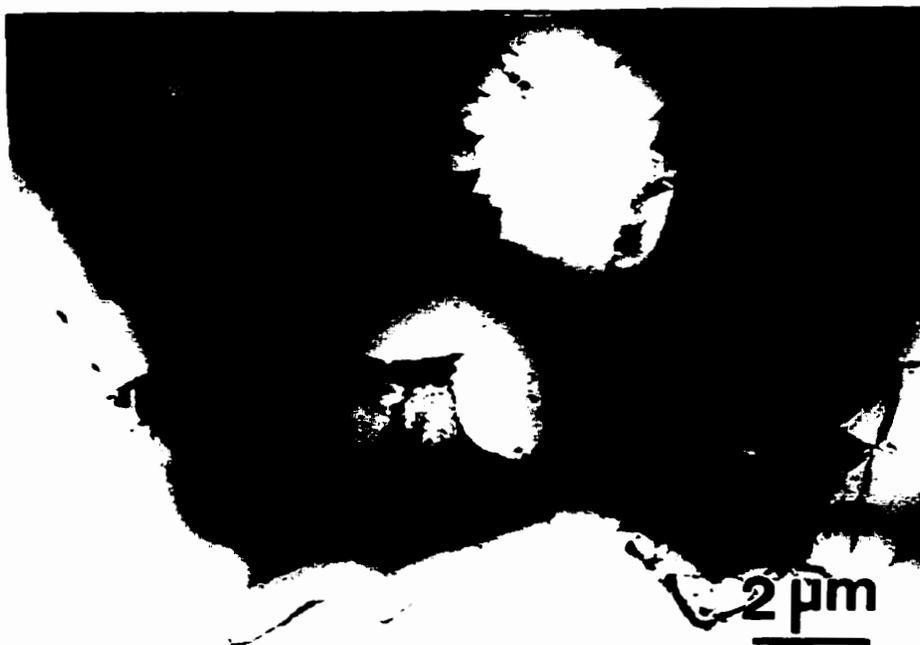
Fig. 5. 44 Cell structures in the worn surface of the HP Al at a depth about 100 μm from the top surface. (Low magnification) Note that the average cell size was about 1.5 to 2 μm.

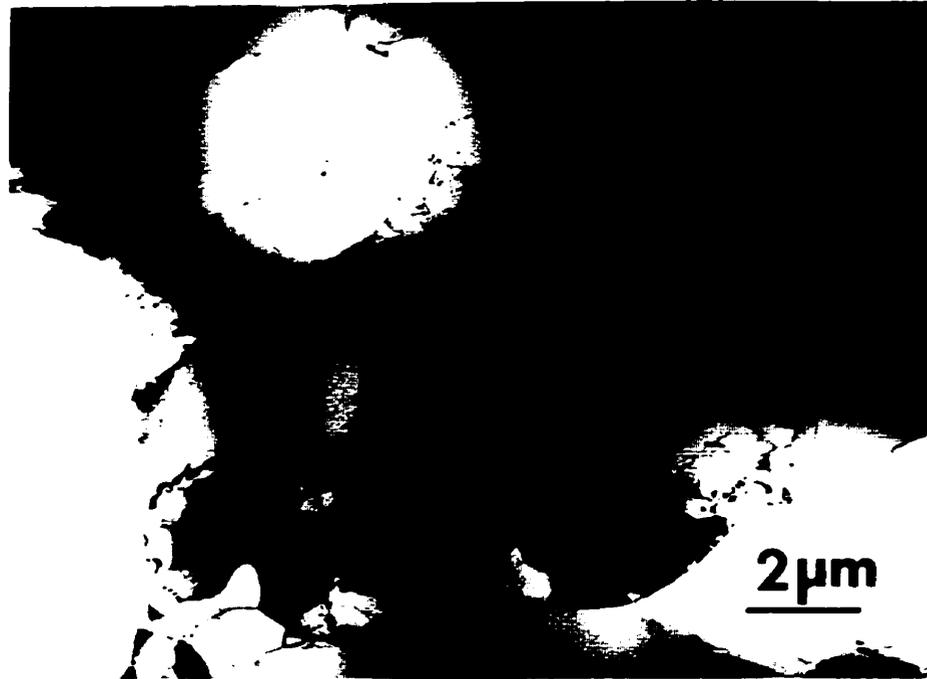
Fig. 5. 45 Subsurface structures in the worn surface of the HP Al at a depth less than 50 μm from the top surface, showing the cells started to get elongated, and that thin and line shaped boundaries formed as indicated by arrows.

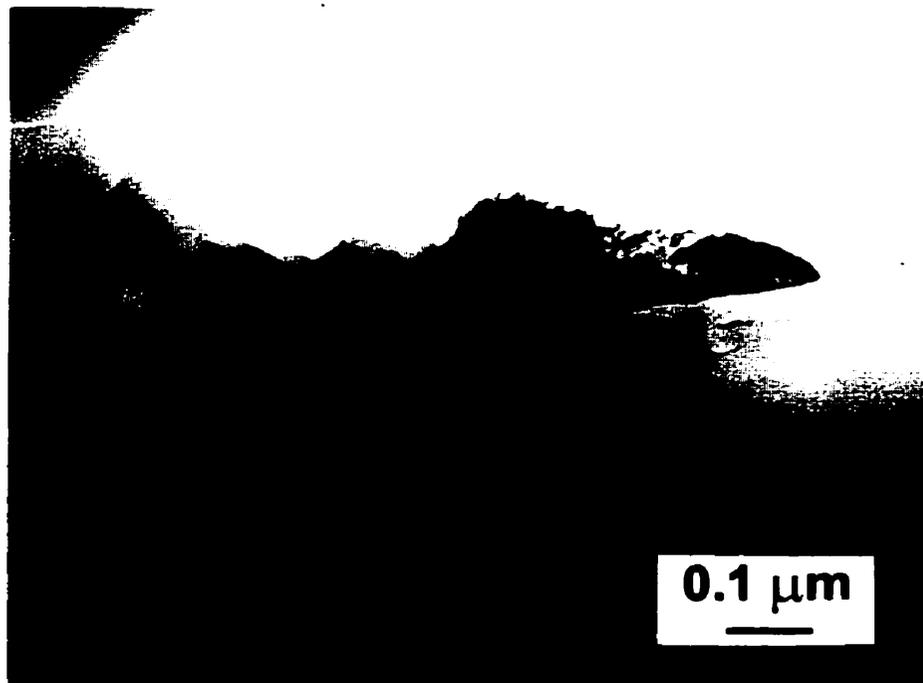
Fig. 5. 46 Microbands in the near surface of the worn surface of the HP Al. The thickness of the microbands is about $0.03 \mu\text{m}$. The tilting angle is about 10° between (a) and (b).

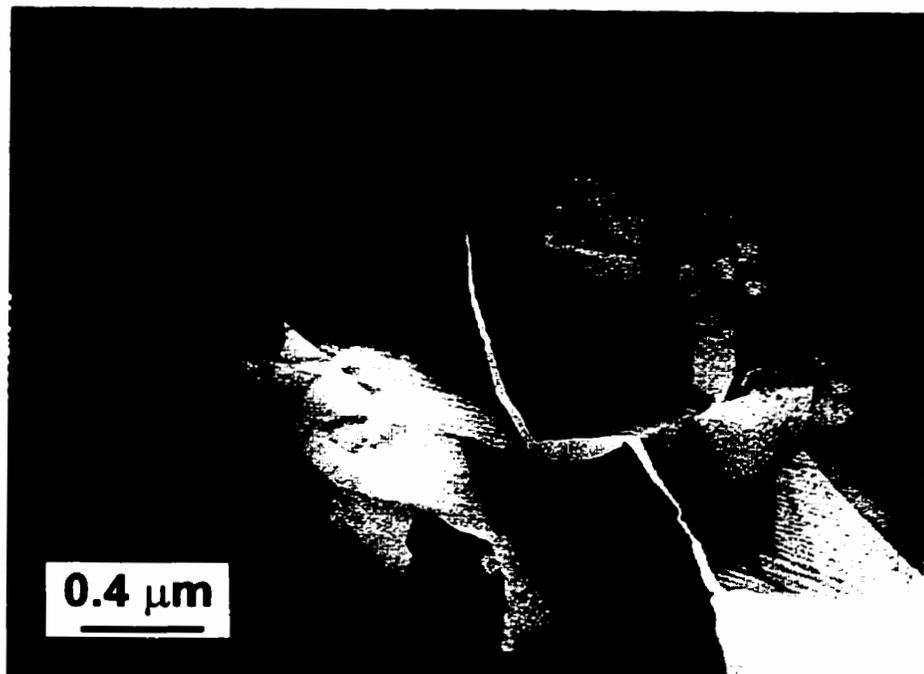
Fig. 5.51 A crack in the Al matrix is associated with the crack in the Si Particle in the subsurface of the worn surface of the Al-Si alloy.

It is also of interest to note that fracture of the Si particles occurred coincidentally with fractures in the Al matrix, as can be seen in Figs. 5.51 and 5.52. This implies that the fracture of the Si particles could be a source of initiation of cracks in the matrix since Si particles were more brittle than the matrix. Similar to the observations by SEM, microvoids were also frequently observed between the Si particles and the matrix, as shown in Fig. 5.53. The microvoids could also be observed in Figs. 5.50 and 5.52. The microvoids could result from debonding at the interface between the Si particles and the matrix and from coalescence of cracks mentioned above during the further deformation generated by the sliding wear.

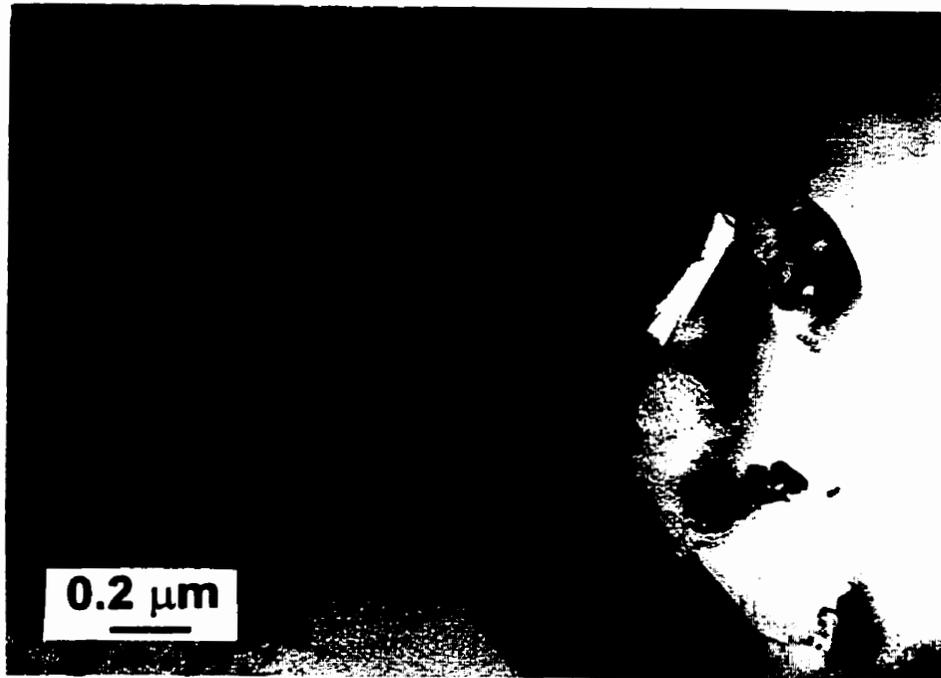
Fig. 5.53 Microvoids were observed at the interface between the Si particles and the Al matrix.

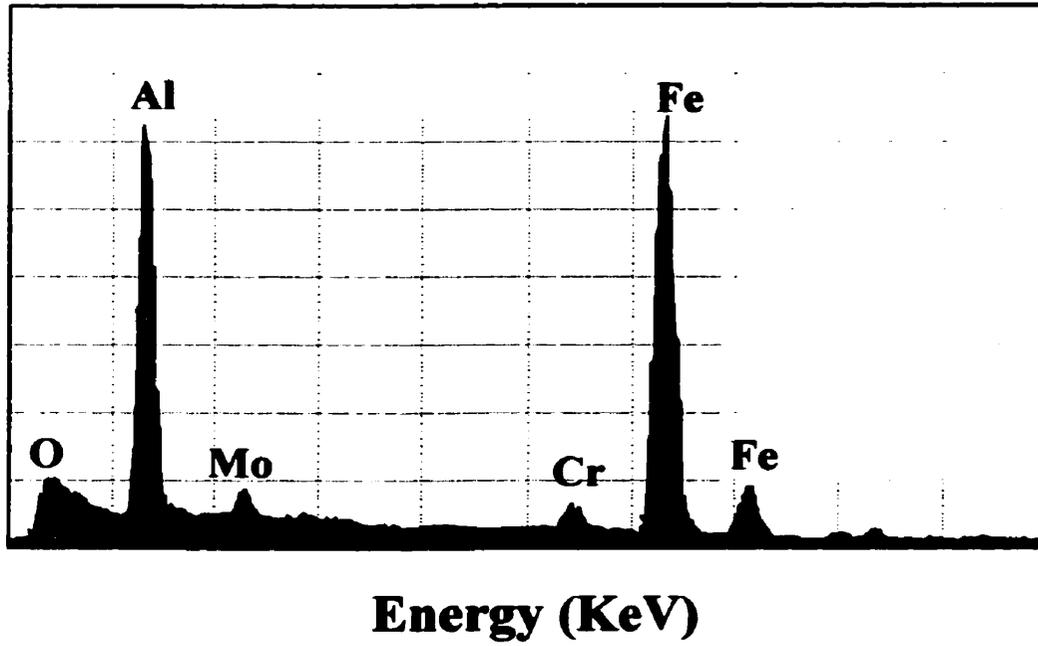
Fig. 5.80 EDS analysis of the ultrafine grained structures in the MML, showing a considerable amount of Fe and Al.

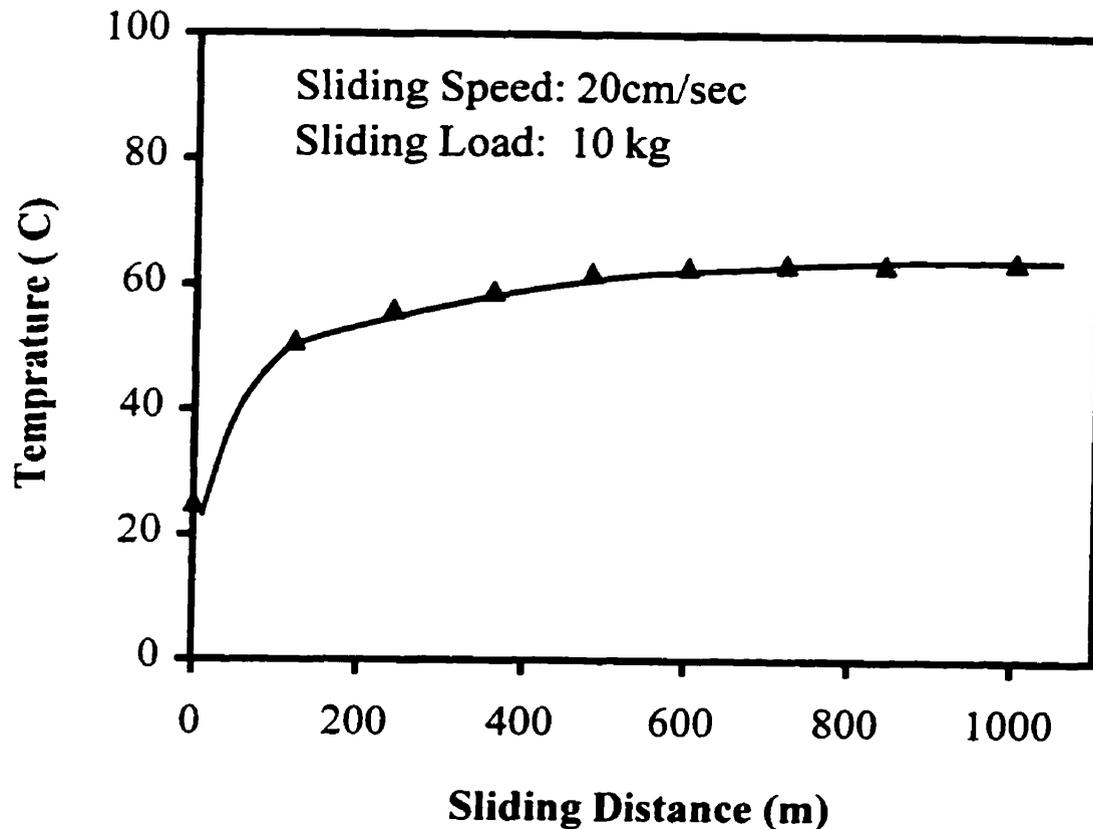
Fig. 5. 83 Average temperature on the worn surface of the Al composite as a function of sliding distance at a load of 10 kg.
