**WEAR BEHAVIOUR AND MICROSTRUCTURAL
CHARACTERIZATION OF WORN SURFACES AND
WEAR DEBRIS OF A HIGH PURITY Al AND AN Al-Si
ALLOY AND AN Al-Si/SiC_p COMPOSITE SLIDING
AGAINST AN M2 STEEL**

XIANYAO LI

DOCTOR OF PHILOSOPHY

Metallurgical Science Laboratory
Department of Mechanical and Industrial Engineering
Winnipeg, Manitoba

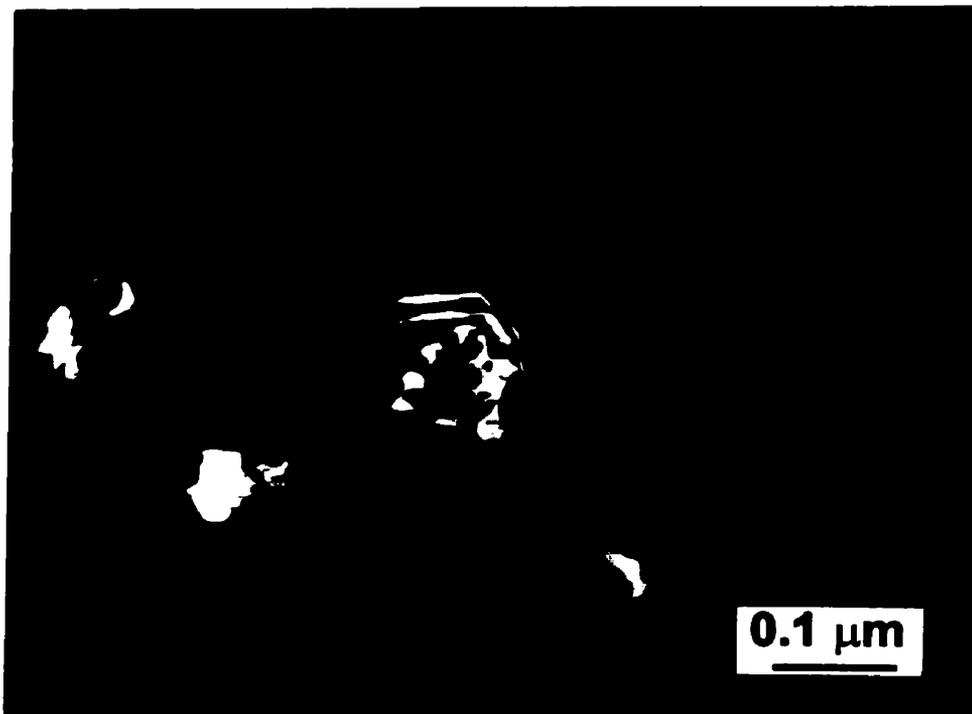
Fig. 5. 84 Recrystallized subgrains in a flake wear debris of the Al-Si alloy at a load of 10 kg. (a) Bright field, and (b) Dark field.

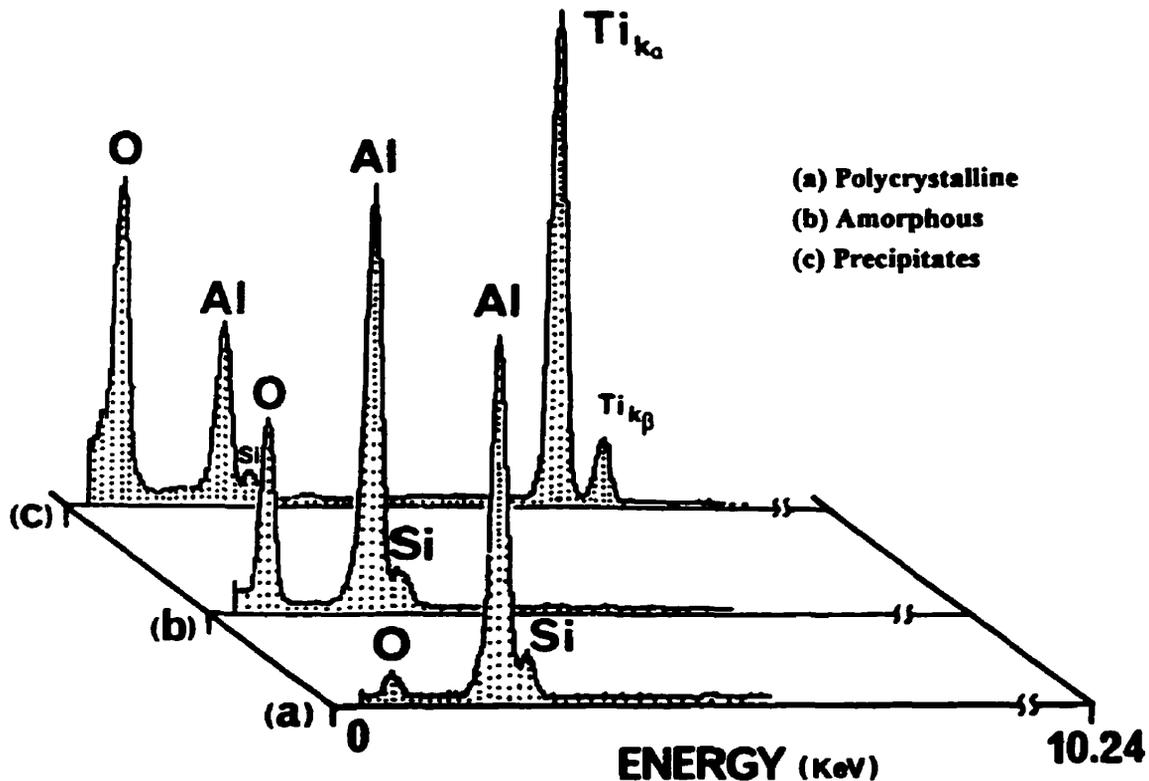
Fig. 6.4 EDS analysis of the ultrafine grained structure (a), amorphous (b) and the precipitate (c) phases in the near worn surface.

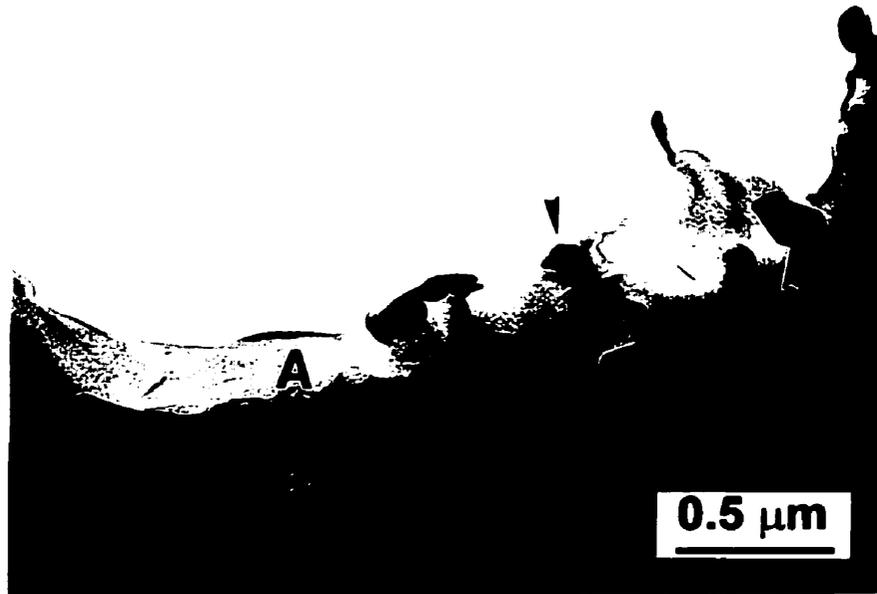
Fig. 6.11 TEM micrograph of the amorphous layer coexisting with the precipitates. Note that internal twinning occurred in some of the precipitates as indicated by arrows.

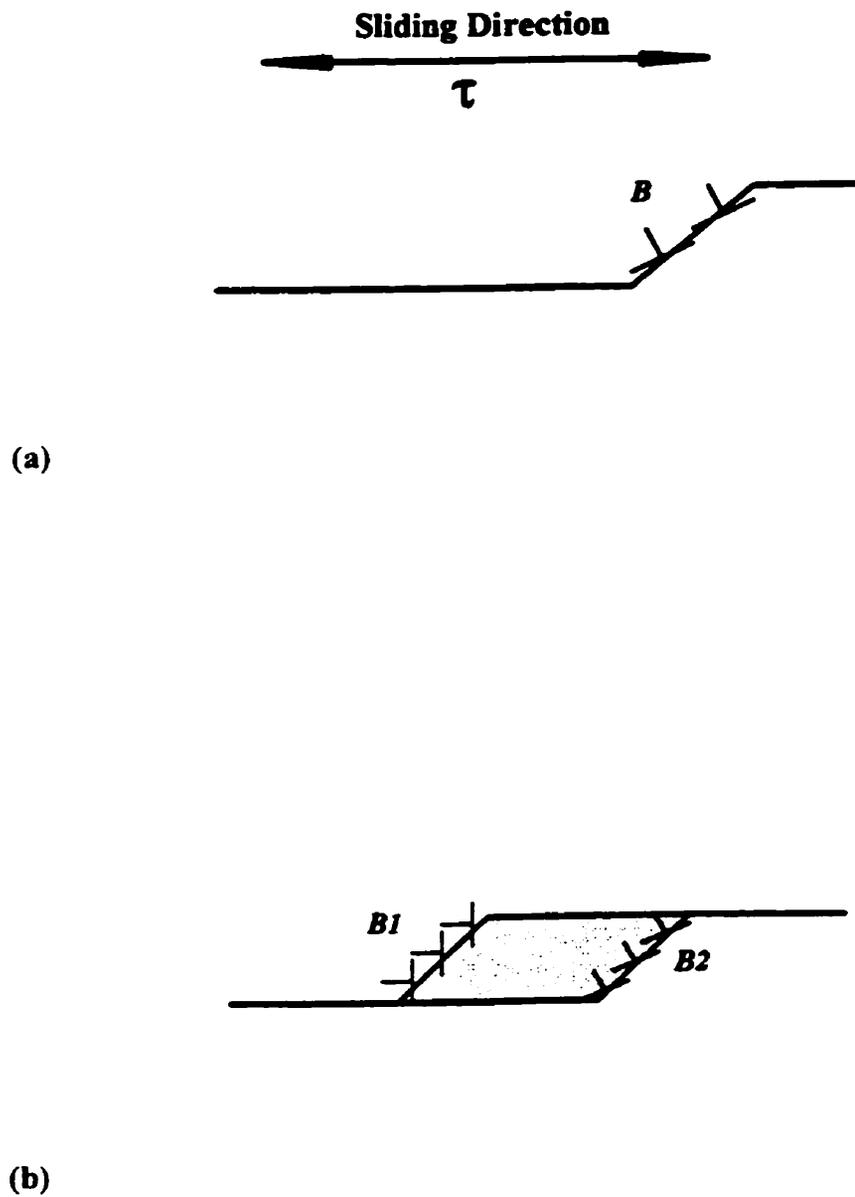
Fig. 6.15 Schematic illustration of dislocation model. Dislocation B suffers severe stress. Some of the dislocations are driven into motion, and some are immobile. A local amorphous region occurs behind the moving of the dislocations and the grain boundary migration.

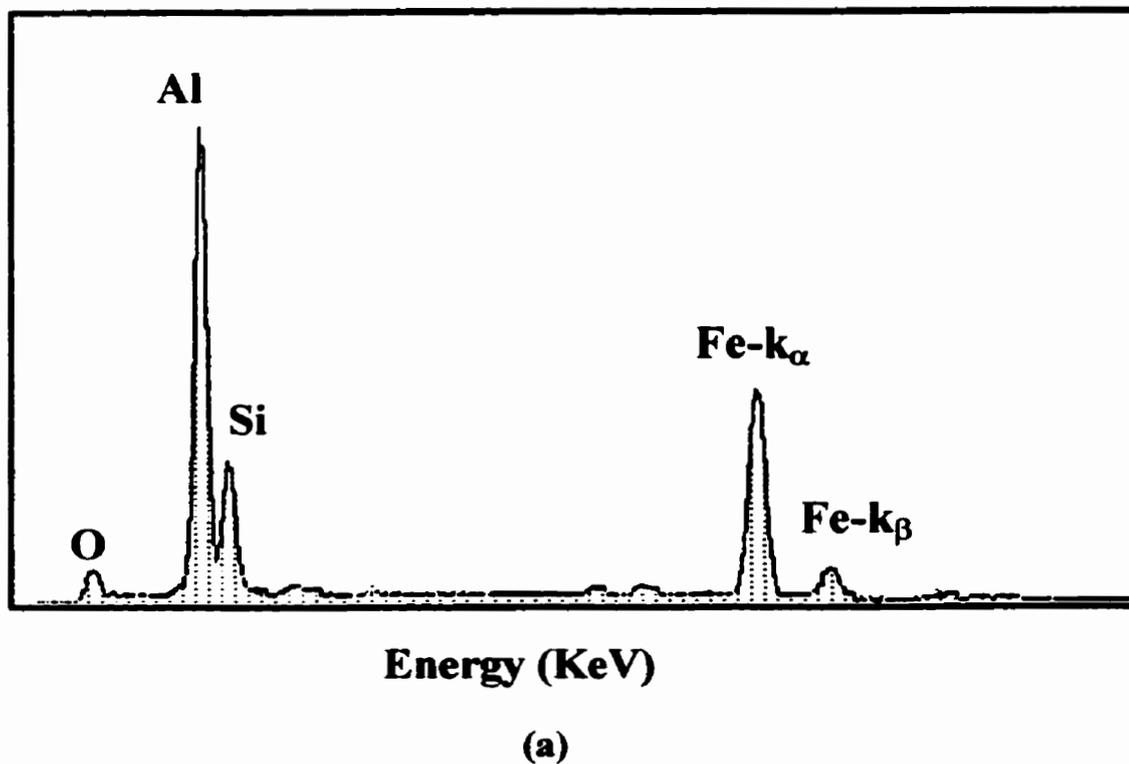
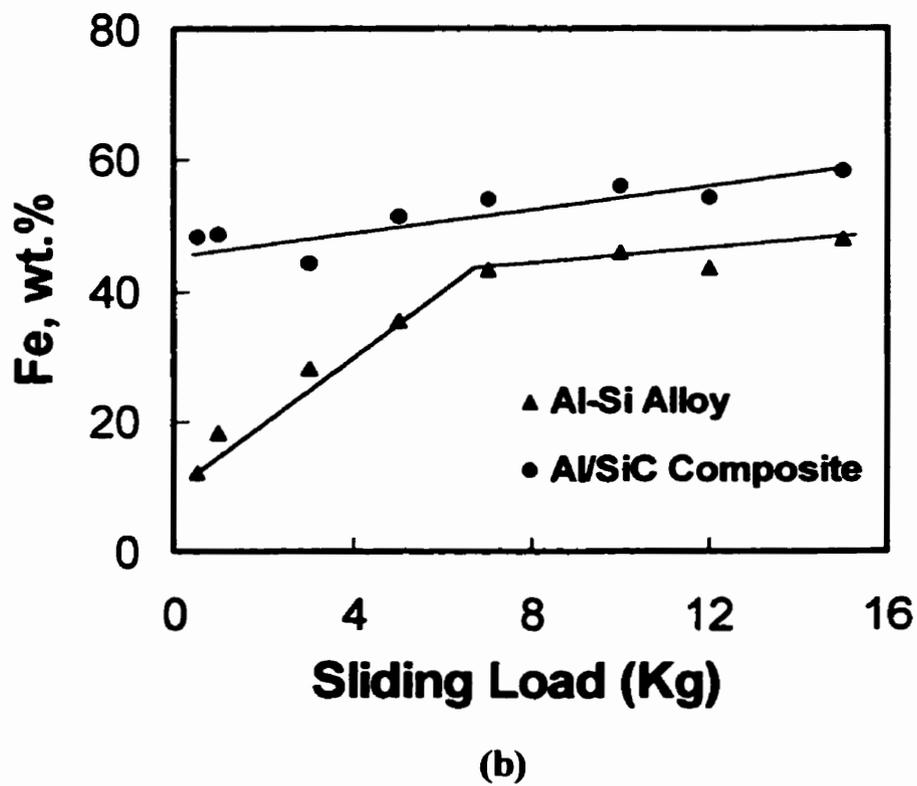
Fig. 7.5 Energy dispersive X-ray analysis of wear debris using SEM-EDS mode.
 (a) EDS spectrum of the debris, showing presence of Fe in the debris;
 (b) Mass percentage of Fe in the debris as a function of the sliding load.

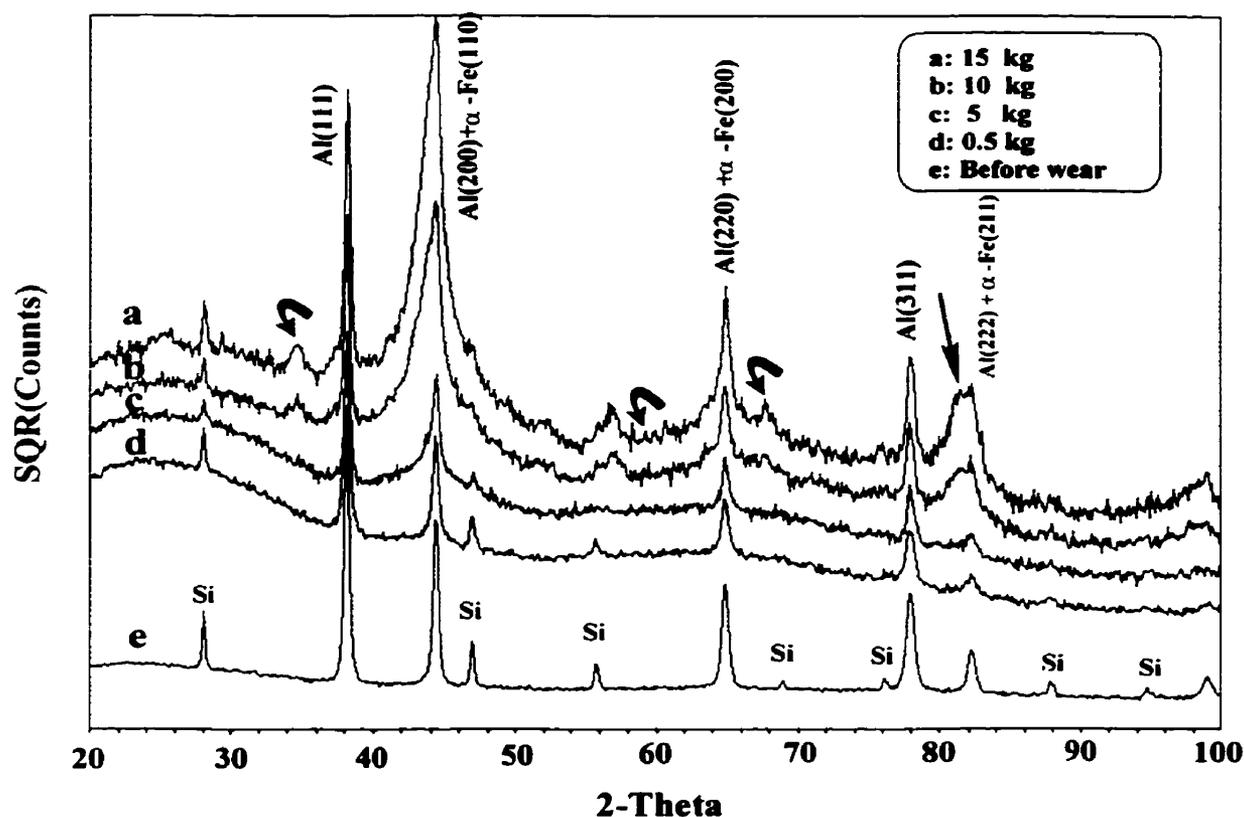
Fig. 7. 19 XRD analyses of wear debris at a variety of sliding loads and of the original Al alloy before wear. The straight arrow indicates a peak shifting away from that of the α -Al and corresponding to the FeAl phases. The curved arrows point to an aluminum oxide phase formed at high loads. Note that these oxide peaks are away from those of Si phases.

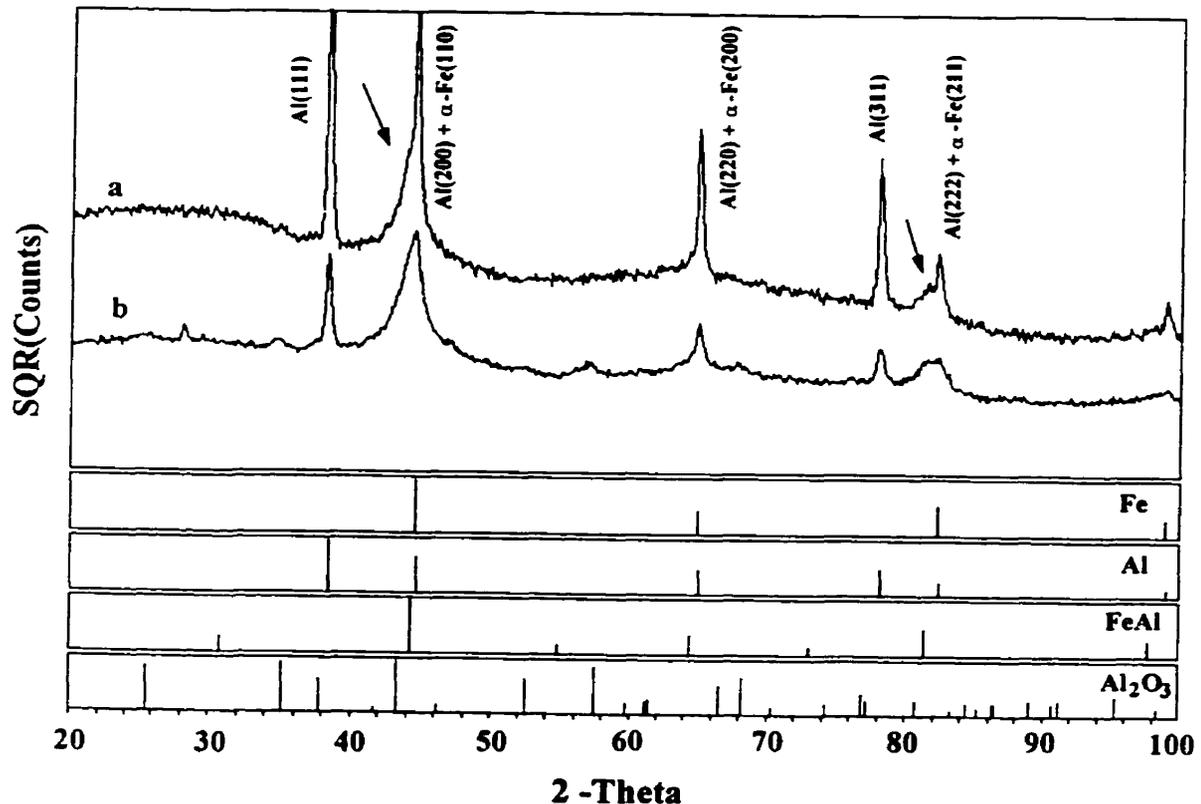
Fig. 7.20 Comparison of XRD analyses of the wear debris of the HP Al in an Ar atmosphere and the Al-Si alloy in the ambient condition. The bottom shows the standard XRD spectra (JCPDS) for different phases.

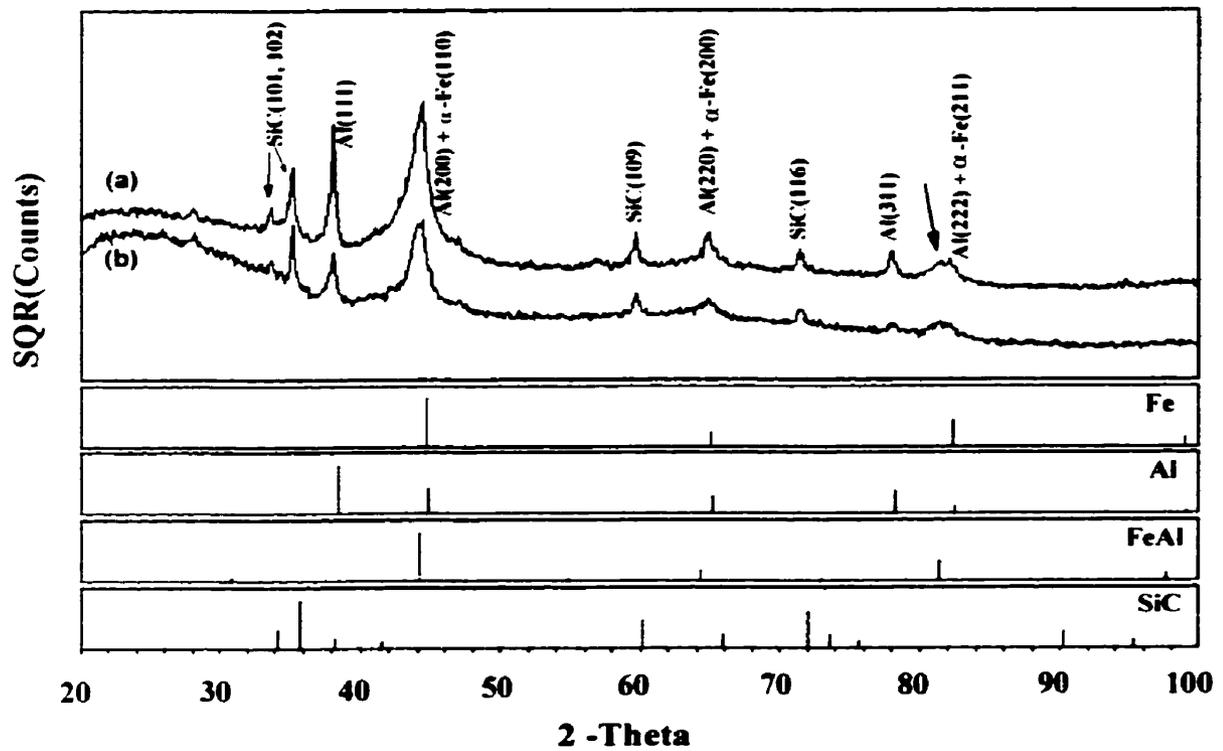
Fig. 7.22 XRD analyses of the wear debris of the Al-Si/SiC at loads of 10 kg (a) and 0.5 kg (b) in the ambient condition. The bottom shows the standard XRD spectra (JCPDS) for different phases.

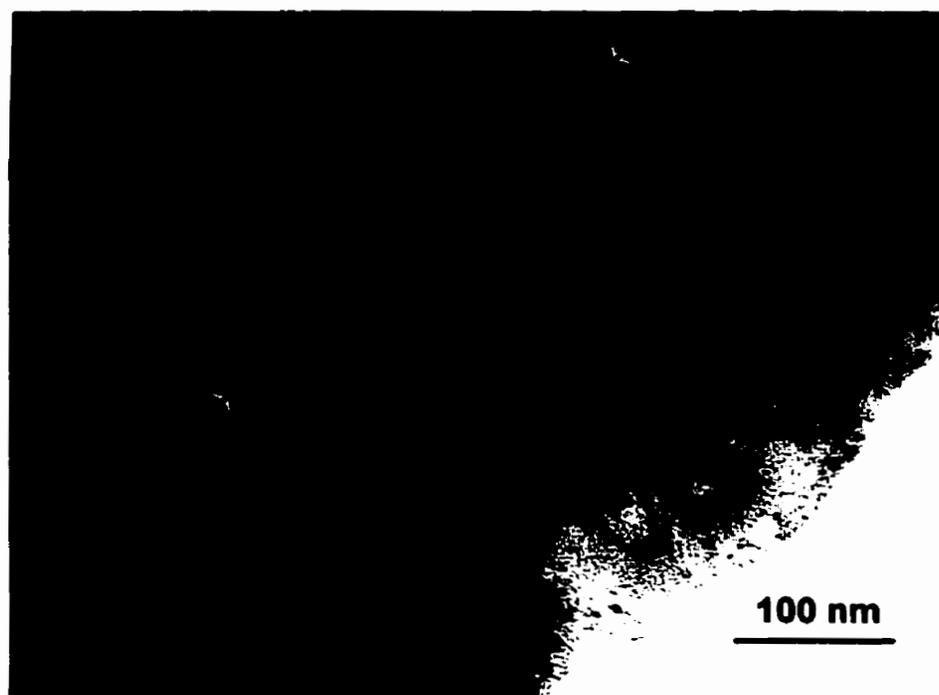
Fig. 7. 25 TEM micrographs of wear debris of Al-Si alloy at a load of 15 kg, showing nanocrystalline structures of a mixture of FeAl and Al_2O_3 . (a) At a low magnification. (b) At a high magnification. The arrows show sub-boundary between regions with different orientations of the lamella structures.

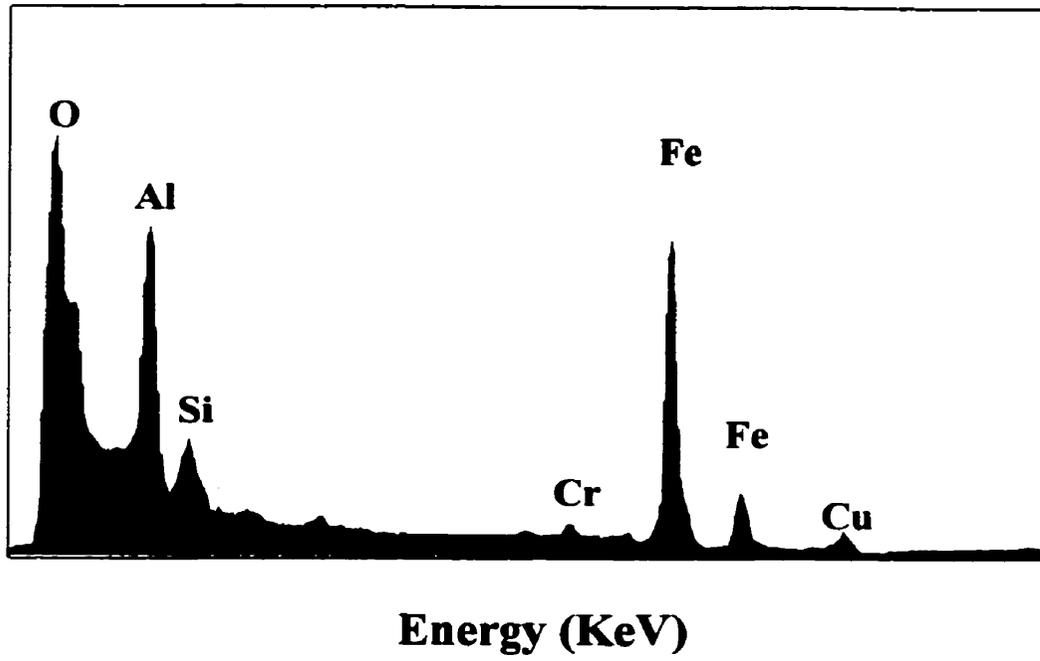
Fig. 7. 26 EDS analysis of the wear debris in Fig. 7.25, showing a considerable amount of Al, Fe and oxygen in the aggregate debris.

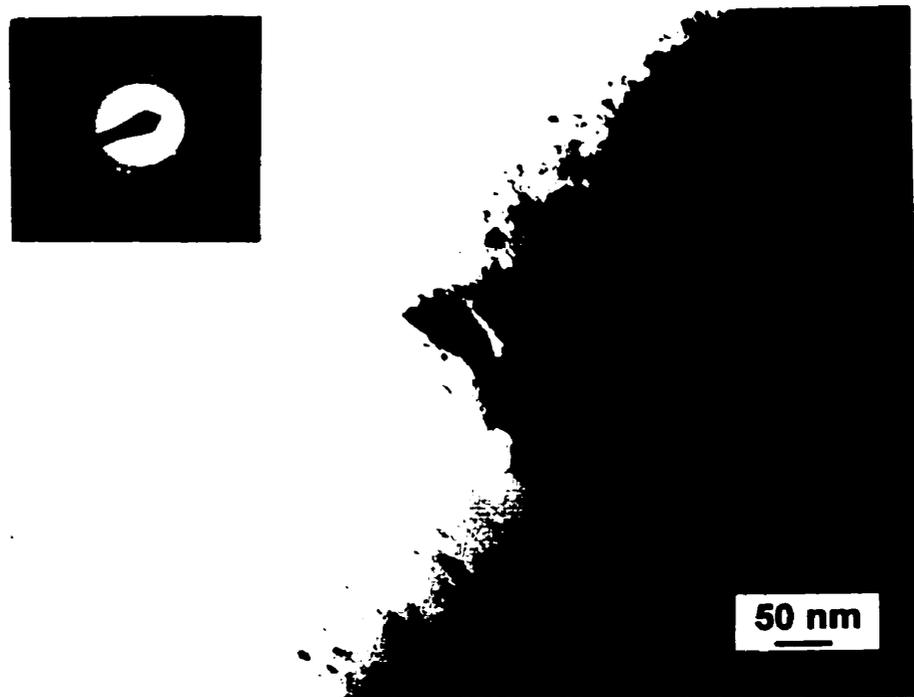
Fig. 7. 28 Partial amorphization of wear debris in the aggregates. The insert shows the electron diffraction of the partial amorphization in the debris.

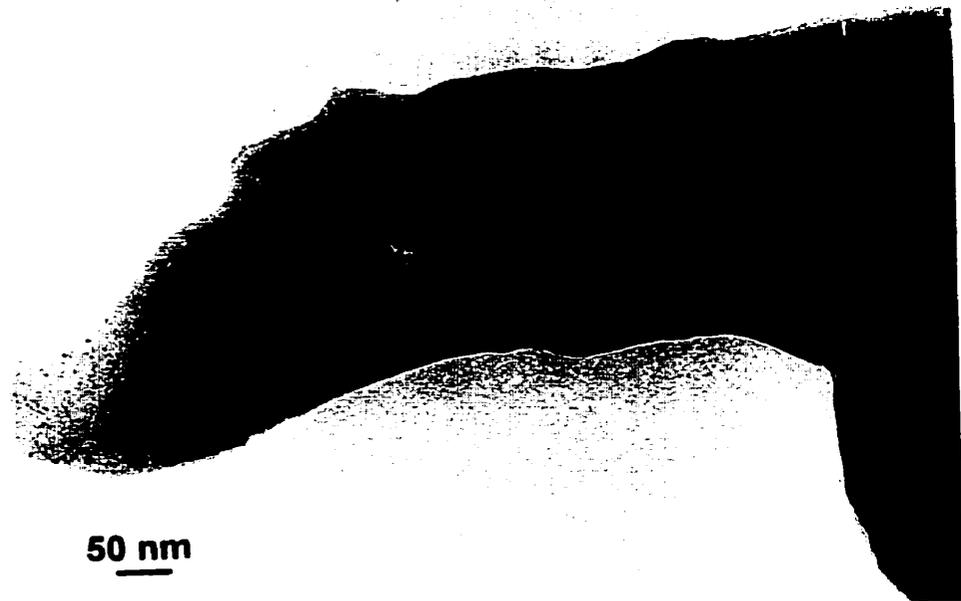
Fig. 7.31 Fragmented Si particles in a very small size were intermixed in the ultrafine grained aggregates in the wear debris of the Al alloys. Note that the Si particles were forced to orient the plastic flow in the ultrafine grained structure.

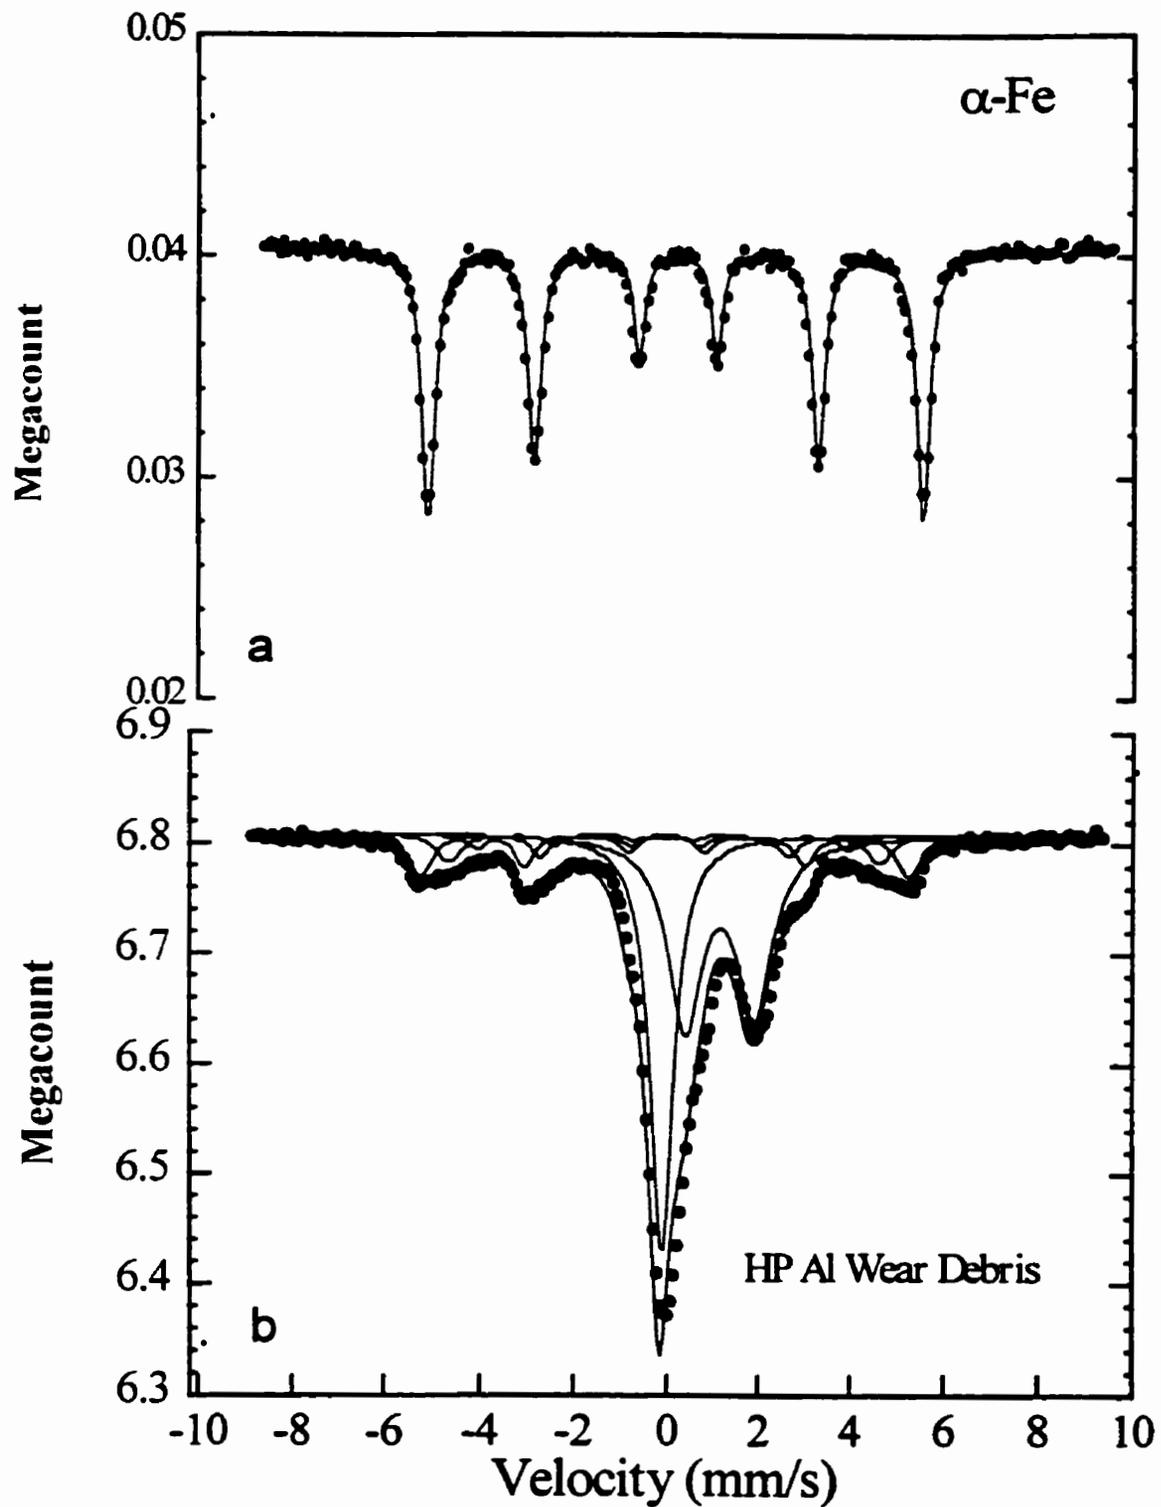
Fig. 7.33 (a) Mössbauer spectrum of α -Fe as a reference; (b) Mössbauer spectrum of the wear debris of the HP Al sliding against the steel ring at a load of 5 kg. The experimental data (dotted patterns) are fit in solid lines using least square method. The velocities are relative to α -iron.

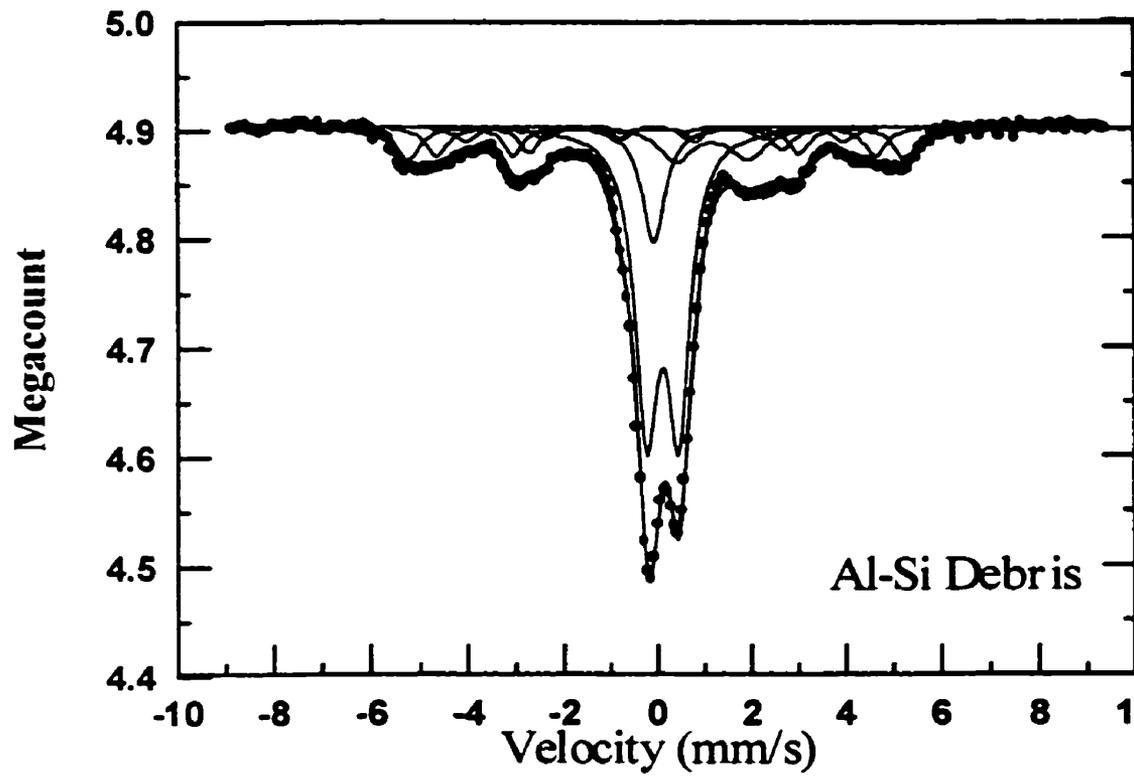
Fig. 7. 35 Mössbauer spectrum of the wear debris of the Al-Si alloy sliding against the steel ring at a load of 12 kg. The experimental data (dotted patterns) are fit in solid lines using least square method. The velocities are relative to α -iron.

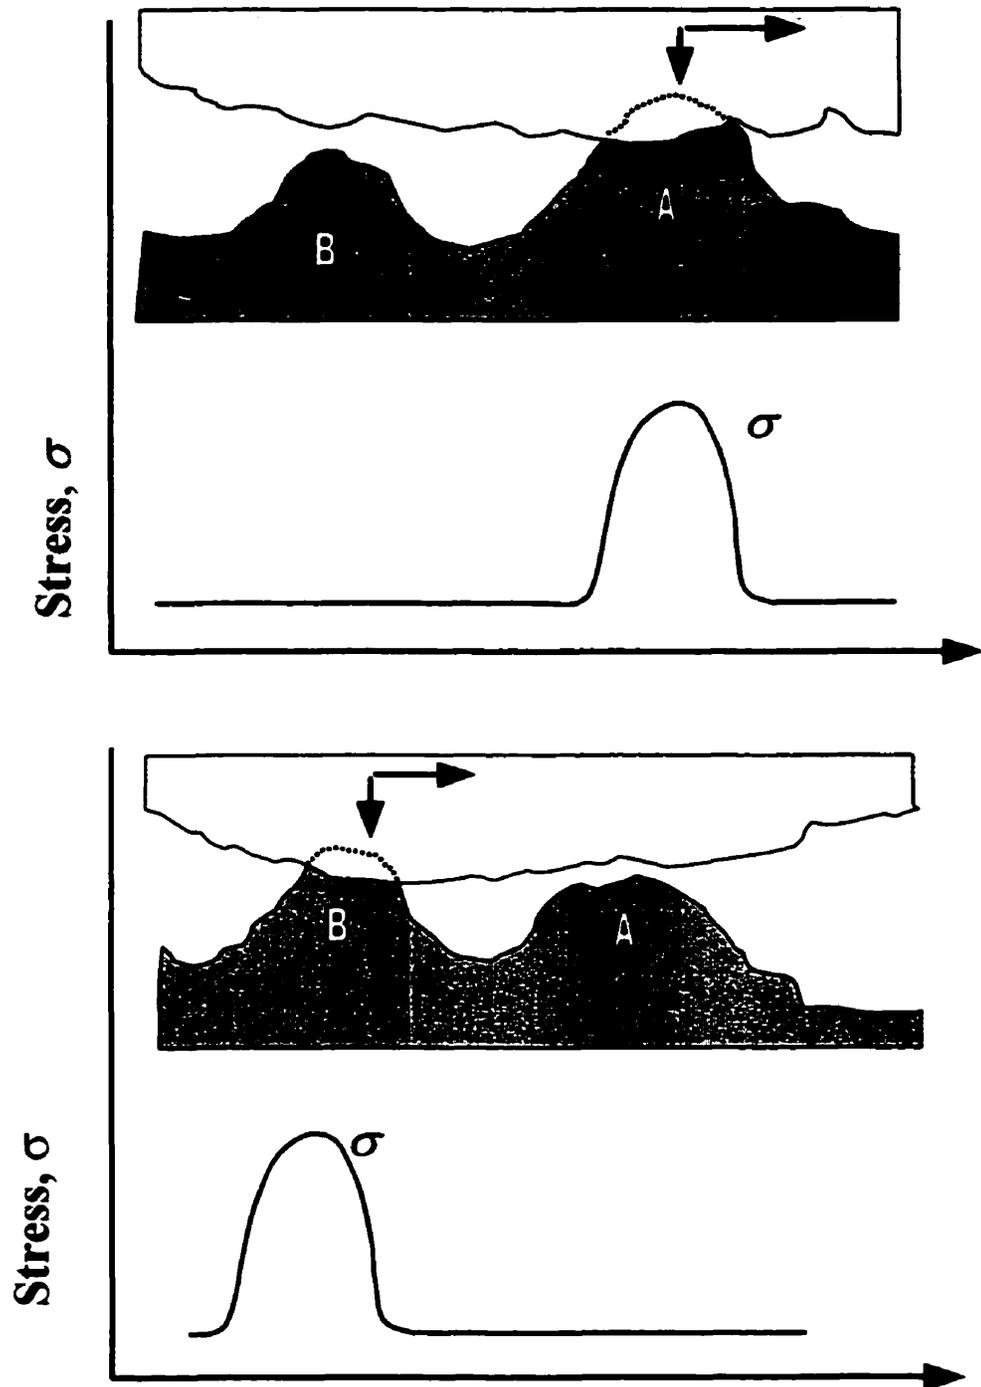
Fig. 7.36 Schematic illustration of the repeated contact and cyclic loading condition of the asperities. (a) Asperity A is loaded; (b) Asperity B is loaded while asperity A plastically deformed.

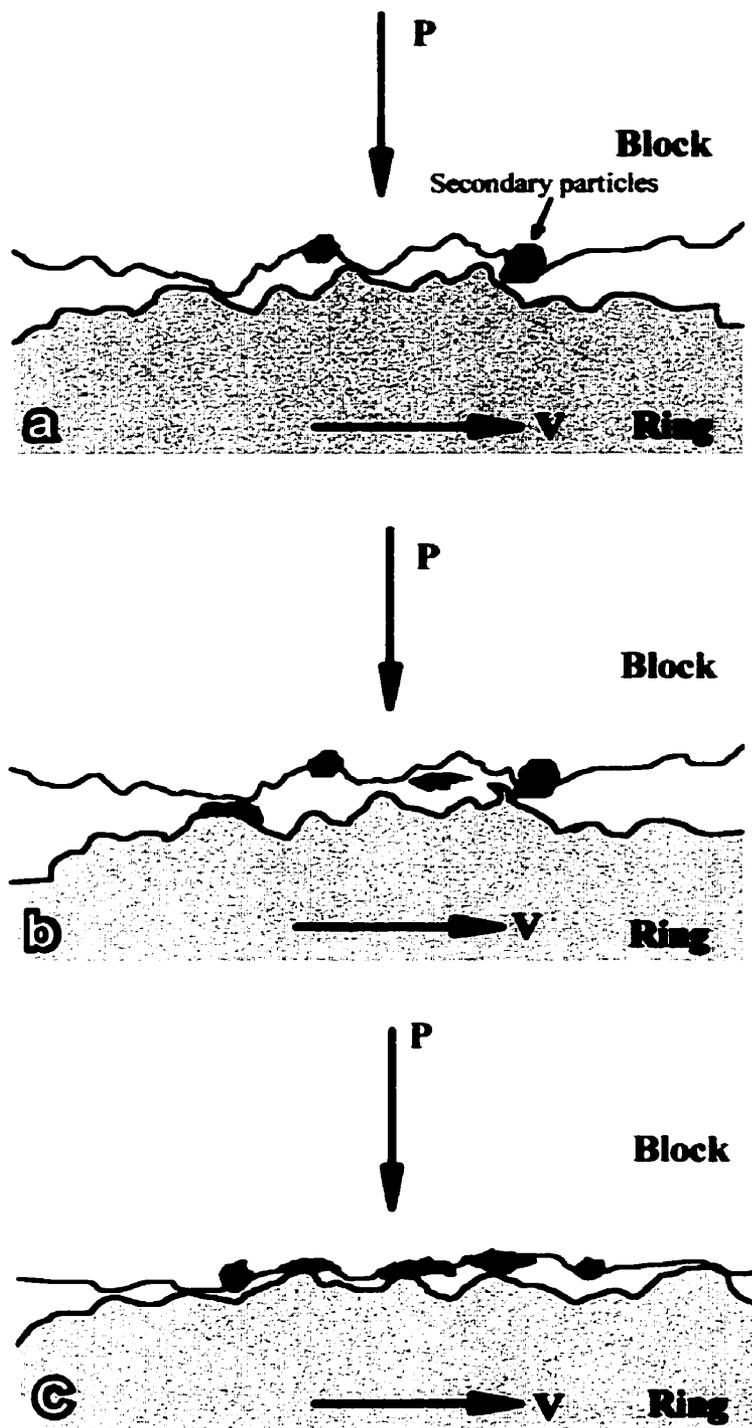
Fig. 7.38 Interaction of asperities between the sliding surfaces in a dry wear of materials containing secondary or reinforcing particles.
