LOAD BEARING SANDWICH PANELS

A THESIS
PRESENTED TO
THE FACULTY OF GRADUATE STUDIES
THE UNIVERSITY OF MANITOBA
AS A REQUISITE TO OBTAINING
THE DEGREE OF
MASTER OF SCIENCE IN ENGINEERING

BY
HARRY GEORGE RICHARD MCKAY

1970

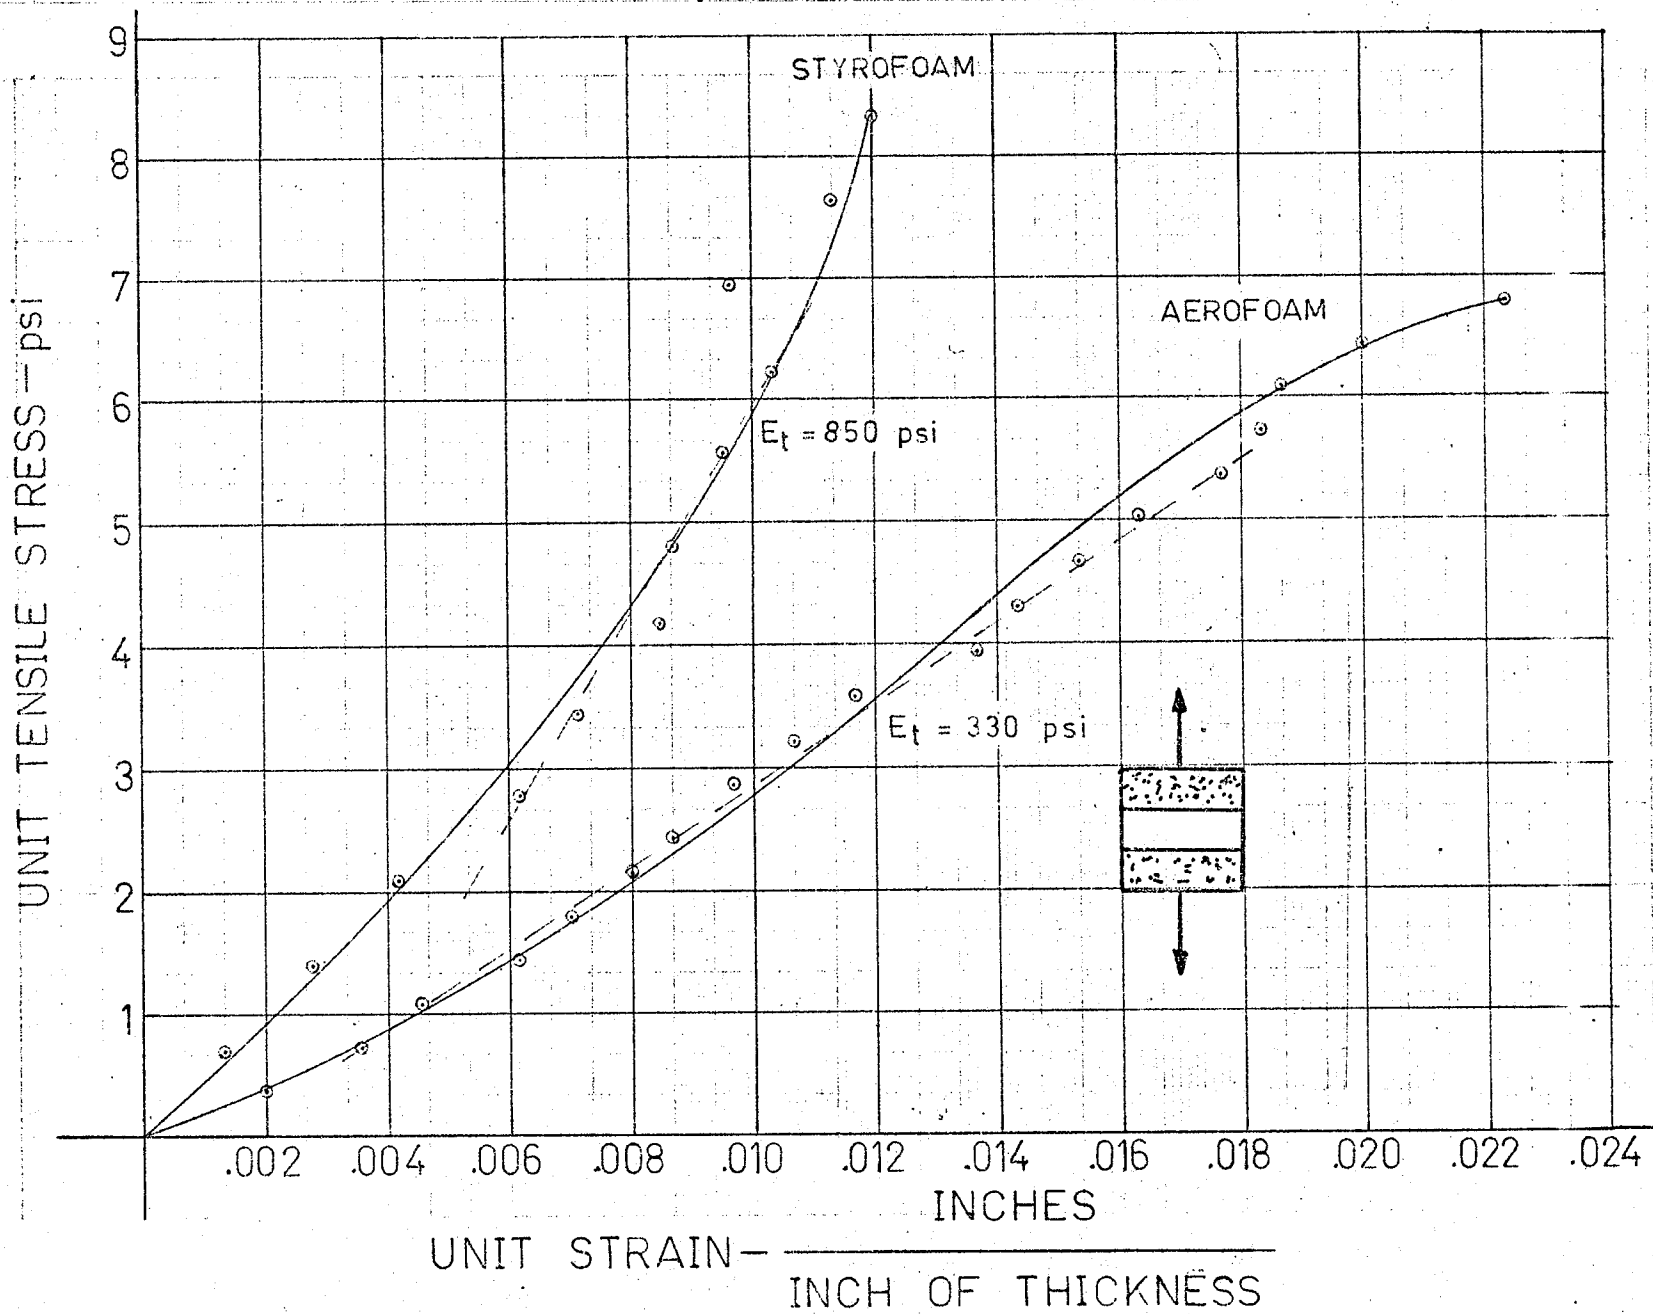
FIG 2

and tested to failure (plate 2). The results were plotted on a stress-strain curve (fig. 2).

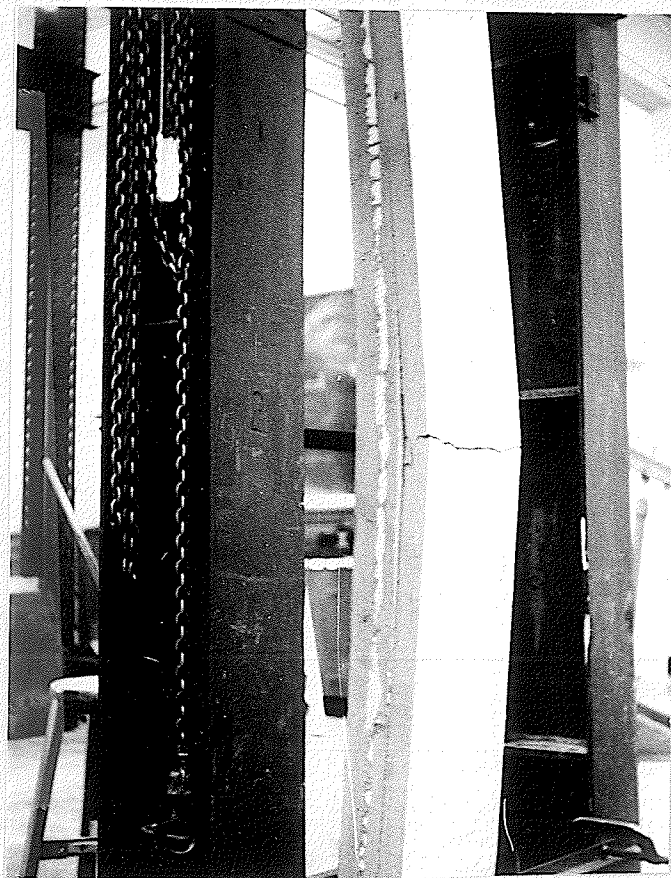
Plate No. 6. Showing panel 9 - 2 at failure.

The panel was again loaded to 52.4 kips, at which time the deflection increased very rapidly, while the load dropped off quickly. The hydraulic jack was continuously pumped to try and maintain a load of 52.4 kips, or 2.10 ksi stress, when the panel broke. A horizontal tension crack appeared 6 inches below the center of the panel immediately before failure, and the panel broke at this crack. The non-load bearing face did not crack through entirely. A separation of the "Aerofoam" and non-load bearing face from the load bearing face was visible for more than 2 feet on either side of the failure crack (plate 6).

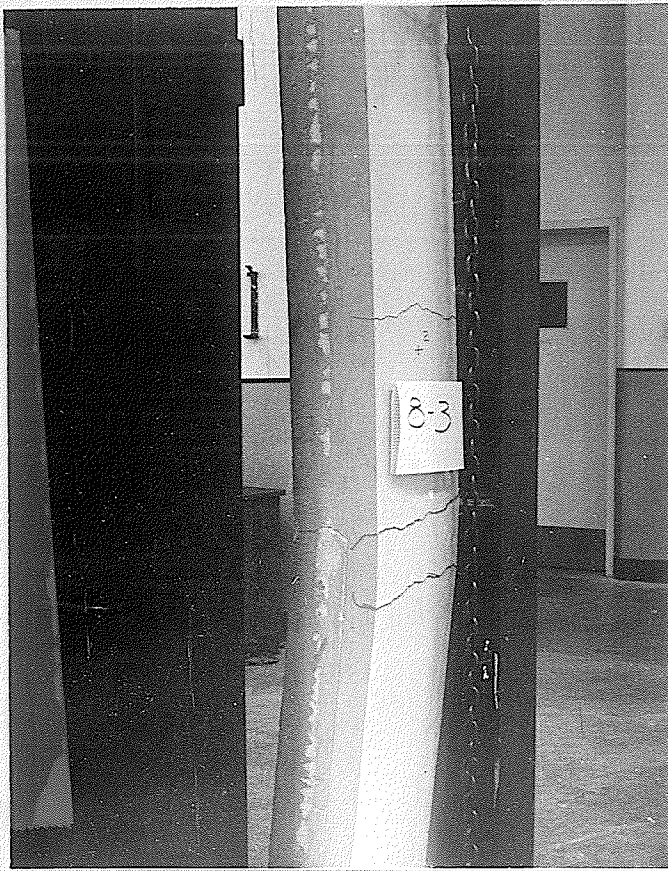
Plate No. 13. Showing panel 8 - 3 at failure.

and the load dropped off to about 26 kips in 1 minute. The load drop-off was accompanied by a gradual increase in deflection, until the panel failed at 26 kips. The failure was a combination of buckling and delamination. The panel cracked through, 10 inches below the center. There was also another tension crack on the load bearing face, 14 inches below the center. Delamination occurred on the bottom part of the panel, with the "Aerofoam" and non-bearing face separating from the load bearing face. There was no visible delamination of the upper part of the panel (plate 13).

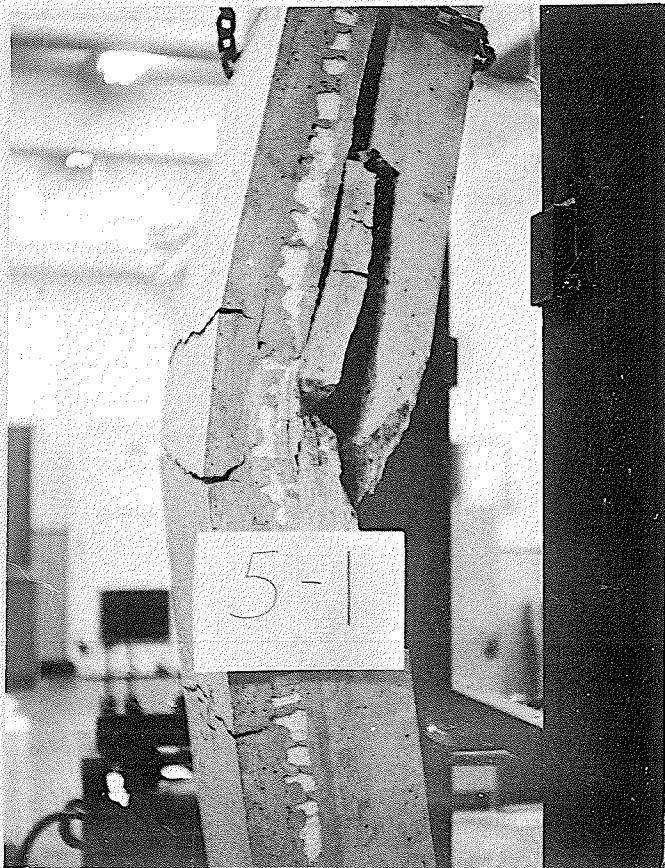
Plate No. 14. Showing panel 5 - 1₂ at failure.

Delamination of the bearing face from the
"Aerofoam" and non-bearing face occurred on the
top half of the panel only (plate 14).

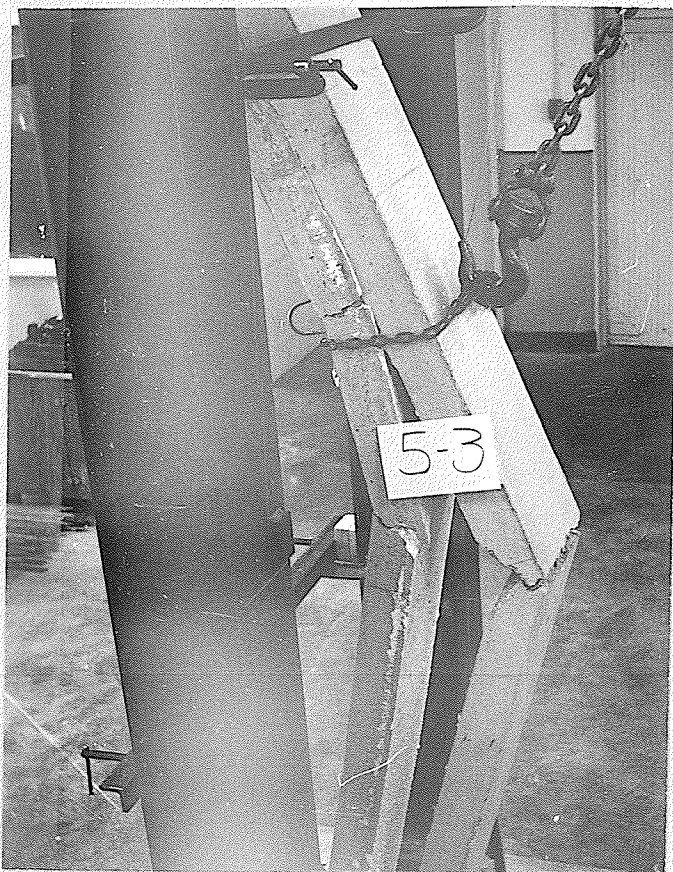
Plate No. 16. Showing panel 5 - 3 at failure.

14 inches above the center, and the other 29 inches above the center. The panel delaminated with the bearing face separating from the "Aerofoam" and non-bearing face (plate 16).

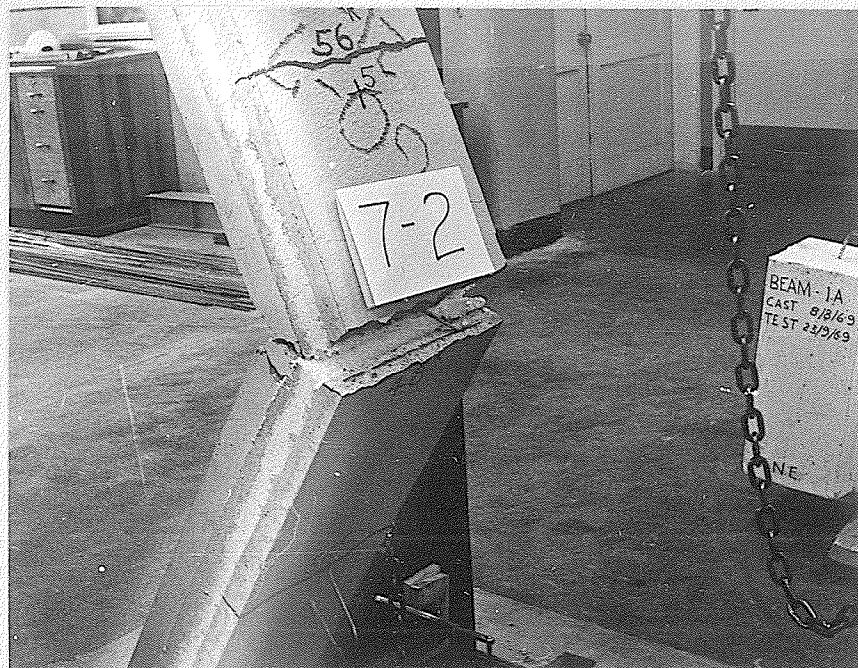
Plate No. 18. Showing panel 7 - 2 at failure.

kips and the panel failed. The panel broke completely in two at 10 inches below the center. Delamination of the bearing face from the "Aerof foam" and non-bearing face was visible on the lower part of the panel only (plate 18).

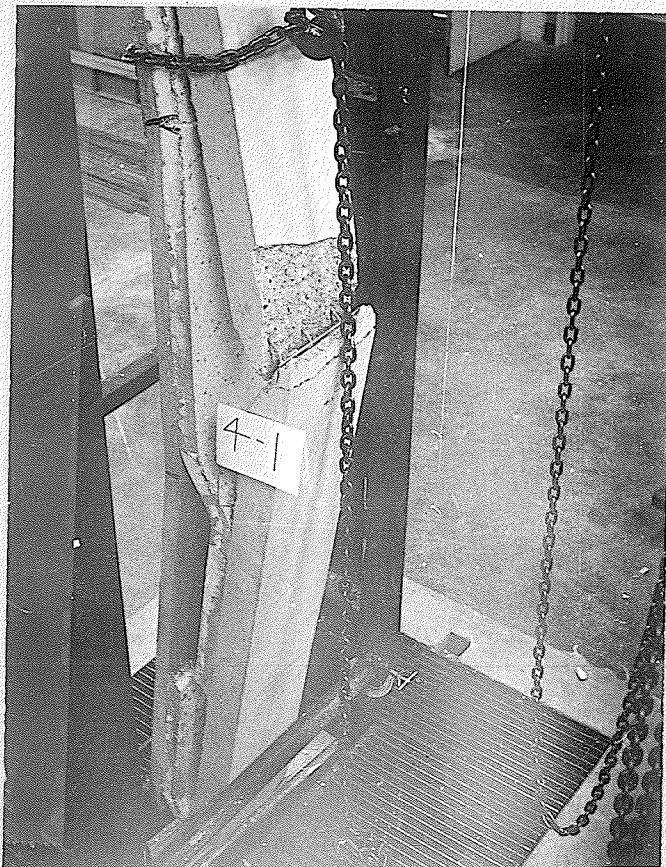
Plate No. 20. Showing panel 4 - 1 at failure.

There were two cracks on the non-bearing face— one 8 inches below the center, and the other 2 feet above the center. Total delamination had occurred. The bearing face separated from the "Aerofoam" and non-bearing face for all but 2 feet of the panel's length. The bearing face separated from the "Aerofoam" and non-bearing face for the bottom 2 feet of the panel. A joint in the "Aerofoam" occurred at this point, and for the next 2 feet the non-bearing face separated from the "Aerofoam" and load bearing face. There was then a 6 inch transition zone, where the "Aerofoam" left the bearing face and joined the non-bearing face, for the rest of the panel's length (plate 20).

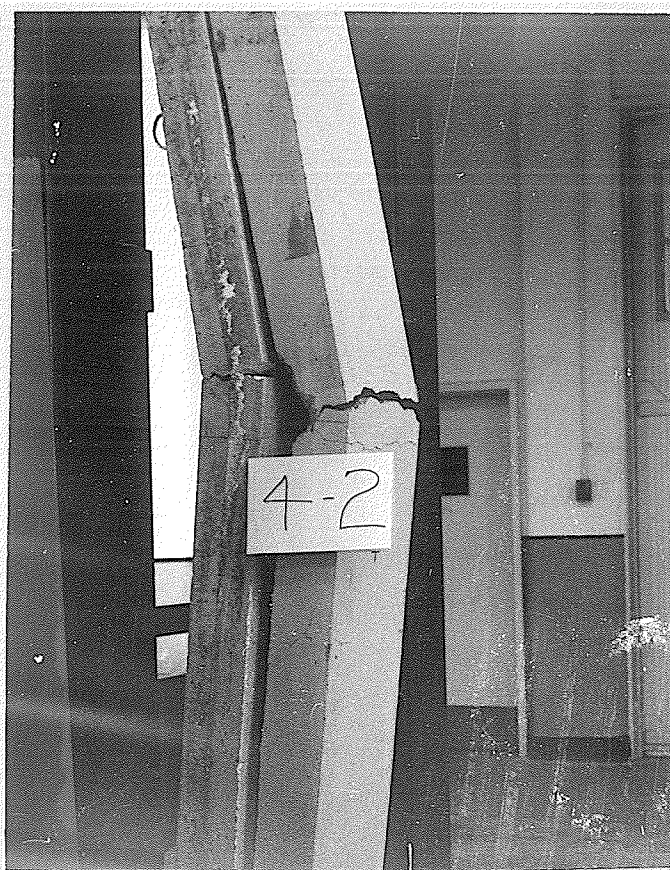
Plate No. 21. Showing panel 4 - 2 at failure.

As the load was applied the panel started to deflect outwards so that the outside surface of the load bearing face was being put into tension due to the lateral deflection. The panel was loaded to 109 kips, or 2.3 ksi stress, and allowed to stand. Delamination of the bearing face from the "Aerofoam" and non-bearing face was visible on the bottom 6 feet of the panel. The deflection was increasing at a good rate as the gauges were removed. The load dropped off continuously and read 97 kips in 10 minutes. The load continued to drop off slowly and the panel failed 5 minutes later, at a load of about 93 kips. Failure was a combination of buckling and delamination. The failure crack was 9 inches up from the center on the bearing face and 10 inches up from the center on the non-bearing face. Total delamination occurred with the bearing face separating from the "Aerofoam" and non-bearing face (plate 21).

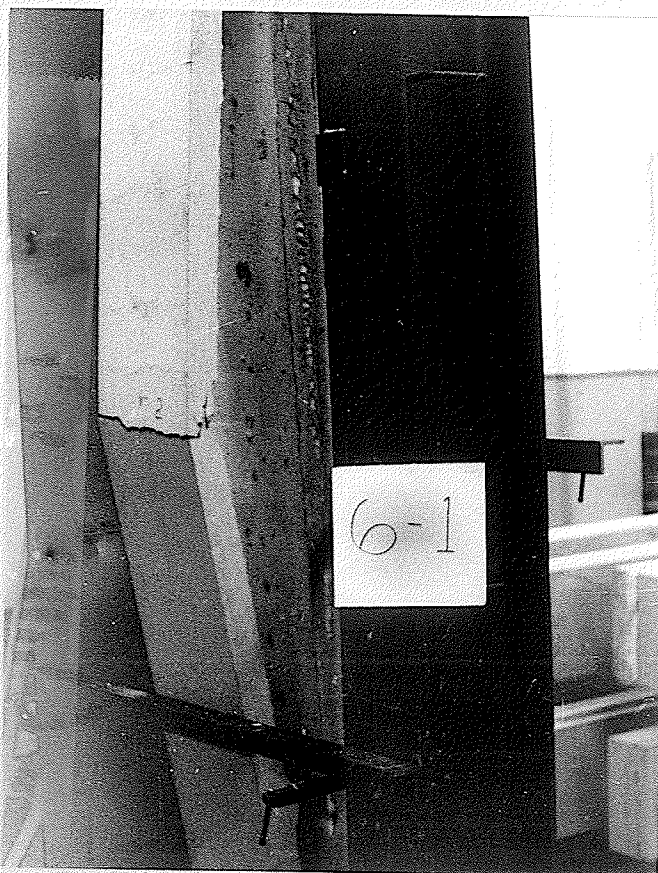
Plate No. 22. Showing panel 6 - 1 at failure.

center. There were approximately 9 cracks on the bearing face, at a distance of from 5 to 8 feet from the bottom of the panel (plate 22). The reason for the cracks on the load bearing face was a reversal in deflection that occurred near the end of the test. The gauges were removed before the panel deflected back to its original position, but by the end of the test it had most probably passed through its original position and placed the outside surface of the load bearing face into tension due to the change in direction of the lateral deflection.

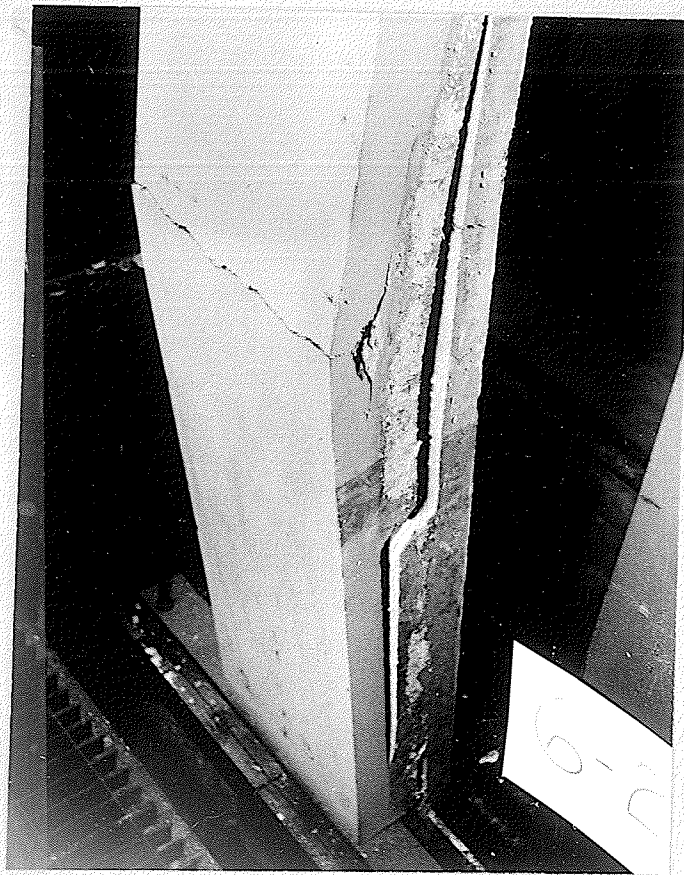
Plate No. 23. Showing panel 6 - 2 at failure.

to about 6 inches below the center. The non-bearing face separated from the "Aerofoam" and bearing face for the bottom 6 inches of the panel. The bearing face then separated from the "Aerofoam" and non-bearing face for the next 15 inches. There was a joint in the "Aerofoam" at this position and the delamination again changed back to where the non-bearing face was alone. This type of separation continued until delamination was no longer visible (plate 23).

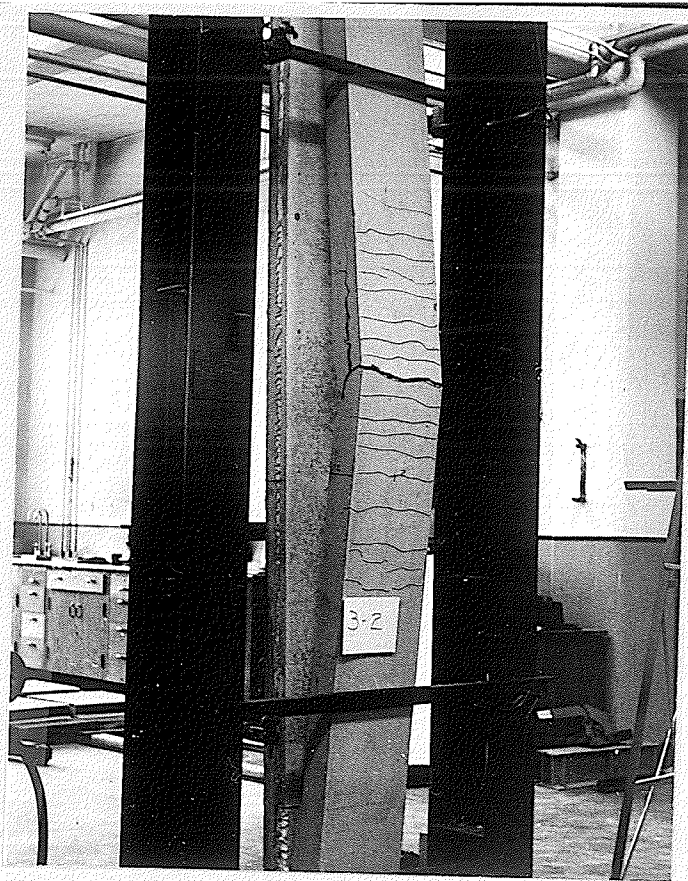
Plate No. 27. Showing panel 3 - 2 at failure.

were 18 tension cracks on the bearing face at failure. The failure crack was 10 inches above the center on the load bearing face. There were 4 cracks on the non-bearing face at 8 inches down from the center, and 4, 9, and 21 inches up from the center (plate 27).

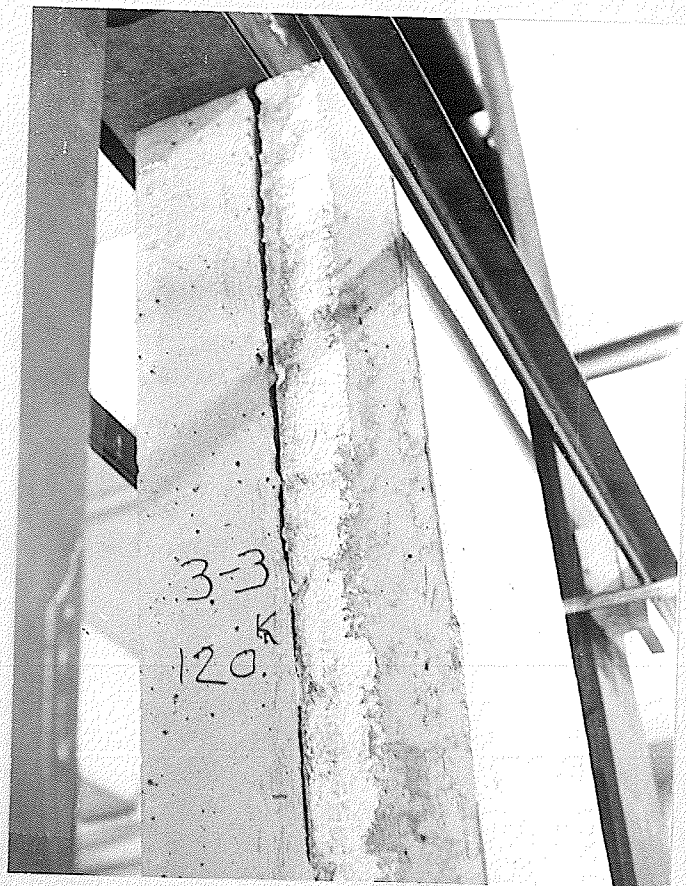
Plate No. 28. Showing panel 3 - 3 during test.

The panel had started to creep at 101 kips and the gauges were removed at 105 kips. The load was increased to 120 kips, or 2.5 ksi stress, and a picture was taken of the top part of the panel (plate 28). The load was then increased to 140.3 kips, at which load the panel failed.

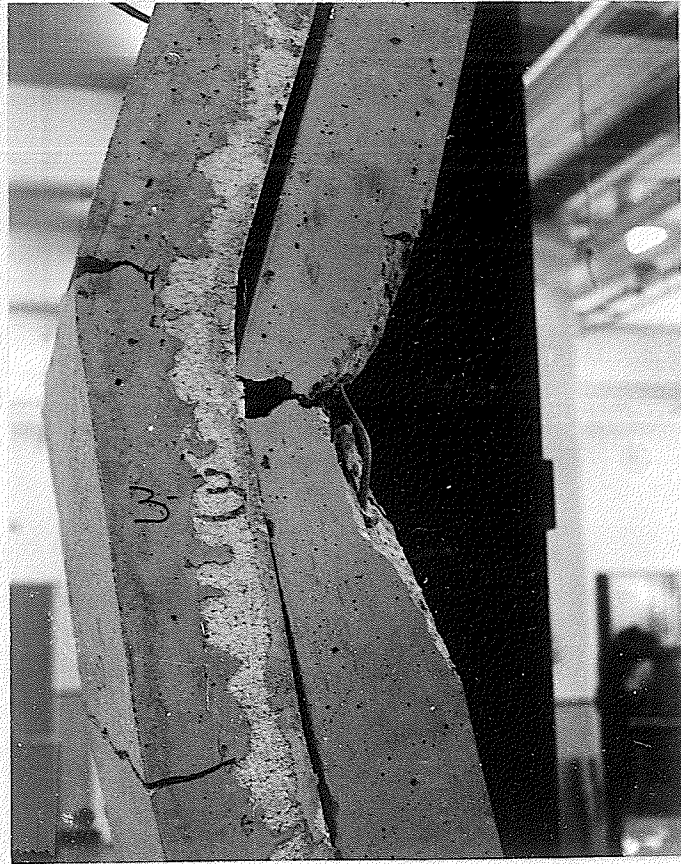
Plate No. 29. Showing panel 3 - 3 at failure.

face. The failure crack was 15 inches above center on the bearing face and 17 inches above center on the non-bearing face (plate 29).

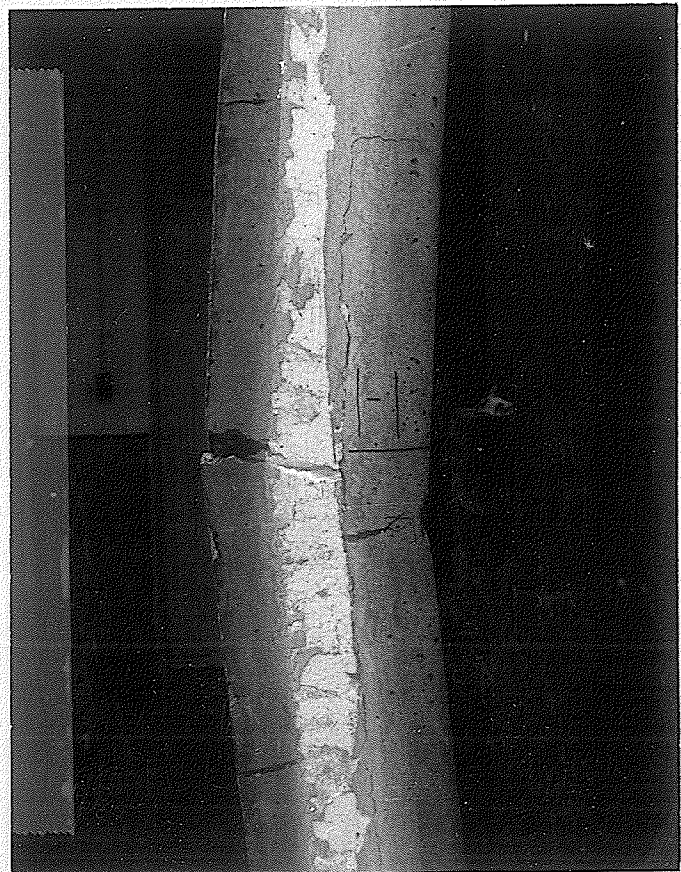
Plate No. 30. Showing panel 1 - 1 at failure.

The load had dropped to 49 kips by the end of this time. The load was then increased very quickly and the panel failed at a load of 52.4 kips. The panel buckled, with the failure crack occurring 1 inch above the center, on the non-bearing face, and right at the center on the bearing face. There was very slight visible delamination in the vicinity of the failure crack. A vertical crack ran between the bearing face and the "Aerofoam", for a distance of 1 to 2 feet on either side of the failure crack (plate 30).

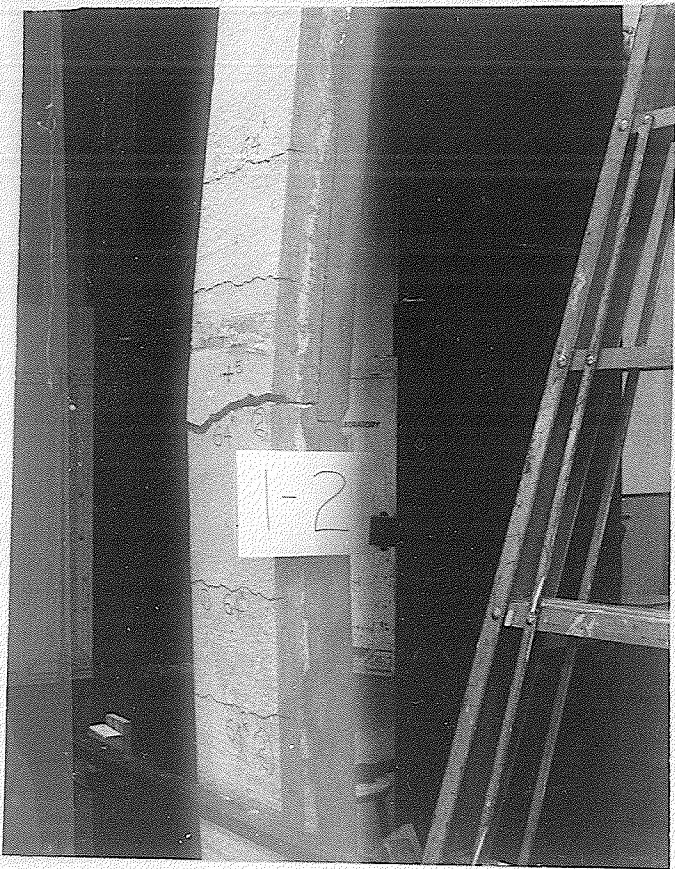
Plate No. 31. Showing panel 1 - 2 at failure.

to stand for two hours. The load dropped to 52.4 kips and the guages increased by 0.3 inches during this time. The center guages were removed. The load was increased very quickly to 60 kips and the panel failed. Failure was mostly buckling along with some visible delamination. The failure crack was 3 inches below center on the bearing face and 2 inches below center on the non-bearing face. A splitting of the bearing face from the "Aerofoam" and non-bearing face was visible for about 3 feet up from the failure crack (plate 31).
