AN INVESTIGATION OF
BLOCK-FORMED STRUCTURAL
MEMBERS

A Thesis presented
to the Faculty of Civil Engineering
The University of Manitoba

by
Richard Linton Vere Edghill
January 1971

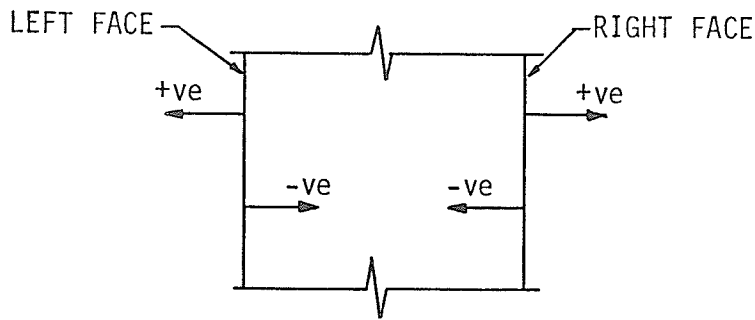
FIGURE 27: WALL SECTION GAUGE DISPLACEMENTS

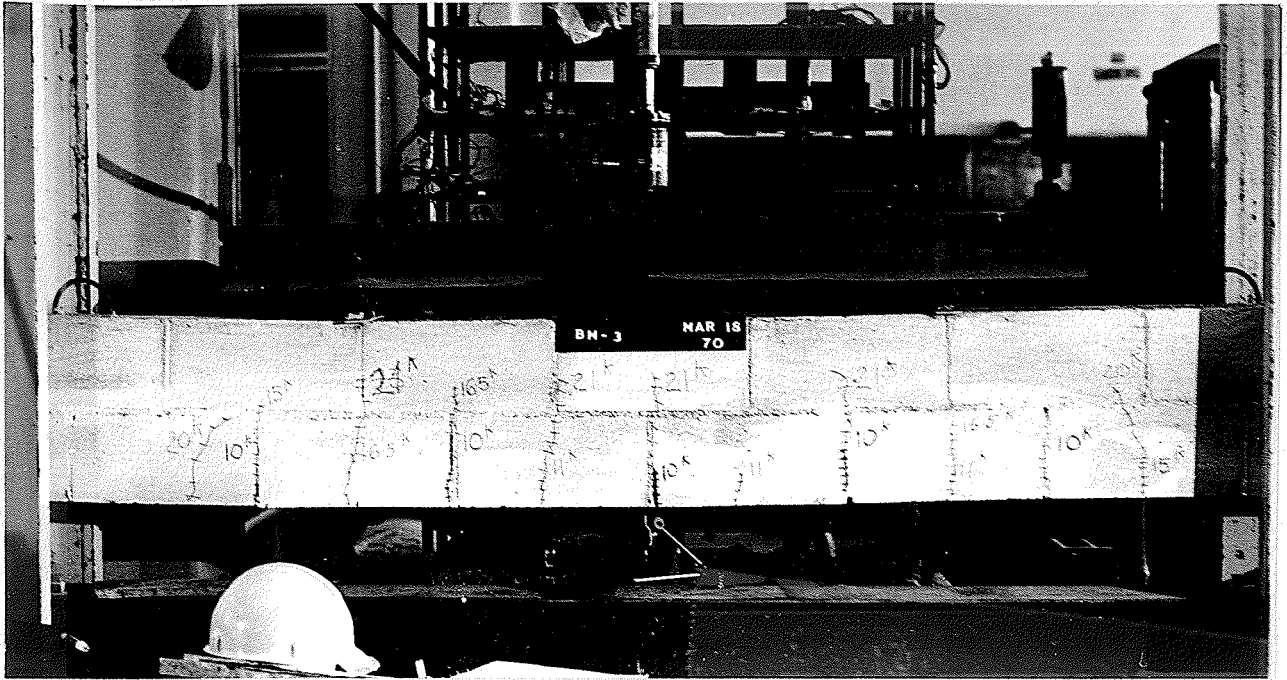
Beam #3 failed at 23.0 kips with a midspan deflection of 0.95 in. and a $P(\text{test}) / P_v(\text{calc.})$ ratio of 1.23. Beam #4 failed at 22.0 kips with a midspan deflection of 0.90 in. and a $P(\text{test}) / P_v(\text{calc.})$ ratio of 1.18.

BEAM 3 SHOWING FLEXURAL FAILURE
FIGURE 39

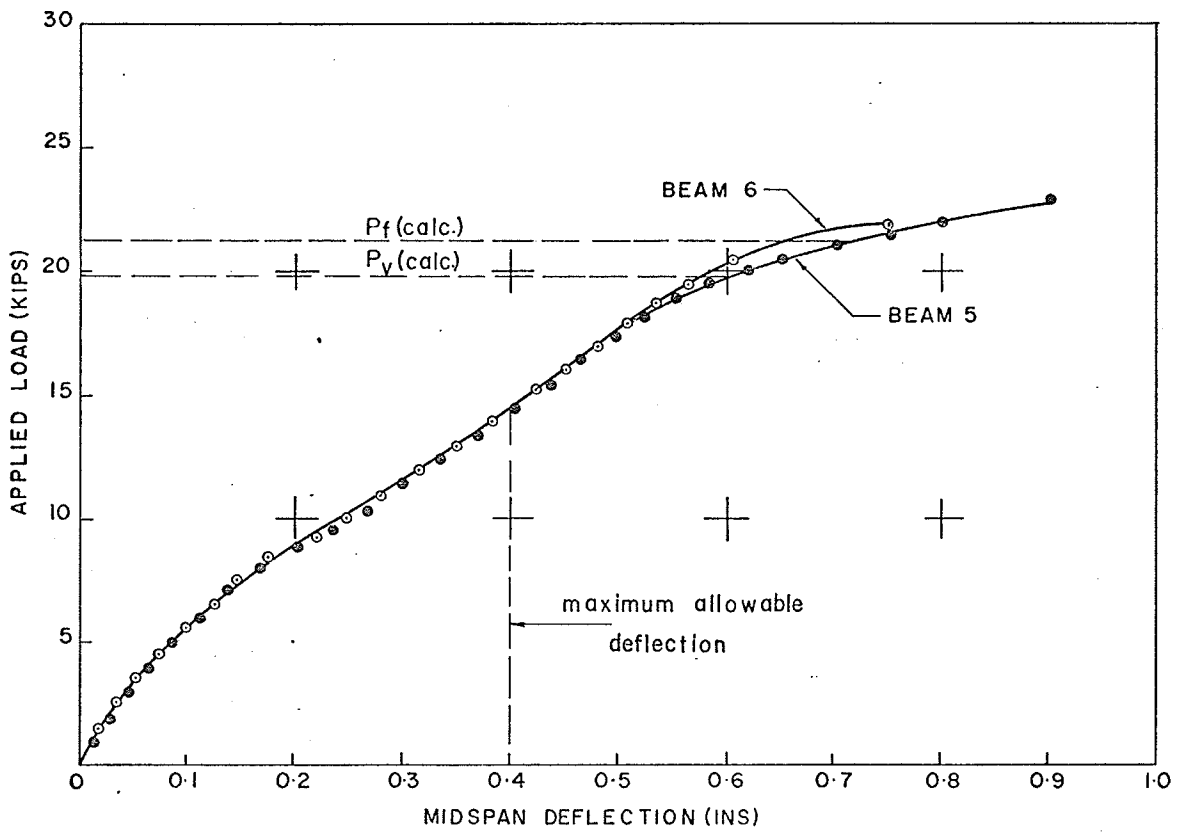
Beam properties were two courses using the U-block in upper course; 0.93% longitudinal steel; concrete strength of 2615 p.s.i. Load-deflection characteristics were similar to beams #3 and #4. The first tension cracks appeared at about 8 kips. This is denoted with a change in slope of the load-midspan deflection curve.

figure 41: details and load-deflection curves for beams 5 and 6

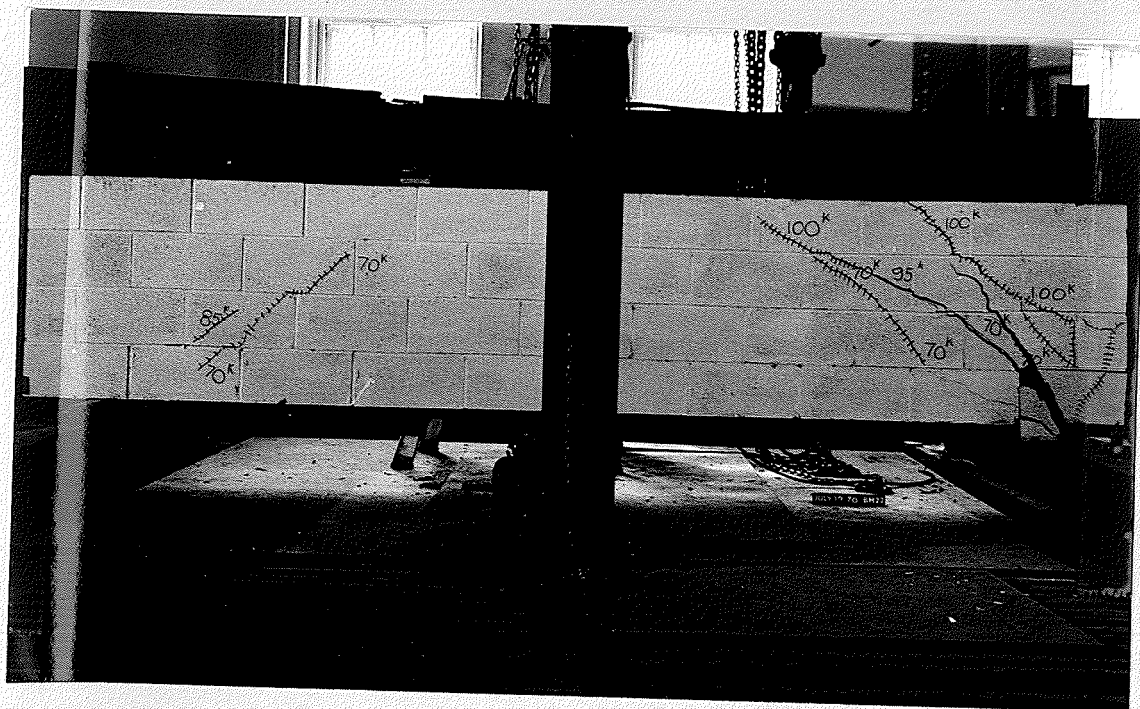
FIGURE 71

BEAM 22 SHOWING SHEAR FAILURE

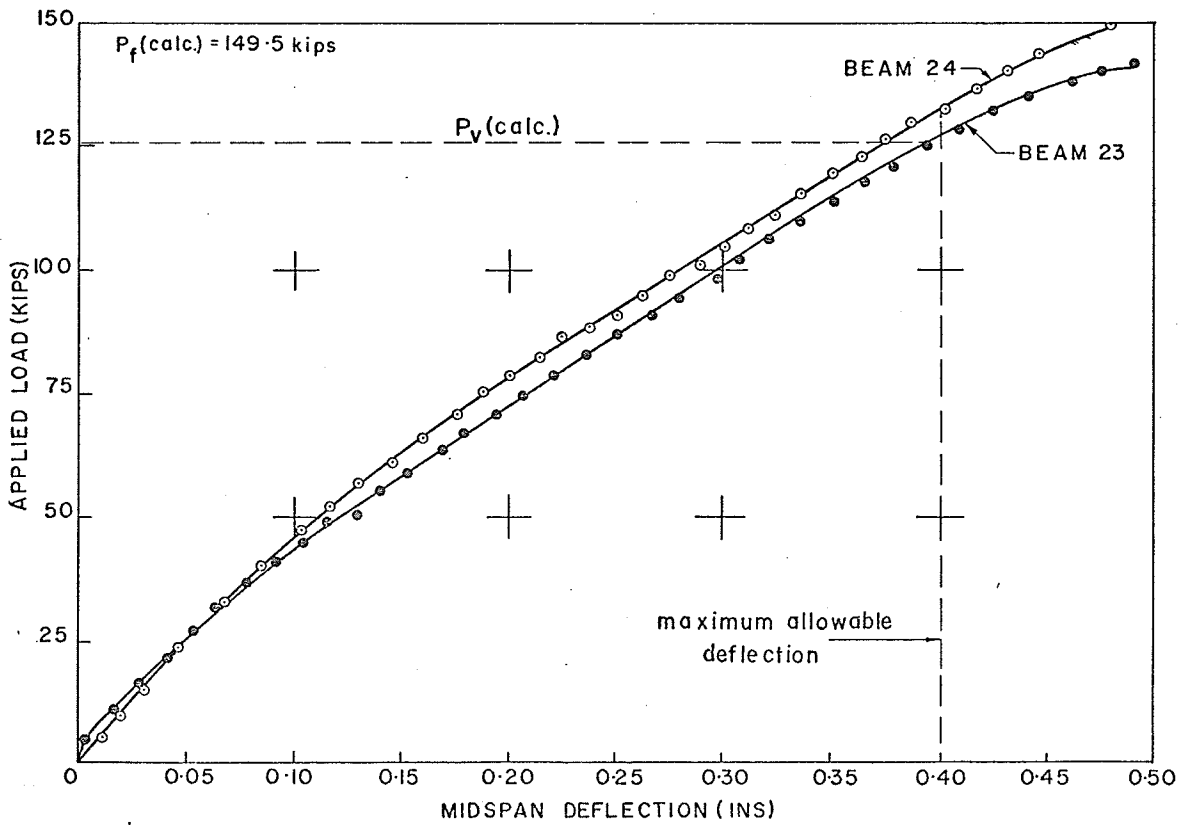
figure 74: details and load-deflection curves for beams 23 and 24

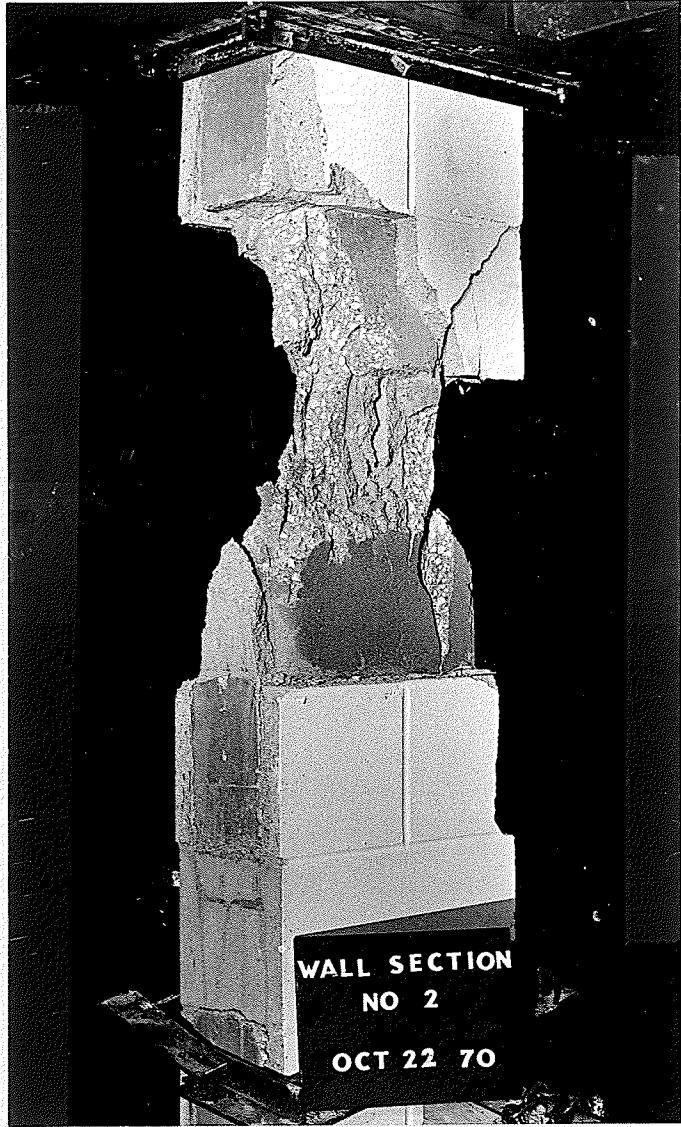
FIGURE 88

WALL SECTION 2 AT FAILURE

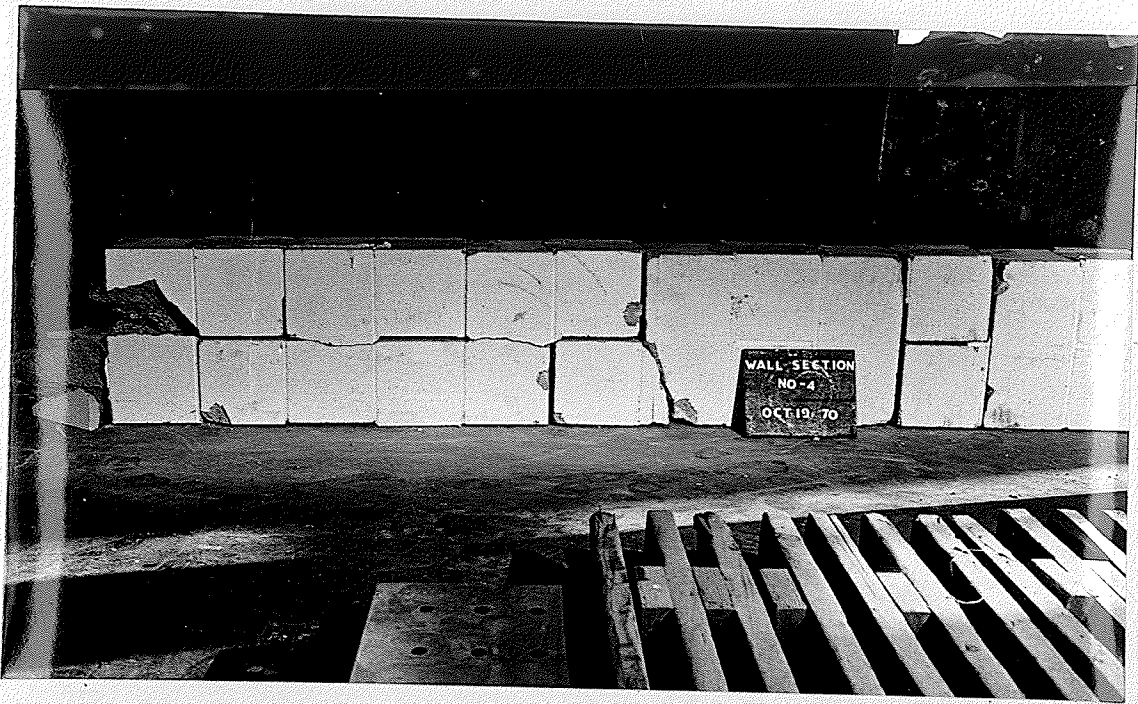
FIGURE 90

WALL SECTION 4 AT FAILURE
