A METAL CONNECTING SYSTEM  
FOR  
'BUSH-POLE' TRUSSES

A Thesis Presented To  
The Faculty of Graduate Studies  
The University of Manitoba

In Partial Fulfillment  
of the Requirement for the Degree  
Master of Science  
in  
Civil Engineering

Metal connectors, fabricated from 24-gauge galvanized sheet metal, were used in the manufacture of two, 24-foot span trusses. The full scale trusses were structurally tested and found to be capable of carrying a dead load approximately four times that which would be imposed on them in Sierra Leone.

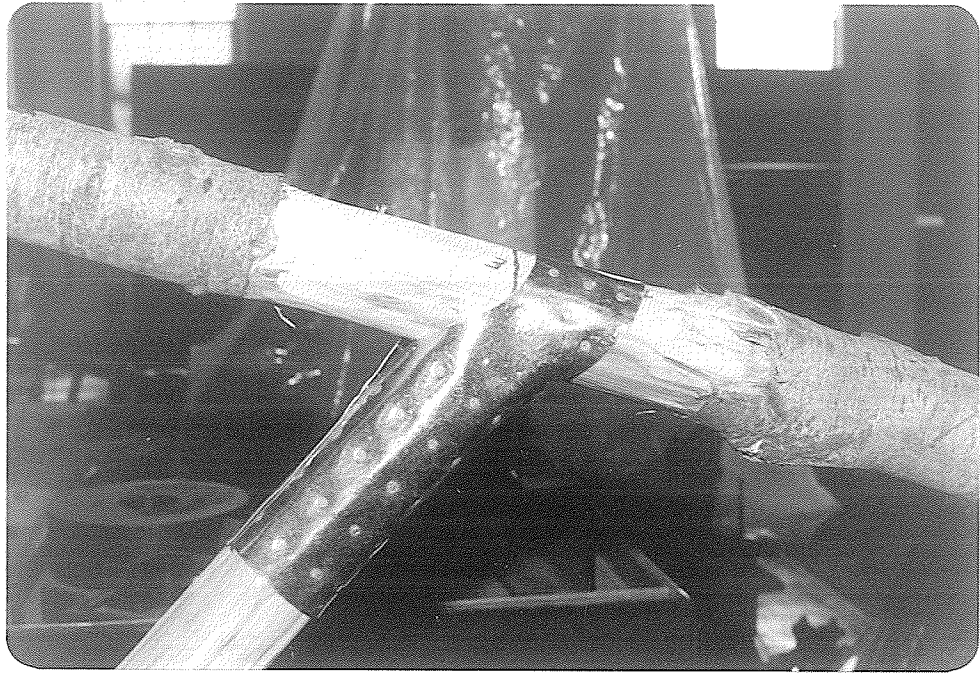
Fig. 2-3: Top Chord / Web Member Connector

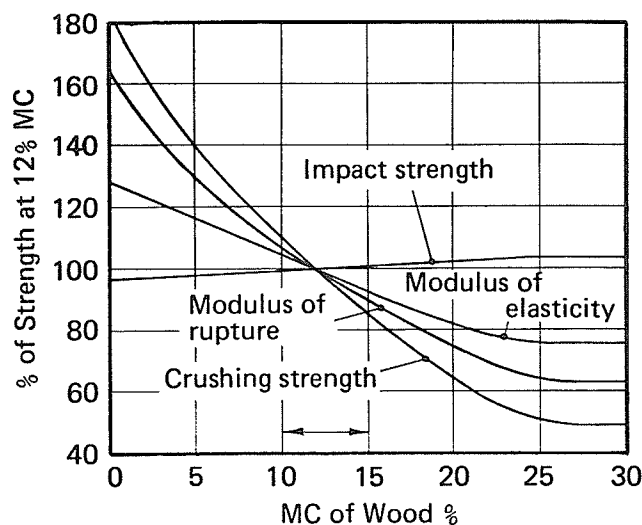
Fig. 3-3: Effect of Moisture on Strength Properties  
(source: CWC Datafile SP-1, 1987, p.5)

- Poplar has a less-consistent timber quality than one would normally expect, and tends to go rotten or 'punky' in the centre (heartwood);
- It is hard to determine or predict the integrity of the timber from the outside, (although this could be said of many species.);
- Poplar does not grow straight, therefore 'built-in' eccentricities were unavoidable. The test truss was, therefore, potentially predisposed to bending or strength reduction in these locations;
- The timber was relatively green, implying a moisture content greater than 19%. A time span of only two weeks elapsed between harvesting of poles from the bush and structural testing. The effect that moisture has on wood can be seen in Fig. 3-3.

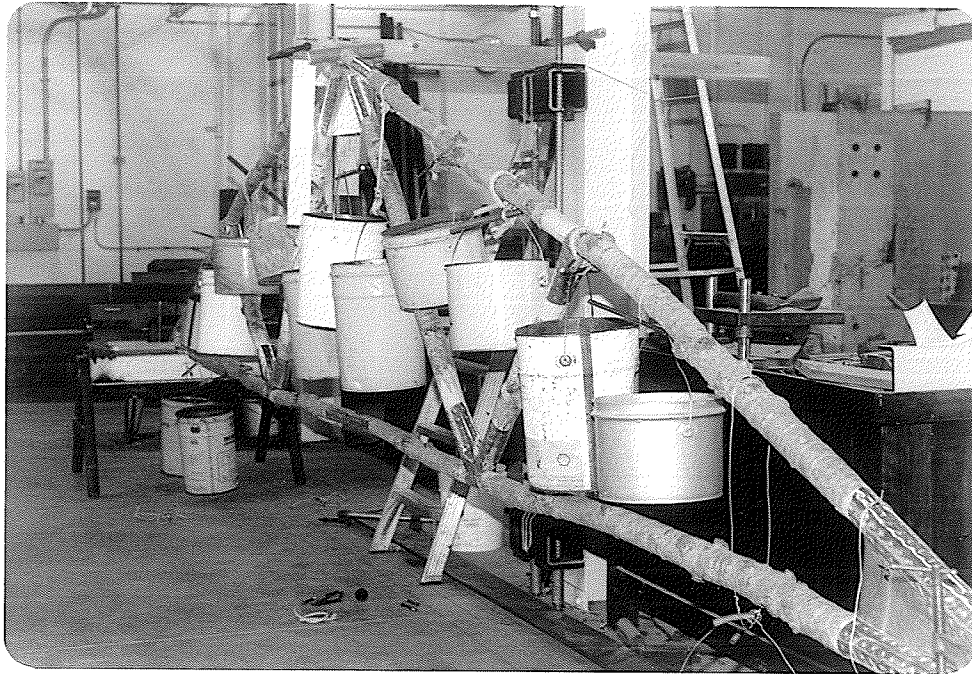
Fig.4-3: General Arrangement for Structural Testing

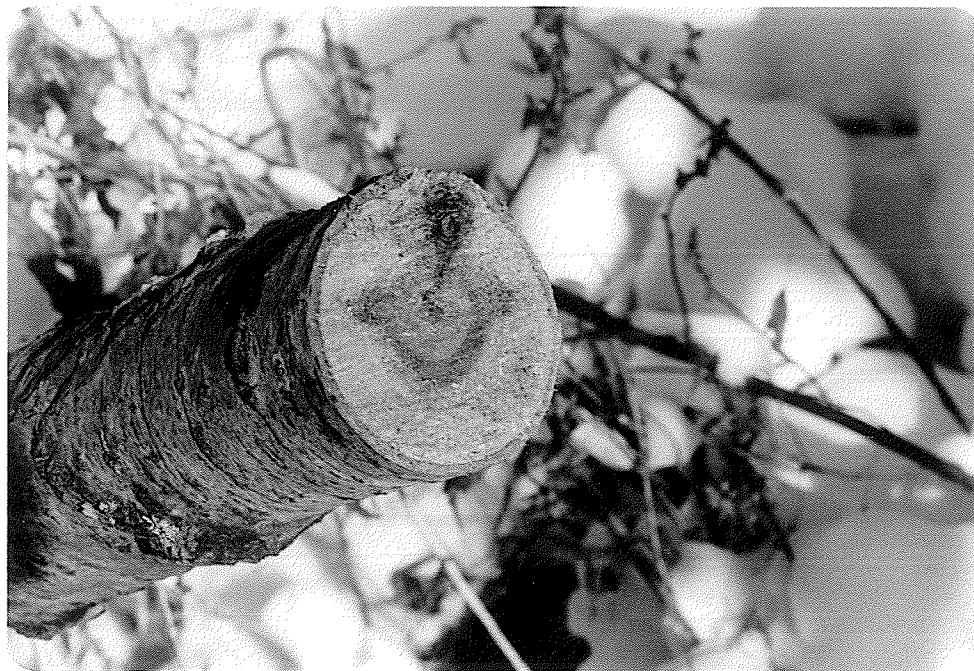
Fig. 4-8: Heartwood at Joint G - Truss T1

After the collapse of the truss, photographs were taken of the failed timber for future reference. The section of the truss around panel point G was cut out and kept for further examination and photographs.

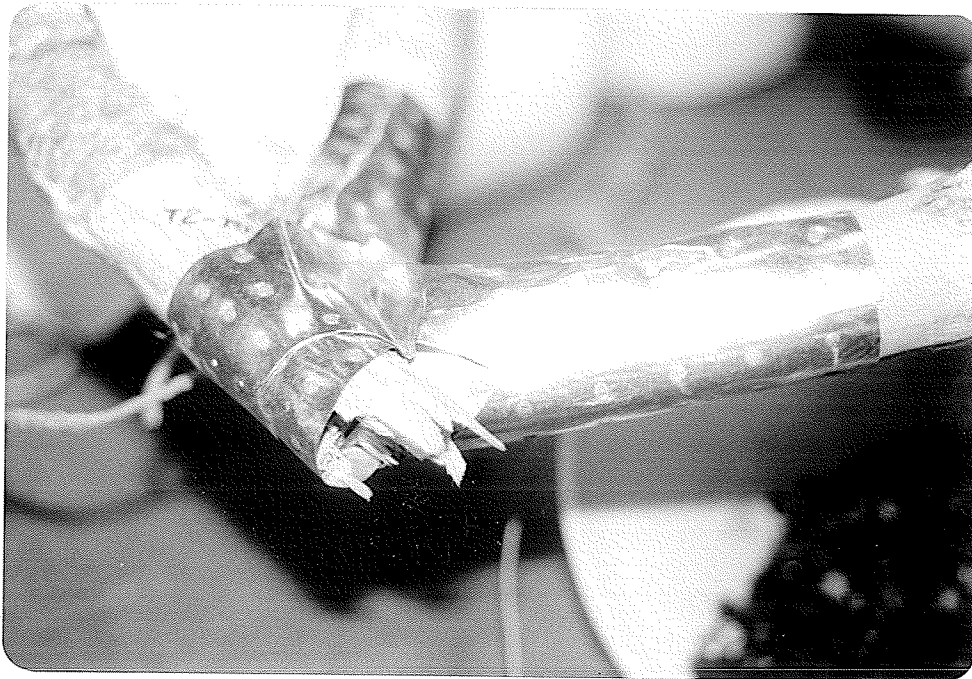
Fig. 5-2: Joint B - Truss T2, Post Collapse

strength and collapsed with the connecting system intact. In particular, after the top chord failure in truss T2, the load was transferred through member BG and the panel point B which resulted in member ABH failing (see Fig. 4-12, p.4.26) Except for a small amount of bending there was no apparent damage to the connector at B. What is particularly interesting is that none of the nails in the connector had been pulled, the connector remained tight to the timber. This implies that there was still quite a bit of strength remaining in the joint.

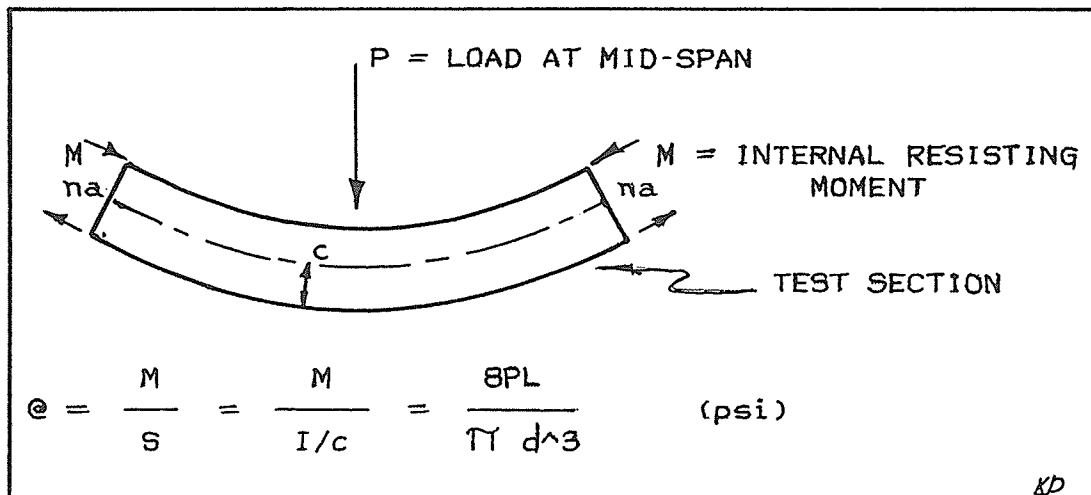
Fig. A2-3: Section Properties in Bending

The stress at the extreme fibre of the pole was computed from the following relationship between the bending moment and the section modulus.

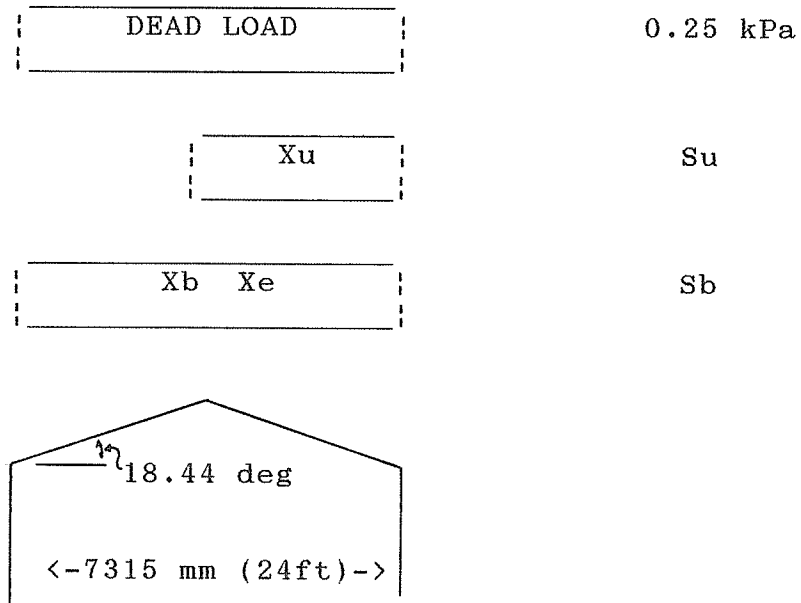
Fig. C2-1: Snow and Dead Loading on Truss

In order to produce the worst case for truss loading the procedures outlined in the Timber Design Manual, (pages 40-44), were followed for balanced (Sb) and unbalanced (Su) snow loading conditions, in conjunction with the appropriate coefficients Xu, Xb and Xe .

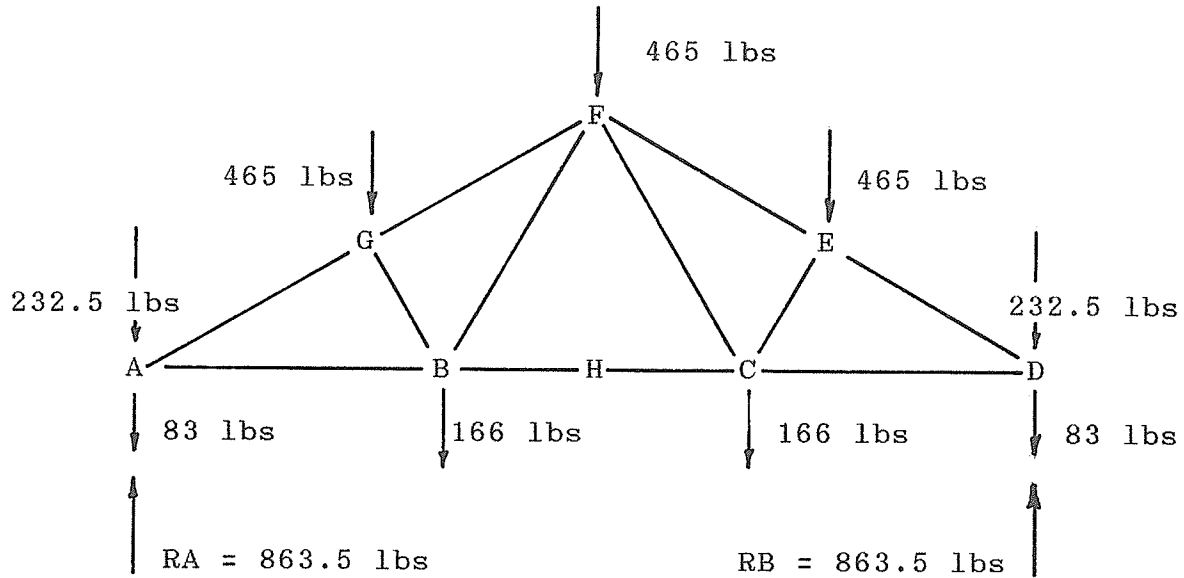
Fig. C3-1: Truss Loading - 24'- 0"

Fig. C3-1 illustrates the loading on a 24' truss with the loads concentrated at the joints.
