**ASSESSMENT OF DEGRADATION OF  
SHALEY LIMESTONE RIPRAP**

**KATHERINE IRENE FRANKLIN**

A Thesis  
Submitted to the Faculty of Graduate Studies  
In Partial Fulfillment of the Requirements for the Degree of

Department of Civil Engineering  
University of Manitoba  
Winnipeg, Manitoba

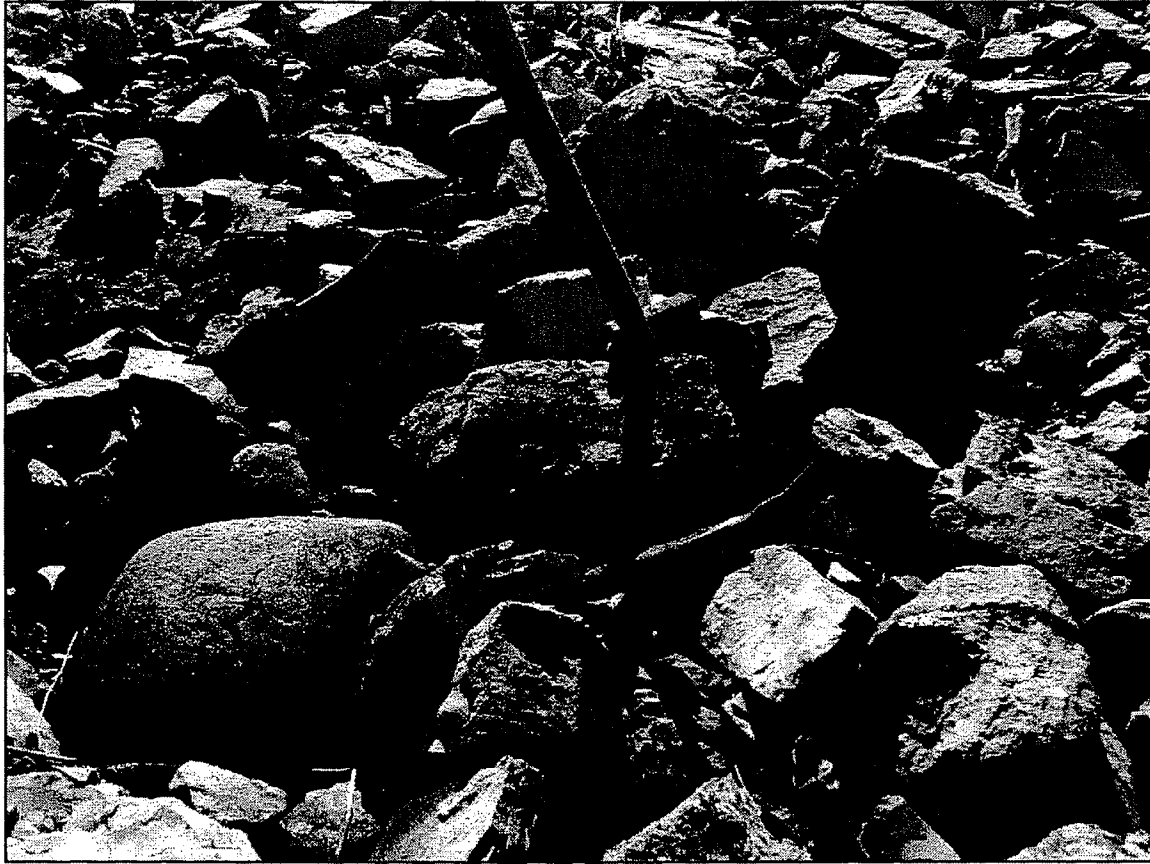
Figure 4.2 Photograph of Grid - Dyke 2 South, Station 79+00 (Middle)

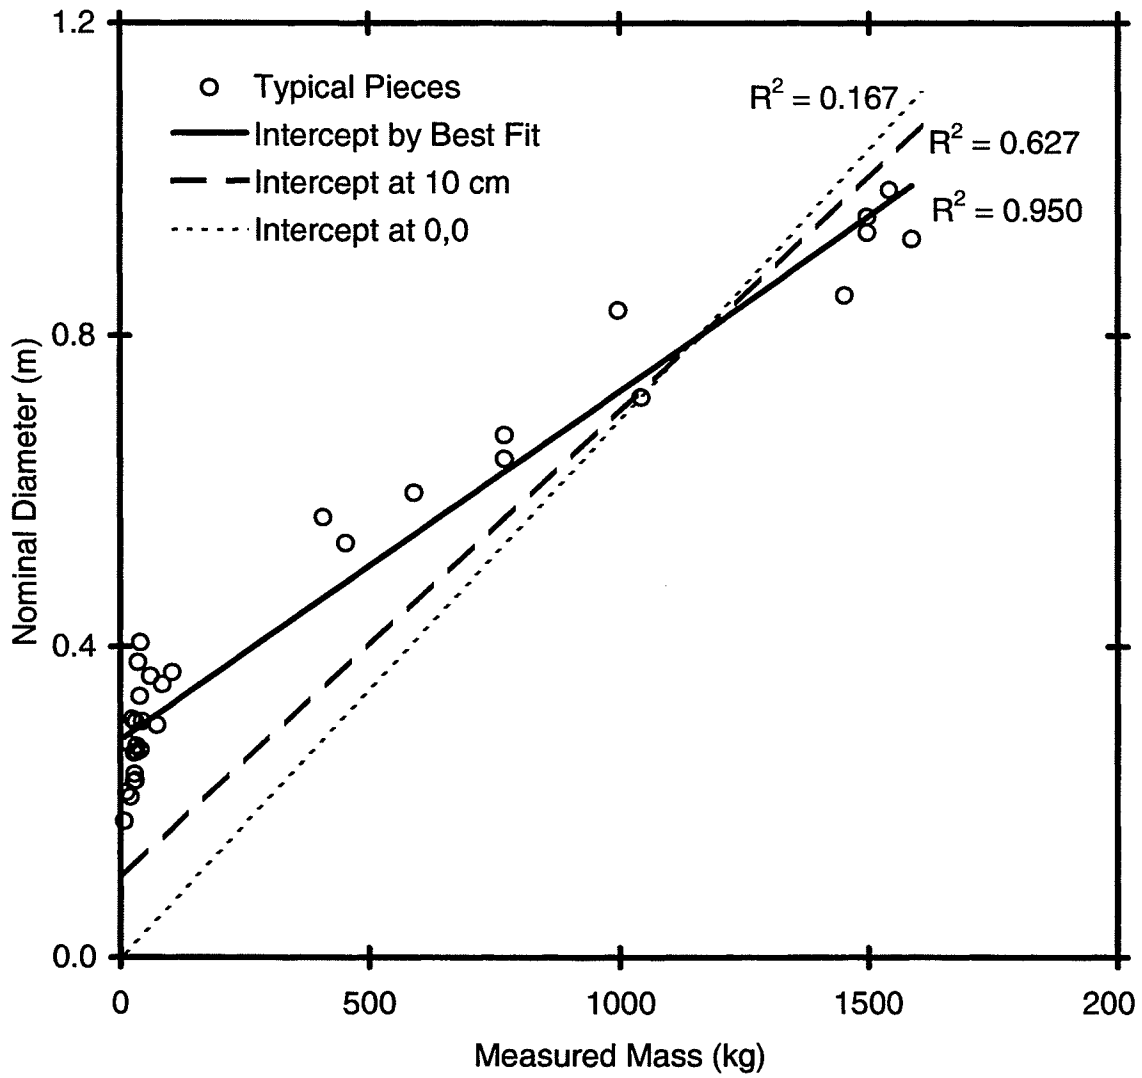
Figure 4.5 Measured Mass versus Nominal Diameter for Typical Riprap Pieces

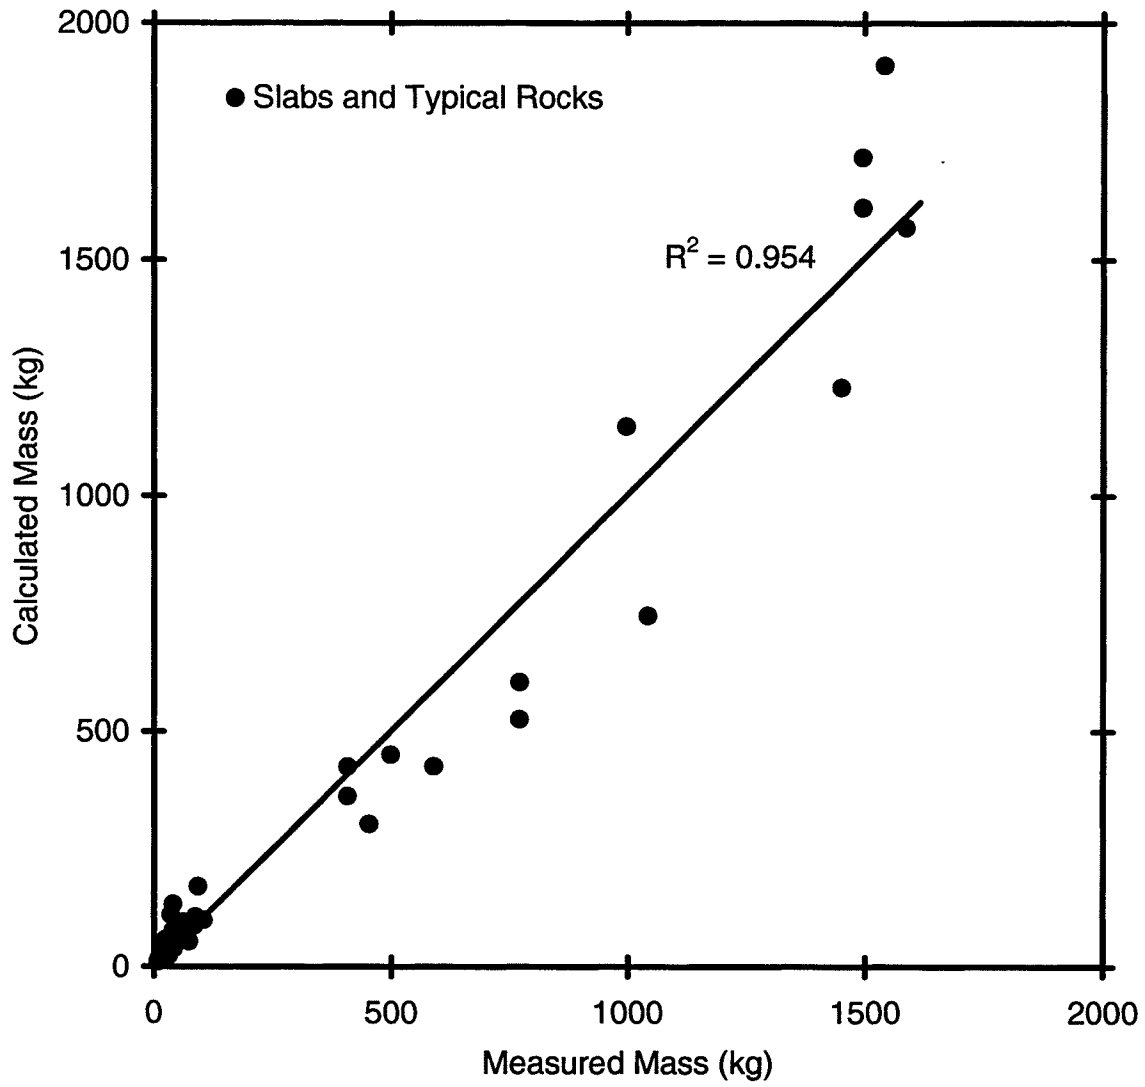
Figure 4.6 Measured Mass versus Calculated Mass for Slabs and Typical Rocks as One Data Set

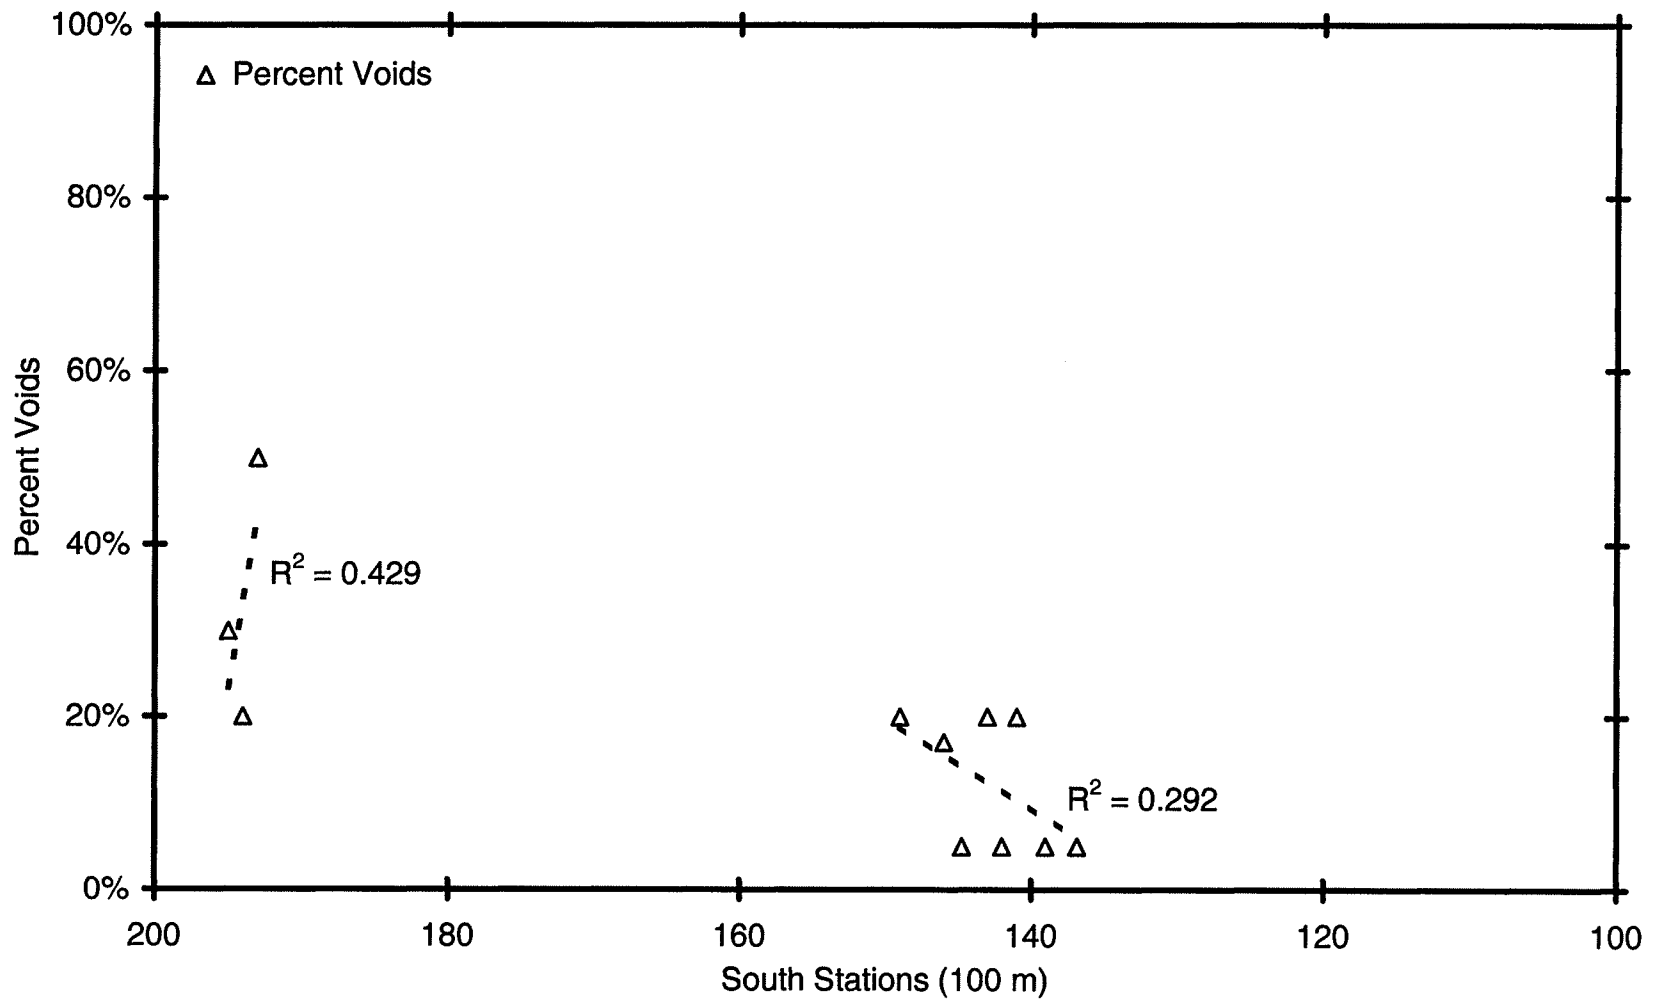
Figure 4.11.a Percent Voids, 2001, Dykes 3 and 4 South

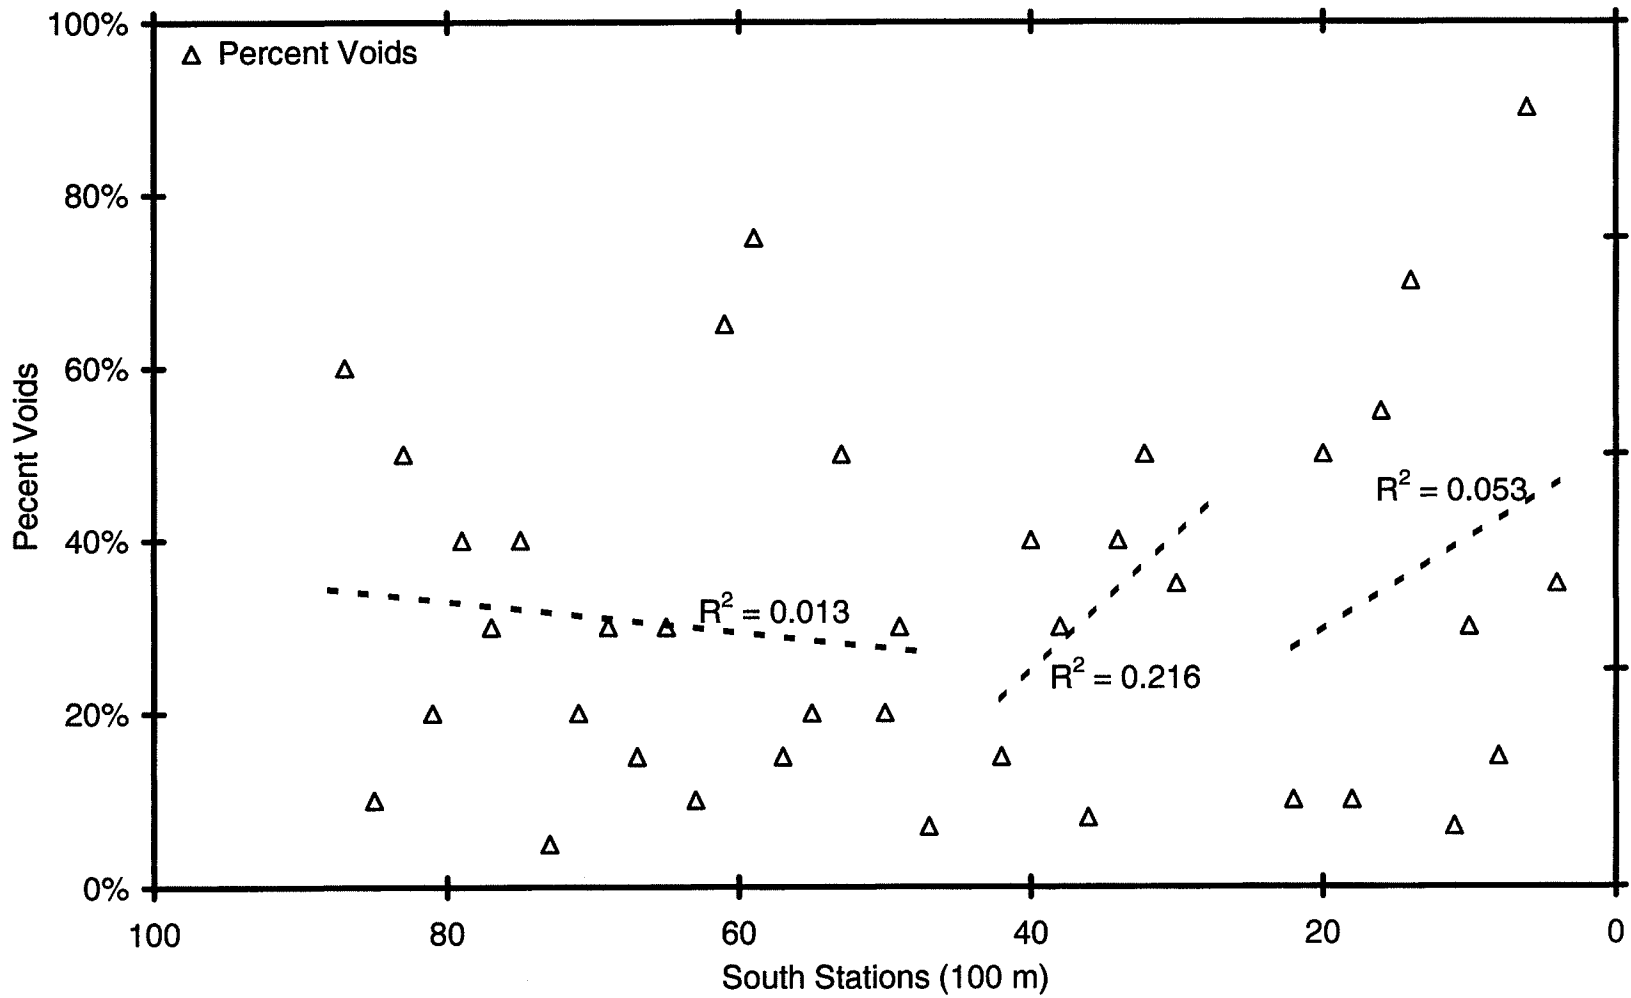
Figure 4.11.b Percent Voids, 2001, Dykes 1 and 2 South

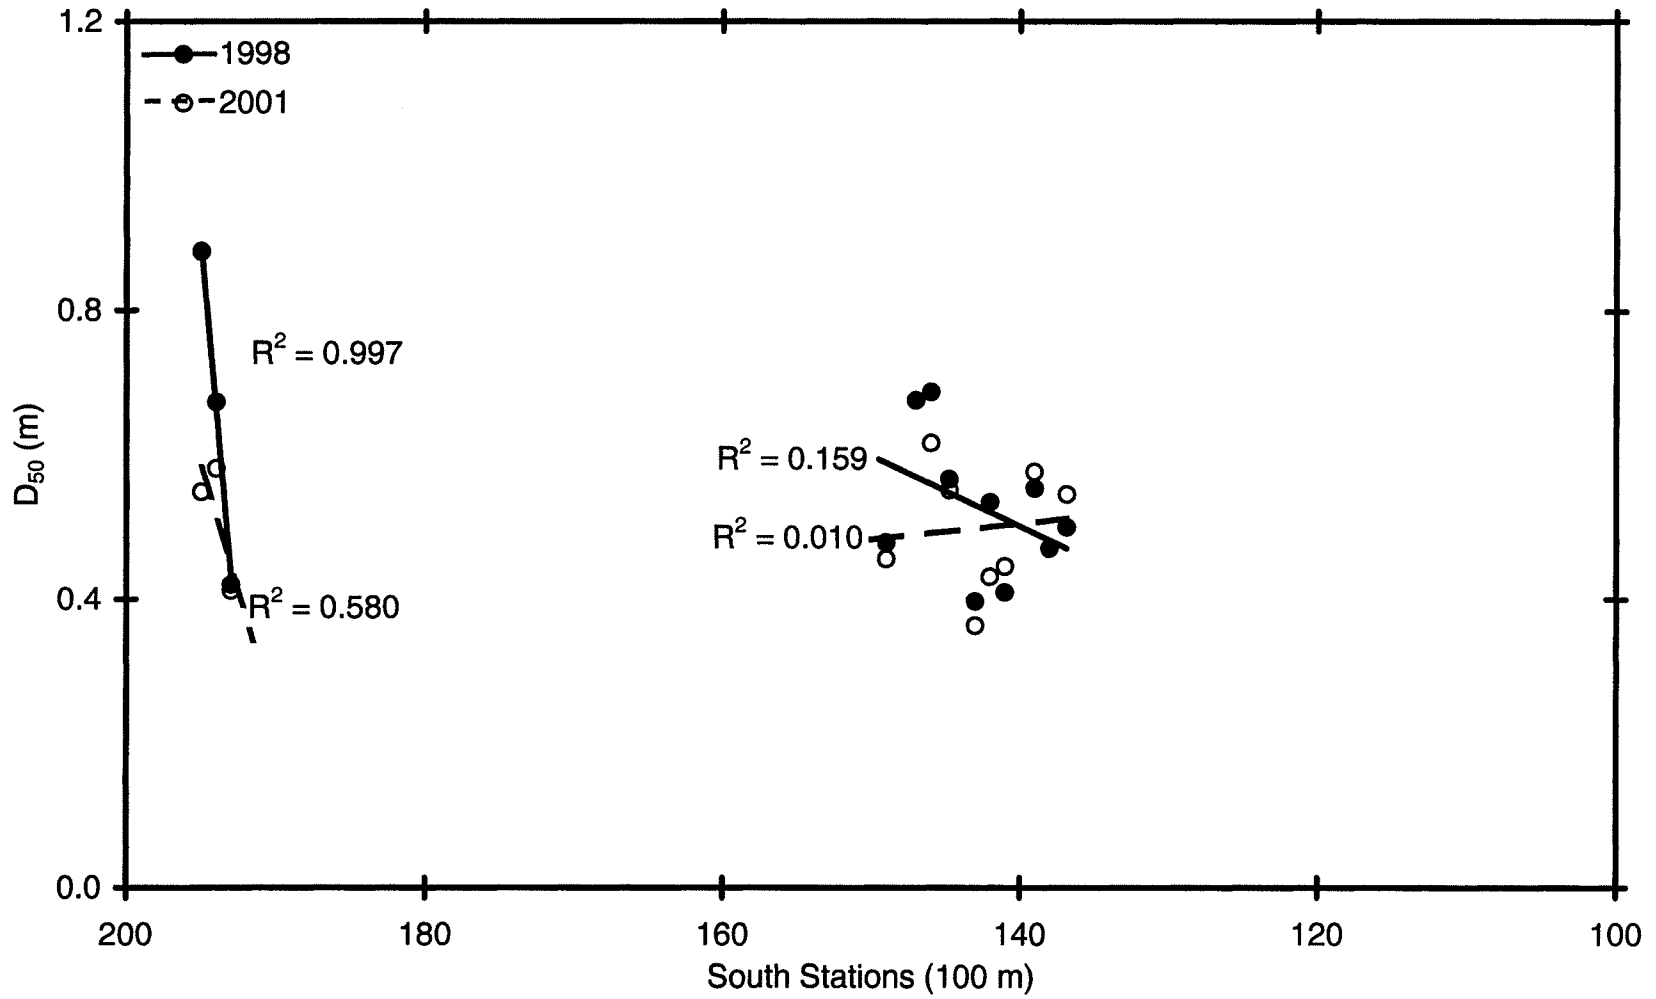
Figure 4.14.a  $D_{50}$  Found by Size-Mass Grading of the Intermediate Dimension, Large Rocks, Dykes 3 and 4 South

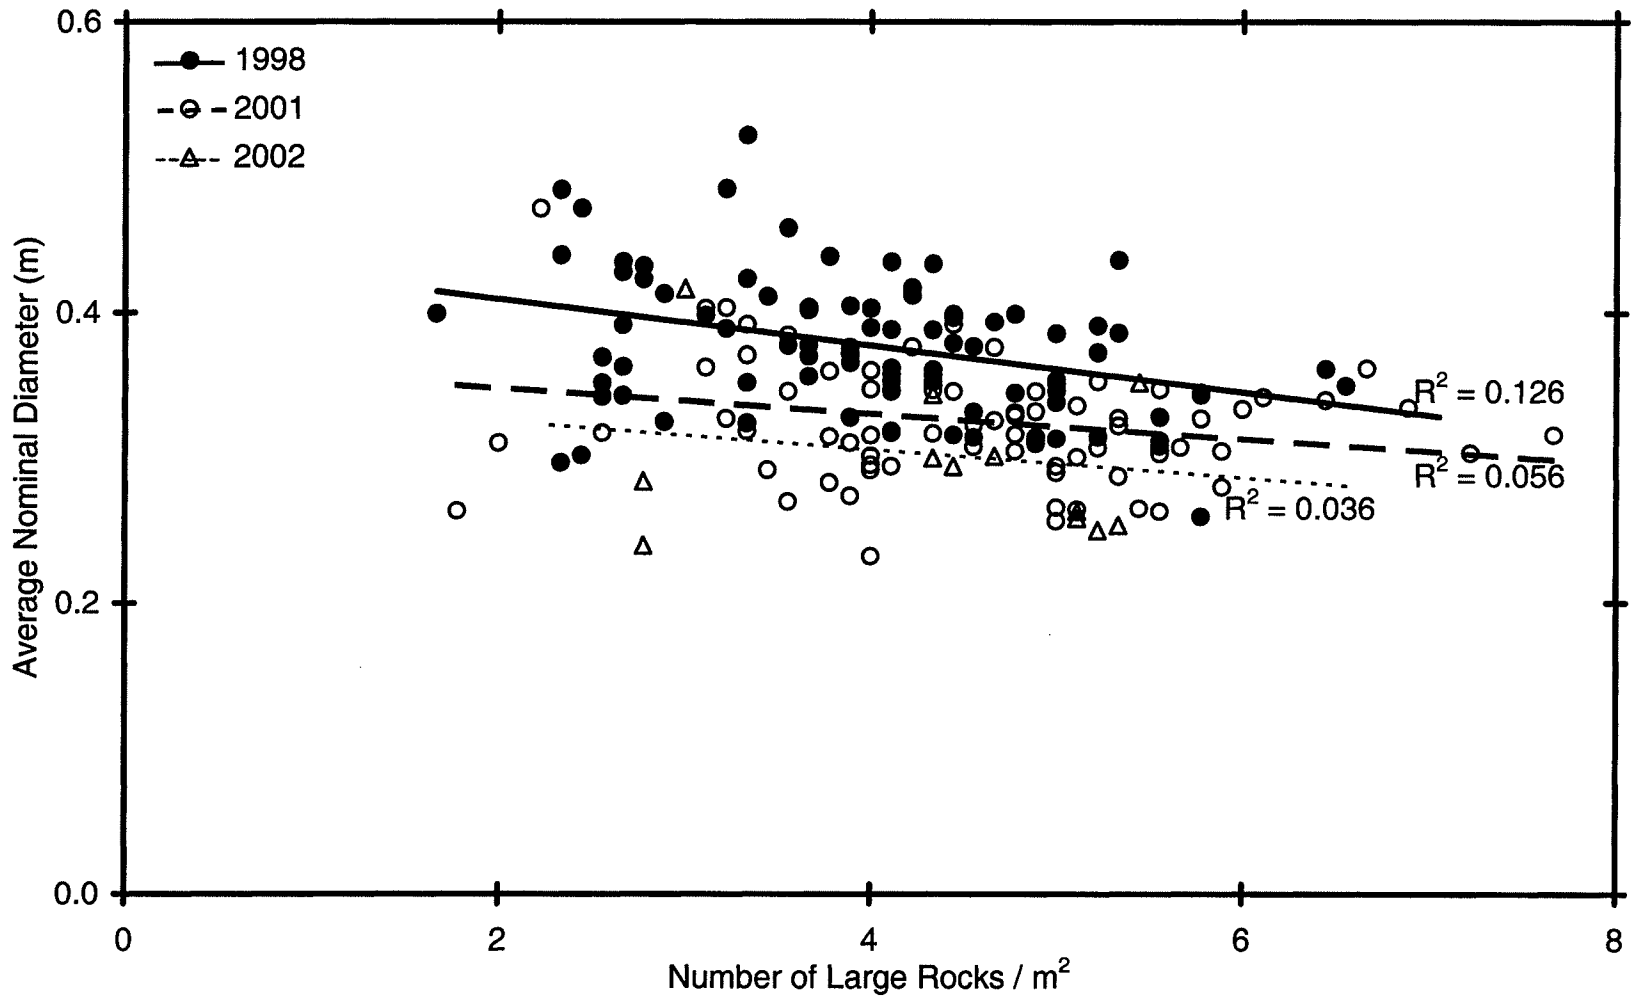
Figure 4.18 Number of Large Rocks versus Average Nominal Diameter

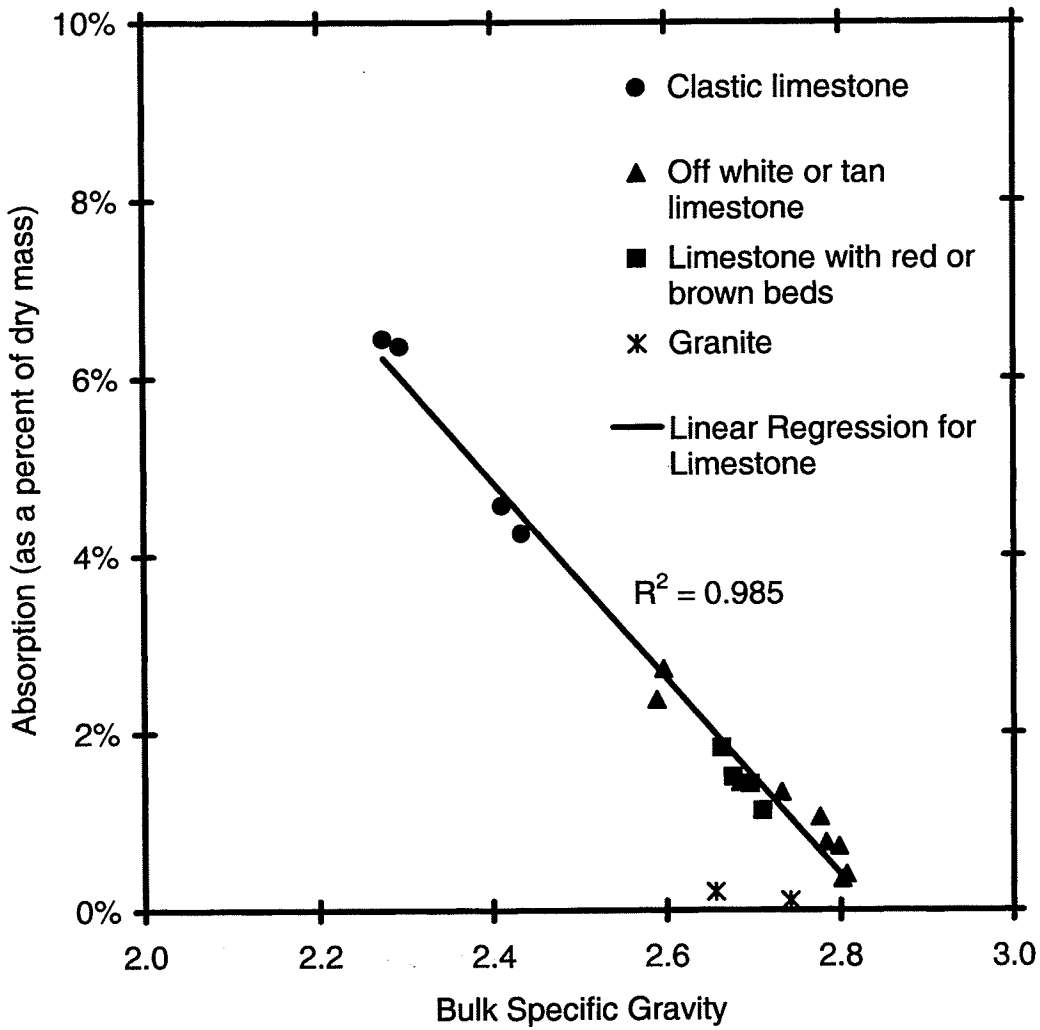
Figure 5.1 Bulk Specific Gravity versus Absorption

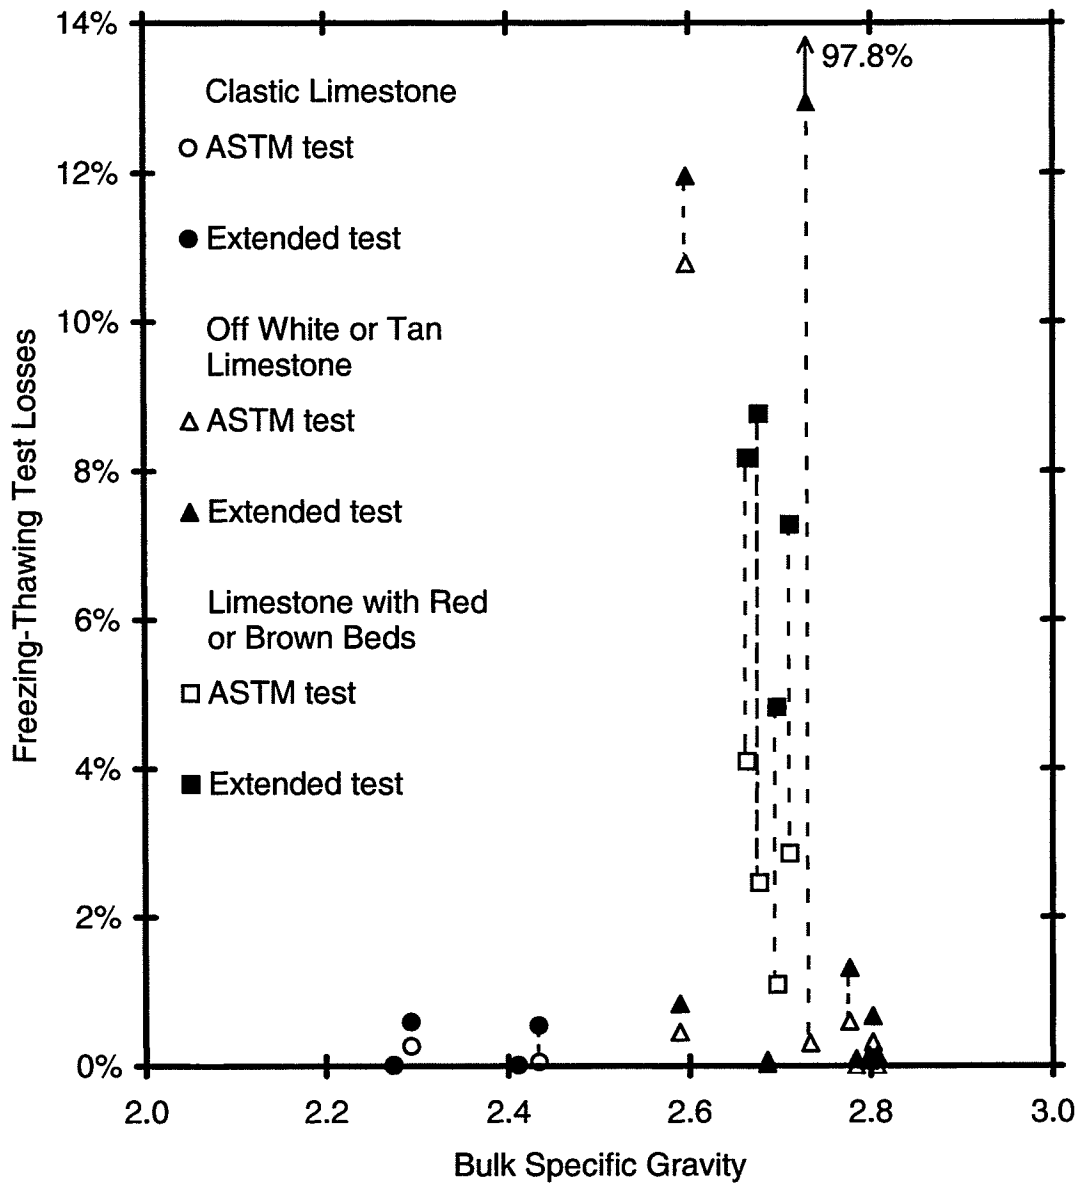
Figure 5.2 Bulk Specific Gravity versus Total Freezing-thawing Losses

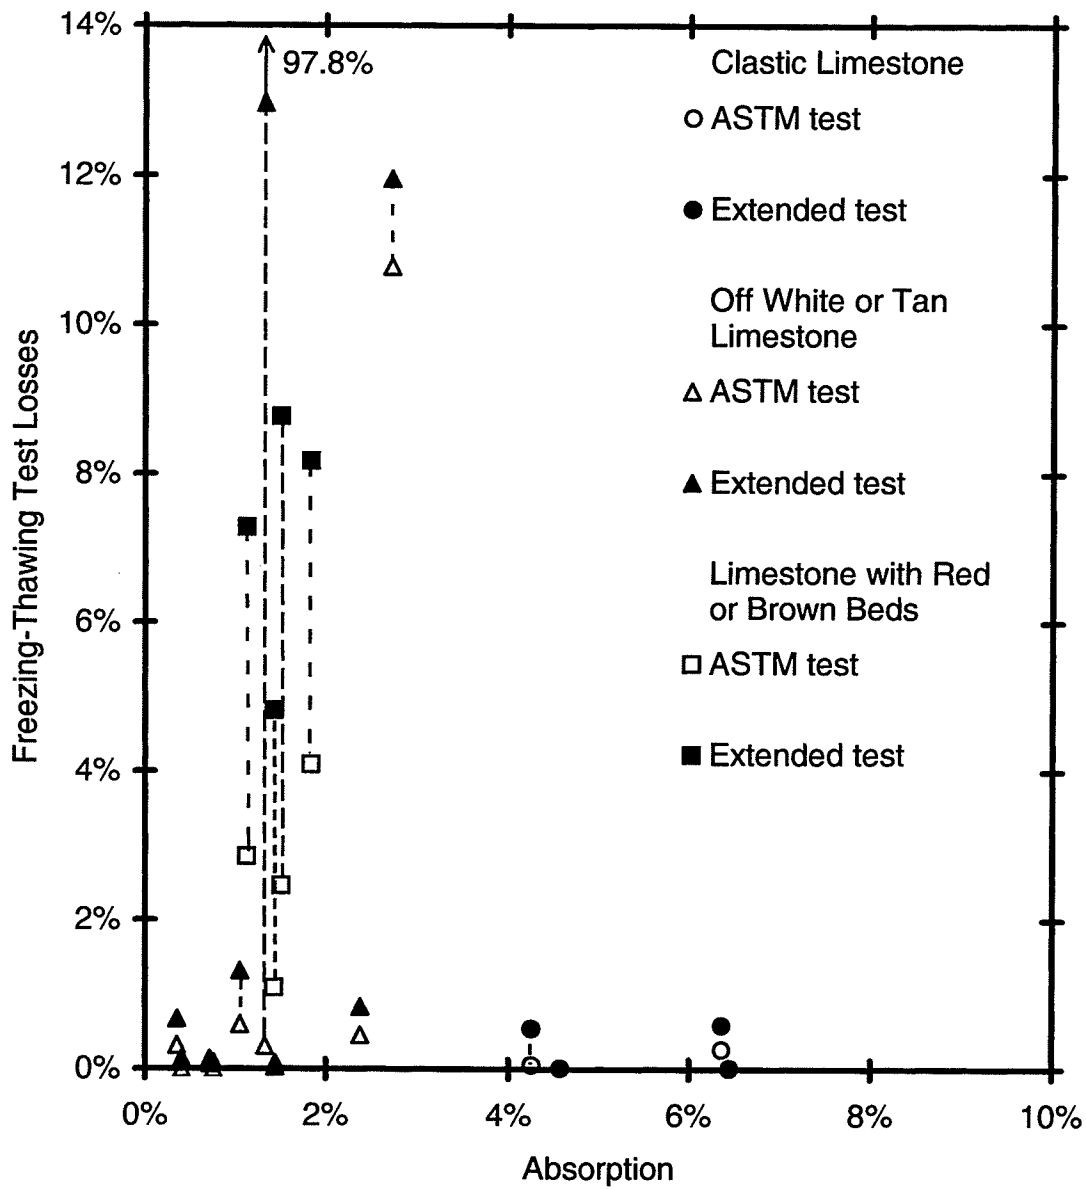
Figure 5.3 Absorption versus Total Freezing-thawing Losses

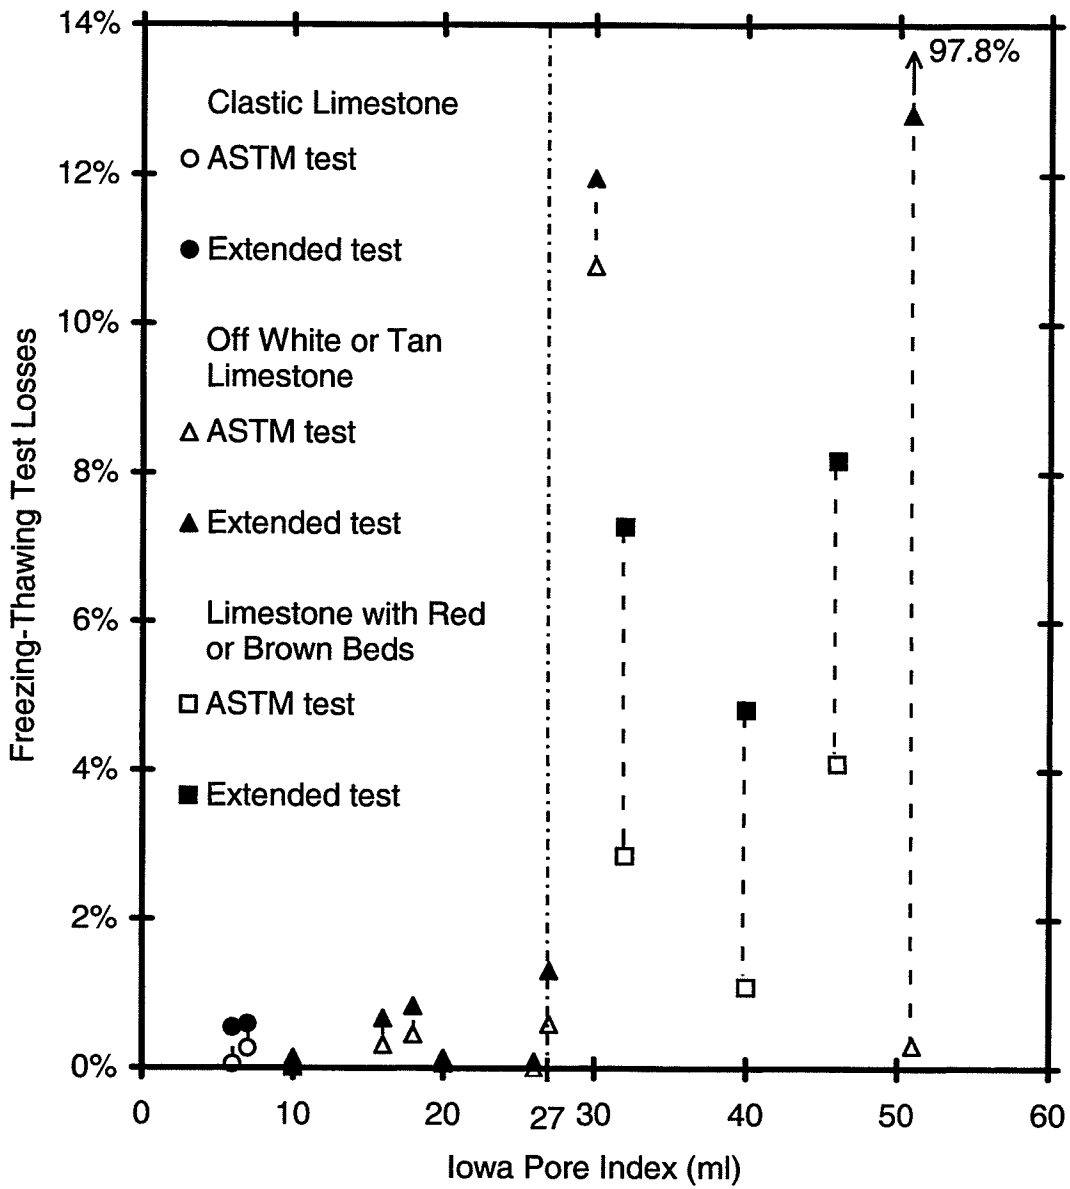
Figure 5.4 Iowa Pore Index versus Freezing-Thawing Test Losses

correlation with freezing-thawing tests. All samples which had an Iowa pore index greater than 27 also had freezing-thawing losses greater than 4%, while those with 27 or less had freezing-thawing losses less than 1.5%.

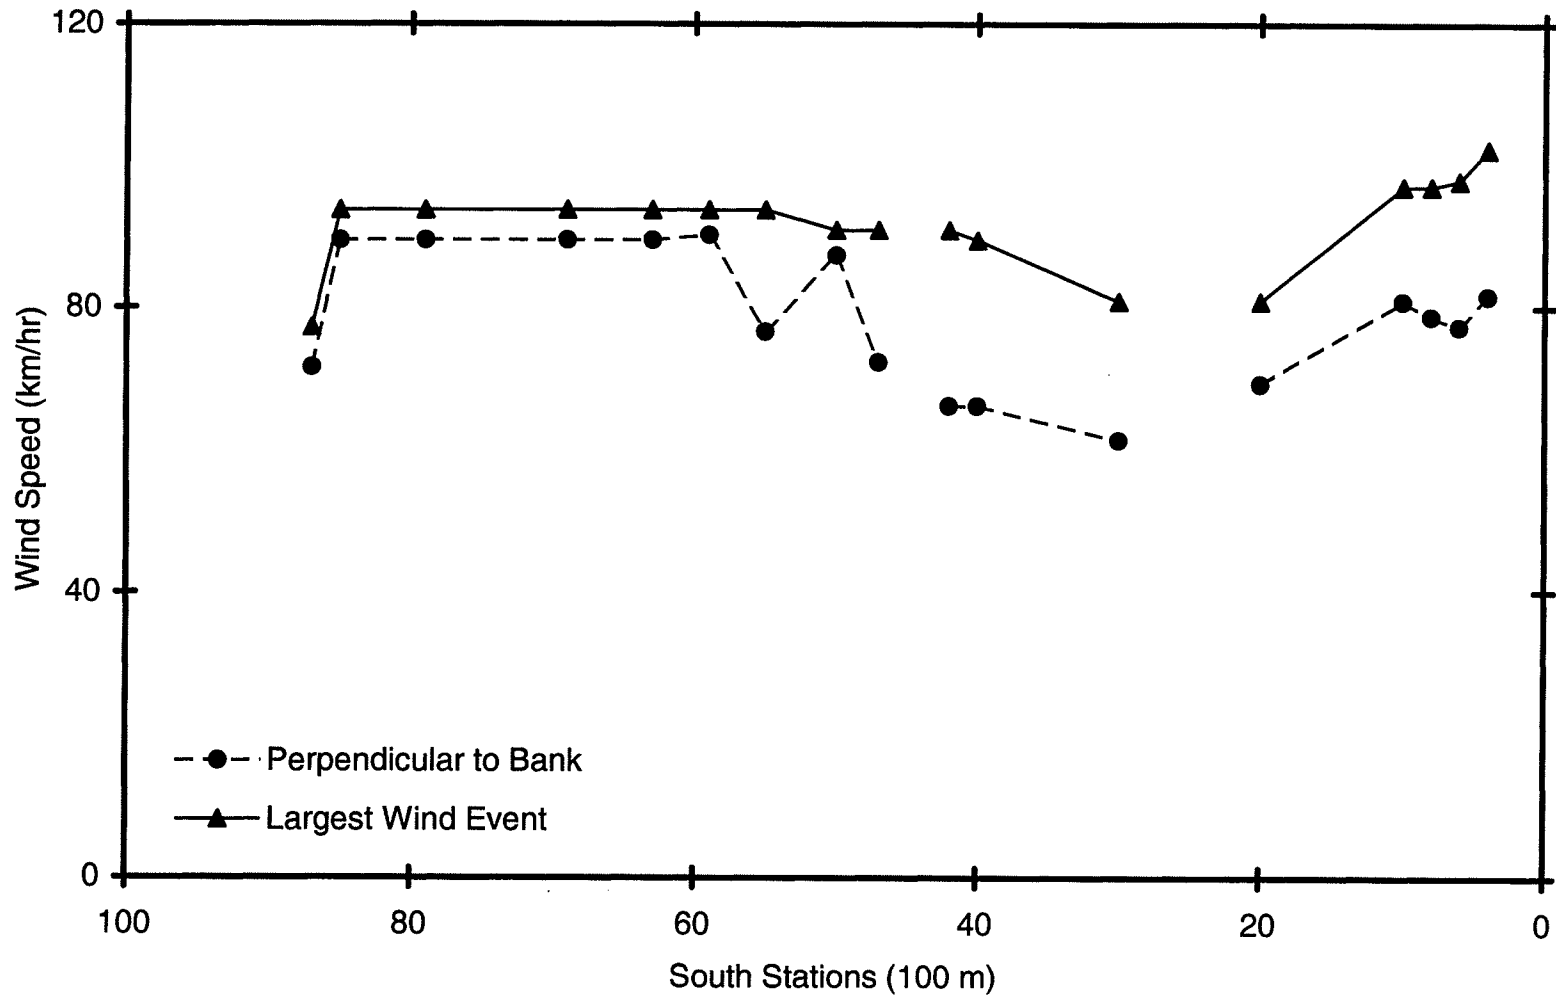
Figure 6.2.b Wind Speed Over Water, Dykes 1 and 2 South

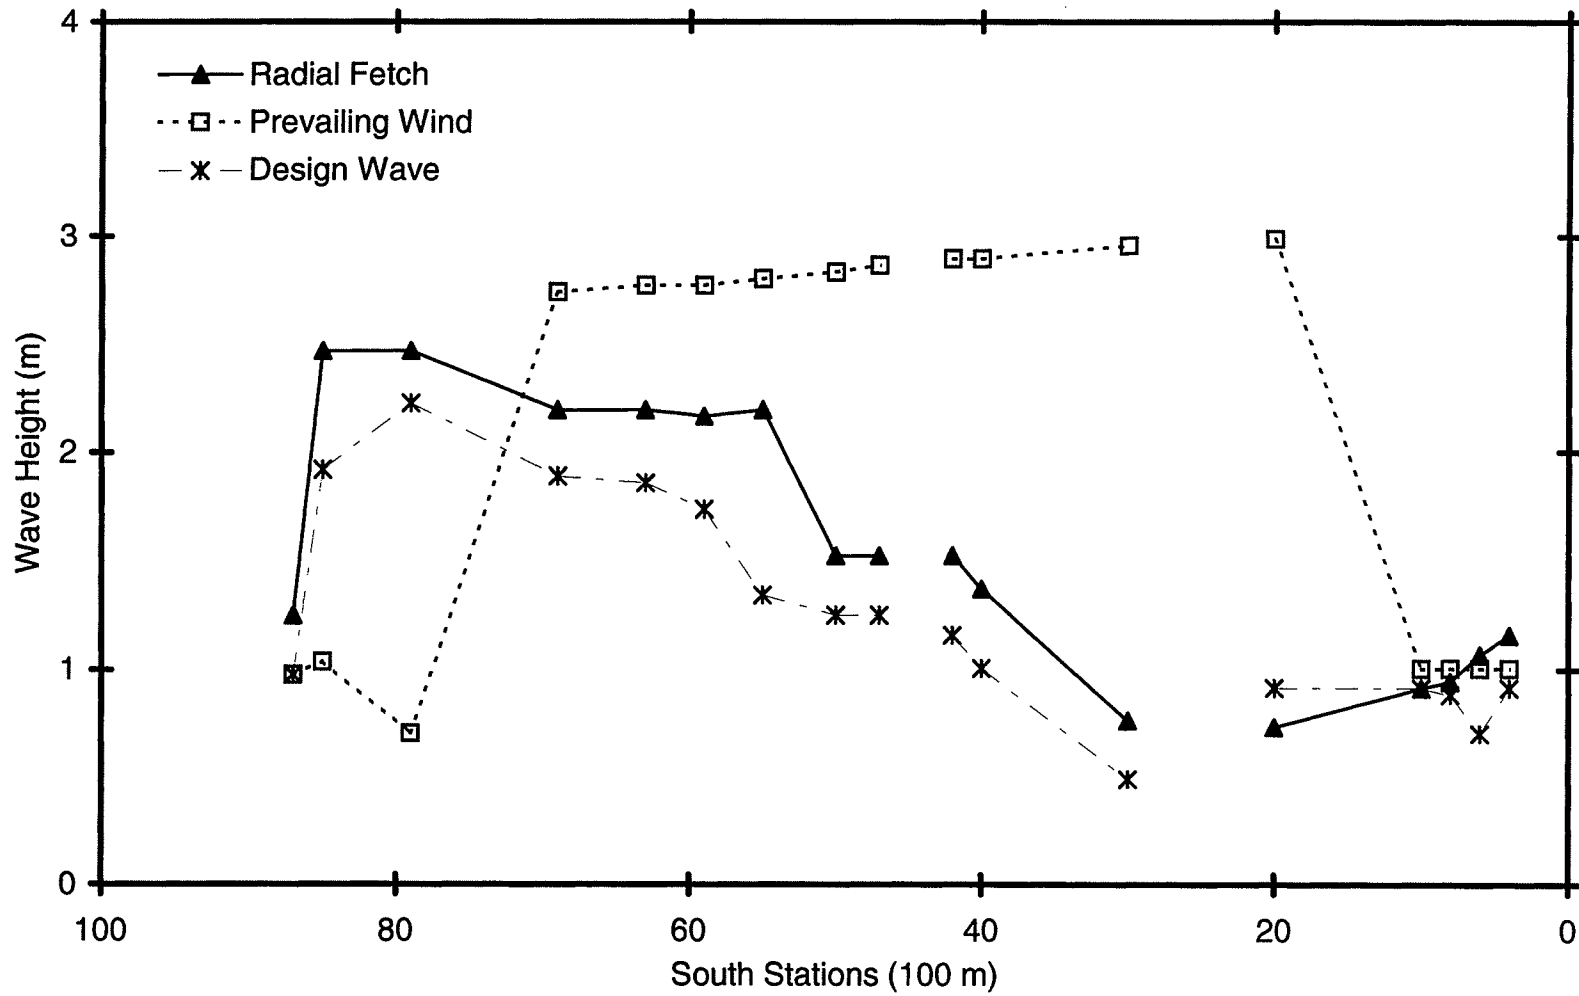
Figure 6.3.b Wave Heights, Dykes 1 and 2 South

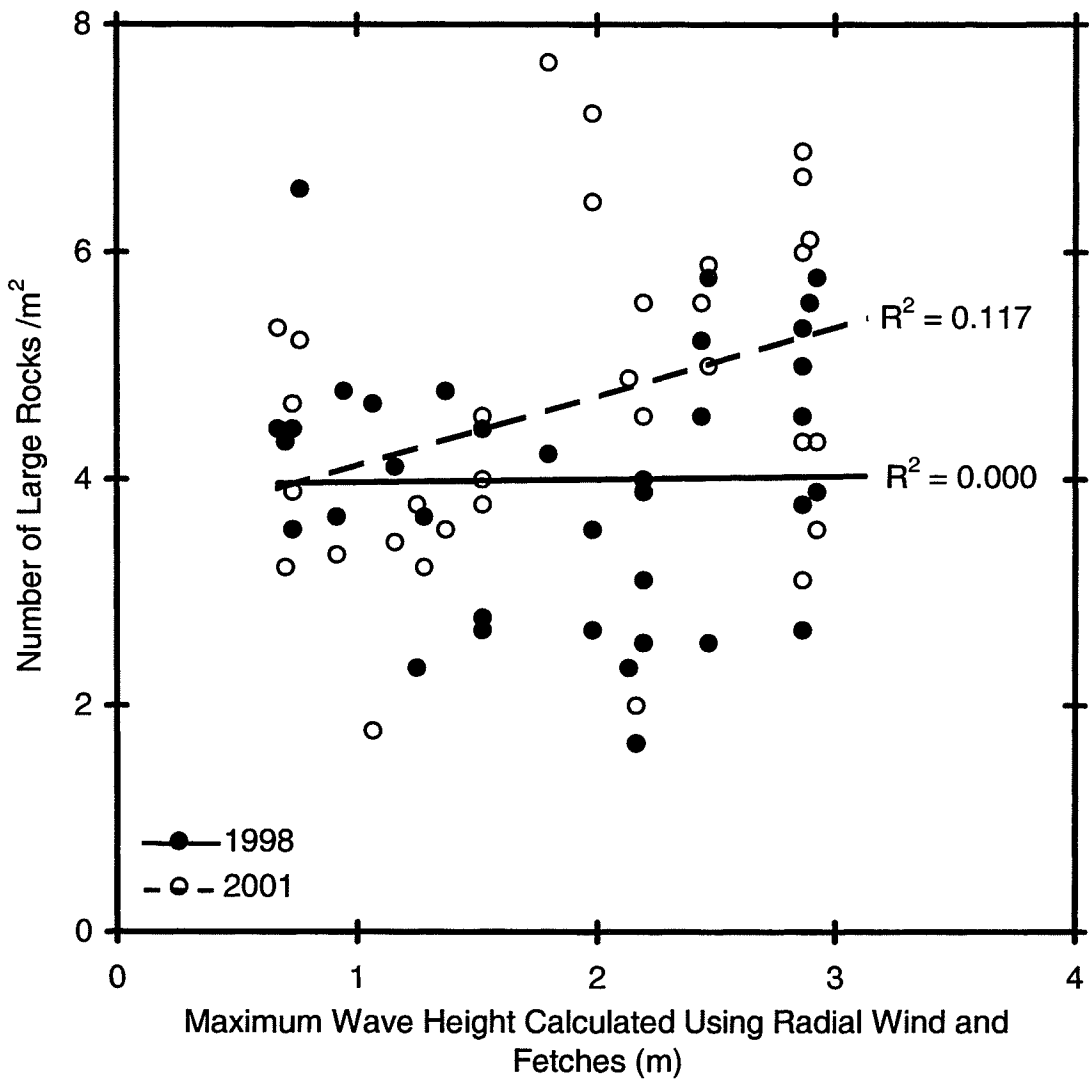
Figure 6.5 Wave Height Using Radial Wind and Fetch versus  
Number of Large Rocks

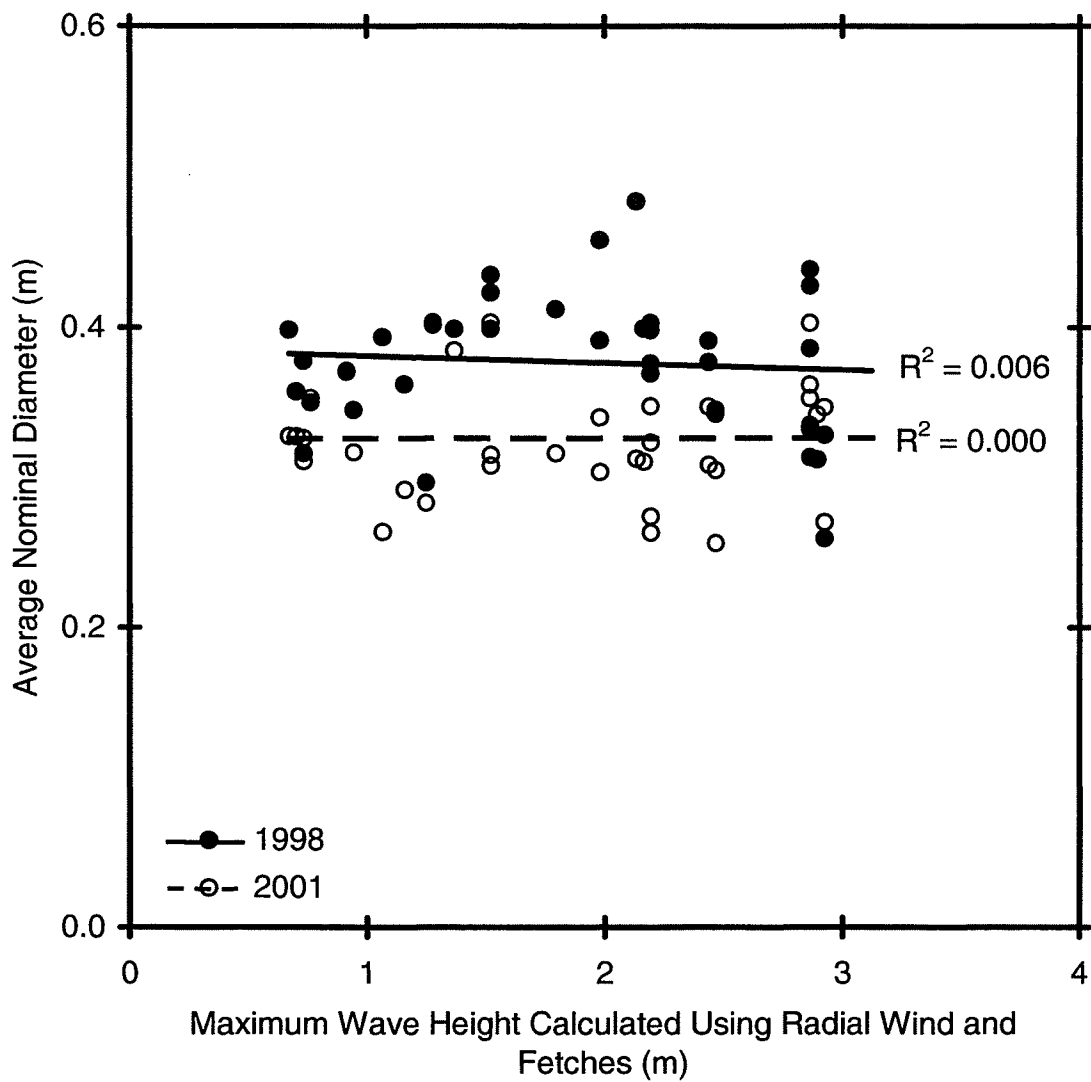
Figure 6.7 Wave Height Using Radial Wind and Fetch versus Average Nominal Diameter
