**THERMO-MECHANICAL FATIGUE OF POLYCRYSTALLINE,
DIRECTIONALLY SOLIDIFIED AND SINGLE CRYSTAL NICKEL
BASE SUPERALLOYS REPAIRED BY LASER BEAM WELDING**

**A Thesis submitted to the Faculty of Graduate Studies of
The University of Manitoba
in partial fulfilment of the requirements of the degree of**

**Department of Mechanical and Manufacturing Engineering
University of Manitoba
Winnipeg, Manitoba**

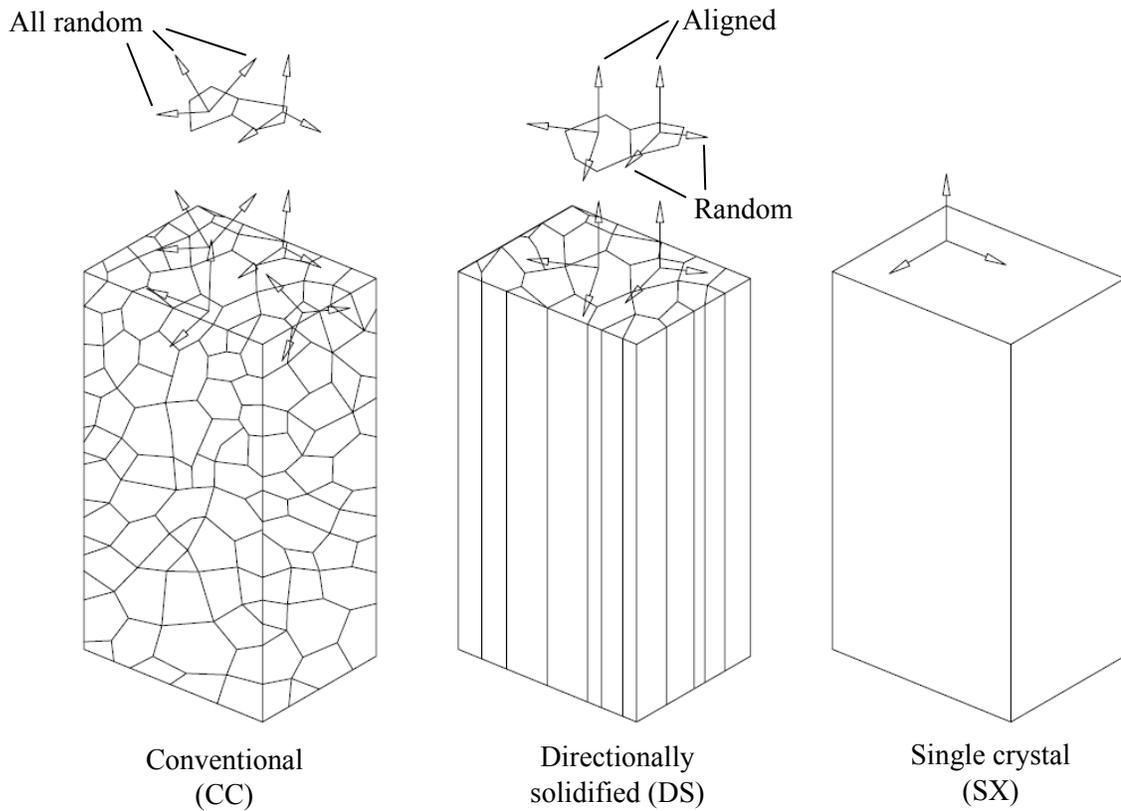
Figure 2 shows a schematic of the three possible casting structures found in industrial gas turbine blades. For highly stressed components such as blades, the casting structure is primarily directionally solidified (DS) or single crystal (SX). With DS, the grain boundaries are aligned parallel to the primary axis of loading and are not subject to creep deformation or crack initiation as with equiaxed cast structures. Also, the concentration of grain boundary strengthening minor elements such as B, C and S can be significantly reduced and, increasing the alloy's melting point and solution heat treatment temperature. This in turn increases the volume fraction of γ' in the precipitation aged condition and increases mechanical properties such as tensile strength and creep rupture.

Figure 2: Schematic of casting solidification microstructures. Based on M. McLean [36].

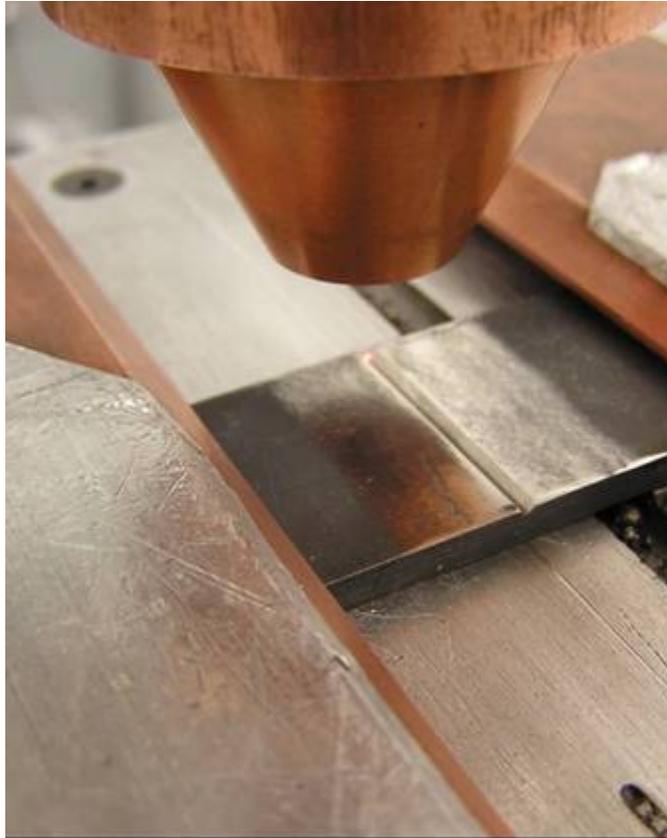
Figure 3: Close-up of laser welding nozzle and v-notch test specimen.

- Continuous beam power: 615 Watts
- Traverse rate: 6.4 mm/sec
- Weld pass spacing: 0.55 mm
- Powder feed rate: 8 grams/minute

- Shield gas: argon
- Nozzle gas flow: 40 L/minute
- Copper chill clamps located 25 mm from weld centreline
- Specimen backing: 300 grade stainless steel plate

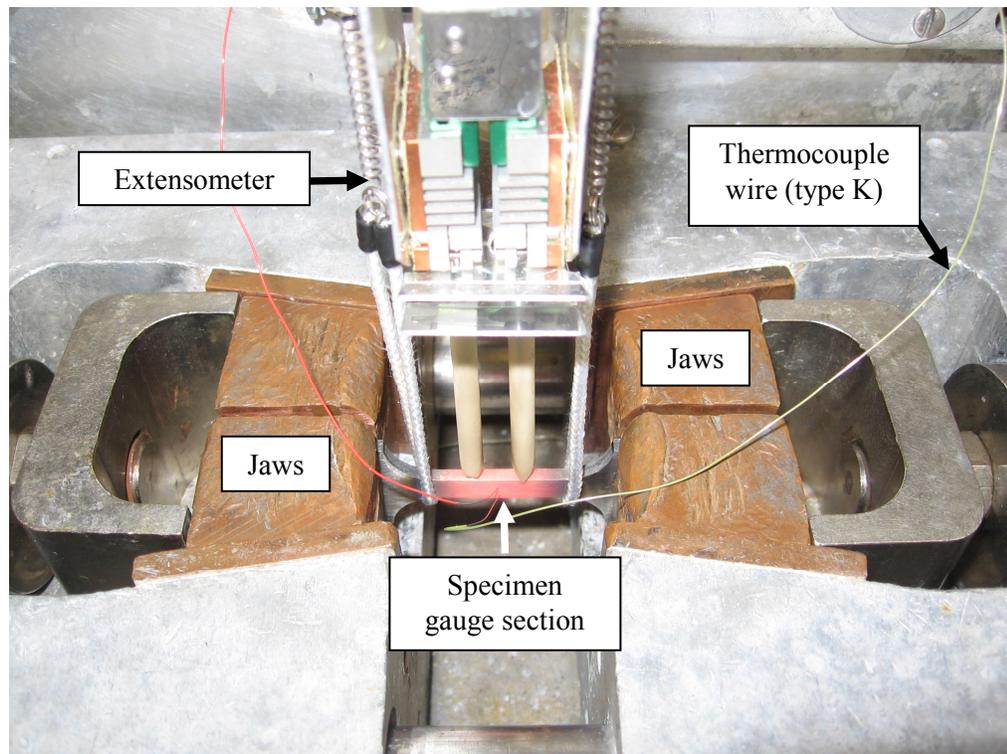
Figure 5: TMF specimen in Gleeble machine (gauge section undergoing heating cycle)

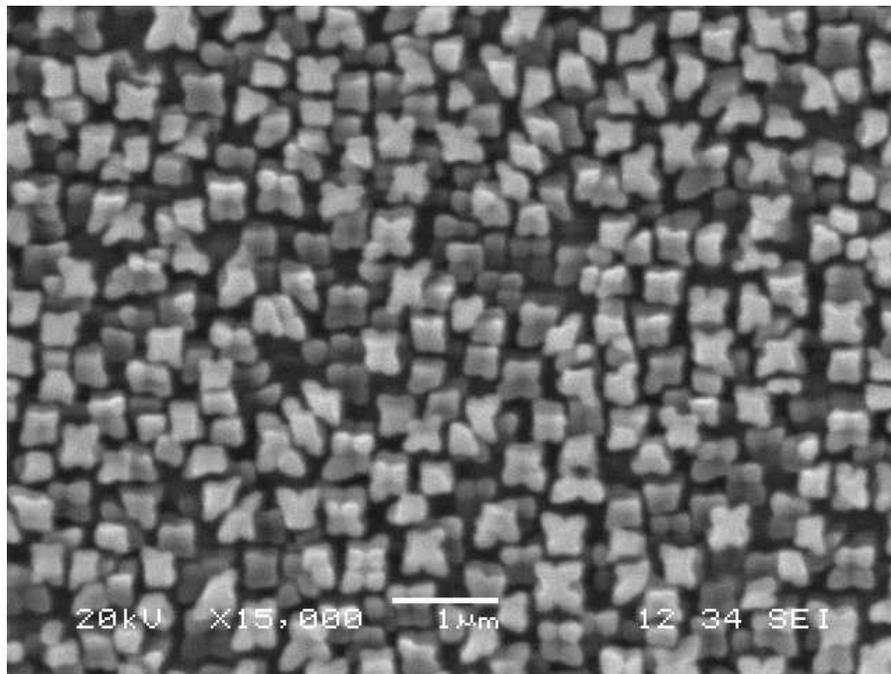
High magnification examination of the microstructure using the SEM revealed a fine unimodal gamma prime in the dendrite cores with a concave and split cubic morphology as shown in Figure 14 and were measured to be 0.32 μm in size. Along the dendrite boundaries, the gamma prime particles were primarily cuboidal in shape with a size of 0.30 μm and are shown in Figure 15. In comparison to the dendrite cores, the interdendritic gamma prime particles were marginally smaller in size with a more pronounced cuboidal morphology.

Figure 14: SEM image of concave and split cubic gamma prime in grain cores in René 80, as-received condition

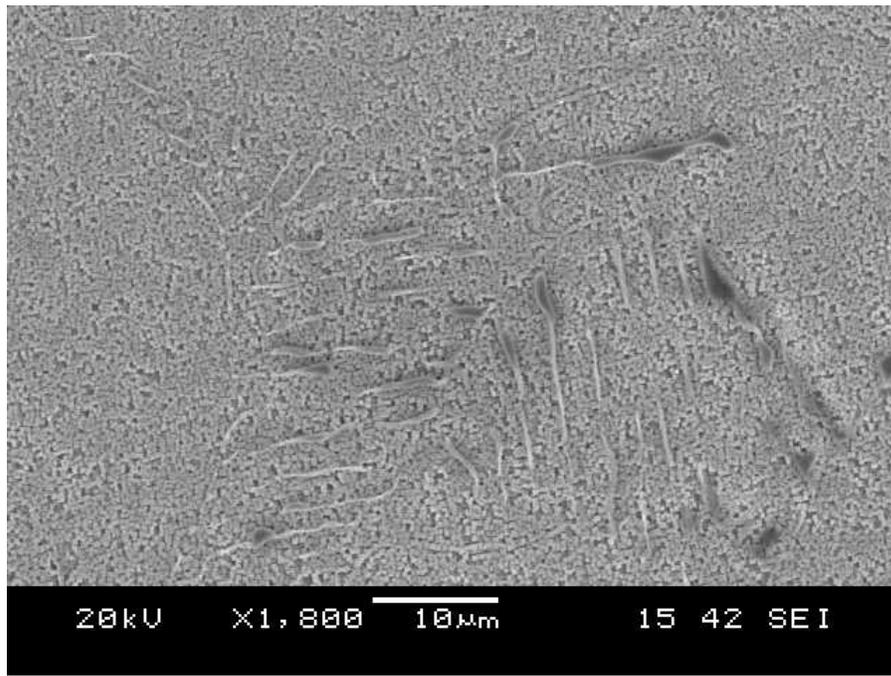
When observed with optical microscopy, the microstructure of single crystal René N5 was relatively featureless with the exception of the carbide particles distributed along interdendritic regions of the alloy. The carbides were in script and blocky form as shown in Figures 18 and 19, respectively.

Figure 18: Script morphology MC carbides in René N5 SX cast alloy, as received condition

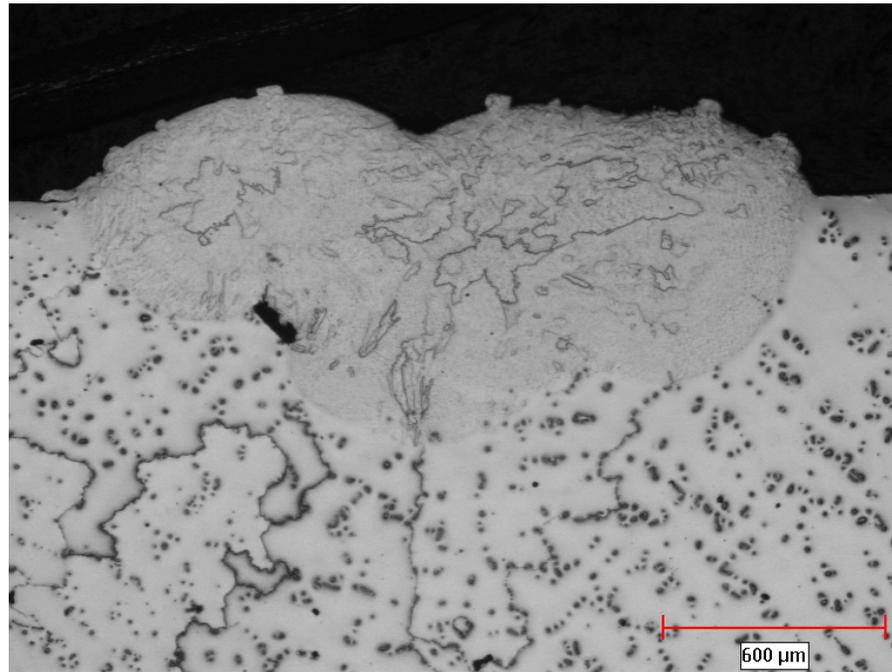
Figure 23: Optical micrograph of the weld fusion zone on the Inconel 738 specimen, as-welded condition

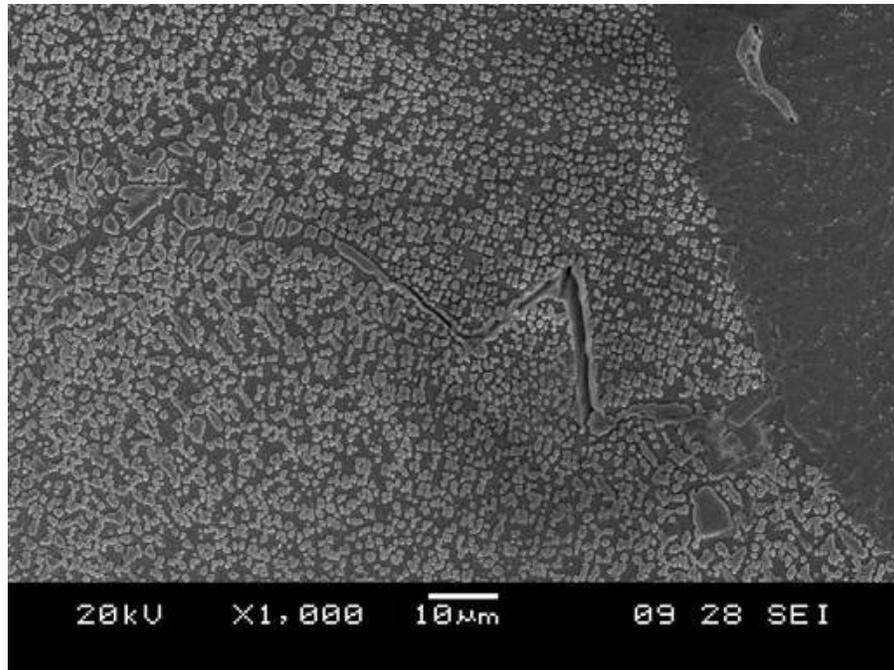
Figure 26: Grain boundary cracking in Inconel 738 weld HAZ

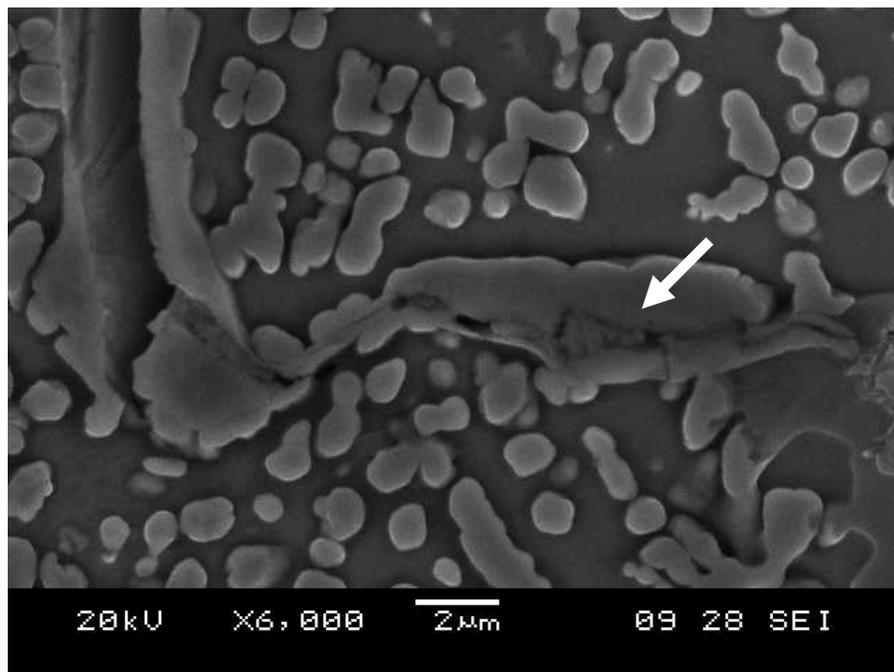
Figure 27: Grain boundary liquation cracking in Inconel 738 weld HAZ

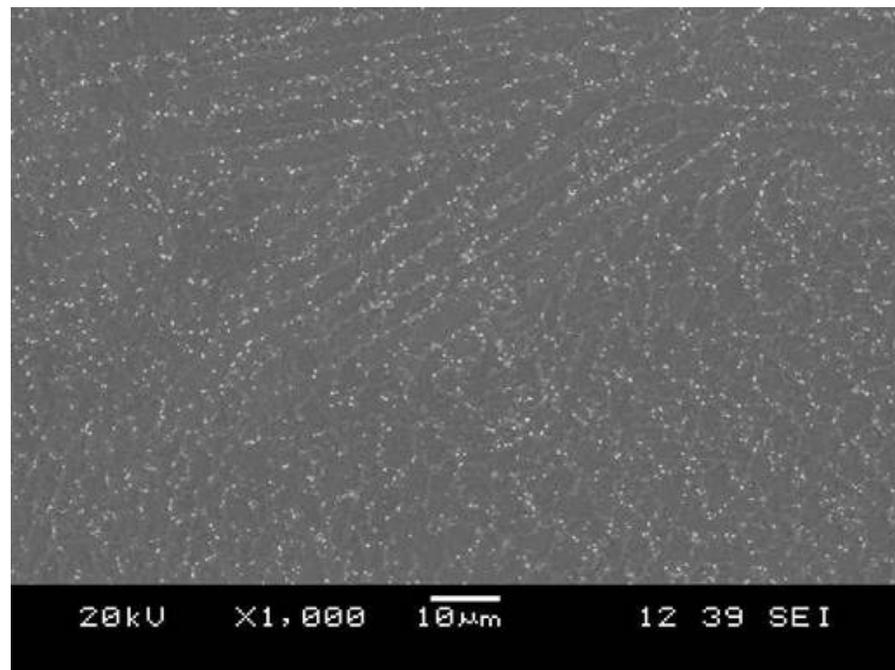
The weld fusion zone consisted of cellular, epitaxial and dendritic stray grain solidification structures. Under SEM examination, a fine dispersed phase was apparent in the interdendritic regions of the weld fusion zone and is shown in Figures 28 and 29 (denoted by arrows). EDS line scans were taken in the weld fusion zone across dendrite arms and Ti, Mo and Nb were detected and found to segregate to the dendrite boundaries. The elemental distribution in the fusion zone is consistent with the findings of Sidhu et al. [4] and represents elemental back-diffusion segregation in the alloy during rapid weld solidification. Based on the high relative concentrations on Ti, Mo and Nb at cell/dendrite boundaries, the minor phase identified in interdendritic regions is that of Ti rich MC-type carbides. No other phases were observed in the weld fusion zone. Refer to Appendix G for an EDS line scan across the fusion zone dendritic solidification structure.

Figure 28: SEM image of Inconel 738 weld fusion zone showing carbide distribution

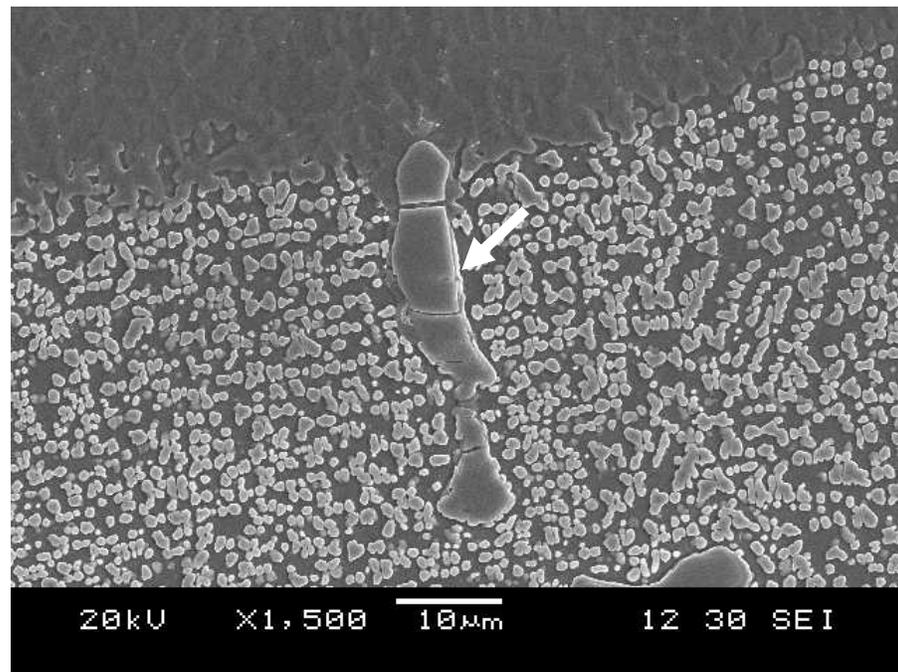
Other MC carbides originally present in the base material were visible shallow in the weld fusion zone and were overtaken by the base material melting during the weld cycle. The carbides remained relatively intact, undergoing minor liquation and dissolution with the molten fusion zone. Figures 32, 33 and 34 show examples of MC carbide liquation and mixing with the weld fusion zone.

Figure 30: Carbide liquation and cracking in Inconel 738 weld HAZ

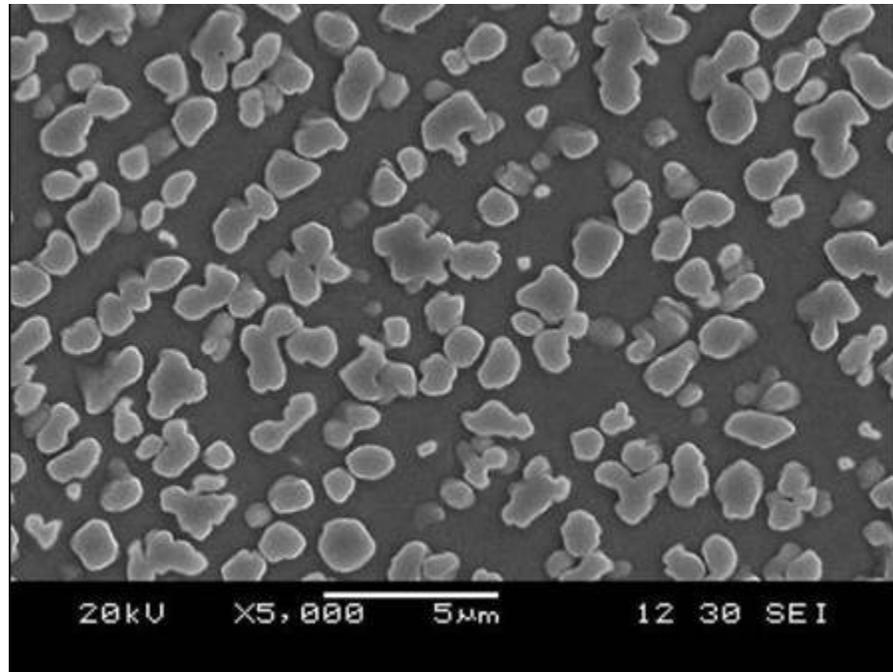
Figure 36: HAZ γ' in welded Inconel 738, dendrite core region

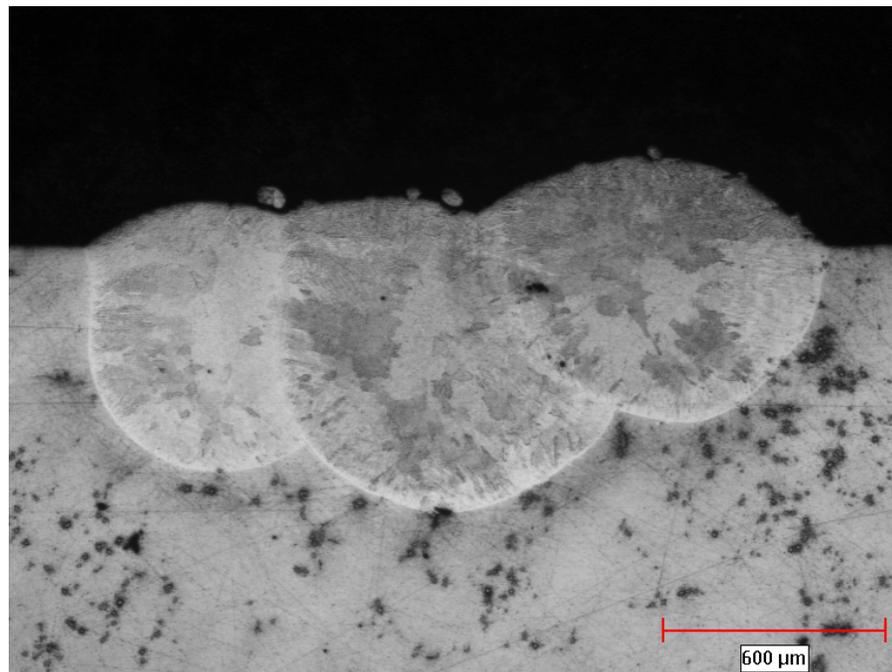
Minor gas porosity was observed throughout the weld fusion zone and was visible in the optical micrograph shown in Figure 37. Localized minor lack of fusion at the weld root was also apparent between the initial weld deposit pass and the parent material. The microstructure of the weld fusion zone in the as-welded condition displayed a layer of epitaxial growth along the fusion zone to parent material interface with stray grains throughout the remainder of the fusion zone. As shown in Figures 37 and 38, the initial solidification occurred by epitaxial mode along the axis of the dominant (highest) thermal gradient according to local conditions and was aligned with the crystallographic orientation of the parent material along the [100] and [010] directions.

Figure 37: Optical micrograph of René 80 in the as-welded condition

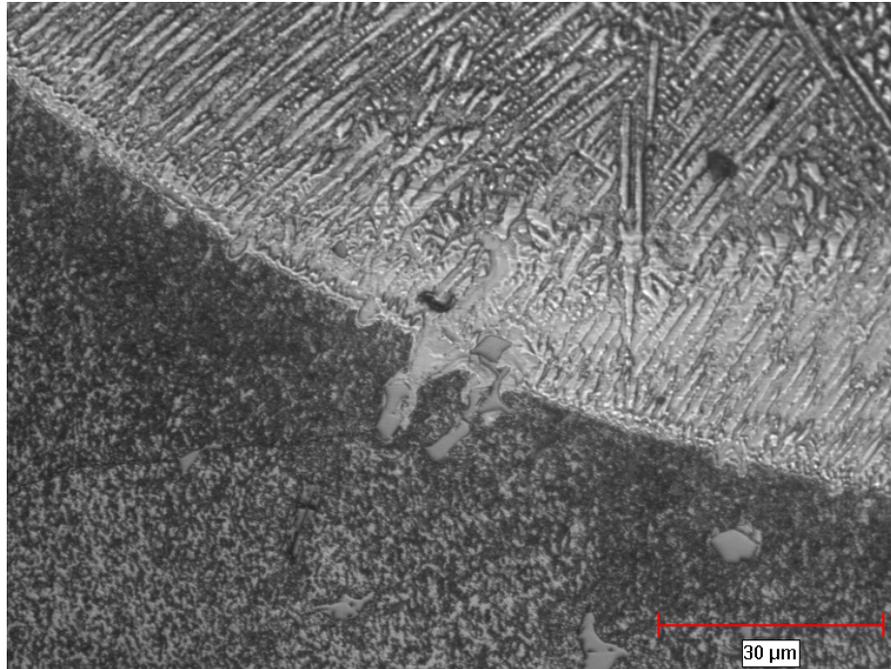
Figure 39: Optical micrograph of the weld fusion zone interface in René 80

Carbide particles were subjected to sufficiently high temperatures to cause partial liquation. As shown in Figure 39, some fragments of the carbide particle are mixed in the fusion zone to a very shallow depth. This suggests very rapid solidification with virtually no mixing near the fusion zone interface.

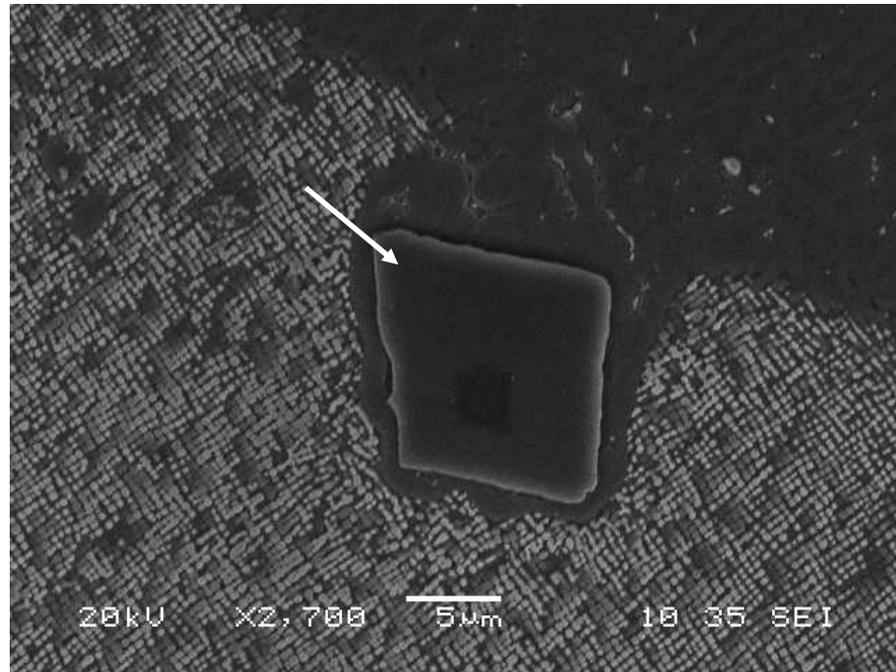
Figure 41: Liquated carbide near weld interface, René 80 alloy

to Appendix J for an EDS linescan across the partially liquated MC carbide shown in Figure 41.

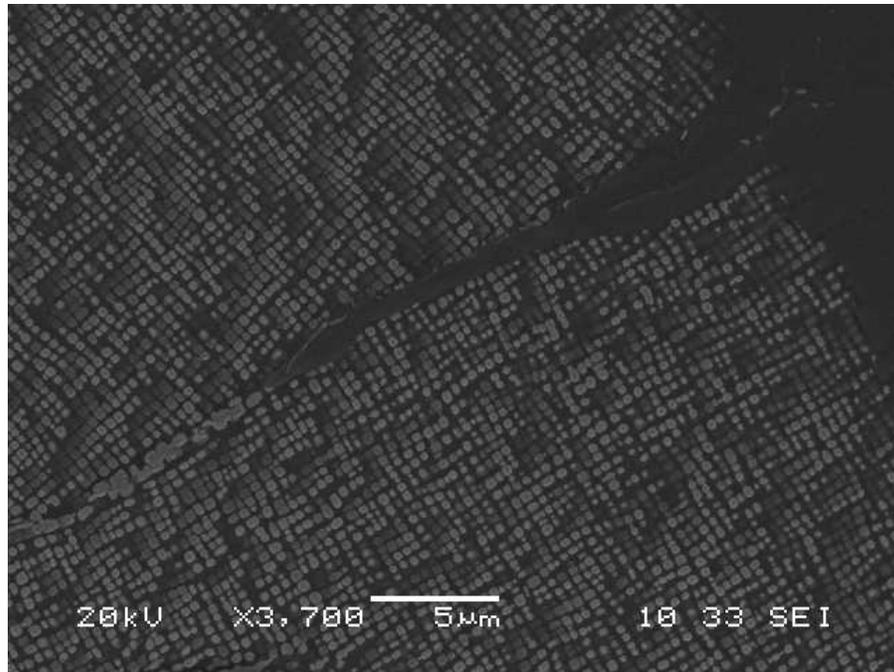
Grain boundary liquation along the interdendritic region of the parent material was observed. A 1 to 3 μm thick layer of re-solidified grain boundary parent material is shown in Figure 42 and 43 with no cracking. Higher magnification imaging revealed some shrinkage porosity aligned with the grain boundary direction but this was considerably less severe than grain boundary liquation cracking found by Sidhu et al. in René 80 from GTAW [5] and similarly for Inconel 738 with LBW [4]. The grain boundary liquation in the weld heat affected zone occurs as a result of γ' melting during the weld thermal cycle. The left side of the SEM image in Figure 42 shows the non-liquated grain boundary with γ' particles along its surface.

Figure 42: Grain boundary liquation near fusion zone interface in René 80

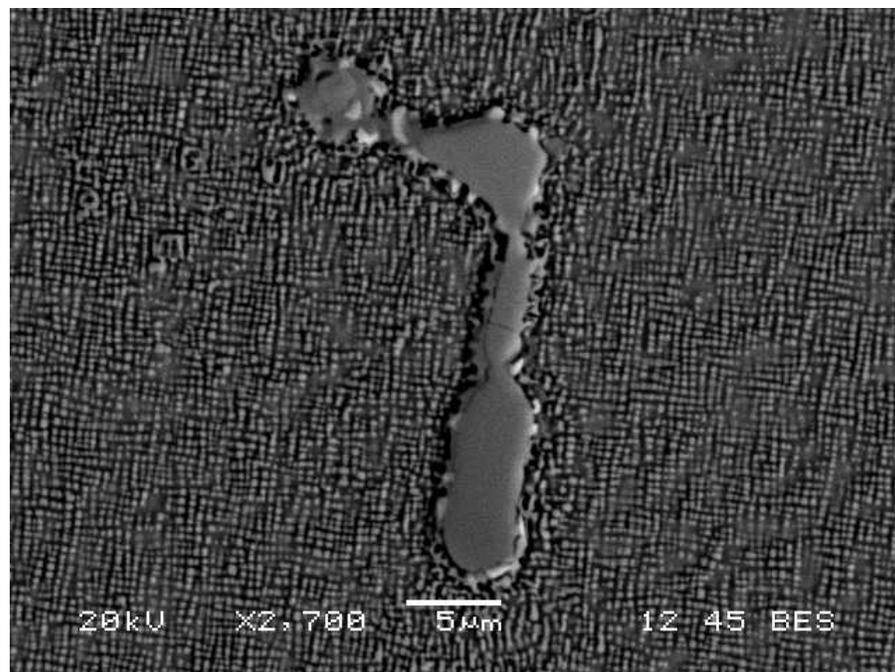
MC carbides throughout the microstructure were examined using the SEM in backscatter electron imaging mode. As shown in Figure 47, a blocky MC carbide particle is surrounded by discrete particles of lighter shade, indicating an increase in mean atomic number relative to the adjacent MC carbide and the γ/γ' prime parent material. EDS point analysis revealed that particles surrounding MC carbides were rich in boron, chromium and molybdenum. The size, morphology and distribution of these particles along with the marked increase in concentration of boride forming elements, confirms they are Cr-Mo rich borides and is in agreement with the results reported by Sidhu et al. [5] on René 80.

Figure 47: Boride phase on MC carbide in René 80 (as-welded UMT condition).

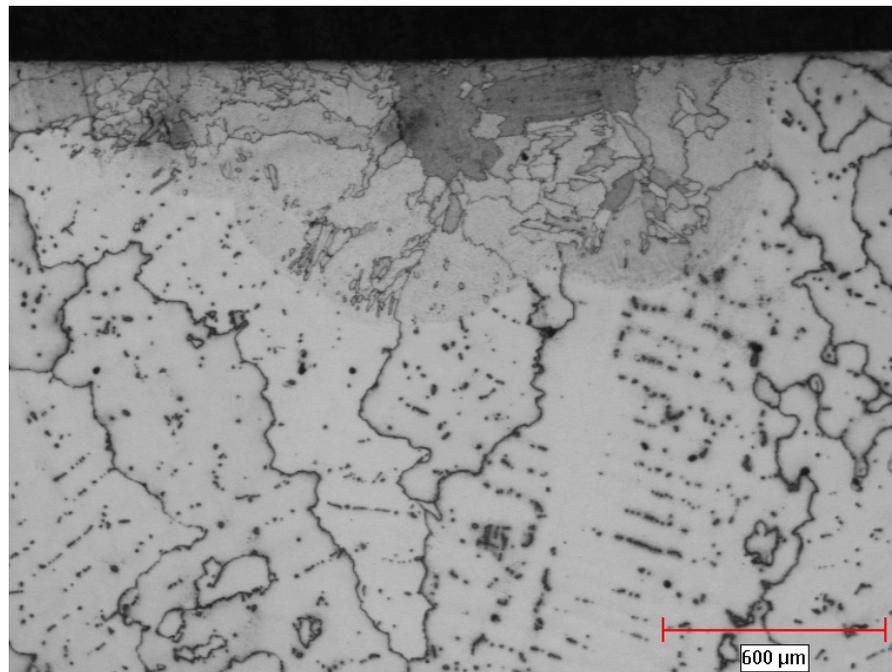
After undergoing the solution and ageing post-weld heat treatment, the fusion zone maintained the mixture of epitaxial columnar and dendritic solidification structures. Throughout the weld fusion zone, the equiaxed dendrites (stray grains) were of comparable size and distribution as was observed in the as-welded condition. Figure 57 shows the post-weld heat treated (STA) microstructure of a Inconel 738 thermo-mechanical fatigue specimen prior to testing. No heat treatment related cracking was visible along the grain boundaries intersected by the fusion zone or within the weld fusion zone. A typical grain boundary intersection with the fusion zone is shown in Figure 58.

Figure 57: Optical micrograph showing the weld cross-section of Inconel 738, post-welded heat treated condition

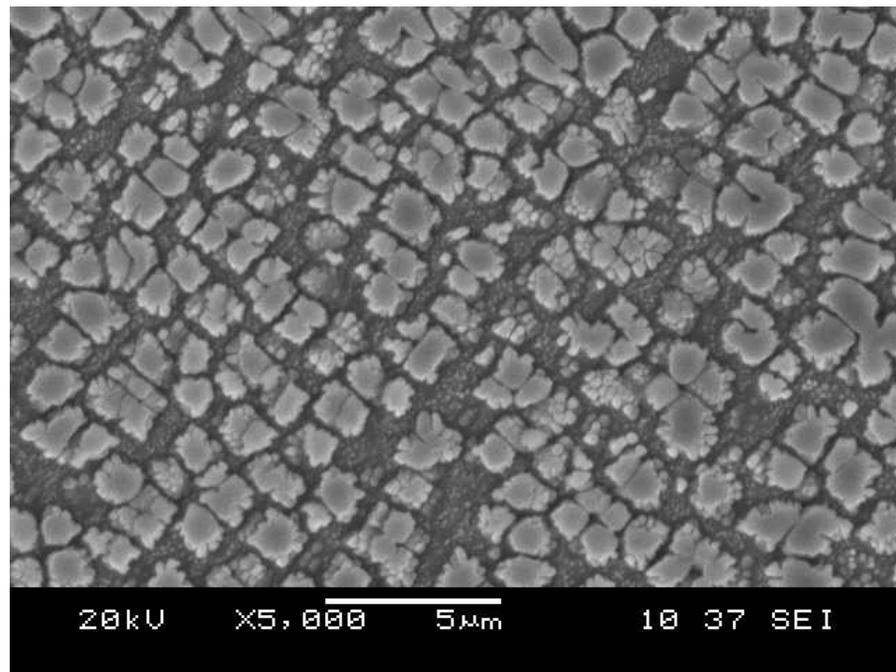
In the base material, the γ' morphology was bimodal, consisting of primary γ' as diced cubes 1.0 to 1.5 μm in size with a fine dispersion of secondary γ' as shown in Figure 60. There was no appreciable difference in the size and morphology of γ' in the HAZ and non-HAZ regions of the base material.

Figure 60: Gamma prime morphology in Inconel 738 base alloy taken in dendritic core locations (non-HAZ)

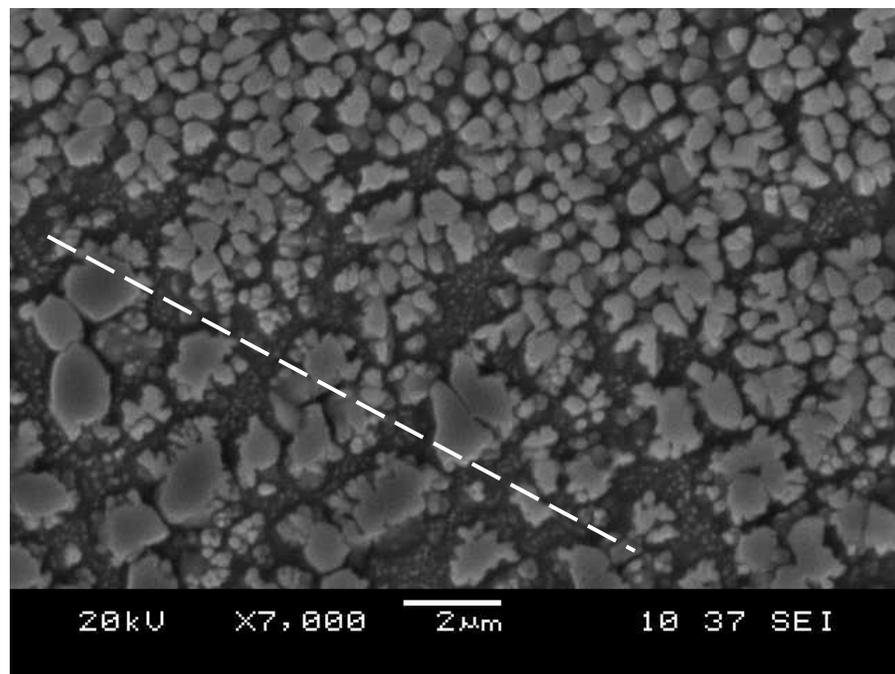
The interface between the fusion zone and base material was discernible by contrast in the size and shape of γ' in the microstructure. Figure 61 is an SEM image of the weld fusion zone to heat affected zone interface. Despite being similar in composition, the Inconel 738 base alloy and Praxair Ni-284-1 (Inconel 738 equivalent) powder show a vastly different aging response with finer γ' particles being formed in the Inconel 738 weld fusion zone during the post-weld heat treatment.

Figure 61: Fusion zone (top right) to parent material (lower left) interface in Inconel 738 base alloy

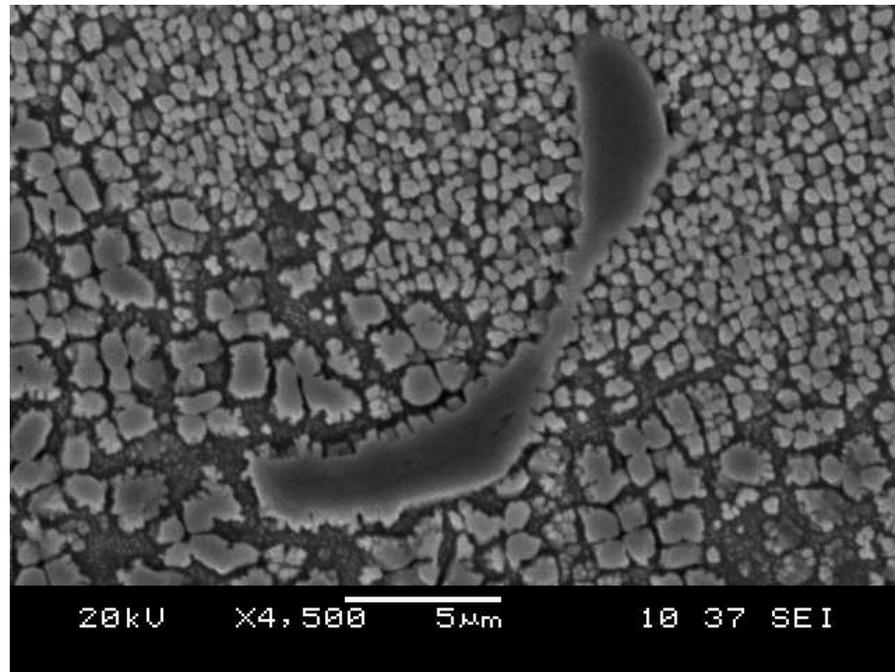
across the particle (dark core and lighter boundary) indicated a gradient in chemical composition of the particle (from core to its edges). Fine cuboidal gamma prime is visible around the perimeter of the carbide particle and illustrates the partial dissolution during the elevated temperature solution and aging treatment (STA). MC type carbides were analyzed by EDS and found to be rich in Ta, Ti and Nb, consistent with MC type carbide in nickel base superalloys [56]. A summary of EDS analysis of carbide in the post-weld heat treated Inconel 738 is provided in Table 16.

Figure 62: Carbide particle along fusion zone (top) and Inconel 738 parent material (bottom) interface.

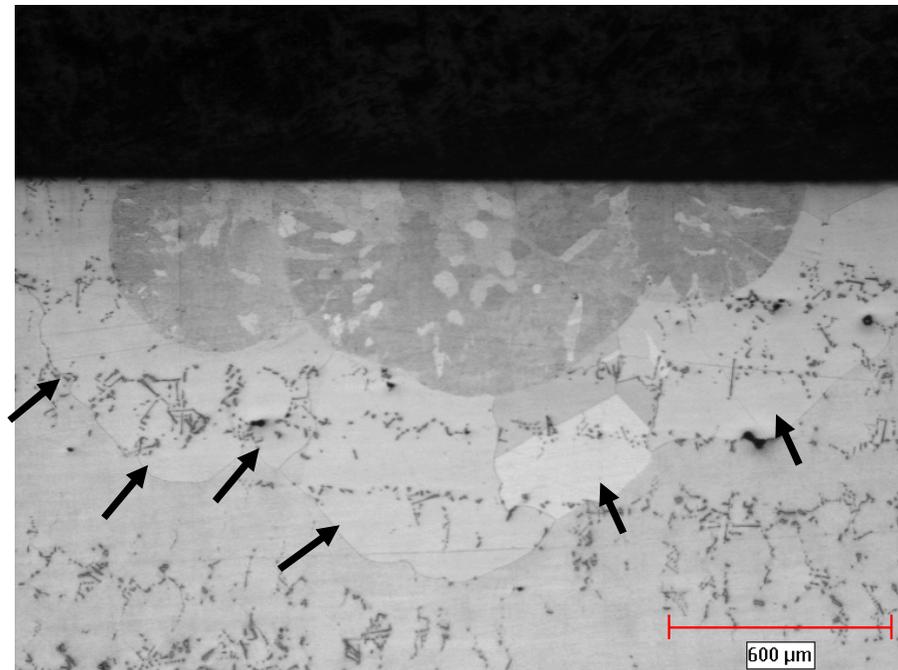
Examination of the weld microstructure in the post-weld heat treated condition revealed the presence of recrystallization in an area surrounding the weld fusion zone. As shown in Figure 63, the weld fusion zone appeared as a darker zone with the rounded profiles of three weld passes being visible. Within the fusion zone, a combination of epitaxially oriented grains and equiaxed stray grains make up the microstructure. In the heat affected zone regions surrounding the fusion zone, large recrystallized grains ranging from 300 to 500 μm in size were discernable from the base material microstructure. Higher magnification examination, as shown in Figure 64 shows good fusion with the parent material with no heat affected zone cracking along the newly formed grains boundaries. Under optical microscopy examination, the newly formed grain boundaries are generally linear in appearance, consisting of facet type interfaces between joining recrystallized grains.

Figure 63: Optical micrograph of LBW in René 80 specimen in the post-weld heat treated condition

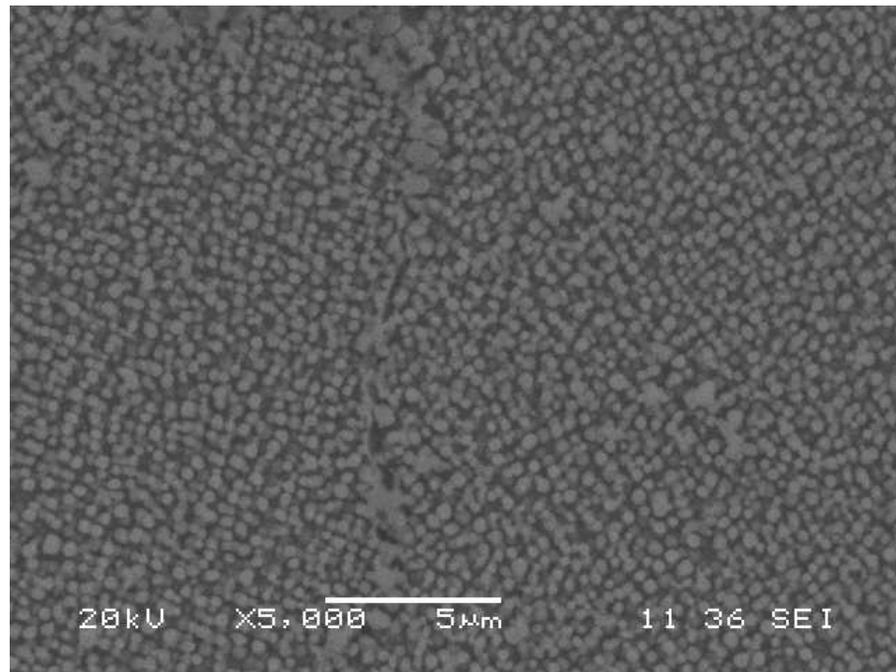
Similar to the welds on Inconel 738 base material, SEM imaging of the weld fusion zone on René 80 showed a fine gamma prime of predominantly spherical shape less than 1 μm in size. Also, a coarse layer of γ' was apparent along grain boundaries in the fusion zone and is shown in Figure 65.

**Figure 65: SEM image of γ' and grain boundary in the weld fusion zone, René 80
LBW specimen**

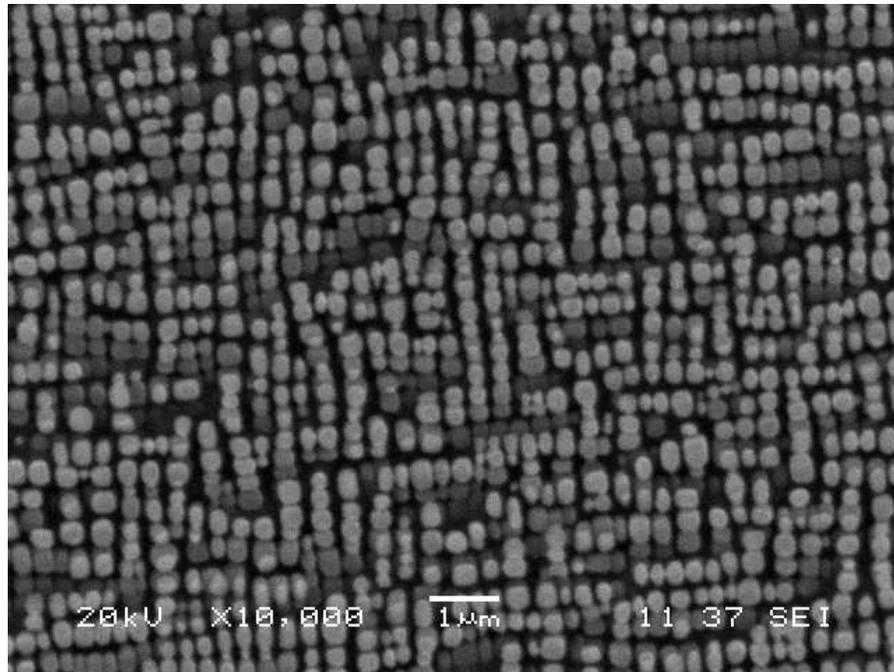
The γ' structure in the parent material non-heat affected zone microstructure was evaluated and determined to be cuboidal in morphology. The size distribution suggested a mild increase in size at the interdendritic regions over that of the dendrite cores. The size of gamma prime in the dendrite core was in the order of 0.2 to 0.3 μm and was in the range of 0.3 to 0.4 μm in the interdendritic regions and is shown in Figure 66.

Figure 66: SEM image of typical γ' in René 80 base material, PWHT condition

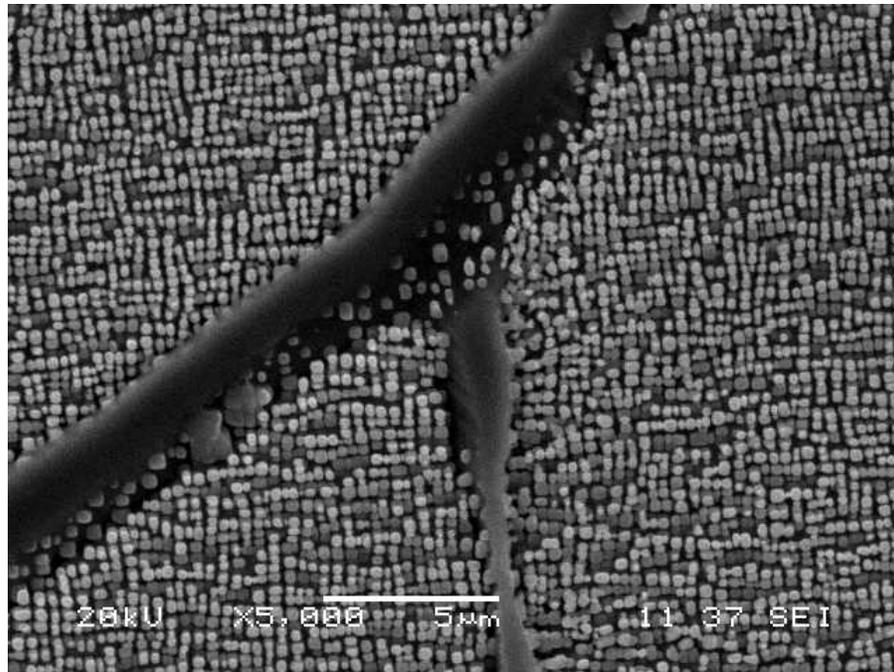
Carbides in the parent material microstructure were examined by SEM and found to have undergone partial dissolution as a result of post-weld heat treatment. As shown in Figures 67, 68 and 69, γ' particles appear on the surface of grain boundary and grain boundary carbide particles. EDS analysis was conducted on a thick region of carbide dissolution along a grain boundary and as summarized in Table 17, the high concentration of titanium is consistent with MC carbides in nickel based superalloys [56]. Refer to Table 18 for EDS analysis of carbides in the non-HAZ regions of René 80 after PWHT.

Figure 67: SEM image of carbide degeneration in along recrystallized grain boundary in PWHT René 80

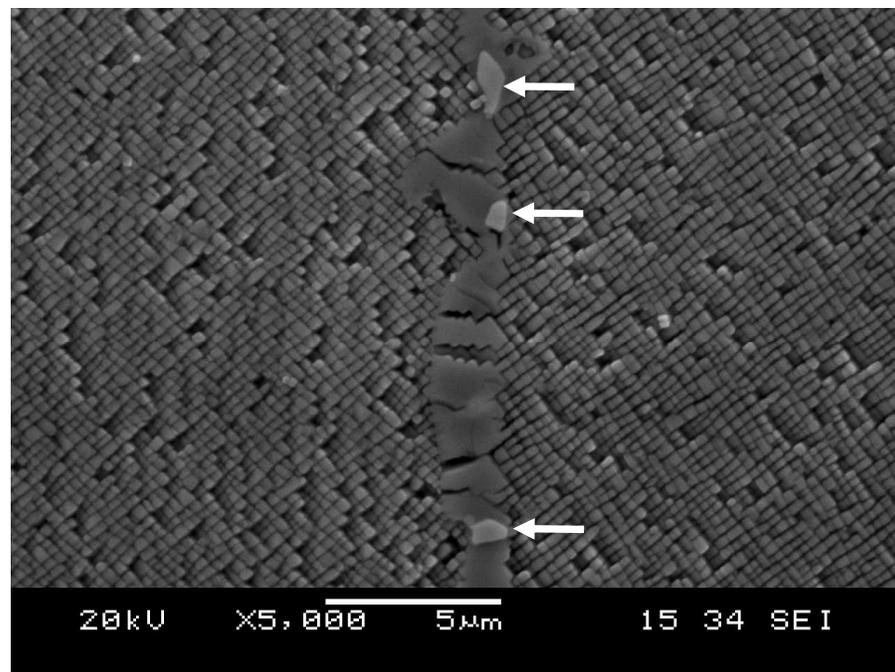
Based on the increase concentration in Cr and Mo, low Ta content and sharp spike for boron, it was suggested that the observed phase along the intergranular layer are Cr-Mo rich borides. Boron is known to have low solubility in nickel and tends to segregate to grain boundaries and this would explain the presence of borides along the newly formed grain boundaries. It must be noted however that the boride phase was not observed in the alloy in the as-received condition.

Figure 74: Cr-Mo-B rich particles along grain boundary between a recrystallized grain (left) and heat affected zone (right) in PWHT René N5

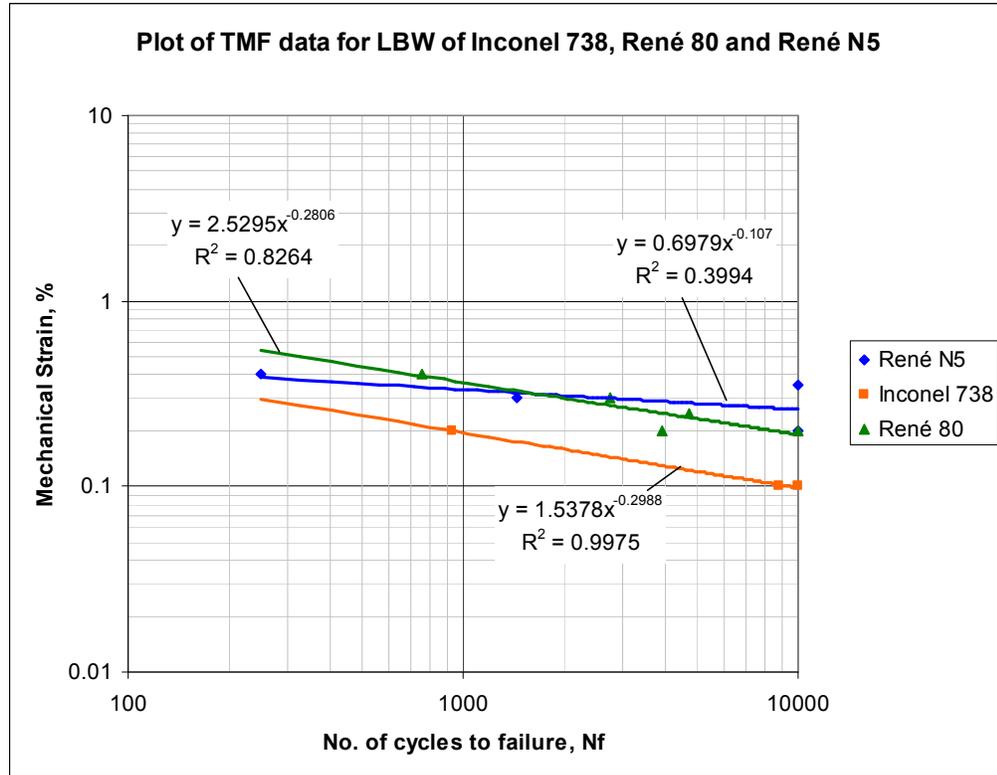
Figure 78: TMF test results for LBW specimens

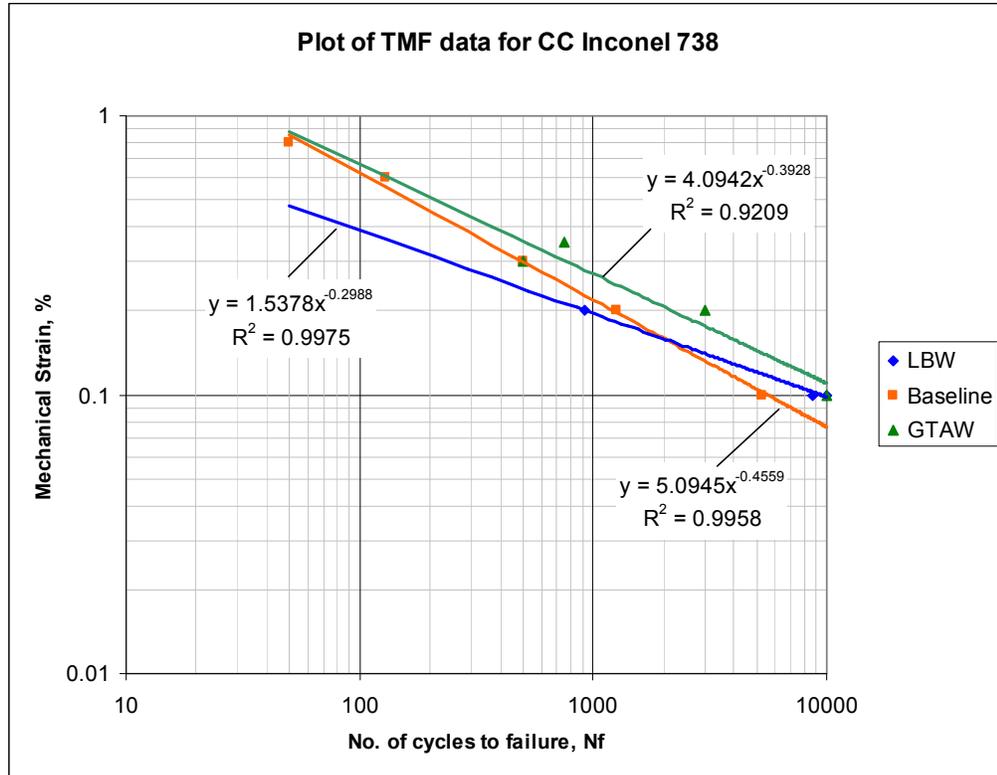
Figure 79: TMF test results for baseline, GTAW and LBW Inconel 738 specimens.

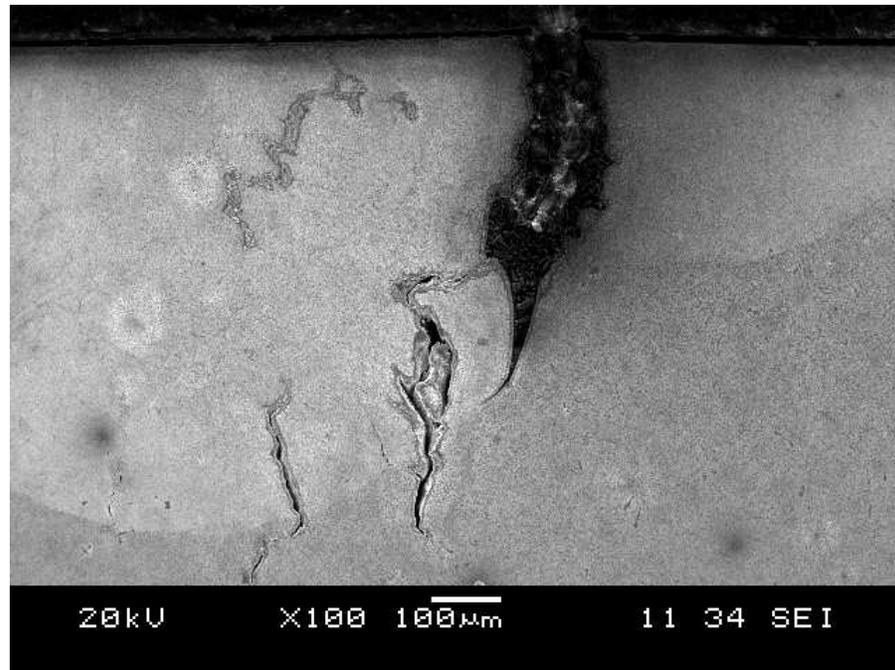
Figure 84: Cracks through fusion zone and Inconel 738 parent material, 0.1% mechanical strain after 8750 cycles

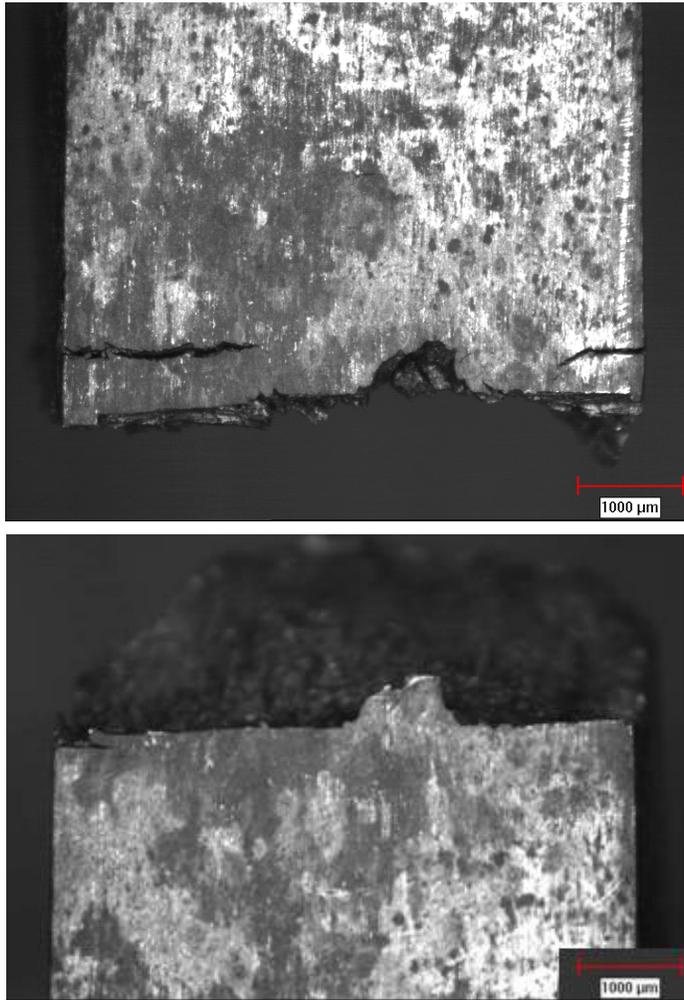
Figure 91: Top view (fusion zone side) of fractured 0.2% mechanical strain Inconel 738 specimen

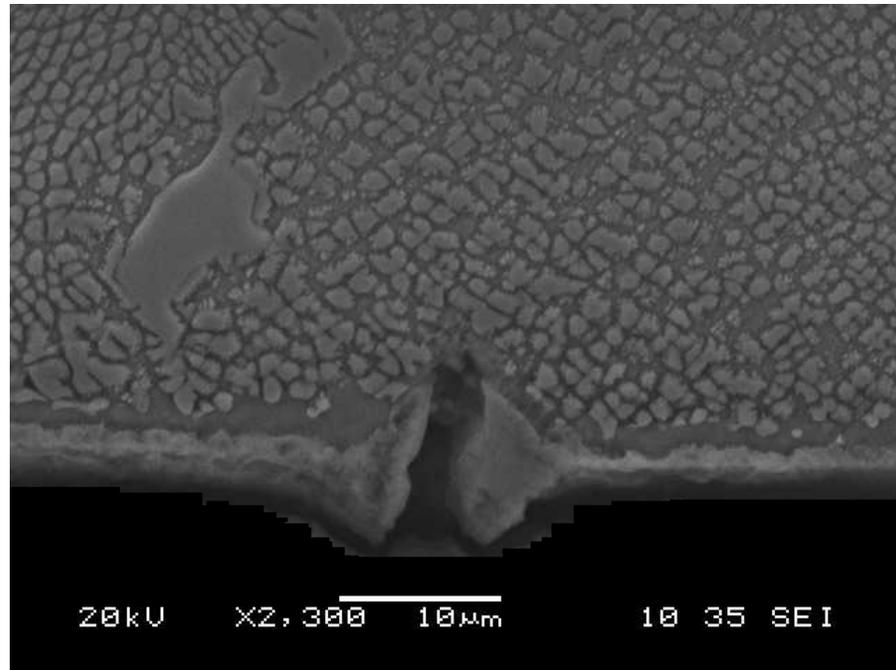
Figure 99: Crack and associated oxidation along surface of Inconel 738 specimen
