**THERMO-MECHANICAL FATIGUE OF POLYCRYSTALLINE,
DIRECTIONALLY SOLIDIFIED AND SINGLE CRYSTAL NICKEL
BASE SUPERALLOYS REPAIRED BY LASER BEAM WELDING**

**A Thesis submitted to the Faculty of Graduate Studies of
The University of Manitoba
in partial fulfilment of the requirements of the degree of**

**Department of Mechanical and Manufacturing Engineering
University of Manitoba
Winnipeg, Manitoba**

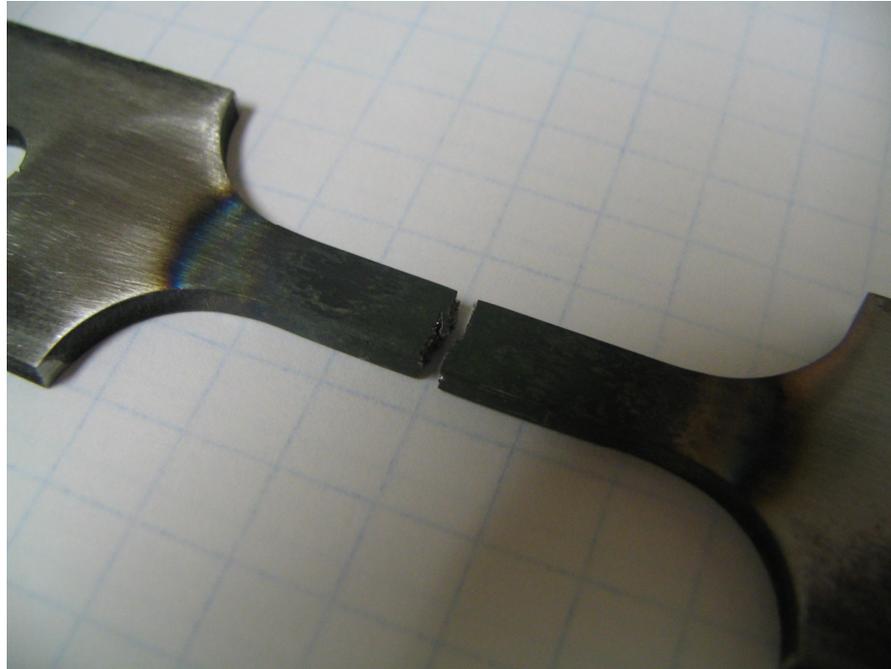
Figure 100: Fractured René 80 TMF specimen, 0.2% strain

Two LBW René 80 specimens were tested under 0.2% strain. One fractured at 3950 cycles while the other ran for the maximum of 10,000 cycles as defined by the upper boundary of testing undertaken in this study. Figure 100 is a photograph of the fractured specimen taken in the as-tested condition. The specimen's gauge section, where heat was applied by resistance heating, exhibited surface oxidation as evidenced by the dark grey/black colour and the blue to straw transition toward to the specimen tabs where copper grips provided cooling. The specimen showed sign of deformation or necking near the fracture.

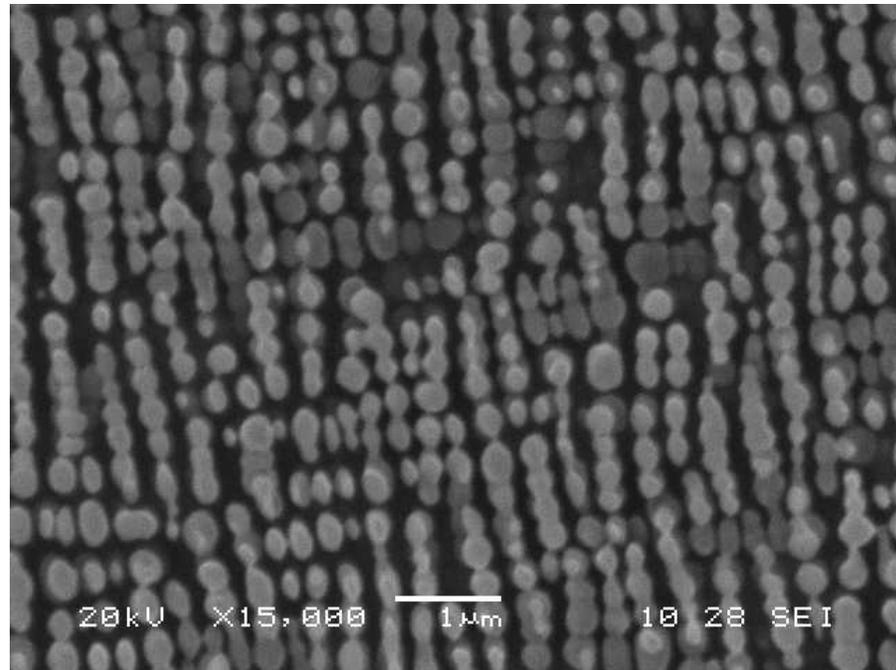
Figure 109: René 80 γ' morphology near crack surface, early stages of rafting

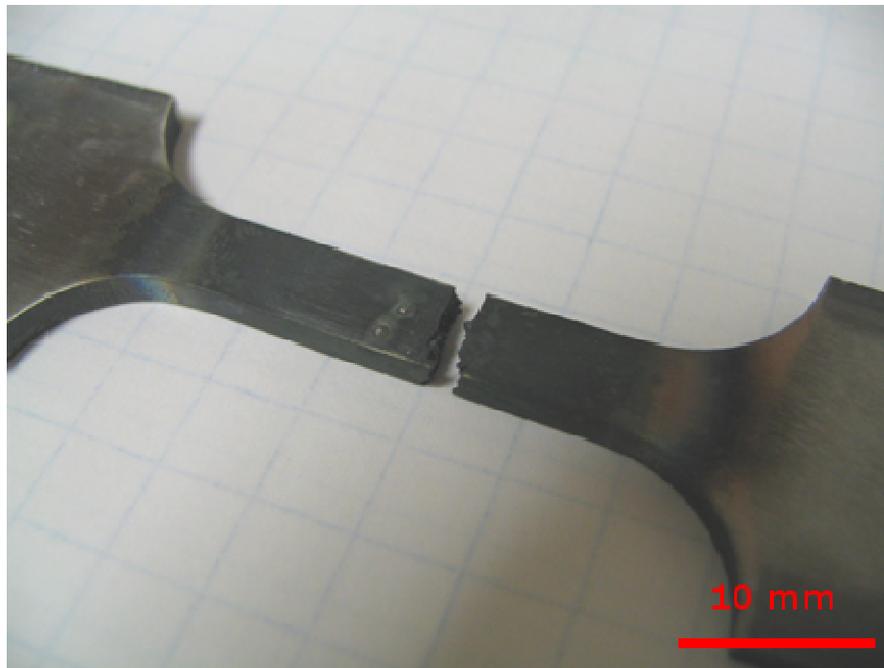
Figure 110: Fractured 0.25% strain René 80 MF specimen

One TMF specimen was tested under an applied strain of 0.25%. The specimen fractured after 4750 cycles and is shown in Figure 110. Similar to the TMF specimen tested at 0.2%, the 0.25 % strain specimen showed oxidation in the gauge section. Low magnification examination under the optical stereomicroscope showed a crack path through the weld fusion zone, recrystallized region and the parent material. The specimen fracture surfaces appeared very similar to those of the 0.2% strain specimen with the exception that oxidation appeared to have occurred over the entire weld fusion zone fracture surface as shown in Figure 111. Also, the crack propagation took an intergranular path in the recrystallized regions as evidenced by the faceted grain structure being exposed.

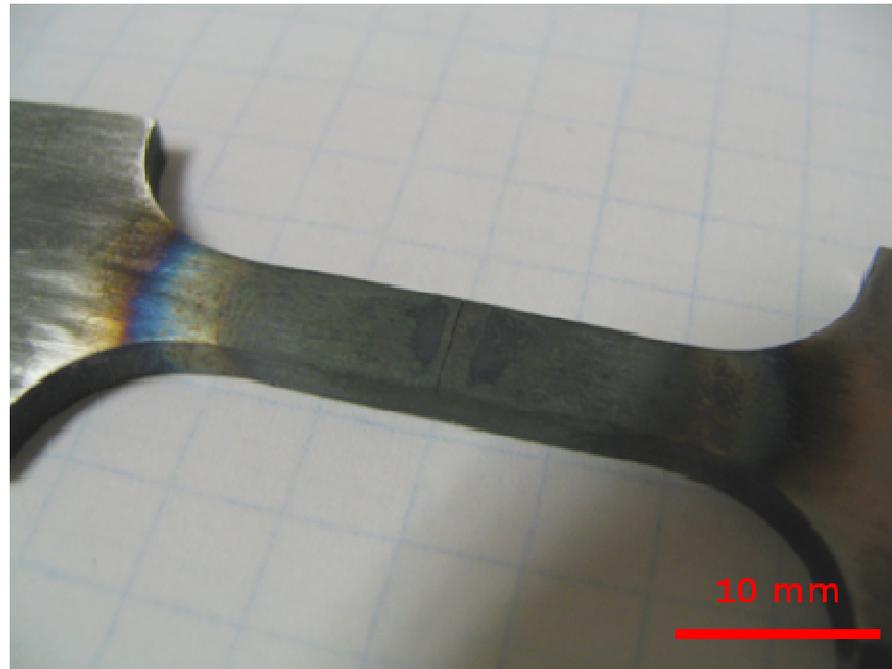
Figure 120: 0.3% strain René 80 TMF specimen

The 0.3% strain specimen (Figure 120) ran for 2750 cycles until a crack was visible in the gauge length. As shown in Figure 121, the crack propagated across the specimen width to a depth of approximately 1 mm. As shown in Figure 122, the crack appears left of centre along the weld fusion zone. Metallographic assessment of the TMF specimen confirmed that the crack initiated in the fusion zone where it is widest, and propagated through to the recrystallized grains and parent material microstructures. The crack bisected the columnar grain structure of the parent material without significant change in

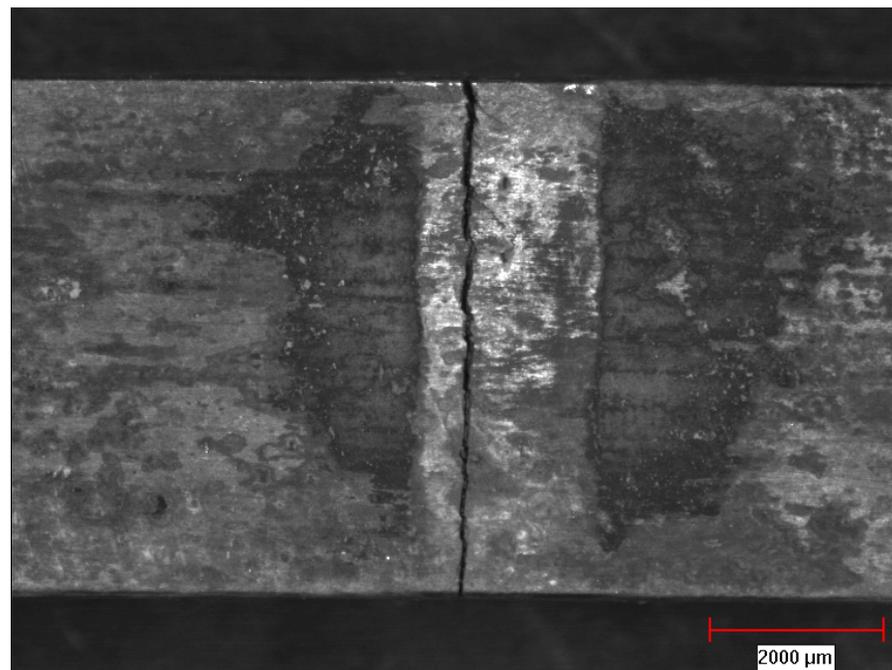
Figure 121: Crack along fusion zone, 0.3% strain René 80

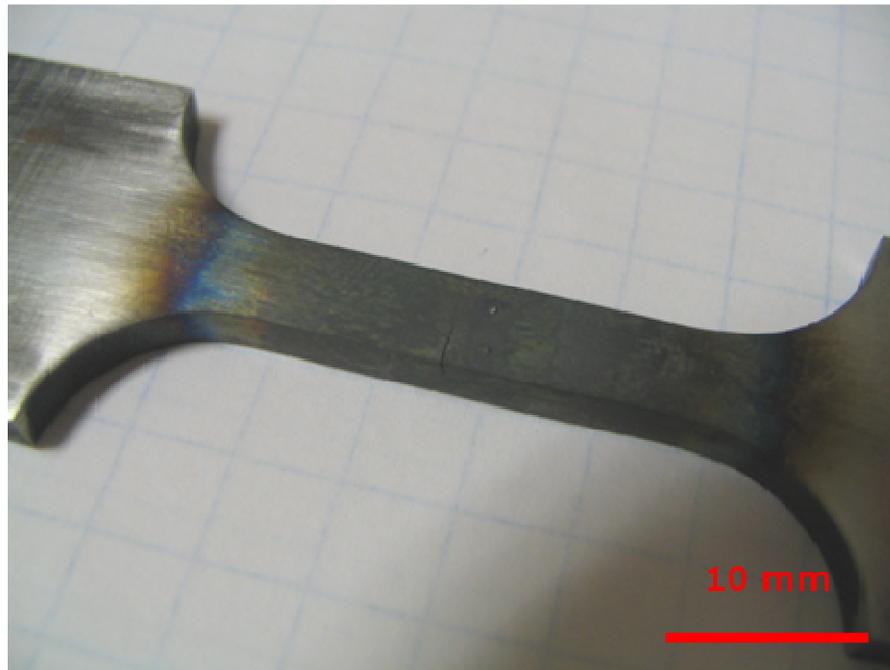
Figure 124: 0.4% strain René 80 TMF specimen

The 0.4% strain specimen (Figure 124) ran for 750 cycles until a crack was detected in the gauge section. Figure 125 shows the specimen gauge section with a surface crack propagating over approximately half the width and to an approximate depth of 1 mm. Figure 126 is an optical stereomicroscope photograph showing the crack across the specimen's width.

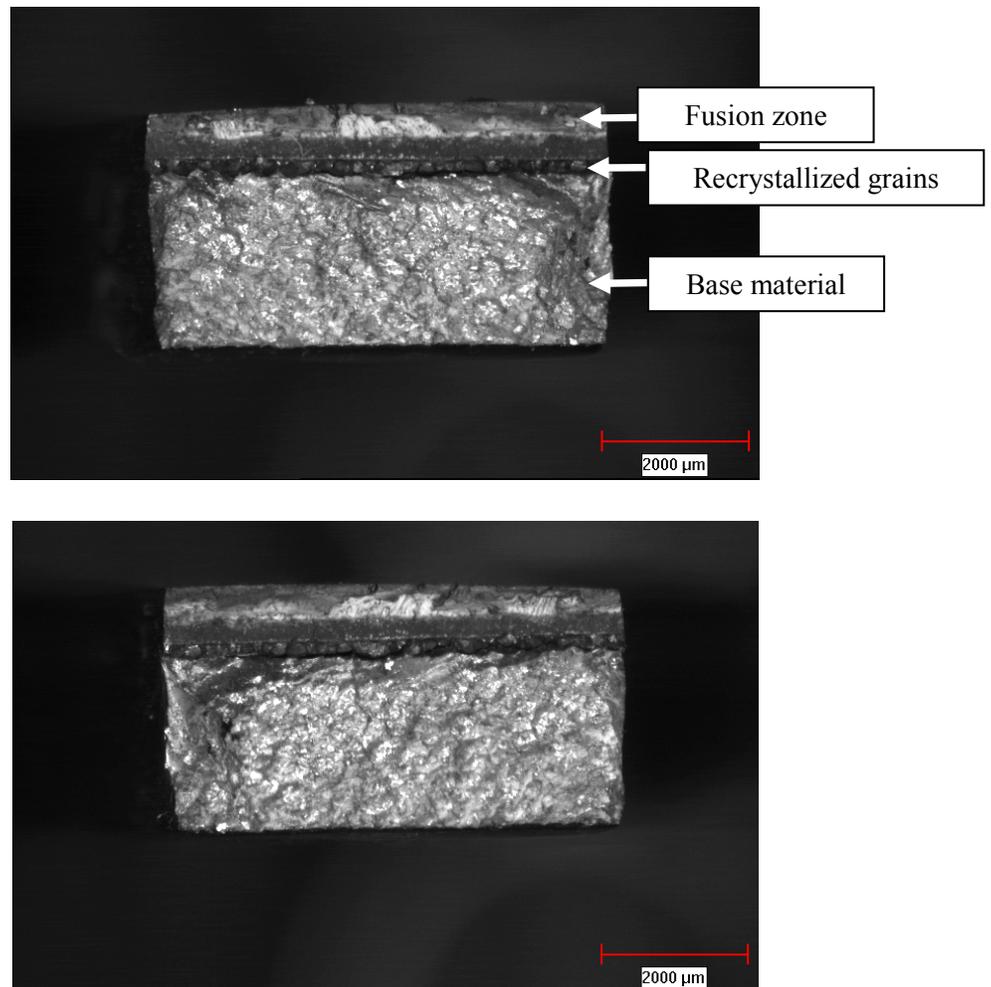
Figure 145: Fracture surfaces of 0.4% strain TMF specimen showing the weld fusion zone and recrystallized grains in the weld heat affected zone.

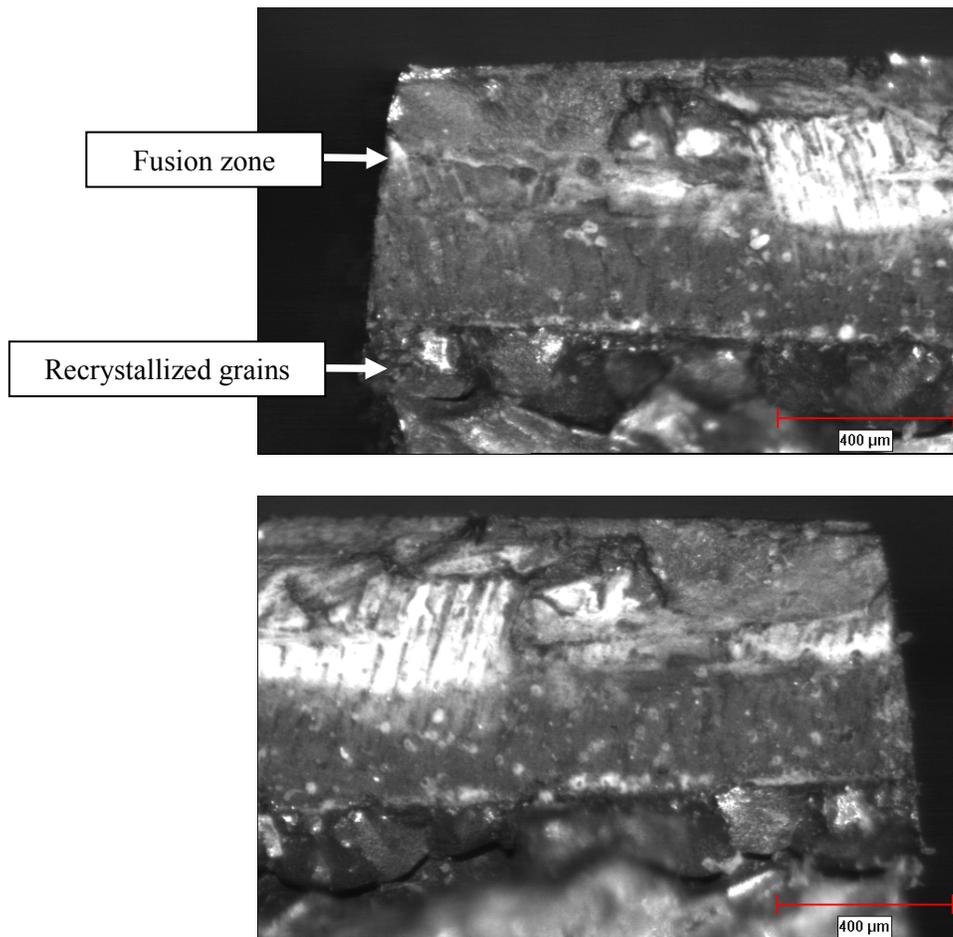
Figure 146: Crack initiation sites at corners in the weld fusion zone in 0.4 strain TMF specimen.

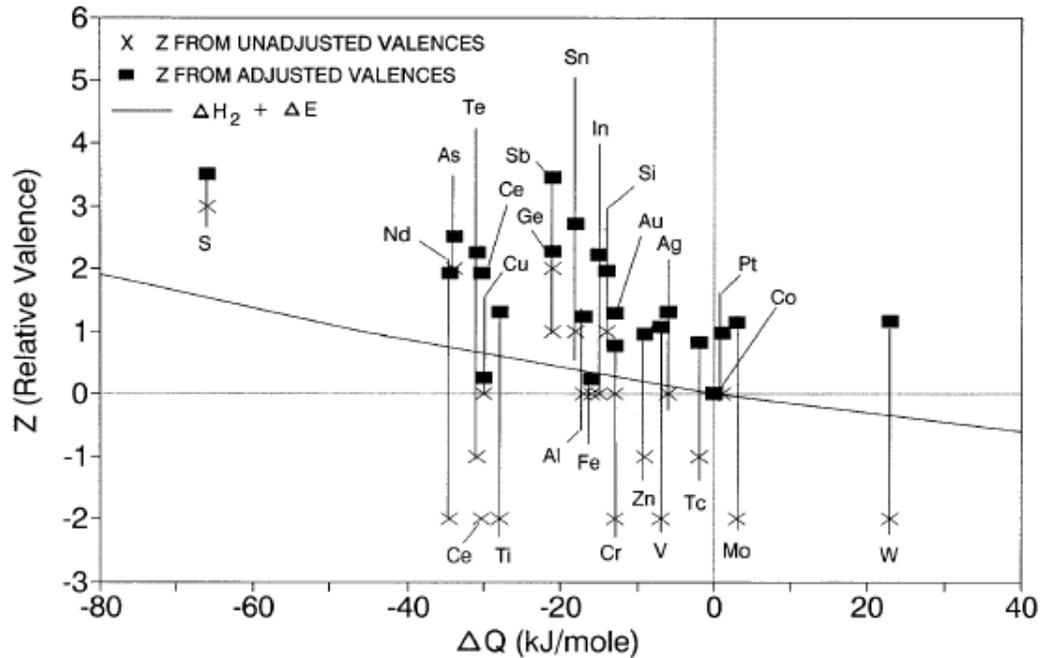
Figure 153: Activation energies for solute impurity diffusion in nickel. © Reprinted with kind permission from Springer Science and Business Media [67].

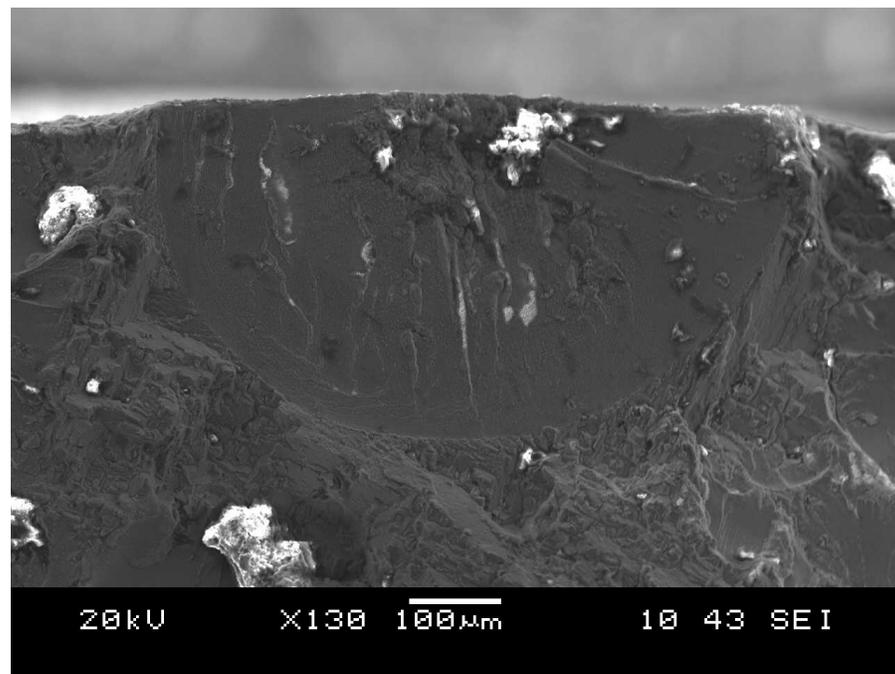
Figure 154: SEM fractograph image of fatigue crack initiation in René 80
