THE OCCURRENCE OF  
MAGNETIC PARTICULATE RESIDUES  
IN VEHICLE PROPANE TANKS

A Thesis  
Submitted to the Faculty of Graduate  
Studies in Partial Fullfillment of the  
Requirements for the Degree of

Department of Mechanical Engineering  
University of Manitoba  
Winnipeg, Manitoba

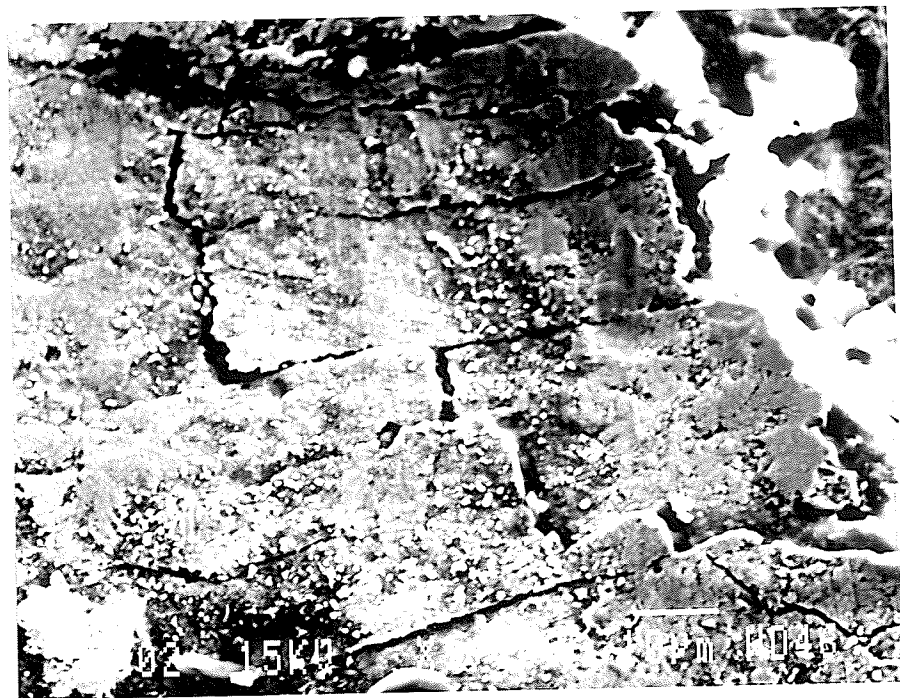
FIGURE 22 Interior Oxide Layer Spallation (1100X)

oxide spallation was clearly observed on the inside oxide of the tank shell. The surface showed a large number of small areas where the oxide had spalled off, and numerous stress cracks. Figure 22 shows parts of the inner oxide layer which have partially lost adhesion, adjacent to a spalled area. The outside tank shell oxide surface showed little evidence of spallation, although stress cracks were found. Both tank end cap oxide surfaces showed little evidence of oxide spallation, but stress cracks were observed.

appears to be by both routes. Figure 22 shows spallation from the interior tank shell oxide. Oxide buckling, characteristic of Route II spallation, is very evident. Figure 18 shows oxide through-thickness cracking which is characteristic of Route I spallation, before release of the oxide particle.

in the vehicle filter residues. Comparison of XRD diffractograms of the residues and tank wall, Figures 6 and 24, respectively, clearly shows the compositional match. It can therefore be concluded that the black magnetic residues are simply flakes of tank wall oxide, which have spalled off. This conclusion is supported by the fact that the one aluminum tank in the DND test fleet failed to produce any black magnetic residue, and by Figure 22 which shows spallation of the interior tank shell oxide layer.

4. The oxide layer spalls off during service (Figure 22), forming the black magnetic particulate residues which accumulate in the motor vehicle filters.

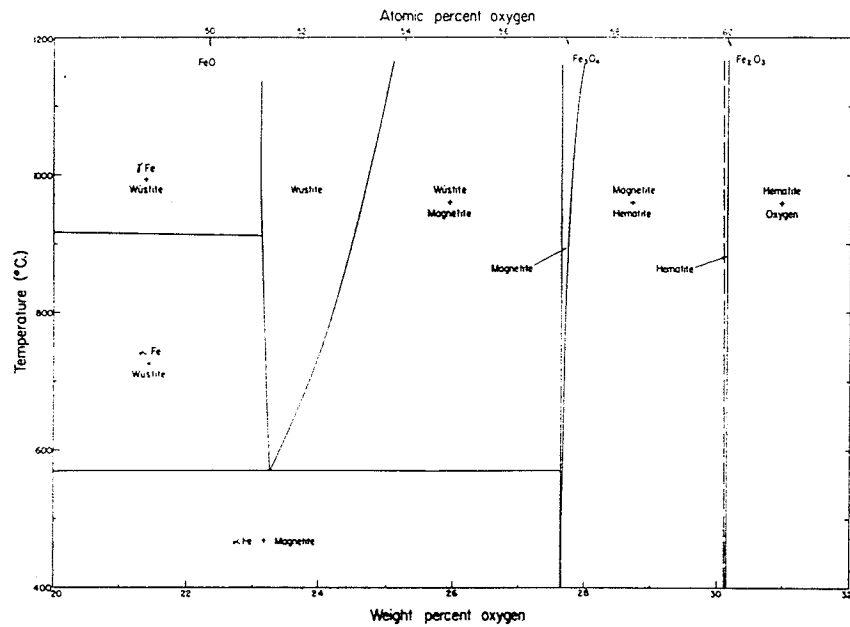
**FIGURE A.1** Fe-O Phase Diagram<sup>7</sup>

Oxide phase stability also depends on oxygen concentration. Figure A.1<sup>7</sup> shows the equilibrium iron-oxygen phase diagram.
