ASSESSMENT OF SANDBAG DIKE PERFORMANCE

**Department of Civil Engineering
University of Manitoba
Winnipeg, Manitoba**

This thesis examines the interface friction characteristics and full-scale testing of sandbag dikes under simulated flood conditions. A laboratory testing program and a full-scale testing program have been conducted to assess the performance of sandbag structures built according to the City of Winnipeg's 1997 design template.

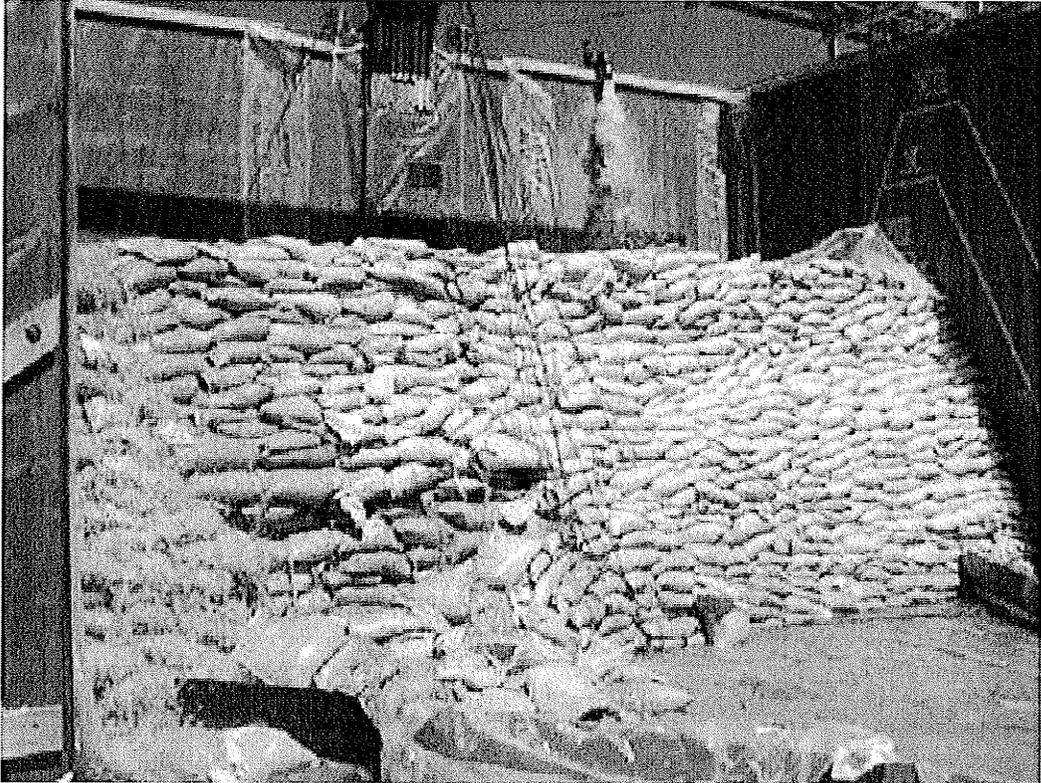
Figure 5.7 – Dike A2 Failing at Overtop Loading.

Figure 5.7 – Dike A2 Failing at Overtop Loading.

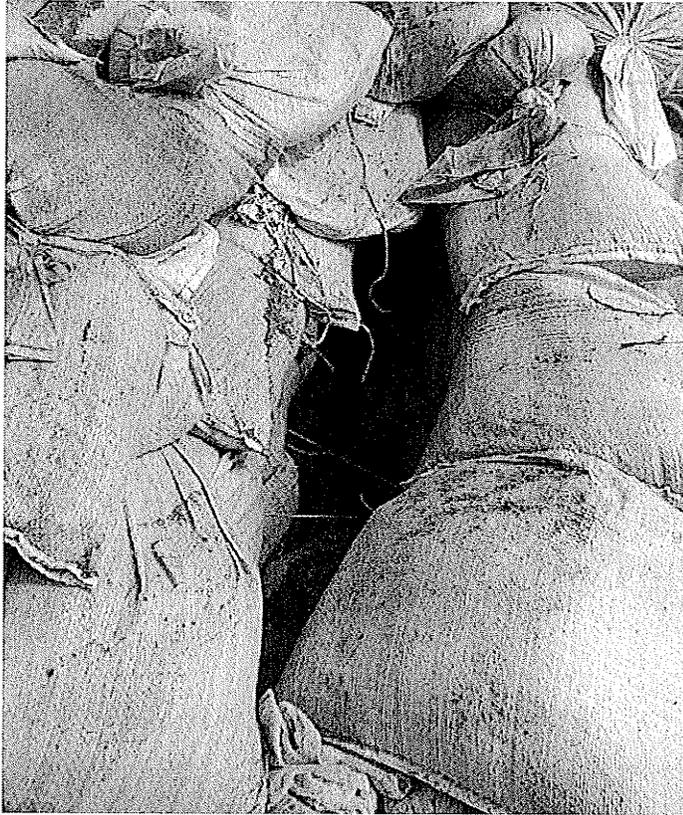
Figure 5.9 – Gap Between Sandbags Observed During Exhumation of Dike A2.

Figure 5.9 – Gap Between Sandbags Observed During Exhumation of Dike A2.
