**STREAM ANALYSIS
AND
OPPORTUNITIES FOR REHABILITATION
OF TRURO CREEK IN BRUCE PARK**

**A Practicum Submitted In
Partial Fulfillment of the Requirements
For The Degree
Master of Natural Resources Management**

**Natural Resources Institute
The University of Manitoba
Winnipeg, Manitoba**

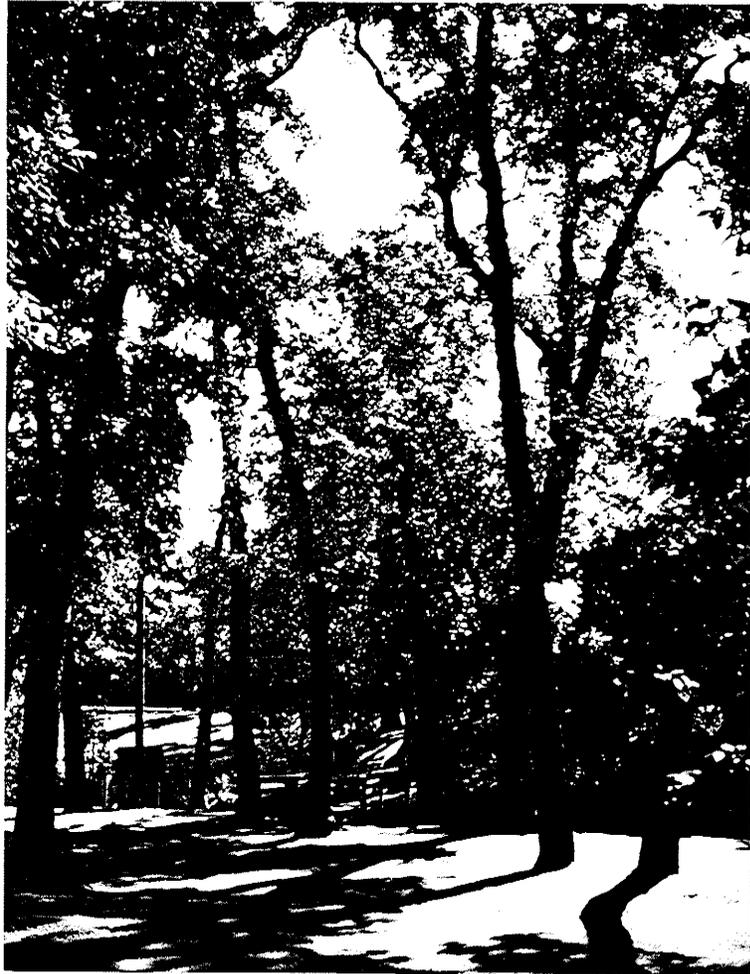
Photo P-1. South end of Bruce Park showing the South Bridge over Truro Creek (July 14, 1993).

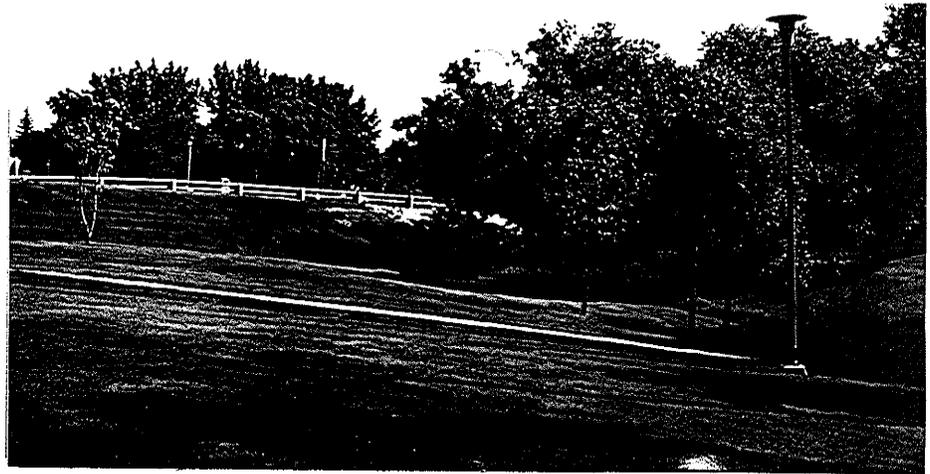
Photo P-2. North end of Bruce Park with the Portage Ave. culvert in the distance (Jul 14/93).

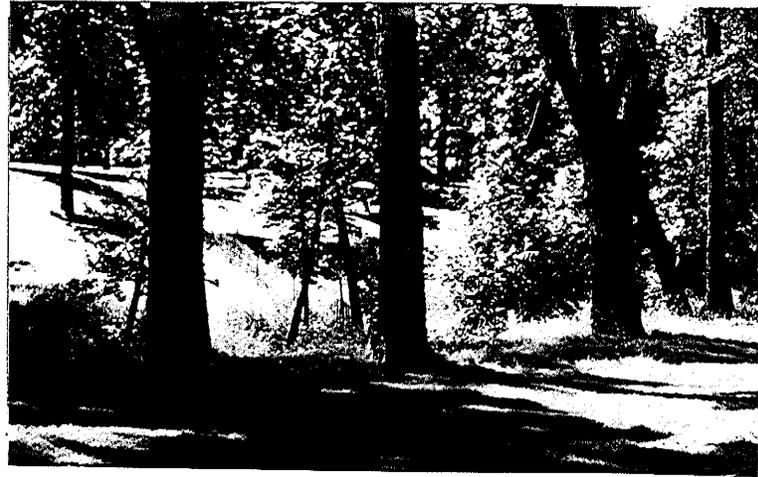
Photo P-3. 'Natural Reach' showing the creek valley and buffer (July 14, 1993).

the City of Winnipeg's Parks Department, marking off where city crews should not mow the grass. The buffer is visible in Photo P-3.

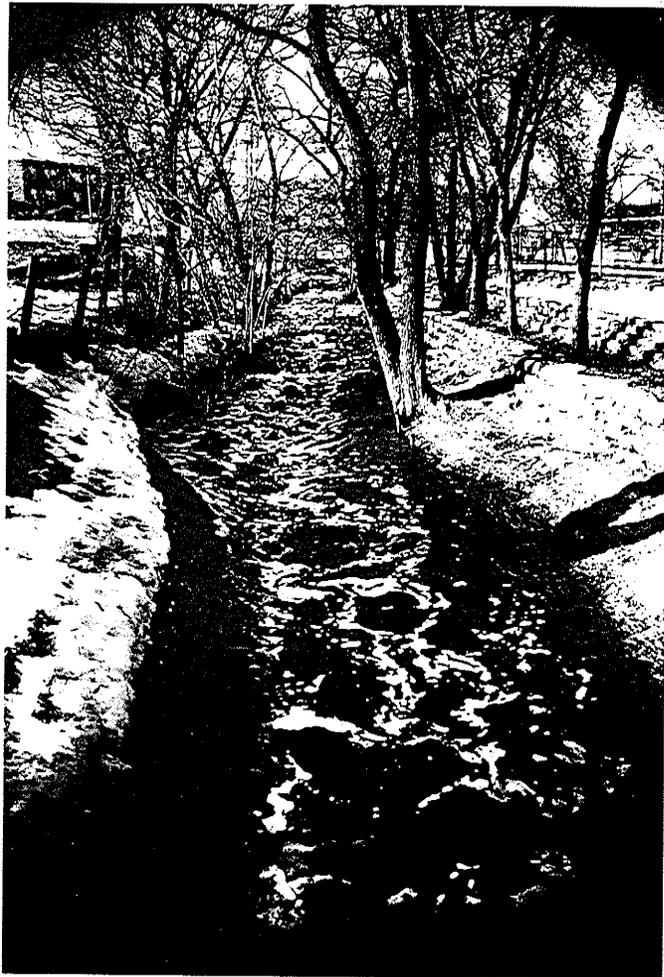
Photo P-4. Truro Creek alongside wading pool in spring (Apr 2/93).

Photographs P-4, P-5A, and P-5B illustrate the erosive power of the creek. Both Photos P-4 and P-5A were taken in the spring of 1993 close to the time of peak flow on Truro Creek. The flow in the creek when the photographs were taken has been estimated at 30 cfs. Photo P-4 shows the creek flowing beside the wading pool area with the asphalt pathway on the left and the tiered retaining wall on the right. Photo P-5A was taken downstream of the playground bridge at the same time. Photo P-5B is an identical view to P-5A except it is under low flow conditions. (See Figure 2 for location.) Photo P-5B illustrates the erosive power of the creek as evidenced by the scour in the middle of the photograph. The city has attempted to halt the erosion by installing some concrete works along the bank and by placing concrete rubble and rocks on the creek bed. The bank works are visible just below the fence posts, which appear at the top of the photograph.

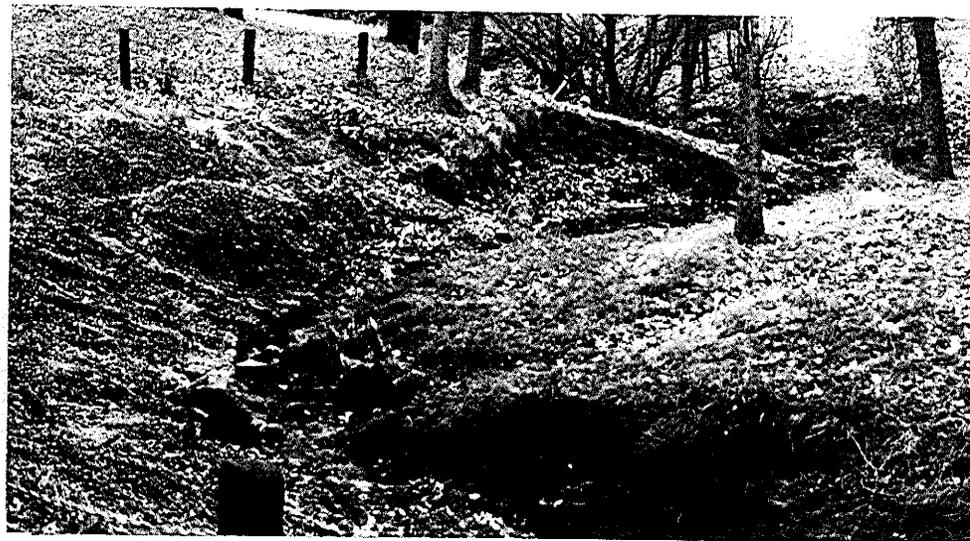
Photo P-5B. Same view as above but at low flow. Note concrete bank works and scours (Nov 3, 1993).

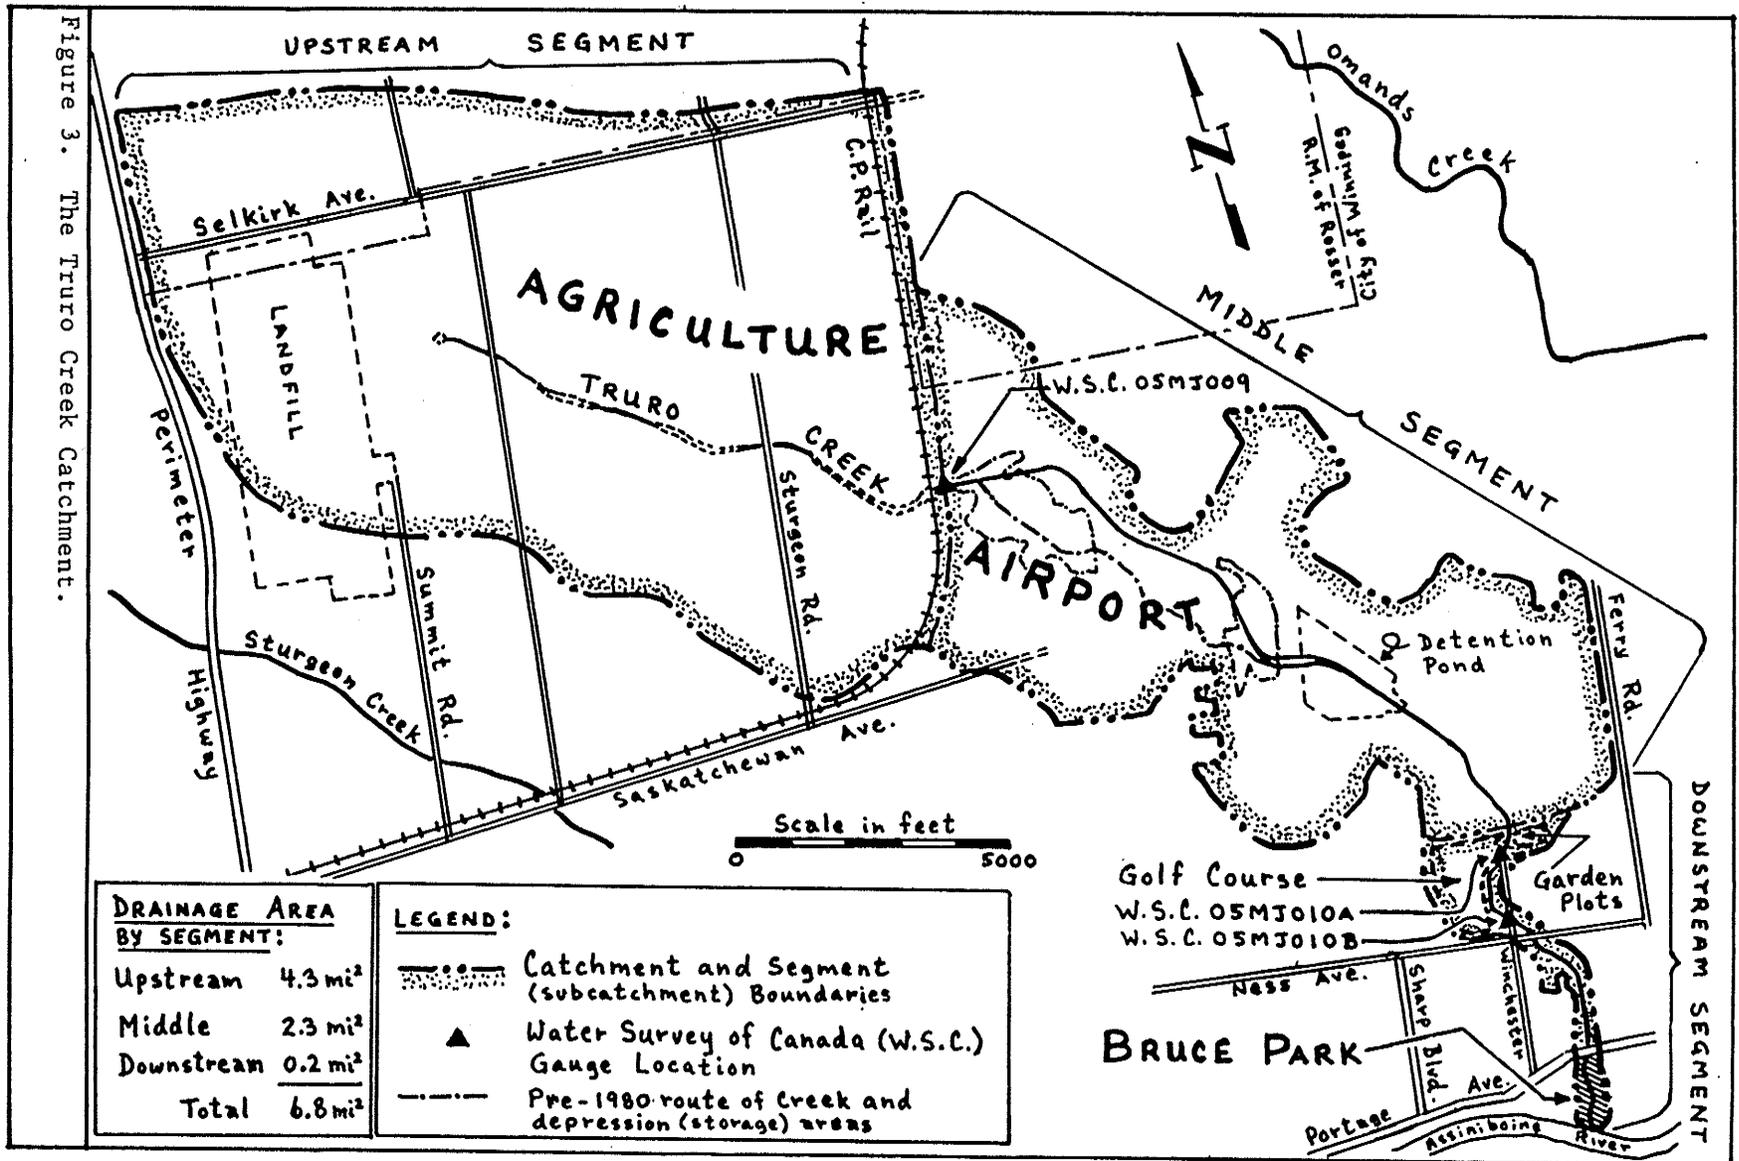
Figure 3. The Truro Creek Catchment.

shown on Figure 3: upstream, middle and downstream. Within the catchment boundary are a number of land uses, by far the predominant ones being agriculture (upstream segment) and the airport (middle segment), with areas of 3.7 and 2.3 square miles respectively. The third largest land use is the Summitt Road Landfill site at 0.7 square miles (upstream segment). In other words, the upstream and middle segments, that is, from the perimeter highway to the south boundary of the airport, account for 97% of the catchment area. The contributing area from the airport boundary south to Bruce Park (downstream segment) is relatively insignificant in size at only 0.2 square miles, or 3% of the total catchment area. The downstream segment would be a little larger but is not because the residential area south of the airport is serviced by a combined sewer system which drains surface runoff water away from Truro Creek. The only contributing areas in the downstream segment are the garden plots just north of Silver Avenue, the Assiniboine Golf Course, and a small riparian strip along the creek.

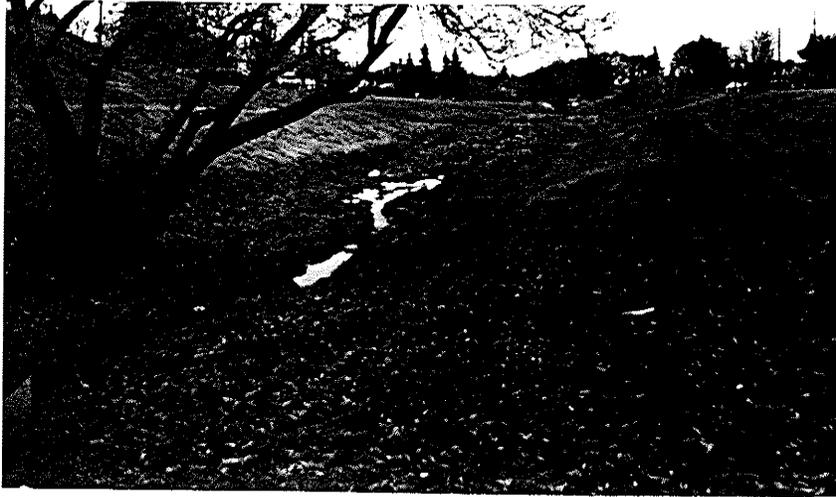
Photo P-6. The creek looking north from Portage Ave. in Truro Park (Nov 3, 1993).

Photos P-6 to P-9 inclusive show views of the creek as one moves in an upstream direction from Bruce Park. The locations from which the first three of these shots were taken are shown on Figure 1 (Chapter 1); the location of the last one (P-9) is not shown on any map. Photo P-6 is a view of Truro Park where the creek is restricted to a well-engineered straight channel. In spite of its condition, the creek still shows a tendency to meander with some pool and riffle development occurring. Photo P-7 shows the Albany Street crossing just south of Ness Avenue. The crossing is quite often overtopped (once every two years on average) as its capacity is less than one-

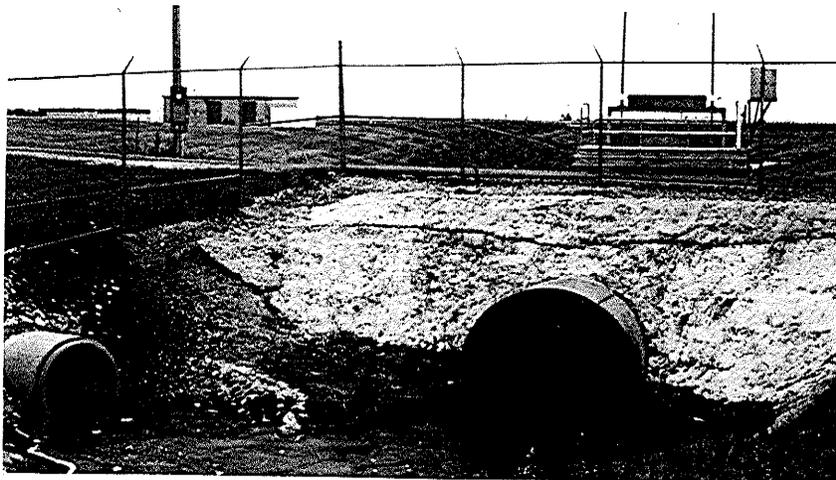
Photo P-8. The Pollution Control Structure at airport outlet (Nov 3, 1993).

half the capacity which generally exists in the reach downstream of the airport. Photo P-8 is a view of the so-called Pollution Control Structure (P.C.S.) at the south boundary of the airport property. The structure is simply a gated culvert controlling the creek flow, which may be closed in the event of an environmental emergency, such as a fuel spill at the airport, following which cleanup may commence. Photo P-9 shows the so-called 'pilot channel' in the upstream segment looking east from Sturgeon Road (photograph location is not shown on any map). Being primarily a swale, the creek channel is not well defined in this segment.

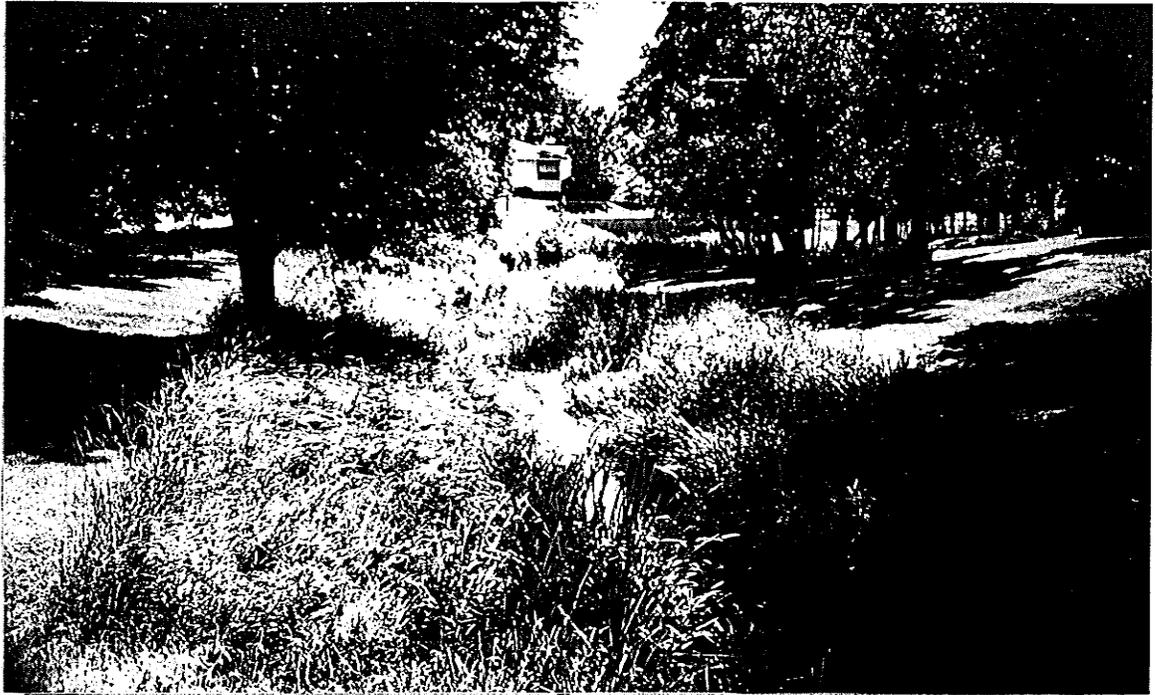
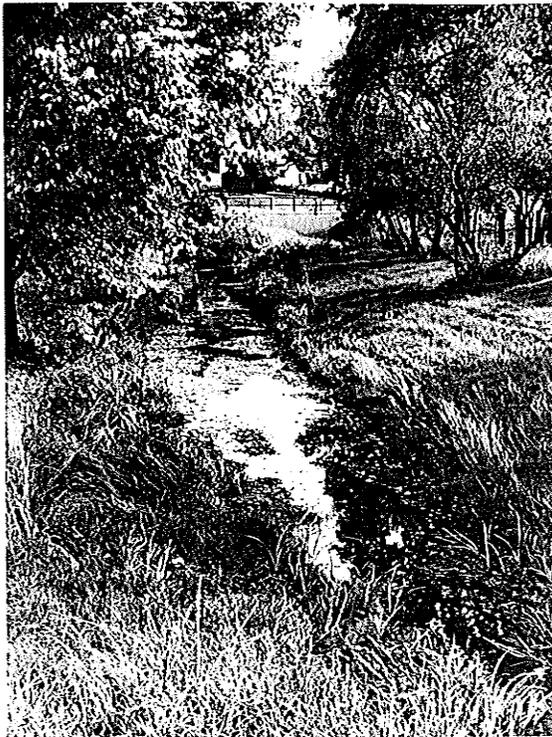
The series of photographs contained in Photos P-10(A), (B), and (C) were taken during the course of 1993 in the reach between Winchester and Linwood Streets just north of Ness Avenue. (See Figure 1 for location.) The photographs provide a pictorial example of a stable riparian area along the creek. Photo (A) was taken in summer. It shows the grass buffer zone which is intended to trap nutrients from runoff and keep them out of the creek which otherwise could be detrimental to the aquatic life. The buffer may also aid somewhat in retarding peak flow runoff to the creek. A fair amount of shade is provided by the mature trees to help cool the water in the creek. In addition, the buffer appears to be amenable habitat for ducks by possibly providing some nesting cover; on May 5, 1993, a pair of mallards (male and female) were observed dabbling in the pool at the site. Photo (B) was taken in September and shows the long grass of the buffer having been mowed and the leaves from the trees having fallen into the

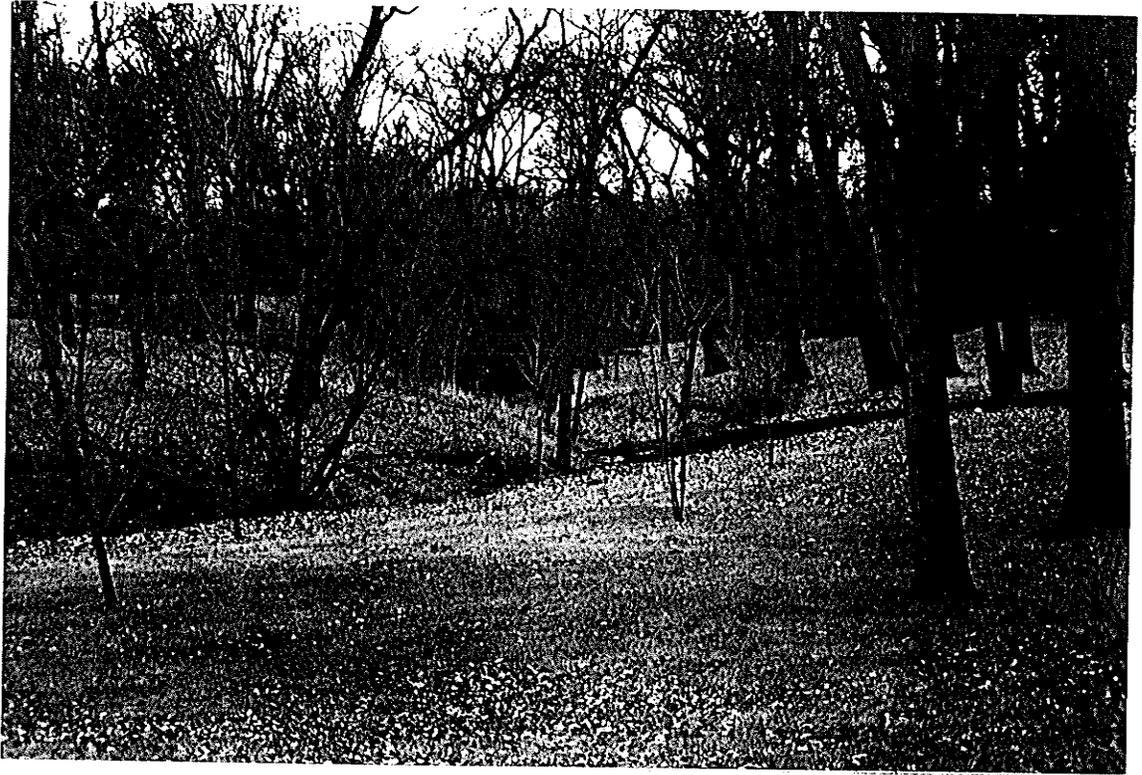
Photo P-11. Creek valley in the 'Natural Reach' with South Bridge in distance. Taken from parking lot. (Nov 3, 1993)

The incised valley and drop through the park are shown pictorially in Photos P-11, P-12 and P-13. Photo P-11 is an overall view of the incised creek valley in the Natural Reach. Photo P-12 is a shot of the creek on the Bruce Park side of the Portage Avenue culvert. Photo P-13 is a view of the eroded east bank south of the South Bridge. The person in the photograph is standing on a point bar at the edge of the creek when the creek is in a low flow condition. The eroded bank appears to be about 15 feet in height. The reader is referred to Figure 2 for the exact location from which these pictures were taken.

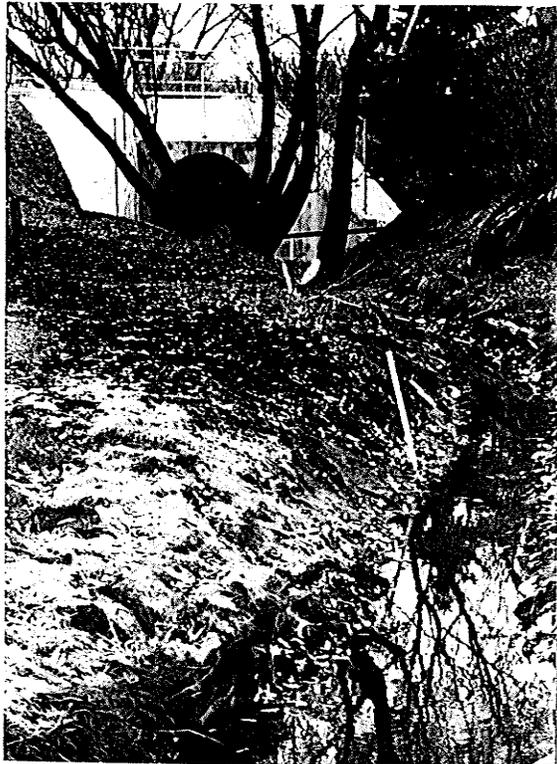
Photo P-12. Portage Avenue culvert (Nov 3, 1993).

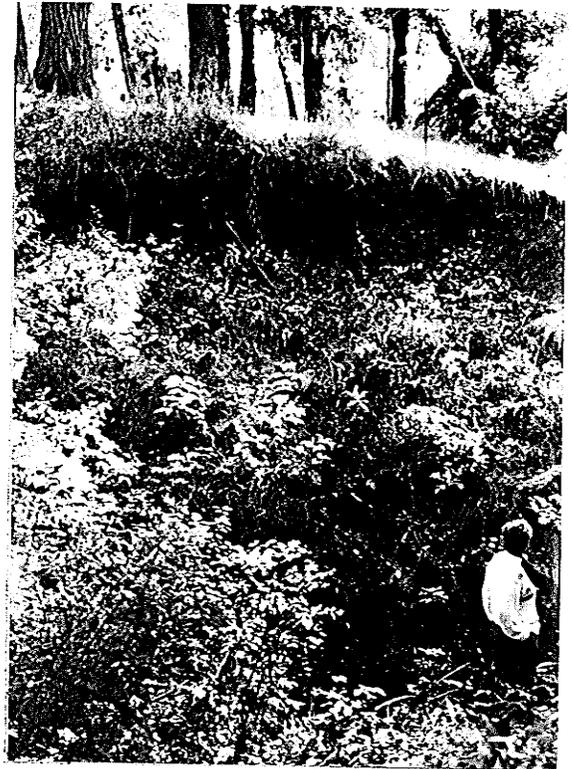
Photo P-13. Erosion south of South Bridge (Sept 25, 1993).

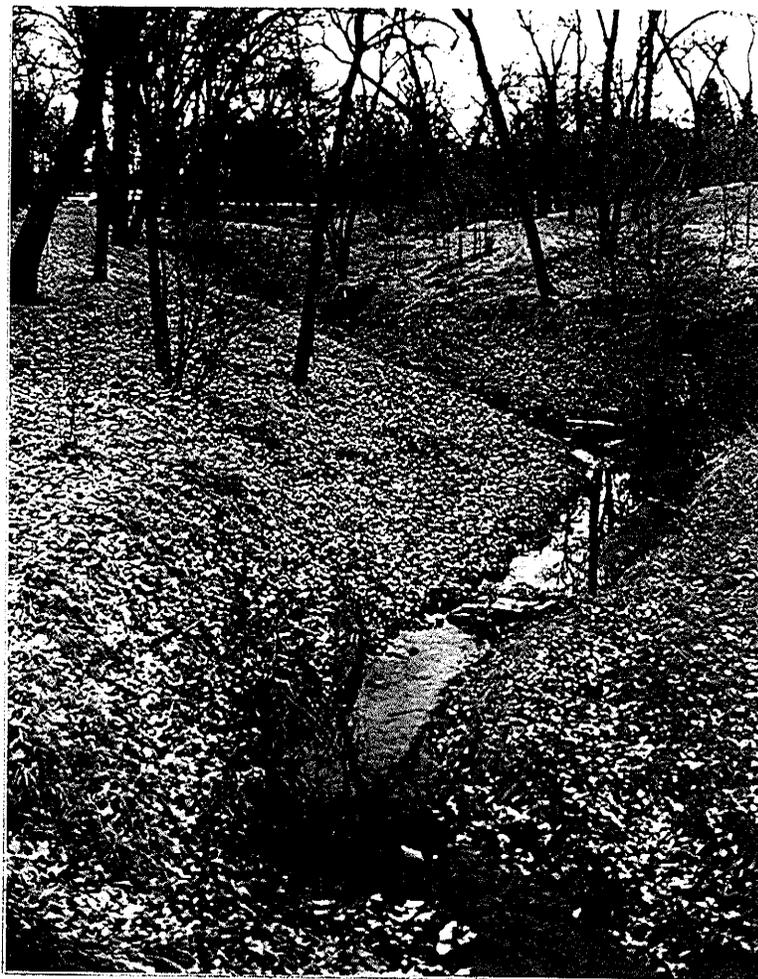
Photos P-14A and B. 'Natural Reach' from South Bridge under two flow conditions:
(A) Flow approximately 30 cfs (April 2, 1993).
(B) Flow less than 1 cfs (Nov 3, 1993).

Photos P-14(A) and(B) and P-15(A) and (B) were taken during 1993 from the locations shown on Figure 20 (same as the triangles on Figure 2). The photographs show the creek at the two flow conditions of high flow (30 cfs) and low flow (less than 1 cfs) which relate to the water level profiles shown on Figure 8.

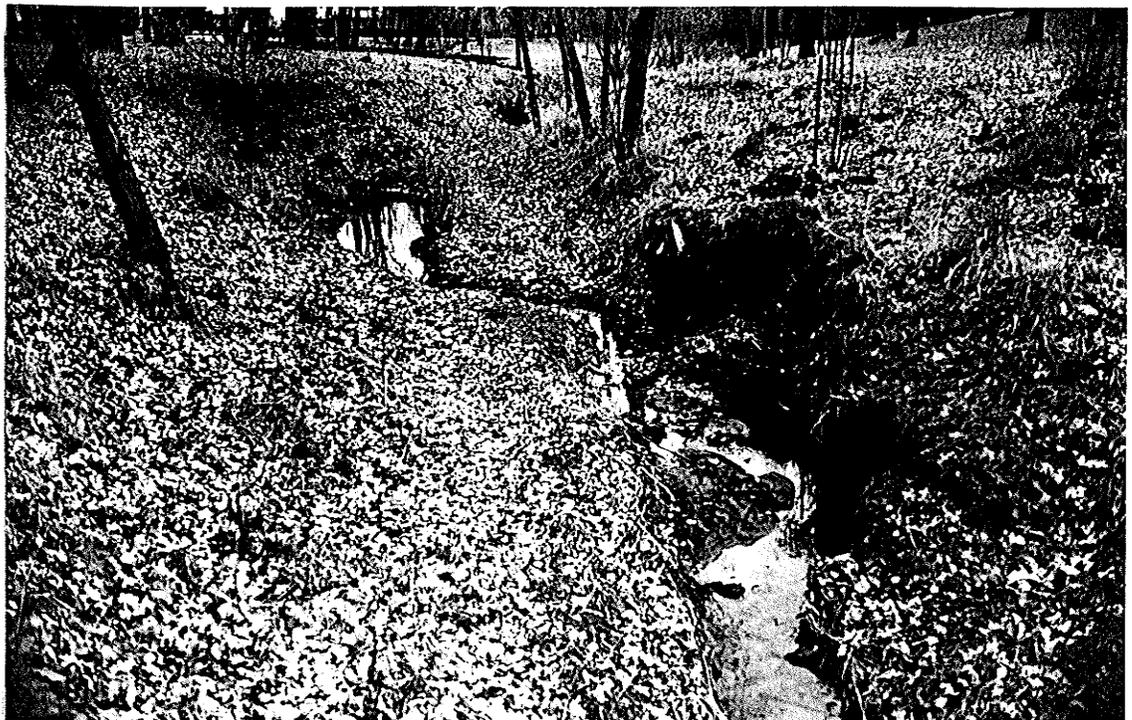
(B)

Photos P-15 A and B. 'Natural Reach' looking north from station 5+20 under two flow conditions:
