# **ANCHORED LOG DECKS**

**Evangeline Rivera Murison**

A Thesis submitted to the Faculty of Graduate Studies  
of the University of Manitoba  
in partial fulfillment of the requirements for the degree of

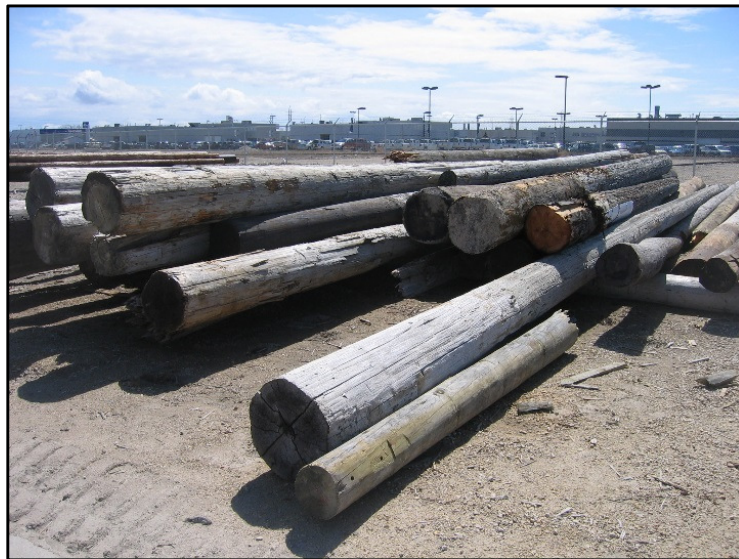
There are currently two wood preservatives used for treating the poles. The first is Chromated Copper Arsenate (CCA) which is a water-based green-coloured preservative. The second is Pentachlorophenol (Penta) which is an oil-based brown-coloured preservative. The preservatives protect the wood against organisms such as termites and fungi. The timber logs used in the experimental program were a random mix of cedar and pines species treated with either the CCA or Penta preservative; some of the poles used in the experimental program are shown in Figure 3-2.

**Figure 3-2. Timber logs for deck panels.**

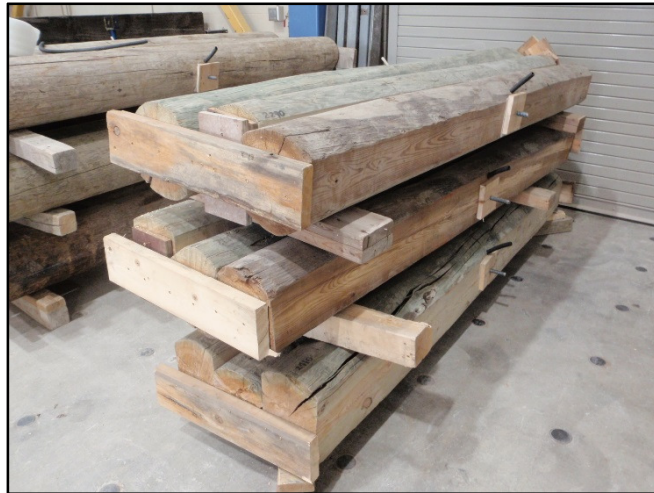
The logs were aligned using their central holes and held in place with timber boards at the ends (Figure 3-5). A total of six panels were constructed initially: three panels with planed logs and three with round logs. In preparation for grouting, a 15 mm steel reinforcing bar was installed in the center of each hole using wood plates on the outer logs (Figure 3-6). Small holes were drilled above the wood plates for injection of the grout. Grouting was conducted by a local contractor (Figure 3-7). The type of grout used was a non-shrink grout. Grout cubes were also prepared during the grouting process.

**Figure 3-5. Timber boards holding planed logs in place.**

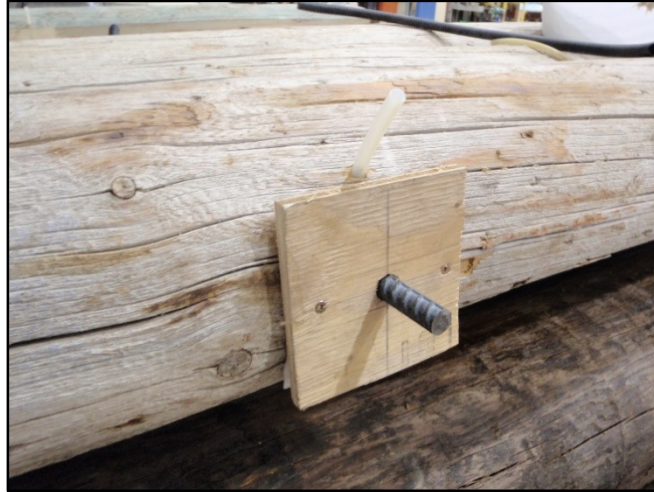
**Figure 3-6. Steel reinforcing bar and grout tube.**

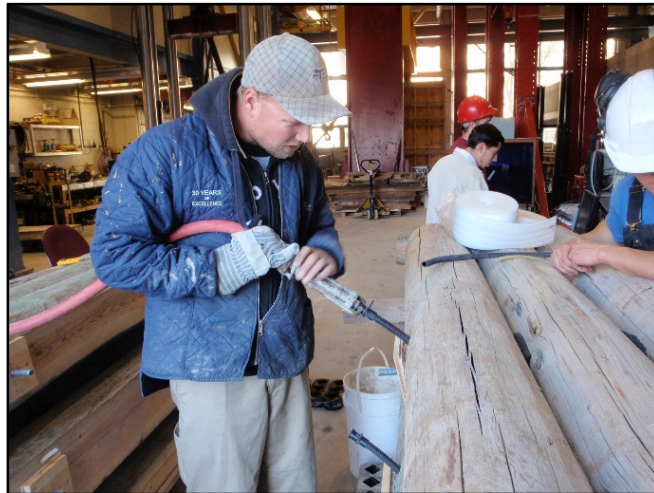
**Figure 3-7. Grouting of log panels.**

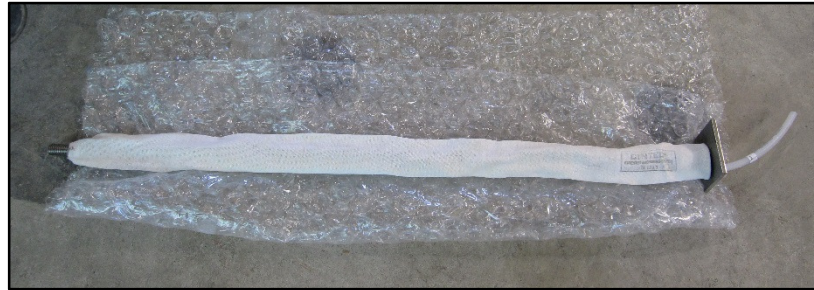
The spaces between the round logs were filled with putty to prevent the leakage of the grout. However, it was observed this was a time consuming and difficult process which did not always guarantee that there would be no leakage. As a result, two additional round log panels were constructed using patented anchoring technology from Cintec Ltd. This innovative technology consists of a 15.88 mm (5/8") stainless steel threaded bar surrounded by a fabric material called the sock (Figure 3-8). Grout is then injected into the 'sock' which expands to fill the hole and contains the grout to prevent any leakage

**Figure 3-8. Cintec anchor with stainless steel bar and fabric sock.**

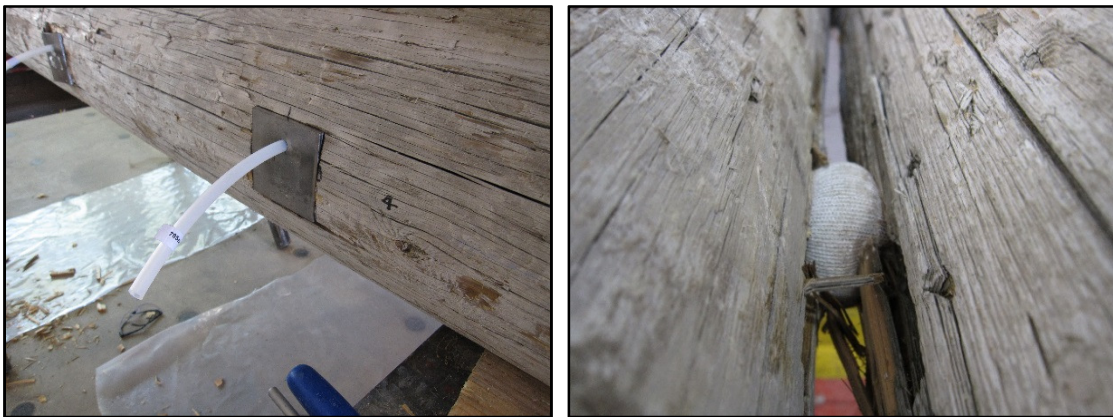
(Figure 3-9). In this figure, it can also be seen that the sock expands in between the logs to effectively enclose the grout.

**Figure 3-9. Cintec anchor installed in log panel and expansion of sock with grout.**

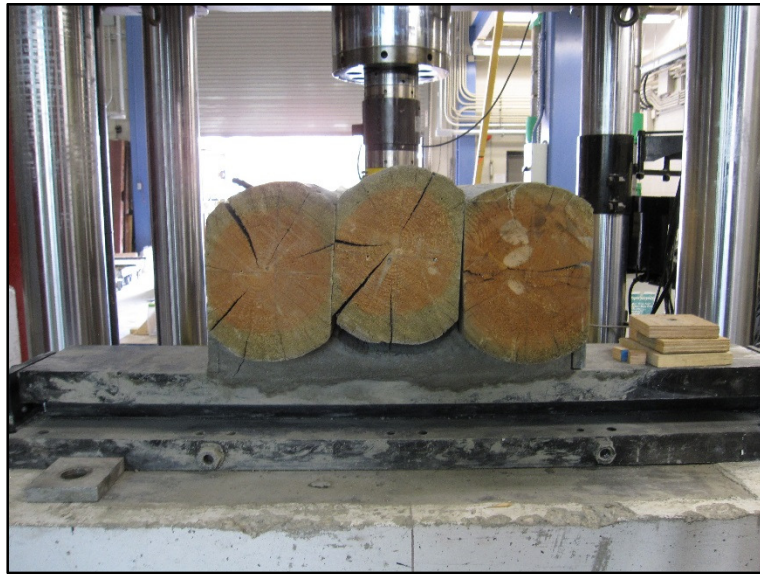
**Figure 3-10. Grout placed underneath logs at supports in small-scale assemblies.**

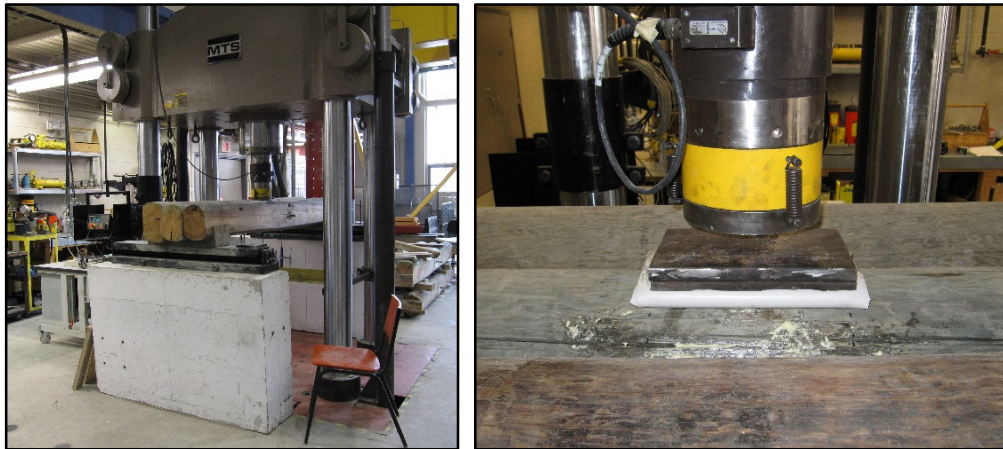
span of the middle log (Figure 3-11). Plaster was placed in between the log and the plate to create a flat surface for the loading plate, which was used to load only the middle log. The purpose of these tests was to determine the amount of load passed on from the directly loaded log to the adjacent logs.

**Figure 3-11. Static test setup and load plate at middle log.**

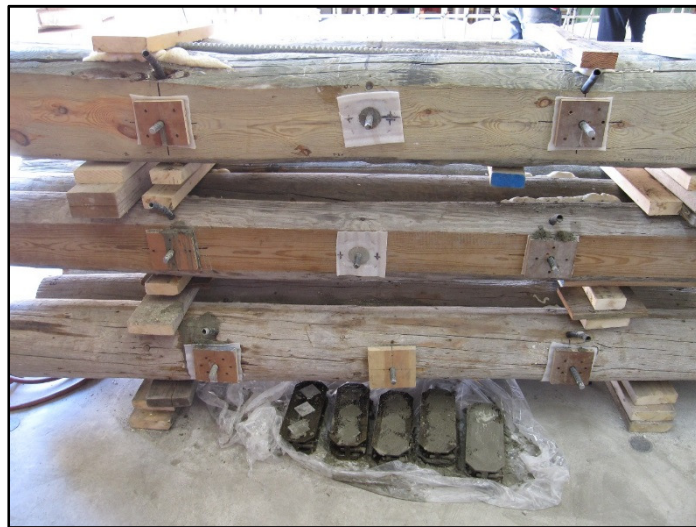
One panel with planed logs and two panels with round logs, each with a grout core at the mid-span, were initially tested under static loading. Upon analysis of the data, it was decided to add grout cores to the remaining panels at the quarter span locations to improve the load distribution (Figure 3-12). The panels were then tested to failure under static loading.

**Figure 3-12. Additional grout cores at quarter span.**

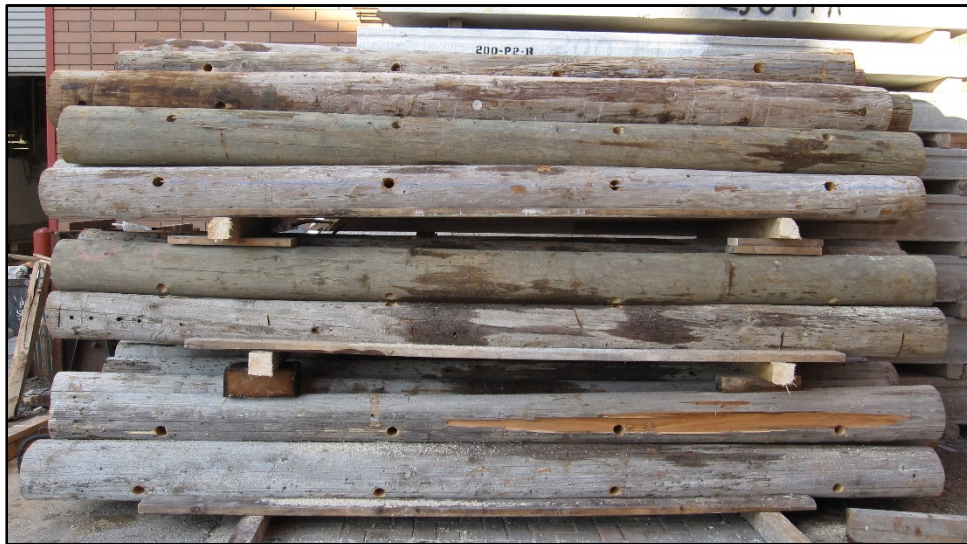
The model of the anchored log deck comprised of a total of five log panels each consisting of 5 or 6 logs. The logs were 4300 mm in length and the diameters of the logs ranged from 200 to 300 mm. The logs were not trimmed due to the high cost of this work. Four 50 mm diameter holes were drilled in each log at a spacing of 1080 mm longitudinally, beginning 530 mm from each end (Figure 3-13). The holes were drilled at a distance of 100 mm from the bottom face of the log.

**Figure 3-13. Logs for the anchored log deck with holes drilled at four locations.**

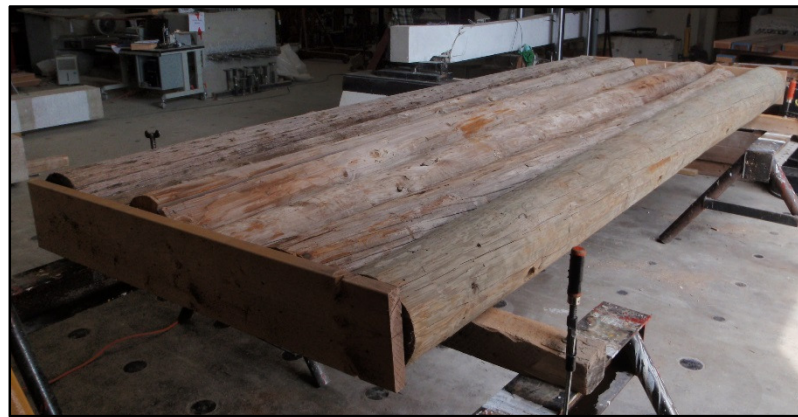
The log panels were constructed as if they would be used in the field. The dimensions of the panels were such that they would fit on a flatbed trailer for shipping. This resulted in assembling panels with 5 or 6 logs to create a panel width of approximately 1524 mm (5'). Similar to the three log assemblies, the logs were aligned according to the four drilled holes and held together with timber boards (Figure 3-14). Due to the taper of the logs, the logs were oriented by alternating the taper between adjacent logs (i.e., placed alternately tip to butt). The goal was to result in a somewhat 'square' panel. Cintec anchors consisting of 15.88 mm (5/8") stainless steel bars were installed and grouted in each of the cores. The operation of grouting the anchors is illustrated in the photographs presented in Figure 3-15.

**Figure 3-14. Full-scale panels with end boards.**

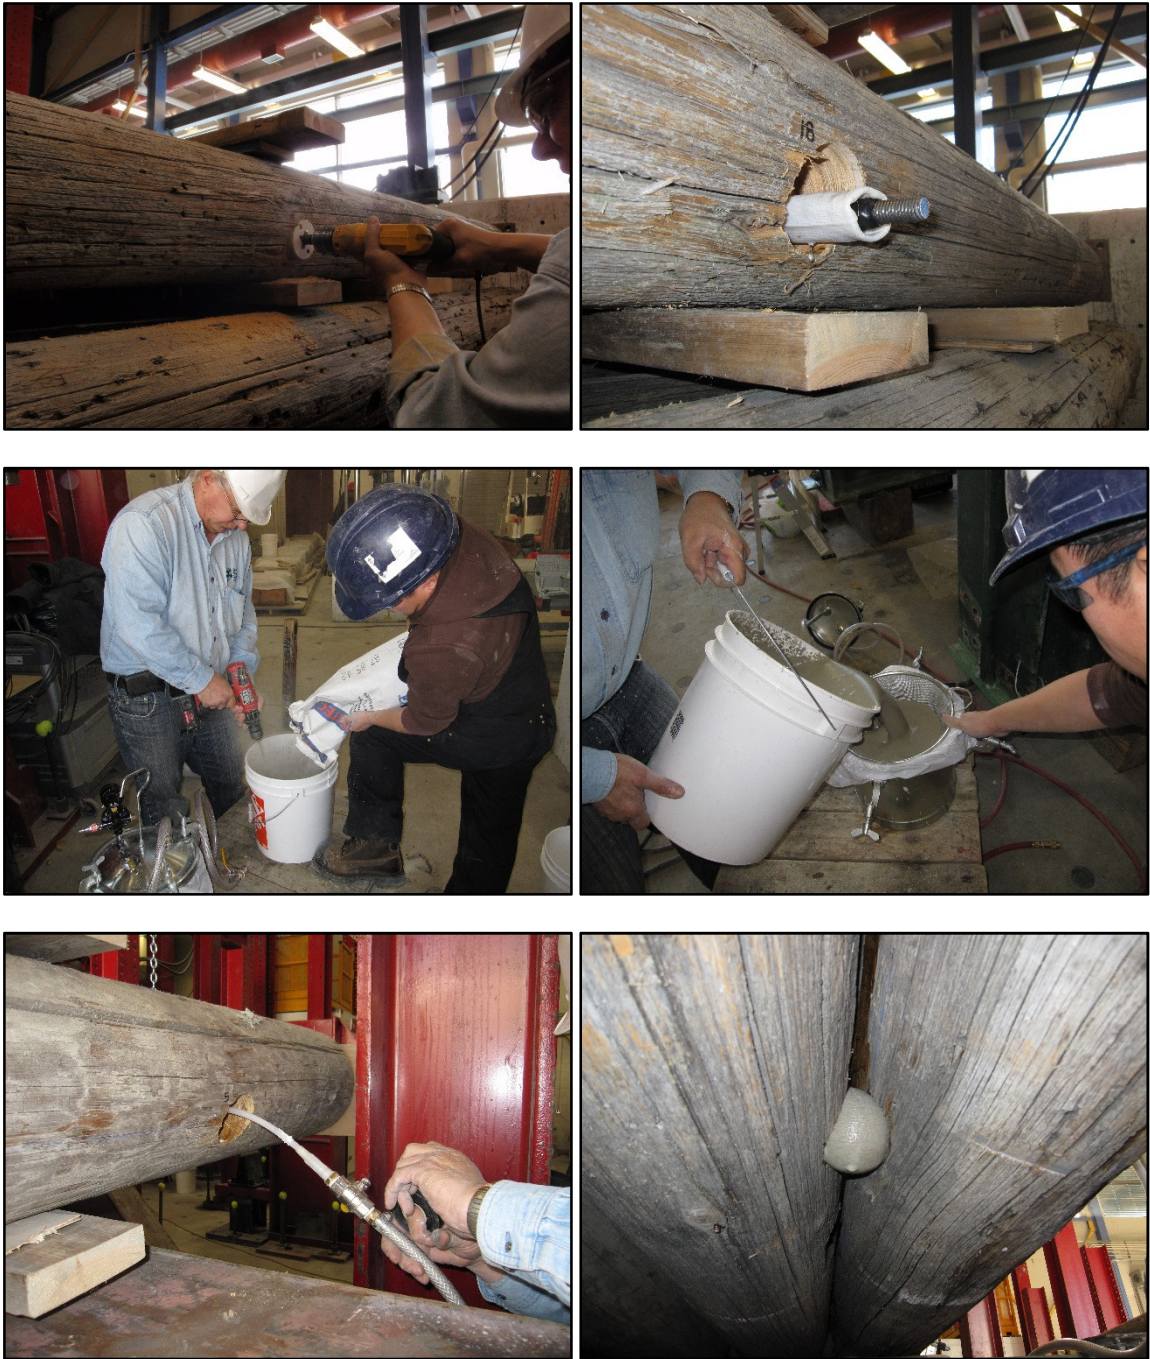
**Figure 3-15. Grouting of Cintec anchors.**

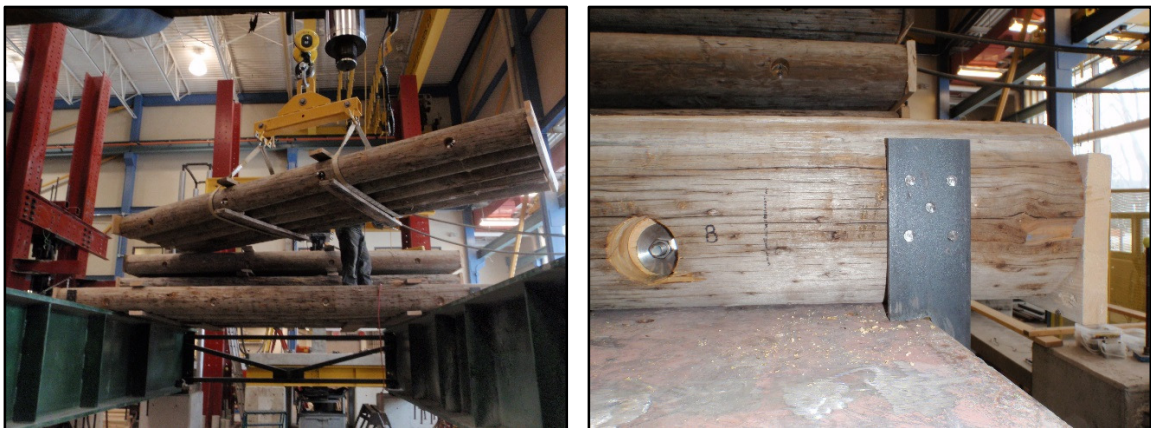
Two steel girders were placed at a center-to-center distance of 3500 mm. Each girder 425 mm wide, 925 mm deep, and 9000 mm long. The girders were placed on four concrete bearing blocks. The log panels were placed side by side on the girders. Although most of the logs were in contact with the girder, there were some logs that required shims underneath. Clip angles were used to attach the panel to the girder (Figure 3-16). The angles consisted of steel plates with notches to fit around the flange thickness and attached to the log with common nails. The steel plates were 102 x 305 x 9.5 mm (4" x 12" x 3/8") thick.

**Figure 3-16. Placement of panels on girders and steel clip angle.**

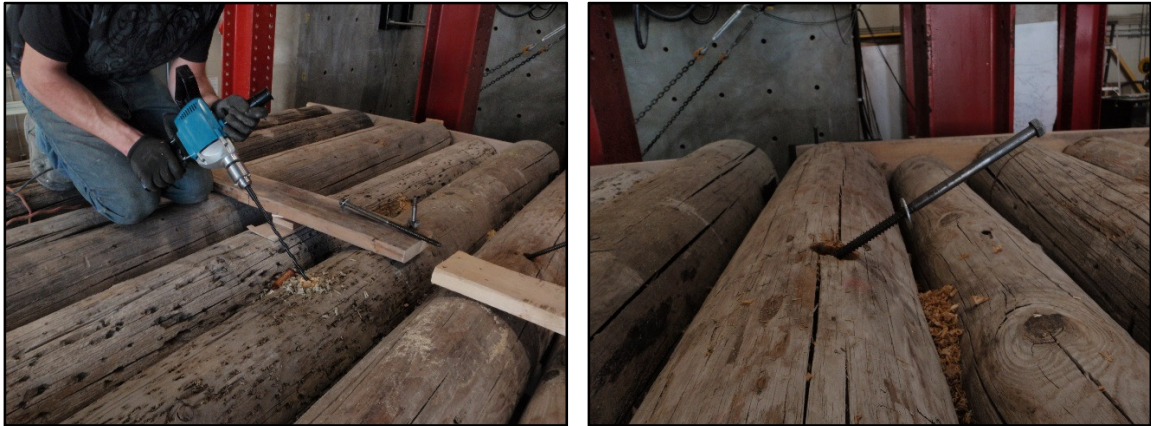
After the panels were placed on the girders, adjacent panels were connected to each other using 50 mm diameter, 305 mm long (1/2" x 12") lag screws drilled diagonally and staggered along with width of the deck. The external logs of two adjacent panels were connected by drilling a diagonal hole from one log to the other and inserting a lag screw through the hole (Figure 3-17). Timber wearing planks were installed on the surface of the deck using lag screws. The planks consisted of four rows of 64 x 286 mm (3" x 12" with actual dimensions of 2.5" x 11.25") rough sawn oak planks placed side by side on

**Figure 3-17. Installation of lag screws to connect panels.**

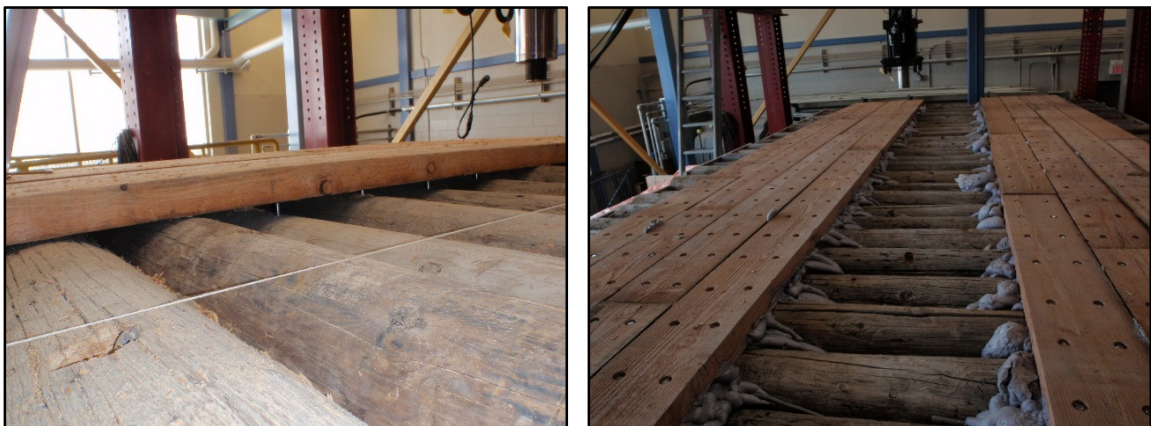
After installation of the planks, it was observed there were large gaps between the planks and the top of some logs. The planks were only in contact with the tallest logs. Thus, expansive spray foam was used to fill the gaps and provide a support material underneath the planks (Figure 3-18). The high density Polyurethane Resin foam is typically used by contractors for slab-jacking, void-filling and stabilizing concrete slabs. The density of the foam depends on the confinement and the compressive strength ranges from 0.6 MPa in an unconfined state and up to 10 MPa in a confined state (Concrete Restoration Services).

**Figure 3-18. Gaps under wearing planks and high density foam.**

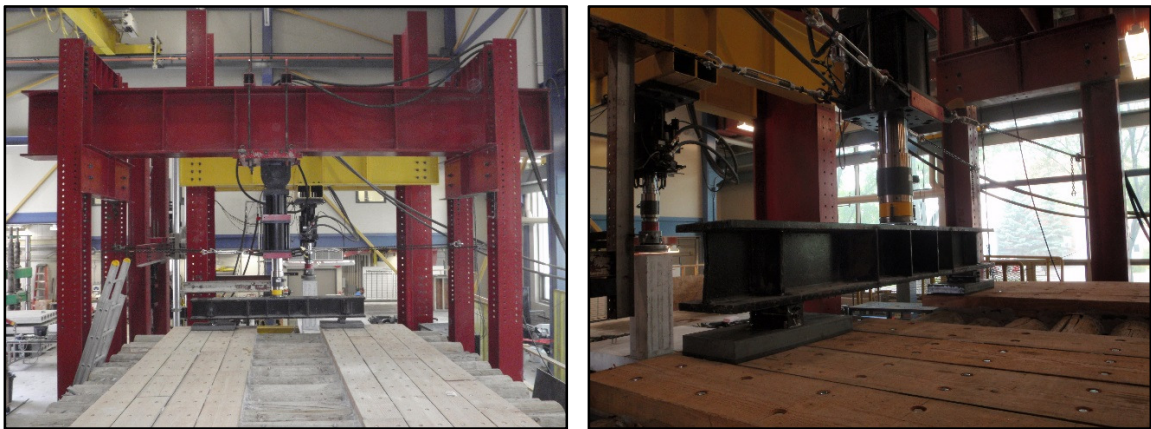
Two static tests were first conducted on the model of the anchored log deck. In the first test, the load was applied directly over the log located at the end of the deck as shown in Figure 3-21. A monotonic load was applied at a rate of 1 mm per minute. This test was a destructive test and loading continued until the load stopped increasing at which point the test was stopped.

**Figure 3-21. First static test location.**

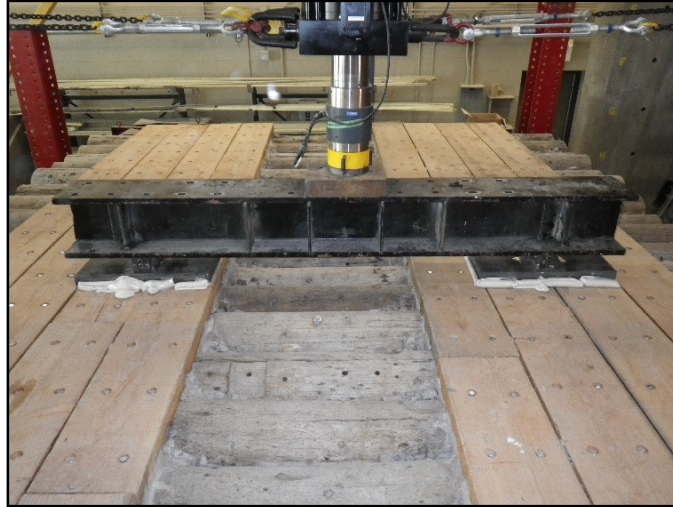
The second test was located near the mid-span of the deck. The load was placed over the end log of one panel as shown in Figure 3-22. The purpose of the test was to determine the amount of load distributed to the adjacent panel. A monotonically increasing load was applied until a maximum load of 300 kN was reached and then the load was removed.

**Figure 3-22. Second static test location.**

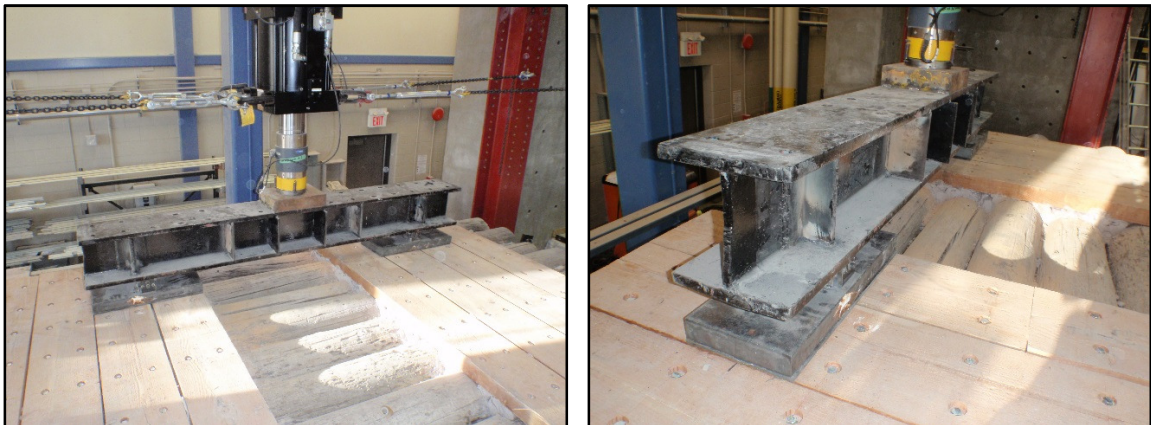
The initial location for the fatigue test was near the opposite end of the deck, approximately between the second and third log from the end (Figure 3-23). Unfortunately, during the setup of the actuator, a large load was applied to the deck accidentally. Before the actuator could be halted, a maximum load of 513 kN had been applied. This resulted in failure of the last two logs at the end of the deck.

**Figure 3-23. Initial fatigue test location.**

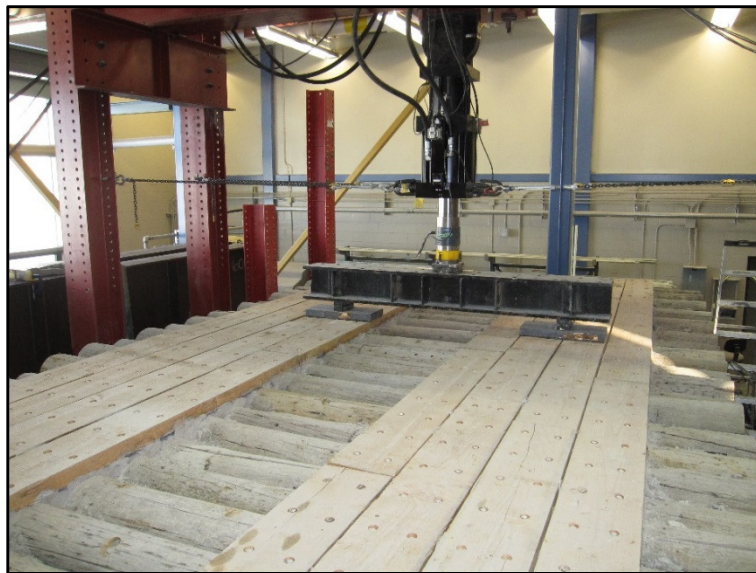
It was decided to move the fatigue test location to the previous second static test location (Figure 3-24). At this location, the load was applied over the end log of a panel. The cyclic (sine wave) loading pattern applied to the deck ranged from a minimum load of 5 kN to a maximum load of 230 kN at a frequency of 0.33 Hz (1 cycle every 3 seconds). In order to maintain a constant loading frequency for the duration of the test, a frequency of 0.33 Hz was chosen. The magnitude of load, 230 kN, chosen for the fatigue test was chosen to be 40% greater than the maximum axle load for a CL-625 truck which is 175 kN (CHBDC 2000). The deck underwent fatigue loading of over 1 million cycles. The results from the fatigue test were used to evaluate the load distribution characteristics between panels under repeated loading.

**Figure 3-24. Fatigue test location.**

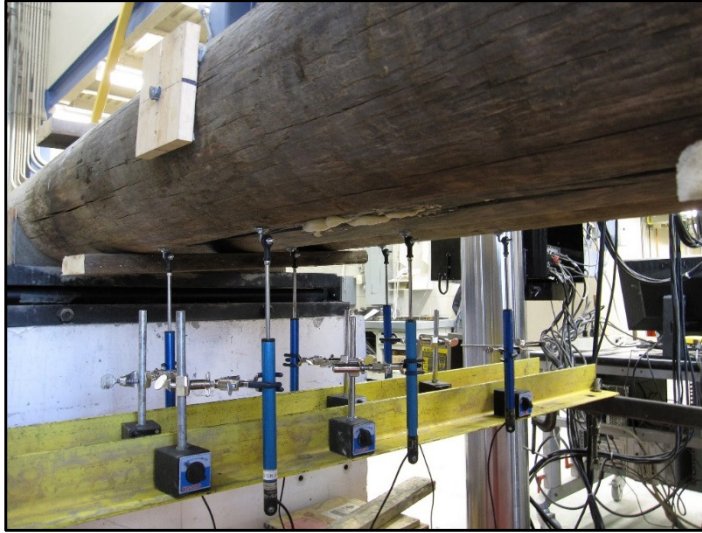
The three-log models were instrumented with a linear variable displacement transducer (LVDT) under each log to measure deflection at mid-span (Figures 4-1 a) and b)). Deflections were measured relative to the structural floor. Steel angles were connected to the loading frame and magnetic bases were mounted on the angle to hold the LVDTs in place. Machine screws, glued to the underside of each log, were used to attach to the LVDTs. A LVDT was also placed under each log at one-third span (Figure 4-1).

b) Placement of LVDTs under each log

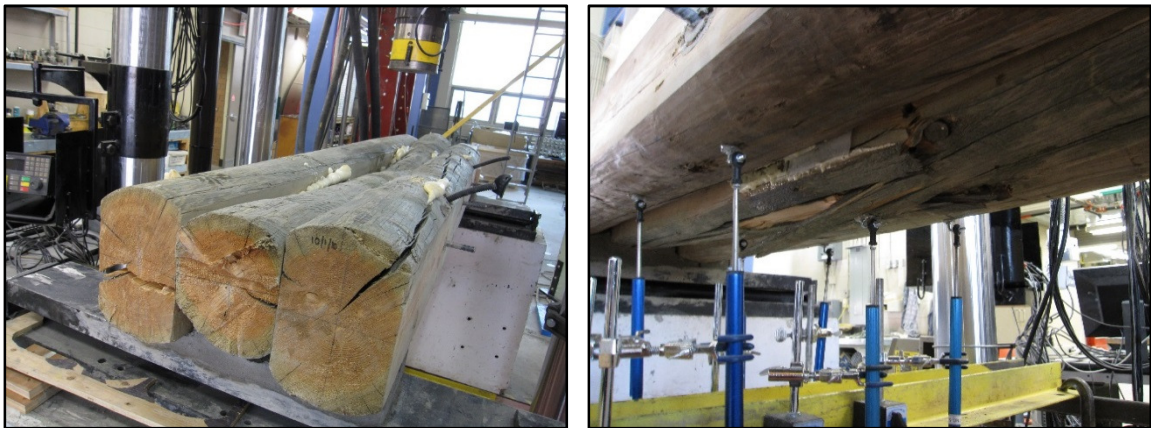
When a timber beam is subjected to bending, its one half is subjected to compression parallel to the grain and the other half to tension parallel to the grain. In addition, horizontal shear is induced parallel to the grain. During the tests, the log models failed in a number of ways. A typical failure of a panel with planed logs is shown in Figure 4-2. In this figure, the middle log sustained the largest deformation and failed in tension. A tension failure consists of cracking and splitting in the tension zone where wood is weak in tension perpendicular to the grain. The outer log on the left side failed in horizontal shear along the grain near the neutral axis and the failure around the grout core of the log is shown in Figure 4-3. In the panels with the round logs, the failure mode was predominately in the tension of the middle log (Figure 4-4).

**Figure 4-2. Deformation and tension failure in planed log panels.**

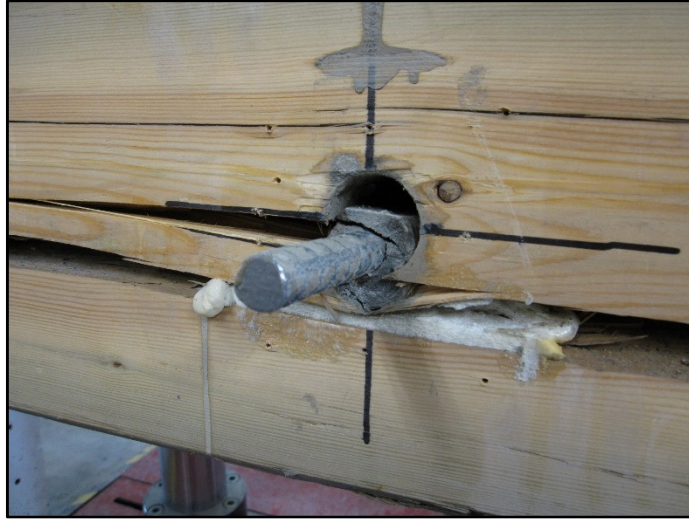
**Figure 4-3. Horizontal shear failure around grout core.**

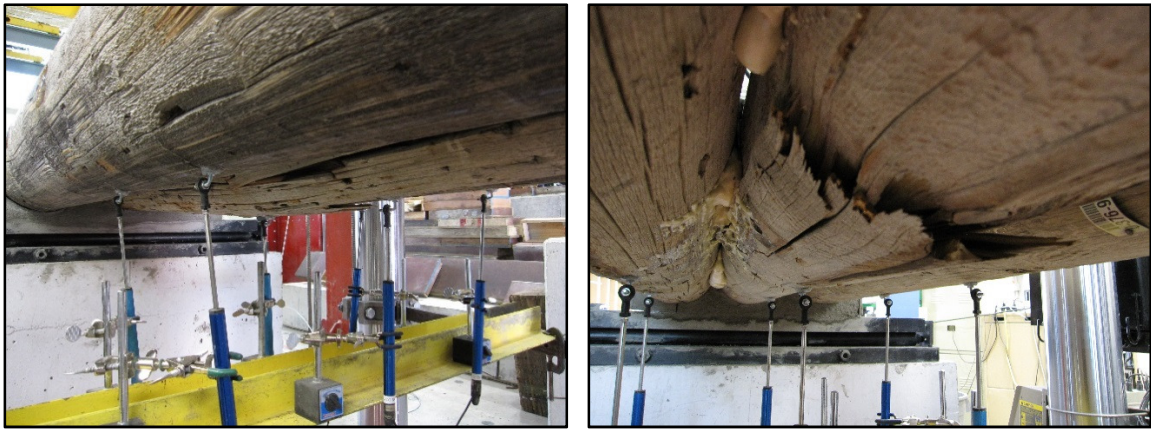
**Figure 4-4. Tension failure of round log panels.**

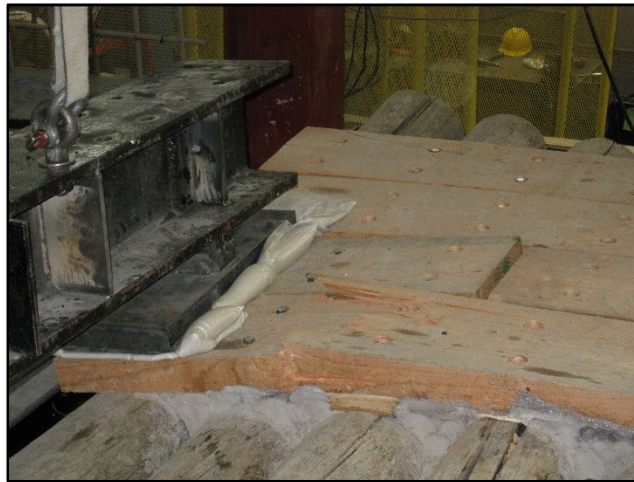
During the test, the wearing planks under the load plate failed at 432 kN (Figure 4-6). The loading continued to a maximum load of 468 kN. At the ultimate load, the outer log (Log #1) directly under the load exhibited a tension and horizontal shear failure as shown in Figure 4-7. The load-deflection plots corresponding to the static test are presented in Figure 4-8. The behavior of the logs is fairly linear until the load reaches approximately 325 kN. After this level of load, the logs start to behave non-linearly as the deck begins to show signs of failure.

**Figure 4-6. Failure of wearing plank.**

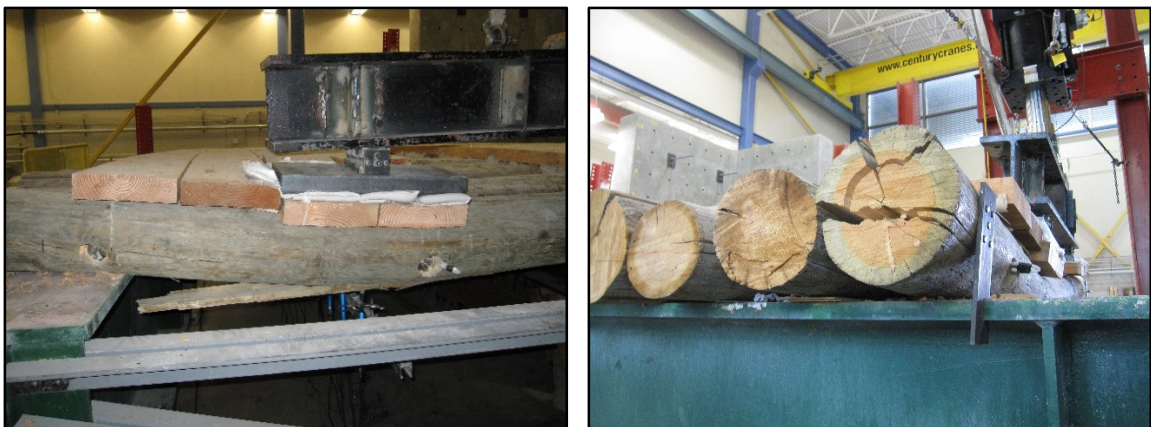
**Figure 4-7. Tension and horizontal shear failure of outer log.**

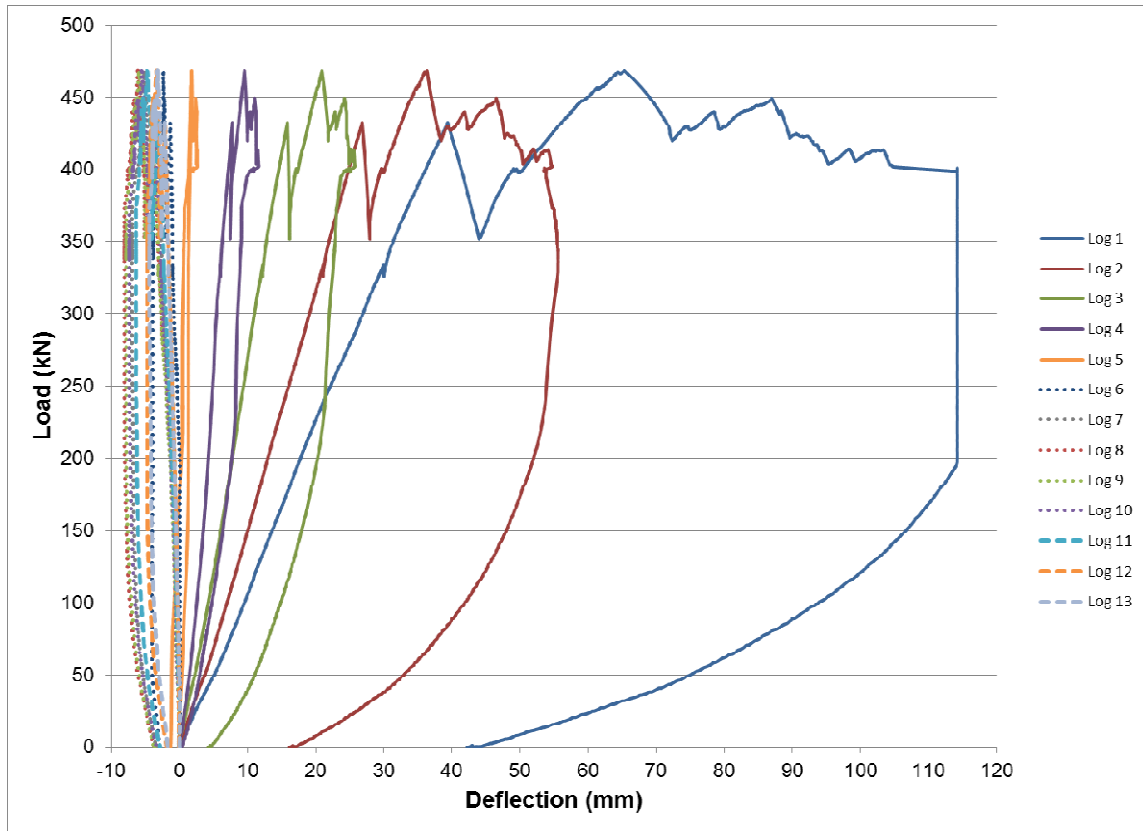
**Figure 4-8. Load vs deflection for static test (end of deck).**

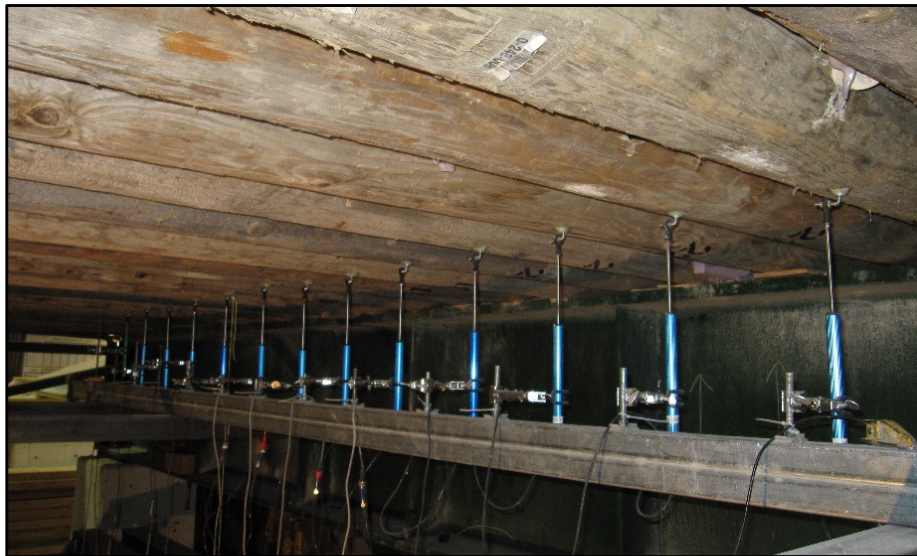
Due to the accidental over-loading and failure of the logs at the initial fatigue test location near the end of the deck, the fatigue test was conducted at the second static test location. The load was applied over Log #18 which is the end log of one panel near the mid-span. The instrumentation scheme was similar to that of the second static test (Figure 4-9) except that Log #12 was not instrumented. The locations of LVDTs are shown in Figure 4-10.

**Figure 4-10. LVDTs located underneath the deck.**

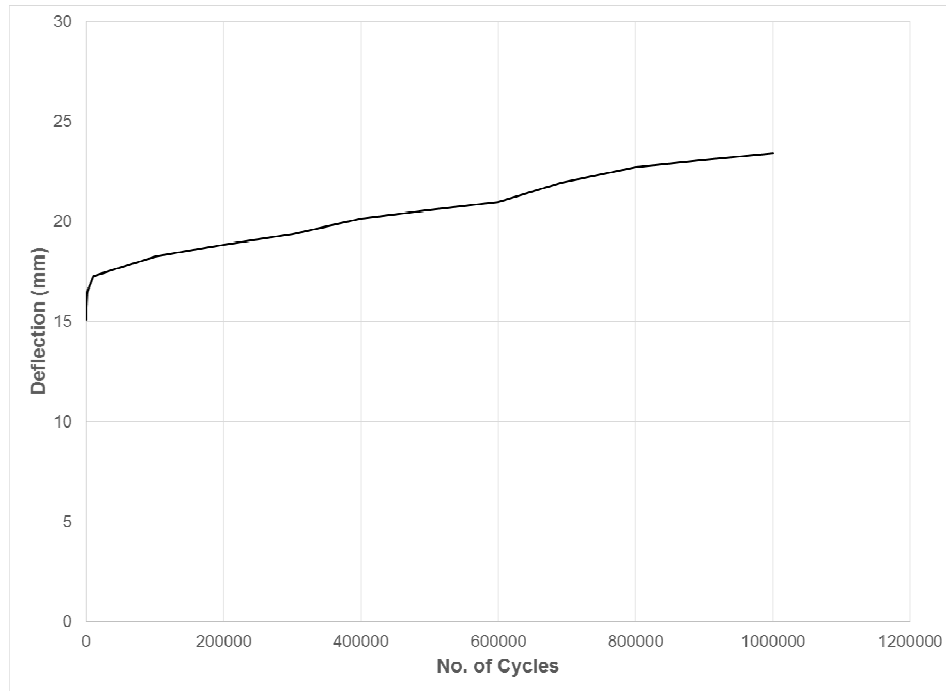
Over the course of the fatigue test, the deflection of Log #18 increased from 15.12 mm to 23.42 mm as shown in Figure 4-12. During the first 10,000 cycles, the deflection increased approximately 2.17 mm to 17.29 mm. At this point the rate of deflection decreased and for the following cycles, the deflection steadily increased an additional 6.13 mm.

**Figure 4-12. Deflection vs number of cycles of Log #18 during fatigue loading.**

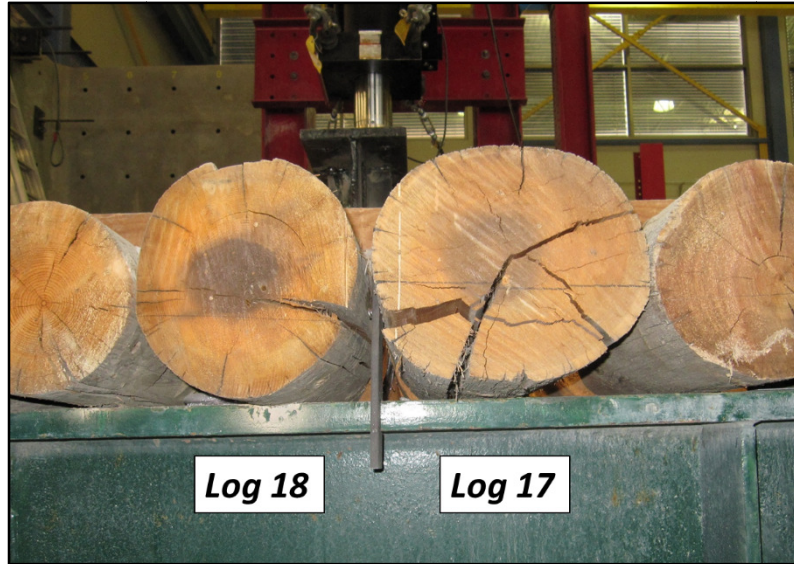
After the fatigue loading was completed, a static load test was conducted at the same location. A monotonically increasing load was applied to a maximum of 614 kN at which point the load suddenly dropped. The stroke of the actuator continued to increase, but the load did not reach the ultimate load. The loading was stopped and removed when it became clear that the deck was not receiving additional load. Upon inspection after the test, it was observed that Log #17 exhibited a horizontal shear failure as shown in Figure 4-13. Inspection of the underside of the logs revealed large splits in Logs #17 and 19 (Figure 4-14). However, no obvious signs of tension failure were found.

**Figure 4-13. Horizontal shear failure of Log #17.**

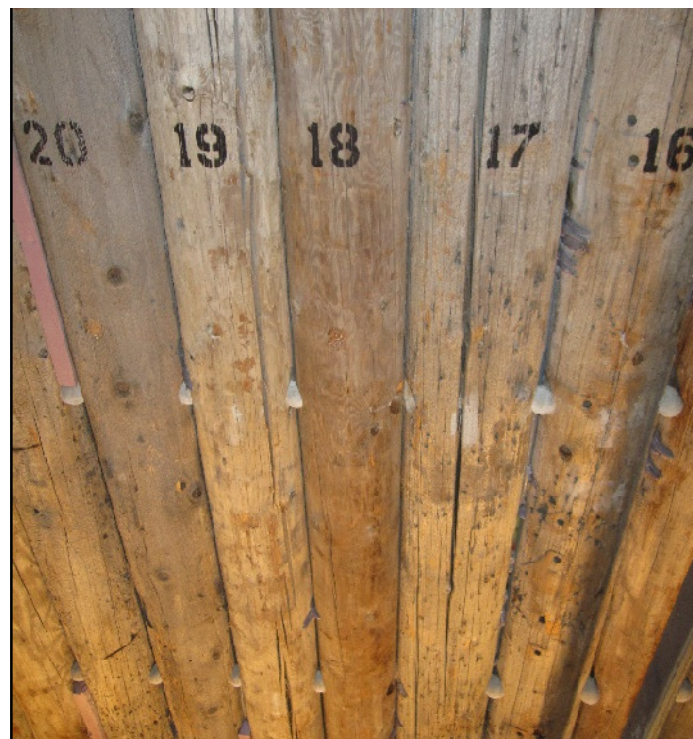
**Figure 4-14. View of underside of logs after static test.**

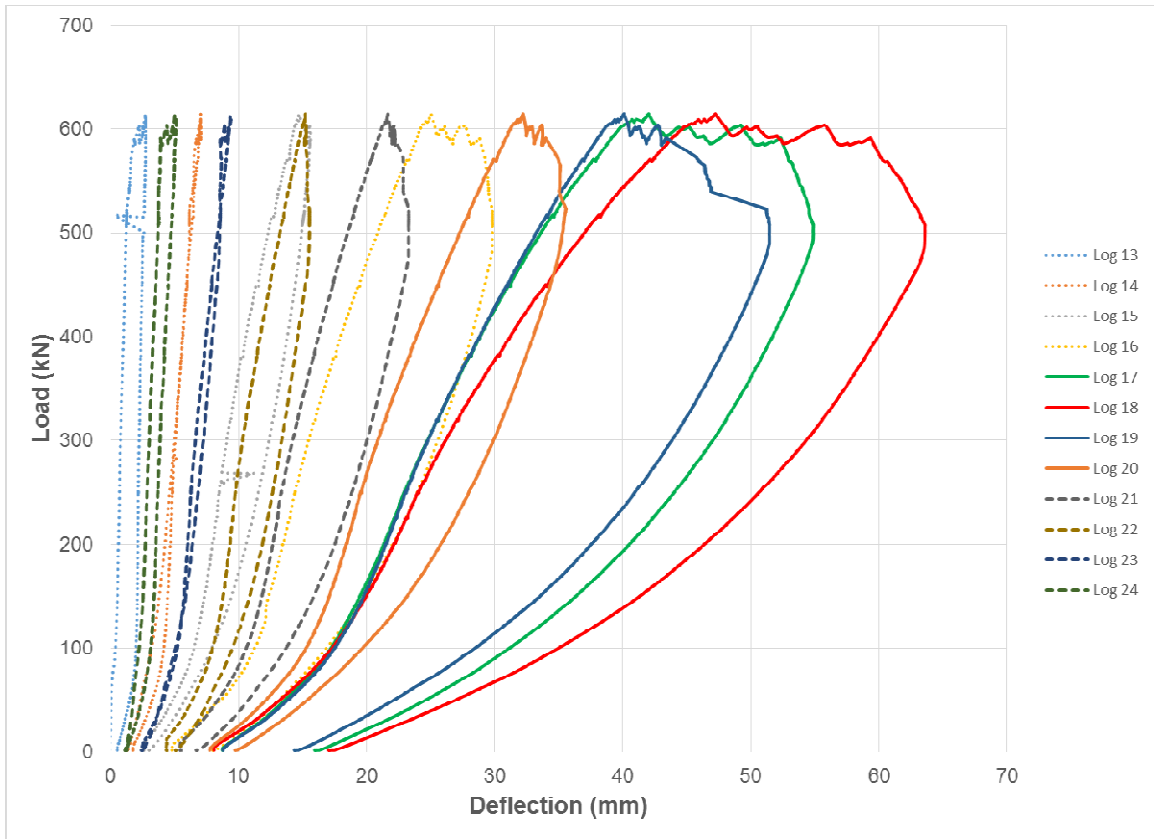
A plot of the load and deflection of the instrumented logs is shown in Figure 4-15. All the logs behaved linearly until reaching a load of approximately 100 kN where the slopes became steeper. The log deflections continued increasing linearly at this slope until the load reached 320 kN where the logs started to behave in a non-linear manner. In Figure 4-15, as the load increases, there are small drops in the load due to the development of splits and cracks in the logs which contribute to the failure at the ultimate load.

**Figure 4-15. Load vs deflection for static test (end of panel).**

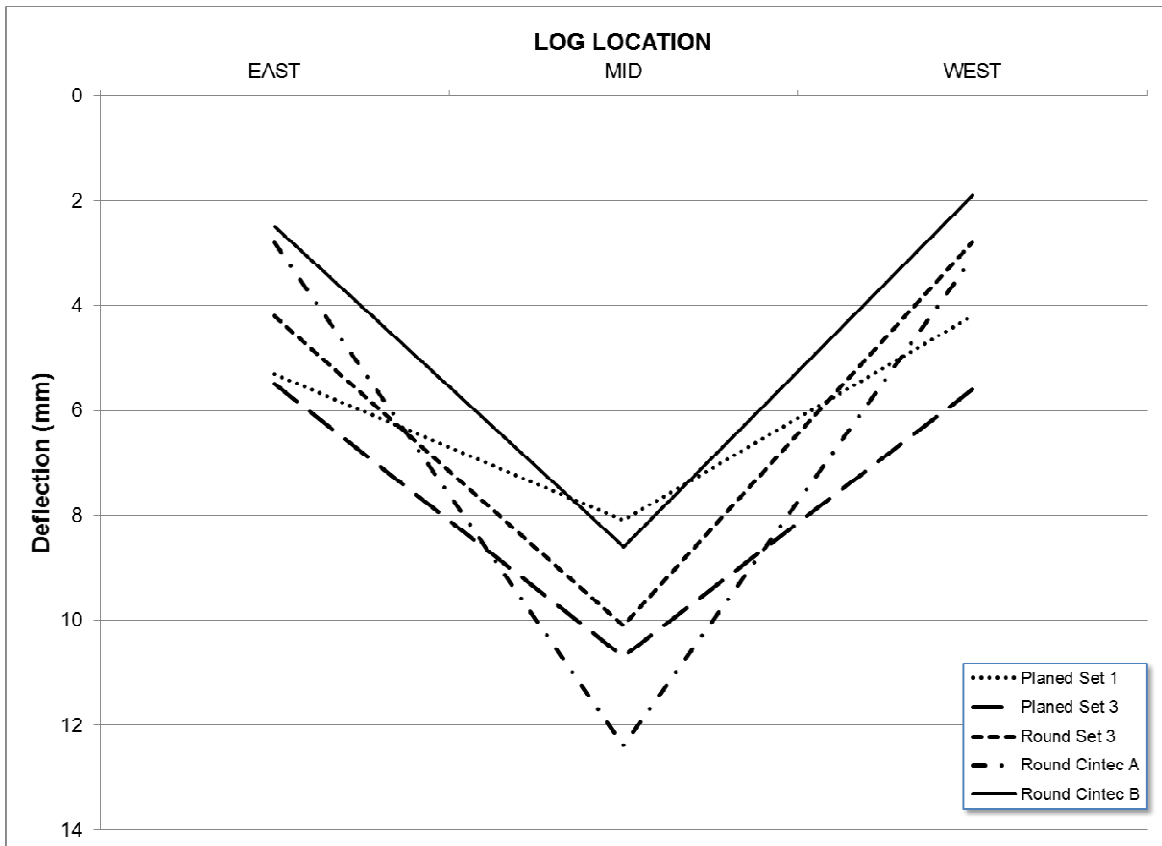
**Figure 5-1. Deflection of logs at 120 kN for panels with three grout cores.**

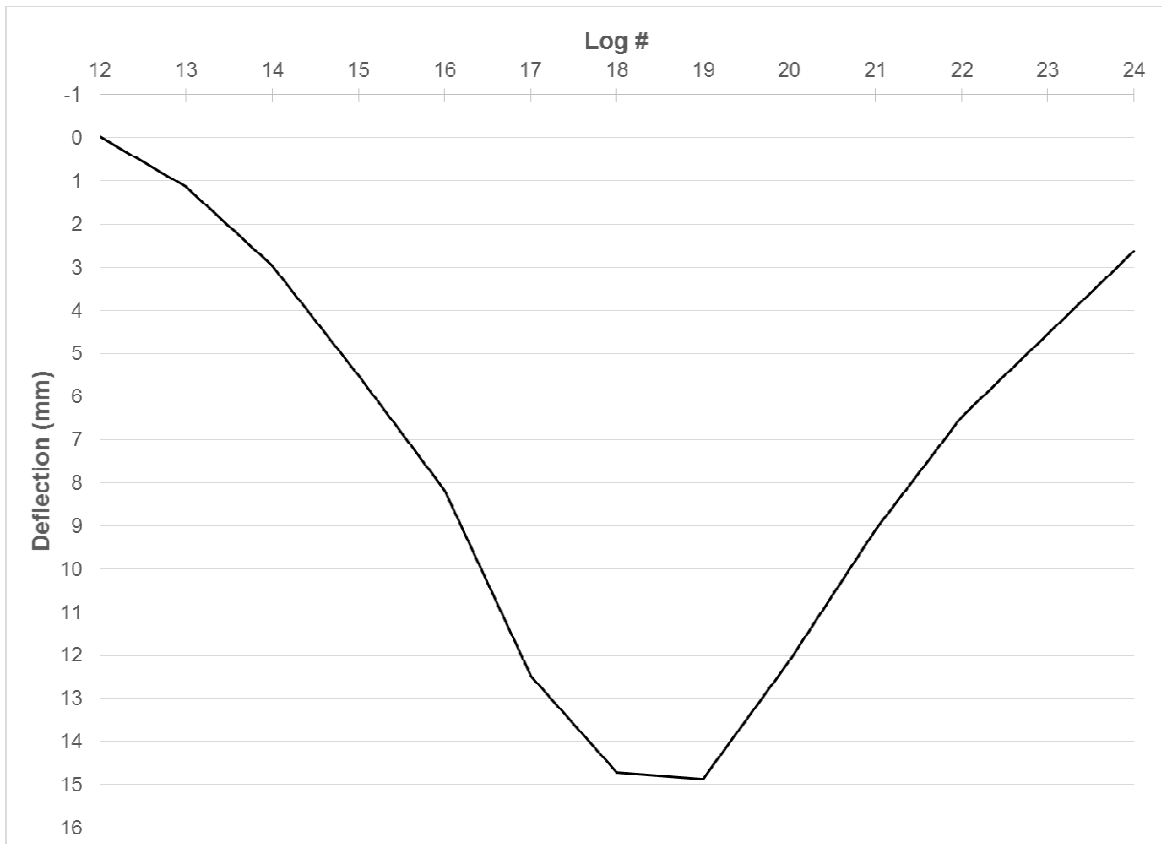
A static test was conducted with the concentrated load over the end log, #18, of a panel located near the mid-span. The load was increased to a maximum of 300 kN after which the loading was removed. The purpose of the test was to determine the load distribution characteristics of the deck. The deflections at the maximum load of 300 kN are shown in Figure 5-3. The load was applied over Log #18.

Figure 5.3. Deflection measurements across the logs at 300 kN.

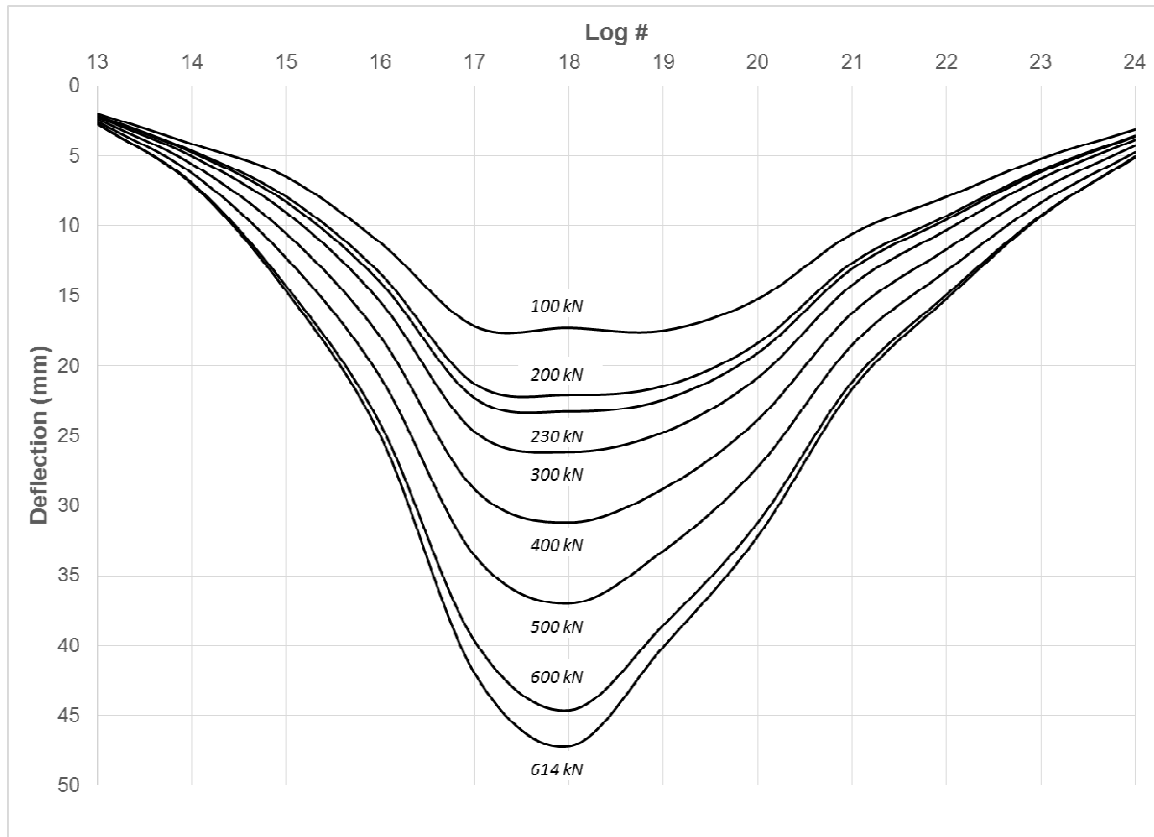
After the deck was subjected to fatigue loading of over 1 million cycles, a static test was conducted with the load at the same location. A monotonically increasing load was applied over Log #18 until failure. The deflections of the instrumented logs at various load levels are shown in Figure 5-5. The maximum load reached during the tests was 614 kN just prior to a sudden drop in load. Based on the deflections in Figure 5-5, at lower loads, there is a larger distribution of load across adjacent logs. However, as the load increases, the distribution pattern tends to become localized so that a large portion of the load is taken by three logs, Logs #17 to 19. The pattern of transverse distribution of loads becomes more and more localized as the load is increased. Although the load is

transferred to the end log (Log #17) of the adjacent panel, the remaining logs in the panel (Logs #13 to 16) receive smaller magnitudes of load.

**Figure 5-5. Deflections of logs during static test.**
