WEST PARK, DELTA, MANITOBA
design in a fragile environment
edward bruce mclachlan

West Park, Delta, Manitoba

- Design in a Fragile Environment

A Practicum submitted to the
Faculty of Graduate Studies in partial
fulfillment of the requirements for the
degree of Master's of Landscape Architecture

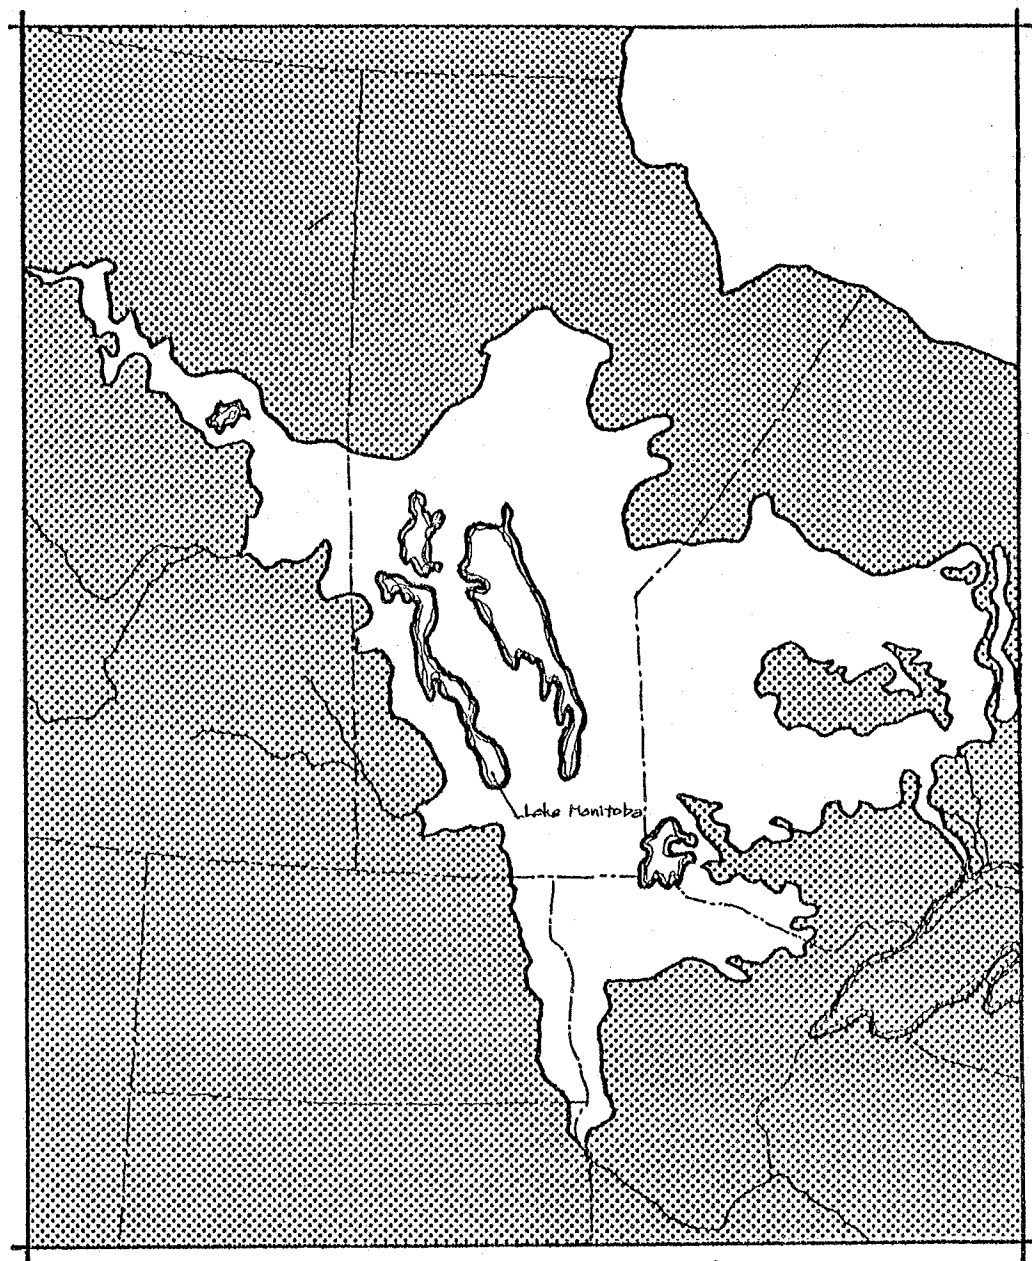
Figure 4. Schematic drawing, Glacial Lake Agassiz (Elson 1967)

Lake Manitoba is a remnant of Glacial Lake Agassiz. The evolution of Lake Manitoba has gone through several major phases, each being associated with a change in the lake's level. These in turn governed any alluvial activity (*Gilliland 1965*). As a result of the final phase, which has seen a rise in the lake level, the south shore has developed into a low sand ridge.

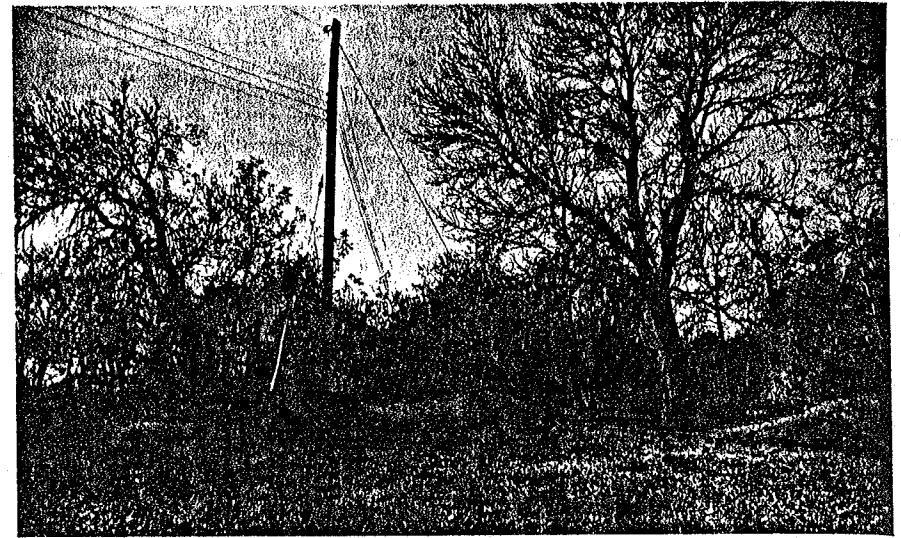
Figure 43. Approximately 2 1/2 feet of soil lost

The development and use of West Park has meant the clearing of the existing shrub and ground vegetation from the level dry land. This initial clearing and the continual use of the park (particularly the uncontrolled use of the car) has prevented the growth of any new trees or shrubs. The effect of this is very obvious when compared to cottage no. 100, which is surrounded by the park. Here, the lot was not cleared and was left in a natural state. In comparison (Table 4), the cottage site has a more luxuriant growth, a much denser canopy and a higher percentage of young trees (mostly Manitoba Maple). There was also no sign of wind damage to the trees on the cottage site, while there were several dramatic examples of wind thrown and broken trees in the park.

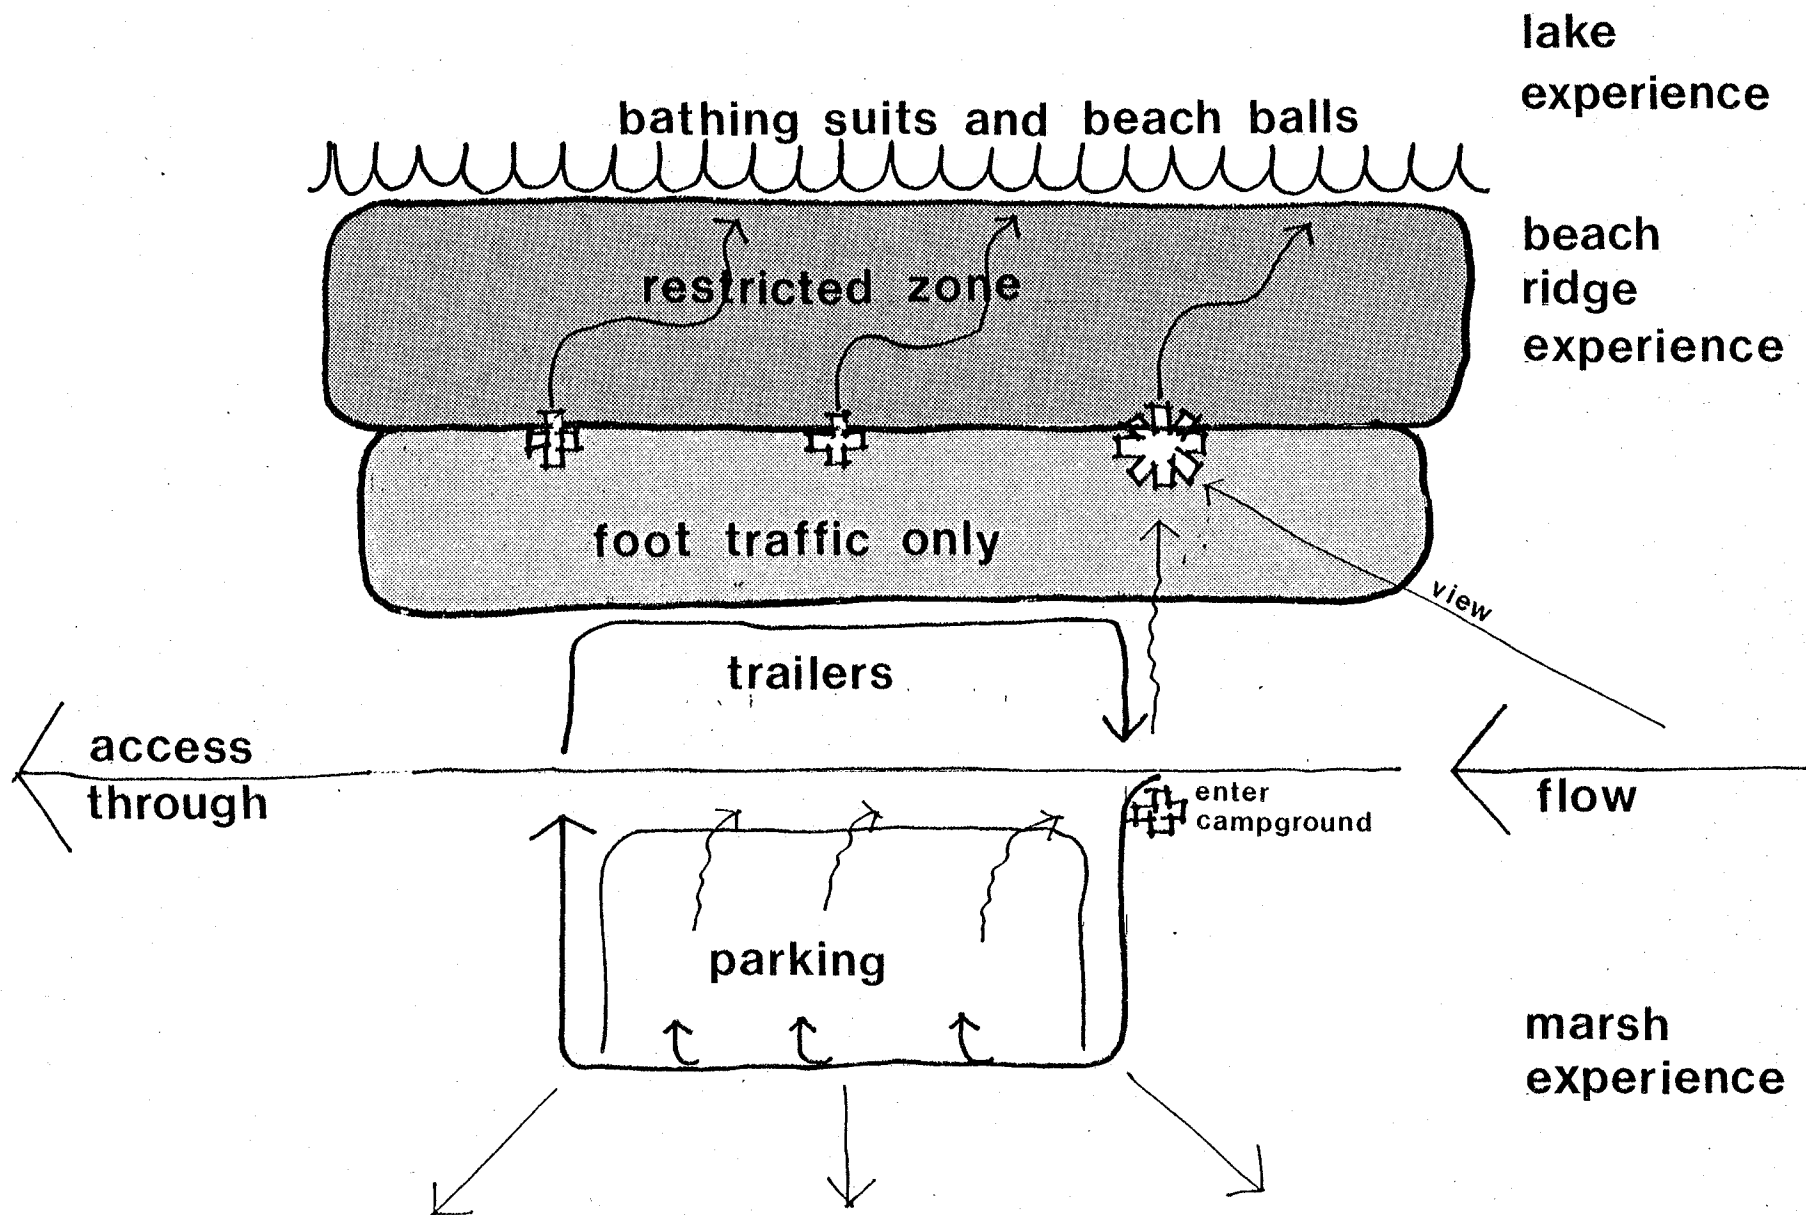
Figure 48.

Conceptual Plan:

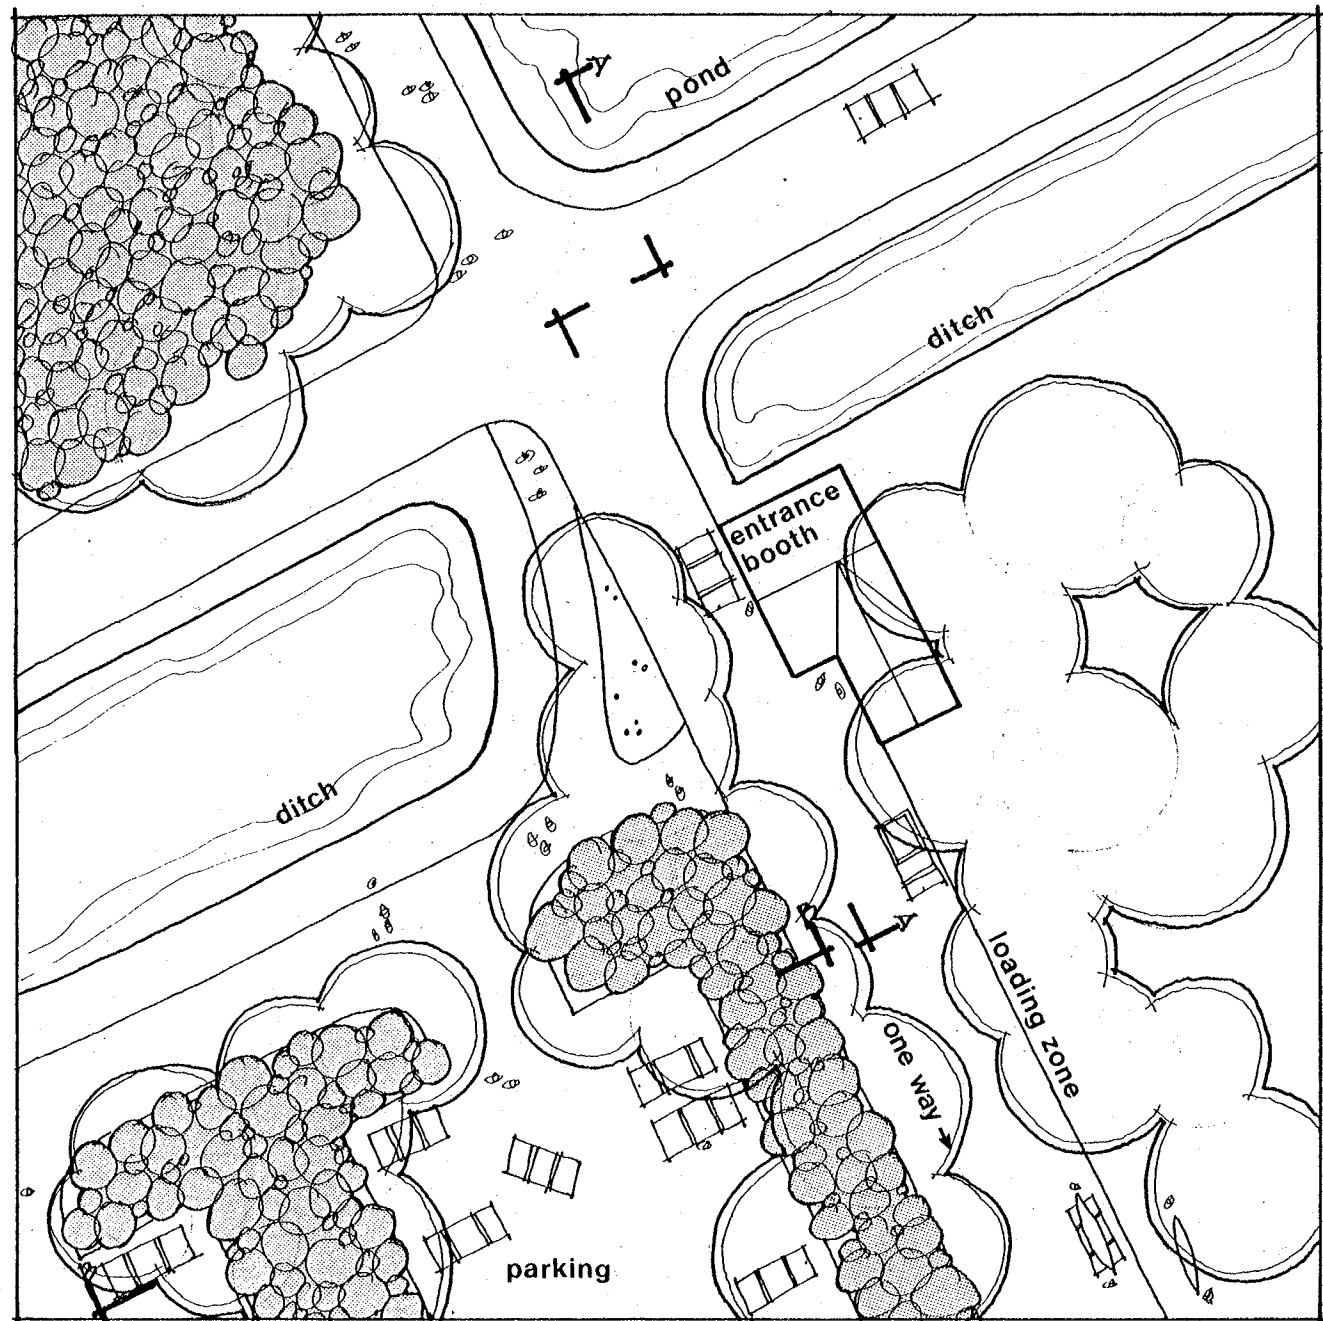
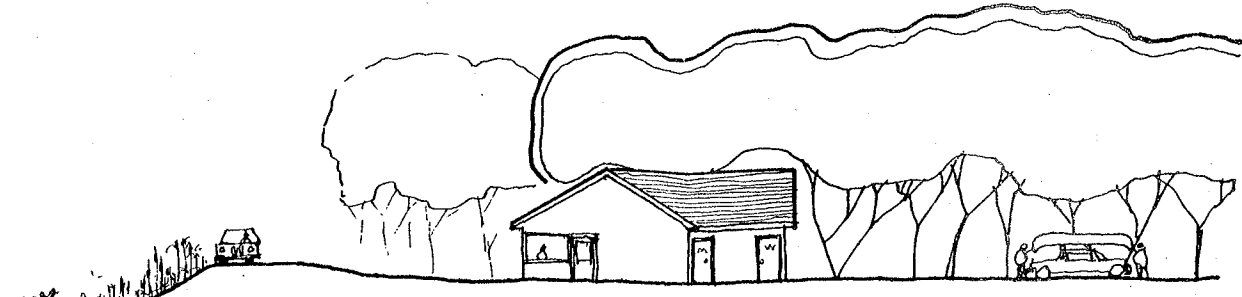
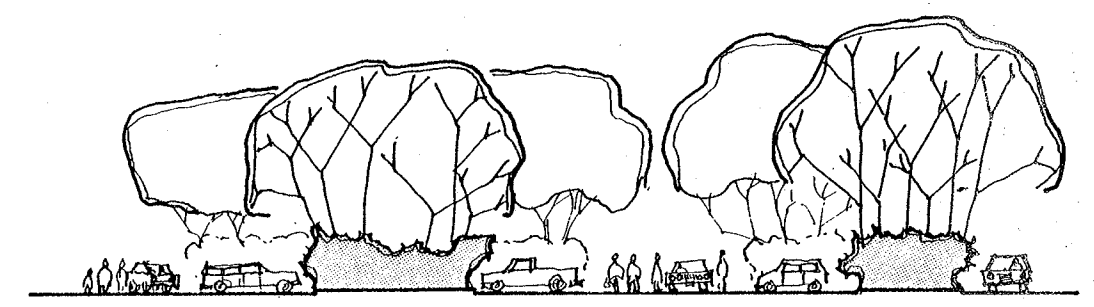
Entrance Booth Figure 50.

Detail A

section A-A
 entrance booth
 washrooms
 storage
 loading zone

section B-B
 parking

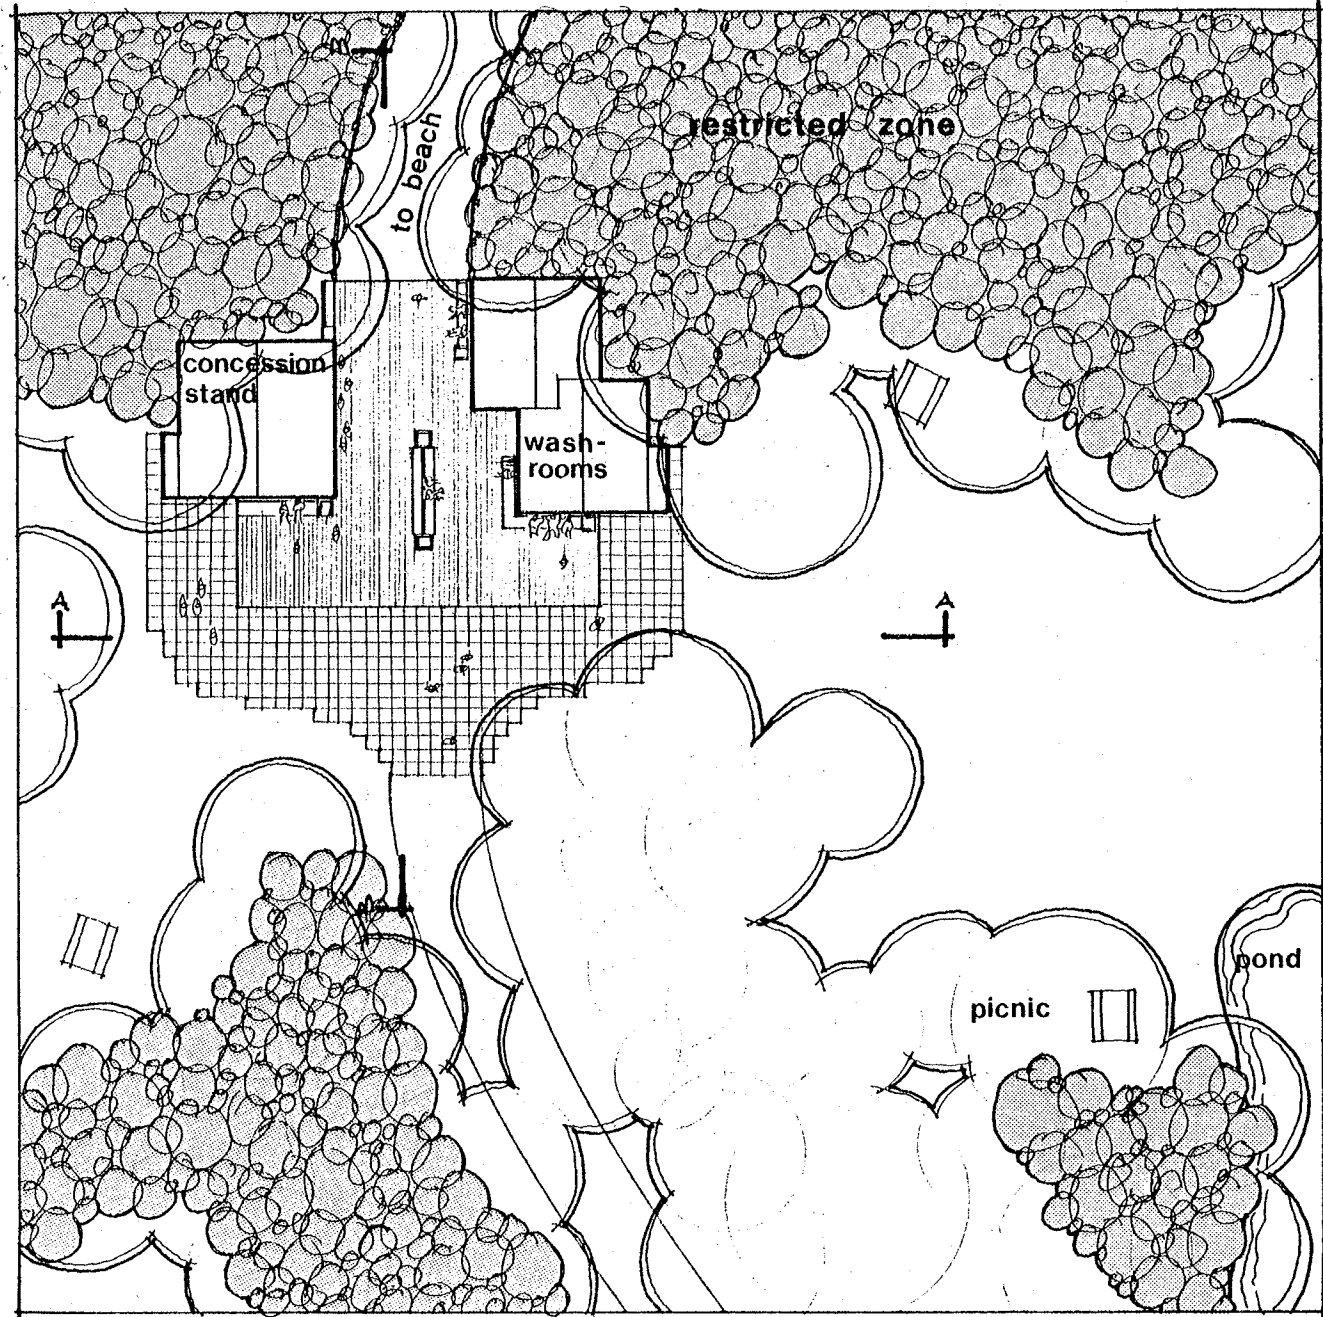
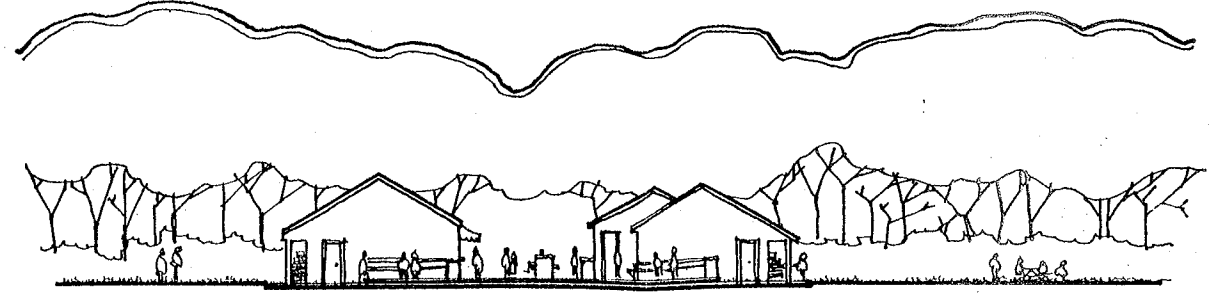
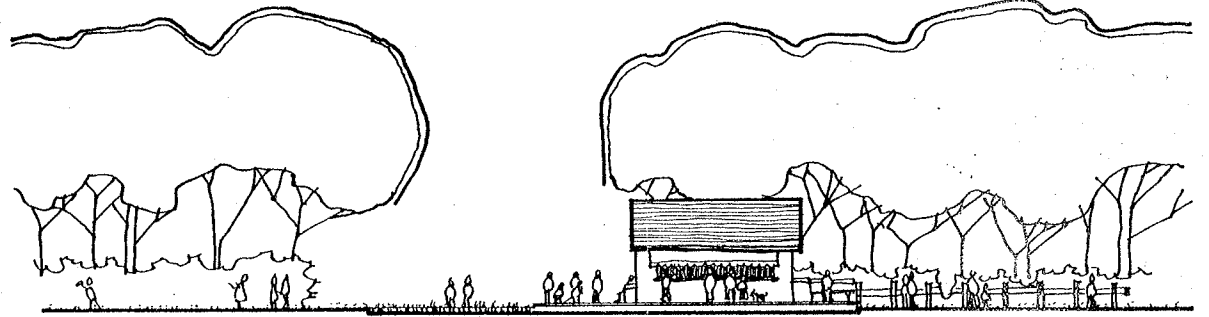
Figure 51.

Detail B

section A-A concession stand
 washrooms
 change rooms/showers
 pay telephone
 firewood supply
 picnicking

section B-B reinforced turf
 deck
 fenced path to the beach

Concession Stand

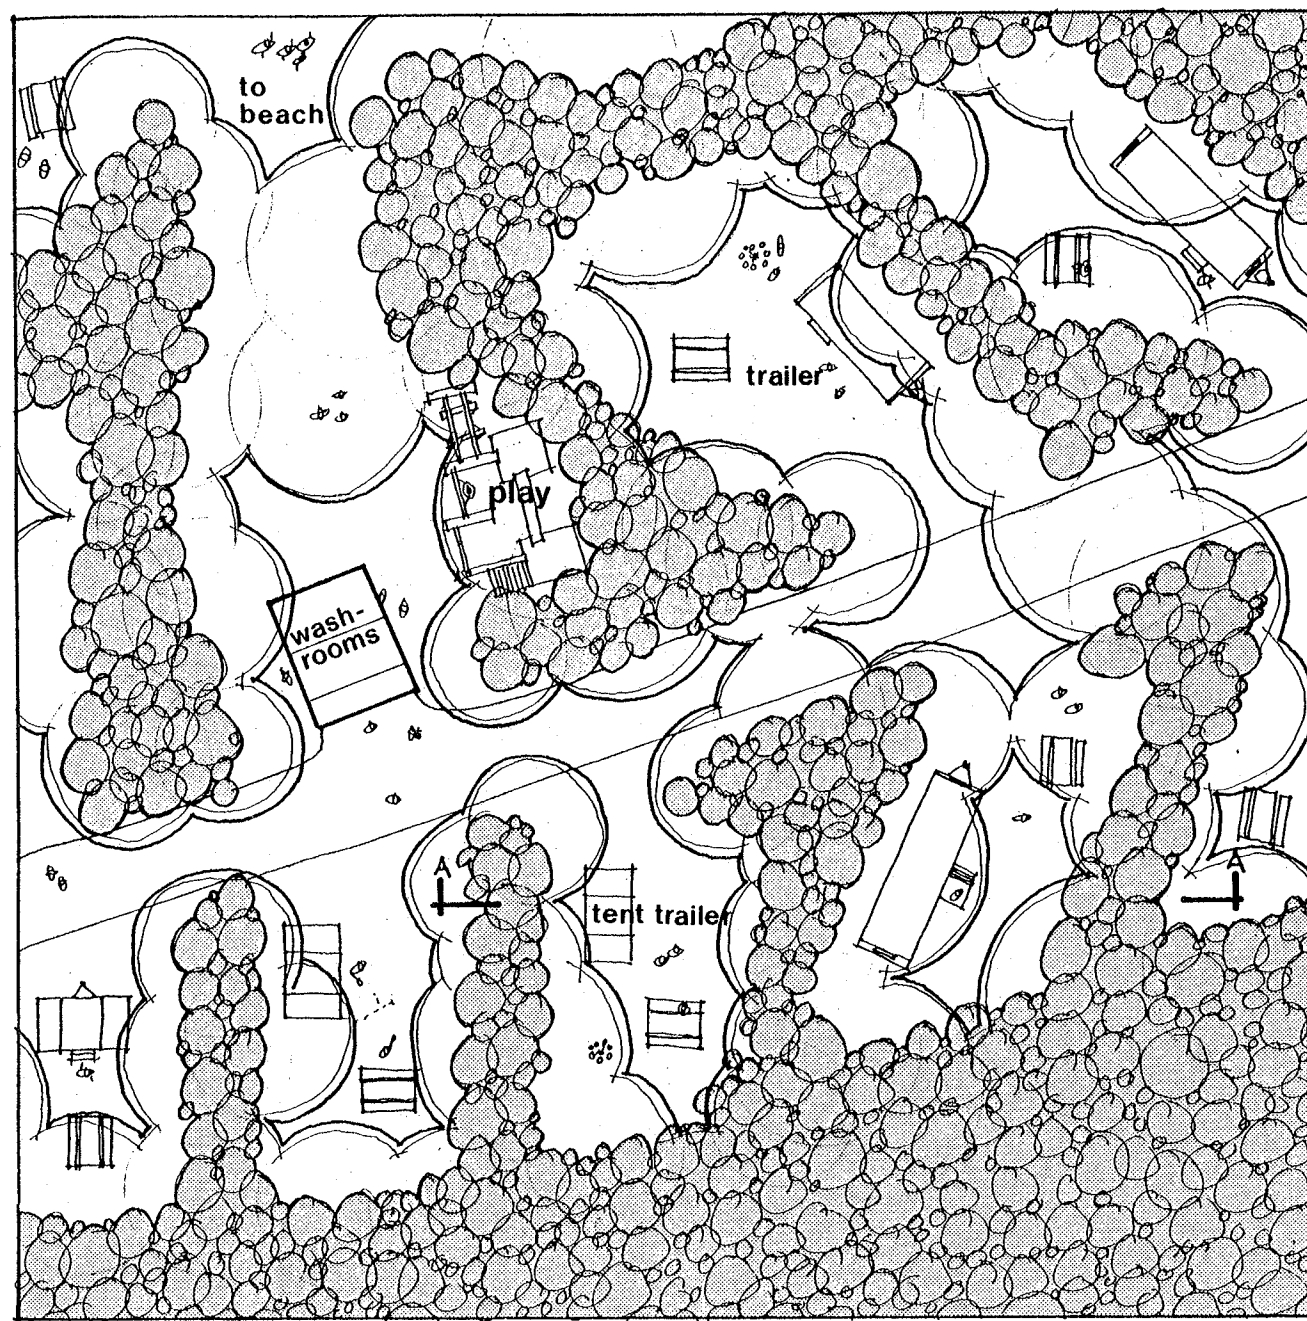
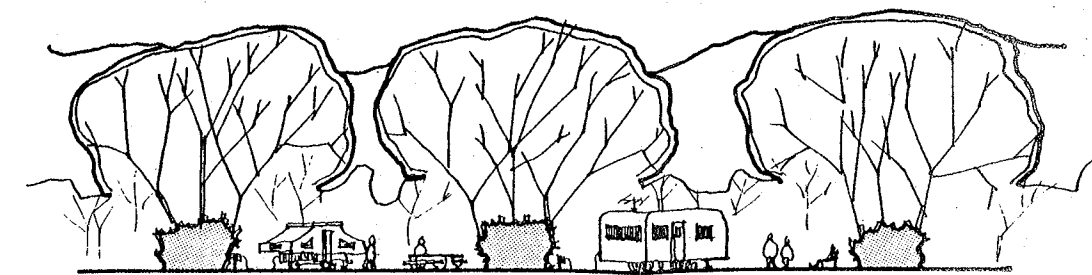
Figure 52.

Detail C

Trailer Site

- section A-A
- trailer and tent trailer sites
 - hydro
 - picnic table
 - fire ring
 - garbage receptacles

- washrooms
 - showers
 - firewood supply
 - drinking water
 - trailer pump out station

- play structure

The campsite inter-plantings (see page 51 for species list) are to provide a greater degree of undisturbed areas for plant succession to occur and to allow for a more diverse tree age and species composition. The ground cover of the campsite should maintain a protective organic mulch on the soil surface, preventing soil compaction and reducing surface run off. Where light conditions and the amount of traffic allows, grassed surfaces should be maintained, but where this is impractical, a 3 to 4 inch layer of wood or bark chips should be installed, except in the area adjacent to the fire-ring, to lessen the chance of ground fires in dry weather.

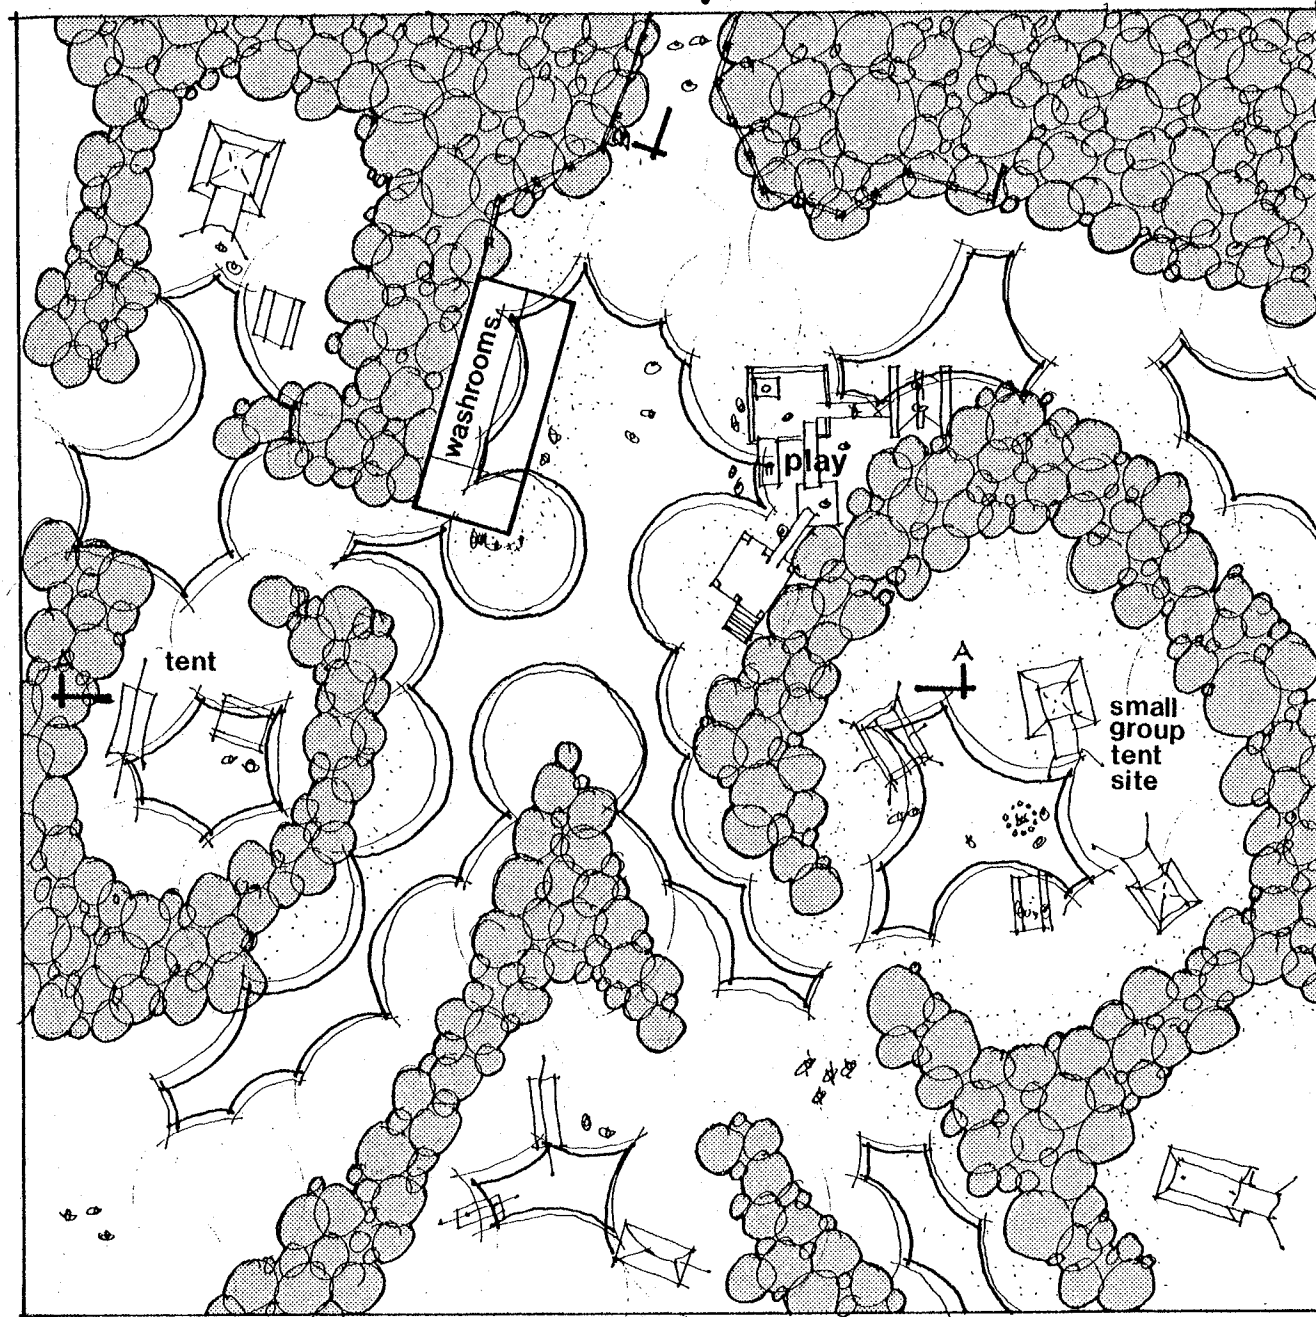
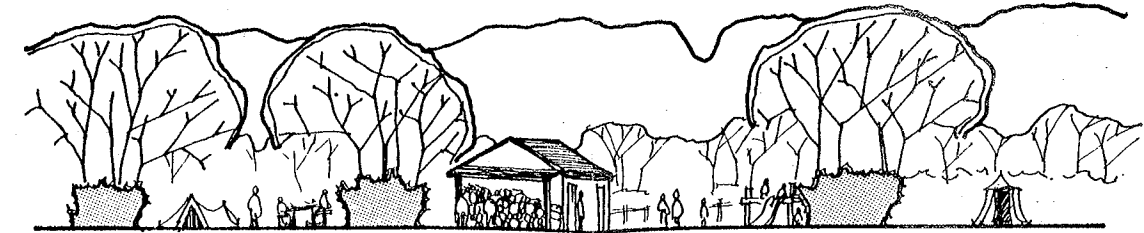
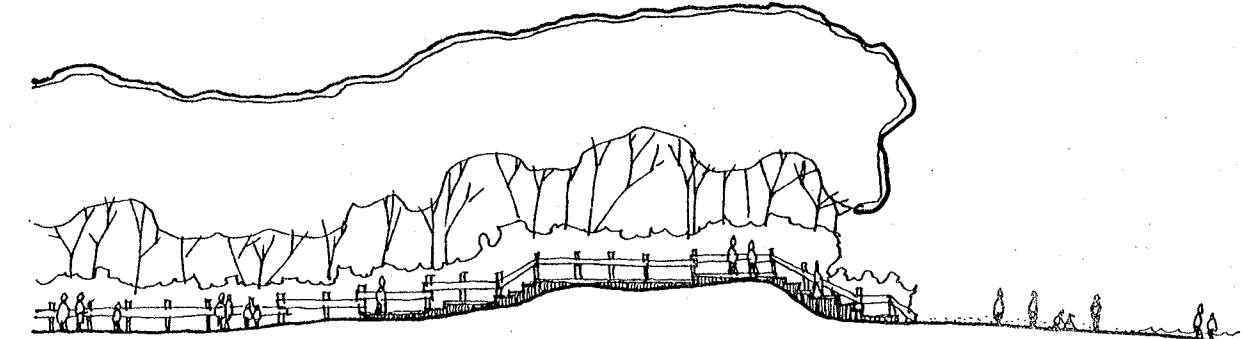
Figure 53.

Detail D

section A-A washrooms showers drinking water firewood supply play structure tent site picnic table fire ring garbage receptacle

section B-B fenced pathway and boardwalk to the beach

Tent Site

There are two different types of tent sites provided, individual sites which are 30 feet x 50 feet and small group sites 60 feet x 60 feet. It was noted that many of the tenters, particularly teenagers or young couples, visited the park in groups with 3 or 4 tents. These users (usually perceived as rowdier in nature), are catered to with 4 sites separated from the other tenters by a pathway and the washroom facilities. As there is no road access allowed to the campsites (service vehicle access to the washroom building is provided), a drop-off zone for unloading gear and supplies is available. The washroom facilities and childrens' play structure for the tenters is similar to the other facilities and is located at the junction of a pathway to the beach.

The pathways to the beach tranverse the forested ridge diagonally to the north-east to restrict the exposure of the path to the wind. A low running fence would restrict people to the pathways which should have a 3 to 4 inch layer of wood or bark mulch maintained on them. On the highest most exposed portions of the ridge, adjacent to the beach, raised boardwalks and stairs would reduce the effect of trampling and erosion along the pathways. The boundary between the beach and the forest should be monitored for damage and a low retaining fence be installed if damage is too severe. If a lifeguard is not deemed necessary for the beach (shallow profile of the lake seen as relatively safe), then a lifebuoy rack should be installed at the end of each pathway.

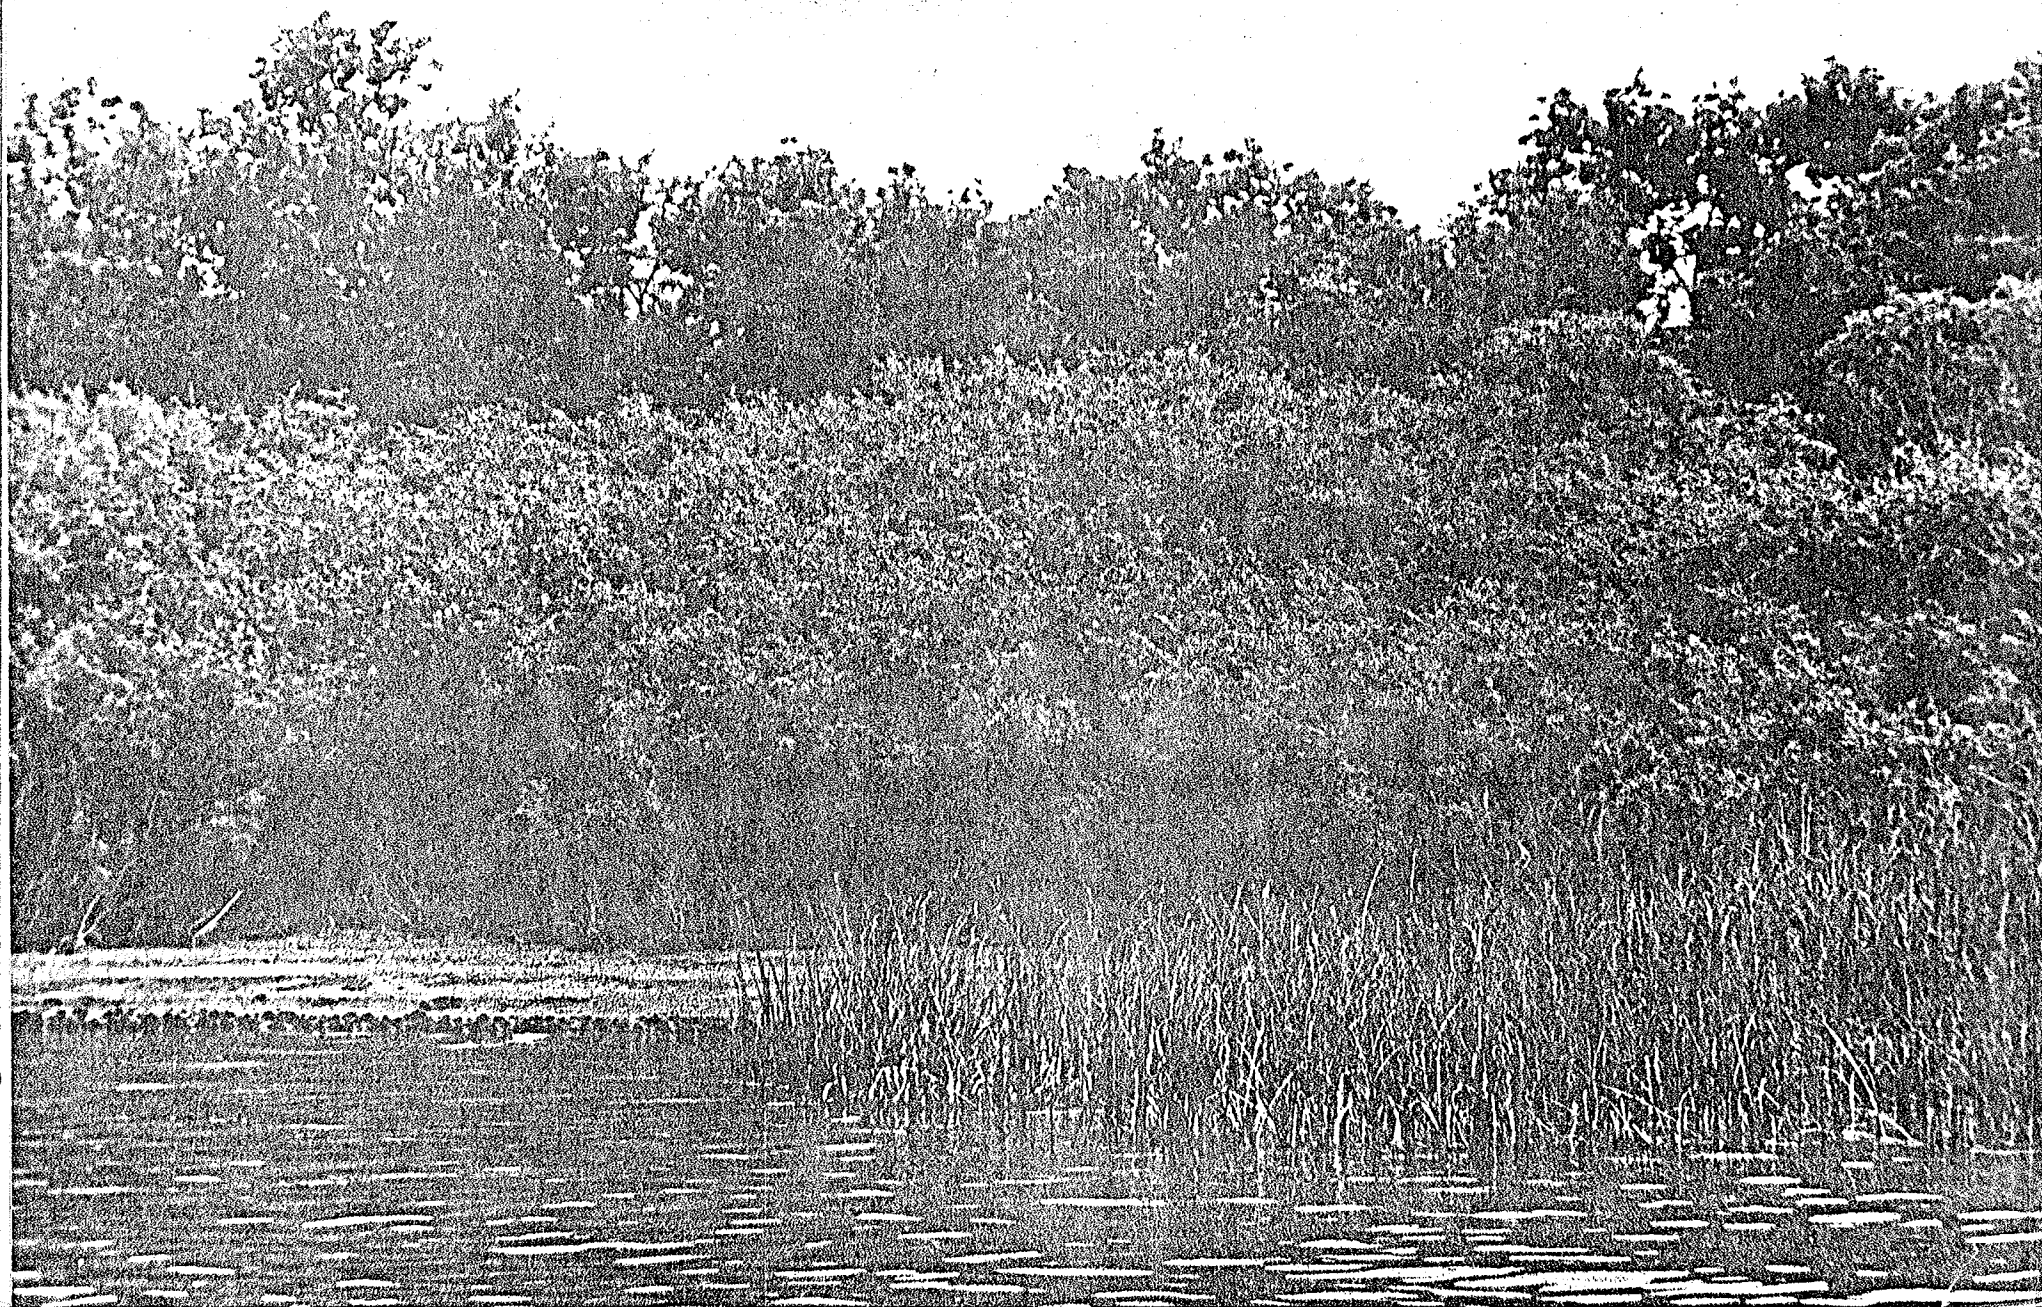
Figure 55. Lakeshore vegetation succession
