**DURABILITY OF GFRP PINS AND REINFORCEMENT IN
HERITAGE CONCRETE STRUCTURES**

Aaron Kroeker

**DEPARTMENT OF CIVIL ENGINEERING
UNIVERSITY OF MANITOBA
AUGUST 2005**

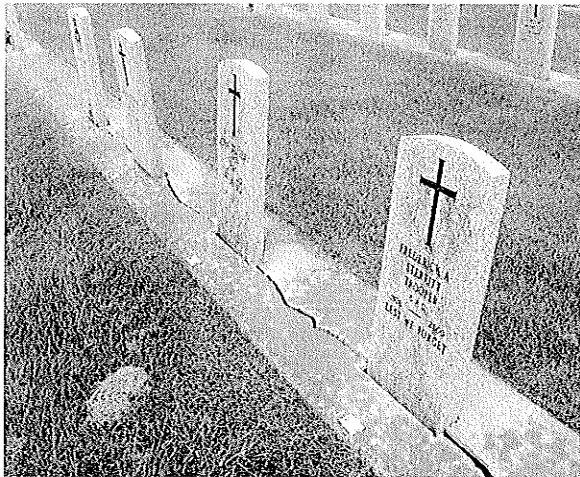
Figure 3. Severe longitudinal cracking.

Another reason for the rapid deterioration is the method used to anchor the grave markers to the support beam. A common method currently used at Brookside Cemetery is to cut a rectangular slot directly into the cured concrete support beam and place the grave markers inside this slot. Cutting directly into cured concrete in this fashion can easily initiate crack development. As can be seen in Figures 1 through 3, the majority of the cracking has started at or near the slot. Once cracking has occurred, water seeps into cracks and causes the steel reinforcement to corrode, increasing its volume and causing spalling. Examples of the spalling of the support beam can be seen in Figure 4.

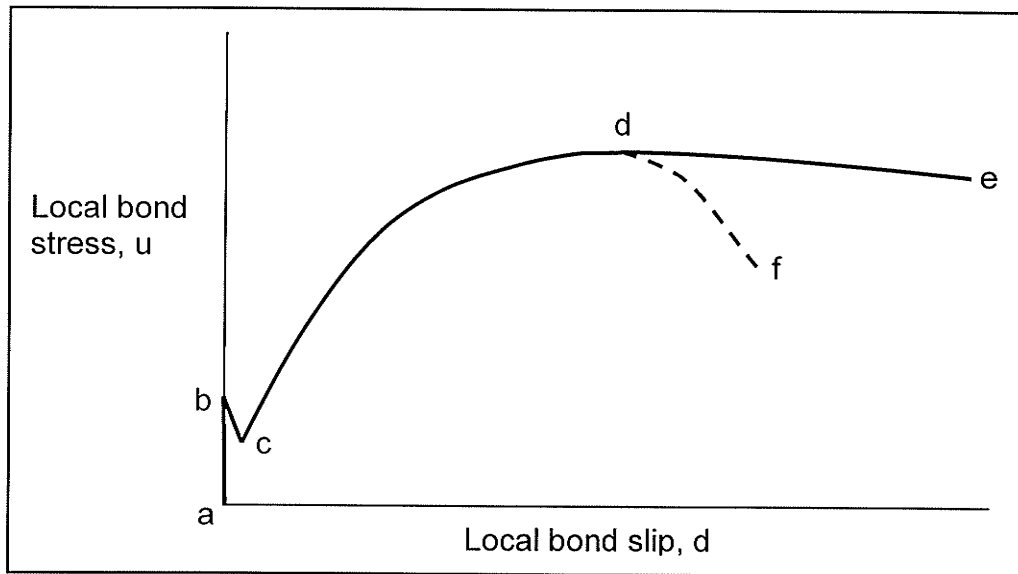
Once the limit of adhesion and static friction is exceeded, the adhesion bond is destroyed and the load drops to the value c , which is governed by sliding friction. Upon further loading and further slippage, the mechanical bearing forces are engaged as the interlocking effect of the bar deformations become significant. At this stage the bond stress is the sum of the sliding friction and mechanical bearing of the bar, with the latter component being more dominant as the displacement increases.

Figure 5. Theoretical Bond Stress – Bond Slip Relationship.

In the slip stage between c and d, relative displacement may occur between reinforcement and concrete at the interface, with slight crushing of the concrete ahead of the bar deformations; or displacements may be along a new cylindrical failure surface concentric with the reinforcing bar, some small distance out from the concrete – bar interface. In either case, a nonlinear relationship is expected, until a maximum bond stress is reached at d.

Performance beyond point d is governed by the depth of the bar within the concrete block. If the bar element is deep within the concrete, far from any end surface or crack face, then the local average bond stress will remain virtually constant, with a slight decrease experienced due to diminishing diameter resulting from Poisson's Effect. The portion of the curve d – e is the result.

However, if the bar element is near a crack face or near the edge of the concrete surface then longitudinal cracks may form along the reinforcing bar. Alternatively, the presence of high principal tensile stresses near the concrete face may lead to cone-shaped failure surfaces concentric with the bar. Either of these cases will

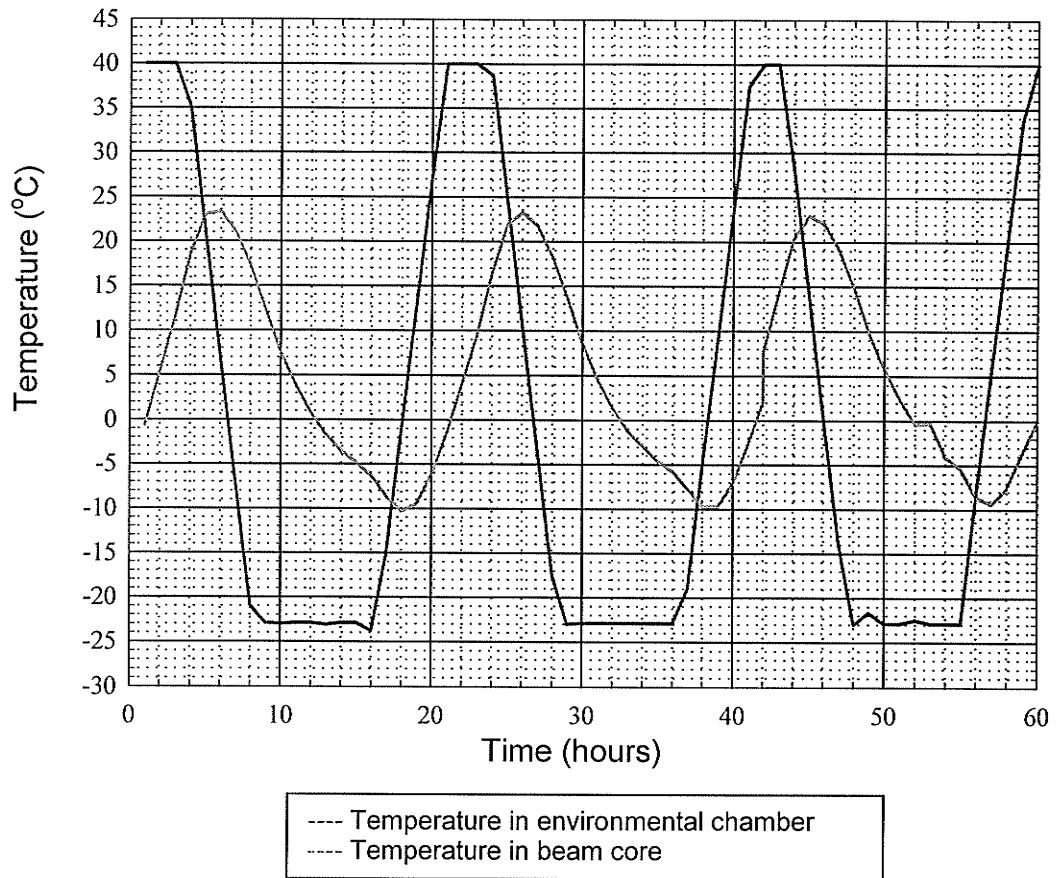
Due to the large thermal mass of the specimens, there was a significant temperature lag between the core temperature of the test specimens and the ambient air temperature in the environmental chamber. In order to monitor the exact internal temperature of the specimens a thermocouple was placed and sealed inside a 152 mm hole drilled into one of the beams. The temperature cycle took approximately 22 hours to reach the desired temperature in the core of the specimens. Figure 13 shows a typical plot of the ambient air and beam core temperatures during conditioning.

Figure 13. Freeze and thaw profile for test specimens.

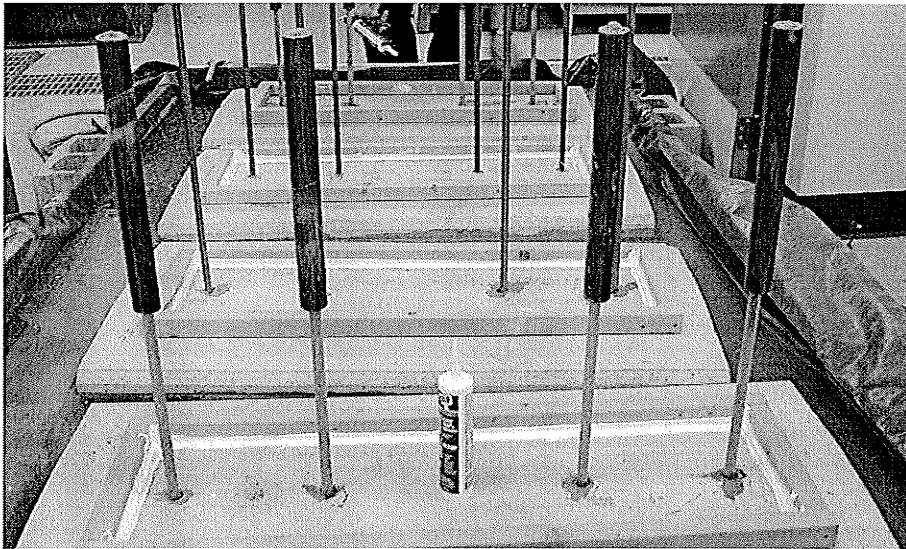
In order to prevent a crushing failure of the GFRP mounting pins during pullout testing, steel sleeves were placed over GFRP rods and were fixed with a highly expansive grout. The pullout test gripping system attached to threads that were cut in the steel sleeves, which prevented direct contact with the GFRP bars. The GFRP sleeves are shown in Figure 26. The stainless steel rods were already threaded which greatly facilitated attachment to the gripping system.

Figure 26. Steel sleeves fixed to GFRP rods to prevent crushing during pullout testing.

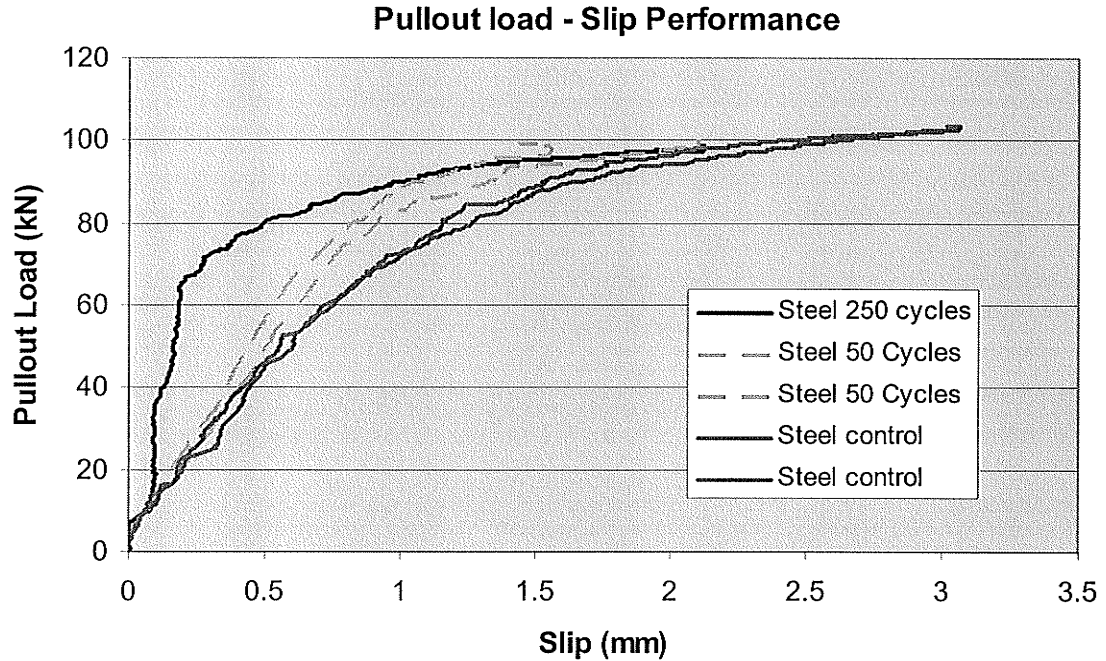
The pullout-slip behaviour of typical stainless steel pullout specimens is shown in Figure 33. Regardless of exposure to freeze/thaw cycles, the curve for the stainless steel specimens was similar to the general shape of the curve for the theoretical bond stress vs bond slip of an element of a reinforcing bar embedded in concrete (Figure 5). Generally, the amount of slip per unit pullout load is relatively small during the initial stages of loading and increases nonlinearly towards the final stages of loading. This means that when the bar is near failure a small increase in load will have a large increase in slip displacement.

Figure 33. Load-slip behaviour of stainless steel pullout specimens.

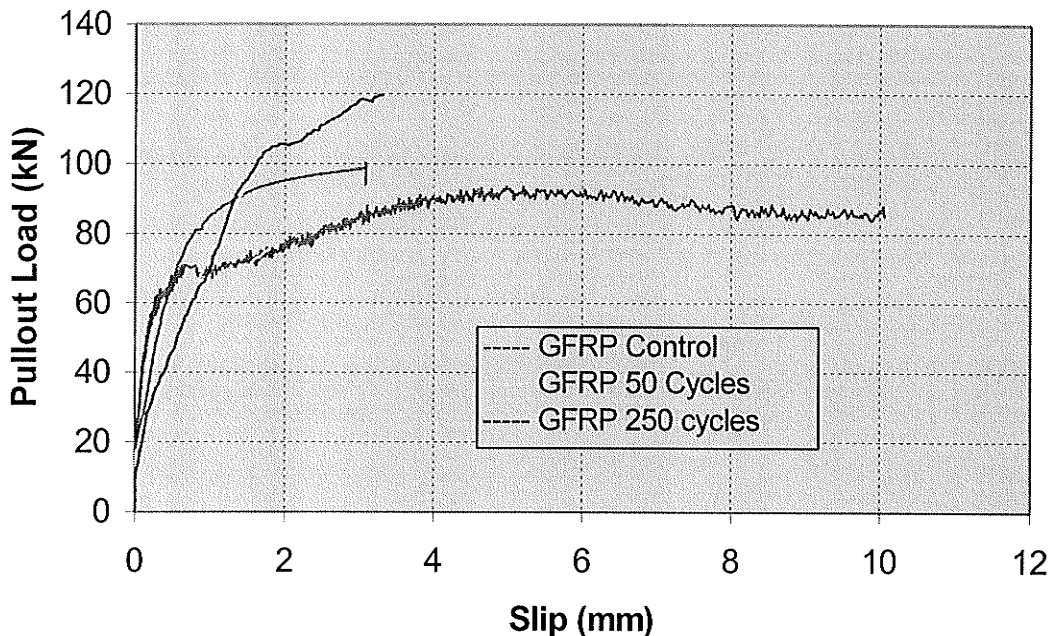
Figure 36. Pullout load – slip performance of GFRP pullout specimens.

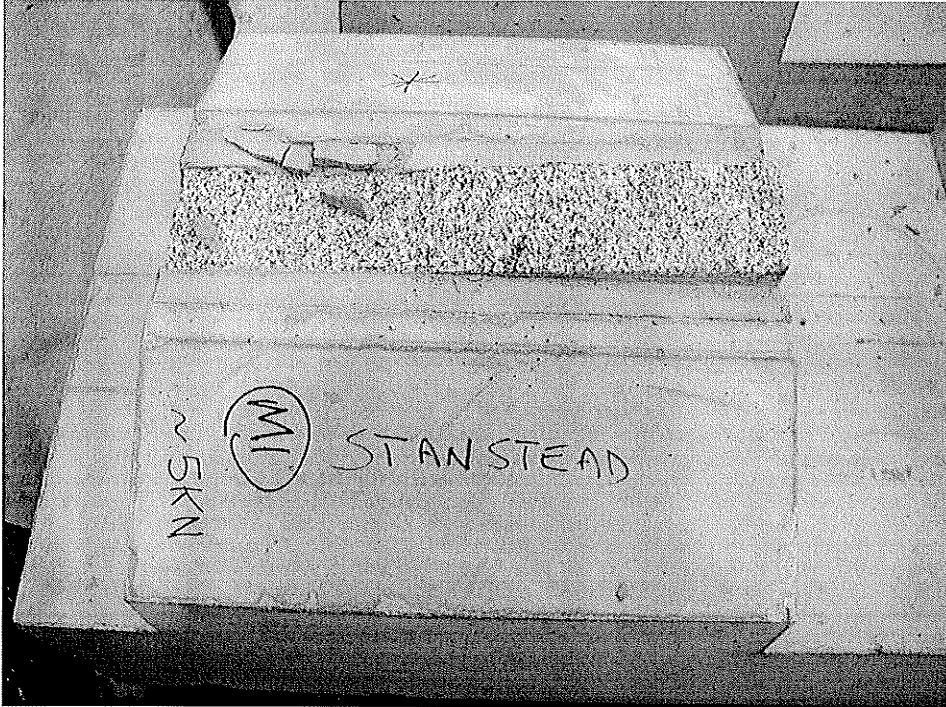
Figure 40. Failed pocket specimen –marker failed flush with concrete bumpers.
