**Survival & Growth of Sandbar
Willow, *Salix interior*, in
Bioengineering Projects, and the
Implications for Use in Erosion
Control in Manitoba**

A thesis submitted to the Faculty of Graduate Studies of
The University of Manitoba
in partial fulfilment of the requirements of the degree of

Master of Natural Resources Management

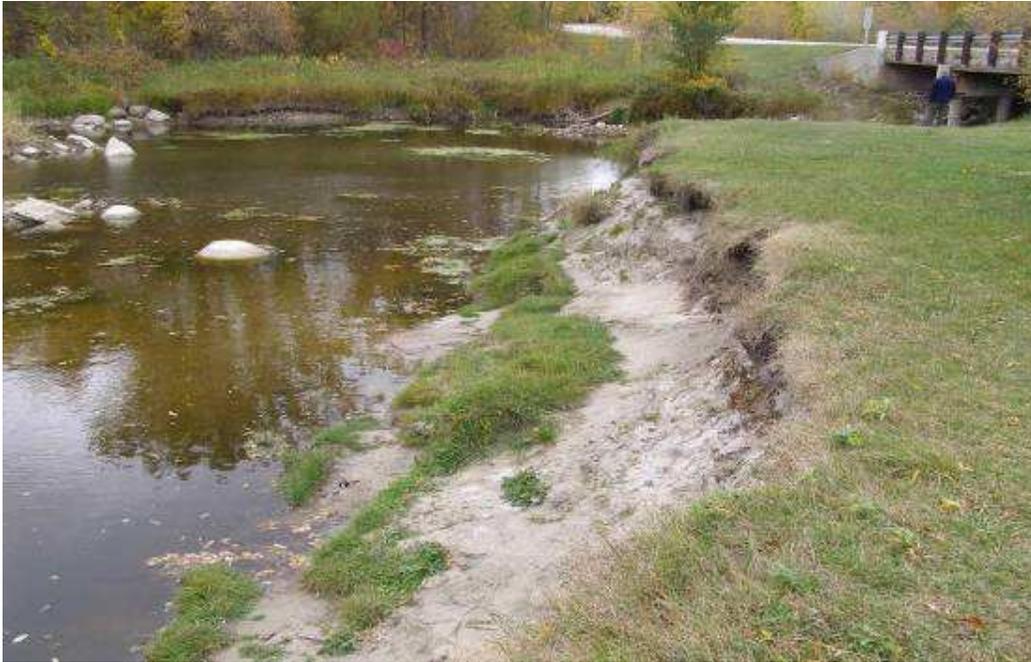
Plate 1 Erosion of coarser grained (sandy) soils showing typical concave stream bank surface, Rat River, Manitoba. July 2011

Erosion was described by Hooke (1979) as corrosion, collapse or slumping, caused by different mechanisms. Corrosion was most likely to take place during periods of high flow (Hooke 1979) and at the outside of meanders where flow velocity was greatest (Ackers and Charlton 1970), whereas collapse or slumping would occur once peak flows had passed. How erosion occurred could be related to the cohesive ability of the soil structure (Thorne 1991) that made up a particular section of river (a reach) whilst the extent and rate of erosion was linked to the level of moisture within the soil (Hooke 1979, Simon and Collison 2001). Less cohesive soils, described principally as having a larger grain size, show erosion that takes place at the level of individual grains (Thorne 1991). Simpson and Smith (2001), working on the Milk River in Alberta, found that reaches with a bank composed of a silt clay mix had narrow incised channels whereas reaches with a predominantly sandy structure were up to three times wider, due to the increase in lateral erosion as opposed to a meandering form taken by the river through the more cohesive sediments.

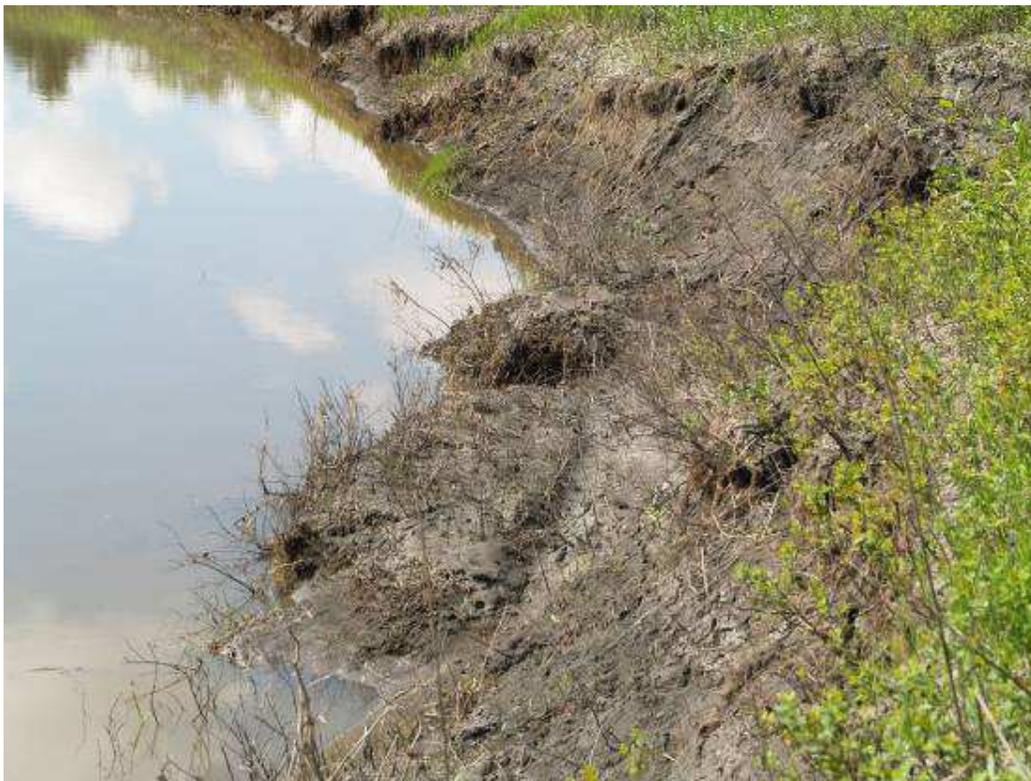
Plate 2 Slumping and subsequent erosion of cohesive soils, Tourond Creek, Manitoba. June 2011

Collapse was identified by large blocks of sediment shearing away from a steep bank (Hooke 1979), resulting either from saturation of a vertical layer at the face of the bank during high water level or from percolation of water from above along a plane parallel to the bank face (Thorne 1991). Slumping is categorized by Thorne (1991) as occurring in cohesive soils when they become saturated with water and may even reach a fluid state. This was the principal method of failure described by Schwert (2003) along riparian areas in the Red River Valley due to the extreme plasticity of the fine grain sediments when saturated by water. In contrast to unsaturated conditions, where both air and water are present and the remaining film of water helps to bind the particles together (Karube and Kawai 2001), the water maintains separation between particles of soil that allows them to move relative to one another (Simon and Collison 2002). Large scale slumping may be caused by water

seepage down through the soil some distance away from the stream until it meets an impermeable layer from where it flows toward the toe of the bank creating a plane along which the mass of soil can move (Fox *et al.* 2007). If the water is flowing through a non-cohesive layer such as sandy soil it can transport soil particles creating a void that further weakens the bank by creating tension cracks that increase the rate of water infiltration (Shields *et al.* 1995).

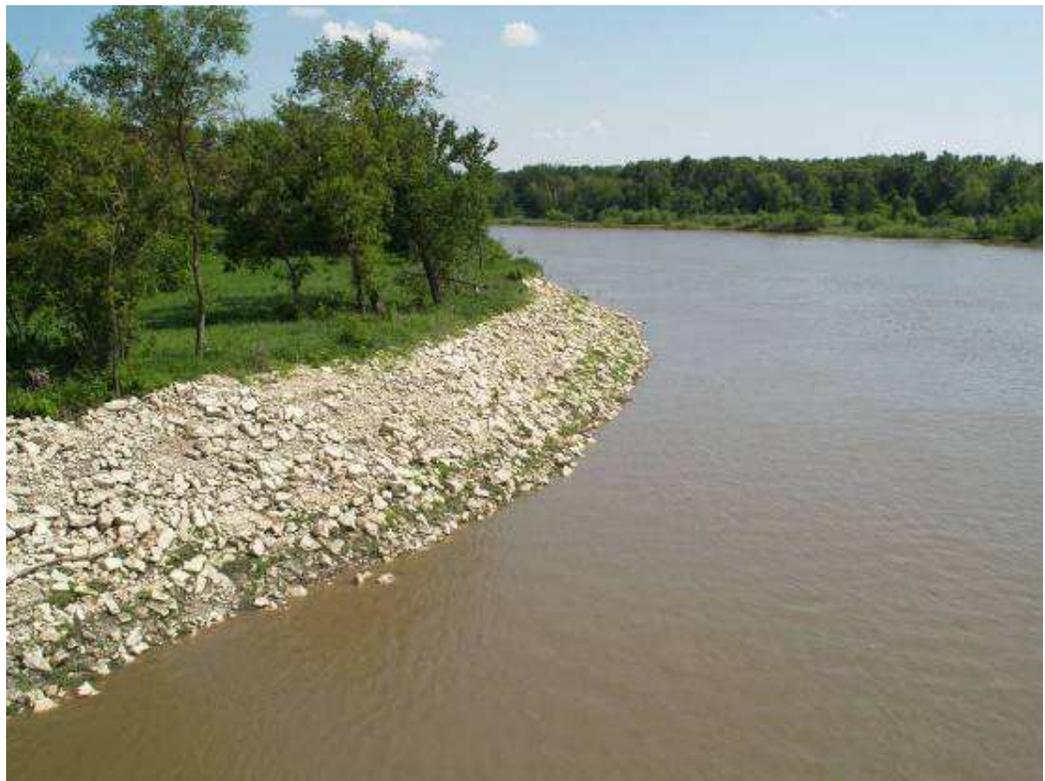
Plate 3 Stone rip-rap applied to from the bank toe to the top of channel, Red River, St Aldophe, Manitoba.

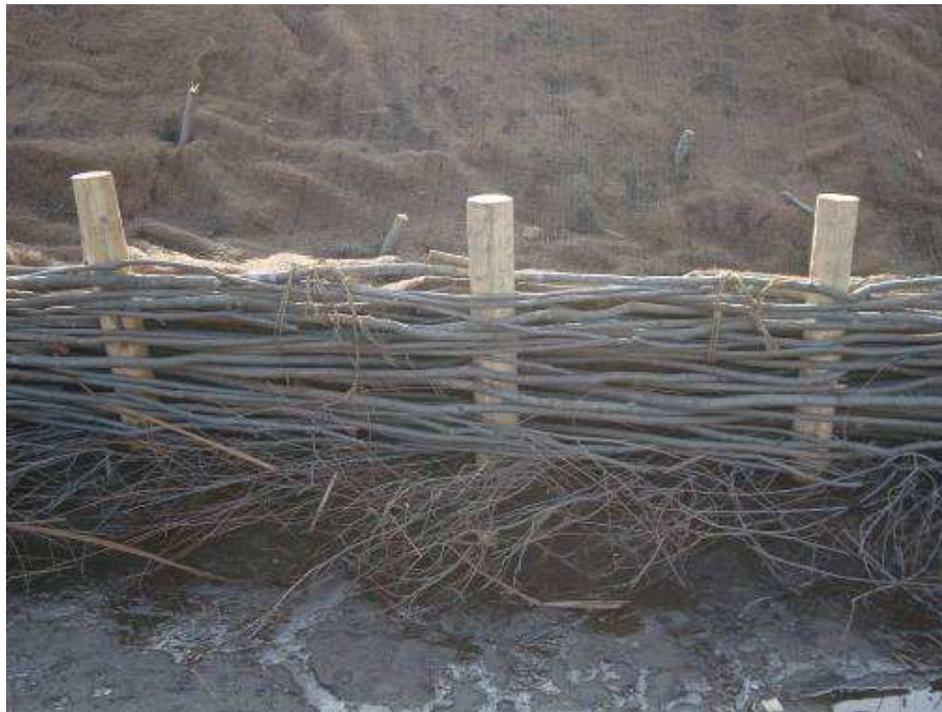
Plate 4 Willow spiling during installation at Minnedosa, October 2011 showing woven cuttings laced horizontally between vertical posts

Care must be taken to ensure good soil contact behind the wall if the willows are to survive and be an effective control measure (www.btcv.org.uk). Given the frequent use of spiling in the UK where labour costs are also high, claims by Sotir (*pers. comm.* cited by Anstead and Boar 2010) that the technique is not used in North America due to the high labour requirement seem unfounded.

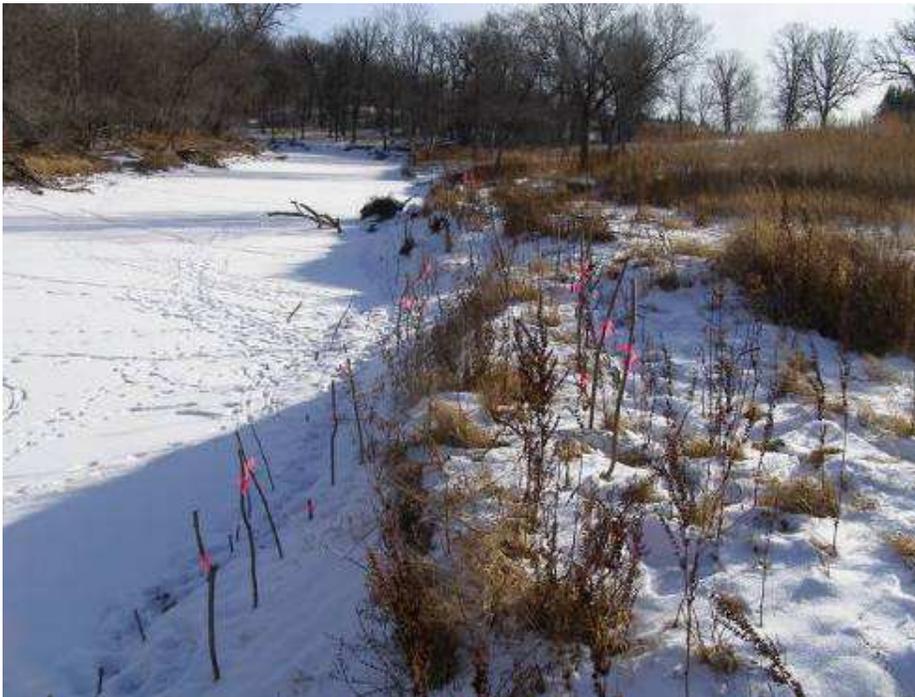
Plate 5 Otterburne willow cuttings showing typical placement of cuttings in rows

The cuttings were then trimmed using manual loppers, half to 0.25m above ground, half to 1m. At each site the position along the row for each

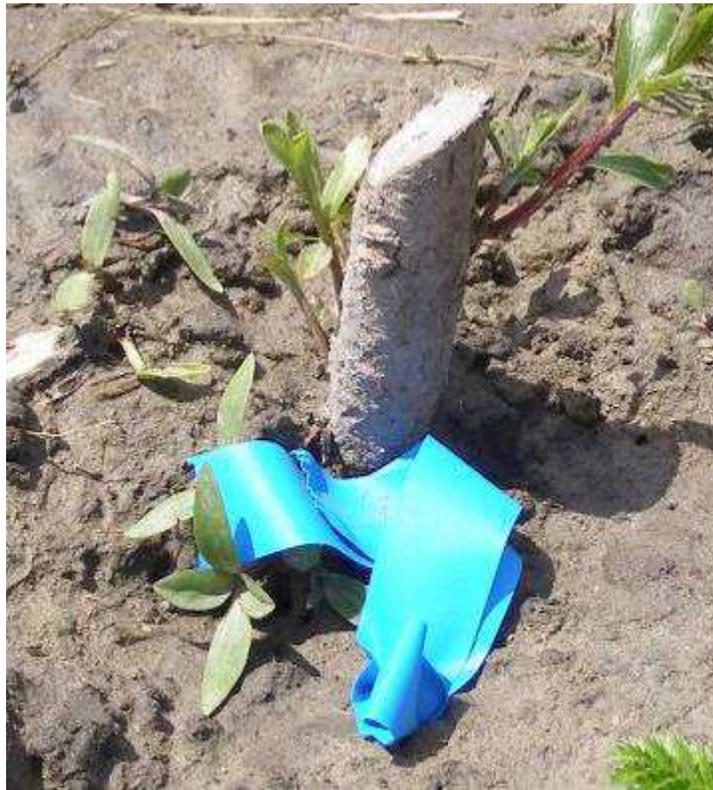
Plate 6 Example of a willow cutting with top cut off by beaver showing subsequent emergence of shoots.

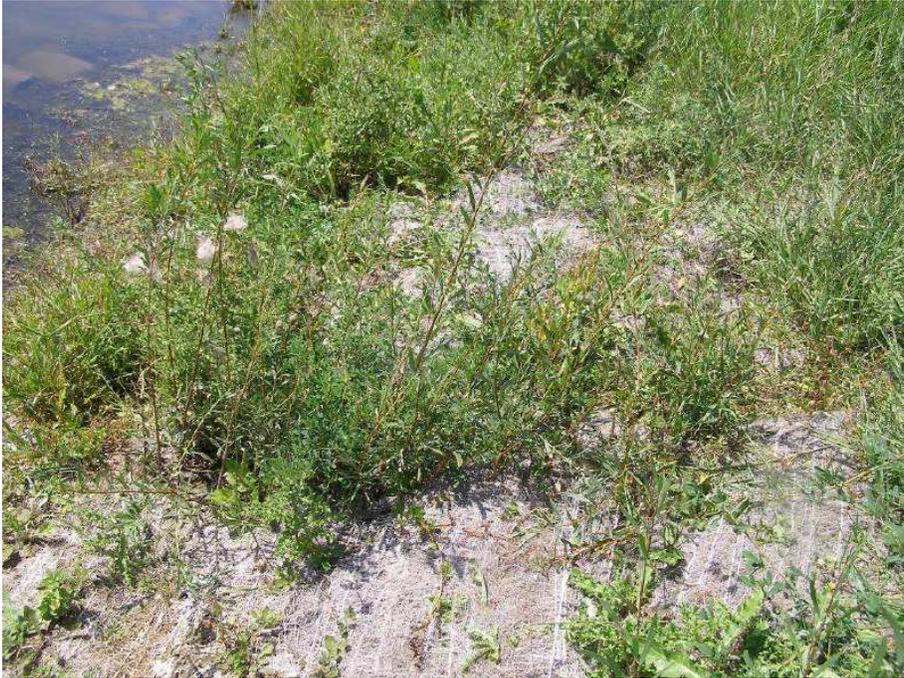
Plate 7 Shoots from vertical willow cutting bundle emerging through erosion blanket at Killarney, July 2012

erosion blanket at the downstream end of the site in an area that had not been planted with stakes.

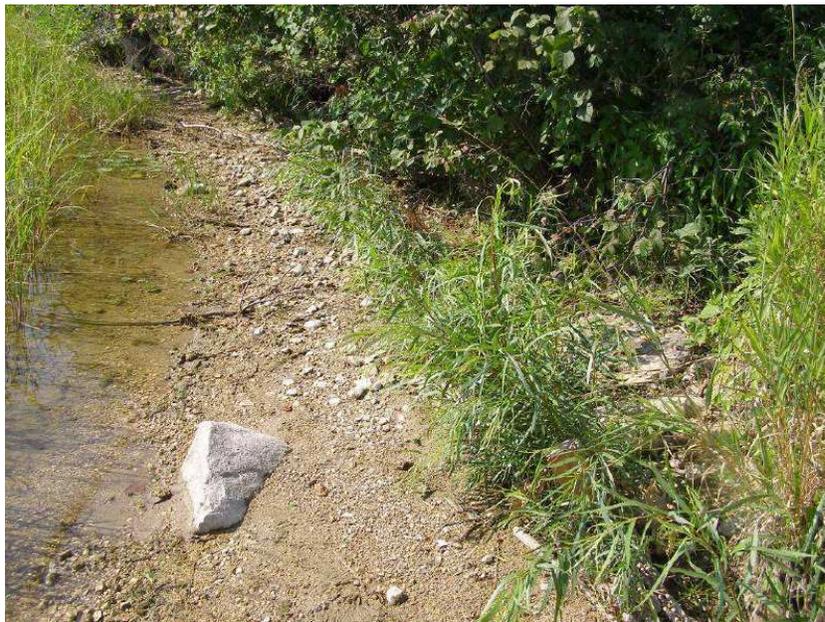
Plate 8 Growth on horizontal willow cutting bundles at St Malo bioengineering project, July 2012. By September more than half of the new shoots had died.

The horizontal willow bundles were completely inundated from when the lake thawed until June when water levels began to recede. Bundles at one end of the site had been damaged by human activity due to the location at a picnic site and boat launch. Spring planted bundles had more and longer shoots than those planted in the fall of the preceding year. Loose soil that had originally been placed on top of the bundles was no longer present leaving the bundles of cuttings exposed. Small roots (approx. 3cm long) were initially visible on some of the spring planted willows but these had disappeared by the following site visit. The majority of the new shoots died as water levels receded later in the summer. Few stems survived to the fall so that differences between spring and fall planted bundles were considerably reduced. Bundles that had been damaged by humans or beaver required re-securing to prevent the remaining material from being lost.

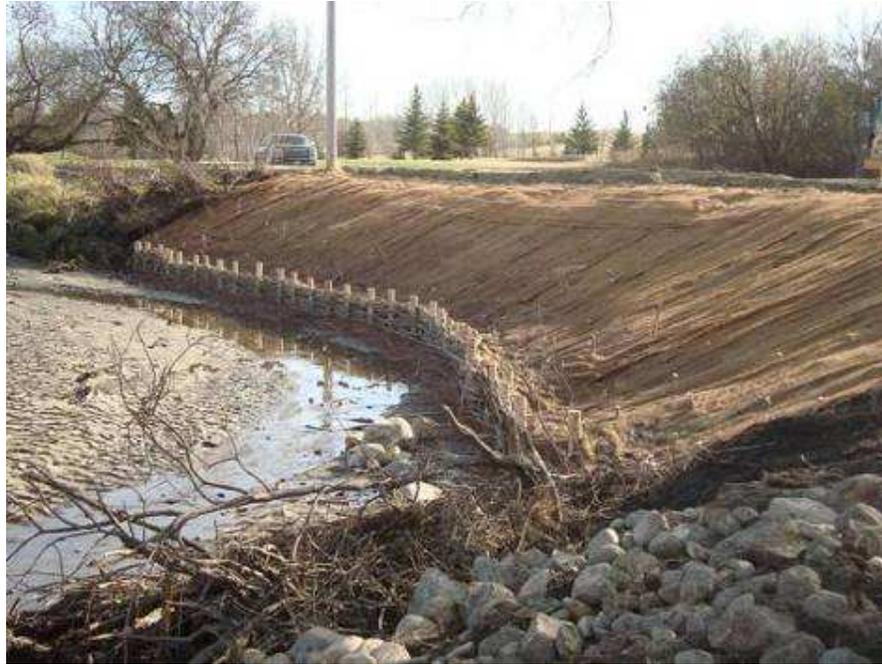
Plate 9 Minnedosa bioengineering project immediately after construction in November 2011, showing woven willow spiling at bank toe and coir erosion blanket covering slope

The uppermost rows of willow spiling had been removed from the spiling by beaver at some point between construction and the first site visit of 2012. When the spiling emerged from the flood waters in August small numbers of live shoots were visible from only the upper rows of the remaining spiling. Normally all parts of the spiling structure would have been expected to grow.

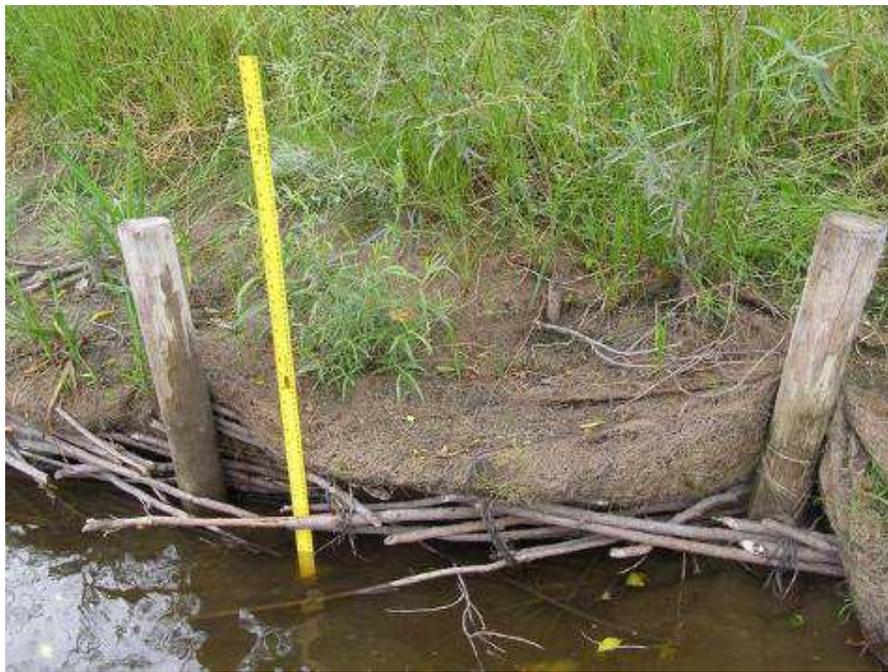
Plate 10 Minnedosa bioengineering in September 2012 showing damage to spiling by beaver leaving bare coir blanket. The live and dead willow cuttings at bottom of slope can also be seen.

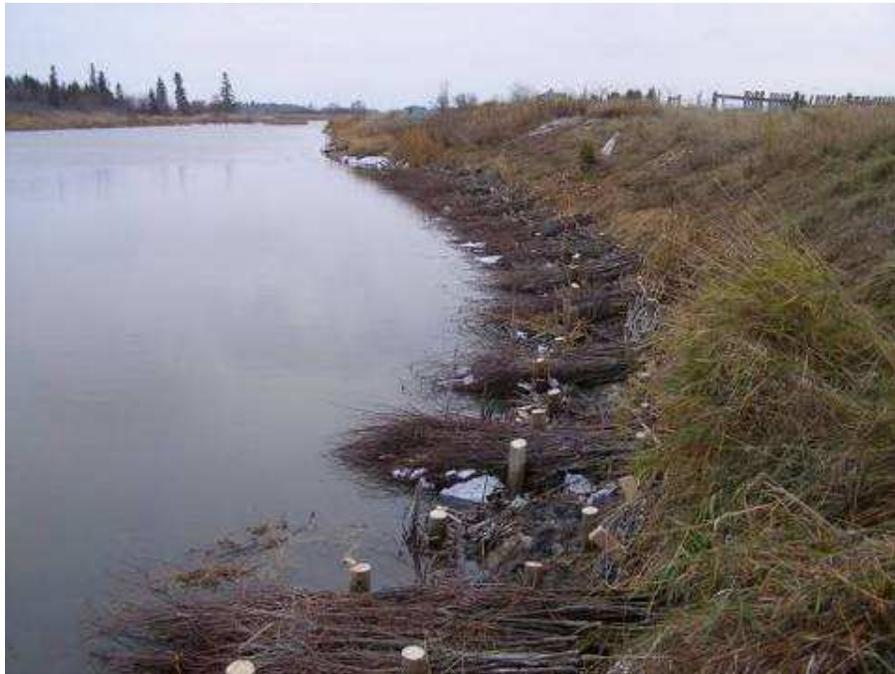
Plate 11 Riverton bioengineering project, shortly after installation in November 2011, showing inert bundles at 90° to bank toe placed to absorb wave energy

Survival and growth of individual willow cuttings was highest (>75%) close to water level, but was less than 25% for cuttings more than 1m above minimum water level. All willow bundles developed numbers of new shoots. In a number of cases maximum shoot length exceeded 100cm by late September 2012. Water levels at Riverton did not follow the same pattern as at other sites in this study. They are determined by levels in Lake Winnipeg so tend to rise slightly during the summer as lake levels increase, fluctuating according to wind direction, before declining again in the fall. Soil around the willow bundles remained in place around the cuttings. Wire holding the bundles of inert willow at the toe had loosened or broken, requiring replacement before the next winter.

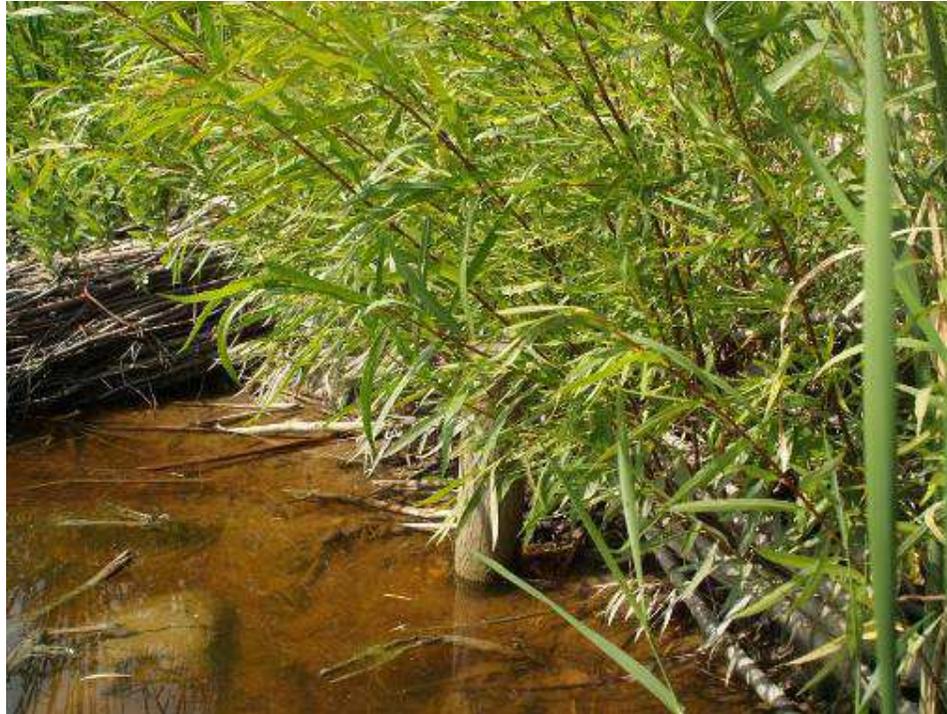
Plate 12 New shoots produced by willow bundles at Riverton grew to > 100cm during 2012.
