**DESIGN AND IMPLEMENTATION OF A RAMMED
INFILL ADOBE AND PLASTIC BOTTLE WALL
SYSTEM IN HONDURAS**

By
Garry Alvin Enns

A thesis submitted to
the Faculty of Graduate Studies
in partial fulfillment of
the requirements for the degree of
Master of Science

June 2015

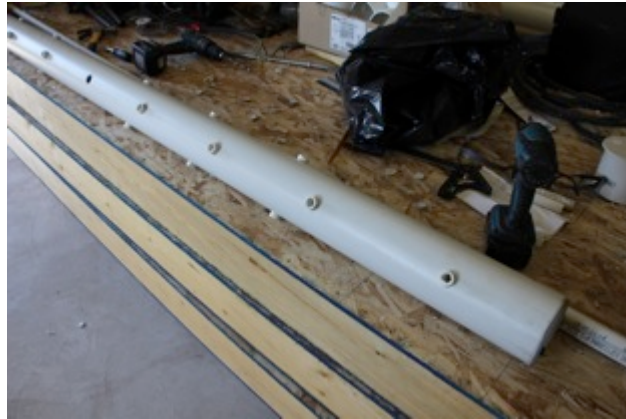
To limit the variables and loads placed upon the earth wall system, the decision was made to utilize CFPTs to transfer the axial roof loads to the foundation. The CFPTs also provided additional racking and transverse resistance but the testing was limited to axial compressive testing. Initial design concepts for the earth wall system included insertion of 13 mm ($\frac{1}{2}$ ") PVC tubes through 102 mm (4") PVC to create tie-through locations for cabling or threaded rod as necessary. Therefore the columns tested included 13 mm ($\frac{1}{2}$ ") PVC inserts at 127 mm (5") spacing aligned 90° to each other as shown in Figure 3, and a single piece of longitudinal 9.5 mm ($\frac{3}{8}$ ") steel rebar.

Figure 3: CFPT with 13 mm (1/2") PVC Inserts

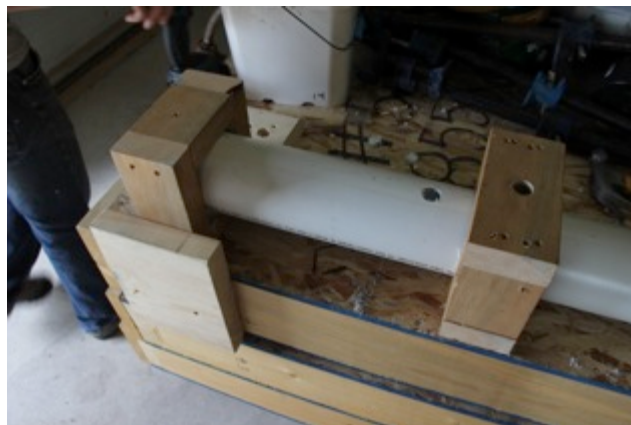
Three rectangular boxes made of nominal 51 mm x 102 mm (2" x 4") lumber with inside diameter equal to the outside diameter of the 102 mm (4") PVC were placed upon a flat working surface to keep the 13 mm (1/2") PVC inserts in line and 90° to each other. One box was secured in place at each end while the third box with a 19 mm (3/4") pilot hole was free to move along the pipe to the locations where holes were to be drilled for the inserts as shown in Figure 4.

Figure 4: Jig for Aligning and Drilling Holes in PVC Tube

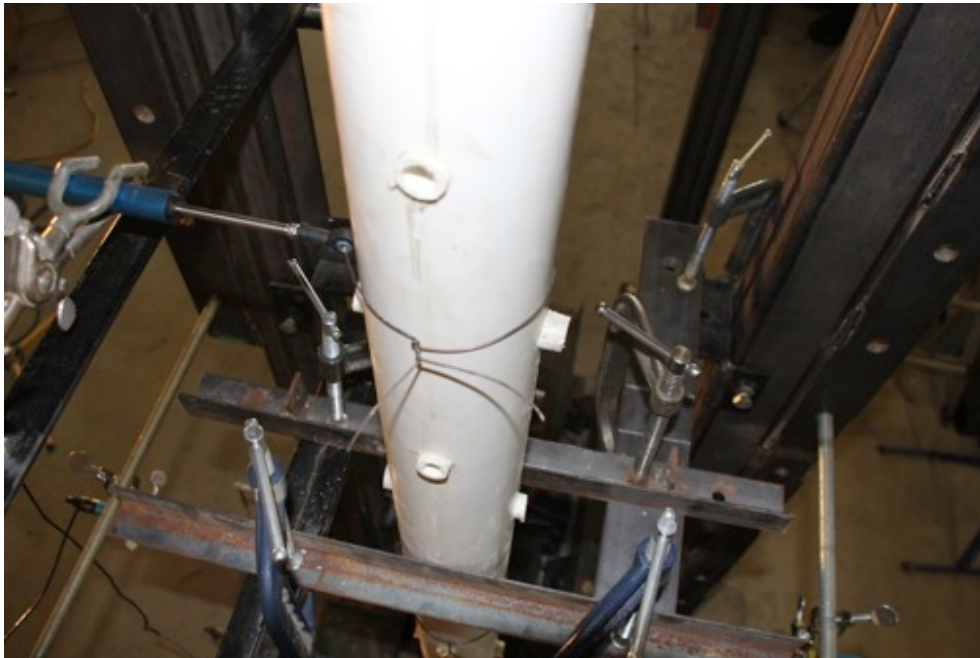
The four CFPTs were restrained to movement parallel to the orientation of the test frame so mid-span deflection data could be collected safely without damaging linear potentiometers as seen in Figure 7. Two linear potentiometers were tied to the mid-span of the column using tie wire, one linear potentiometer at each ¼ point from the top and bottom, and a linear potentiometer on the crosshead.

Figure 7: CFPT Axial Test Restrained Movement

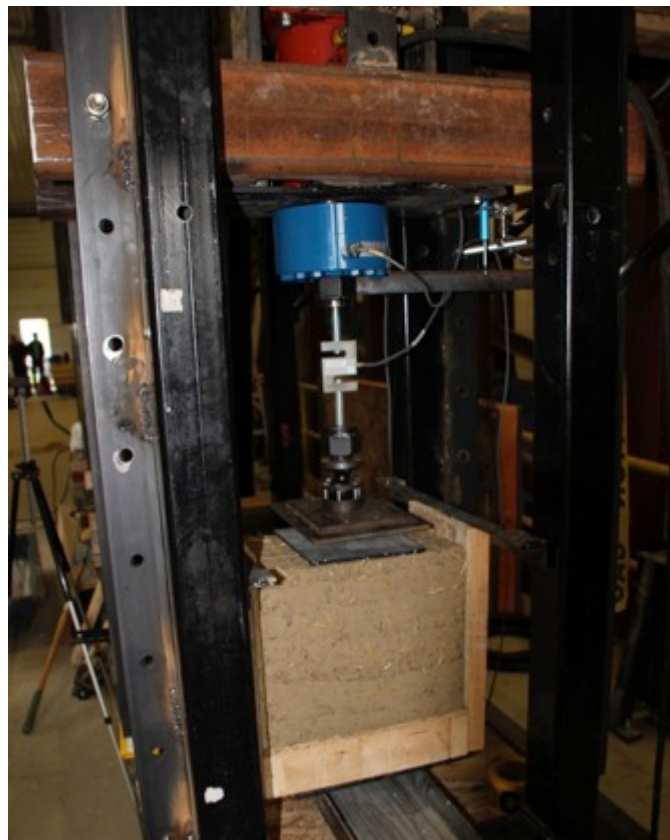
Figure 12: Infill Block Axial Test

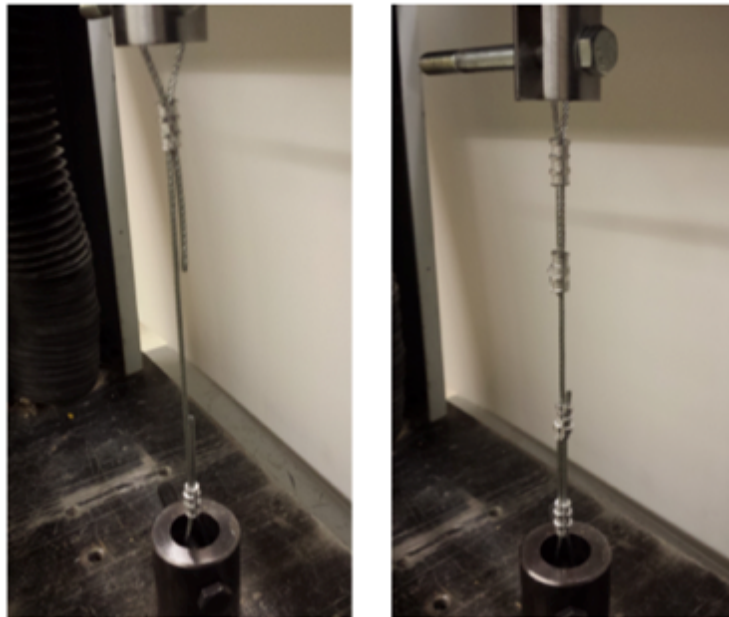
Racking resistance in the wall was provided by 3 mm (1/8") (7x7) galvanized aircraft cable of a rated 7562 N (1,700 lb) breaking strength. The cables were clamped using aluminum cable sleeves and the connection was tested to determine if one sleeve was sufficient or if two were required as seen in Figure 13. Plotting tension vs. displacement during the tension test provided the basis for determining an appropriate tension of the cables in the wall system.

Figure 13: Single (L) and Double (R) Aluminum Cable Sleeve Connection Test

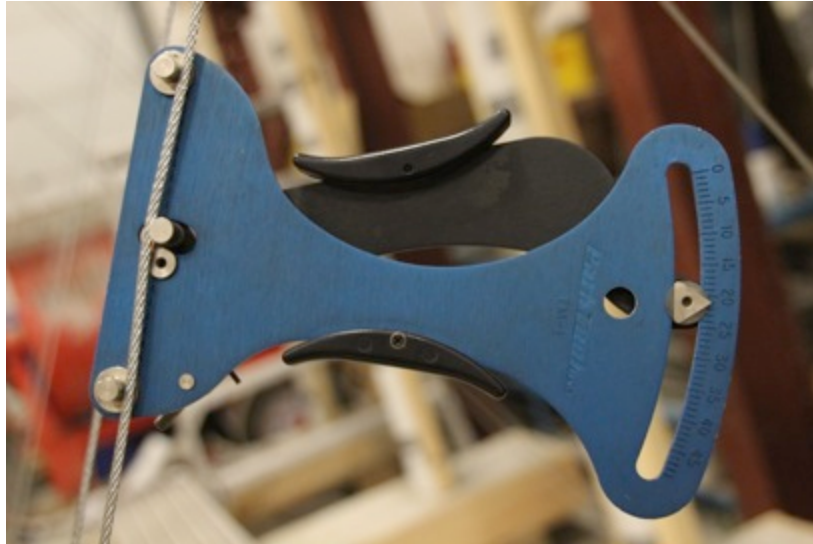
tension meter as shown in Figure 14. For the development of the calibration curve used for the spoke tension meter see Appendix A.

Figure 14: Tensioning Aircraft Cable with Bicycle Spoke Tension Meter

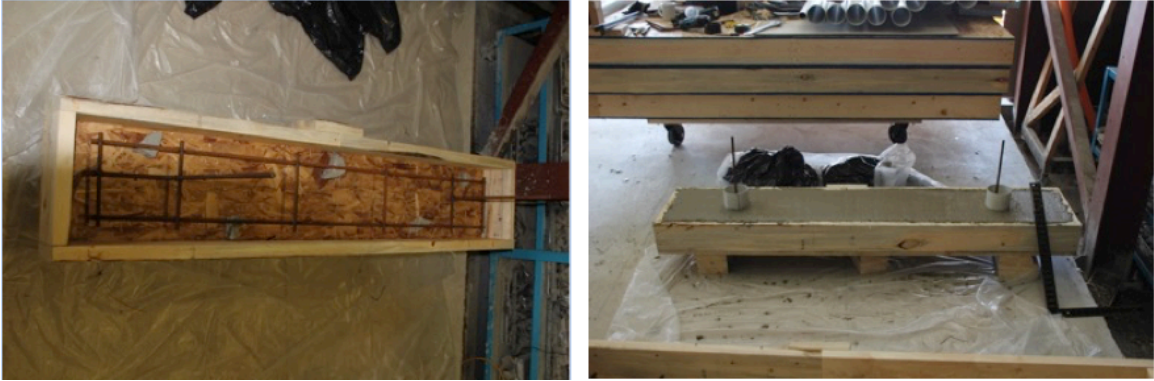
Eight footings were poured using a 3:1 (A-base gravel: cement) ratio, 1.8 m x 0.3 m x 0.1 m (6' x 1' x 5.5") (l x w x h) as seen in Figure 15. Concrete was consolidated using the end of a trowel. Rebar dowels protruded a foot out of the concrete at column locations. 152 mm (6") long PVC unions cut from the connection end of 102 mm (4") pressurized PVC tubes were placed into the concrete footings at 1.2 m (4') on center before the concrete set as seen in Figure 15. The unions protruded 76 mm (3") above the footing and leveled using a 1.2 m (4') level.

Figure 15: Empty Concrete Footing (L) & Poured With 102 mm (4") PVC Unions (R)

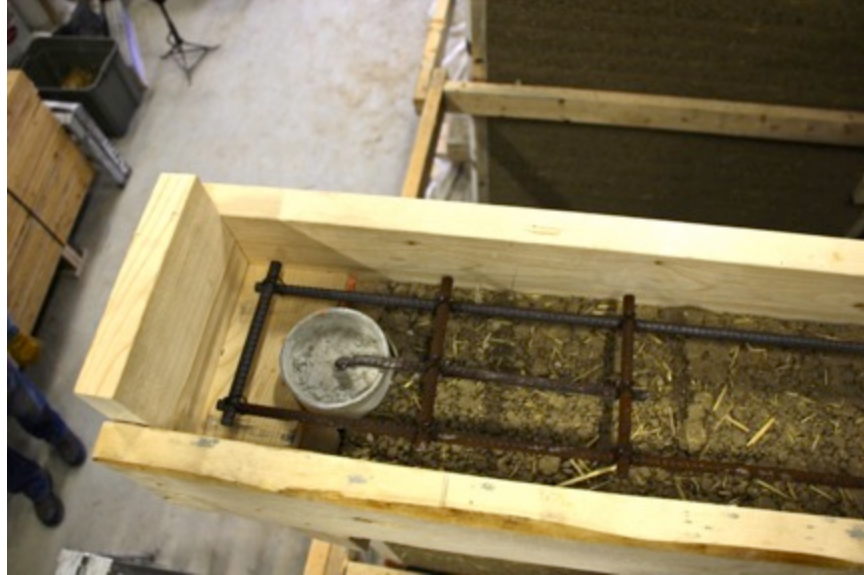
The 102 mm (4") thick bond beam was cast using a 4:1 (A-base: cement) ratio the width of the 230 mm (9") wall and 1.5 m (5') long to fully encase the columns in the bond beam as seen in the formwork for the bond beam in Figure 20. Concrete was consolidated using the end of a trowel.

Figure 20: Bond Beam Formwork and Rebar

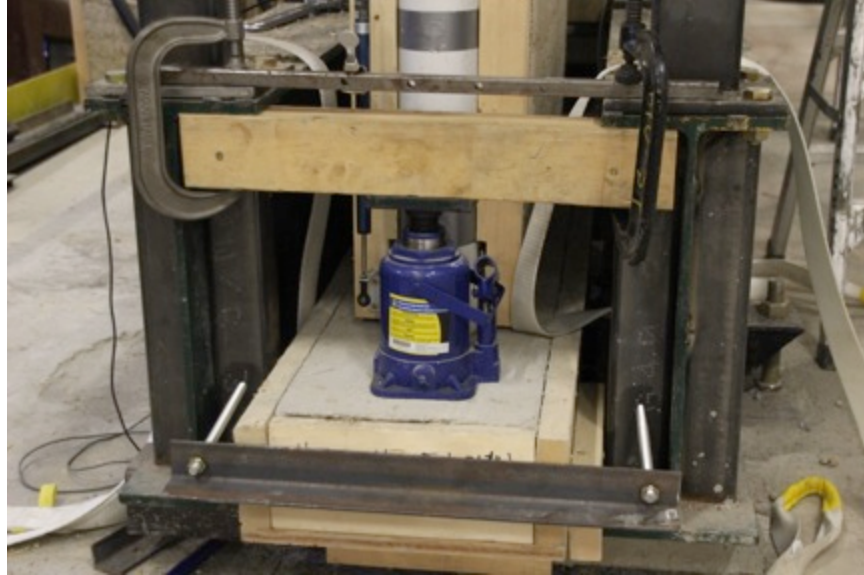
The footings were fixed in place to prevent any uplift or lateral movement during the test as seen in Figure 22. Linear potentiometers were attached to the bottom of the columns to monitor any uplift separation of the columns from the footing as seen in Figure 22. Steel supports placed loosely along the length of the bond beam protected the walls from lateral movement perpendicular to the applied load as seen in Figure 23.

Figure 22: Cyclic Loading Footing Restraint and Linear Pot

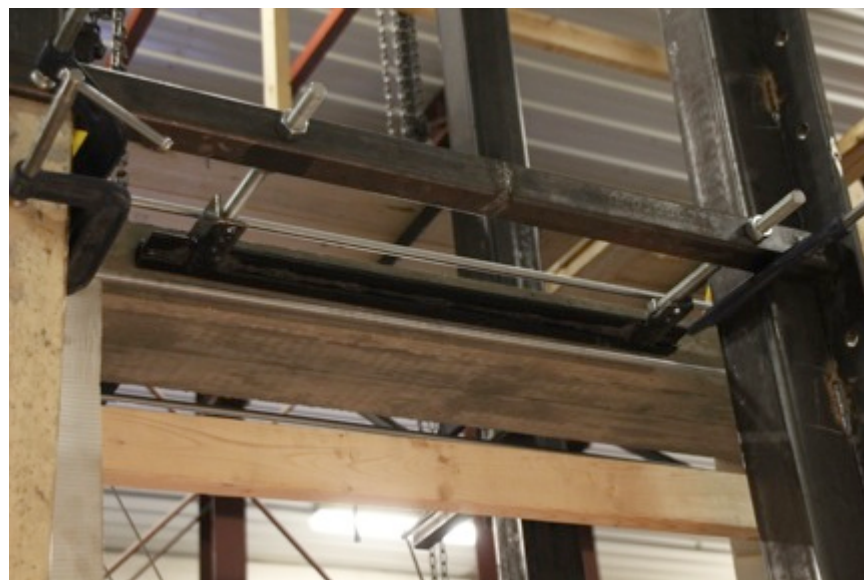
Figure 23: Lateral Support on Bond Beam During Cyclic Racking

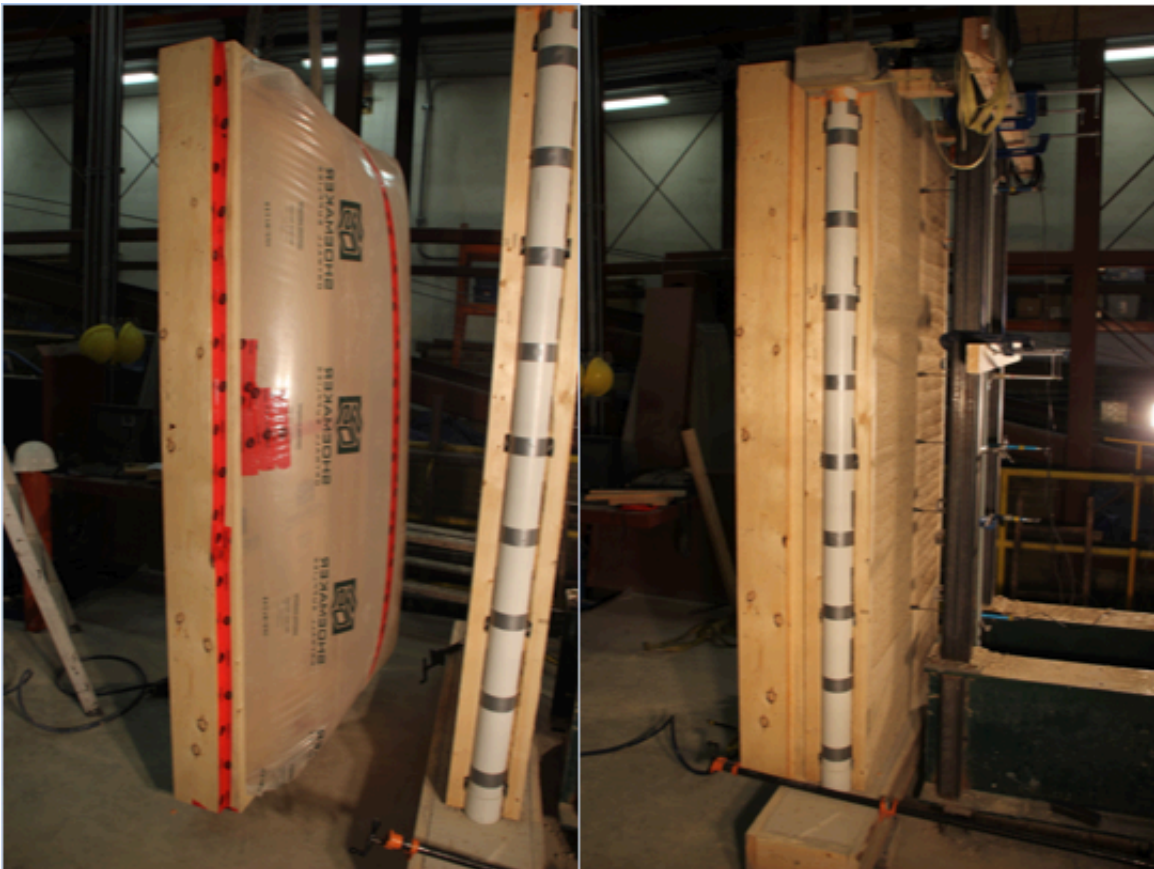
range of 0-5 psi and recorded using a data acquisition system. A 20 gallon air compressor was used to fill the pressure bag chamber and flow rate was controlled using a standard air compressor regulator valve set at 30 psi. Five linear potentiometers were used to measure the displacement of the earth wall on the opposite face of the loaded surface. The wall systems were not loaded to ultimate failure to avoid damaging the pressure bag system. The test was stopped when the pressure inside the chamber reached 257 psf (well above the design load for the wall system of 32 psf) equaling half the designed capacity of the wood frame containing the pressure bag as calculated in APPENDIX C.

Figure 25: Airbag Assembly Pressurized (L) and Secured to Wall System (R)

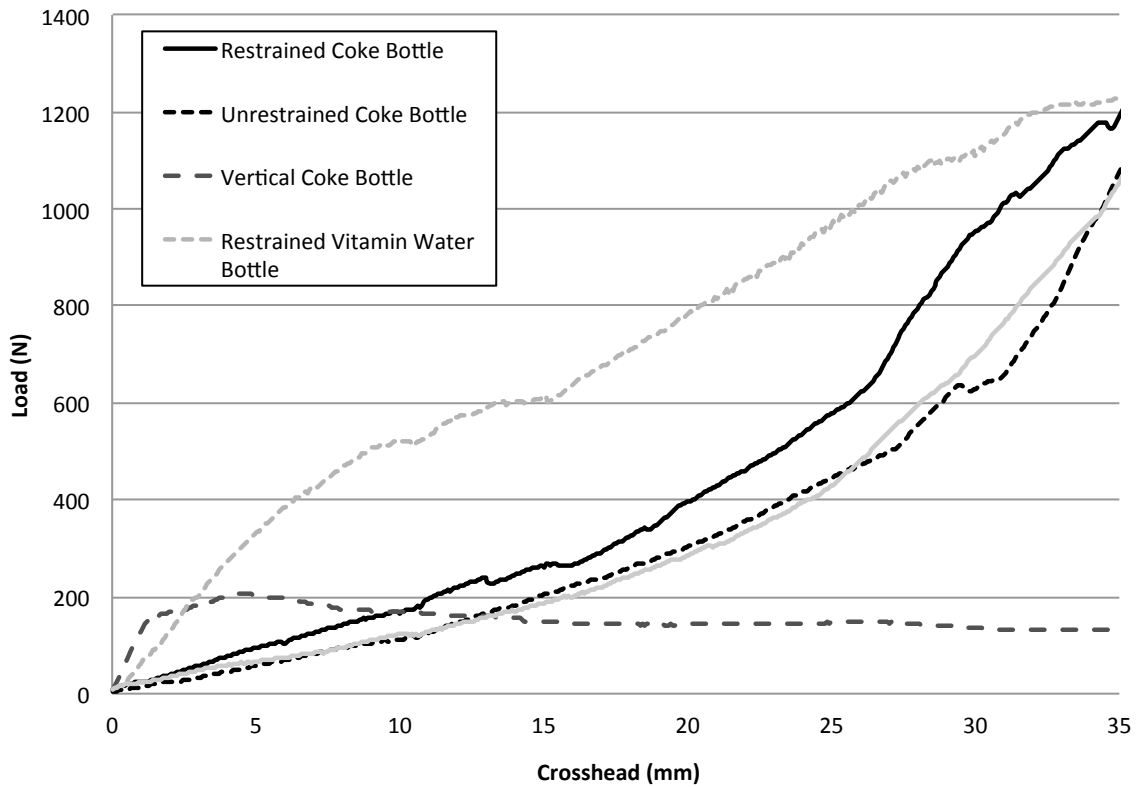
Figure 26 contains the results of testing bottle strength as described in Section 3.1.2. The graph ends at a crosshead displacement of 35 mm (1.4") as results varied greatly beyond that measure and is nearly 50% of the bottles initial height of 76 mm (3") (when bottles lay horizontal).

Figure 26: PET Bottle Compressive Strength

As a result of the compressive strength testing of bottles seen in Figure 26, the decision was made to place the bottles horizontally in the earth. The vertically oriented bottles took high load in the initial few mm of loading, but after 4 – 5 mm of crosshead movement, they reached ultimate strength and slowly lost the ability to handle load. The horizontally laid bottles continually took more load until the bottles were less than half their original width. Neither the vertically or horizontally oriented bottles failed suddenly. The failure consistently occurred when the bottle cap lost its seal and air began to escape. Significant axial load was not placed upon the bottles as the bottles are placed on top of each other with adobe loosely packed around them so either orientation would have theoretically worked.

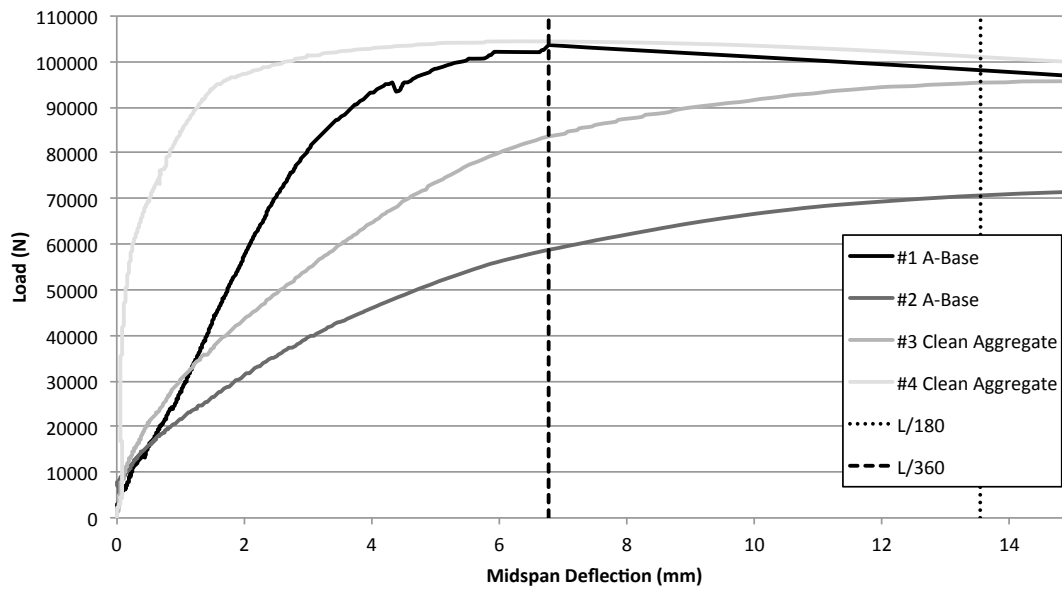
The axial capacity of the four CFPTs tested according to Section 3.1.1.2 are shown in Figures 27 & 28. Two serviceability limits of L/180 and L/360 (L = 2.4 m or 8') are included in the graphs.

Figure 27: CFPT Column Axial Tests – Crosshead Displacement

Figure 28: CFPT Column Axial Tests – Mid-span Deflection

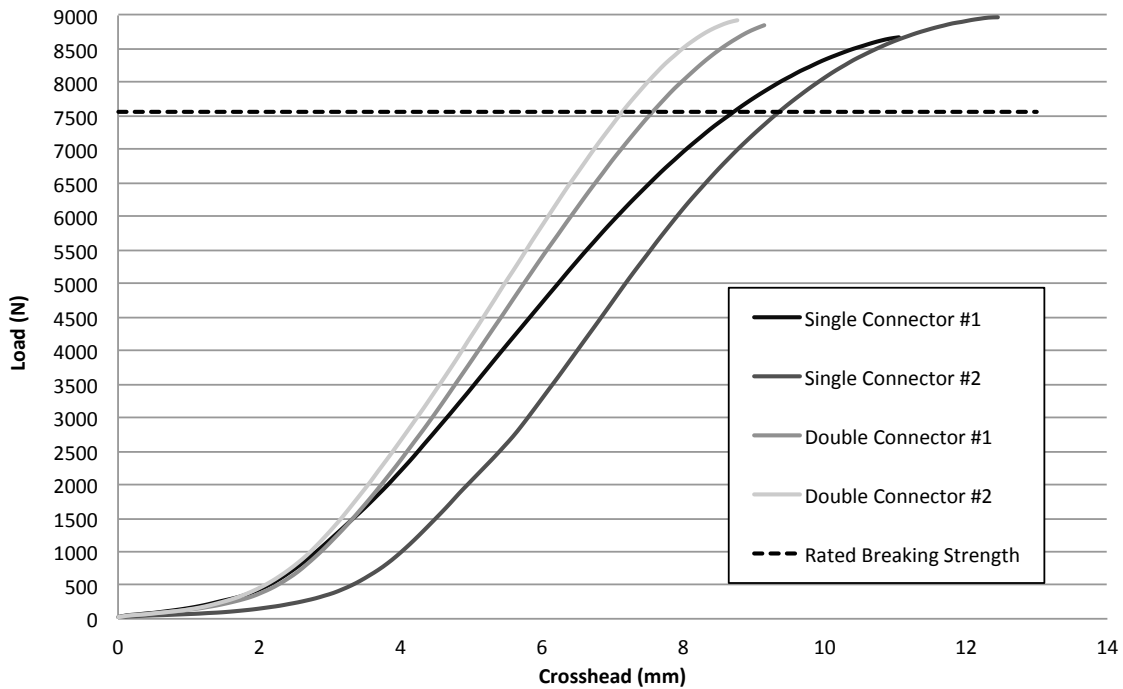
Figure 33 shows the ultimate capacity of the aircraft cable tested with single or double aluminum sleeve connectors as described in Section 3.1.4.1. The graph also indicates the rated breaking strength of the cable.

Figure 33: Aircraft Cable Tension Tests for Single & Double Connectors

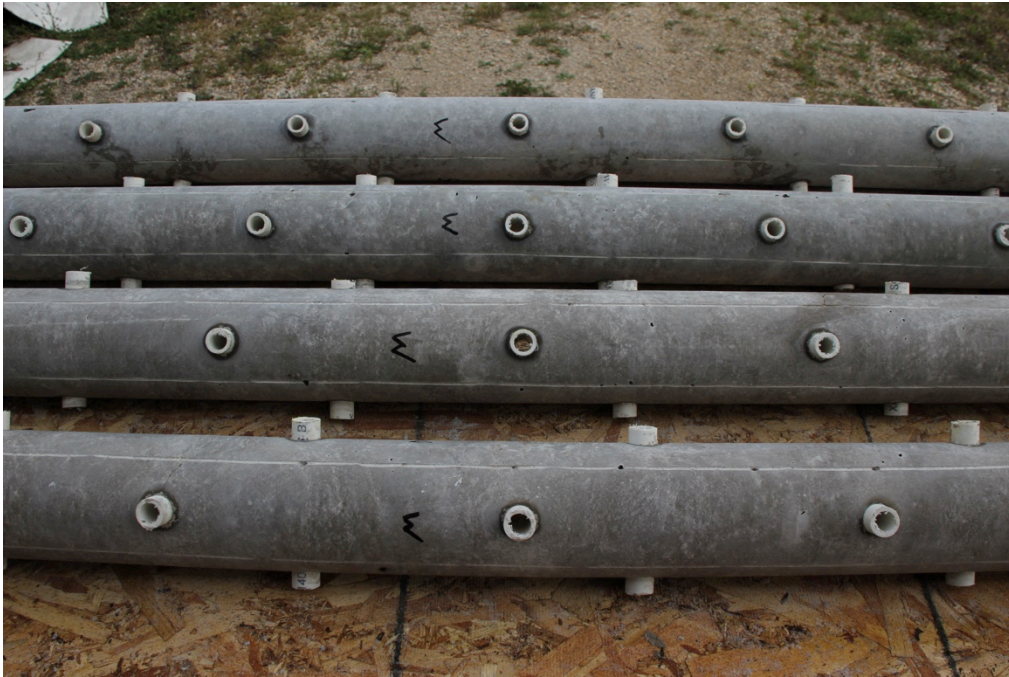
note that the axial capacity was determined after only 7 days of concrete curing. As the 7-day strength is roughly 70% of strength found after 28 days of curing, the actual capacity of the column will be significantly higher. The crosshead movement of 6.8 mm is the limiting serviceability factor as the load at L/360 at mid-span deflection is roughly 58.5 kN, nearly double the load of the crosshead movement serviceability limit. There is sufficient capacity for the design load of 22.9 kN calculated in Appendix G. The #2 column (A-base mix) had the lowest ultimate strength and was expected to be as the mix was noted to be drier than the other columns and was more difficult to pour into the column. The drier mix did not produce noticeable voids in the concrete as compared to the other columns as seen in Figure 38.

Figure 38: CFPTs After Testing @ Mid-Span (ordered #1 closest to # 4 farthest)

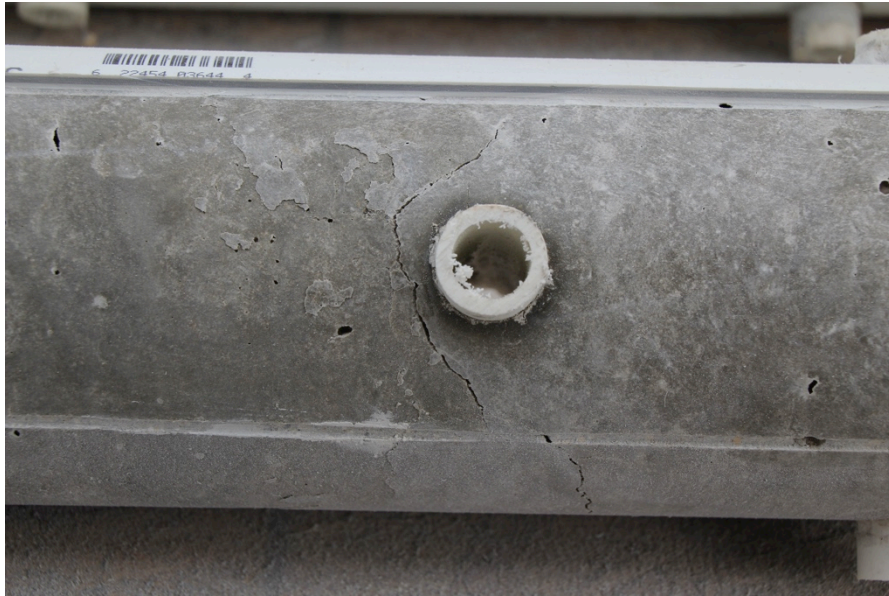
Upon removal of the PVC tubing from the cast concrete after testing, hairline cracks were observed primarily at the locations of the 13 mm ($\frac{1}{2}$ ") PVC inserts as shown

in Figure 39 as an example from the #3 column (clean aggregate mix). The columns were very elastic and rebounded back to original shape. The PVC showed no visible signs of damage.

Figure 39: CFPT Hairline Crack @ 13 mm (1/2") PVC Insert Location

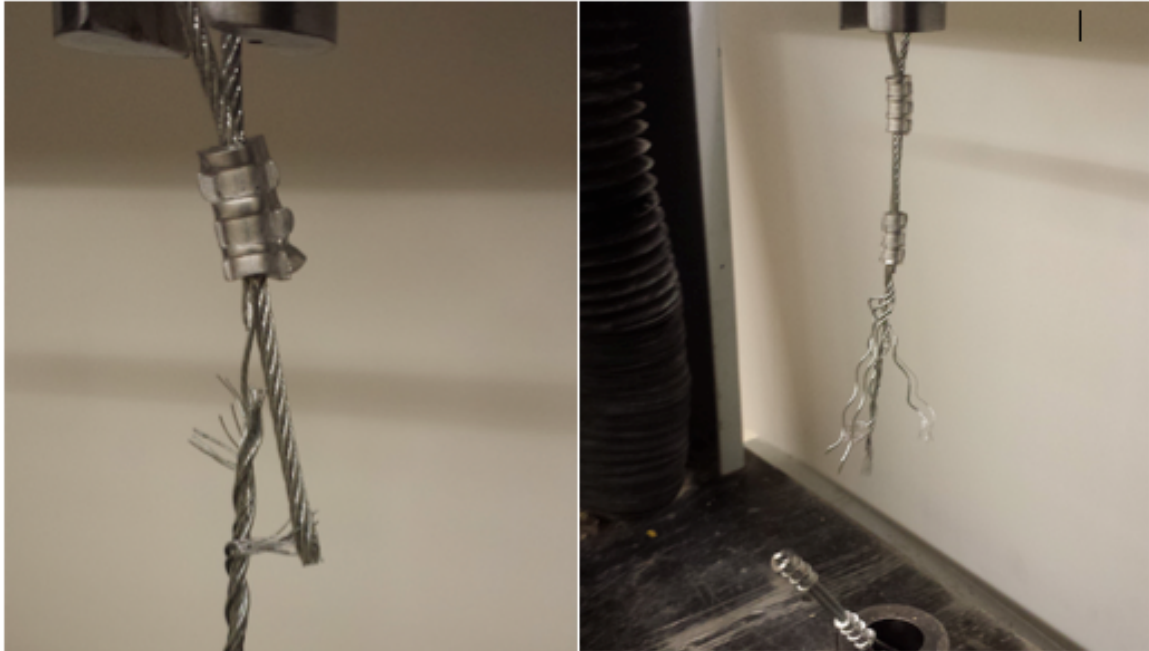
There was no difference in the ultimate tension capacity of the cable between using one or two aluminum sleeve connectors. The cable consistently failed at the location of the

connector as seen in Figure 41. The lowest breaking strength of 8674 N (1950 lbs) was 15% higher than the rated breaking strength of 7562 N (1700 lbs).

Figure 41: Aircraft Cable Tension Test Failure

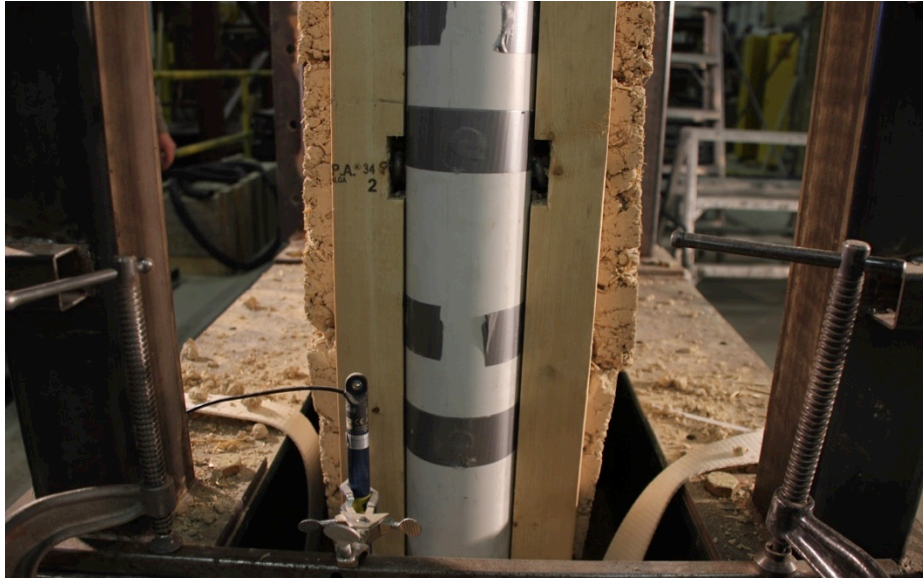
Failure was consistently observed at two main locations. The critical failure occurred roughly 1800 mm (70”) from the top as the compacted adobe separated from the wall system as seen in Figure 42. The compacted adobe separated from the wall as layered sections with diagonal cracking near the locations of the aircraft cable as observed in Figure 43. The addition of dimensional 51 mm x 102 mm (2” x 6”) lumber in Honduras to cover the wood spacers on the columns may serve to increase the racking capacity as it would restrain the compacted adobe from separating. Figure 43 also shows the second location of failure – the vertical separation between the top two infill layers.

Figure 42: Racking Wall 1 - Compacted Adobe Separation @ 1800 mm (70") From Top

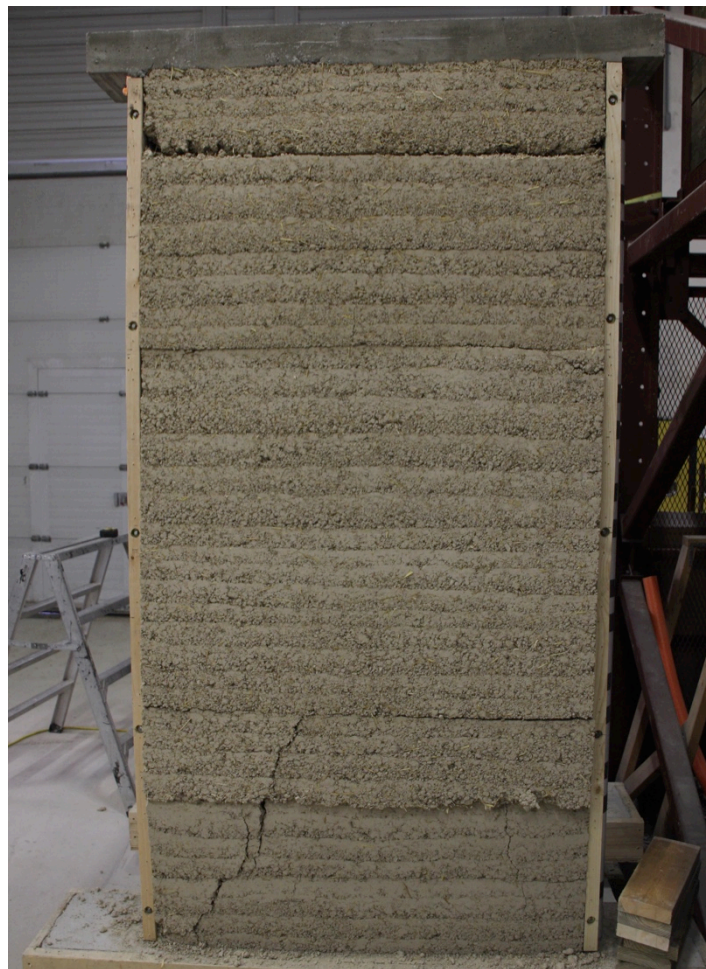
Figure 43: Racking Failure Wall 3

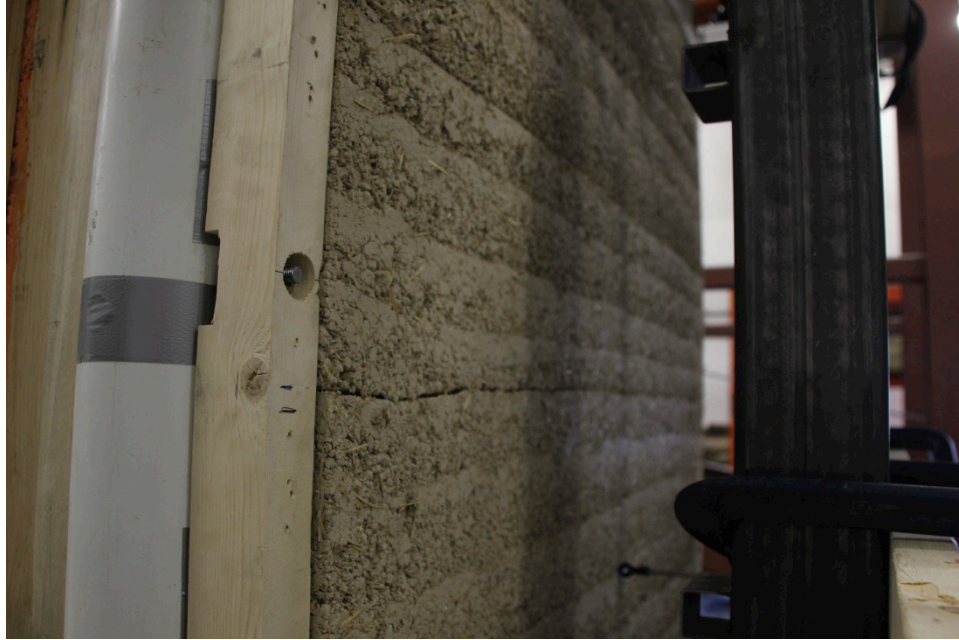
The adobe wall section displaying the highest deflection under load was consistently located 1000 mm (39.5") from the top of the bond beam seen in Figure 44 (linear potentiometer in the center of the wall near the bottom of the picture). This location was centrally located between barbed wire reinforcement. Also seen in the figure is a crack developing between the lifts as the lower lift has displaced more than the lift above which has barbed wire to aid in lateral resistance (wire location evident by the threaded rod).

Figure 44: Airbag Transverse Displacement @ 1000 mm (39.5") From Top

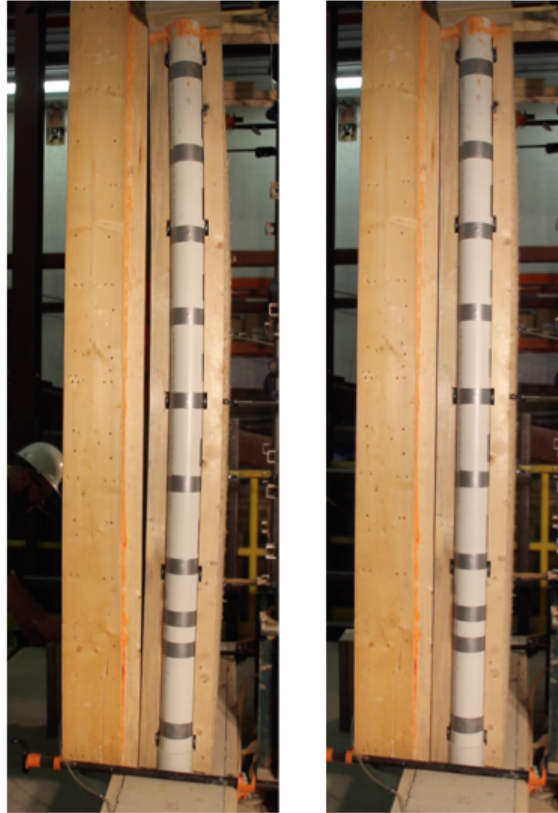
The decision to monitor the deflection at the location between the two final lifts at 305 mm (12") from the top of bond beam was a result of the separation failure during cyclic racking. Minimal movement was observed at this location during the first and second transverse tests. This may be from the proximity of the concrete bond beam attracting the transverse loading as load is attracted to stiffness. Moving the location of the linear potentiometer from 305 mm (12") to the mid-point of a column for the third and final test showed the elasticity of the CFTP after the pressure was released. Figure E - 2 of Appendix E shows the column retracting from a deflection of 21 mm to 4 mm after loading with Figure 45 showing the deflection during and after loading by observing the gap between the wall system and the airbag containment.

Figure 45: Airbag Transverse Deflection (L) & Retraction (R)

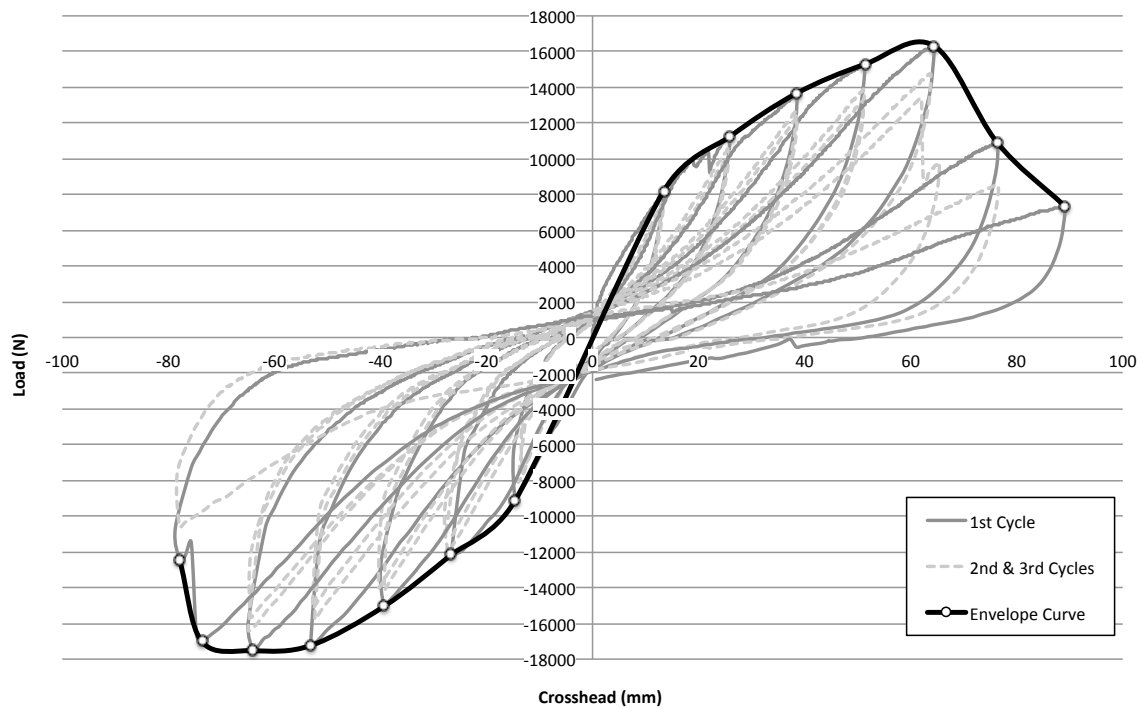
Figure D - 2: Detailed Cyclic Racking Wall 3

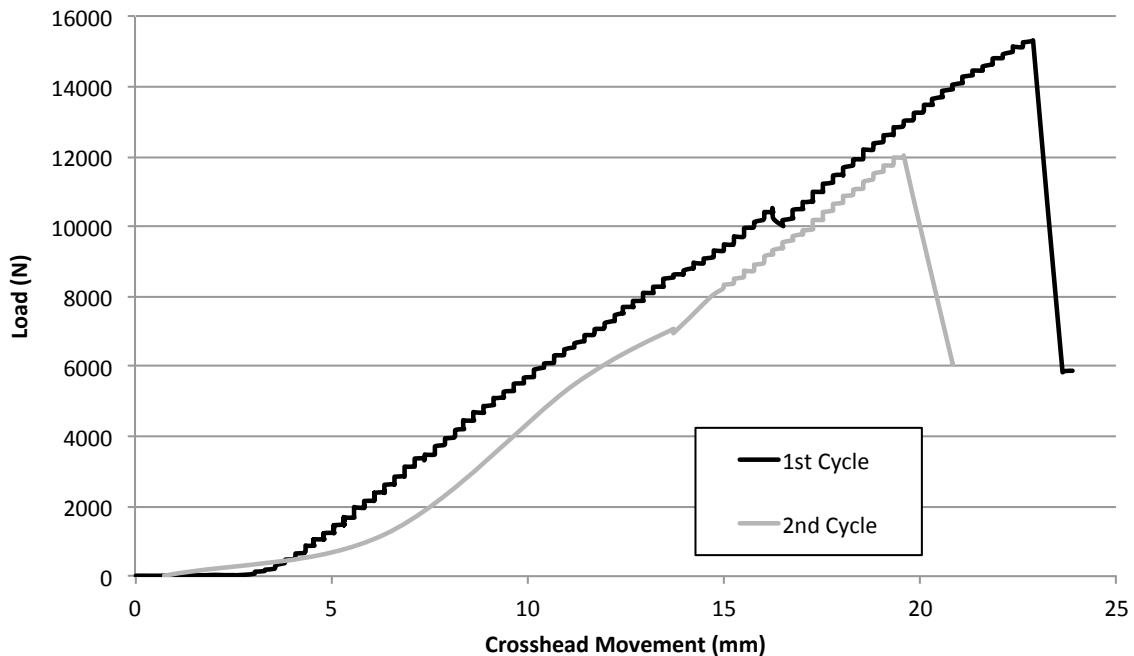
Figure F - 1: Empty 102 mm (4”) PVC Tube Axial Test Results
