**EXAMINING THE PRESENCE OF
ARCHING ACTION IN EDGE-
STIFFENED BRIDGE DECK
CANTILEVER SLAB OVERHANGS
SUBJECTED TO A STATIC AND
FATIGUE WHEEL LOAD**

A Thesis

Doctor of Philosophy

Department of Civil Engineering
University of Manitoba
Winnipeg, Manitoba, Canada

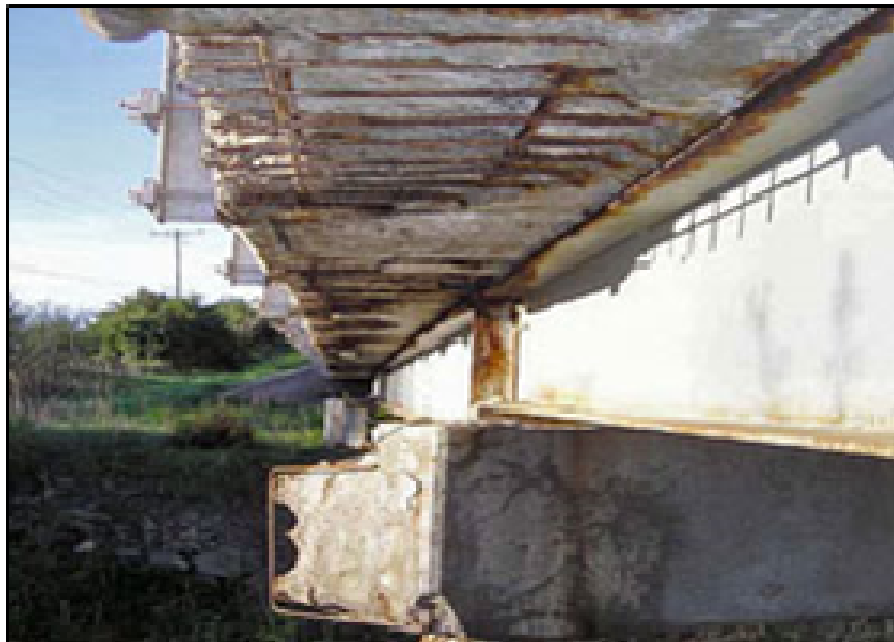
Figure 1-1(b): Deterioration caused by the corrosion of internal steel reinforcement in a cantilever overhang

Bridge deck slabs, perhaps, are the most important component of a bridge's superstructure. They are directly subjected to the loads induced by passing traffic. They are also the component of a bridge's superstructure that is the most exposed to environmental effects (Figure 1-1(a)). One of the major contributors to the deterioration of concrete bridge deck slabs in colder climates is the penetration of chlorides as a result of the application de-icing chemicals or other ice retarding agents (Figure 1-1(b)). Chloride penetration into the concrete deck accelerates the deterioration of the internal reinforcing steel. Concrete bridges in marine environments also deteriorate at an increased rate due to exposure to salt water. Steady increases in allowable truck weights have also proven to be a contributing factor to the deterioration of highway bridges. Many existing bridges were designed for a service life of 50 years. Many case studies have demonstrated that concrete bridge deck slabs have not been able to withstand the environmental and service conditions that they are subjected to. It is well known and documented that bridge deck slabs across Canada have required rehabilitation or complete replacement prior to their 50 year projected service life.

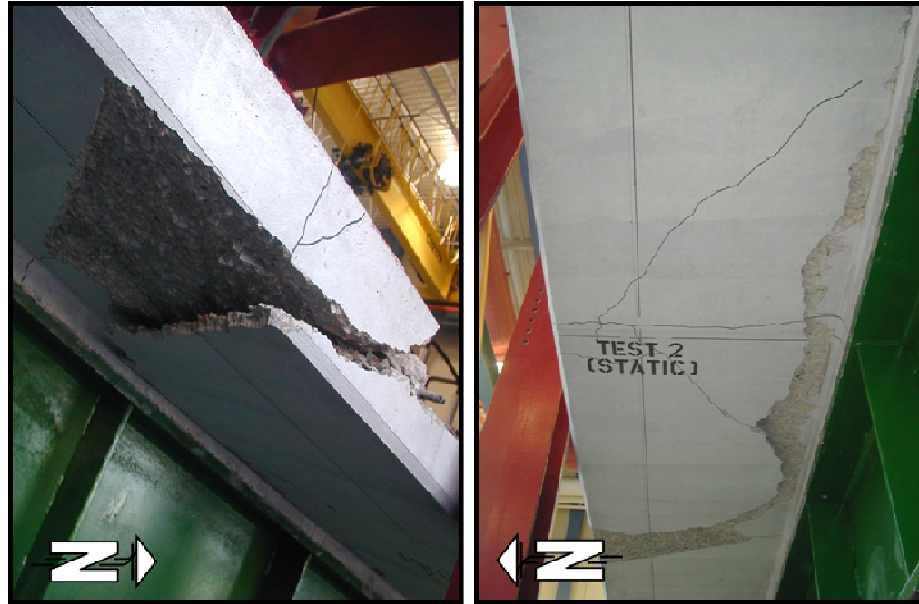
Figure 2-23(b): Bottom view of semi-circular punching type failure for the cantilever section with top transverse CFRP reinforcement subjected to static monotonic loading (Klowak, 2007)

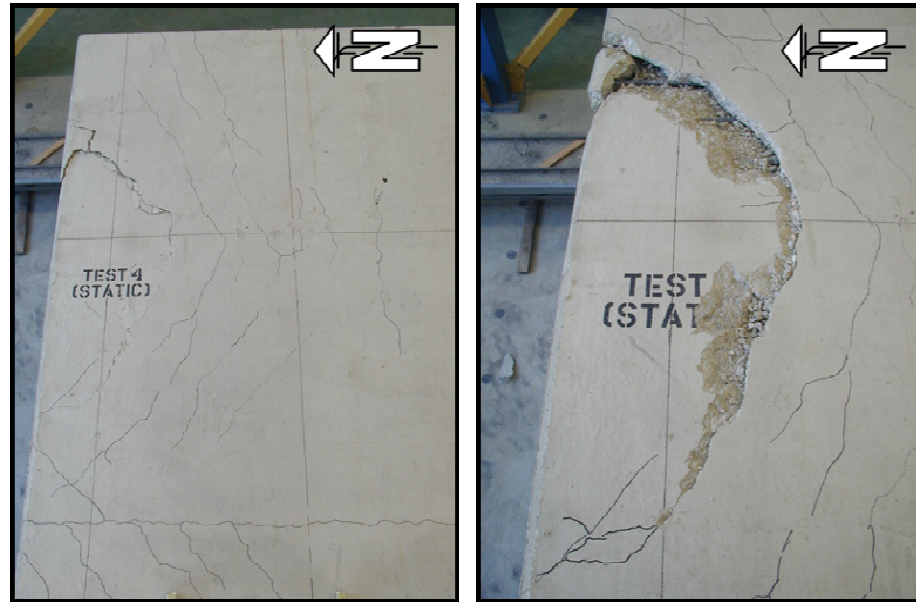
Figure 2-24(a): Top view of semi-circular punching type failure for the cantilever section with top transverse steel reinforcement subjected to static monotonic loading (Klowak, 2007)

The cantilever with top transverse steel reinforcement failed an ultimate load of 301 kN. The punch angles along the center-line of the loading plate in the east and south (towards girder) directions of the steel reinforced cantilever were roughly 15° and 28° respectively (Figure 2-24(a) and 2-24(b)).

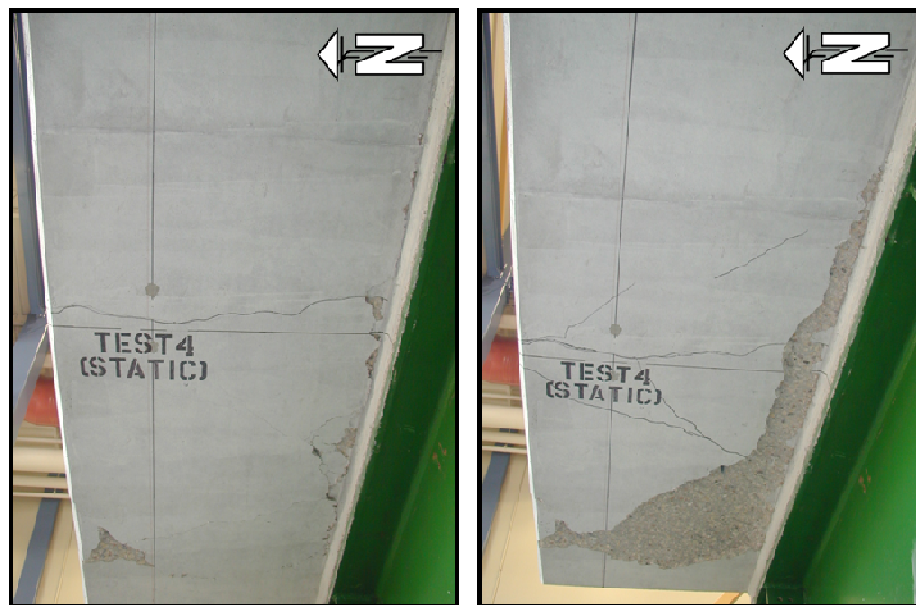
Figure 2-24(b): Bottom view of semi-circular punching type failure for the cantilever section with top transverse steel reinforcement subjected to static monotonic loading (Klowak, 2007)

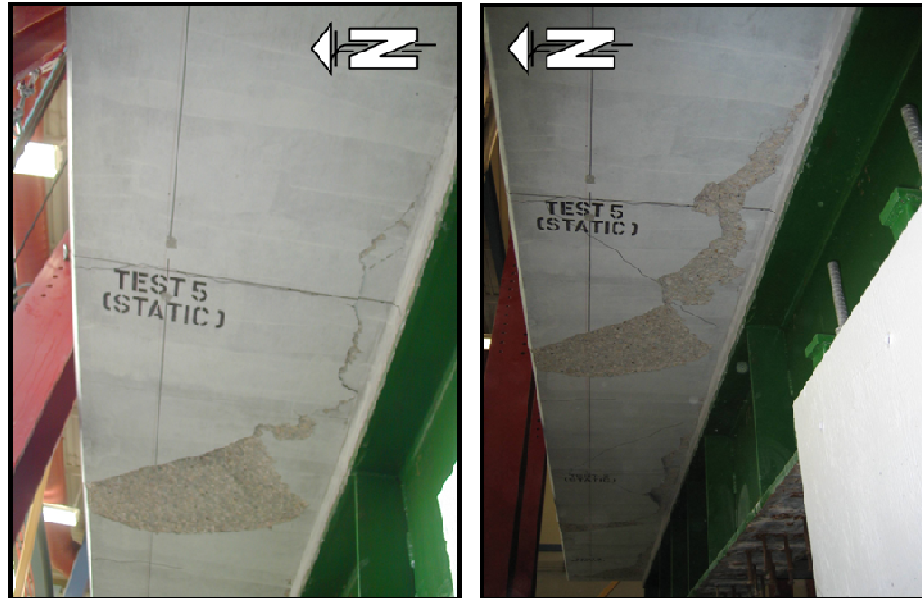
Figure 2-25(b): Bottom view of semi-circular punching type failure for cantilever section with top transverse GFRP reinforcement subjected to static monotonic loading (Klowak, 2007)

The final cantilever section that was tested under a static monotonic load until failure was the cantilever section with top transverse GFRP. The punch angle along the center-line of the loading plate in the east direction was determined to be approximately 9° and roughly 36° in the south direction (towards girder). Figure 2-25(a) and Figure 2-25(b) illustrate the semi-circular punching type failures from the top and bottom view of the cantilever respectively.

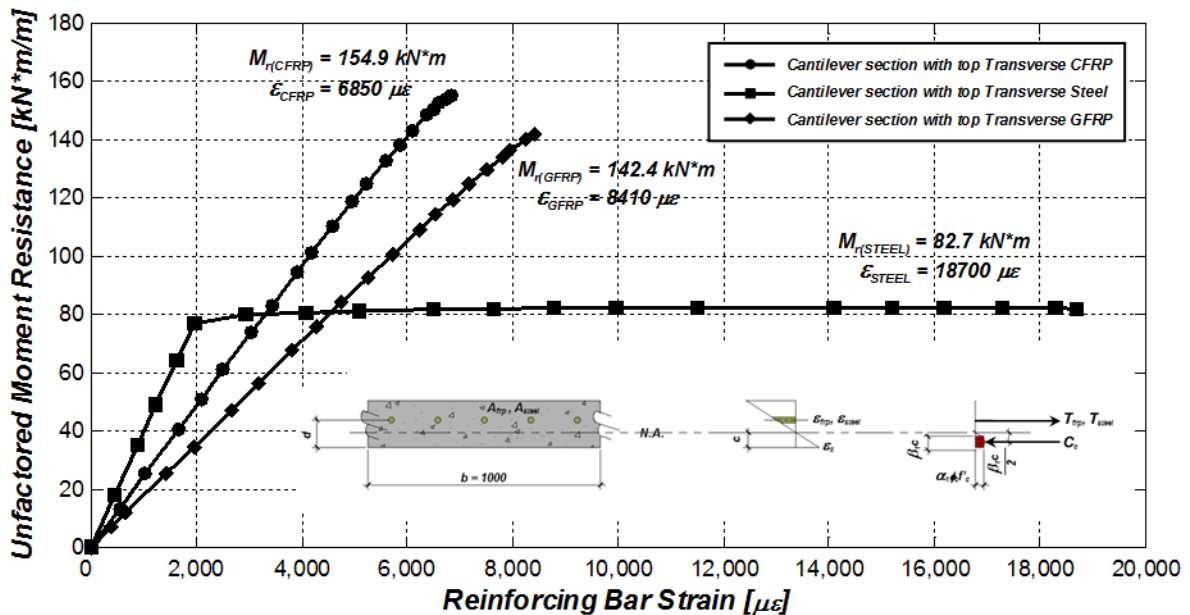
Figure 2-26(b): Plot of un-factored nominal moment resistance versus reinforcing bar strain for a 1000 mm wide section of all the cantilever sections based on strain compatibility (Klowak, 2007)

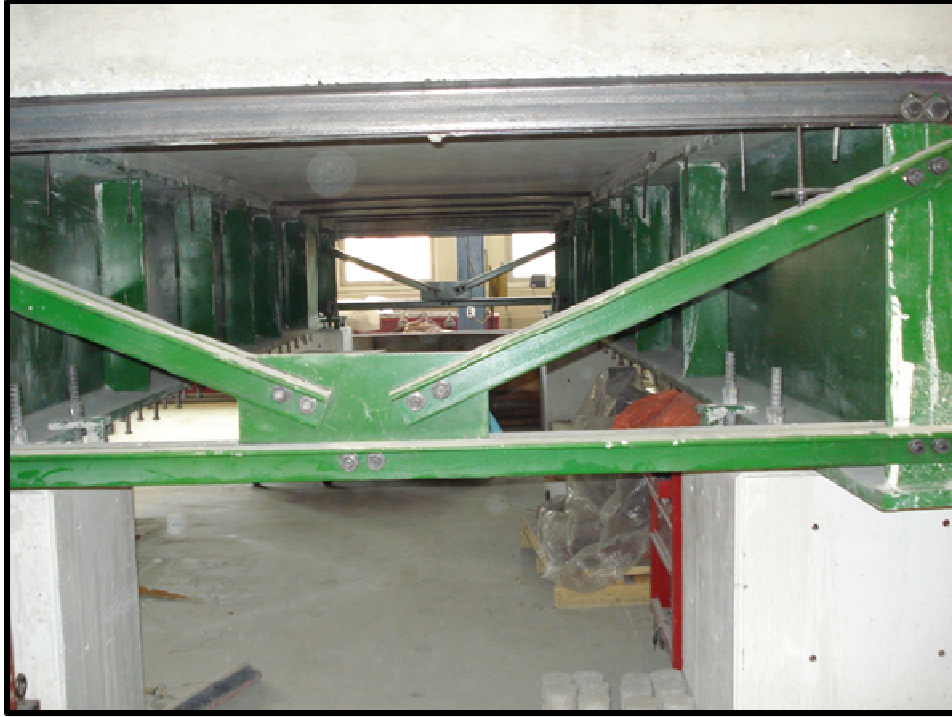
Figure 3-2(a): Photograph of end diaphragm

members, and back-to-back 76 X 76 X 13 mm thick steel angles for the diagonal and bottom members (Figure 3-1(c)). Steel Nelson studs measuring 22 mm in diameter and 250 mm in length were welded to the top back-to-back angles in order facilitate composite action for the two transverse free edge beams discussed in Section 3.1.2.1. The diagonal and bottom members of the diaphragm were connected by a 635 X 254 X 19 mm thick steel plate as shown in Figure 3-2(a). A photograph steel girders is shown in Figure 3-2(b).

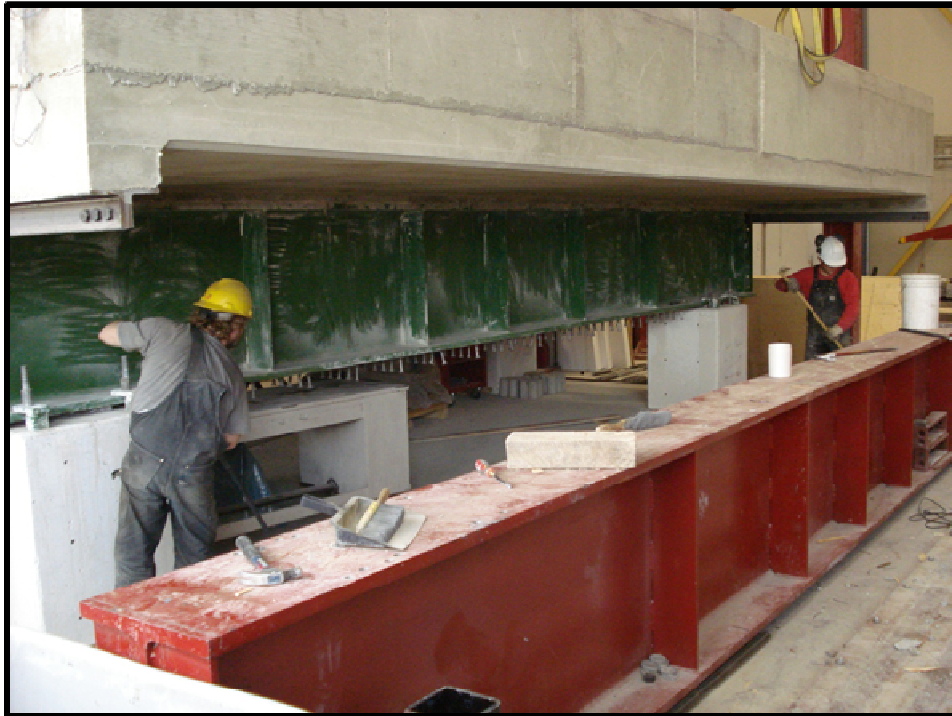
Figure 3-2(b): Photograph of steel girders after the removal of cantilever formwork

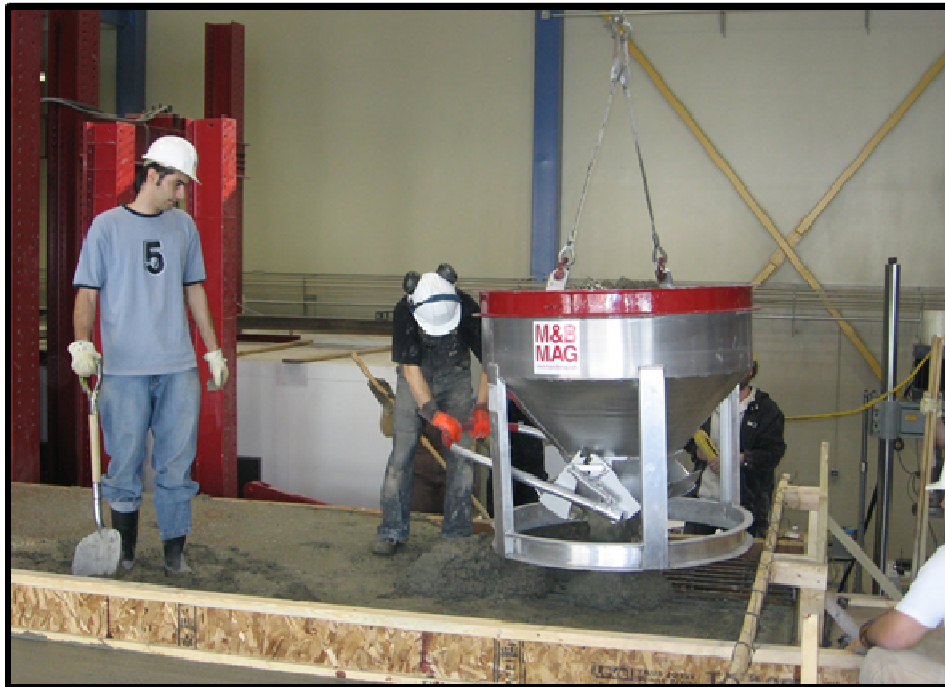
Figure 3-3: Photograph of concrete placement for experimental bridge deck slab

The bridge deck, for the purpose of this report, consists of the cantilever overhangs, the internal panel, edge beams located at the two transverse free edges, and the haunches located over the girders. A photograph illustrating the placement of the concrete is shown in Figure 3-3. The bridge deck was a continuous cast-in-place concrete deck measuring 9150 mm in length and 6500 mm in width (Figure 3-4(a)). The deck slab thickness was 200 mm and it included 75 mm deep haunches over each of the steel girders. The internal panel of the deck

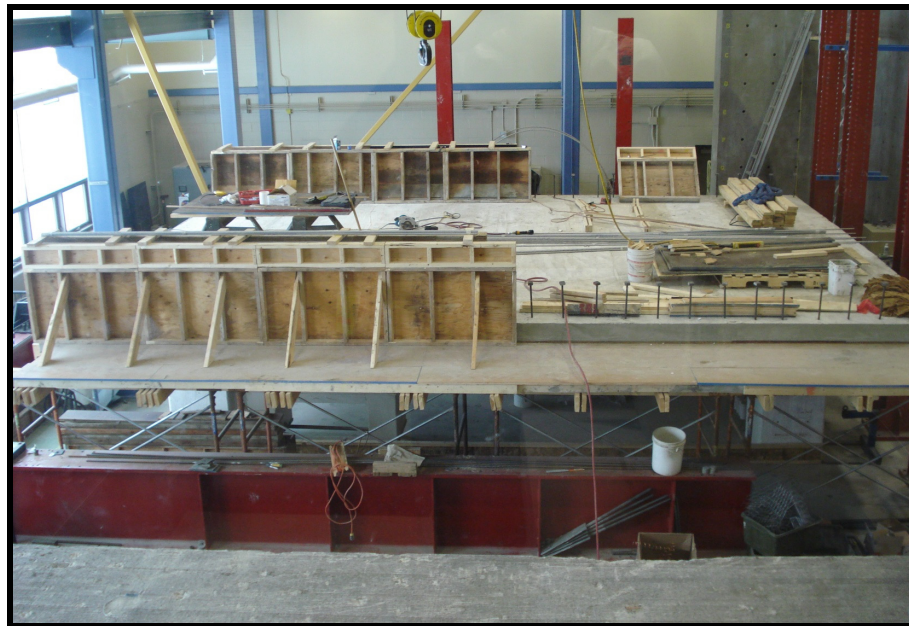
**Figure 3-7:** Photograph of traffic barrier wall construction

In order to simulate traffic barrier walls representative of those found on actual bridges, the barrier walls were cast with a pour joint at mid-span of the longitudinal length of the test bridge deck. The traffic barrier walls for the test bridge deck were cast in two different stages and connected via steel dowels and included a typical pour joint detail discussed in Section 3.1.3.4 (Figure 3-3(a)). The length of the barrier walls between the pour joints was 4575 mm. The overall height of the barrier wall was 775 mm and the width at the base was 450 mm. The face of the barrier walls that would be subjected to an impact from passing traffic had to be at different angles as shown in Figure 3-6. The specified concrete strength was identical to the strength of the deck and was 35 MPa. Specified concrete parameters are outlined in Table 3-3. The concrete properties obtained from cylinder testing are given in Table 3-4. A photograph illustrating the formwork and barrier wall construction is shown in Figure 3-7.

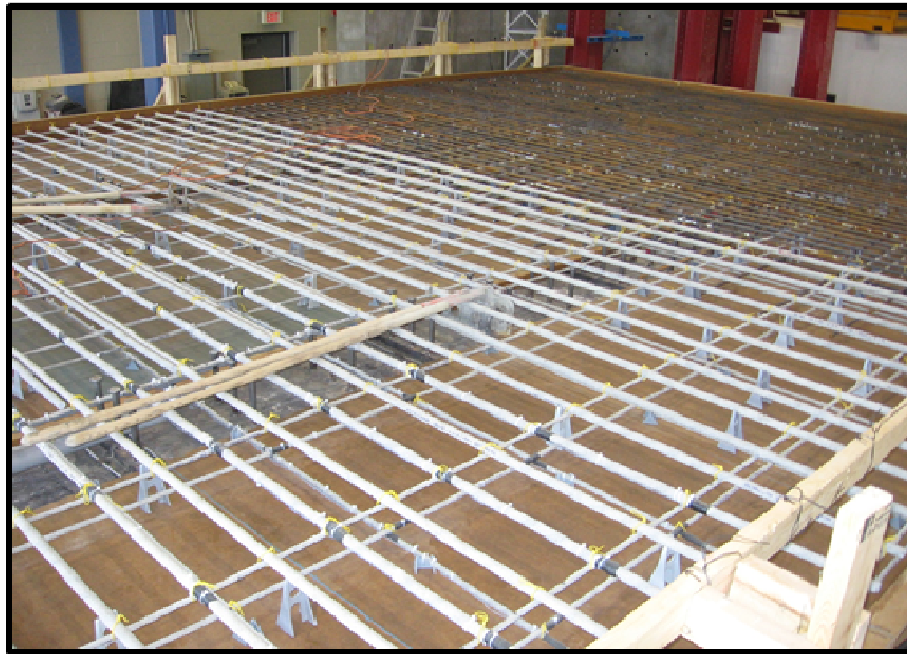
Figure 3-8: Photograph of internal GFRP and steel reinforcement prior to concrete placement

The experimental bridge deck, although cast monolithically, was divided into two different sections (Figure 3-8). The north half of the bridge was comprised of a corrosion/steel free GFRP hybrid innovative design and the south half of the deck used conventional deformed steel reinforcement designed based on the empirical design method outlined in the CAN/CSA S6-06 CHBDC 2006 (Figure 3-9(a)). The following two sub-sections describe in detail the reinforcing details for the entire bridge deck which included internal panel reinforcement, cantilever overhang reinforcement, and reinforcement provided in the edge beams located at the transverse free edges of the bridge deck. For practical purposes, the reinforcement description will be described in terms of bottom reinforcement, top reinforcement, and reinforcement provided in the transverse free edge beams.

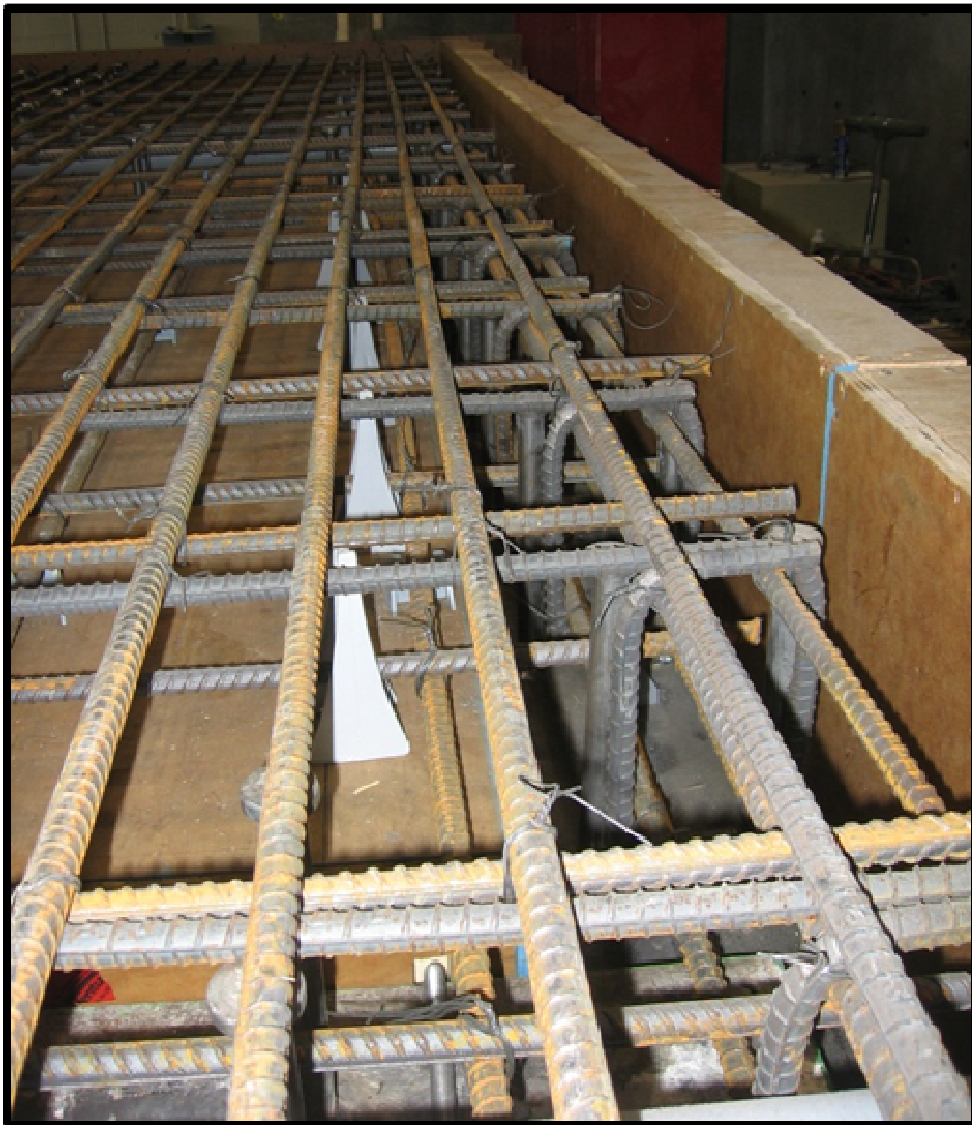
Figure 3-10: Photograph showing transverse steel bars and stirrups located in transverse edge beam

The reinforcement for the edge beams located at the north and south transverse free edges of the deck slab consisted of four additional 15M steel transverse bars (two on the top and two on the bottom) as well as stirrups (Figure 3-15). The stirrups were comprised of 15M steel bars with a long leg on the top of the stirrup to aid in achieving composite action between the concrete slab and the steel angles (Figure 3-16).

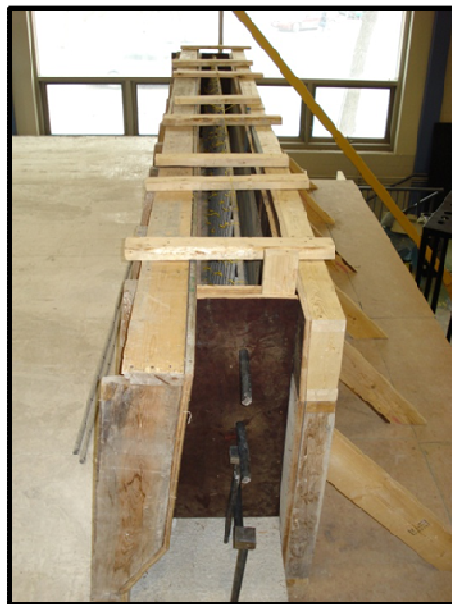
Table 3-15: Photograph of traffic barrier wall construction showing reinforcement

19 longitudinal GFRP bars spaced equally over the height of the barrier wall (approx. 135 mm). No. 10 GFRP vertical reinforcing bars were provided at a spacing of 150 mm center-to-center. Two additional No. 19 GFRP bars were provided at the locations shown in Figure 3-14). Table 3-6 provides the reinforcing bar schedule for the traffic barrier walls.

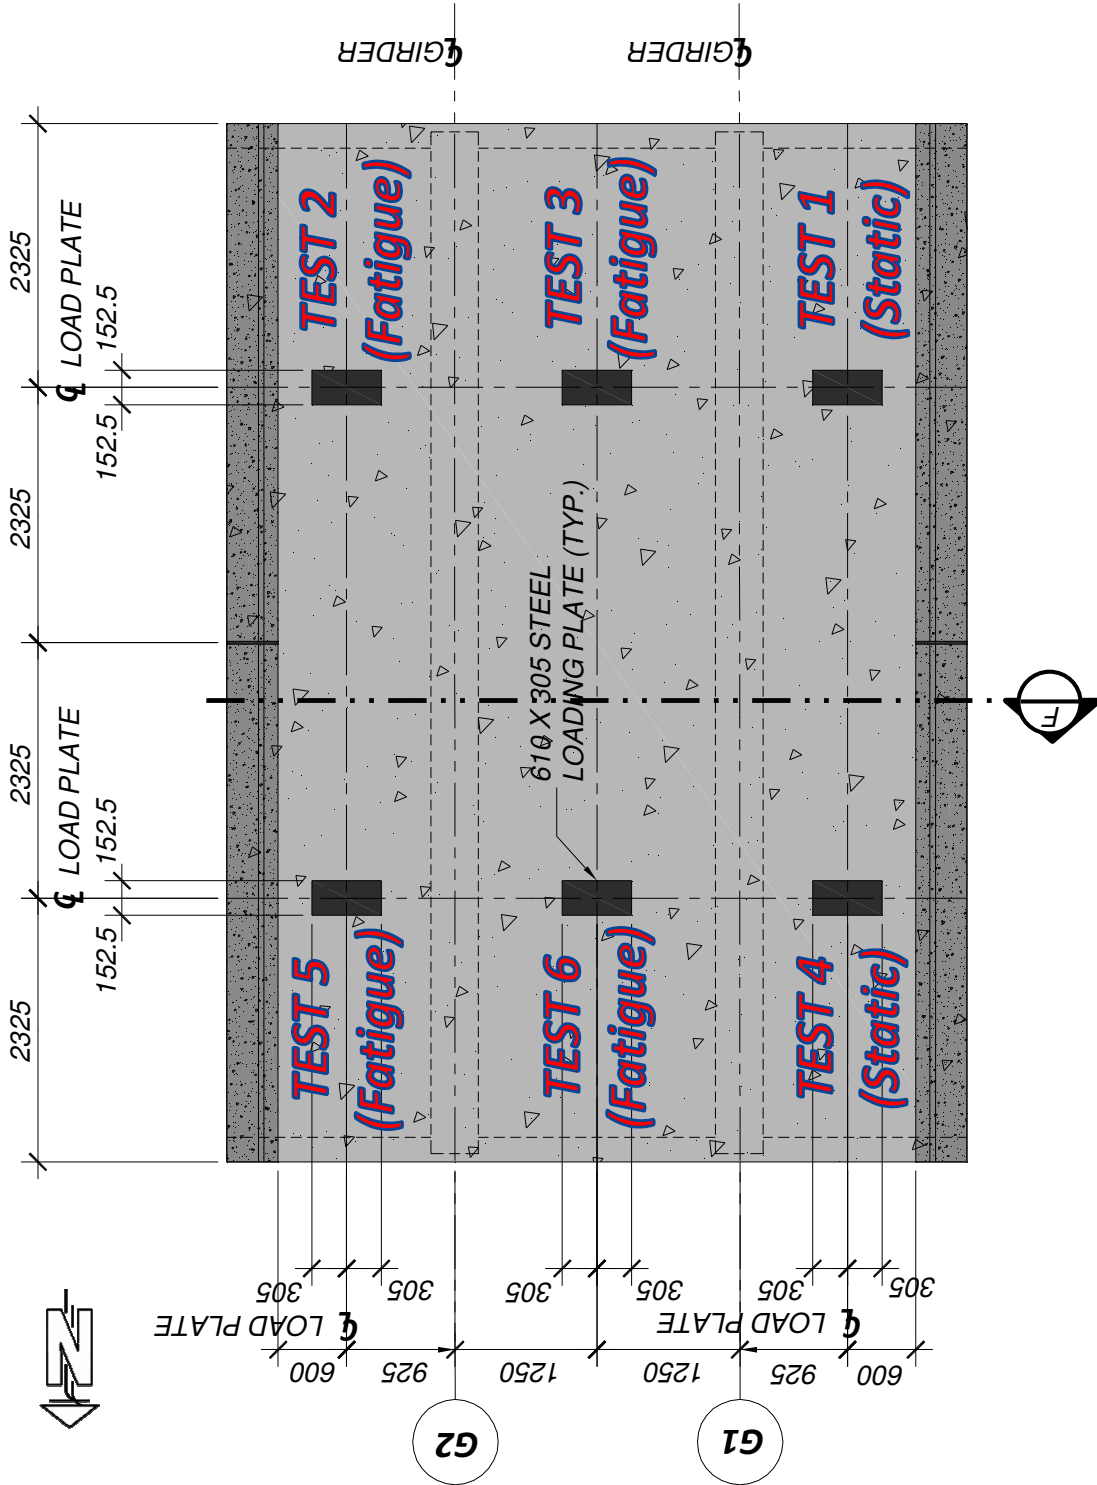
Figure 3-16(a): Plan view of testing scheme

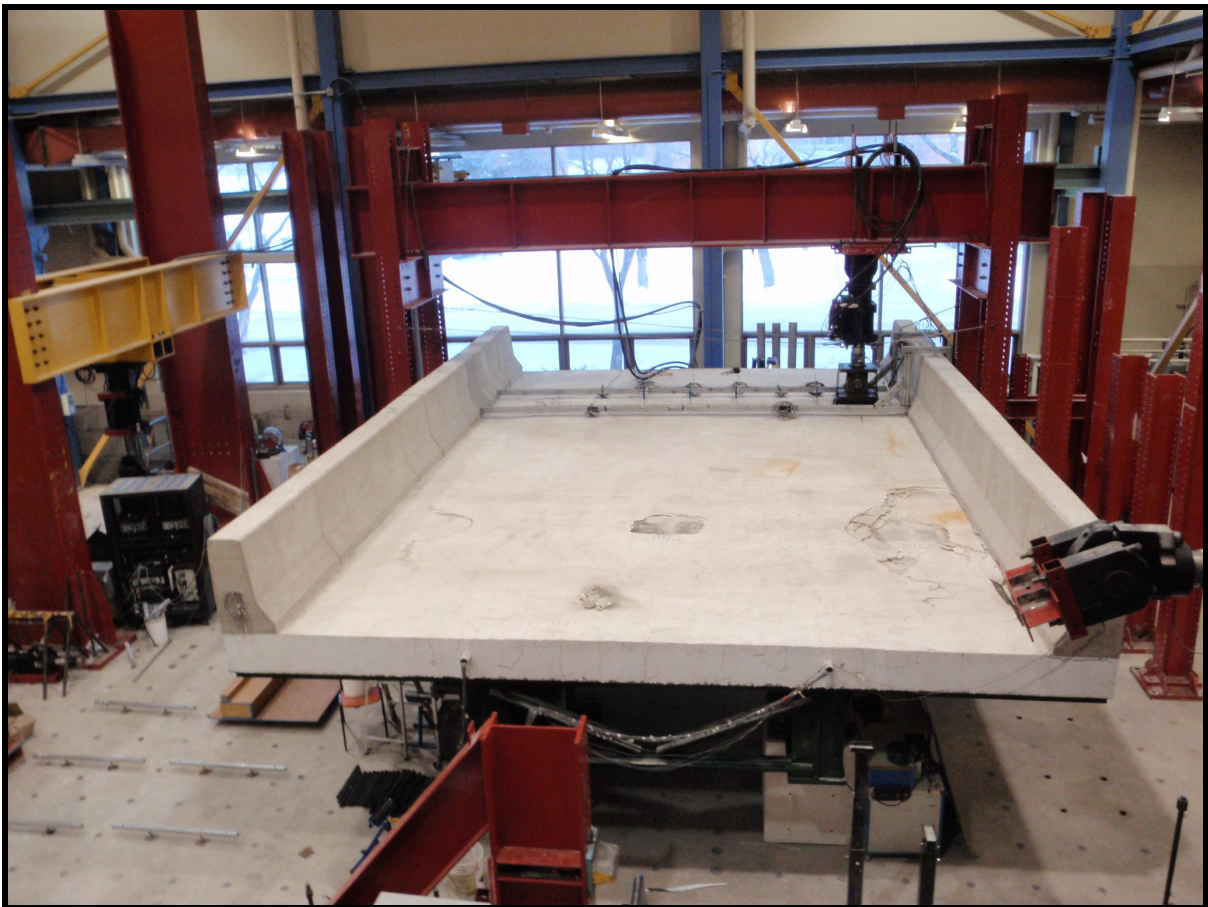
Figure 3-17: Photograph of test set-up for static and fatigue destructive testing of cantilevers

The preparatory work for each static and destructive test of the full-scale experimental bridge deck cantilever overhangs consisted of providing support for the superstructure (i.e. the steel girders and concrete deck). It involved the design and construction of the steel load frame, re-locating or moving the load frame to test each cantilever section, as well as setting up instrumentation and connecting it to a data acquisition system. It should be noted that the set-up for each of the four test locations was identical. To avoid repetition, a generalized description of the set-up is outlined in the following sub-sections pertaining to the details of how the superstructure was supported, details of the load frame, and the instrumentation required to provide important information about the performance and behaviour of each of the different cantilever sections. Figure 3-17 shows the full-scale test set-up.

Four concrete blocks measuring 750 X 750 X 1000 mm in depth were used to support the steel girders and the bridge deck slab. Plywood bearing pads that measured 400 X 400 X 38 mm thick were placed between the concrete block supports and steel girders. In order to avoid any up-lift on the adjacent girder when a cantilever was loaded, steel tie-downs were used along with high-strength Dywidag bars to post-tension both girders and the concrete supporting blocks to the structural floor.

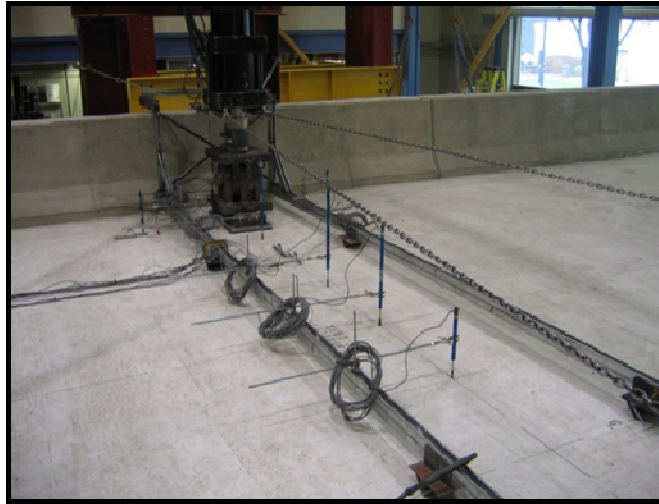
Figure 3-20: Photograph illustrating the LVDT supporting apparatus used to measure deflections of the cantilever and internal panel relative to the girders

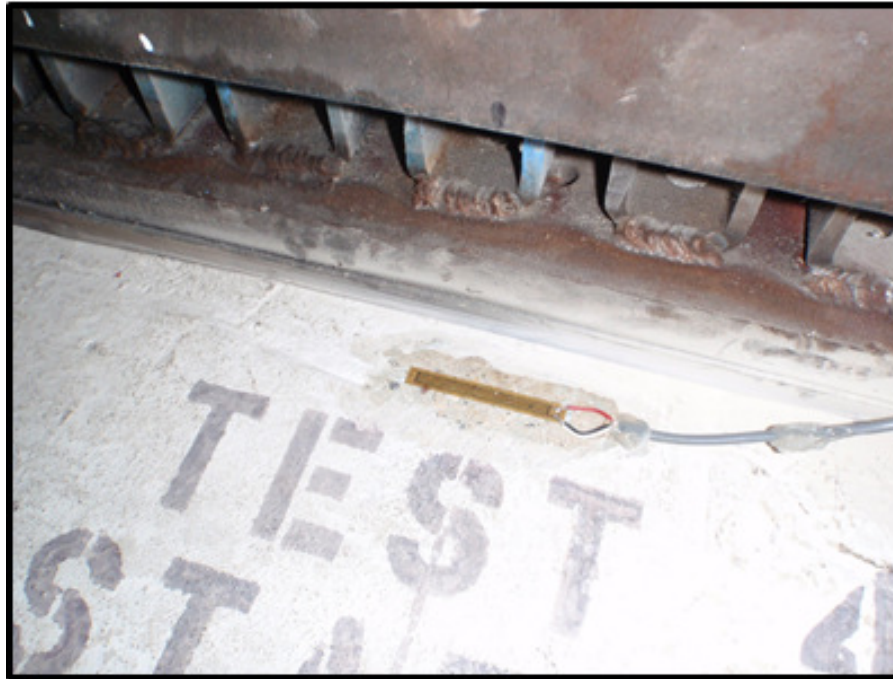
Figure 3-25: Photograph illustrating location of a concrete strain gauge placed in the transverse direction on the top surface of the cantilever slab overhang near the steel loading plate

After observations from the static and fatigue testing of the cantilever with steel reinforcement, researchers decided to place 50 mm long concrete strain gauges on the top surface of the cantilever slab in close proximity of the steel loading plate. The gauges were placed as close as possible to the loading steel loading plate orientated such that they would measure strain magnitudes in the transverse direction, or the direction in which flexural strains due to negative moments should be present. Researchers felt that gauges in the location shown in Figure 3-25 would greatly increase the understanding of the cantilevers

behaviour. Observations with respect to strain magnitudes would also aid in determining the presence of arching-action.

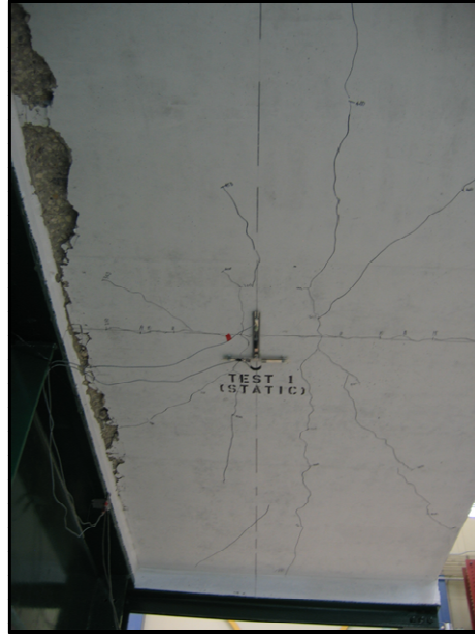
Figure 3-27(a): Photograph showing pi gauge locations on the underside of the cantilever slab overhand under the loading plate (typical all test locations)

Pi gauges with a gauge length of 200 mm were used to measure crack widths for static and fatigue loading destructive testing. The pi gauge locations for all four tests were identical. Two pi gauges were placed over the girder to measure crack widths due to flexure in the region of maximum negative moment. Two additional pi gauges were placed on the underside of the cantilever located below the loading plate to monitor static and fatigue crack widths based on crack patterns observed by Klowak 2007. All of the pi gauges were connected to the data acquisition system via extension cables and recorded static and fatigue crack widths at 2 Hz and 4 Hz respectively. Photographs showing the pi gauges installed on the underside of the cantilever slab overhang and on the top concrete surface over the girder are presented in Figures 3-27(a) and 3-27(b) respectively.

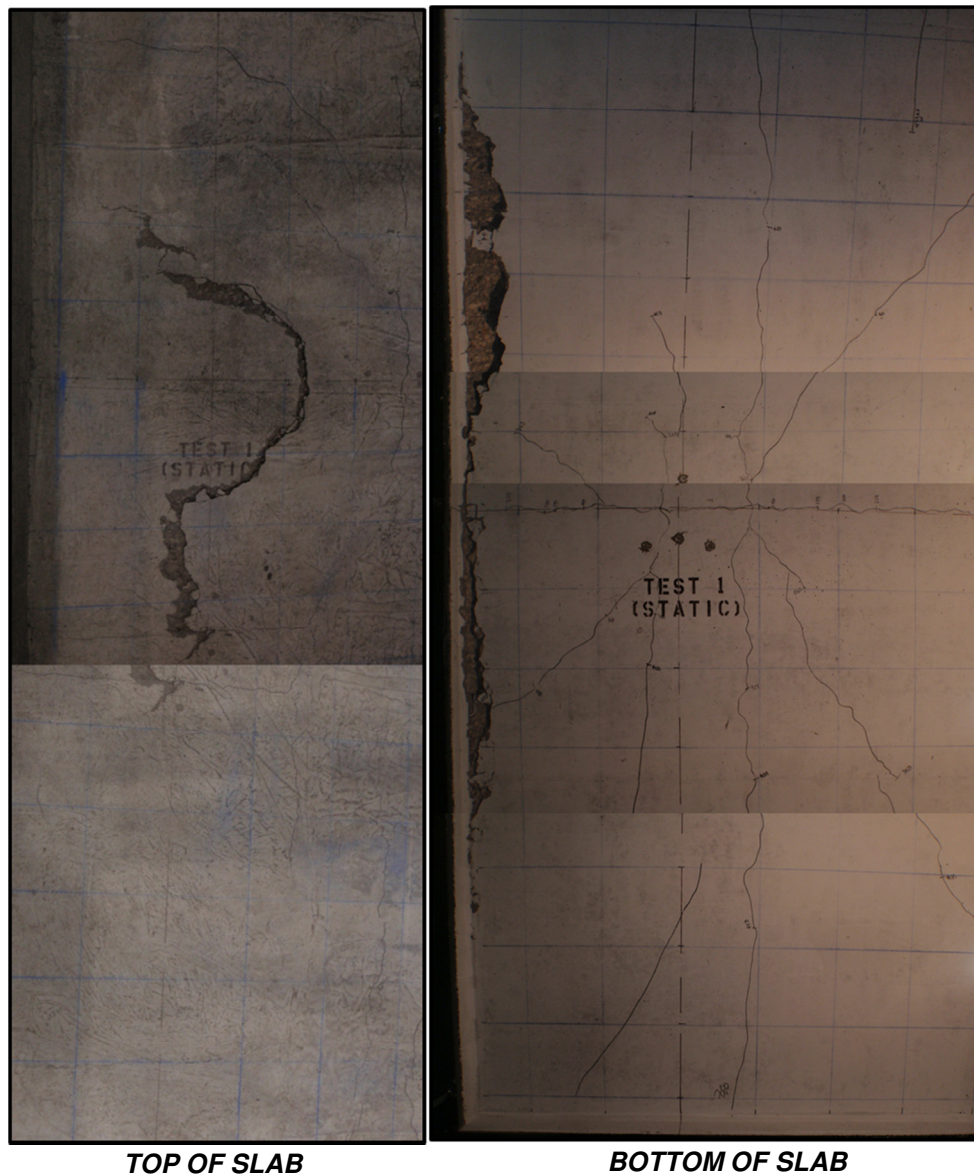
Figure 4-50: Photograph illustrating top and bottom crack patterns for the cantilever section with steel reinforcement subjected to static monotonic loading

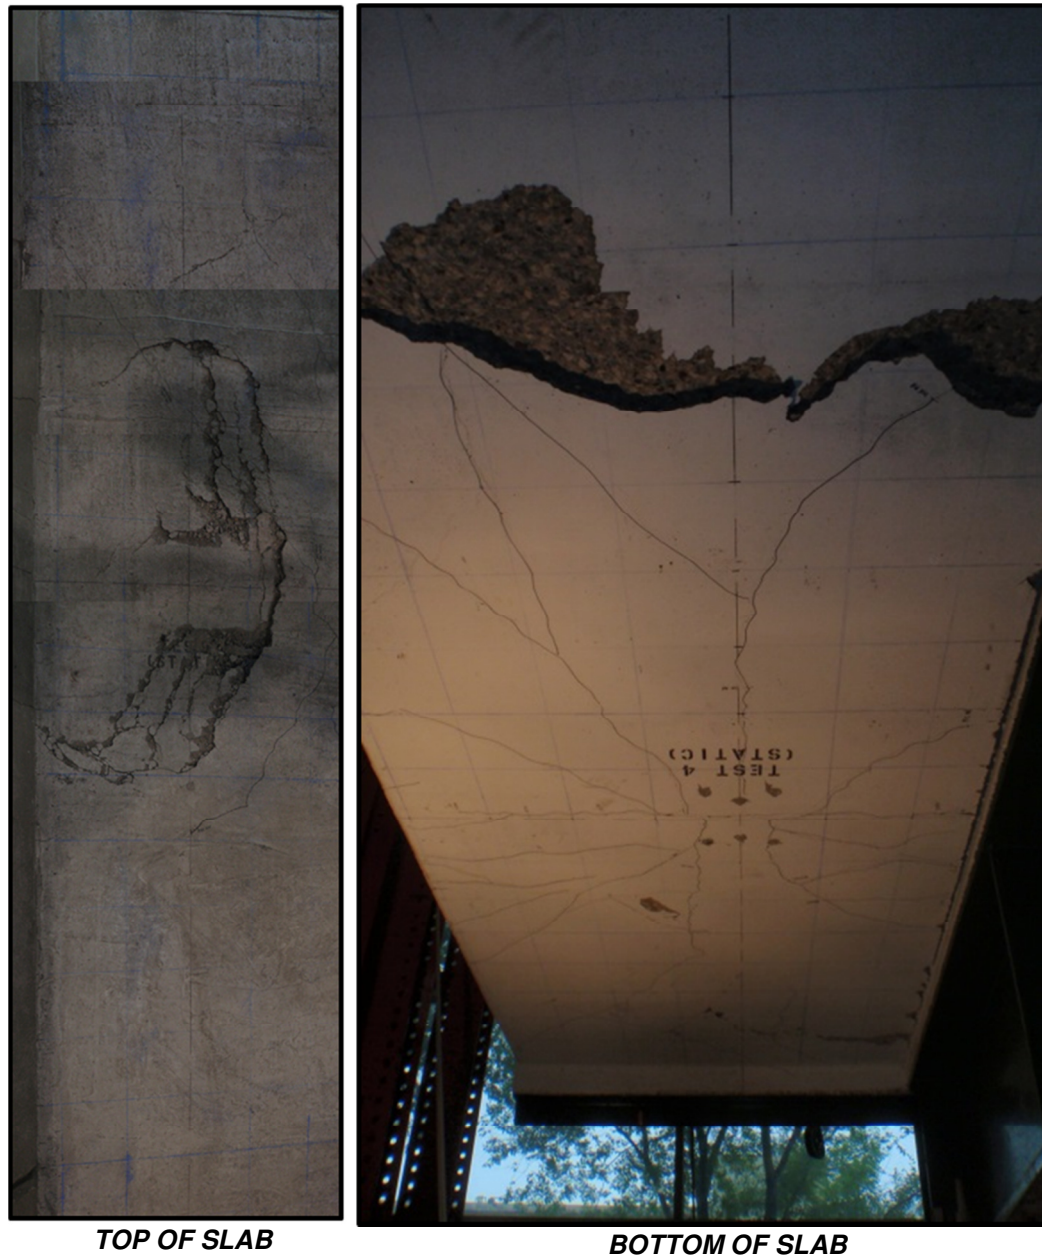
Figure 4-51: Photograph illustrating top and bottom crack patterns for the cantilever section with GFRP reinforcement subjected to static monotonic loading

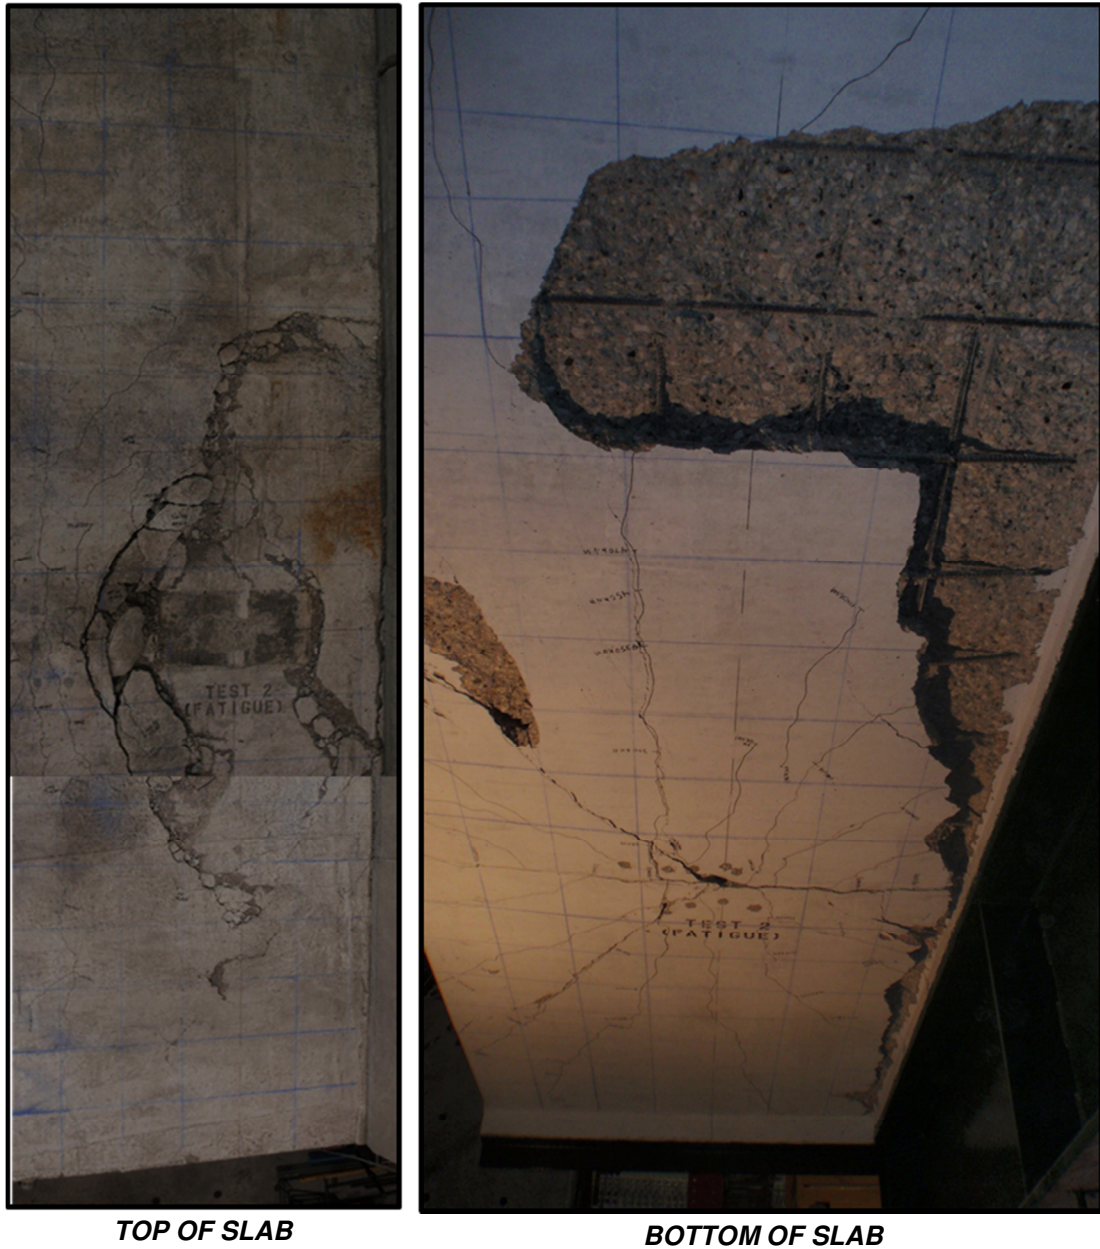
Figure 4-58: Photograph illustrating top and bottom crack patterns for the cantilever section with steel reinforcement subjected to fatigue cyclic loading

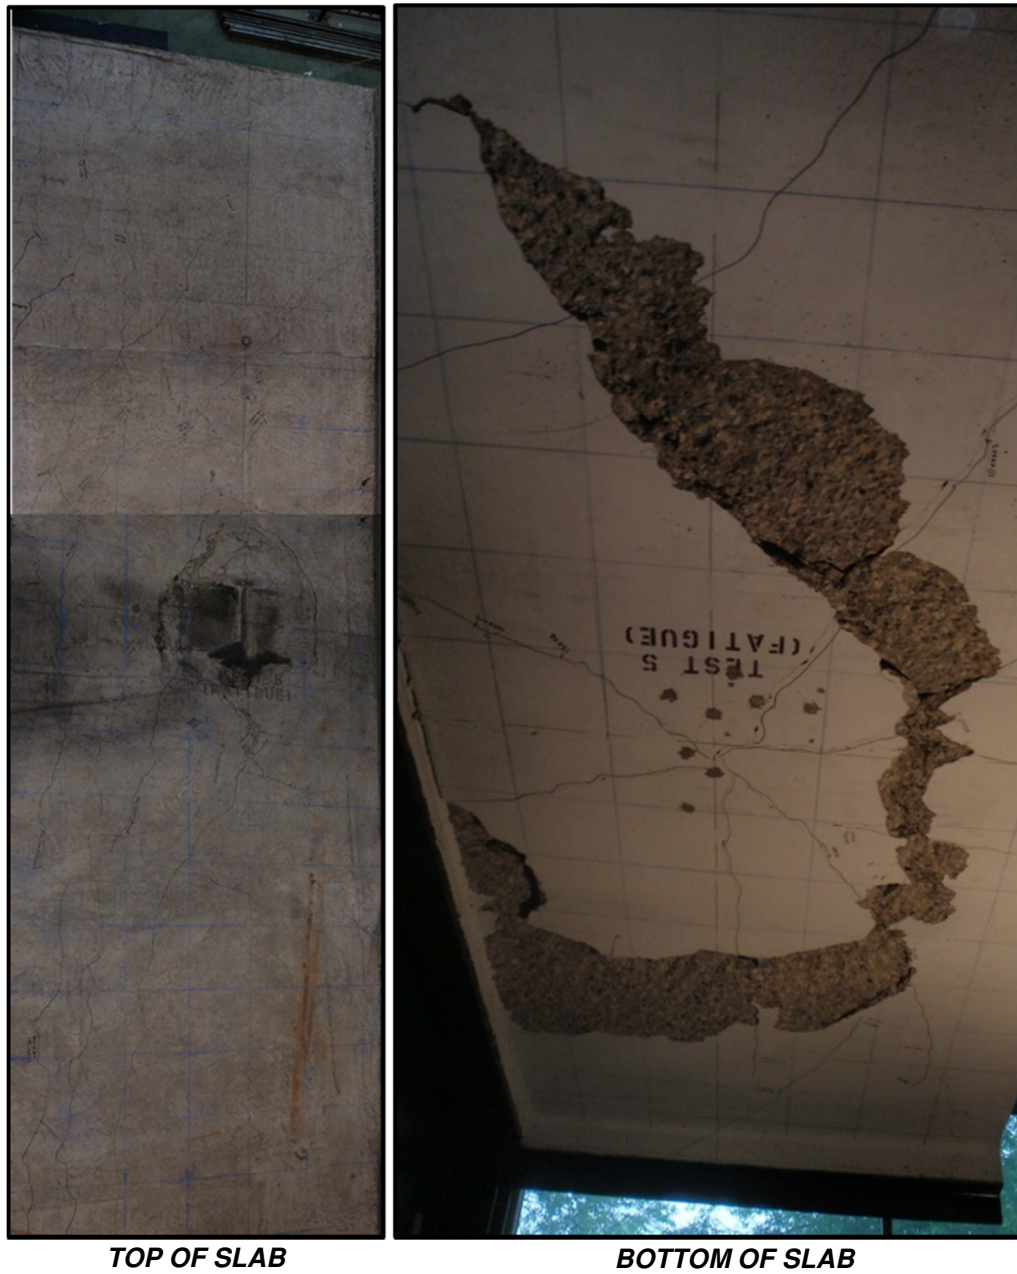
Figure 4-59: Photograph illustrating top and bottom crack patterns for the cantilever section with GFRP reinforcement subjected to fatigue cyclic loading

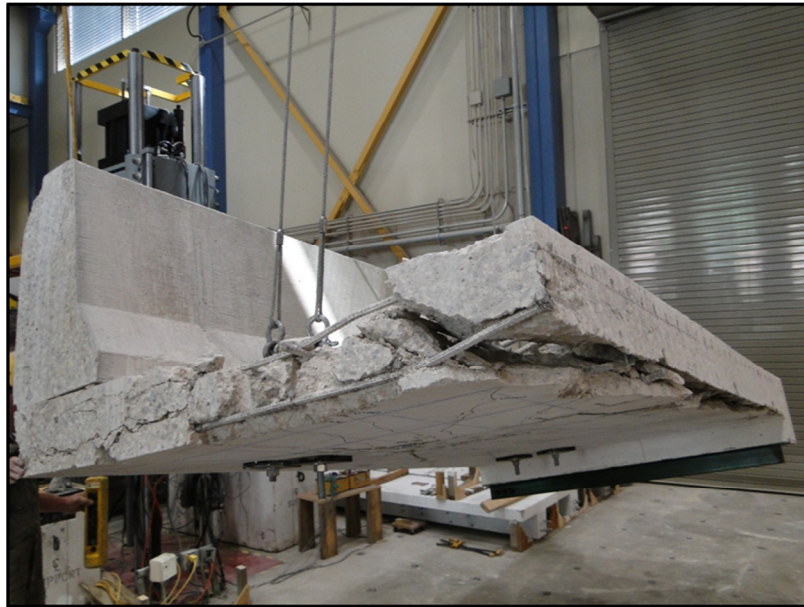
Figure 4-71: Photograph taken during demolition illustrating diagonal shear cracks and punch cone representative of punching shear failure for the cantilever with steel reinforcement subjected to a fatigue cyclic load

punching shear failure at the ultimate of 520 kN. The damage compared to the static test was much greater due to the fatigue loading conditions.

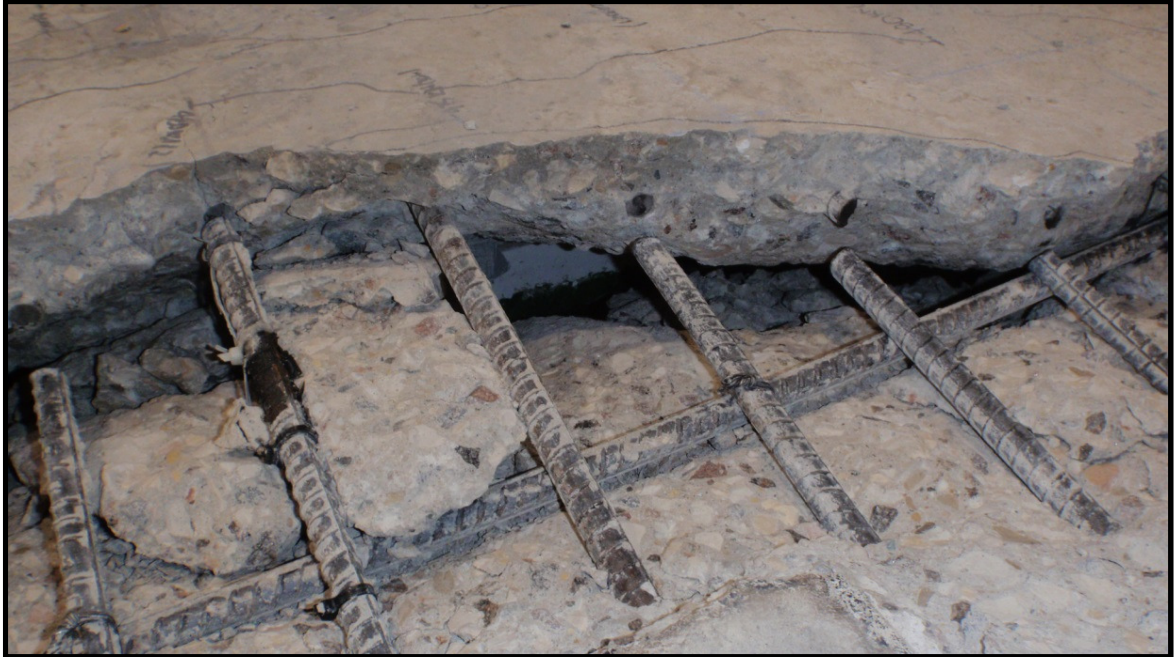
Figure 4-72: Photograph illustrating the rupture of the top transverse steel reinforcement for the cantilever with steel reinforcement subjected to a fatigue cyclic load

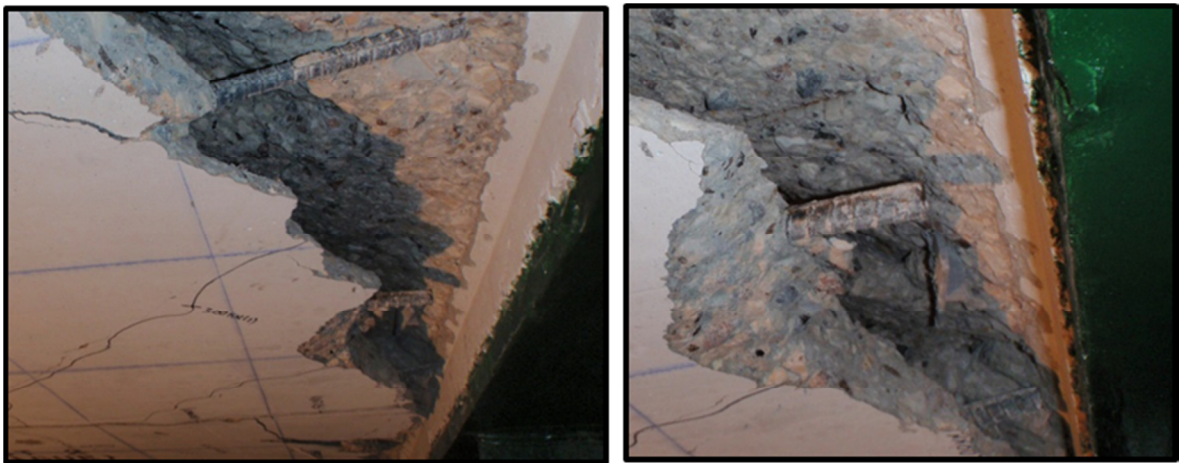
Figure 4-73: Photograph illustrating the rupture of the bottom transverse steel reinforcement for the cantilever with steel reinforcement subjected to a fatigue cyclic load
