**EXAMINING THE PRESENCE OF
ARCHING ACTION IN EDGE-
STIFFENED BRIDGE DECK
CANTILEVER SLAB OVERHANGS
SUBJECTED TO A STATIC AND
FATIGUE WHEEL LOAD**

A Thesis

Doctor of Philosophy

Department of Civil Engineering
University of Manitoba
Winnipeg, Manitoba, Canada

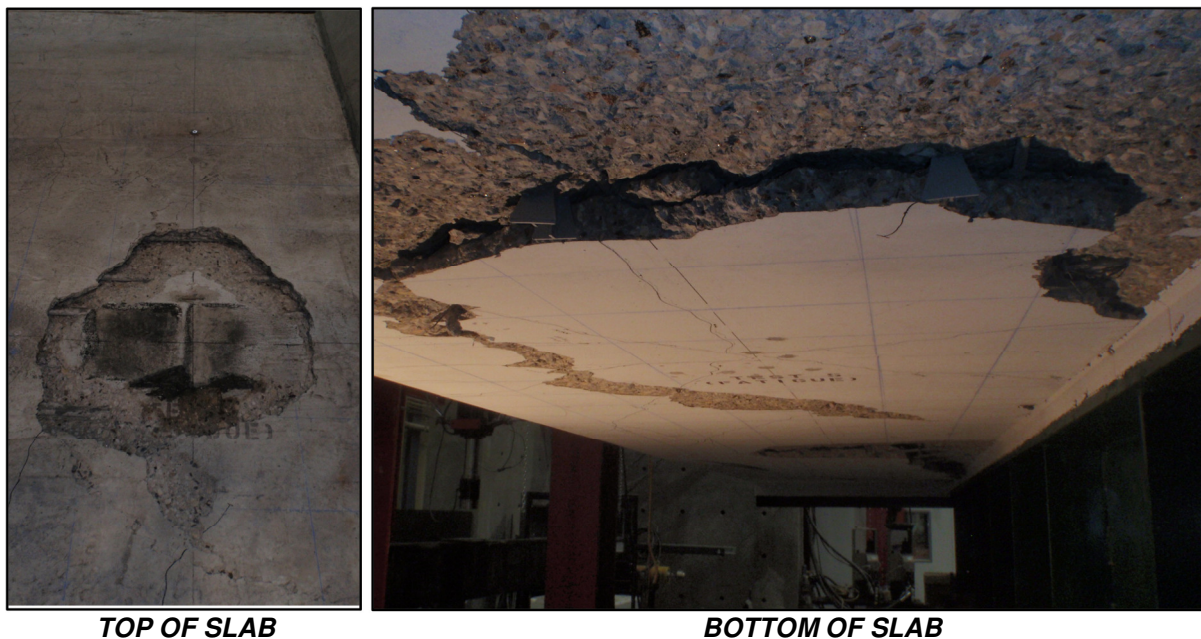
Figure 4-74: Photographs illustrating the top and bottom view of the pronounced punch cone for the cantilever with GFRP reinforcement

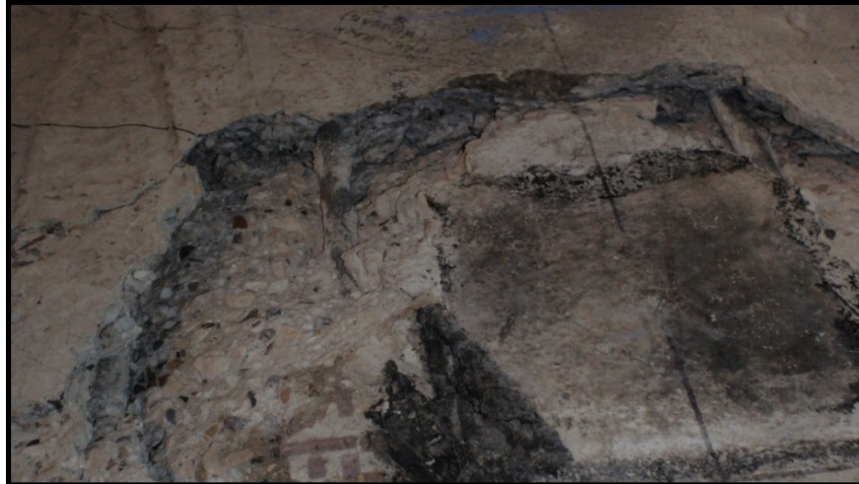
Figure 4-75: Photograph illustrating the top view of the pronounced punch cone for the cantilever with GFRP reinforcement (no rupture of top transverse GFRP reinforcing bars)

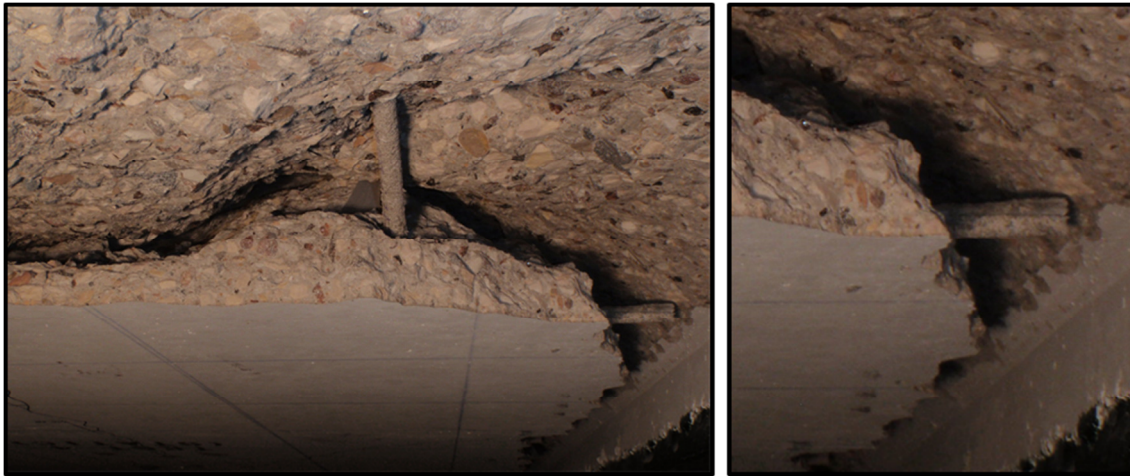
Figure 4-76: Photographs illustrating the rupture of the bottom transverse GFRP reinforcement for the cantilever with GFRP reinforcement subjected to a fatigue cyclic load

Three of the bottom transverse GFRP bars in the vicinity of the loading plate were ruptured (Figure 4-76). Punch angles along the transverse and longitudinal center lines of the applied load were measured. The punch angles along the longitudinal center line of the loading plate

in the north and south directions were determined and measured about 19° and 21° respectively (Figure 4-77). The punch angles in the transverse direction were calculated to be 51° in the east direction (towards the barrier wall) and 29° in the west direction (towards the girder).

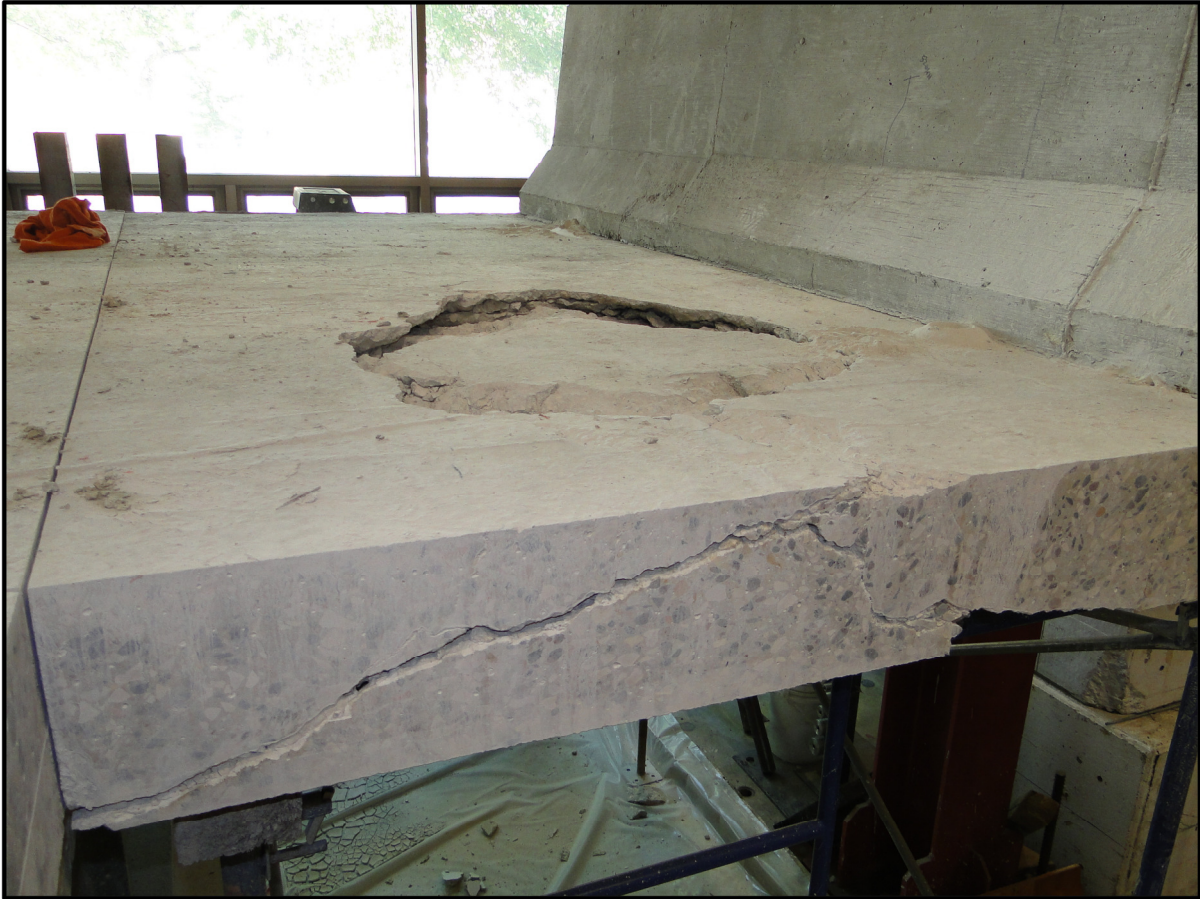
Figure 4-77: Photograph taken during demolition illustrating diagonal shear cracks and punch cone representative of punching shear failure for the cantilever with GFRP reinforcement subjected to a fatigue cyclic load

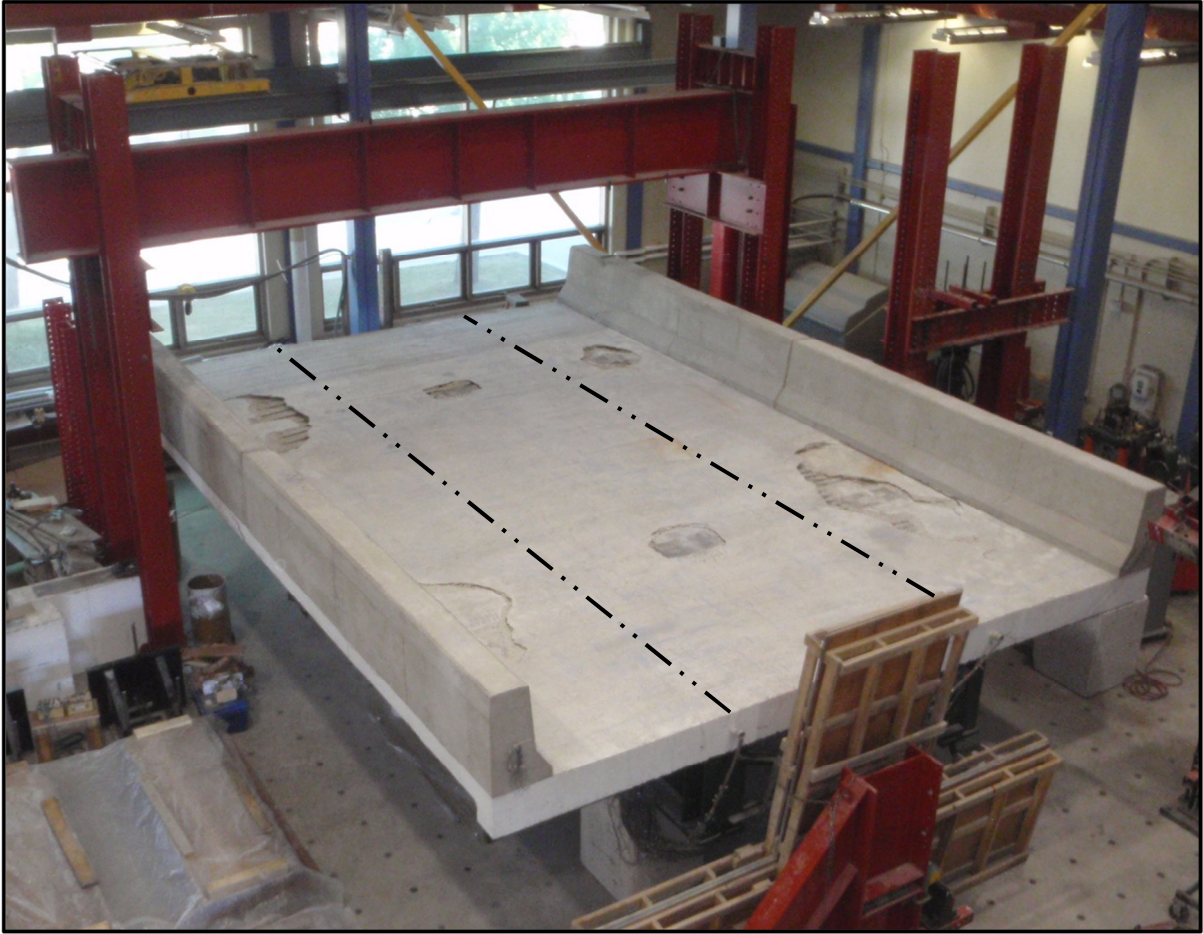
Figure 4-78: Photograph of the entire experimental bridge deck slab illustrating punching shear failures of the cantilever sections

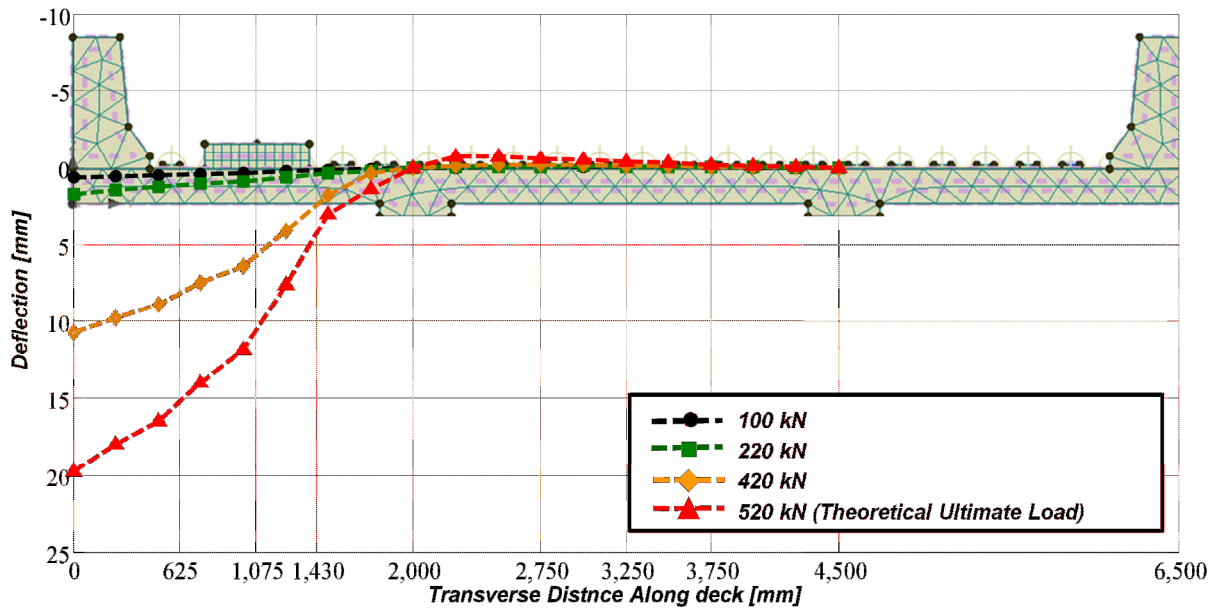
Table 5-22: Theoretical transverse deflection profiles along the transverse center-line of the applied load for the cantilever section with GFRP reinforcement

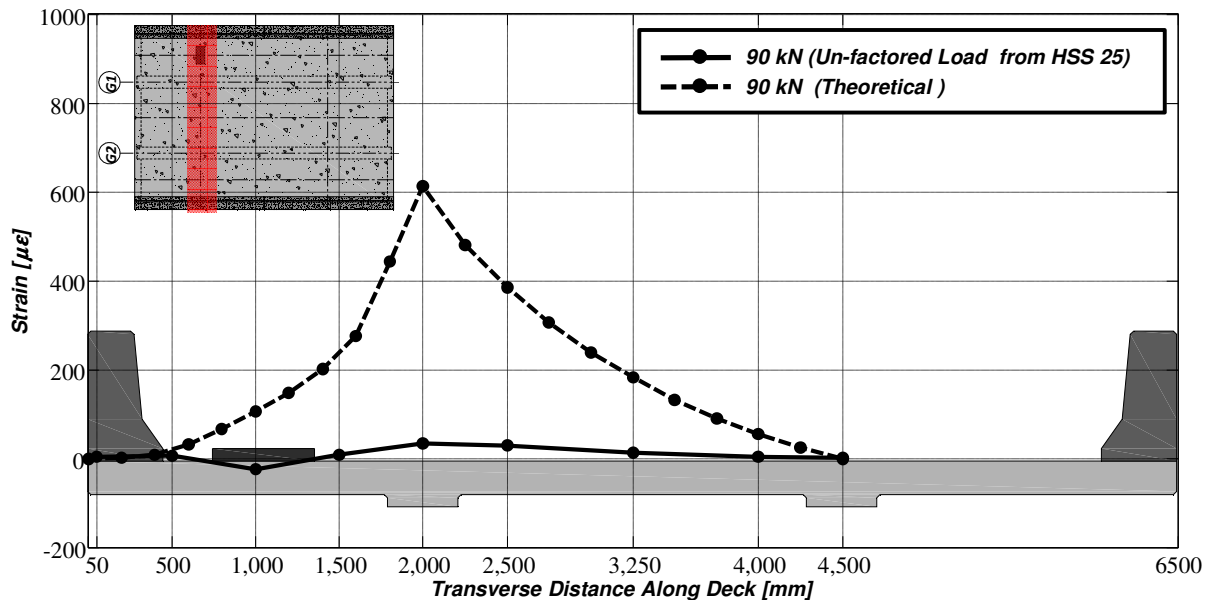
Figure 5-34: Comparison of experimental and theoretical top transverse reinforcing bar strain profiles along the transverse center-line of the applied load for the cantilever section with steel reinforcement subjected to static monotonic loading (service loads)
