BEHAVIOUR OF ULTRA-HIGH PERFORMANCE CONCRETE AS A JOINT-FILL MATERIAL FOR PRECAST BRIDGE DECK PANELS SUBJECTED TO NEGATIVE BENDING

David Rodrigues Coelho Amorim

A Thesis submitted to the Faculty of Graduate Studies of
The University of Manitoba
in partial fulfilment of the requirements of the degree of

Department of Civil Engineering
University of Manitoba
Winnipeg

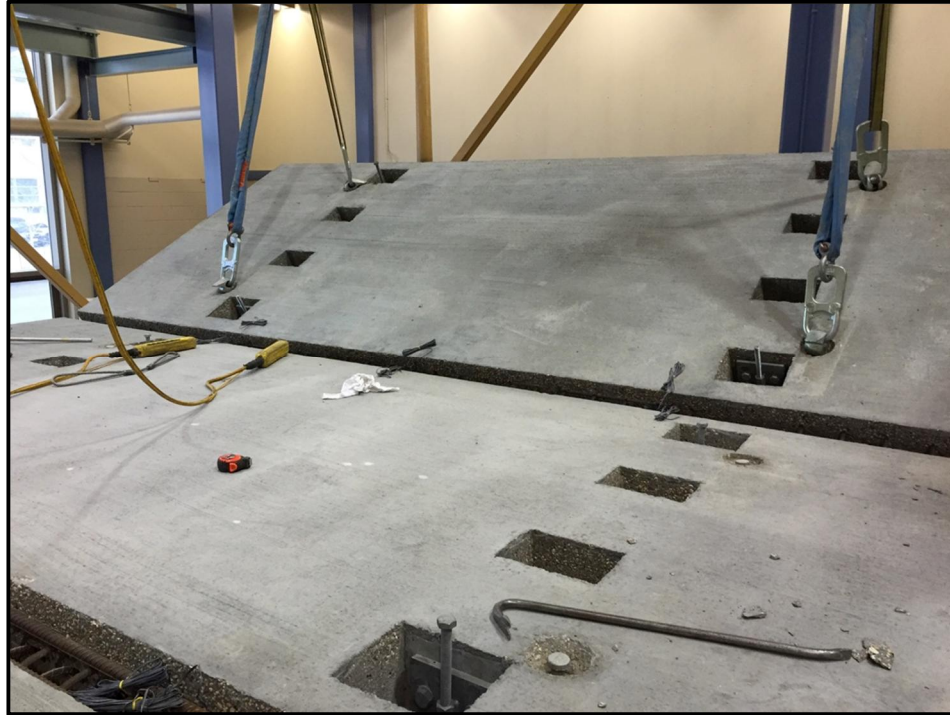
To solve this issue, the panels had to be steeply raked, or tilted, to try to clear the shear studs as shown in Figure 3-20. Ultimately, the researchers managed to place the panels but unfortunately caused minor cosmetic damage. The damage was limited to spalling of the inside faces of several shear pockets and breakage of the joint bottom lip in several locations as shown in Figures 3-21 and 3-22 respectively. Overall, the researchers do not believe that this damage affected the research results.

Figure 3-20 – Placement of TS2 Panels Utilizing Steep Tilt

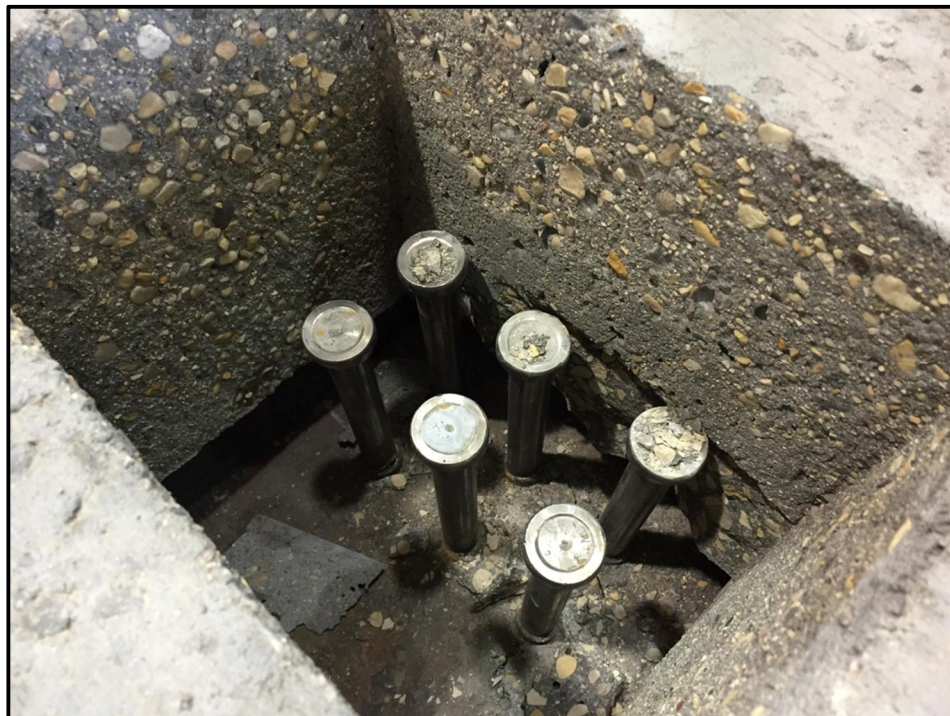
Figure 3-21 – Damage to Inside Face of TS2 Shear Pockets (Panel C2) During Placement

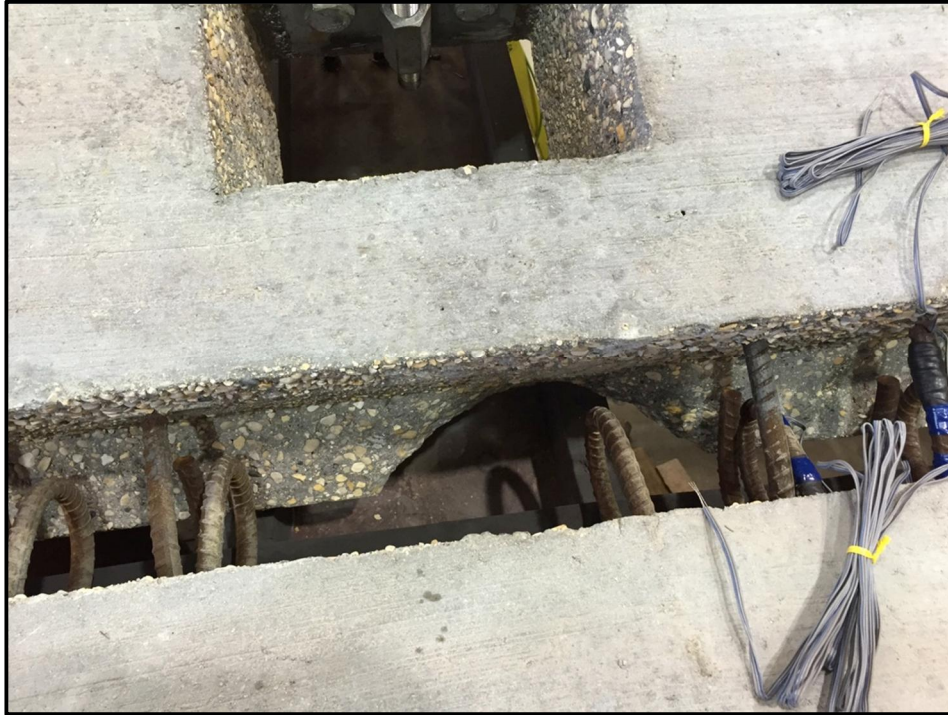
Figure 3-22 – Damage to Bottom Lip of Joint (East Joint of TS2 – Panel E2) During Placement

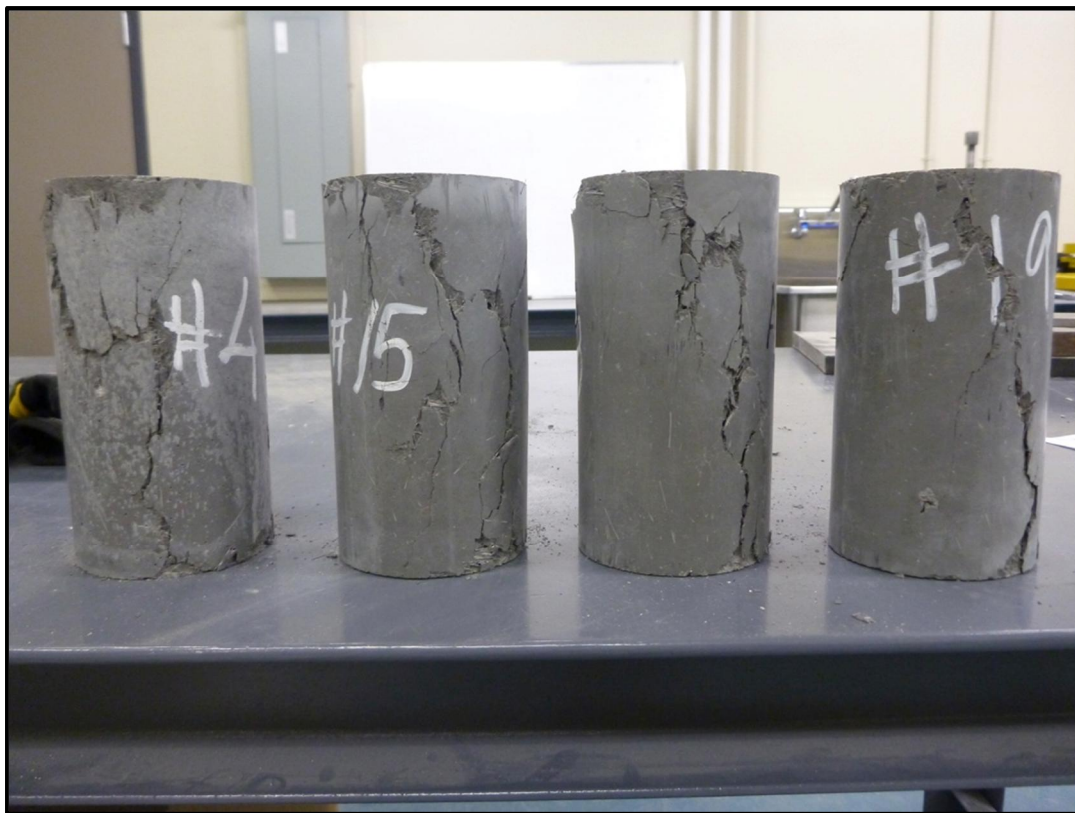
With the exception of several cylinders tested after 268 days, all UHPC cylinders displayed a similar failure pattern. The cylinders remained mostly intact with the failure surface splitting the cylinder from side to side. The failure surface did not typically progress through the tops or bottoms of the cylinders. This failure mode, consistent with typical failures in other fibre-reinforced concretes varies drastically from that observed in concrete without fibers. Concretes lacking fibers typically fail in an explosive fashion with an hourglass type failure surface. Figure 4-3 depicts the typical UHPC failure pattern.

Figure 4-3 – Typical UHPC Failure Pattern

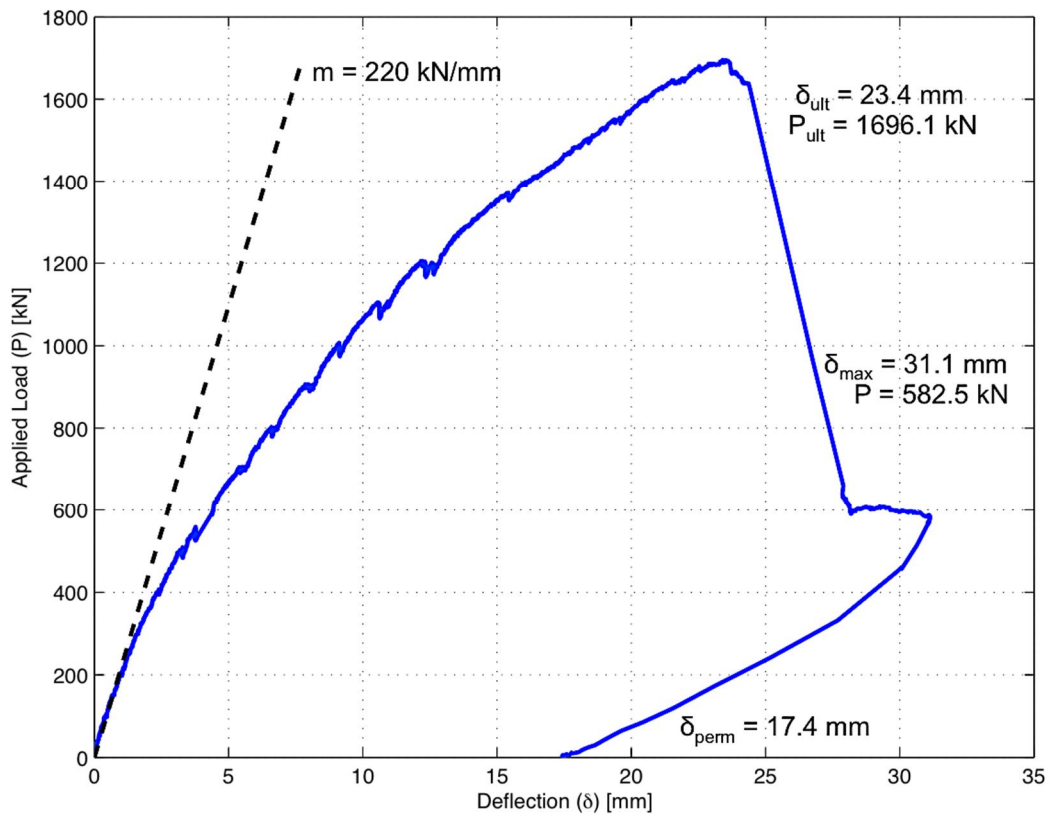
Figure 4-5 – Load-Deflection Curve for LVDT 4 (Loading Point) [Test #1]

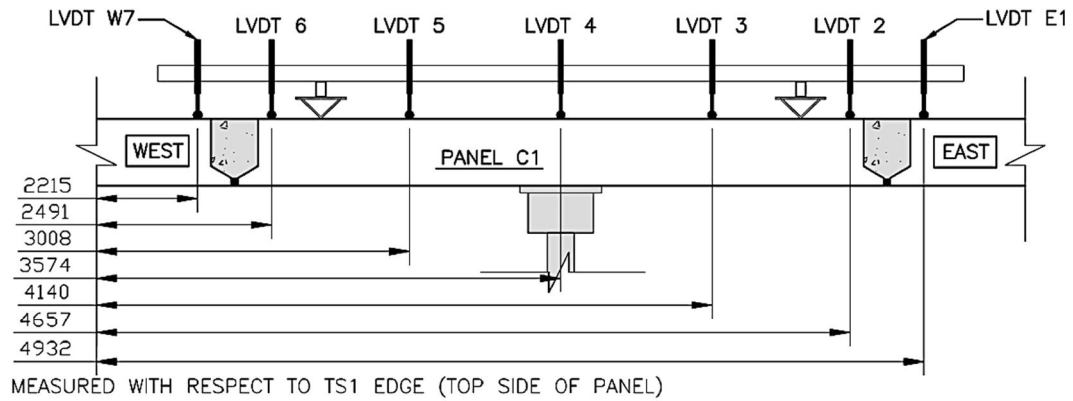
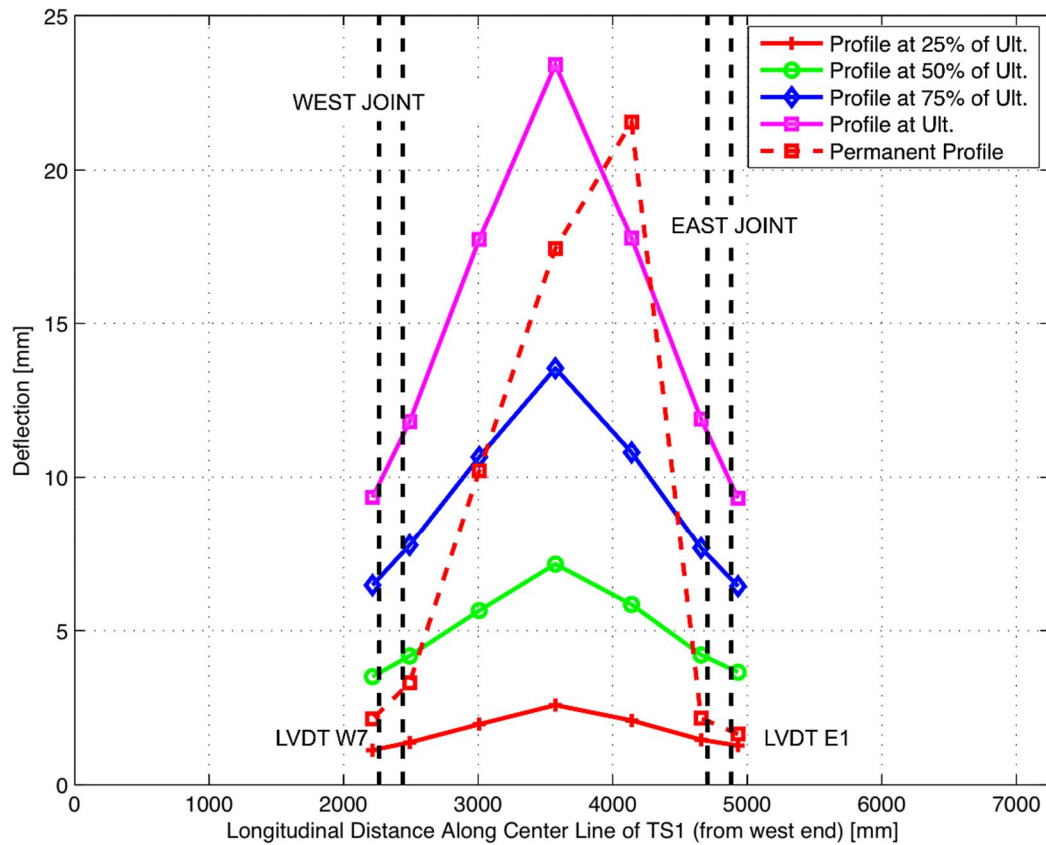
Figure 4-6 – Longitudinal Deflection Profiles (Test #1)

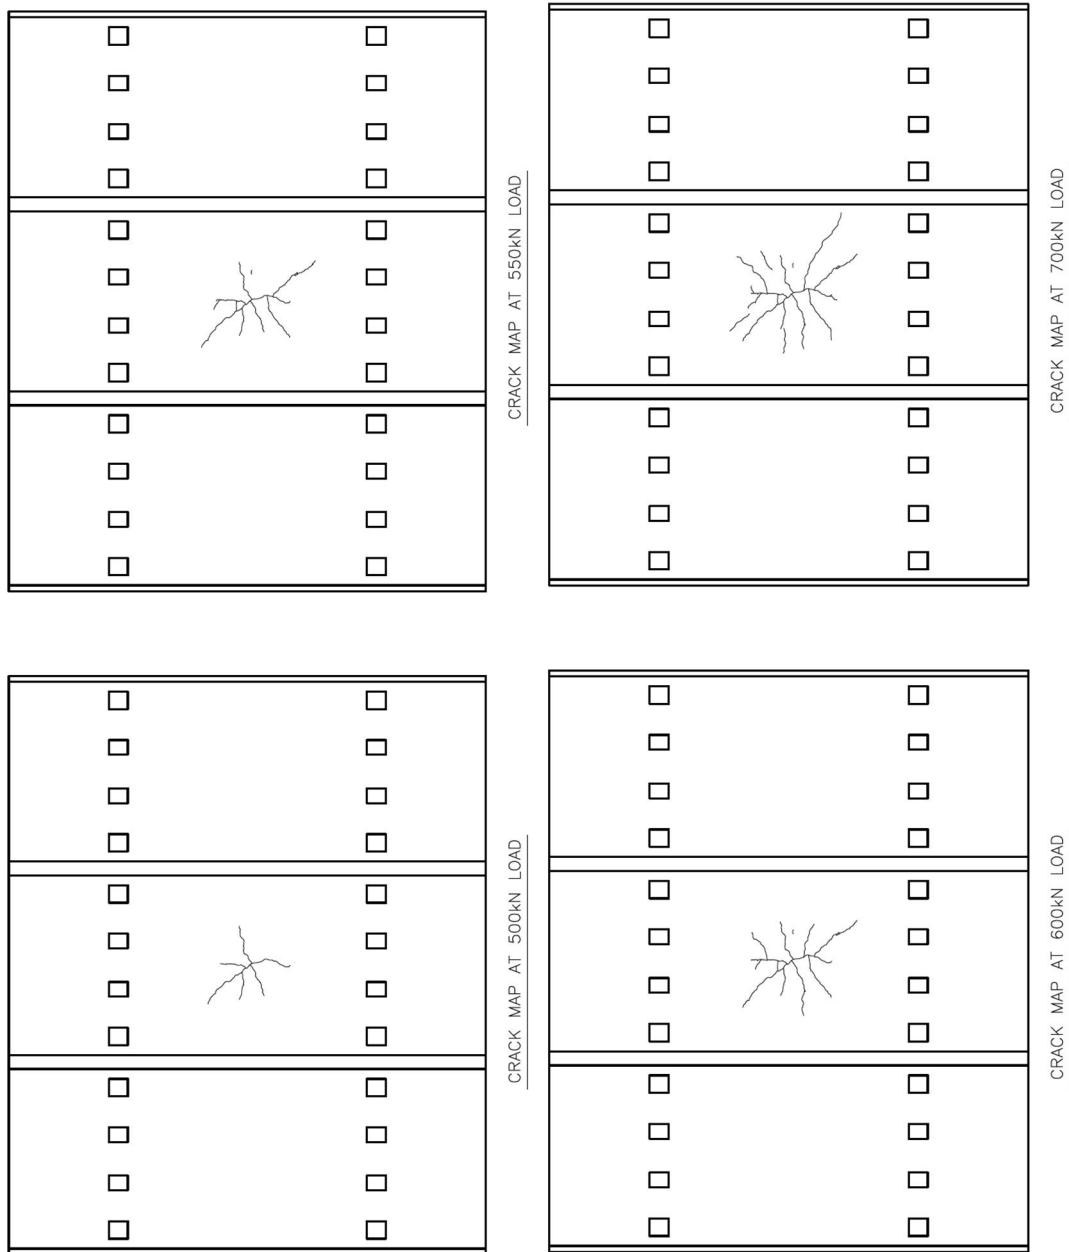
Figure 4-15 – Crack Progression from 500 kN to 700 kN (Test #1)

Cracks were mapped by the researchers at the onset of cracking (visually observed to occur at 500 kN), 550, 600, 700, 800, 900, 1000, 1100, 1200 kN and post failure. Cracks were not mapped past 1200 kN during the test due to safety reasons. The visual crack mapping results are presented herein. Figures 4-15 to 4-17 depict the progression of crack formation from 500 kN to 1200 kN.

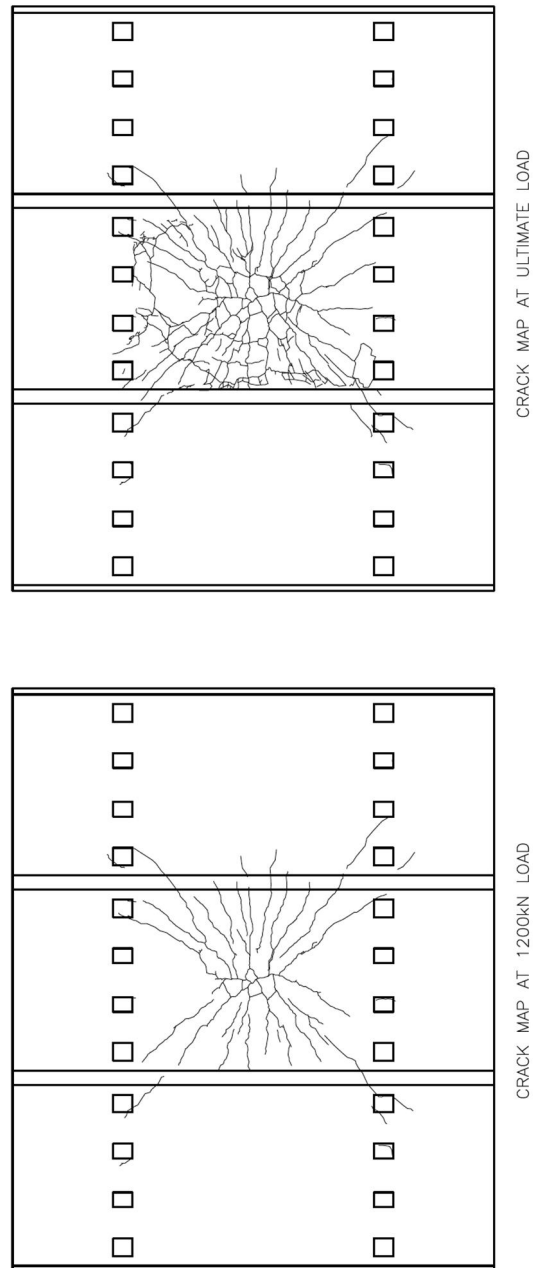
Figure 4-17 – Crack Progression from 1200 kN to Failure (Test #1)

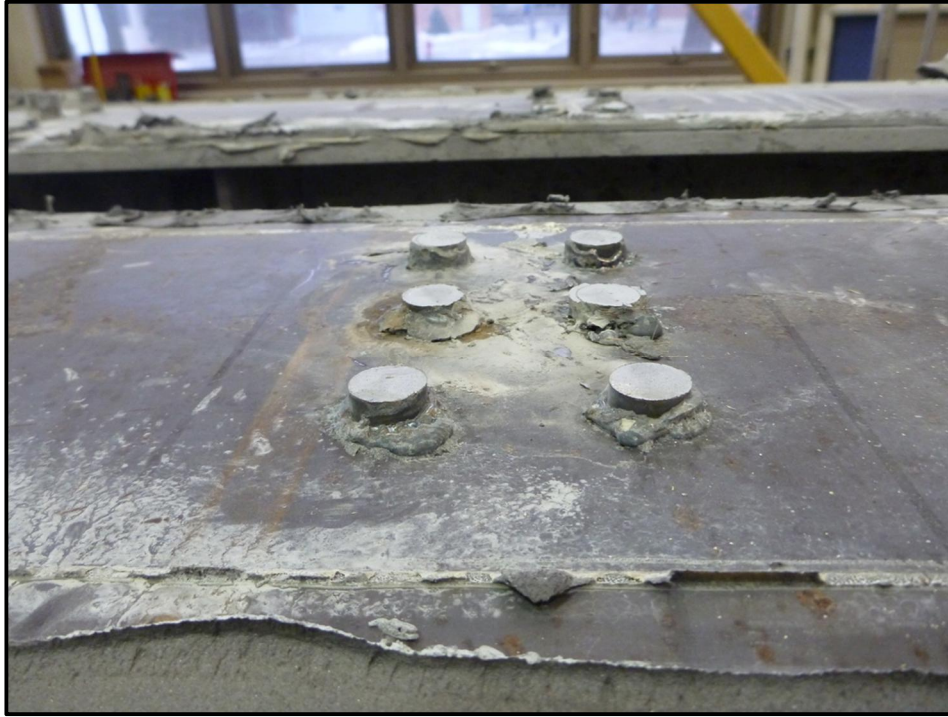
Figure 4-21 – Undamaged Shear Stud Cluster Far From Loading Point (Test #2)

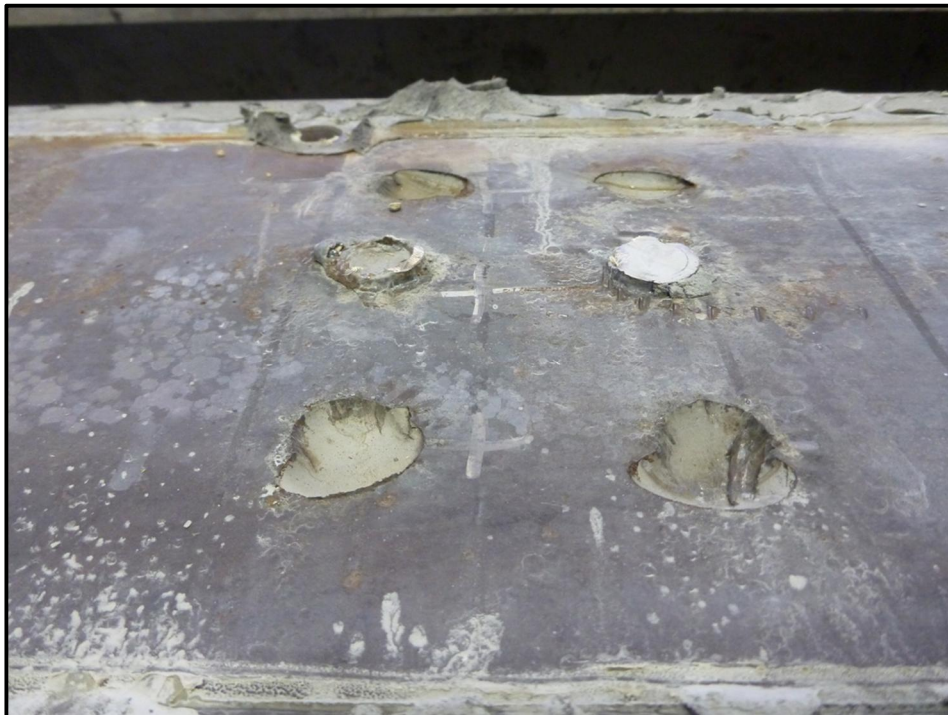
Figure 4-22 – Damaged Shear Studs In-Line with Loading Point (Test #2)

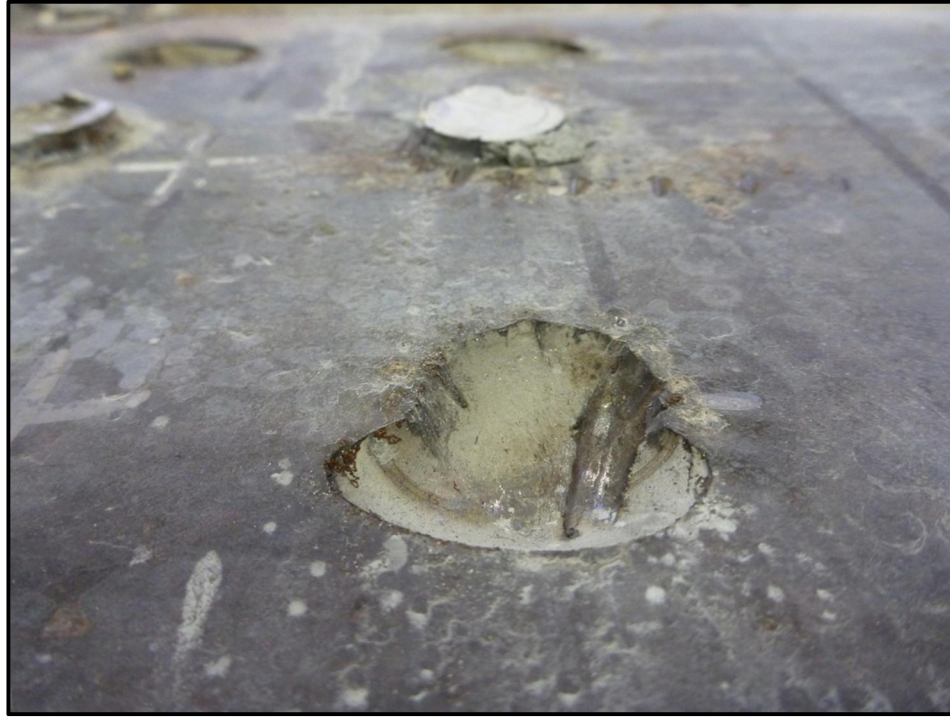
Once the researchers were satisfied that the proposed test method and set-up performed adequately, Test #2 was stopped and the specimen was demolished and removed from the lab. During the demolition, damage to the shear studs resulting from the fatigue test was observed in the two full-depth pockets along either girder closest to the west joint in panel W1. Figures 4-21 depicts undamaged shear studs from a pocket far from the loading point while Figures 4-22 and 4-23 depict the damaged shear studs from the pocket inline with the loading point. It should be noted that these pictures are after removal of the deck panels by cutting along the haunch with a concrete saw. Due to the conical depression in the top girder flange, shown clearly in Figure 4-23, it appears as though the shear studs failed due to fatigue along the girder flange and weld material interface.

Figure 4-23 – Close-up of Damaged Shear Stud Weld (Test #2)

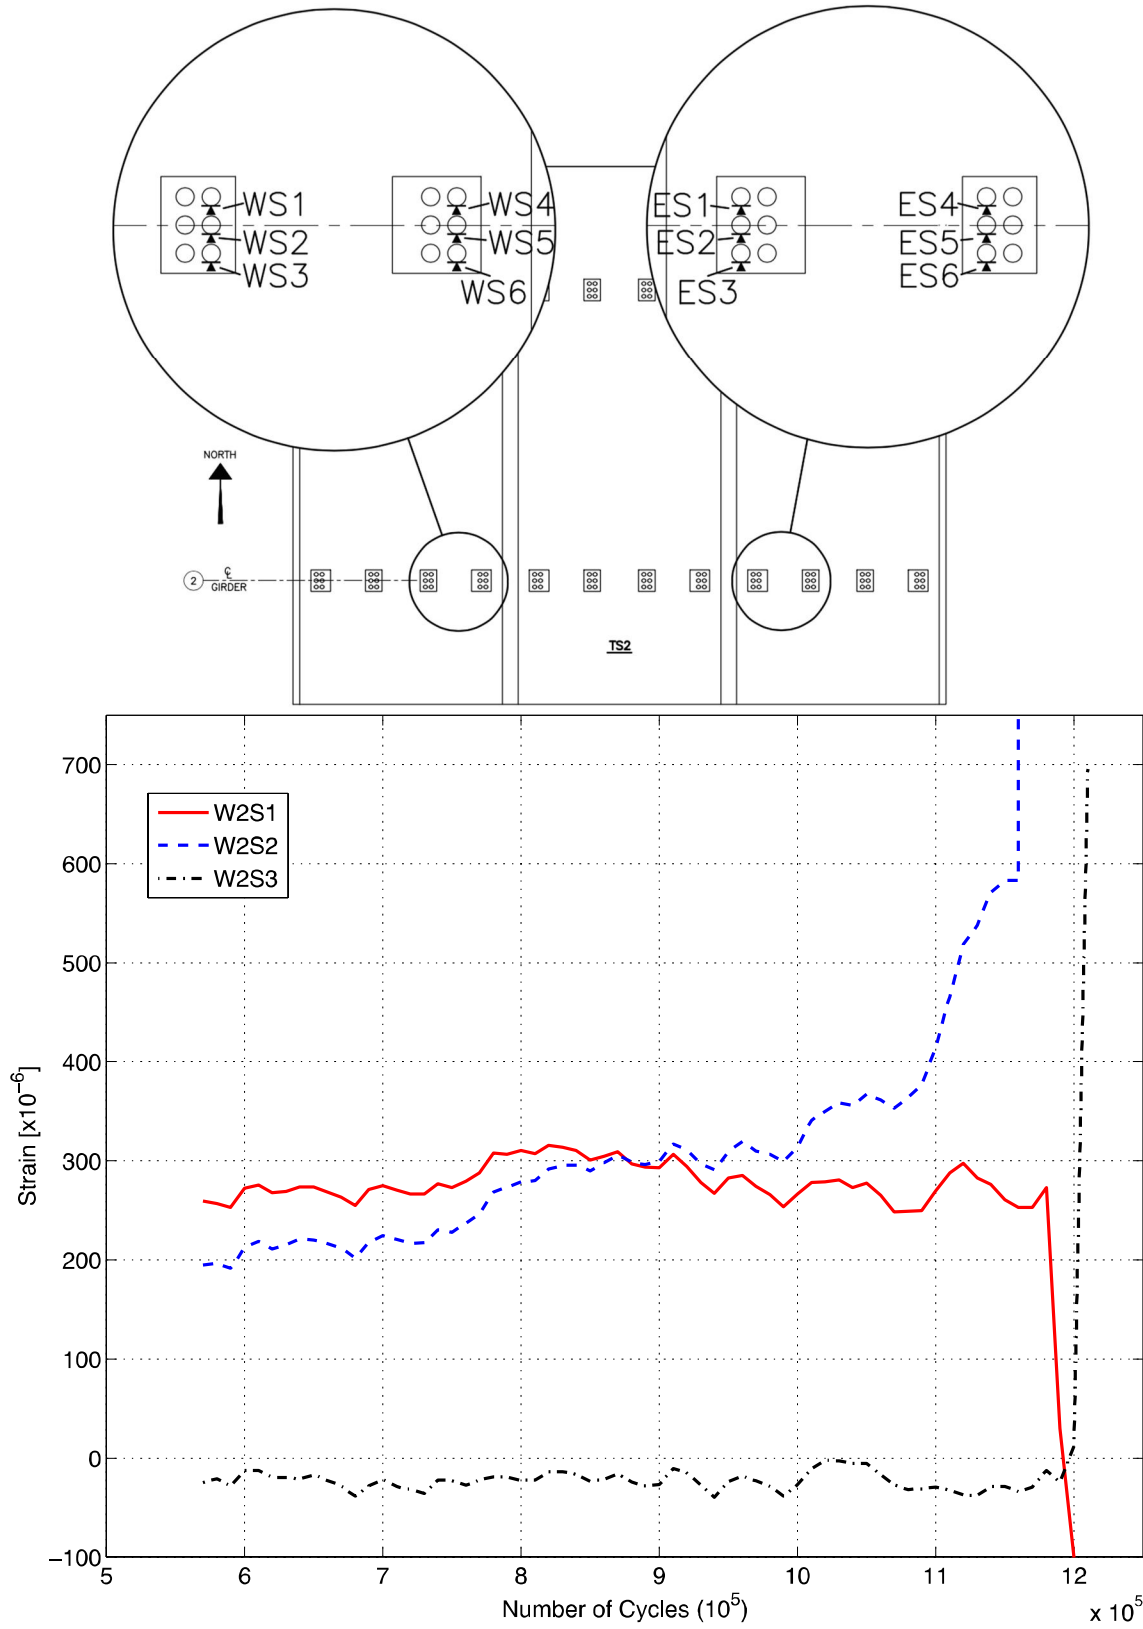
Figure 4-32 – Shear Stud Strains W2S1, W2S2 and W2S3 (Test #3)

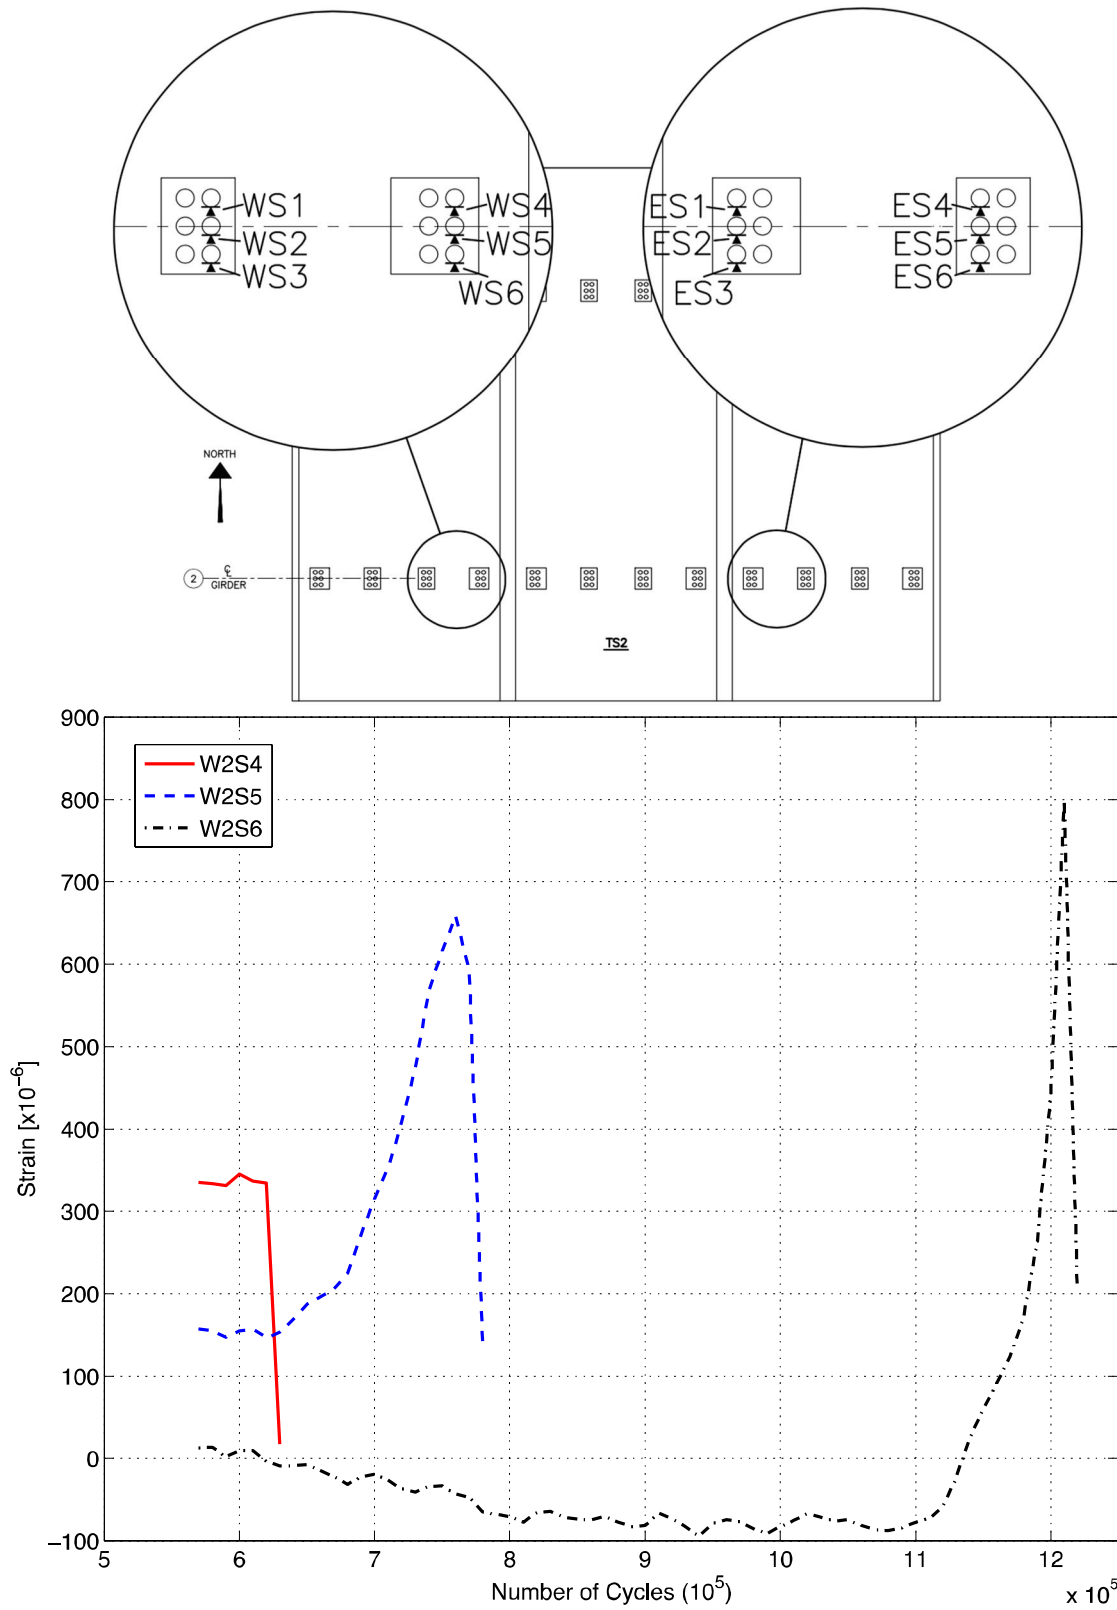
Figure 4-33 – Shear Stud Strains W2S4, W2S5 and W2S6 (Test #3)

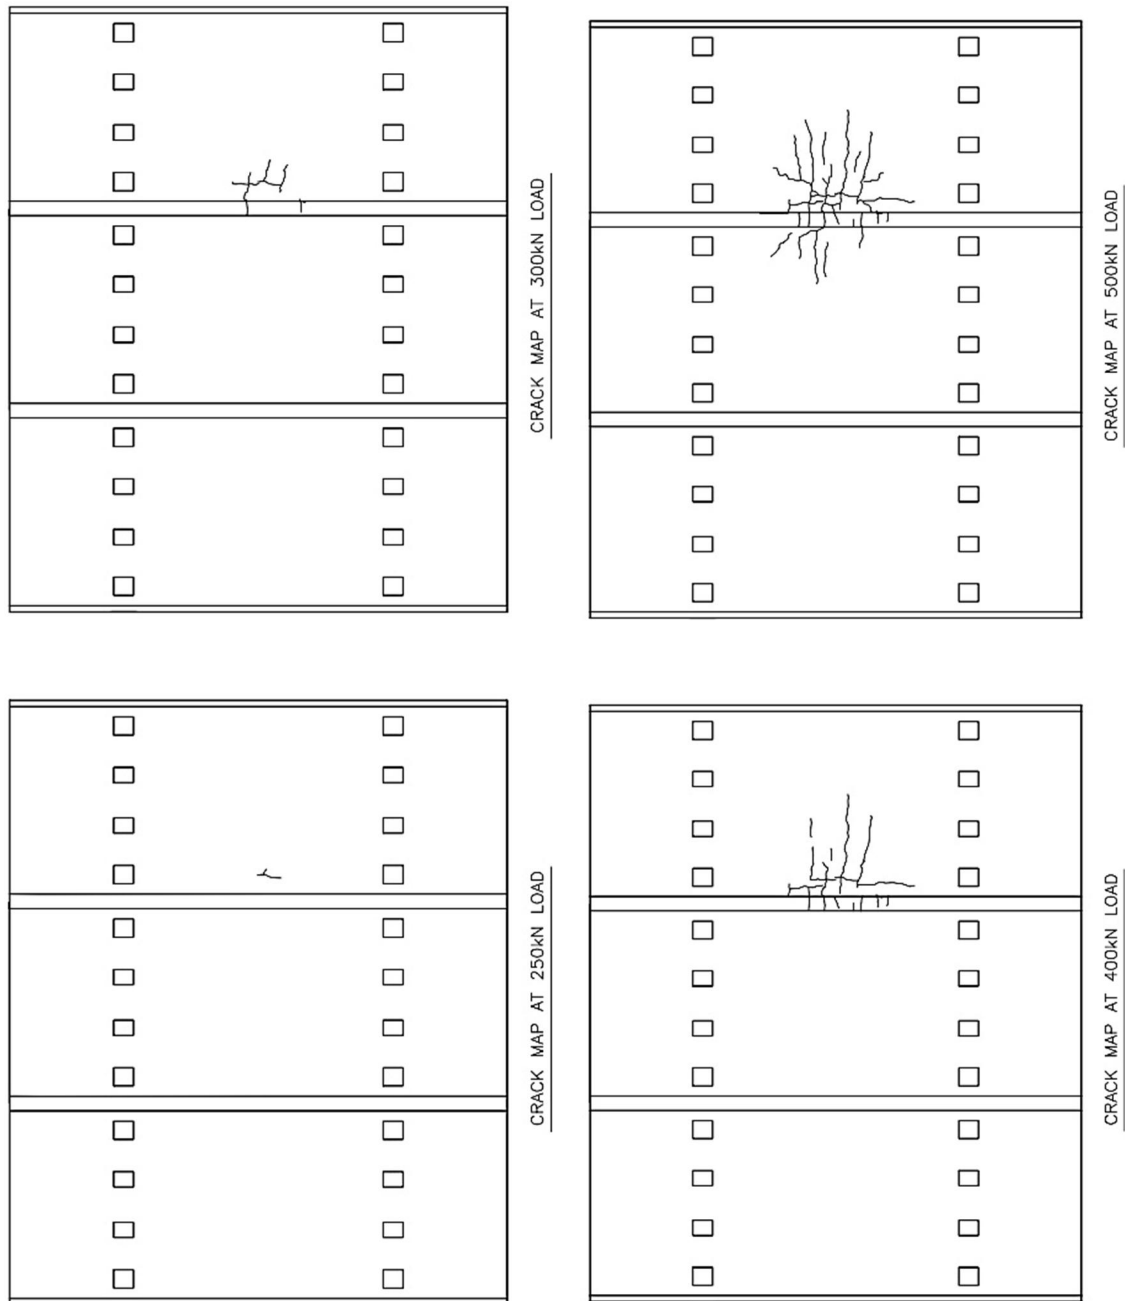
Figure 4-44 – Crack Progression from 250 kN to 500 kN (Test #4)

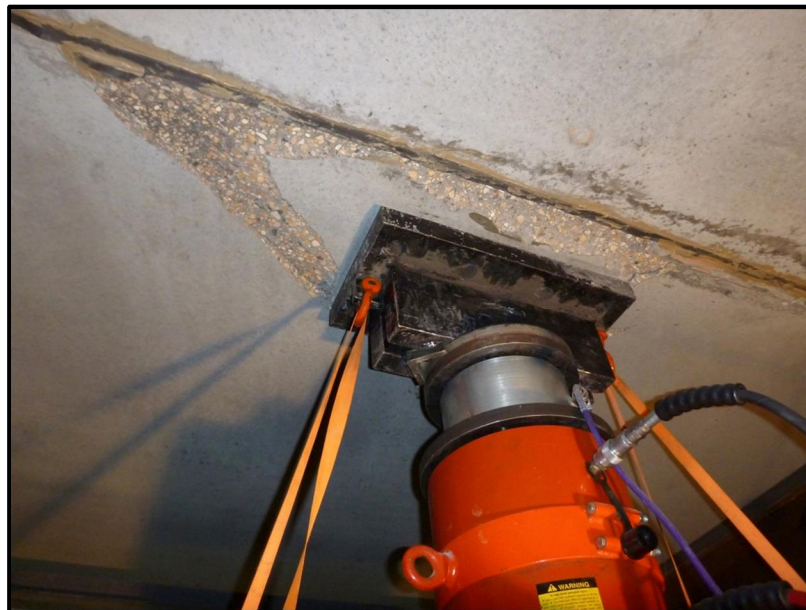
Figure 4-48 – Punching Shear Failure on Deck Soffit (Test #4)
