Slope Stability Evaluation of an Old Earth Fill Dam
Founded on Glaciolacustrine Clays

Moises Alfaro III

Department of Civil Engineering

University of Manitoba

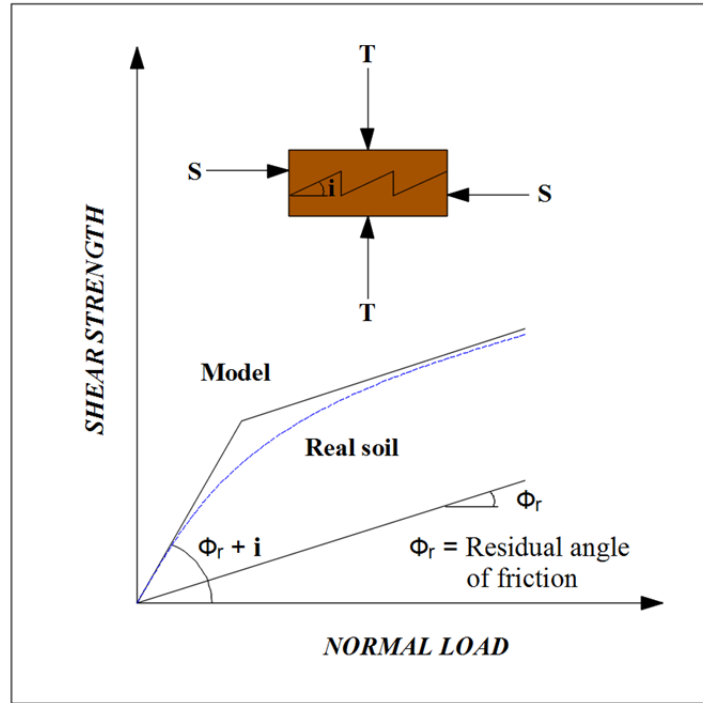
Figure 2-1. Shear strength of model specimen having rough surfaces (after Yoshida, Morgenstern, and Chan 1991)
 © Canadian Science Publishing.

Patton (1966) did an experimental study to describe the behavior of fissured clay. Figure 2-1 shows the shear strength model of fissured clays having a rough surface. Under low normal stress the specimen moves over the teeth (*fissured surface*) when being sheared, contributing to a higher frictional resistance and dilatancy. As the normal stress increases, the tendency of the teeth to be sheared off increases and dilatancy decreases. Under a very high normal stress, the tendency of the material to dilate will be suppressed and the shear plane will be forced to pass through the intact material resulting in a lower frictional resistance.

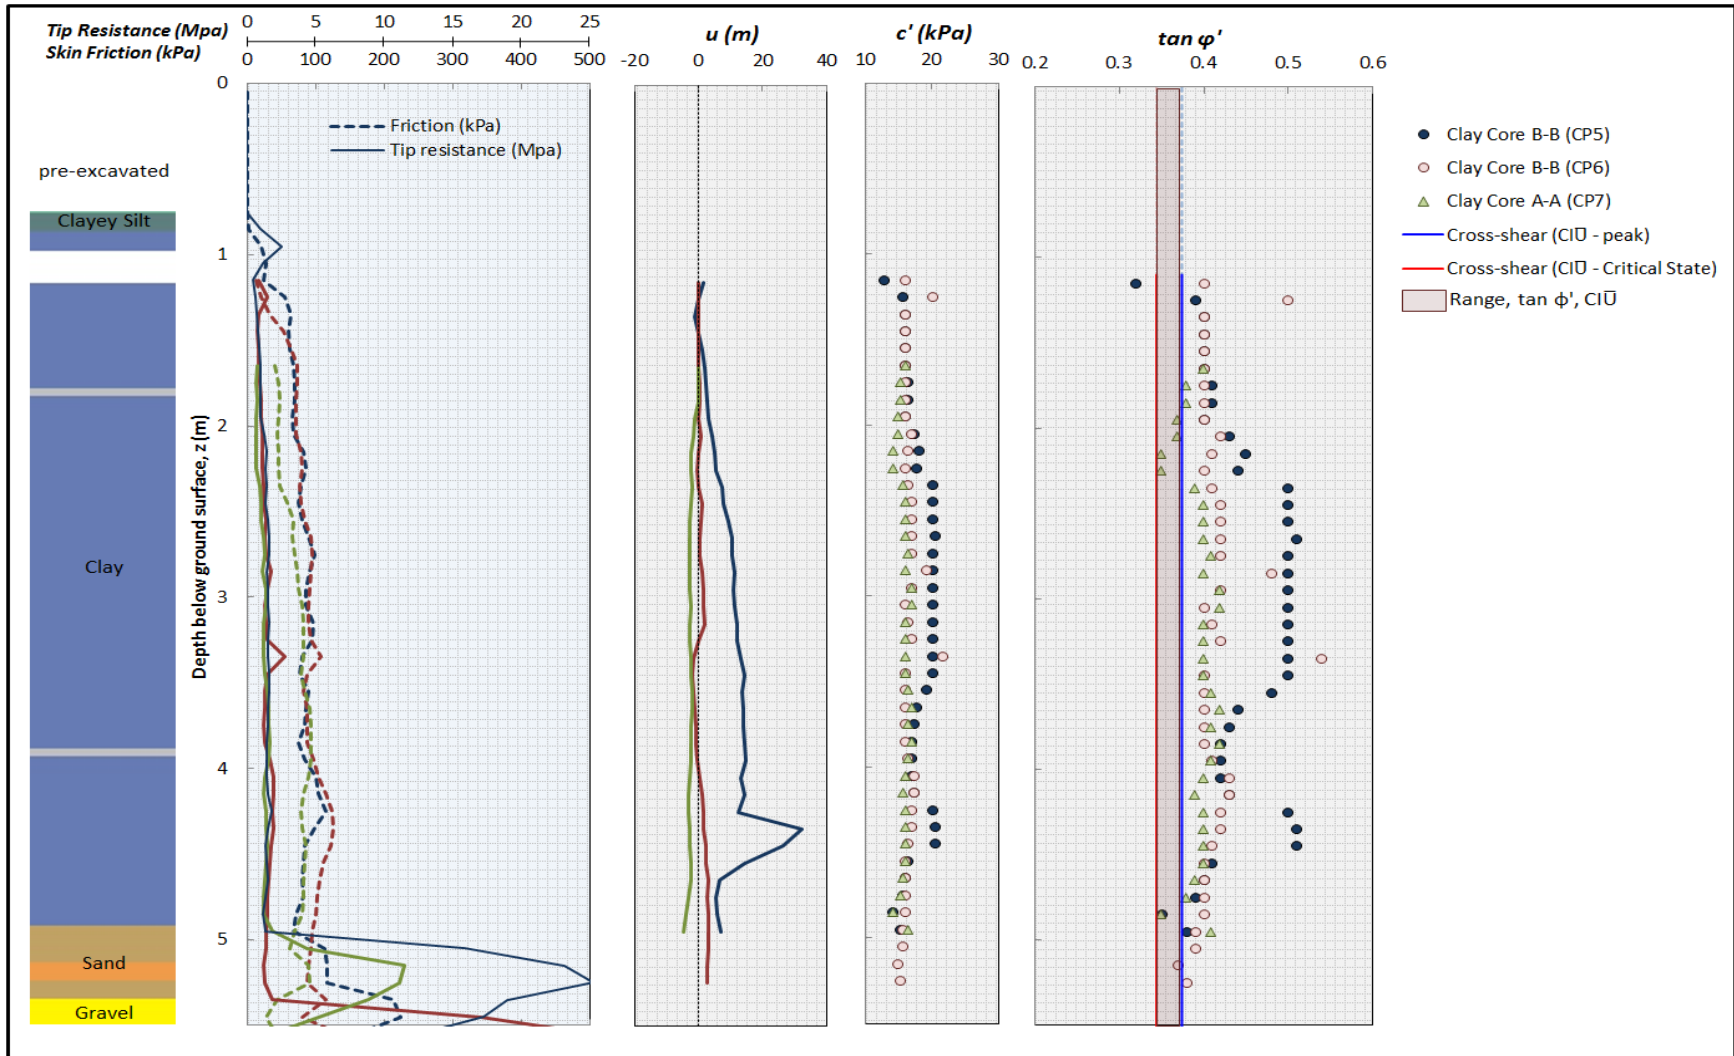
Figure 3-4. CPTu data and correlated drained parameters (ϕ' and c') from clay core.

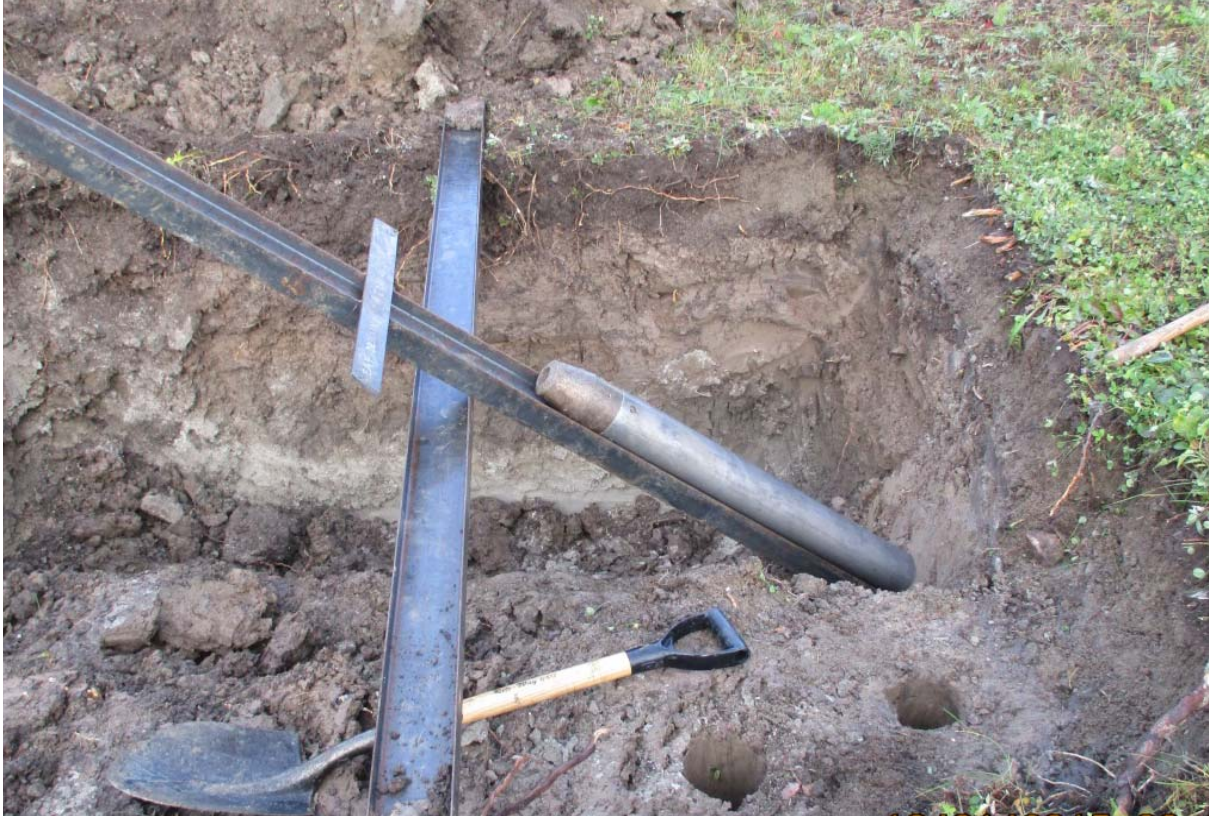
Figure 3-11. Inclined samples pushed into the test pit walls.

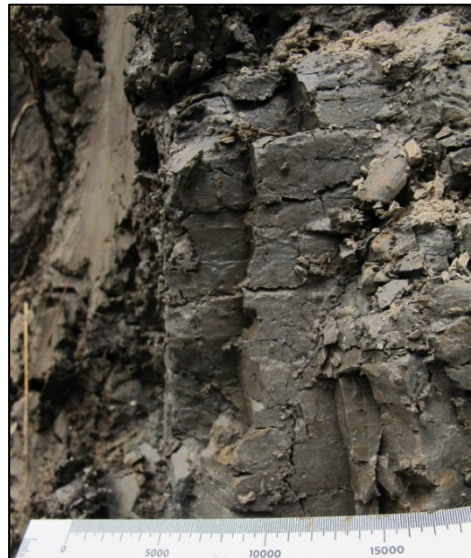
Figure 3-14. Fissured clay foundation from Test Pit 2 at depth = 7 ft.

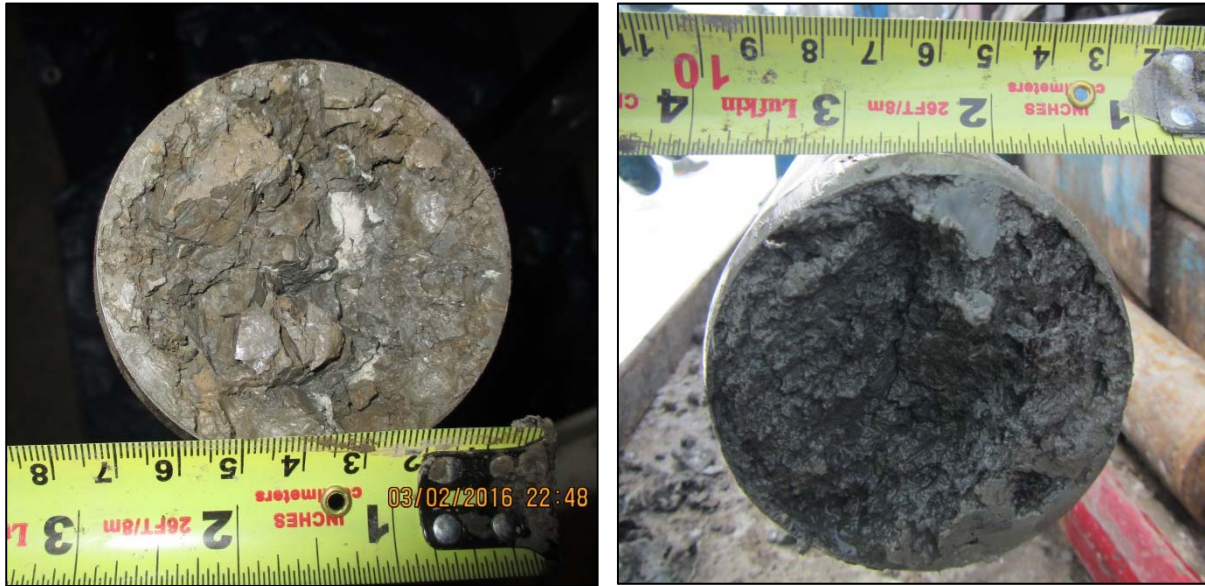
Figure 3-15. Off-shore samples. Fissured clay foundation at Section A-A (left), and soft clay blanket at Section B-B (right).

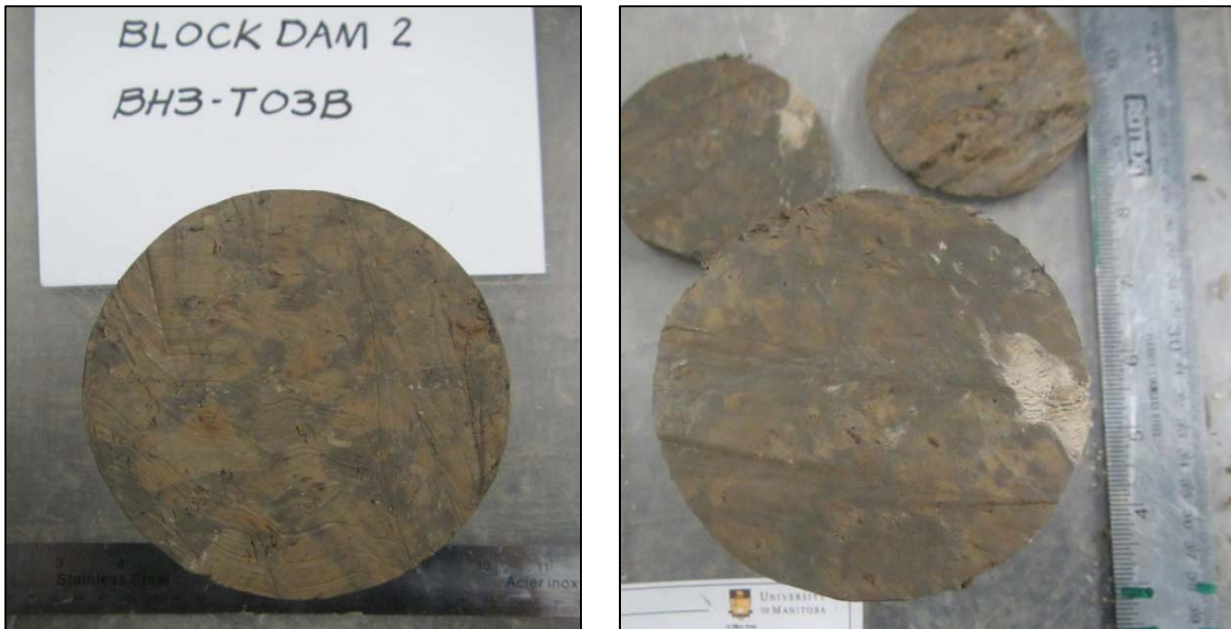
Figure 3-16. Clay core (left) and clay foundation (right) samples.

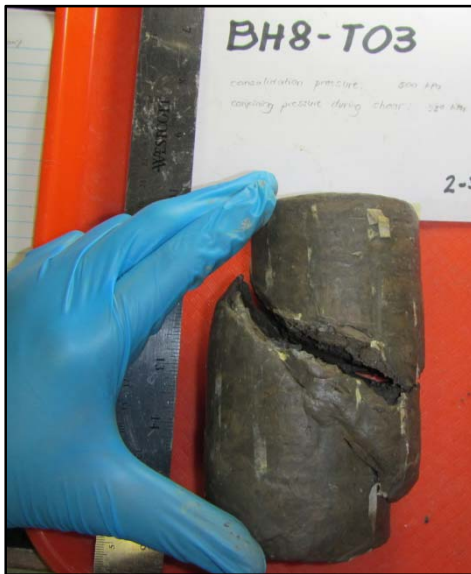
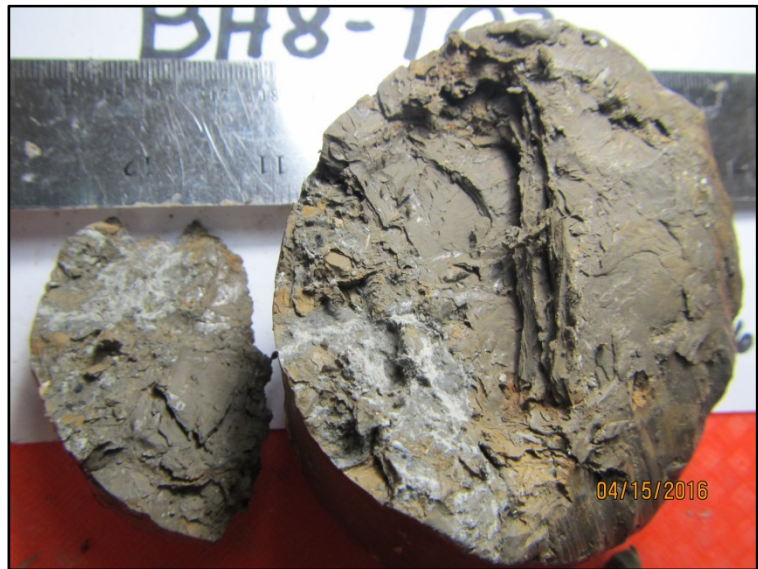
Figure 3-17. Clay core sample breaks easily along horizontal planes with silt lenses.

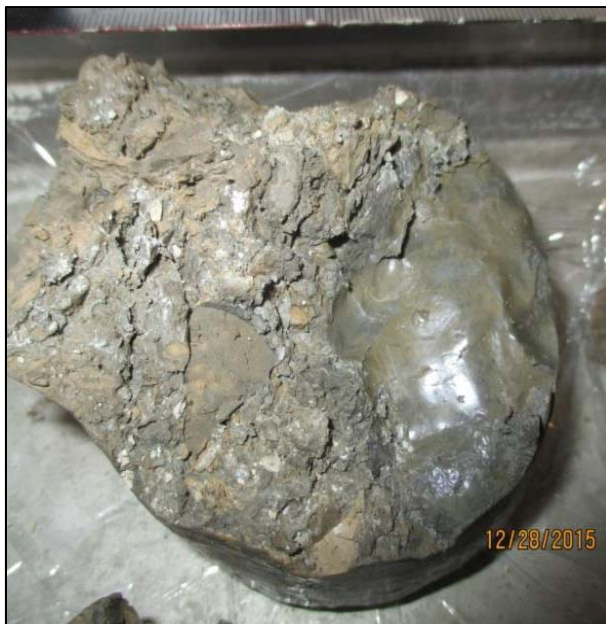
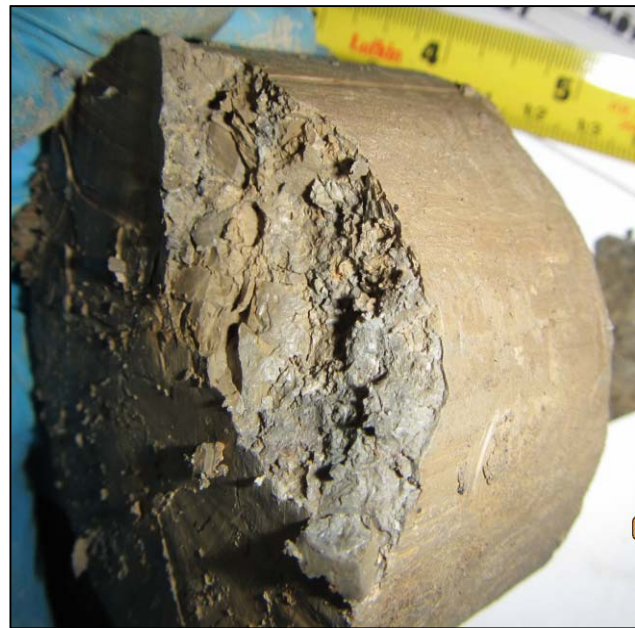
Figure 3-18. Polished fissures from clay core (left) and clay blanket (right) samples.

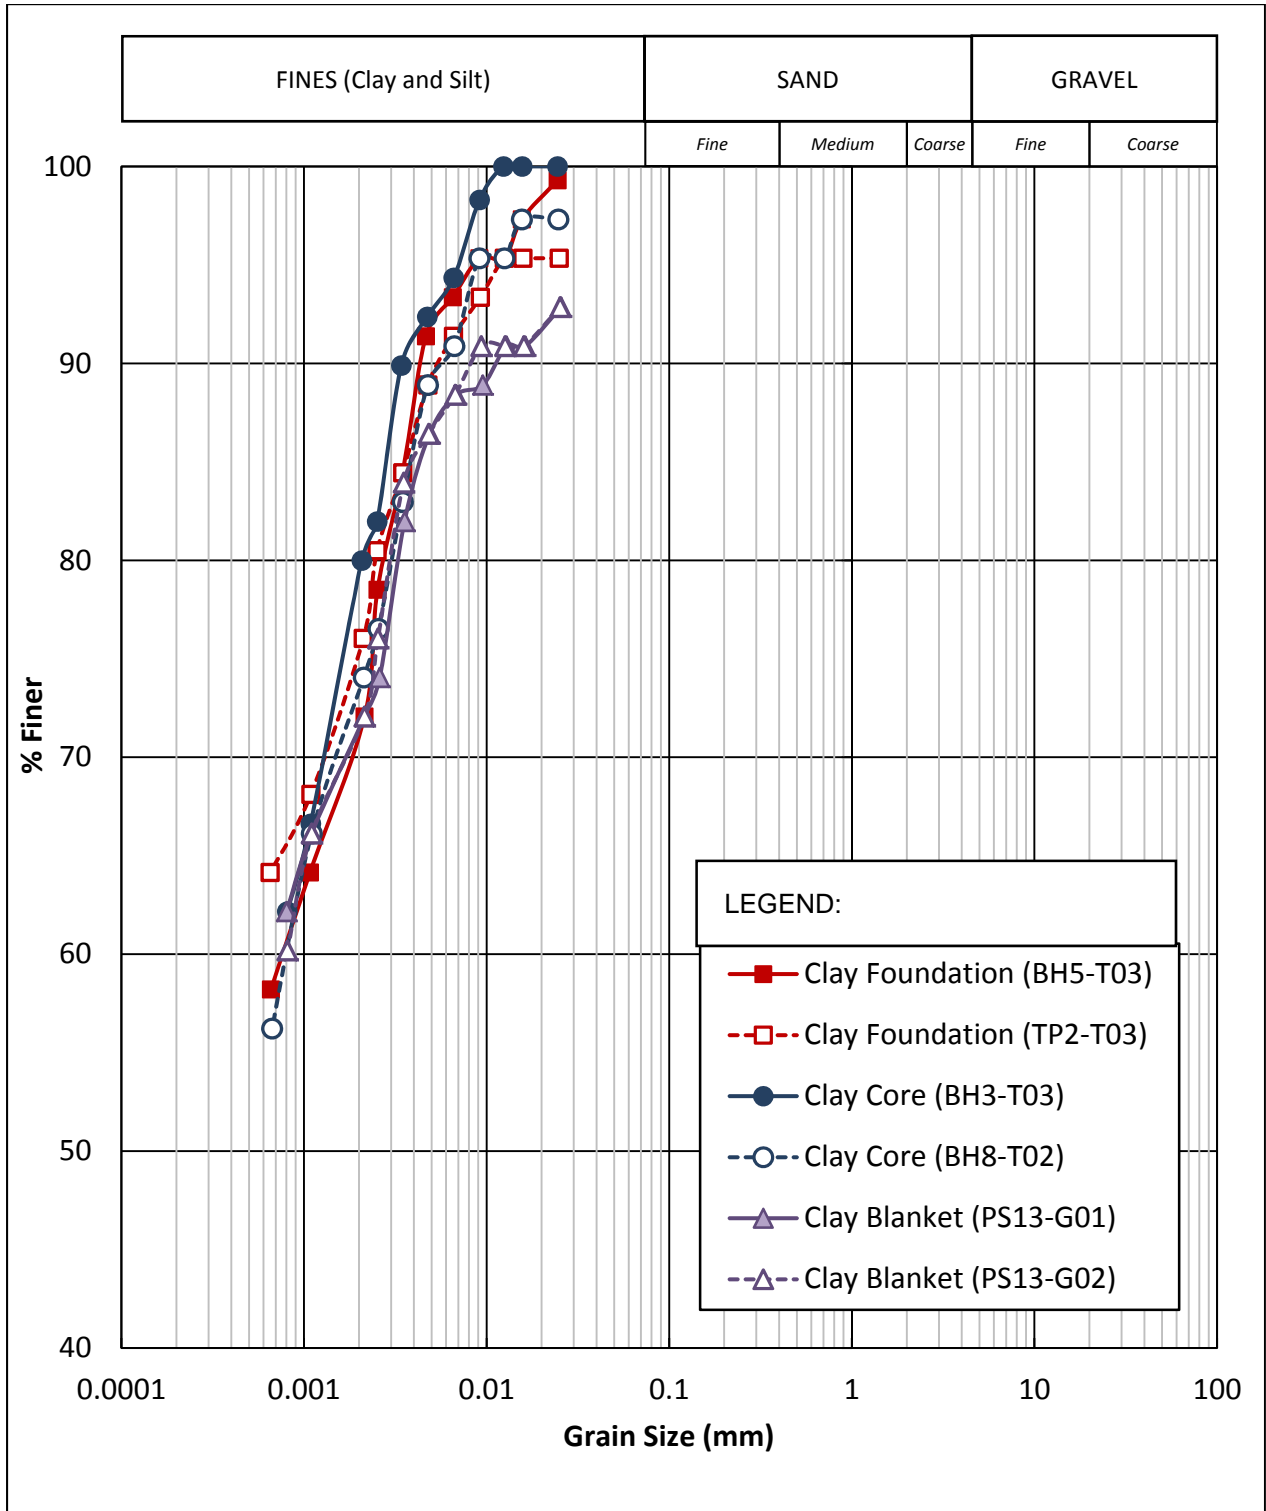
Figure 3-19. Particle size distribution curve.

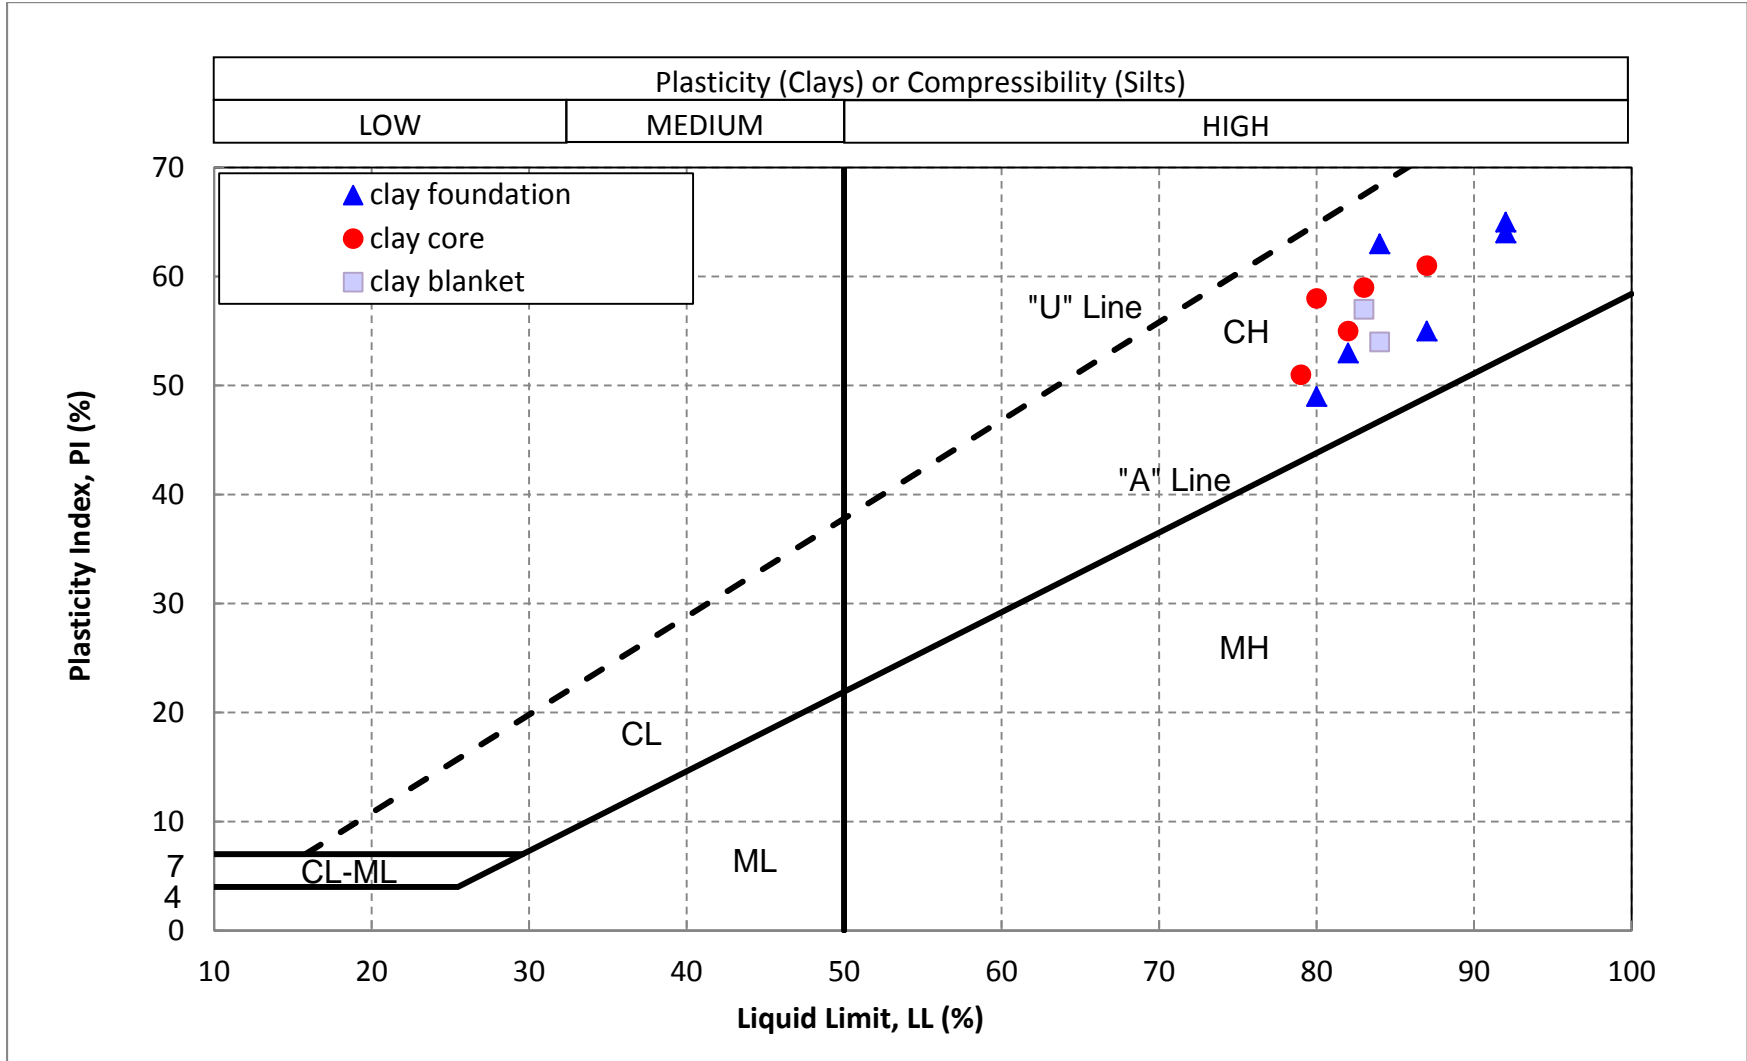
Figure 3-20. Plasticity chart.

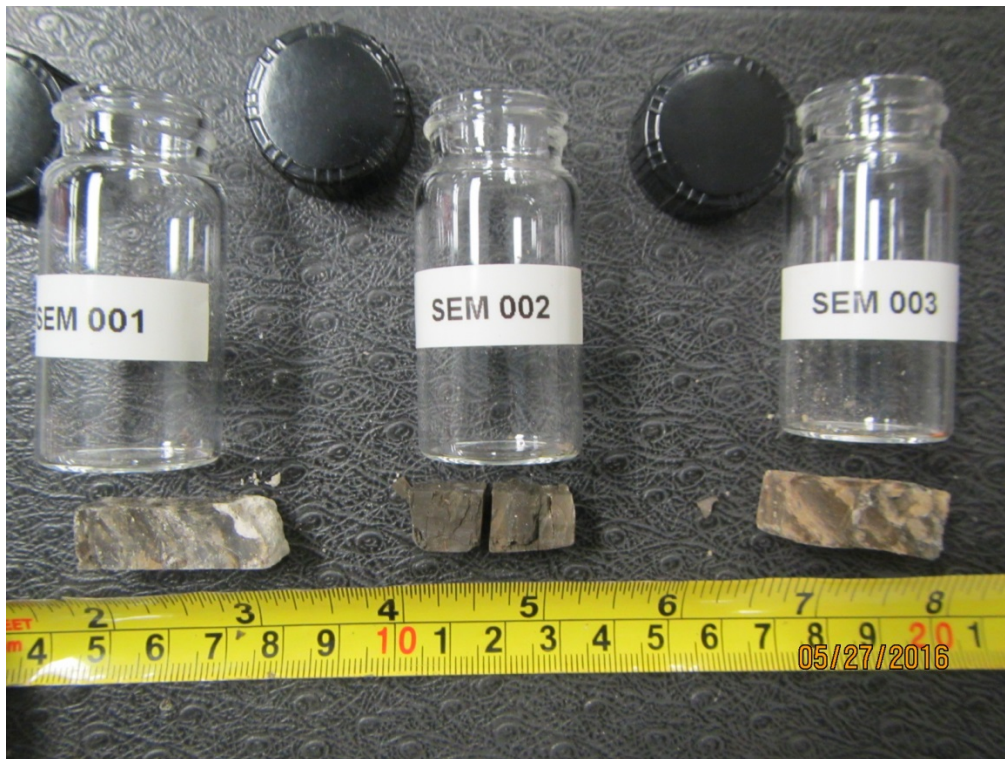
Figure 3-21. 2 cm x 1 cm specimens for SEM testing.

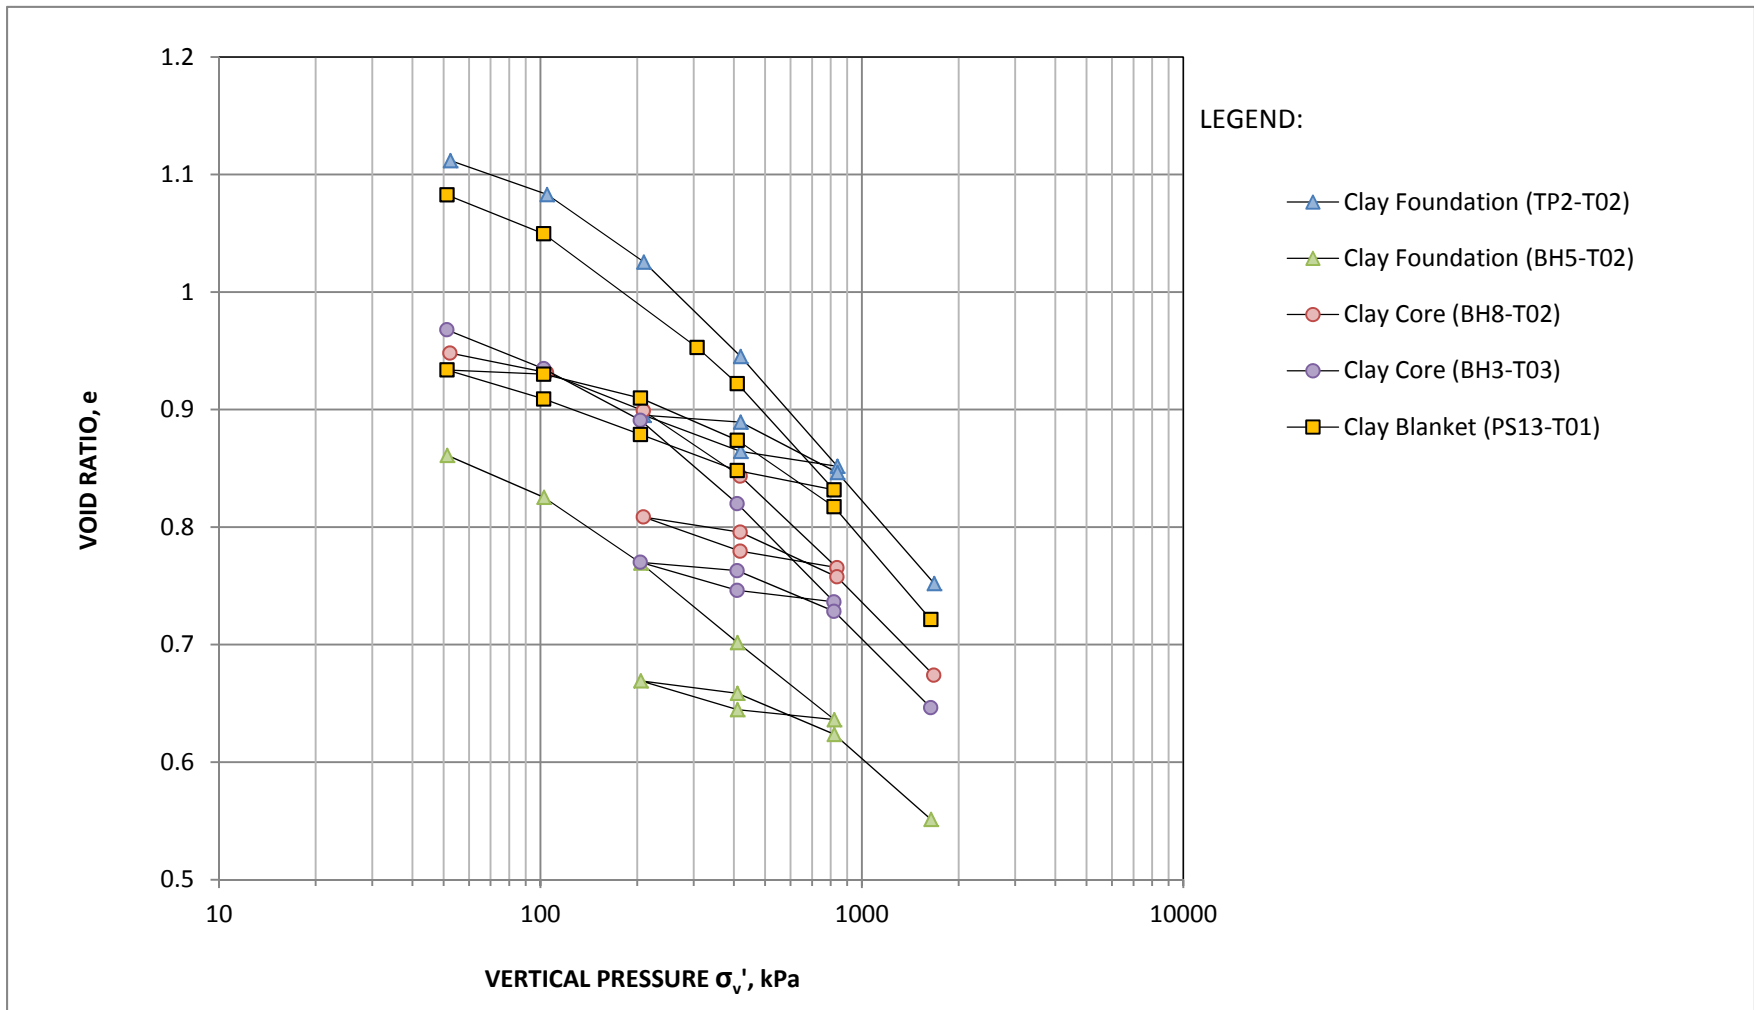
Figure 3-33. 1D consolidation results.

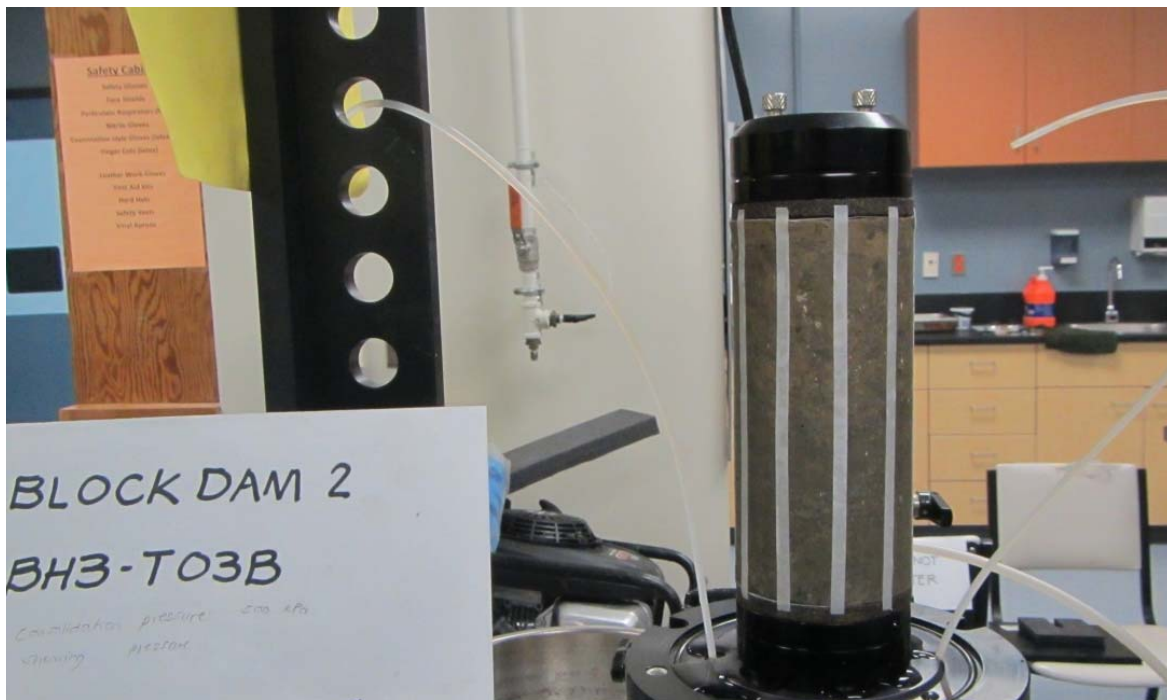
Figure 3-35. 71.12 mm diameter triaxial specimen from clay core.

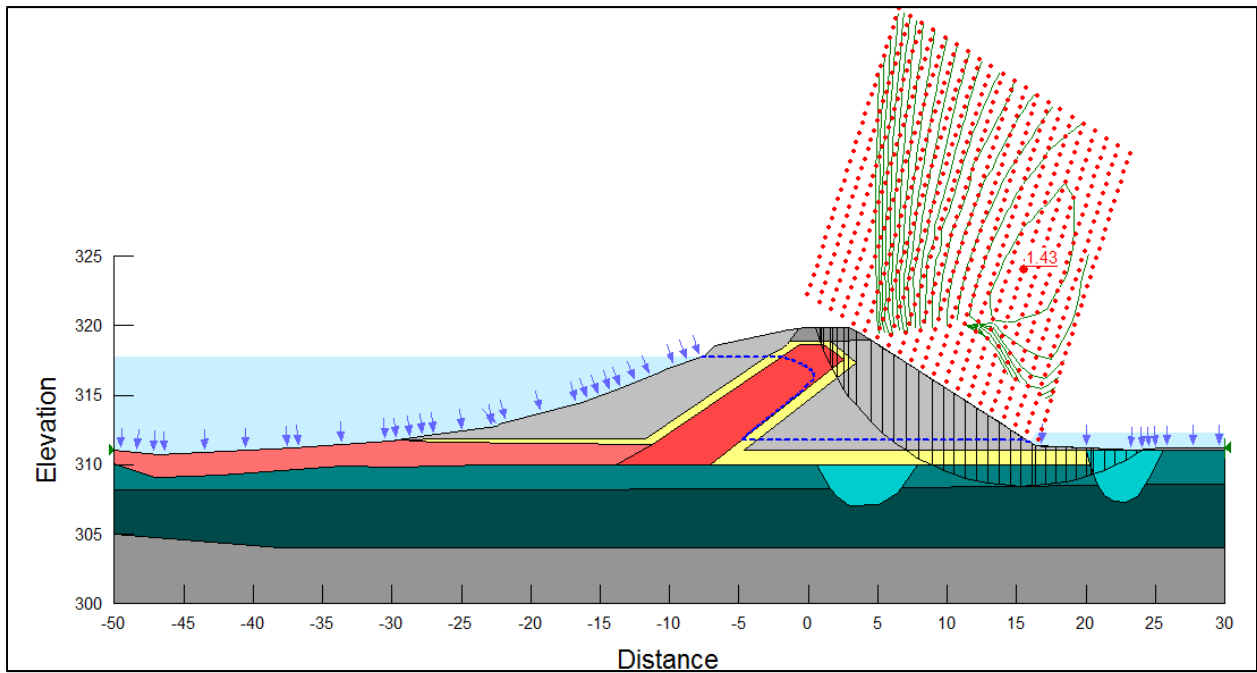
Figure 4-20. Slope-stability analysis of Section B-B downstream slope, Case B.

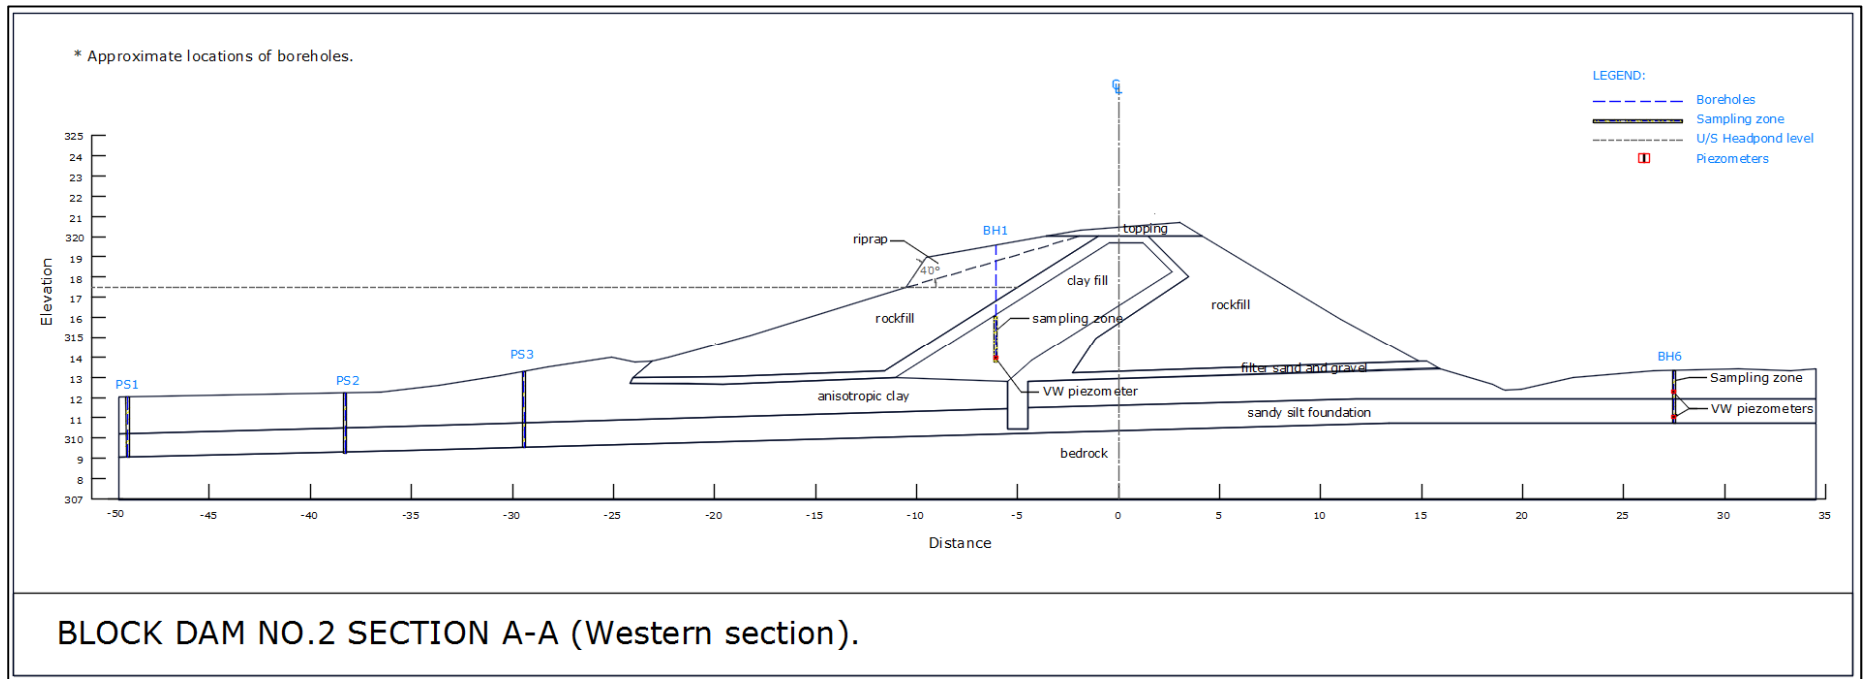
Appendix 3. Section A-A sampling and instrumentation profile.

Section A-A has an inclined clay core protected by a layer of filter material and rockfill on both upstream side (U/S) and downstream side (D/S). Natural clay underlies the western section of the dam, stretching from the U/S side to the D/S side of the embankment. Being the only exposed clay, the natural clay foundation became the focus of previous investigations. A thin layer of sandy silt underlies the natural clay foundation, and overlies the bedrock. Groundwater is observed at approximately 1.5 m below ground surface.
