Behaviour of Concrete Pavements Exposed to De-icing Salts: Field and Laboratory Studies

A Thesis submitted to the Faculty of Graduate Studies of

The University of Manitoba

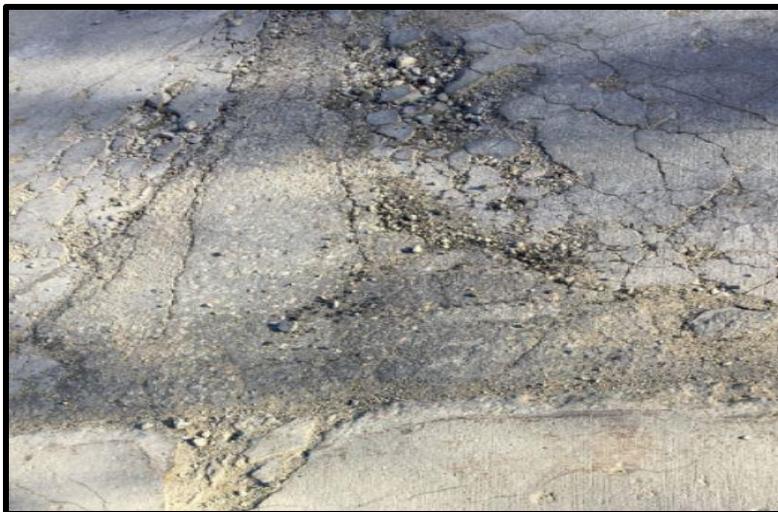
D-cracking is a progressive distress in concrete pavement generally associated with coarse aggregate in concrete pavement. Use of non-frost resisting coarse aggregate propagates D-cracking because of its inability to withstand F/T action. Concrete which is critically saturated by moisture penetration through cracks and joints subjected to repeated F/T exhibit the signs of D-cracking (Schwartz, 1987). Generally, it is found initially at the intersection of longitudinal and transverse joint sections and lately at transverse cracks. The cracking starts at the corner areas and then proceeds along the joints. Moreover, D-cracking generally initiates at the base of the pavement and progresses upward with time (Koubaa and Snyder, 2001). It becomes visible at the pavement surface as a series of small cracks often accompanied by discoloration of the affected portion. D-cracking weakens the concrete and may eventually lead to its disintegration near the joint areas. Figure 2.1 shows the D-cracking problem at a pavement joint.

Figure 2.1: D-cracking of concrete pavement.

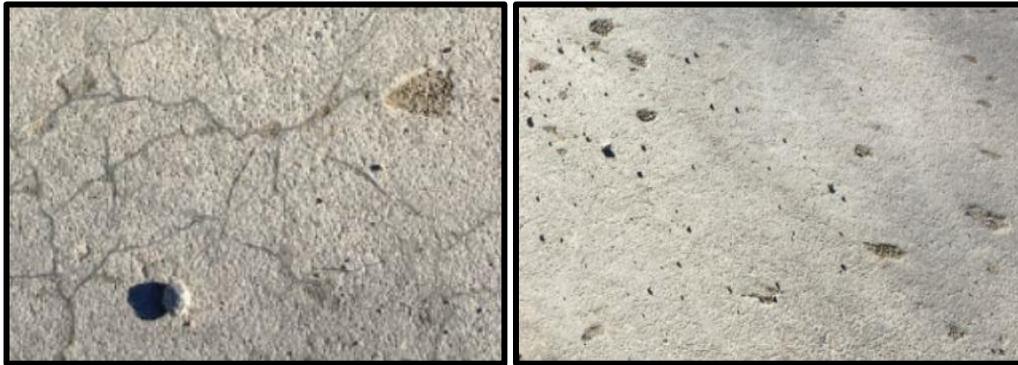
where small parts of concrete break away from the surface of concrete pavement (Bautista and Basheer, 2008). Figure 2.3 represents the pop-out distress of concrete pavement.

Figure 2.3: Pop-out at concrete surface.

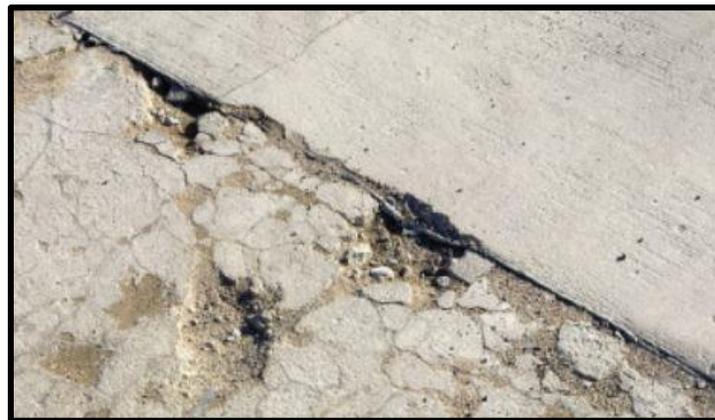
cracked edges. An accelerated slab failure may occur if crack spalling occurs due to the movement of two individual slabs against each other during the events of repeated heavy loading (Bautista and Basheer, 2008). Under traffic load, the micro cracking caused by the improper joint action known as ‘Chattering Action’ may lead to early-age minor spalling (Detwiler et al., 2001). In a joint seal damage, accumulation of incompressible materials such as soil or rocks in the joint allows water to infiltrate inside and prevents the slabs to expand which may result in buckling, spalling or shattering of concrete pavement (Shahin, 2005). Joint spalling in concrete pavement is shown in Figure 2.4

Figure 2.4: Joint Spalling

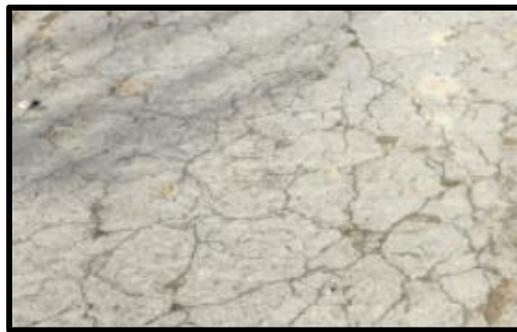
Map crazing or map cracking is the hairline cracks appearing on the surface of a concrete pavement (Figure 2.5). It is a network of shallow depth cracks usually occur by over finishing but can also be induced by the alkali-aggregate reaction. Map cracking can lead to the surface scaling and make concrete vulnerable to more durability issues (Shahin, 2005).

Figure 2.5: Map crazing/ cracking

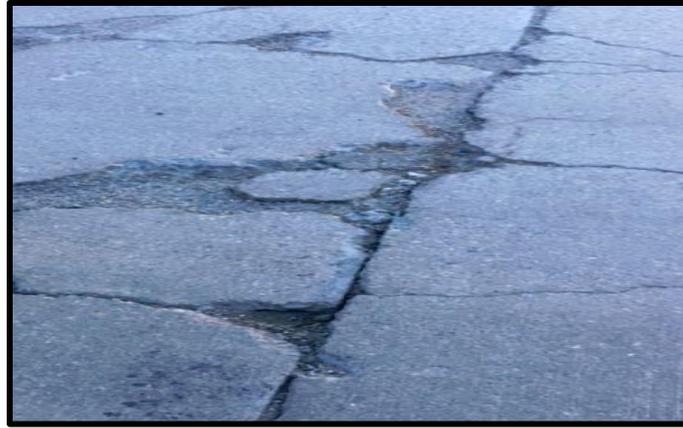
The signs of premature deterioration are not initially visible; however, they are observed after a considerable amount of damage had taken place in the joint areas. The damage may initiate at the bottom and advance towards the top surface resulting in joint spalling, huge mass loss and cracking at and near the joint areas. Previous in-situ evaluation (Jones et al., 2013) of the affected pavement areas (joints) revealed that in many cases, the joints continued to hold water (solution) long after the wetting event (Figure 2.7). Micro-cracks, close to the joints, are saturated with trapped water, thus shadowing may often appear. Where shadowing is observed, the system is not well drained and subsequently the joint exhibits significant loss of material. Furthermore, it has been observed that where the joints were damaged, generally the sealant had failed and a 'Bulb' shaped damaged zones were spotted underneath the sealed joints in some cases (Arribas-Colón et al., 2012).

Figure 2.7: Joint deterioration of concrete pavement

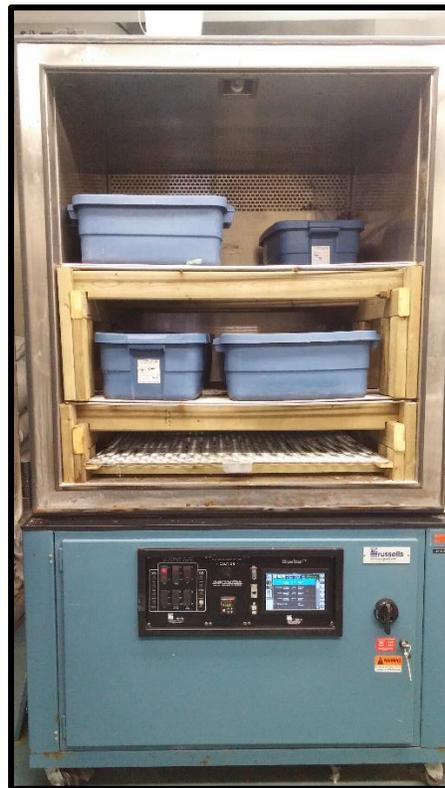
before exposing to the F/T condition. The duration of one F/T cycles was 12 hours: freezing at $-18\pm 1^{\circ}\text{C}$ for 7 h and thawing at $4\pm 1^{\circ}\text{C}$ for 3.5 h, and 45 min. to ramp to the minimum freezing temperature or the maximum thawing temperature. Every two weeks, the samples were brought outside of the environmental chamber for visual observation and to measure the mass and length change along with the change in relative dynamic modulus of elasticity (RE_d) of the concrete specimens. When any specimen showed considerable surface damage or reduction in RE_d value of more than 80% of the initial value, then the exposure regime was terminated for the specimen and samples were reserved for microstructural analysis.

Figure 3.2: Environmental chamber used for F/T exposure.

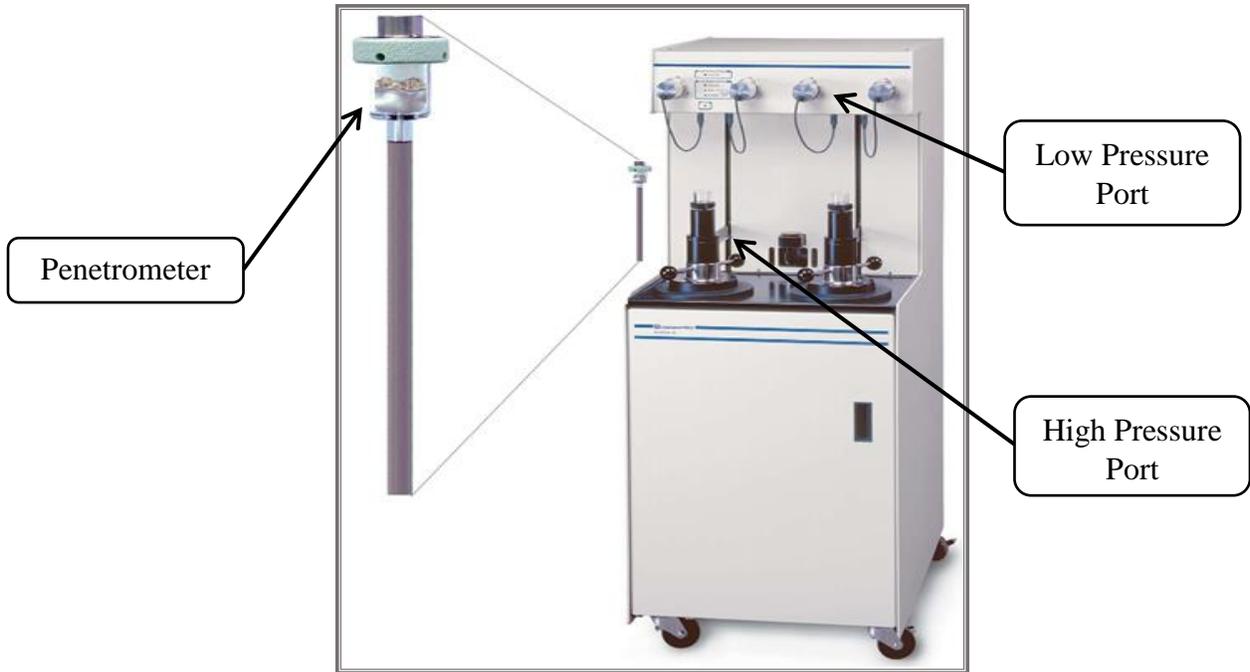
occur at higher drying temperatures. The contact angle and the surface tension of mercury were taken as 130° and 485 dynes/cm, respectively.

Figure 3.4: MIP apparatus.

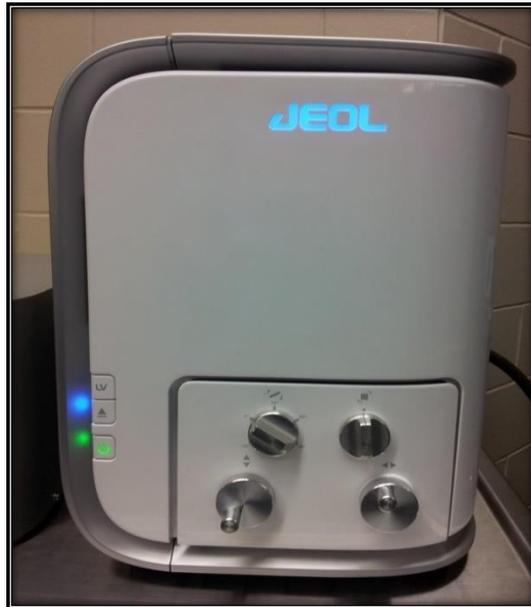
be examined by scanning electron microscopy (SEM) assisted with energy-dispersive X-ray analysis (EDX). A visual representation of the used SEM sample chamber is shown in Fig. 3.5. The samples were coated with a fine layer of carbon before performing the analysis to make the surface conductive and to improve the sample imaging. To complement the analysis of the SEM, the reaction products within the cementitious matrix, were analyzed by X-ray diffraction (XRD, Cu-K α) on powder samples collected from the surface (0-20 mm from the exposed surface) of selected specimens. The XRD device is presented in Fig. 3.6. This powder was prepared from carefully extracted fracture pieces (not including large coarse aggregate) of specimens, which were pulverized to fine powder passing through sieve #200 (75 μ m). Samples were collected from the deteriorated concrete specimens and pulverized to fine powder to detect the formation of sulfate-bearing products in cementitious matrix. For XRD, scan speed of 2°/min and sampling interval of 0.01° 2 θ was used for all the samples. Furthermore, the samples were heated up to 500°C with a ramp temperature of 5°C/min in the DSC tests (Fig. 3.7).

Figure 3.5: SEM sample chamber where the fracture pieces were mounted

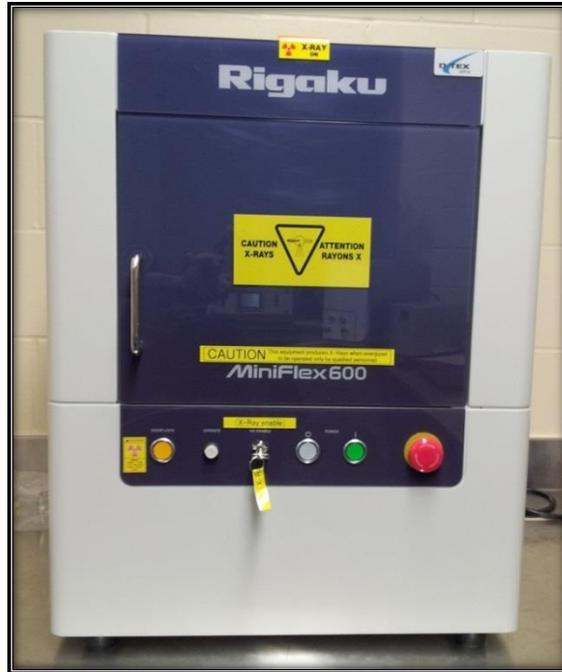
Figure 3.6: XRD instrument where the powder samples were mounted

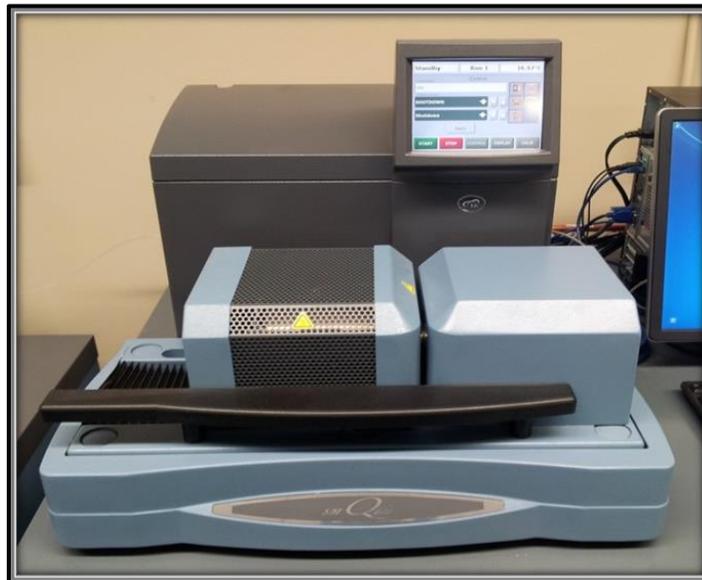
Figure 3.7: DSC instrument where the powder samples were mounted.

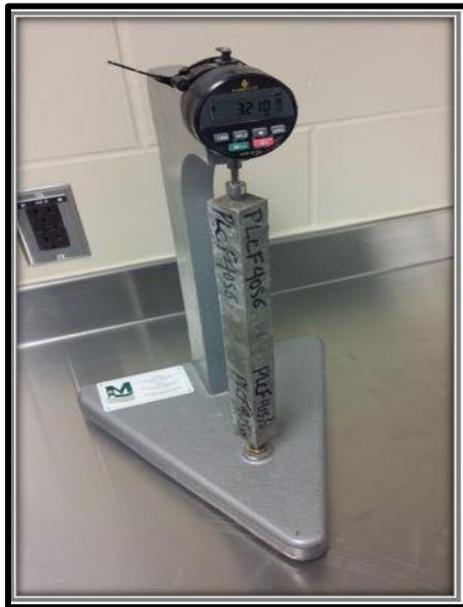
expansion. Fig. 3.8 shows the comparative length change apparatus. In case of mass change, the initial mass value was used to calculate the mass change versus time of exposure for concrete specimens exposed to different de-icing salt solutions. The internal damage (development of micro-cracks) of concrete prisms exposed to continued freezing and thawing conditions, was evaluated by the comparison of dynamic modulus of elasticity. According to ASTM C215 (Year; Standard Test Method for Fundamental Transverse, Longitudinal, and Torsional Resonant Frequencies of Concrete Specimens) the dynamic modulus of elasticity of all the specimens was recorded and RE_d (change in dynamic modulus of elasticity over time) was determined. The test setup for the dynamic modulus of elasticity measurement is shown in Fig. 3.9. To detect the mechanism of failure and difference in reaction products, concrete specimens were studied by microscopy, thermal and mineralogical analyses. The SEM and XRD were conducted according to the procedure described in section 3.4.2.

Figure 3.8: Length comparator utilized for determining the change in length of concrete prisms.

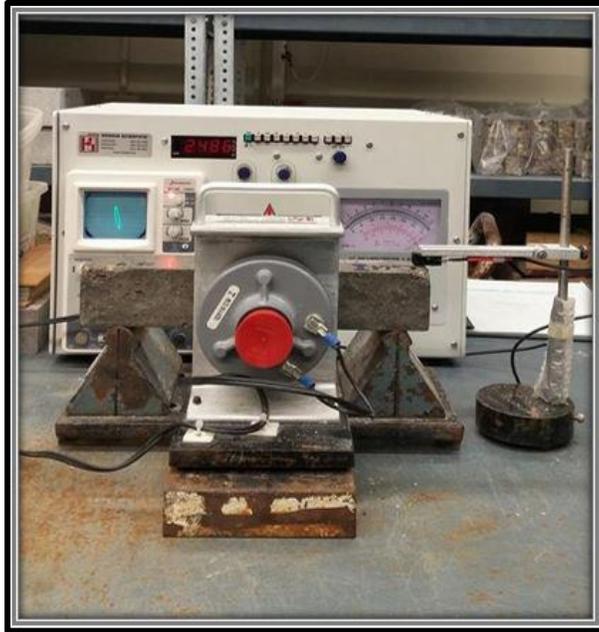
Figure 3.9: Sonometer apparatus used to determine the dynamic modulus of elasticity

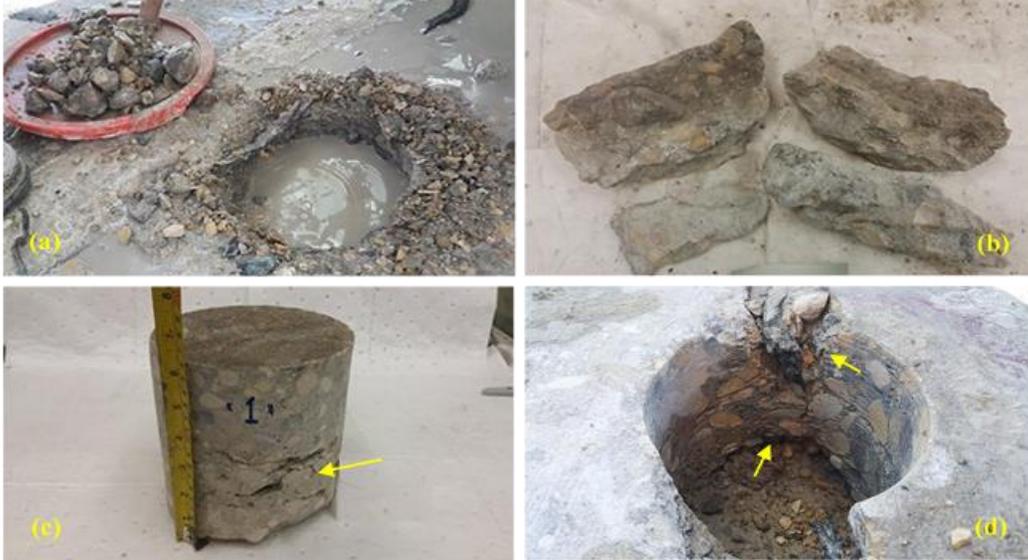
In many cases, the damage to the joints was extensive and the concrete crumbled during the coring process (Fig. 4.2a); therefore, it was not possible to obtain full cores in these locations, where they ended up into several pieces, as for example shown in Fig. 4.2b. Parallel cracks were also a common damage feature of concrete cores in these locations (e.g. Fig. 4.2c), and the damage was generally found in both top and bottom parts (Fig. 4.2d).

Figure 4.2: An example from regional roads showing: (a) damage of concrete during the coring process, (b) fractured cores, (c) sub-parallel cracks in the extracted cores, and (d) damage of top and bottom parts.

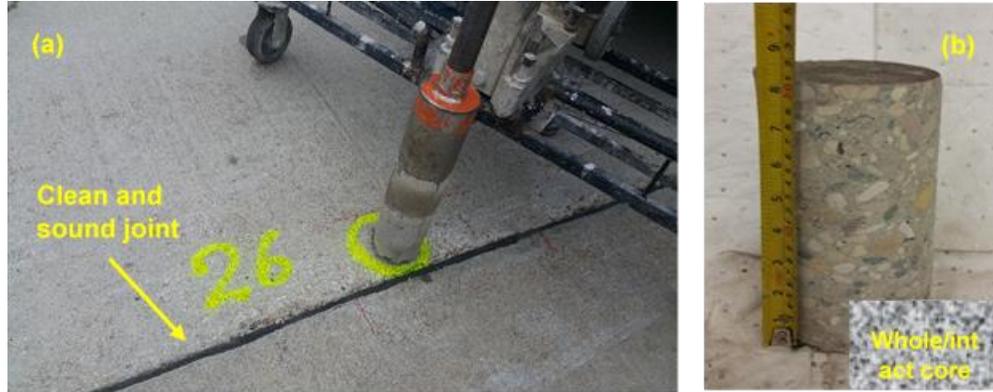
In comparison to the regional roads, the residential streets were in excellent conditions, except that the concrete surface occasionally exhibited surface scaling and pop-outs in the parking lane. Most of the joints were clean and sound, and there was no evidence of faulting or spalling (e.g. Figs. 4.3a). The pavement cross slop and drainage system appeared to be effective as water continued draining after wet events as adequately as designed. During coring, it was observed that core holes drained well compared with core holes of regional roads. Also, the cores extracted at and near joints appeared sound and intact; they were cleanly and fully drilled with excellent conditions (e.g. Fig. 4.3b).

Figure 4.3: An example from a residential street showing: (a) sound joint without evidence of faulting or spalling, and (b) whole/intact core.

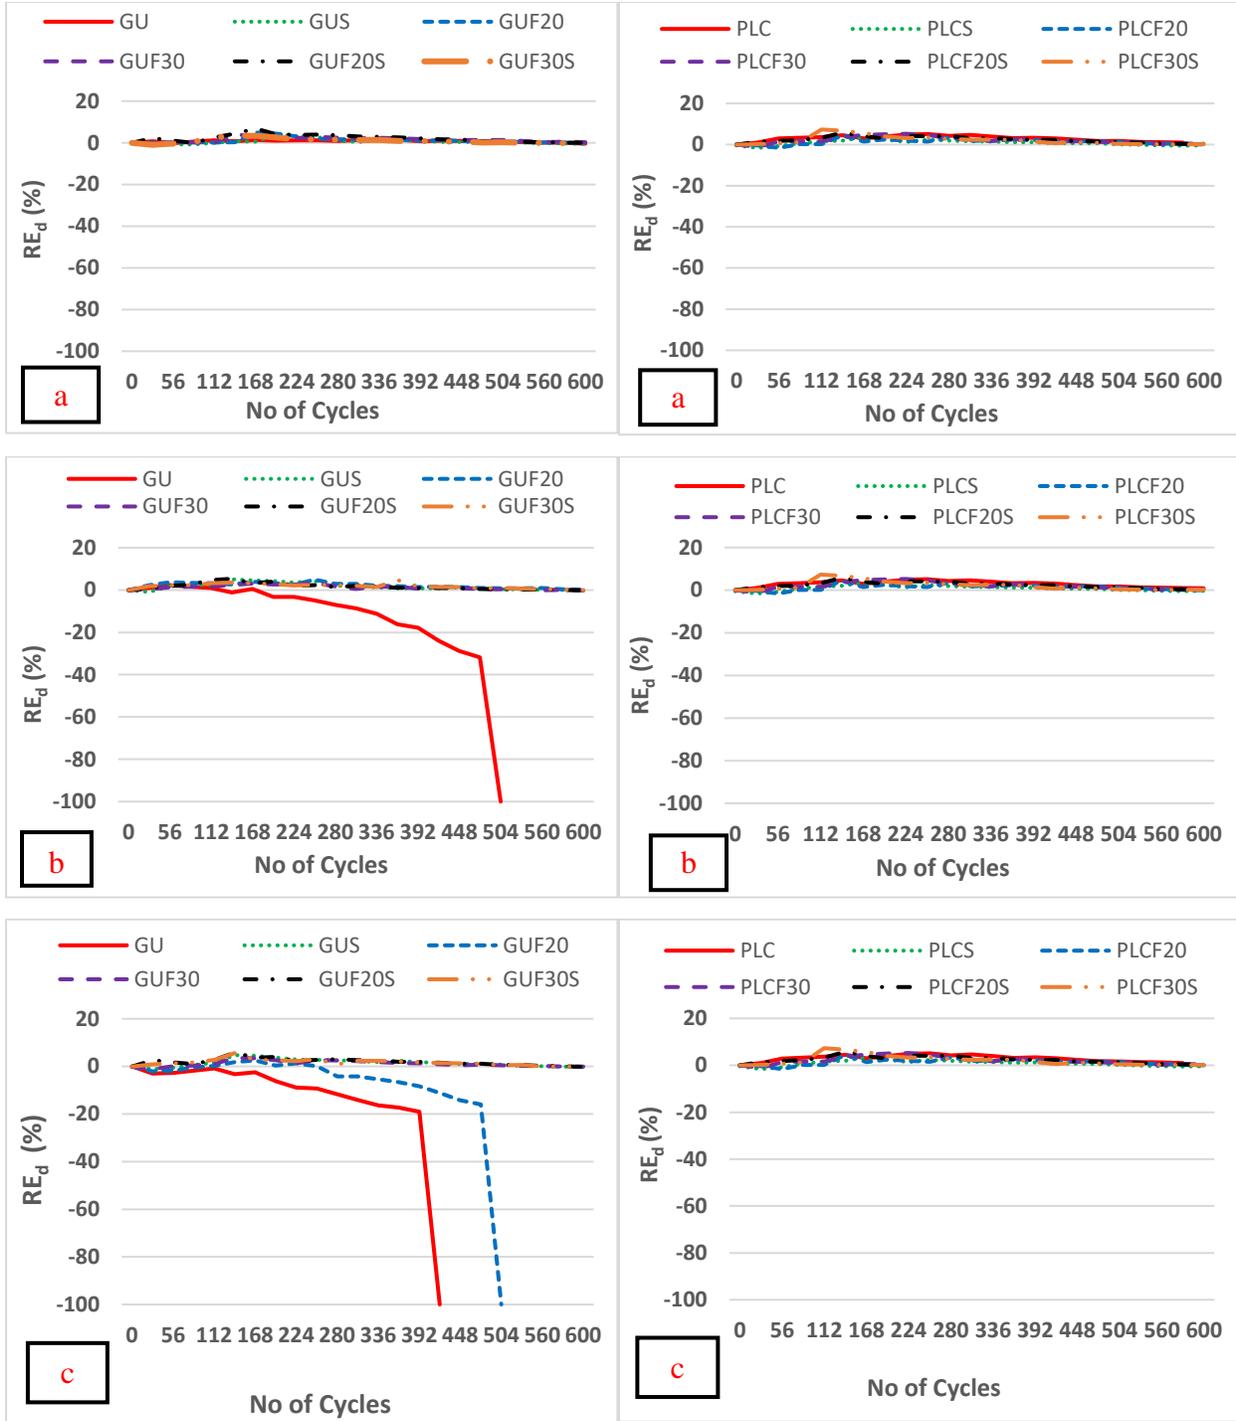
Figure 5.10: RE_d vs. the time of F/T exposure for GU (left) and PLC (right) group specimens exposed to: (a) NaCl, (b) MgCl₂ and (c) CaCl₂ salt solutions.
