Relationship between Textile Irregularities and Pre-Mature Rupture of Polyester Vascular Graft Knitted Fabric

A Thesis submitted to the Faculty of Graduate Studies of

Department of Biosystems Engineering

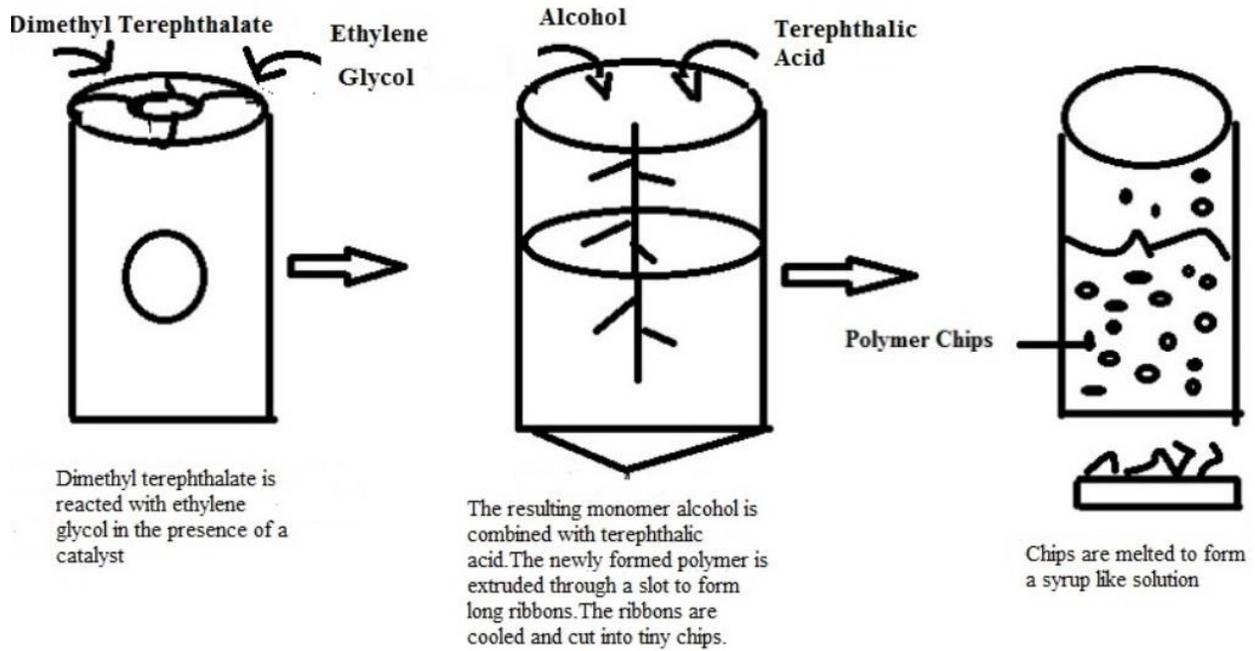
Figure 1.3. Melt spinning procedures – reaction and polymerization bath.

Polyester is produced through melt spinning which is the most economical fibre forming process. Polymer pellets are fed into one end of the extruder. With the help of screws, the pellets are carried into a barrel where heat and shear are applied to soften the polymer. The screw helps to deliver the molten polymer to a spinneret, which has up to 1000 'shaped holes' that create the fibre cross-section, as high pressure forces the molten polymer through the shaped holes, whereupon the extrudate is stretched and solidified. Molecular orientation is achieved by taking up the fibre as much as 100 times faster than it is extruded (Warner, 1995). The fibres are then solidified by cooling with flowing air and subsequently drawn or stretched to further increase the molecular alignment in the axial direction (*Figures 1.3 and 1.4*). During the spinning process, various chemicals can be added depending on the end uses (flame retardant, antistatic, dye ability) of the fibres.

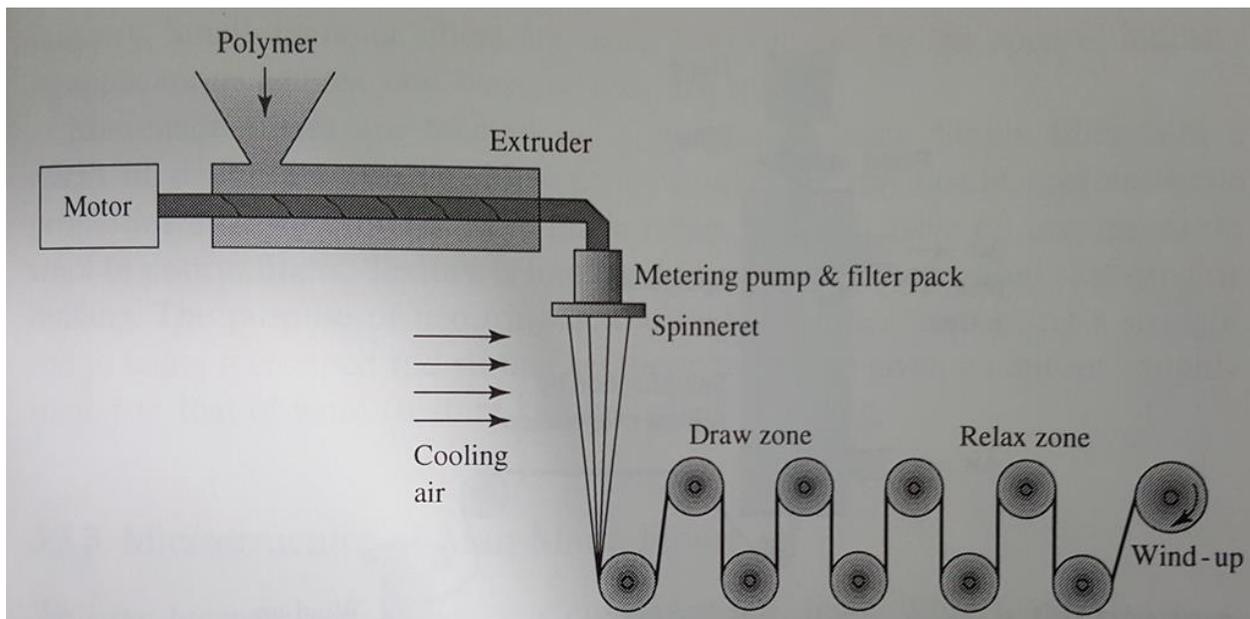
Figure 1.4. Melt spinning procedure - Schematic diagram of filament formation (Warner, 1995).

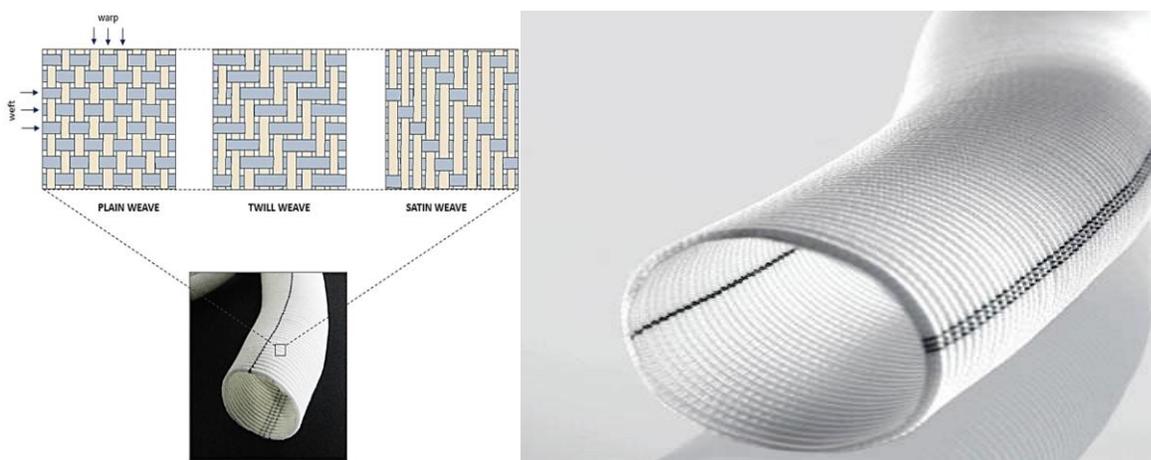
Figure 1.5. Polyester vascular prosthesis woven graft (Singh, Wong, & Wang, 2015).
[Used with permission]

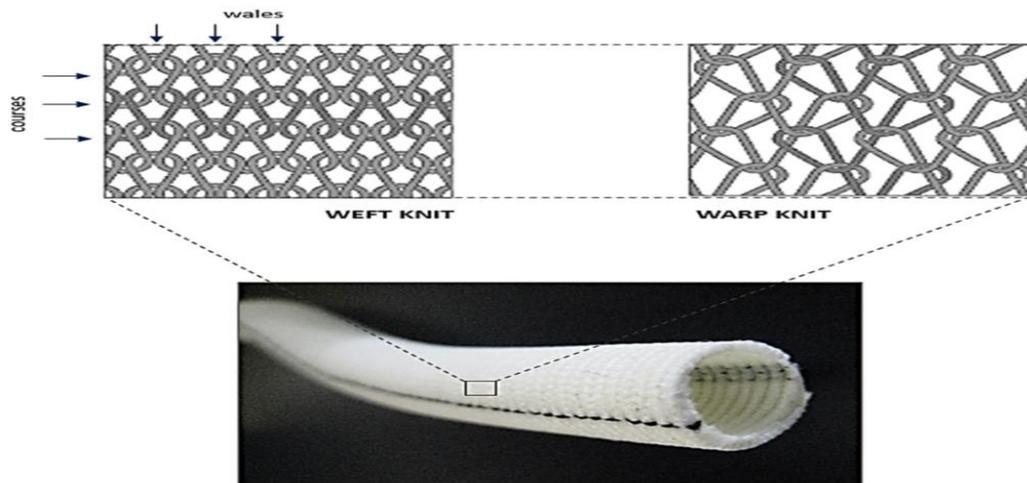
Figure 1.6. Polyester vascular prosthesis knitted graft (Singh, Wong, & Wang, 2015).
[Used with permission]

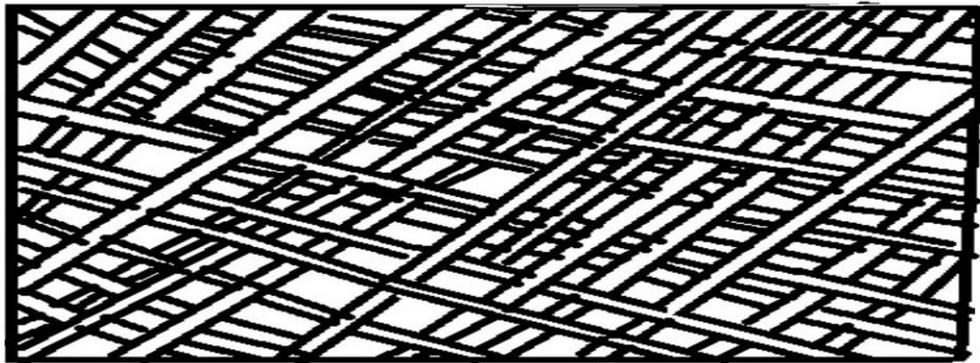
Figure 1.7. Extruded (non-woven) vascular graft.

For the manufacture of a non-woven graft, biocompatible polymeric materials are extruded through an orifice in the presence of electrostatic charges, producing elongated non-woven or extruded grafts. Electrostatic charges help to gather all the broken fibres during spinning and create sufficient interfibre bonding and expected pore sizes (*Figure 1.7*). The details of fibre spinning for non-woven vascular grafts are given elsewhere (O'Mahony, 2011).

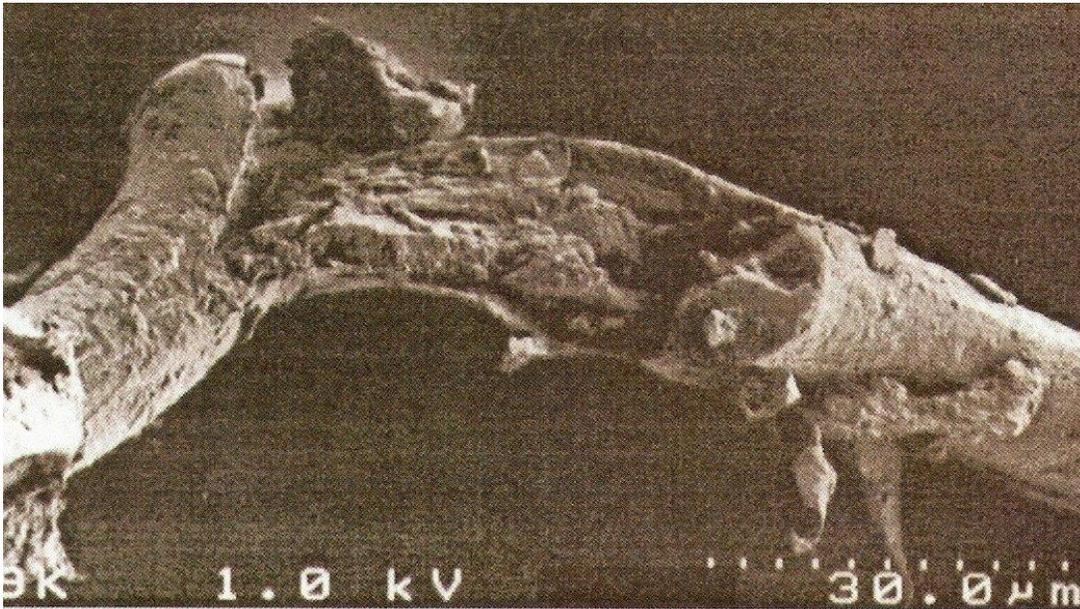
Figure 1.8. A 13-Year-Old PET Vascular Graft Showing a Fracture in the Centre and the Relatively Smooth Surface of the Filament on the Right Side (Riepe et al., 1997, p.544).
[Used with permission]

vessel (thrombectomy) and flexion (bending) with body movements after implantation has significant effects on the deformation of polyester grafts. Examples of ruptured polyester filaments are shown in *Figures 1.8 - 1.10*.

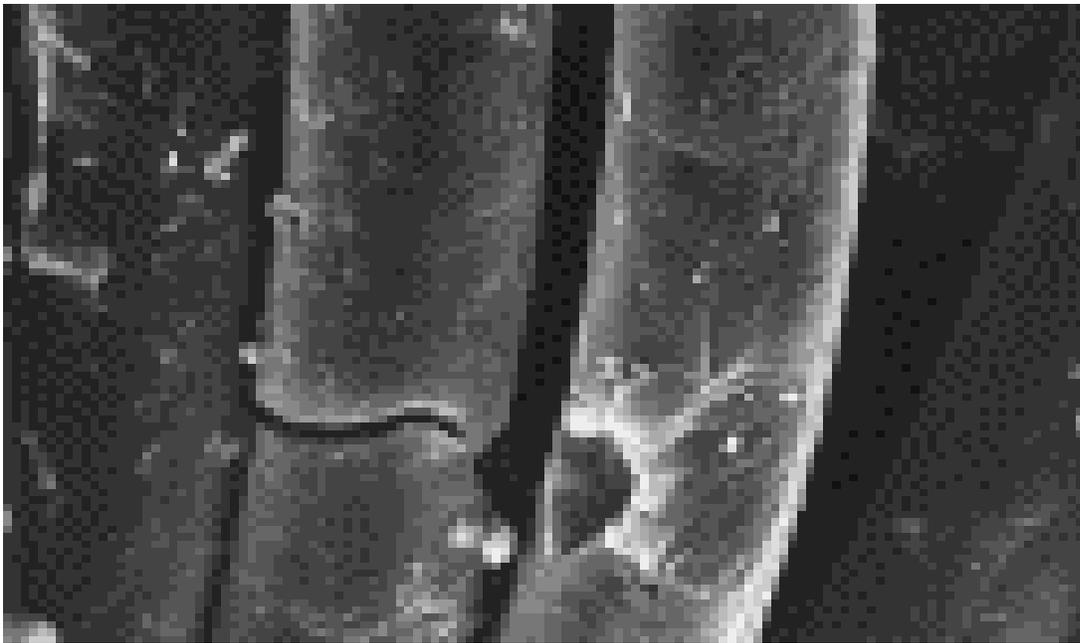
Figure 1.9. Cracks and holes in the explanted graft (Rahman, 2012, p.111).
[Used with permission]

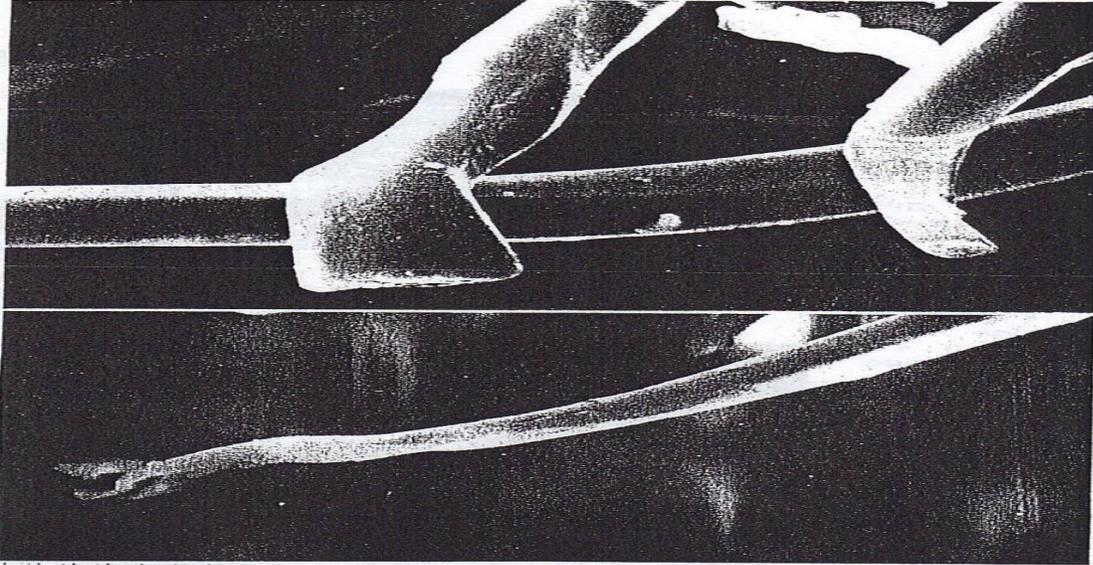
Figure 1.10. Broken, abruptly ruptured thinned out polyester filament. (Rahman, 2012, p.111).
[Used with permission]

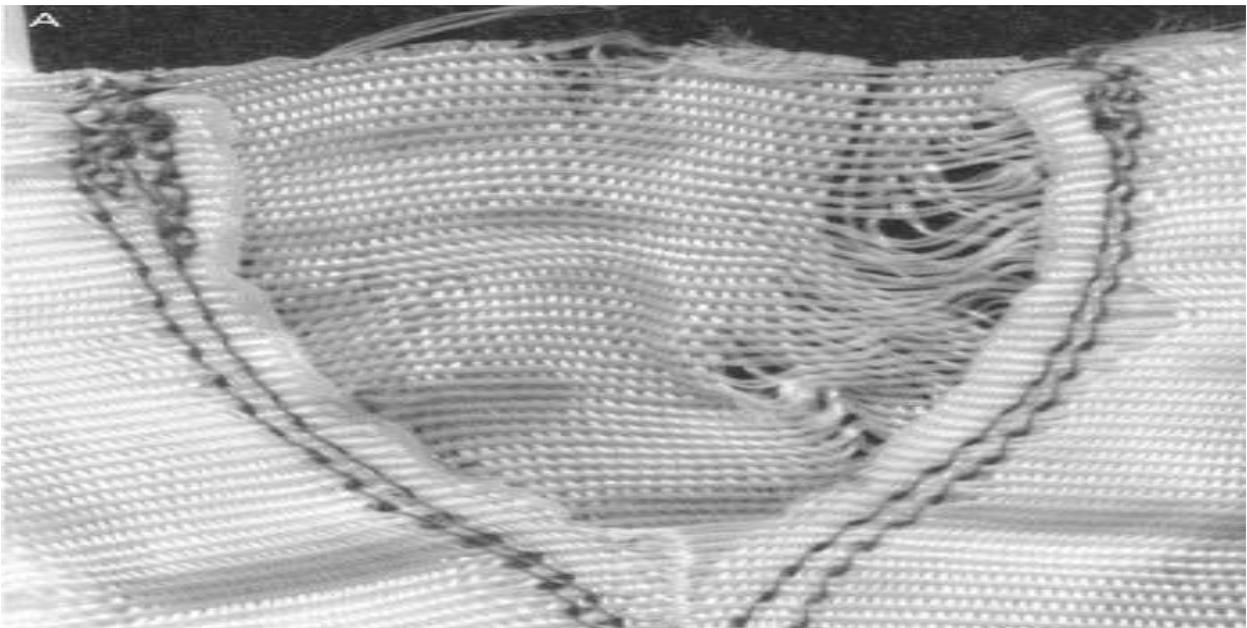
Figure 1.11. Macroscopic view of shifting of warp yarns at the level of suture in woven stentor endoprotheses (Chakfe et al., 2004, p. 36).
[Used with permission]

Finally, both *in vivo* and *in vitro* studies on different causes of premature rupture of polyester grafts were studied. However, the role of tears and holes on the graft strength of the explanted woven and knitted polyester grafts as shown in *Figures 1.11-1.23* has not been studied.

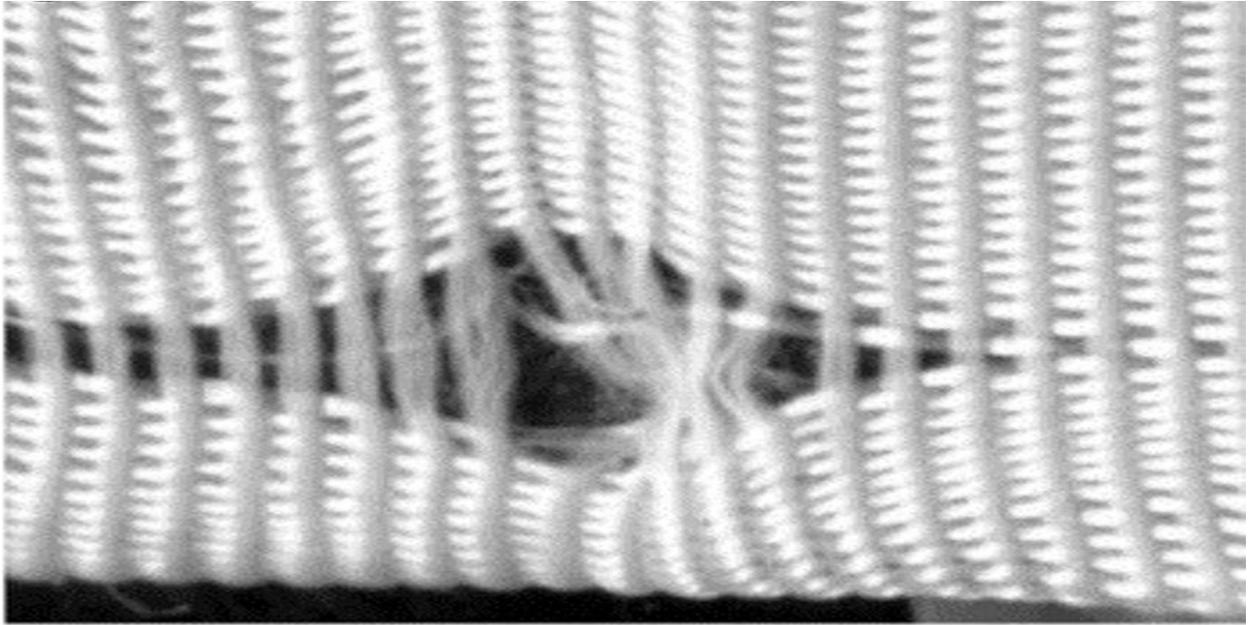
Figure 1.12. Macroscopic view of shifting of warp yarns in woven stent endoprosthesis, probably related to the protrusion of a stent (Chakfe et al., 2004, p. 36).
[Used with permission]

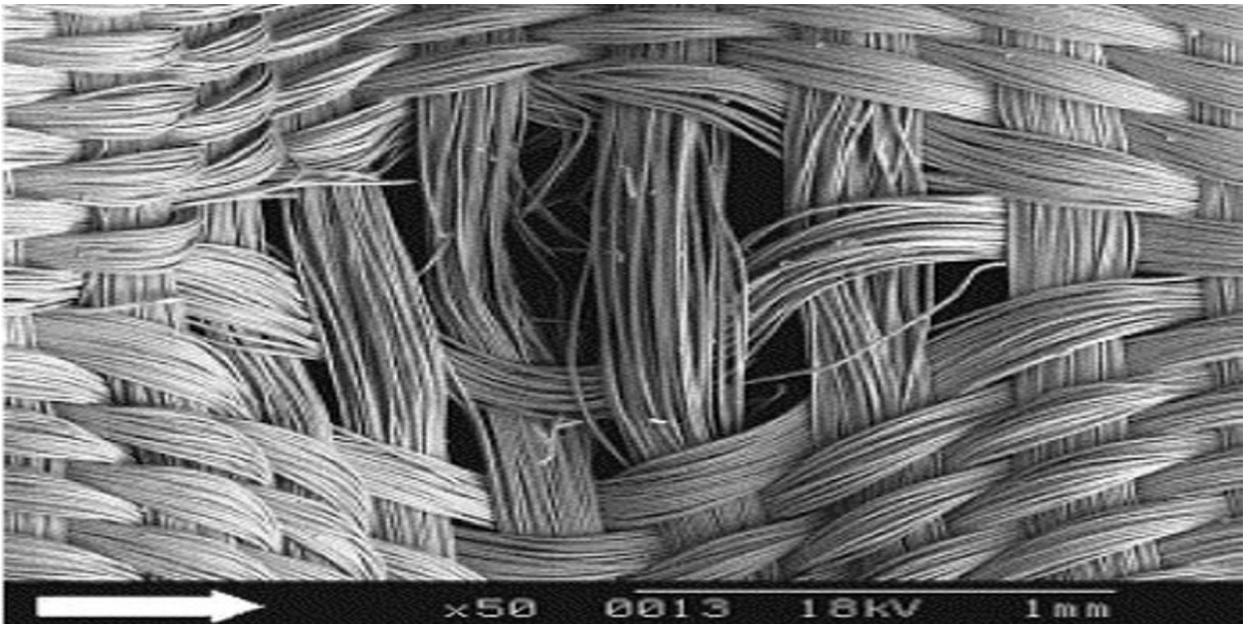
Figure 1.13. SEM Image (Original Magnification: x 50): No major lesion of the filaments at the level of a shifting of the warp yarns in woven structure (Chakfe et al., 2004, p. 36).
[Used with permission]

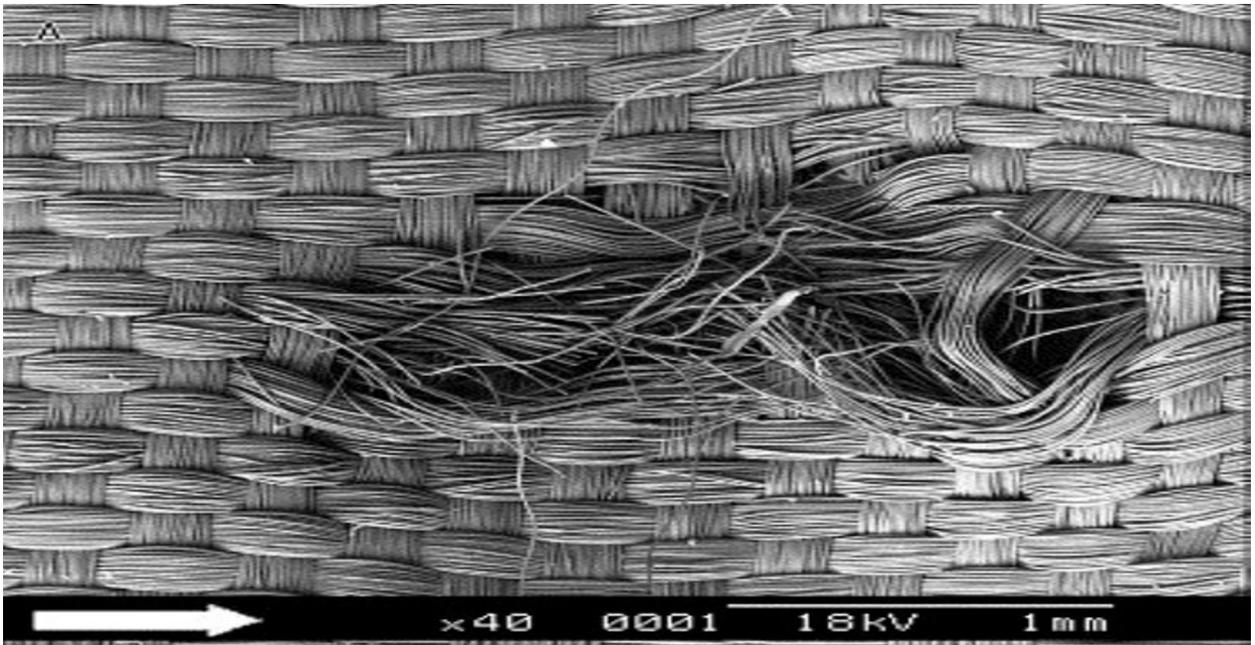
Figure 1.14. SEM image (original magnification: x 40) of the ruptures of filaments on the crinkled warp yarns on the external side of the textile in Vanguard Endoprosthesis (arrow: warp direction) (Chakfe et al., 2004, p. 37).
[Used with permission]

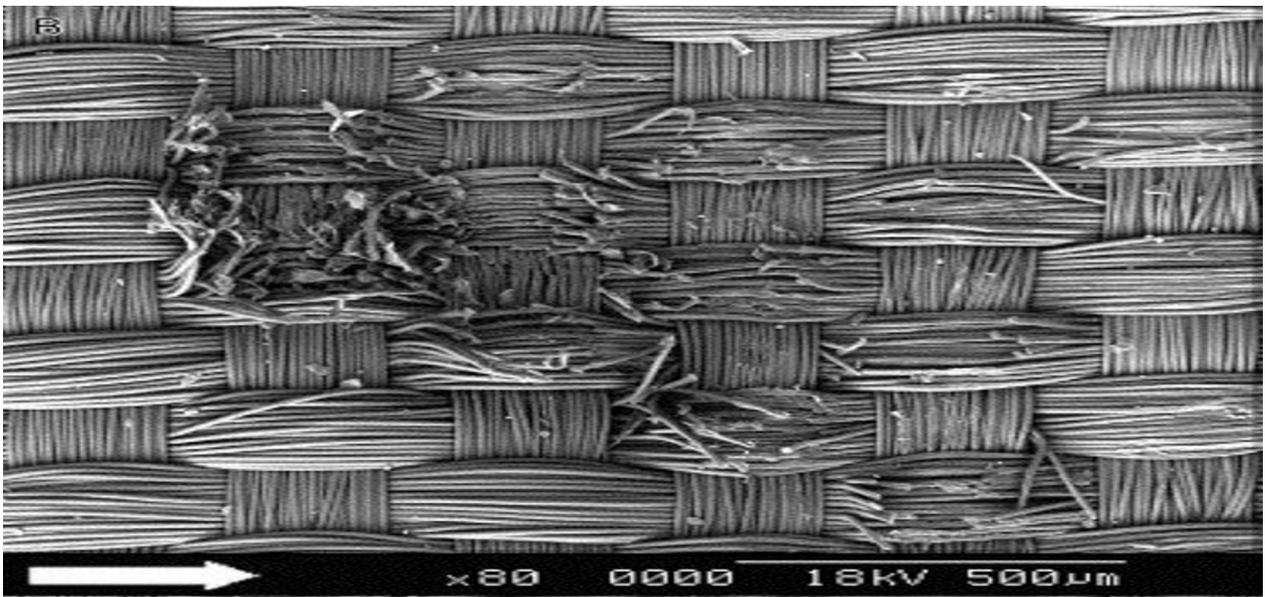
Figure 1.15. SEM image (original magnification: x 80) of the ruptures of filaments on the crinkled warp yarns on the external side of the textile in Vanguard Endoprosthesis (Chakfe et al., 2004, p. 37).
[Used with permission]

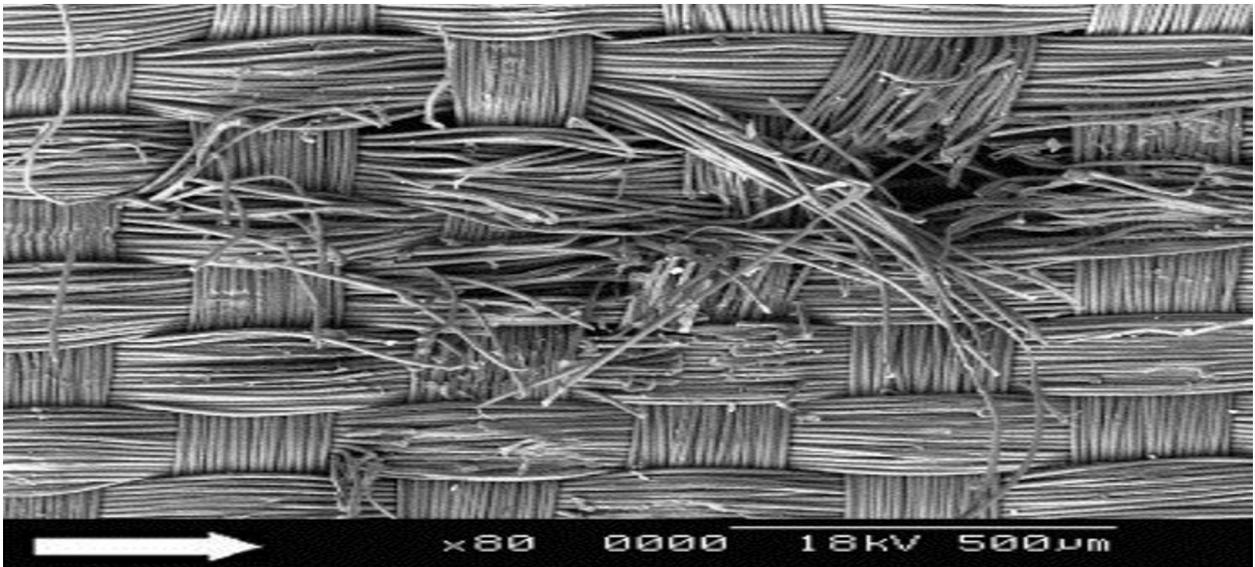
Figure 1.16. SEM Image (Original Magnification: x 80): of the ruptures of filaments on the crinkled warp yarns on the external side of the textile in Vanguard Endoprosthesis (arrow: warp direction) (Chakfe et al., 2004, p. 37).
[Used with permission]

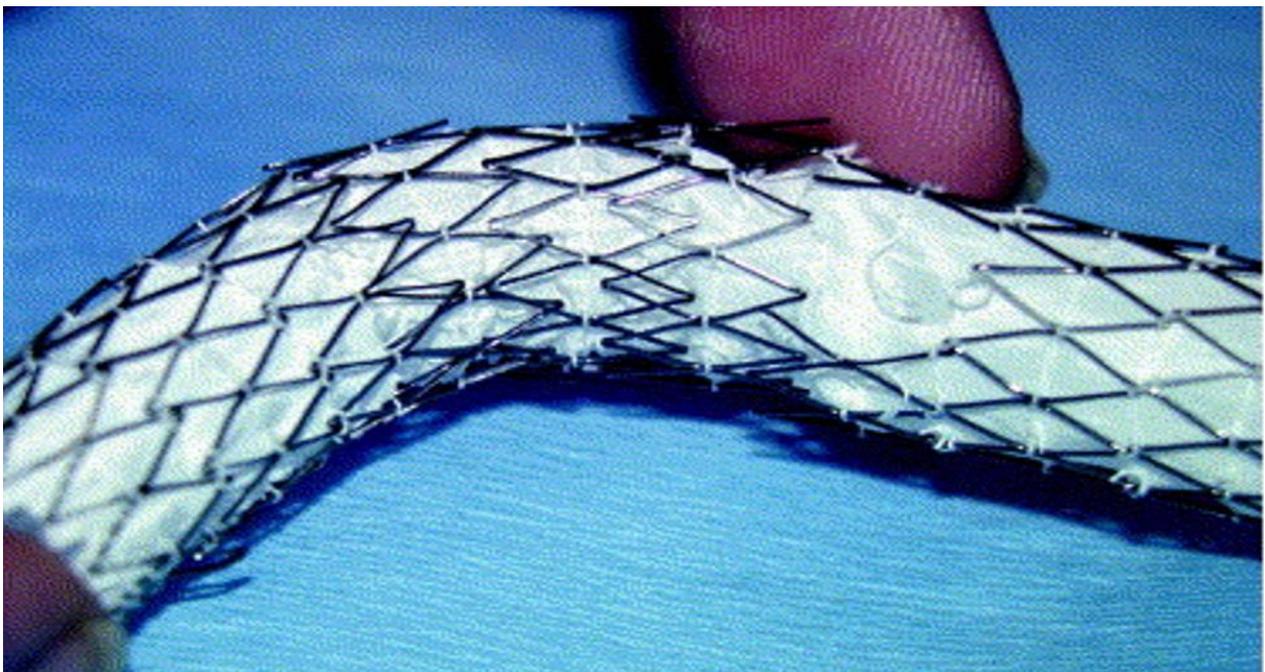
Figure 1.17. Macroscopic view of ruptured stents and ligatures in AneurX Endoprosthesis (Chakfe et al., 2004, p. 38).
[Used with permission]

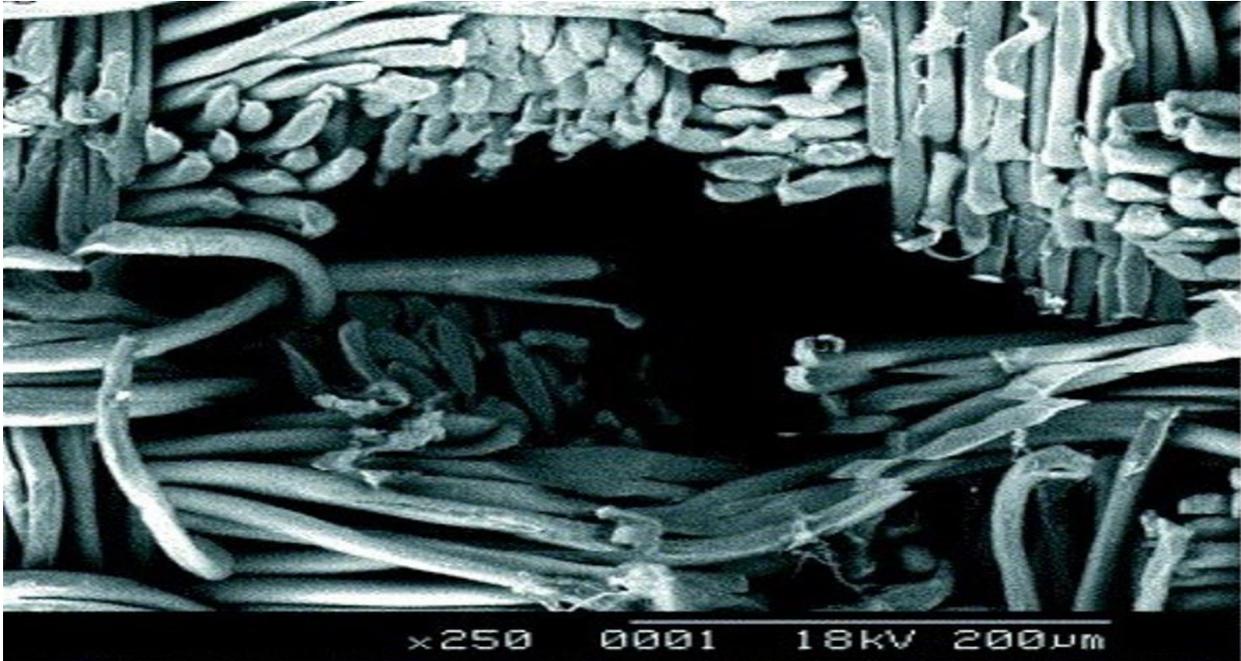
Figure 1.18. SEM Image (Original Magnification: x 250): Hole with degradation of the filaments related to the contact with the stent of the AneurX Endoprosthesis. (Chakfe et al., 2004, p. 38).

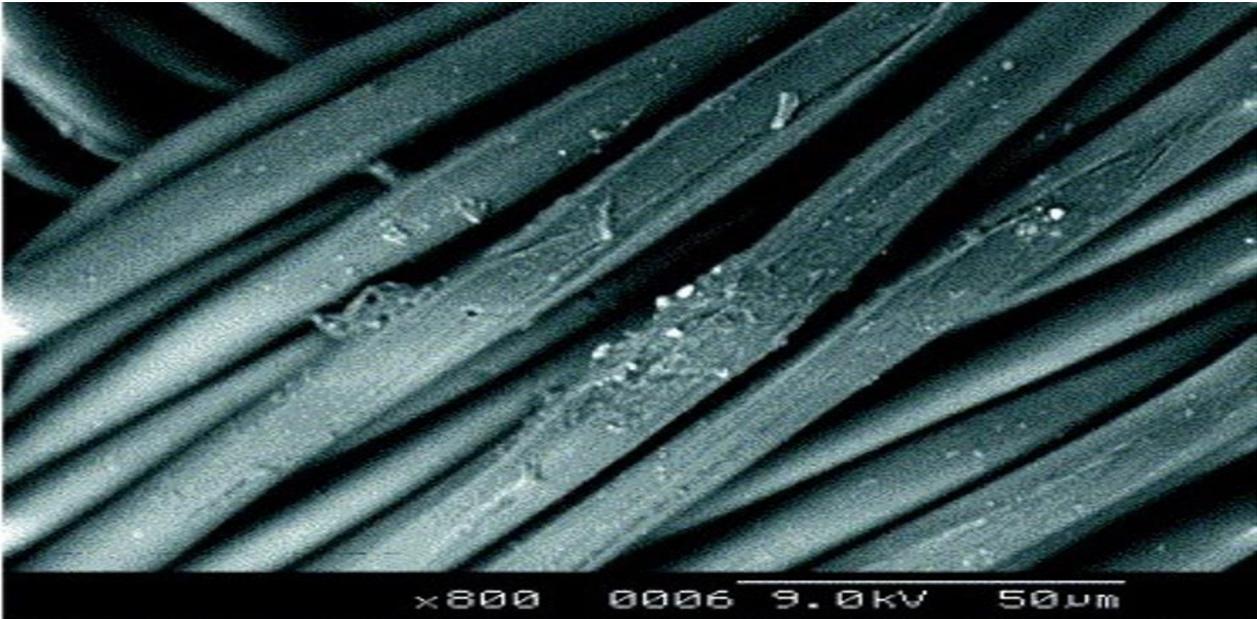
Figure 1.19. SEM Image (original magnification: x 800): Filaments erosions at the contact between the metallic structure of the stents and the textile in AneurX Endoprosthesis (Chakfe et al., 2004, p. 38).

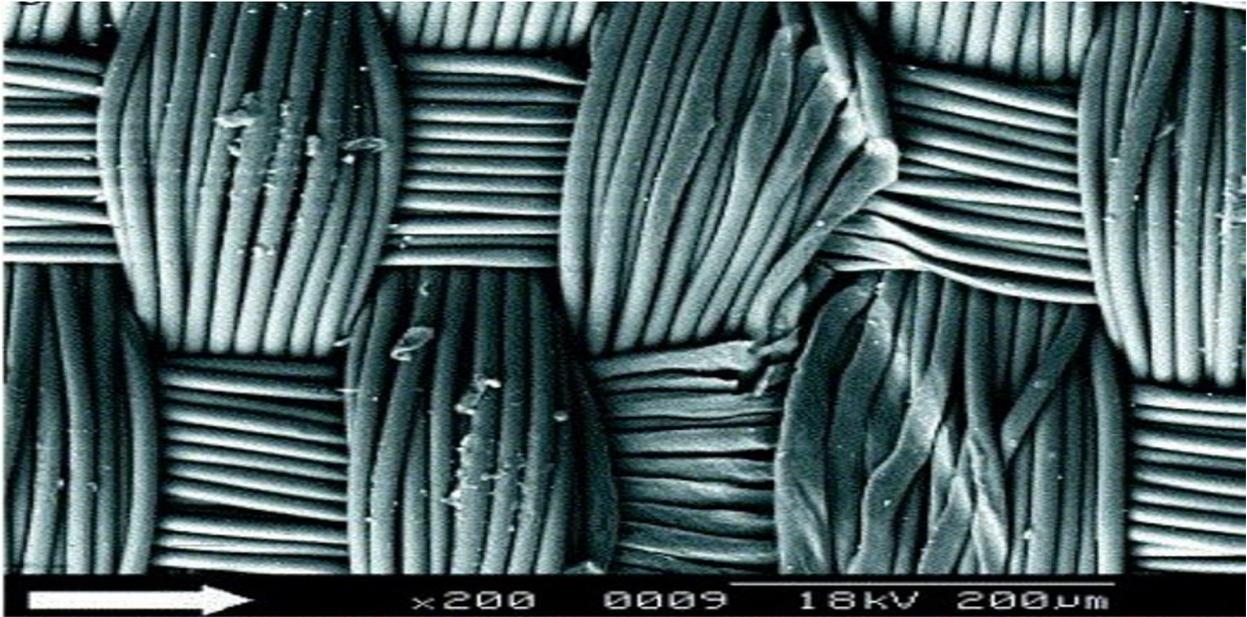
Figure 1.20. SEM image (Original Magnification: x 200): Lesions created by the stents on the external side of the textile in AneurX Endoprosthesis (arrow: warp direction) (Chakfe et al., 2004, p. 38).

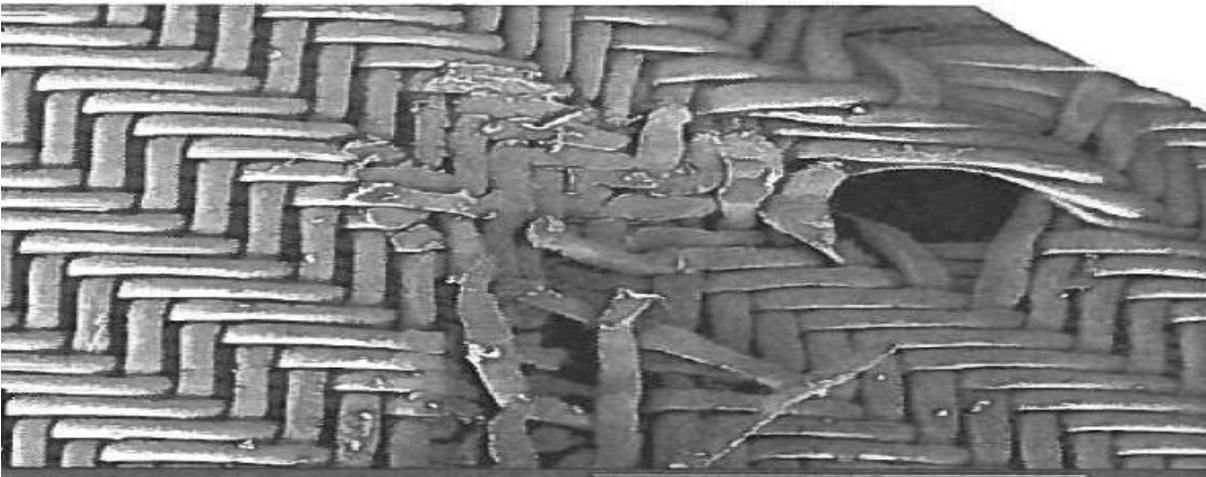
Figure 1.21. SEM image (Original Magnification: x 200) of the puncture of filaments when inserting the braided ligature into Talent Endoprosthesis (Chakfe et al., 2004, p. 40).

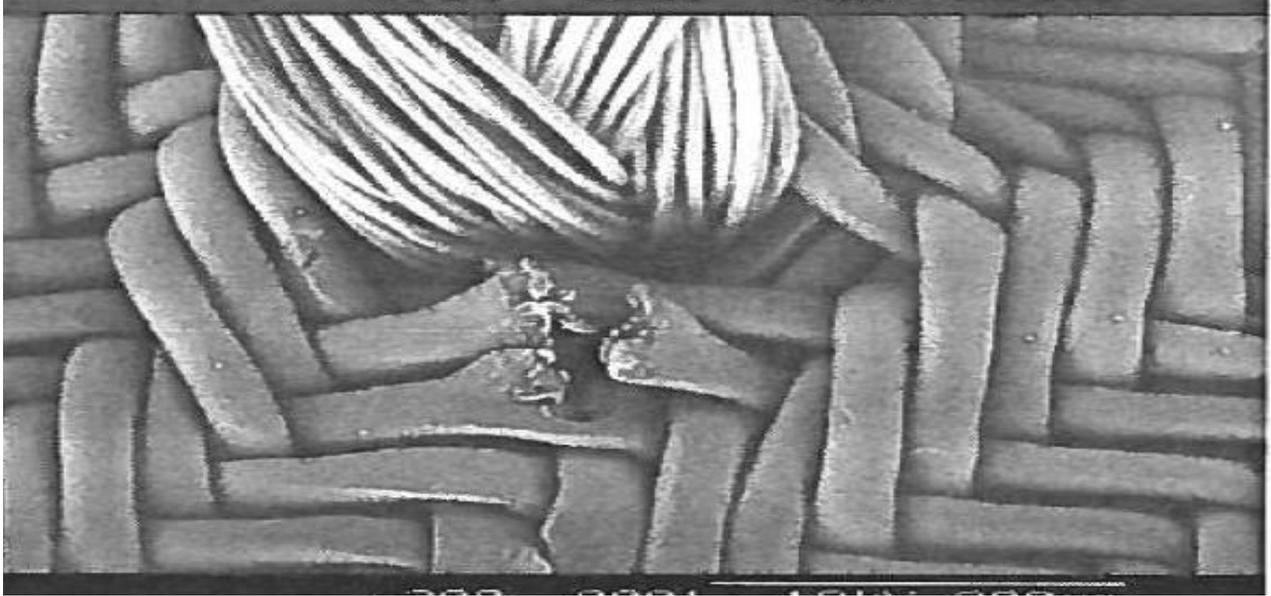
Figure 1.22. SEM Image (original magnification: x 100) of the hole developed at the contact of the stent in Talent Endoprotheses (Chakfe et al., 2004, p. 40).
[Used with permission]

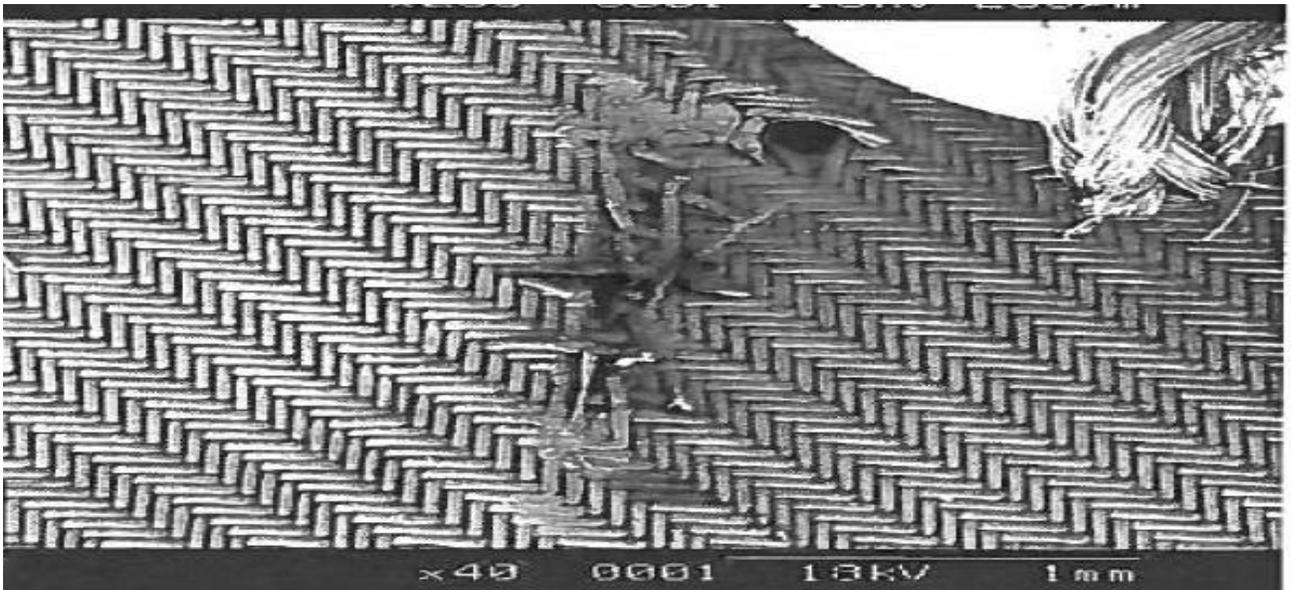
Figure 1.23. SEM Image (original magnification: x 50) of the hole - Signs of wear filaments in Talent Endoprotheses (Chakfe et al., 2004, p. 40).
[Used with permission]

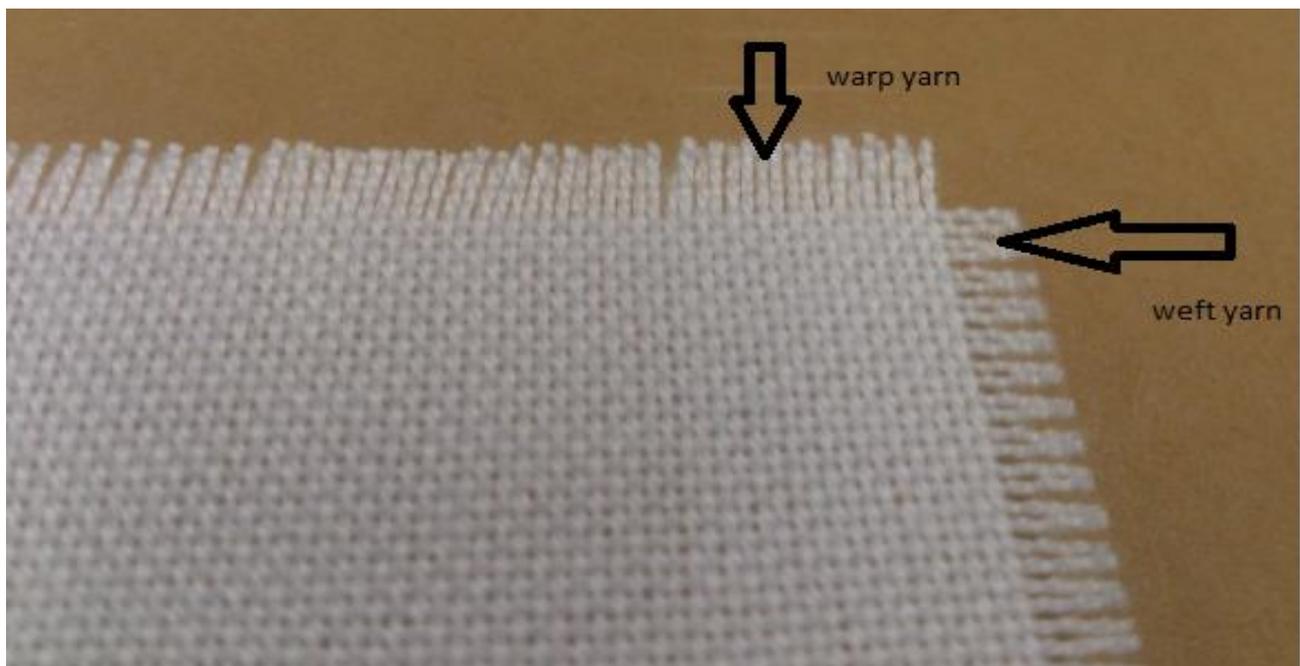
Figure 2.1. 100% Dacron woven fabric (Plain, 1/1).

One hundred percent Dacron polyester double ply spun yarn (Z-twist) plain woven fabric type 64 (Lot 1669, style 763) – semi dull, was obtained from TESTFABRICS INC. A picture of the Dacron fabric used in this study is shown in *Figure 2.1*. For yarn testing (for example, tex, dia), yarn from the weft direction (cross-wise) of this fabric was pulled out as weft yarn is generally weaker and more irregular than warp yarn (yarn in vertical direction).

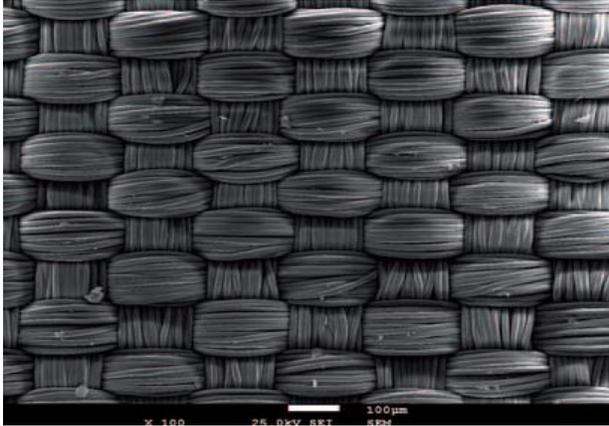
Figure 2.2. SEM of an endovascular prosthesis woven fabric (plain) (Santos, Figueiredo, Rocha, & Tavares, 2012, p. 335) [Used with permission]

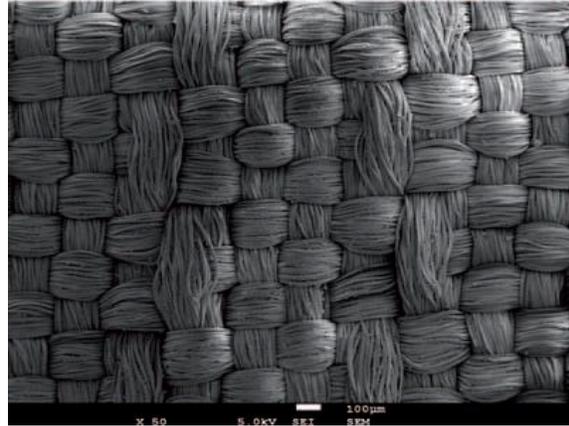
Figure 2.3. SEM of an endovascular prosthesis woven fabric (twill)

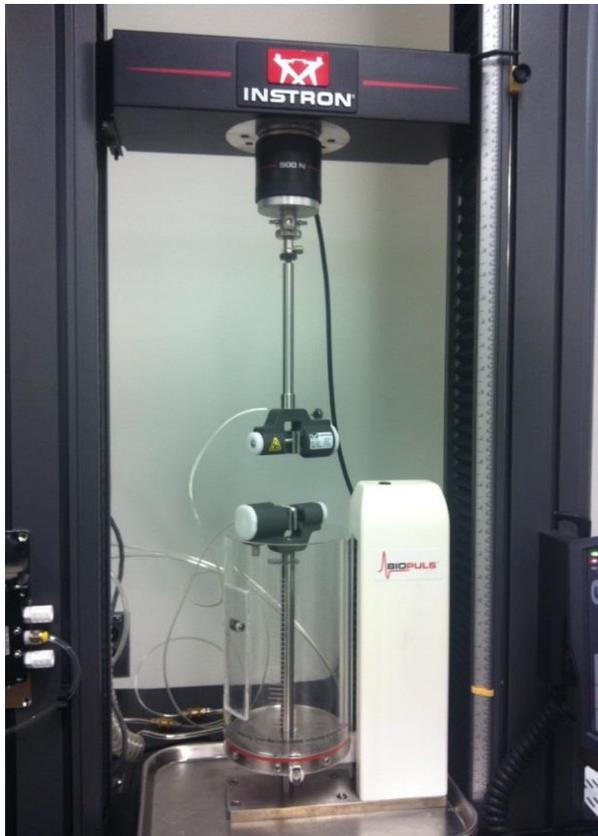
Figure 2.5. INSTRON (Model: 5965) Universal tester with biobath (Bio-Puls).

To measure the breaking load, Instron Universal Tester, Model 5965 was used. The Instron is equipped with BioPuls-bath and heating device (*Figures 2.5* and *2.6*). In order to conduct the rupture test for yarn from woven fabric, in blank medium, in water (pH=7) and in alkaline conditions (pH = 12.6) under different fractional loading conditions, yarns (35 inches long) from the weft direction of the fabric were pulled out. The breaking load and elongation of the yarn were determined using a gauge length of 3 inches and at a speed of 20 mm/minute. The load cell selected was 500N for this entire study. The breaking load of the virgin yarn was used to conduct the test under different fractional loading conditions.

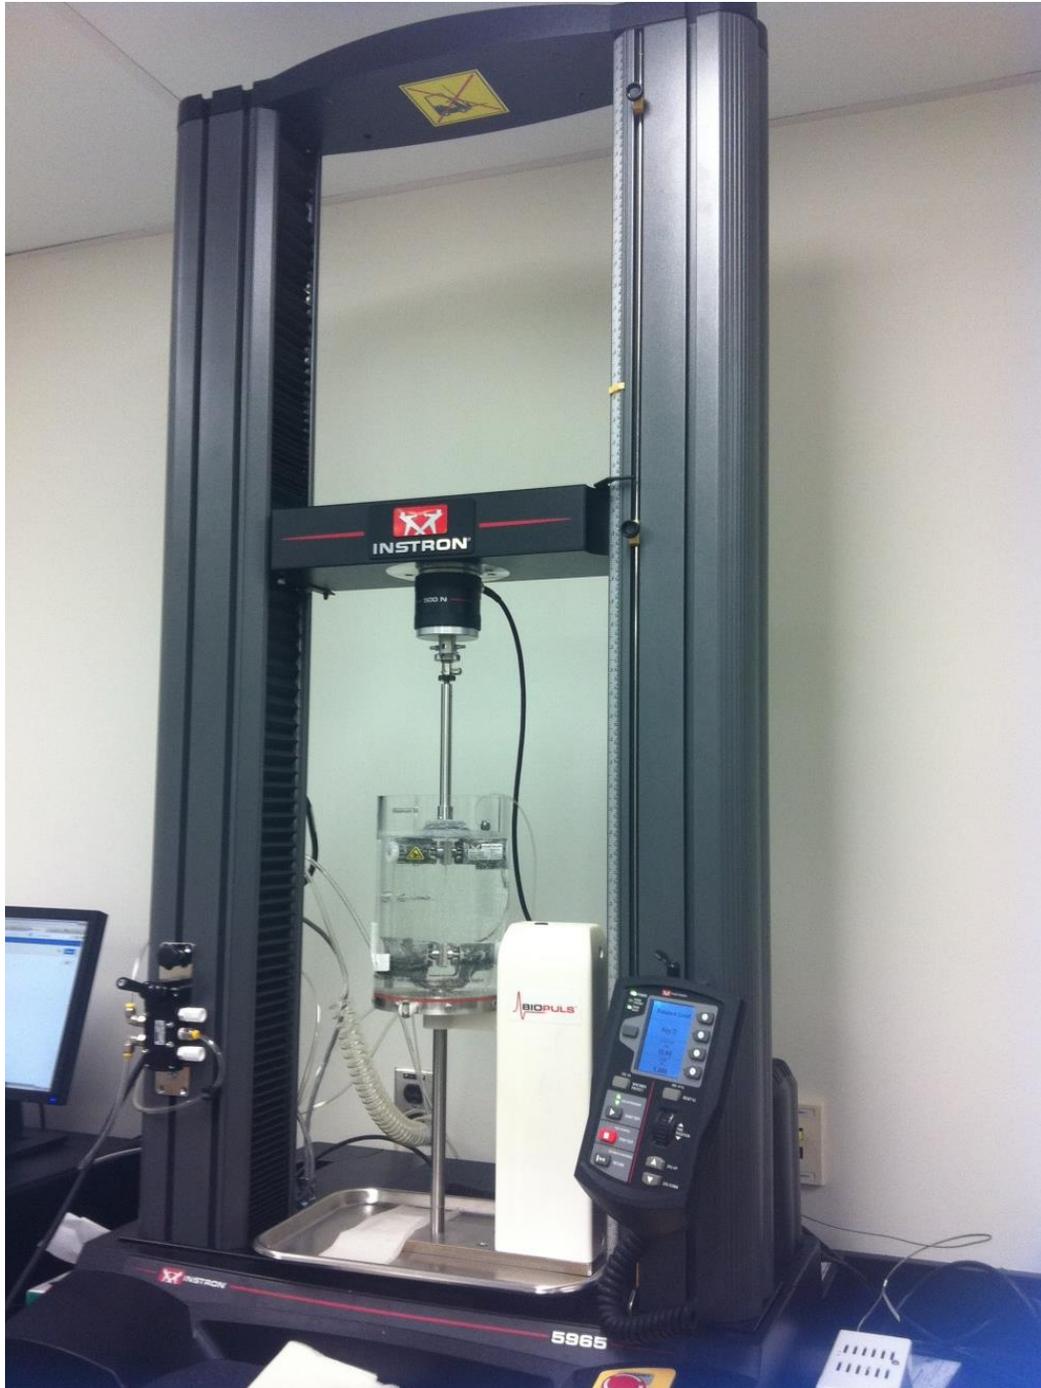
Figure 2.7. Yarn in water during testing in Instron.

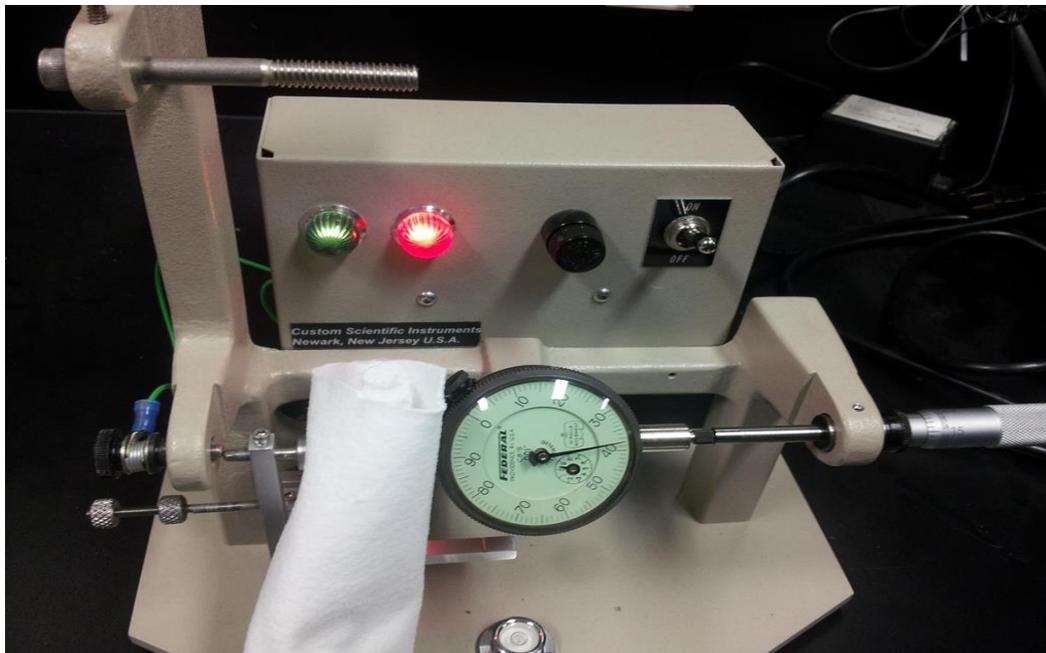
Figure 2.12. Fabric Thickness Tester.

Before testing, all fabrics were conditioned at 20⁰ C and 65% relative humidity for at least 48 hours according to ASTM D 1776. Two fabric samples were randomly chosen from six samples that were obtained from the vascular graft manufacturer, Bard Peripheral Vascular (USA). The thickness at 10 different spots on each fabric swatch was taken using Low Pressure Thickness Gage, Model CSI-49 (*Figure 2.12*).

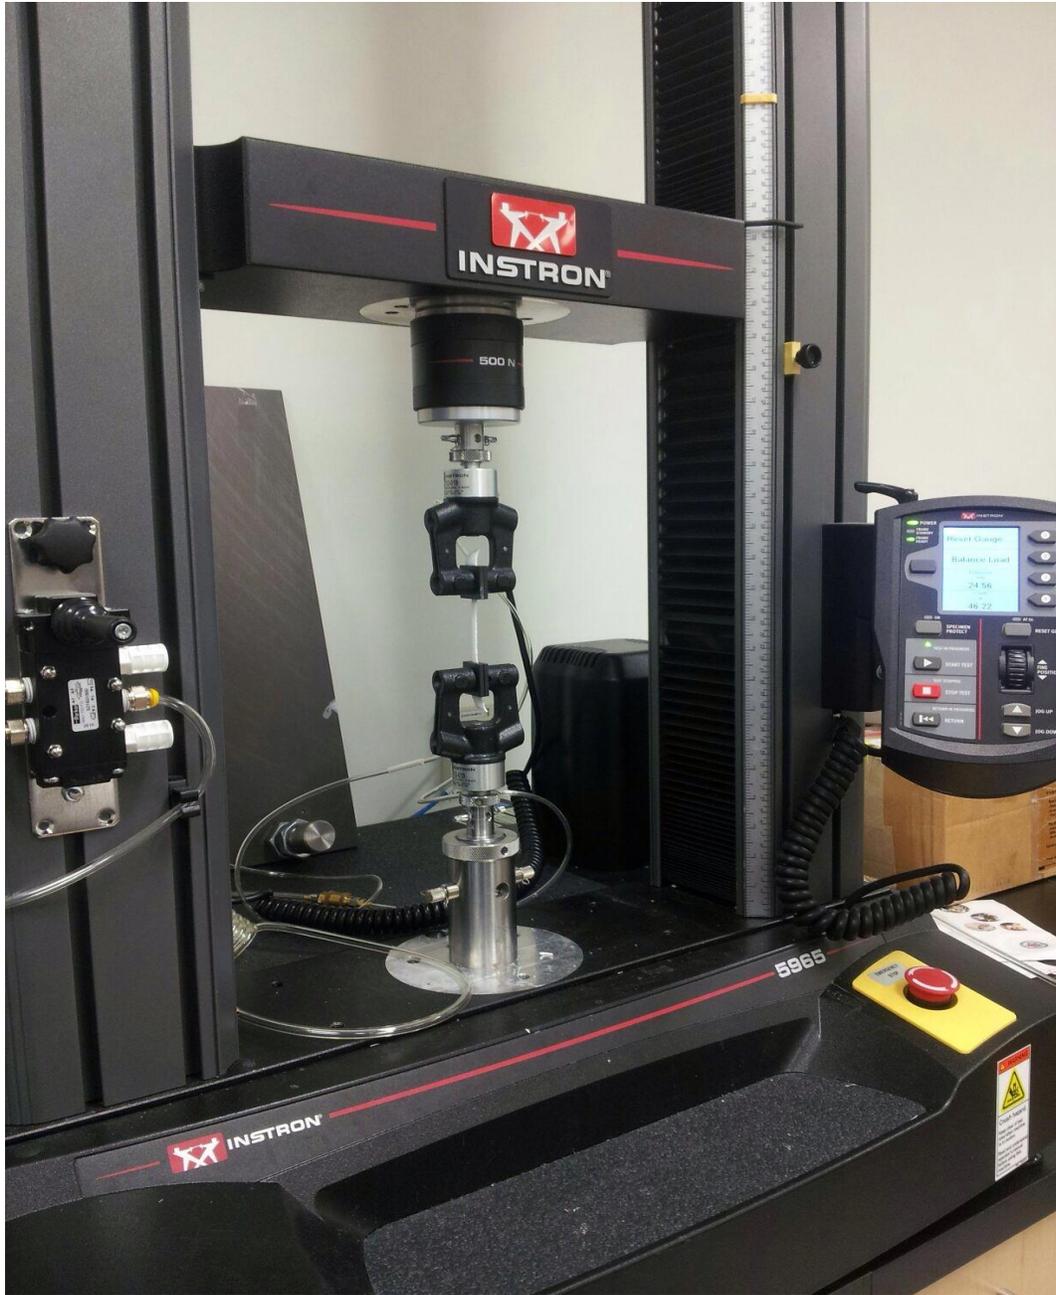
Figure 2.13(a). Fabric breaking strength measurement in Instron.

The two different holding loads (90% and 80%) used were calculated based on the original breaking load of the same sample. The steps in setting up the parameters in Bluehill software for testing the sample under specified load are given in Appendix D.
