Relationship between Textile Irregularities and Pre-Mature Rupture of Polyester Vascular Graft Knitted Fabric

A Thesis submitted to the Faculty of Graduate Studies of

Department of Biosystems Engineering

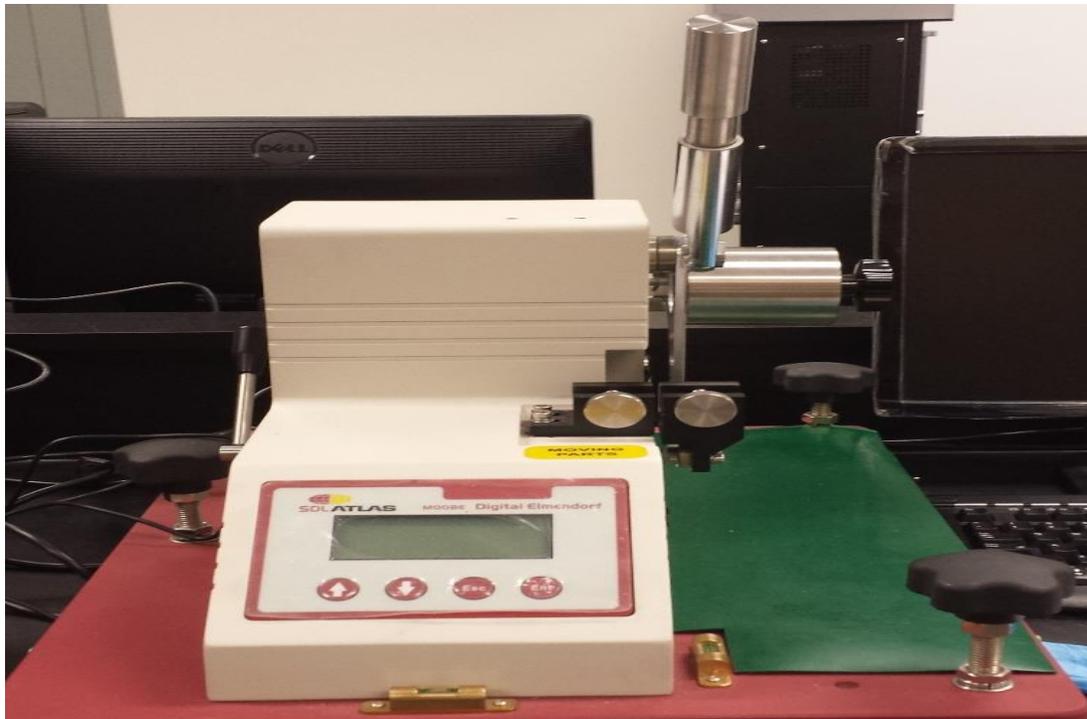
Figure 2.16. Digital Elmendorf tearing tester, Model M008E.

To measure the tearing strength of yarn, Digital Elmendorf Tearing Tester, Model M008E (from SDL Atlas) was used (*Figure 2.16*). Test procedure was followed according to the ASTM D1424-09 (ASTM, 2009).

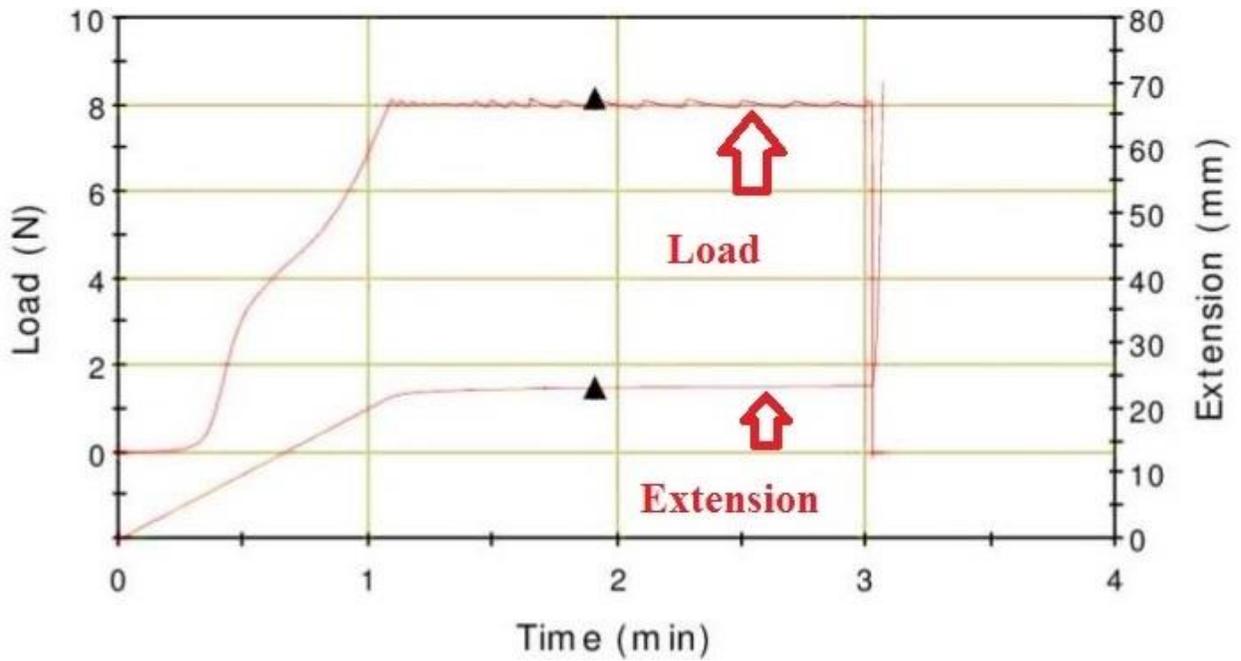
Figure 3.2. Sample A1-2 (blank, 80% fractional load, preset holding time 5 minutes, sample broke after 3.06 minutes).

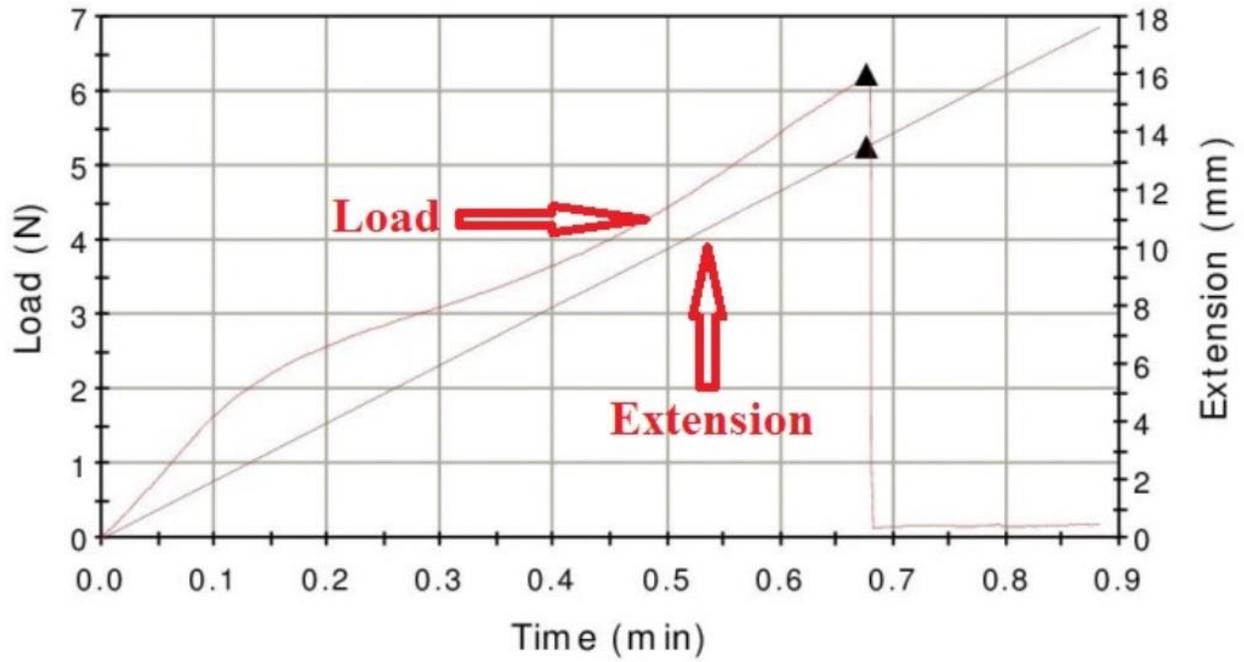
Figure 3.3. Sample A1-3 (medium-water, 80% fractional load, preset holding time 5 minutes, sample broke after 0.68 minute).

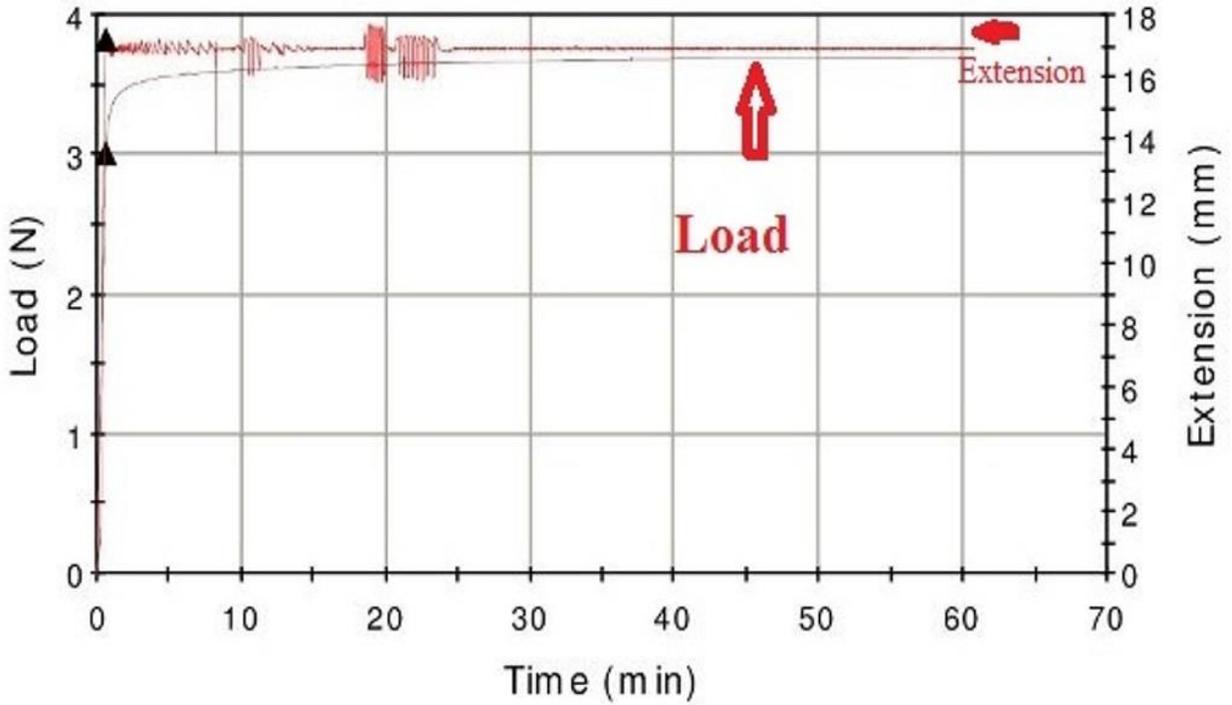
Figure 3.5. Sample A2-2 (medium-water, 60% fractional load, pre-set holding time 1hr, no breakage).

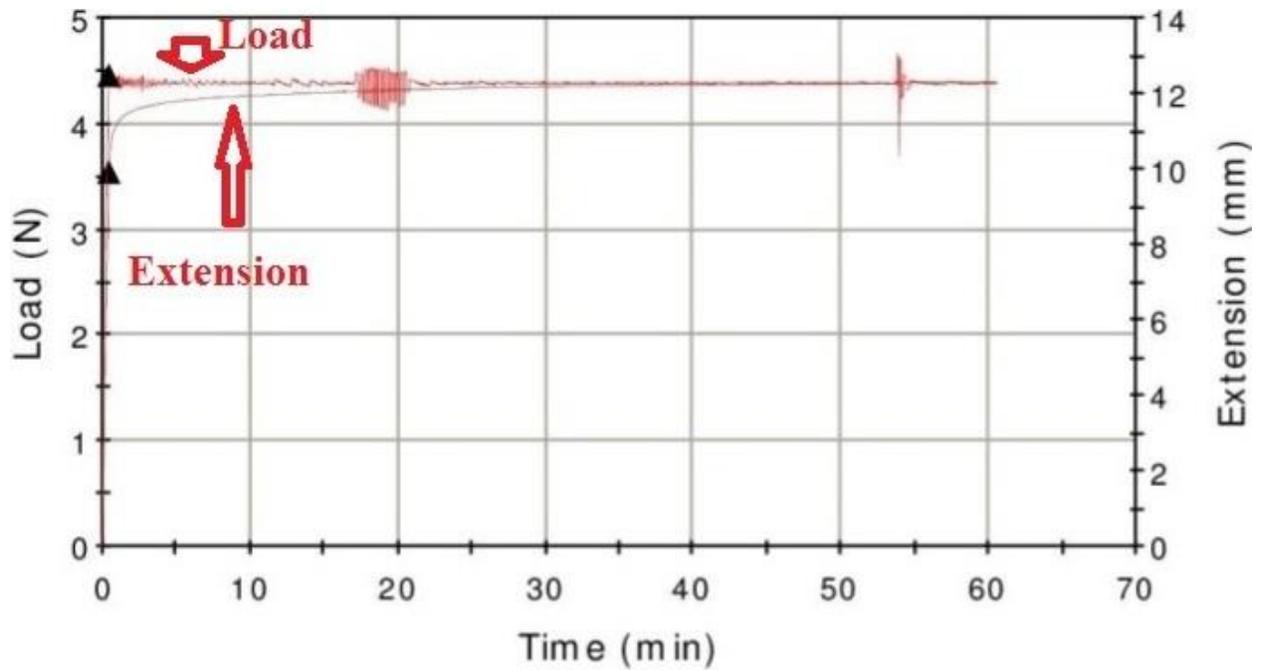
Figure 3.6. Sample A2-3 (medium-water, 70% fractional load, pre-set holding time 1hr, no breakage).

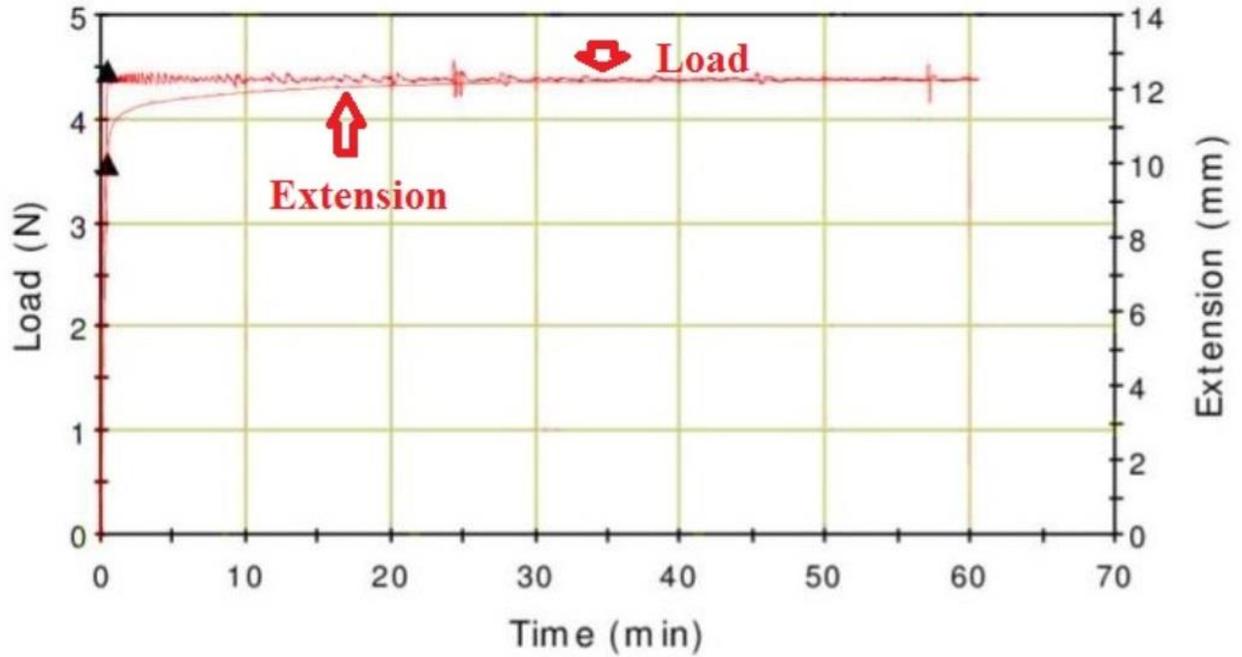
Figure 3.7. Sample A2-4 (medium- alkali, 70% fractional load, pre-set holding time 1hr, no breakage).

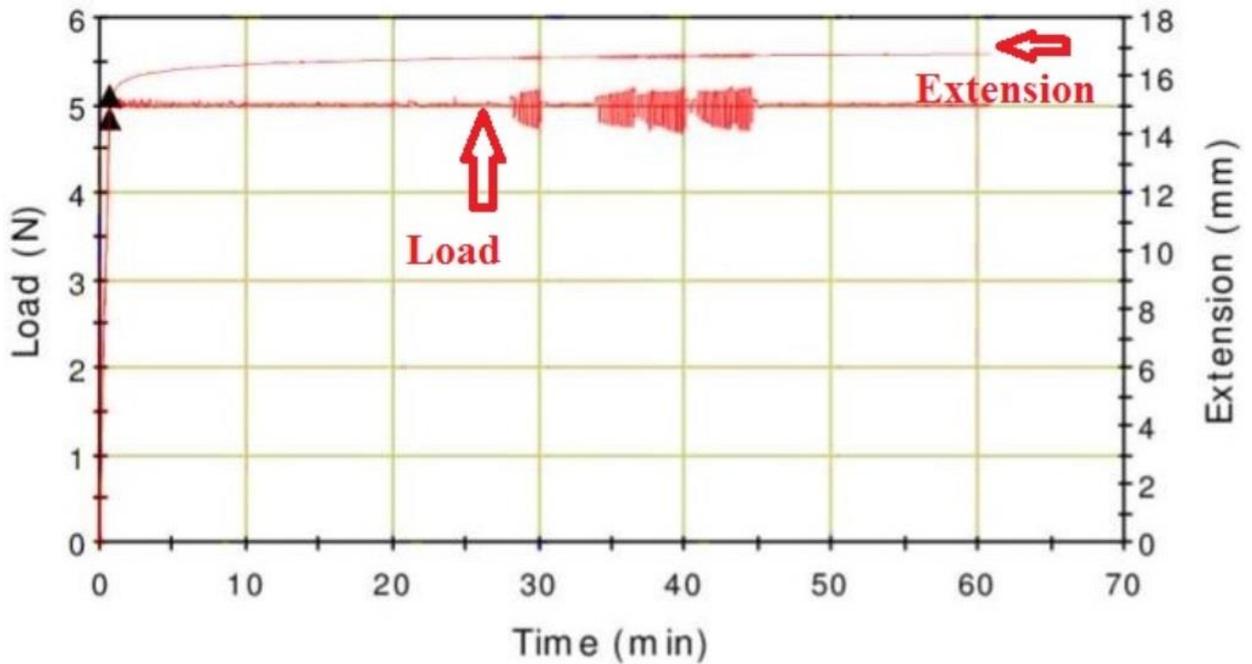
Figure 3.8. Sample A2-5 (medium-alkali, 80% fractional load, pre-set holding time 1hr, no breakage).

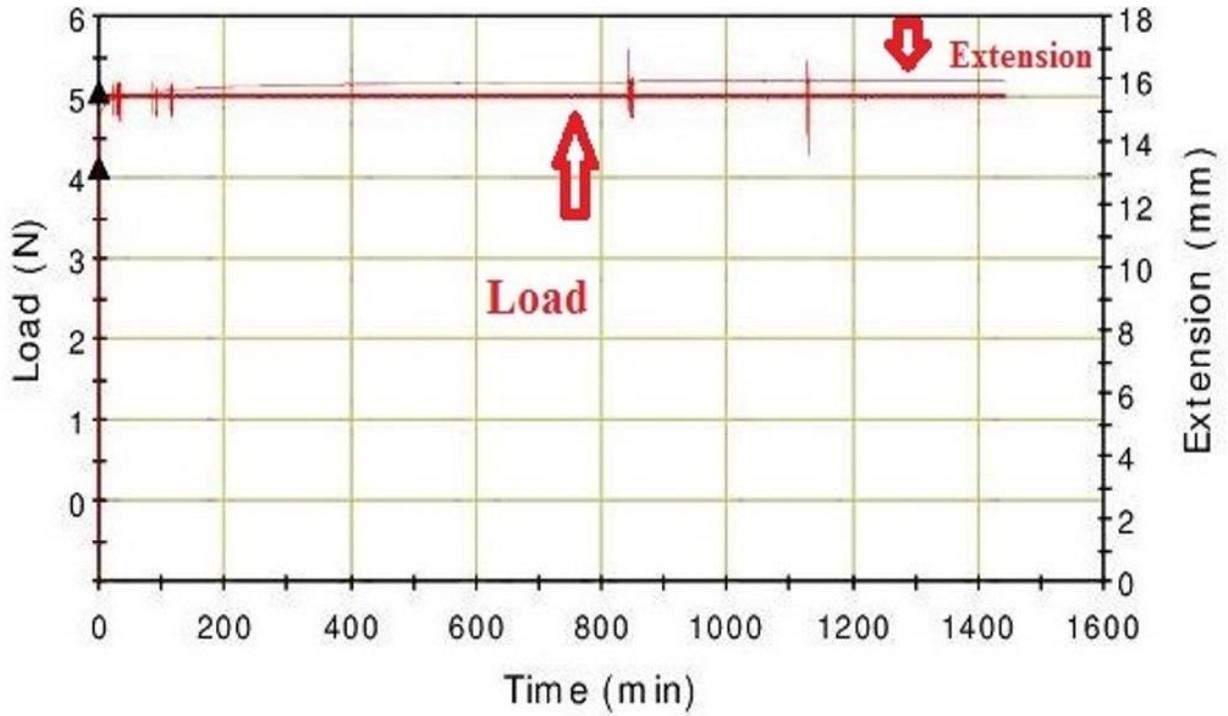
Figure 3.9. Sample A2-6 (medium-water, 80% fractional load, pre-set holding time 24hrs, no breakage).

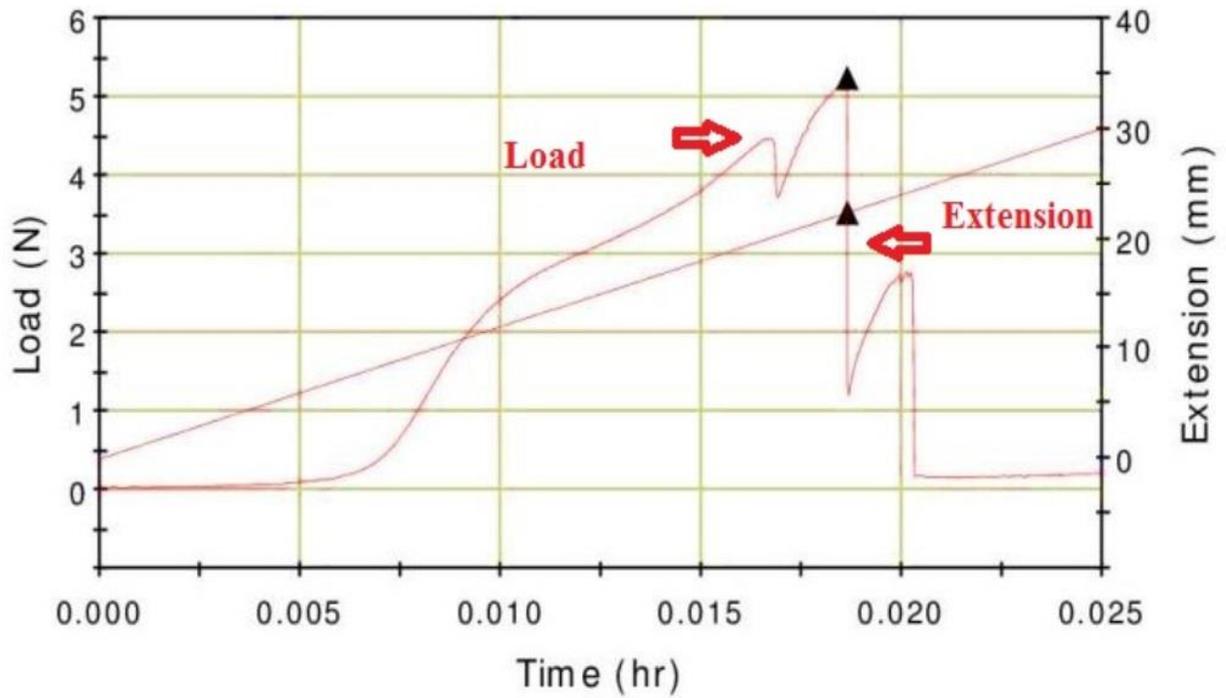
Figure 3.11. Sample A3-2 (medium-water, 80% fractional load, pre-set holding time 72 hrs, sample broke after 1.08 minutes).

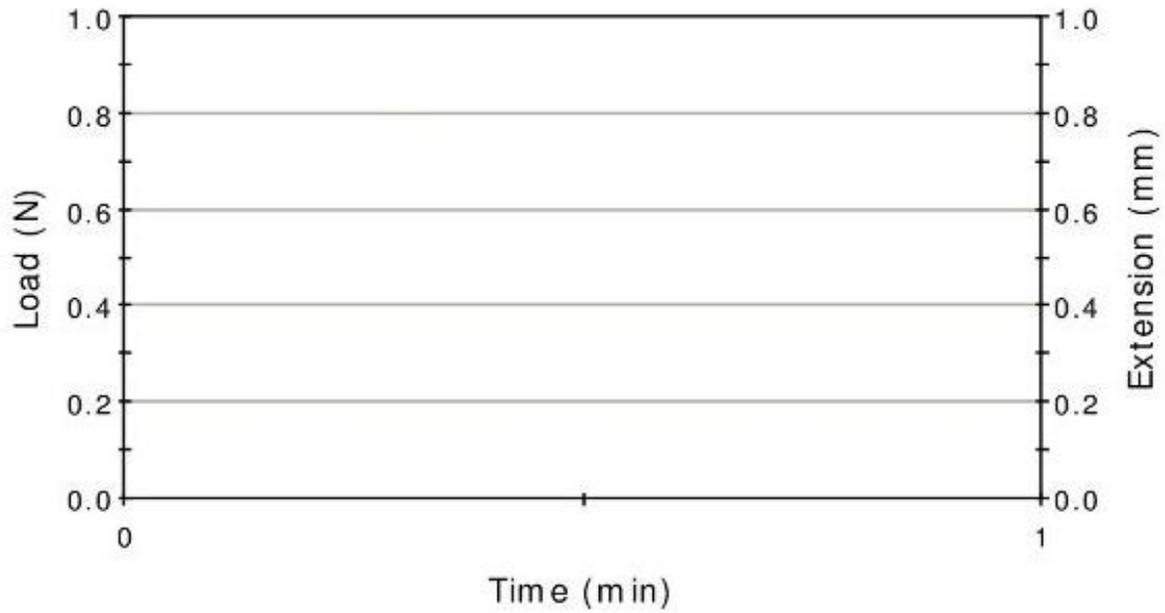
Figure 3.13. Sample A3-4 (medium- water, 80% fractional load, pre-set holding time 72 hrs, no breakage -computer froze).

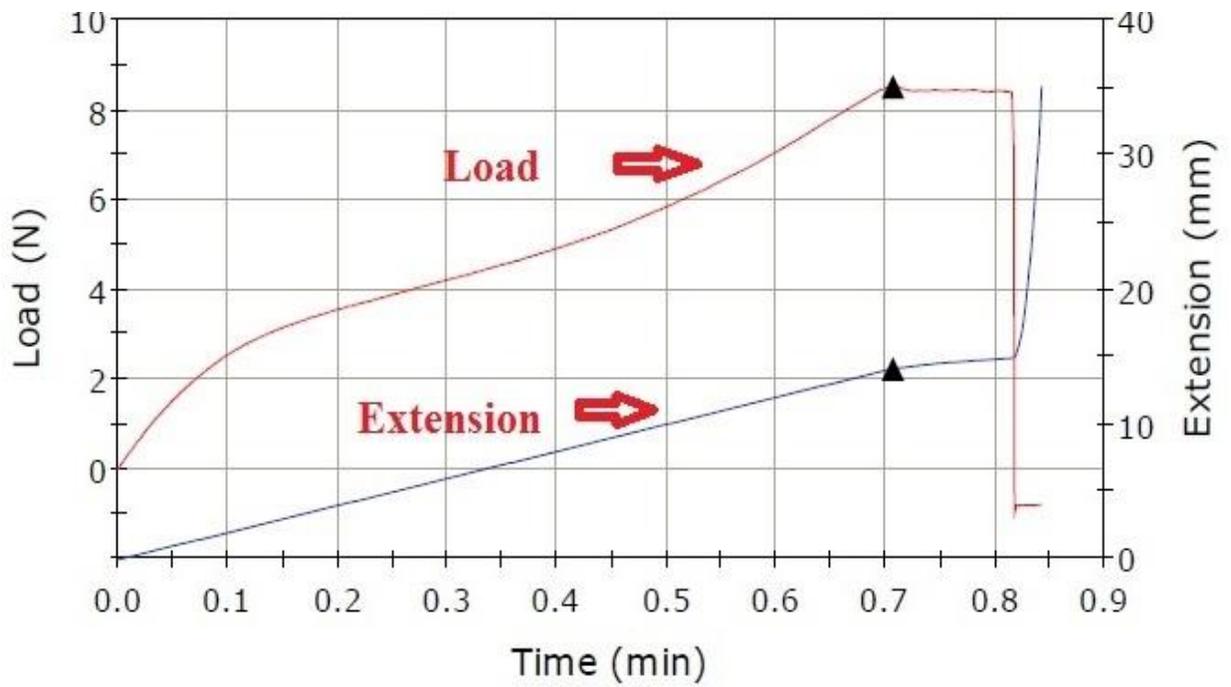
Figure 3.15. Sample A4-2 (blank, 98% fractional load, pre-set holding time 1hr, sample broke after 0.84 minute).

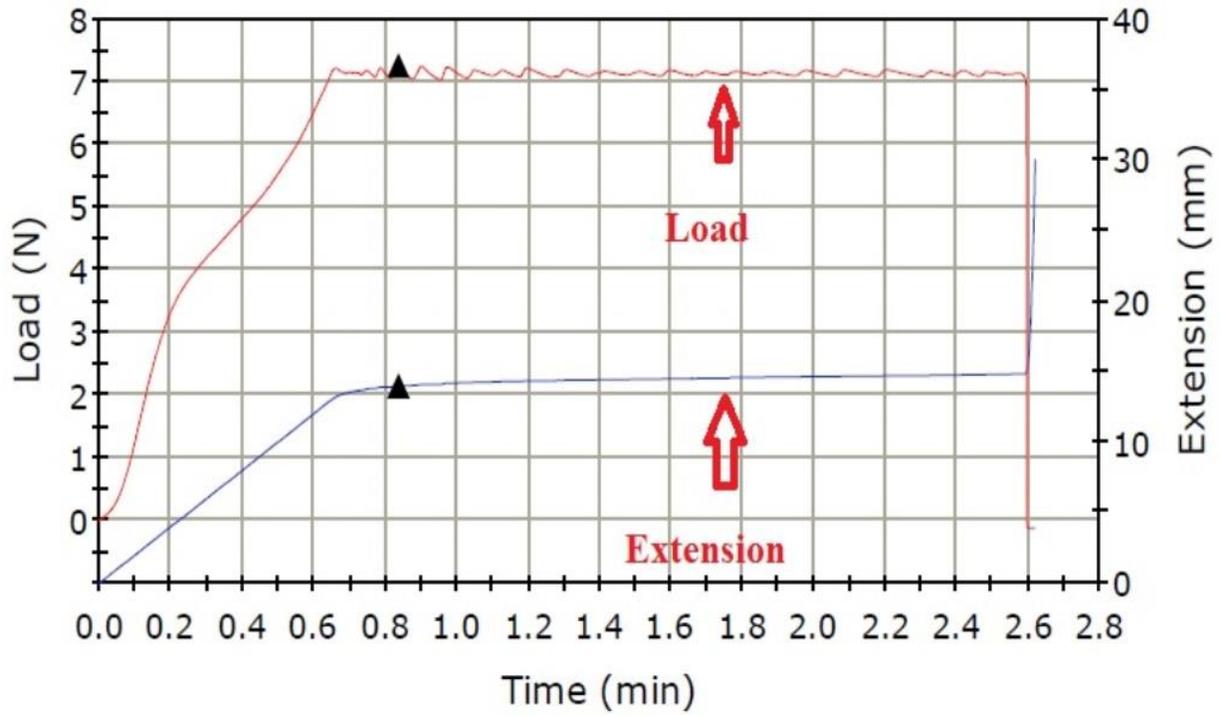
Figure 3.17. Sample A4-4 (blank, 90% fractional load, pre-set holding time 1 hr but sample broke after 2.62 minute).

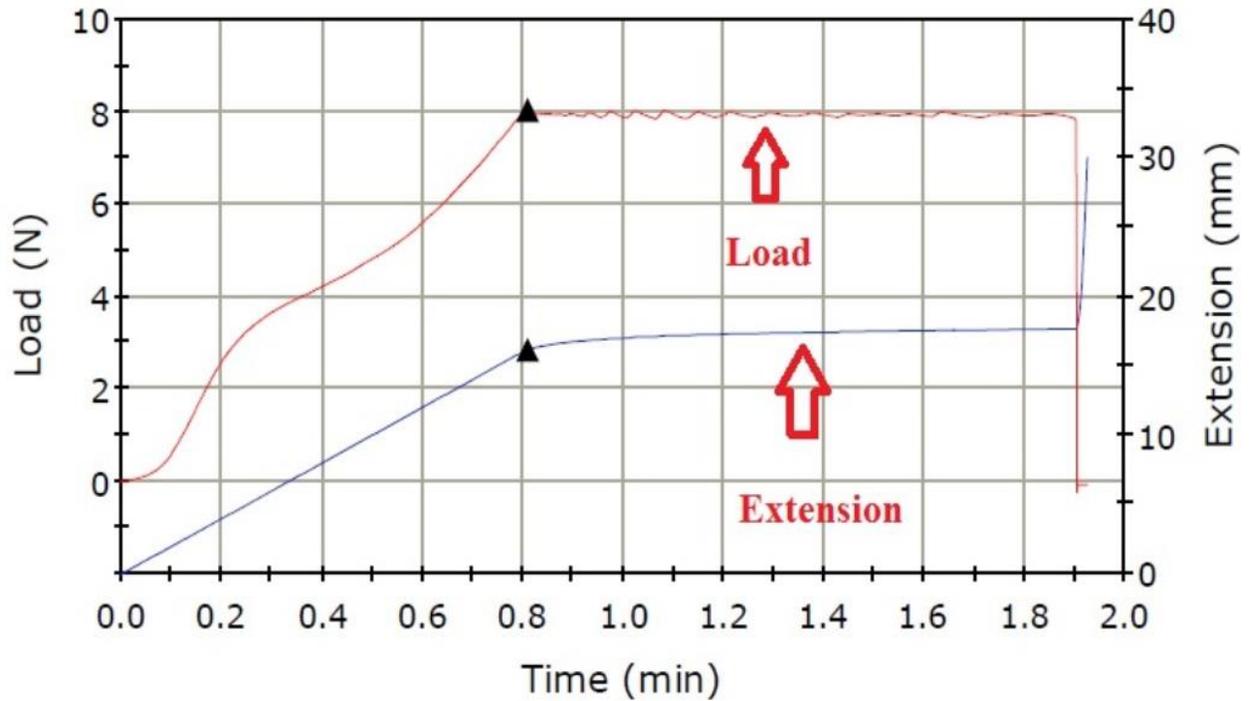
Figure 3.19. Sample A5-2 (blank, 90% fractional load, pre-set holding time 1 hr, sample broke after 1.92 minute).

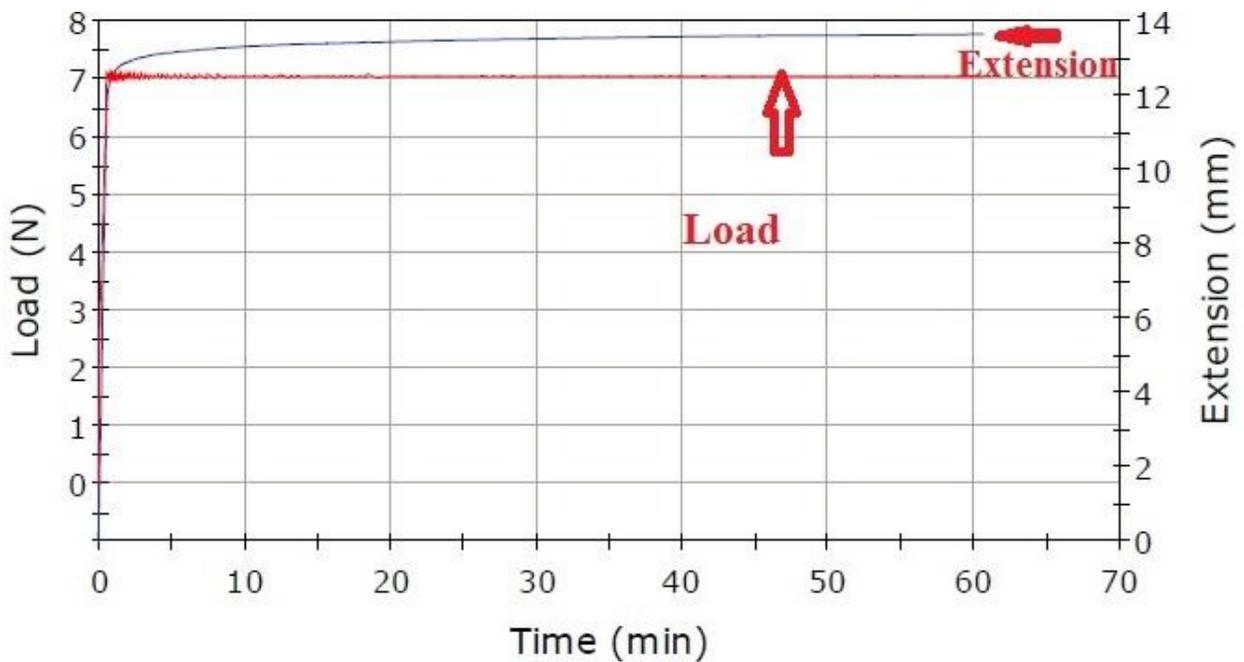
Figure 3.20. Sample A5-3 (blank, 80% fractional load, pre-set holding time 1hr, no breakage).

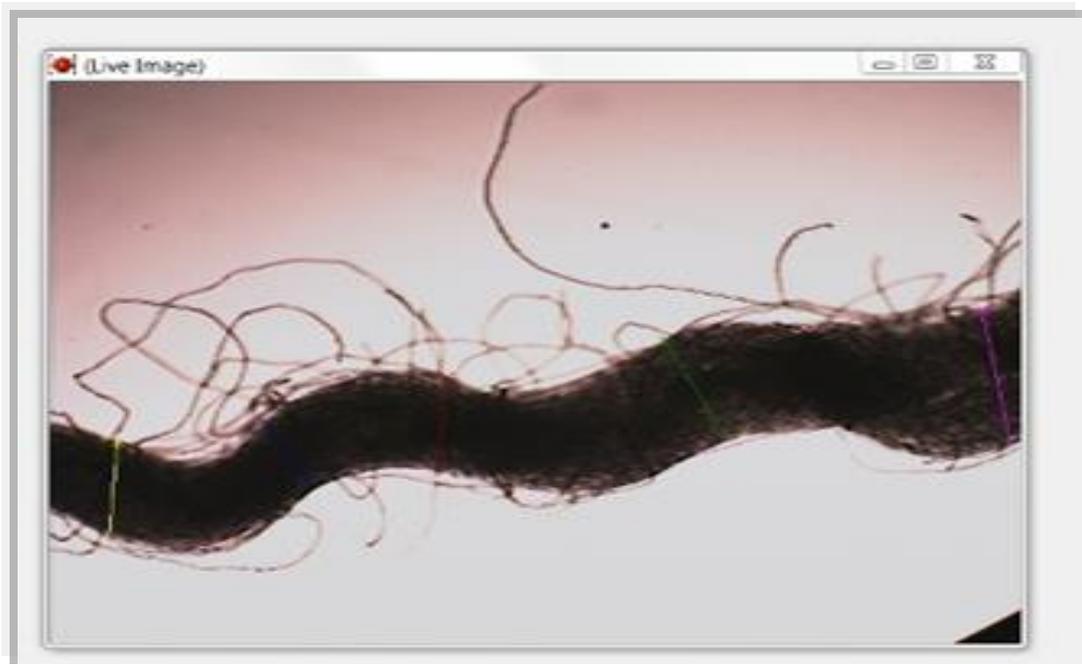
Figure 3.21. Bioquant picture of virgin polyester (maximum diameter: 572.14 μm , minimum: 319.3 μm).

Since the yarn breakage occurred at different breaking loads both for virgin samples and those with pre-set holding loads (for example, 80% holding load samples) as well as polyester grafts in vivo, it was suspected that the variation in breaking loads might have originated from the virgin polyester samples. Accordingly, the variation in yarn diameter was calculated (shown in *Figures 3.21 and 3.22*). These two figures were taken from two different places along the same single yarn using Bioquant Life Science Image Analysis System (Section 2.5). Along the length of the yarn, the largest diameter measured was 572.14 μm and the minimum diameter 319.3 μm (*Figure 3.21*). In another location of this yarn, the maximum and minimum diameters were found to be 584.24 μm and 426.46 μm respectively (*Figure 3.22*). The average variation was 56.73% and 31.2%, calculated using the mean value for thick and thin places.

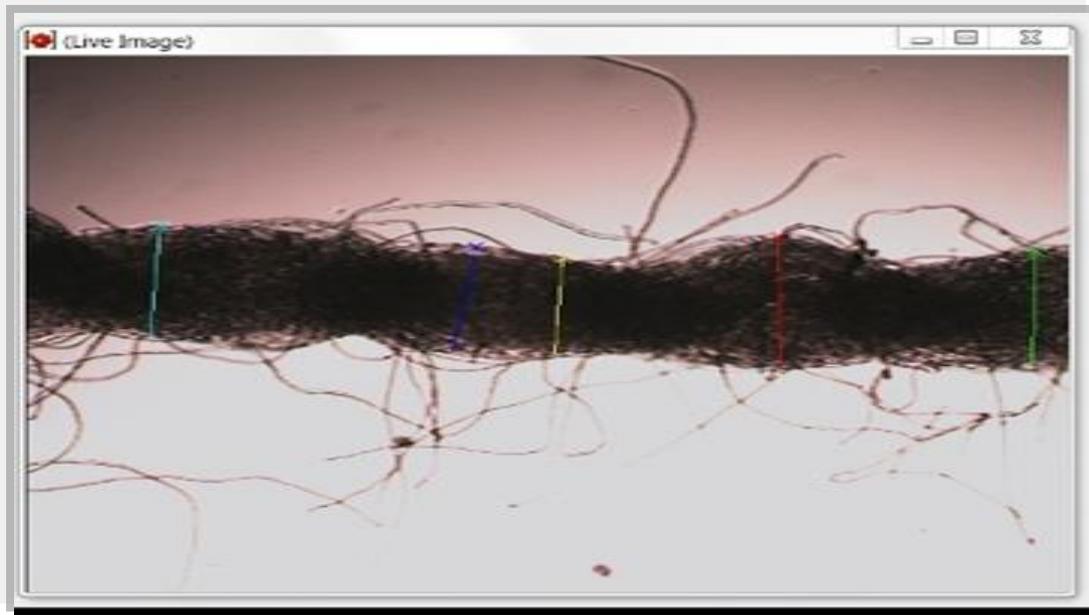
Figure 3.22. Bioquant picture of virgin polyester (maximum diameter: 584.24 μm , minimum: 426.46 μm).

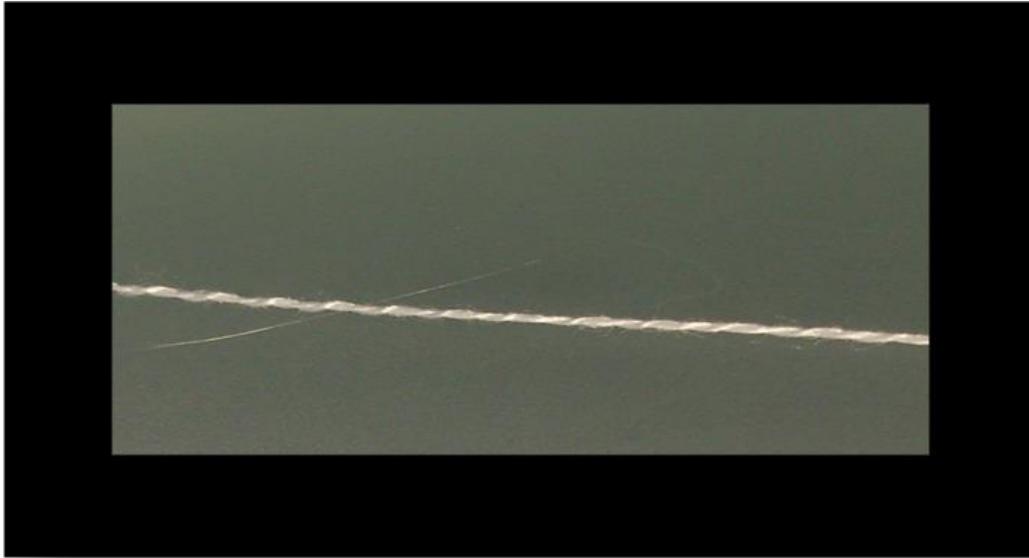
Figure 3.23. Original yarn (without broken ends).

The fracture behaviour of the yarn is shown in *Figures 3.23 - 3.26*. During yarn breakage, it was found that no fibre breakage occurred. The fibres within the yarn, which are bound by twisting, pulled out from the yarn core as a result of tension load and split into two separate yarns (*Figure 3.26*). During the break, the yarn lost twists per inch and the fibres lost cohesion (*Figure 3.25*). This loss of cohesive force among the fibres was responsible for yarn breakage.

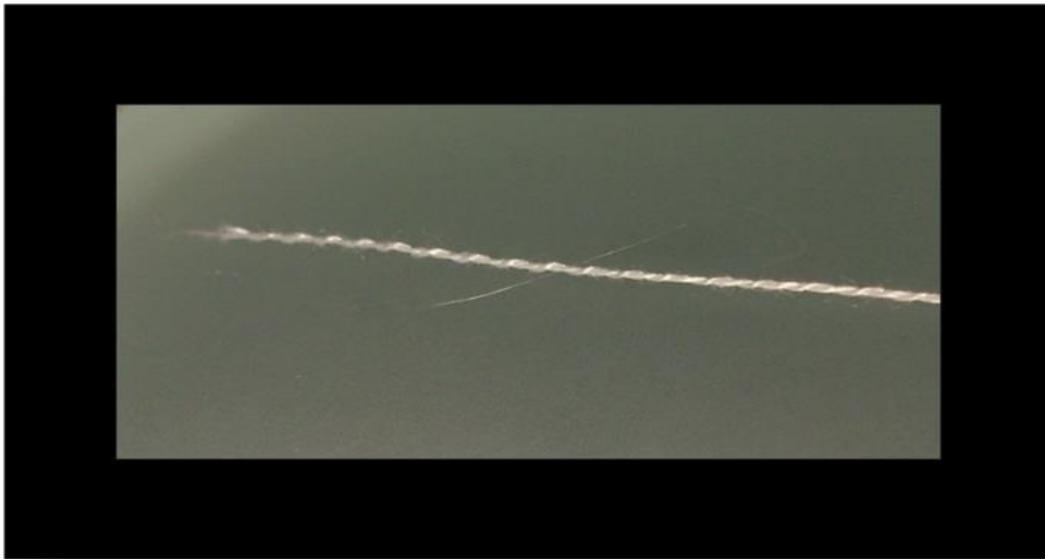
Figure 3.24. Dacron sample A2-1 (after breakage).

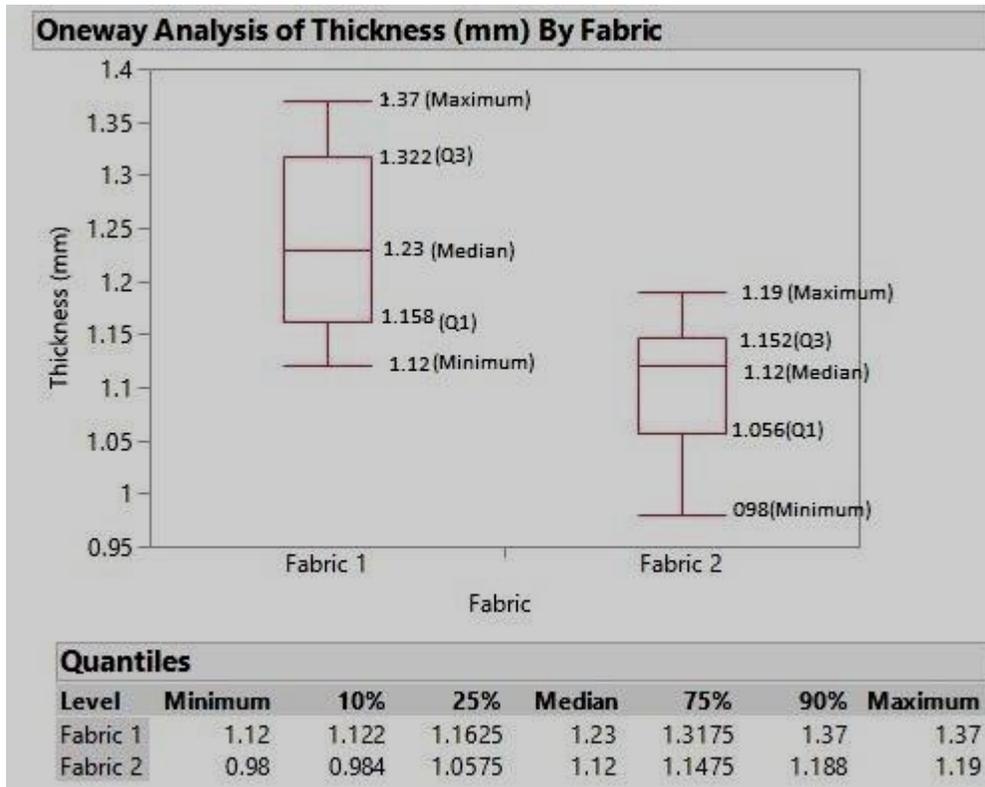
Figure 4.1. Side-by-side boxplot of thickness of *DVPVGKF #1* and *# 2*.

Upper Inner fence = $Q3 + (1.5 \times IQR) = 1.152 + (1.5 \times 0.096) = 1.296$ Equation IV

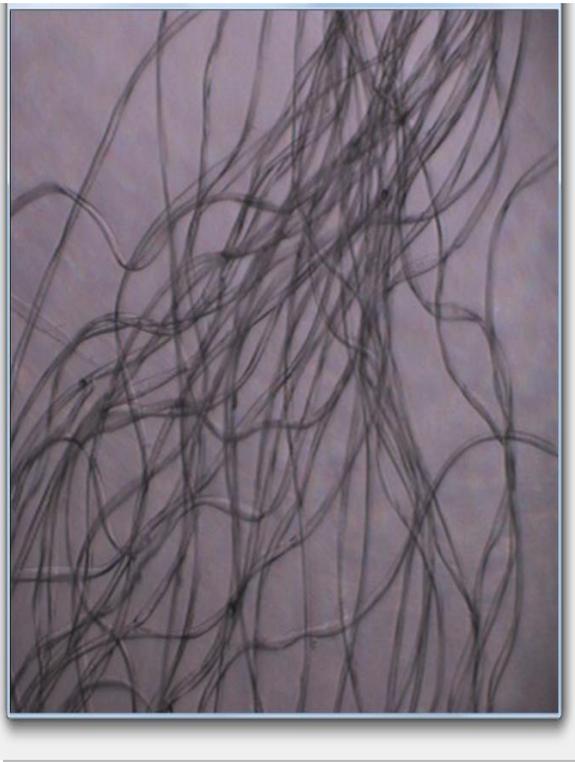
Figure 4.2. Number of filaments (= 34) in multifilament yarn # 1.

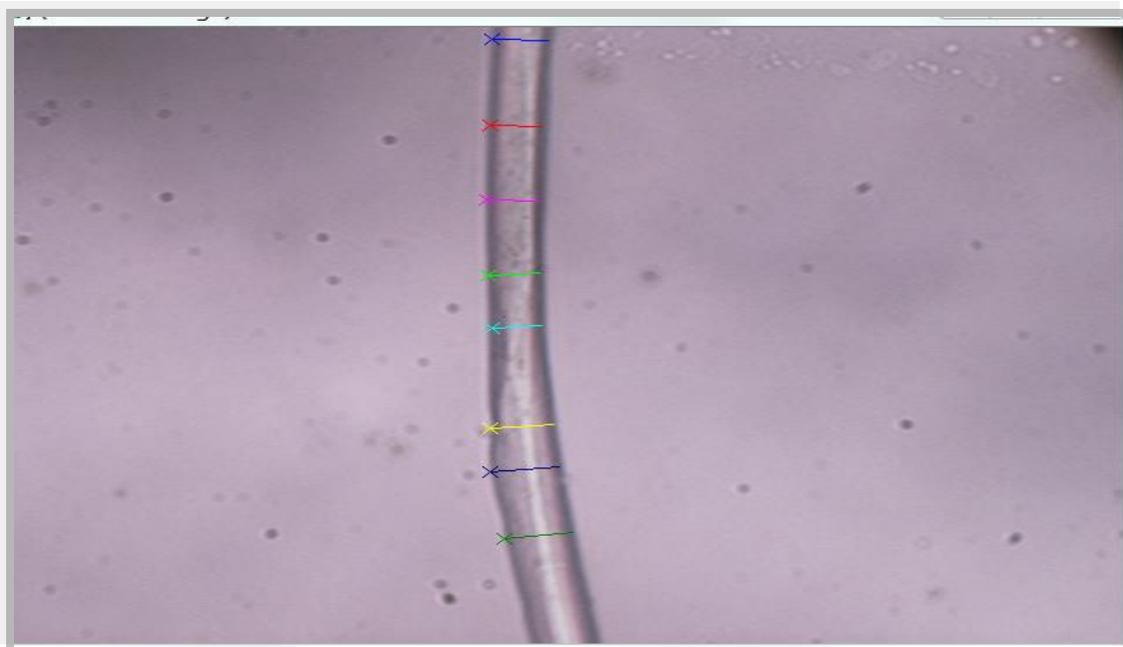
Figure 4.5. Single filament # 2 diameter measurements.

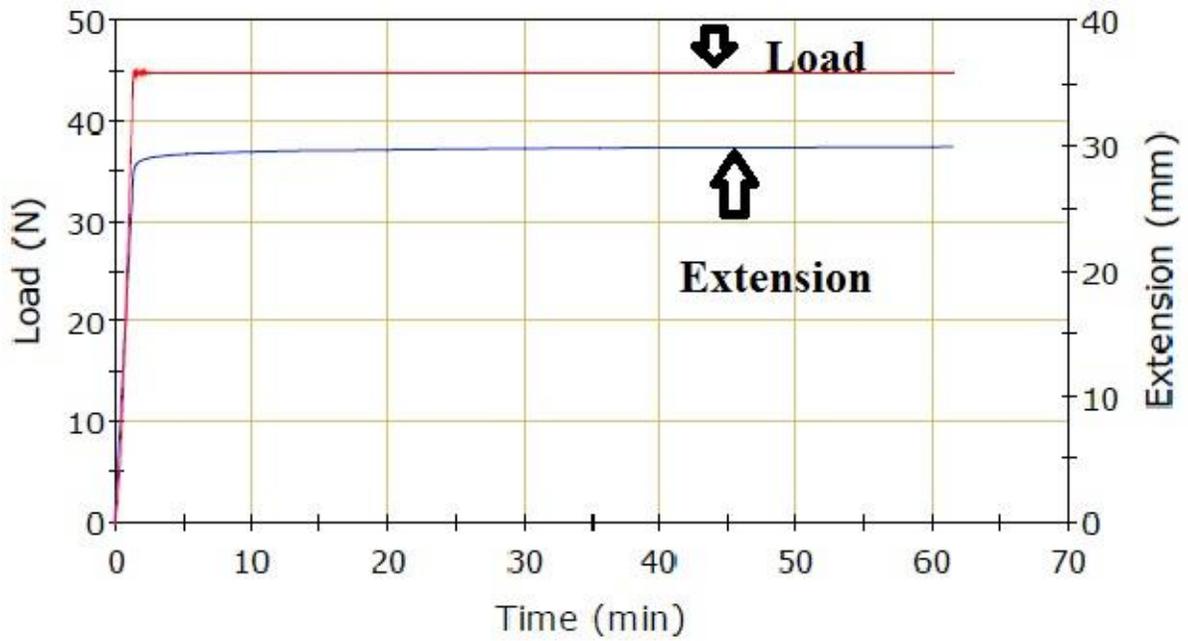
Figure 4.9. Sample# B4 (90% fractional load of sample B2, pre-set holding time 1hr, sample did not break).

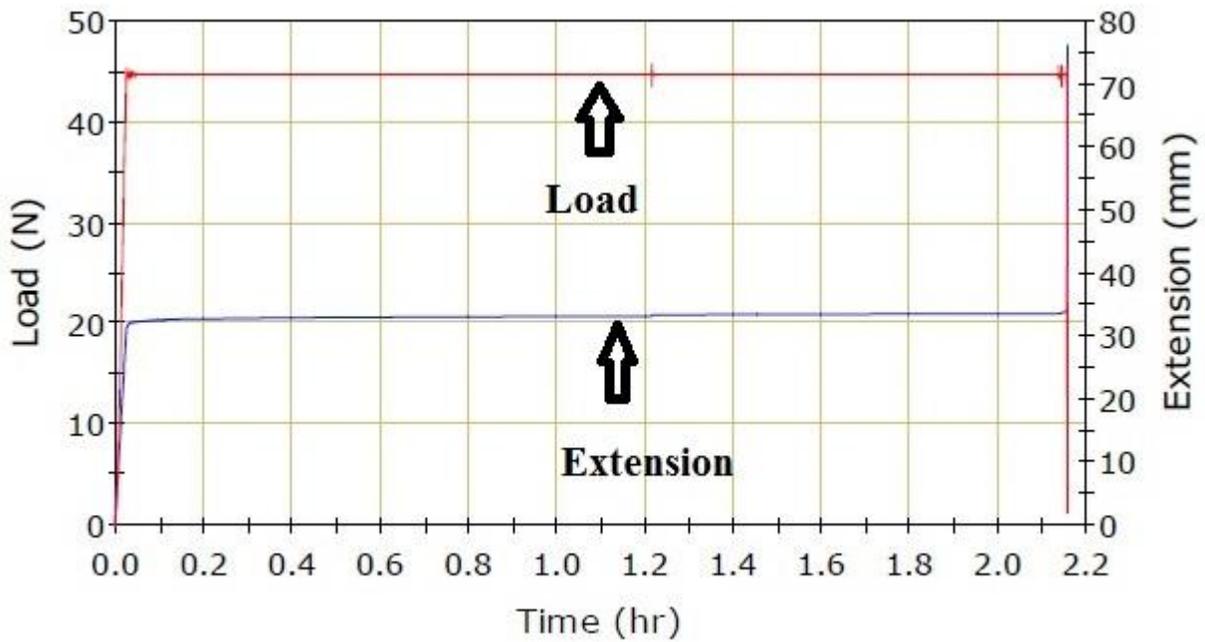
Figure 4.10. Sample # B5 (90% fractional load of sample B2, pre-set holding time 24hr, sample broke after 129.25 minutes).

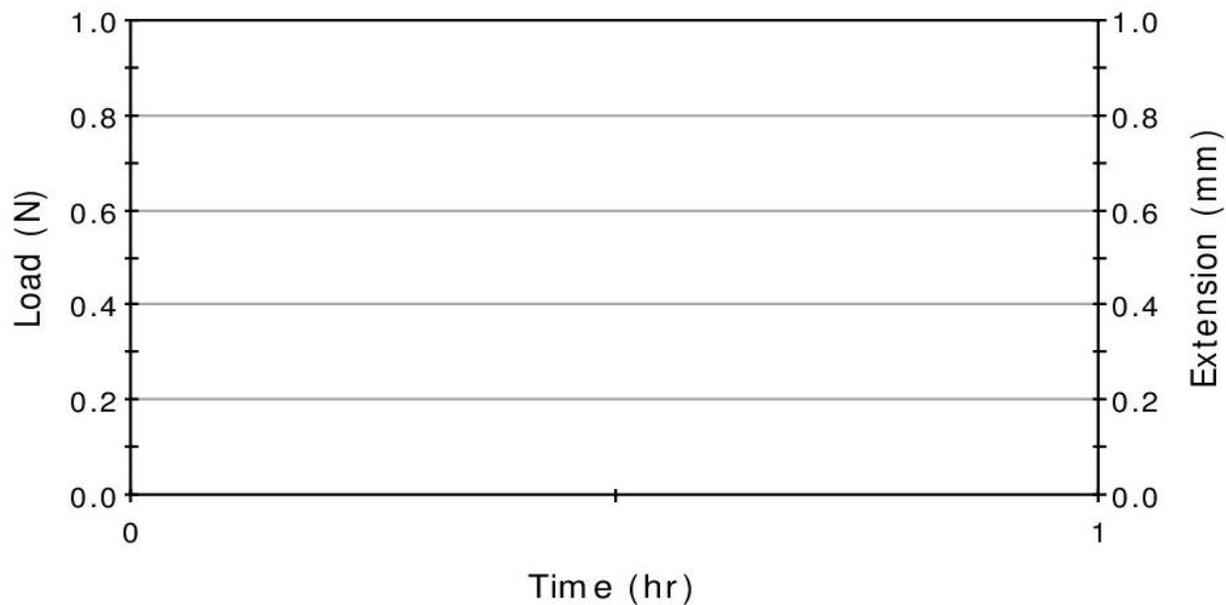
Figure 4.11. Sample # B6 (80% fractional load of sample B3, pre-set holding time 48hr, sample did not break. computer froze after 32 hr).

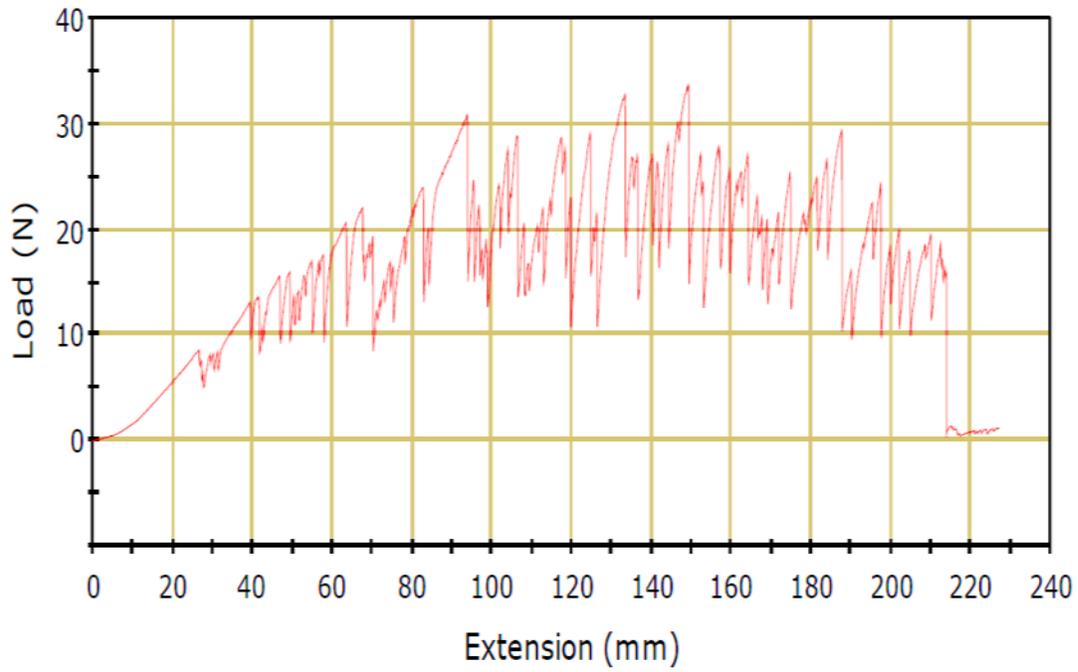
Figure 4.19. Tearing strength of virgin sample.

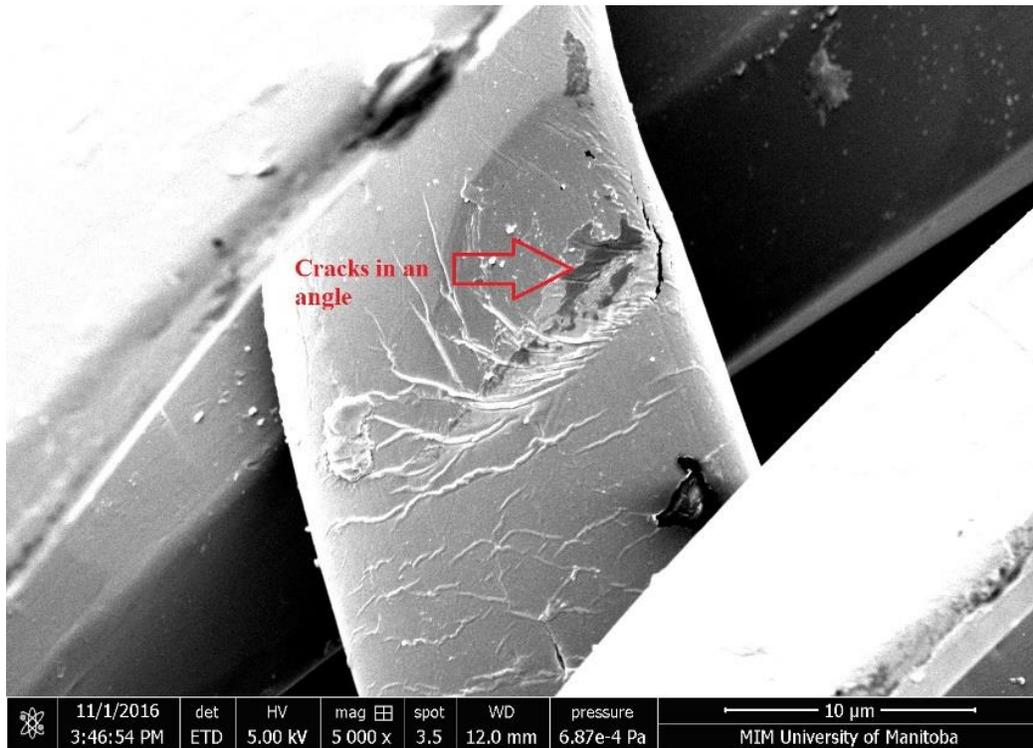
Figure 4.30. *DVPVGKF* sample treated with 4% NaOH in water at 40°C for 30 minutes.

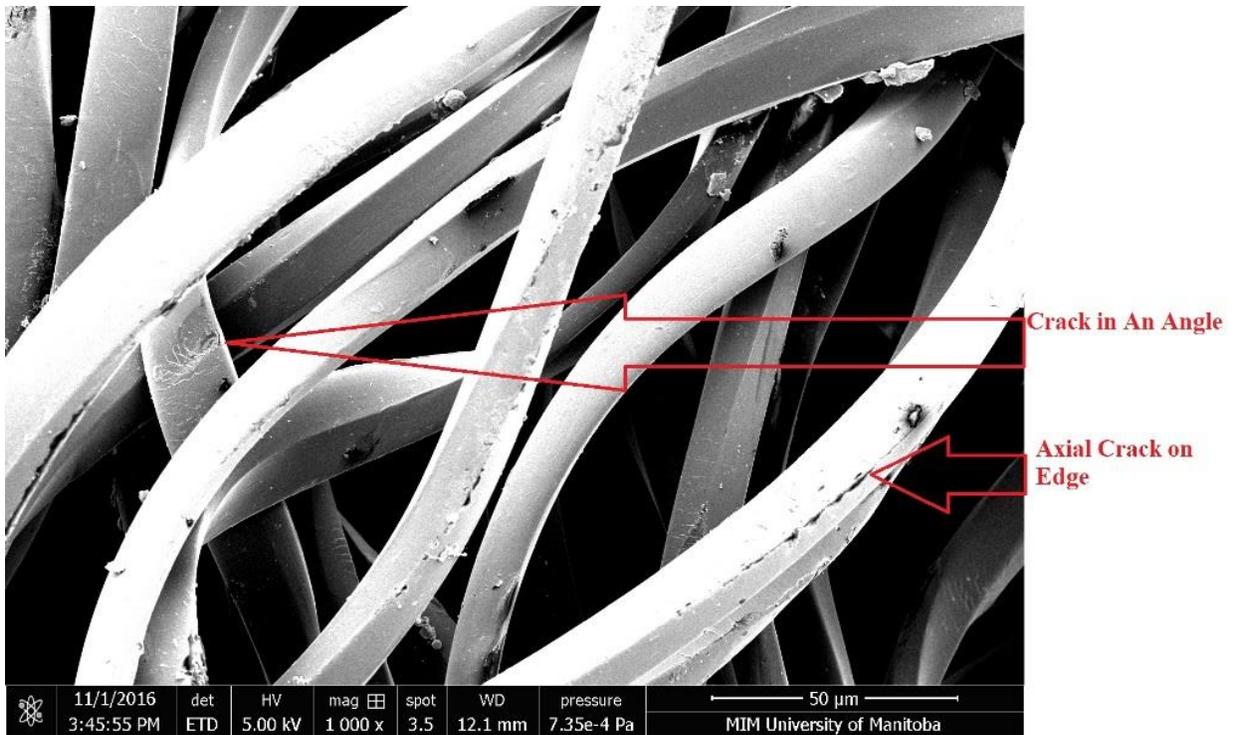
Figure 4.31. *DVPVGKF* sample treated with 4% NaOH in water at 40°C for 30 minutes.

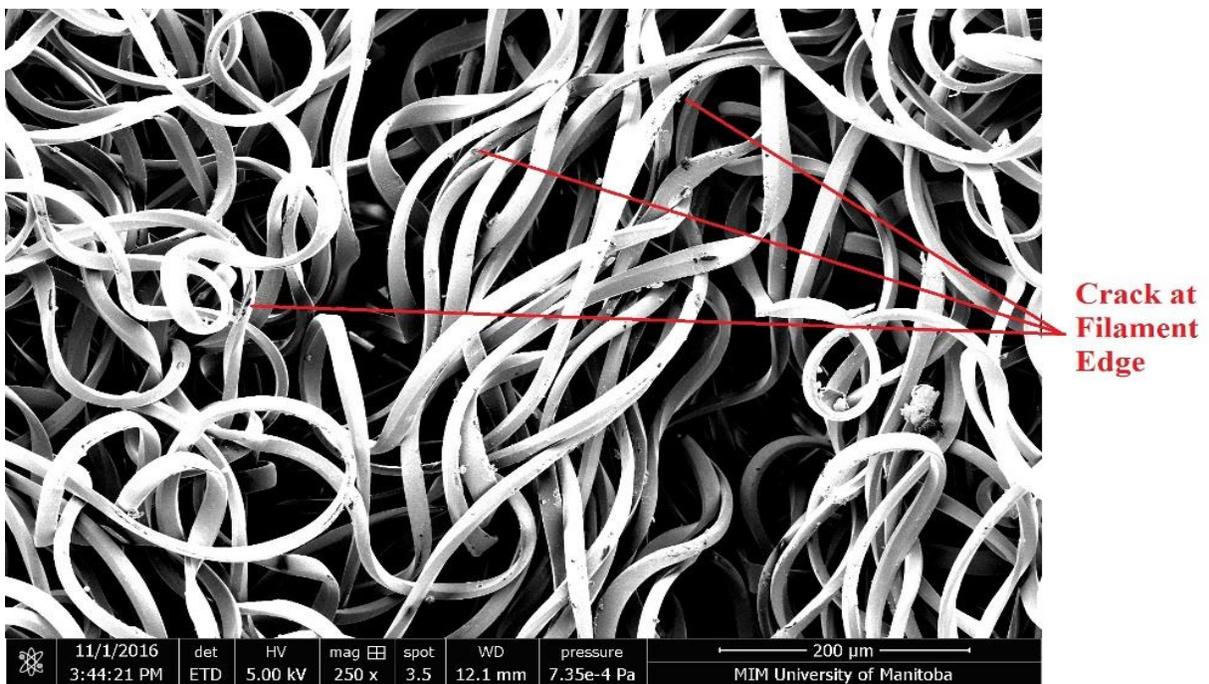
Figure 4.32. *DVPVGKF* sample treated with 4% NaOH in water at 40°C for 30 minutes.
