Relationship between Textile Irregularities and Pre-Mature Rupture of Polyester Vascular Graft Knitted Fabric

A Thesis submitted to the Faculty of Graduate Studies of

Department of Biosystems Engineering

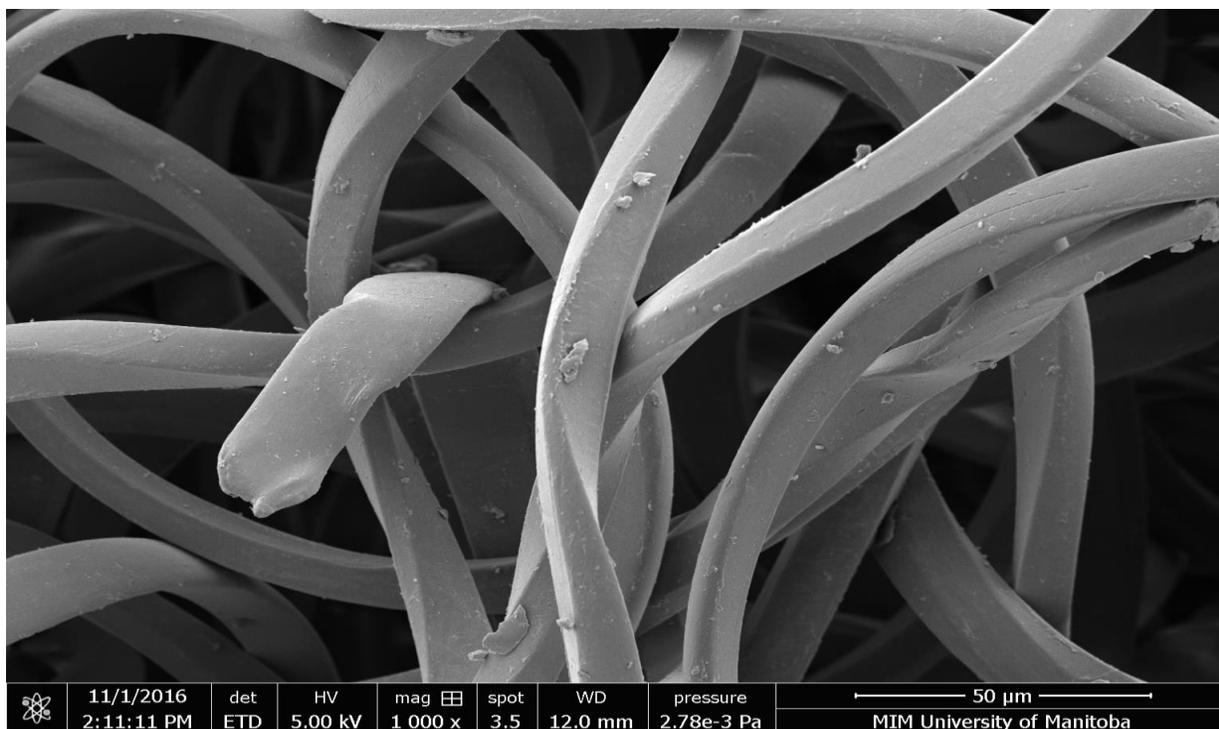
Figure 4.33. *DVPVGKF* sample treated with methanol in 4% NaOH at 40°C for 10 minutes.

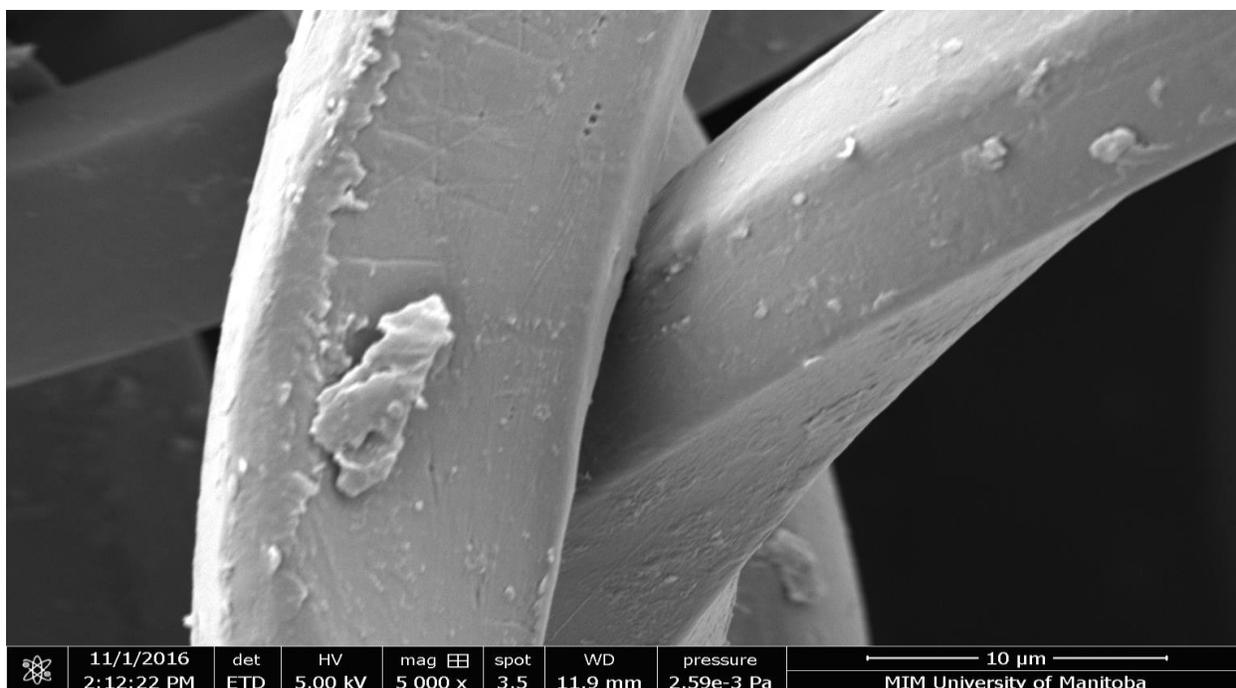
Figure 4.34. *DVPVGKF* sample treated with methanol in 4% NaOH at 40°C for 10 minutes.

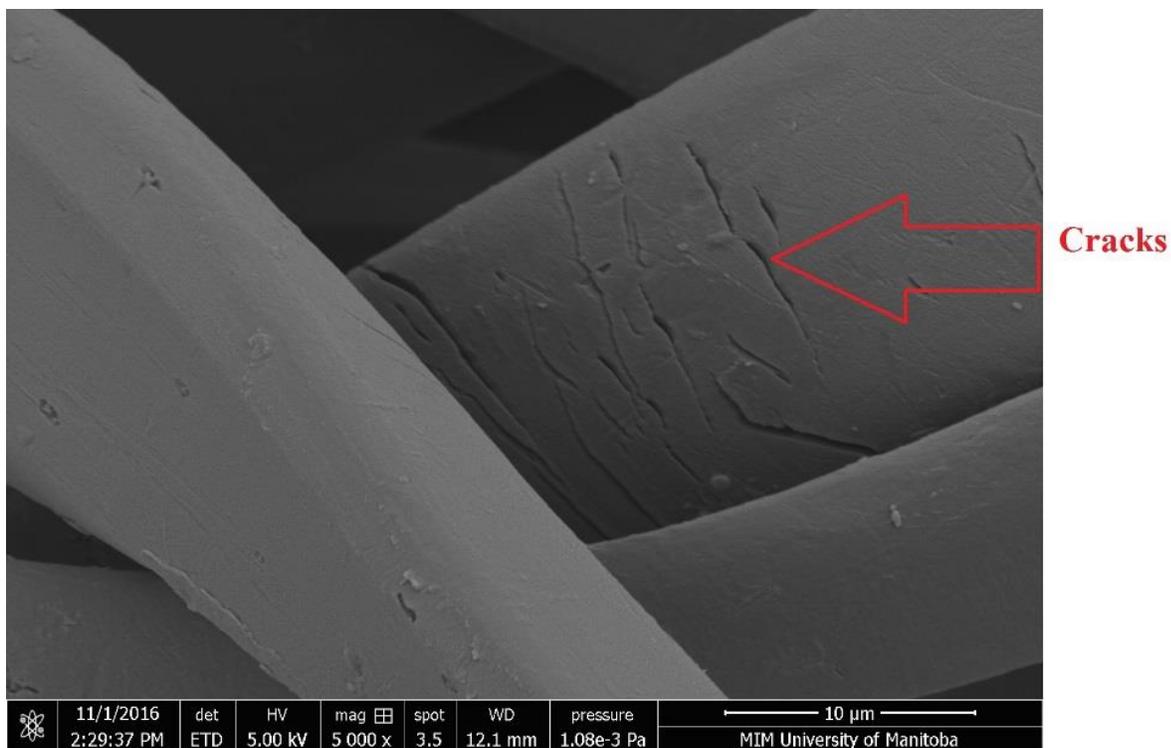
Figure 4.35. *DVPVGKF* sample treated with methanol in 4% NaOH at 40°C for 20 minutes.

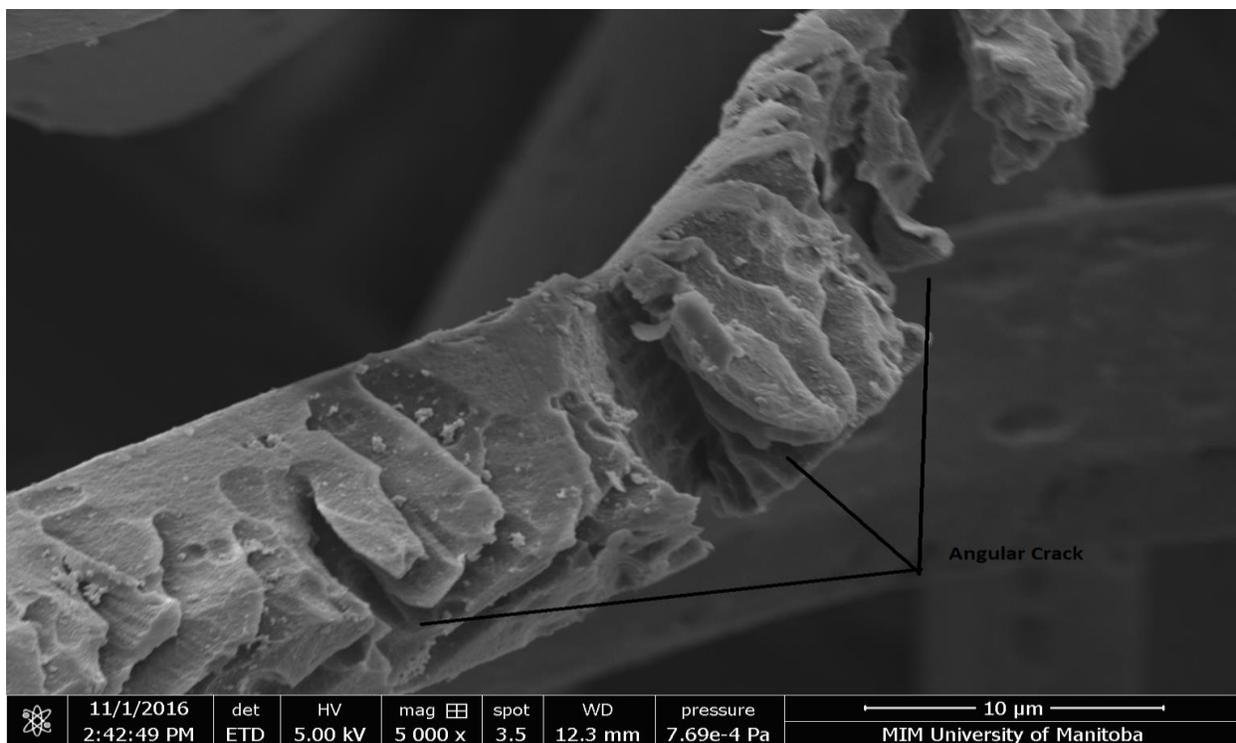
Figure 4.36. *DVPVGKF* sample treated with methanol in 4% NaOH at 40°C for 30 minutes.

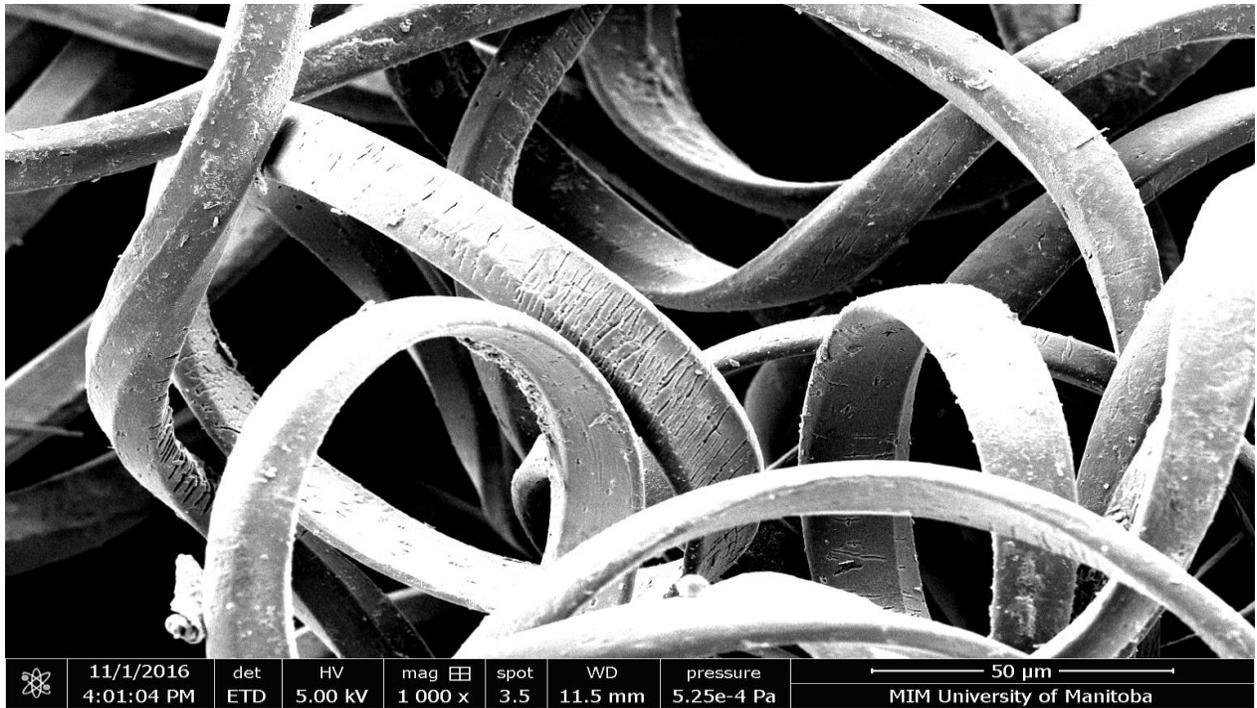
Figure 4.37. *DVPVGKF* sample treated with methanol in 2% NaOH at 40°C for 20 minutes.

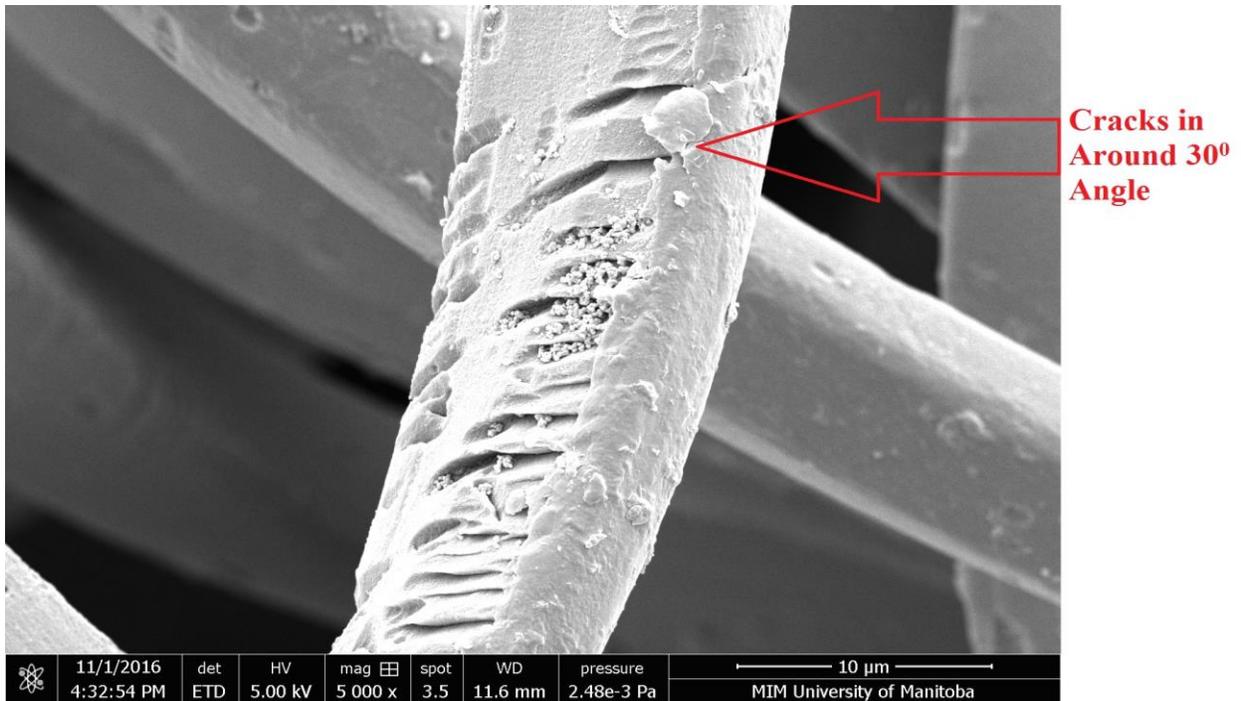
Figure 4.38. *DVPVGKF* sample treated with ethanol in 2% NaOH at 40°C for 30 minutes.

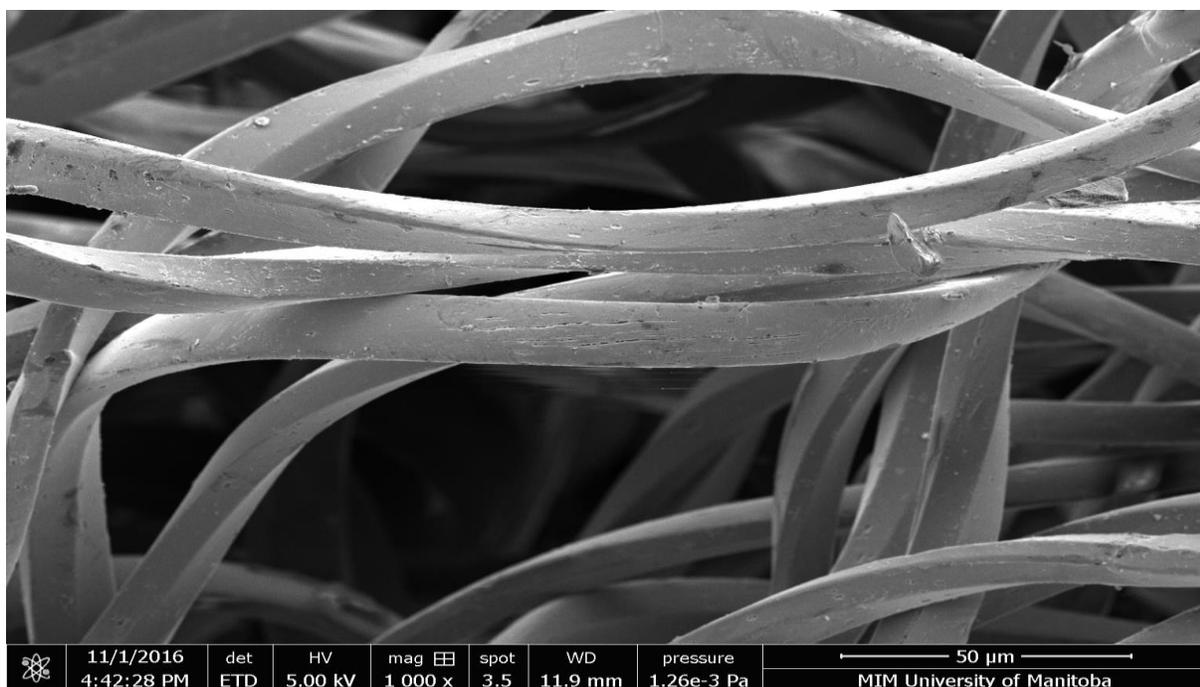
Figure 4.39. *DVPVGKF* sample treated with ethanol in 4% NaOH at 40°C for 10 minutes.

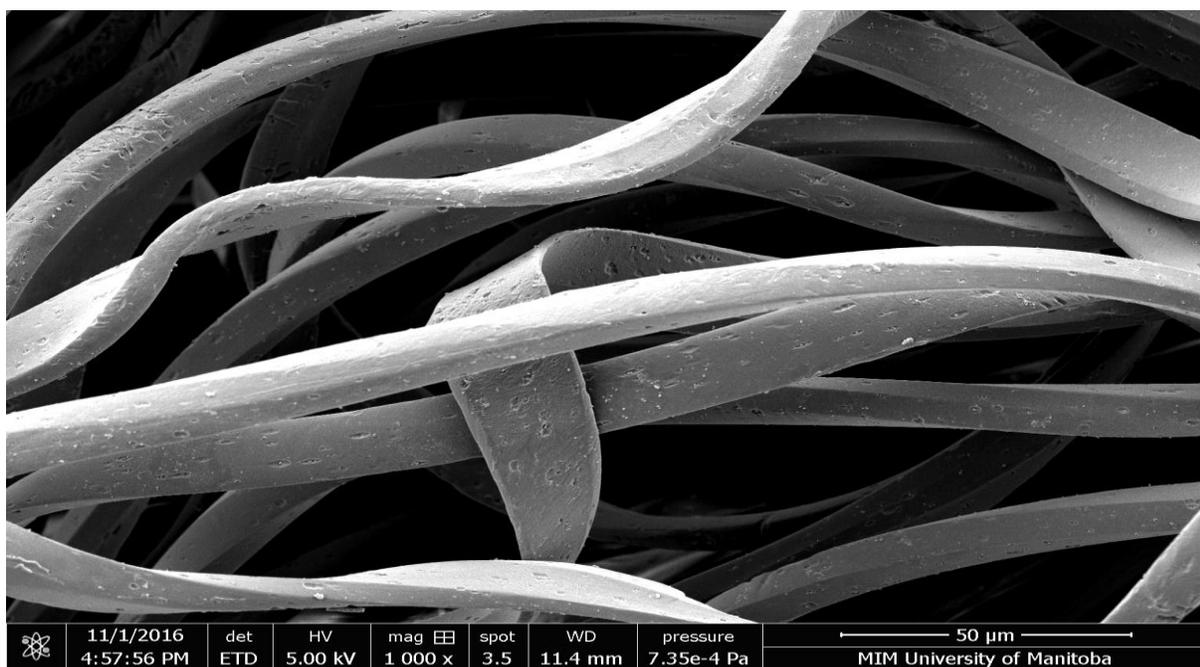
Figure 4.40. *DVPVGKF* sample treated with ethanol in 4% NaOH at 40°C for 20 minutes.

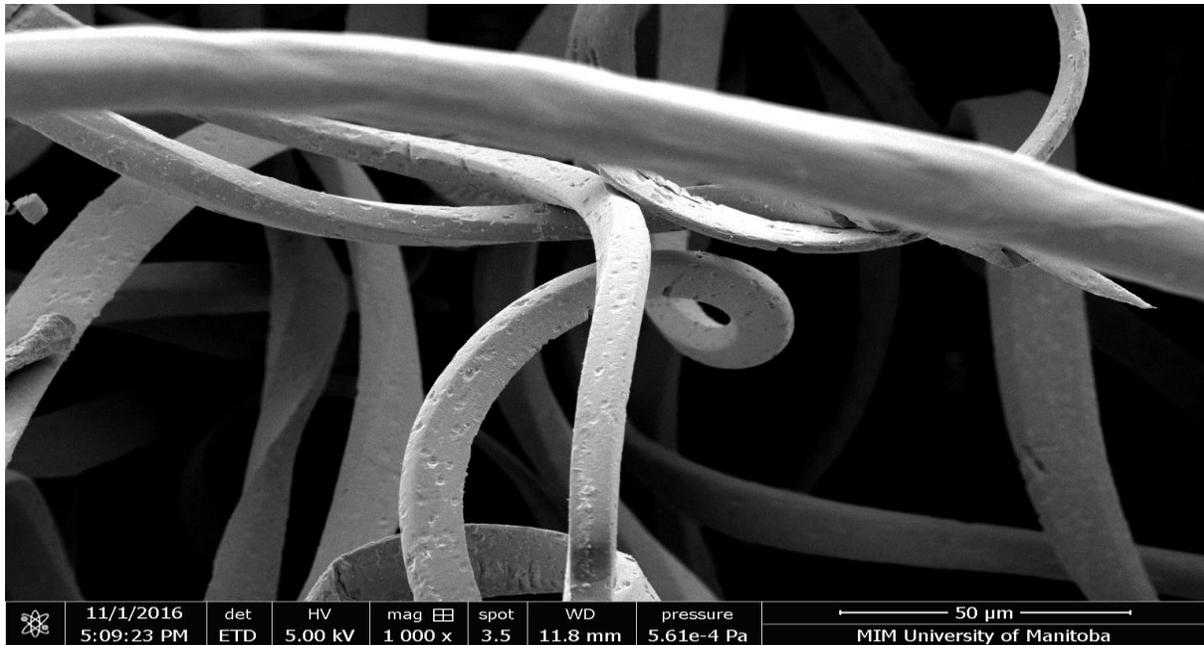
Figure 4.41 (a). *DVPVGKF* sample treated with methanol in 4% NaOH at 40°C for 30 minutes.

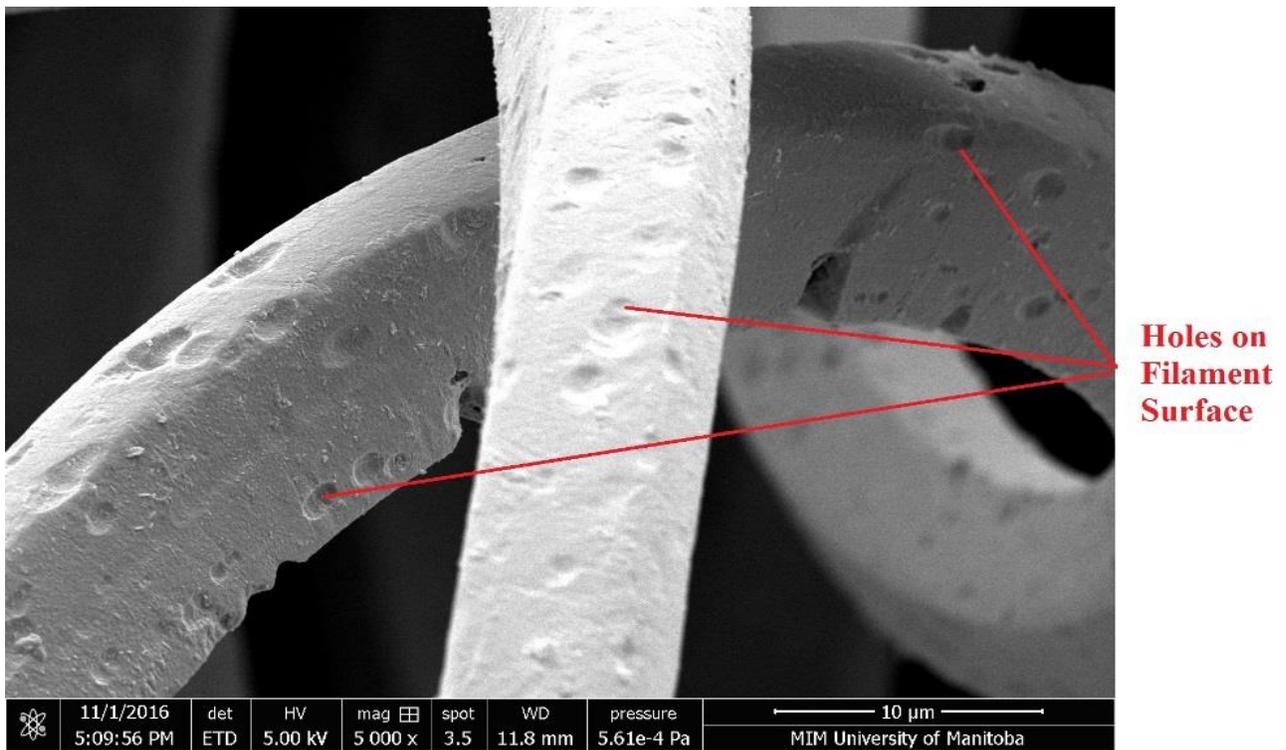
Figure 4.41 (b). *DVPVGKF* sample treated with ethanol in 4% NaOH at 40°C for 30 minutes.
