**DETECTION AND LOCALIZATION OF DAMAGE IN  
FIBER REINFORCED POLYMER BARS USING  
ACOUSTIC EMISSION DETECTION, MICRO COMPUTED  
TOMOGRAPHY, AND SCANNING ELECTRON  
MICROSCOPY TECHNIQUES**

A thesis Submitted to the Faculty of Graduate Studies of  
The University of Manitoba

**Doctor of Philosophy**

Department of Civil Engineering

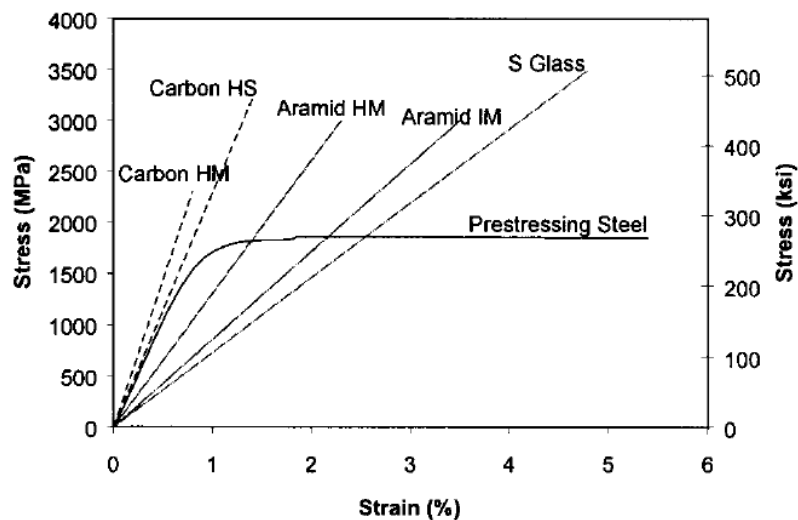
**Figure 1.1** Tensile stress strain relationship for FRP rebars compared with steel rebar

However, FRP composites have a brittle behaviour and demonstrate a linear stress – strain curve, and have relatively low modulus of elasticity. The modulus of elasticity is in the range of 110 – 140 GPa for CFRP and 45 – 65 GPa for GFRP bars, while the modulus of elasticity of steel is 200 GPa as shown in Figure 1.1. Since FRP materials are relatively new in civil engineering applications and frequently subjected to environmental changes condition, it would be beneficial to use non-destructive testing (NDT) methods that have the potential to detect damage at loads well below failure. This is particularly important for FRP bars as they do not exhibit any external signs of damage until their brittle failure.

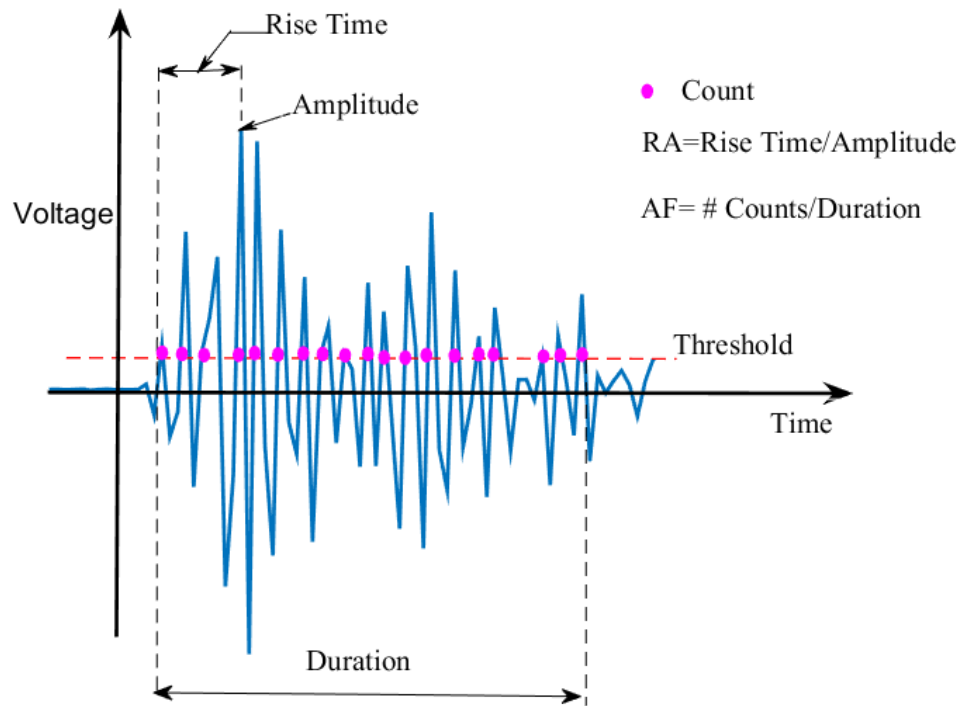
**Figure 2.3** AE signal characteristics

the acoustic properties of the transferring material, the sensor type, and the wave path (ASM International Handbook Committee 1990). After amplification and digitizing, an AE signal is represented as a voltage vs. time plot. AE waves can be analyzed in three domains: time domain, frequency domain, and time-frequency domain. Basic parameters in time domain are shown in Figure 2.3.

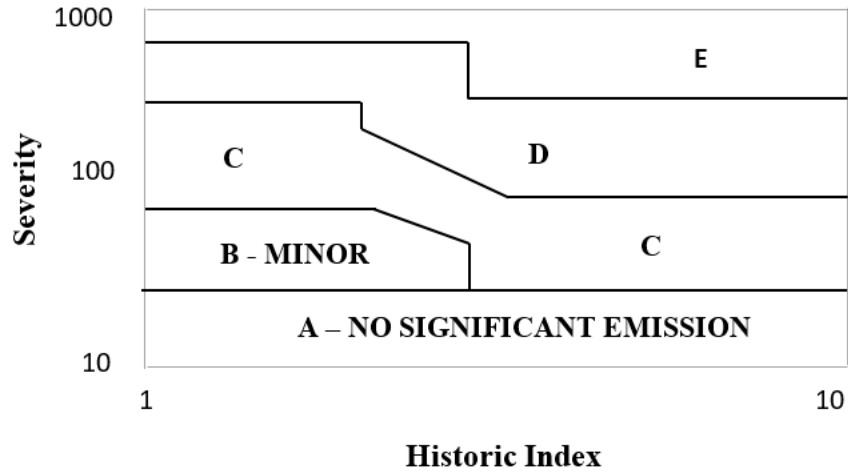
**Figure 2.7** Intensity analysis zones for FRP vessel (reproduced from Gostautas et al. 2005)

Hence, the historic index and the severity are important parameters for intensity analysis which helps to identify the onset of a significant damage and its propagation. The intensity of an acoustic emission source can be determined by plotting severity vs historic index in a log-log chart as shown in Figure 2.7. The zones A to E are explained in Table 2.4.

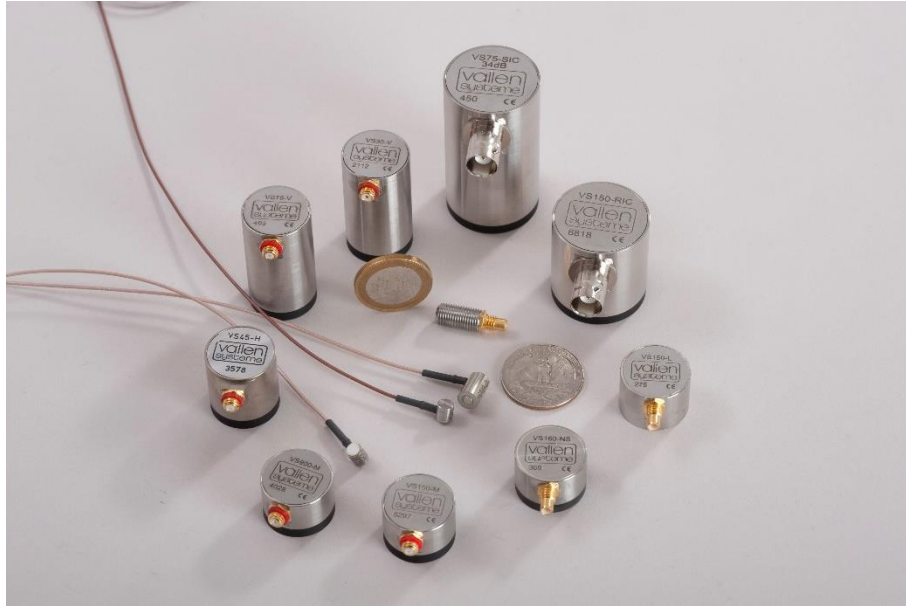
**Figure 2.8** Vallen System Sensor Collection. (Used with permission of Vallen System)

There are various types of acoustic emission transducers used in different structures and materials. The most significant factor for the AE to be successful is the choice of a correct transducer in terms of sensitivity and frequency response. Generally, the AE transducers are piezoelectric (PZT) devices. The frequency response is affected by the size and the type of the transducer (ASTM E1316 2006). In order to insure an effective transition of the AE signals from the test specimens to the transducers, a suitable coupling is required. The AE transducers are attached to the surface of the structure using magnetic holders or glues. The frequency range of the transducers varies from (20 kHz – 2.2 MHz) depending on the sensor type and the material under testing (Vallen 2002). In FRP composites, sensors with range of 100 kHz – 200 kHz are applicable (CARP 1999). Figure (2.8) below shows the commercial types of the transducers.

Two types of piezoelectric transducers are used in FRP monitoring, resonant and broadband (wideband) transducers. The resonant transducers have varying frequencies appropriate for concrete: (R6I) resonant with sensitivity equal to (40-100) kHz and R15I resonant with sensitivity equal to (80-200) kHz. The resonant sensors are less expensive and more sensitive at their resonance frequency (Vallen 2002). Accordingly, this type is used near the damage source to minimize amplitude attenuation and in other cases that other AE features rather than frequency content are required. Other AE features such as energy, amplitude, and arrival time should be recorded with the same type of sensors. The broadband sensors are preferred for practical structural monitoring in case background noise is the problem such as friction and impact which results from the surrounding environment and in case the frequency or model analyzing is required (Vallen 2002). It is important to know that one type of damage mechanism can produce different signals from

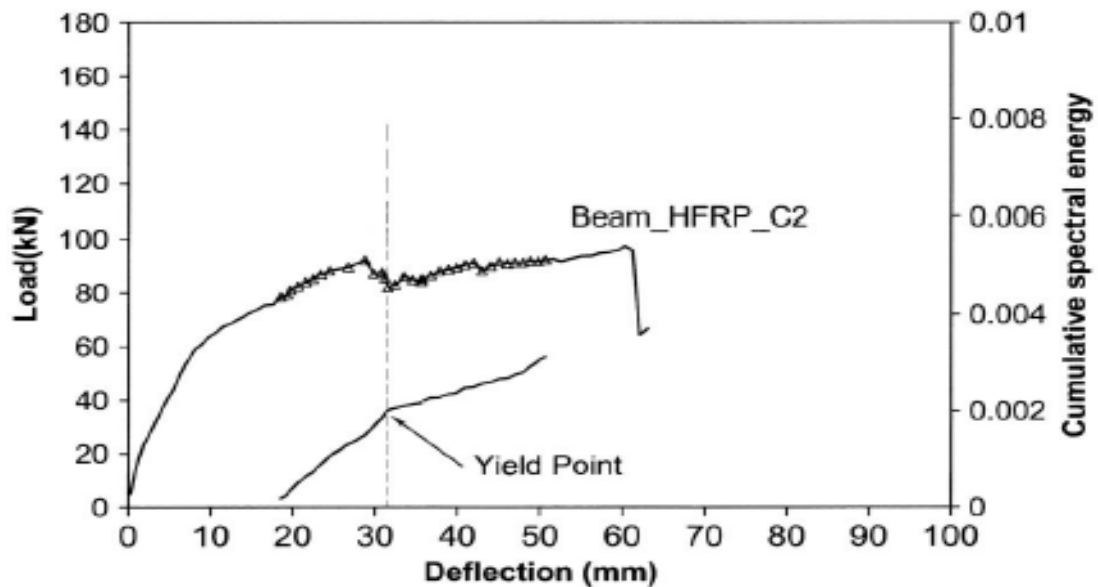
**Figure 2.12** Correlation of AE with the load deflection curve and cumulative spectral energy (Liang et al. 2011, With permission from ASCE)

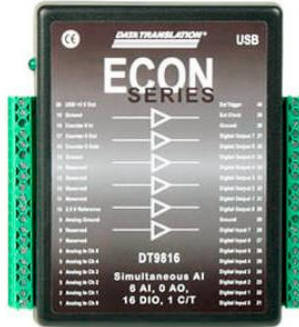
**Figure 3.1** DT9816-S, 16 bit with maximum 750 kHz sampling rate for one channel

The equipment that was used to collect acoustic emission signals in this study is MISTRAS (Massively Instrumented Sensor Technology for Received Acoustic Signals), which is manufactured by Physical Acoustic Corporation. The main components of MISTRAS are a multi-channel Data translation device (DT9816-S 16 bit with maximum 750 kHz sampling rate for one channel as shown in Figure 3.1.

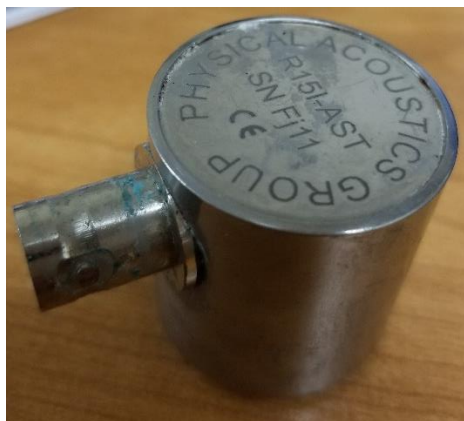
**Figure 3.2** R15I-AST Transducer

Two piezoelectric sensors type R15I-AST, manufactured by MISTRAS, (see Figure 3.2) were used to pick up the AE signals. Each sensor has an integral preamplifier with gain at 40 dB to increase the incoming voltage of the signal for easier transmission and conversion by Analogue to Digital Converter (ADC). The operating frequency range is 80 – 200 kHz. The diameter of the sensor is 29 mm, the height is 31 mm, and the weight is 70 g (MISTRAS 2014).

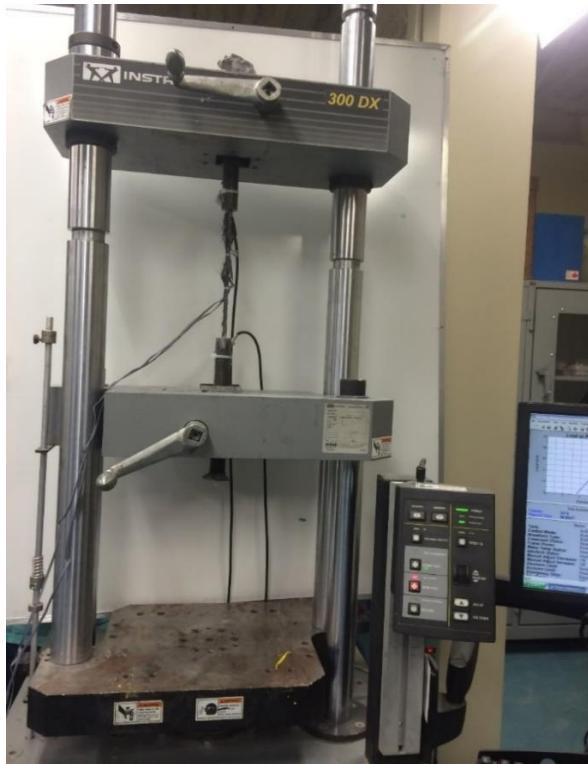
**Figure 3.3** Instron 300 DX machine

- Servo-hydraulic testing machine, Instron 300 DX, was used for testing CFRP size 2 and GFRP size 4 bar specimens under increasing tensile loads as shown in Figure 3.3.

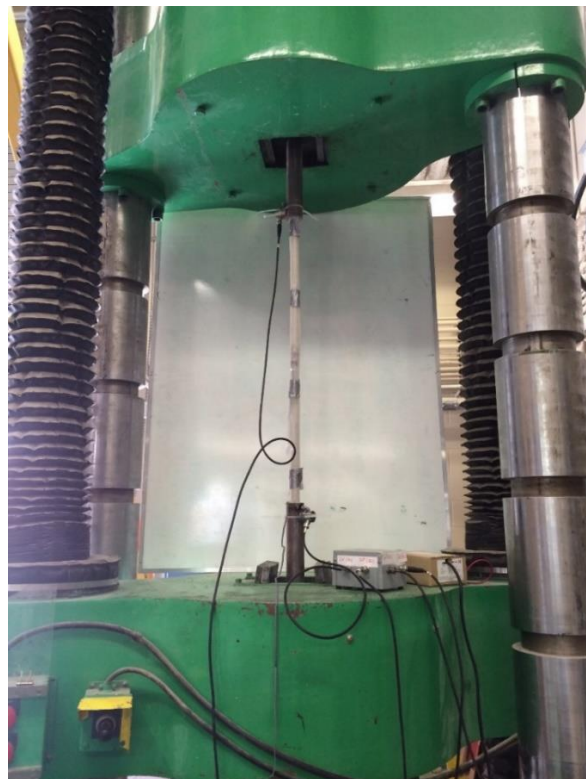
**Figure 3.4** Baldwin 600 XHV machine

- Servo-hydraulic testing machine, Baldwin 600 XHV, was used for testing CFRP size 4 and GFRP size 6 bar specimens under ramping tensile loads as shown in Figure 3.4.

The maximum capacity of the machine is 600 kN.

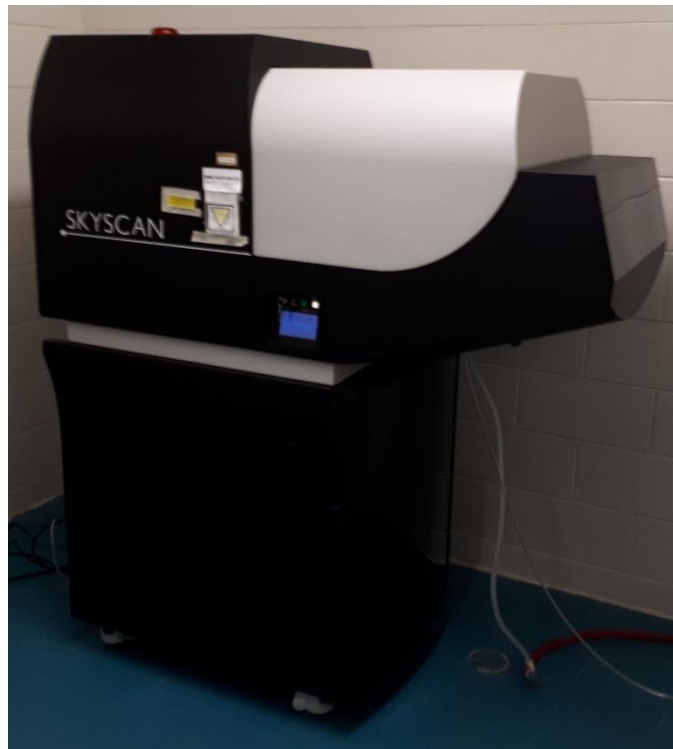
**Figure 3.5** SkyScan 1176 micro-CT scanner

SkyScan 1176 micro-CT scanner (Bruker Micro CT, Kontich, Belgium), as shown in Figure 3.5, was used to acquire  $\mu$ CT images at 9  $\mu$ m resolution with an angular step size of  $0.5^\circ$ . Three scans were acquired at each angular position and averaged.

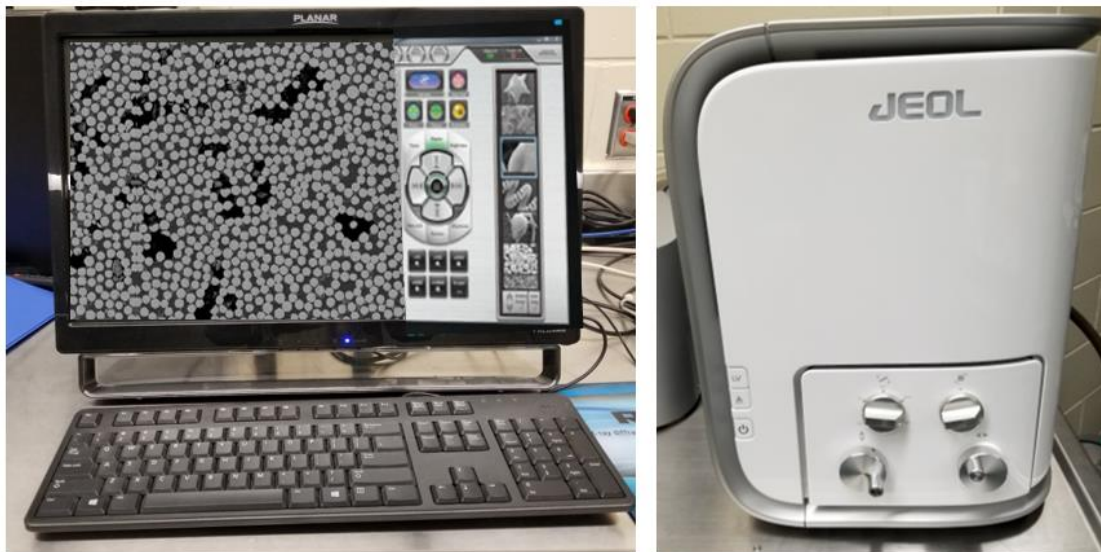
**Figure 3.6** JEOL JCM-6000 NEOSCOPE II Benchtop SEM

- JEOL JCM-6000 NEOSCOPE II Benchtop Scanning Electron Microscope, as shown in Figure 3.6, with magnifications range (10X-60000X) was used for providing cross section and transverse section images of FRP rebars.

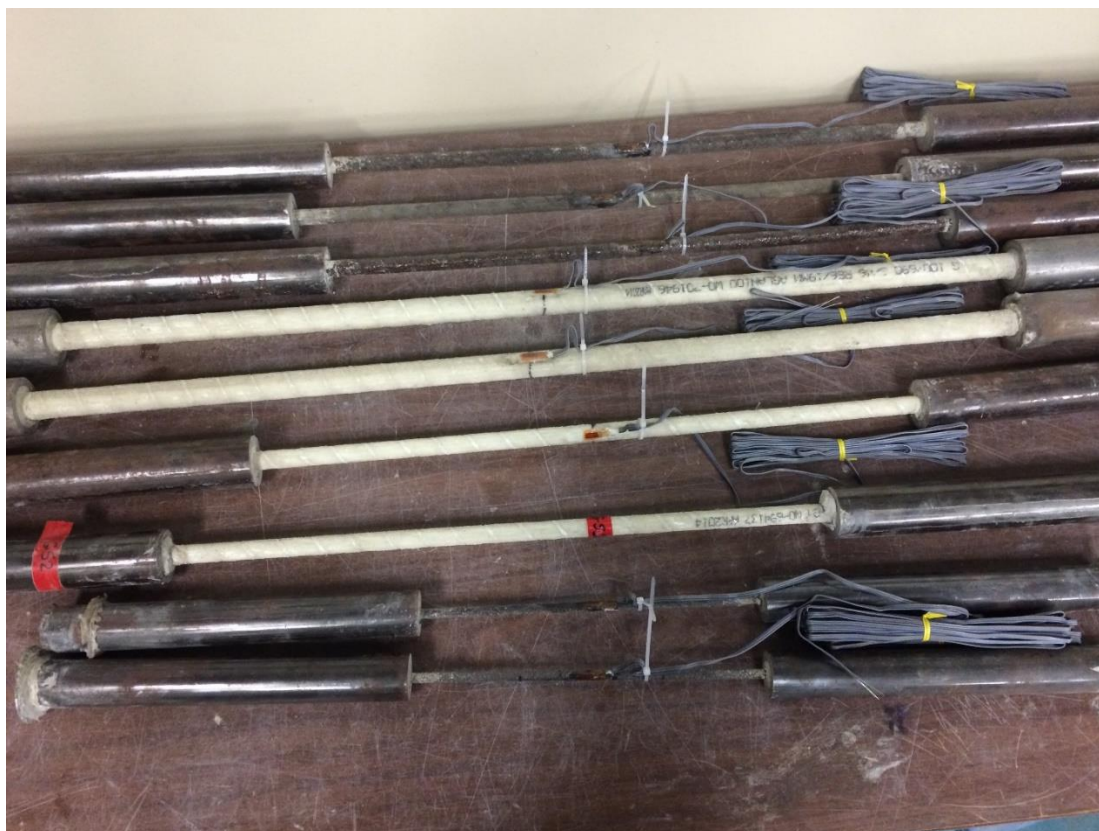
**Figure 3.8** Types of GFRP and CFRP samples

AE characteristics. the method given in Annex B in the CSA S806 (2012) was used to prepare the specimens (CSA 2012) as shown in Figure 3.8. The code requires that the tension force be applied to the samples indirectly to prevent FRP crushing in the anchorage zone. As a result, FRP specimens were anchored into steel pipes with expansive grout that were gripped by the testing machine. Servo-hydraulic load system was used for the tensile loading test as shown in Figure 3.9. Strain gauges with gauge length of six millimetres and resistance of  $120 \Omega \pm 0.3 \%$  were glued on the surface of each specimen at the centre of the bar after removing the sand coating. A brief description of the FRP types, properties, and their configurations are listed in Table 3.1.

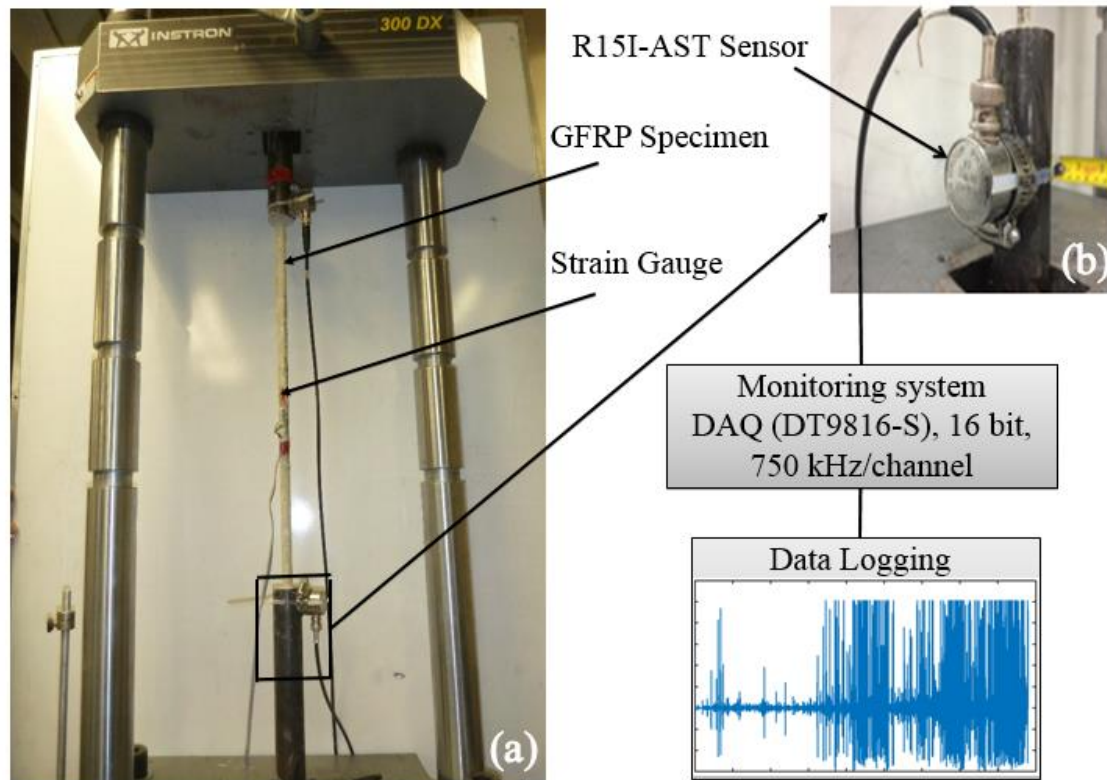
**Figure 3.9** AE system set up for the tensile load testing. (a) FRP specimen with anchors in servo-hydraulic load frame (b) Sensor coupled to the anchor using couplant gel

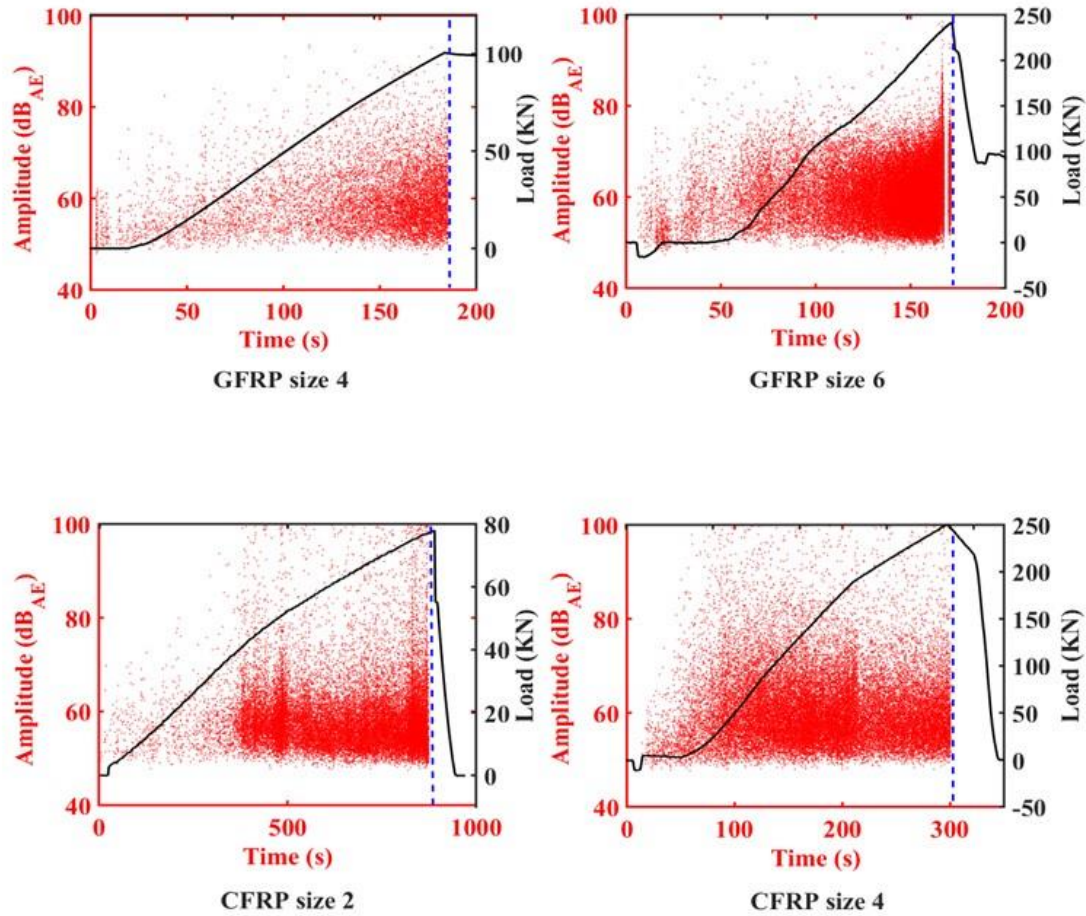
**Figure 4.2** Amplitude vs. time with load time superimposed. Dashed line represents time at which failure occurred for CFRP size 2 and GFRP size 6. CFRP size 4 and GFRP size 4 were loaded up to 93% and 95% predicted ultimate load respectively

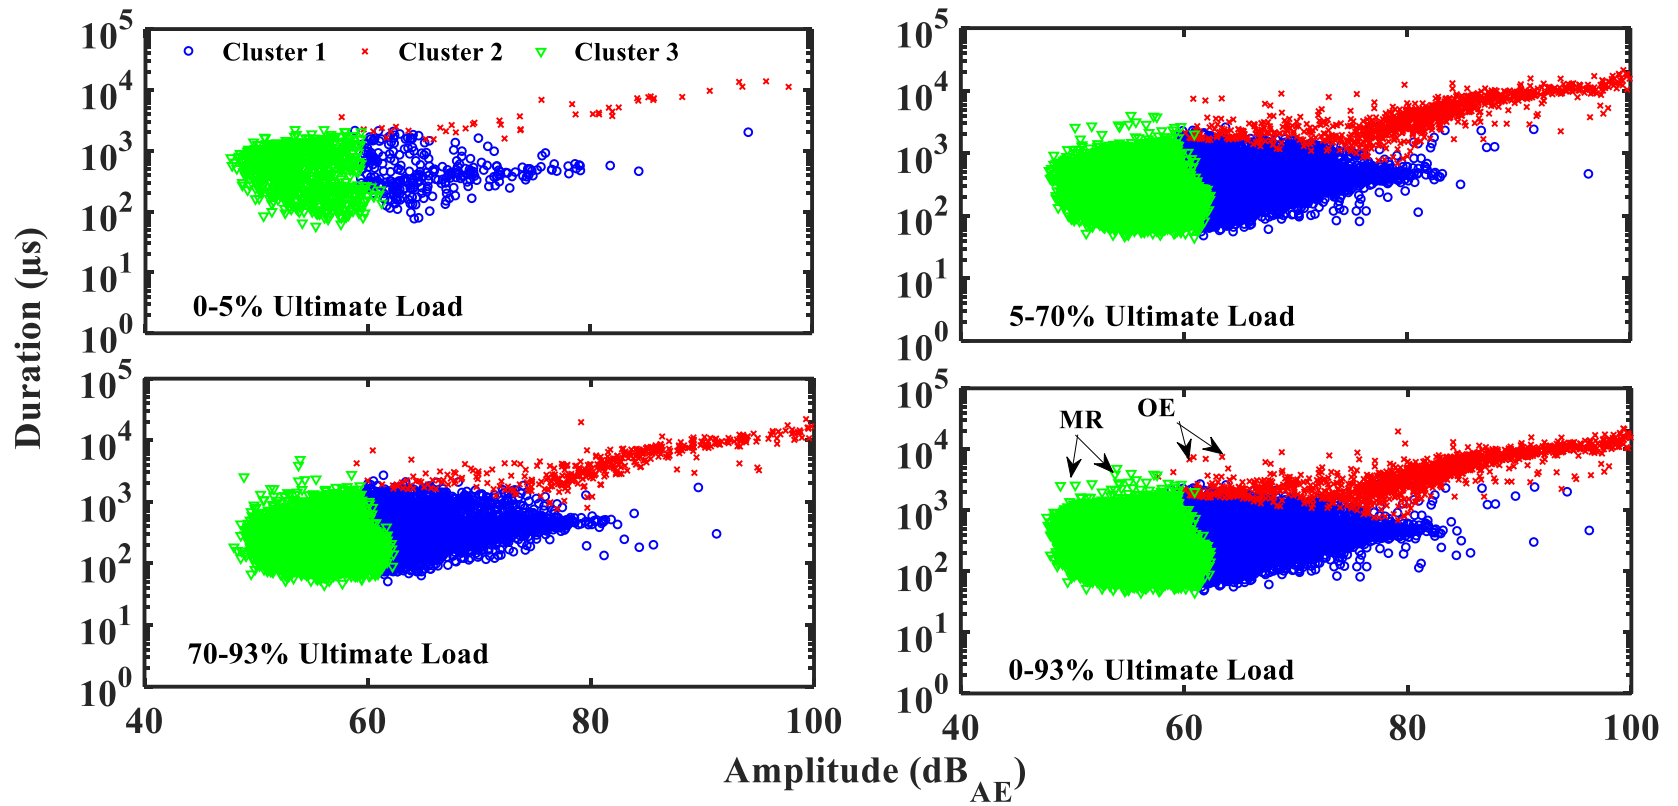
**Figure 4.5** Duration vs. Amplitude for three stages in CFRP size 4 specimen. Duration is the time of a signal from the first point exceeding the threshold level to the last one. MR: mechanical rubbing; OE: overlapping events; cluster 1: debonding; cluster 2: fiber breakage; cluster 3: matrix cracking

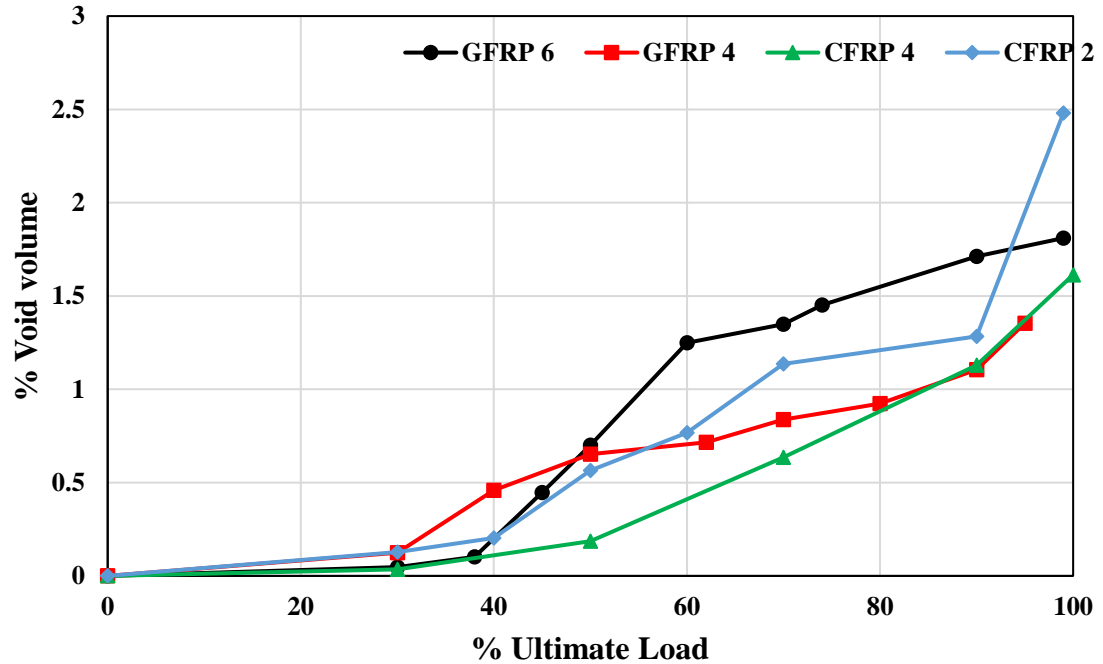
**Figure 5.7** Ratio of the void volume as a function of the increasing tensile loading, after subtracting the void percentage of the control bars formed during the pultrusion process
