SOME MORPHOMETRIC PROPERTIES AND EROSION RATES
OF GULLIES ALONG A PORTION OF THE MANITOBA ESCARPMENT

ROBERT VINCENT YOUNG

A THESIS
SUBMITTED TO THE FACULTY OF GRADUATE STUDIES
IN PARTIAL FULFILLMENT OF THE REQUIREMENTS FOR THE DEGREE
OF MASTER OF ARTS

MAY 1975

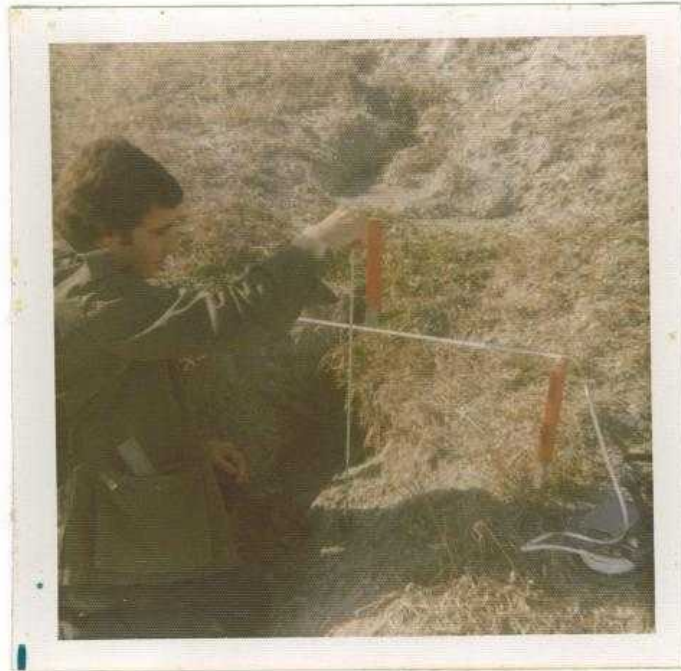
Plate 3.1

section measurements to be made with an accuracy of $1/16$ of an inch. An illustration of this method is presented in Plates 3.1 and 3.2.

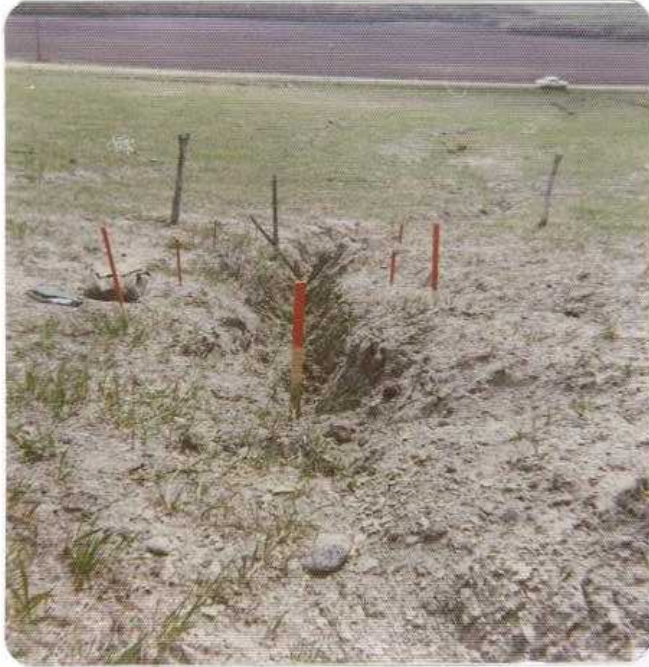
Plate 3.3
Eden Farm Gully 1 looking east

The Eden Farm Gullies show most clearly the effects of man's activities upon the initiation of gullies. The 1946 aerial photographs show the Eden Farm Gully 1 as a small shallow gully located on improved pasture. The Eden Farm Gully 2 first appears on the 1958 aerial photographs, while the Eden Farm Gully 1 is already well-developed by 1958. In 1946 the site of the gullies contained a field access road and cattle paths. By 1958 the field access road had turned into a large deep gully, and the Eden Farm Gully 2 is a tributary gully to what was once a field access road. In 1946 a cattle path had developed along a fence row and by 1958 this cattle path had turned into a deeply incised gully. The field access road channelized flow down the ruts of the road with the end result being a gully. The cattle path alongside the fence row intercepted natural downslope runoff, channelized the flow down the cattle path, resulting in the development of a gully.

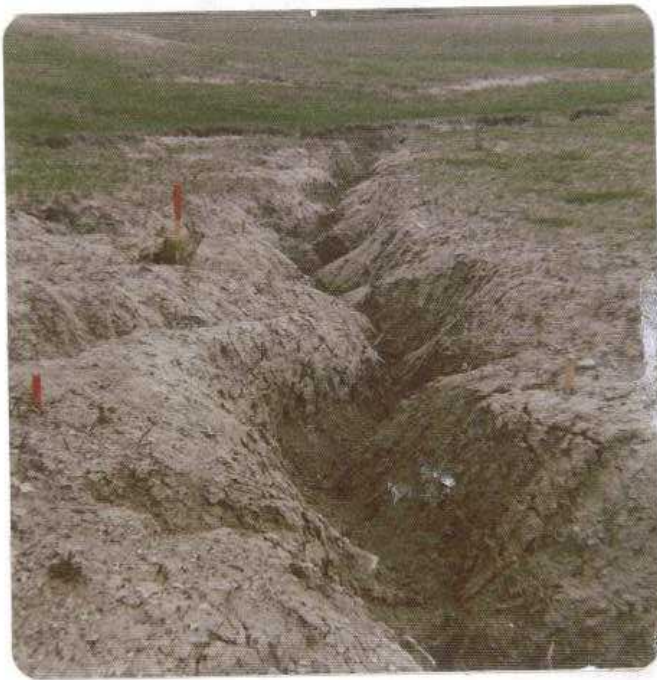
Plate 3.4
Eden Farm Gully 2 looking south-east

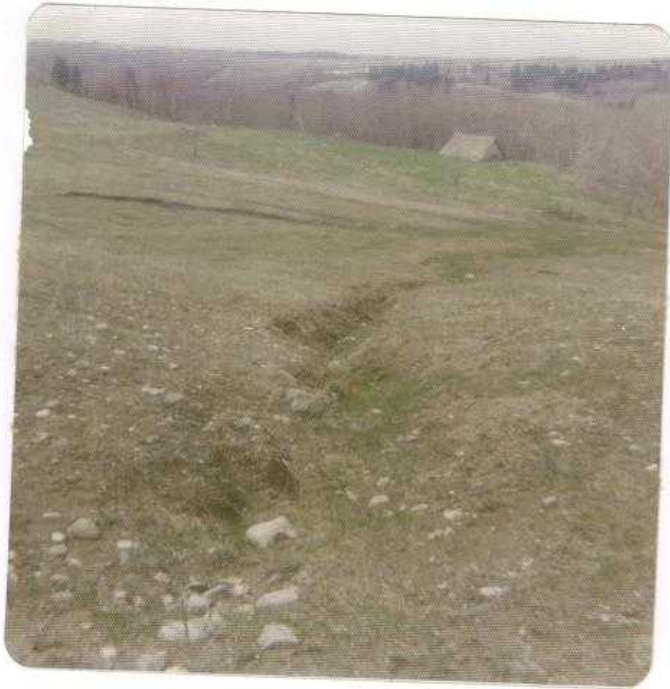
Plate 3.5

Polonia Gully looking west

The 1946 aerial photographs show that the Polonia Gully was present in 1946. From 1946 until the present, the drainage basin of the Polonia Gully has been under grain cultivation. The natural vegetation has been removed and replaced with grain crops. The cultivated drainage basin has a slope of 16.40 per cent. Ireland et al. (1939) recommended that in South Carolina the steepest slope suitable for cultivation for most soils was 12 per cent. A contributing cause of the Polonia Gully may be the cultivation of this steep slope.

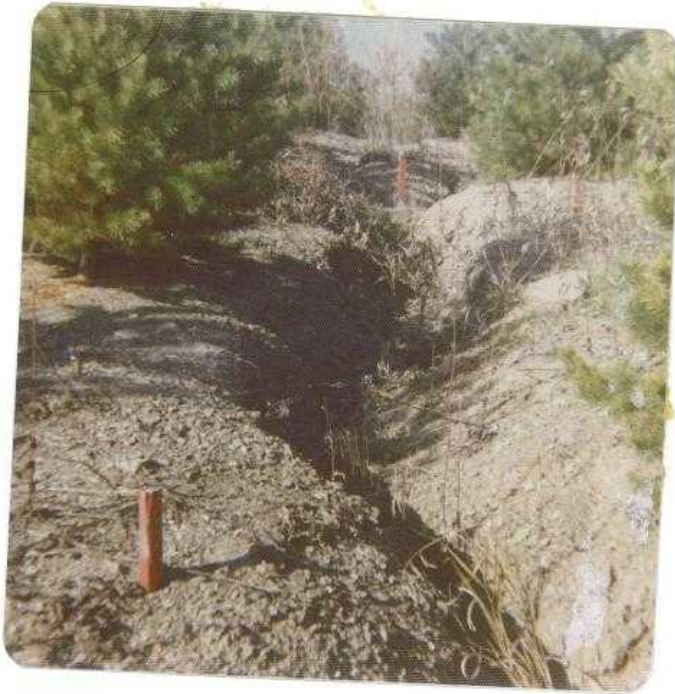
Plate 3.6

Rosedale Gully 1 looking west. The Rosedale Gully 2 is alongside but not visible. Note vegetation growing within the gully channel.

1958 aerial photographs, but they are not present on the 1946 aerial photographs. From 1958 until 1967 the Rosedale Gully sites were situated on improved pasture. Because of the steep slopes, shallow topsoil, and overgrazing by cattle, this land had reached exceedingly low productivity. In 1967 the Manitoba Provincial Government purchased this land and revegetated it with grasses and trees, with hopes of returning the badly eroded terrain to its natural condition. Because of the land misuse prior to 1967, the Rosedale Gullies developed upon what was once improved pasture.

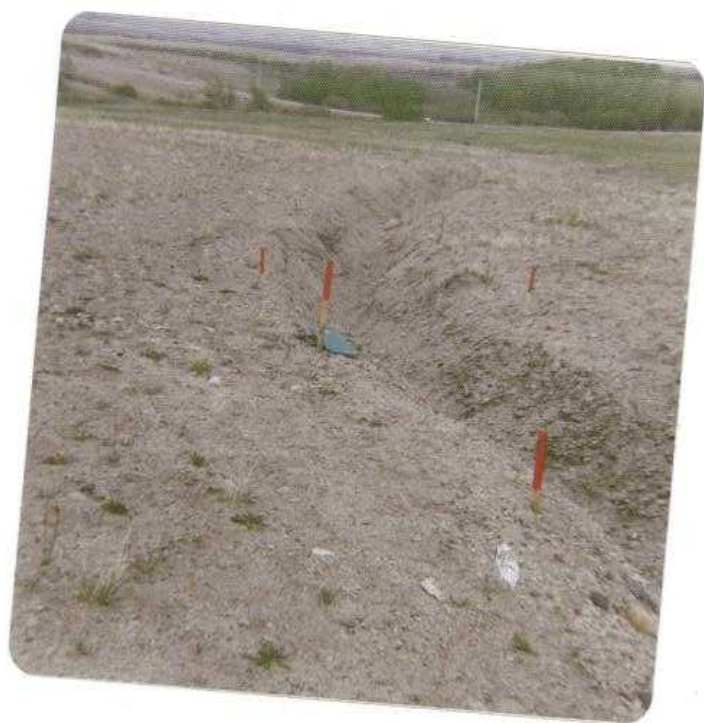
Plate 3,7

Roadside Gully looking south

The Roadside Gully was also present on the 1946 aerial photographs. The aerial photographs show that from 1946 until 1958 the Roadside Gully drainage basin was planted in grain crops. From 1958 until the present, the drainage basin has been used as improved pasture. Although the hillslope is much gentler than that of all the other gullies (6.7 per cent), the replacement of natural vegetation with grain crops may have been a contributing factor in the development of the Roadside Gully.

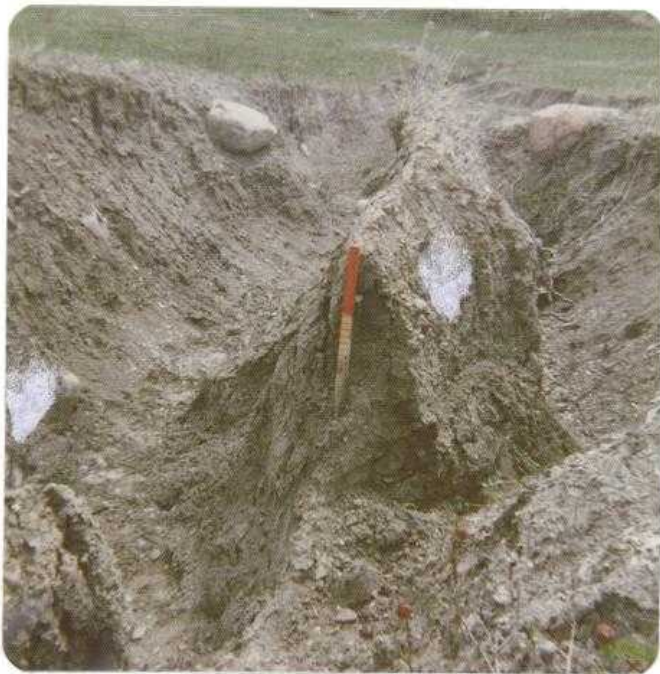
Plate 3.9

A closer view of the gully in Plate 3.8
The marker stake is approximately 2 feet long.

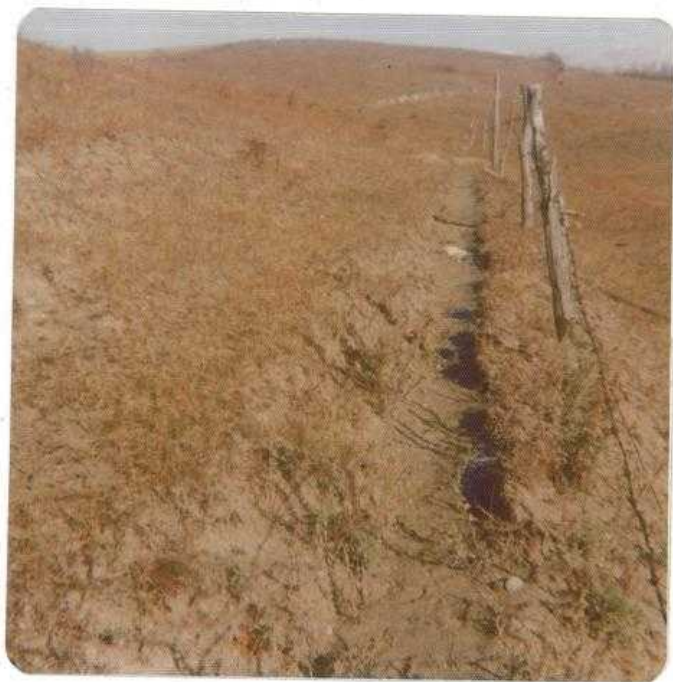
Plate 3.10

A cattle path developing parallel to a boundary fence at the Eden Farm Gully 2 site. The cattle path intercepts downslope runoff. In time the cattle path may develop into a gully.

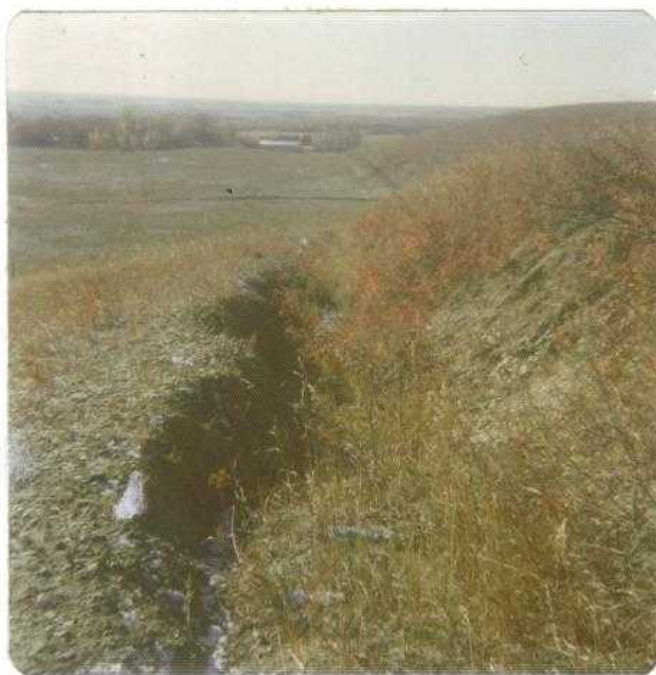
Plate 3.11

A fully developed gully running parallel to an abandoned boundary fence at the Eden Farm Gully 2 site. Parallel to this abandoned fence was once a cattle path similar to the cattle path in Plate 3.10.

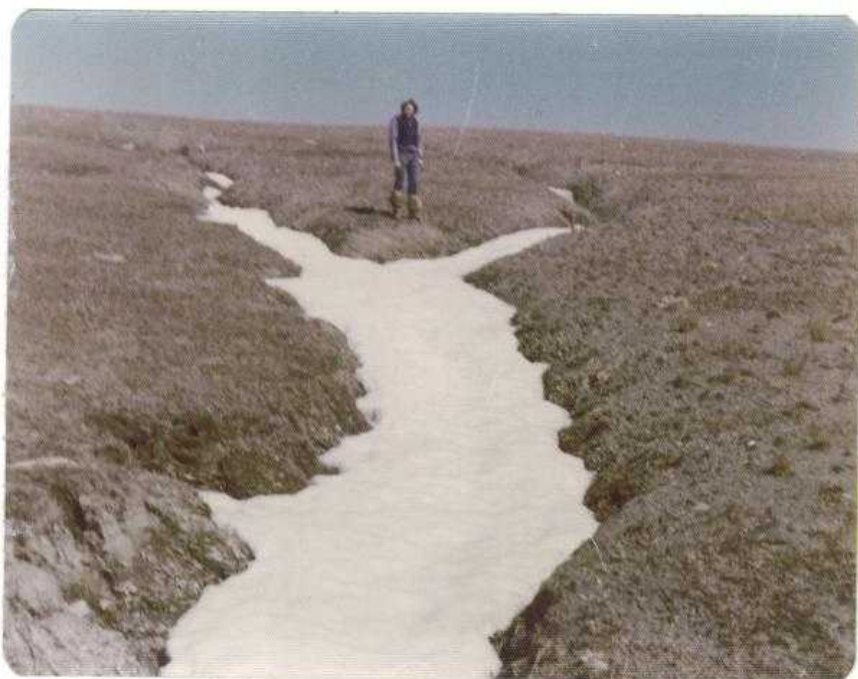
Plate 5.1

Snow remains in the Roadside Gully long after the snow has melted from the drainage basin. The picture was taken April 21, 1974, and the snow in the gully had melted by May 13, 1974.
