**STRUCTURAL PERFORMANCE OF GFRP REINFORCED
BALCONY SLAB WITH THERMAL BREAK**

Arezo Rasouli

A Thesis submitted to the Faculty of Graduate Studies of
the University of Manitoba
in partial fulfillment of the requirements for the degree of

Department of Civil Engineering
University of Manitoba
Winnipeg, MB, Canada

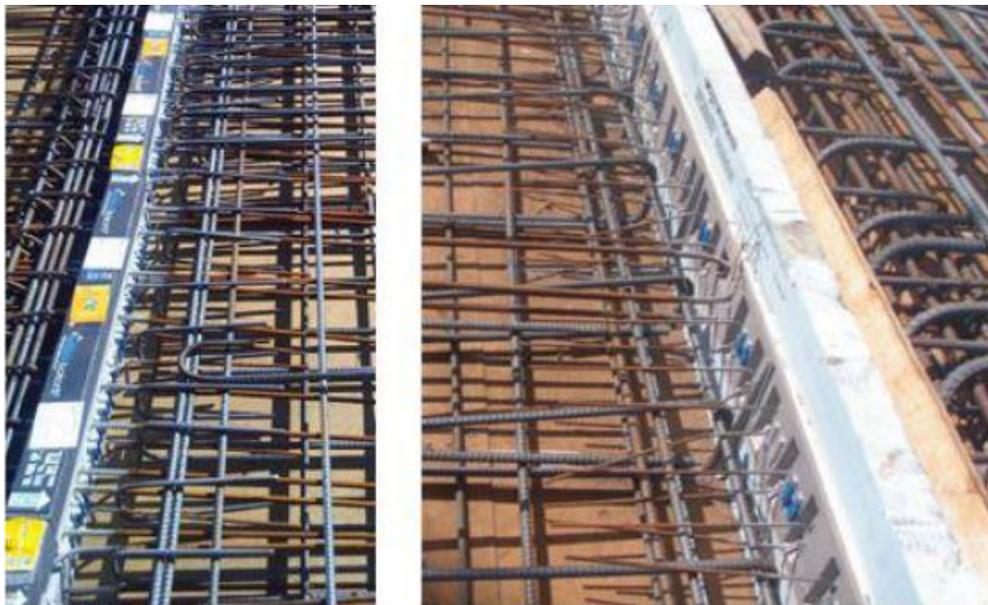
Figure 1 Schöck Isokorb® thermal break in concrete balcony (Chafik, 2015)

According to Schöck, when its thermal breaks are used in balconies and parapets of a building, they decrease a building's heat loss by as much as 14%. Schöck's thermal break is light and easy to carry and install, and its installation takes about 5 minutes per each balcony. Furthermore, inserting a thermal break during casting, as opposed to wrapping a balcony slab with insulation, decreases construction costs by up to 10% (Saunders, 2020). Figure 1 shows the use of Schöck Isokorb® thermal breaks in a concrete balcony slab in Canada. According to Schöck Isokorb® the efficiency in preventing heat loss of this thermal break is about 50% (Chafik, 2015).

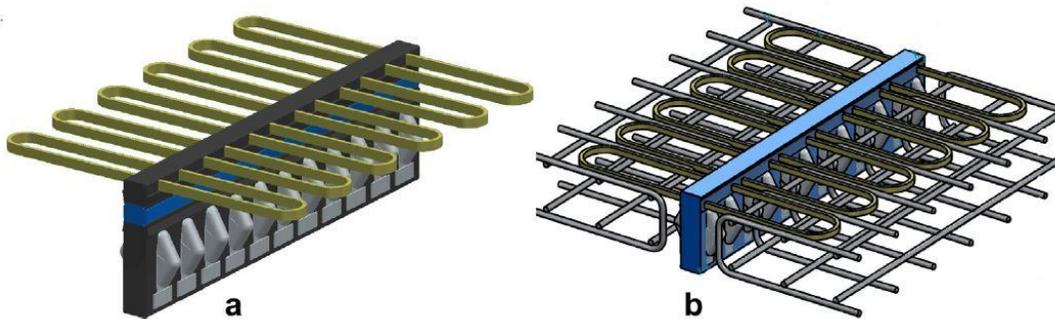
Figure 2 Thermal break: a) prefabricated A/GFRP b) the break placed from top into pre-installed concrete slab reinforcement (Goulouti et al., 2016)

The thermal break proposed in (Goulouti et al., 2016) is a multifunctional component. Moment and shear forces from the balcony concrete slab are transferred through the thermal break to the inner concrete slab of the building. The proposed thermal break has a thermal conductivity which is much smaller compared to the currently used stainless steel bars in balcony connectors. Because AFRP has greater stiffness, the author proposed the use of AFRP loops to transfer the moment-tensile force of the balcony cantilever. They proposed to use a short pultruded GFRP component for bearing the compression force. A hexagonal component made of AFRP or GFRP which has a polyurethane core is attached to the pultruded GFRP component and its function is to transfer the shear force through an inclined compression diagonal. Figures 2 and 3 show the thermal break and its AFRP loop.

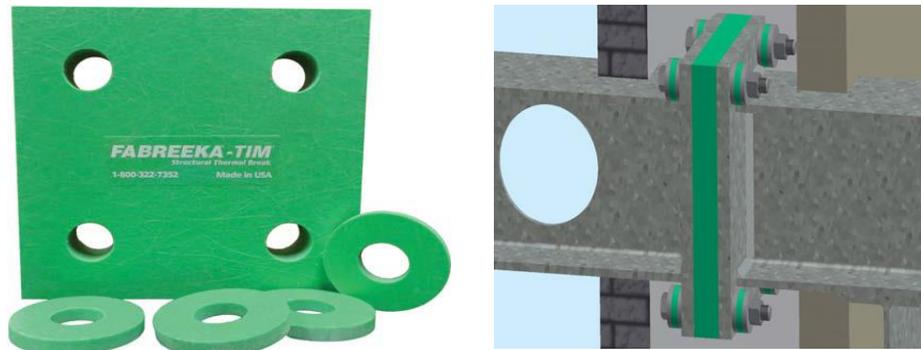
Figure 4 Fabreeka-TIM[®] thermal break

Fabreeka produces a thermal break/insulating material using a fiberglass-reinforced laminate composite. According to the company website, the thermal break is an efficient, energy-saving product which inhibits thermal bridging in structural connections. The thermal break is used between flanged steel connections and can bear loads. According to the company, their thermal break is not only resistant to conduction of heat, but also has high compressive strength: “Fabreeka International's thermal insulation material has a per-inch R-value of 0.56 and a thermal conductivity of 3.113 W/mK and is far superior to steel (R-0.003) or concrete (R-0.08), providing a structural thermal break between flanged steel framing members.”(Fabreeka International Inc., 2016). Figure 4 shows the Fabreeka-TIM[®] thermal break.

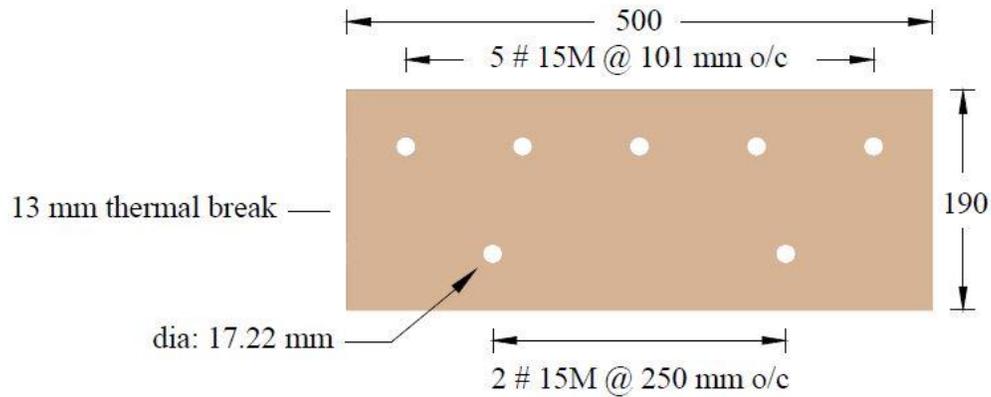
Figure 5 Thermal break dimensions

Three different types of thermal breaks with thickness of 13 mm were used in the slabs: Armatherm™ 500, DOW and UHMW. The key difference between these thermal breaks is their thermal conductivity, which is 0.0562 W/mK for Armatherm™ 500 (Armadillo, 2019), 0.2306 W/mK for DOW (Jasper Plastics, 2020), and 0.4093 W/mK for UHMW (Technical Products Inc., 2018). Thermal breaks were placed midway along the length of the specimens. Holes were pre-drilled in the thermal break so that longitudinal rebars could pass through it. The objective was to compare the thermal and structural performance of these thermal breaks and find the most suitable material for use with GFRP reinforced balcony slabs. Figure 5 shows the dimensions of thermal breaks for the nine specimens.

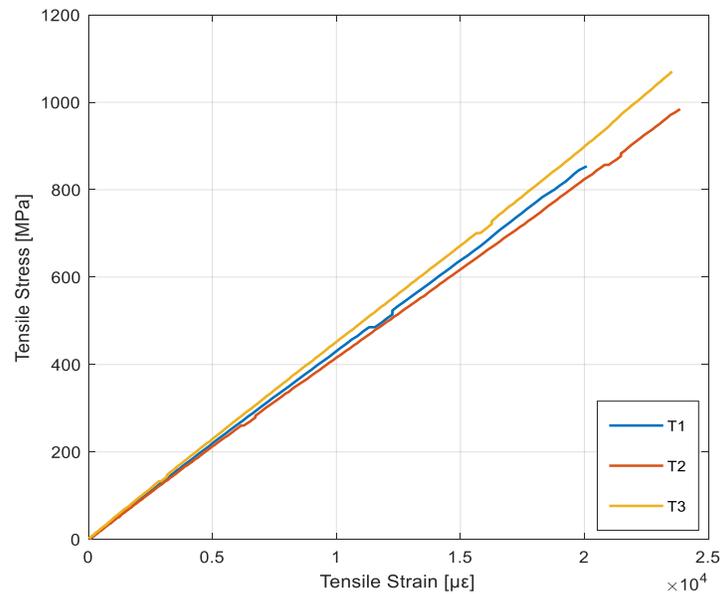
Figure 6 Three GFRP rebars tested in tension

The materials are linear elastic until failure; hence they do not yield. This behaviour can be seen in Figure 6 from the results of testing three #15M GFRP rebars in tension.

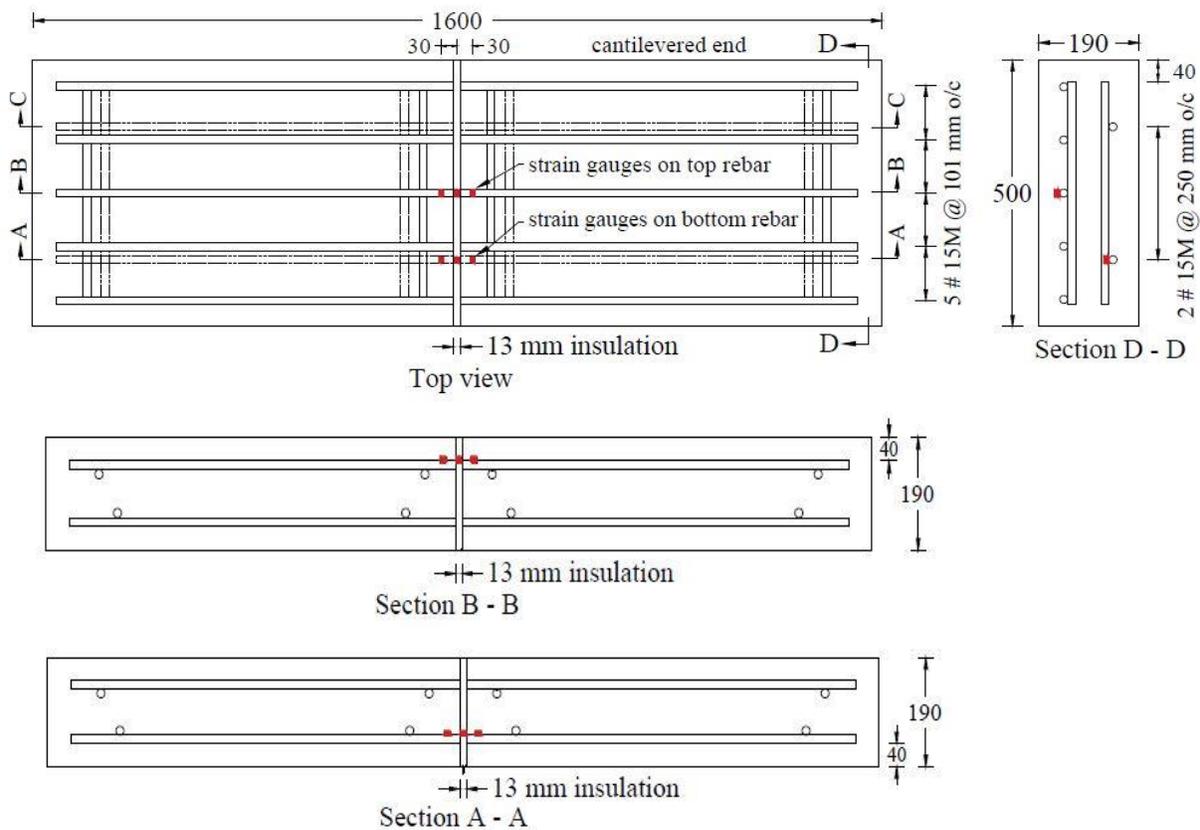
Figure 7 Location of strain gauges on specimens shown in red dots

Naming convention for strain gauges was as follows; the support side of the slab was labeled north (N), the middle of the slab was denoted as M, the cantilever side was labeled south (S). T stands for top, B for bottom. There were two longitudinal sections in each slab called AA and BB. Section AA is along the bottom rebar, and section BB is along the middle top rebar as shown in Figure 7. As an example, ST-BB means south top gauge in the BB section. The data from strain gauges were plotted as strain [$\mu\epsilon$] versus load [kN]. Reinforcement sketches are shown in Figure 8.

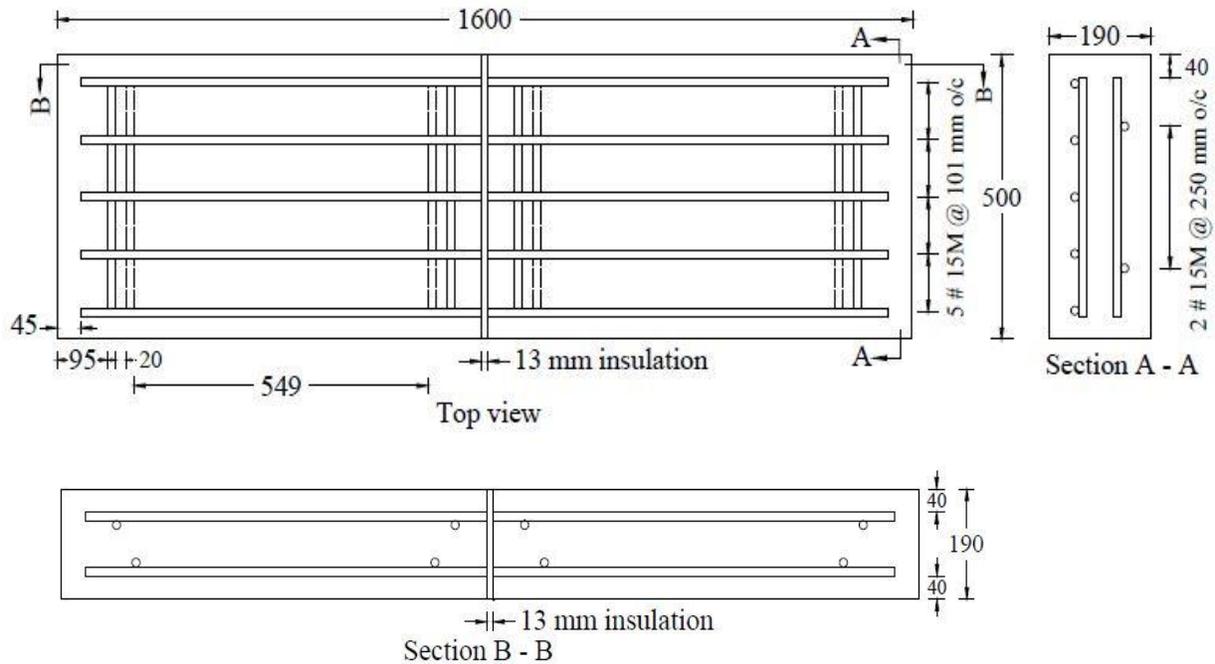
Figure 8 GFRP reinforced slab

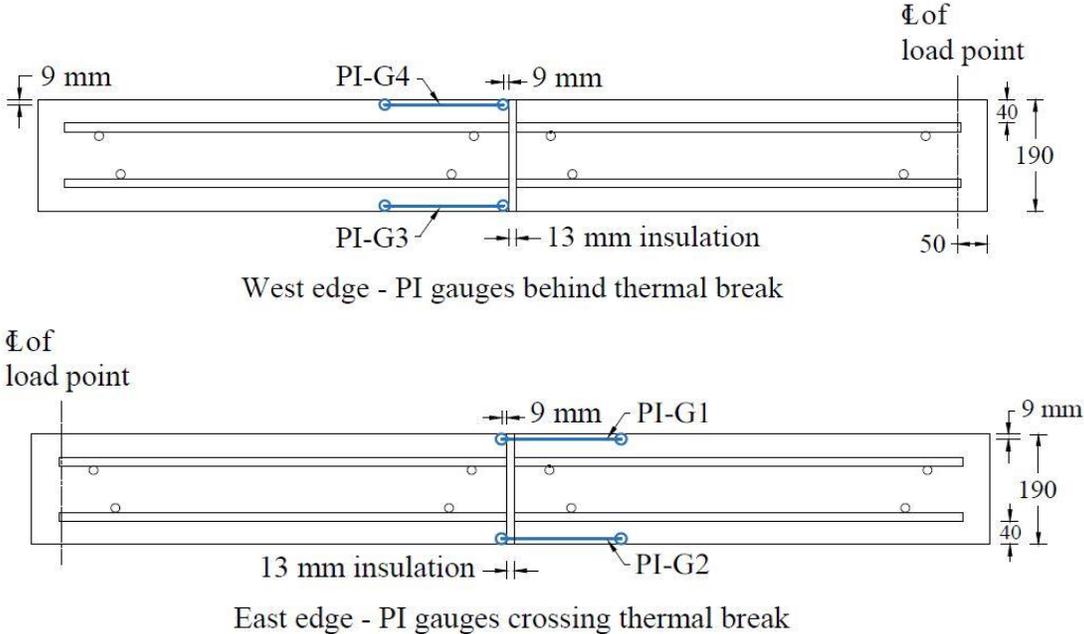
Figure 9 Drawing of PI gauge arrangement

crossed the thermal break towards the support part of the slab. See Figure 9 for a drawing of PI gauge arrangement on all nine specimens.

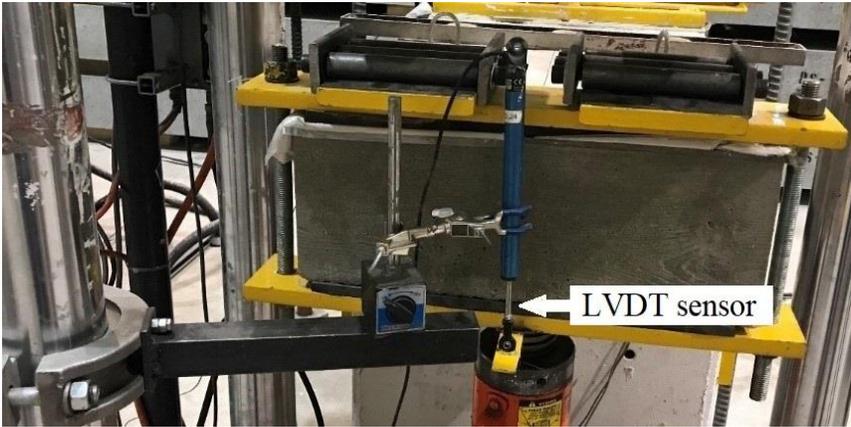
Figure 10 Location of LVDT

Linear Variable Deflection Transducer (LVDT) sensors measured the vertical displacement of the slab due to the applied load. For all specimens, an LVDT was installed at the cantilever end, 90 mm away from the load point, to measure the deflection/displacement of the cantilever tip. The test was carried out under deflection control and was set at 2 mm/minutes. Figure 10 shows the position of the LVDT. Figure 11 shows the slab side naming as well as the locations of the two supports.

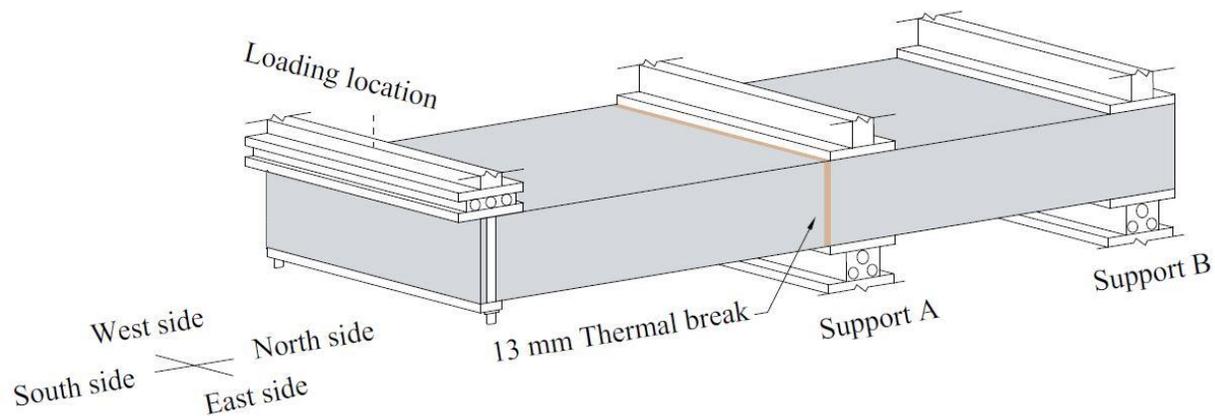
Figure 11 Naming of slab sides, supports and location of load at the tip of the cantilever slab

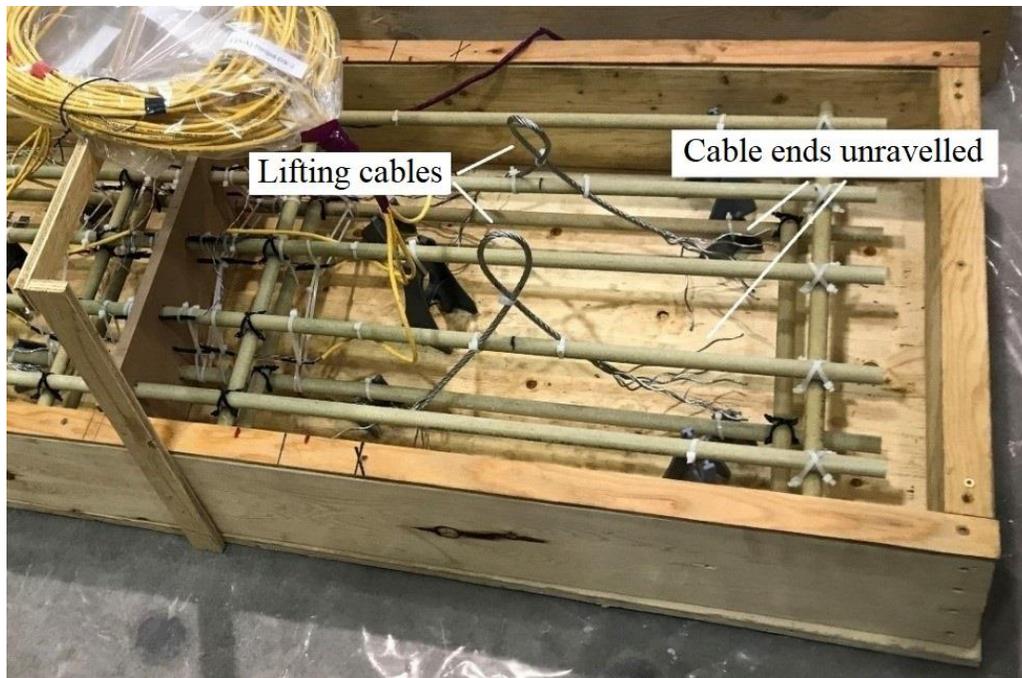
Figure 12 Lifting cables

In order to have zero bending moment at the thermal break while lifting the slab, two lifting cables were placed symmetrically at a distance of 40 cm from thermal break. Thus, four lifting cables were used per slab. Each cable had a length of 70 cm and a diameter of 6 mm. Each lifting cable was tied using zip ties to the top longitudinal rebar. To make sure lifting cable is well anchored in the concrete, the wires at the ends of the cable were unravelled and spread out. See Figure 12 for clarification.

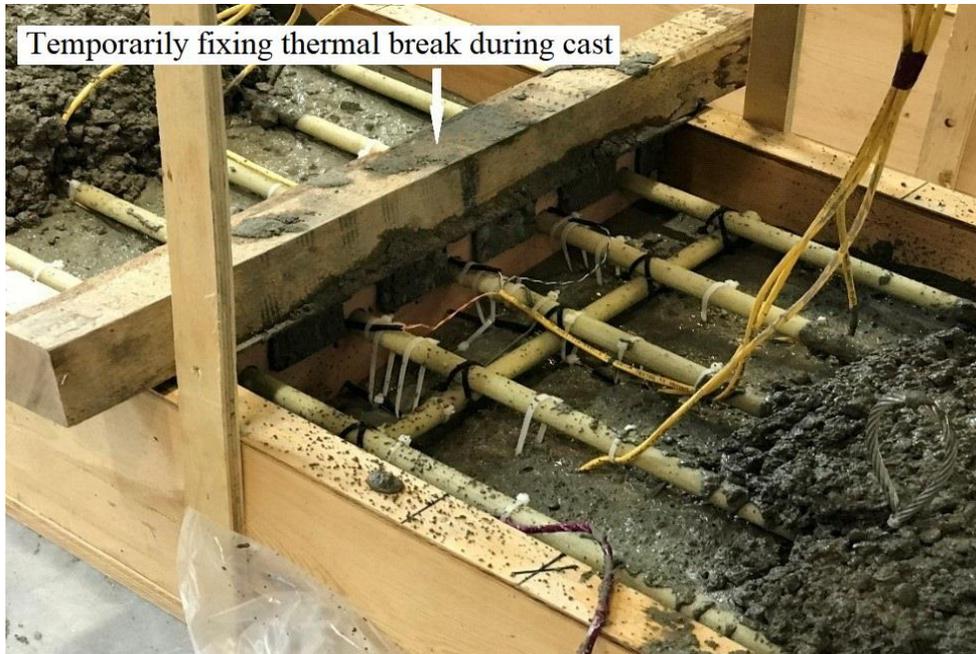
Figure 13 Temporary “fixer” for thermal break during cast

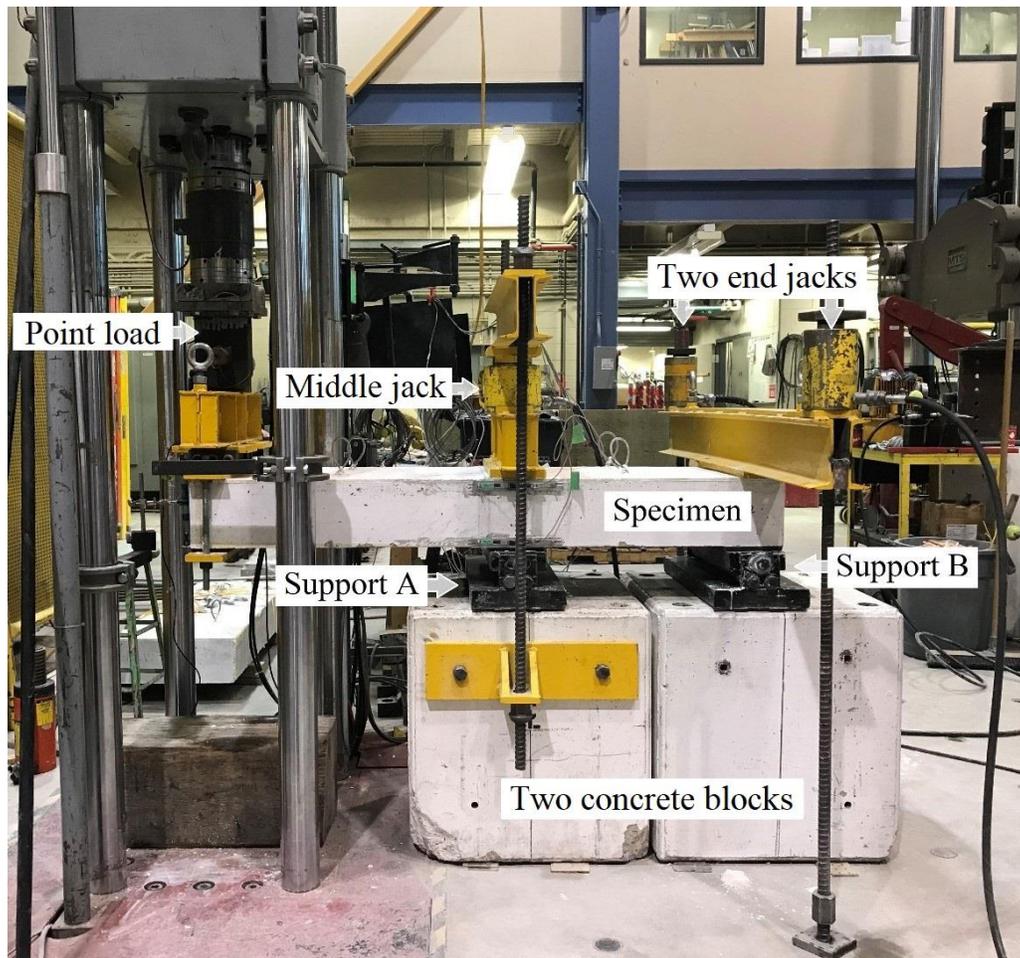
Figure 14 Support setup during structural test

Three jacks were used to apply downward pressure on the slab at the supports to stabilize the slab during loading. One was in the middle, above roller support A, and the other two were above support B. The support A was assumed to have a negative moment due to the applied point load at the free end of the cantilever. The aim of this support was to simulate a wall between the balcony and the inside section of the slab, as well as to prevent the rotation of the slab. The aim of jacks at support B was to prevent the slab from being moved upward due to the downward point load that was applied at the tip of the cantilever during test. The jacks and supports at points A and B helped to fix the specimen in place during test. The test setup is shown in Figure 14.

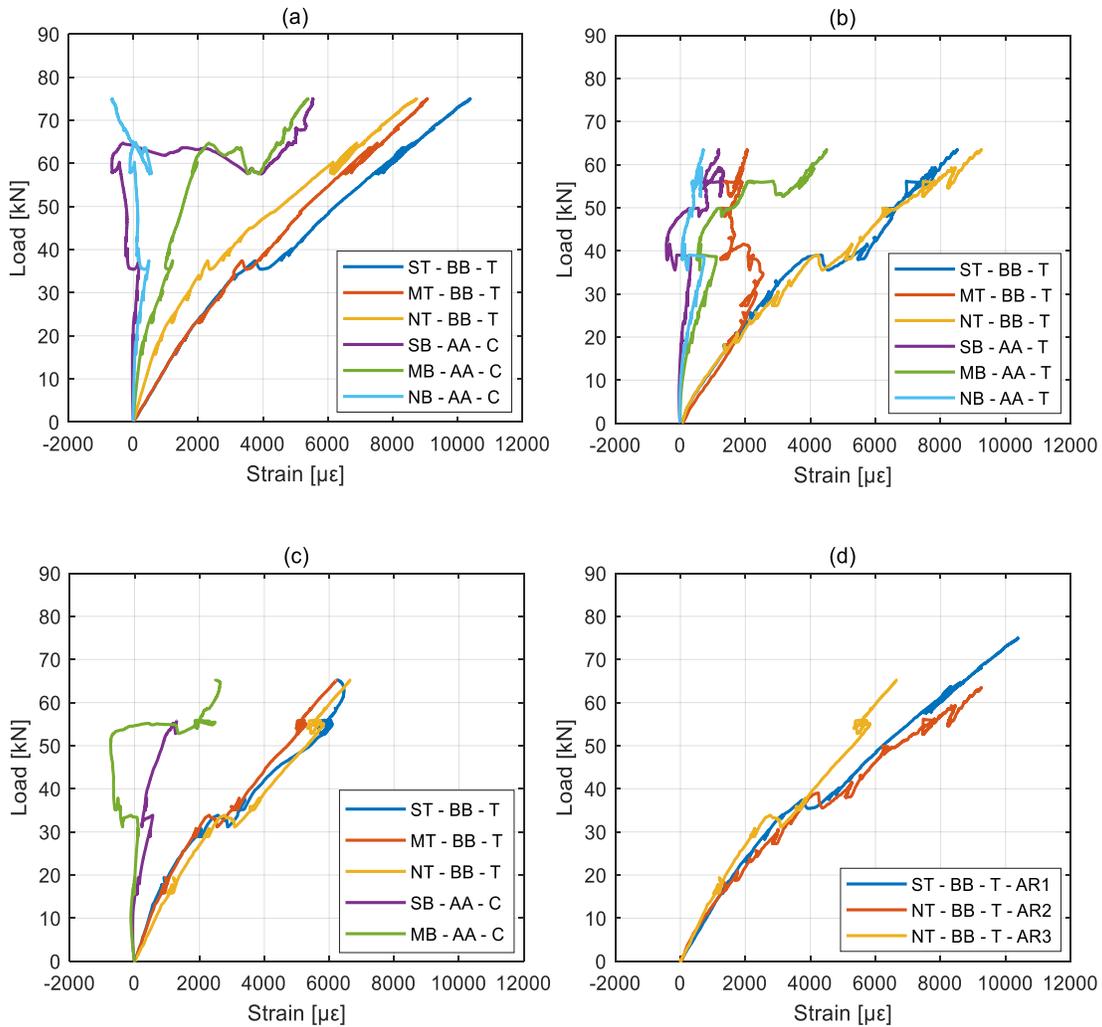
Figure 15 Strain in reinforcement at the maximum moment location: (a) AR1, (b) AR2, (c) AR3 and (d) maximum strains from all AR specimens

to the extreme compression fibre. It is well known that the depth of compression zone in GFRP reinforced concrete reduces significantly after cracking.

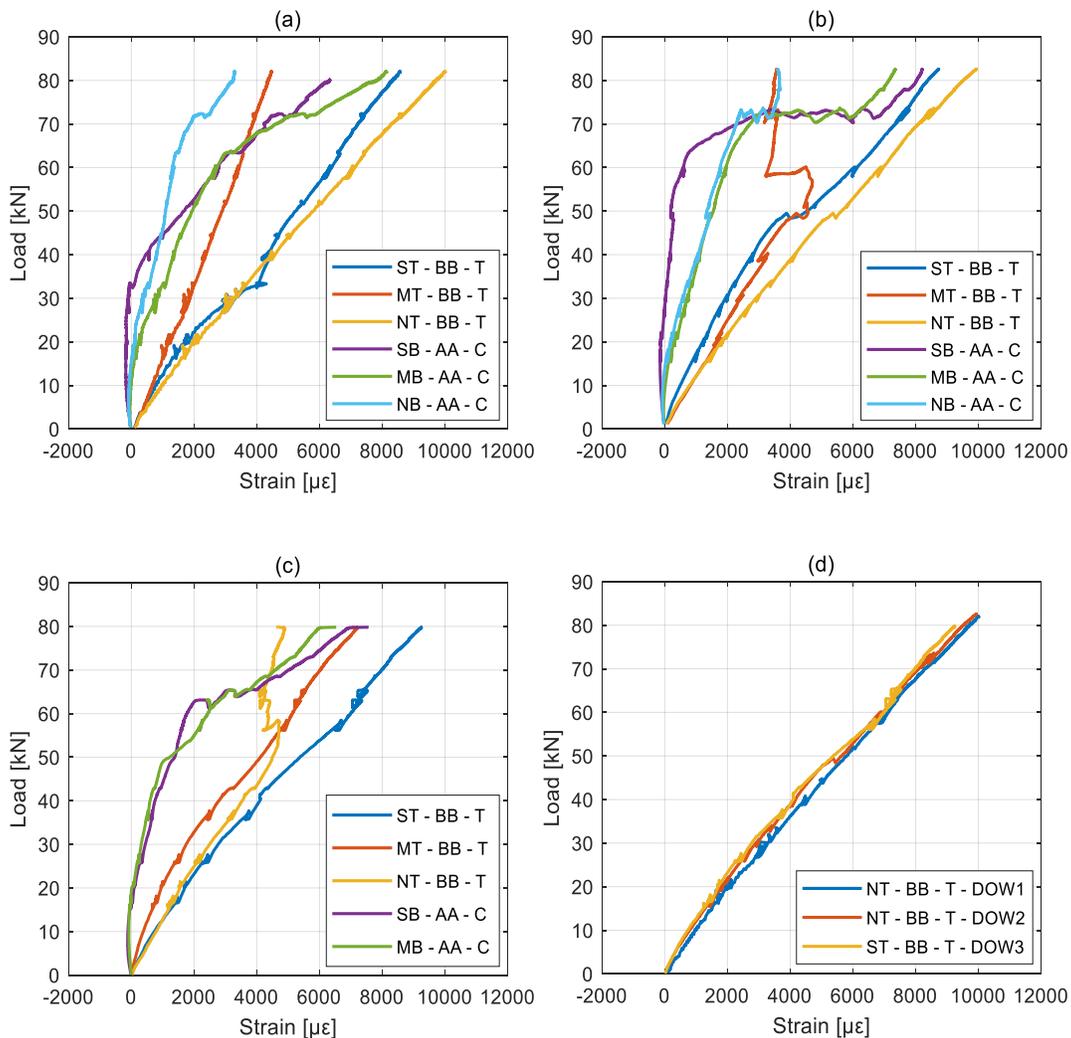
Figure 16 Strain in reinforcement at the maximum moment location: (a) DOW1, (b) DOW2, (c) DOW3 and (d) maximum strains for all DOW specimens

Figure 16 shows strain gauge data for DOW specimens. In Figure 16 all plots were terminated at the failure load for each slab.

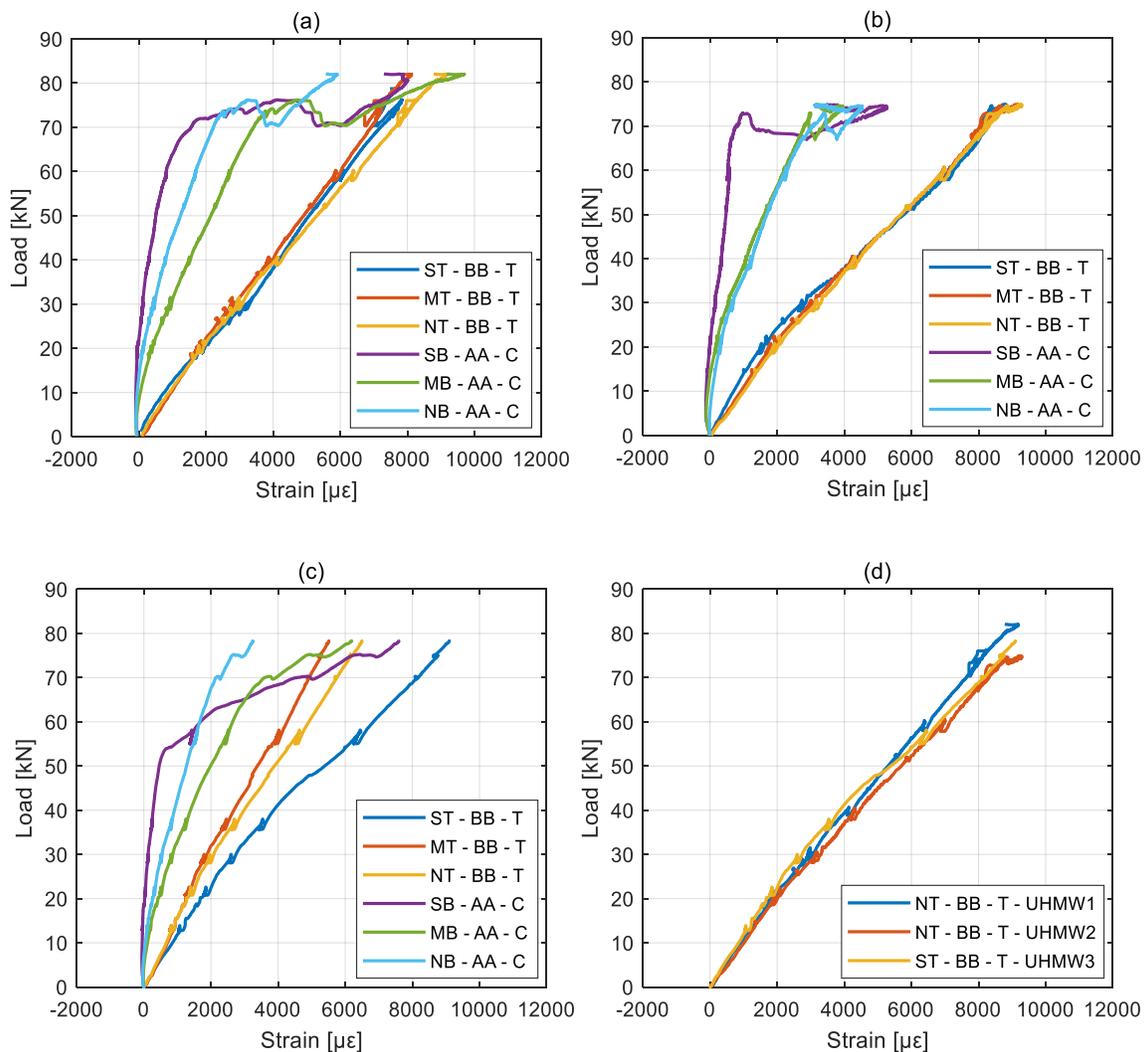
Figure 17 Strain in reinforcement at the maximum moment location: (a) UHMW1, (b) UHMW2, (c) UHMW3 and (d) maximum strains for all UHMW specimens

Figure 17 (d) shows the comparison of the three maximum strain plots from each of the UHMW slabs. The plots indicate that all specimens displayed a similar behaviour in tension.

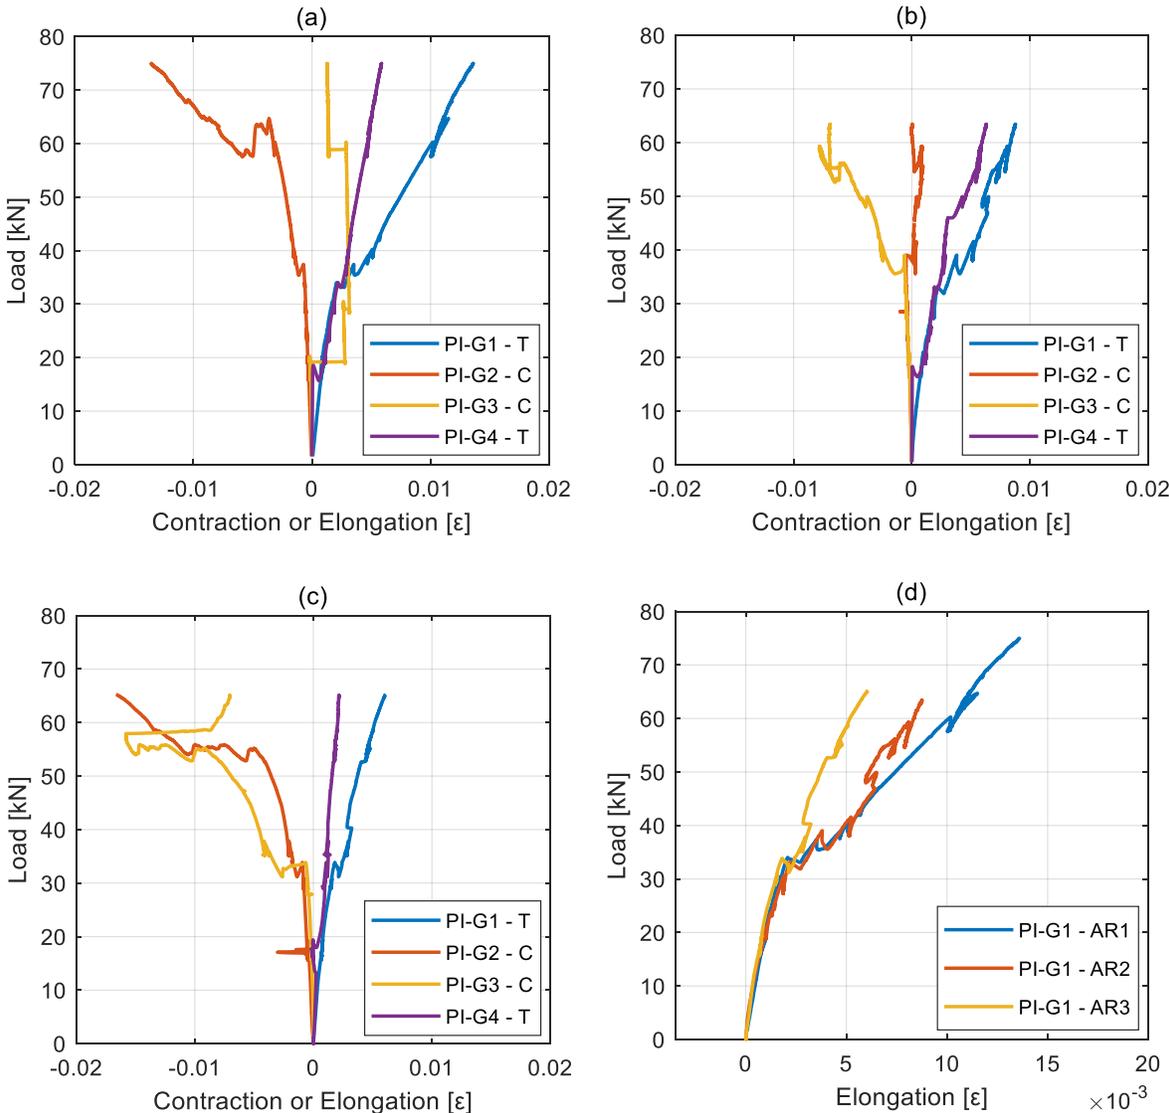
Figure 18 Contraction and elongation in concrete at the thermal break location: (a) AR1, (b) AR2, (c) AR3 and (d) maximum elongation from all AR specimens

largest values were recorded in the two gauges PI-G1 that was installed with the thermal break in the gauge length, and PI-G3. The onset of visible compression on the bottom of the slab and dilation in the tension at the top of the slab started in slab AR3 at 34 kN, which is very consistent with the data obtained from slabs AR1 and AR2. Further compression of the thermal break is visible in Figure 18 (c) at 55 kN. The amount of elongation at the top was +0.00607 and the amount of contraction was -0.01664 at the bottom of the slab. These largest values were recorded in the two gauges that were installed with the thermal break in their gauge length, PI-G1 and PI-G2.

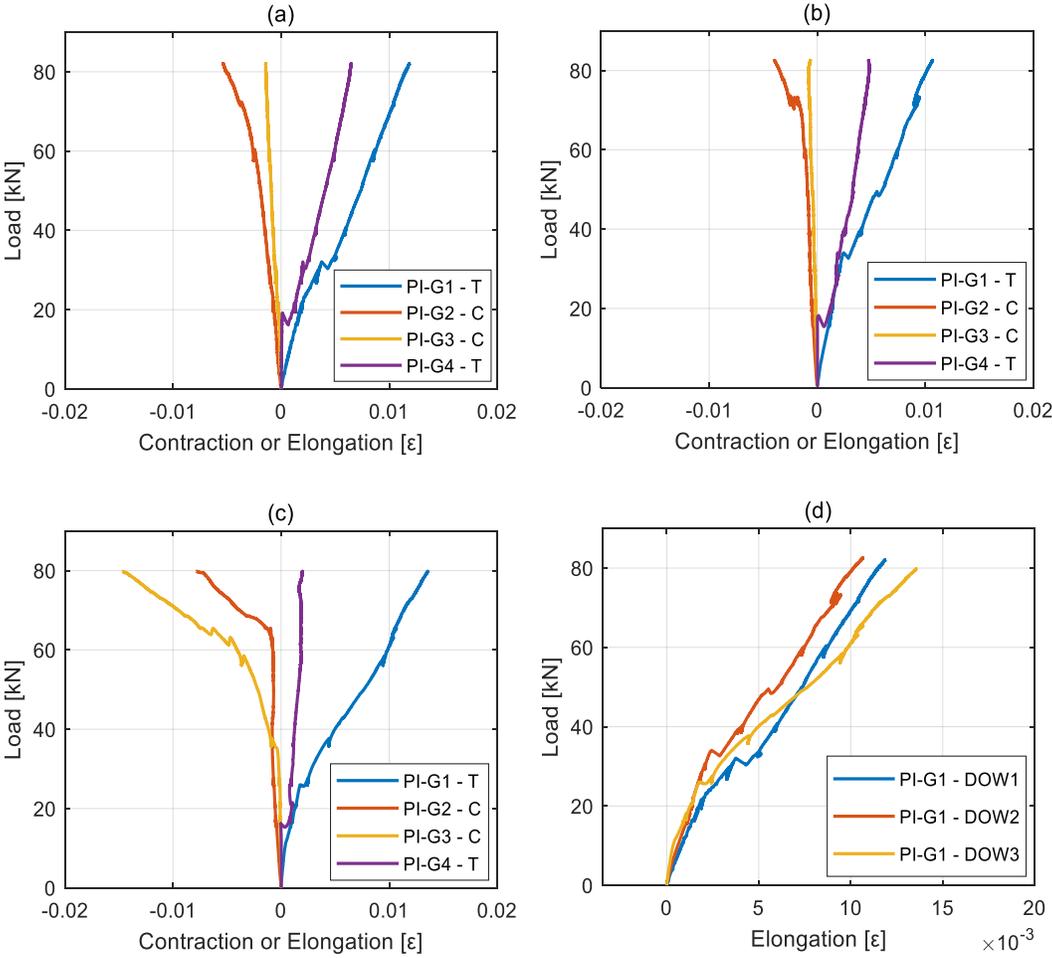
Figure 19 Contraction and elongation in concrete at the thermal break location: (a) DOW1, (b) DOW2, (c) DOW3 and (d) maximum elongation from all DOW specimens

Figure 19 shows PI gauge data for the DOW specimens.

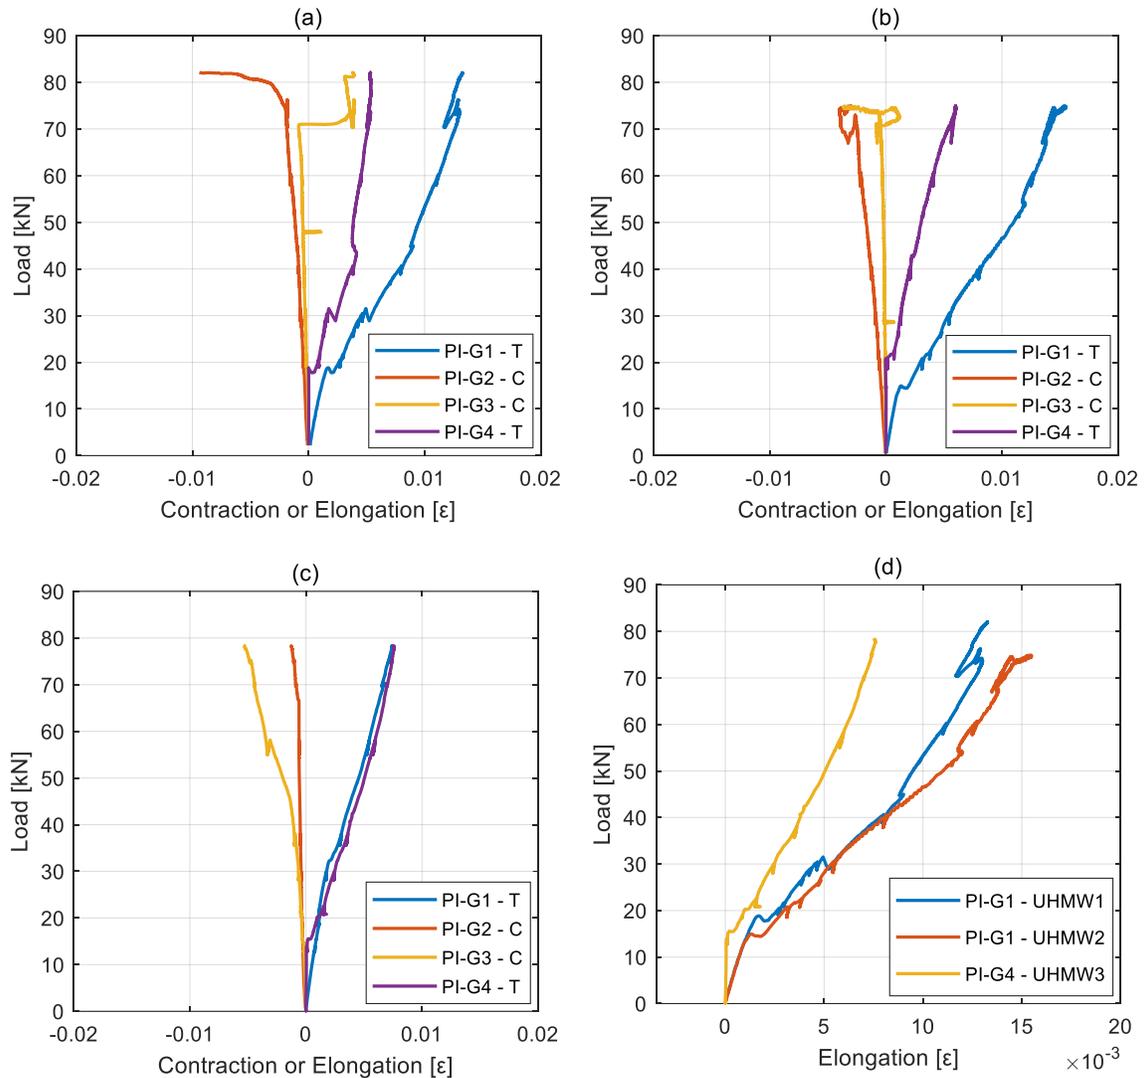
Figure 20 Contraction and elongation in concrete at the thermal break location: (a) UHMW1, (b) UHMW2, (c) UHMW3 and (d) maximum elongation from all UHMW specimens

The maximum elongation in the UHMW slabs is plotted in Figure 20 (d). The graph shows that UHMW1, UHMW2 and UHMW3 reached the maximum elongation of 0.01328, 0.0155 and 0.00754, respectively. The average elongation for the three UHMW slabs is 0.01211.

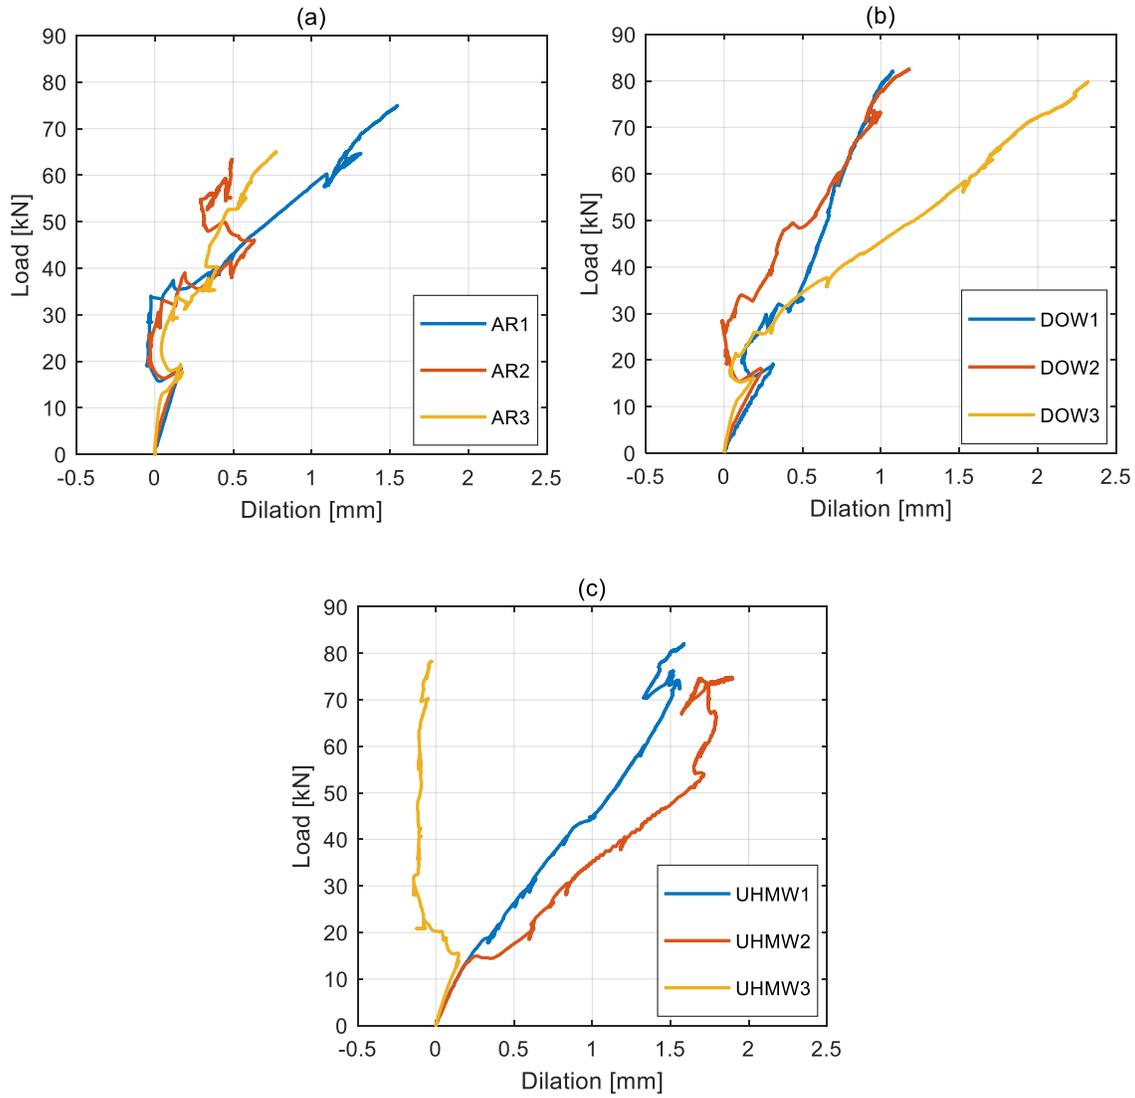
Figure 21 Dilation between concrete and thermal break at the maximum moment location: (a) AR, (b) DOW and (c) UHMW

The largest total dilation on each side of the thermal break for AR slabs was 1.56 mm at a load of about 75 kN. For DOW slabs the largest dilation was 2.33 mm at a load of about 80 kN. For UHMW slabs the largest dilation was 1.91 mm at a load of about 75 kN.

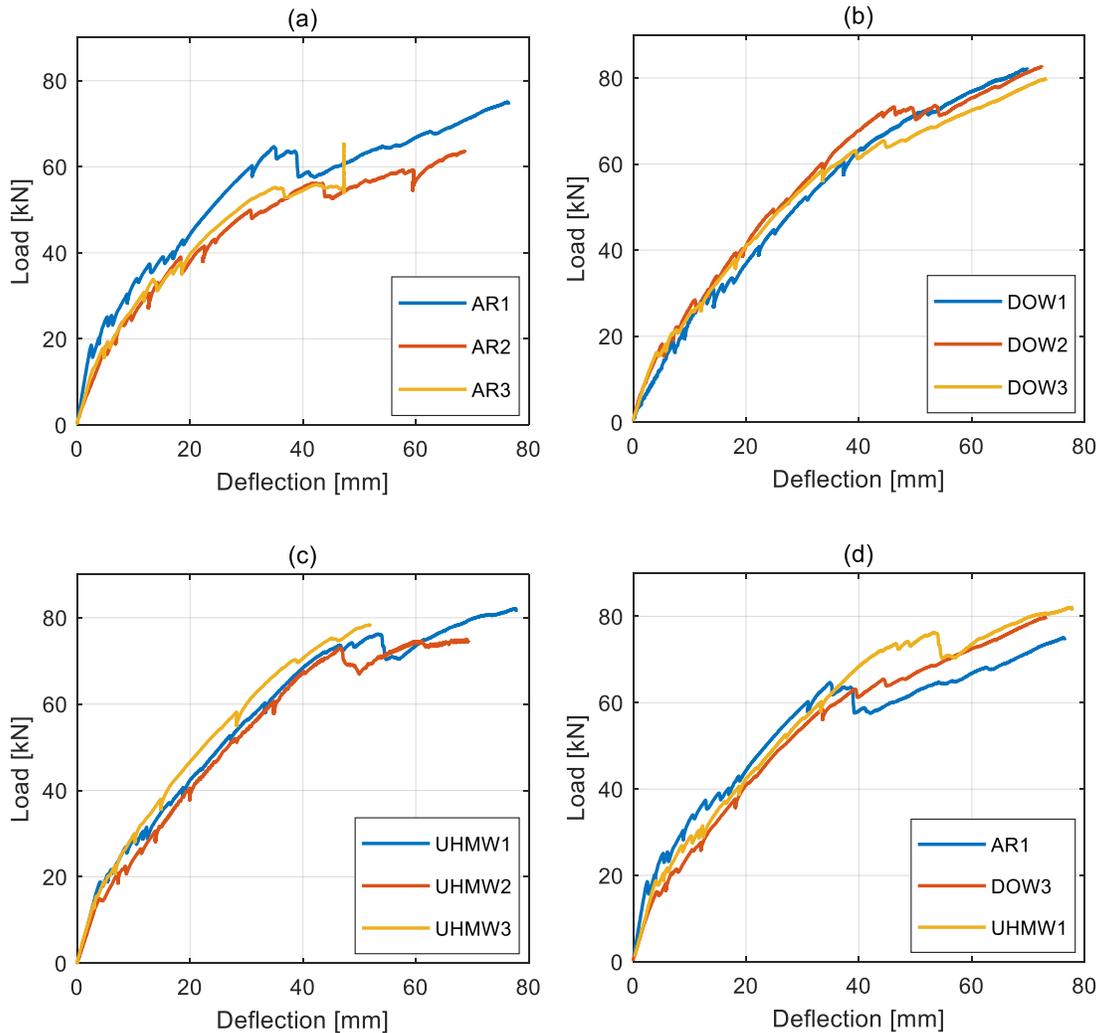
Figure 22 Deflection at the cantilever side of the slabs: (a) AR slabs, (b) DOW slabs, (c) UHMW slabs and (d) comparison of maximum deflections from each group of slabs

Figure 22 (b) shows the load-deflection curves for DOW slabs. The first drop in the curve indicates cracking of the slabs that occurred at 19 kN, 18.2 kN and 16 kN for DOW1, DOW2 and DOW3 slabs, respectively. The failure loads of the slabs were 82, 82.5, and 80 kN for DOW1, DOW2 and DOW3 respectively.

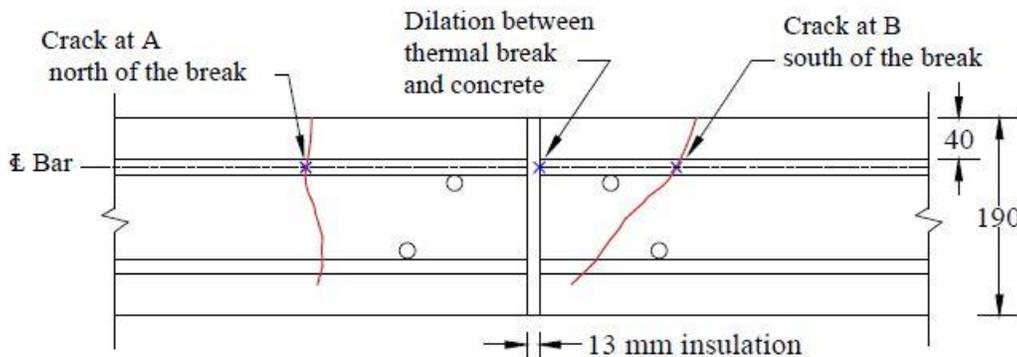
Figure 23 Dilation and crack widths measured at points A and B on west side of each slab

The dilation between thermal break and concrete was measured for each specimen. For each slab crack widths on the west of the slab on the two sides of thermal break, shown as points A and B in Figure 23, were measured. Figure 23 is a general outline of where dilation between concrete and thermal break as well as crack widths were measured in all specimens. Measurements of dilation between concrete and the thermal break as well as the crack widths were done to compare the performance of the three thermal breaks.

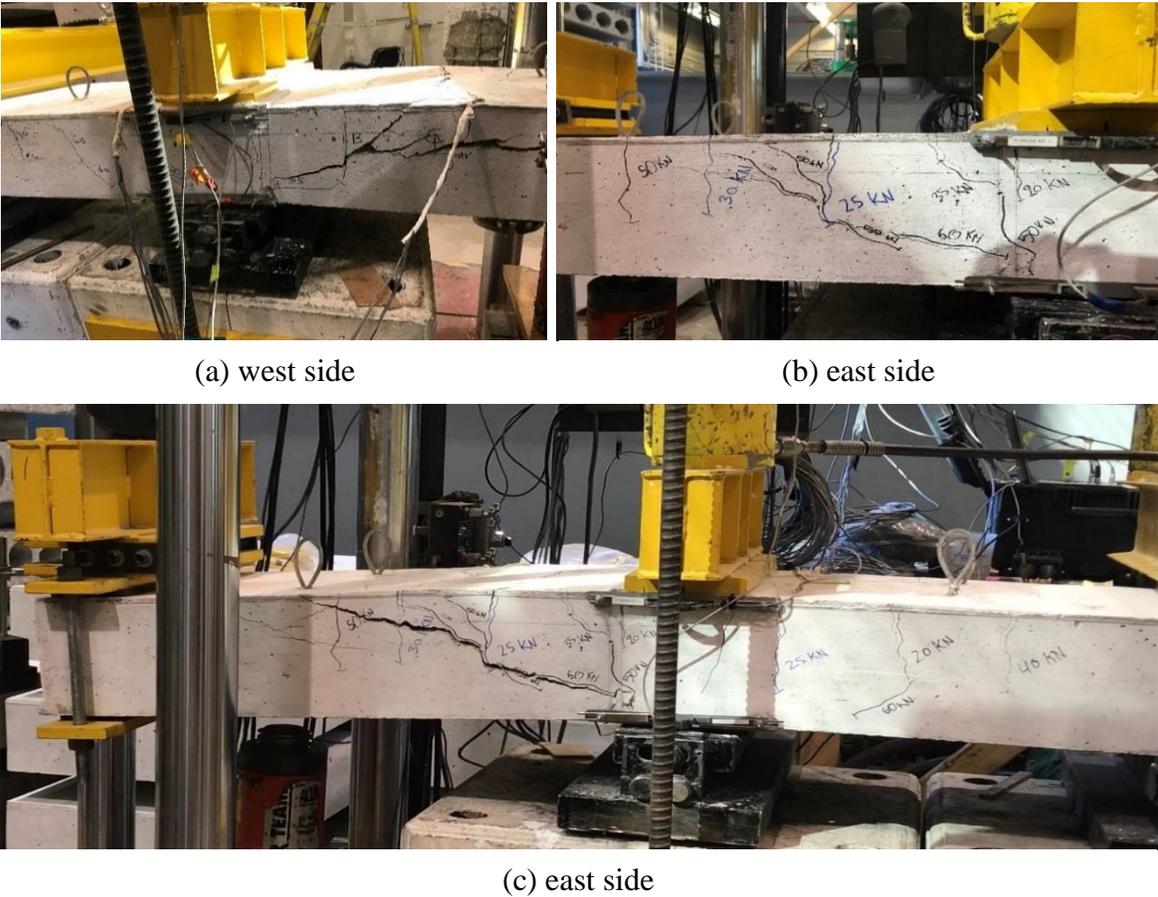
Figure 24 West and east sides of the cantilever end of AR3

side and 21 degrees on the east. They started at the top in the tension zone and moved to the bottom/compression zone of the slab, as the depth of neutral axis decreased. Vertical cracks formed at lower loads and as the load increased, diagonal shear cracks started to appear as well. As shown in Figure 25, a visible crack opened at the bottom of AR3 slab between the thermal break and concrete at a load of 30 kN. This dilation took place on the cantilever side of the specimen.

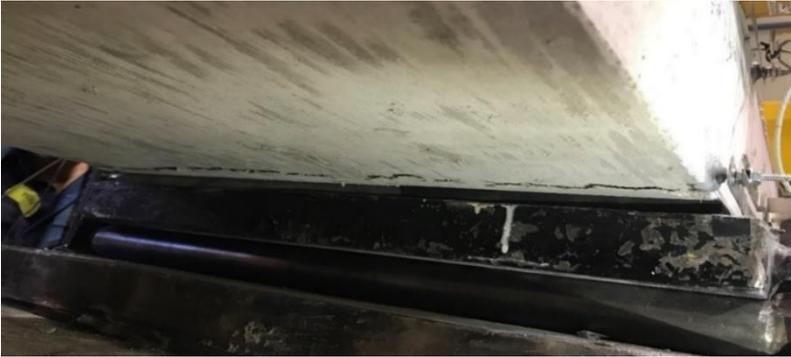
Figure 25 Crack under the slab close to support at the cantilever end of AR3

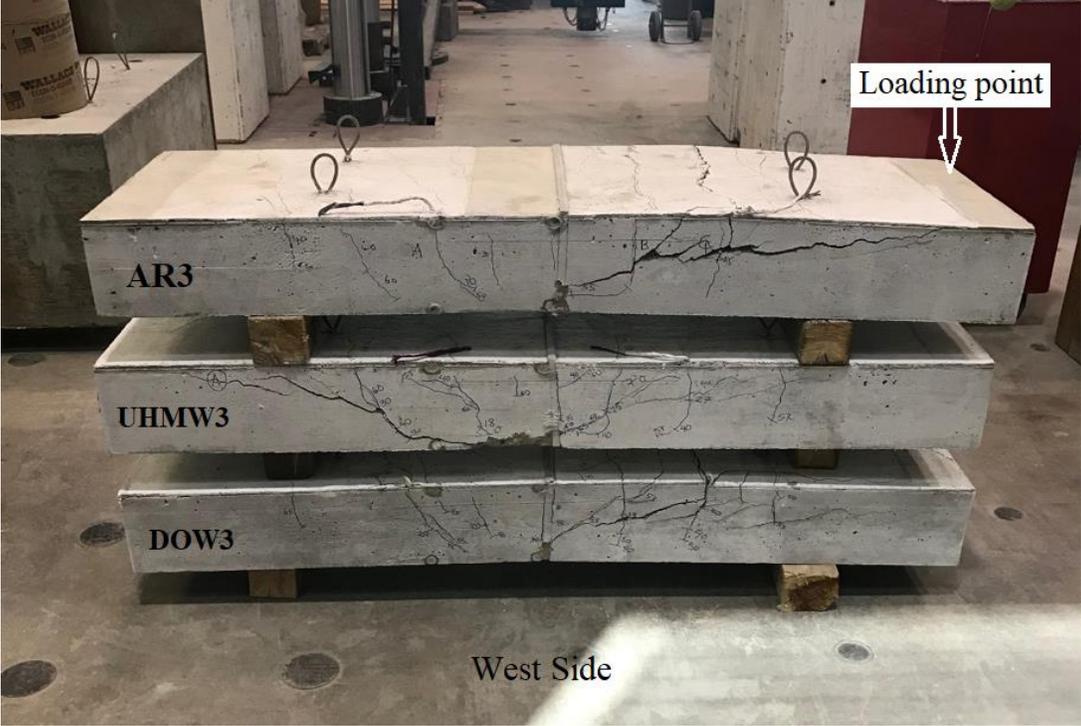
Figure 26 West side: AR3, UHMW3 and DOW3

Figure 26 shows the west side of AR3, UHMW3, and DOW3 (from top to bottom) after failure, while Figure 27 shows the east side of the same slabs. These three slabs were tested structurally only.
