**STRUCTURAL PERFORMANCE OF GFRP REINFORCED
BALCONY SLAB WITH THERMAL BREAK**

Arezo Rasouli

A Thesis submitted to the Faculty of Graduate Studies of
the University of Manitoba
in partial fulfillment of the requirements for the degree of

Department of Civil Engineering
University of Manitoba
Winnipeg, MB, Canada

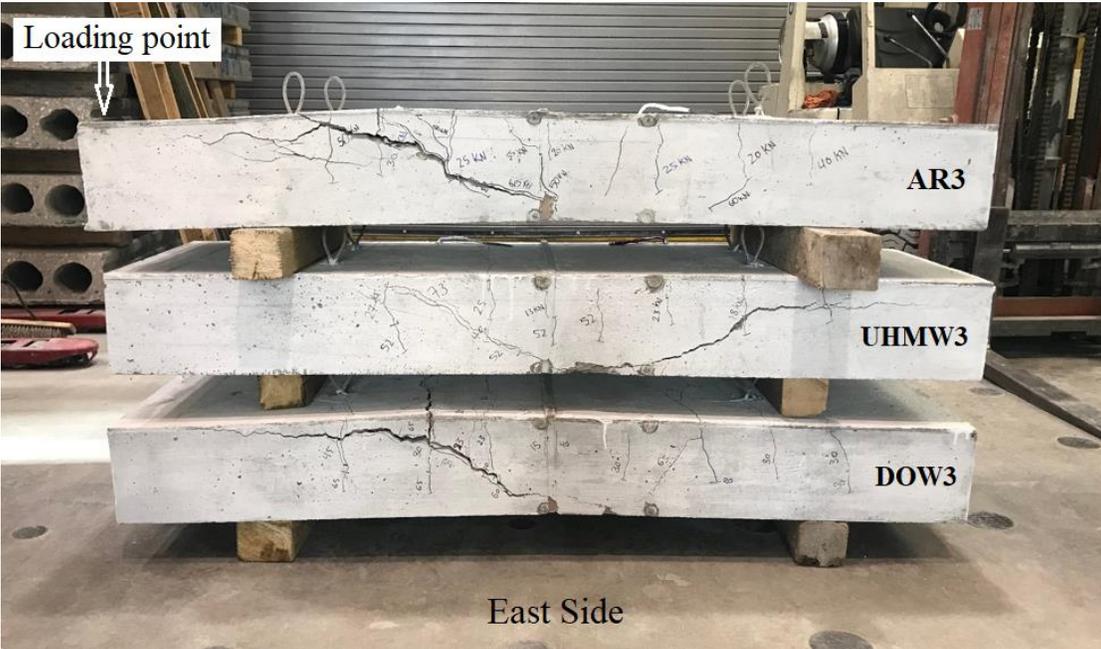
Figure 27 East side: AR3, UHMW3 and DOW3

Figure 26 shows the west side of AR3, UHMW3, and DOW3 (from top to bottom) after failure, while Figure 27 shows the east side of the same slabs. These three slabs were tested structurally only.

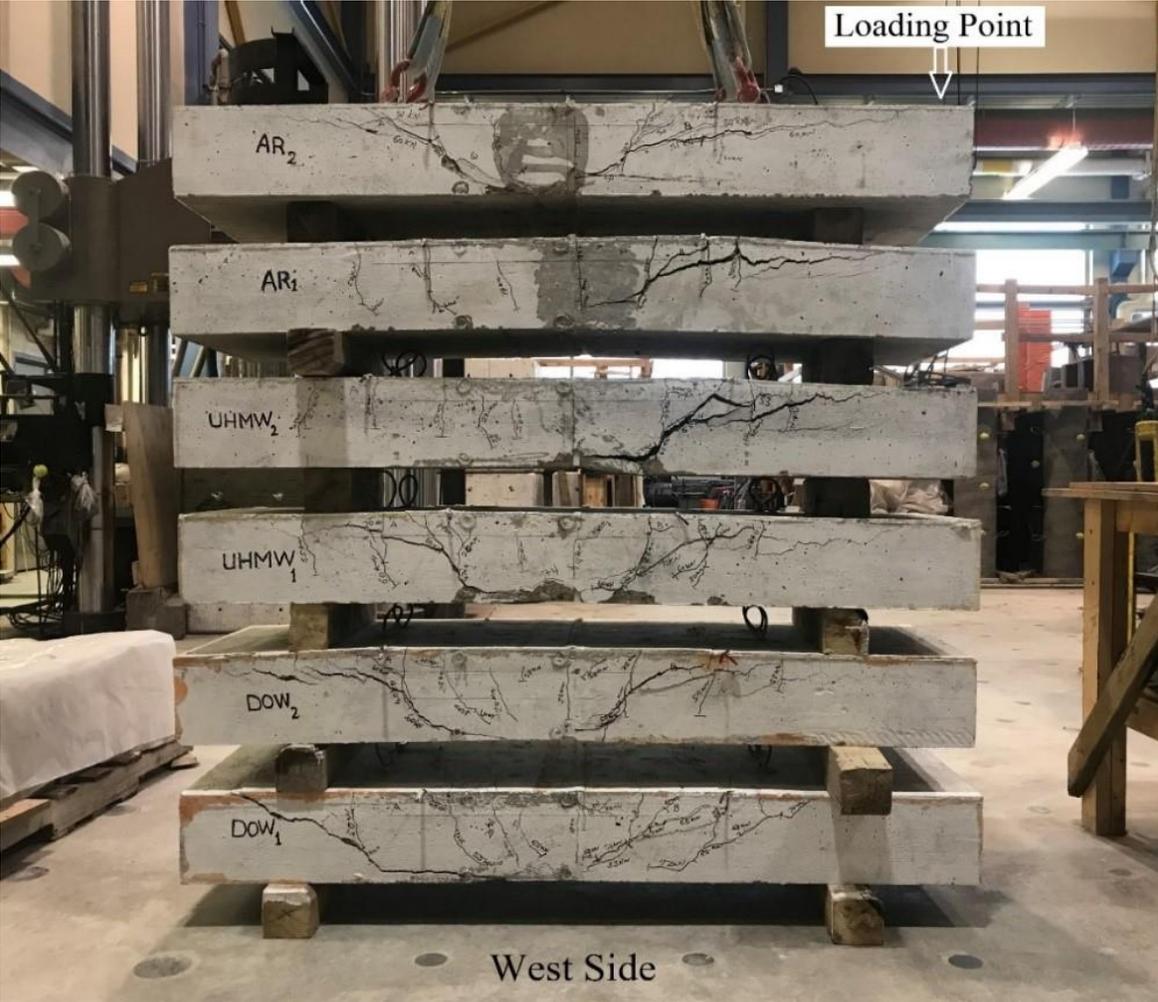
Figure 28 West side: AR1, AR2, UHMW1, UHMW2, DOW1 and DOW2

Figures 28 and 29 show the west and east sides of AR1, AR2, UHMW1, UHMW2, DOW1, and DOW2 after failure.

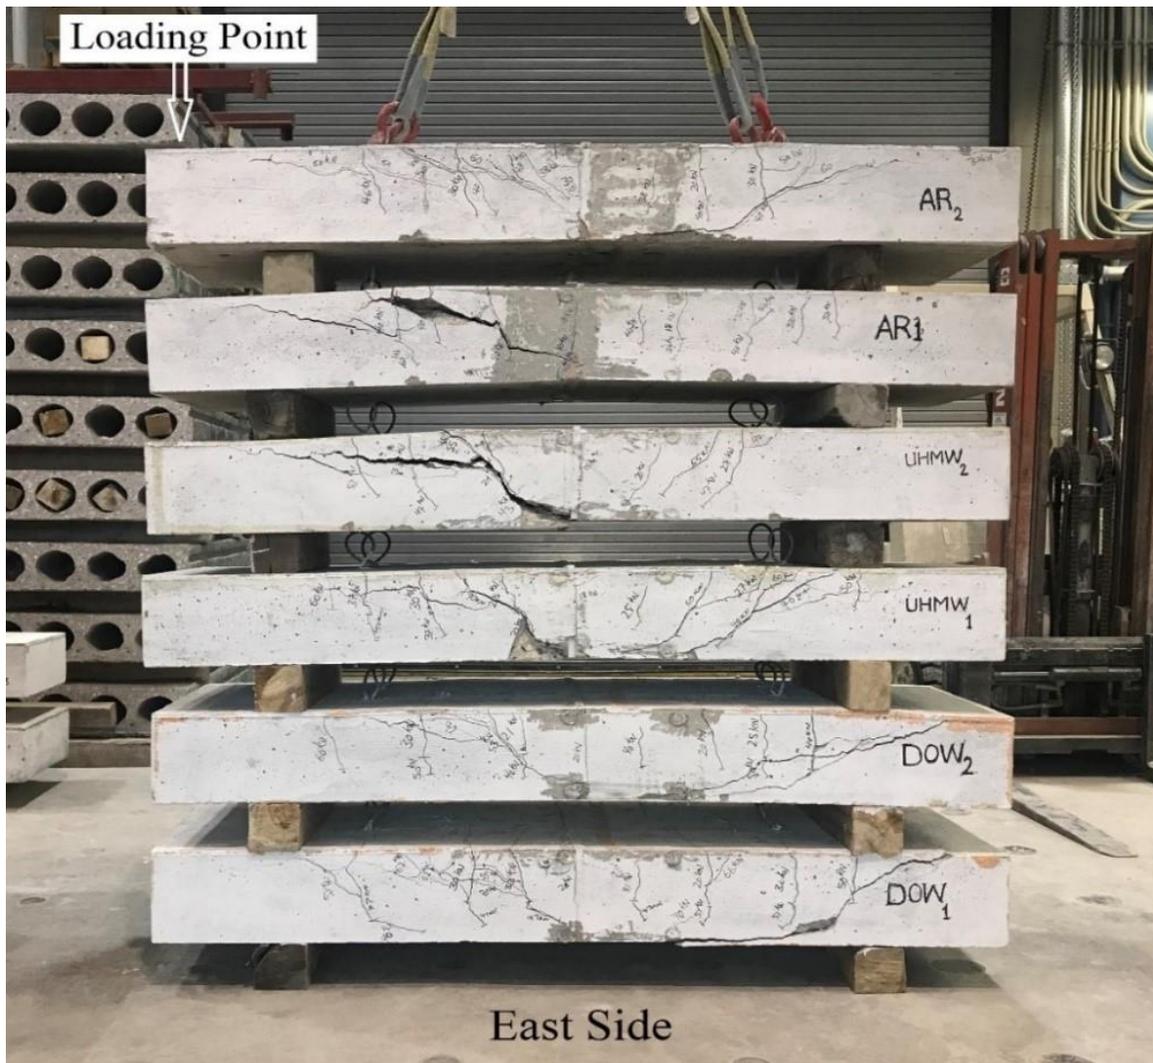
Figure 29 East side: AR1, AR2, UHMW1, UHMW2, DOW1 and DOW2

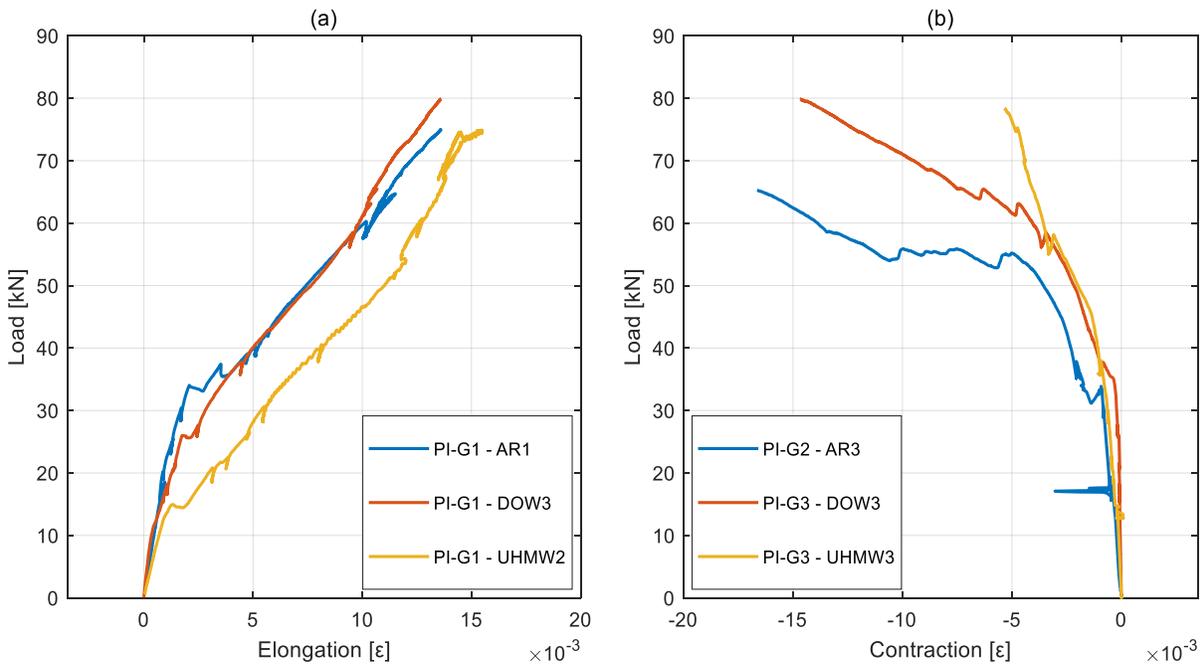
Figure 30 PI gauges on concrete slabs at the thermal break location: (a) largest elongation and (b) largest contraction

Figure 30 shows that elongation was linear up to loads of about 15 kN, 26 kN, and 34 kN for UHMW2, DOW3, and AR1, respectively. Beyond these loads a rapid deformation can be seen in all specimens. Similar behaviour was observed in the contraction plots. The specimens behaved linearly up to a load of about 34 kN. A more rapid deformation started from a load of 58 kN until failure. The largest elongation, 0.0155, occurred at a load of about 75 kN. The largest contraction, -0.0166, happened at a load of about 65 kN. The deformations indicate that the thermal break could carry some compressive load up to 56 kN. Figure 30 (a) shows that in the tension zone the dilation at UHMW thermal break started at a lower load compared to other two thermal breaks. On the other hand, in compression zone the three thermal breaks were compressed at the same load of around 55 kN, meaning that their compressive strength is similar, as seen in Figure 30 (b).

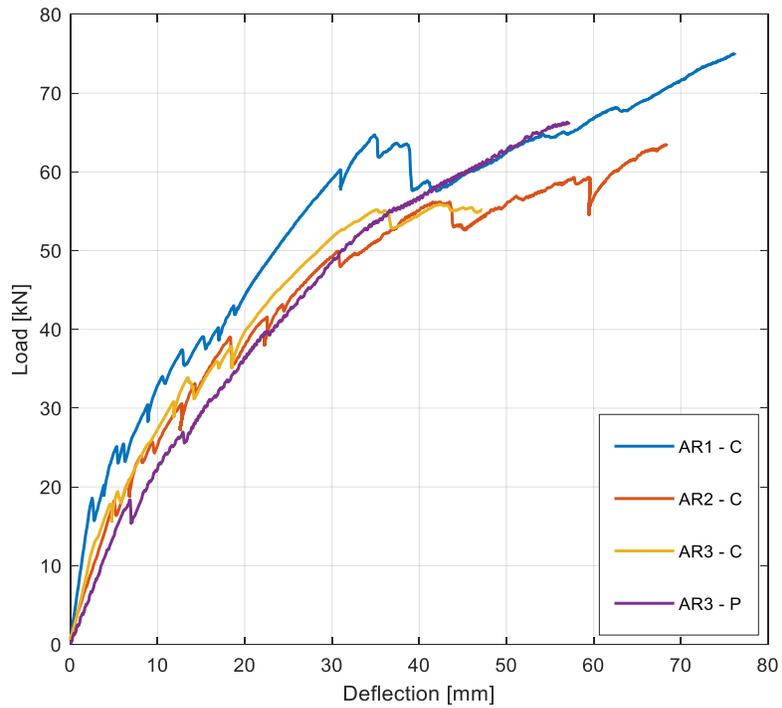
Figure 31 Comparison of maximum deflection between Phase I (Boila, 2018) and Phase II

deflection. A thinner thermal break means a smaller gap in concrete between the floor slab and the cantilever slab which means the structure is stronger. Moreover, the GFRP reinforcement scheme used in this study leads to a smaller deflection. For percentage comparison of deflections in the two study, see Table 23 below.

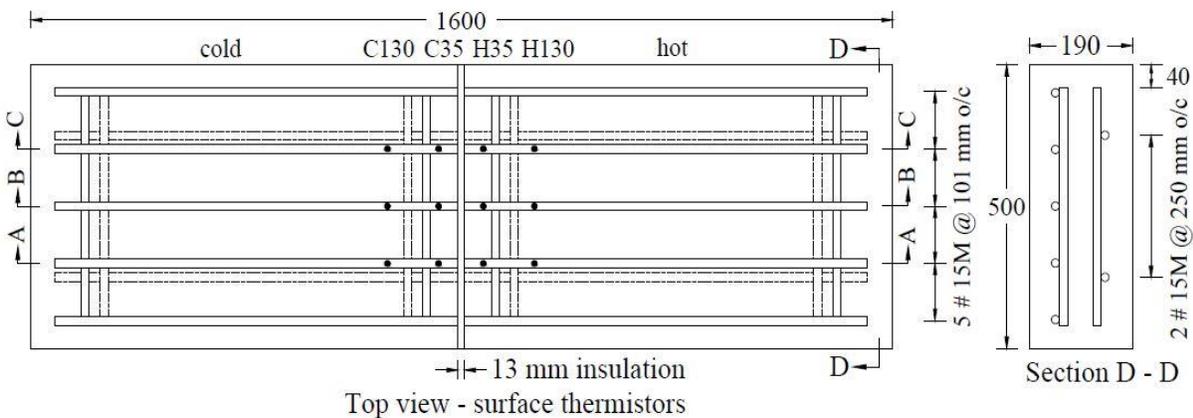
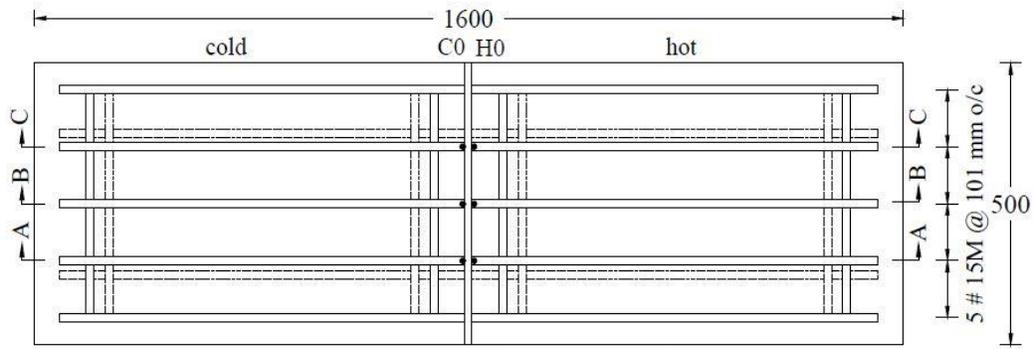
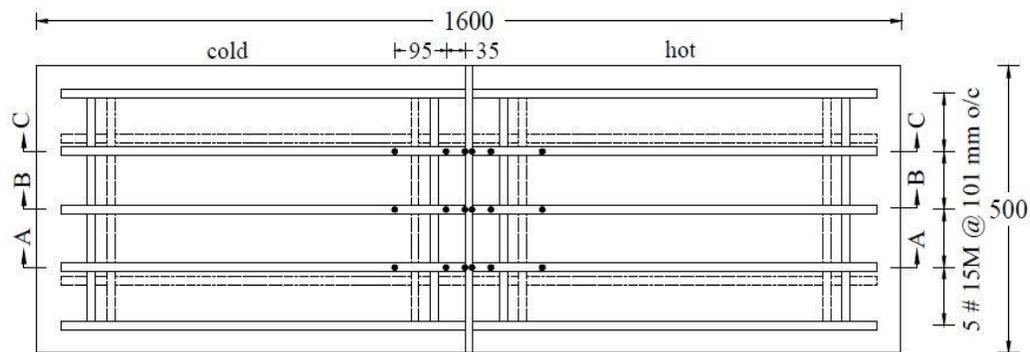
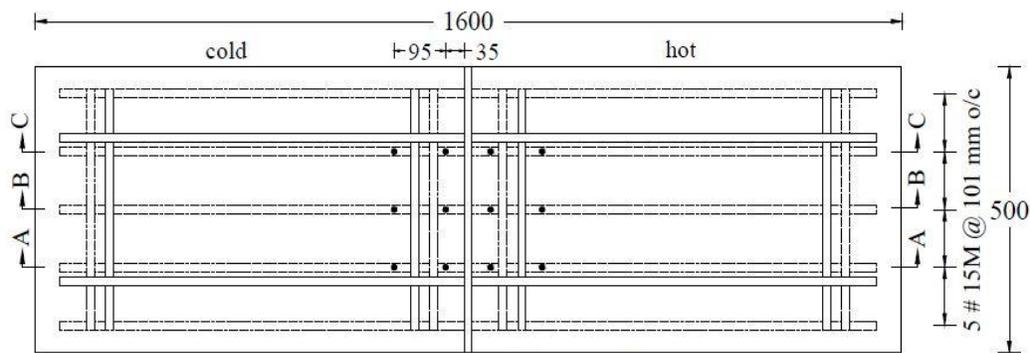
→ 13 mm insulation
Top view - on rebar thermistors

→ 13 mm insulation
Top view - middle thermistors

→ 13 mm insulation
Bottom view - bottom thermistors

In all, a total of 48 thermistors were used in each balcony slab. To label the thermistors in drawings and plots, the following convention was used: cold/hot side – distance from thermal break – layer which thermistor belongs to – section – type of thermal break & slab number. For example, C130-T-A-AR1 means the thermistor is on the cold side, at a distance of 130 mm from thermal break; ‘T’ means it is in the top layer; ‘A’ means section AA, and AR1 means the slab was the first slab with an Armatherm™ 500 thermal break. Each thermistor was at one of the following three distances from the origin/thermal break: 0 (the ones in contact with thermal break), 35 mm, and 130 mm. Thermistor distances from thermal break and other details are shown in Figure 33.

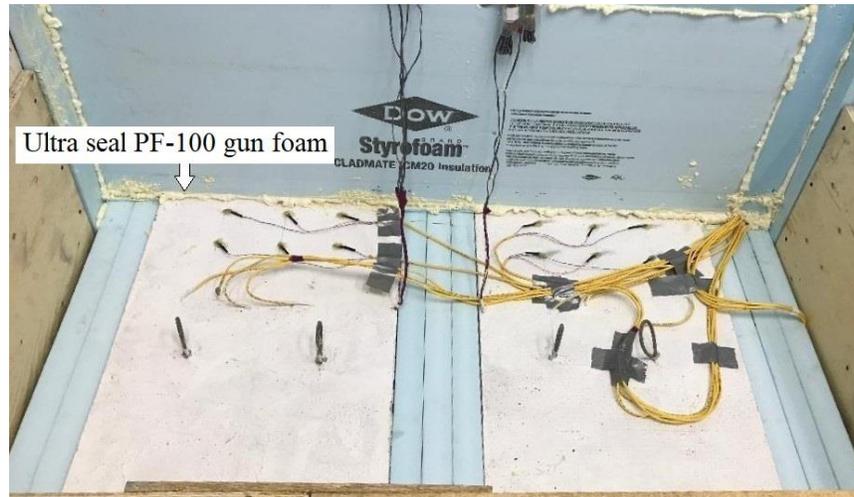
Figure 34 Styrofoam (blue) and gun foam (white) used to thermally separate the cold and hot sides

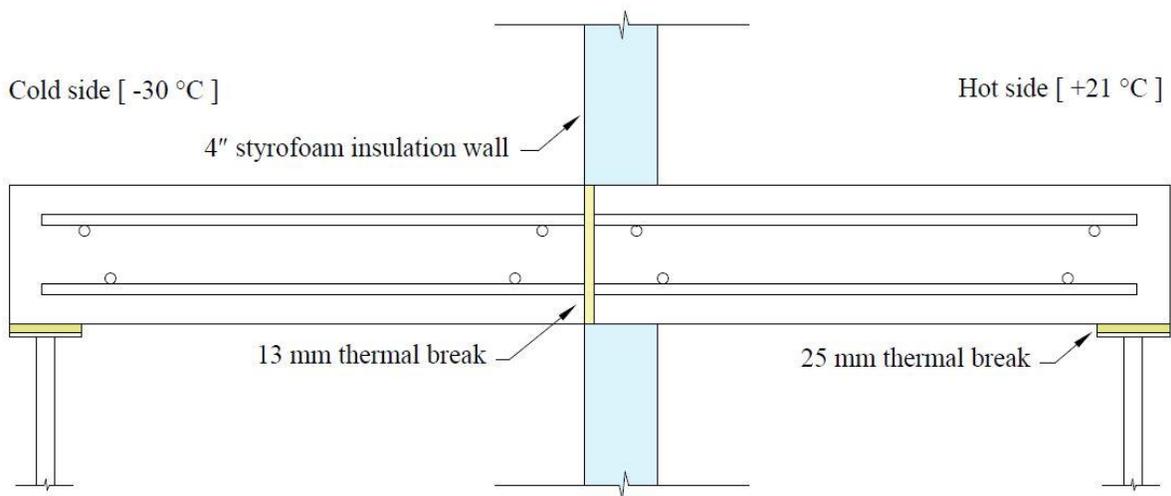
Figure 35 Position of thermal break

Each slab was put in the chamber such that the cantilever end was in the cold area. The thermal break is much thinner (0.5 inches) than the insulating Styrofoam wall (4 inches), and it was positioned underneath the edge of Styrofoam wall on the cold side to localize the greatest temperature adjacent to the cold side. See Figure 35 for more clarification.

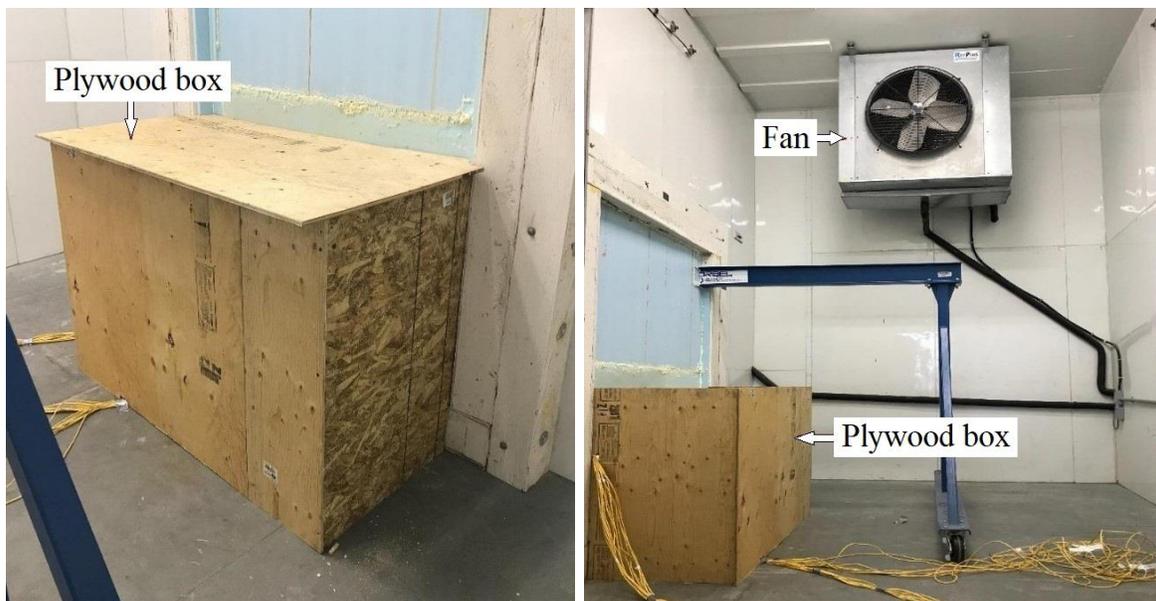
Figure 36 Plywood boxes to ensure uniform heat/cold distribution

The cold and hot compartments of the thermal chamber were each equipped with a fan. The fan on the cold side blew cold air into the compartment and was controlled to maintain the temperature at a fixed and uniform cold temperature. Similarly, the fan on the hot side blew hot air into the compartment and was controlled to maintain the temperature at a fixed and uniform hot temperature. To reduce difficult-to-measure forced convection effects due to the fans, plywood boxes were built around the slabs on both the cold and hot sides. The plywood used for making boxes had a thickness of 12 cm, a height of 100 cm, and width of 150 cm and covered the exposed slabs entirely. The plywood box is shown in Figure 36.

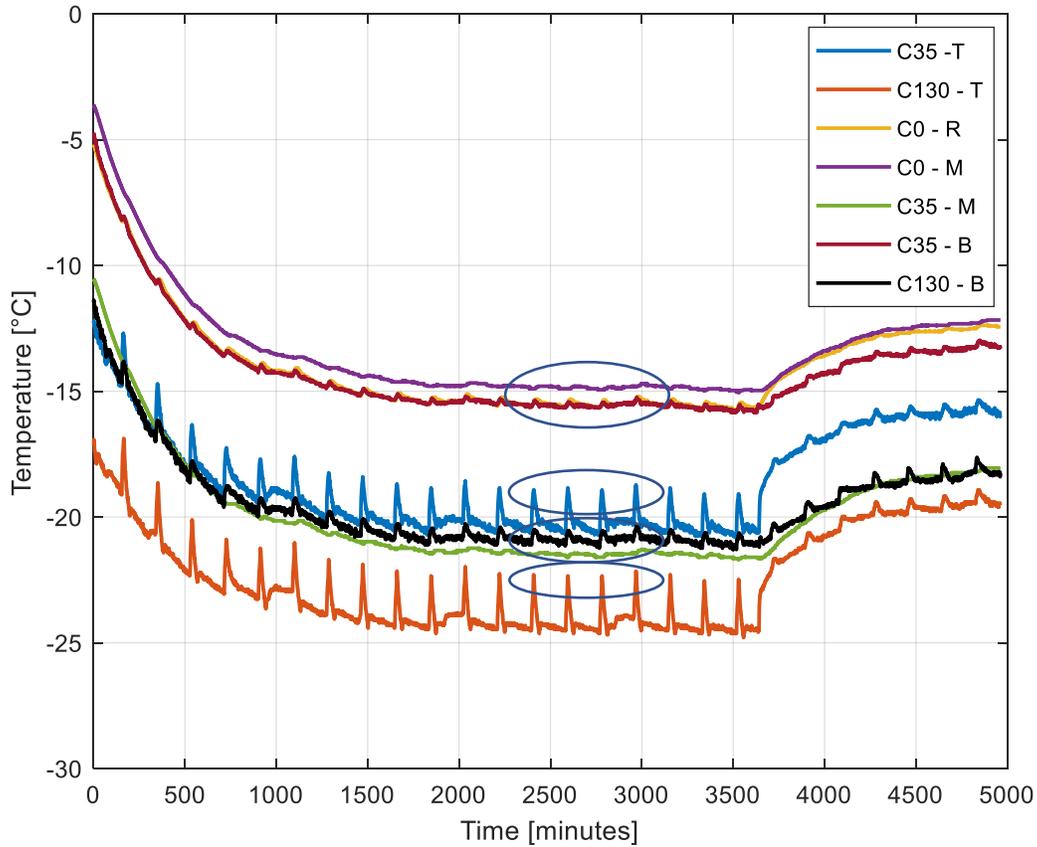
Figure 37 Temperature profile [sec A], cold side, SS1, AR1

A typical transient temperature plot is shown in Figure 37 for the cold side SS1 AR1 case. Initially the temperatures decrease and reach pseudo-steady state temperatures after approximately 1500 minutes. Due to the defrost cycle of the refrigeration cycle used to cool the cold side there are temperature spikes in the data. Average steady state temperatures were estimated based on 560 minutes of data beginning at approximately 2400 minutes. The averaged ranges are highlighted by the ellipses in Figure 37. This general approach was used for all thermal testing.

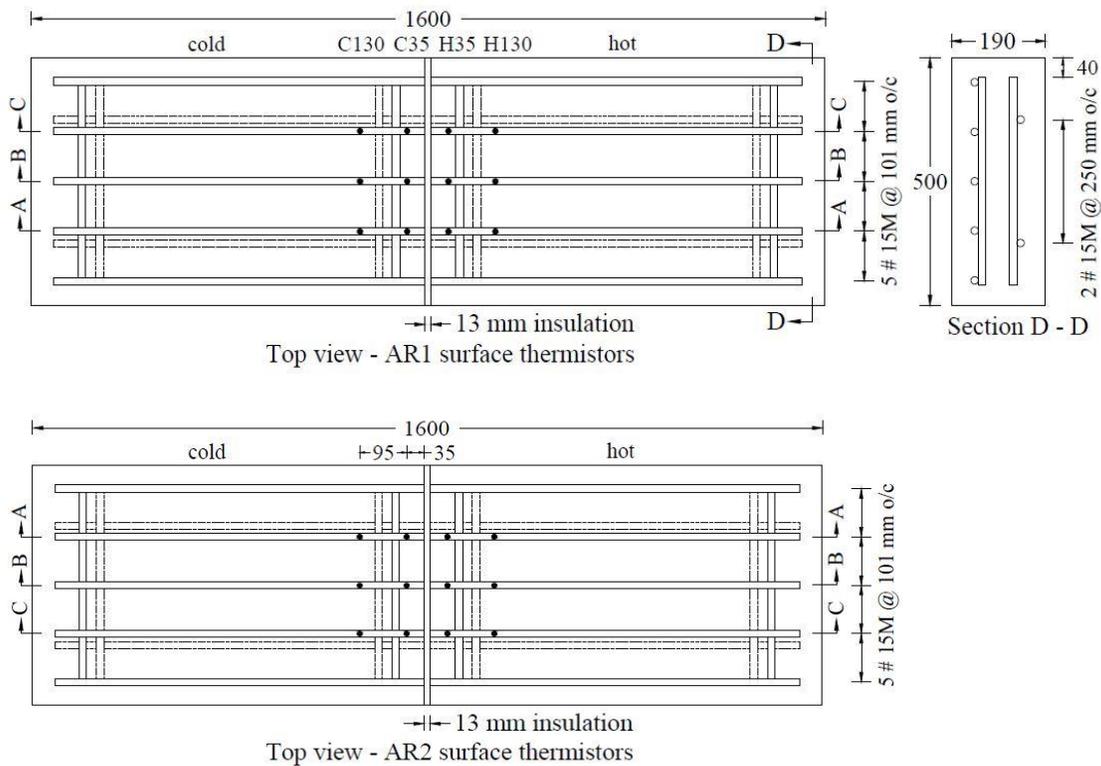
Figure 38 Drawings of AR1 and AR2 specimens inside thermal chamber

Placement of sections for AR1 and AR2 slabs is shown in Figure 38. Section AA of AR1 was placed next to section AA of AR2. In both AR1 and AR2 slabs 13 mm thick Armatherm™ 500 insulation separated the cold and hot ends.

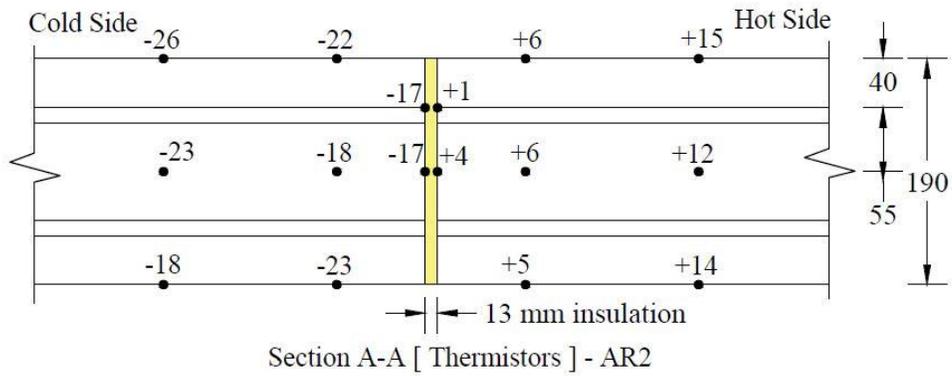
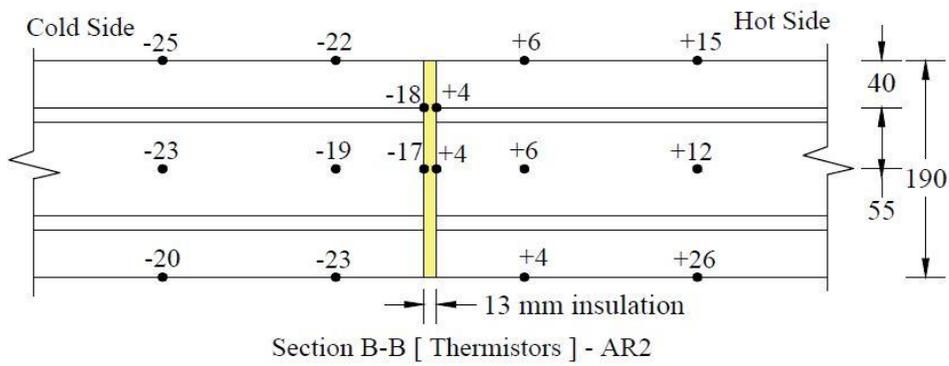
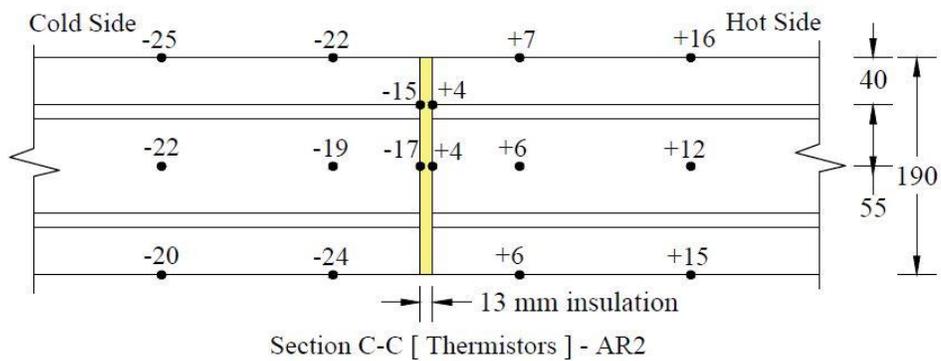
Figure 40 Sections AA/ BB/ CC for AR2 – SS1

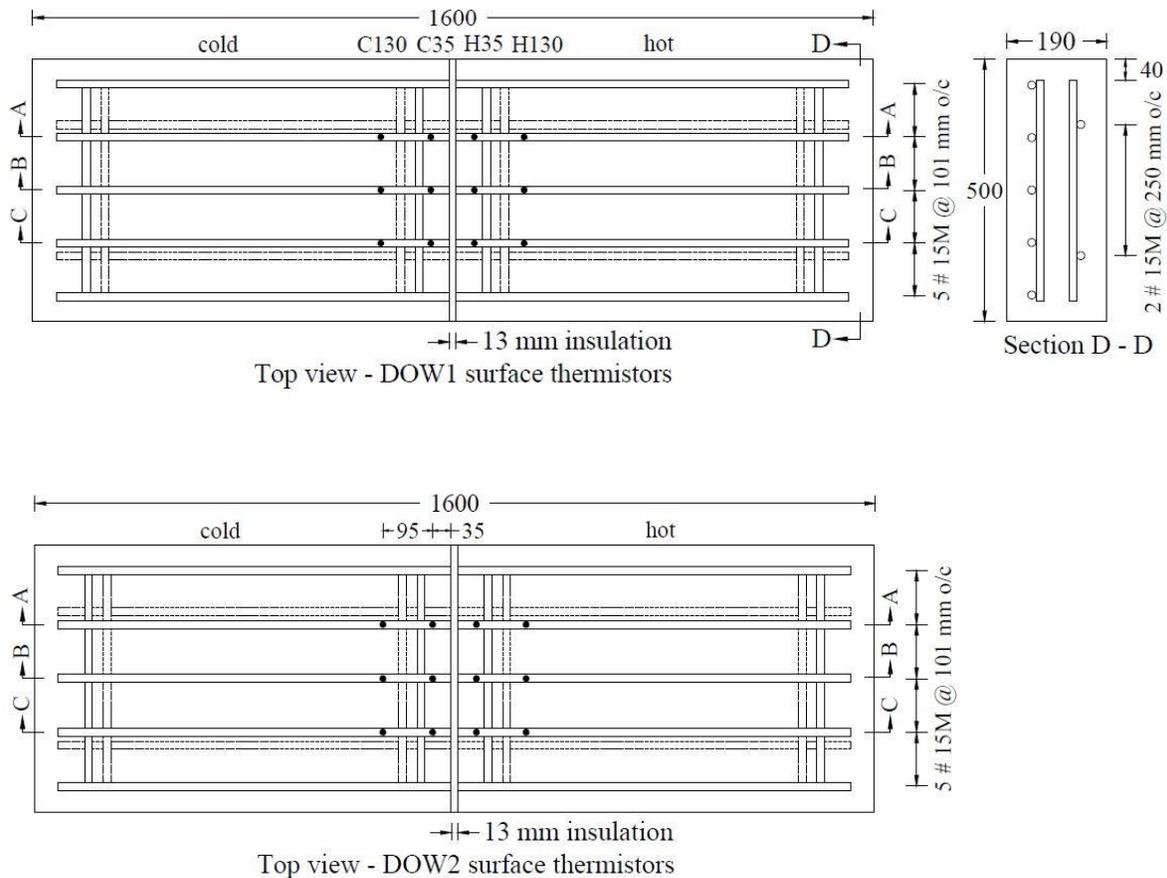
Figure 41 Drawings of DOW1 and DOW2 inside thermal chamber

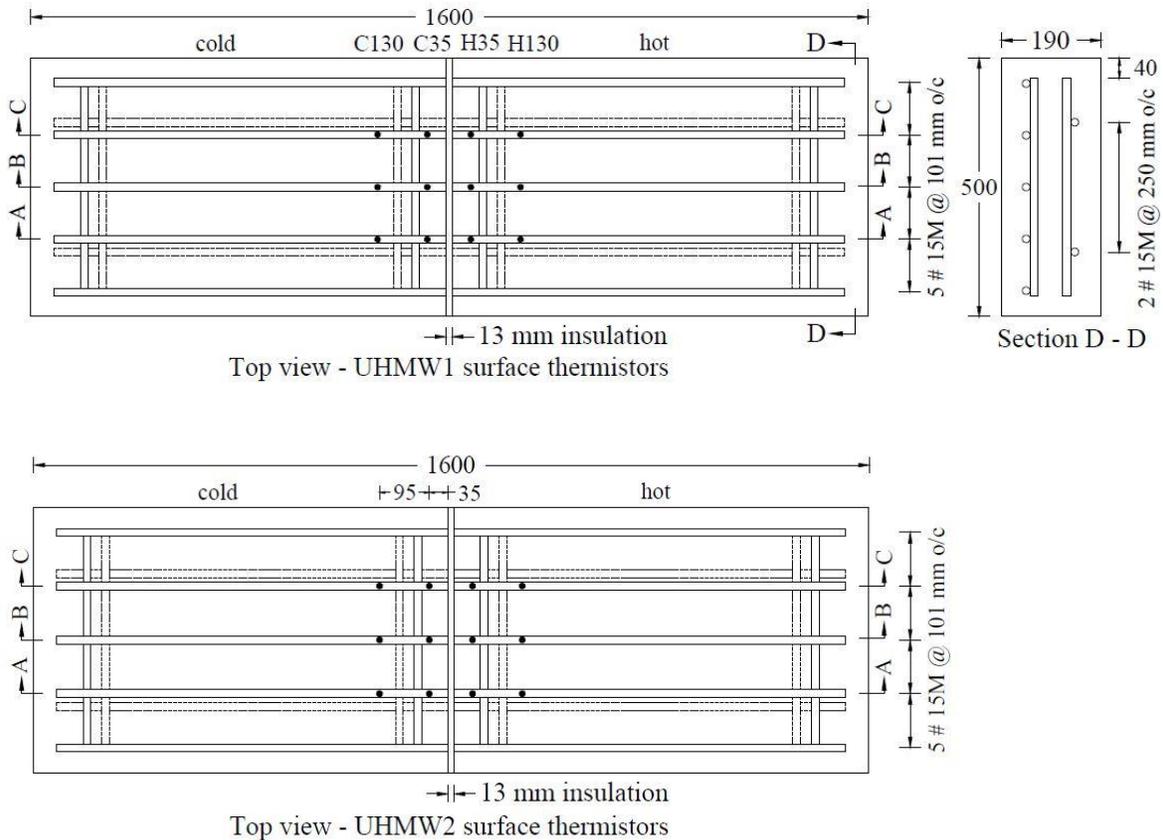
Figure 44 Drawings of UHMW1 and UHMW2 specimens inside thermal chamber

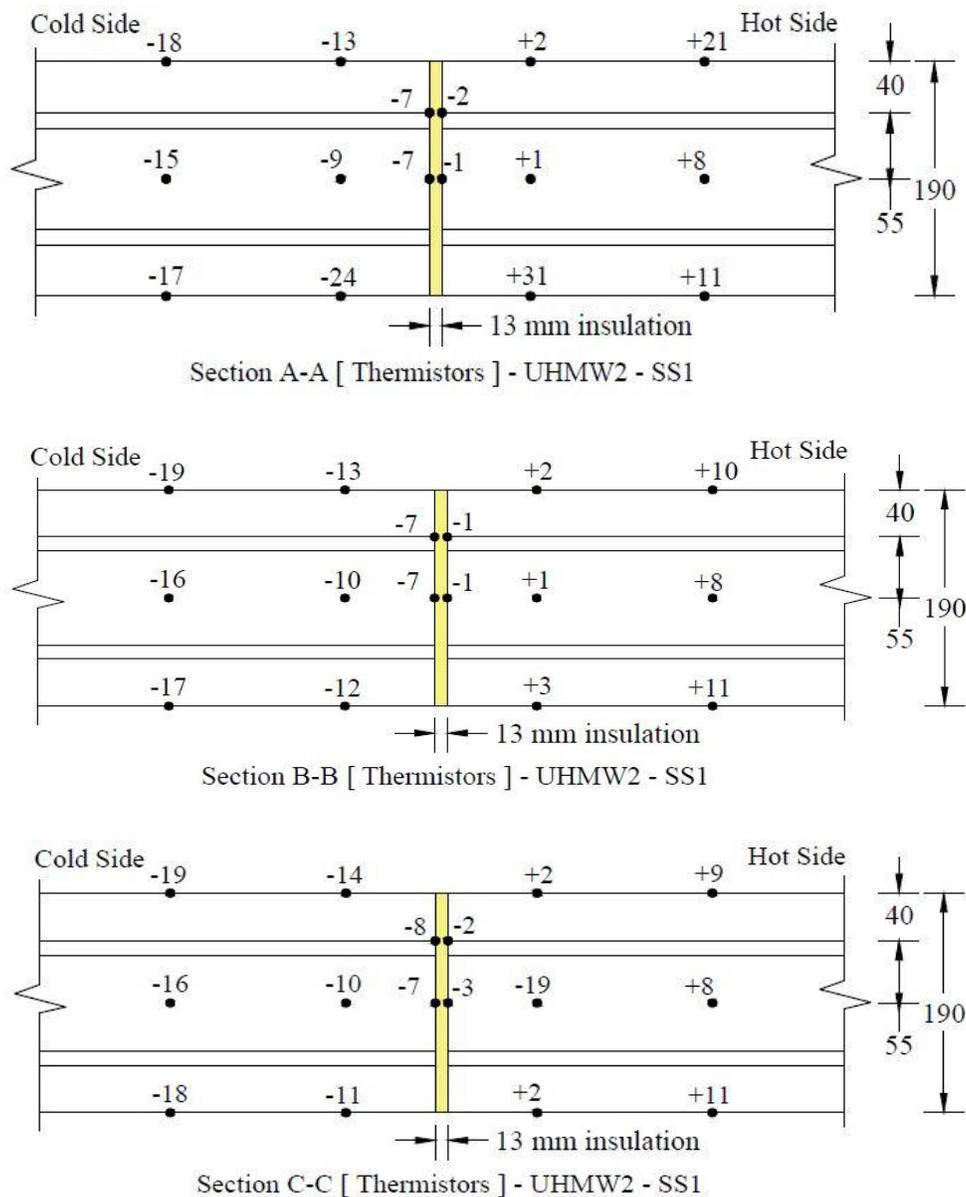
Figure 46 Sections AA/ BB/ CC for UHMW2 – SS1

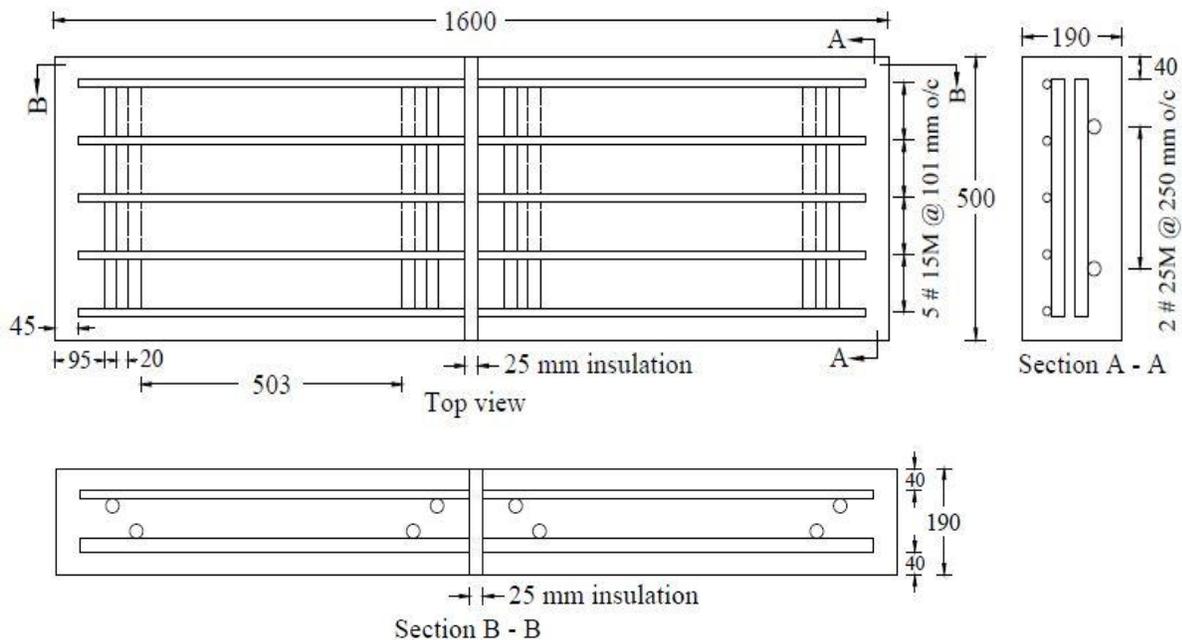
Figure A 1 GFRP reinforced slab (all dimensions are in mm)

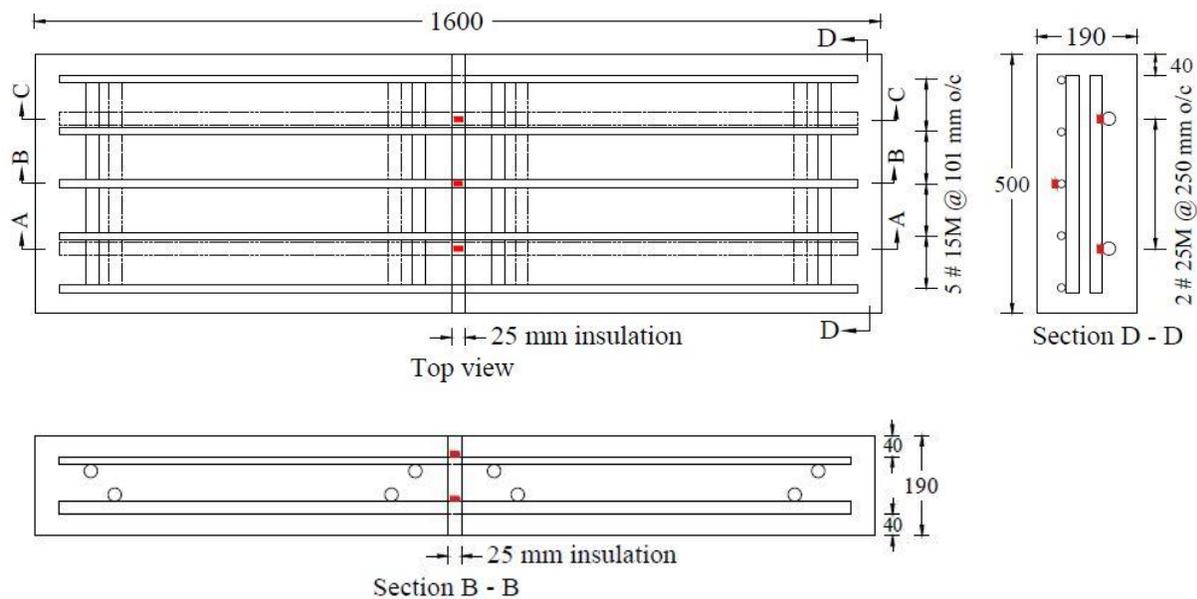
Figure A 2 Location of strain gauges shown as red dots

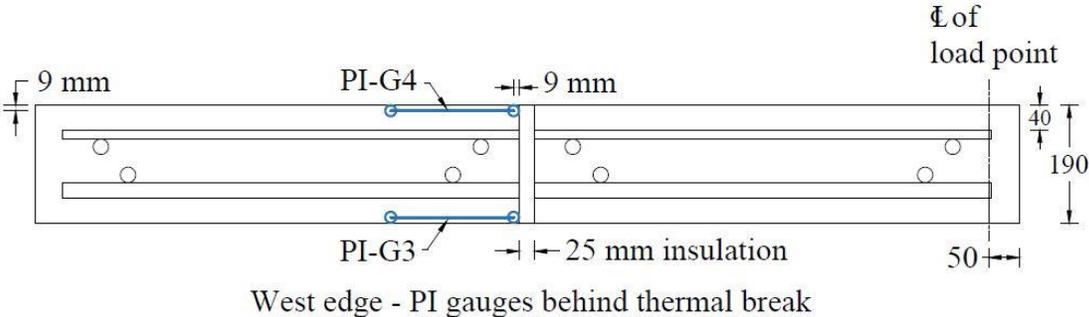
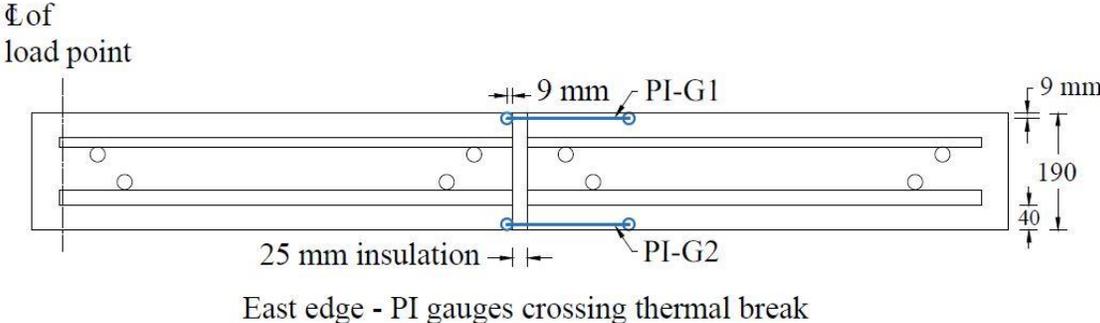
Figure A 3 Sketch of PI gauges for specimens

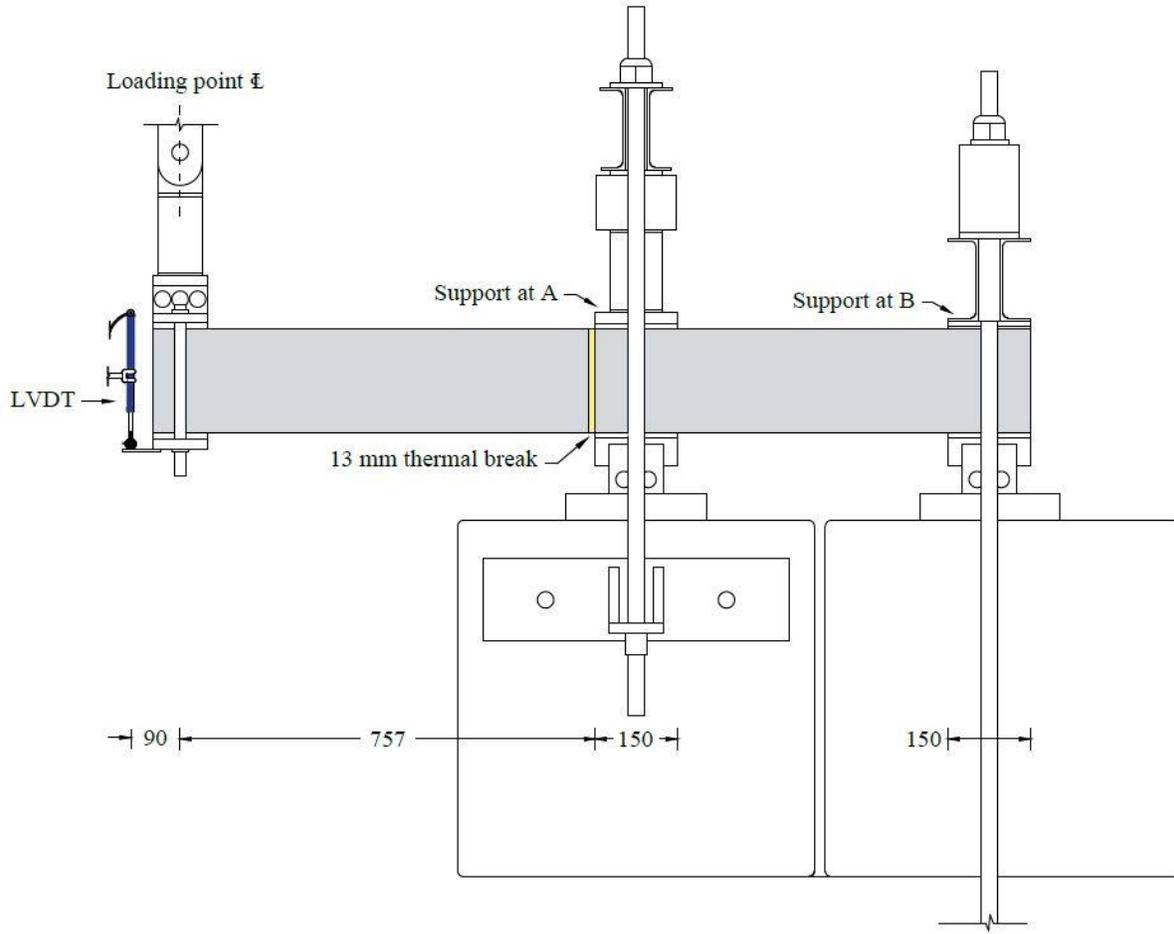
Figure A 4 LVDT position from loading point (all dimensions are in mm)

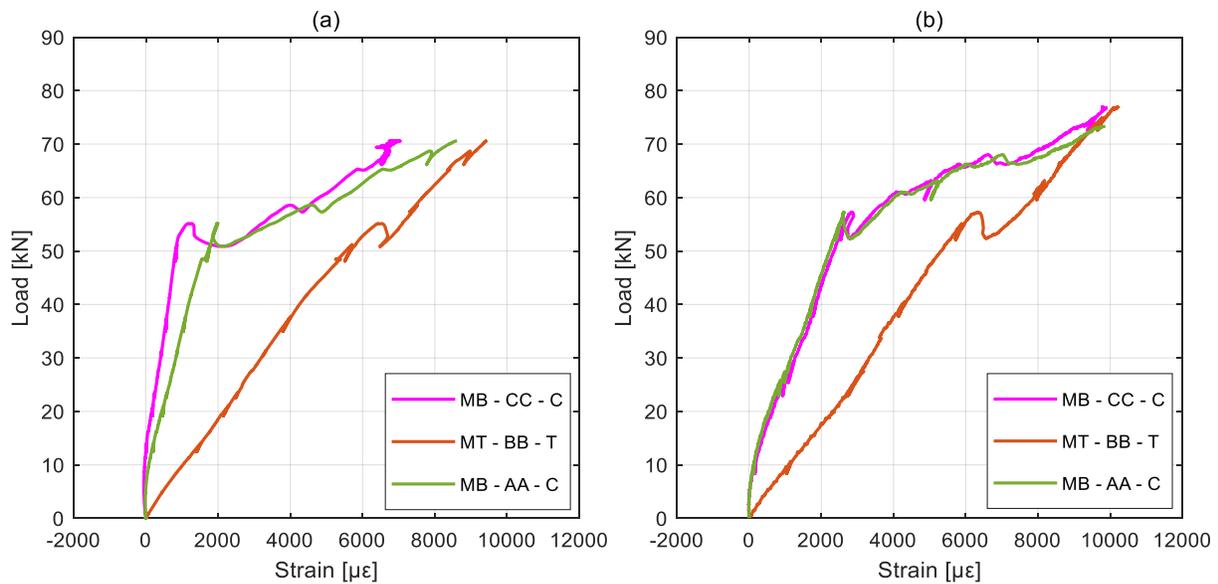
Figure A 5 Strain in reinforcement at maximum moment location: (a) slab1 and (b) slab2

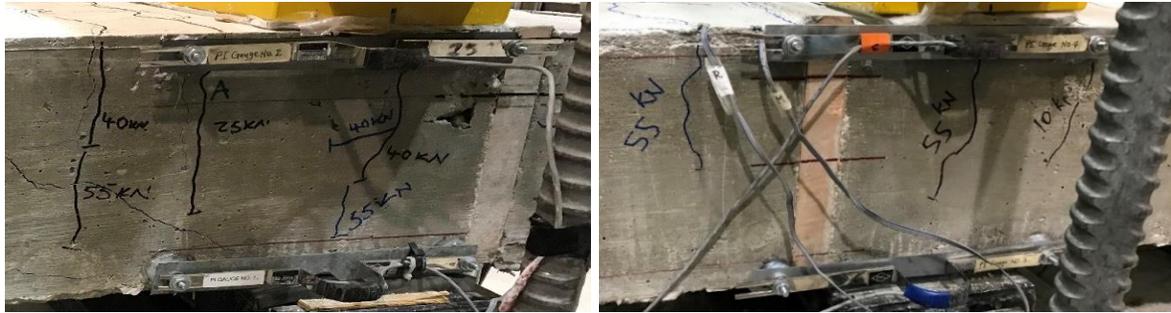
(a) west edge

PI Gauges: PI gauges were installed on each specimen to measure the strain and crack widths on concrete. Figure A6 shows the location of PI gauges on the west and east sides of the second specimen. PI gauge locations for the first specimen were the same as that shown in Figure A6.

Two PI gauges were installed per slab side: PI gauges 1 and 2 were installed on the east side, and 3 and 4 on the west side of the slab. PI gauges 1 and 4 were in tension (on the top) and PI gauges 2 and 3 were in compression (at the bottom). PI gauges 1 and 2 had the thermal break within their gauge length. PI gauge 1 recorded the dilation at the thermal break-concrete interface. PI gauge 2 recorded compression of the thermal break.

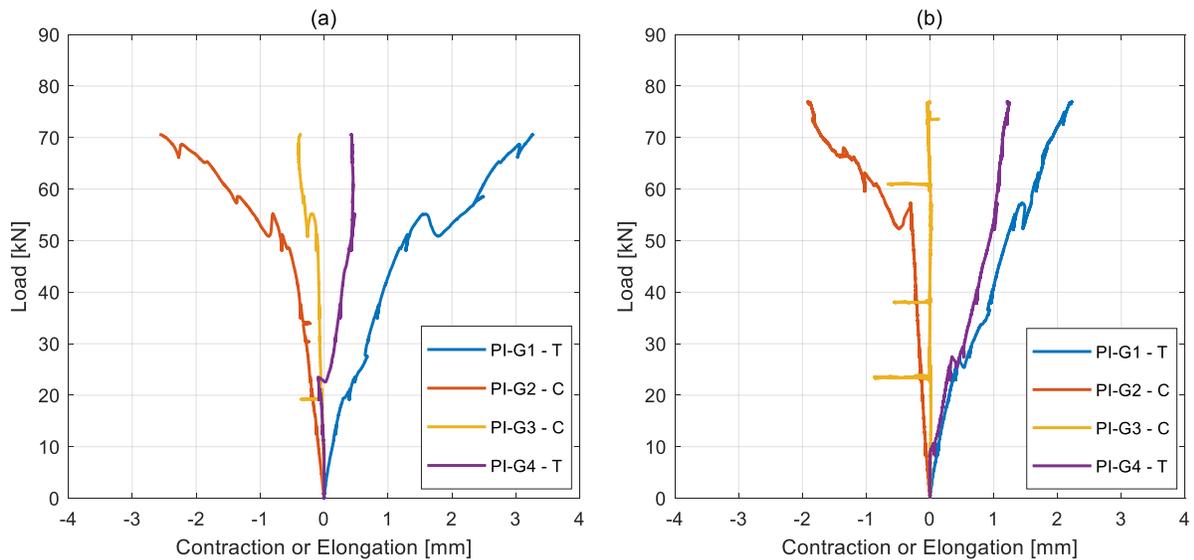
Figure A 7 Contraction and elongation of PI gauges on concrete: (a) slab 1 and (b) slab 2

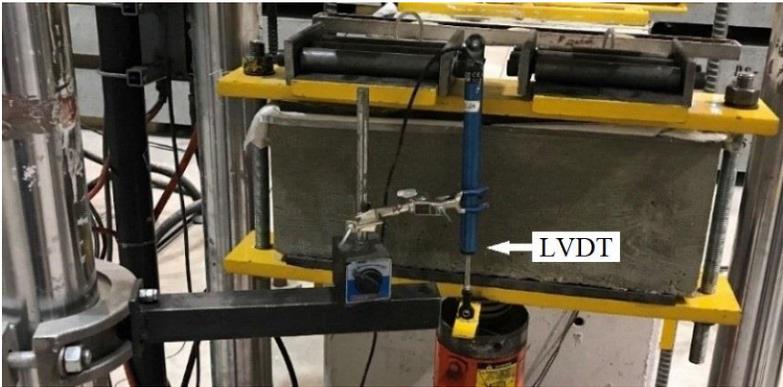
Figure A 8 Location of LVDT on specimens

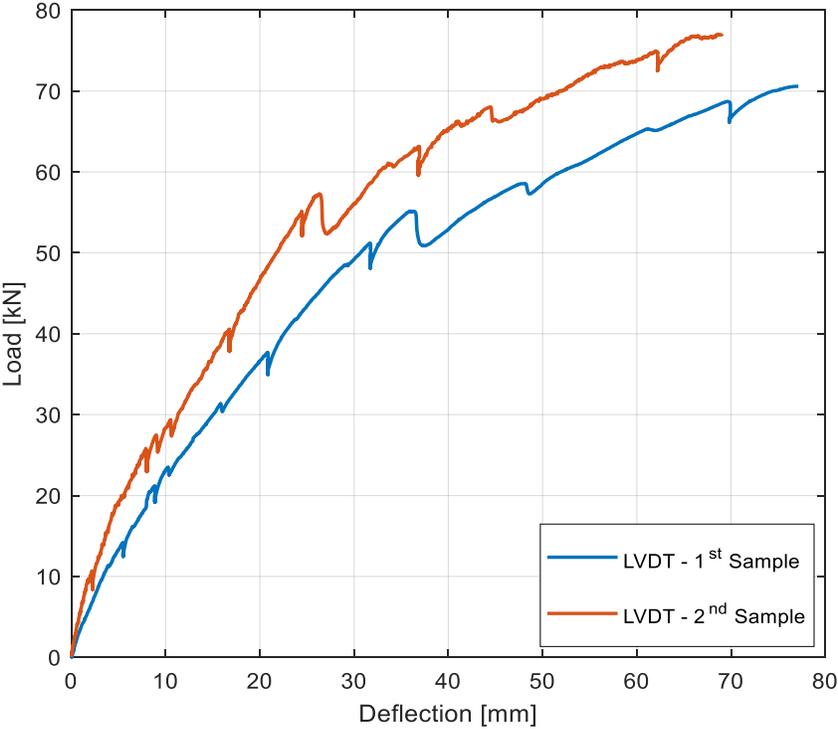
Figure A 9 Load Deflection for the two specimens

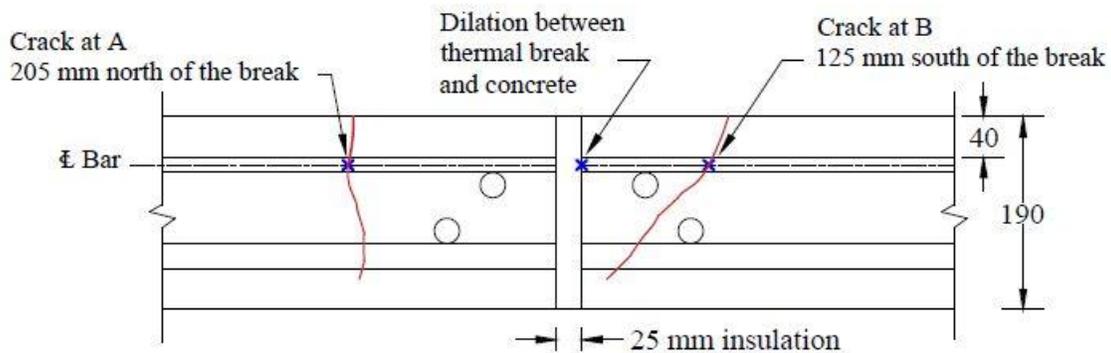
Figure A 10 Dilation and cracking cross section on the west side for the 2nd specimen

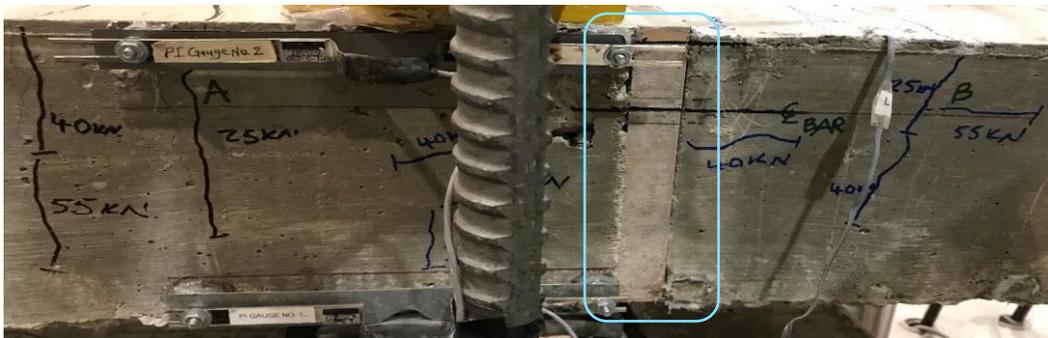
Figure A 11 Dilation between thermal break and concrete, 2nd specimen

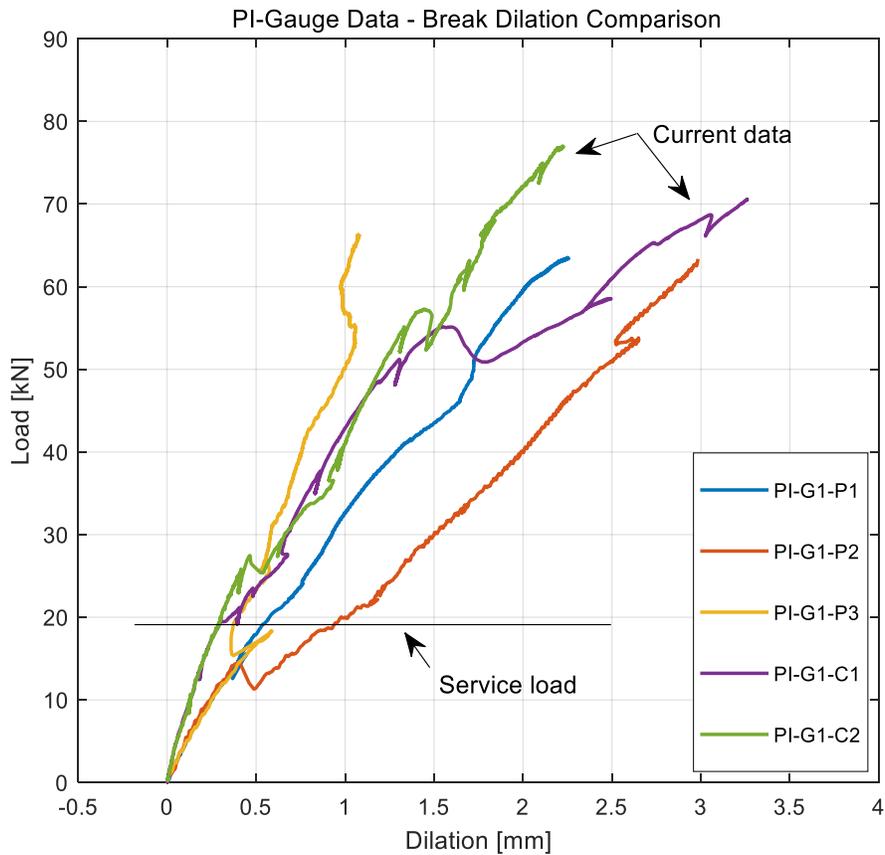
Figure A.12 Top east edge PI gauge results from Boila (2018) and the current study
