**STRUCTURAL PERFORMANCE OF GFRP REINFORCED
BALCONY SLAB WITH THERMAL BREAK**

Arezo Rasouli

A Thesis submitted to the Faculty of Graduate Studies of
the University of Manitoba
in partial fulfillment of the requirements for the degree of

Department of Civil Engineering
University of Manitoba
Winnipeg, MB, Canada

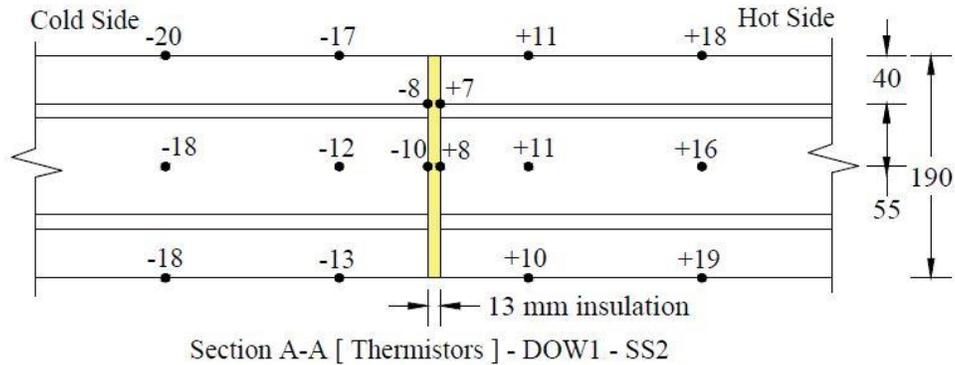
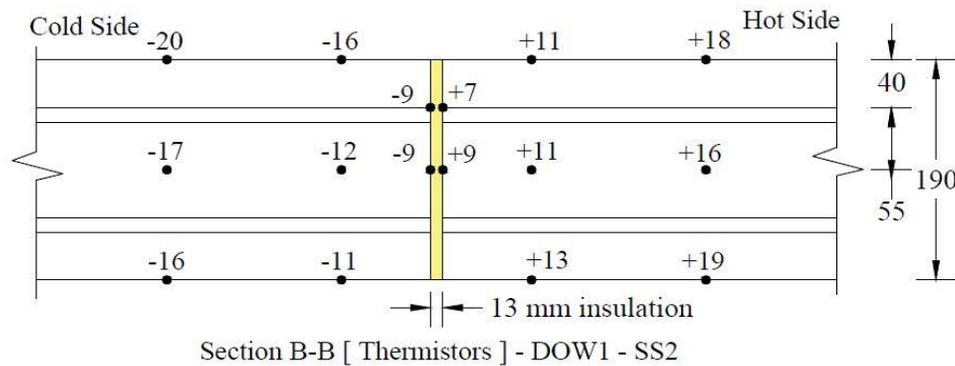
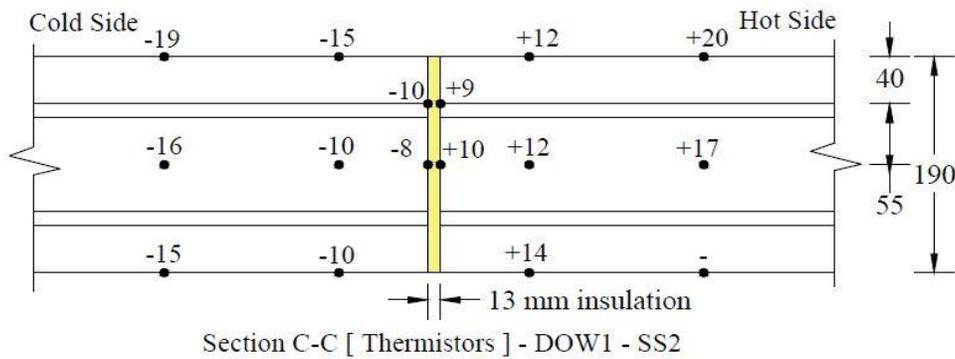
Figure B 1 Sections AA/ BB/ CC for DOW1 – SS2

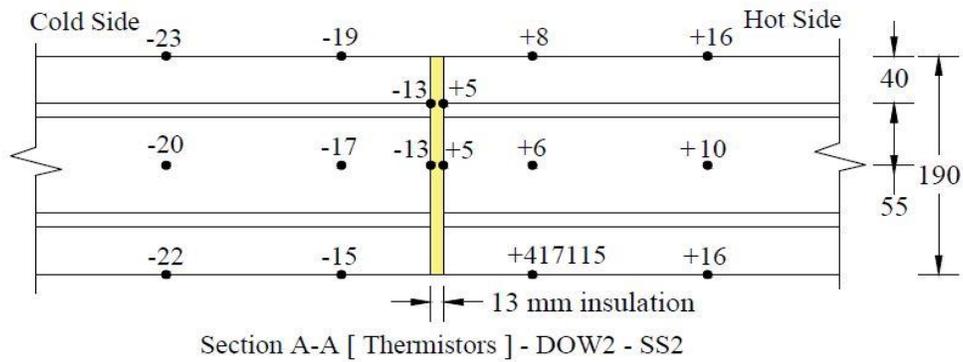
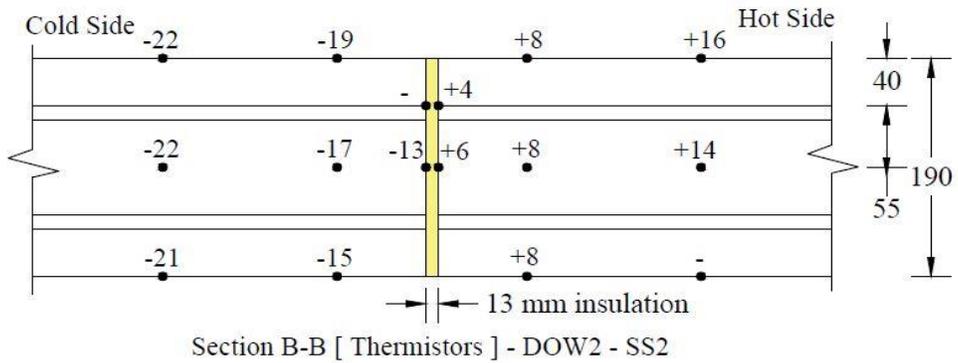
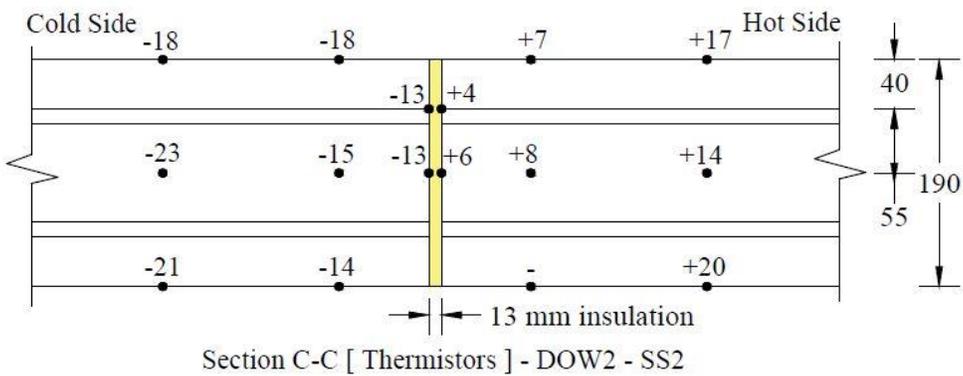
Figure B 2 Sections AA/ BB/ CC for DOW2 – SS2

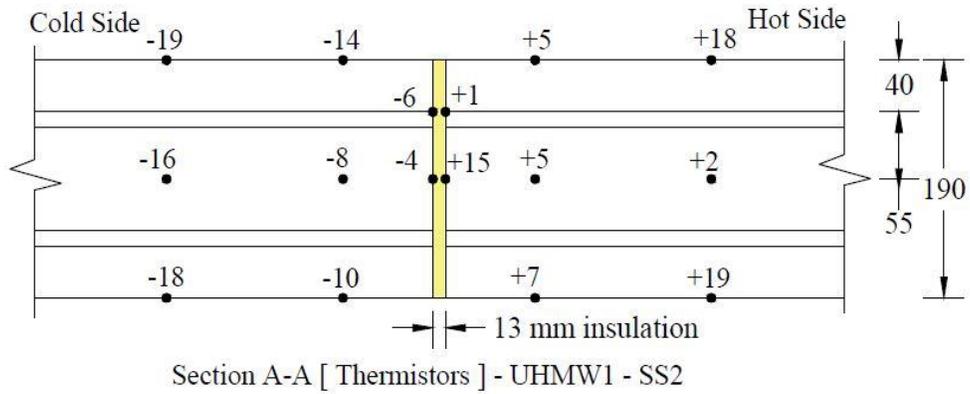
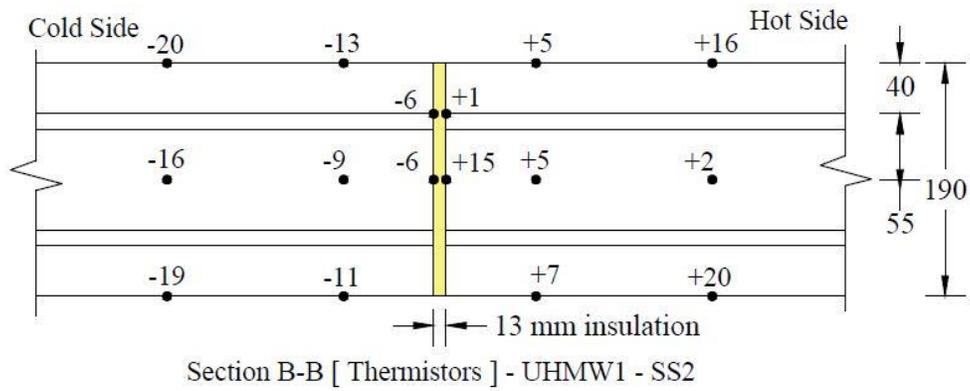
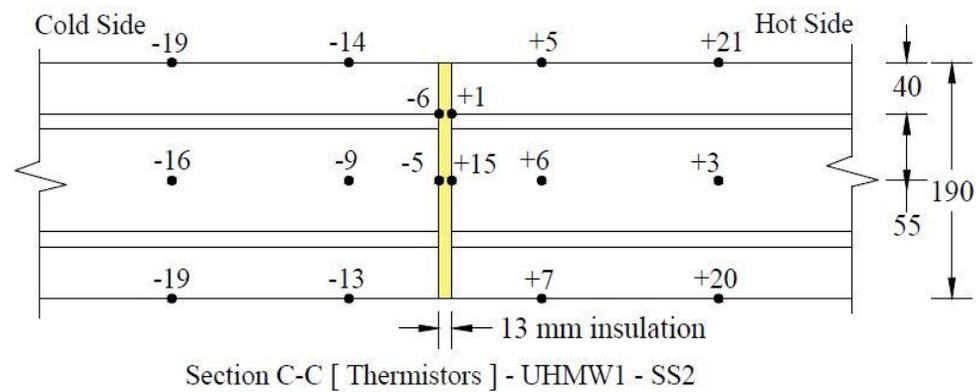
Figure B 3 Sections AA/ BB/ CC for UHMW1 – SS2

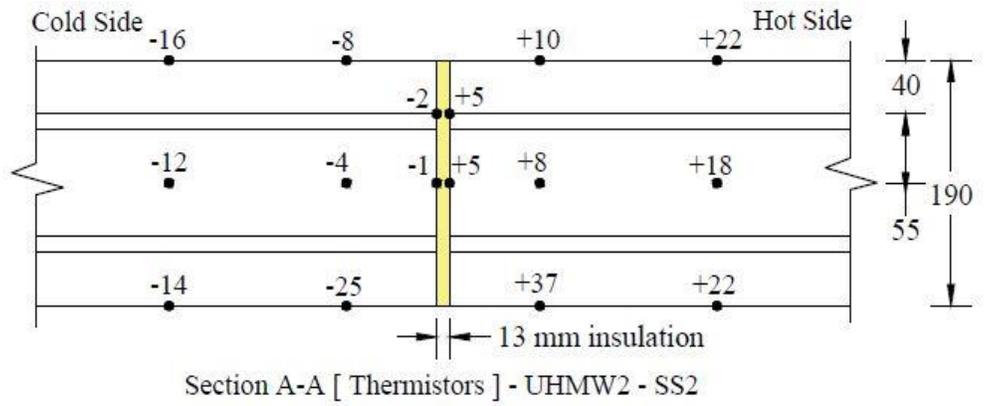
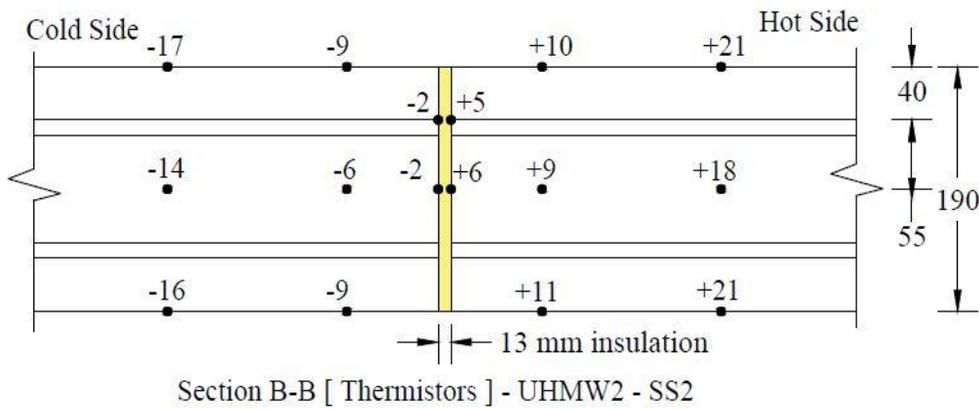
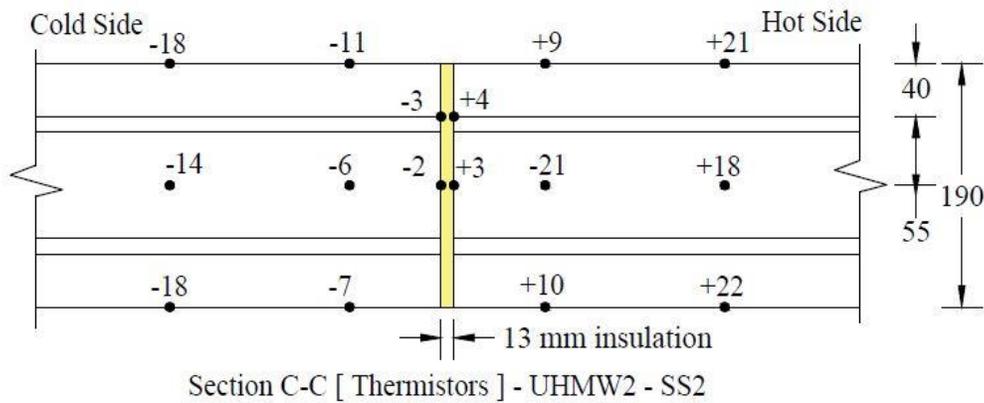
Figure B 4 Sections AA/ BB/ CC for UHMW2 – SS2
