OPERATING PERFORMANCE OF AUTOMATED PEDESTRIAN DETECTORS
AT SIGNALIZED INTERSECTIONS

A Thesis submitted to the Faculty of Graduate Studies of
The University of Manitoba
in partial fulfilment of the requirements of the degree of

Department of Civil Engineering
University of Manitoba
Winnipeg

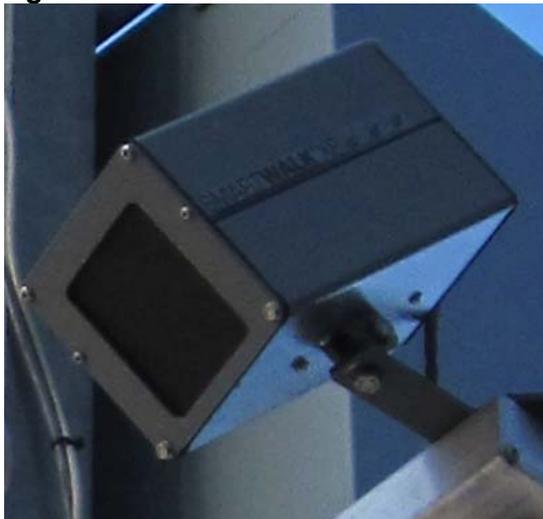
Figure 1: MS Sedco Smartwalk XP

Dharmaraju, Noyce and Lehman (2001) state that microwave radar detectors transmit electromagnetic radiation toward the area of interest from an antenna, mounted overhead or on the side, that illuminates approaching or departing objects. When an object passes through the beam, a portion of the transmitted radiation is reflected back to the antenna. The authors further explain that there are two types of microwave detectors. The first transmits a continuous wave of constant frequency and the change in frequency of the reflected wave is used to calculate the speed of the object. Detectors with such capability alone cannot detect motionless objects. However, detectors that are sensitive to very small motion are being developed. The second type of detectors transmit a saw-tooth waveform, also called frequency modulated continuous wave (FCWM), in which the transmitted frequency constantly changes. The FCWM provides both presence and passage detection. Figure 1 shows an image of the MS Sedco Smartwalk XP microwave detector.

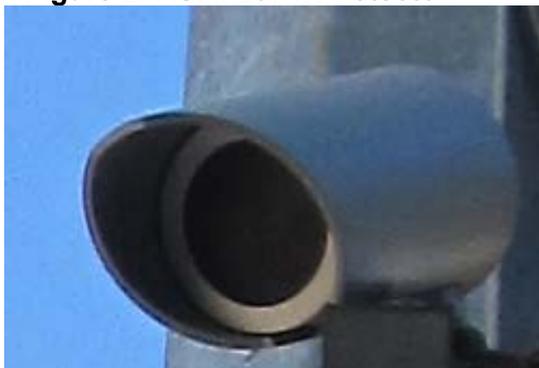
Figure 2: ASIM 207 IR Detector

These detectors operate in a way similar to that of passive infrared (PIR) vehicle detectors except in application as both pedestrians and vehicles emit and reflect energy. According to Klein, Mills and Gibson (2006) passive [infrared] sensors transmit no energy of their own. Rather they detect energy from two sources: (1) energy emitted from vehicles, road surfaces, and other objects in their field of view and (2) energy emitted by the atmosphere and reflected by vehicles, road surfaces, or other objects into the sensor aperture. The energy captured by passive infrared sensors is focused by an optical system onto an infrared-sensitive material mounted at the focal plane of the optics. The infrared sensitive element then converts the reflected and emitted energy into electrical signals. Real-time signal processing is used to analyze the signals for the presence of a vehicle. Figure 2 shows an image of the Xtralis Asim 207 IR detector which uses passive infrared detection.

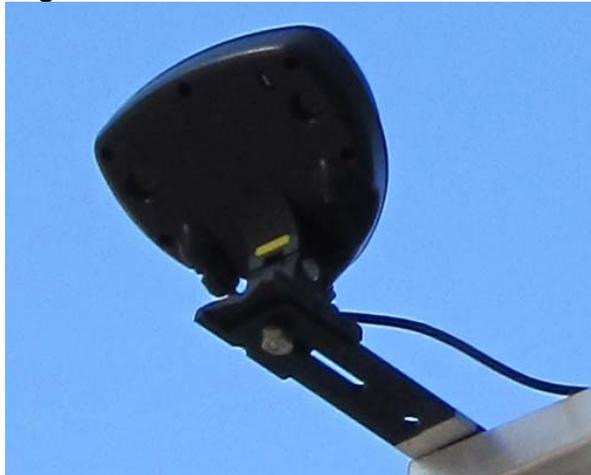
Figure 3: AGD 640 Detector

The addition of IR detection with video image processing allows an APD to detect pedestrians in low light conditions. Bu and Chan (2005) state that an infrared camera is not that sensitive to the change of lighting condition and that the advantage of an infra-red sensor is the ability to detect pedestrians without illuminating the environment. Figure 3 shows an image of the AGD 640 detector which combines infrared detection with stereovision.

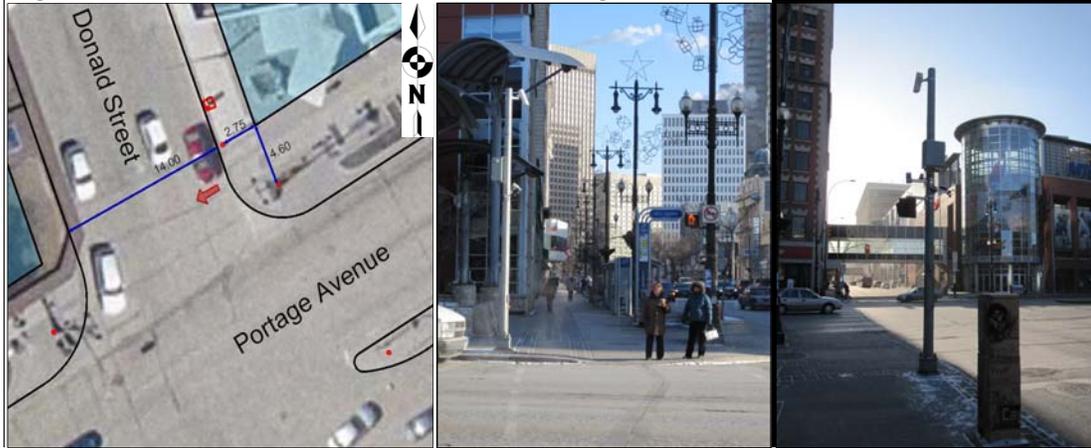
Figure 5: Intersection of Donald St & Portage Ave

Note: Intersection drawing created from City of Winnipeg CAD and Ortho data (left), photo facing east from the northwest corner (middle), photo facing south from the northeast corner (right).

The selected curbside wait area for APD field analysis is located on the northeast corner of the intersection of Portage Avenue and Donald Street for the northeast to northwest pedestrian intersection crossing movement. The curbside geometry on the northeast corner of Donald Street and Portage Avenue has dual separated curb ramps for two directions of governed pedestrian crossing.

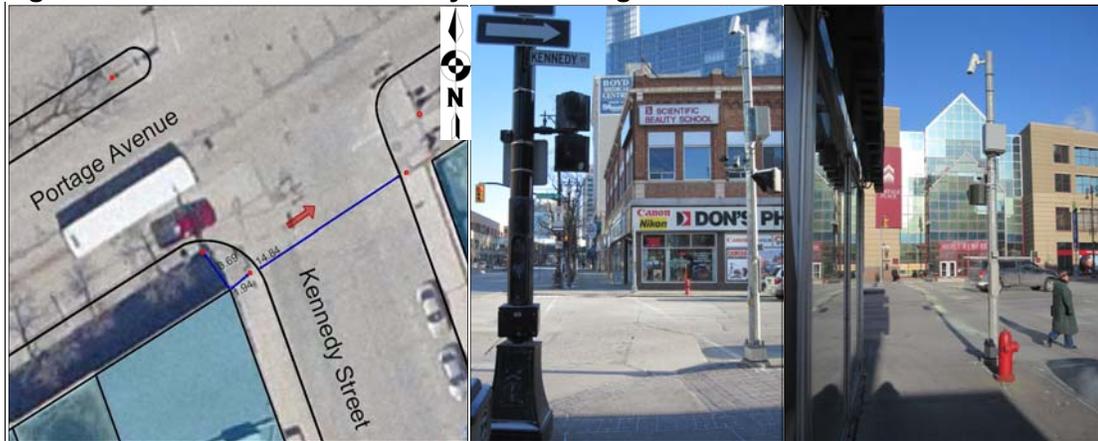
Figure 6: Intersection of Kennedy St & Portage Ave

Figure 6 illustrates the curbside geometry of the intersection with clear sidewalk widths, and intersection crossing distances in meters. Figure 6 also presents pictures of the detected curbside wait area and the APDs with installed data collection equipment.

Note: Intersection drawing created from City of Winnipeg CAD and Ortho data (left), photo facing east from the southwest corner (middle), photo facing north from the southwest corner (right).

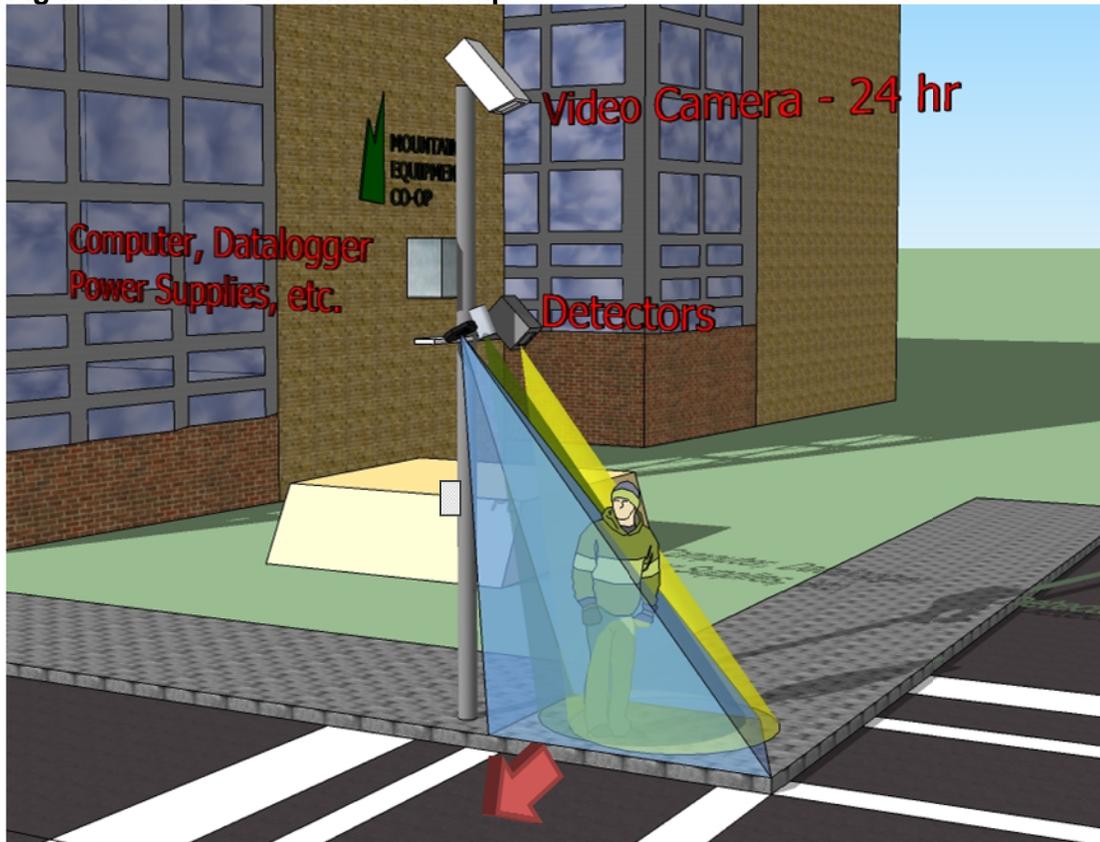
Figure 7: APD Data Collection Setup

evaluation setup required that each APD have equal opportunity to monitor the same intersection crossing wait area. Each APD was installed with the manufacturer's instructions and installed as to avoid interference from other detectors or data collection equipment. Interference between detectors can occur when one detector is mounted in a way that diminishes or hampers another detector's field of view. Figure 7 illustrates the typical setup for the detectors including the pedestrian crossing direction as indicated by a red arrow. APDs are not manufactured to a uniform standard for detection zone dimensions, shape or area, and have varying installation requirements, detection modes, and configurability. Figure 7 illustrates the approximate detection zones for each APD by color (infrared/video– blue, infrared – green, and microwave – yellow).

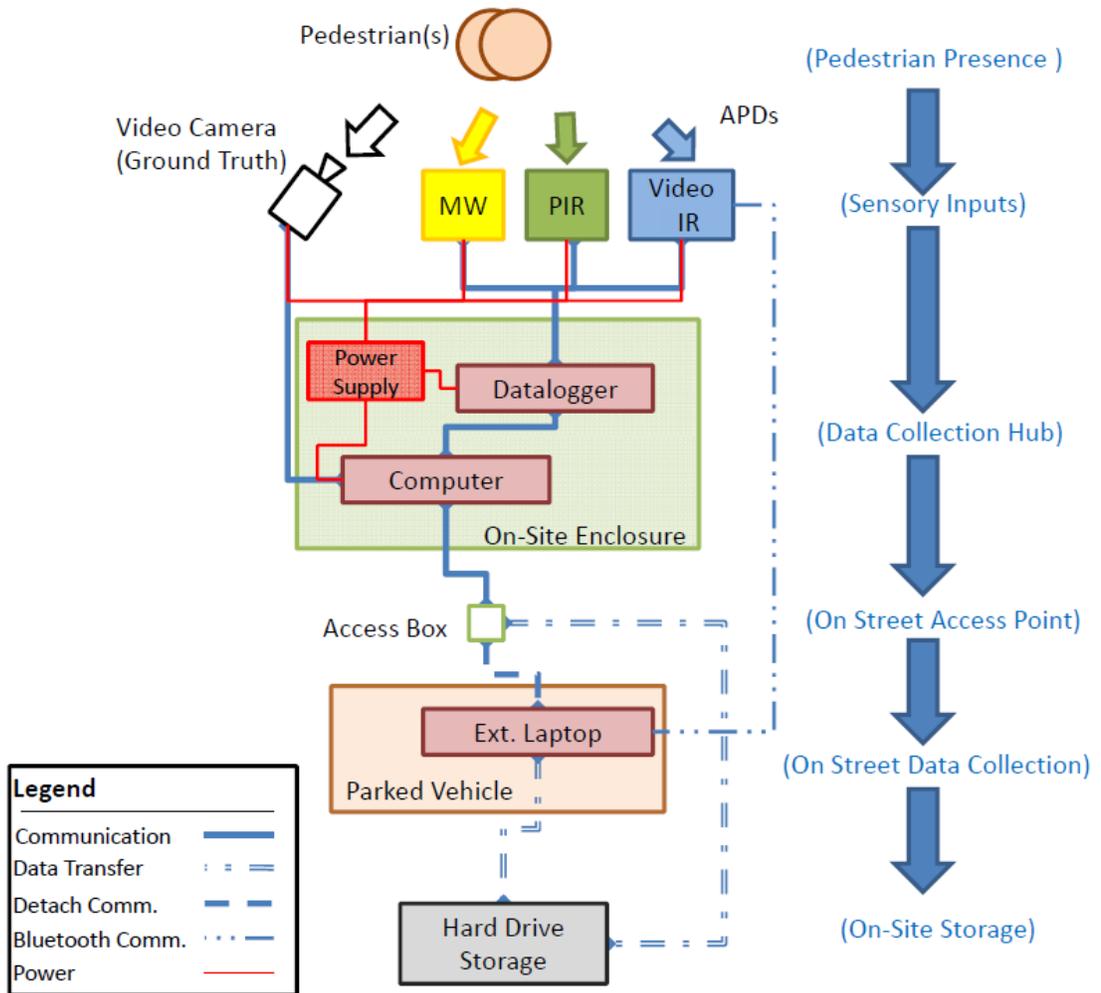
Figure 8: APD Data Collection Schematic

As Figure 8 illustrates, once a pedestrian arrives at the APD observed curbside of the signalized intersection the pedestrian's activity is recorded by a continually running digital video camera. The datalogger located inside the onsite data collection enclosure scans the electrical outputs of the APDs for pedestrian calls. The call status of each APD is recorded with a

corresponding time-stamp by the datalogger on the datalogger's internal memory. Video data from the digital video camera is stored on the hard drive of the onsite computer for weekly retrieval. The datalogger is connected to the onsite computer using a serial (RS-232) connection to enable the collection of the APD call data from the datalogger's internal memory and to view the real-time call status.

The onsite computer has an Ethernet and USB cable wired to an access box accessible at street level to facilitate the networking of an external laptop and transference of data to a high capacity USB flash drive. The video and APD call data is collected weekly through the use of remote computer control software accommodated by the direct Ethernet network connection from the onsite computer to the external laptop. Once the video and APD call data have been exported to the USB flash drive the data is transferred to an off-site location for processing, analysis, and secure storage.

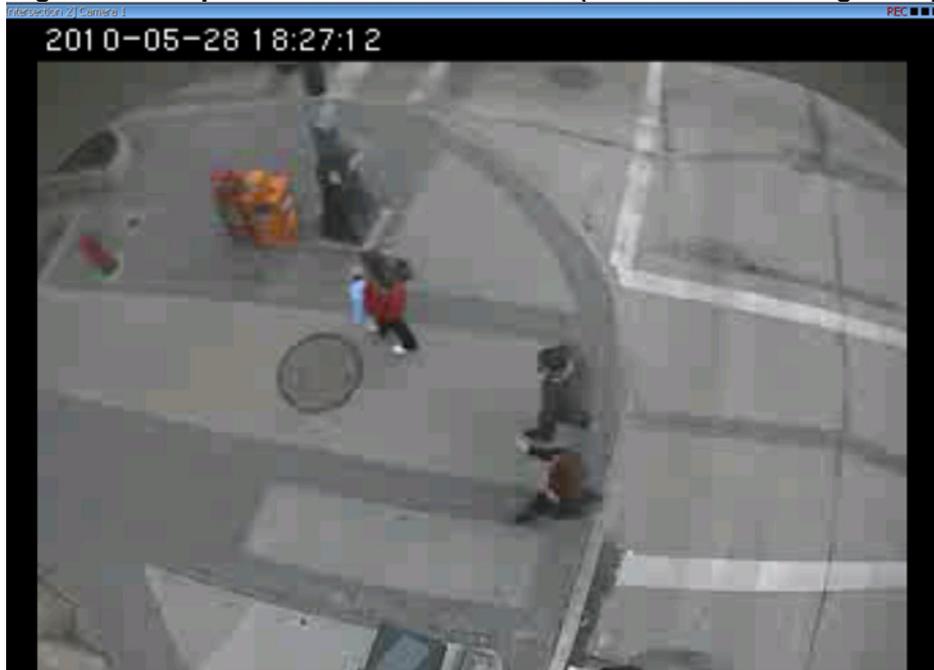
Figure 9: Sample Video Data Screenshot (Donald St & Portage Ave)

The video camera and datalogger are both connected to the onsite computer. The onsite computer's date and time are referenced by both the video camera and datalogger to maintain clock synchronization of video and APD call data. The clock synchronization enables the analysis of APD performance by comparing video data to corresponding APD call data.

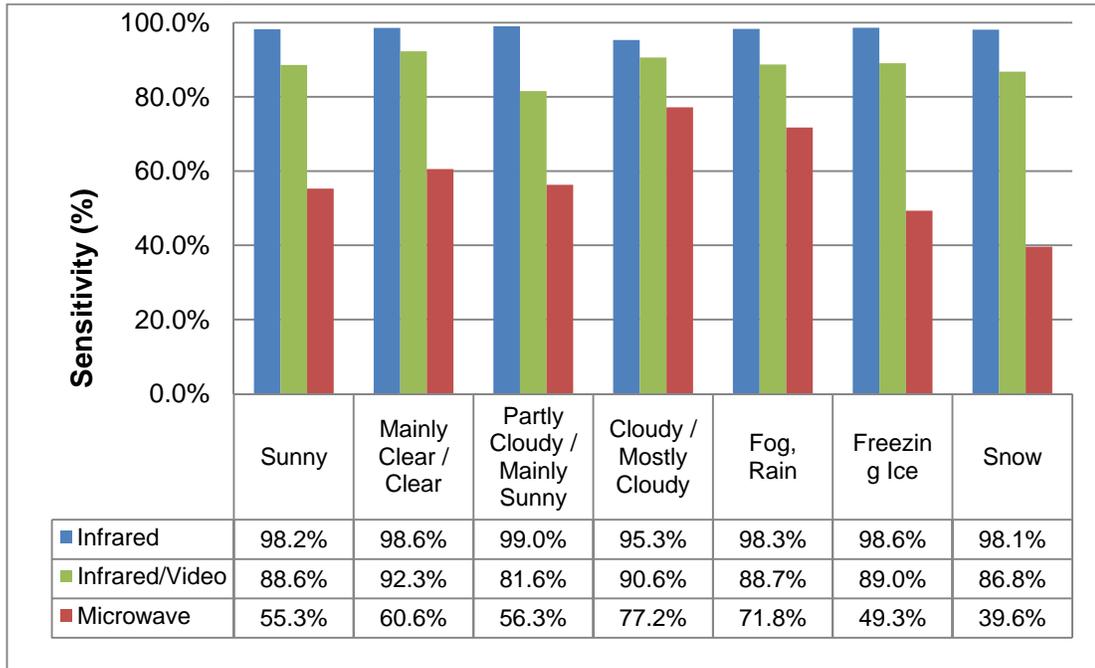
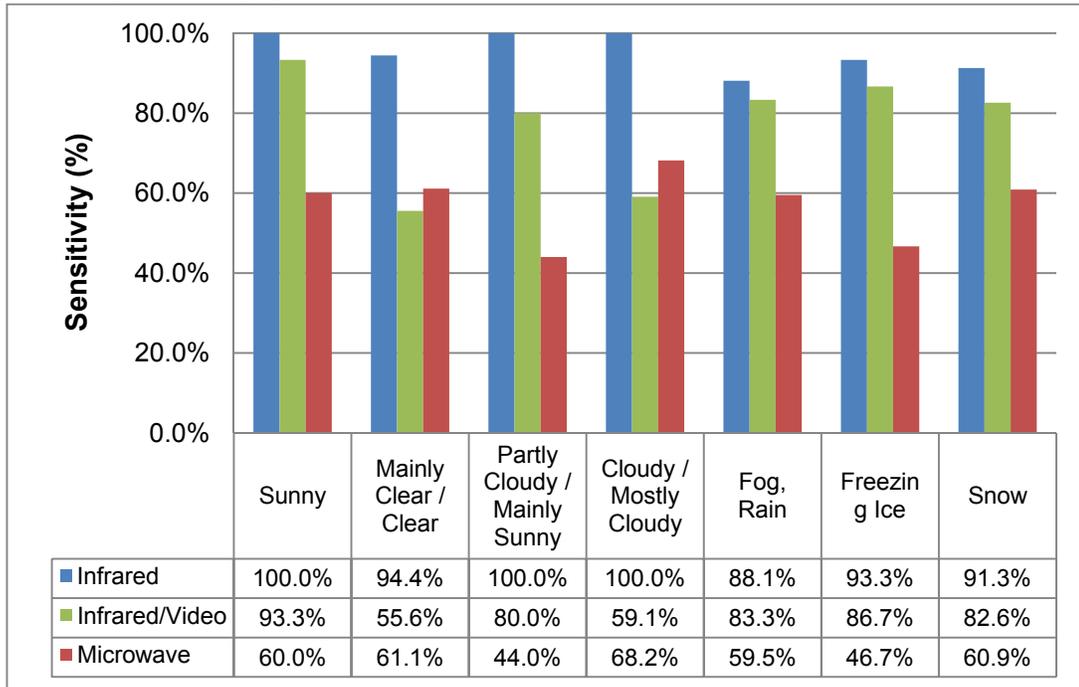
The research found that the infrared detector has the highest sensitivity in all recorded weather conditions, ranging from 95 to 99 percent at the Donald St. site, and from 88 to 100 percent at the Kennedy St. site. The microwave detector has the lowest sensitivity for all weather conditions, ranging from 40 to 77 percent at the Donald St. site, and from 44 to 68 percent at the Kennedy St. site. The lowest sensitivity for this detector is during periods of snow fall or freezing ice, or when it is partly cloudy. The infrared and video detector performs best when it is sunny, with sensitivity over 90 percent. The overall APD performance is better at the Donald St. site than at the Kennedy St. site.

Figure 10: APD Sensitivity as a Function of Weather Conditions (Donald & Portage)

Figure 12: APD Sensitivity as a Function of Weather Conditions (Kennedy & Portage)

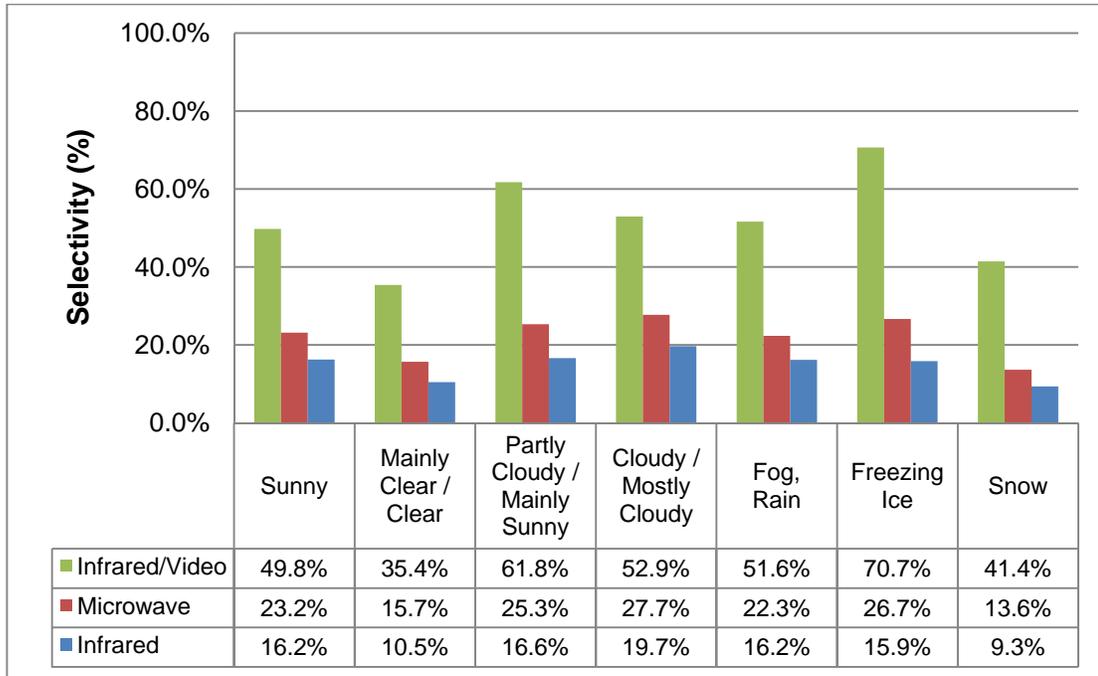
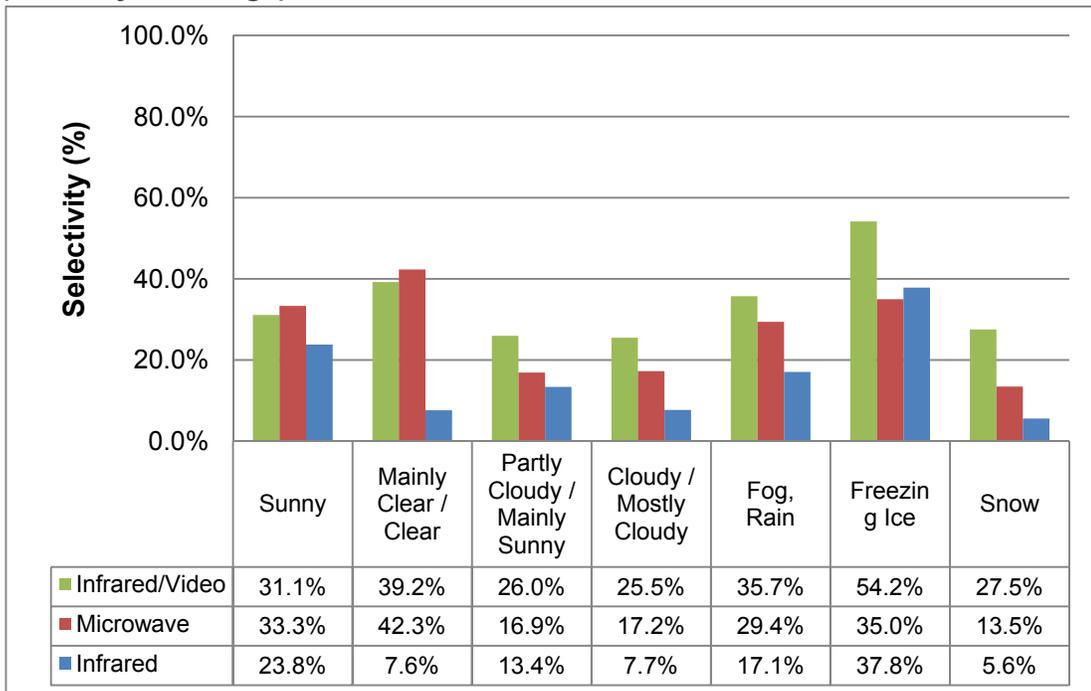
Regarding APD selectivity, in general, it is low under all weather conditions for all detectors, except for the infrared/video detector at the Donald site. The

selectivity rates for the infrared and microwave detectors range between 6 and 42 percent at the two sites. This means that under these weather conditions, there is a false detection rate of anywhere between 58 and 94 percent, depending on the detector and the site.

The infrared/video detector shows the highest selectivity of all APDs for all analyzed weather conditions. However, its best performance is under freezing ice conditions, resulting in a selectivity rate of 70 percent.

Figure 11: APD Selectivity as a Function of Weather Conditions (Donald & Portage)

Figure 13: APD Selectivity as a Function of Weather Conditions (Kennedy & Portage)

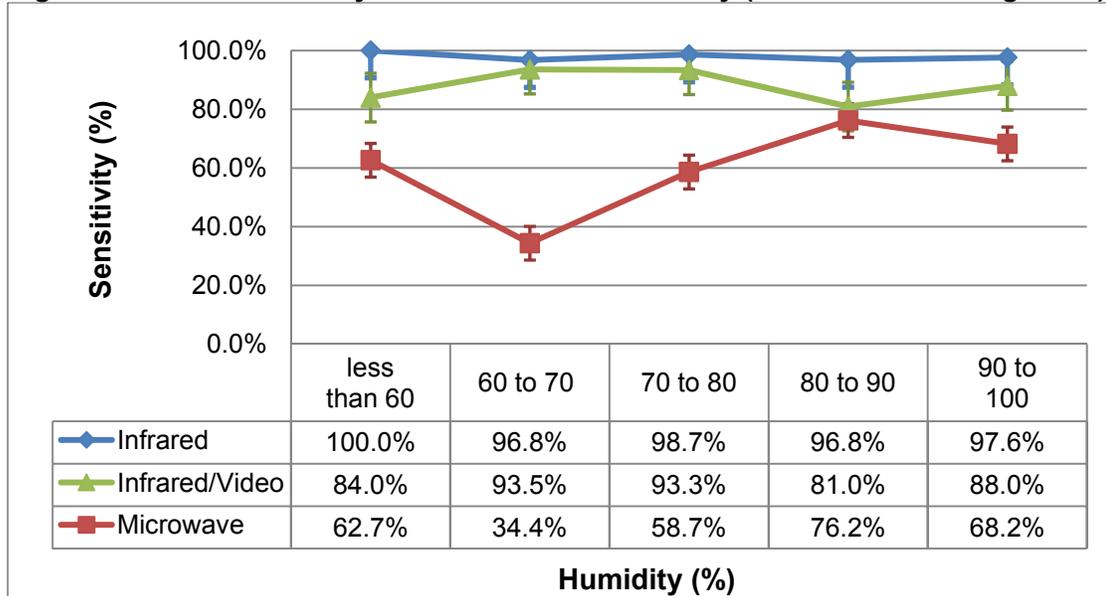
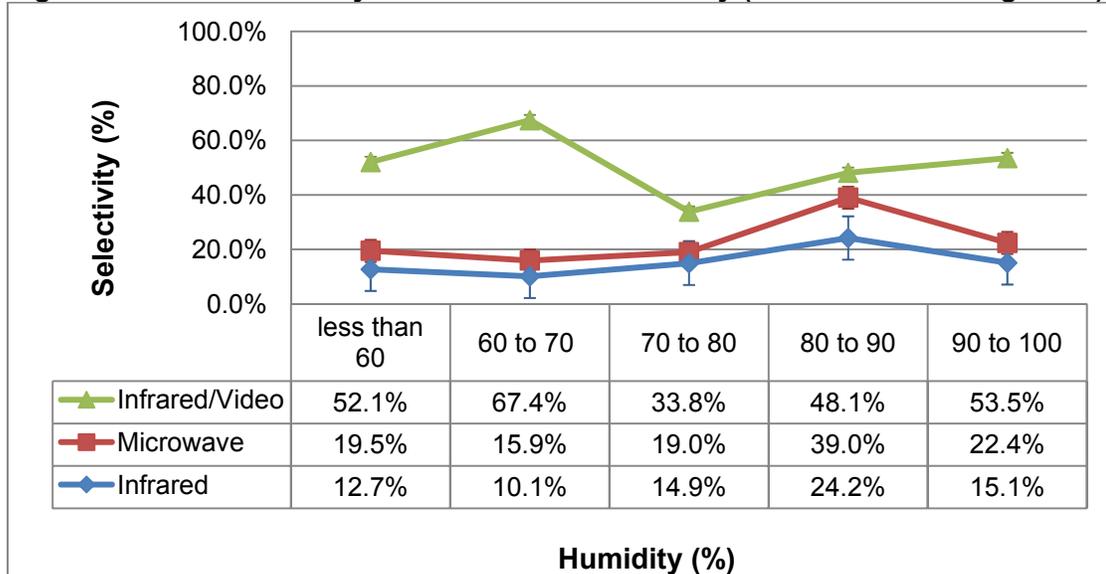
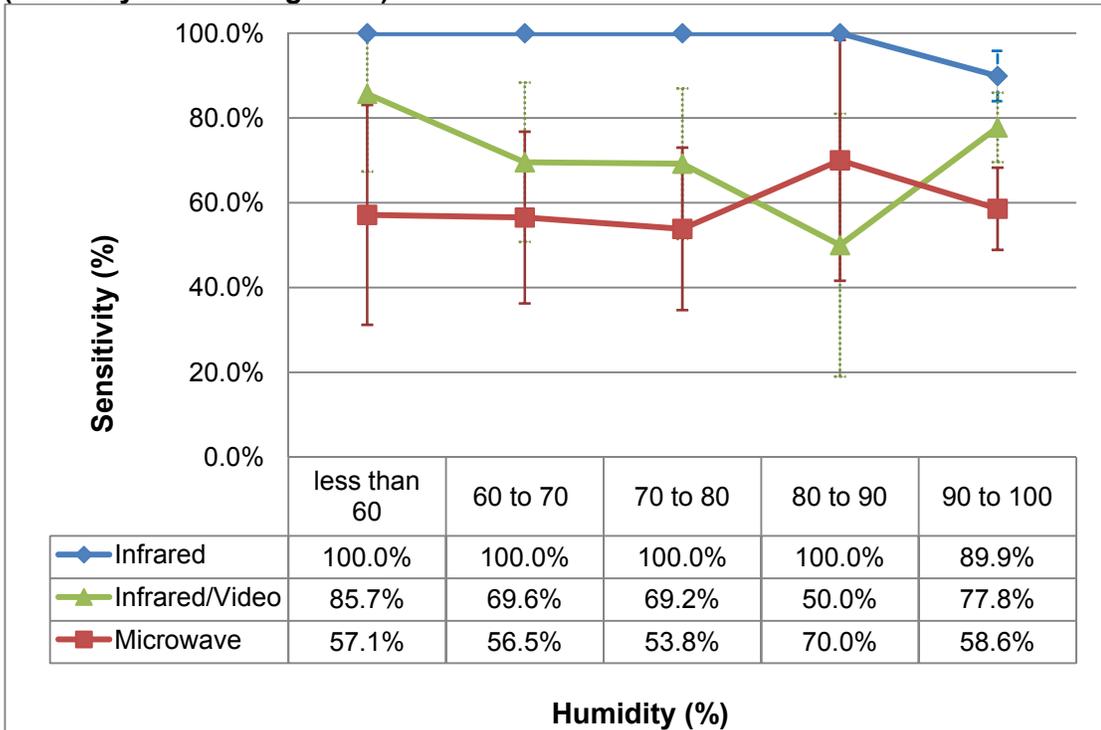
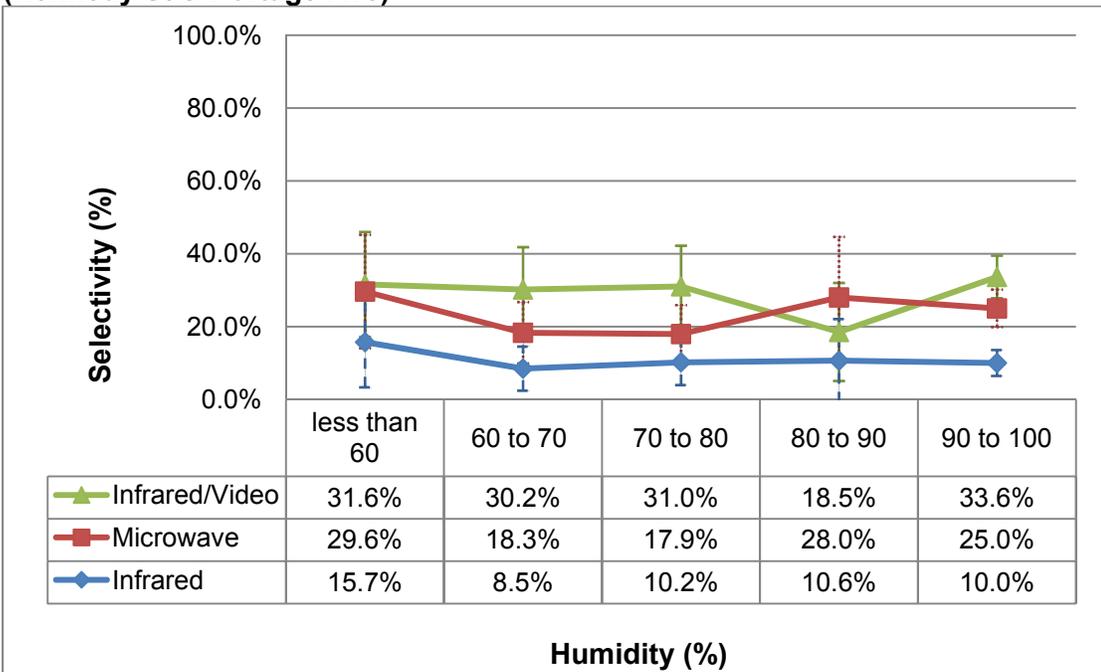
Figure 14 and Figure 15 illustrate the sensitivity and selectivity of the three detectors at Donald St & Portage Ave site as a function of the humidity level.

Figure 16 and Figure 17 illustrate the same variables for the Kennedy St & Portage Ave site.

As the figures illustrate, the infrared detector has the highest sensitivity in all humidity ranges with relatively little change throughout the humidity spectrum at both sites. The infrared/video detector operates with a sensitivity rating over 80 percent at all humidity levels at the Donald St site. The microwave detector operates at the lowest sensitivity of the three at both sites, except for humidity levels between 80 and 90 percent. This detector experiences a sensitivity drop of about 40 percent from the 80 to 90 percent humidity range as compared to the 60 to 70 percent humidity range. The microwave detector's performance in the 60 to 70 percent humidity range represents a drop of 28 percent from the detector's overall sensitivity performance at the Donald St site.

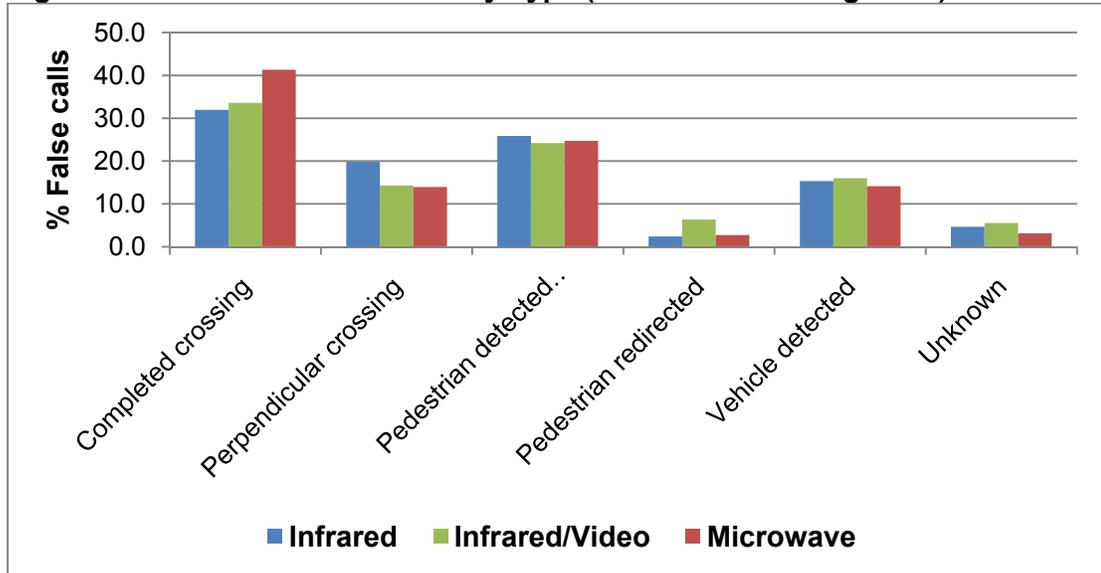
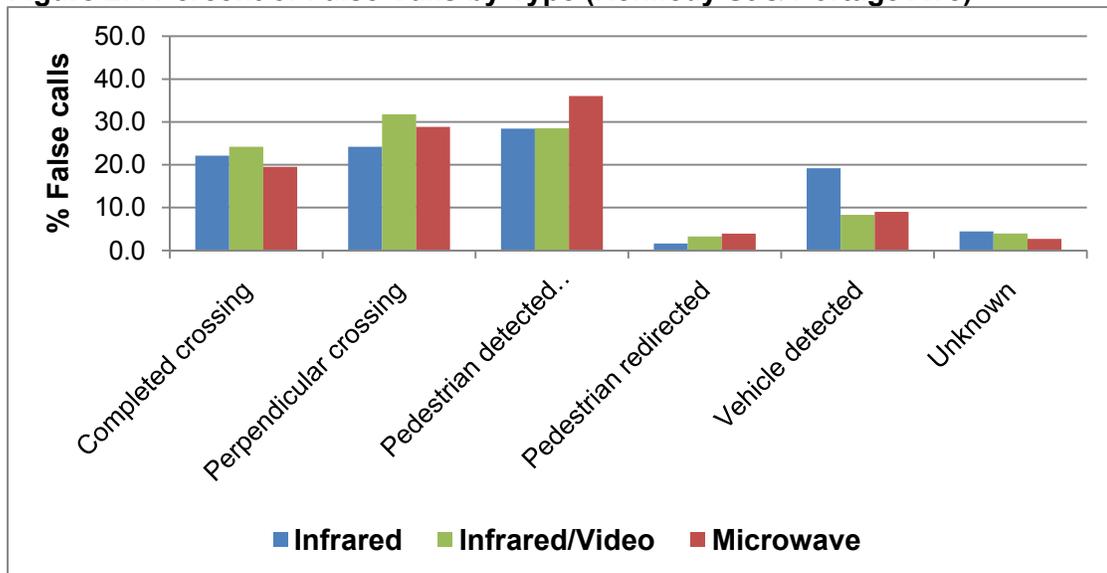
Figure 26: Percent of False Calls by Type (Donald St & Portage Ave)

Figure 27: Percent of False Calls by Type (Kennedy St & Portage Ave)

The Donald St & Portage Ave site has fewer false calls caused by pedestrians crossing without waiting. This is expected as the vehicular flow perpendicular to the pedestrian crossing direction is greater at Donald St & Portage Ave site

than at Kennedy St & Portage Ave site. The lower the vehicular volume, the greater the potential for gaps between vehicles, which allows pedestrians to cross without the need of proper accommodation by the traffic signal.

Based on the causation of false calls (as illustrated in Table 15, Figure 26, and Figure 27), Table 18 shows a number of options that could help reduce the number of false calls experienced by these detectors under the given conditions of this type of field test.

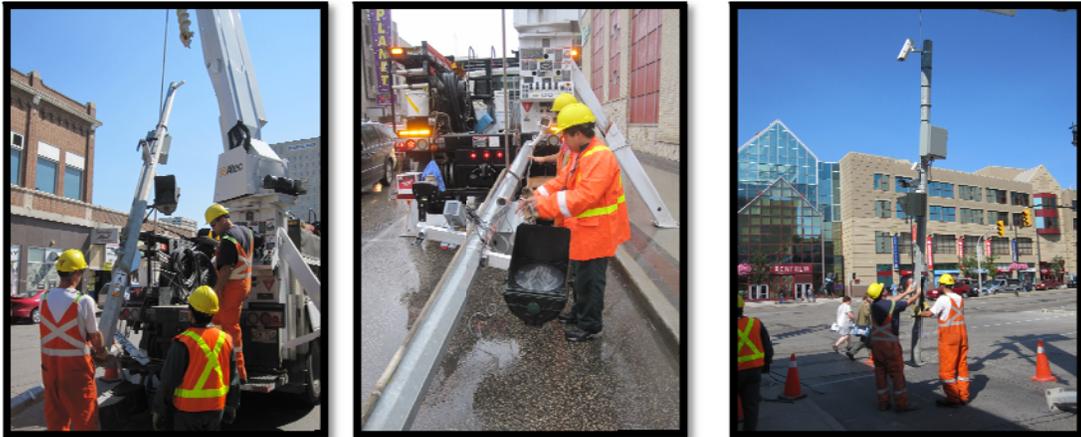
A 5.5 m pole with a roughly aligned and affixed camera mount and APD mounting arms was transported to one of the sites, and then removed from the City of Winnipeg Traffic Signal's line truck. The 3.05 m onsite pole was

disconnected from power, and then removed from its position at the intersection and exchanged for the 5.5 m pole. Once exchanged, power was connected to the study equipment from pre-existing power cables. The detectors were installed at a height of 3.05 m.

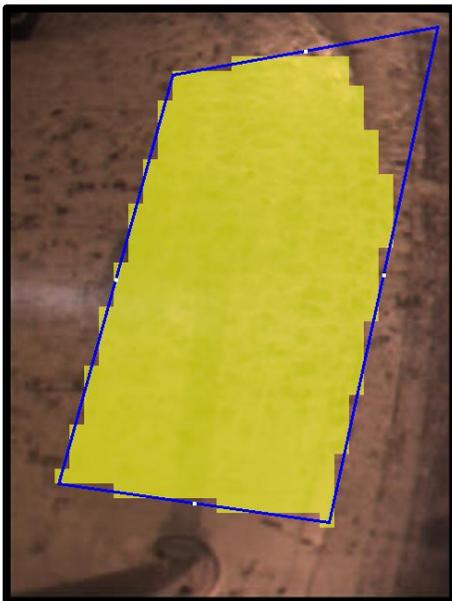
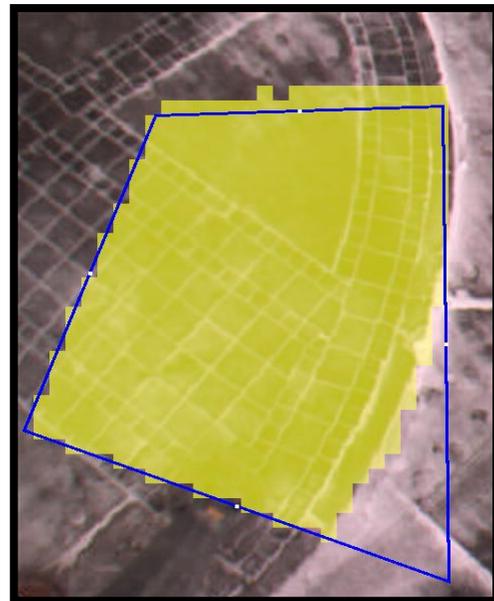
The AGD software then allows the installer to inscribe a four-sided polygon on the image of the zone of detection which encompasses the area of detection the installer requires. The setting of fine adjustments then allow the installer the ability to remove areas within the polygon where detection is not required.
