**Stabilization of Natural Clay Riverbanks with Rockfill
Columns:
A Full-Scale Field Test and Numerical Verification**

A Thesis submitted to the Faculty of Graduate Studies of
The University of Manitoba

Department of Civil Engineering
University of Manitoba
Winnipeg

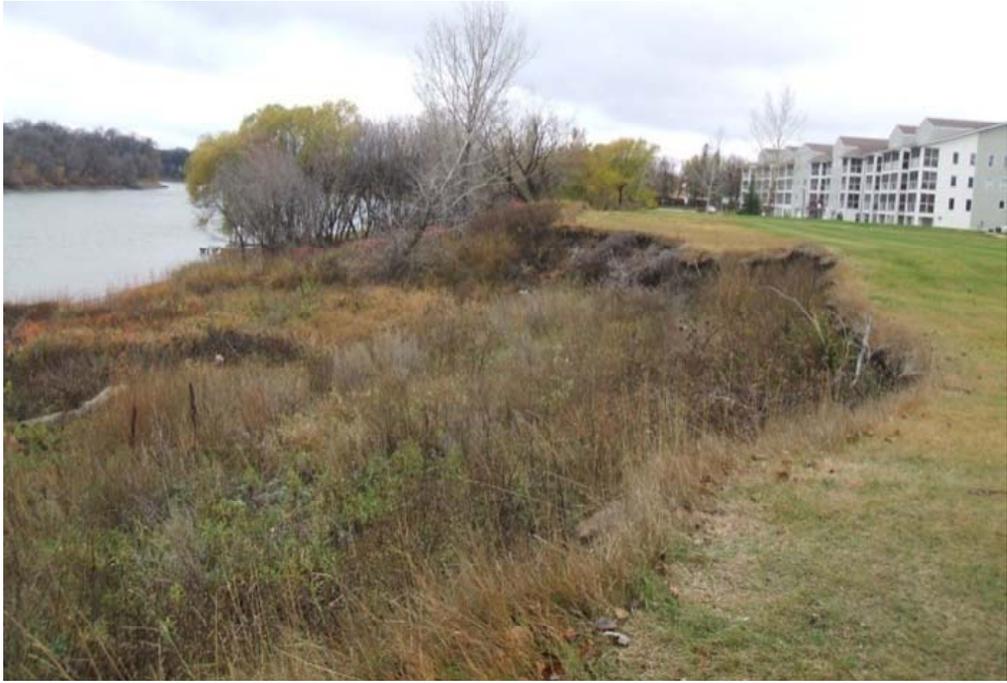
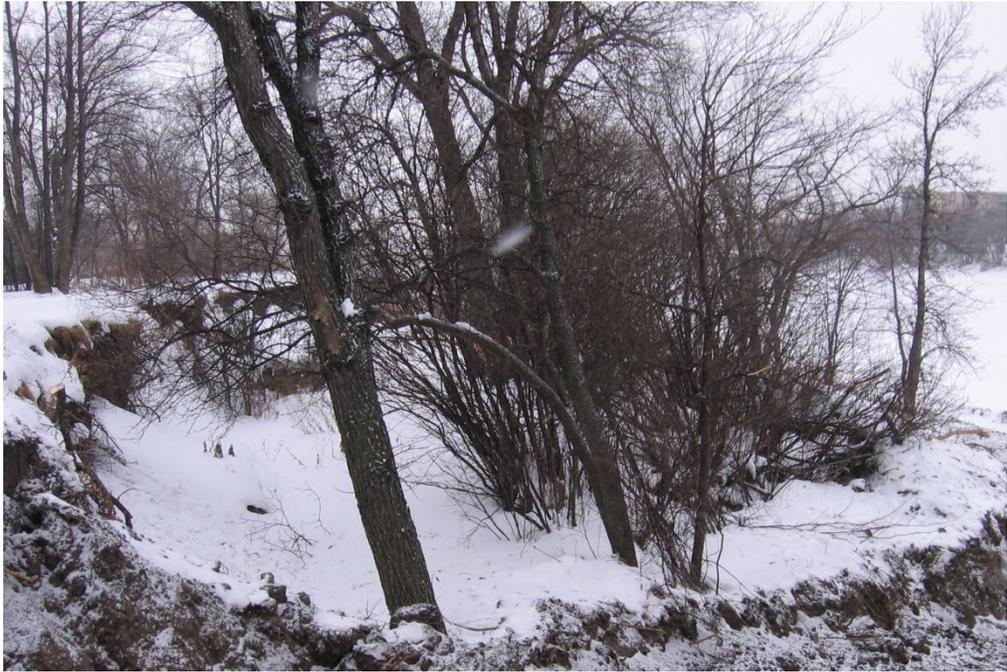
Figure 1.1. a) and b) Examples of failed riverbanks in The City of Winnipeg.

periods saturate the banks. When the river level drops following the event, high porewater pressures can remain in the clay banks after the buttressing effect of the floodwater is gone. The high porewater pressures reduce the effective stresses, and therefore the strength of the in-situ soils, potentially leading to slope failure. Figure 1.1 shows two failed sections of bank in the City of Winnipeg.

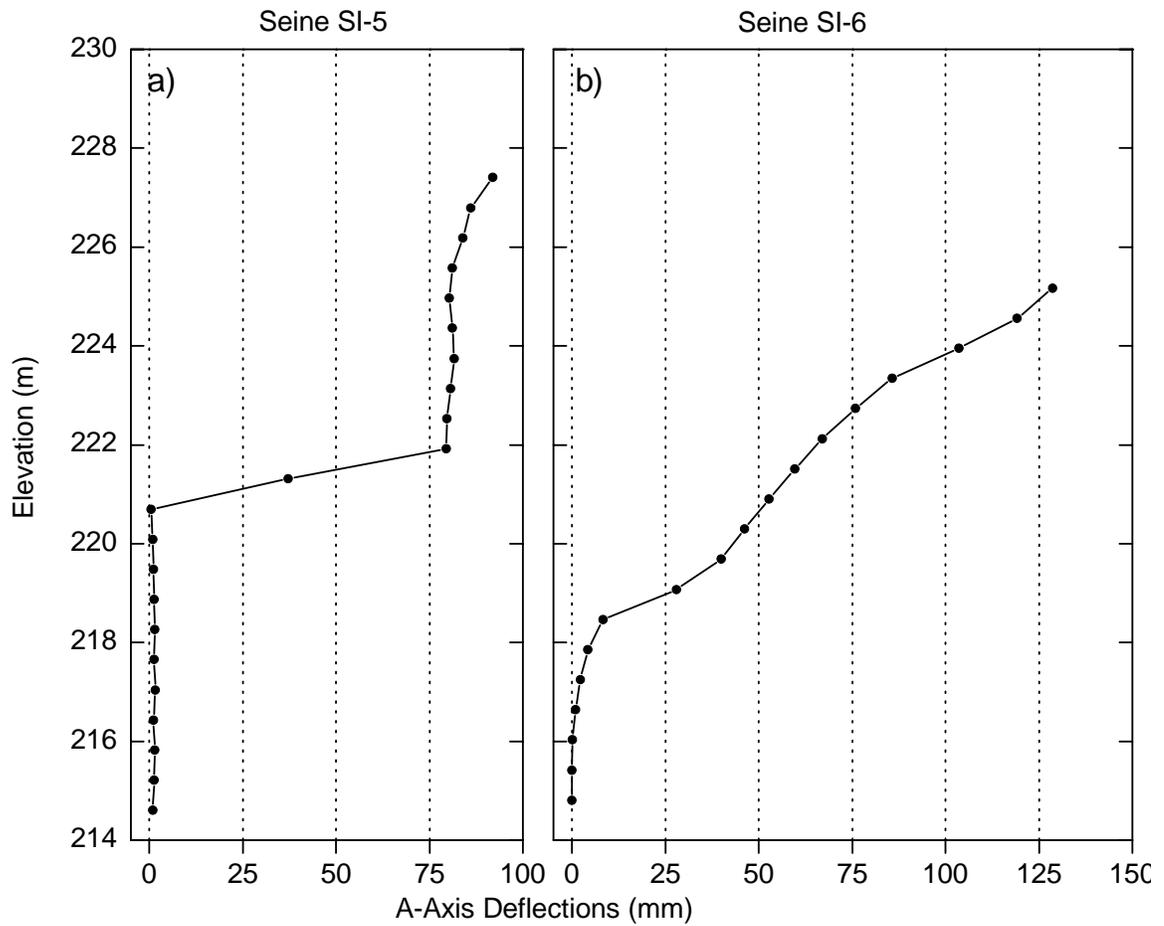
Figure 1.2. Post-construction displacements measured over an 4.5 year period at the Seine River Siphon stabilization project a) near crest, up-slope of columns b) between rows of columns (updated from Yarechewski and Tallin 2003)

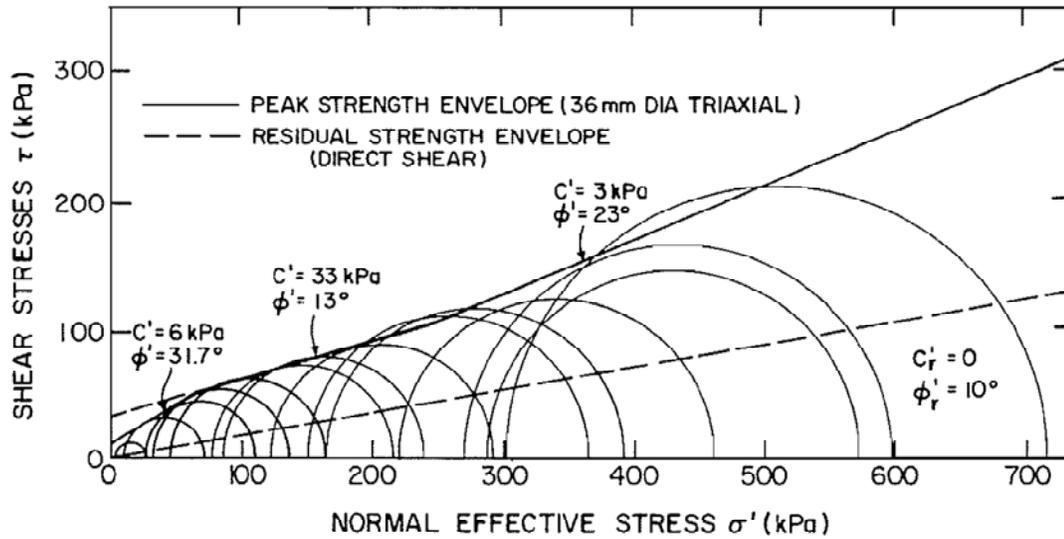
Figure 2.1 Three-part peak strength envelope (after Baracos and Graham 1981)

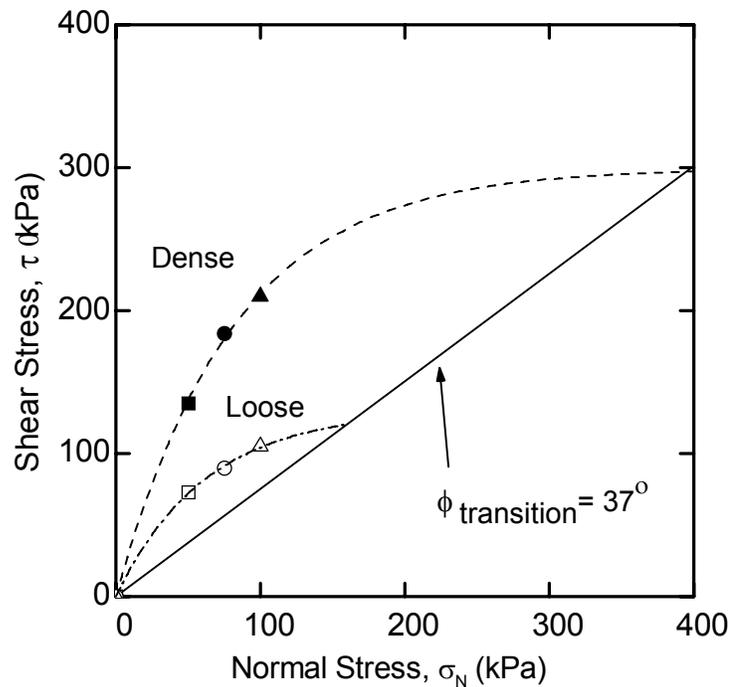
Figure 2.2 Shear strength envelopes for loose and dense rockfill samples. After Abdul Razaq (2007). Reproduced with permission from Abdul Razaq, April 2010.

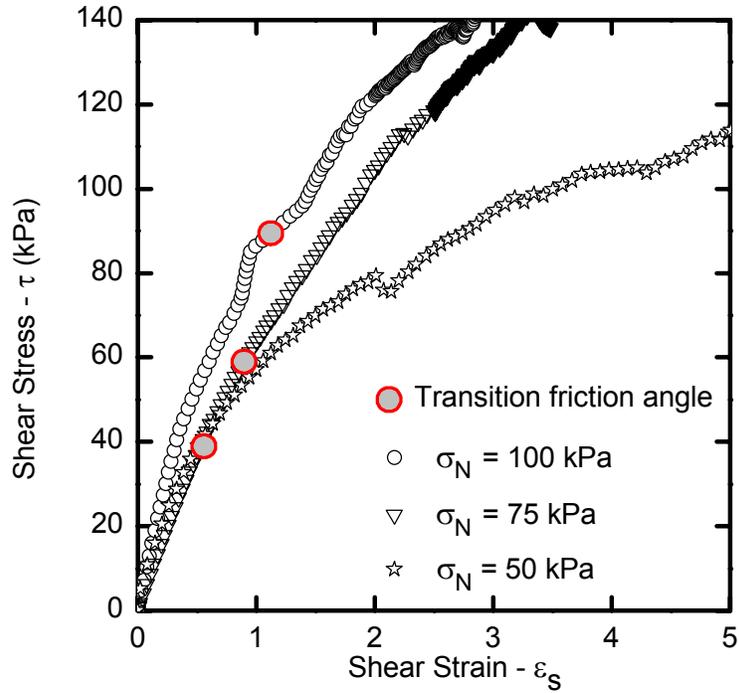
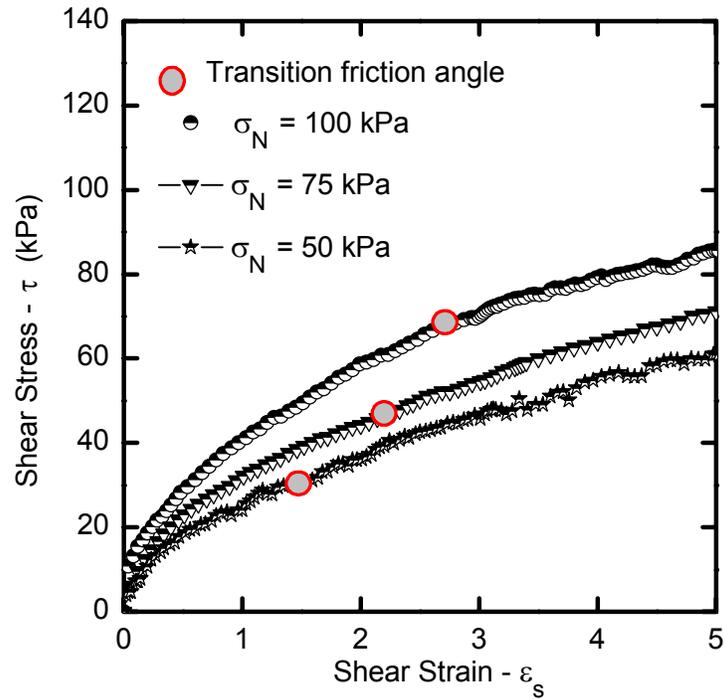
Figure 2.3. Shear mobilizations of a) dense rockfill and b) loose rockfill materials. After Abdul Razaq (2007). Reproduced with permission from Abdul Razaq, April 2010.

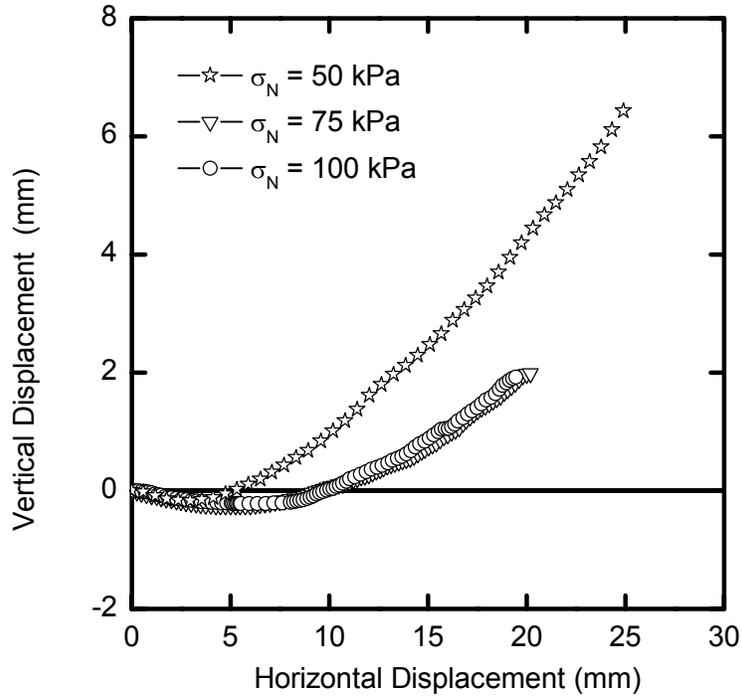
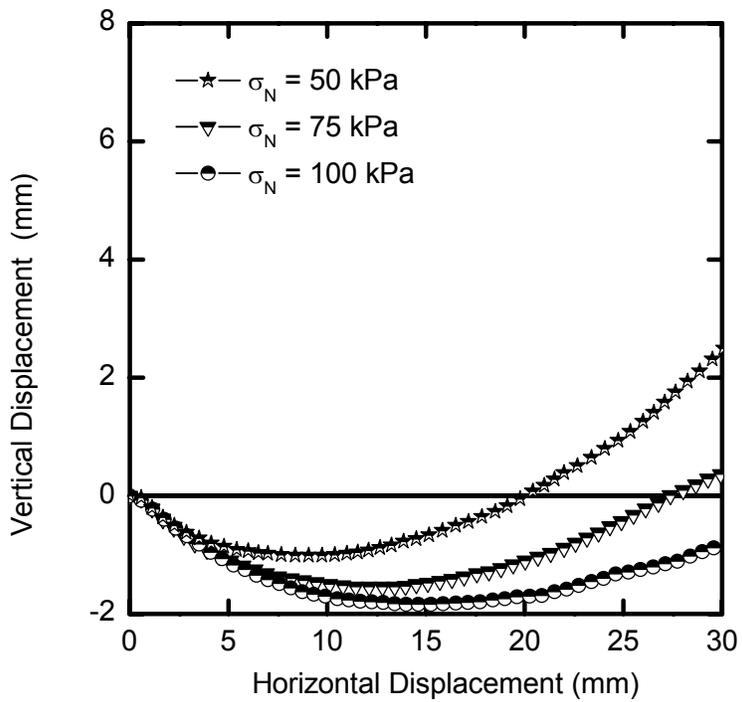
Figure 2.4. Dilation of a) dense and b) loose rockfill samples. After Abdul Razaq (2007). Reproduced with permission from Abdul Razaq, April 2010.

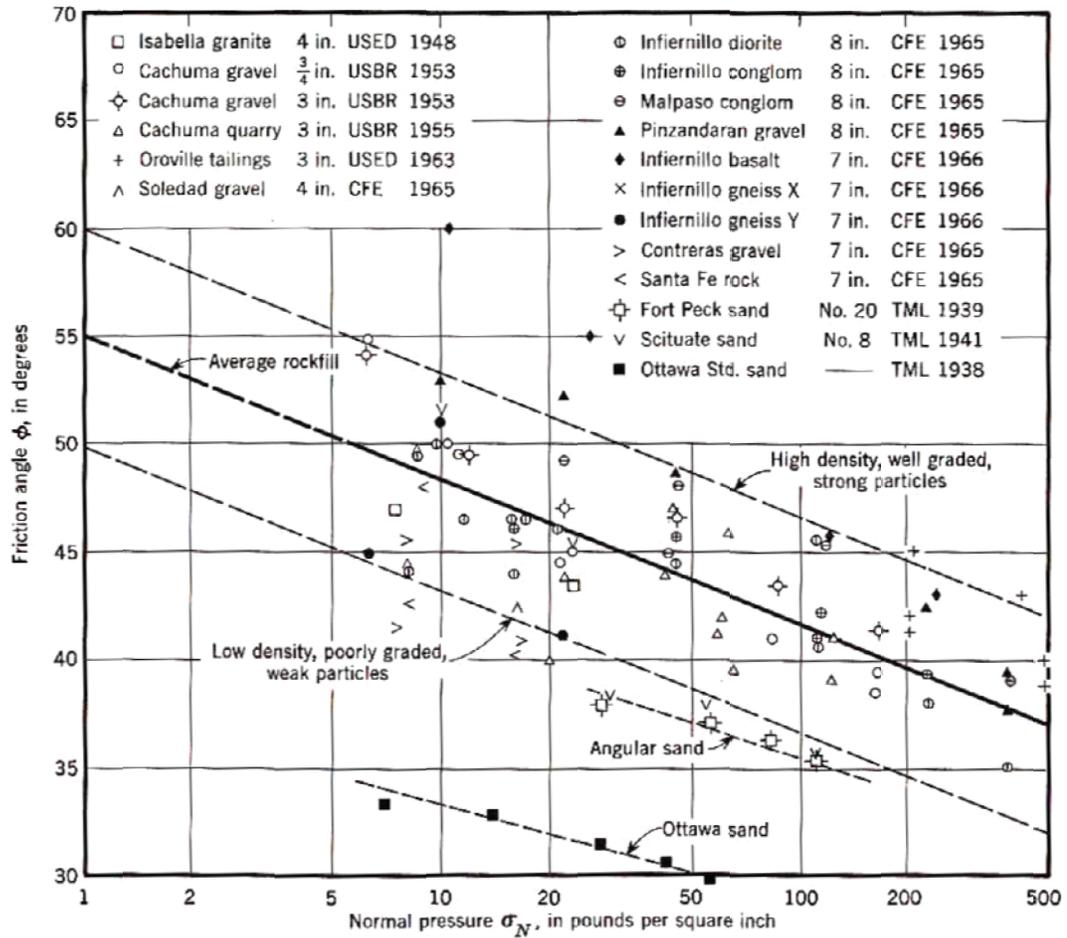
Figure 2.5. Friction angle plotted vs. normal pressure for a variety of gravels, rockfills and sands. After Leps (1970). Reproduced with permission from ASCE, January 2010.

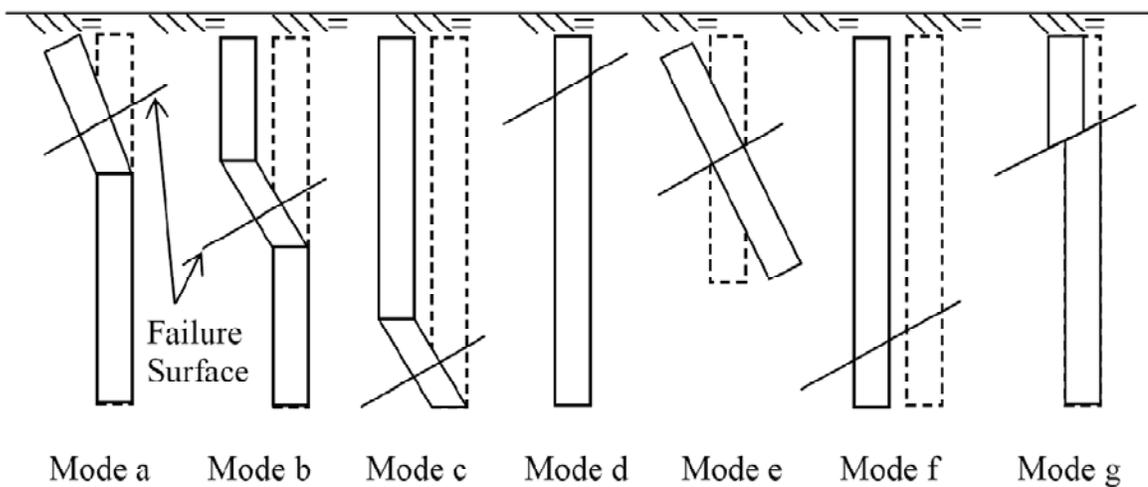
Figure 2.12. Failure mechanisms for non-rigid columns. After Navin and Filz (2005). Reproduced with permission from ASCE, June 2010.

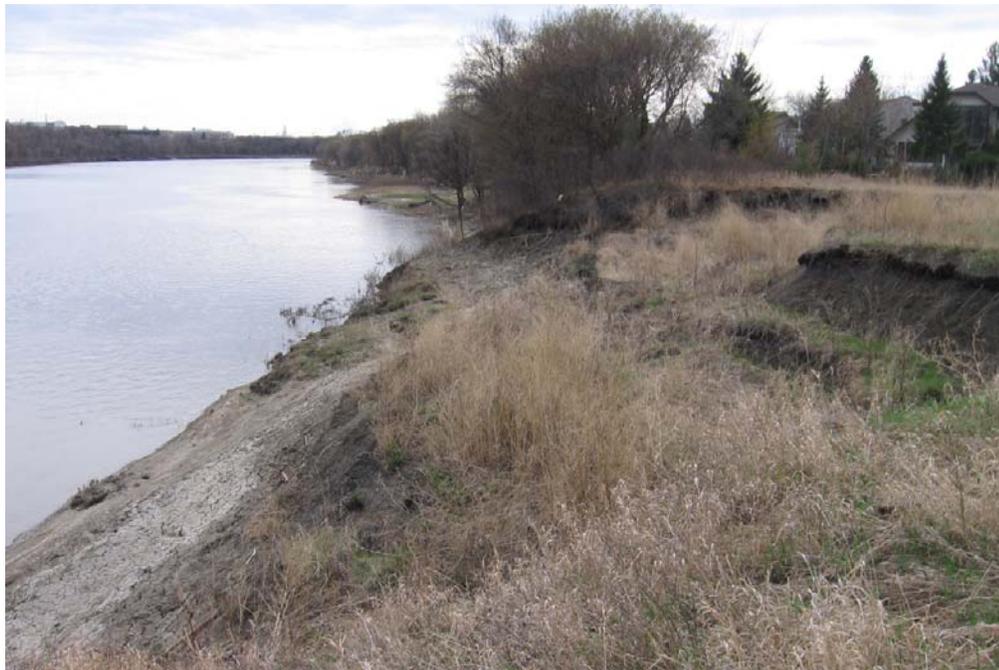
Figure 3.7. Failed slope immediately downstream of test section. Photo taken April 2007 with high water levels.

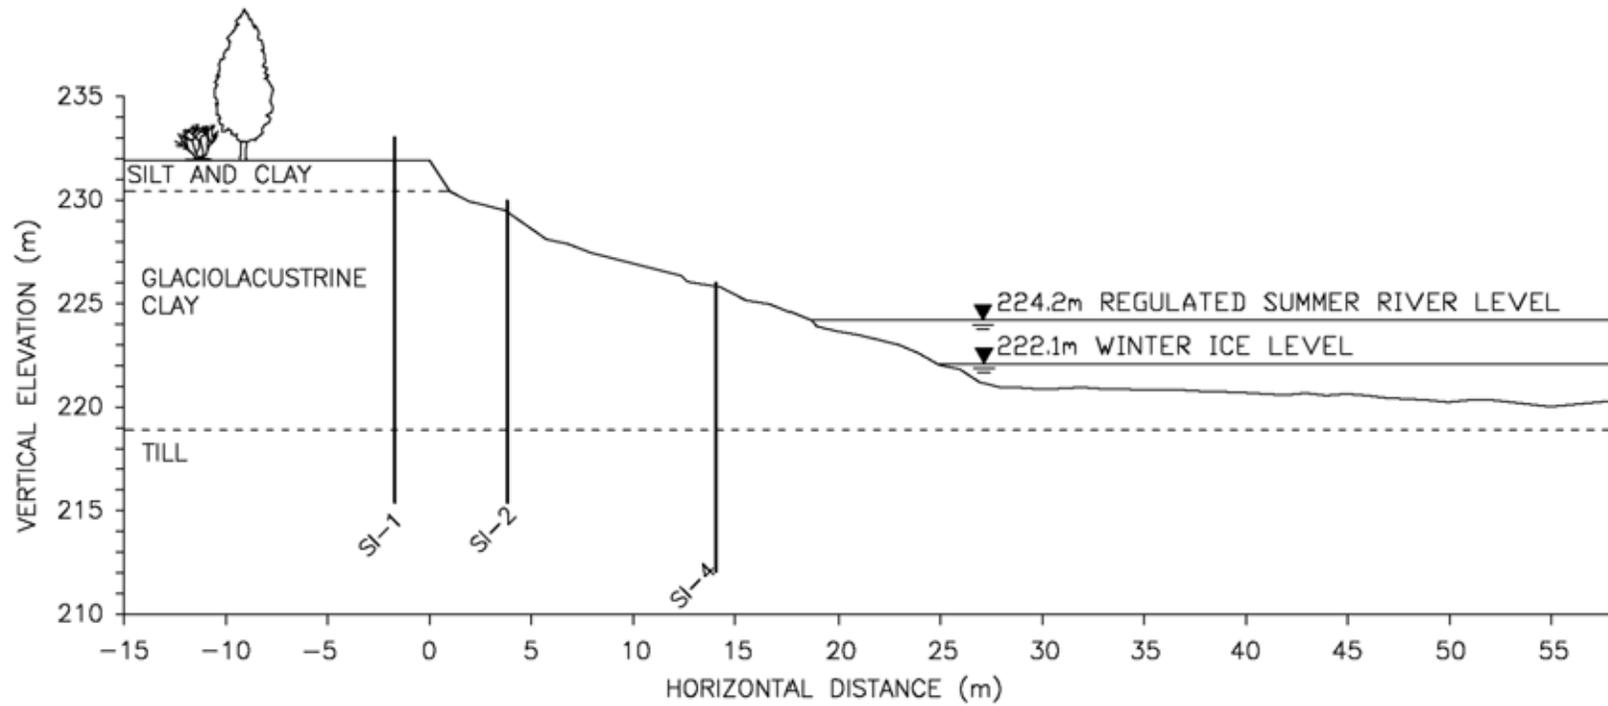
Figure 3.8. Cross section of research showing locations of Phase 1 instrumentation, prior to major site work.

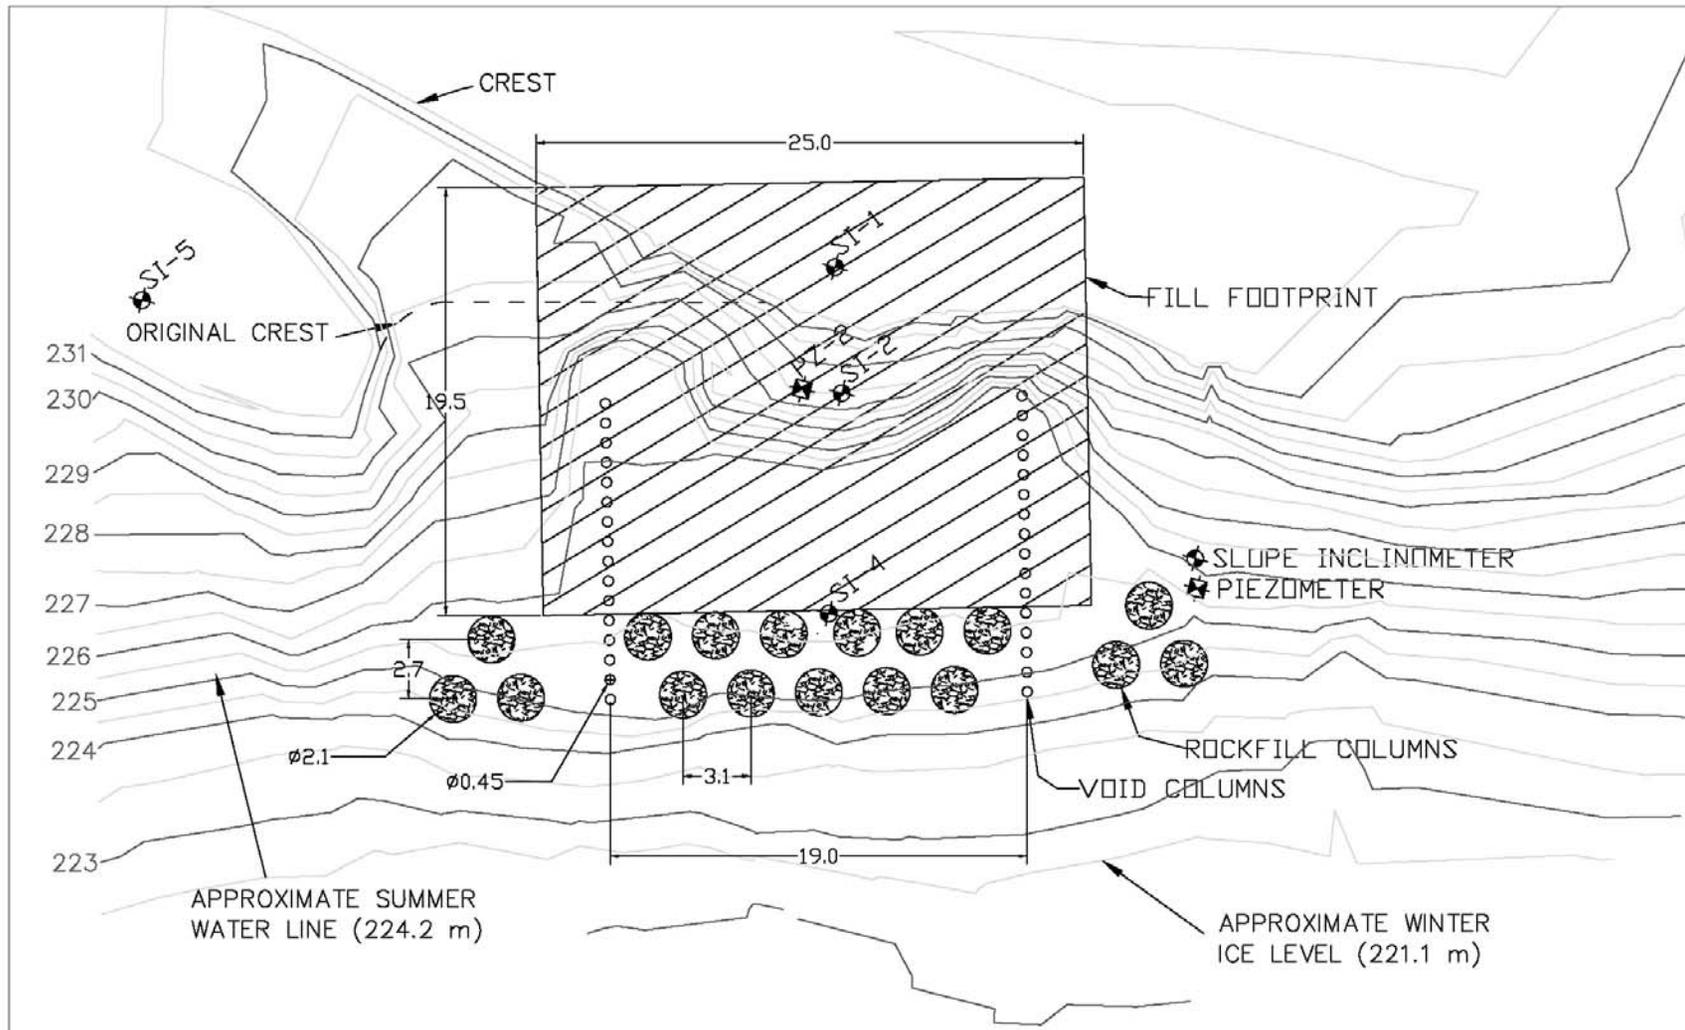
Figure 3.9. Plan view of research site showing elevation contours before the test loading. Some grading was done to accommodate the construction of the rockfill columns and void columns.

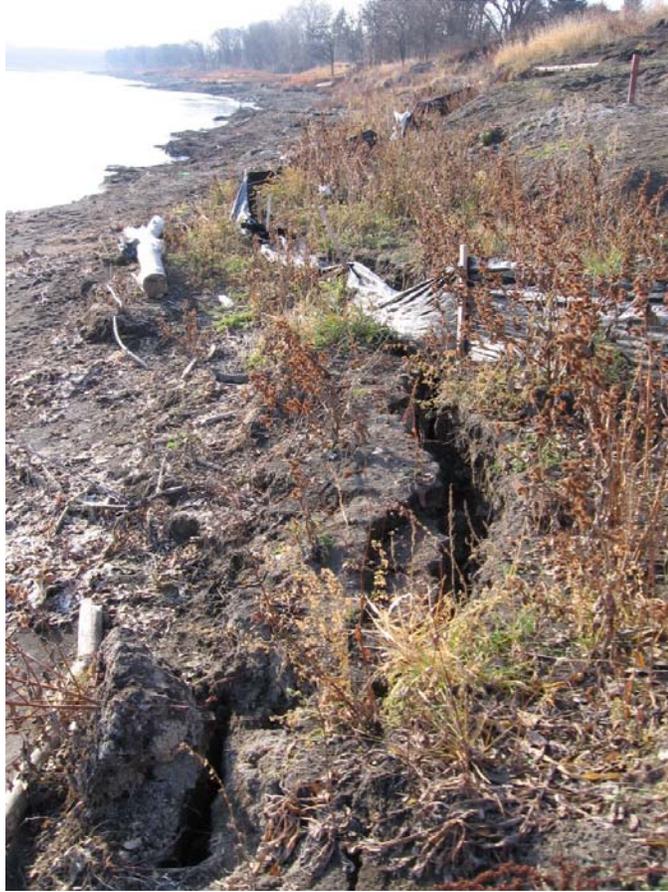
Figure 3.11. Tension crack formed along lower bank during fall drawdown.

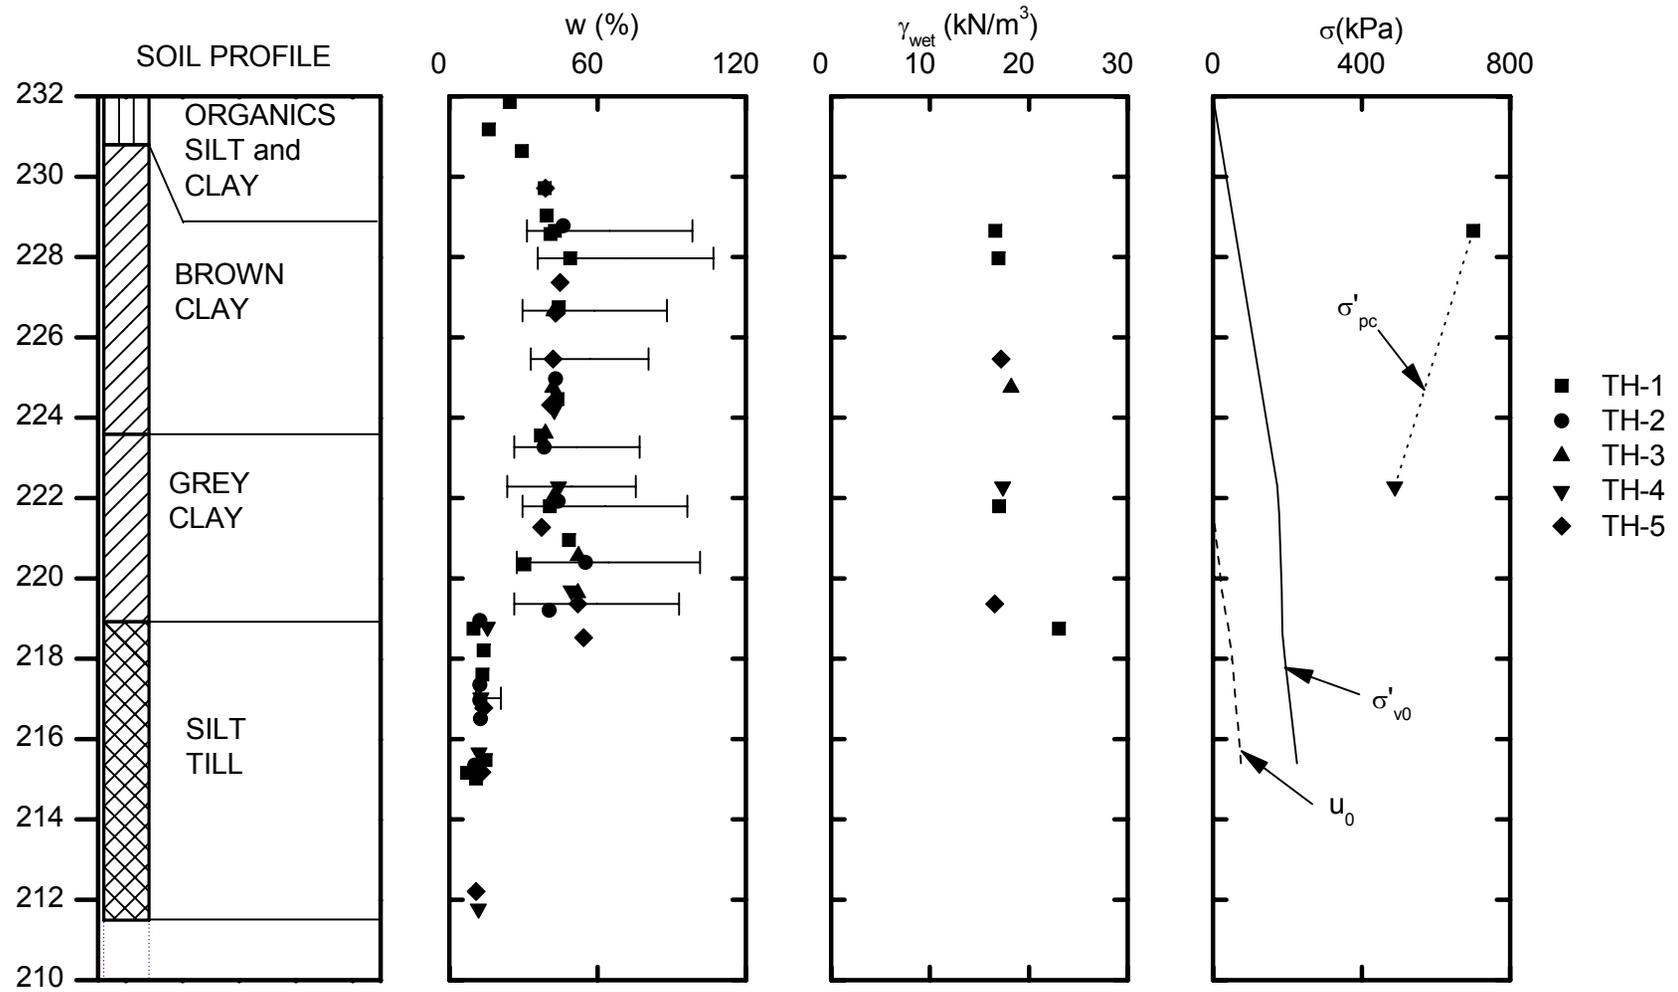
Figure 3.12. Summary of stratigraphy and select laboratory results

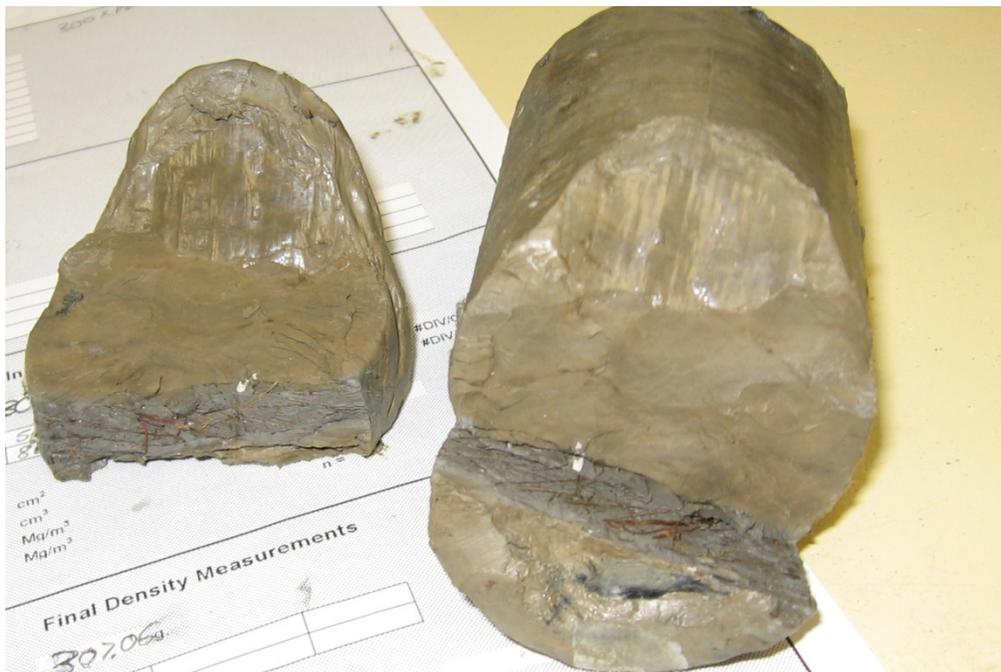
Figure 3.14. Triaxial specimen of brown clay showing vertical fissure with rootlets. Sample T6 from TH-1 at elevation 228.6 m.

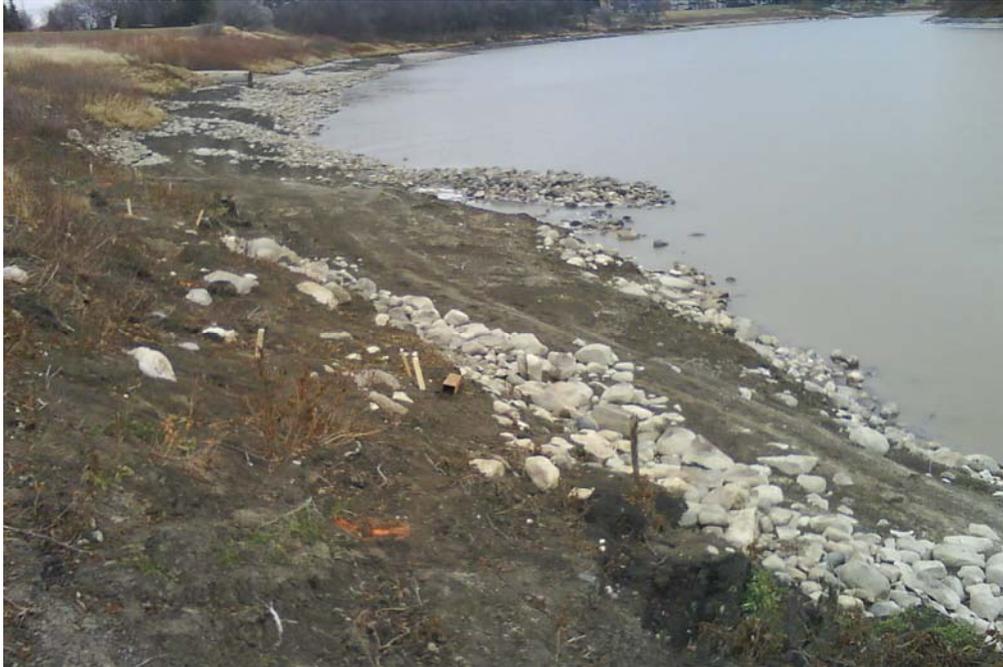
Figure 3.15. Lower bank of test section, showing exposed rip-rap. Looking upstream from south edge of test section. November 2007.

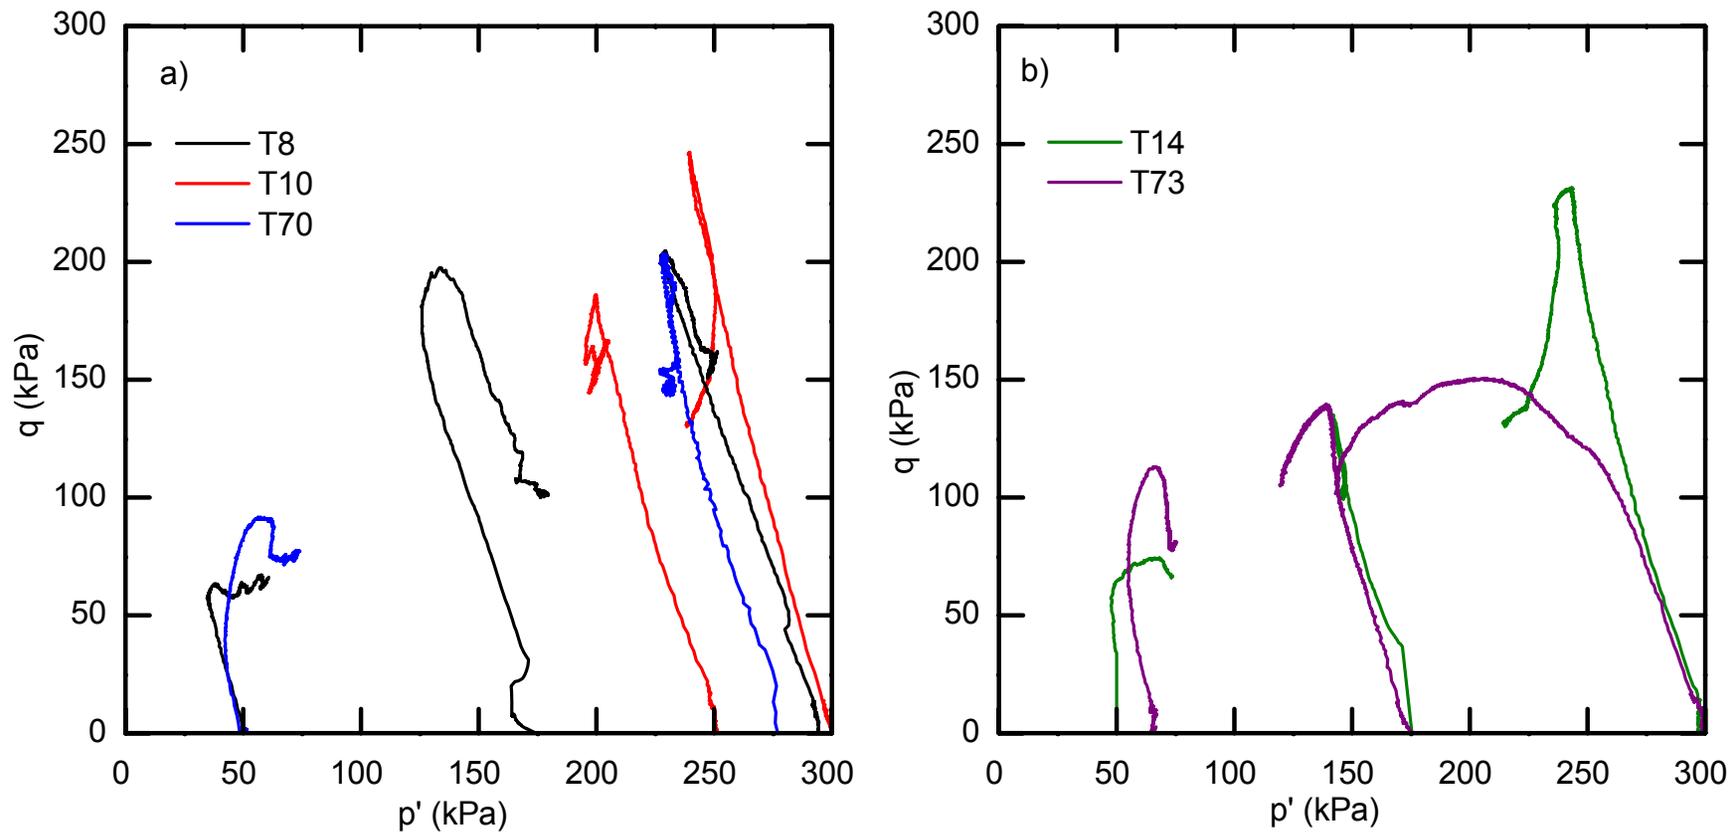
Figure 3.18. q - p' plots for triaxial tests for a) specimens of brown clay and b) specimens of grey clay

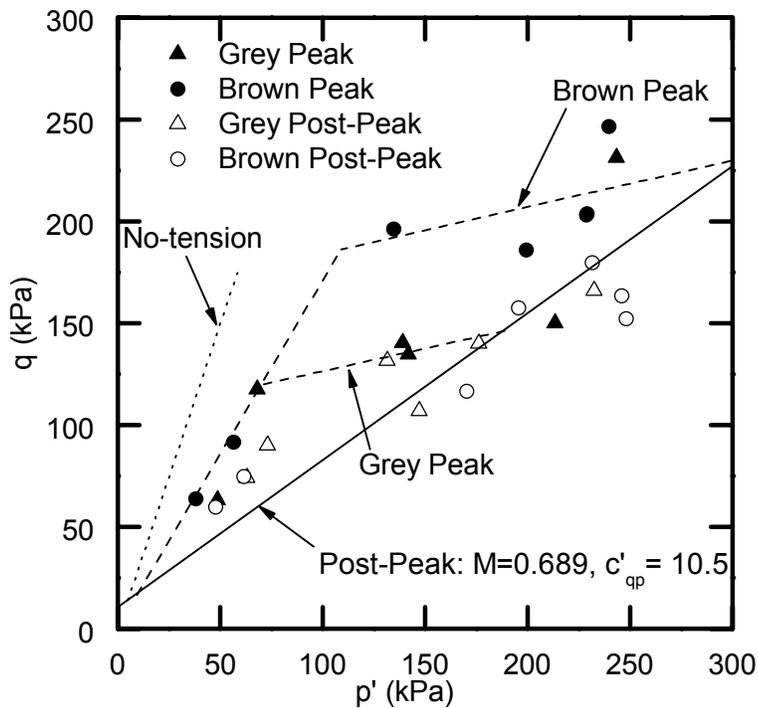
Figure 3.20. Peak and post peak strengths for grey and brown specimens with interpreted failure envelopes.

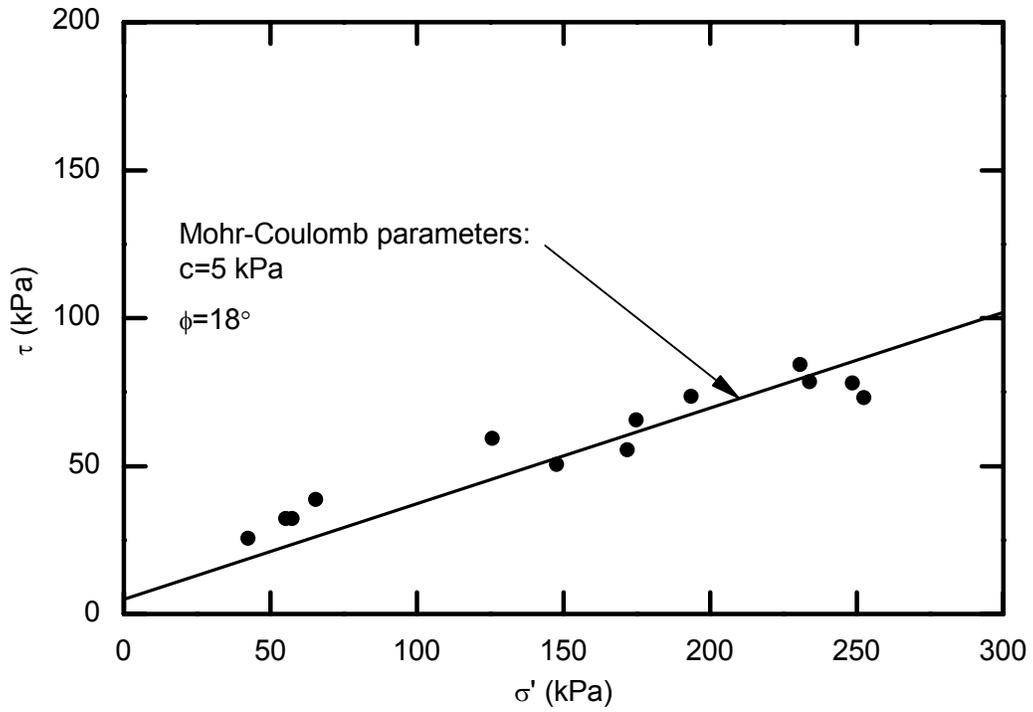
Figure 3.21. Mohr-Coulomb failure envelope for post-peak strength of clay.

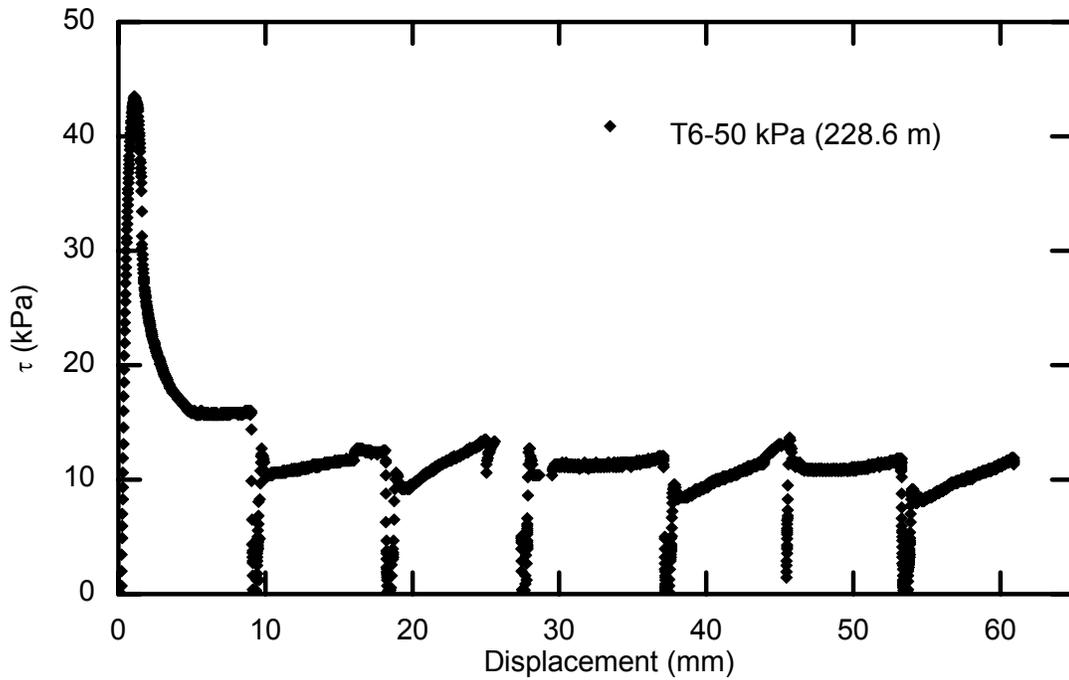
Figure 3.22. Direct shear results for sample T6 tested with a 50 kPa normal stress with multiple reversals.

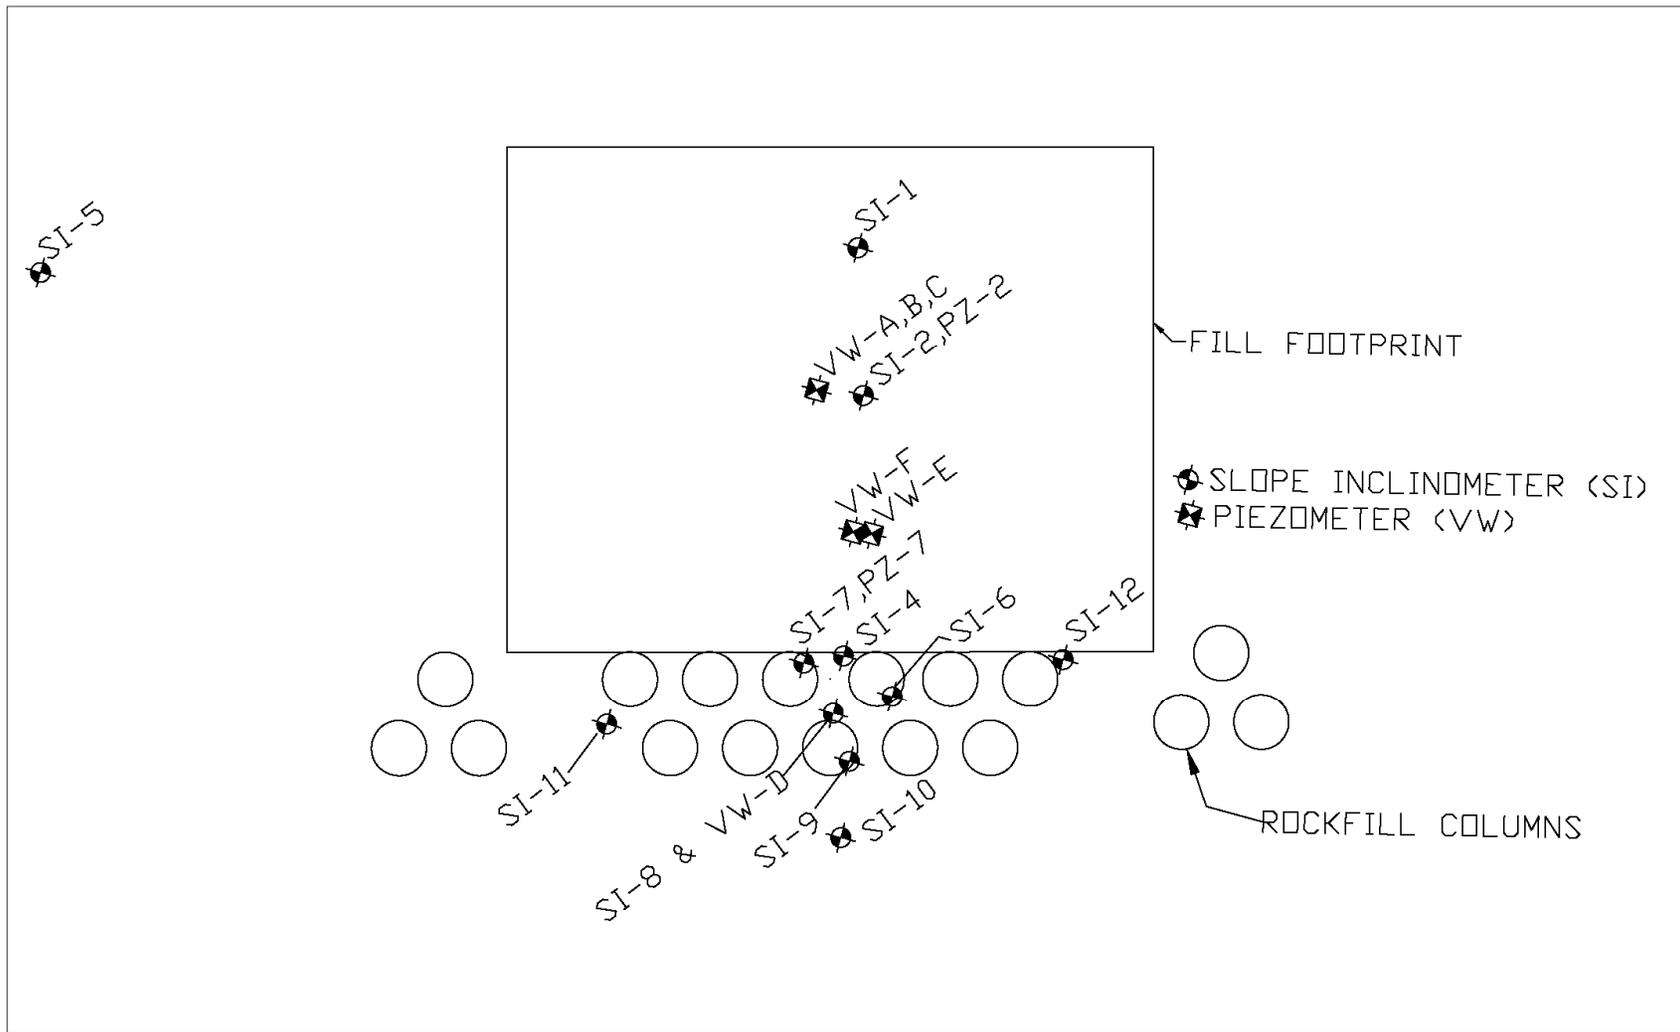
Figure 4.1. Instrumentation layout at the research test site. See Figure 3.9 for a more detailed site layout.

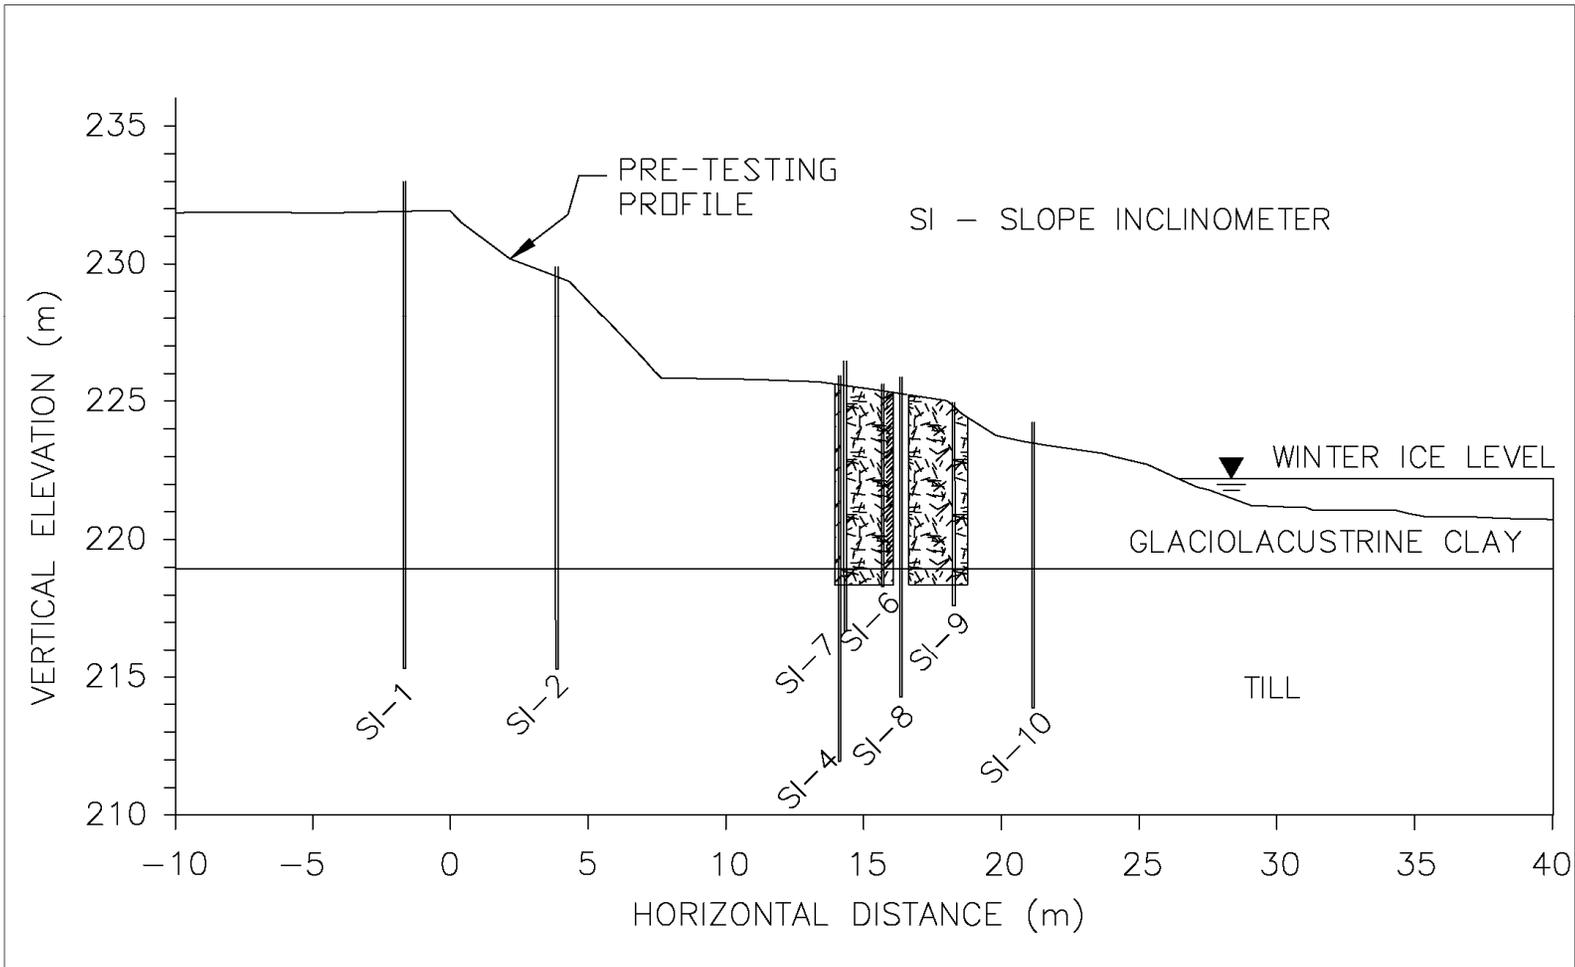
Figure 4.2 Instrumentation cross section with slope inclinometer installations.
