**Stabilization of Natural Clay Riverbanks with Rockfill
Columns:
A Full-Scale Field Test and Numerical Verification**

A Thesis submitted to the Faculty of Graduate Studies of
The University of Manitoba

Department of Civil Engineering
University of Manitoba
Winnipeg

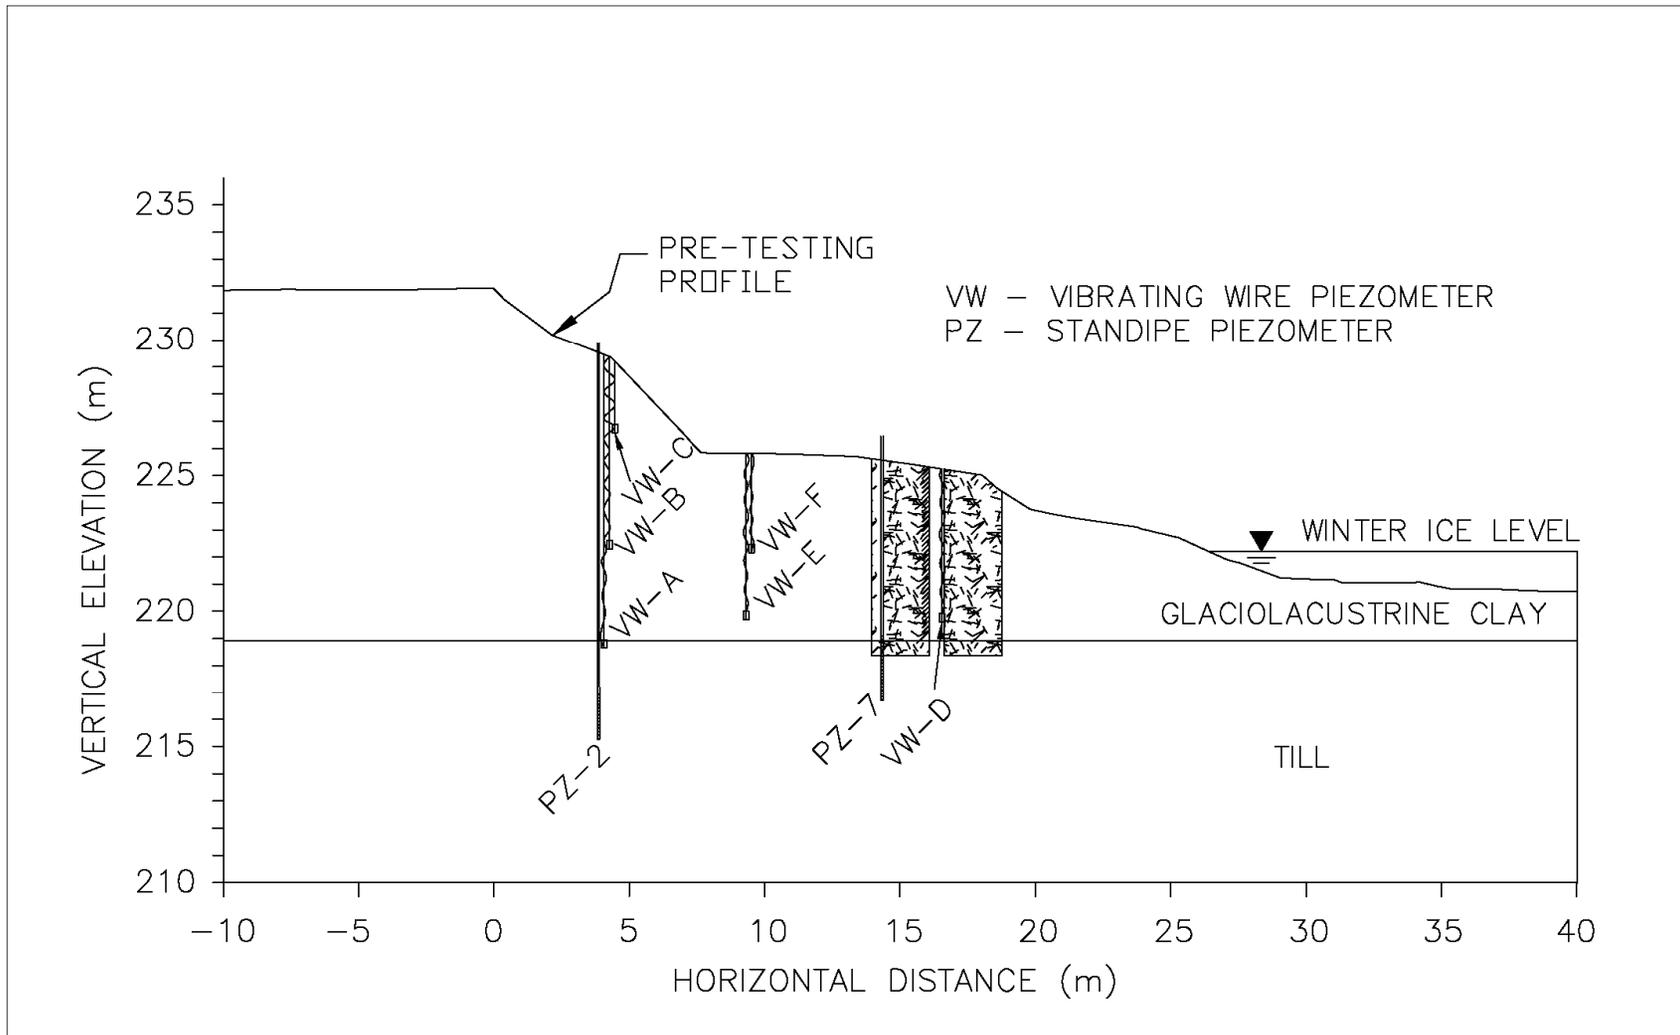
Figure 4.3. Instrumentation cross section with piezometer installations.

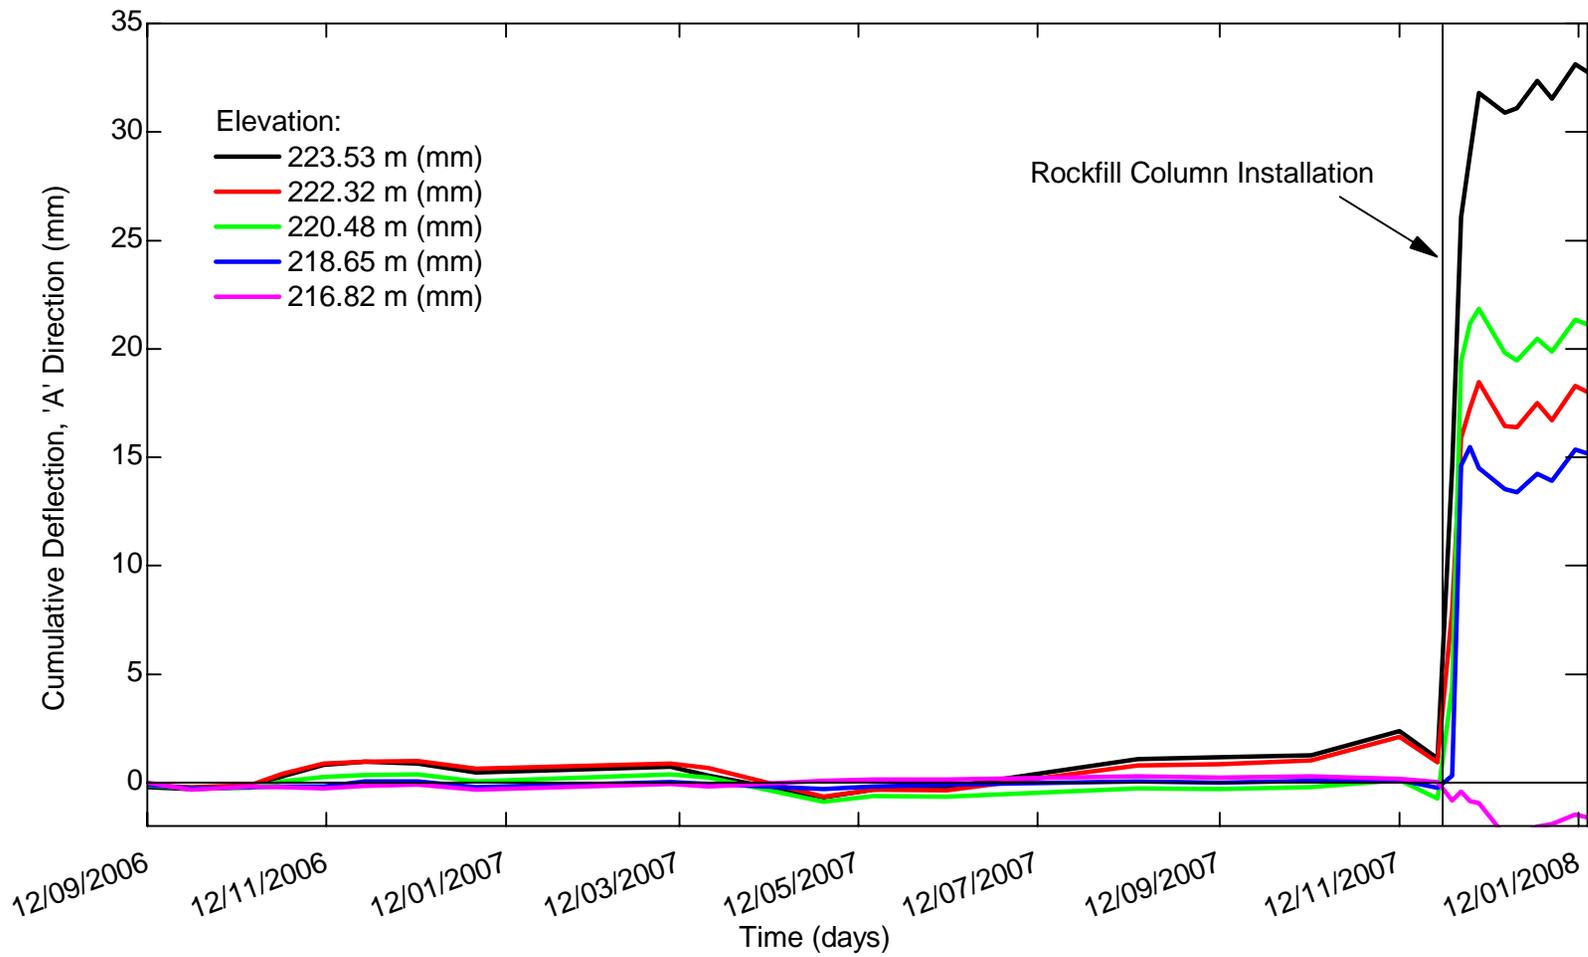
Figure 4.9. Time vs. displacement for SI-4, from the time of installation to the beginning of the test loading.

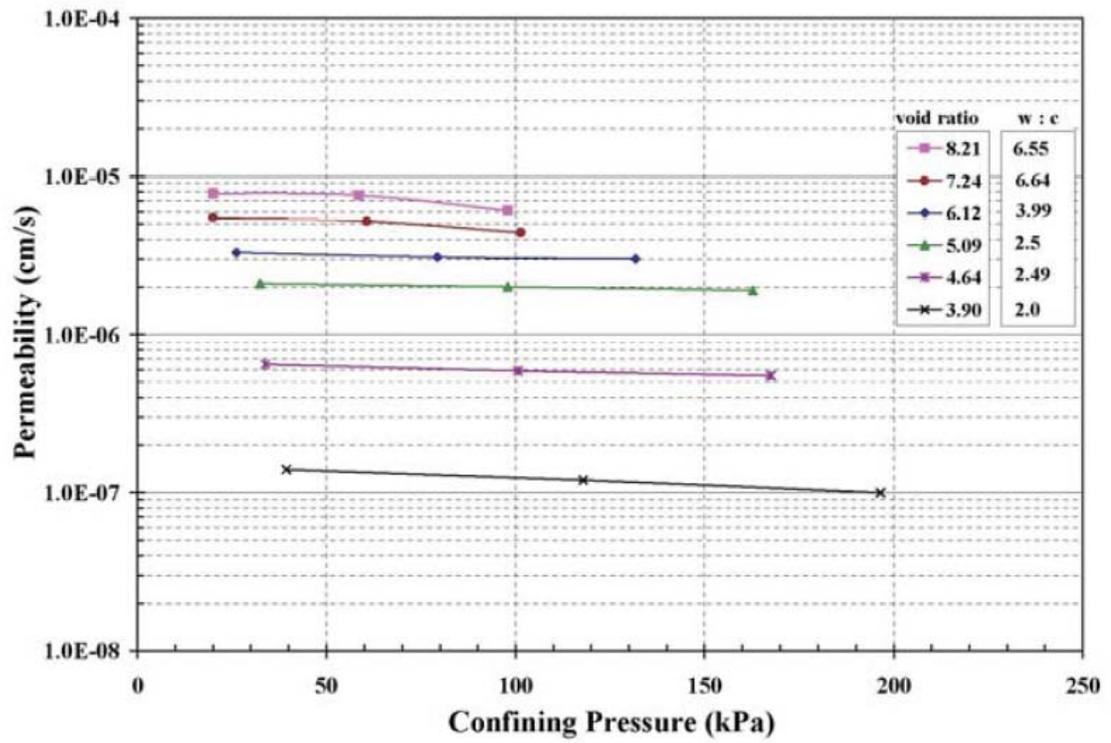
Figure 4.10. Recommended water:cement ratios for grout used for backfilling piezometers. After Contreras et al. (2008). Reproduced with permission from Contreras, January 2010.

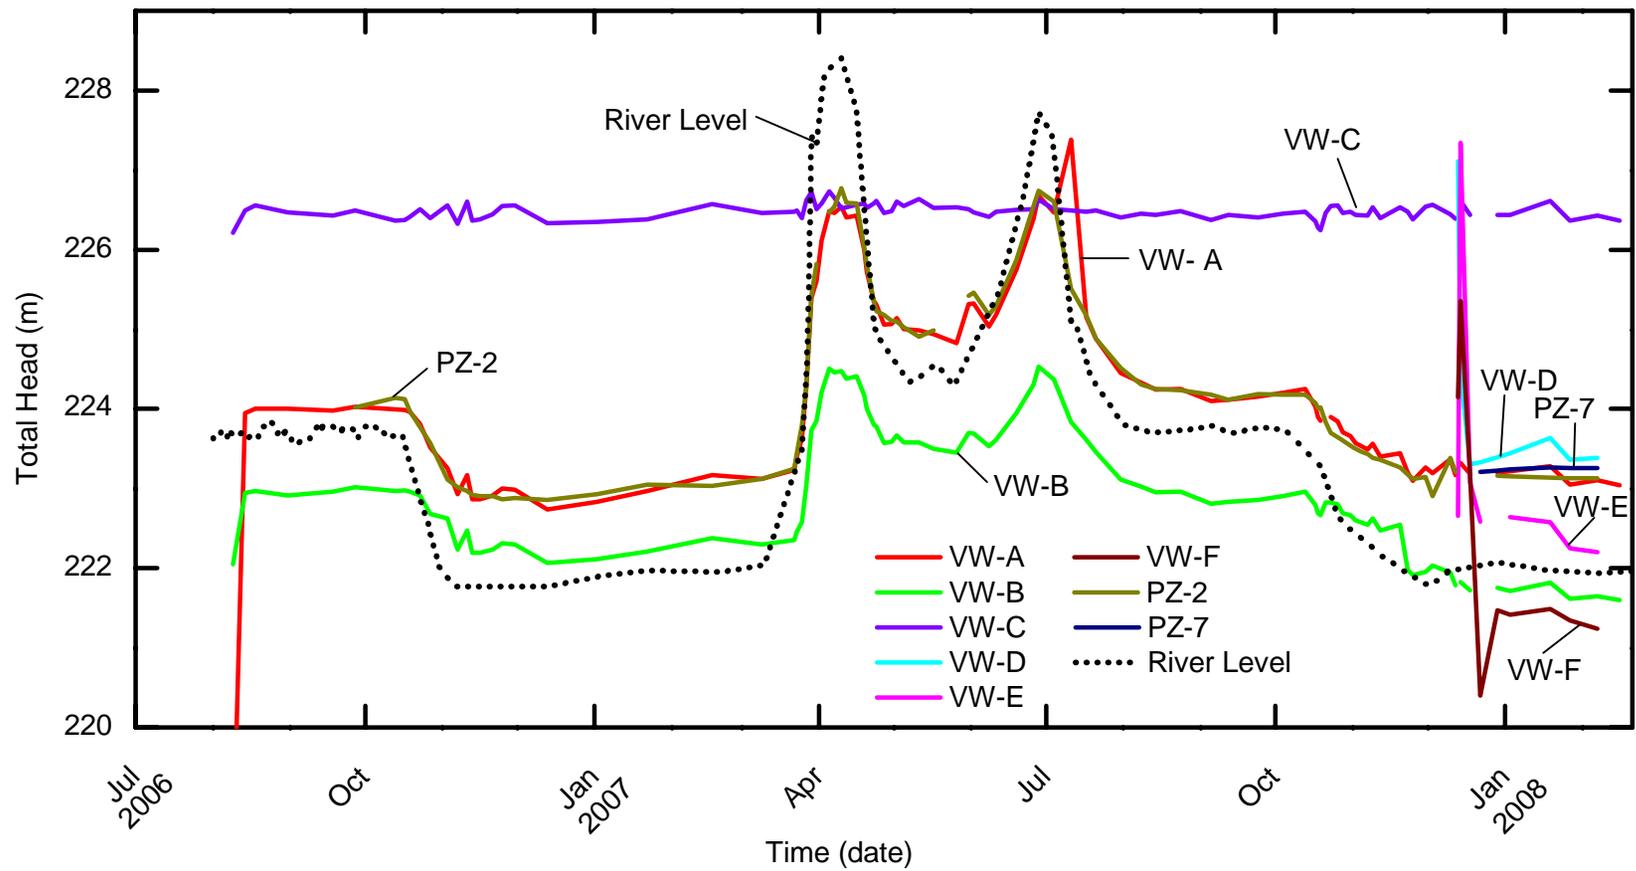
Figure 4.11 River levels and total heads measured at test site prior to field test (Aug 2006 to February 2008)

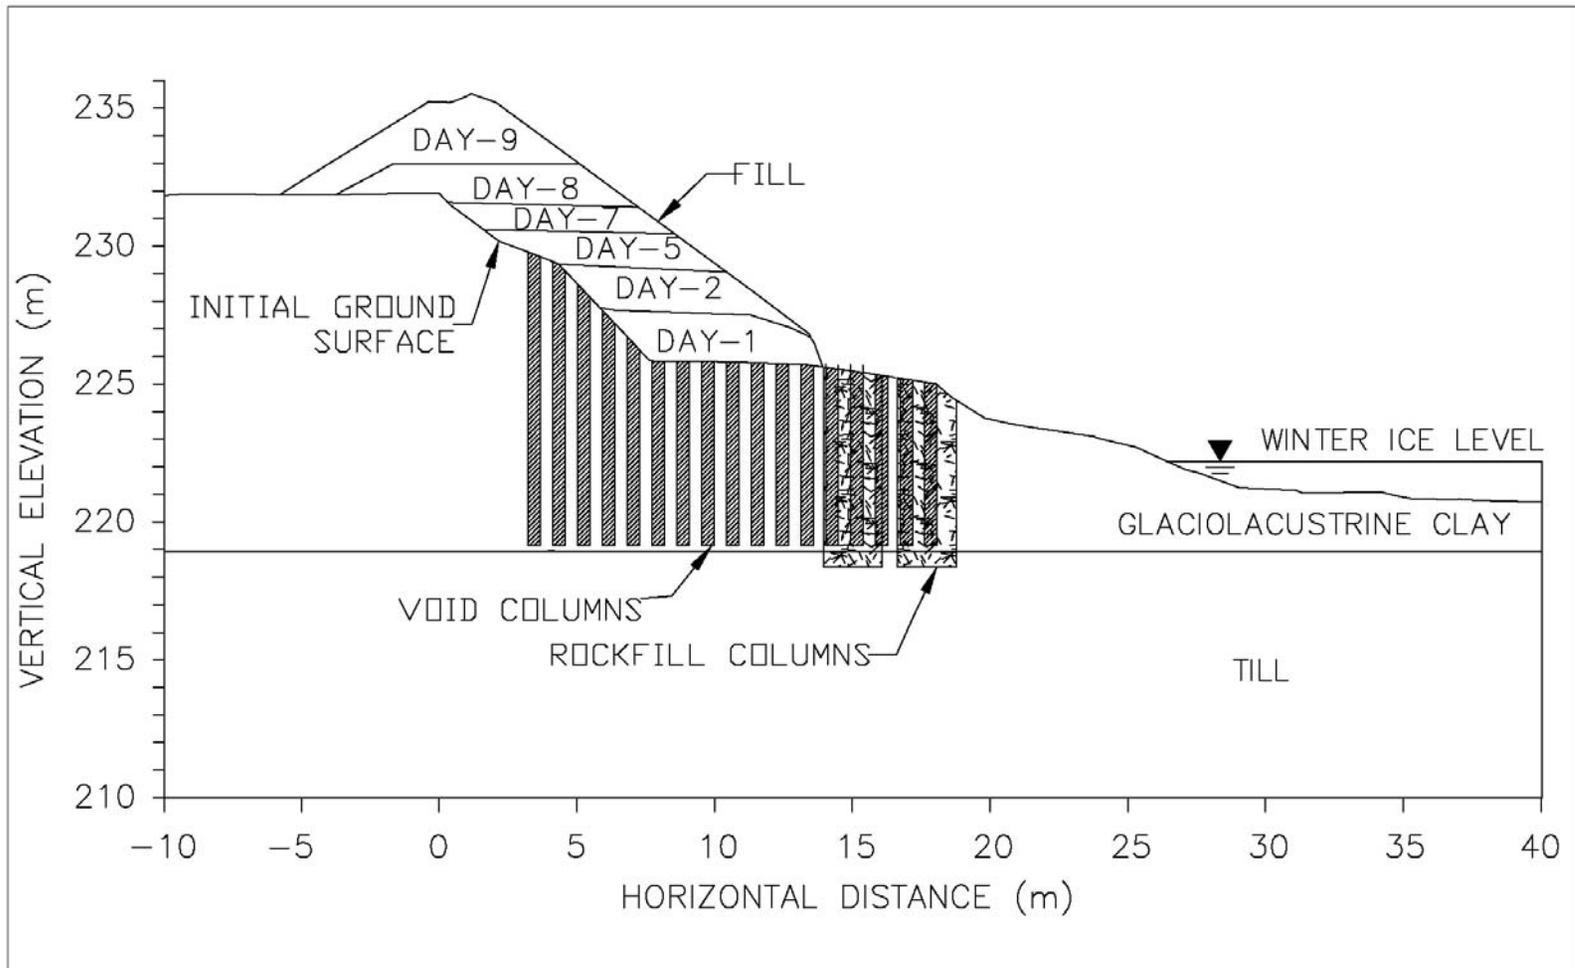
Figure 5.3. Cross section showing void columns and fill pile.

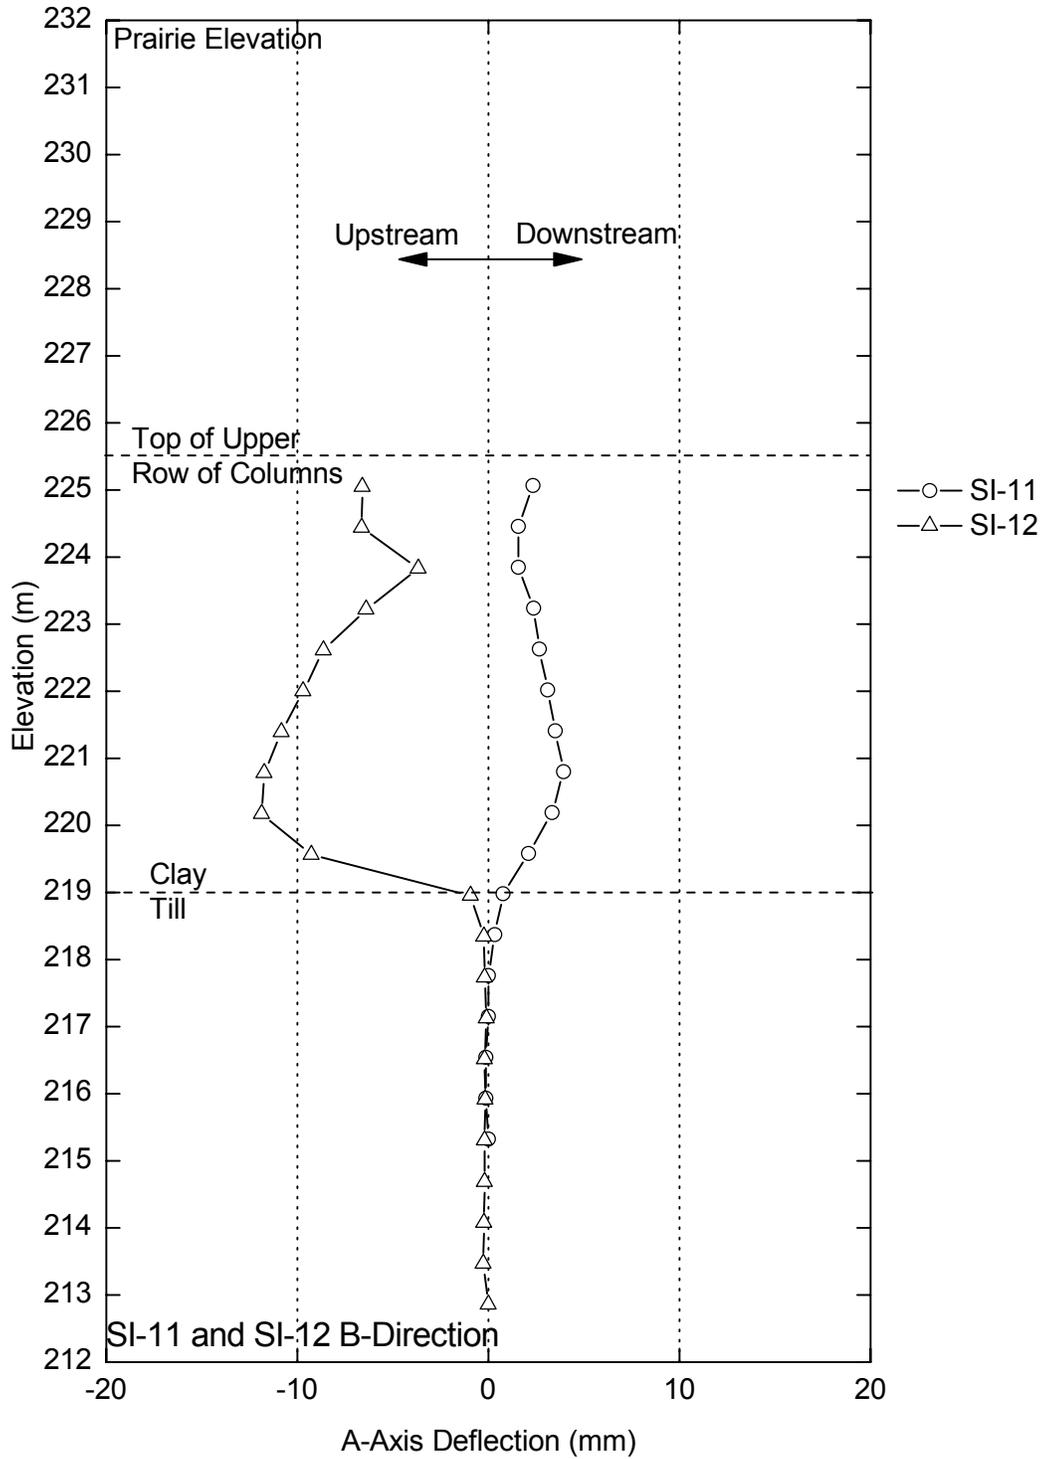
Figure 5.4. B-direction displacements measured in SI-11 and SI-12 over the test loading period to look at the effect of the void columns.

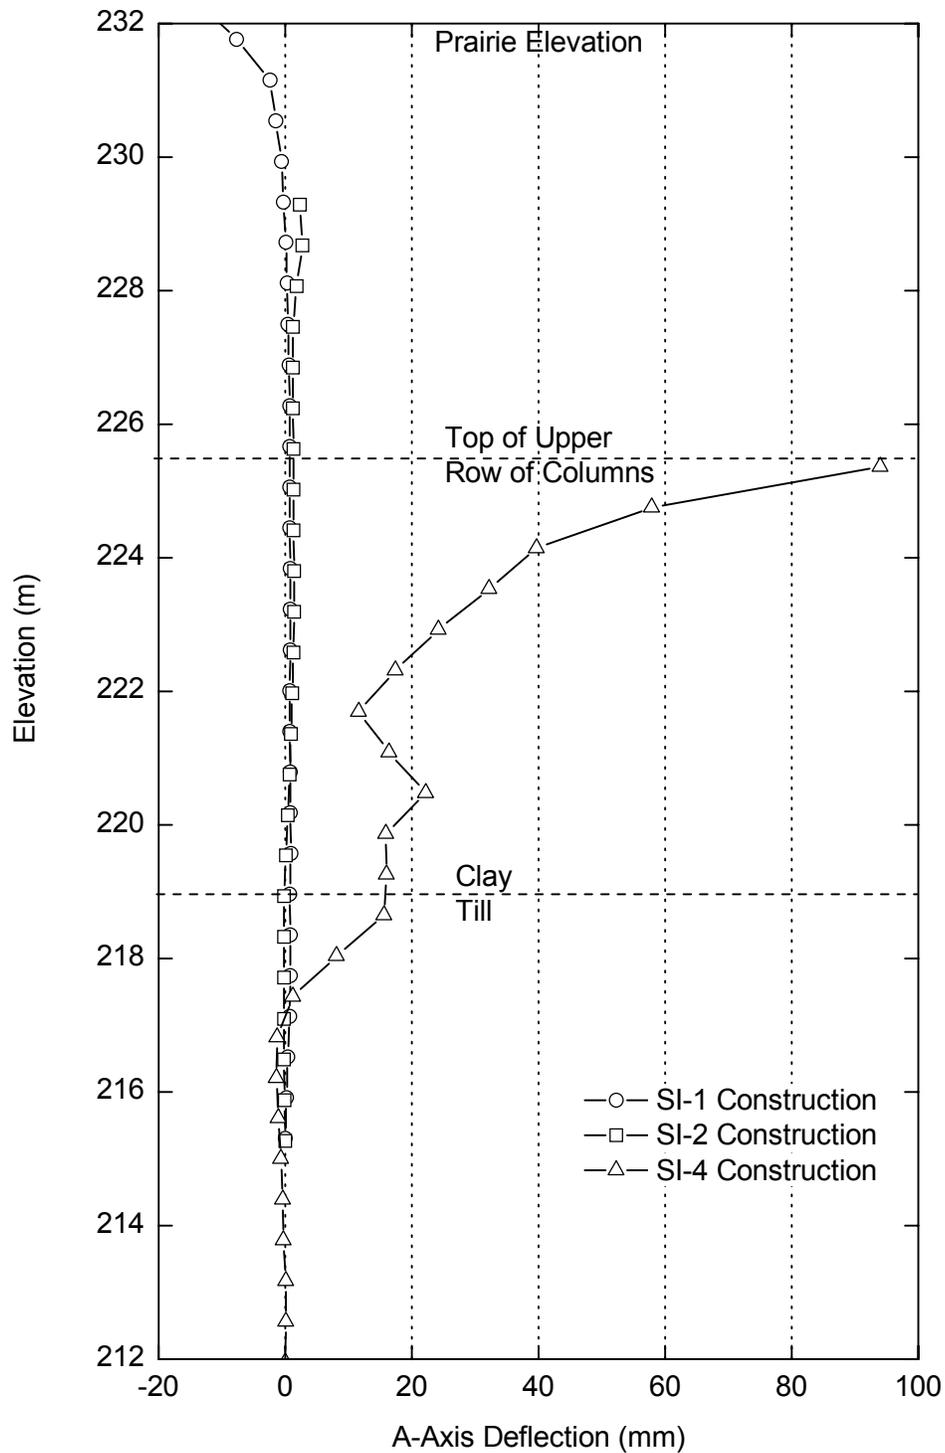
Figure 5.8. Deformations measured in SI-1, 2 and 4 from October 2007 to February 2008. The columns were installed in November 2007.

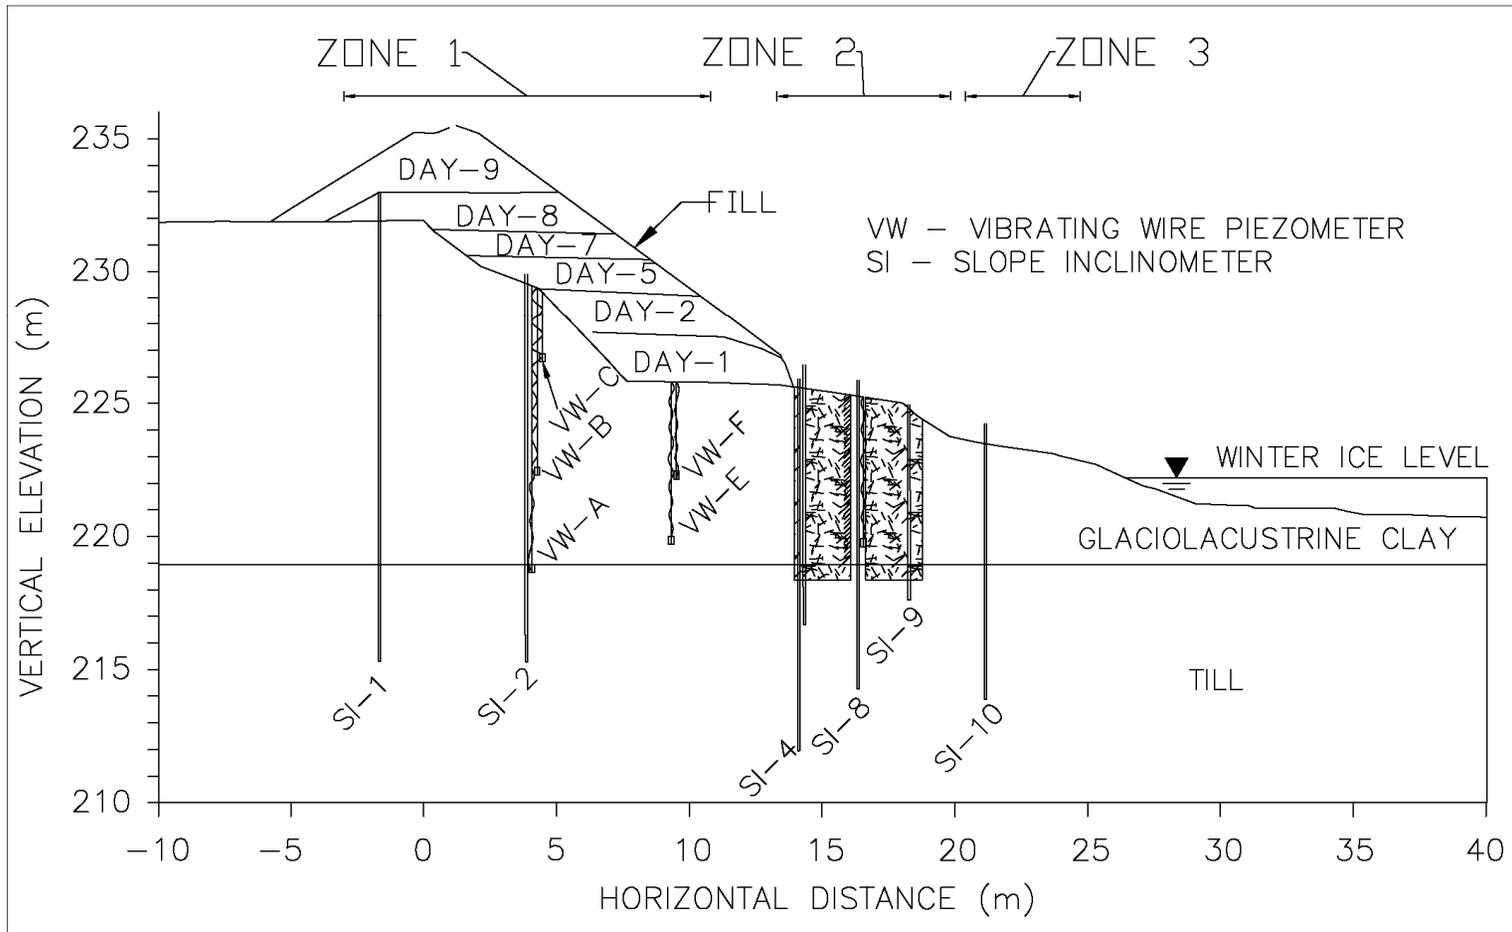
Figure 6.3. Select instrumentation and instrumentation zones at the research test site.

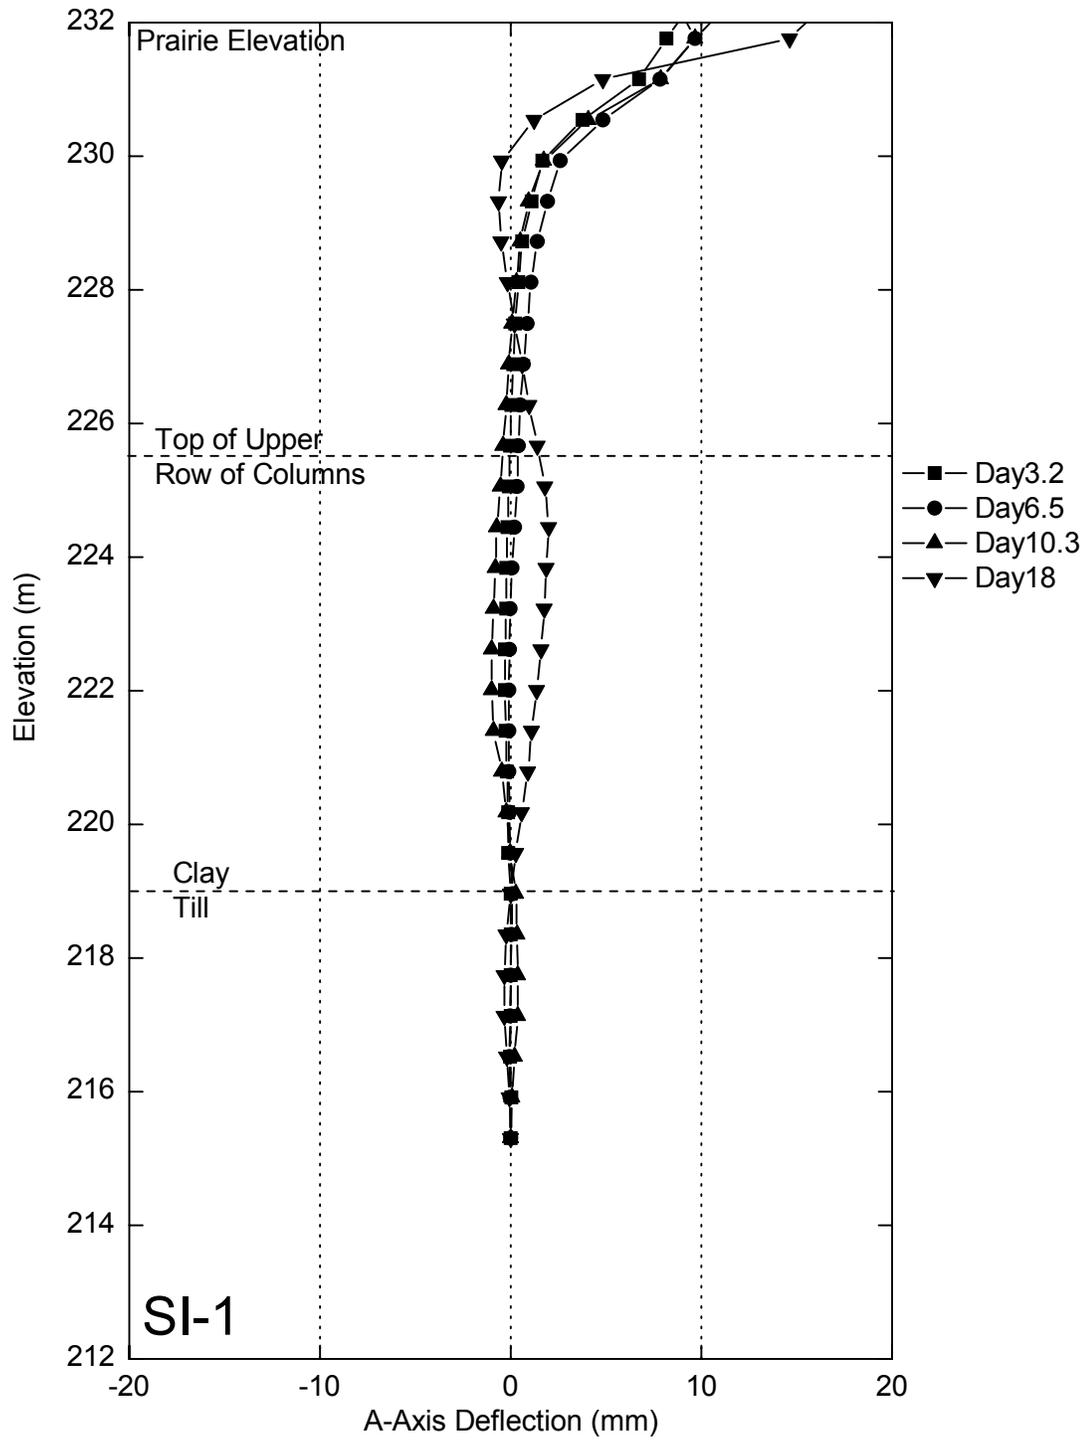
Figure 6.4. SI-1 deflections during the field test. Back from crest of slope.

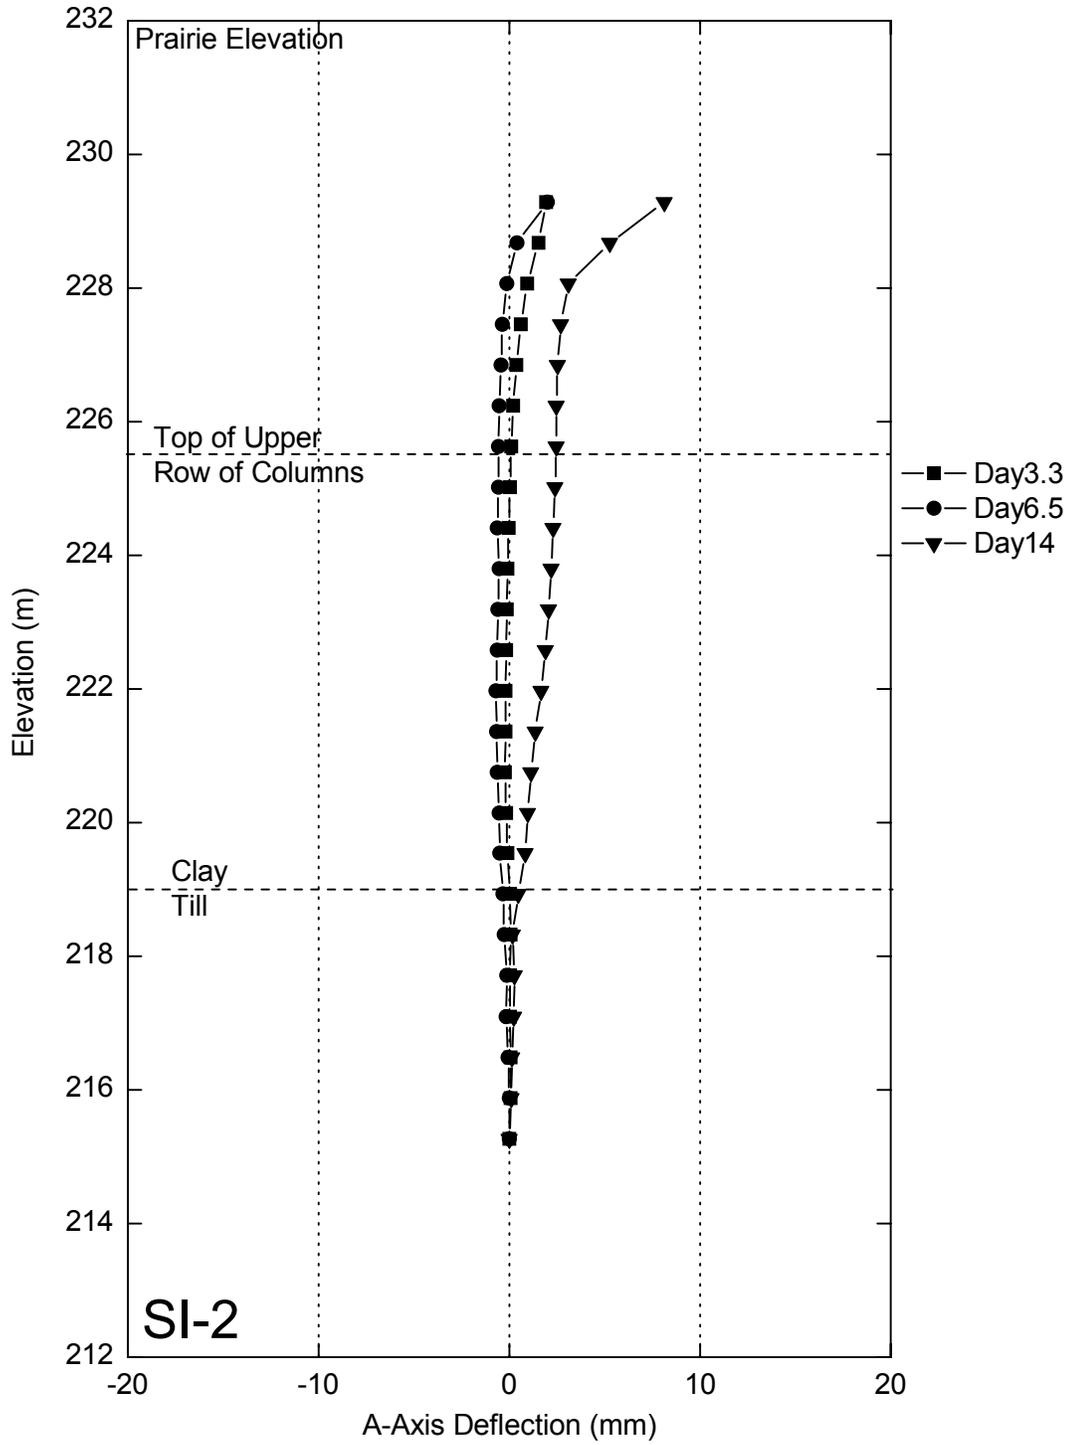
Figure 6.5. SI-2 deflections during field test. Downslope from crest.

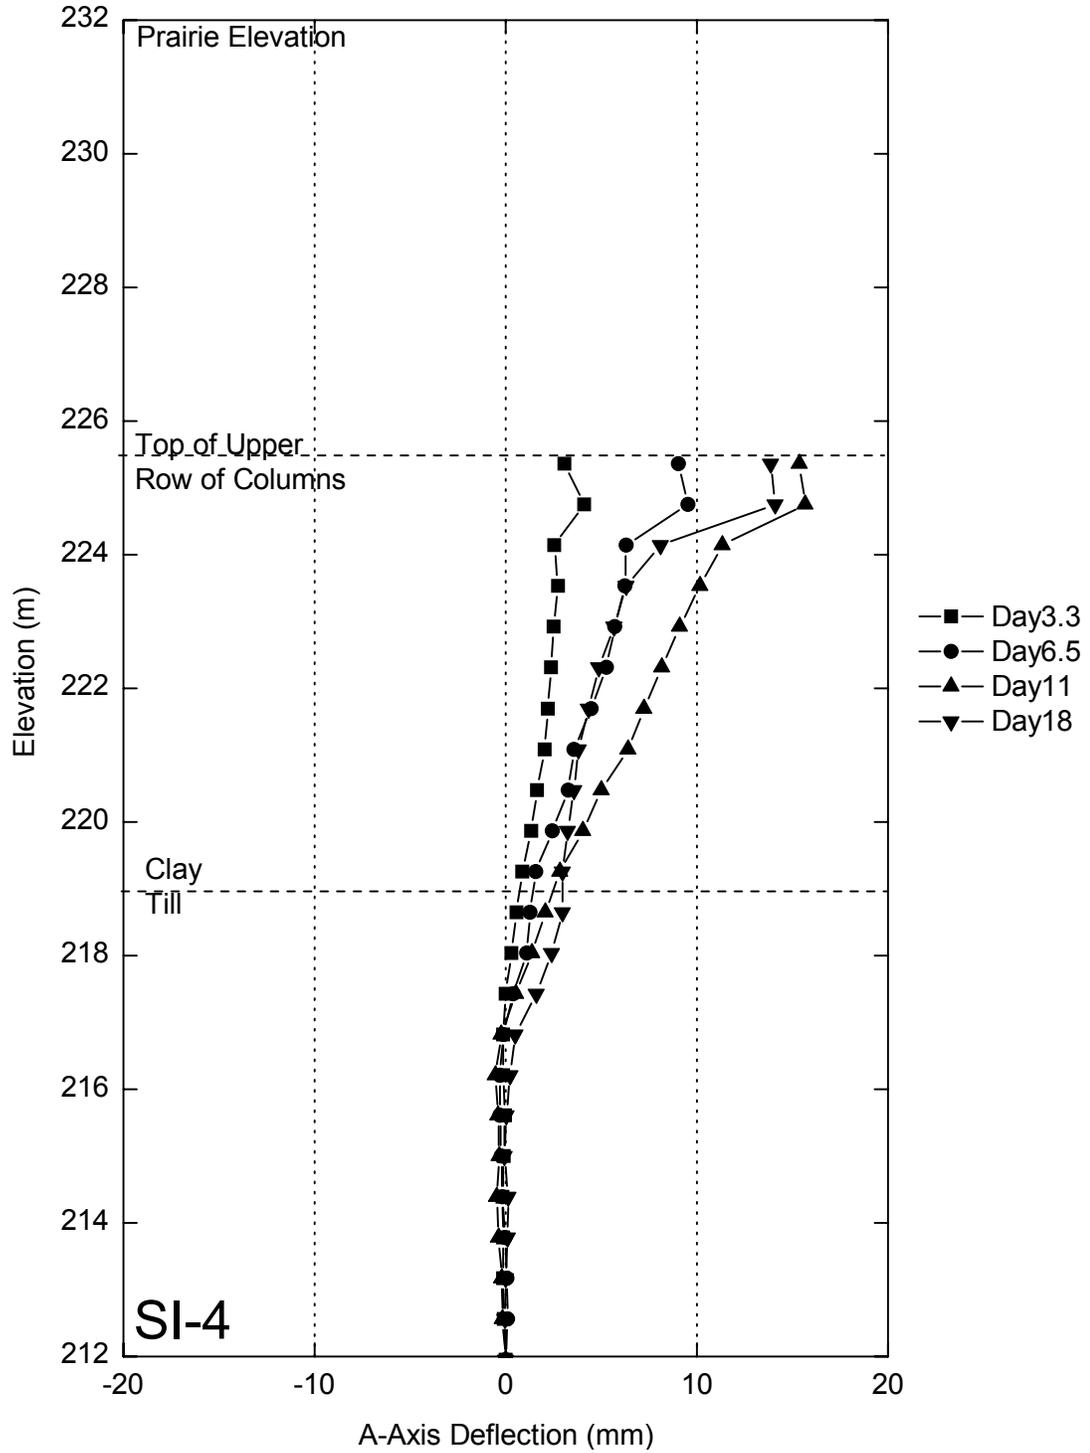
Figure 6.6. SI-4 deflections during field test. Installed between rockfill columns in upper row.

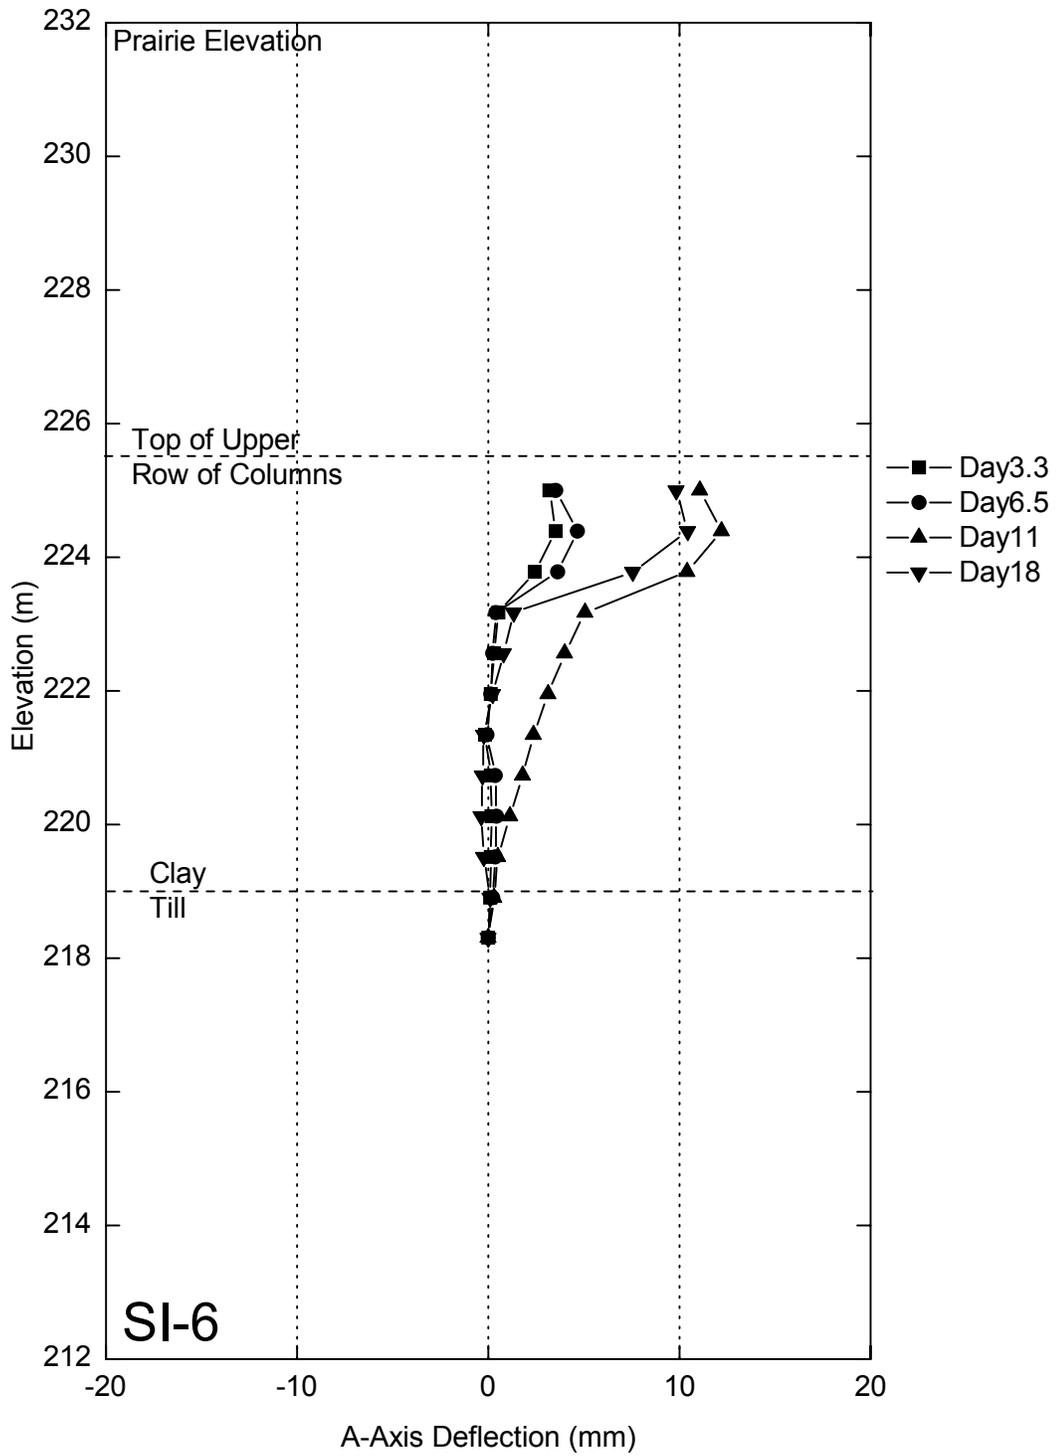
Figure 6.7. SI-6 deflections during field test. Installed in a column in upper row.

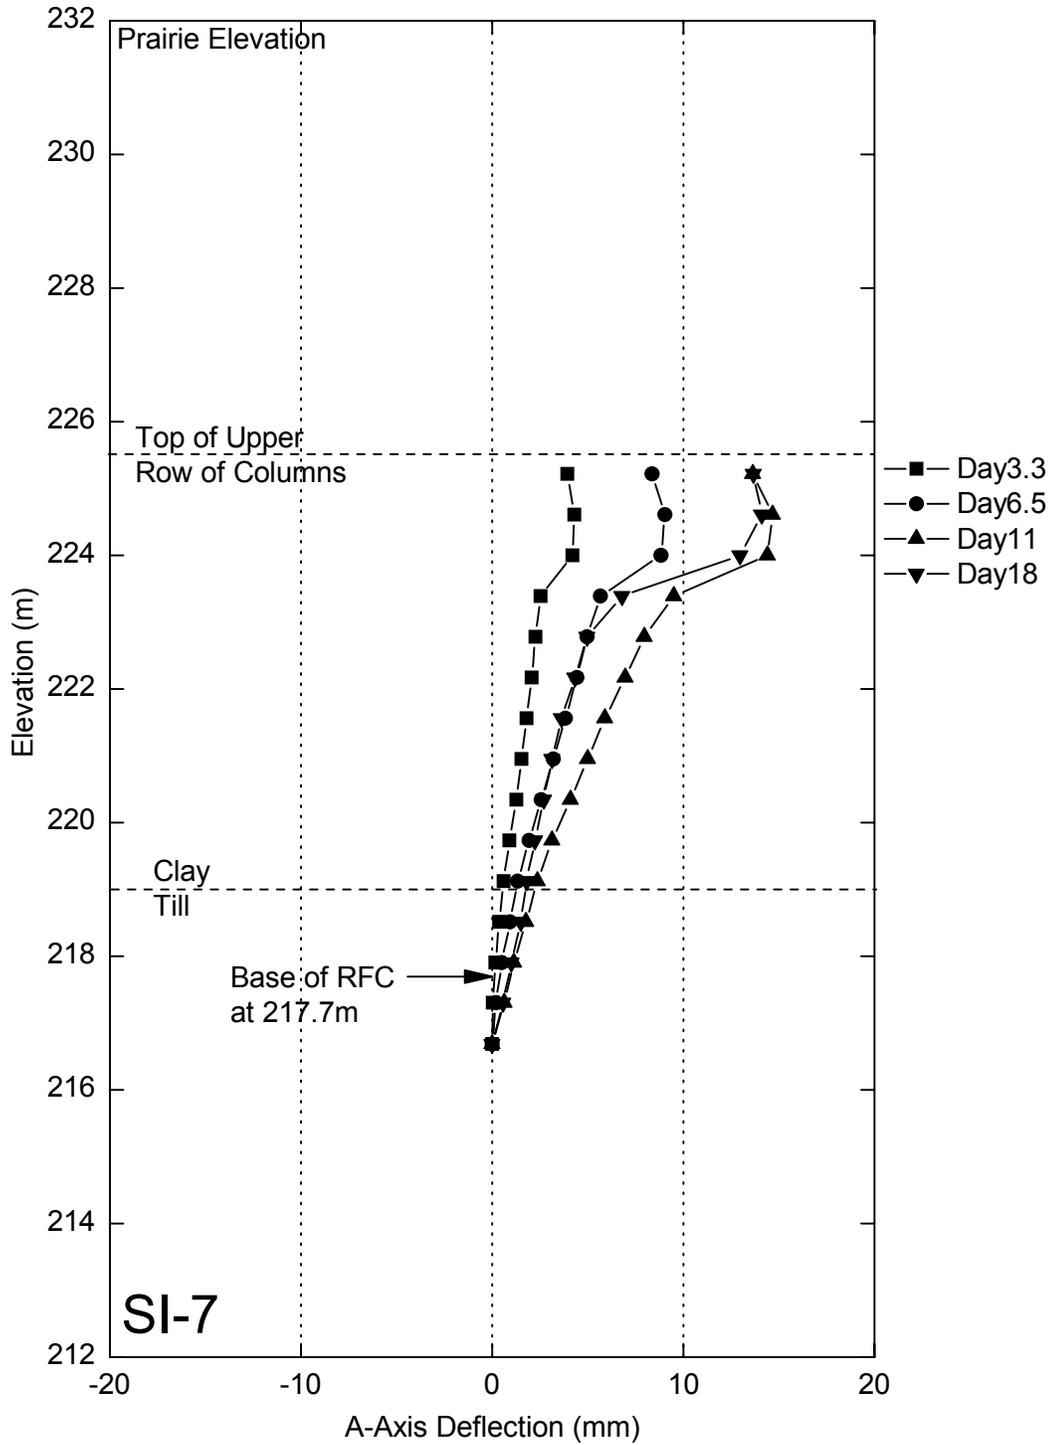
Figure 6.8. SI-7 deflections during field test. Installed directly in a rockfill column in the upper row.

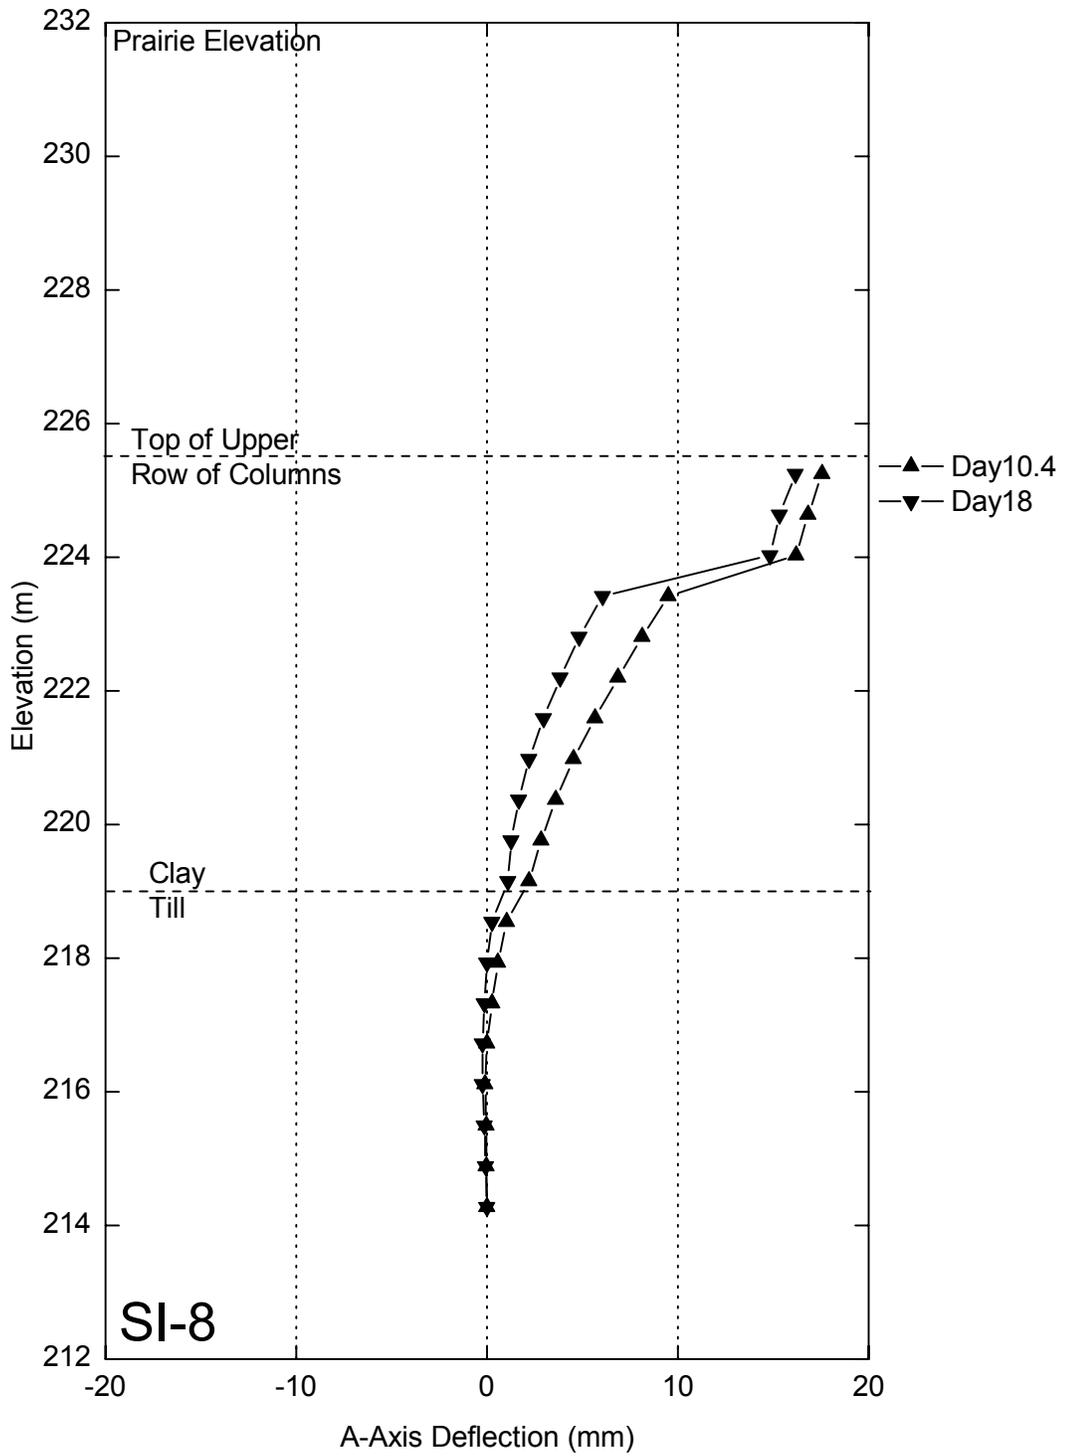
Figure 6.9. SI-8 deflections during the field test. Installed between rows of rockfill columns

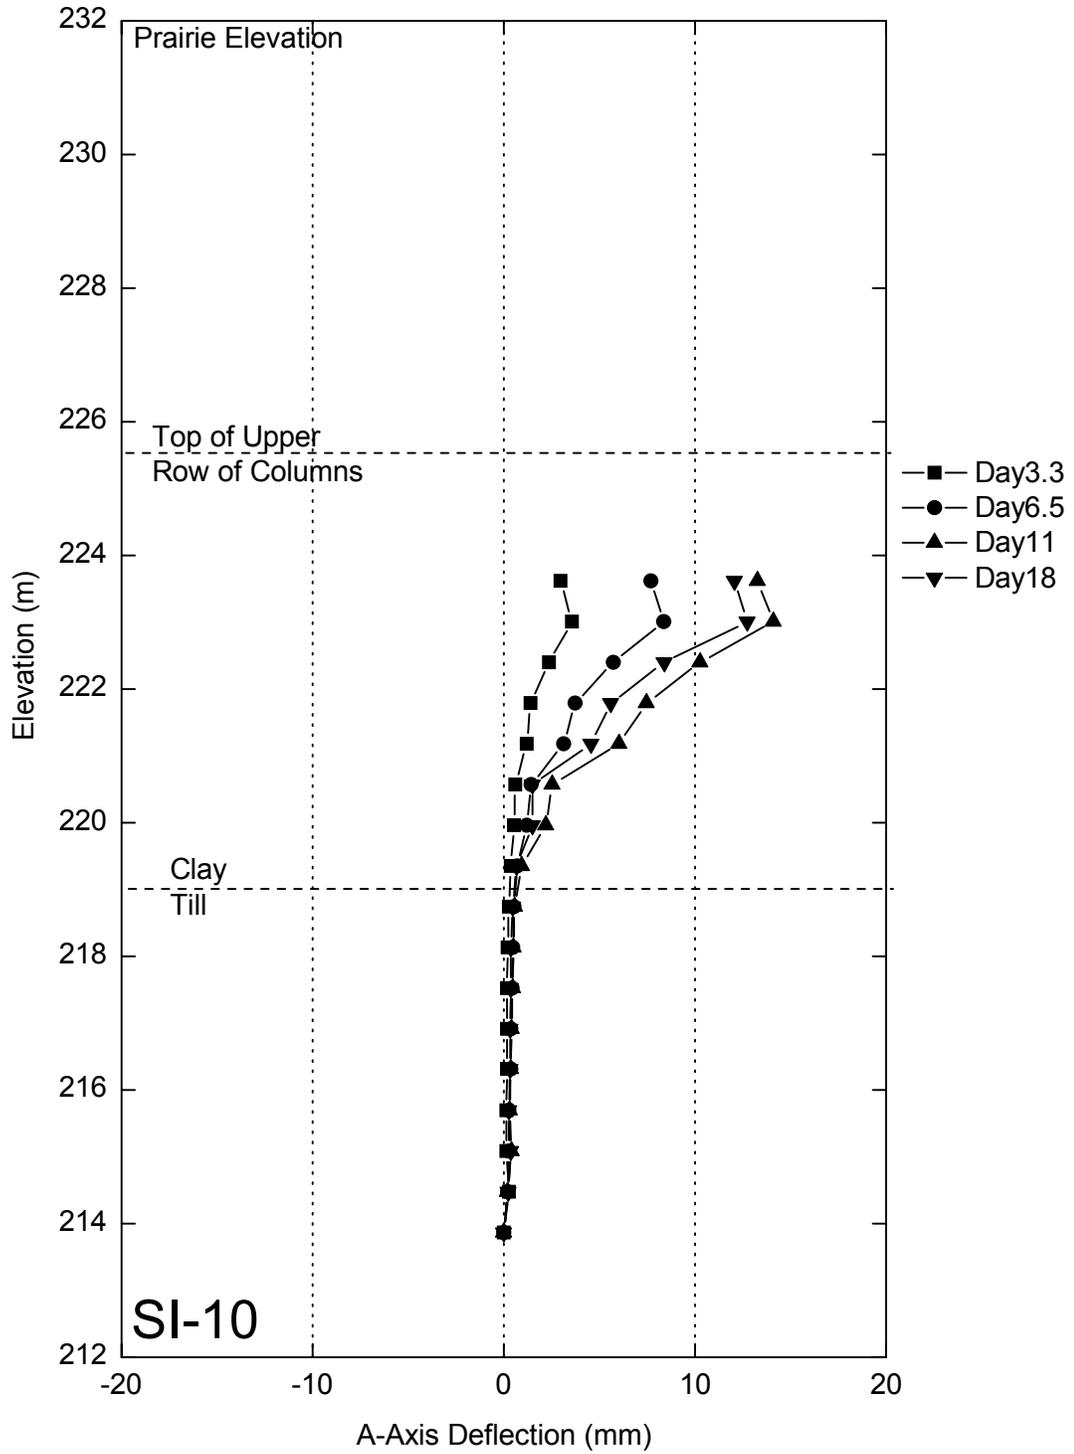
Figure 6.11. SI-10 deflections during the field test. Installed downslope of columns.
