**Stabilization of Natural Clay Riverbanks with Rockfill
Columns:
A Full-Scale Field Test and Numerical Verification**

A Thesis submitted to the Faculty of Graduate Studies of
The University of Manitoba

Department of Civil Engineering
University of Manitoba
Winnipeg

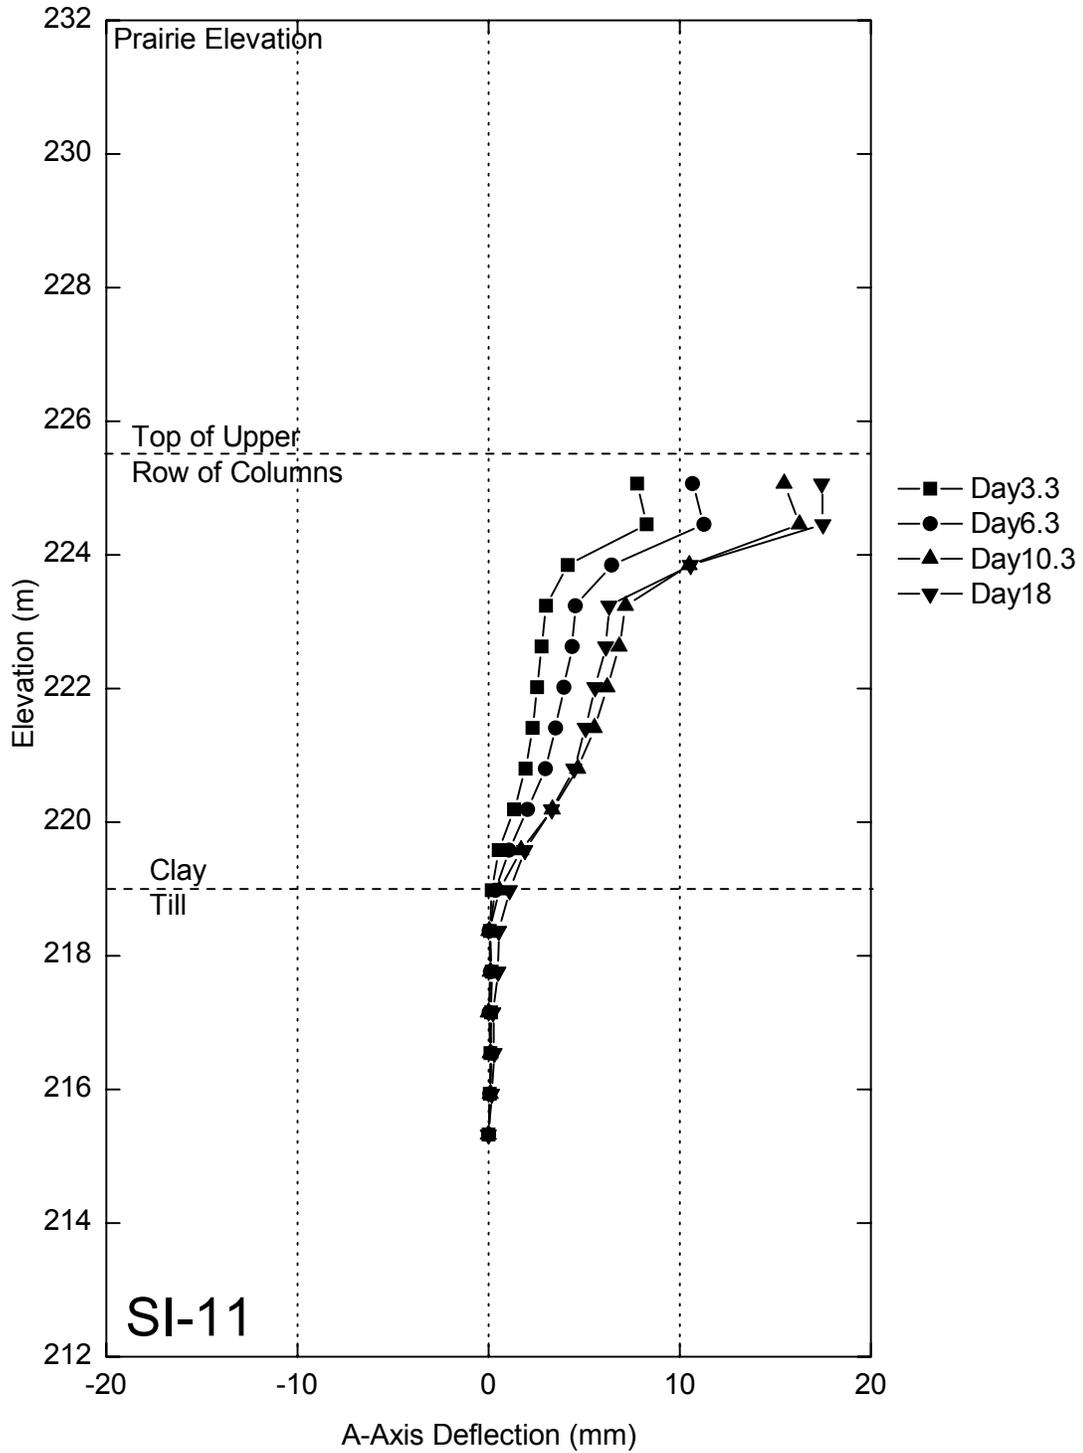
Figure 6.12. SI-11 deflections during the field test. Installed near downstream edge of test site, between rows of columns.

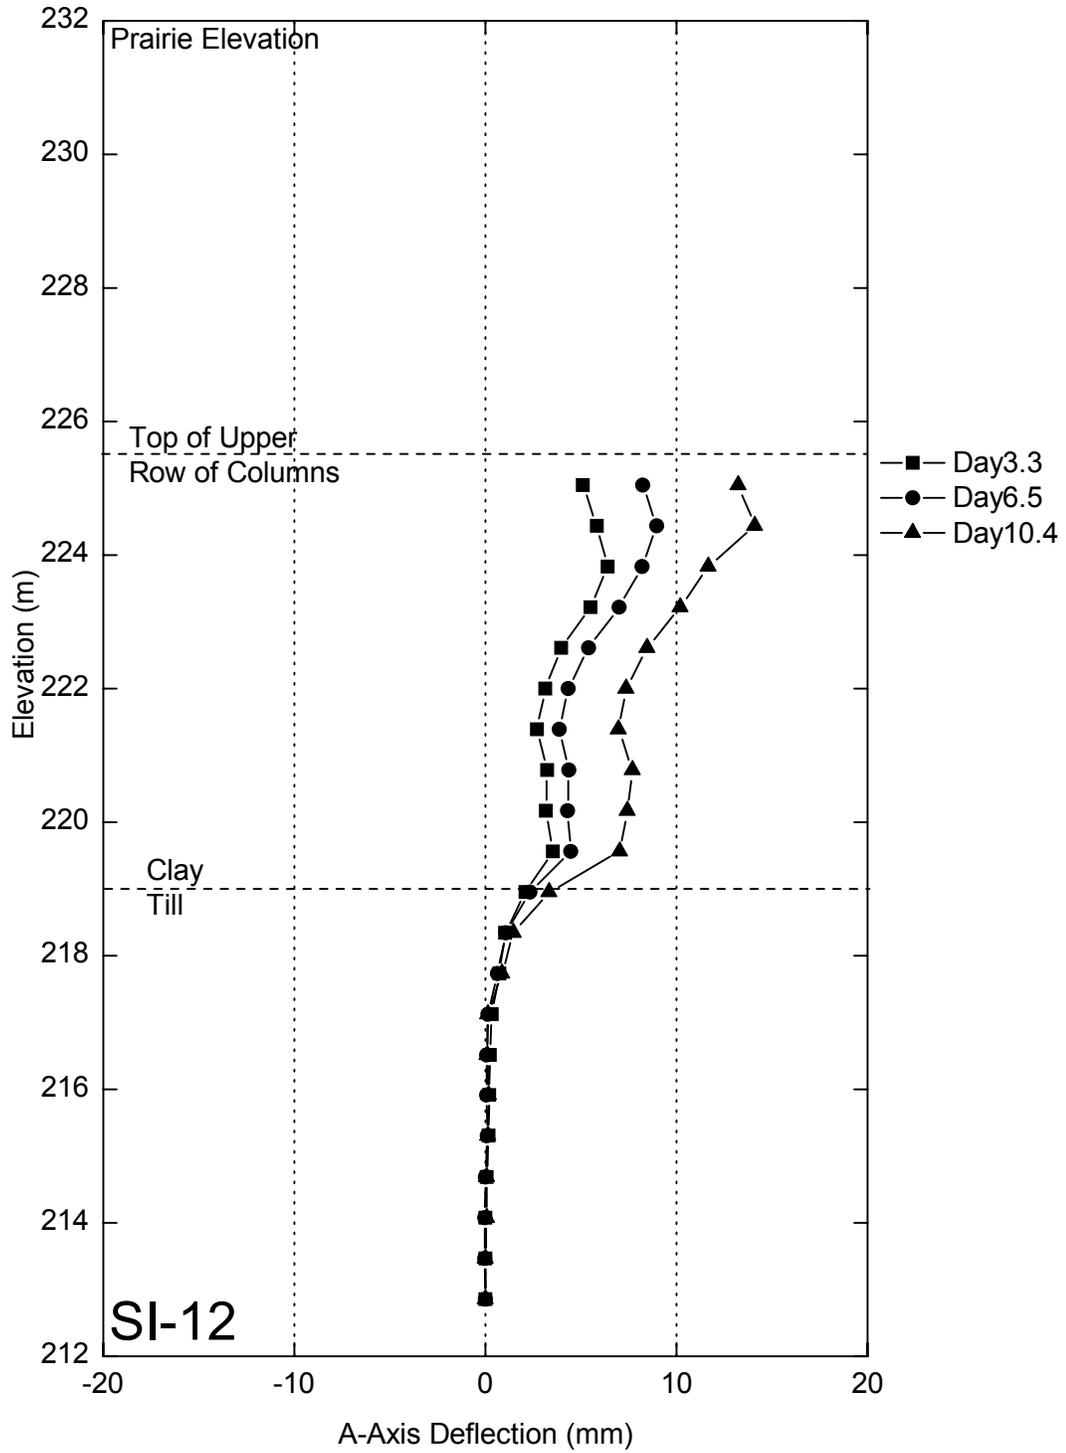
Figure 6.13. SI-12 deflections during the field test. Installed near upstream edge of test section, upslope of columns.

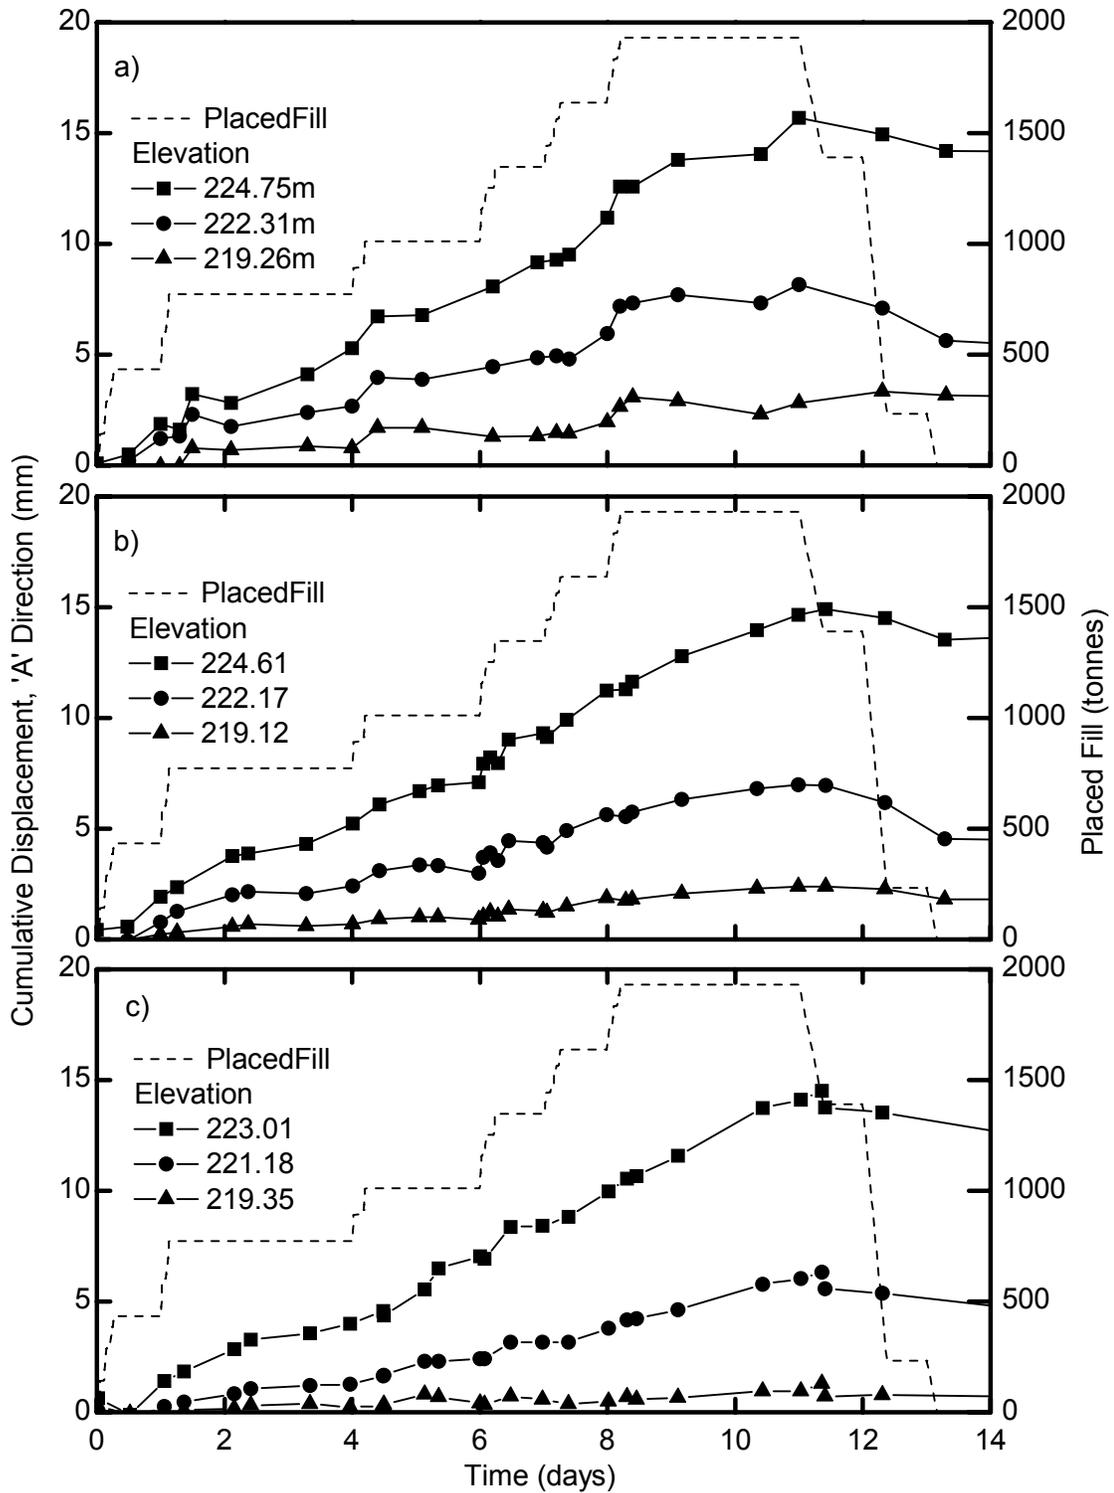
Figure 6.14. Cumulative displacement vs. time at specified elevations for a) SI-4 and b) SI-7 and c) SI-10

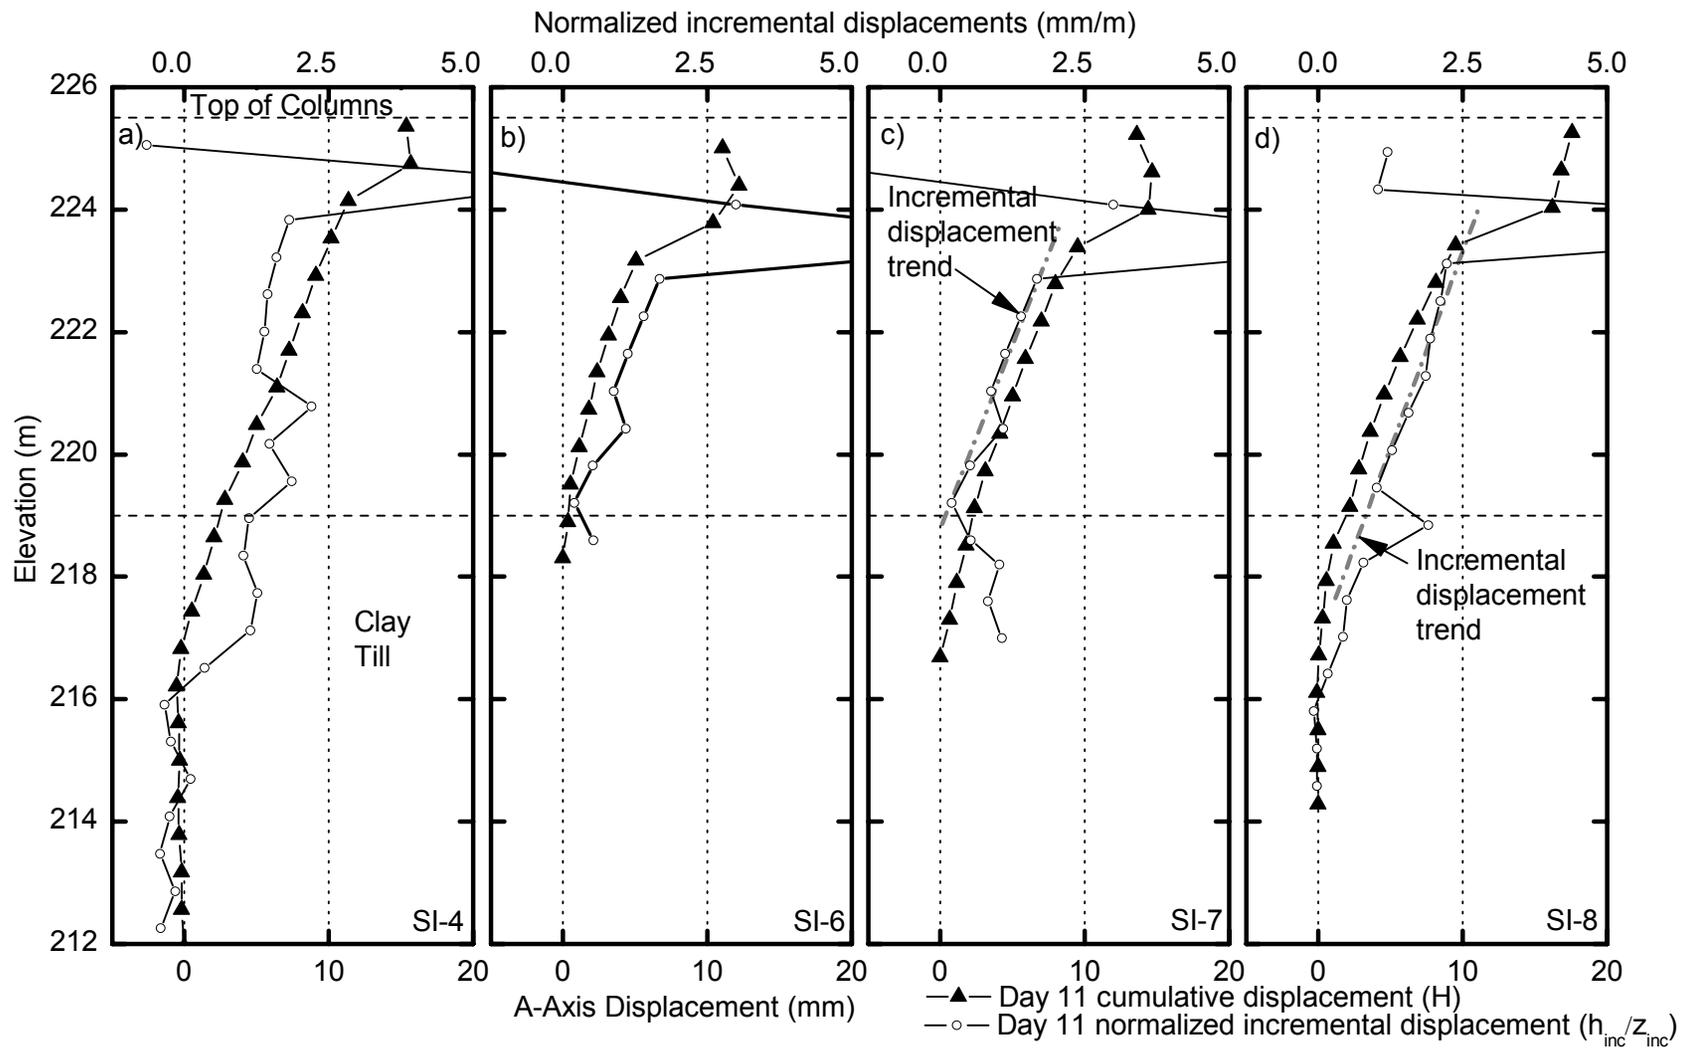
Figure 6.16. Cumulative displacements and normalized incremental displacements for a)SI-4, b)SI-6, c) SI-7, d) SI-8.

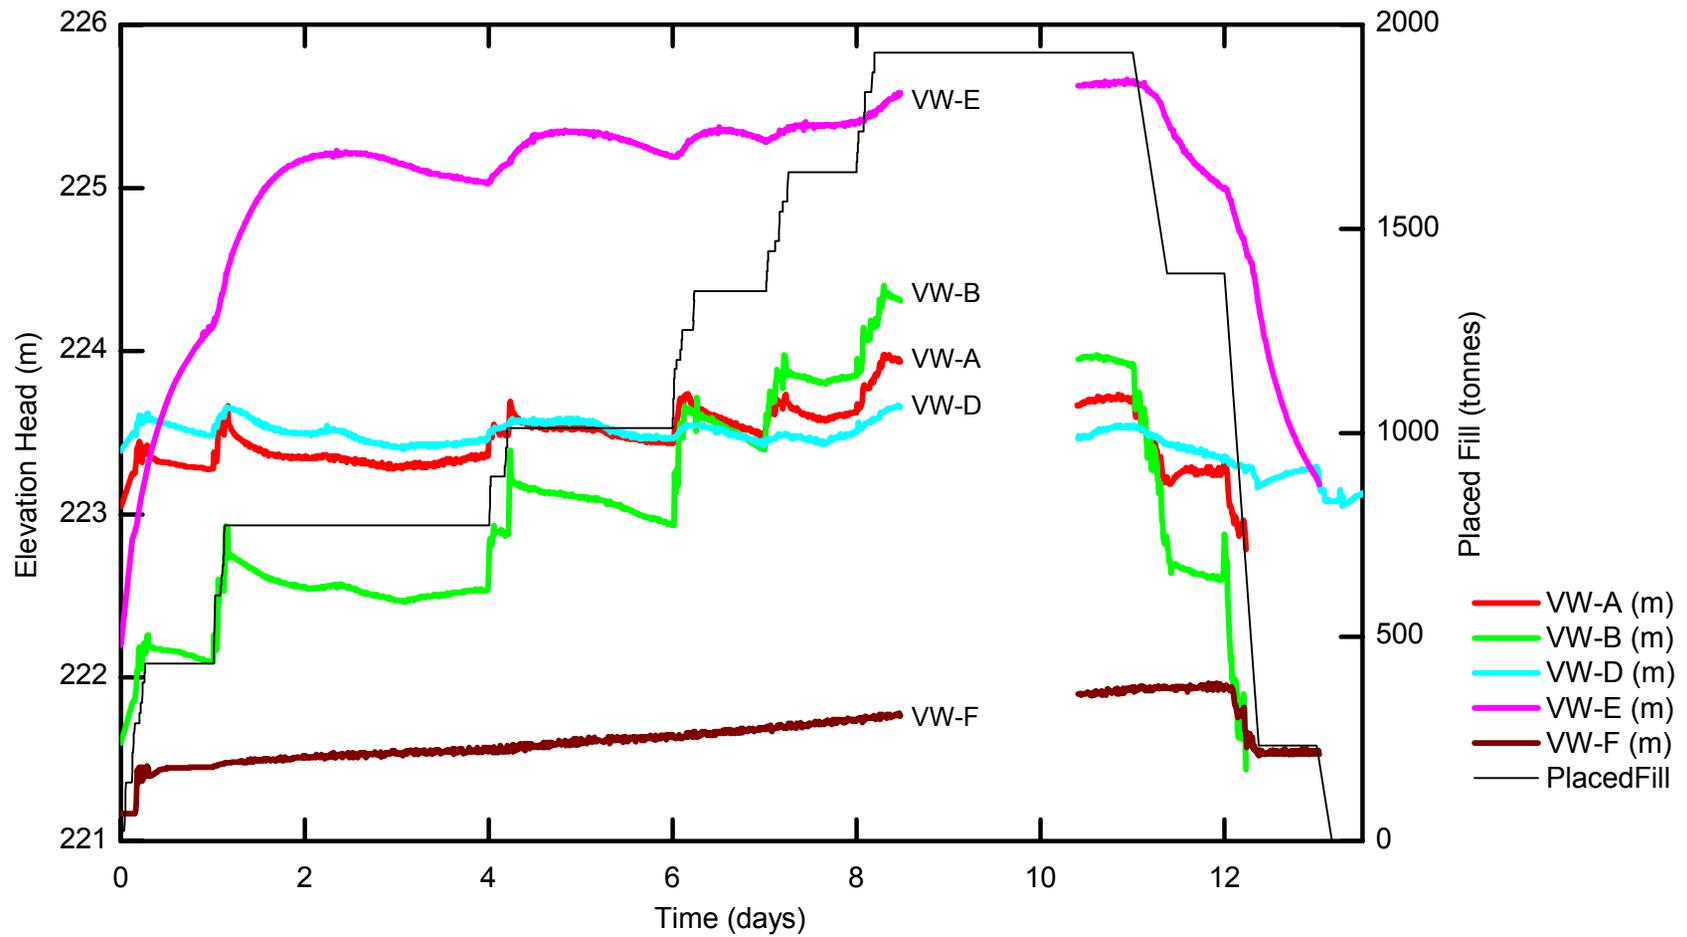
Figure 6.19. Porewater pressure response to loading and unloading

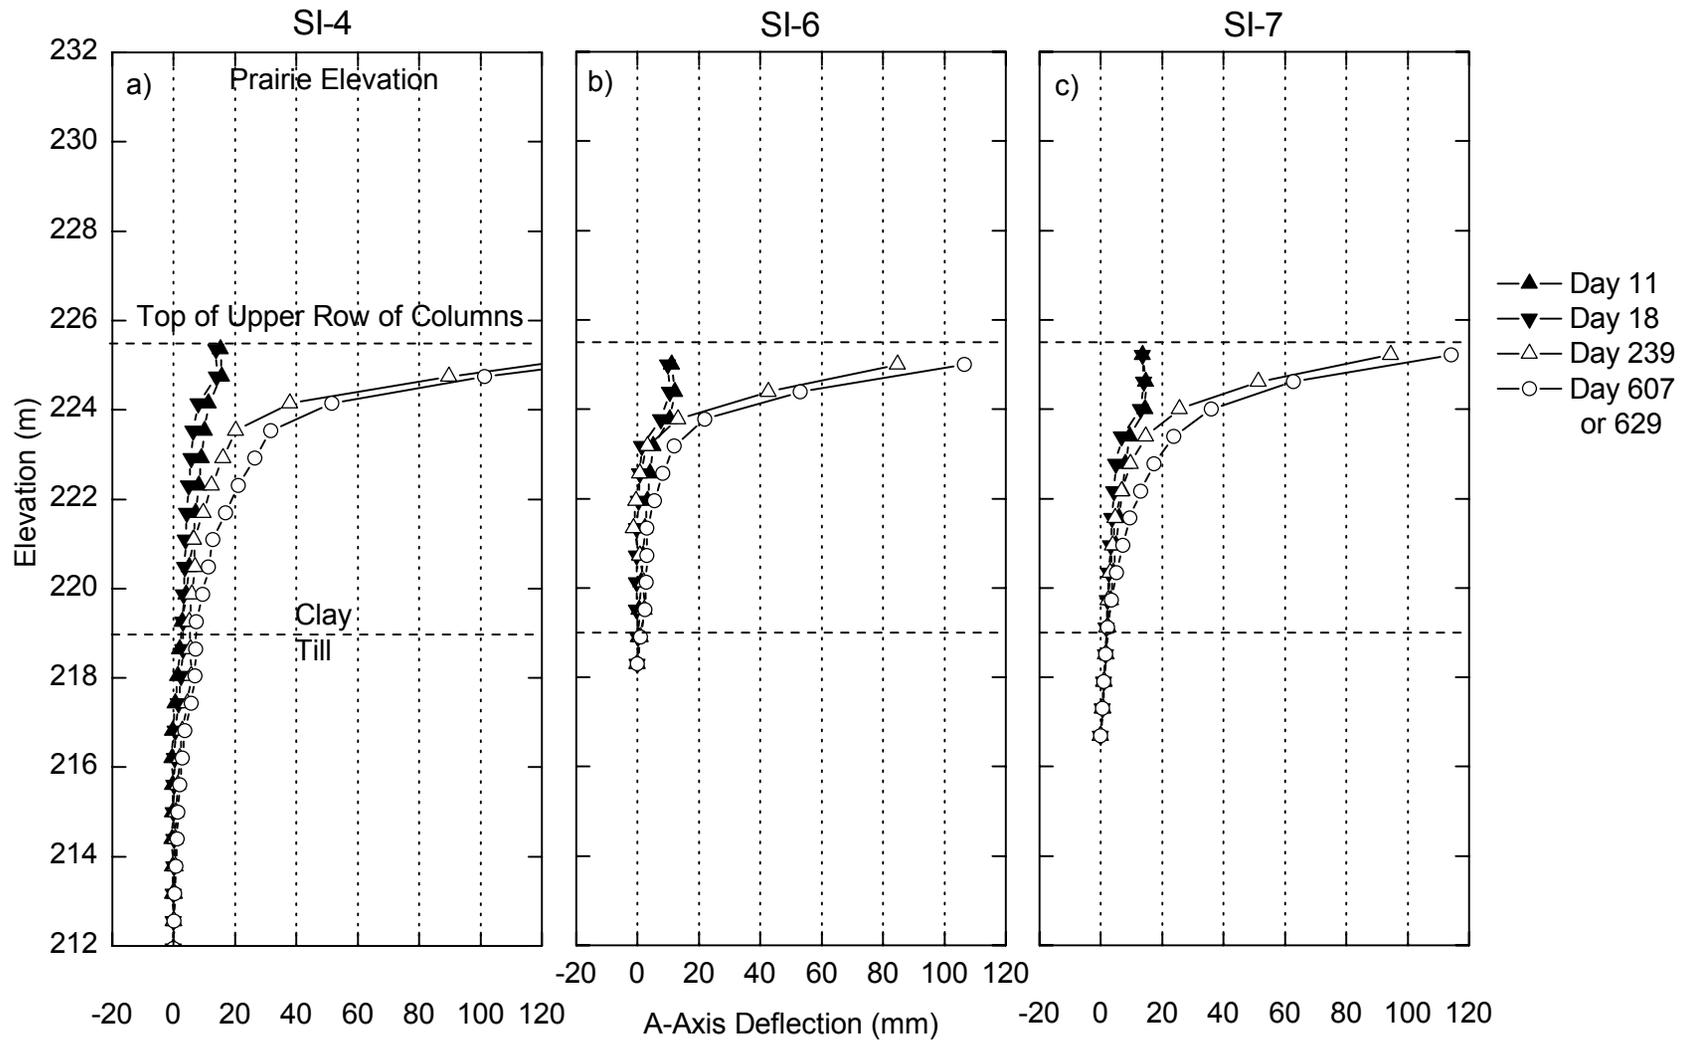
Figure 6.20. Displacements measured after test loading a) SI-4, b) SI-6, c) SI-7

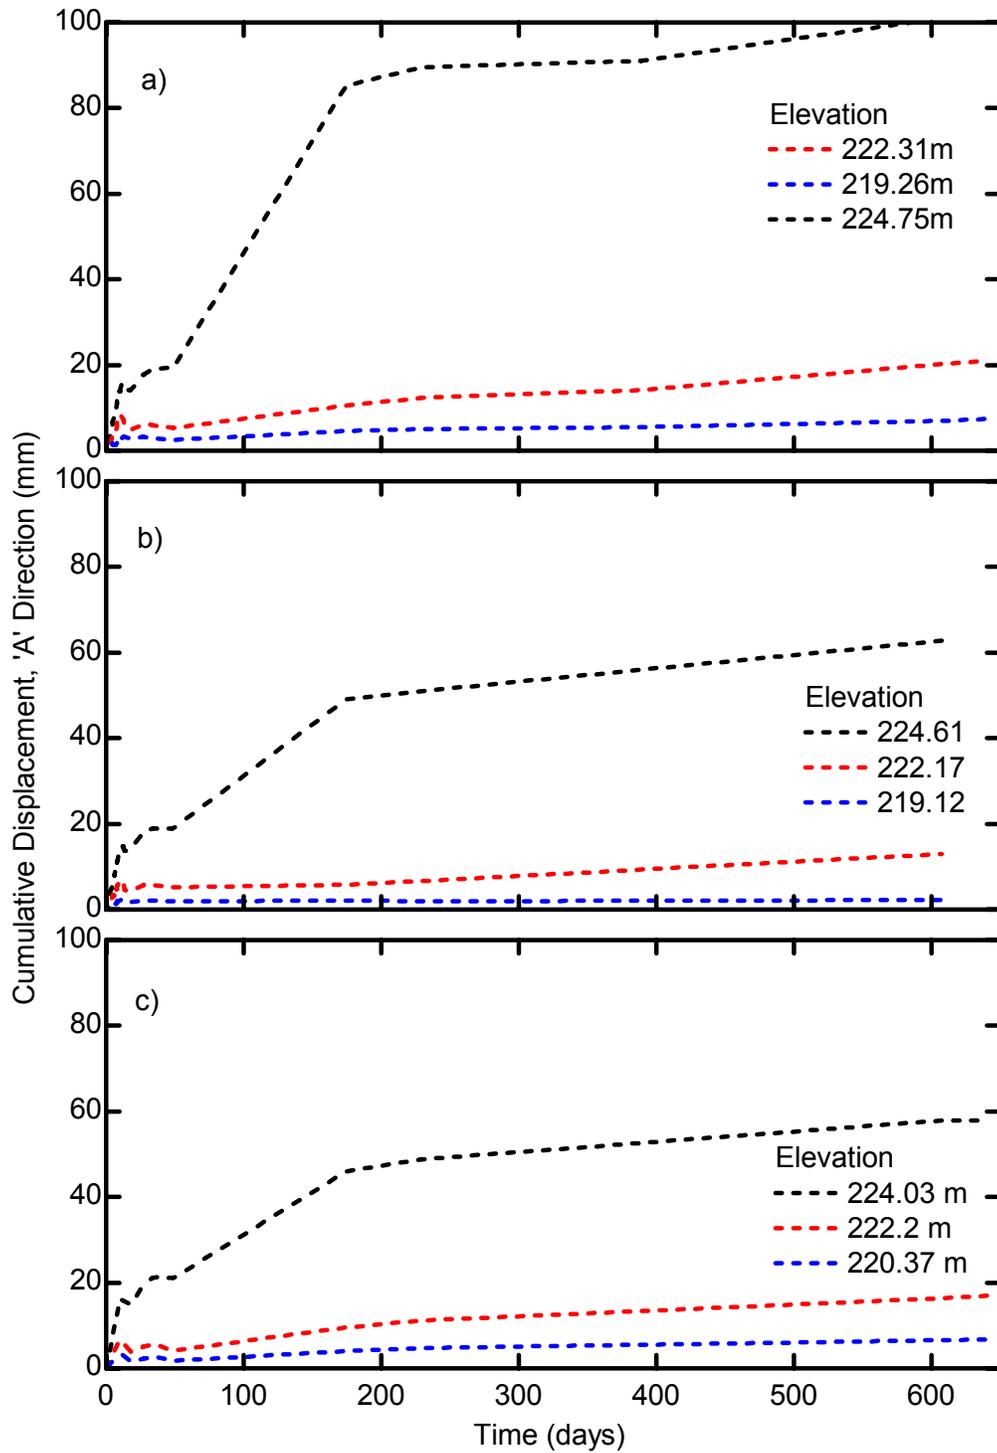
Figure 6.22. Displacement plotted against time at select elevations for a) SI-4, b) SI-7, and c) SI-8.

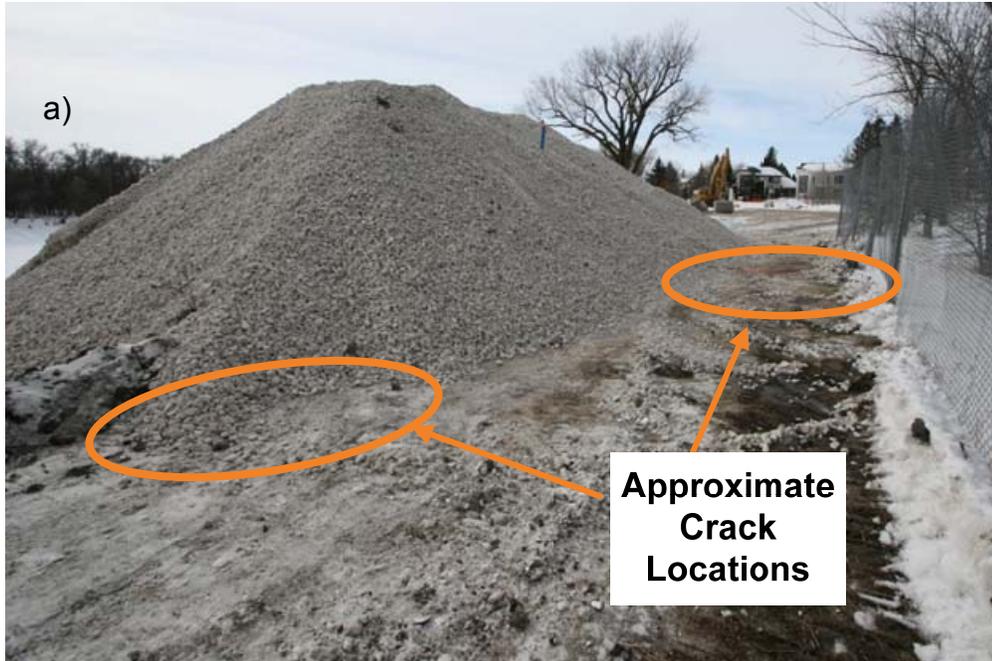
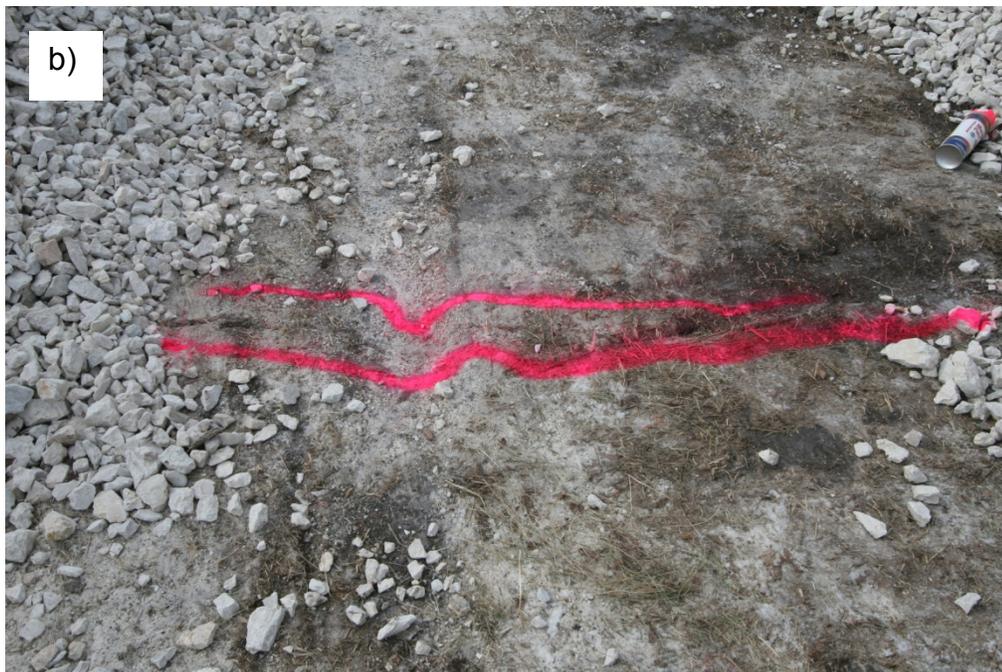
Figure 6.23. a) Locations of cracking at test site on day 10 of testing b) crack at crest near centerline of test section

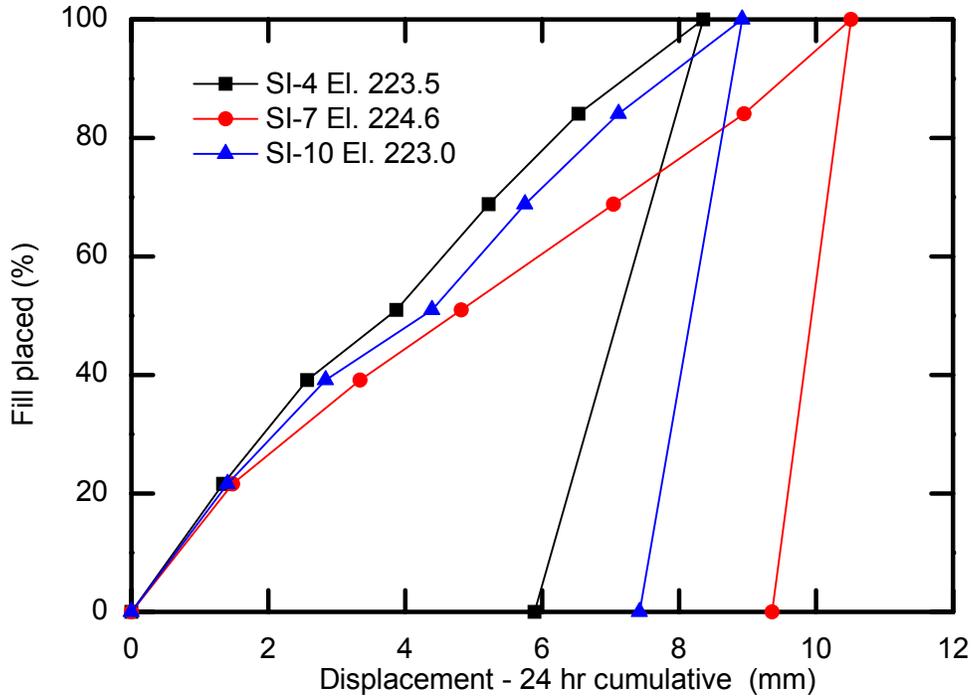
Figure 6.24. Percentage of total fill placed versus cumulative displacement, including unload.

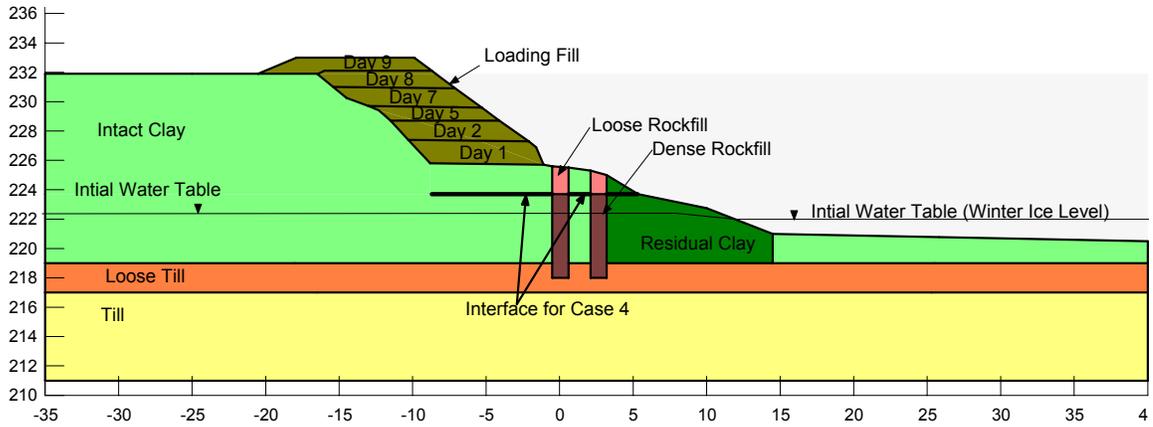
Figure 7.1. Typical section of test loading used in numerical analysis.

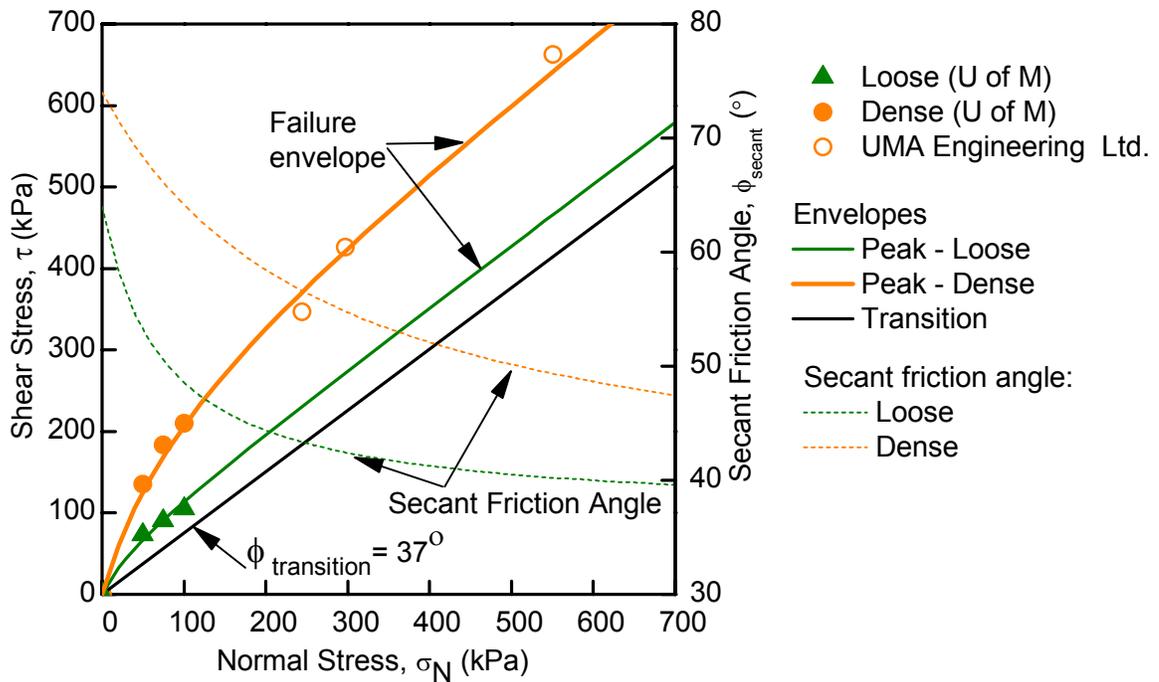
Figure 7.2. Interpreted failure envelopes for rockfill using method presented in Maksimovic (Maksimovic 1996).

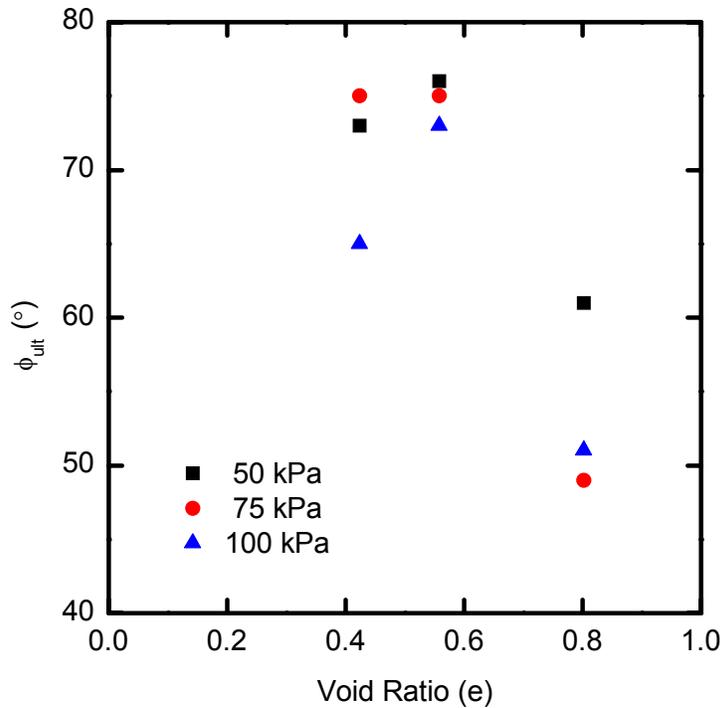
Figure 7.3. Friction angle corresponding to the estimated ultimate strength (asymptote to a fitted hyperbolic stress-strain curve) versus void ratio for crushed rockfill.

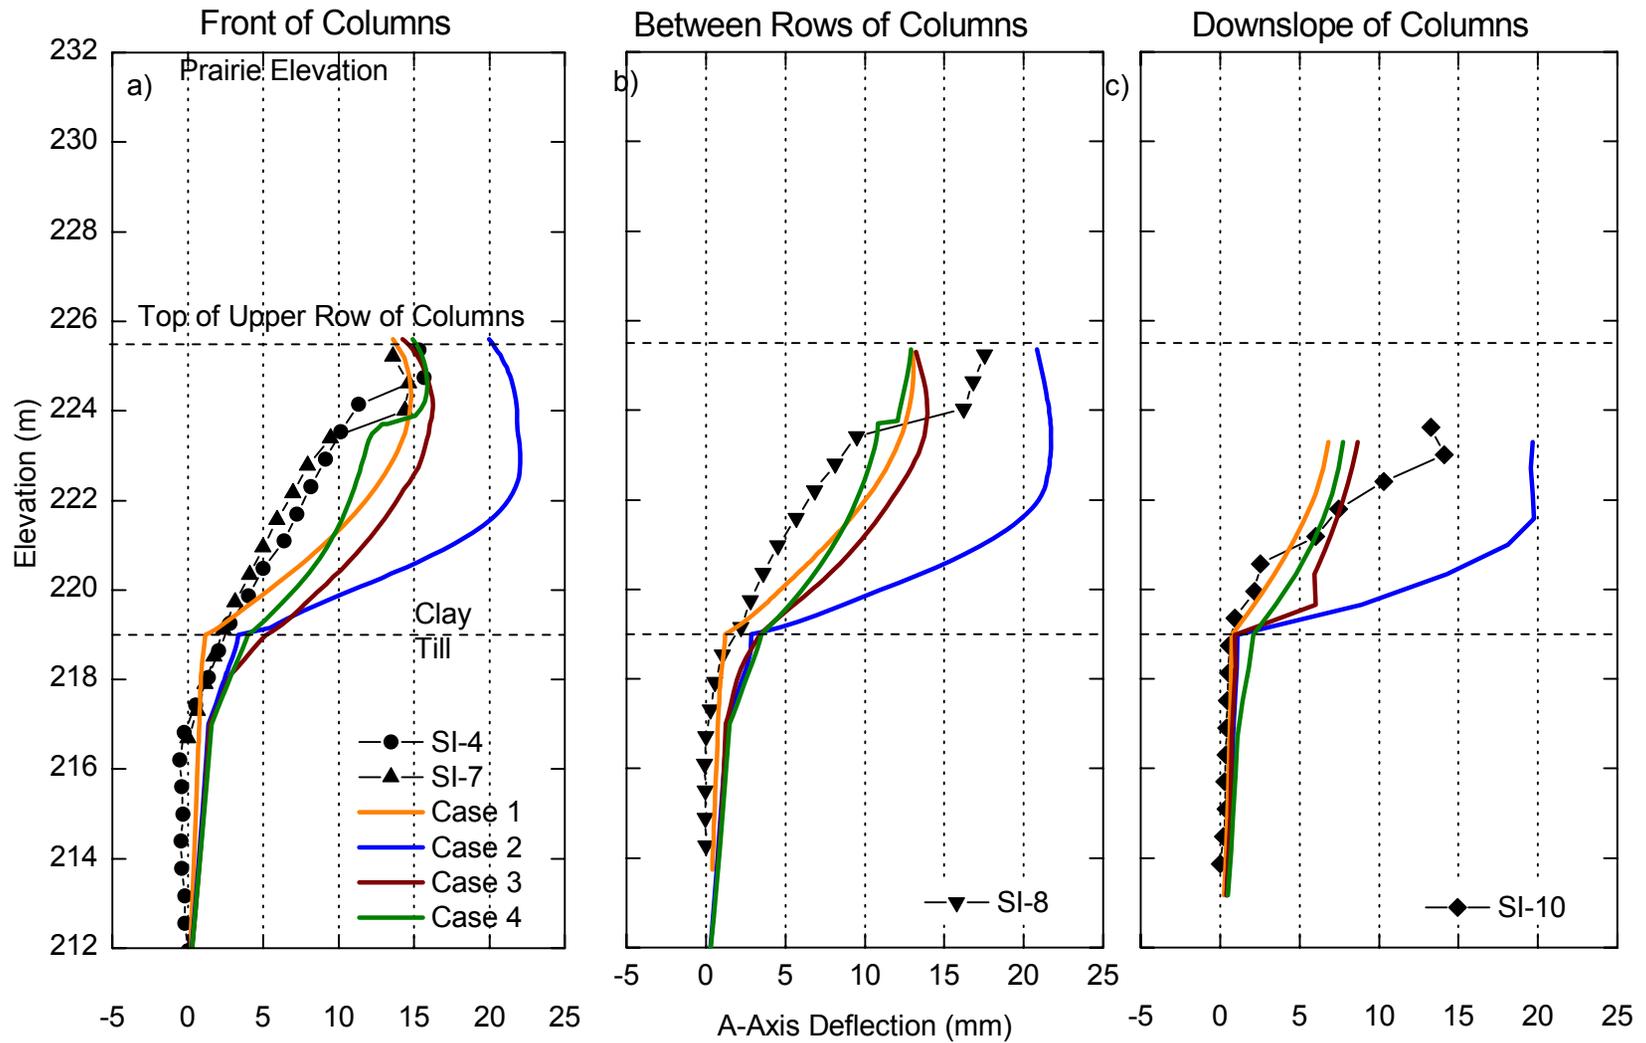
Figure 7.13. Measured displacements compared to modeled displacements from the four modeling cases.

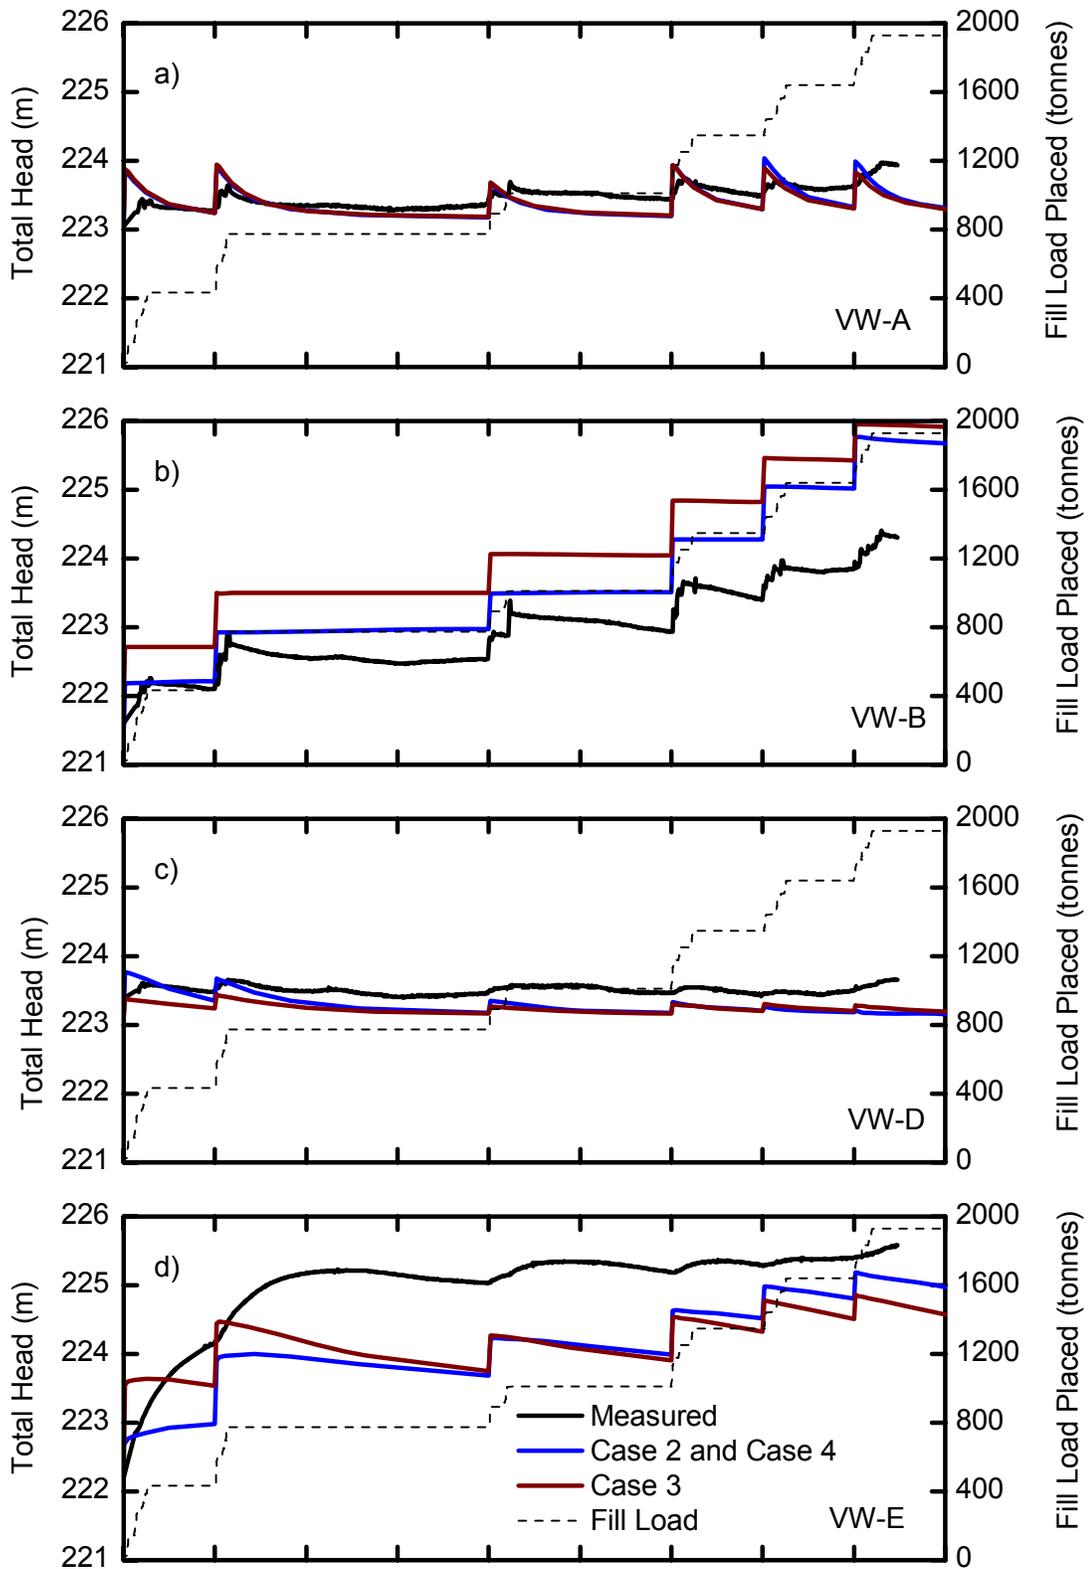
Figure 7.14. Modeled versus measured porewater pressures for a) VW-A, b) VW-B, c) VW-D and d) VW-E.

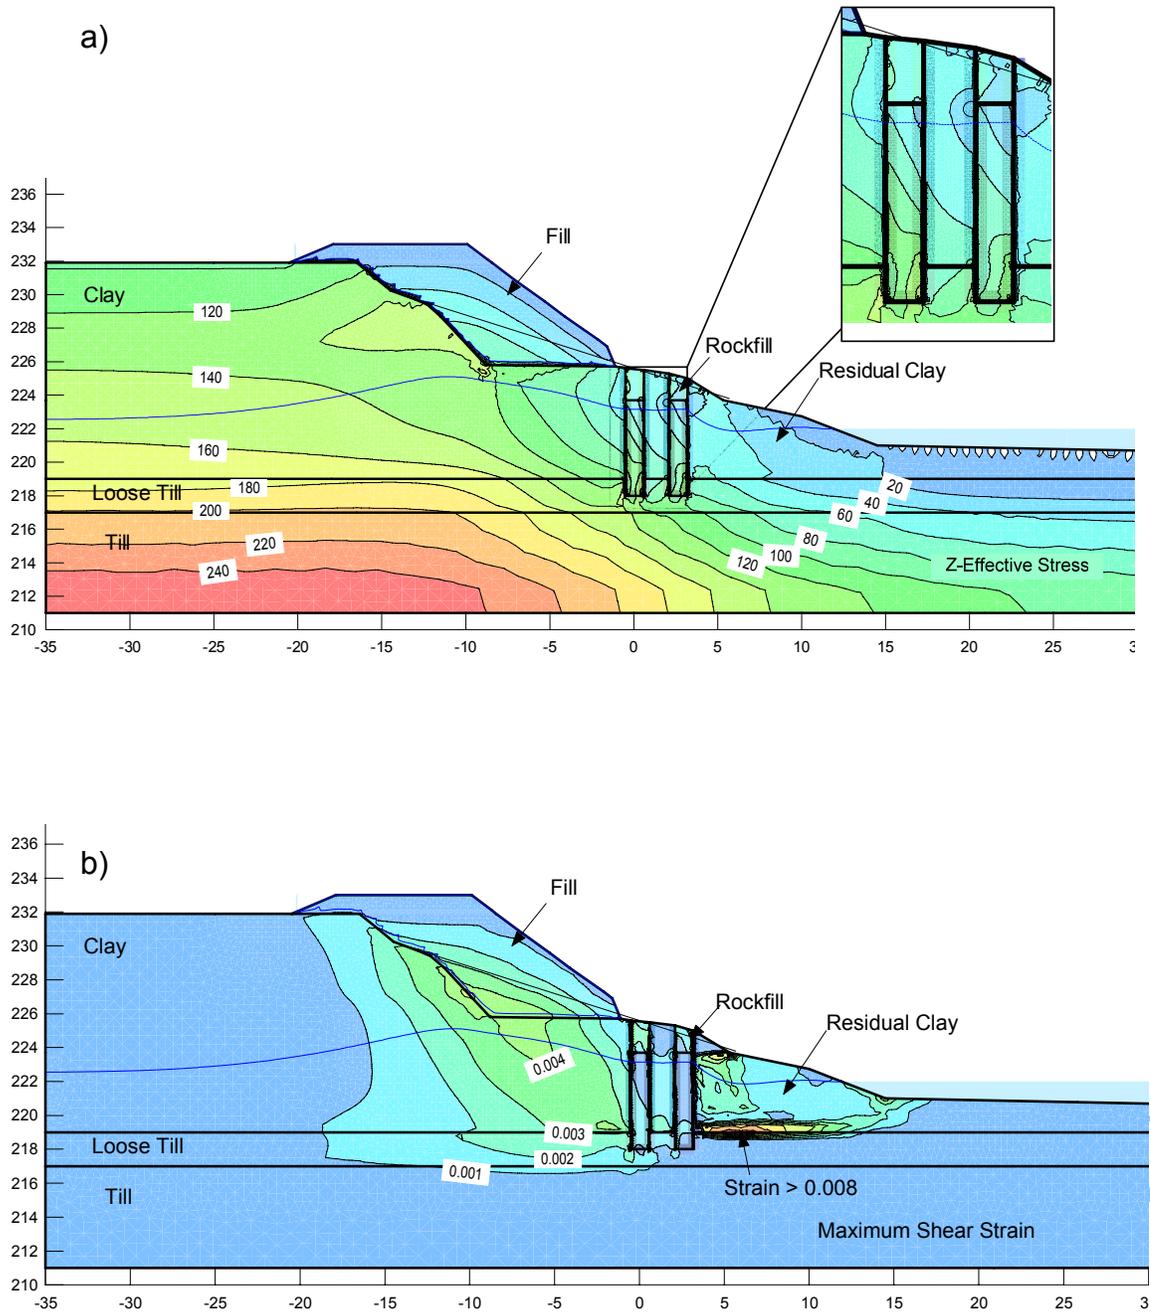
Figure 7.22. Case 3: a) Contours of Z-effective stress, and b) maximum shear strain.

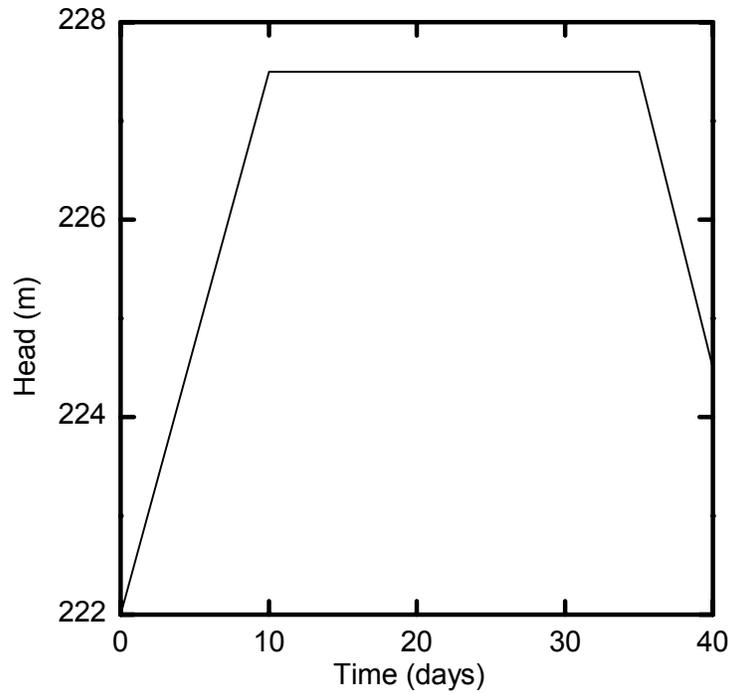
Figure 7.28. Total head boundary condition for simulated flood event.

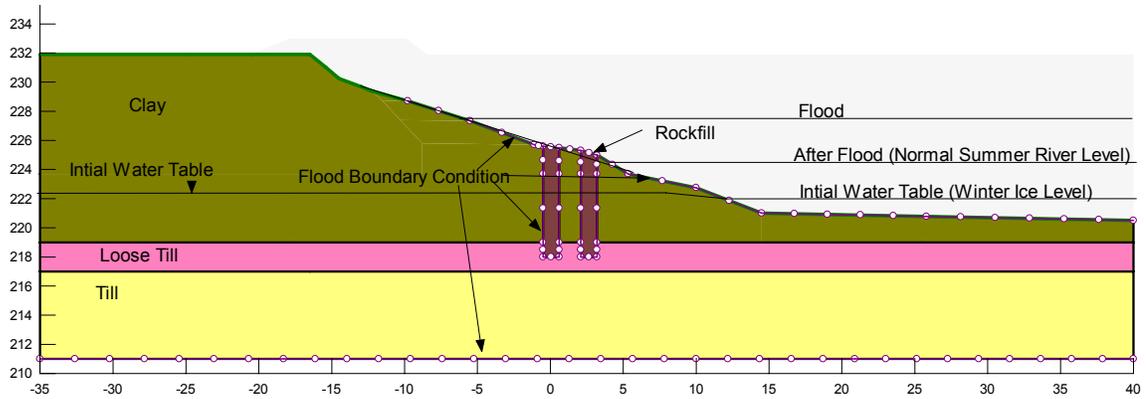
Figure 7.29. Boundary conditions for flood event analysis.

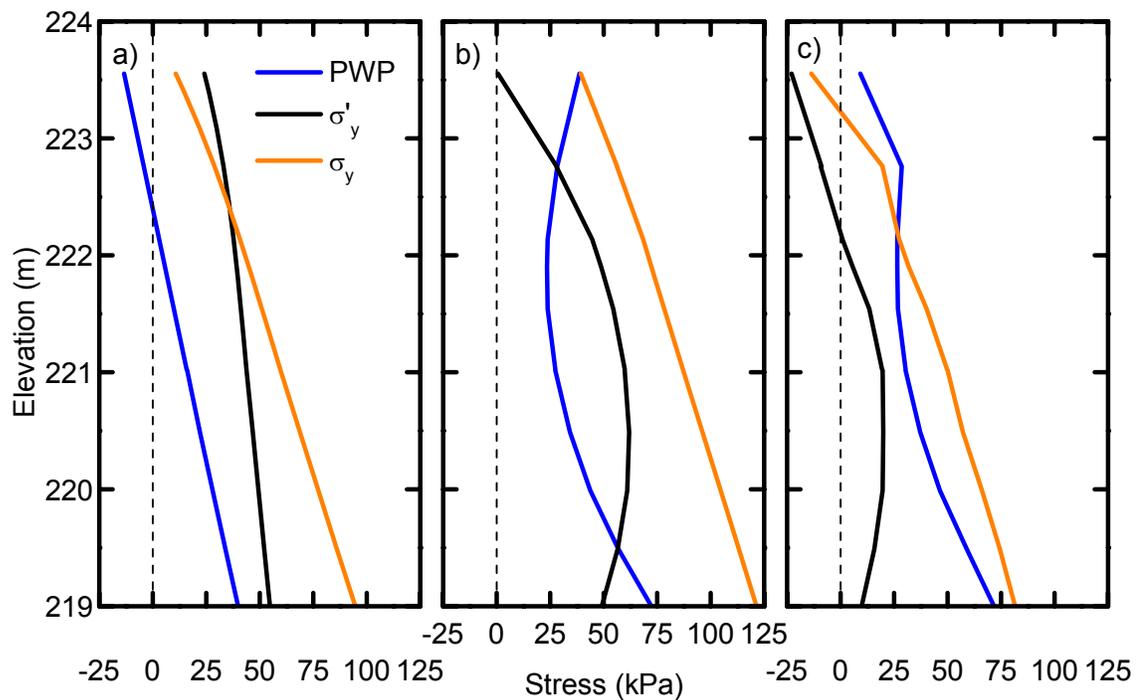
Figure 7.30 Porewater pressure, vertical effective and vertical total stress distributions in clay for a) initial condition b) day 35 of flood stage c) immediately after drawdown.
