**Stabilization of Natural Clay Riverbanks with Rockfill
Columns:
A Full-Scale Field Test and Numerical Verification**

A Thesis submitted to the Faculty of Graduate Studies of
The University of Manitoba

Department of Civil Engineering
University of Manitoba
Winnipeg

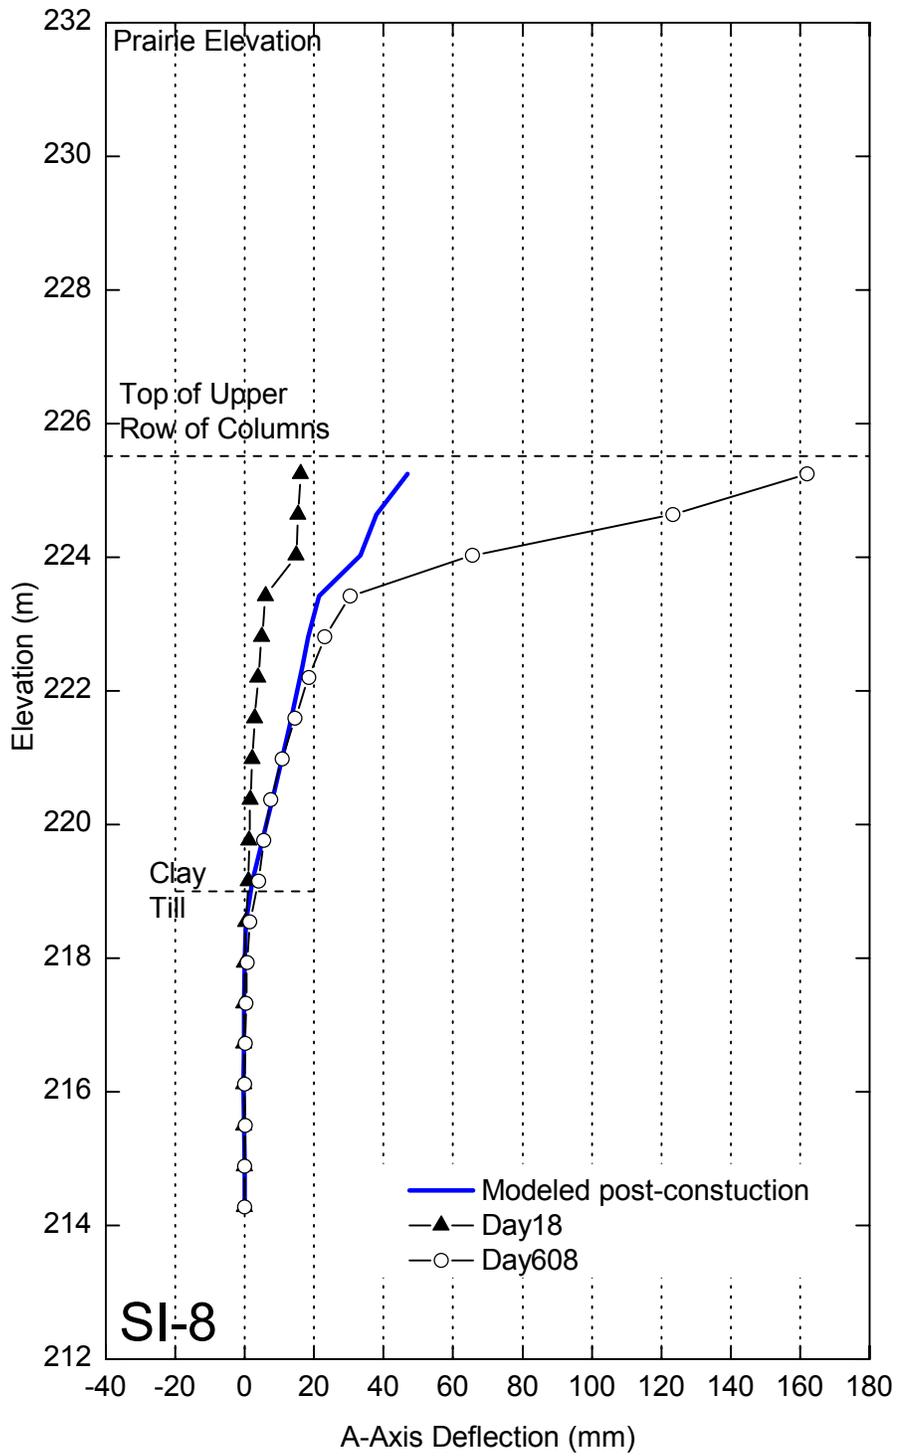
Figure 7.31 Post-test displacements from the research site, both measured and modeled.

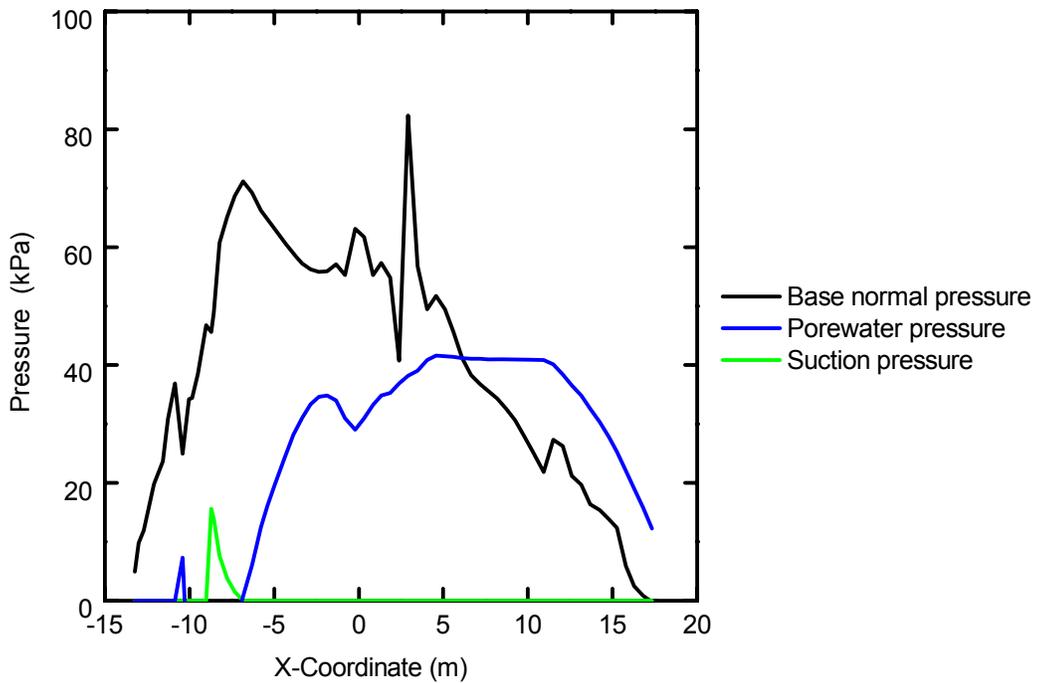
Figure 7.35. Distribution of normal, porewater and suction pressures along slip surface 1719 (day 9)

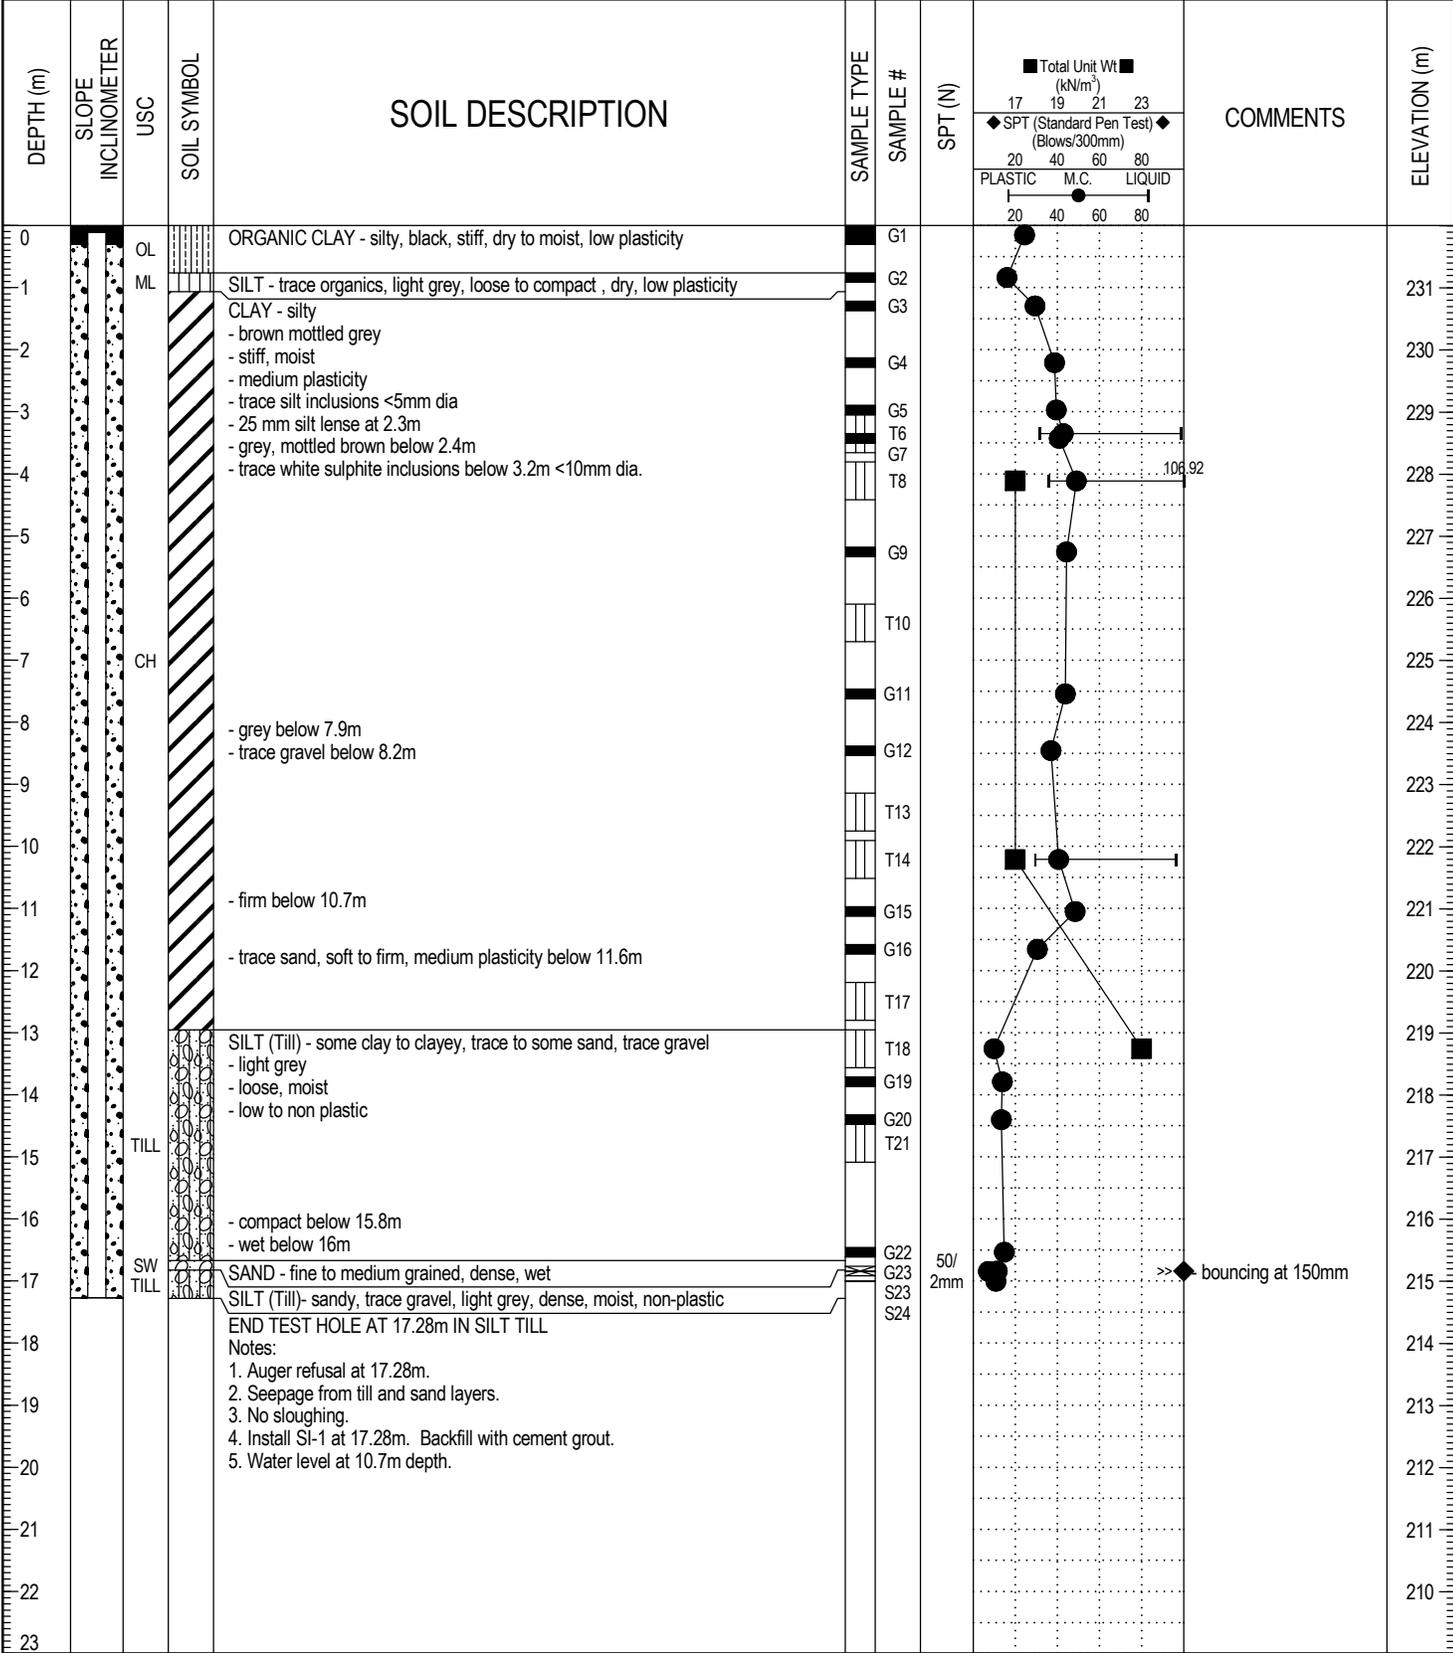
LOG OF TESTHOLE KENDALL'S LOGS.GPJ UMA.GDT 9/8/10

PROJECT: Rockfill Column Test Site	CLIENT: University of Manitoba	TESTHOLE NO: TH-1				
LOCATION: Top of Bank N 5,520,043.6 E 635,005.0		PROJECT NO.:				
CONTRACTOR: Paddock Drilling Ltd.	METHOD: 125mm dia. Solid Stem Auger	ELEVATION (m): 232.006				
SAMPLE TYPE	GRAB	SHELBY TUBE	SPLIT SPOON	BULK	NO RECOVERY	CORE
BACKFILL TYPE	BENTONITE	GRAVEL	SLOUGH	GROUT	CUTTINGS	SAND

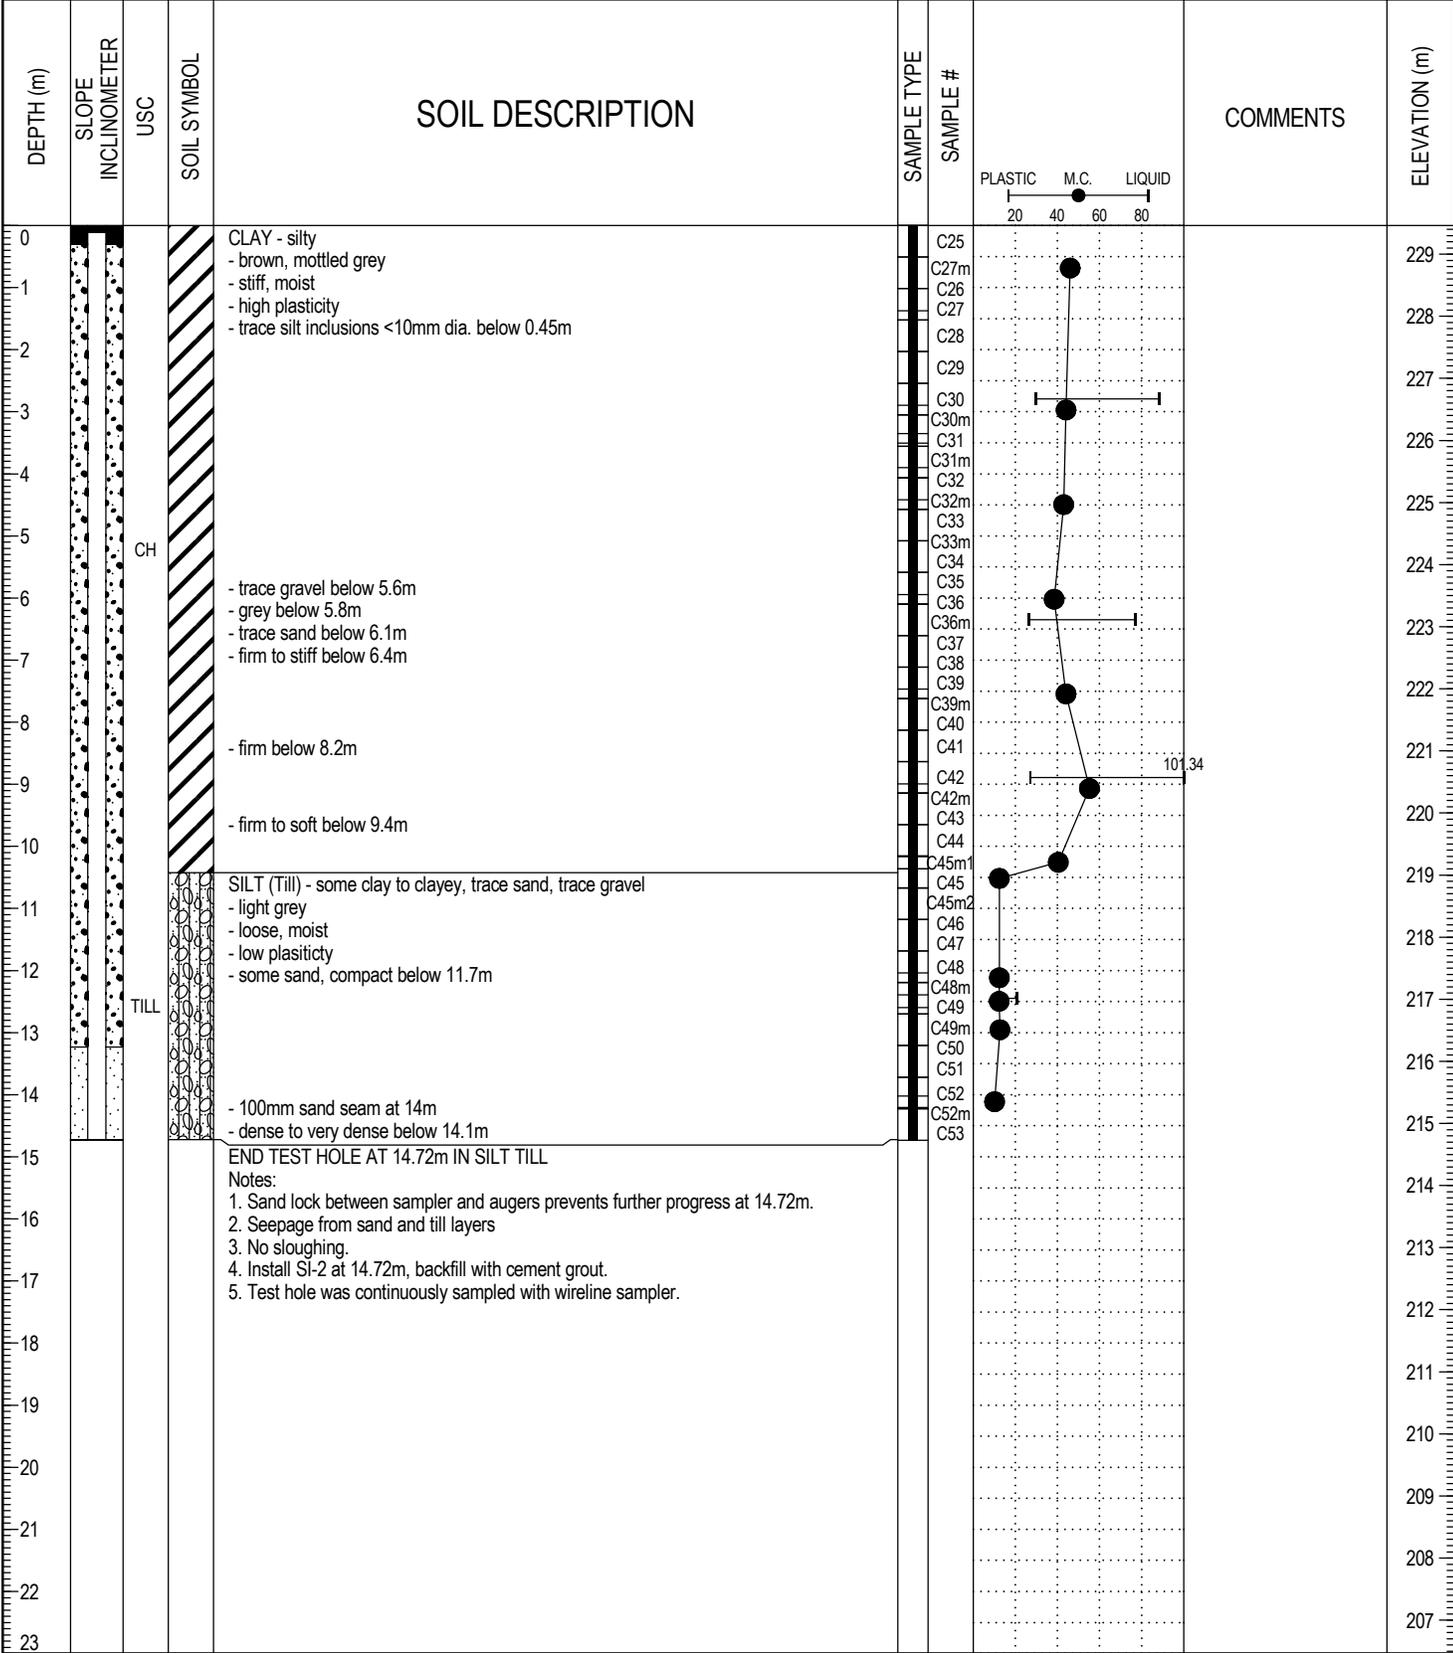
LOG OF TESTHOLE KENDALL'S LOGS.GPJ UMA.GDT 9/8/10

PROJECT: Rockfill Column Test Site		CLIENT: University of Manitoba		TESTHOLE NO: TH-2		
LOCATION: Below Crest N 5,520,038.1 E 635,006.7				PROJECT NO.:		
CONTRACTOR: Paddock Drilling Ltd.			METHOD: 125mm dia. Solid Stem Auger		ELEVATION (m): 229.462	
SAMPLE TYPE	GRAB	SHELBY TUBE	SPLIT SPOON	BULK	NO RECOVERY	CORE
BACKFILL TYPE	BENTONITE	GRAVEL	SLOUGH	GROUT	CUTTINGS	SAND
