AN H.V.D.C. INSTABILITY AT  
A.C. SYSTEM FREQUENCY

A REPORT PRESENTED TO  
THE DEPARTMENT OF ELECTRICAL ENGINEERING  
UNIVERSITY OF MANITOBA

by  
D. T. Y. TANG

The h.v.d.c. link of Manitoba Nelson River project had experienced this form of instability. The following report describes and examines this phenomenon, based on the experience of Manitoba Nelson River Project; and attempts to relate this phenomenon with those reported in the papers (1, 2, 3).

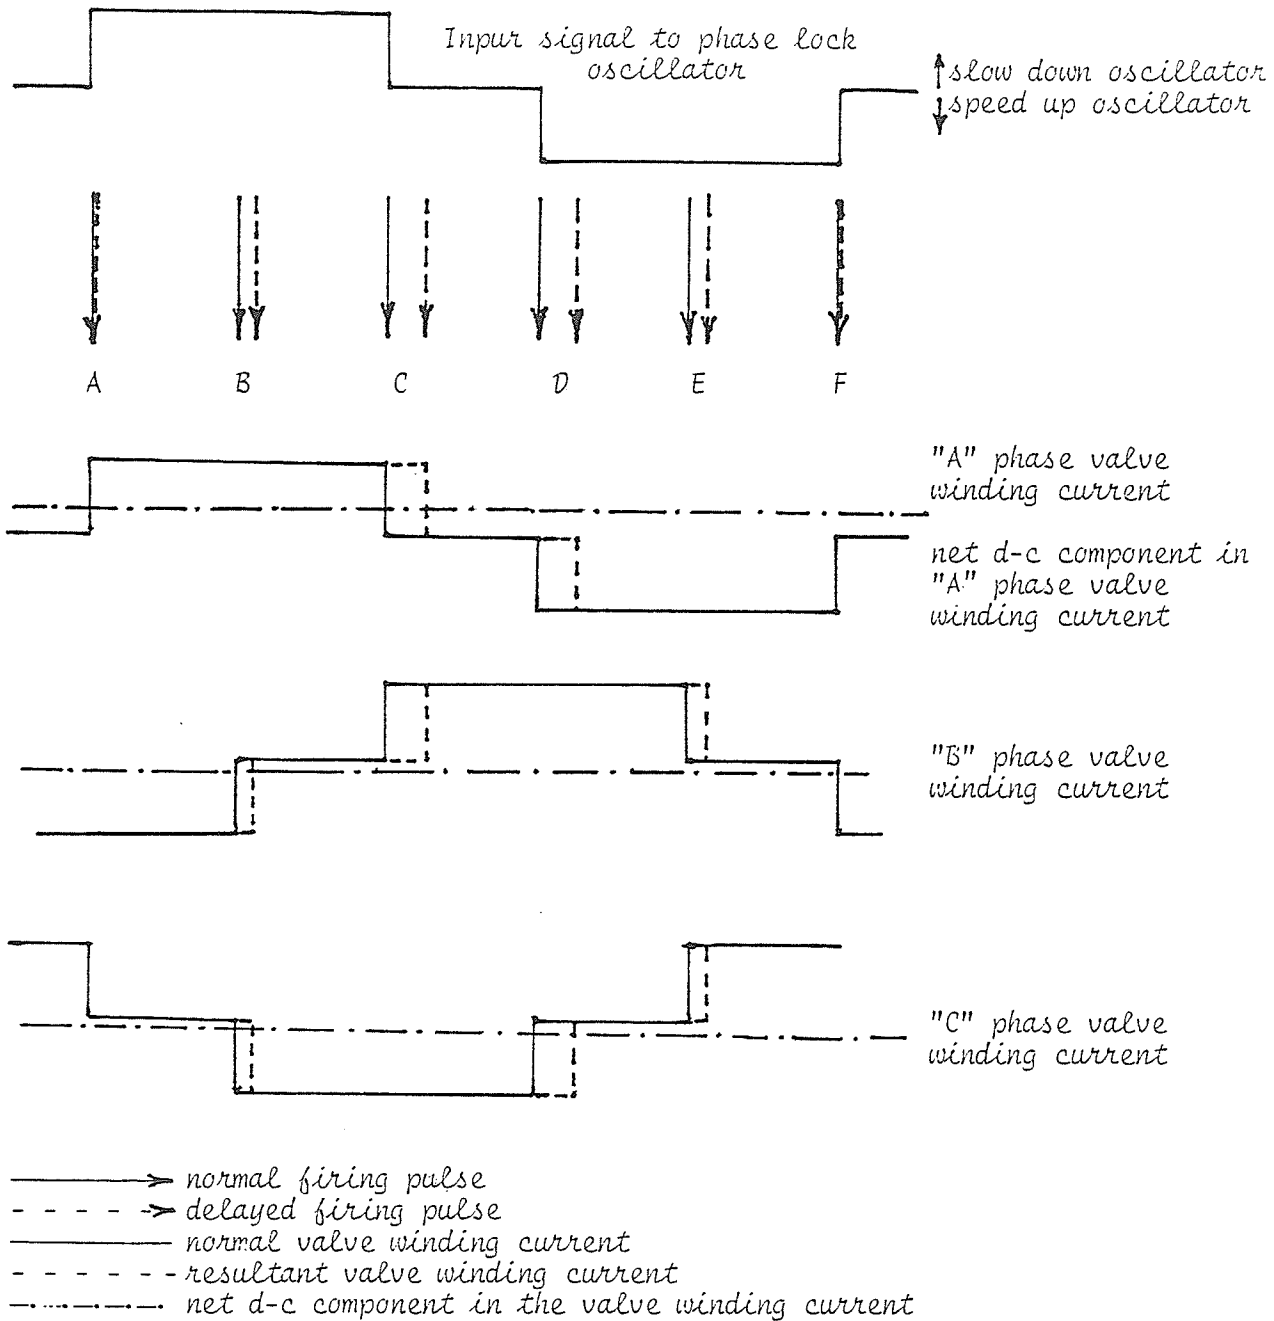
Fig.6 The d-c component in the valve winding current as the result of injection of our ac voltage signal into the phase lock oscillator.

Figure 6 illustrates an injection of an a.c. signal proportional to 'A' phase valve winding current, into the auxiliary input of the phase lock loop; and the resultant d.c. component in the valve winding current.

The positive cycle of this phase has a net reduction of  $1X$  degree (see figure 6). The negative cycle has an increase of  $1X$  degrees. The d.c. component for this phase is proportional to  $2X$  degrees negatively.

In core saturation instability, the saturation of the convertor transformer is induced by uneven firing. The mechanics of the uneven firing are similar to the action of the flux controller, as shown in Figure 6. The degree of core saturation is proportional to the severity of the uneven firing. The main cause of this uneven firing in the case of BPI is the  $di/dt$  feedback which is over ten times (twelve times when  $di/dt = .3$  and twenty times when  $di/dt = .5$ ) the normal current feedback for any oscillation. Therefore, increasing  $di/dt$  signaled more uneven firing and thus more transformer saturation; which in turn meant that the likelihood of achieving core saturation instability was correspondingly higher.

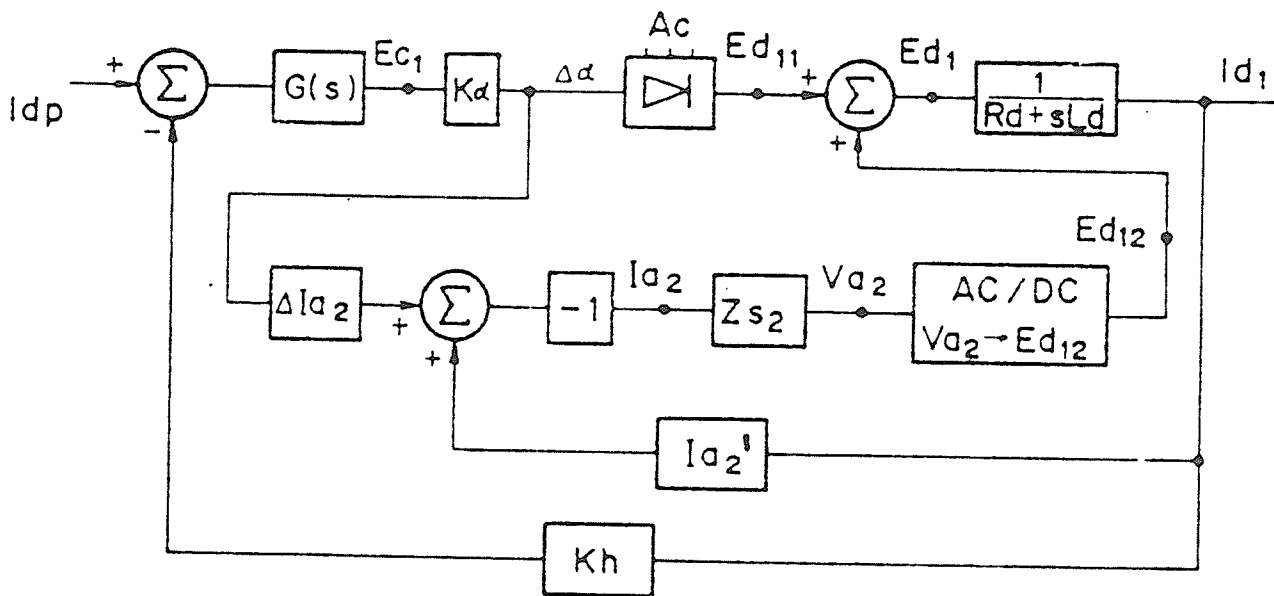
Fig.8 Detail non-linear model

Figure 8 is the detailed block of the model. It contained the standard d.c. control loop with additional frequency conversion due to rectification; that is, second harmonic voltage on the a.c. side converts into fundamental component on the d.c. side while the fundamental component of the d.c. current converts into the second harmonics on the a.c. side. The contribution of second harmonics caused by core saturation was not included.

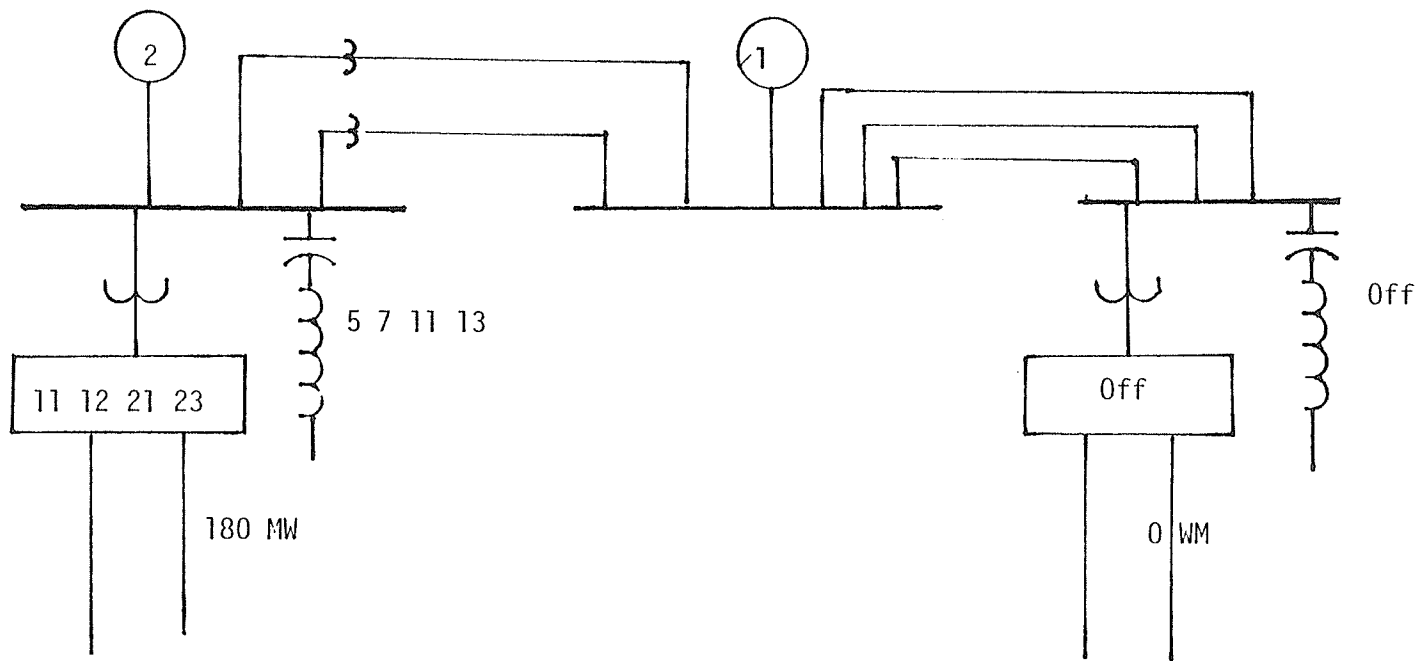
Fig.9 System Configuration July 30, 1980 2:13

The configuration of the northern collector system prior to the disturbance is shown in Fig. 9. The transient fault recording is included in Appendix E.

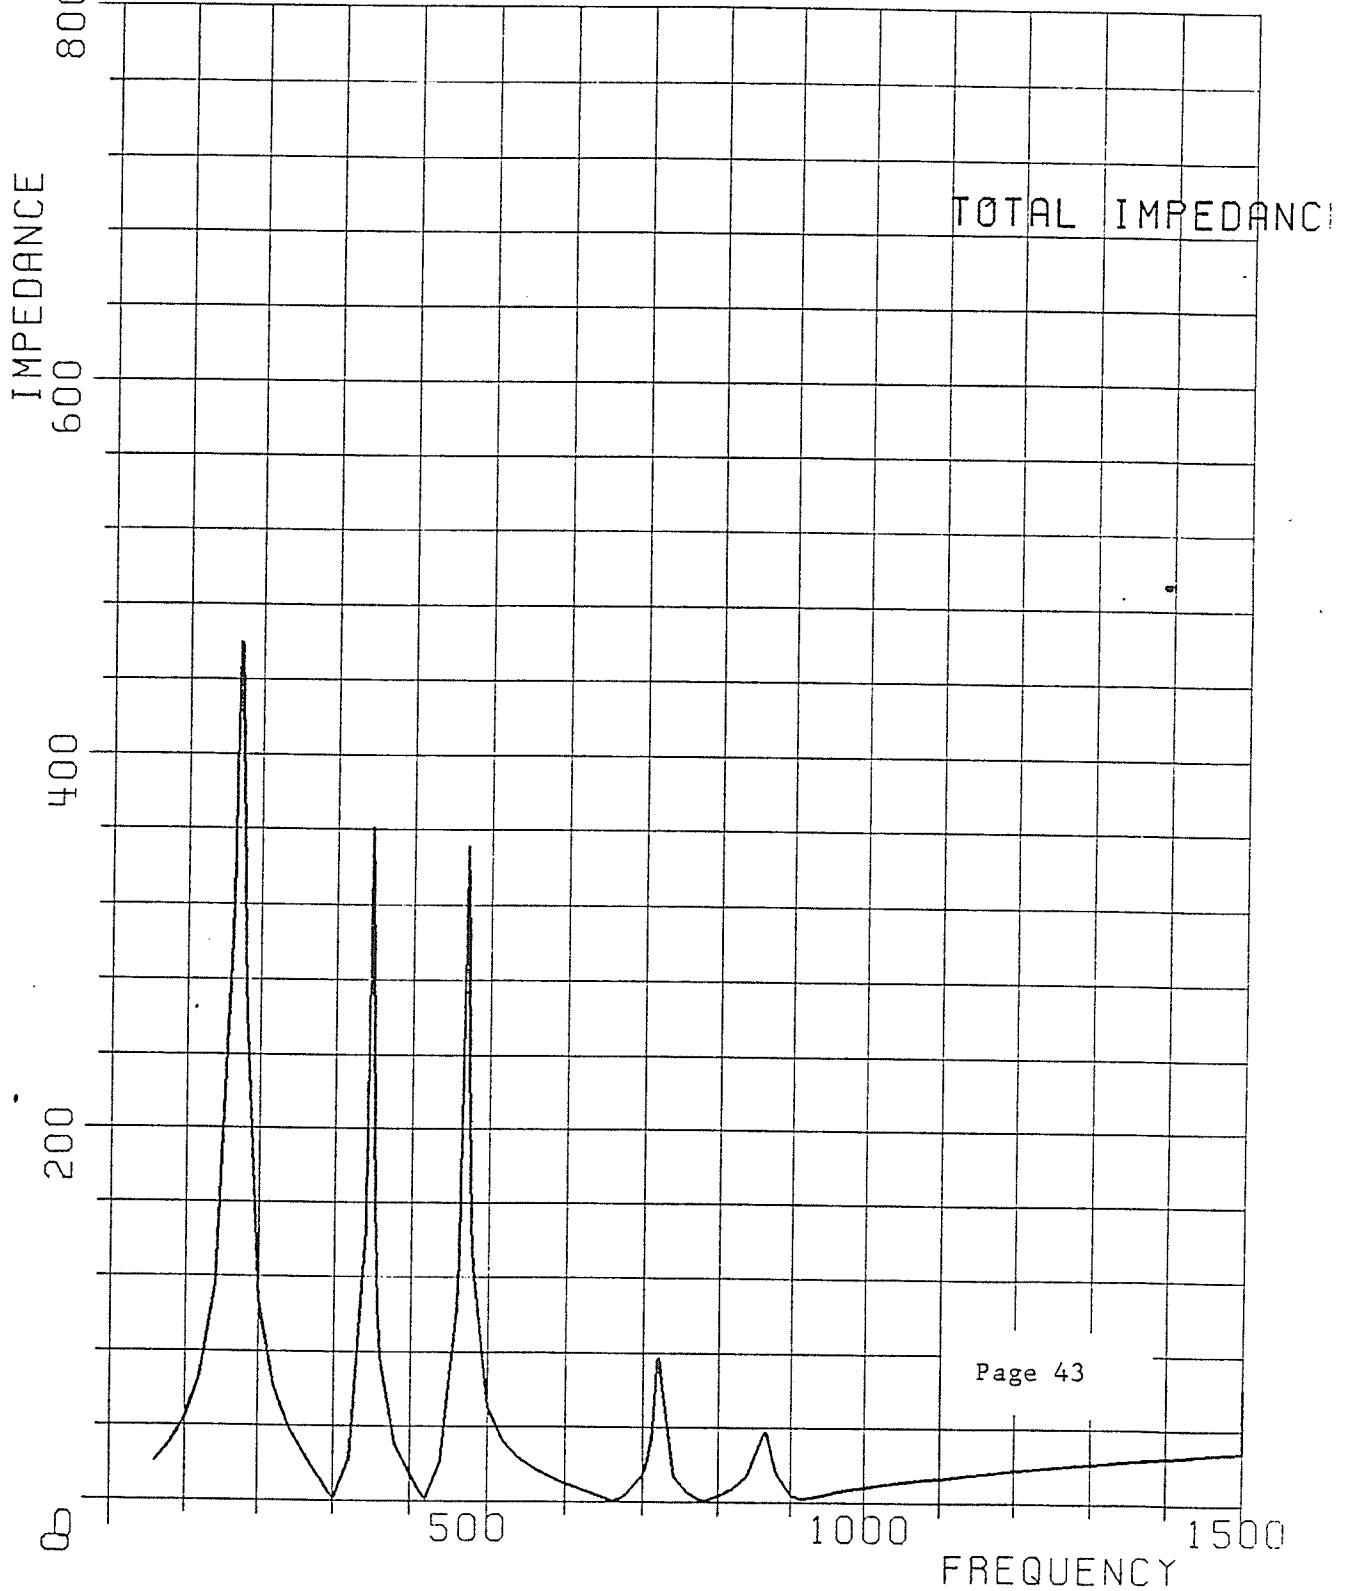
Fig.11 System impedance profile for July 30,80 disturbance after LS unit tripped

IMPEDANCE AT RADISSON STATION:  
2 -KETTLE UNITS, 0 -LONG SPRUCE UNITS  
2 -RADISSON - LONG SPRUCE LINES,  
3 -LONG SPRUCE - HENDAY LINES  
FILTERS AT RADISSON - 5 7 11 13  
FILTERS AT HENDAY - NONE

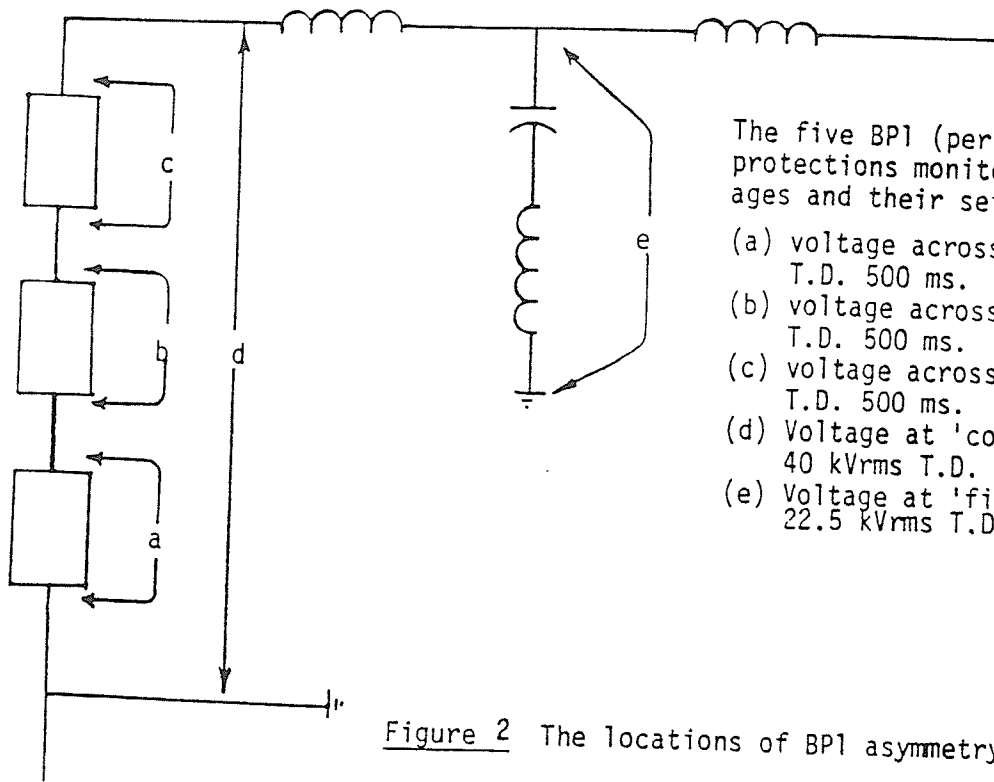
Figure 2 The locations of BPI asymmetry protection monitorings

The existing level settings of the valve group asymmetry protection (30 kVrms) and the convertor side asymmetry protection (40 kVrms) suggest that they are meant for misfire or commutation failure which produces an

- The five BPI (per pole basis) asymmetry protections monitor the following voltages and their settings:
- (a) voltage across VG 1. Set at 30 kVrms T.D. 500 ms.
  - (b) voltage across VG 2. Set at 30 kVrms T.D. 500 ms.
  - (c) voltage across VG 3. Set at 30 kVrms T.D. 500 ms.
  - (d) Voltage at 'convertor side'. Set at 40 kVrms T.D. 2 sec.
  - (e) Voltage at 'filter side'. Set at 22.5 kVrms T.D. 2 sec.

From the above discussion, the range of level setting for d.c. filter asymmetry protection becomes apparant: it has to be higher than 33 kVrms to overlook transformer energization and has to be lower than 60 kVrms to provide backup protection for misfire and commutation failure. A setting of 50 kVrms is thus recommended.

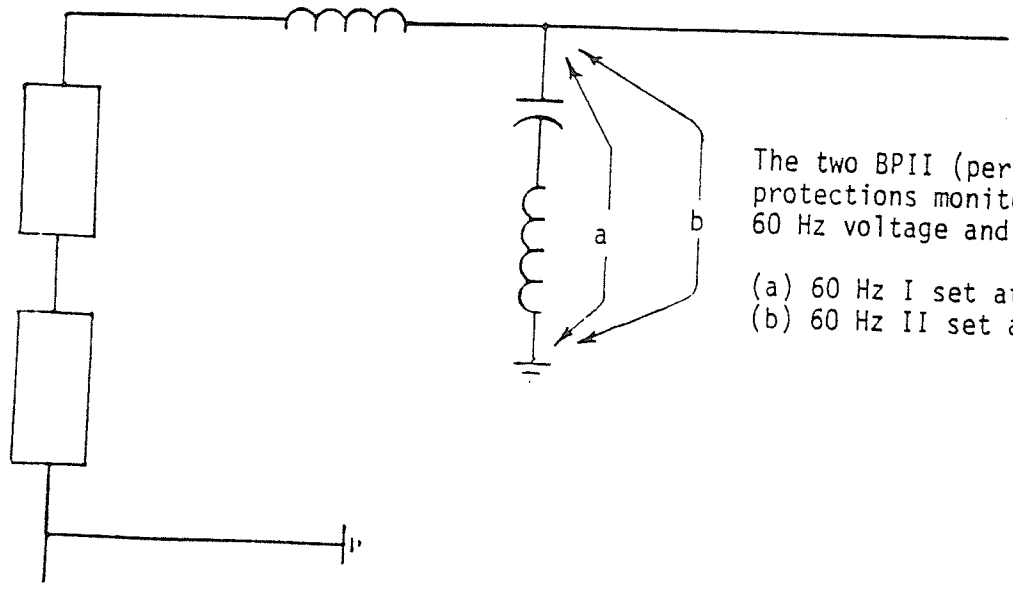
Figure 3 The location of BPII 60 Hz protection monitorings

Bipole II has two asymmetry protections (Fig 3): 60 Hz I and 60 Hz II. They are similar to Bipole I asymmetry protections. The 60 Hz I is set at 40 kVrms for 200 ms. and the 60 Hz II is set at 80 kVrms for 25 ms. Their functions are for protection against persistent commutation failure, misfire, and for similar faults in the remote station during telecom failure. Since very little has been documented about the purpose of the asymmetry protections on Bipole I, it appears reasonable that BPI is provided with asymmetry protections for the similar reasons as Bipole 2.

- The two BPII (per pole basis) 60 Hz protections monitor the 'filter side' 60 Hz voltage and their settings are:
- (a) 60 Hz I set at 40 kVrms 150 ms
  - (b) 60 Hz II set at 80 kVrms 25 ms

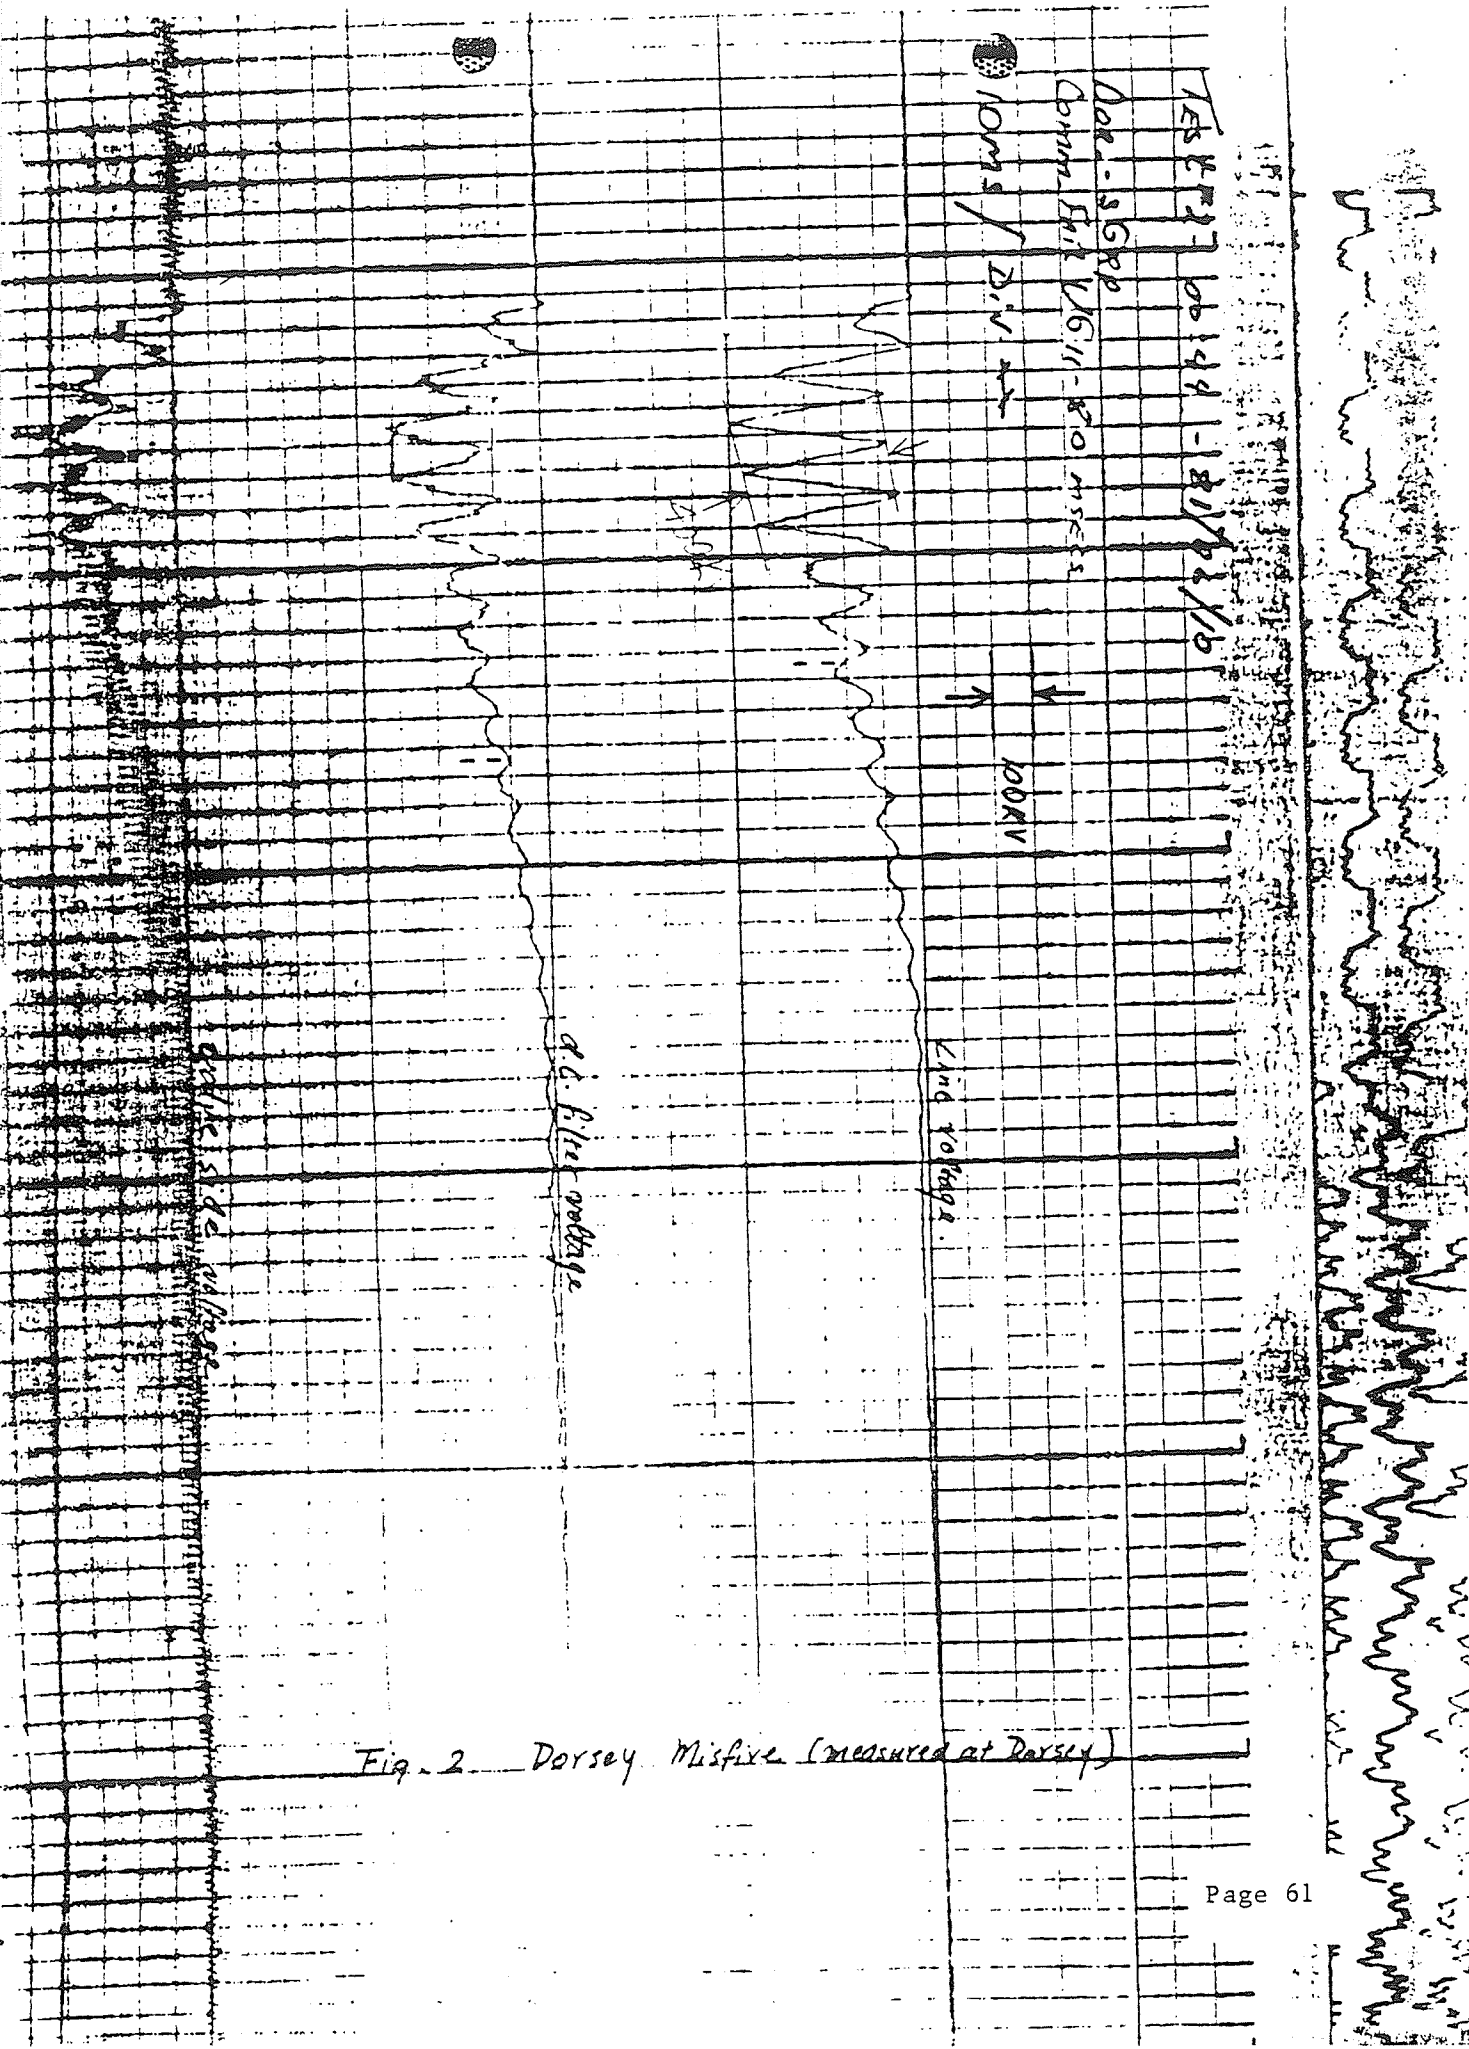
Fig. 2 Dorsey Misfire (measured at Dorsey)

Misfire was initiated by blocking firing pulses to a valve in VG11 for 80 to 100 ms. Both stations, Dorsey and Radisson initiated their own set of misfire in the configurations of three groups, two groups, and one group of pole 1. The voltages at valve side, d.c. filter and line side were monitored and recorded. (Sample test results are as attached Fig. 1 and Fig. 2)

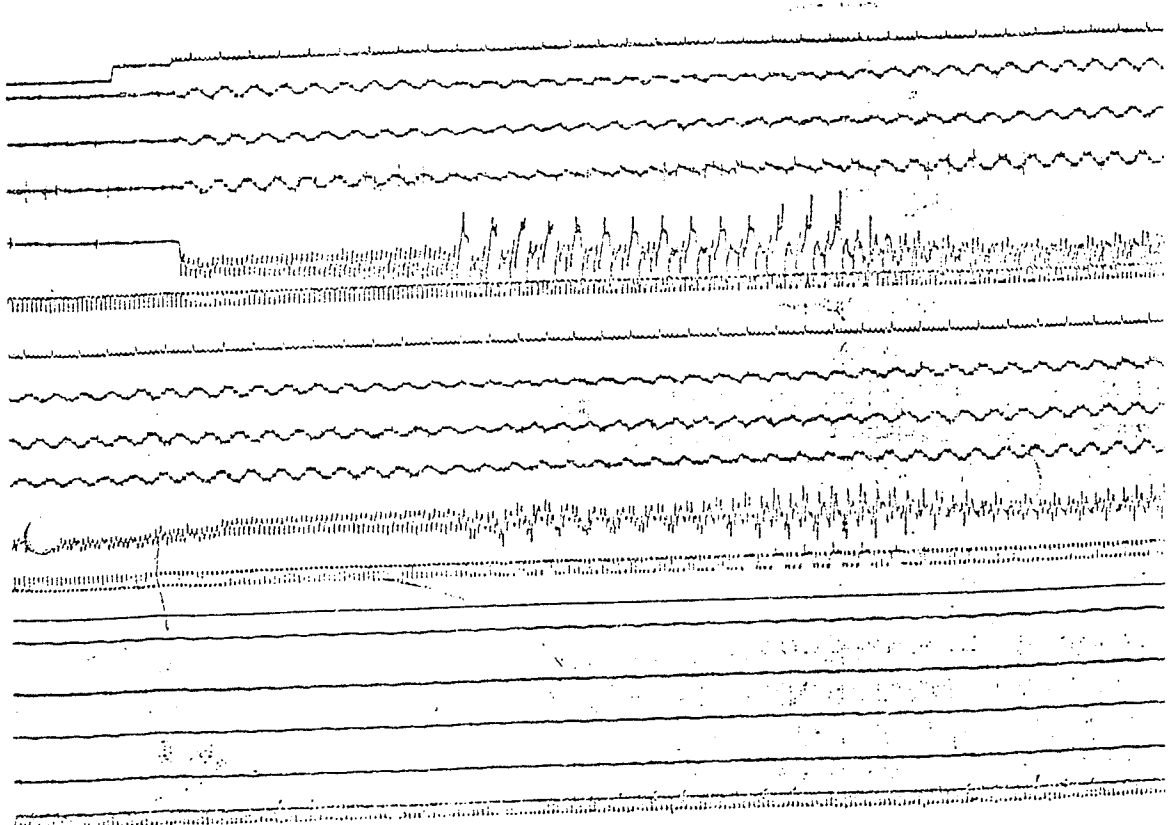
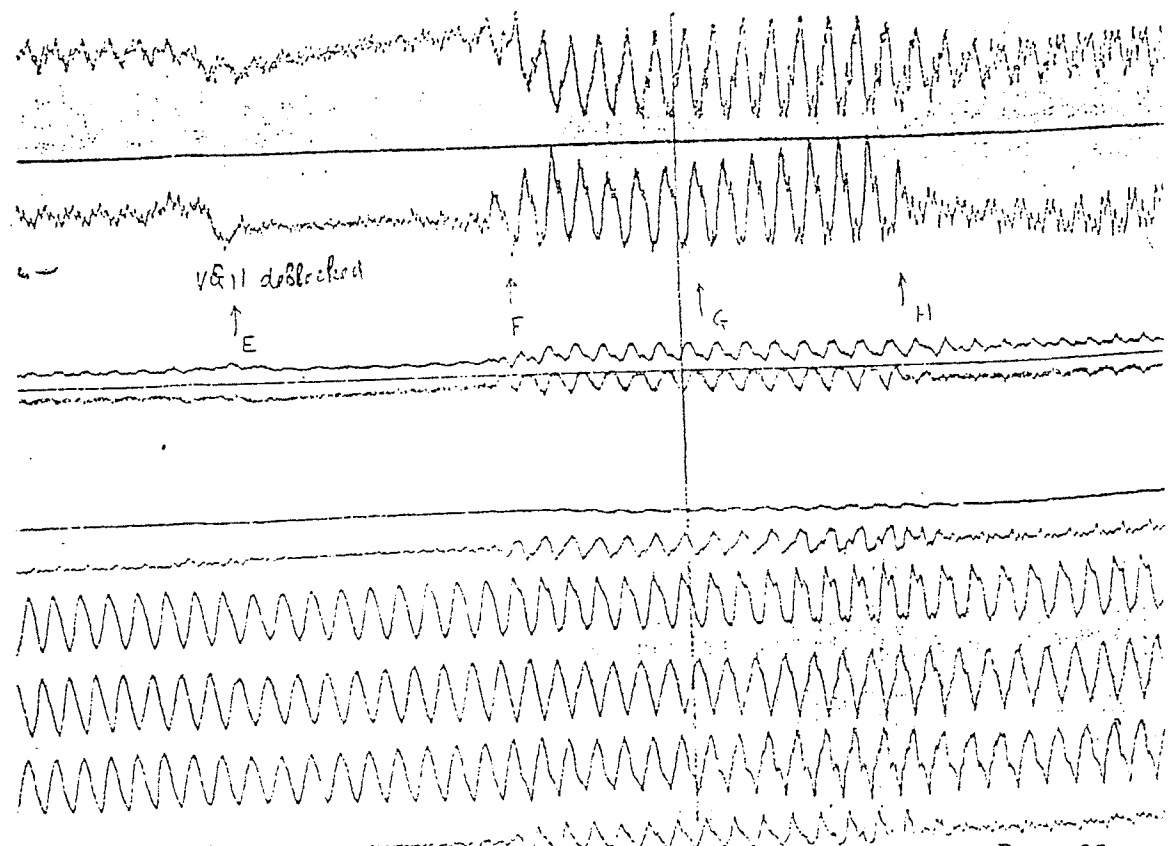
:13      POLE 1. - RADISSON

↑ Long Spruce  
unit tripped

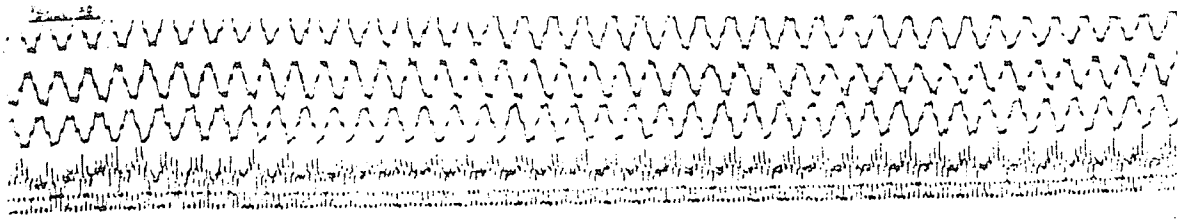
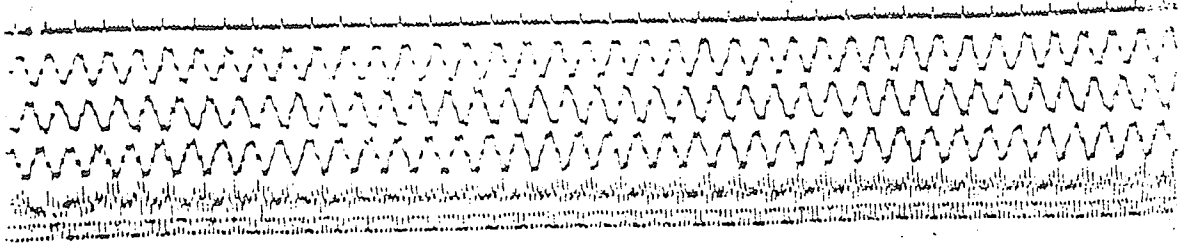
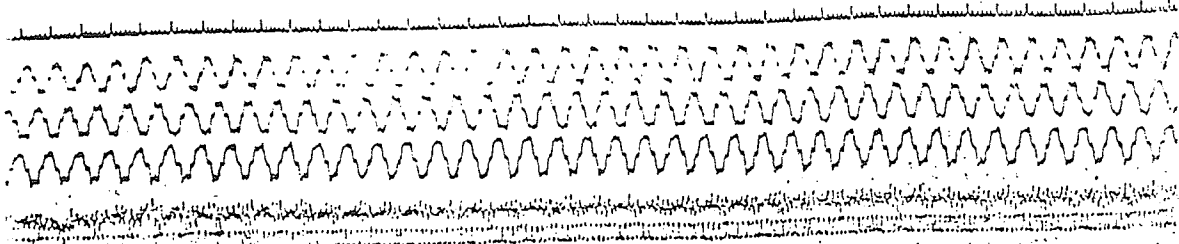
↑ pole 1 blocked by  
asymmetry protection

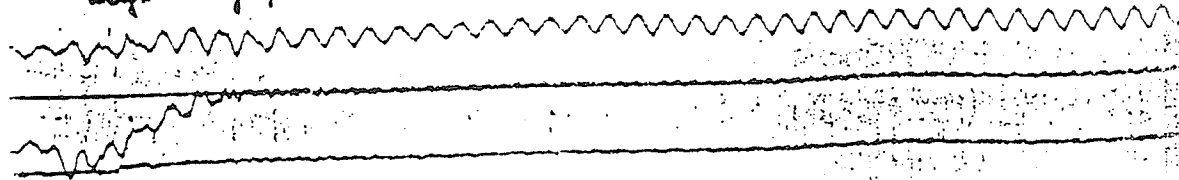
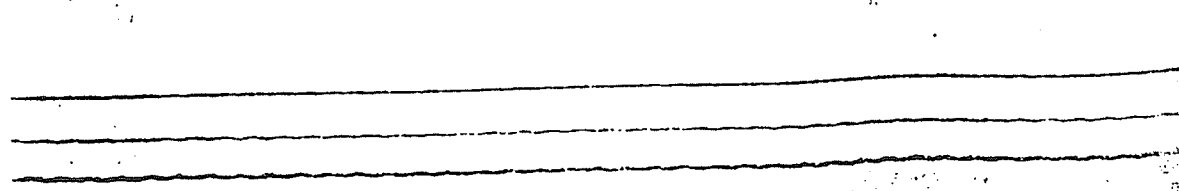
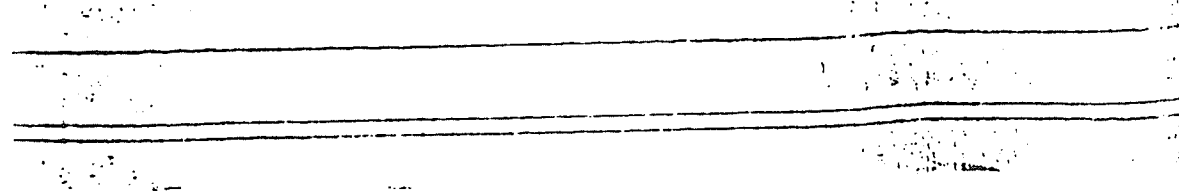
↑ Pole 2 blocked by asymmetry protection
