THE ANALYSIS OF FRACTURED Ti-6Al-4V MODULAR REVISION HIP STEMS WITH THE USE OF RADIOGRAPHIC ASSESSMENT, FINITE ELEMENT ANALYSIS, AND MECHANICAL TESTING

Department of Mechanical and Manufacturing Engineering

University of Manitoba

Five failed retrieved modular Ti-6Al-4V hip stems were examined to determine causes of failure. Investigation included microscopic and macroscopic analysis, finite element analysis, and mechanical testing of the modular hip implant. Method of failure was found to be fatigue, with crack initiation occurring on the lateral side of the modular junction. Bony ingrowth across the modular junction and on the proximal body was not present on both medial and lateral sides. Finite element analysis confirmed that the highest point of stress was where the crack was initiating, its magnitude, and that by utilizing a medial bone support, overall stresses on the modular implant decreased significantly. Tensile and hardness tests of the stem material produced results that were consistent with standard values. Fatigue results followed typical S-N curves and indicated that failure in vivo should have occurred after 10 million cycles. Implant assembly involves pulling th

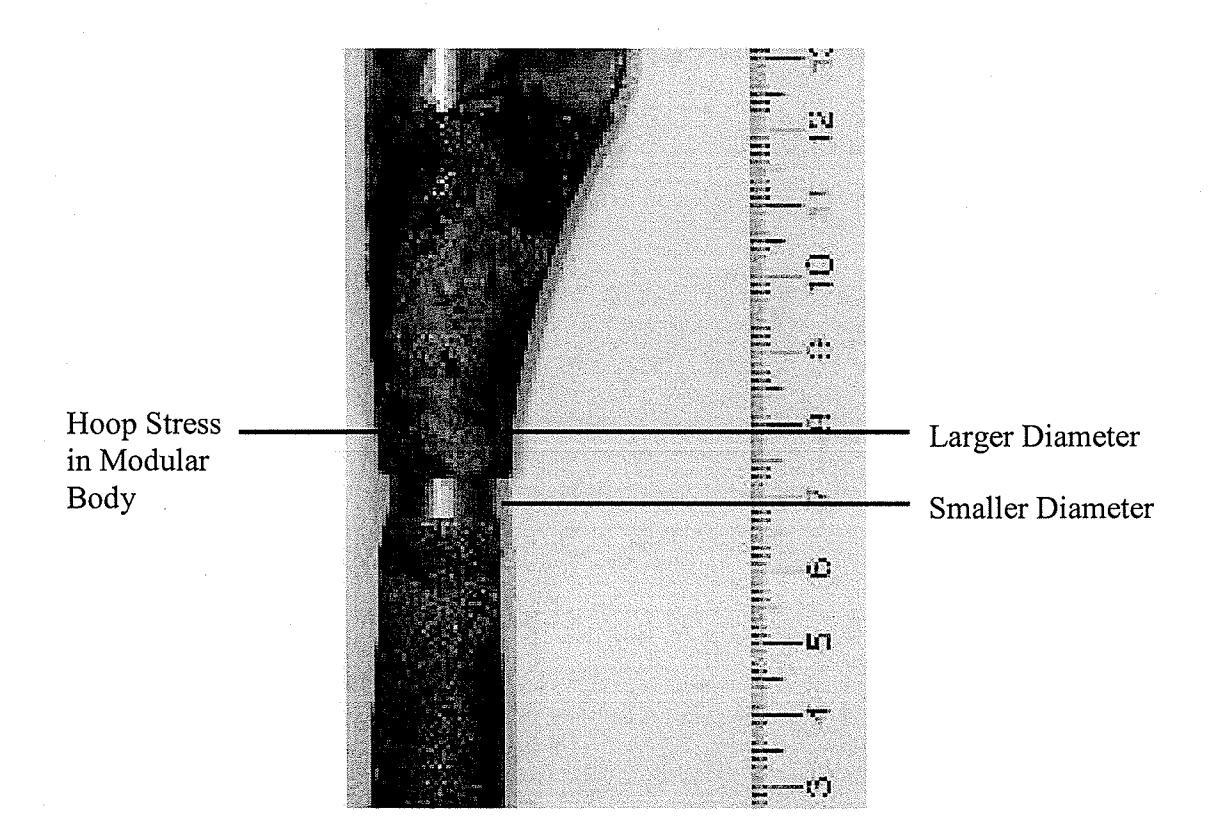
FIGURE 7: CLOSE-UP OF THE MODULAR JUNCTION

First, Figure 7 shows the modular junction of the stem and the body. The diameter of the stem by itself is smaller than the diameter of the body with the upper part of the stem inside of it. This creates a stress riser at the junction since the part goes from a

24
larger diameter to a smaller diameter, with a sharp corner separating the two. Second, when the stem is pulled up into the body component and then tightened, high compressive forces are introduced all around the stem inside the body of the implant (i.e. hoop stress). This hoop stress tends to introduce a circular notch on the modular stem. The combination of a stress riser due to section change and the presence of a notch possibly introduced by the circumferential stress of the implant body dictate that if the hip implant fractures, the break would likely occur at the modular junction.

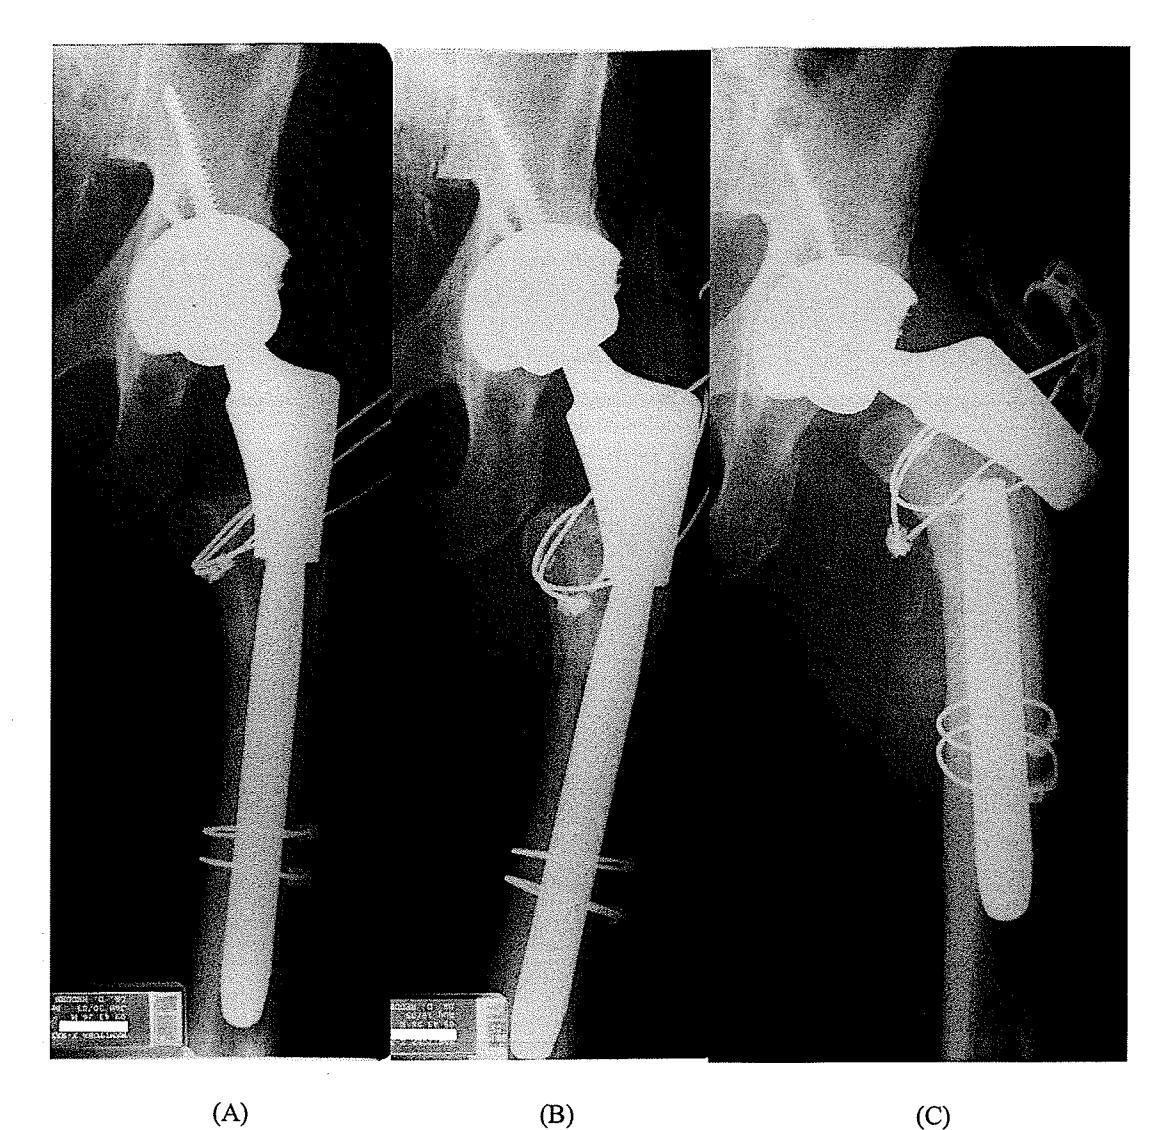
FIGURE 8: PROGRESSION OF MODULAR IMPLANT FAILURE, (A) 9.5 MONTHS IN VIVO, (B) 40 MONTHS IN VIVO, (C) 40.5 MONTHS IN VIVO

Figure 8 shows the progression to failure of the same modular implant implanted in the body. Figure 8(A) shows the modular hip system after being implant for only 9.5 months. It can be seen that the axis along the stem and the body components is straight. However, in Figure 8(B), the axis along these components is starting to bend. This would indicate crack initiation has already occurred. Figure 8(C) shows the same implant less than two weeks later, where the proximal end is completely separated from the distal end. Over the course of approximately one year, the UMJRG at Concordia Hospital in Winnipeg, Manitoba, Canada collected five failed modular hip implants. These implants fractured at the same modular junction on the implant. Since it is still commonly used, the failure of the modular hip implant requires examination to better understand the causes of failure and to investigate ways to mitigate the clinical risk. Failed implants, such as those being investigated here, play a significant role in the study of prostheses, their performance in vivo, and for advances in orthopaedic technology, which can lead to safer and more reliable joint replacement for patients.

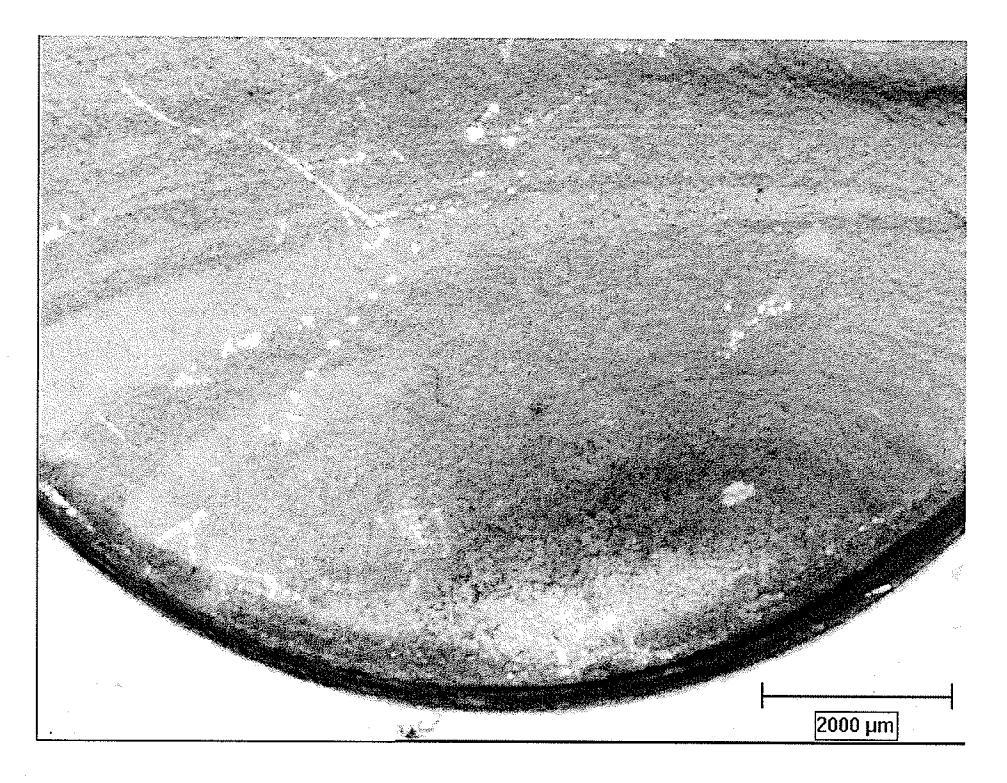
Figure 25 shows the slow fatigue zone and the rapid fracture zone for implant #4. Crack initiation occurs towards the bottom of the section. Unlike the other implants examined to this point, implant #4 shows a very small slow fatigue zone in comparison to implants #1, #2, and #3. Therefore, it is clear that rapid crack propagation and stem fracture occurred soon after crack initiation in the stem. This is somewhat unusual since a large rapid fracture area is typical of high loads. However, Table 6 shows that this implant was taken from the lightest person in the study (\approx 72 kg). Due to the rapid failure of the implant, this also means that corrosion in the crevice from extracellular fluid did not attack the slow fatigue zone for as long as the other implants that were examined. Since this area was not corroded as heavily, the slow fatigue zone is not significantly darker in appearance than the rapid fracture zone. Therefore, the transition zone between the slow fatigue area and the rapid fracture area is difficult to see. Beachmarks are evident and their curvature clearly indicates that crack initiation occurred on the lateral side of the stem, which is located at the bottom of Figure 25. Minor damage can be seen due to the mating fracture surface.

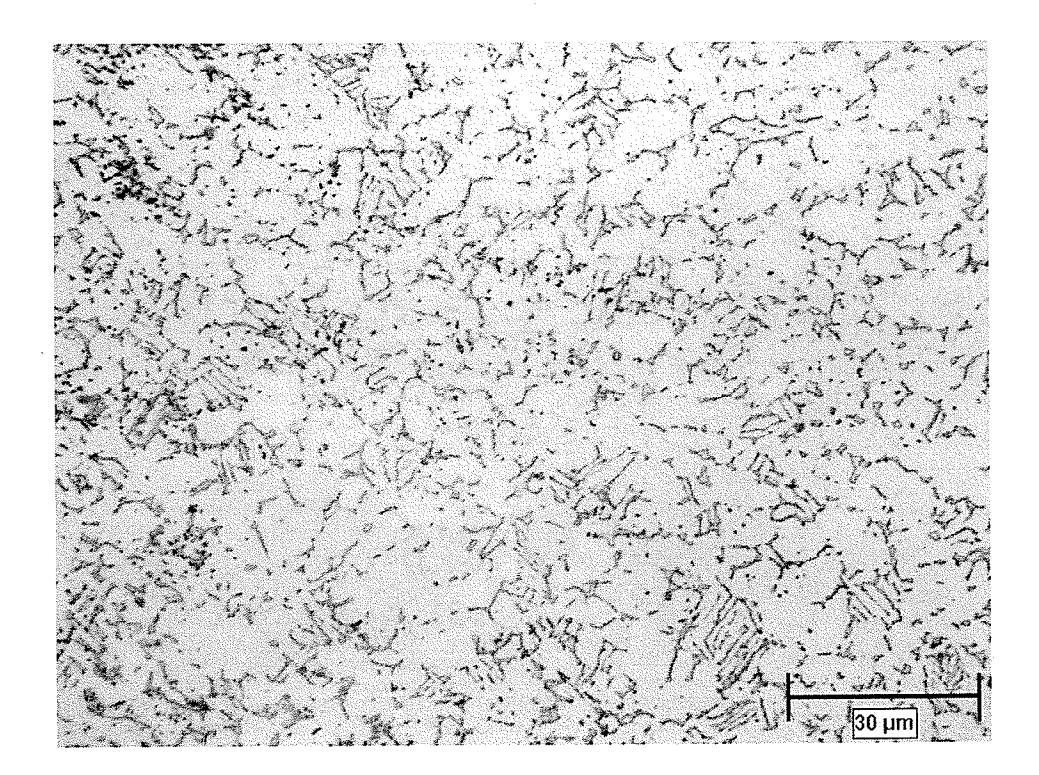
FIGURE 29: CROSS-SECTION SAMPLE OF TI-6AL-4V STEM FROM IMPLANT #3, MOUNTED, POLISHED, AND ETCHED TAKEN AT 1000X

Figure 29 shows a cross-section sample in the transverse plane of the stem from implant #3 that has been mounted, polished, and etched. This sample was etched until there was some bubbling on the surface when immersed in the etching solution, which was approximately 5-10 seconds. This image is representative of all five implants that are being examined in this study. Grain boundaries are mostly visible in Figure 29. Any additional etching to make grain boundaries more visible only caused over-etching to occur. This is a typical microstructure for Ti-6A1-4V alloy and there are no apparent defects or impurities [24].

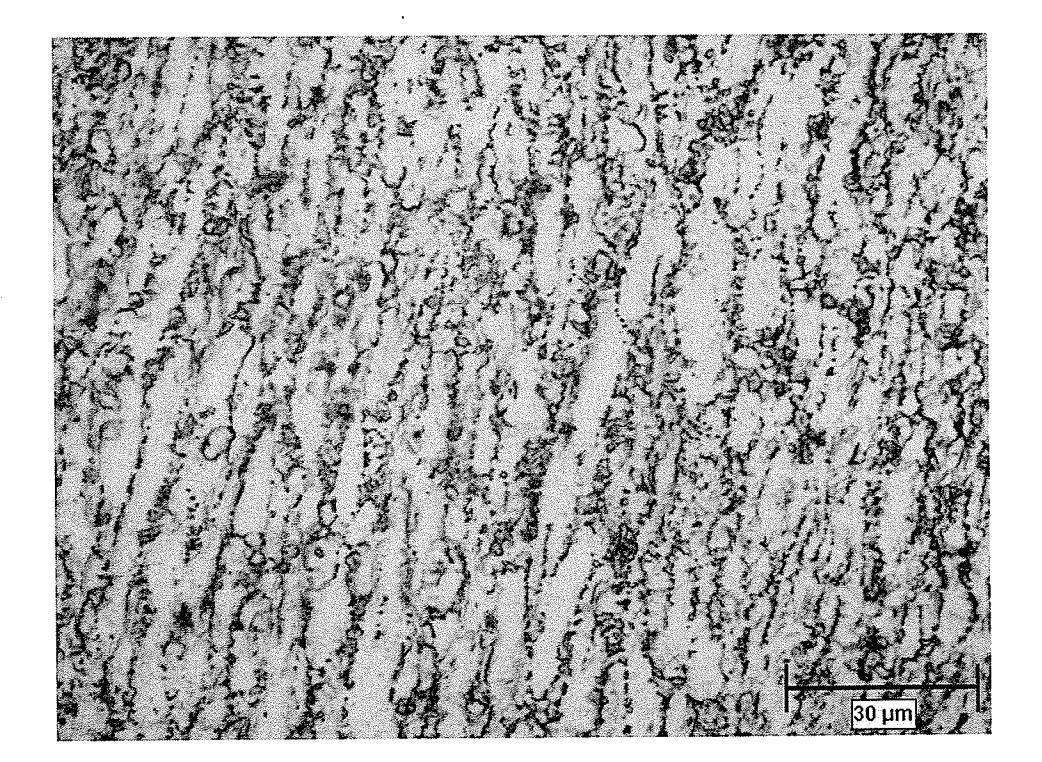
FIGURE 30: AXIAL CROSS-SECTION SAMPLE OF TI-6AL-4V STEM FROM IMPLANT #2, MOUNTED, POLISHED, AND ETCHED TAKEN AT 1000X

Figure 30 shows a vertical cross-section sample in the axial plane of the stem from implant #2 that has been mounted, polished, and etched. This sample was also etched until there was some bubbling on the surface when immersed in the etching solution, which was approximately 5-10 seconds. It can be seen that on a 90° plane difference from Figure 29, the grains appear stretched. These elongated grains mean that the Ti-6Al-4V material was cold-worked in the stem manufacturing process and simply indicate directionality of rolling. In Figure 30, the lighter matrix is α -phase and the darker particles are β -phase. This is also a typical microstructure for Ti-6Al-4V alloys [24].

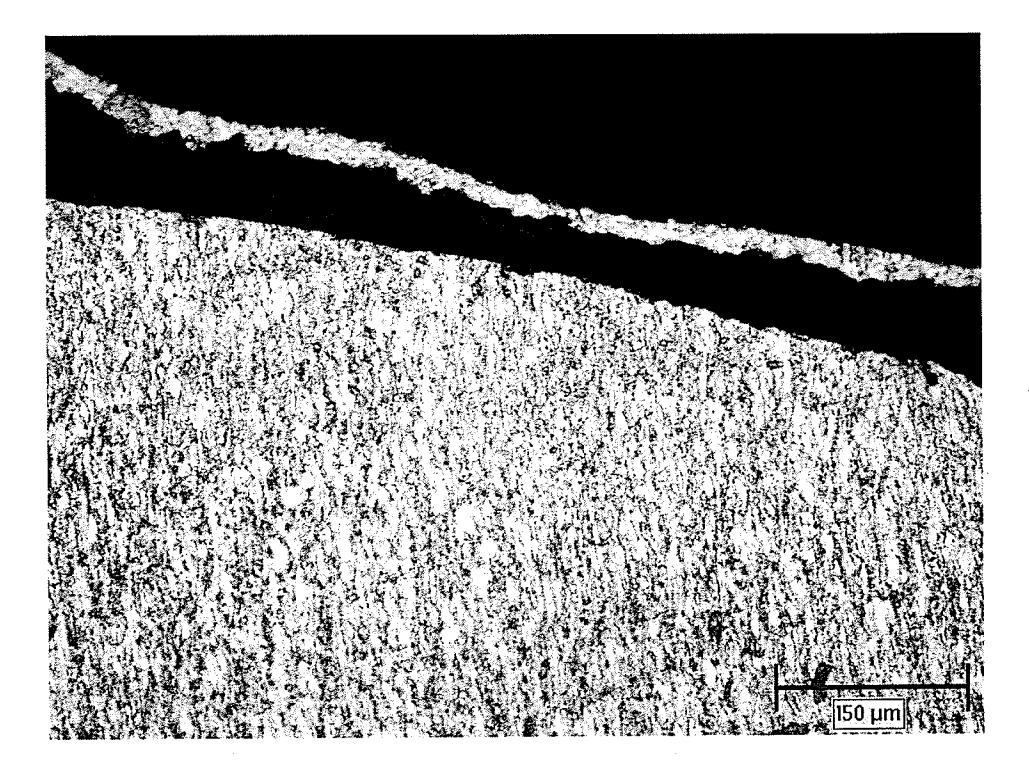
FIGURE 31: AXIAL CROSS-SECTION SAMPLE OF TI-6AL-4V STEM FROM IMPLANT #2, MOUNTED, POLISHED, AND ETCHED TAKEN AT 200X, FRACTURE SURFACE IS ALONG THE TOP OF THE SECTION

Figure 31 shows a vertical cross-section sample in the axial plane of the stem from implant #2 that has been mounted, polished, and etched for approximately 5-10 seconds. It can be seen that there is a thin layer above the stem sample. This appears to be the layer of unknown material that was seen before in the optical microscope pictures. During the high temperature and high pressure of the mounting process in Bakelite, the layer seems to have separated from the fracture surface. This layer was analyzed under the SEM and the rest of the sample was broken out of the Bakelite with the intent to view the fracture surface without the layer.

The sample that was studied in Figure 31 that showed the layer separated from the fracture surface was examined under the SEM. Initially, this layer was thought to be biological. However, when chemical analysis was done only on the layer, the peaks that the EDS generated showed mostly titanium, with smaller peaks of aluminum, vanadium, and oxygen. Also, if the layer was biological, the surface would have started to charge

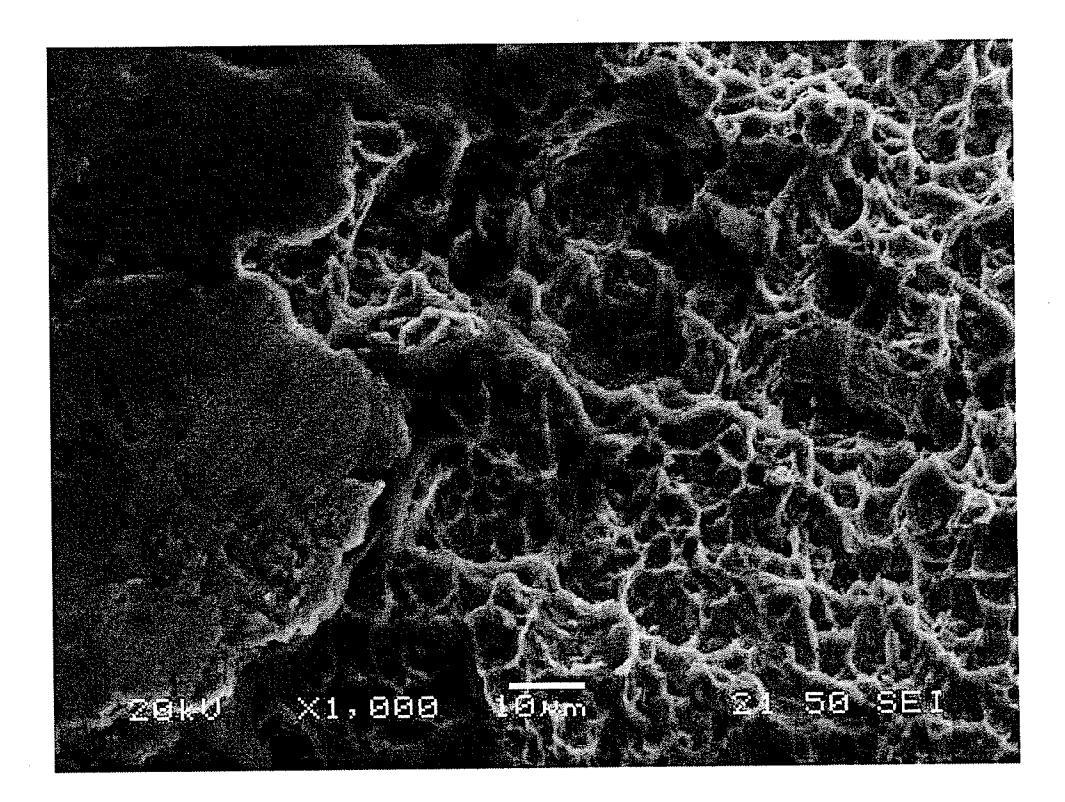
FIGURE 32: SEM IMAGE OF IMPLANT #2, RAPID FRACTURE ZONE TAKEN AT 1000X

Figure 32 shows the rapid fracture zone of implant #2. This image shows that during rapid fracture, the stem broke in a cup-and-cone ductile manner. This was the case for all five fractured implants that were studied. The left side of this image shows a flat smooth area. This is what the damaged area appears to be under a magnification of 1000x. This occurs when the mating proximal fracture surface comes into contact with the distal fracture surface under load, causing flattening of any topography that was created during repeated cycles.

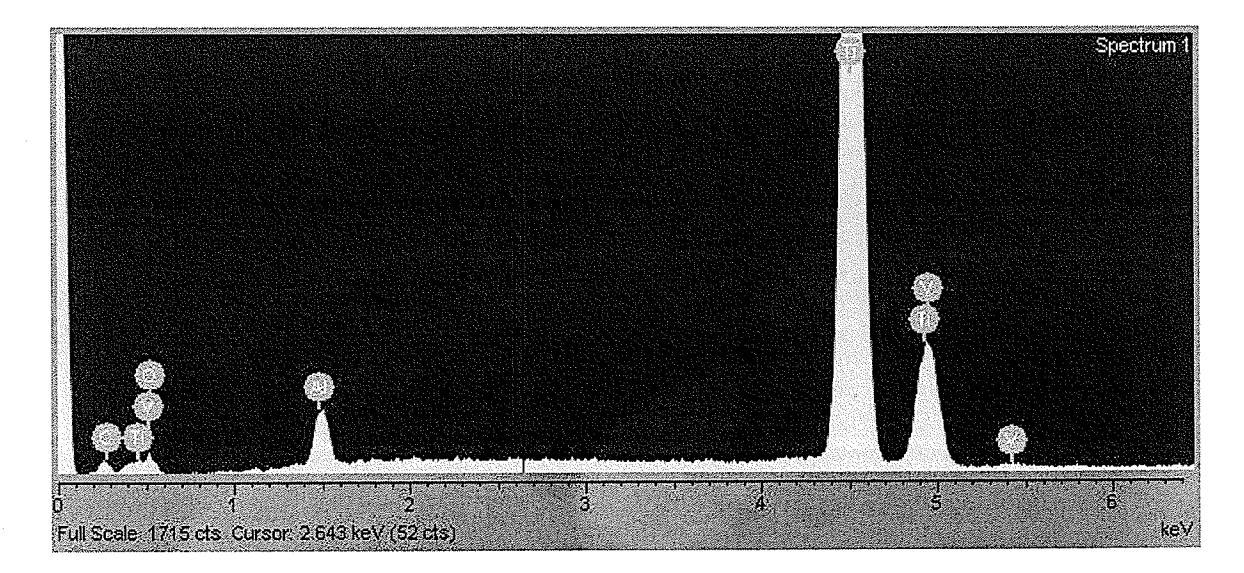
FIGURE 33: CHEMICAL ANALYSIS OF THE FRACTURE SURFACE OF IMPLANT #1 USING EDS ON THE SEM

Figure 33 shows the results of the chemical analysis done on the fracture surface of implant #1 using EDS on the SEM. This analysis confirms the relative presence of titanium, aluminum, and vanadium in the alloy being studied and does not show any presence of impurities. Analysis of all five implants gave very similar spectra. It can be seen that the highest and most prominent peak is titanium, followed by smaller peaks of aluminum and vanadium.

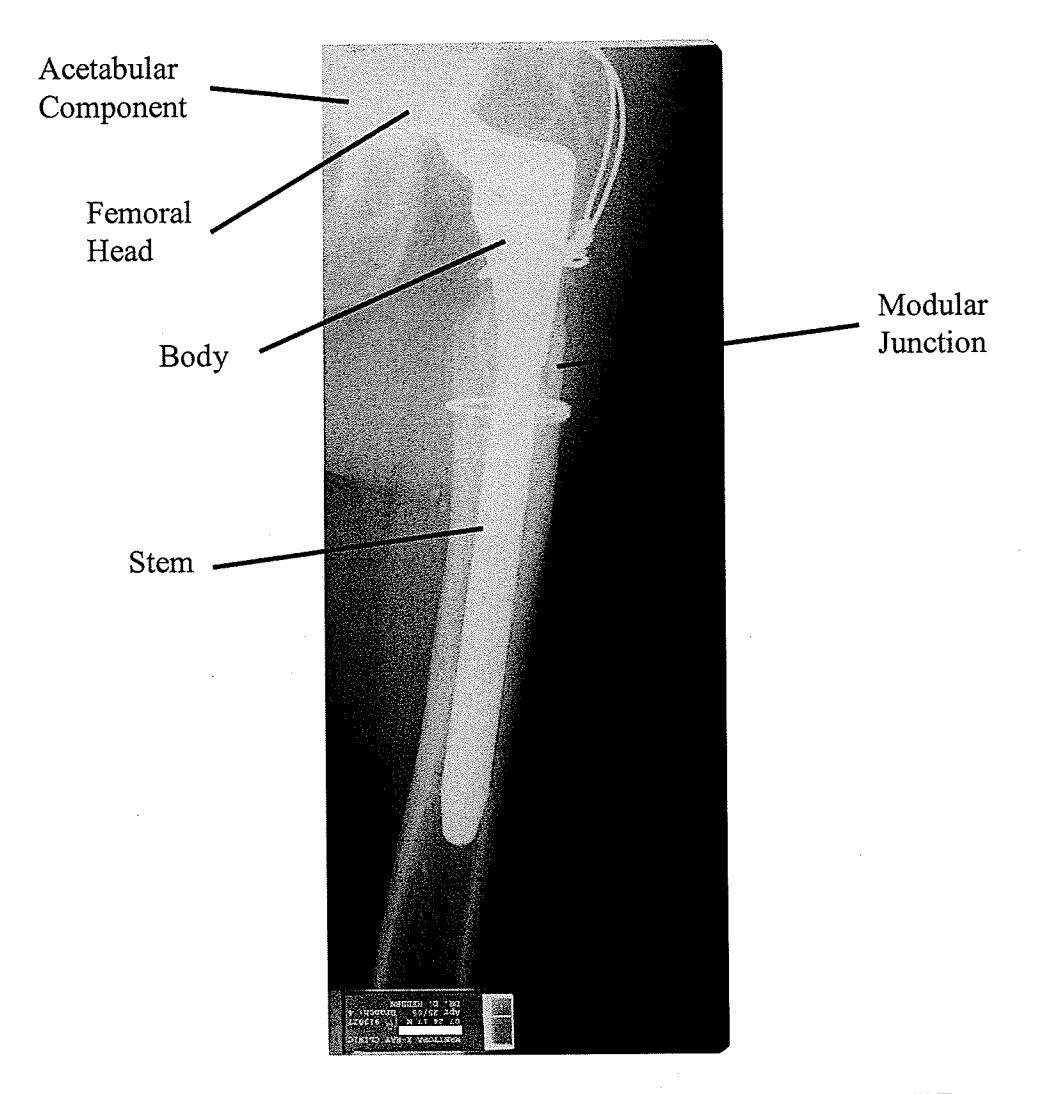
FIGURE 35: RADIOGRAPH OF IMPLANT #1 BEFORE STEM FRACTURE

Figure 35 shows the radiograph of implant #1 prior to implant failure. From this image, it can be seen that the stem is fixated in the femur since there are no reactive lines surrounding the femoral stem. In fact, there was no subsidence when comparing this to the previous radiograph. This confirms stem fixation. A close-up of the medial and lateral bone at the body can be seen in Figure 36.

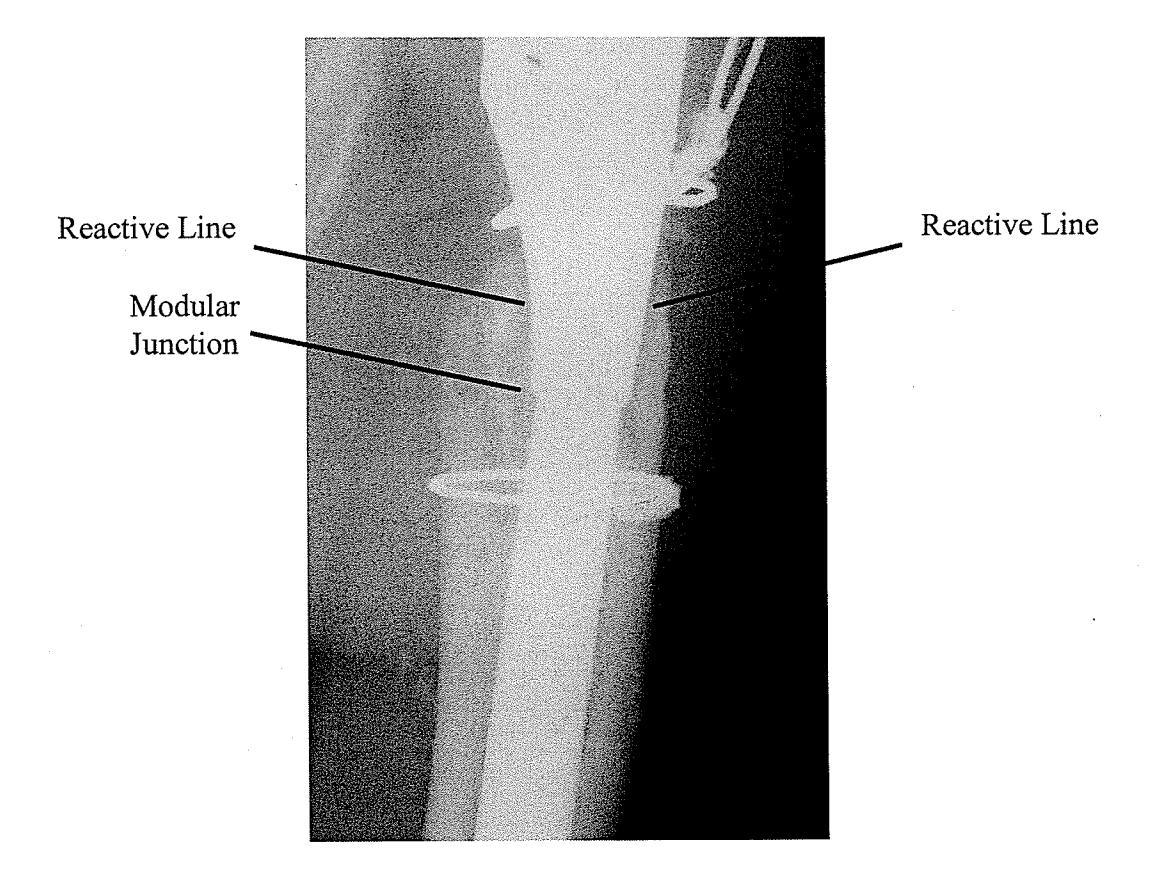
FIGURE 36: CLOSE-UP OF RADIOGRAPH OF IMPLANT #1

By examining the medial bone as shown in Figure 36, it is clear that there is less than 50% present. Although the medial bone is continuous across the modular junction, there does not appear to be medial bone ingrowth at the body. By examining the lateral bone, it is also clear that the femur extends across less than 50% of the body. Similarly, the lateral bone is continuous over the modular junction, but does not appear to be ingrown onto the body. There are no spot welds present.

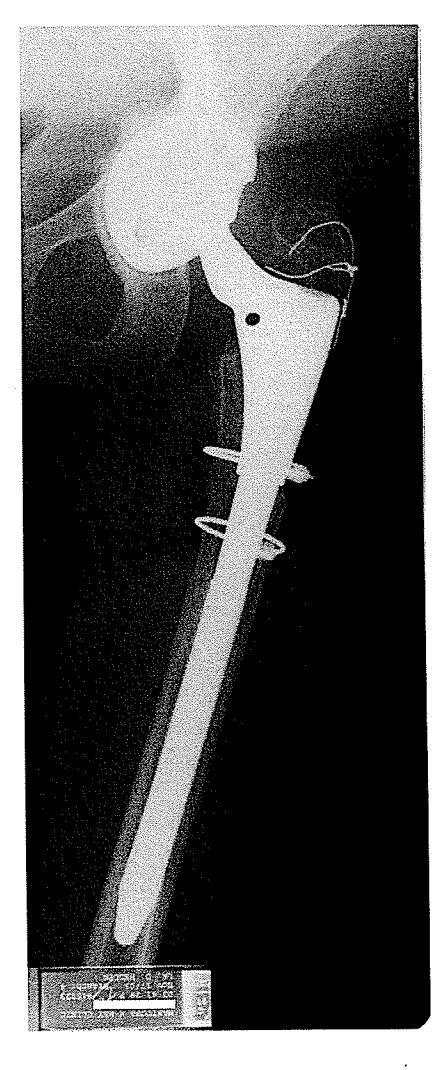
FIGURE 37: RADIOGRAPH OF IMPLANT #2 BEFORE STEM FRACTURE

Figure 37 shows the radiograph of implant #2 prior to implant fracture. From this image, it can be seen that there are no reactive lines along the stem. Therefore, stem fixation has been achieved. A close-up of the medial and lateral bone at the body is shown in Figure 38.

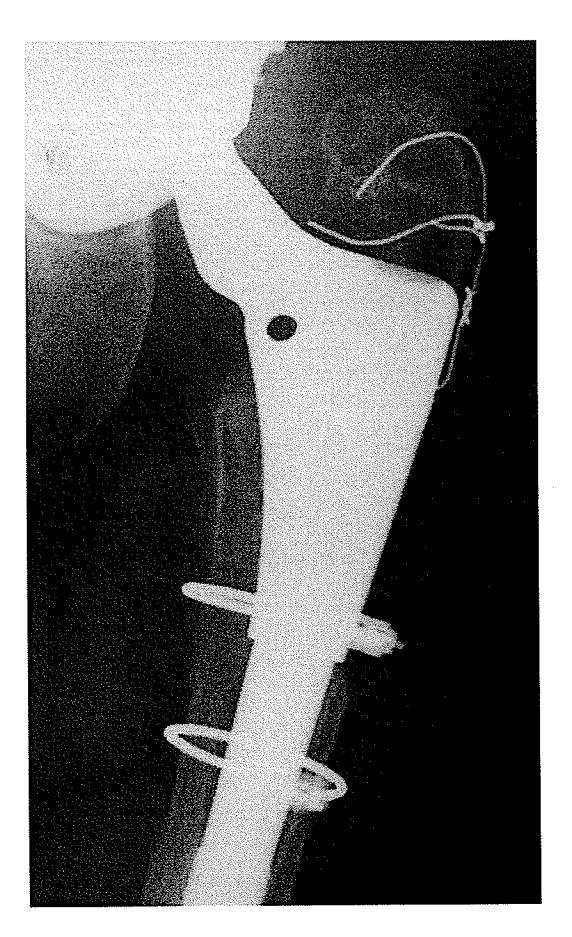
FIGURE 38: CLOSE-UP OF RADIOGRAPH OF IMPLANT #2

By examining Figure 38, it can be seen that there is greater than 50% of medial bone at the body. It can also be seen that the medial bone is continuous across the medial junction and that it is probable that bone has ingrown here. On the other hand, there is close to 0% of lateral bone at the body. Although there is evidence that the greater trochanter is present, there is no lateral bone connecting this to the femoral shaft.

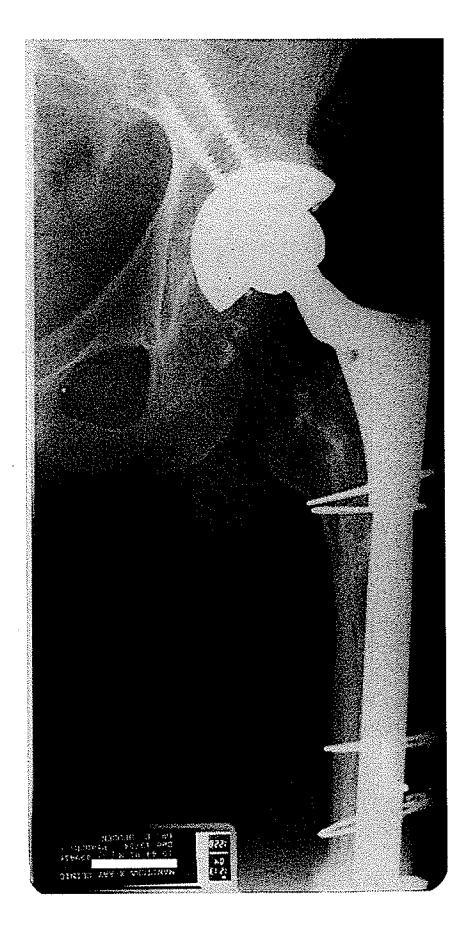
FIGURE 39: RADIOGRAPH OF IMPLANT #3 BEFORE STEM FRACTURE

Figure 39 shows the radiograph of implant #3 prior to implant fracture. This image shows stem fixation with no reaction lines along the canal of the femur. A close-up of the medial and lateral bone at the body can be seen in Figure 40.

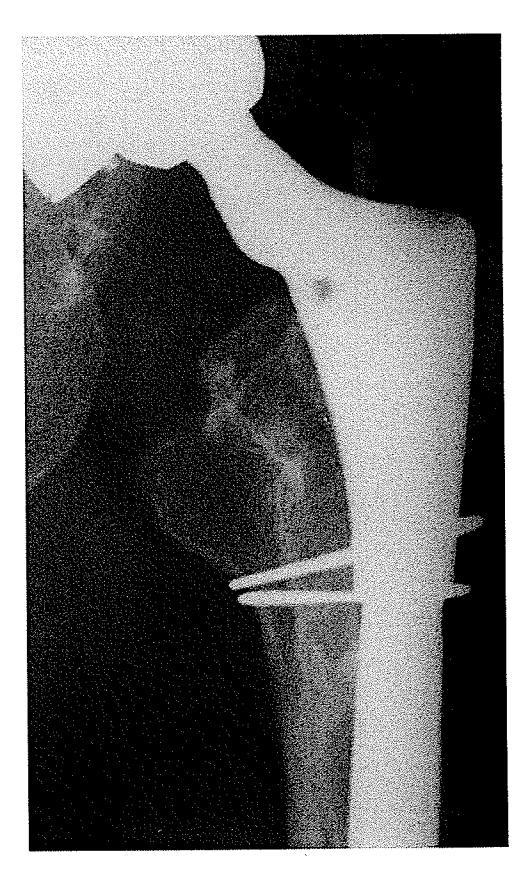
FIGURE 40: CLOSE-UP OF RADIOGRAPH OF IMPLANT #3

Figure 40 shows that there is greater than 50% of medial bone at the body. In fact, it appears as though the medial bone and lesser trochanter are very comparable to a healthy femur. It can also be seen that the medial bone is continuous across the medial junction and that most likely, the bone has ingrown here. There is also greater than 50% of lateral bone at the body. However, the lateral bone is not continuous over the modular junction and is not ingrown into the body.

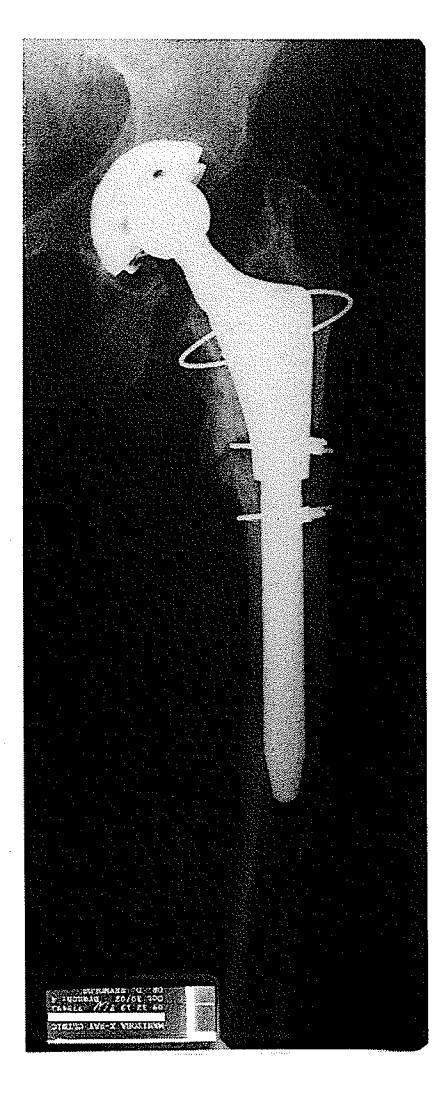
FIGURE 41: RADIOGRAPH OF IMPLANT #4 BEFORE STEM FRACTURE

Figure 41 shows the radiograph of implant #4 prior to implant fracture. From this image, it can be seen that the stem is fixed distally in the femur. There are no reactive lines present around the stem. A close-up of the medial and lateral bone at the body can be seen in Figure 42.

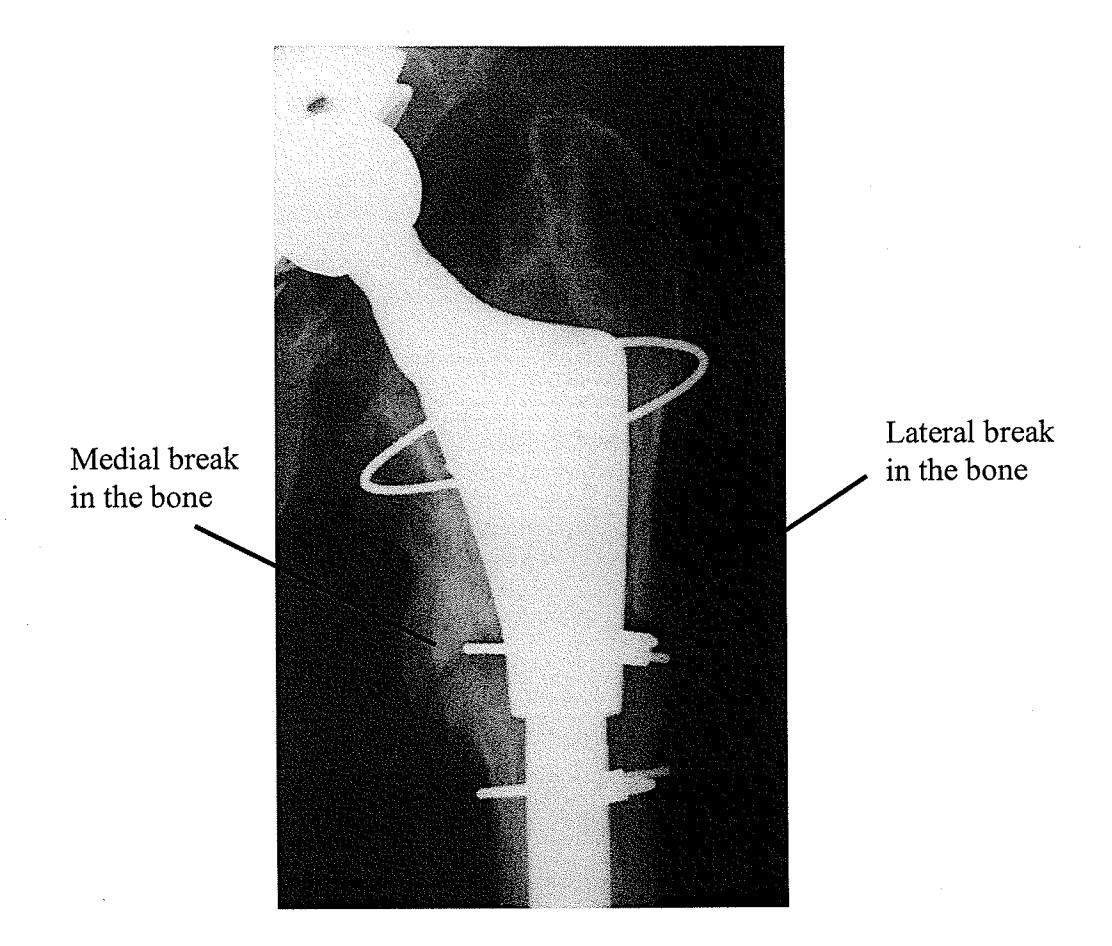
FIGURE 42: CLOSE-UP OF RADIOGRAPH OF IMPLANT #4

Figure 42 shows that there is greater than 50% of medial bone at the body. However, the radiograph shows that the medial bone is not continuous over the modular junction since there is a break in the bone slightly above the modular region. Due to the fact that there is no medial ingrowth, the small portion of the bone that extends slightly over the modular junction is disregarded. The lateral side has greater than 50% of bone present, but experiences the same problem as the medial side in that there is no ingrowth. The lateral bone also contains a break in the bone slightly above the modular region, but since there is no bone ingrowth on the lateral side, the small portion of bone that extends slightly over the modular junction is disregarded. Therefore, it is considered that the lateral bone is not continuous over the modular junction.

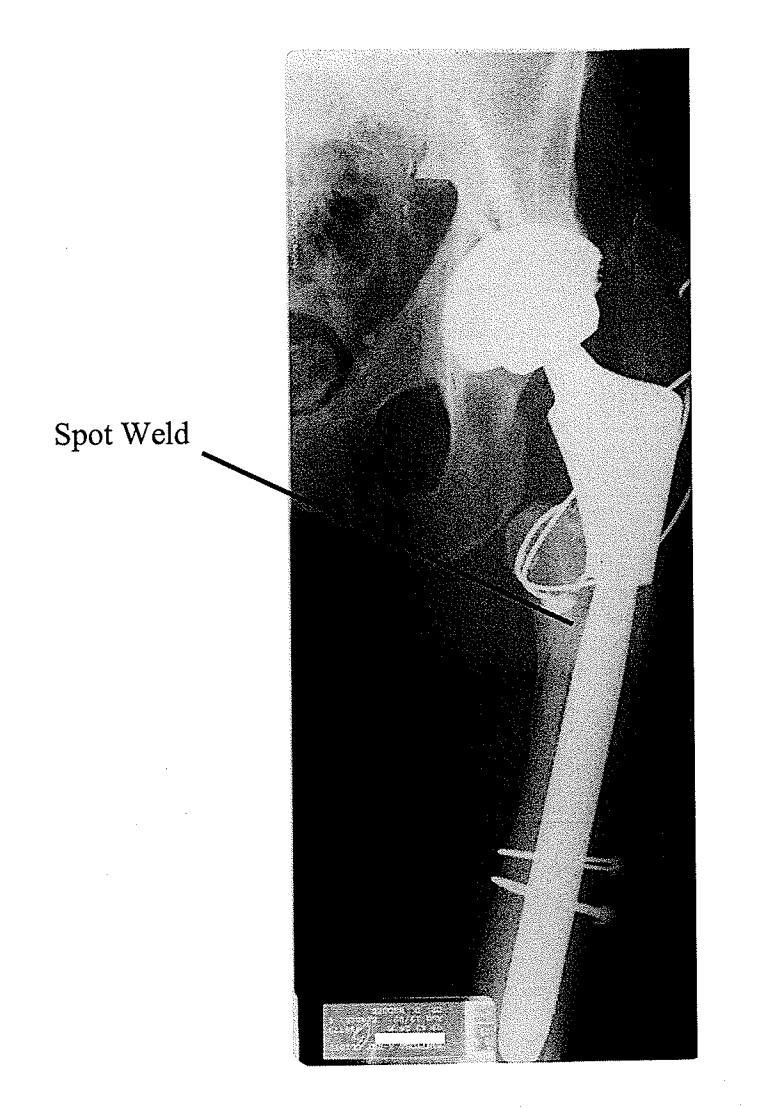
FIGURE 43: RADIOGRAPH OF IMPLANT #5 BEFORE STEM FRACTURE

Figure 43 shows the radiograph of implant #5 prior to implant fracture. This image shows that the stem is fixated distally in the canal of the femur. A spot weld directly below the modular junction can be seen on the medial side and there is a lack of

reactive lines along the stem in the femur. These provide confirmation of stem fixation. A close-up of the medial and lateral bone at the body can be seen in Figure 44.

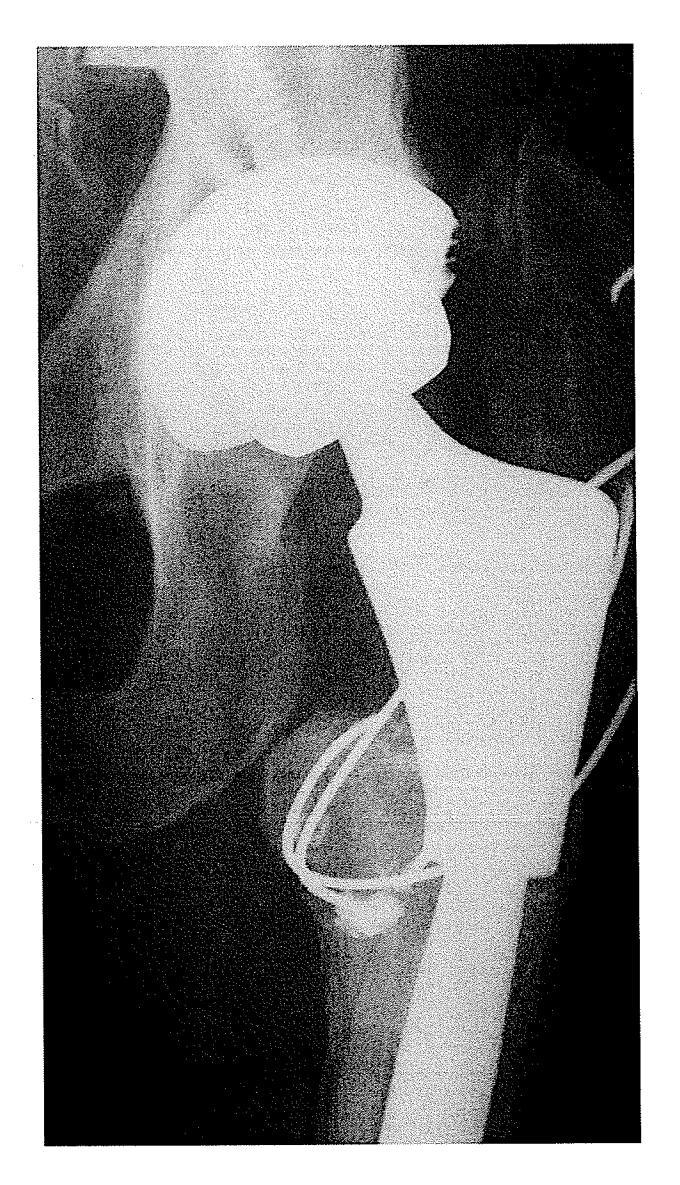
FIGURE 44: CLOSE-UP OF RADIOGRAPH OF IMPLANT #5

Figure 44 shows that there is less than 50% of medial bone present. Despite this, the medial bone is continuous over the modular junction and is ingrown into the body of

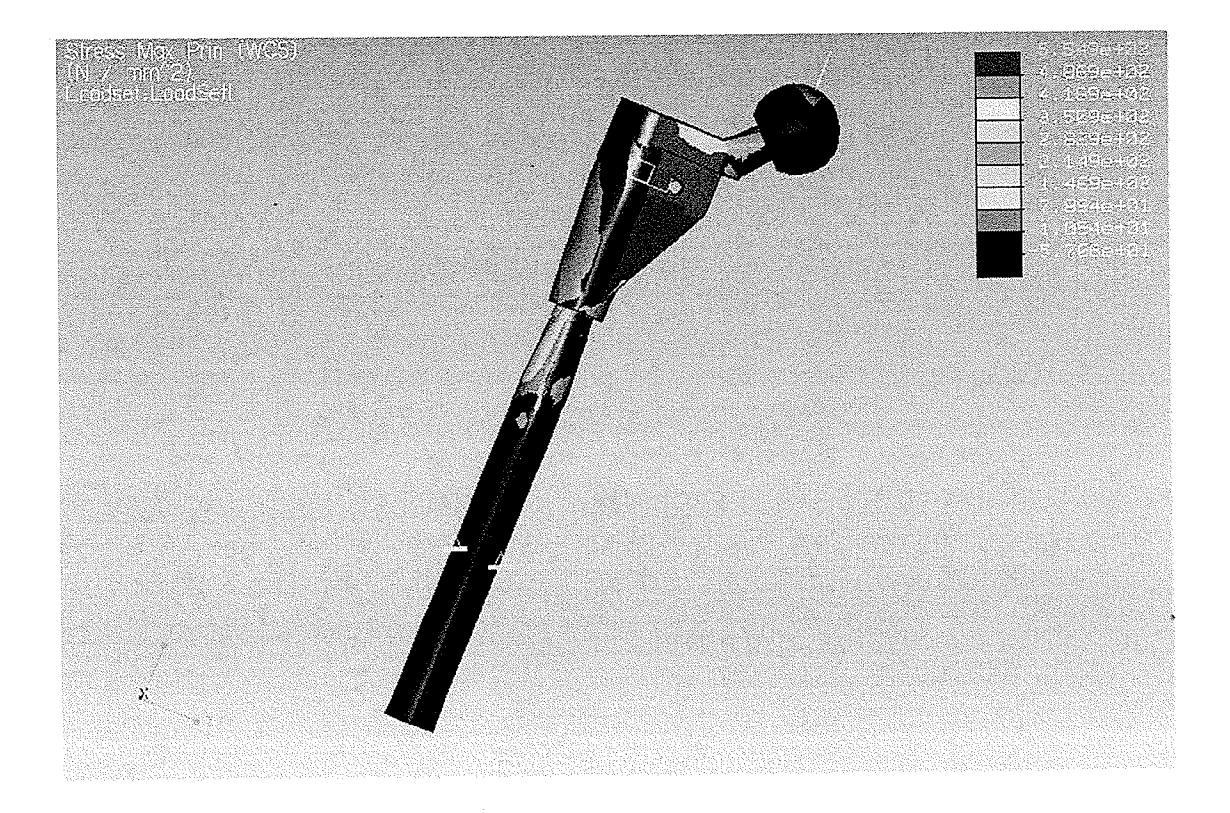
FIGURE 46: ANTERIOR VIEW OF THE FINITE ELEMENT ANALYSIS RESULTS OF THE MODULAR HIP IMPLANT

Figure 46 shows the stress distribution through the modular hip implant when a stress of 2,072 N is applied to the femoral head and the distal stem is fixed. It can be seen that the majority of the modular implant experiences approximately 5.7 N/mm², or 57 MPa, and is in compression, which is indicated by the negative value on the scale. However, lighter areas indicate tensile forces, which can be seen by the positive values on the scale. Although the neck of the body component that is mated with the femoral head experiences tensile forces on the superior side, these stresses are low (\approx 79 MPa) in comparison to the lateral side of the modular junction of the stem and body. This can be seen in Figure 47.

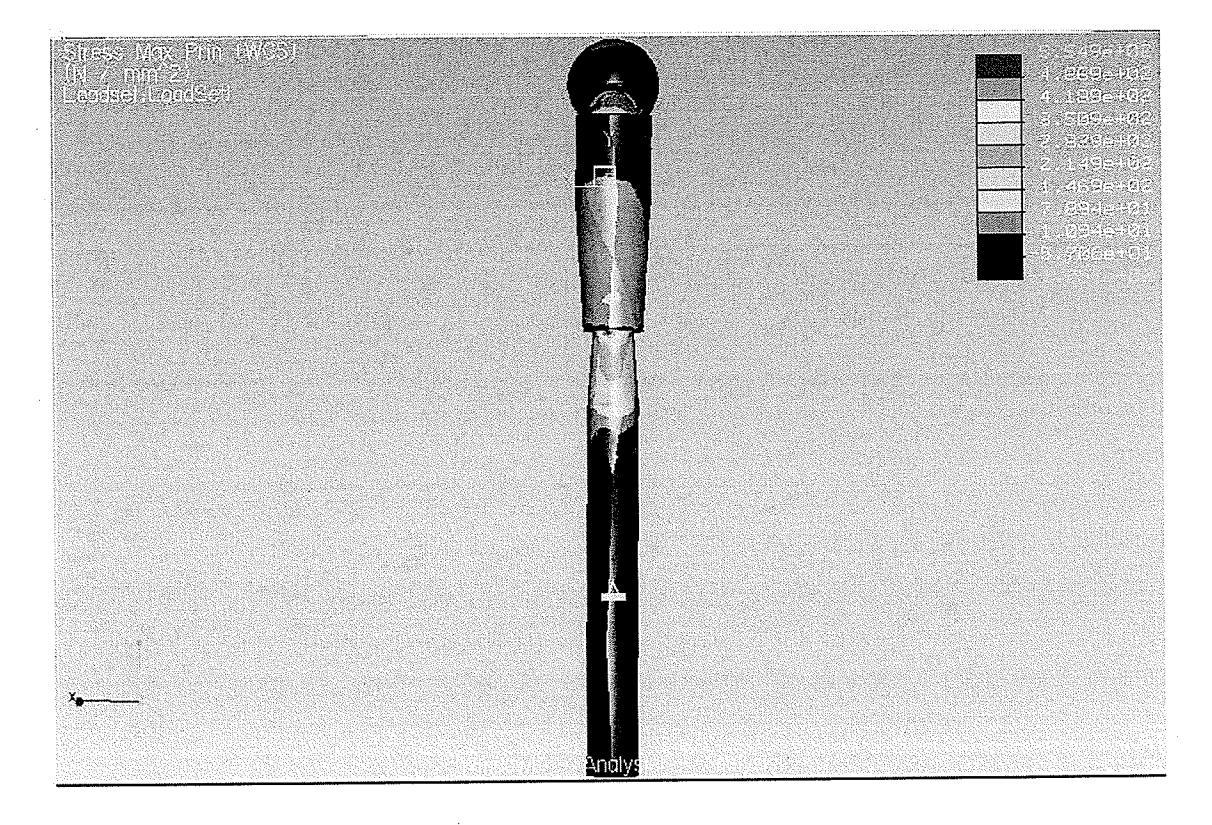
FIGURE 47: LATERAL VIEW OF THE FINITE ELEMENT ANALYSIS RESULTS OF THE MODULAR HIP IMPLANT

In Figure 47, the modular junction is the only part of the entire implant that experiences high stresses. The lateral side of the body experiences approximately 11 MPa, whereas the lateral side of the stem varies in stress. Figure 45 provides a close-up view of lateral side of the modular junction.

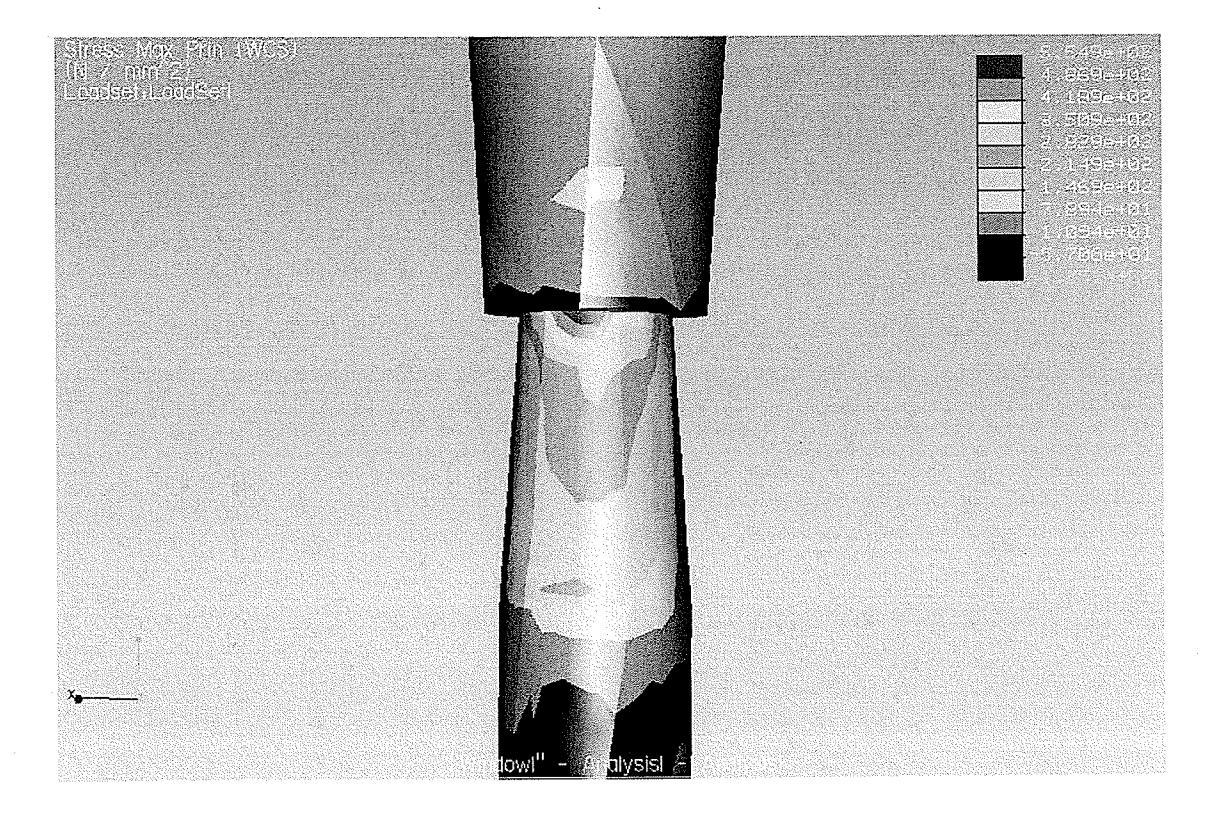
FIGURE 48: LATERAL VIEW OF THE FINITE ELEMENT ANALYSIS RESULTS OF THE MODULAR JUNCTION

From the close-up shown in Figure 48, it can be seen that as the modular junction on the lateral side is approached from the distal end, the stresses increase from approximately 11 MPa to 487 MPa. Although there is a high stress created at this interface, it is important to note that the typical yield strength of Ti-6Al-4V is 950 MPa and the fatigue strength or limit at 500,000 cycles and higher is approximately 420 MPa, which was shown in Table 2. The stress created at the junction, as shown by Figure 48, is slightly higher than the implant's fatigue strength and is approximately half the yield stress. This may contribute to failure of the modular stem.

It can be seen that the stress calculated is slightly higher than the value given through Pro-Mechanica (487 MPa). A higher value was expected in our calculations. This is because in the FEA, the bending moment created from the load at the femoral head causes a tensile force at the modular junction, yet the load also creates a compressive force throughout the stem. Therefore, this causes a decrease in the tensile component applied resulting in a slightly lower stress at the modular junction in the FEA. When doing calculations using equations, this factor is not considered, thus resulting in a slightly higher stress at the modular junction. Also, the calculated value is exceeding the fatigue strength or limit of Ti-6Al-4V at 500,000 cycles and higher.
