THE ANALYSIS OF FRACTURED Ti-6Al-4V MODULAR REVISION HIP STEMS WITH THE USE OF RADIOGRAPHIC ASSESSMENT, FINITE ELEMENT ANALYSIS, AND MECHANICAL TESTING

Department of Mechanical and Manufacturing Engineering

University of Manitoba

Five failed retrieved modular Ti-6Al-4V hip stems were examined to determine causes of failure. Investigation included microscopic and macroscopic analysis, finite element analysis, and mechanical testing of the modular hip implant. Method of failure was found to be fatigue, with crack initiation occurring on the lateral side of the modular junction. Bony ingrowth across the modular junction and on the proximal body was not present on both medial and lateral sides. Finite element analysis confirmed that the highest point of stress was where the crack was initiating, its magnitude, and that by utilizing a medial bone support, overall stresses on the modular implant decreased significantly. Tensile and hardness tests of the stem material produced results that were consistent with standard values. Fatigue results followed typical S-N curves and indicated that failure in vivo should have occurred after 10 million cycles. Implant assembly involves pulling th

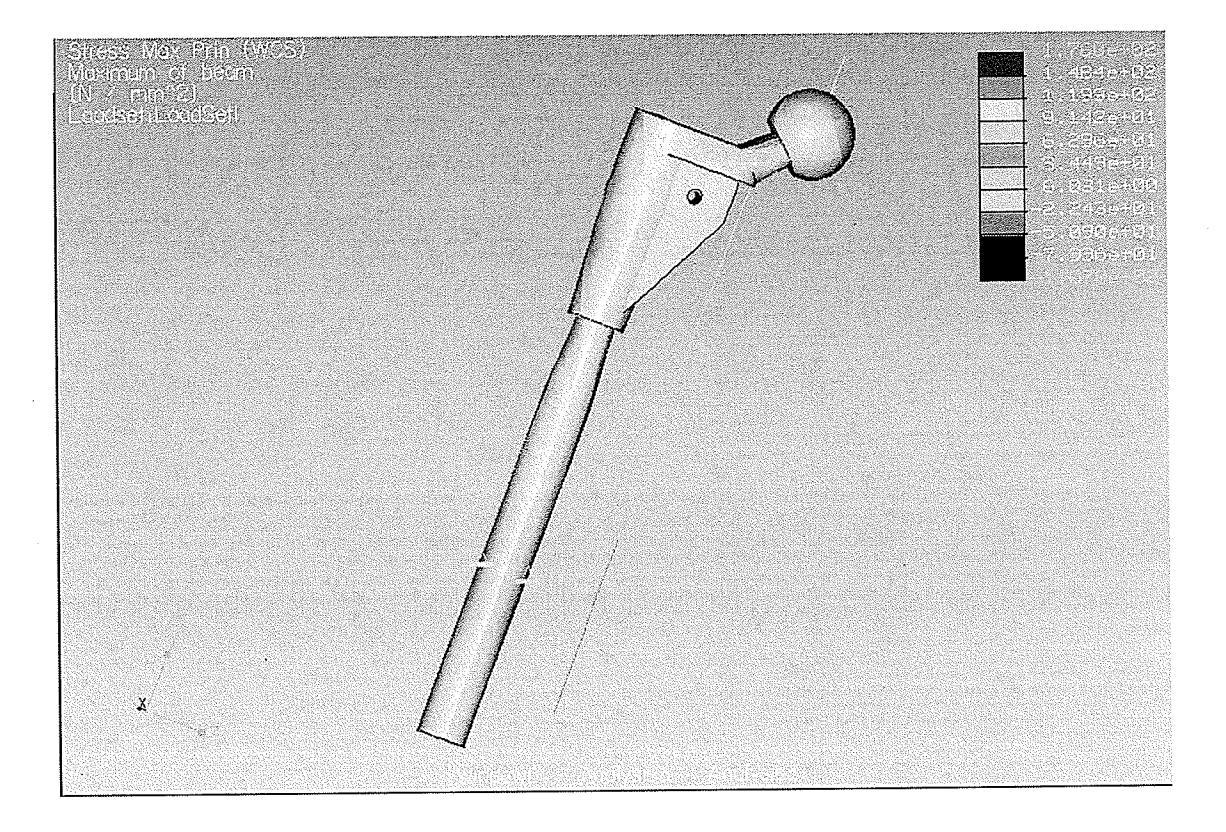
FIGURE 50: ANTERIOR VIEW OF THE FINITE ELEMENT ANALYSIS RESULTS OF THE MODULAR HIP IMPLANT WITH THE MEDIAL BONE SUPPORT

From Figure 50, it can be seen that the overall stress distribution in the modular hip implant has decreased significantly. The majority of the implant now experiences only approximately 22 MPa of compressive stress. It can also be seen that the neck of the body component that is mated with the femoral head now experiences a slightly smaller tensile force of approximately 60 MPa. More importantly, the stress experienced at the modular junction decreased. This can be seen in Figure 51.

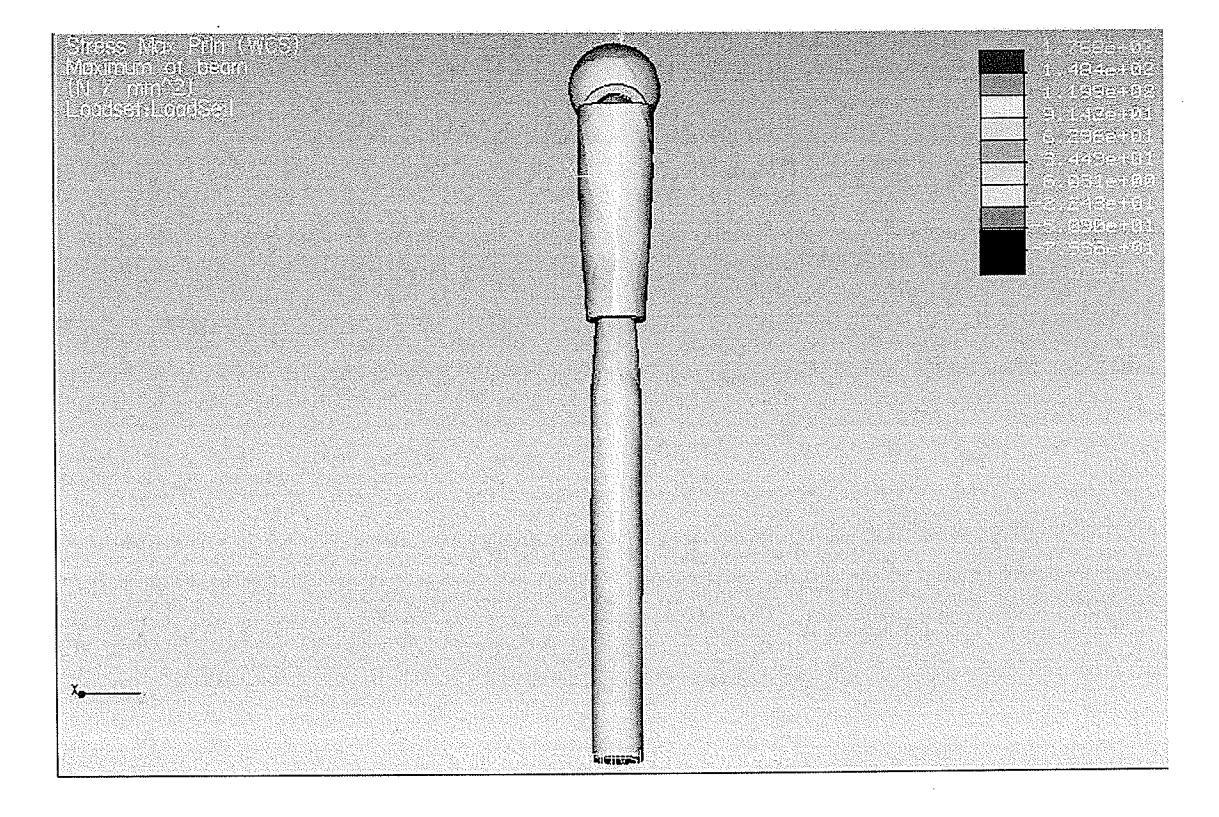
FIGURE 51: LATERAL VIEW OF THE FINITE ELEMENT ANALYSIS RESULTS OF THE MODULAR HIP IMPLANT WITH THE MEDIAL BONE SUPPORT

Figure 51 shows that the stresses on the lateral side of the modular implant have decreased significantly. A closer image of the modular junction can be seen in Figure 52.

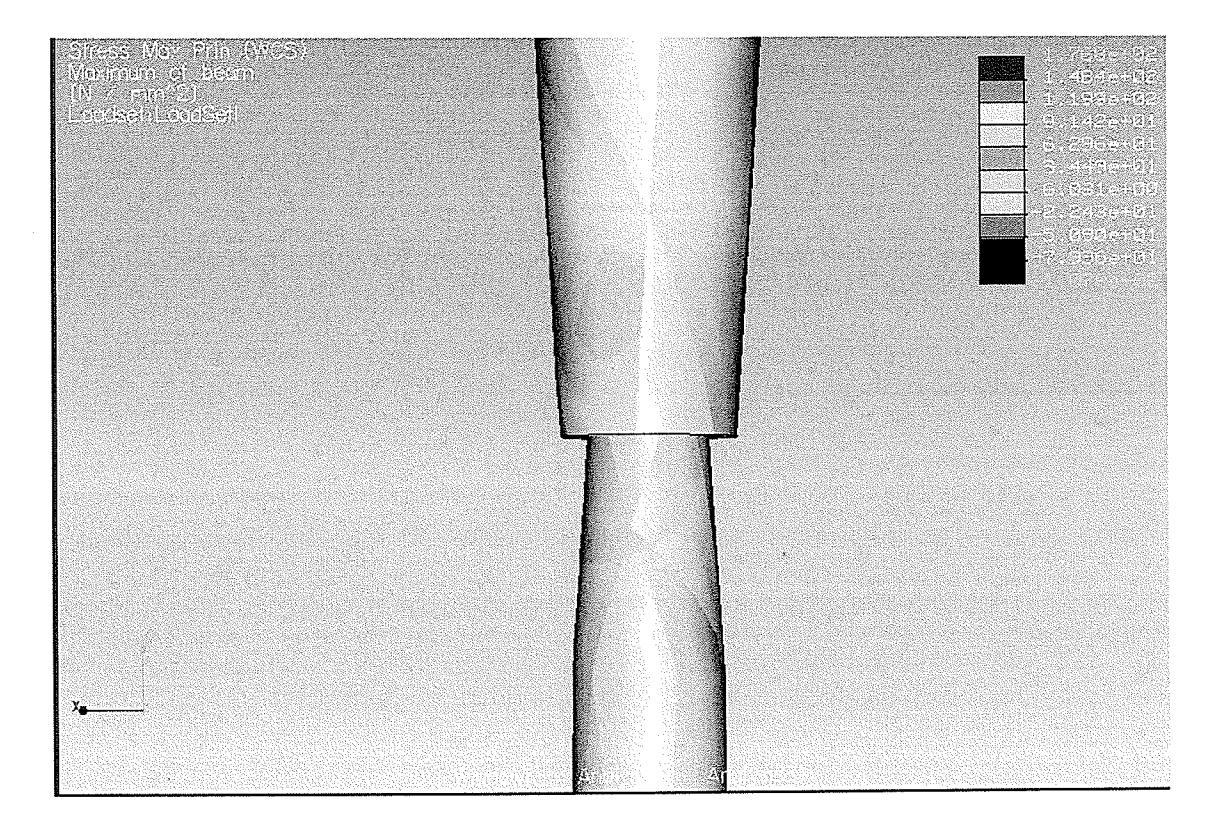
FIGURE 52: LATERAL VIEW OF THE FINITE ELEMENT ANALYSIS RESULTS OF THE MODULAR JUNCTION WITH THE MEDIAL BONE SUPPORT

From the close-up shown in Figure 52, it can be seen that the new stress at the modular junction is approximately 60 MPa in tension, which is significantly less than before (487 MPa).

This calculated value is again slightly higher than the value found using the program (60 MPa). This is again due to the fact that a compressive force is created in the FEA at the stem, which causes a decrease in the tensile component applied at the same location. Therefore, this creates slightly lower stresses at the modular junction than in the calculations.

Given the mathematical relationships above, it can be seen that if the distance that the moment acted over in equation 4.2 were reduced, the overall stress that the modular junction would experience would decrease as well, as shown by equation 4.3. Therefore, a medial bone support was added to the three-dimensional model to act as a medial bone graft and to compare the stress created at the modular junction. In Pro-Mechanica, the medial support was assumed to be similar to a vertical beam support and was constrained at the distal end to allow no movement. This assumes osseointegration of the bone graft added in vivo. An image of the modular implant model with the bone support is given in Figure 49.

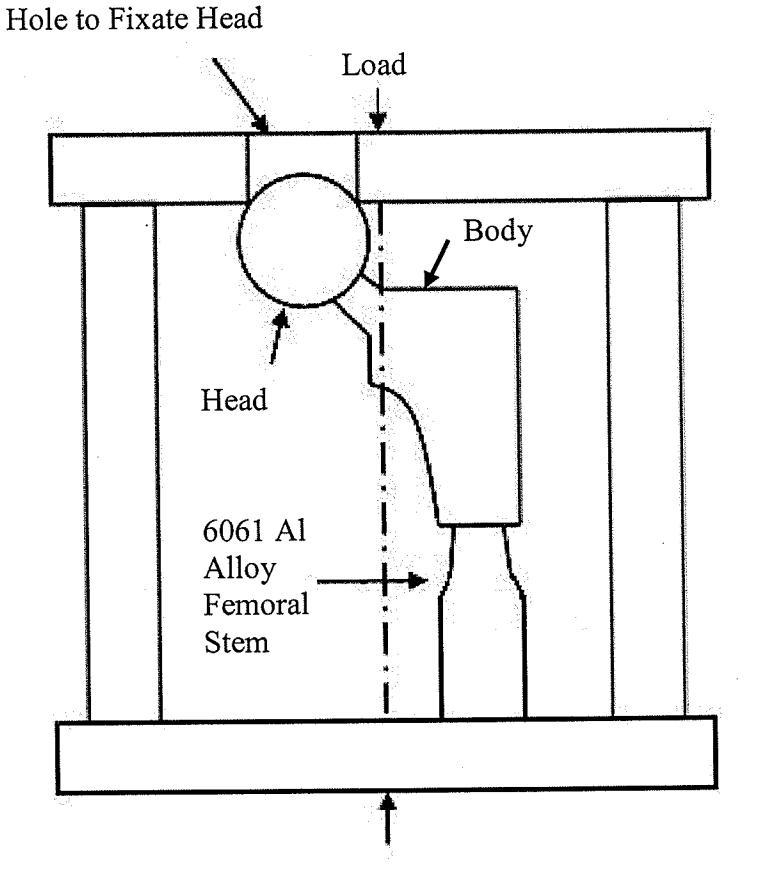
FIGURE 53: SCHEMATIC OF MODULAR HIP IMPLANT WITH THE 6061 AL ALLOY STEM IN COMPRESSION CAGE, WITH FEMORAL HEAD FIXED IN POSITION

These two tests that were stopped involved the femoral head sitting in this hole. The modular implant experienced high cycles at a high load, yet nothing happened to the 6061 aluminum alloy stem. Thus, the test was stopped in both cases. Since the femoral head sat in the hole made in the top circular plate, the ball was securely fixated and

created compressive forces in the whole implant, rather than tensile forces. Therefore, the implant did not break nor bend at the modular junction. Although fracture of the implant did not occur, one of the rods of the compression cage ended up fatiguing and fracturing due to the high load and high cycles. Thus, this rod plus its opposite rod, which were attached to the top circular plate of the compression cage, were replaced.

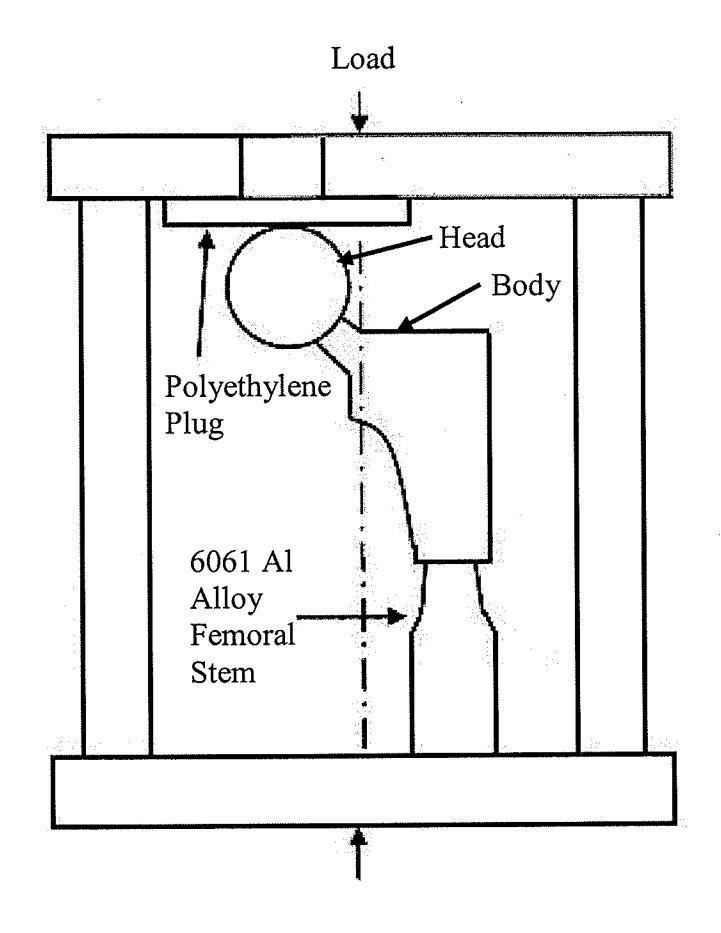
FIGURE 54: SCHEMATIC OF MODULAR HIP IMPLANT WITH THE 6061 AL ALLOY STEM IN COMPRESSION CAGE USING POLYETHYLENE PLUG

One test was done using this type of plug. However, due to the high loads that were used, the femoral head wore away most of the polyethylene and caused it to break apart. This created a similar situation as the last, where the femoral head was restricted and compressive forces were created. Since nothing was happening to the stem, the load was increased several times until the stem bent due to the load being too high.

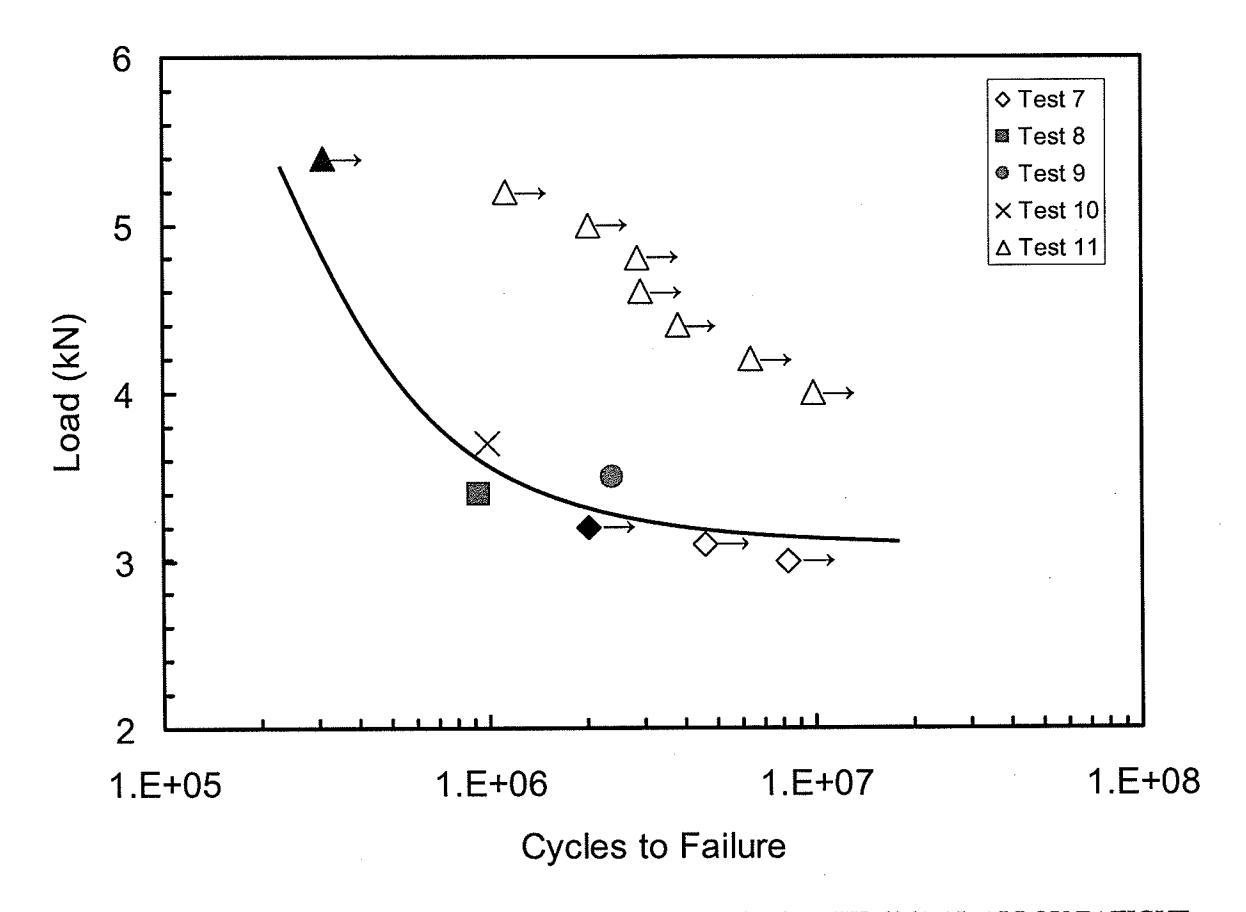
FIGURE 56: S-N CURVE (LOAD VS. CYCLES TO FAILURE) FOR THE 6061 AL ALLOY FATIGUE TESTS USING THE 6061 AL ALLOY PLUG ONLY

Figure 56 shows the fatigue results for tests 7-11, in which only the 6061 aluminum alloy plug was used to cover the hole in the top circular plate. The points that are filled in with colour each indicate a separate test, and indicate where the stem broke. The points that are not filled in with colour indicate how many cycles the stem underwent until the load was increased. These points continue to increase in load until the modular stem fractured by fatigue. Because of this, each of these successive points has an arrow attached to it. This means that if the stem was set to fatigue only at that load, the stem would have gone through more cycles than recorded in the test. By looking at the points at which the stem broke, an S-N curve shows the trend from test to test. The overall trend is that when the stress applied decreases, the number of cycles that the implant can undergo before failure increases. In general, it can be seen that at lower loads, the femoral head could eventually slide on the 6061 aluminum alloy plug and cause the modular stem to fail. However, as the load increased to higher values, the femoral head could not slide due to the high frictional and compressive forces between the femoral head and the 6061 aluminum alloy plug. Thus, the entire implant experienced compression and the head was restricted in movement. This would explain why the stem underwent almost 10 million cycles before failure.

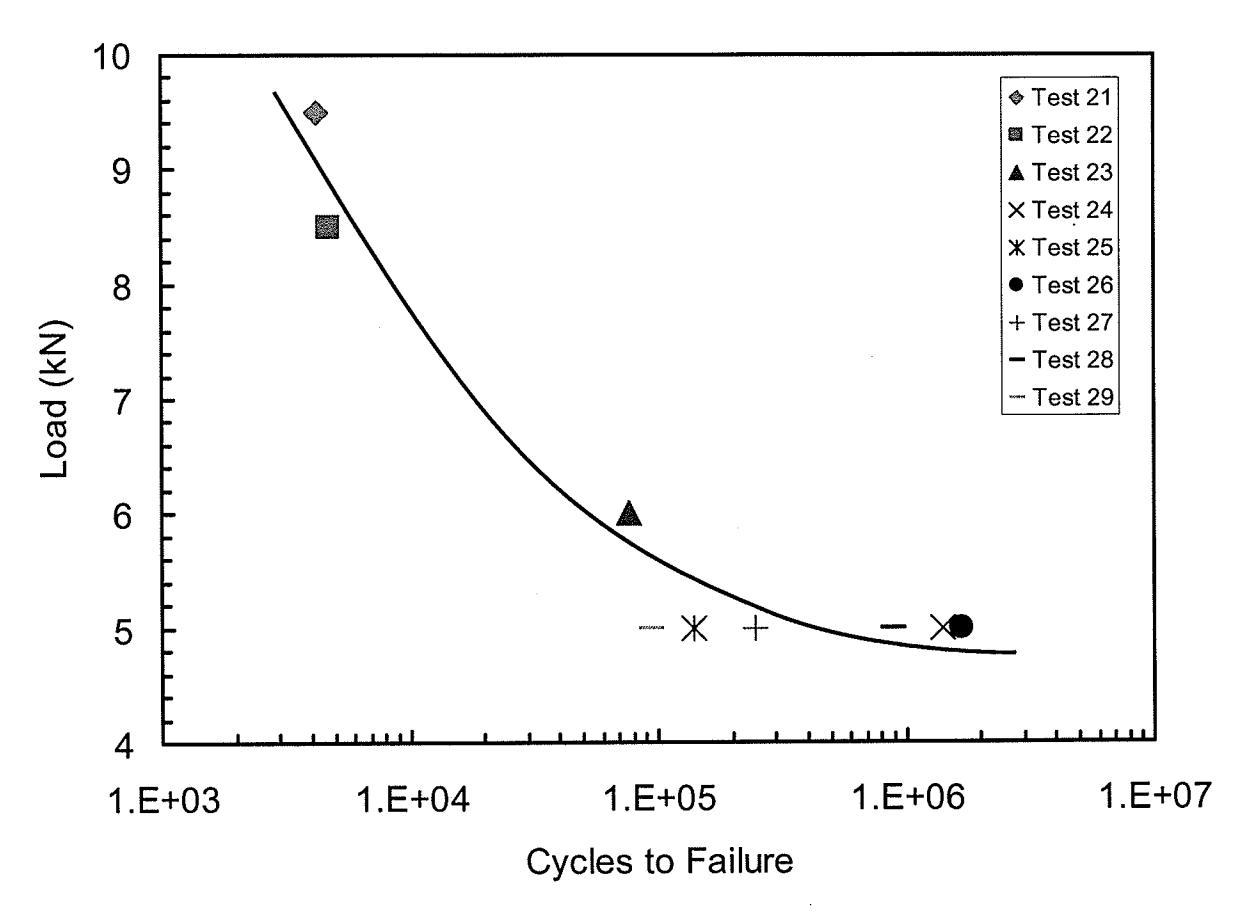
FIGURE 57: S-N CURVE (LOAD VS. CYCLES TO FAILURE) FOR TI-6AL-4V FATIGUE TESTS USING THE 6061 AL ALLOY PLUG WITH THE TEFLON SLIDER

Figure 57 shows the fatigue results for tests 21-29 for the Ti-6Al-4V stems. In these tests, the 6061 aluminum alloy plug with the Teflon slider was used to prevent any type of restriction to the femoral head. Each point on the graph indicates where the modular stem broke. Similar to Figure 57, an S-N curve can be drawn through the points which clearly shows the trend of the graph. As the stress applied decreases, the number of cycles that the implant can undergo before failure increases. As previously mentioned, the modular stem for test 25 was cut too short, and thus was likely not fixated properly in the holder in the compression cage. Due to this discrepancy, the recorded number of cycles to failure is inconsistent with the trend for tests 21-24 and test 26, and can be seen

clearly in Figure 57. Test 29 also deviates from the trend created by tests 21-24 and test 26. This is because the holder was worn out in the location where the modular stem was fixated and this was not noticed until after the test was completed. This caused the stem again to not be fixated properly and led to premature stem fracture.

Recall in section 4.2, it was found that the retrieved modular implants experienced approximately 4 million cycles before failure under a load of 2 kN in vivo. According to the S-N curve in Figure 57, it is estimated that under a 2 kN load, the implant should experience over 10 million cycles prior to failure. However, this is not the case. Therefore, there must be another mechanism causing the implants to fail by fatigue.

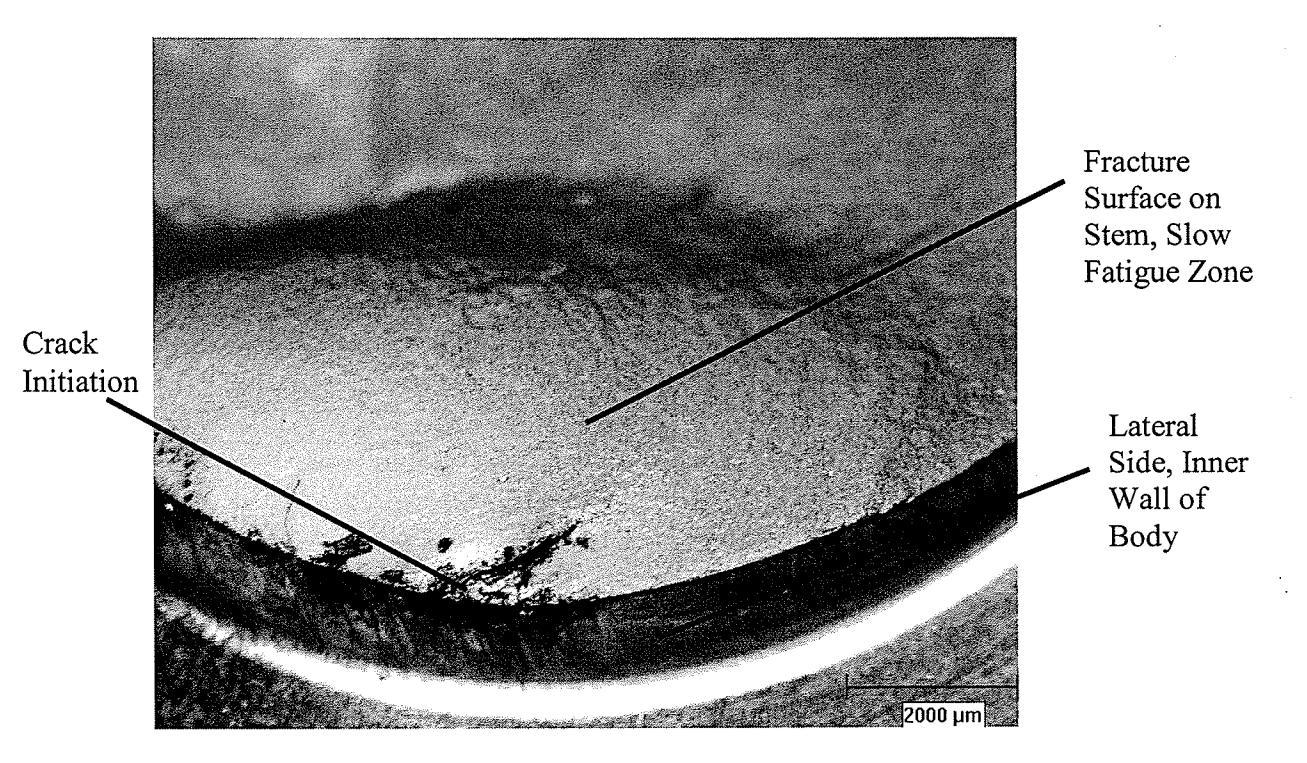
FIGURE 59: TYPICAL FRACTURE SURFACE FROM TI-6AL-4V FATIGUE TESTS 27 AND 28 TAKEN AT 10X, CRACK INITIATION IS TOWARDS THE BOTTOM OF THE SECTION

Figure 59 shows that crack initiation occurs towards the bottom of the section. Also, crack initiation of the stem occurring slightly above the bottom surface of the body component. According to the scale in the image, this crack started approximately 2 mm higher than the fracture surface of Figure 58. After the crack has formed, it then propagates downwards towards the interface and then finally breaks off. The fracture surface created in tests 27 and 28 are topographically exact replicas of the five fractured stems that occurred in vivo. For comparison purposes, an image of the fracture surface of implant #1 can be seen in Figure 60.

As shown, the fractures of tests 21-26 are different than the fractures of tests 27 and 28. This is because crack initiation always occurs at the point of highest stress. In tests 21-26, the residual stresses on the stem were in compression, thus counteracting the tensile forces applied. Therefore, the highest stresses created on the stem were the bending stresses created directly at the interface caused by the load applied to the femoral head. This explains why crack initiation occurred at this location. In tests 27 and 28, the residual stresses on the stem are tension. Therefore, when the load is applied to the femoral head, the highest stresses occur on the stem within the body component. This

explains why crack initiation occurs slightly above the modular junction. Once the crack is initiated, the material at that location is relieved of the tensile stresses that were once there. This causes the crack to propagate to the area with the next highest stresses, which would be towards the modular junction. This creates the uneven fracture surface that was noted on the stems.

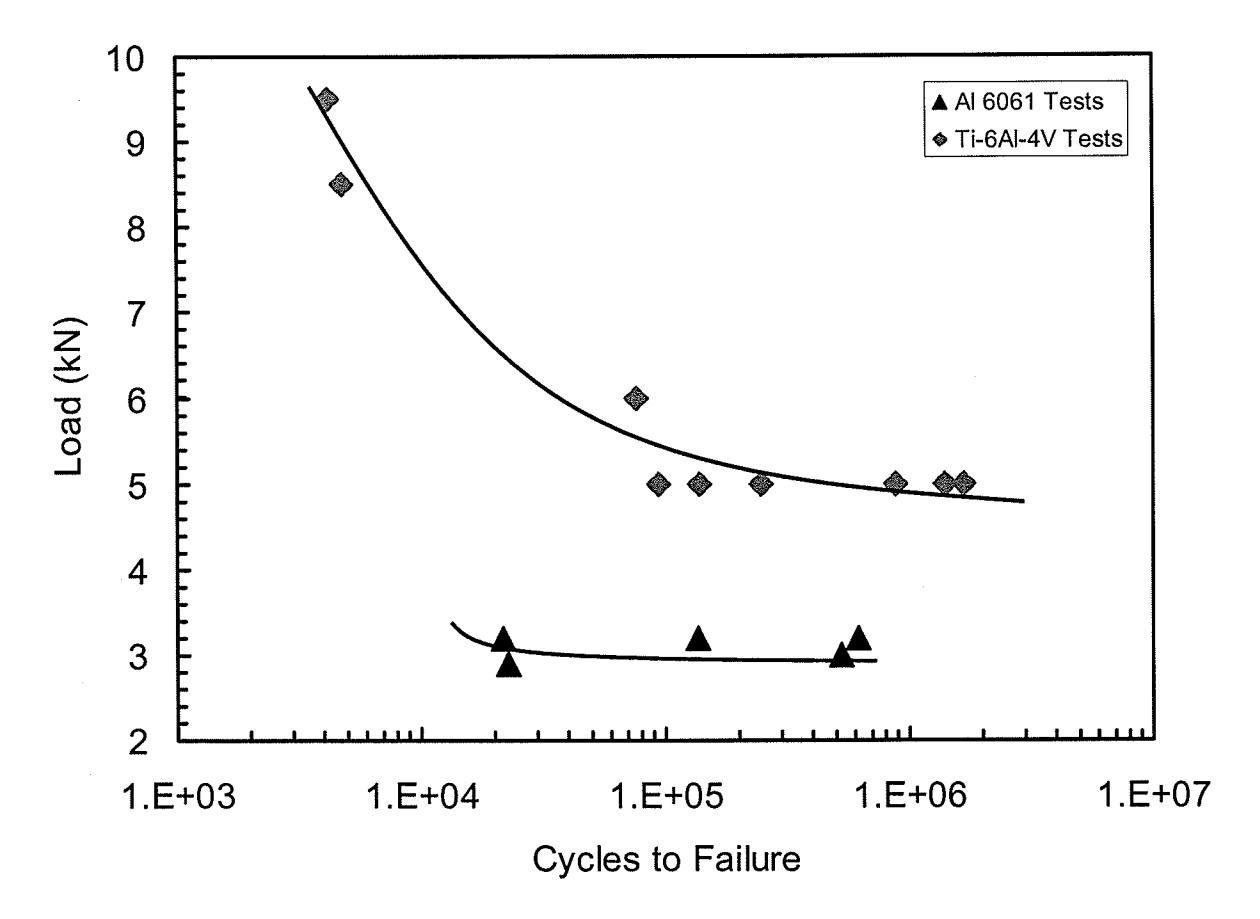
FIGURE 61: S-N CURVE (LOAD VS. CYCLES TO FAILURE) FOR ALL TESTS USING THE 6061 AL ALLOY PLUG WITH THE TEFLON SLIDER

Figure 61 shows the S-N curves created with the fatigue test results of these tests. It can be seen that the 6061 aluminum alloy stems had comparable cycles to failure at 3 kN to that of the Ti-6Al-4V stems at 5 kN. It was initially thought that the number of cycles to failure that the stem would be able to withstand would be dependent on the material's tensile strength [18]. However, as found in the tensile tests conducted, the average tensile strength for the 6061 aluminum alloy was approximately 290 MPa (42 ksi) and the tensile strength for Ti-6Al-4V was 913 MPa (132 ksi). Therefore, since the tensile strength of Ti-6Al-4V was approximately 3 times that of the 6061 aluminum alloy, then according to equation 4.6, the load that the stem can withstand giving comparable cycles to failure should be approximately 3 times as well. The tests that were cycling at 5 kN were only at a 1.7 times load increase than that of the tests that were cycling at 3 kN. This value is almost half of what was predicted. Thus, the failure of the stem must be dependent on another material property.

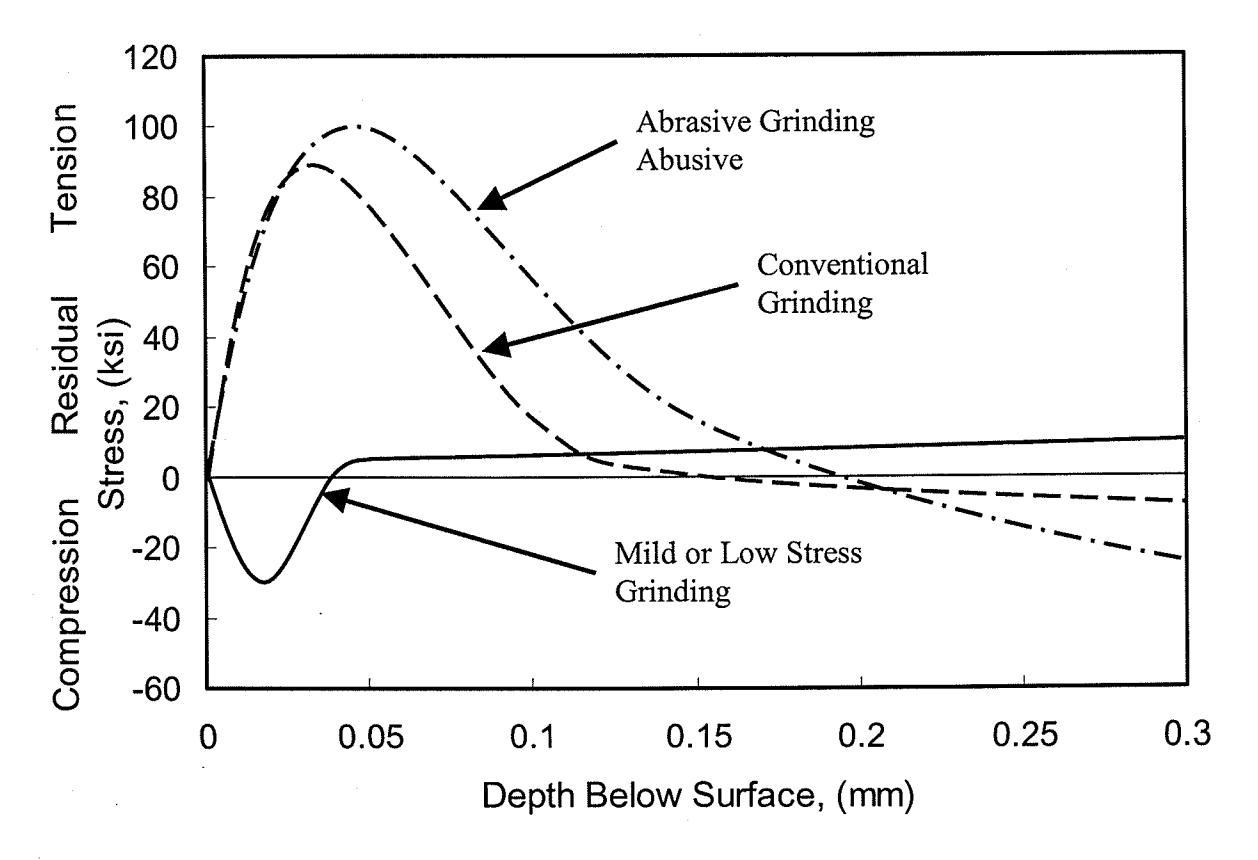
FIGURE 62: TYPICAL GRINDING STRESSES PRODUCED BY SURFACE GRINDING [32]

Figure 62 shows the magnitude of stresses that can be created on the surface of the modular stem by grinding. If mild or low stress grinding was not employed during the fabrication process, at less than 0.05 mm from the surface of the stem, there could be up to 620 MPa (90 ksi) of residual tensile stresses. This amount is very significant. As found before in the finite element analysis, the stress on the lateral side at the modular junction was approximately 487 MPa on average. Therefore, if conventional grinding was used, the stress would be approximately 1107 MPa, or 1 GPa, on the lateral side at this junction. This value is higher than the fatigue strength or limit at 500,000+ cycles, the yield stress, and the ultimate tensile strength for Ti-6Al-4V, and does not even include the extra residual tensile stress that is added from pulling the stem up into the body component. However, by looking at Figure 62, if mild or low stress grinding is used on the modular stem during the fabrication process, then this residual stress becomes 207 MPa (30 ksi) in compression at a distance of less than 0.05 mm from the surface. This would counteract the stresses created in vivo and thus would create a lower stress at the modular junction. Therefore, it would be very important to ensure that the modular stems are machined using mild or low stress grinding processes.

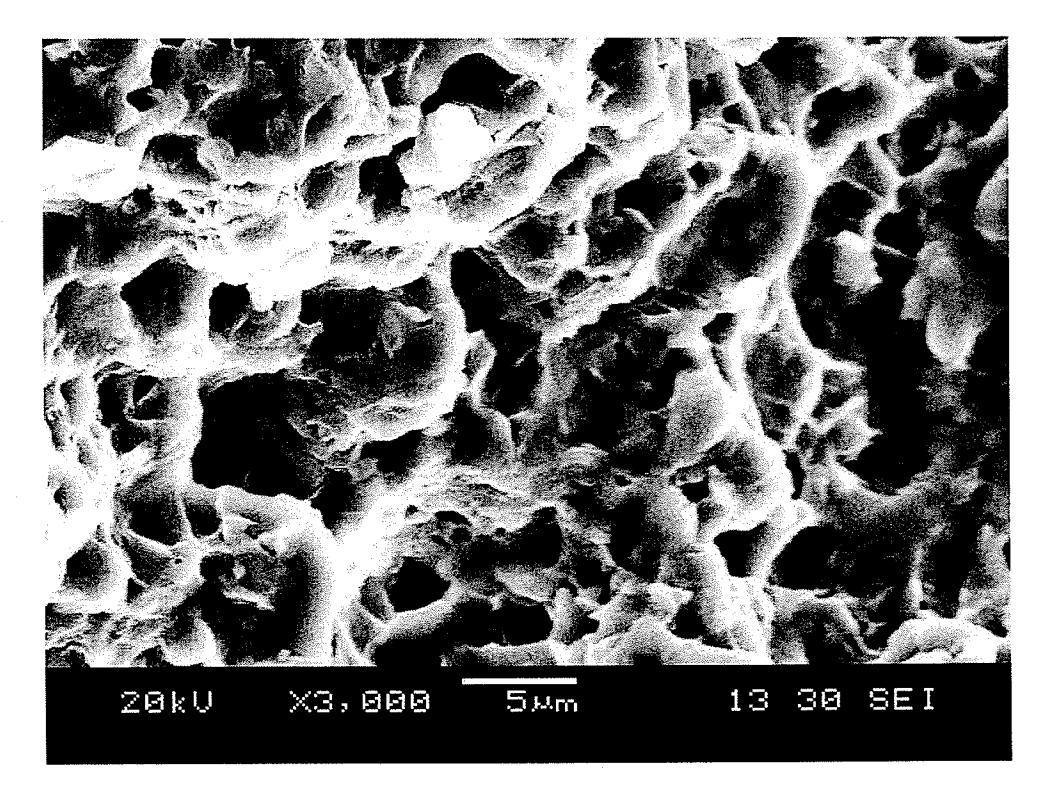
FIGURE 63: SEM IMAGE OF TI-6AL-4V FATIGUE TEST 27, RAPID FRACTURE ZONE TAKEN AT 3000X

Figure 63 shows an SEM image of the rapid fracture zone. This image clearly indicates a ductile fracture due to the presence of cups and cones. Unlike Figure 32, there is no damage in this image and all features are very clear and distinct. The slow fatigue area was then examined under the SEM for striations. An image of this is seen in Figure 64.

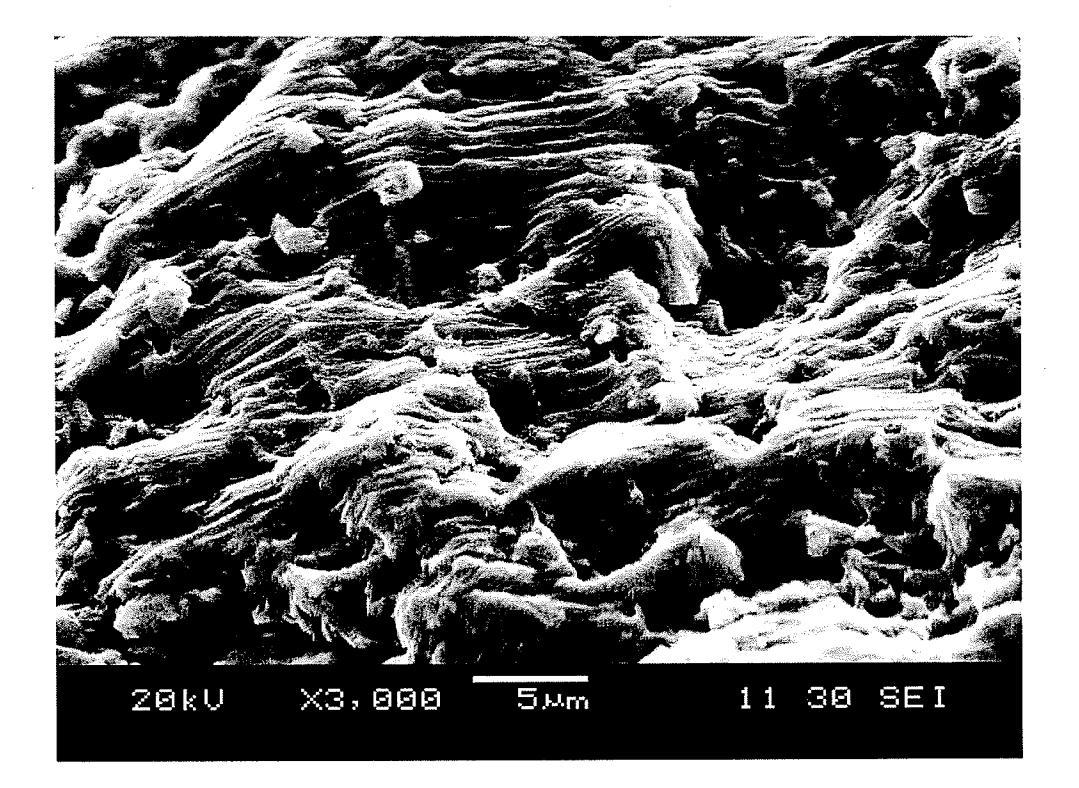
FIGURE 64: SEM IMAGE OF TI-6AL-4V FATIGUE TEST 27, SLOW FATIGUE ZONE TAKEN AT 3000X

Figure 64 shows an SEM image of the slow fatigue zone. Since there is no TiO_2 layer present, the striations on the surface are clear to see, which are perpendicular to the direction of crack propagation. Each striation, or ripple, indicates every time the crack propagated further after crack initiation. According to the scale, each striation is approximately 1 micron apart. Thus, the crack tip propagated approximately 1 micron at a time before it became a rapid ductile failure. It can be seen in Figure 64 that the fracture surface is not flat. This is due to the toughness of the material.
