AN INVESTIGATION INTO RIVER BANK IMPROVEMENT
IN THE WINNIPEG AREA

A Thesis
Presented to
The Faculty of Engineering
University of Manitoba

by
Edwin H. Klassen
March 1963

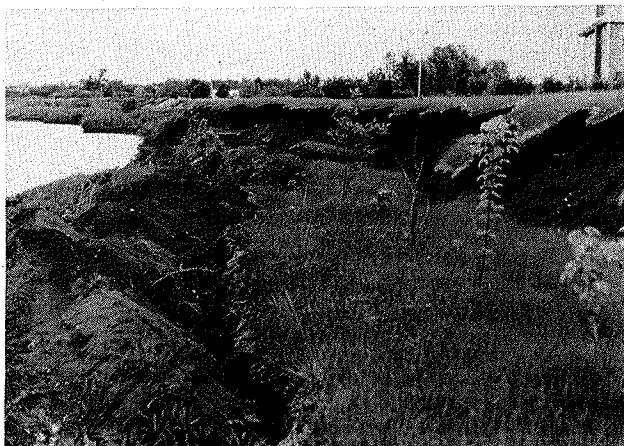
PHOTOGRAPH 1 - Recent Slide
Concave Edge, East Bank
Height 33 ft. Average Slope 6.8 : 1

The main causes of bank failure by sliding are the overloading of banks by man, and secondly the reducing of the factor of safety against sliding by bank saturation and erosion. Indiscriminate dumping of waste or spoil material and the stockpiling of equipment and building supplies along the river banks, which has been common practice in certain areas, tend to overload the banks and may often contribute to subsequent slides. In April 1951 Bill 70, "An Act to amend the Rivers and Streams Act" was passed in the Manitoba Legislature. This act provides that no person or persons, without a permit, shall deposit any material or erect any structures within one hundred and fifty feet from the normal summer water level. Even this, later studies have indicated, may be inadequate. Dumping on the river banks has not, at the present time, been sufficiently widespread to make any appreciable change in the carrying capacity of the channel, although it does result in increased velocities where dumping has taken place, producing localized erosion. The driving of piles and placing of riprap has proven to be quite adequate for minor toe erosion but a survey of these installations has shown that when a slide occurs, these installations have moved along with the sliding banks. Photographs number 1 to number 6, page 5, show

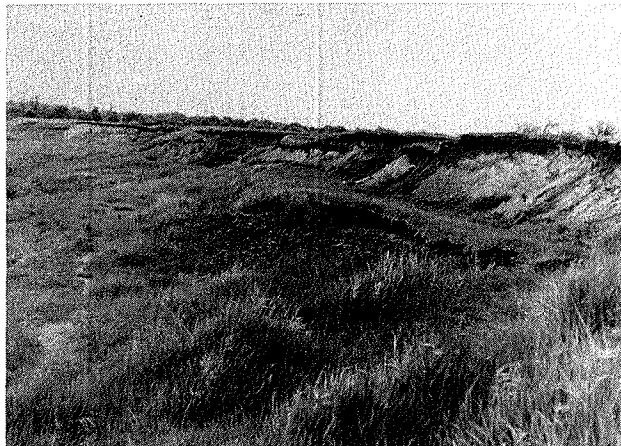
PHOTOGRAPH 2 - Older Slide
Concave Edge, East Bank
Height 33 ft. Average Slope 6.7 : 1

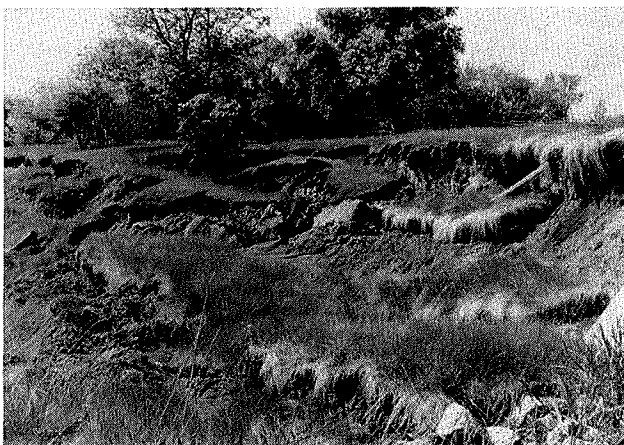
PHOTOGRAPH 3 - Recent Slide
Concave Edge, West Bank Looking South
Height 40 ft. Average Slope 5.1 : 1

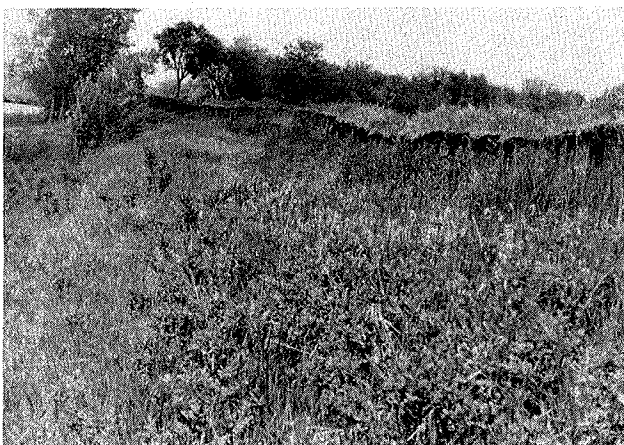
PHOTOGRAPH 5 - Old Slide
Convex Edge, East Bank
Height 30 ft. Average Slope 5.4 : 1

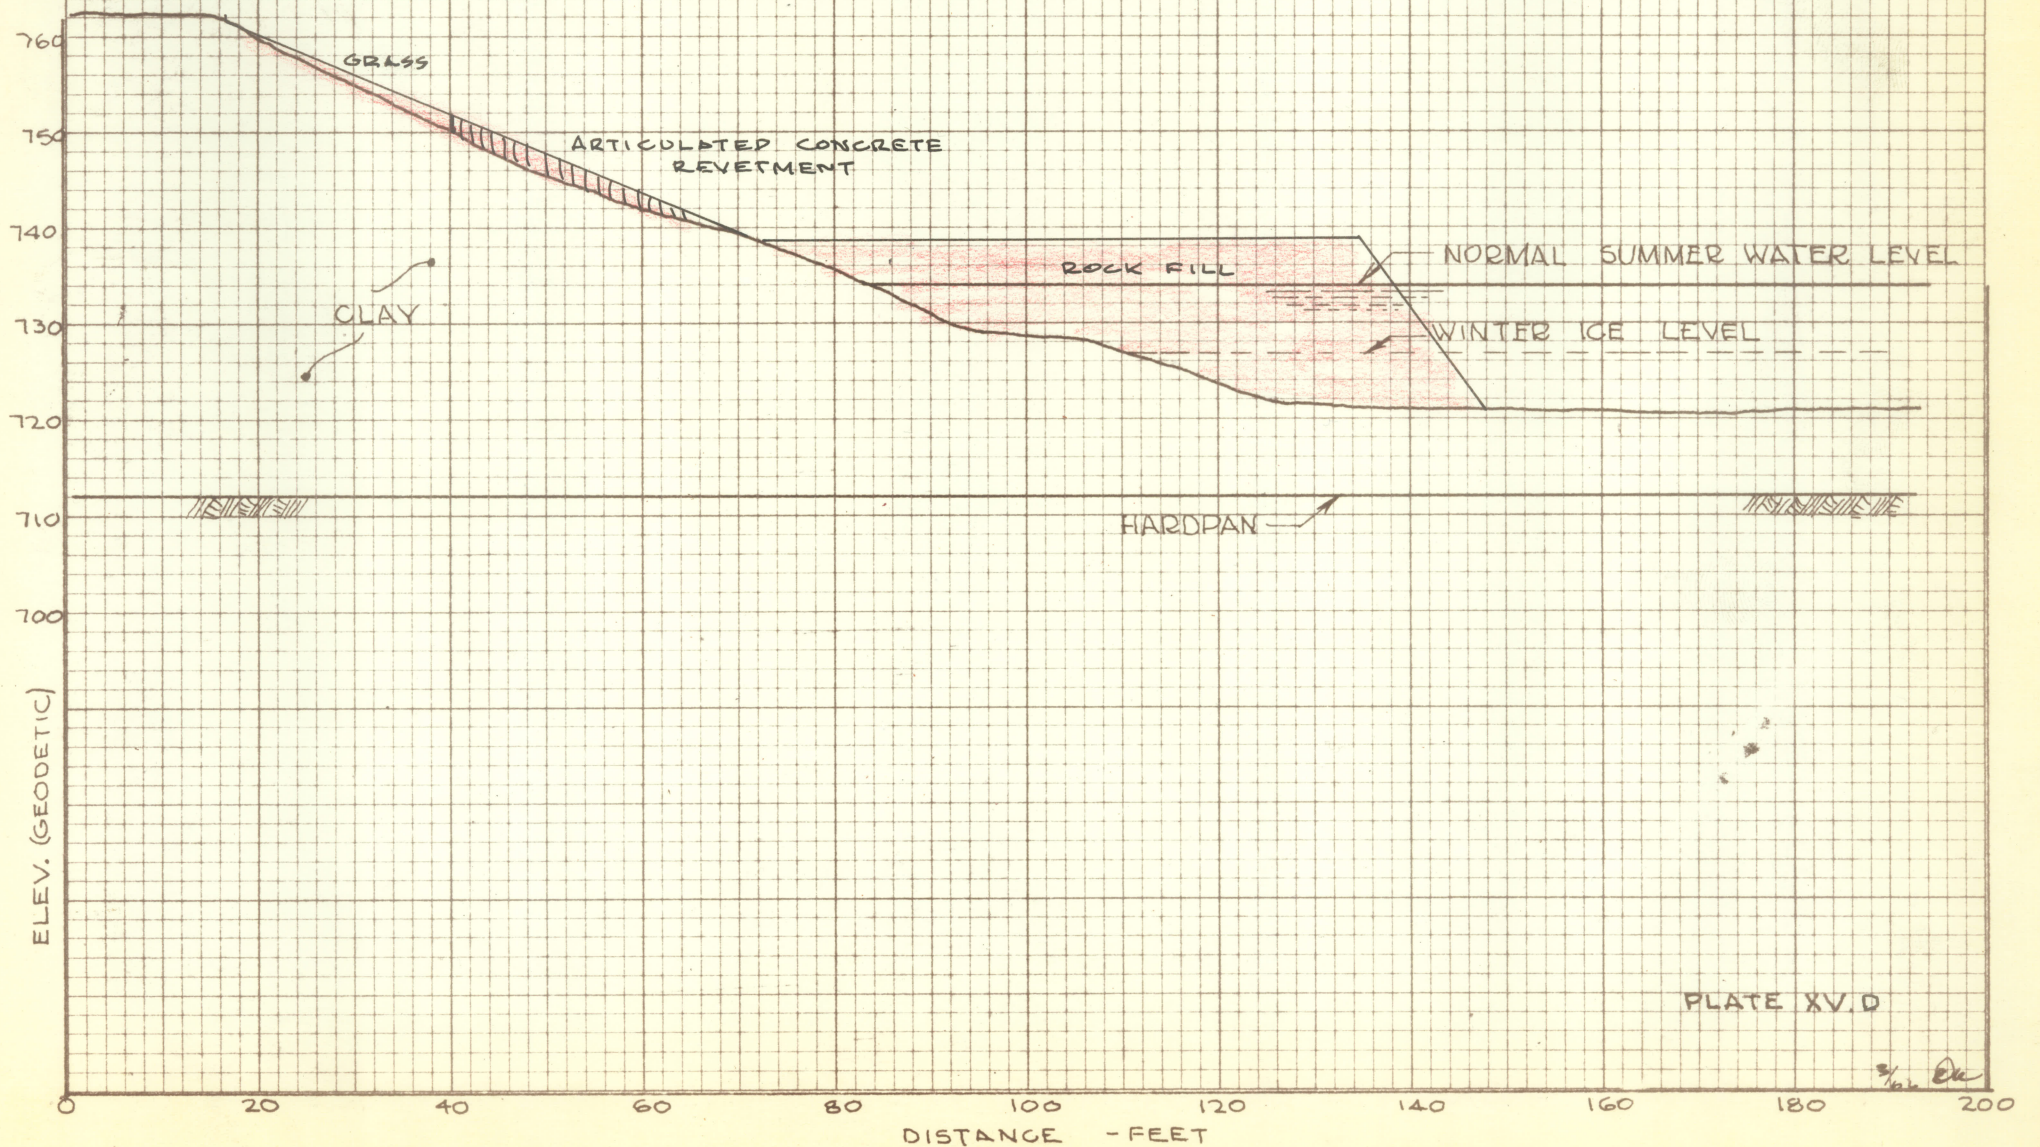
TYPICAL RIVER CROSS-SECTION

The overall design is shown on Plate XVII, page 85A. The design is admittedly of a preliminary nature. A

check should be made on the external stability due to changes in wall and slab thicknesses. Balanced steel ratios have been used and should be checked due to alterations in wall and slab design.

However, it is thought that the overall design gives the approximate proportions of a wall that is required to withstand the maximum earth pressures. Perhaps further investigations would alter the ratio of height to width resulting in a more economical cross section. It must be realized that a wall resting on hardpan is on a very rigid support, as compared to a wall resting on clay, for example. Hardpan, when cleared of overlying loose rubble and gravel, can resist a bearing pressure of up to 15 kips per square foot. More accurate design would, needless to say, reduce the retaining wall and base slab thicknesses somewhat.
