SNOW DRIFT STUDY
CANADIAN FORCES STATION ALERT

A Practicum
presented to the University of Manitoba
in partial fulfillment of the
requirements for the degree of
MASTER OF CITY PLANNING
in
DEPARTMENT OF CITY PLANNING

Winnipeg, Manitoba, 1986

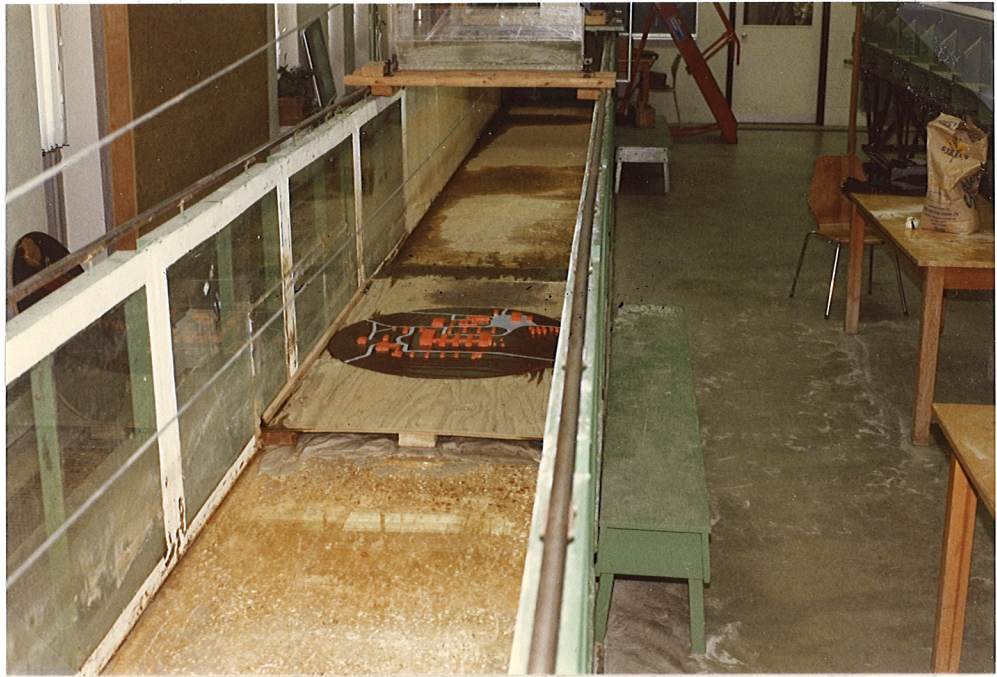
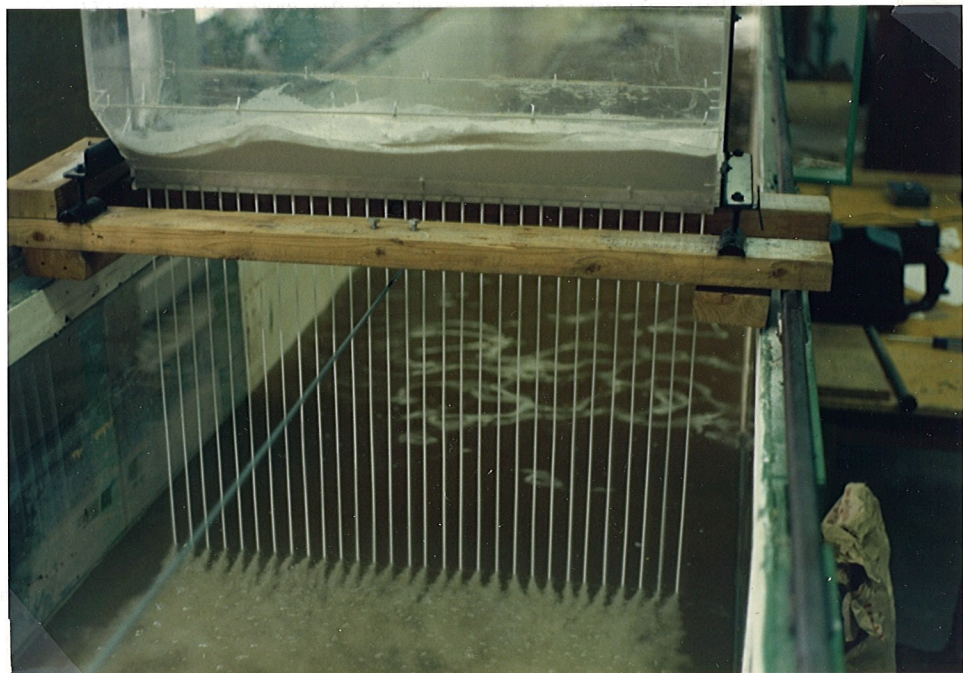
Figure 3-6 Sand Hopper

Sand hopper relative to model.

Sand hopper dispensing sand during testing.

The position of the sand hopper was critical because if it were too close or too far away, not enough sand would reach the model. The amount of drifting sand that would cover the model was determined by the quantity of sand placed in the hopper. Figure 3-6 (a) shows the sand hopper in its position relative to the model and (b) at the time when sand is being dispensed through it during testing.

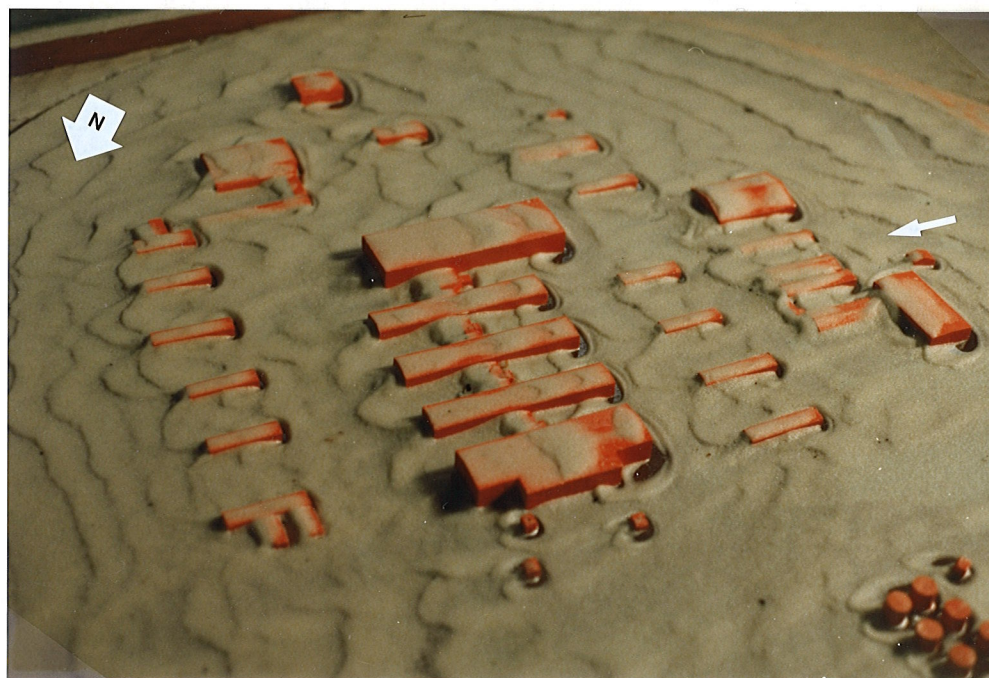
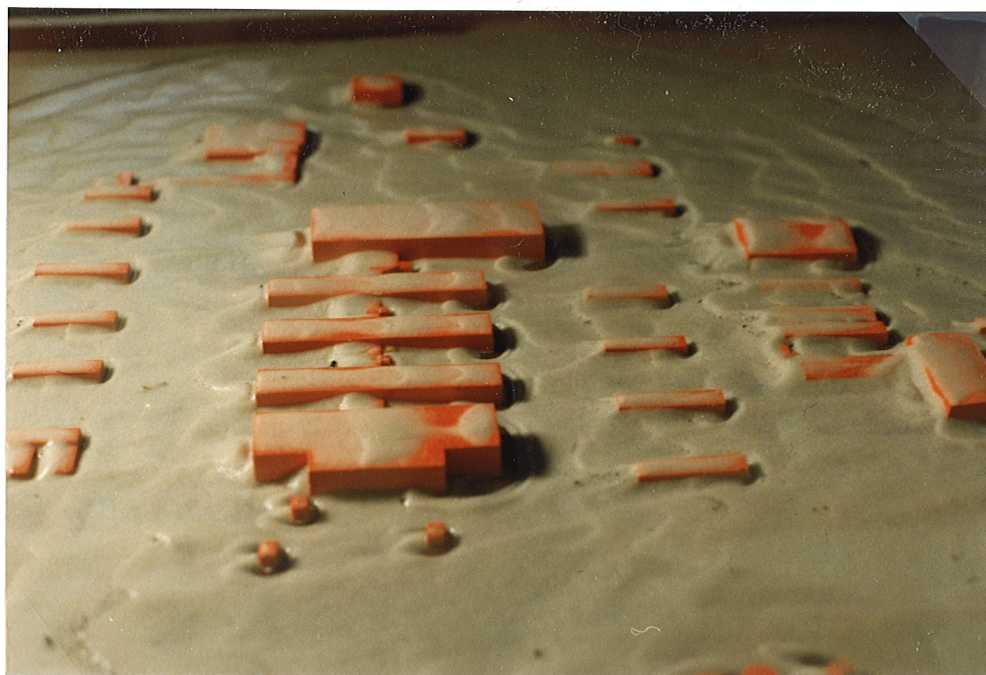
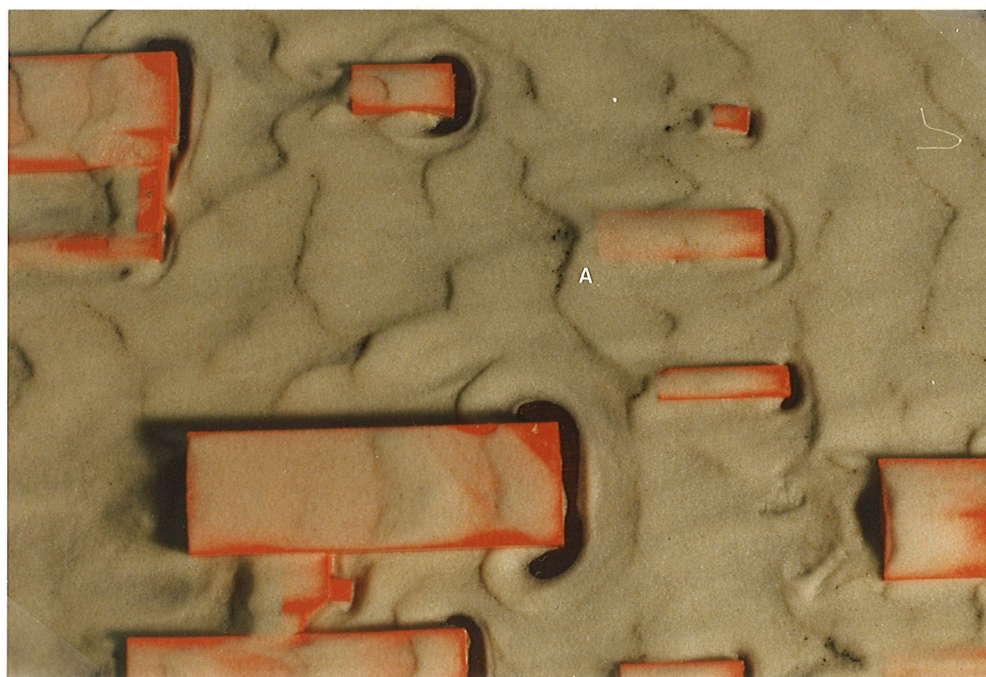
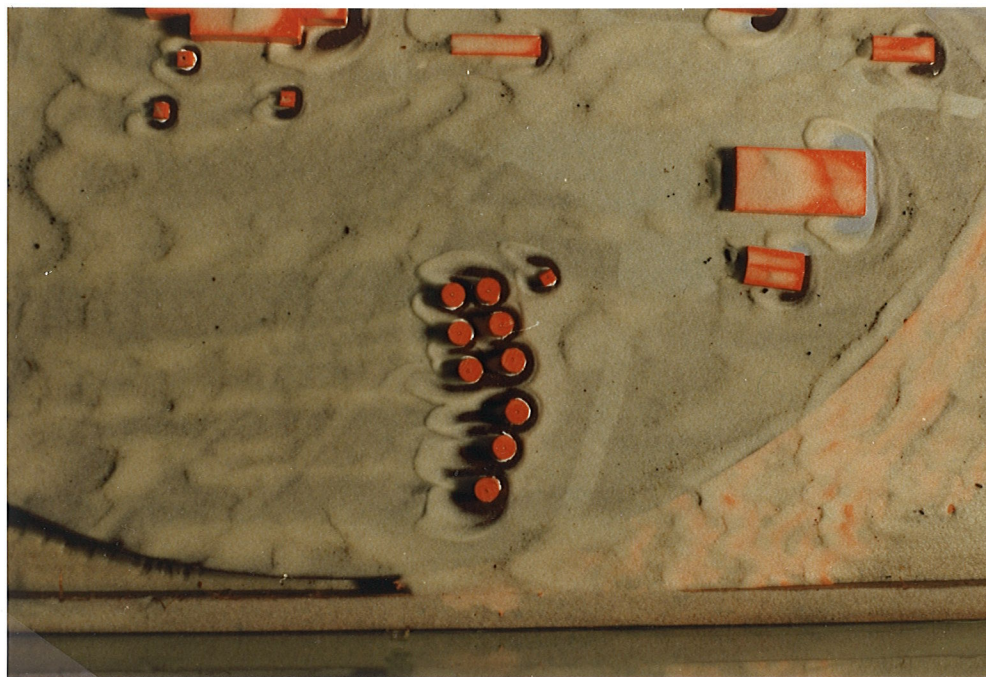
Figure 3-8 Heavy Drifting - Present Site

View from the West. Arrow indicates wind direction.

View from the North. Arrow indicates wind direction.

View from the northwest at a low angle. Note that drifting has reached the top of most of the smaller buildings on the northeast side, while the southwest is mostly clear.

Note the extensive drifting occurring at the northeast corner of the Power Plant, Bldg 20 (A). The power plant's exhaust system is located in this corner of the building and a large cover had to be constructed over the exhaust because of serious drifting problems here in the past.

Drifting on the northeast side of the linkways is up to the roof (A), while the southwest side is not as extensive (B).

Drifting has been very extensive along the northeast side of the technical buildings, especially between Buildings No. 11 and 12 (A).

Drifting around the fuel storage tanks has been minor since the circular shape allows the flow to be more laminar, thus reducing eddies on the leeward side.

In the second run, a larger quantity of sand was applied in order to cause more extensive drifting to occur on the model. The results of this run are shown in Figure 3-8. An interesting observation during this testing was the minimal drifting which occurred around the fuel storage tanks when compared with drifting around the buildings. This was because the circular shape of the tanks caused a smoother wind flow around them and thus reduced the eddies that caused drifting.

Figure 3-12 indicates where some drifting problem areas have existed in previous years, as defined by DCER - Special Projects Officer Northern. Comparing this with laboratory results (Figure 3-8) shows that all areas where drifting has been a problem in the past have shown considerable drifting in the laboratory.

A more recent indication of drifting provided by 1 CEU, as the result of a site visit in November 1985, is shown in Figure 3-13. Although no extensive drifting had occurred up to this time, areas where drifting was noted compared favourably with laboratory results presented in Figure 3-8. 1 CEU's information also appears to indicate

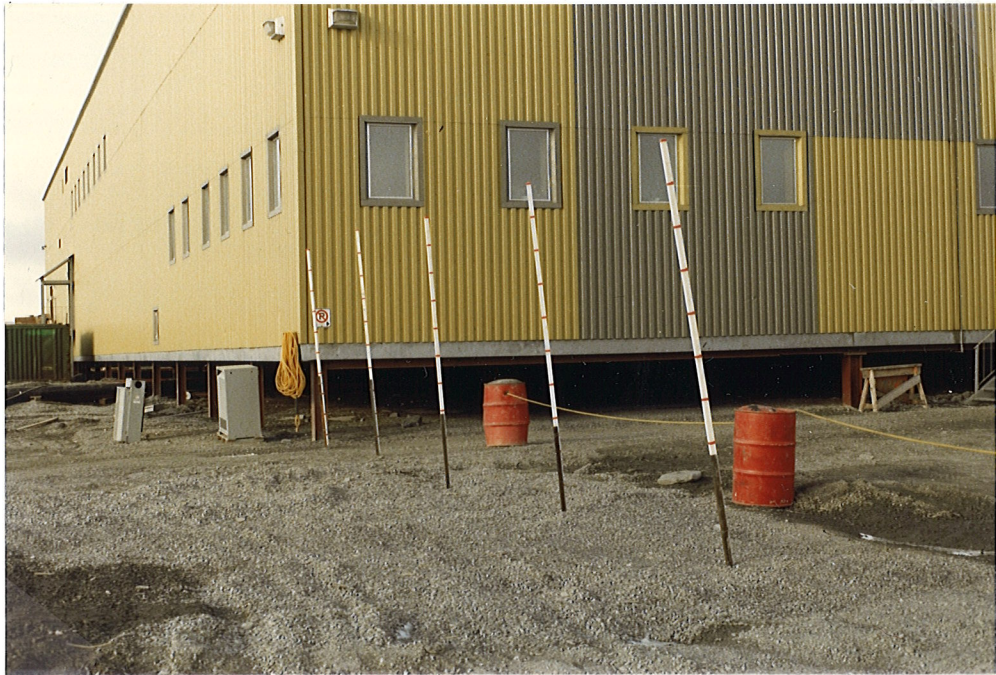
Figure 3-10 Snow Stakes Positioned

Snow stakes are positioned on east side of Building 125, location "D".

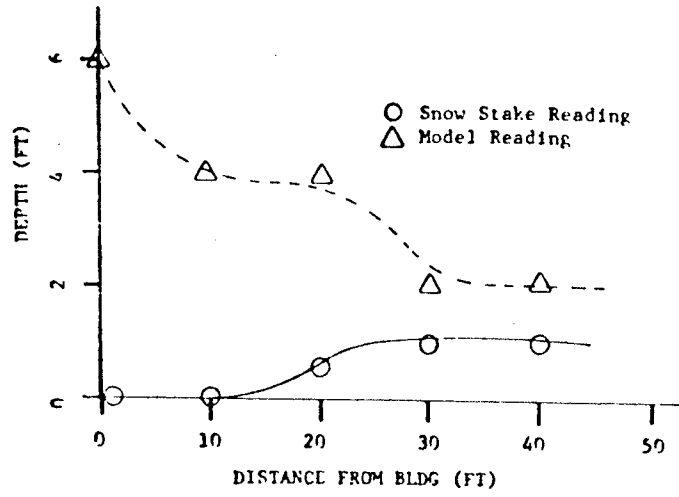
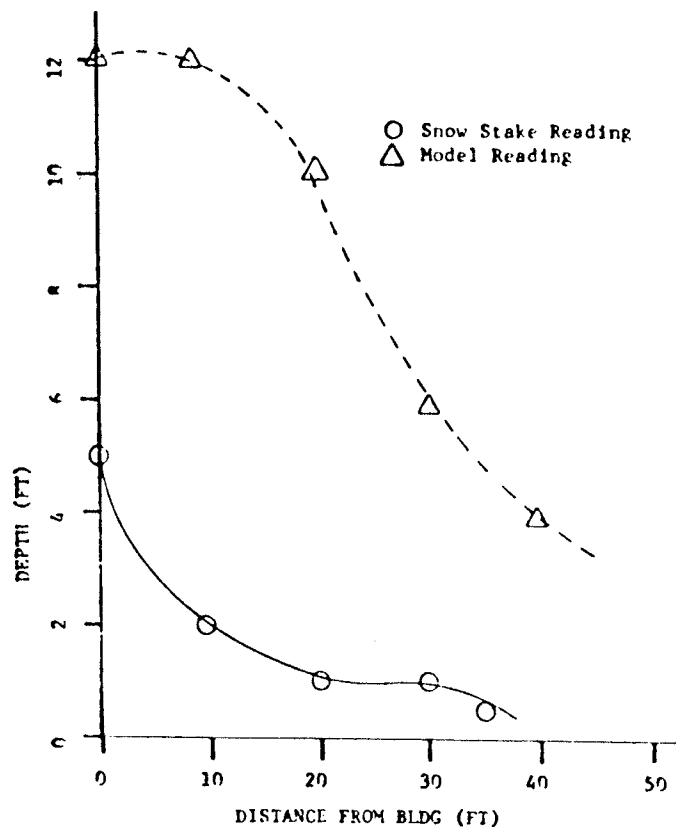
Figure 3-11 Snow Stakes and Model Readings

Area "A"

Area "B"

Area "C"

Area "D"

Area "E"

Area "F"

Area "G"

Laboratory data was then plotted against field data. These results are shown in Figure 3-11.

As can be seen from Figure 3-11 the correlation between results obtained in the field and laboratory results is somewhat inconclusive. One of the reasons for this was the fact that actual drifting at Alert was the result of winds blowing from a more westerly or northerly

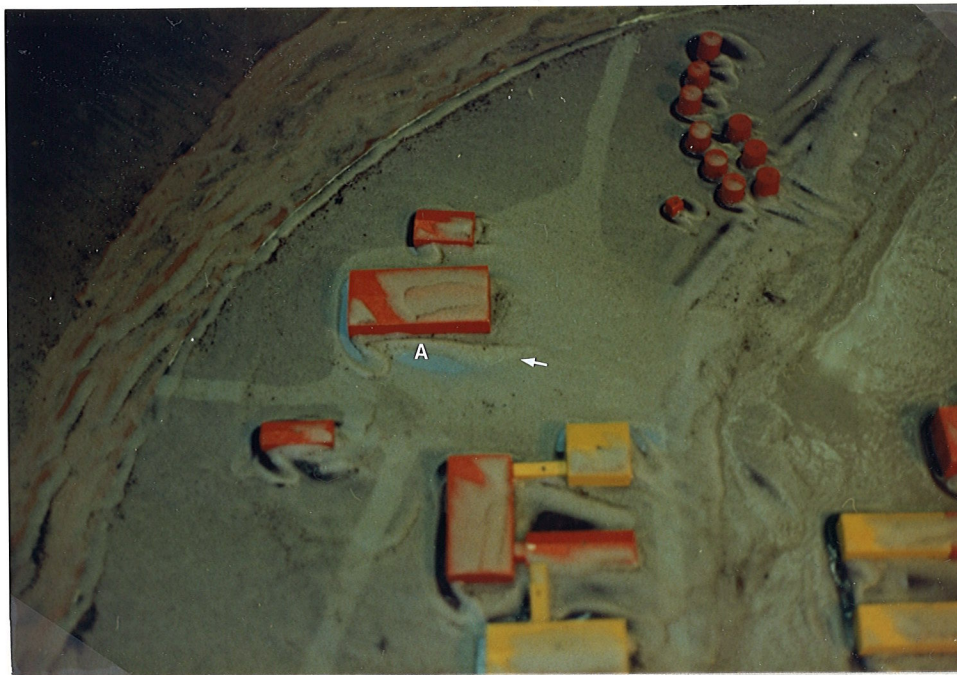
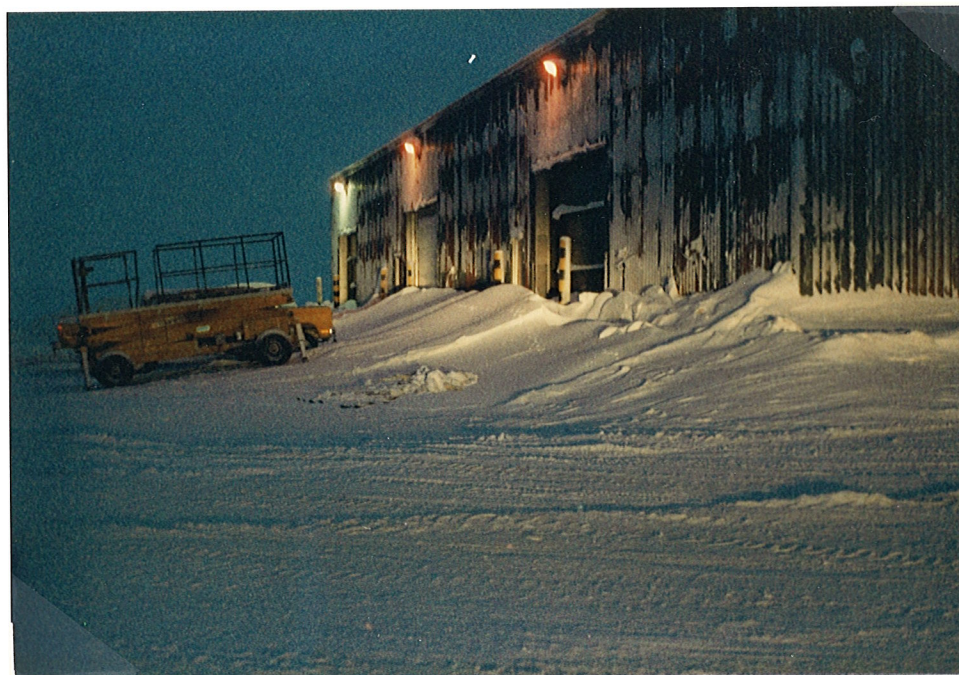
Figure 3-15 Comparison of Results

(a)

Drifting from the west (Proposal B). A large drift is formed on the southeast side of Building No. 113 (A). Arrow indicates direction from which photograph below was taken.

(b)

Drifting on the southeast side of Building No. 113. Photo taken during site visit, 14 February 1986.

actual drifting on site. Figure 3-15 (a) shows the drifting pattern obtained when testing Proposal B from the west. This figure provides a close look at the drifting on the southeast side of Building No. 113. Figure 3-15 (b) shows the on site drifting during the February site visit. As can be seen from Figure 3-15, results in the laboratory are almost identical to actual onsite drifting.

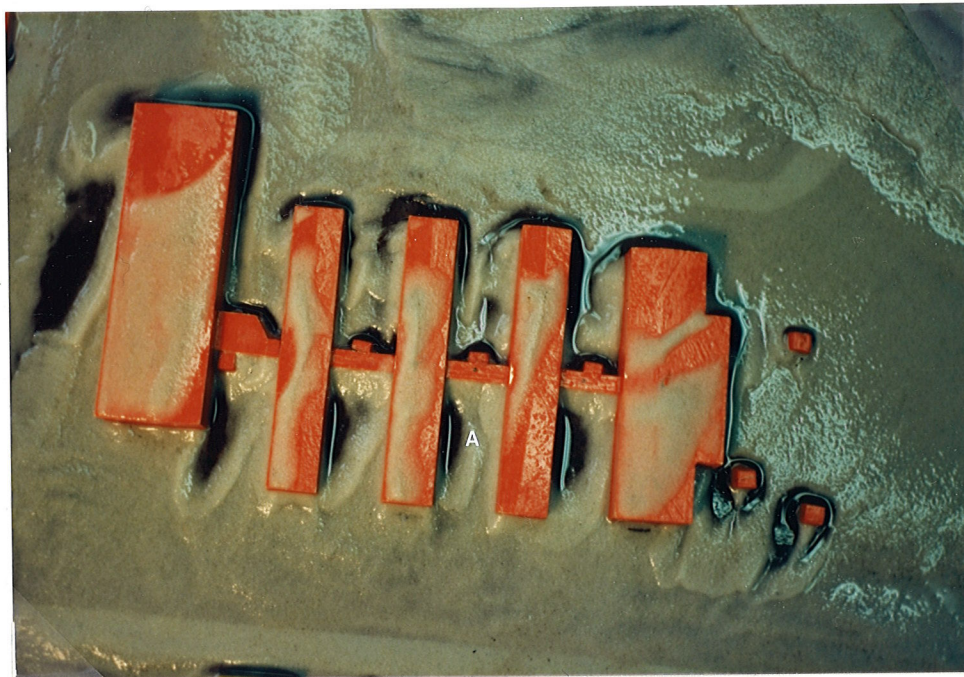
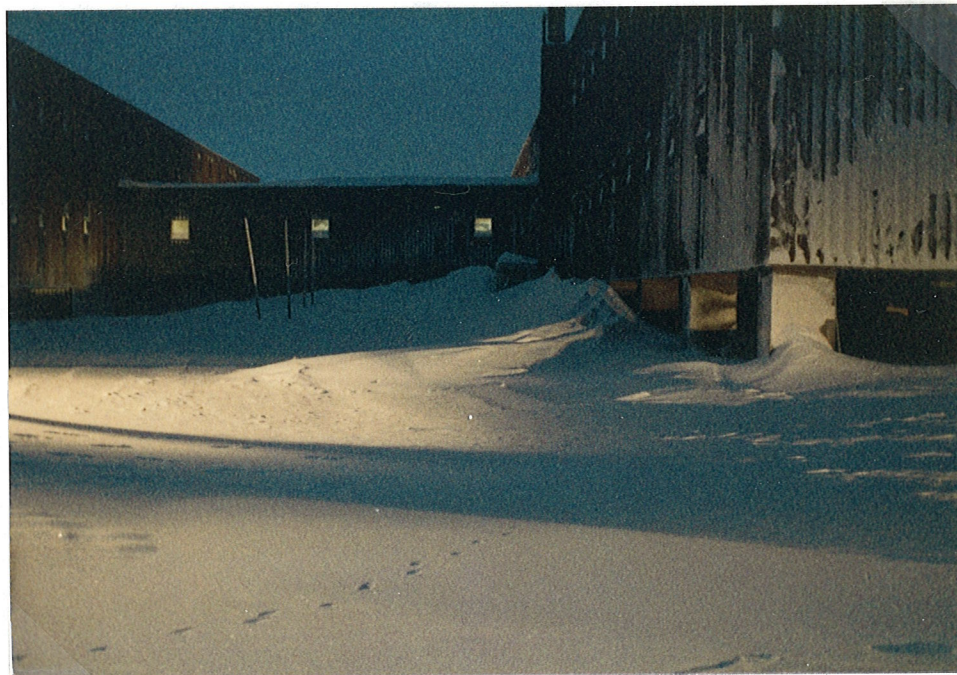
Figure 3-16 Comparison of Results

(a)

Drifting from the west (Proposal C). Note the drifting pattern which has occurred between the barrack blocks (A).

(b)

Drifting in area (A) above during site visit, 14 February 1986.

In Figure 3-16 another comparison was made between laboratory results and actual on site drifting. Here, drifting is shown between Barrack Block Nos. 115 and 116, and the similarity of results with on site drifting. Although the pattern is similar, some scouring has occurred on site because the barrack blocks are approximately 1 metre above ground, while on the model the buildings were not raised.

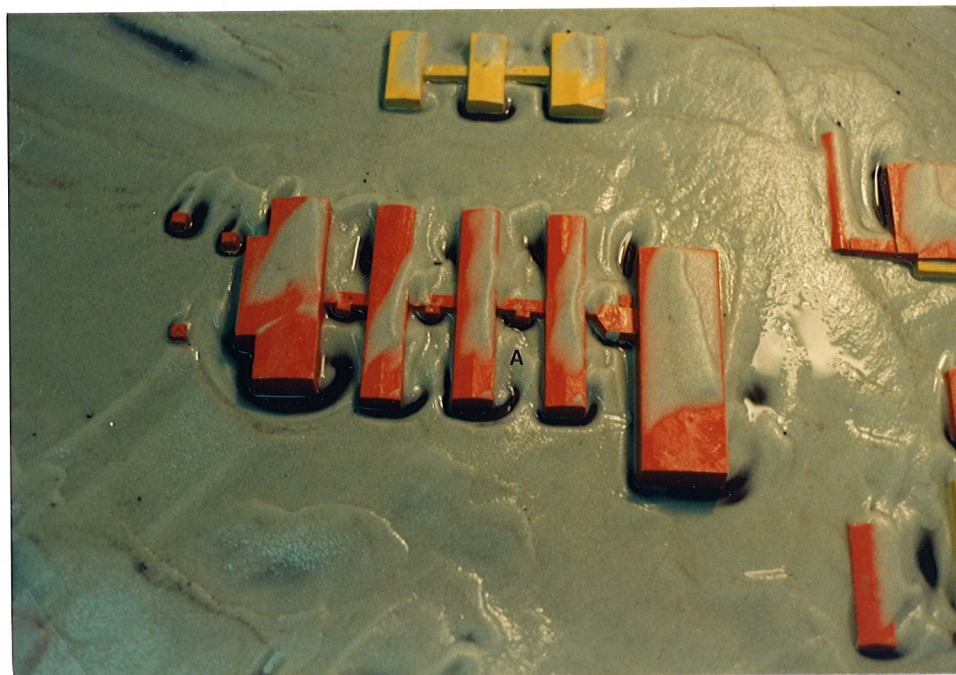
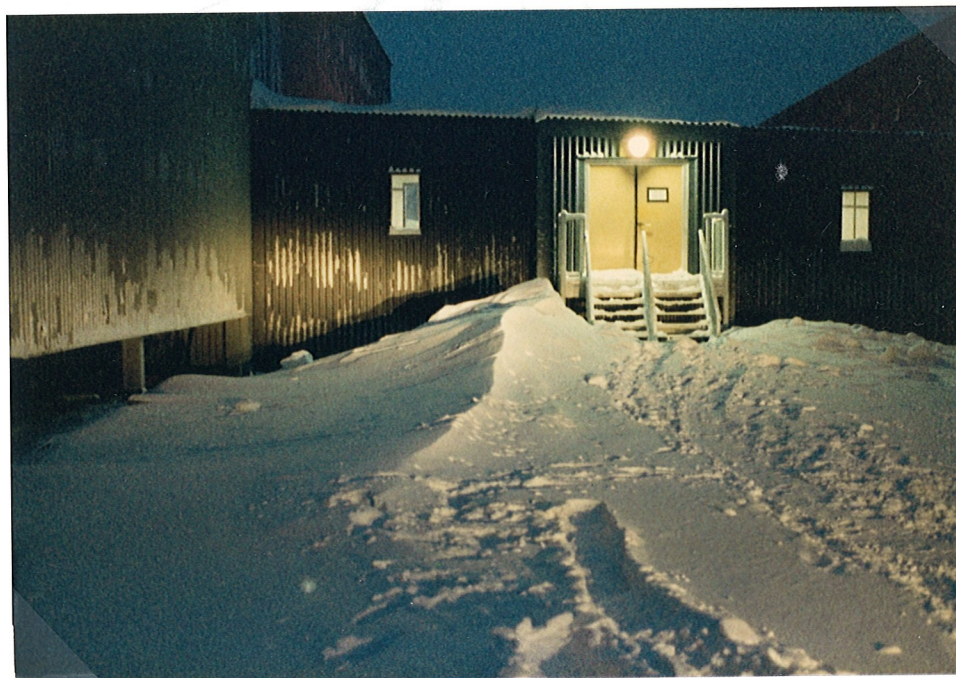
(a)

Drifting from the west (Proposal C). Drifting is evident between the barrack blocks, especially on the southeast side (A).

(b)

Drifting in area (A) above during site visit, 14 February 1986.

In Figure 3-17 drifting between the barrack blocks is viewed from the southwest. Again actual drifting on site, although similar to test results, has been scoured because of the raised barrack blocks.

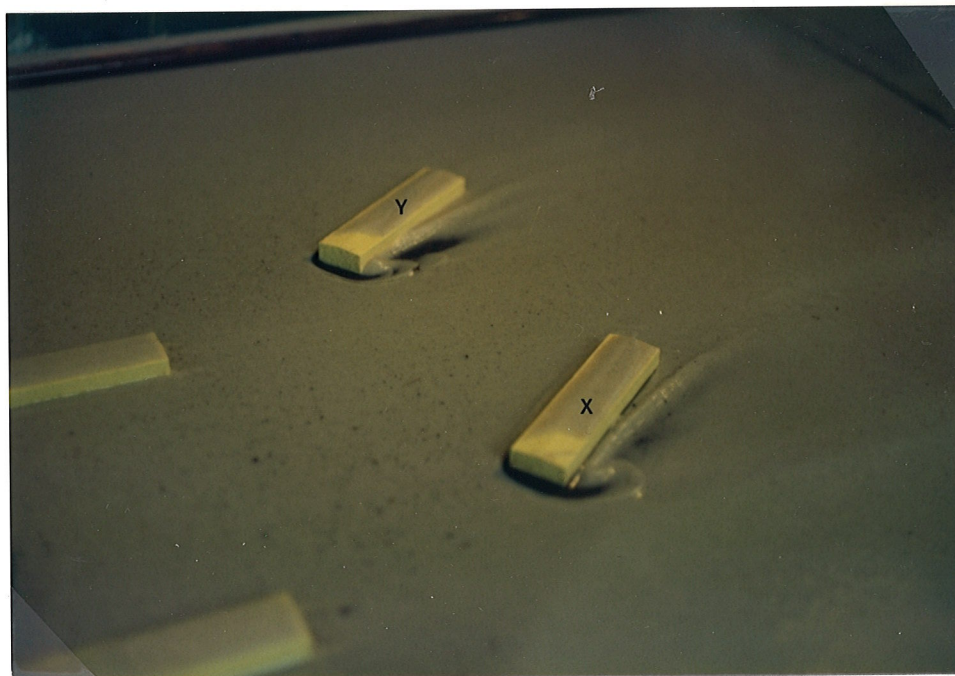
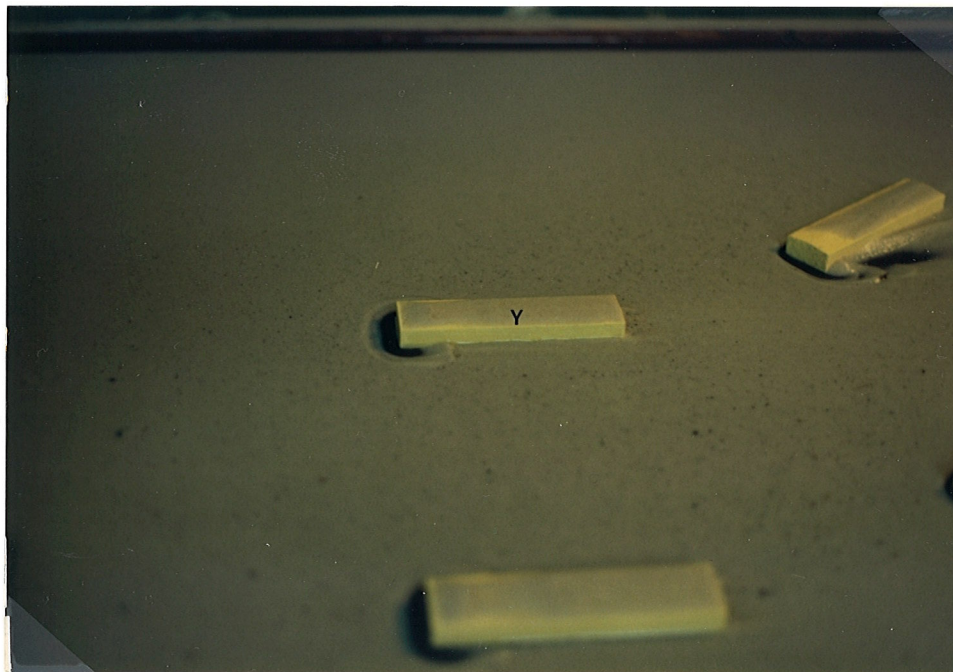
Figure 3-21 Drifting on Test Buildings

(a)

Drifting appears to be very similar around both pair of buildings. Raised buildings are indicated by "X" while ground level buildings are indicated by "Y". Arrow indicates flow direction.

(b)

Scouring is occurring along the side of the raised building (X) while the ground level building has drifting against the side (Y).

(c)

Drifting has been scoured along the side of the raised building (X).

(d)

Drifting is against the side of the ground level building (Y).

The buildings were placed in the water flume on a flat piece of plywood so that the drifting would be directed to the end of two buildings (one building raised and one flat) while the other two buildings were placed at 45° to the first two (again with one building raised and one flat) as per Figure 3-20. One test run was then conducted with the results presented in Figure 3-21.

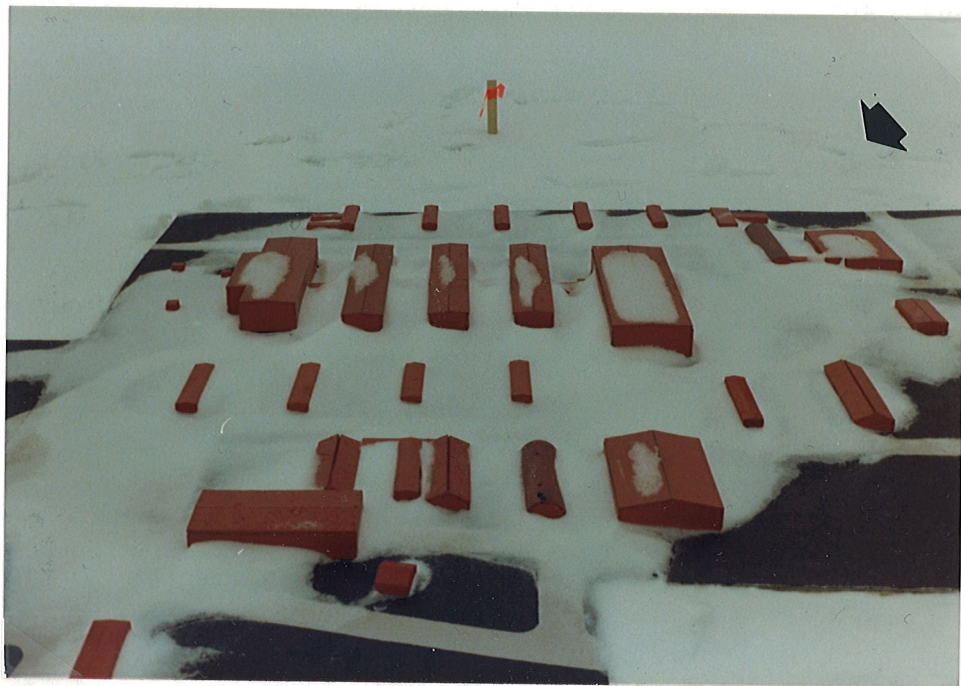
Figure 4-4 Outdoor Model - 3 February 1986

Drifting on the model had occurred from the east (with respect to the model). Although snow drifting from winds in this direction is not considered a problem, the result illustrates the type of drifting which can occur on the model. Arrow indicates wind direction.

model would occur from the west or southwest with respect to it, these results were only useful in that they showed the type of drifting the model might produce. Figure 4-4 shows the results of this test.

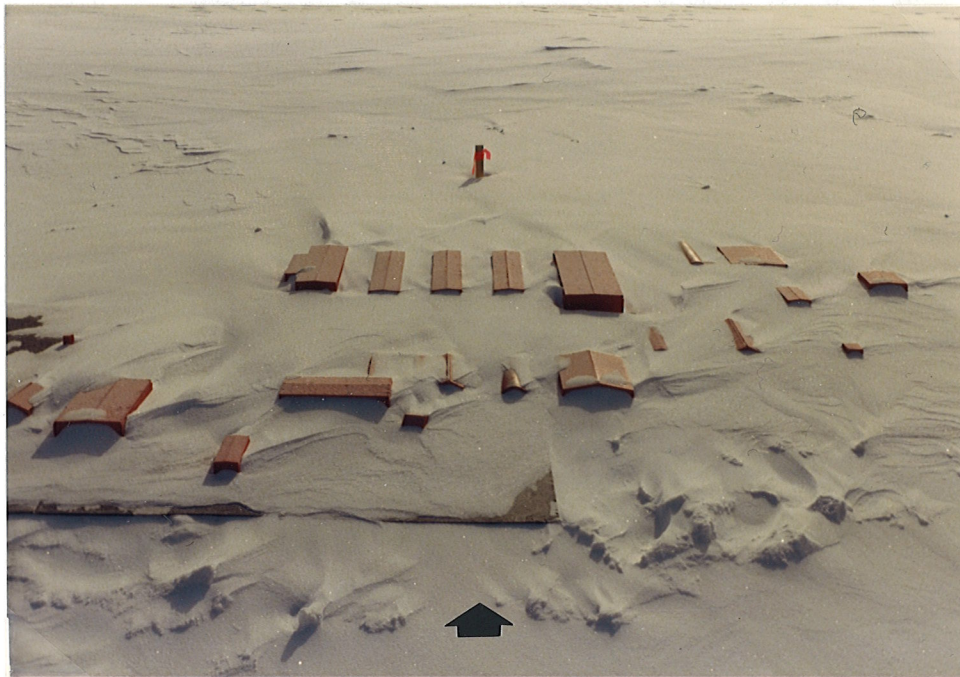
Figure 4-6 Outdoor Model - 10 February 1986

View from the southwest.

Drifting on the model has occurred from the southwest. As can be seen, the drifting has completely covered many of the buildings making any comparison with other data very difficult. Arrow indicates wind direction.

The third set of results was obtained on 10 February, after drifting had occurred from the northwest. With respect to the model, this drifting was from the "southwest". As can be seen from the results (Figure 4-6), many of the buildings have been completely covered with drifting snow, making it impossible to determine drifting patterns. Because of the extent of snow coverage, it was not possible to make any correlation with results obtained in the water flume or actual drifting on site.

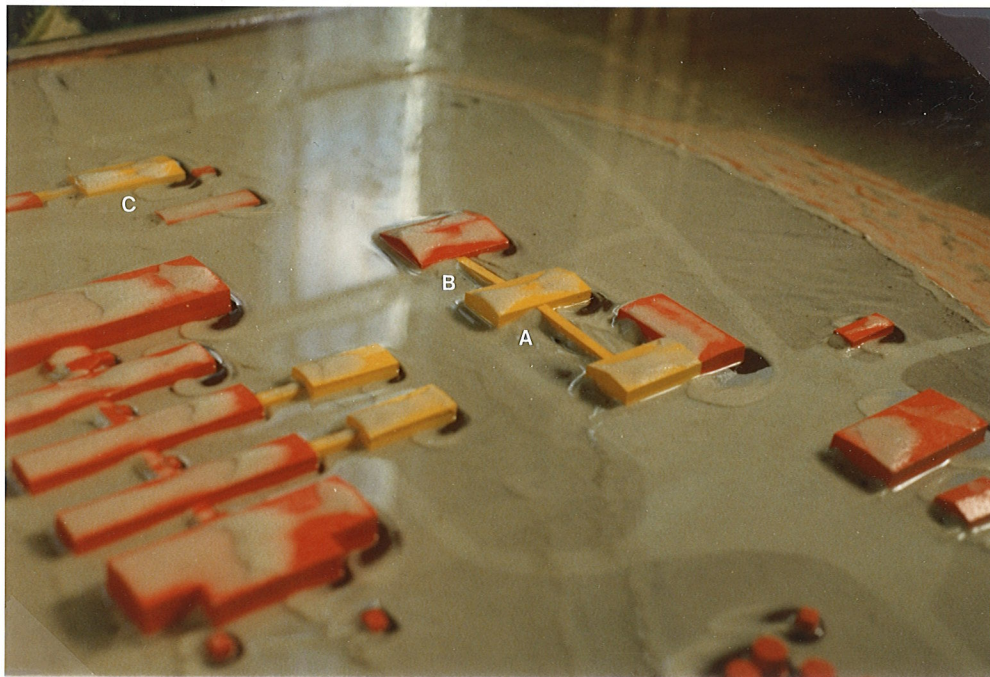
Figure 5-4 Proposal A - Heavy Drifting from the Southwest

(a)

View from the north. Arrow indicates wind direction.

(b)

View from the north. Note the large drifts formed on the northeast sides of the new firehall (A) and the supply building (B). Extensive drifting can also be seen on the northeast side of the new power plant (C).

For this test, the model was first oriented so that direction of flow would be from the southwest. As in the previous test, two runs were conducted, the first with a small amount of sand and the latter with a larger amount. Test results from the first and second run are shown in Figures 5-3 and 5-4 respectively.

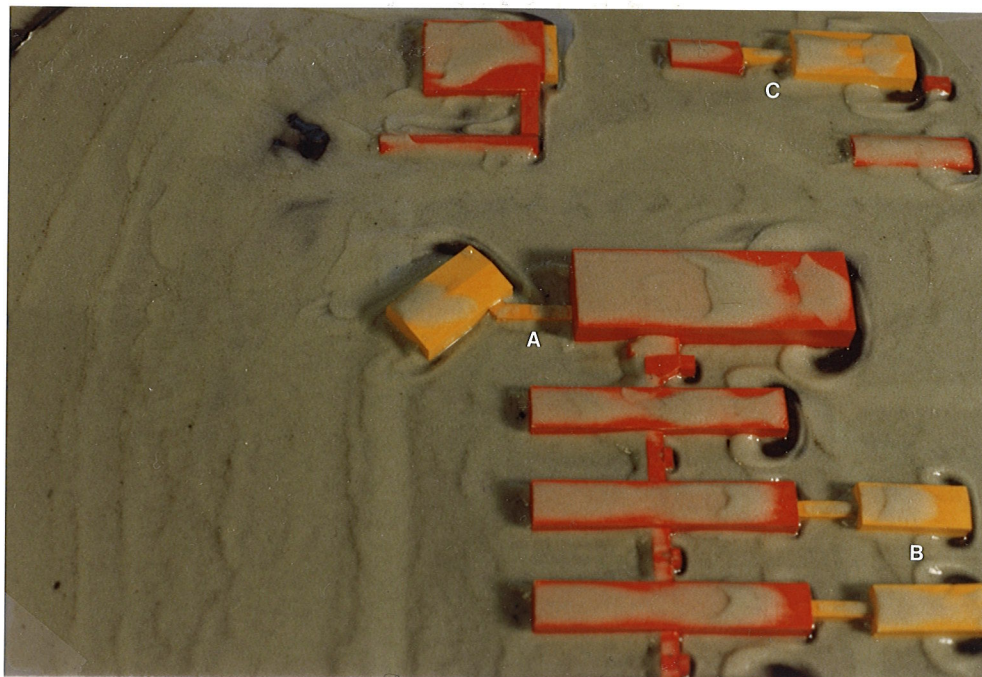
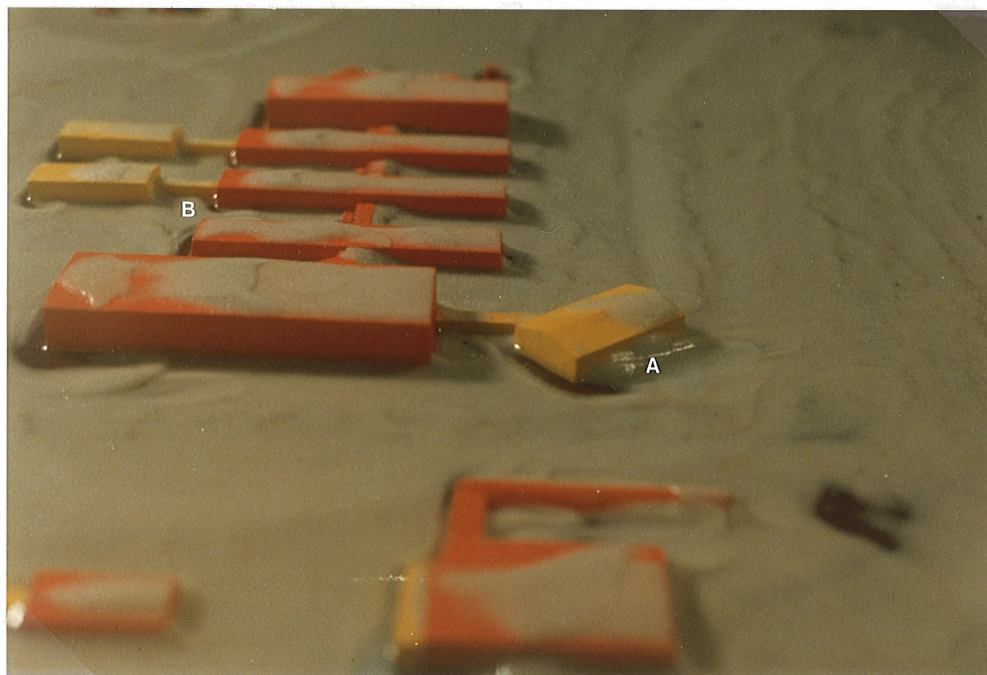
Figure 5-4 Proposal A - Heavy Drifting from the Southwest (Continued)

(c)

View from the northeast. Extensive drifting has occurred along the linkway to the new Senior Staff Mess and Quarters (A). Extensive drifting can also be seen between the transient quarters (B) and the north corner of the new power plant (C).

(d)

View from the southeast. Note the large drifts that have formed on the east side of the new Senior Staff Mess and Quarters (A). Drifting can also be seen near the linkways to the new transient quarters (B).

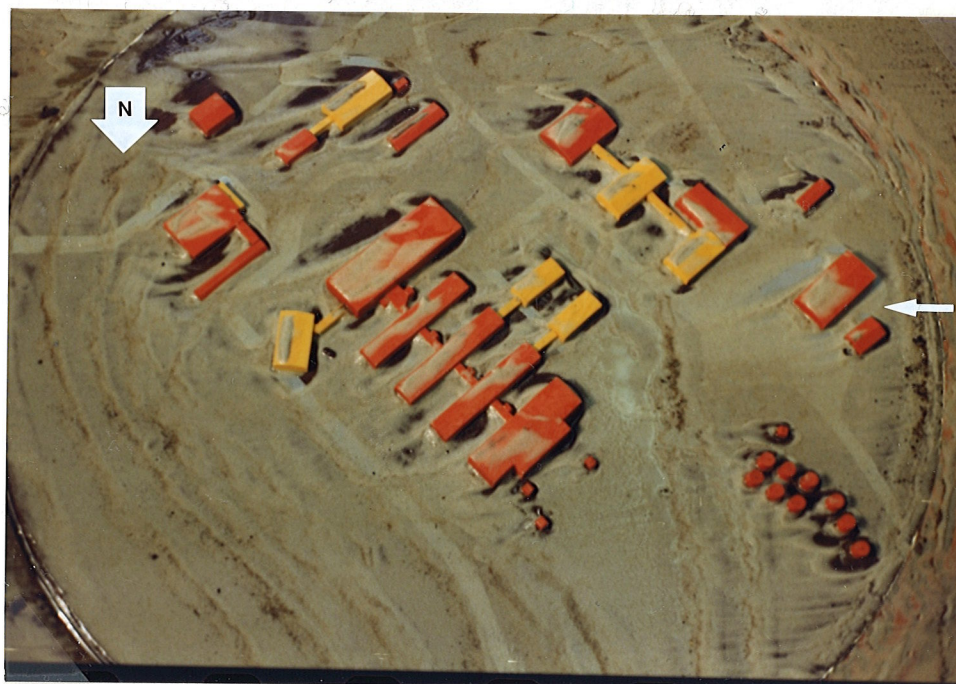
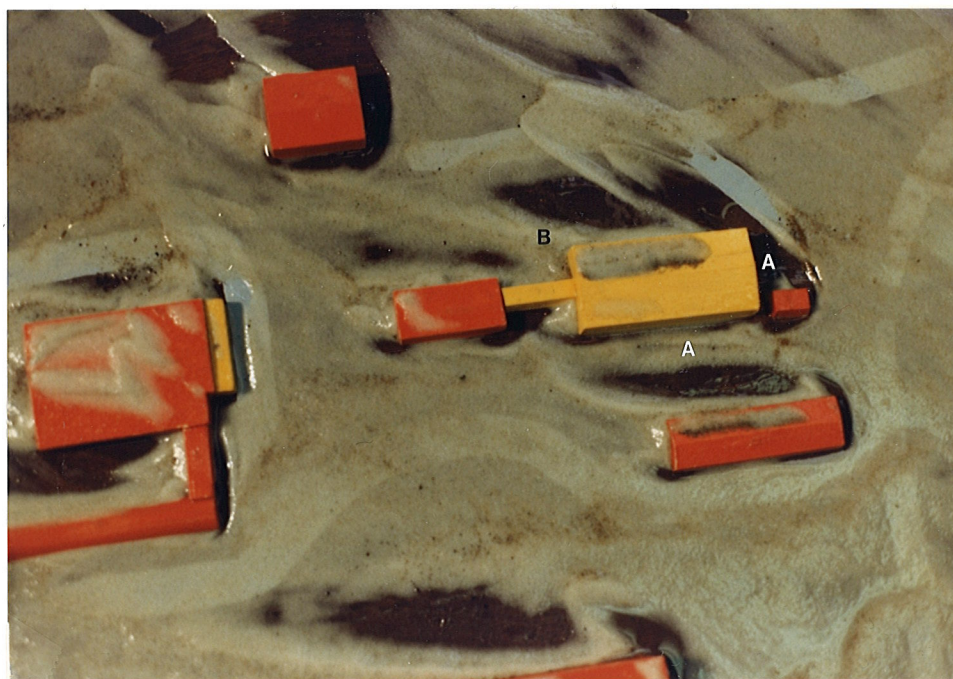
Figure 5-5 Proposal A - Light Drifting from the West

(a)

View from the north. Arrow indicates wind direction.

(b)

The new power plant is mostly clear of snow to southwest and northwest (A). Drifting, however, has developed on both sides of the linkway and on the southeast side (B).

The model was then rotated so that wind direction would be from the west and two more runs similar to the previous testing, were conducted. The results obtained from these tests are presented in Figures 5-5 and 5-6 respectively.

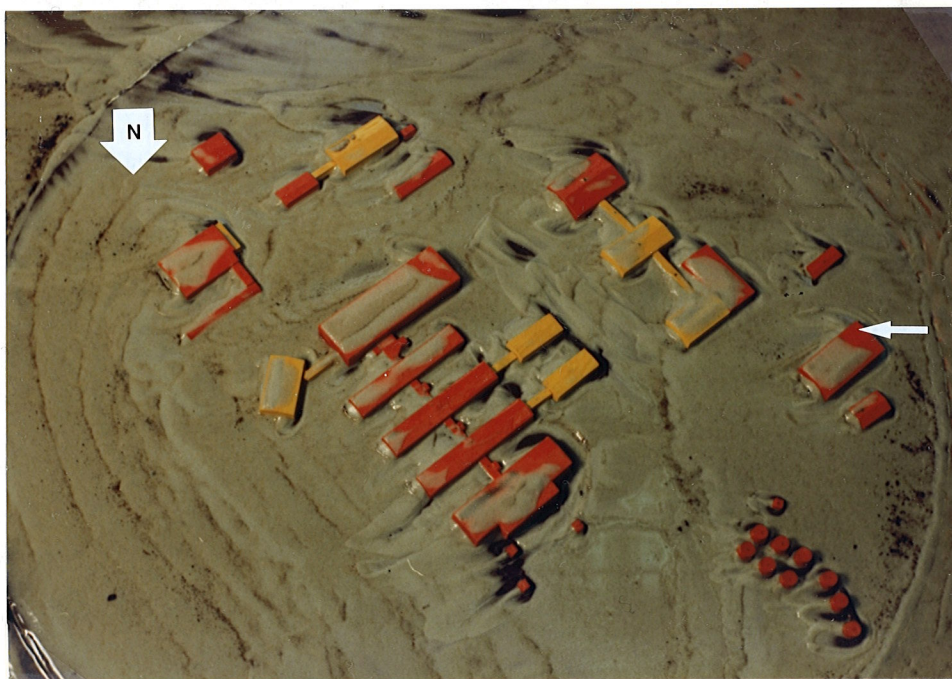
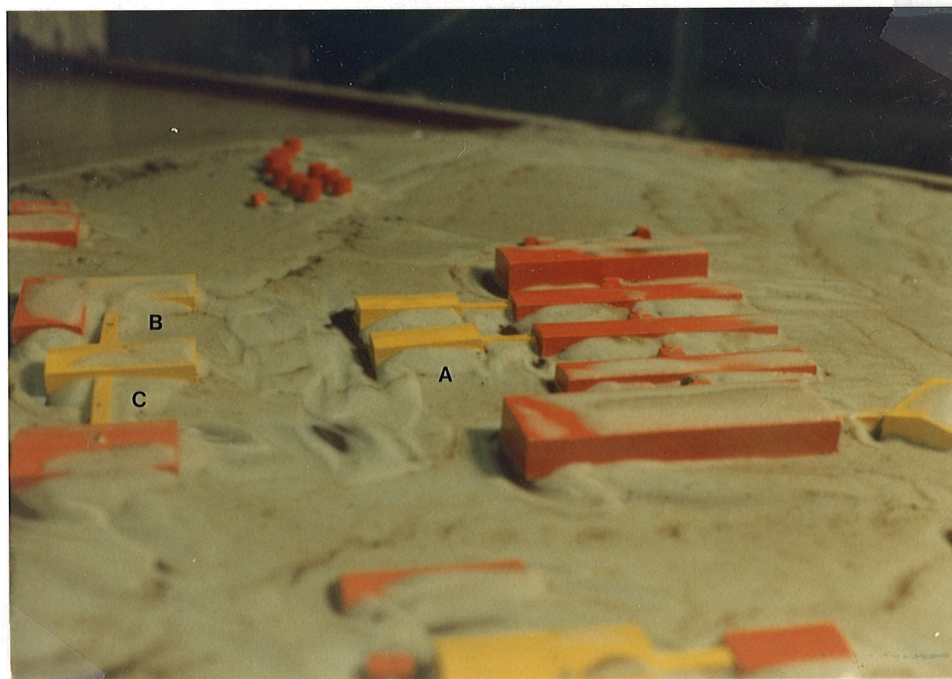
(a)

View from the north. Arrow indicates wind direction.

(b)

View from the northwest. Extensive drifting can be seen on the southeast sides of the transient quarters (A), the MSE Supply (B) and the firehall (C).

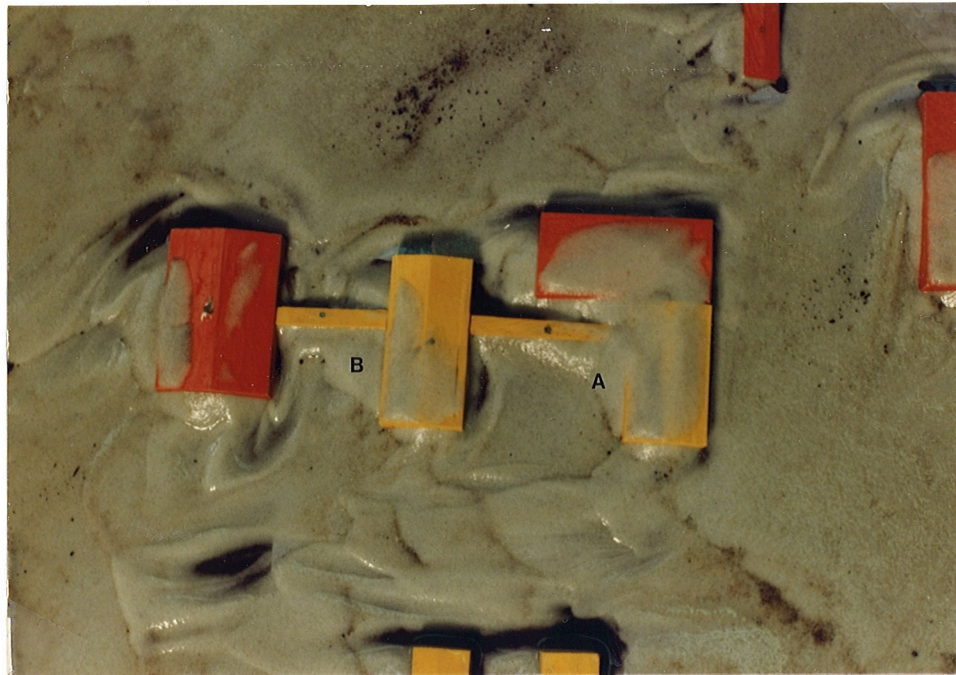
Figure 5-6 Proposal A - Heavy Drifting from the West (Continued)

Top view of technical buildings again show the drifting on the southeast sides of MSE Supply (A) and the firehall (B).

Extensive drifting can be seen on the southeast side of the linkway to the Senior Staff Mess (A) and on the southeast side of the transient quarters (B). Drifting between the barrack blocks is also extensive (C).

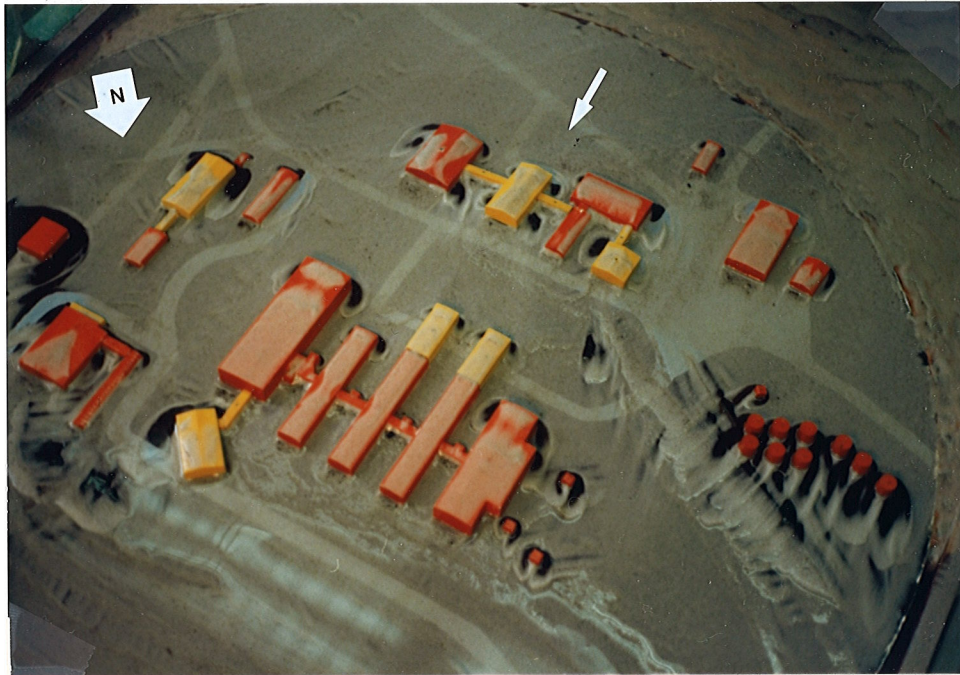
Figure 5-9 Proposal B - Light Drifting from the Southwest

Similarly to the previous proposal, Proposal B was tested from both the west and southwest, with both light and heavy drifting for each direction. The results for drifting from the southwest, with light and heavy drifting, are shown in Figure 5-9 to 5-10 respectively, while Figures 5-11 and 5-12 respectively contain the results for light and heavy drifting from the west.

View from the north. Arrow indicates wind direction.

View from the west. Extensive drifting is occurring between the new MSE Building and Building No. 16 (A) and on the northwest side of the linkway and in front of Building No. 17 (B).

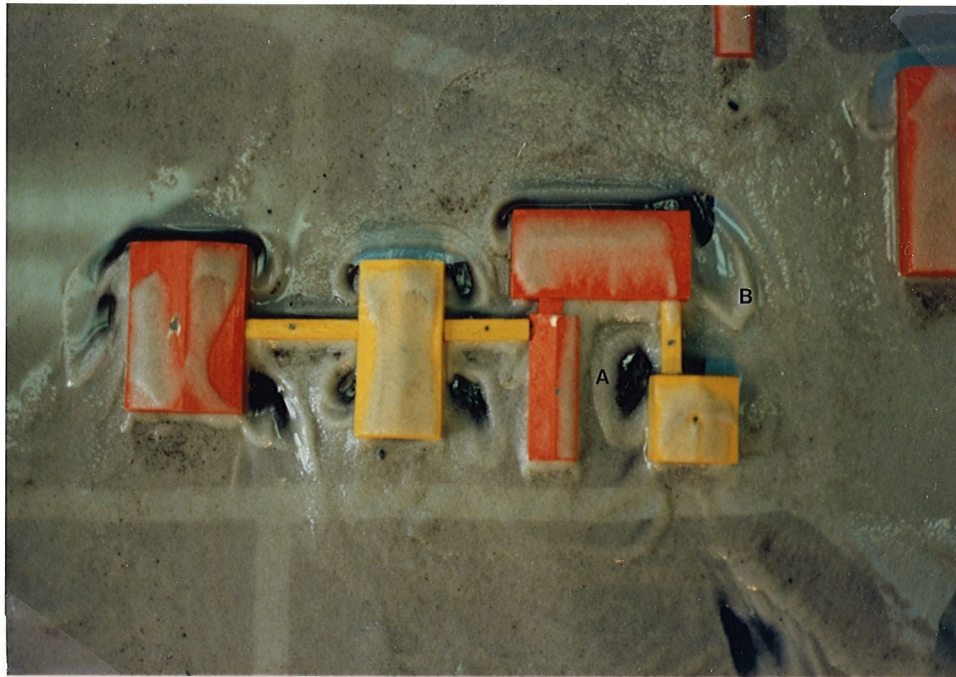
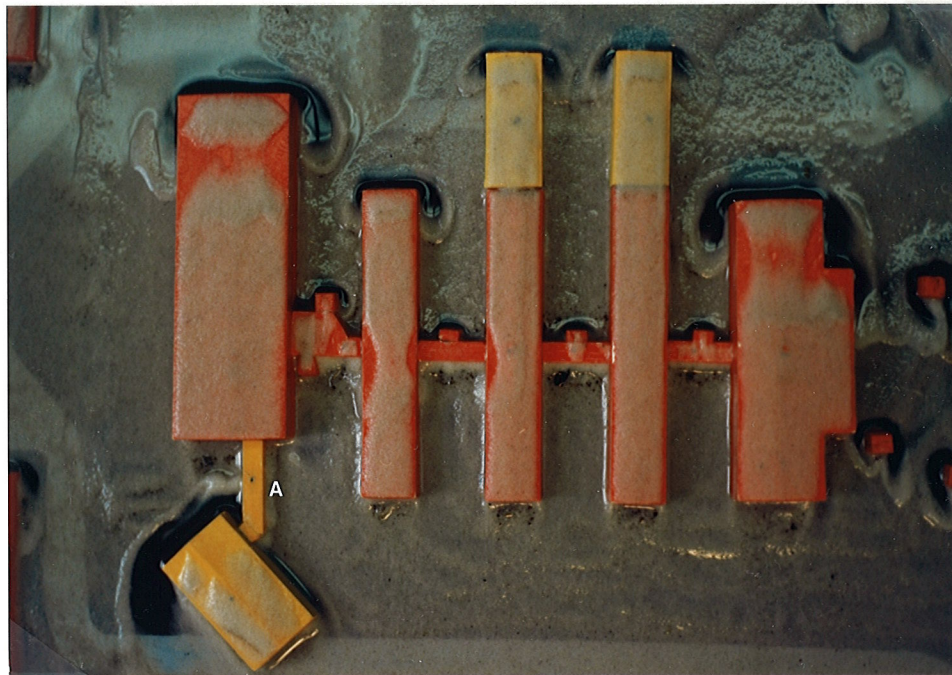
Figure 5-9 Proposal B - Light Drifting from the Southwest (Continued)

Top view of technical buildings. Large drifting is evident between Building No. 16 and the new MSE Building (A) and in front of the MSE Garage (B).

Drifting is event around the linkway to the Senior Staff Mess (A), however, no serious drifting is occurring around the transient quarters.
