SNOW DRIFT STUDY
CANADIAN FORCES STATION ALERT

A Practicum
presented to the University of Manitoba
in partial fulfillment of the
requirements for the degree of
MASTER OF CITY PLANNING
in
DEPARTMENT OF CITY PLANNING

Winnipeg, Manitoba, 1986

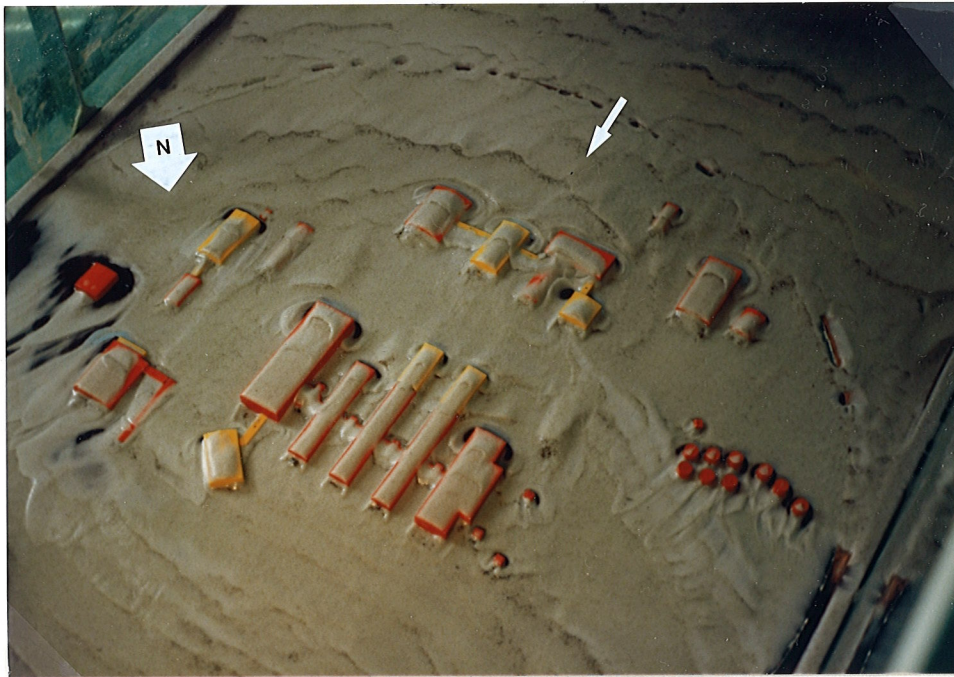
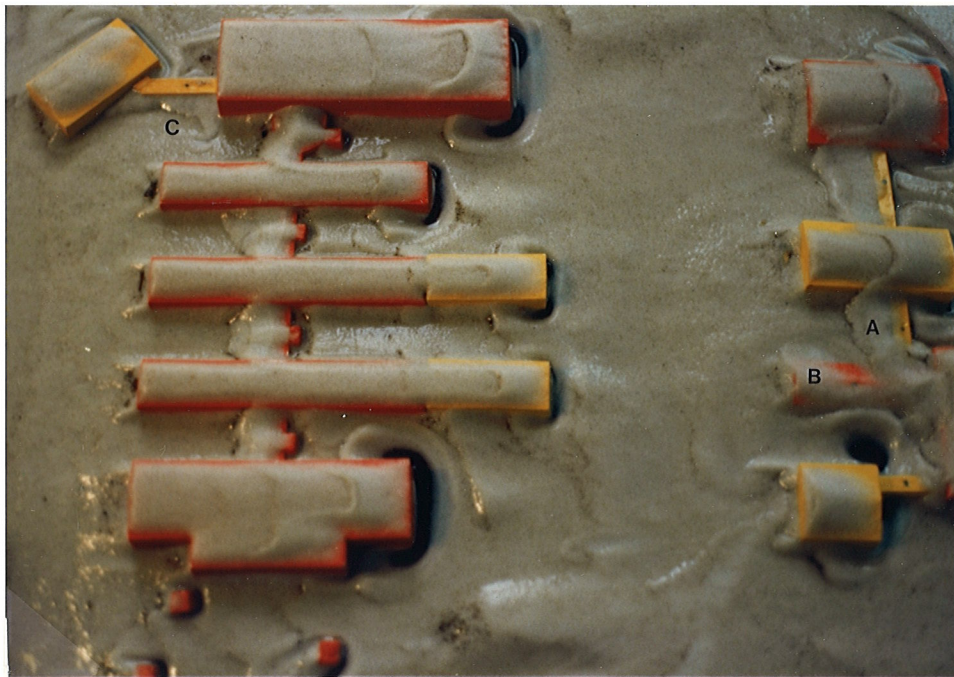
Figure 5-10 Proposal B - Heavy Drifting from the Southwest

View from the north. Arrow indicates wind direction.

Extensive drifting has occurred on the northeast side of the linkways joining the technical buildings (A) with Building No. 16 almost buried (B). Drifting is also heavy along the linkway to the Senior Staff Mess (C).

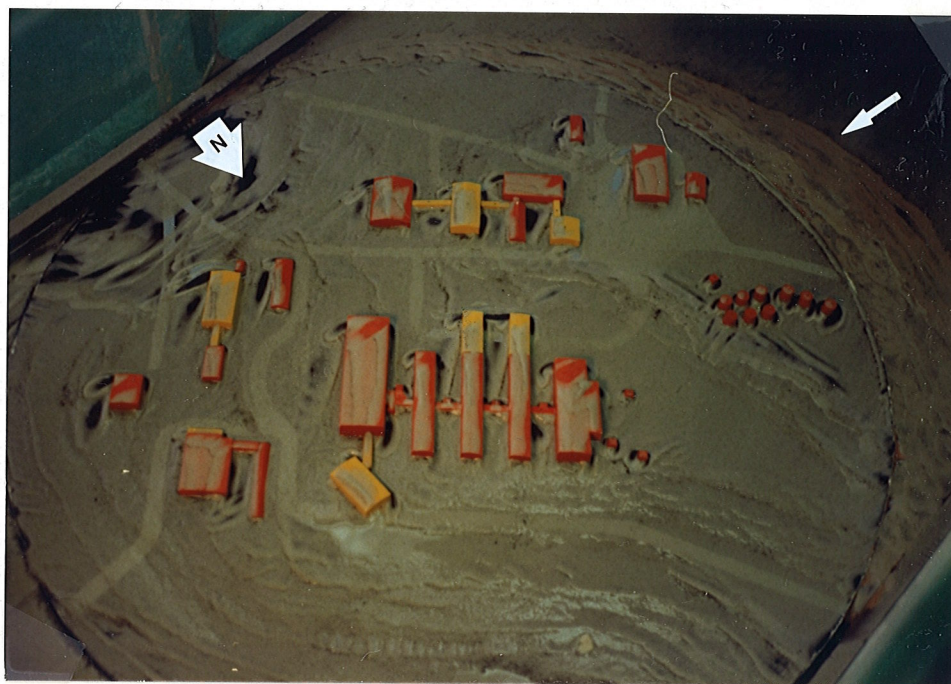
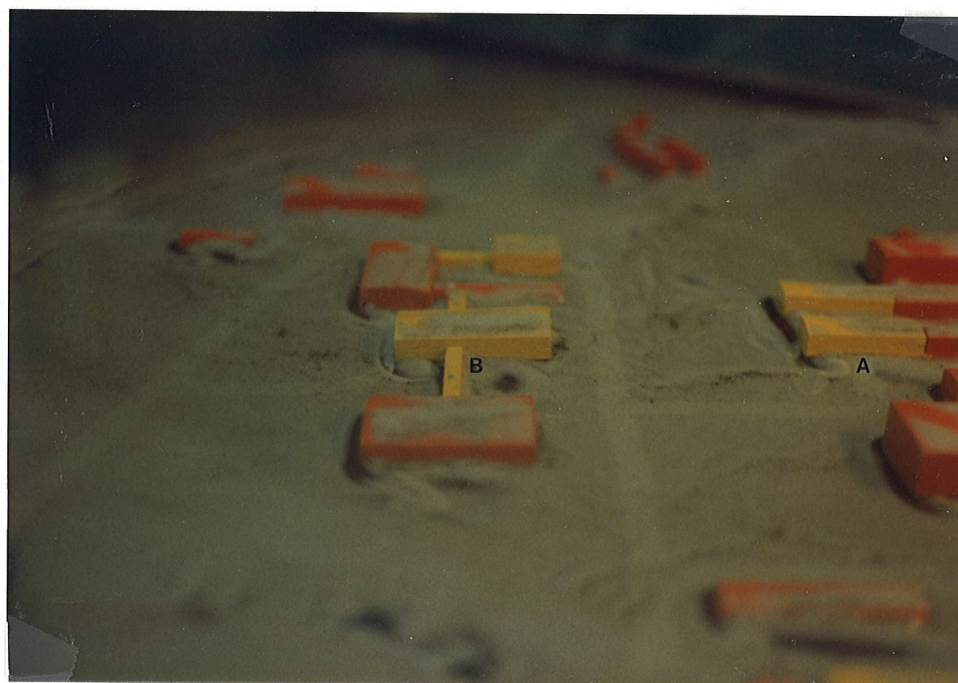
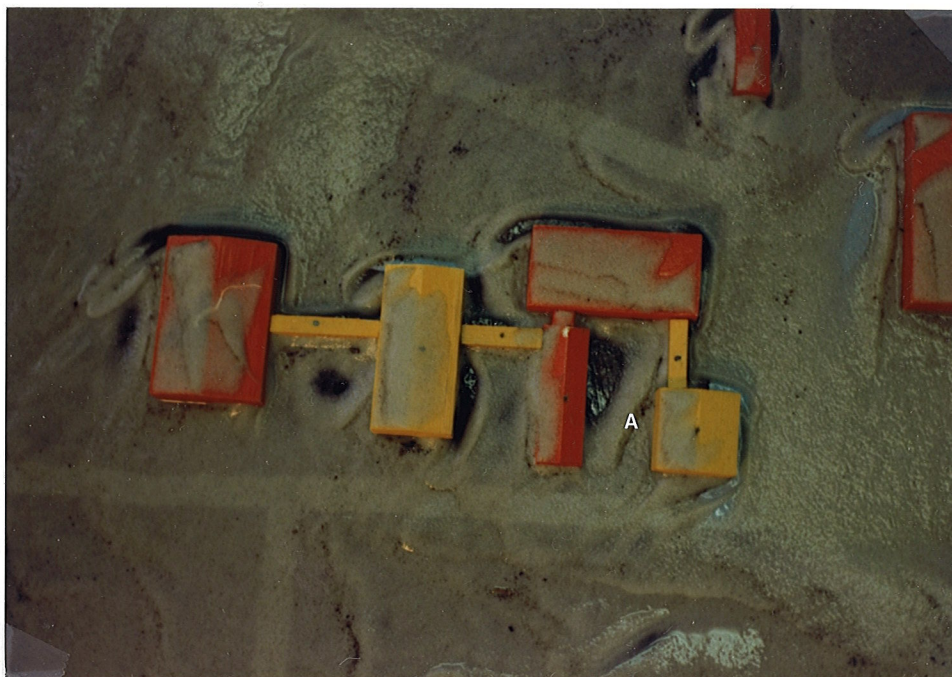
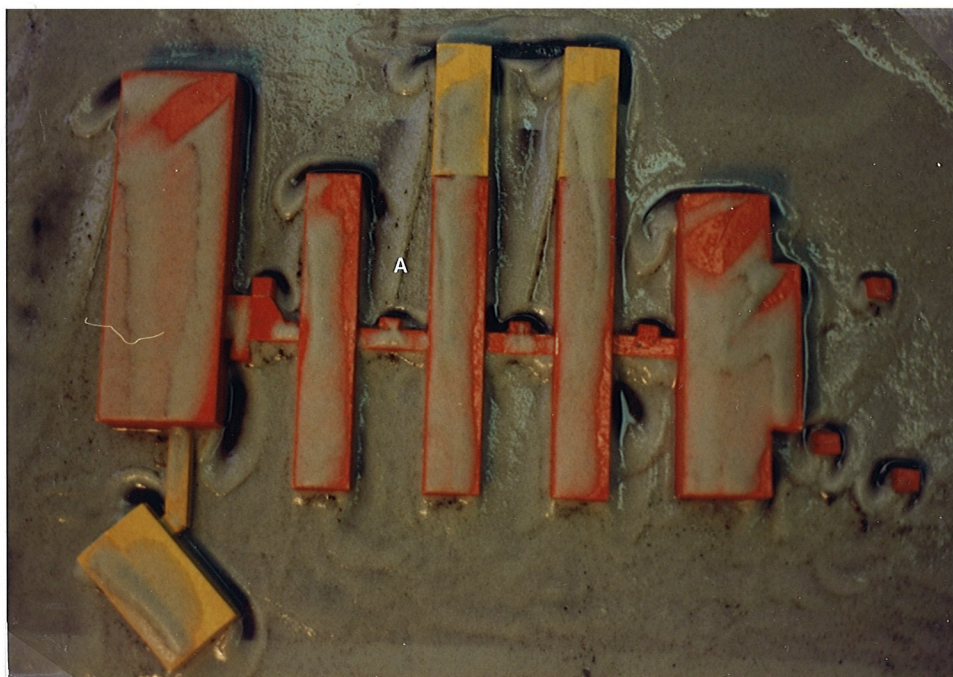
Figure 5-11 Proposal B - Light Drifting from the West

View from the northeast. Arrow indicates wind direction.

View from the southeast. Drifting is developing on the southeast side of the transient quarters (A) and the firehall (B).

Top view of the technical buildings. A large drift has formed between Building No. 16 and the new MSE Building (A).

Large long drifts on the southeast sides of barrack blocks No. 115 and 116 have formed as a result of the new transient quarters (A).

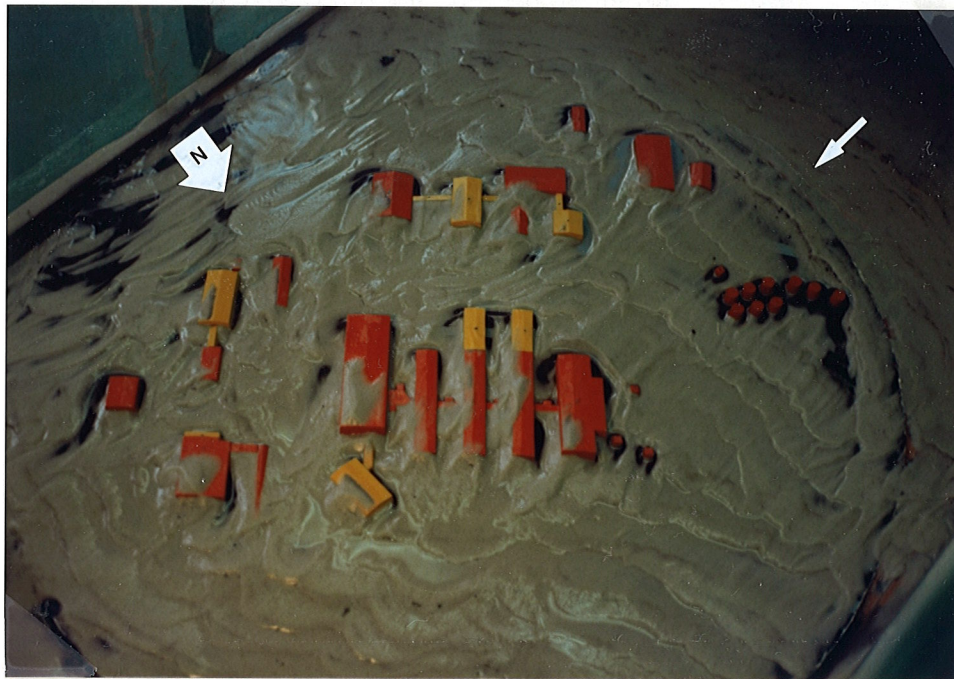
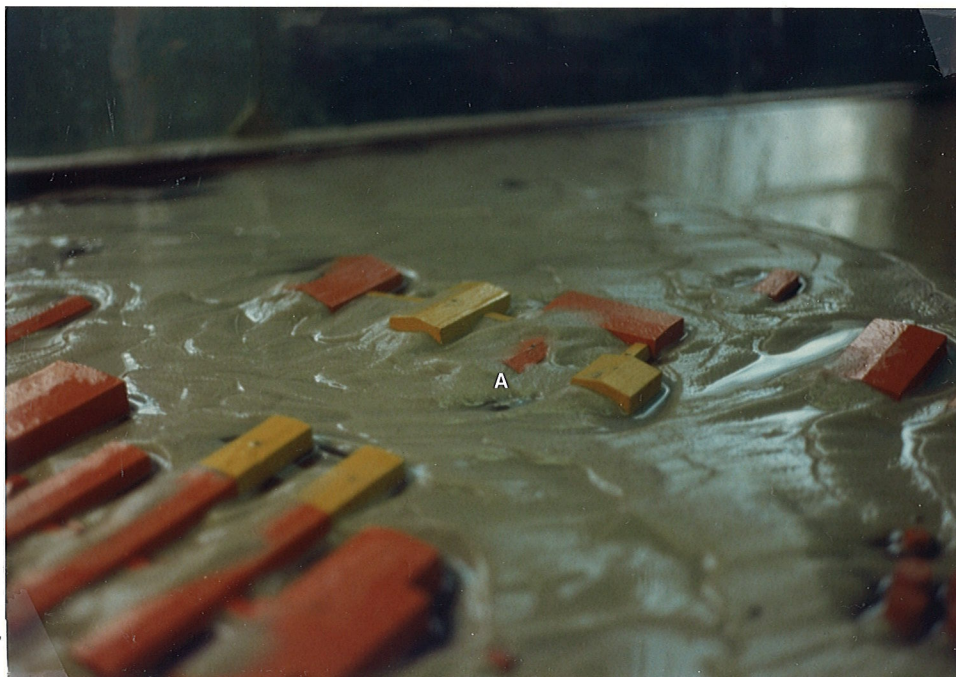
Figure 5-12 Proposal B - Heavy Drifting from the West

View from the northeast. Arrow indicates wind direction.

View from the north. Extensive drifting has occurred around the technical buildings with Building No. 16 almost buried (A).

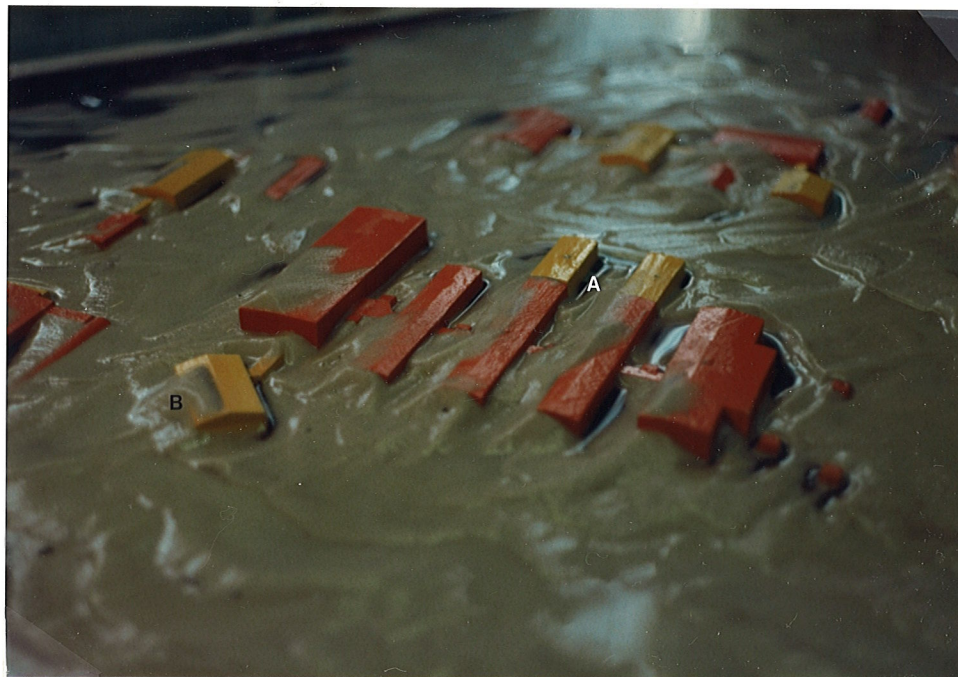
Figure 5-12 Proposal B - Heavy Drifting from the West (Continued)

View from the northeast. The northwest sides of the transient quarters are almost clear of drifting (A). Heavy drifting has occurred on the east side of the Senior Staff Mess (B).

The southeast side of barrack blocks Nos. 115 and 116 have extensive drifting as a result of the transient quarters (A).

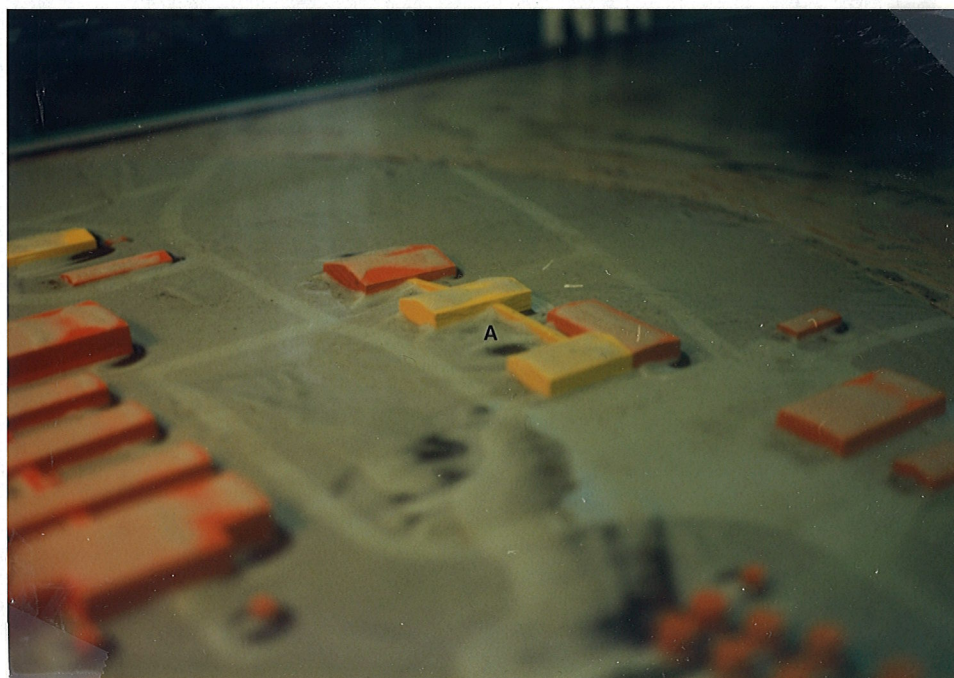
Figure 5-16 Proposal C - Light Drifting from the Southwest

View from the west. Arrow indicates wind direction.

View from the north. Drifting is starting to occur on the northeast side of the linkways between the technical buildings (A).

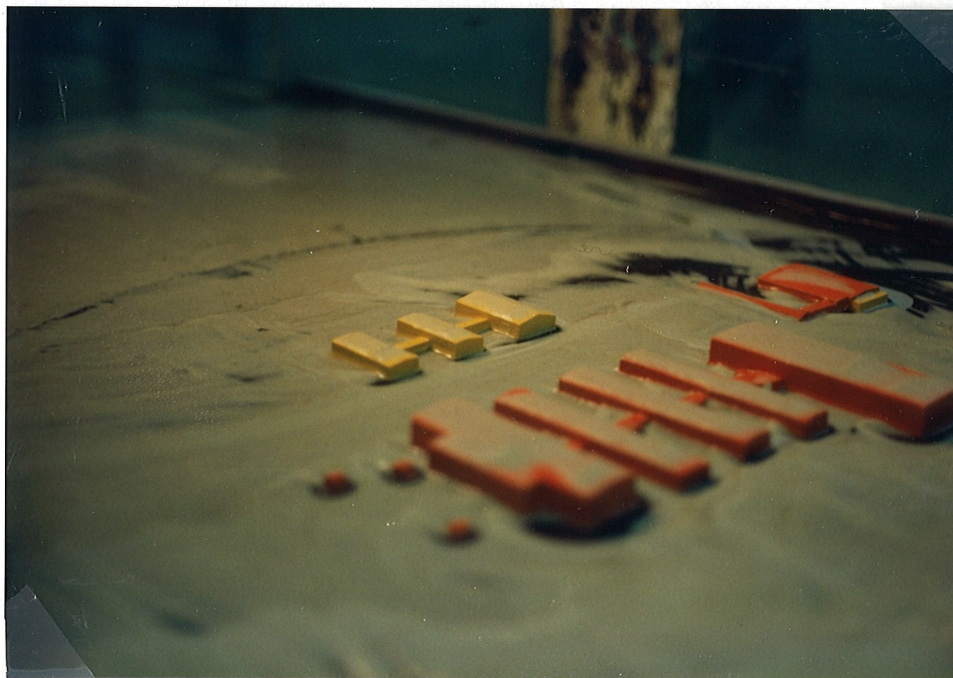
Figure 5-17 Proposal C - Heavy Drifting from the Southwest

View from the west. Arrow indicates wind direction.

Drifting is very light around the Senior Staff Mess and transient quarters.

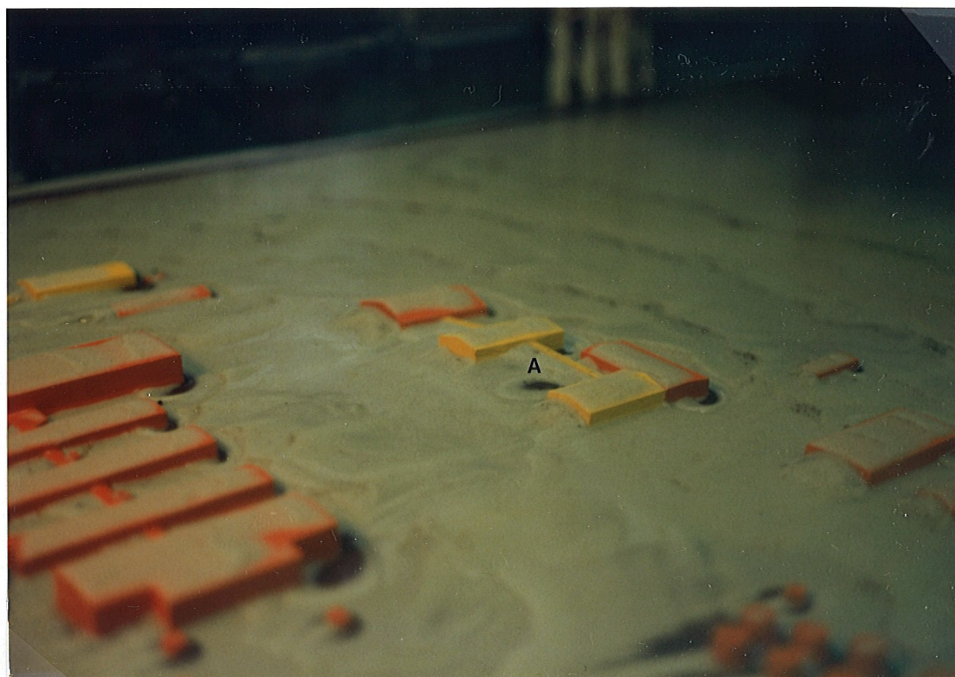
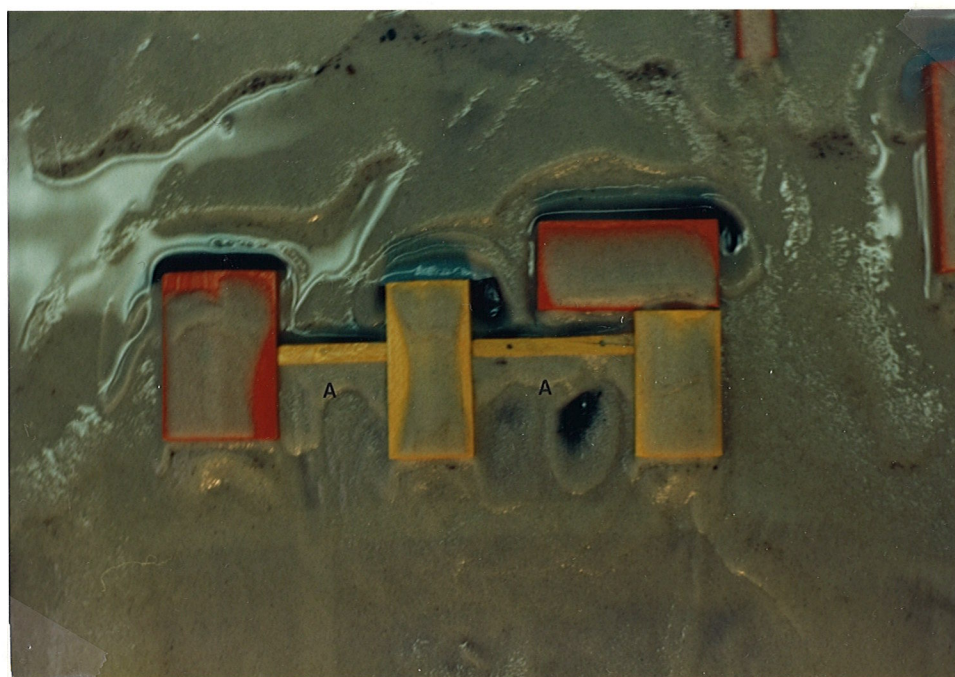
Figure 5-17 Proposal C - Heavy Drifting from the Southwest
(Continued)

Drifting is extensive northeast of the linkways joining the technical buildings (A).

Top view of technical buildings showing drifting northeast of linkways (A).

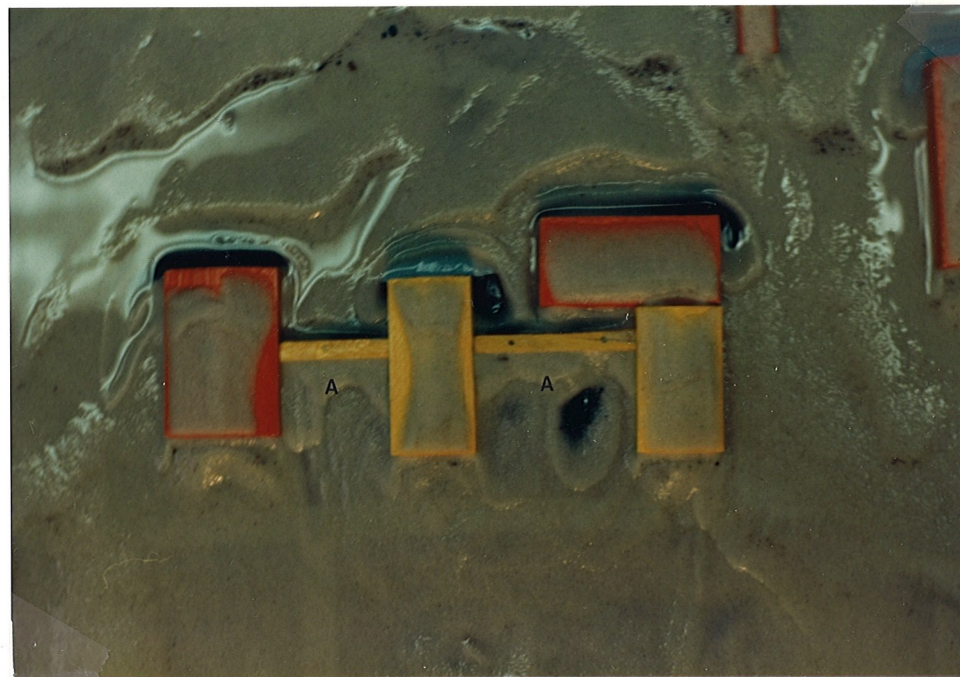
Figure 5-17 Proposal C - Heavy Drifting from the Southwest
(Continued)

Drifting is extensive northeast of the linkways joining the technical buildings (A).

Top view of technical buildings showing drifting northeast of linkways (A).

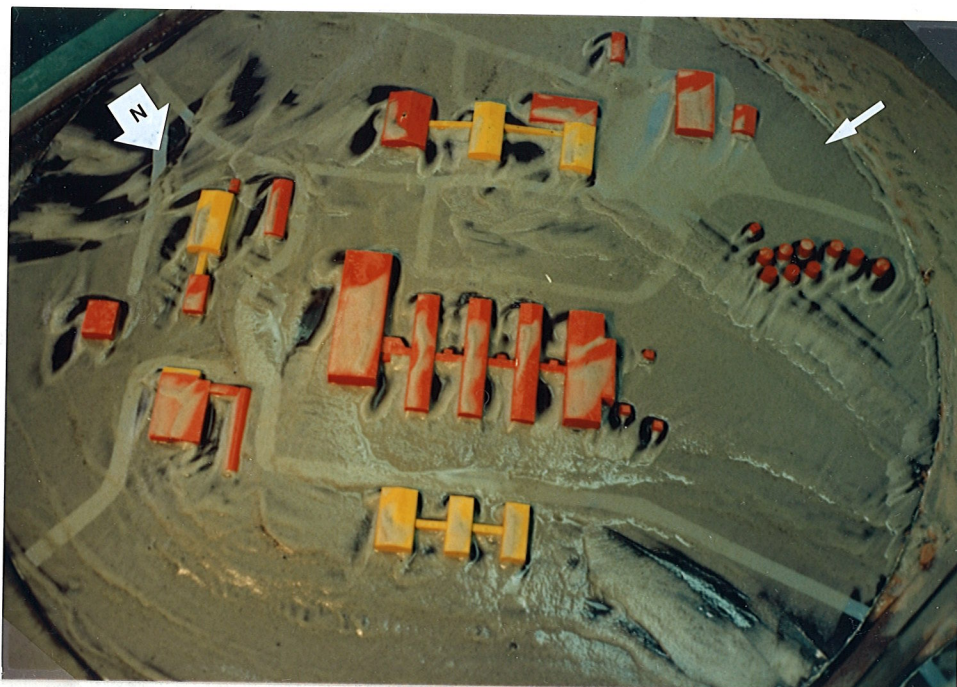
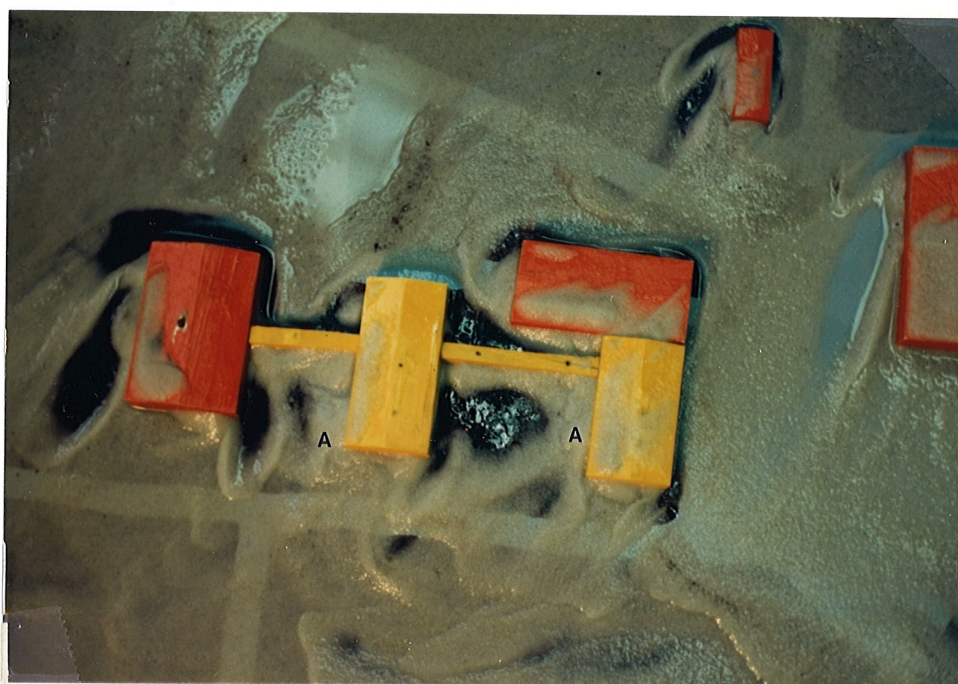
Figure 5-18 Proposal C - Light Drifting from the West

View from the northeast. Arrow indicates wind direction.

Drifting around the technical buildings is more extensive on the southeast sides (A) than the northwest side.

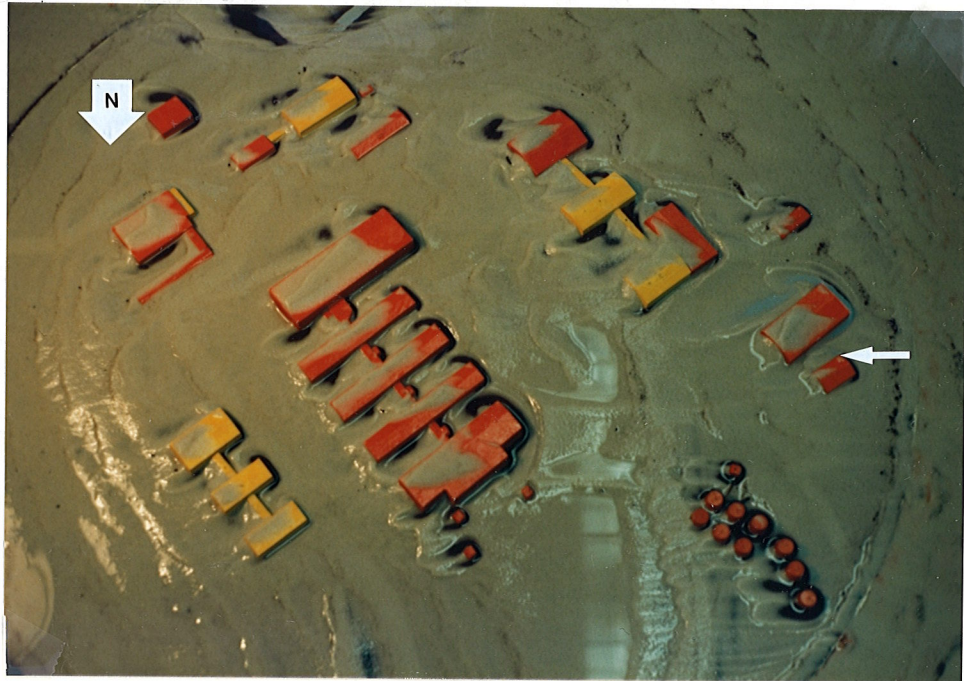
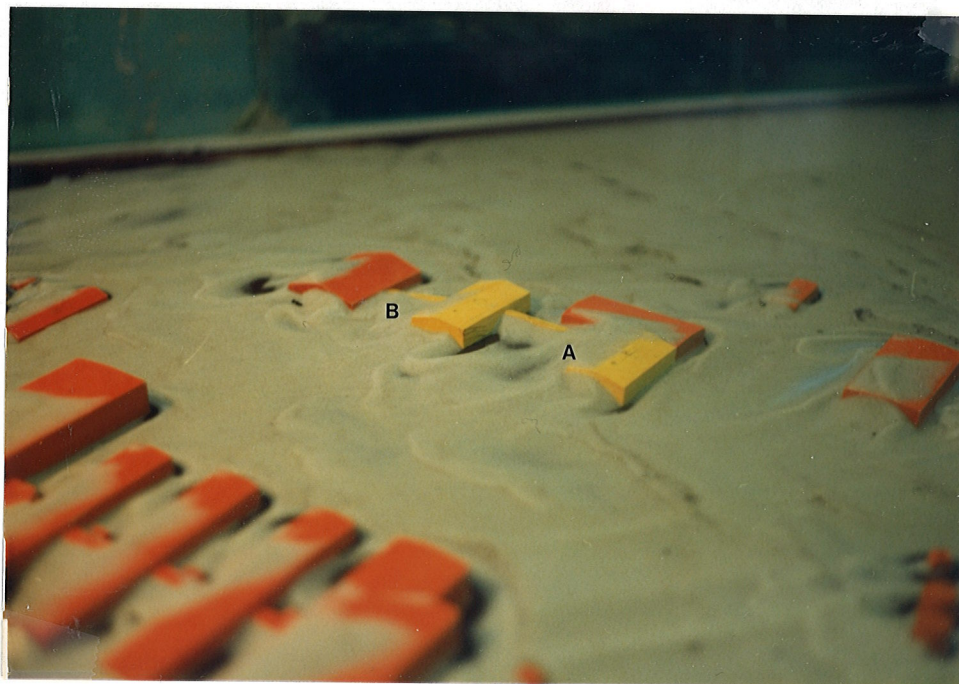
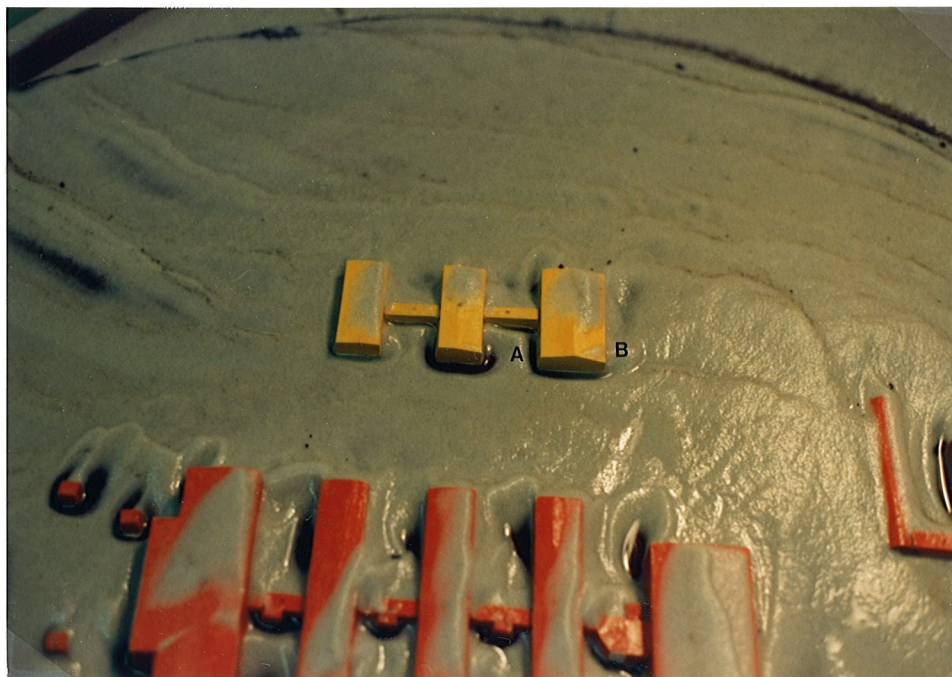
Figure 5-19 Proposal C - Heavy Drifting from the West

View from the north. Arrow indicates wind direction.

Extensive drifting has occurred on the southeast side of the new MSE Building (A) and between the Supply and Firehall Buildings (B).

View from the southwest. Drifting can be seen between the buildings (A) and on the southeast side of the Senior Staff Mess (B).

View from the north. Drifting on the northeast side of the linkways is extensive (A).

From the tests it was observed that the Senior Staff Mess and transient quarters have caused a minimal amount of drifting in comparison with the other proposals. The worst drifting for this site layout appears to occur from westerly winds. The technical buildings have extensive drifting on the southeast side, especially with a west wind. The extent of this drifting is further illustrated in Figure 5-20.

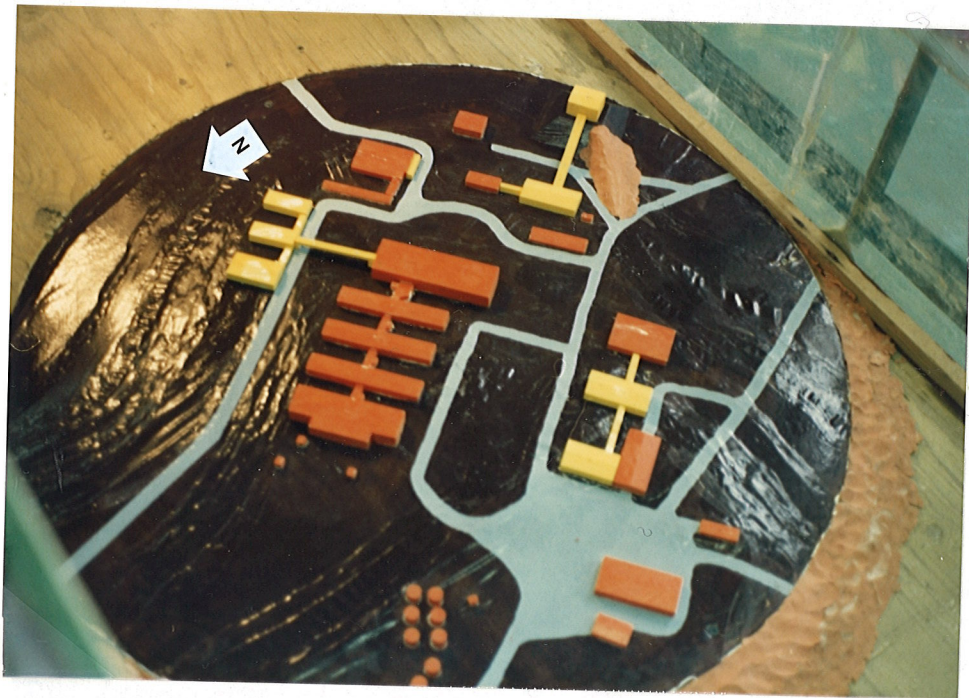
Figure 5-23 Proposal D - Site Layout

Site layout showing new buildings in yellow and existing buildings in orange for Proposal D.

plasticine and a 10% slope was created. The site layout for Proposal D is shown in Figure 5-22, while the model revised for this proposal is shown in Figure 5-23.

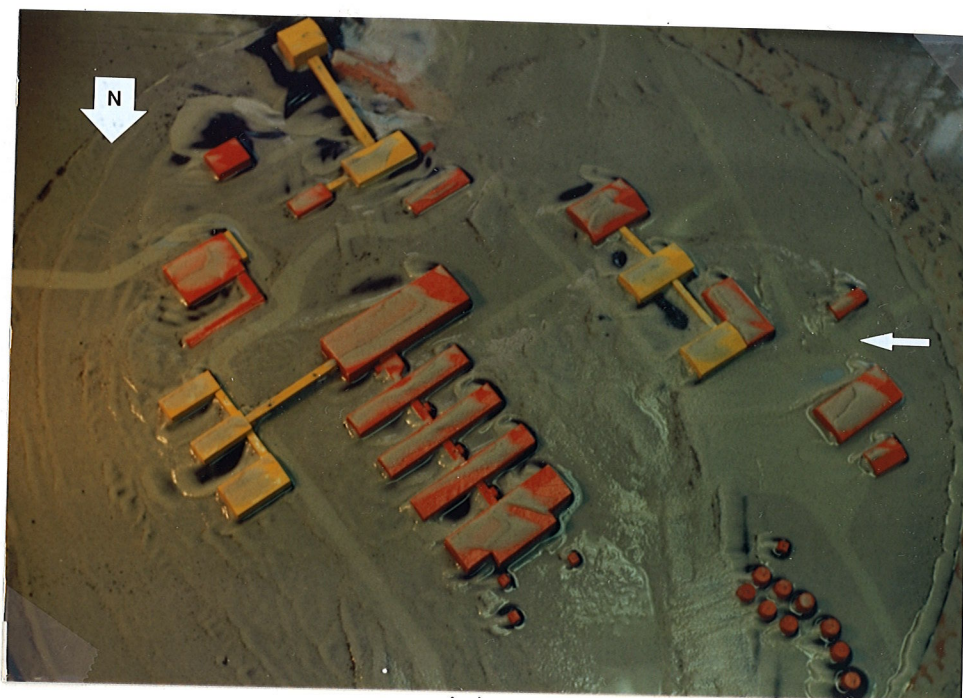
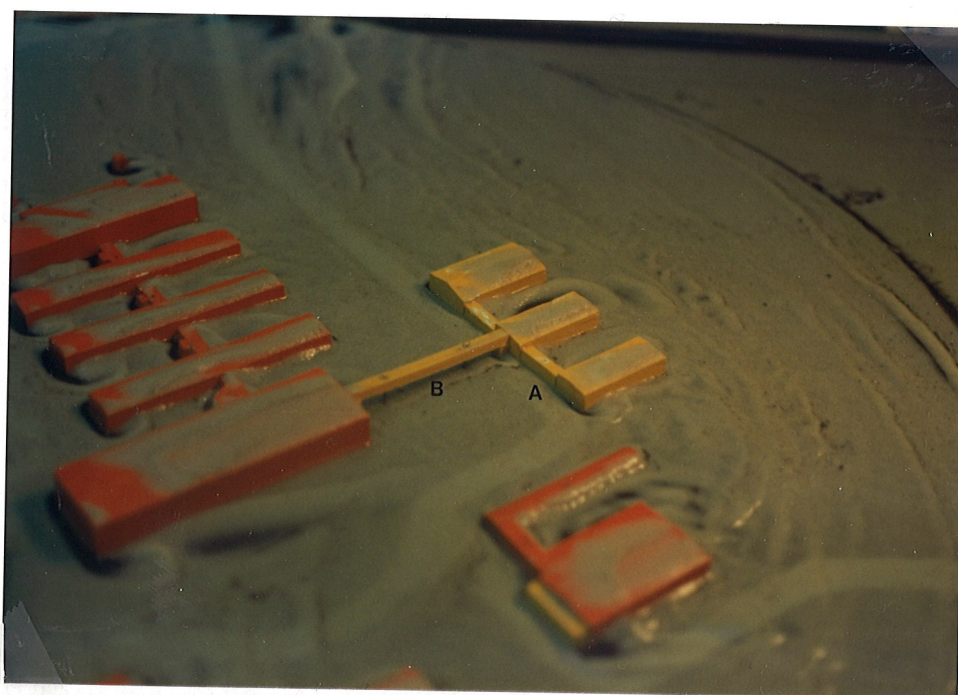
Figure 5-24 Proposal D - Light Drifting from the West

View from the north. Arrow indicates wind direction.

View from the south. Drifting is minimal on the southwest side of the Senior Staff Mess and transient quarters (A). The skywalk is also clean of drifting (B).

Since the new power plant was on the edge of the model, it was only meaningful to test it from one direction, namely the west. If the model had been tested from the southwest, the new power plant would have been directly against the side of the water flume, thus giving very poor results because of the slower velocity of the water near the sides. However, experience gained with other tests provide a reasonable assumption as to the probable results. Test results for light and heavy drifting from the west are shown in Figures 5-24 and 5-25 respectively.

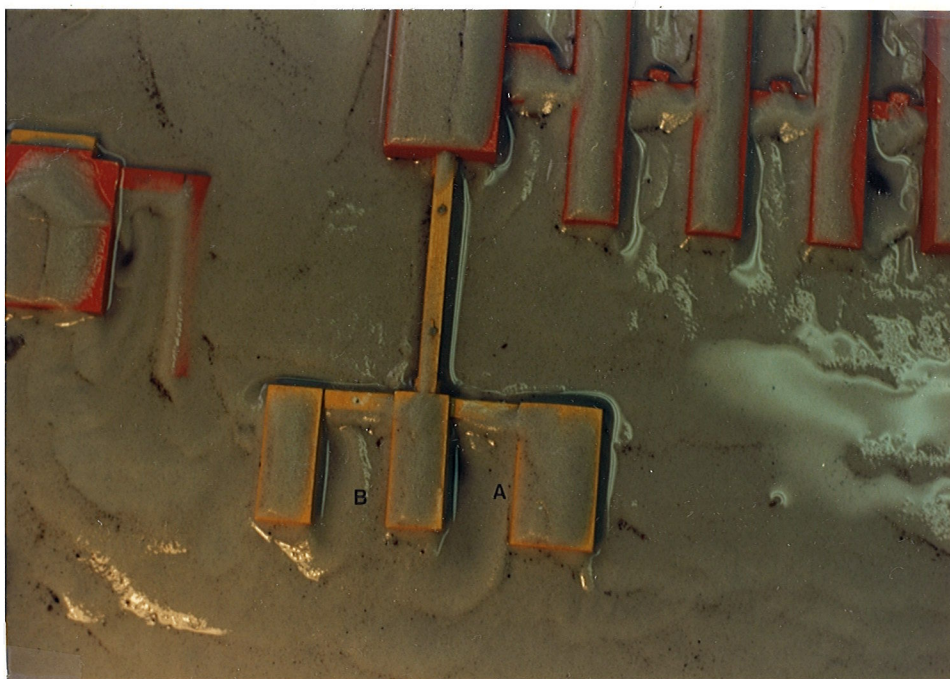
A large drift has formed on the southeast side of the Senior Staff Mess (A). Drifting appears to be also extensive between the transient quarters (B).

Drifting around the new thermal power plant is extensive between the road and the linkway (A) with large drifting southeast of the new power plant (B).

In Proposal D, drifting appears to be more extensive around the Senior Staff Mess and transient quarters than in Proposal C as shown in Figure 5-26. The skywalk, however, appeared to cause very little drifting.
