A THESIS

SEDIMENTATION AND EROSION STUDIES IN WILSON CREEK WATERSHED, MANITOBA, WITH PARTICULAR REFERENCE TO

SHALE BANK RETREAT

THE UNIVERSITY OF MANITOBA

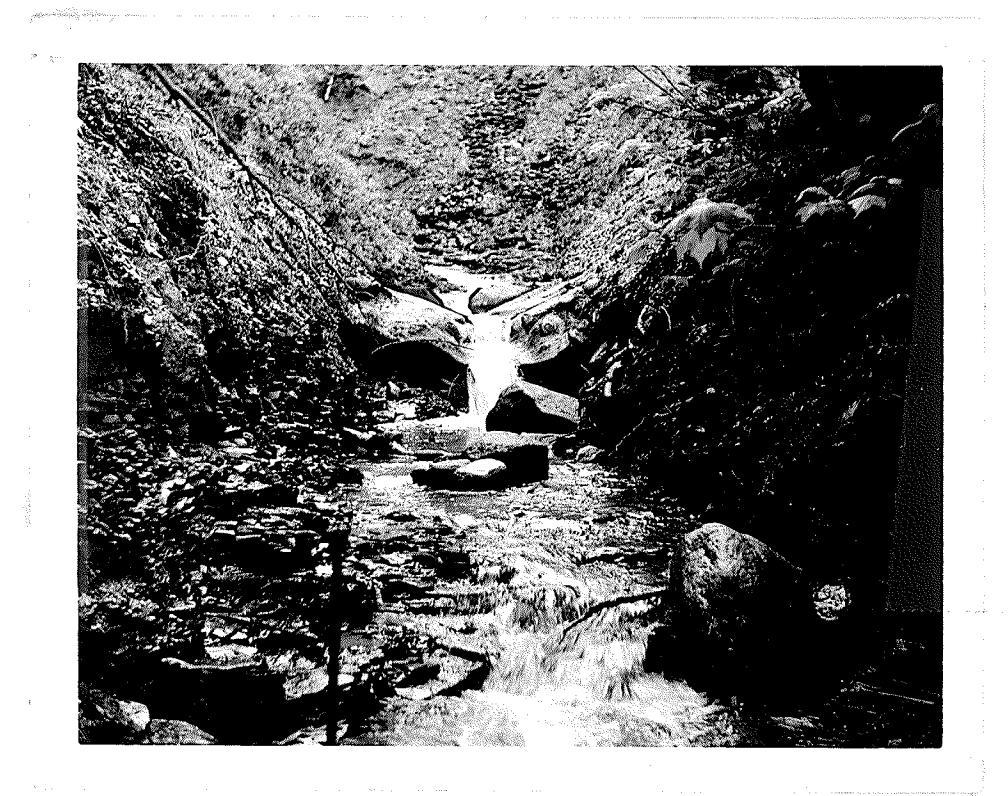
Figure 3. V-Shaped Valley Cutting Through Shale Bedrock.

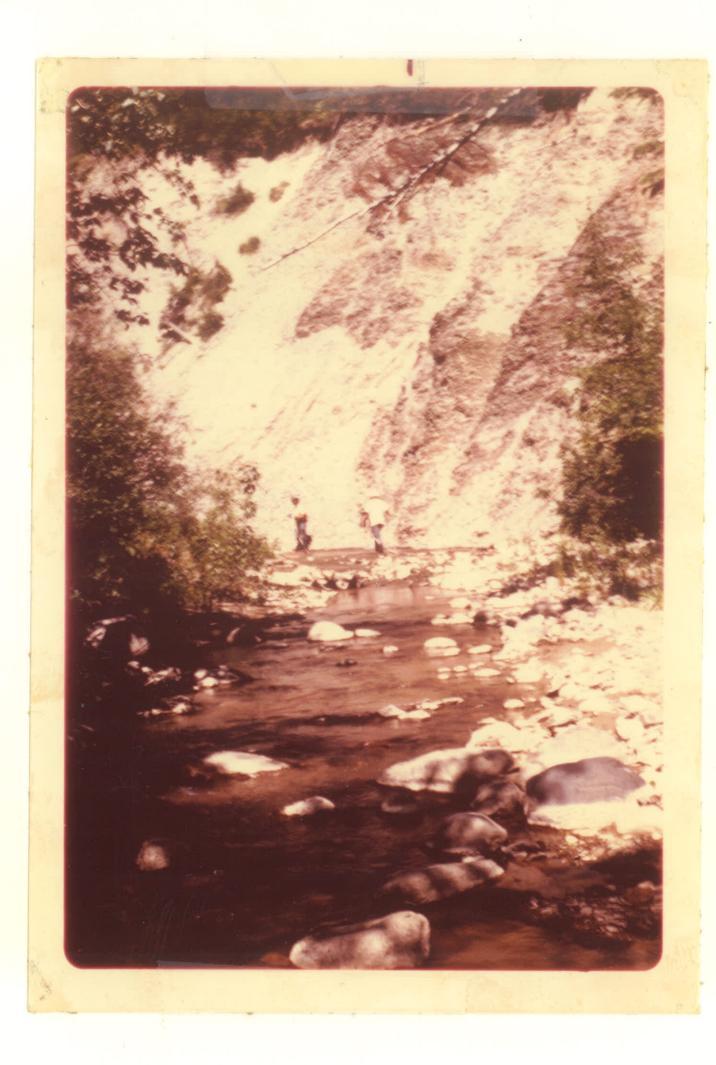
Figure 4. Shale Banks Exposed to the Agents of Weathering, Mass Wasting and Erosion.

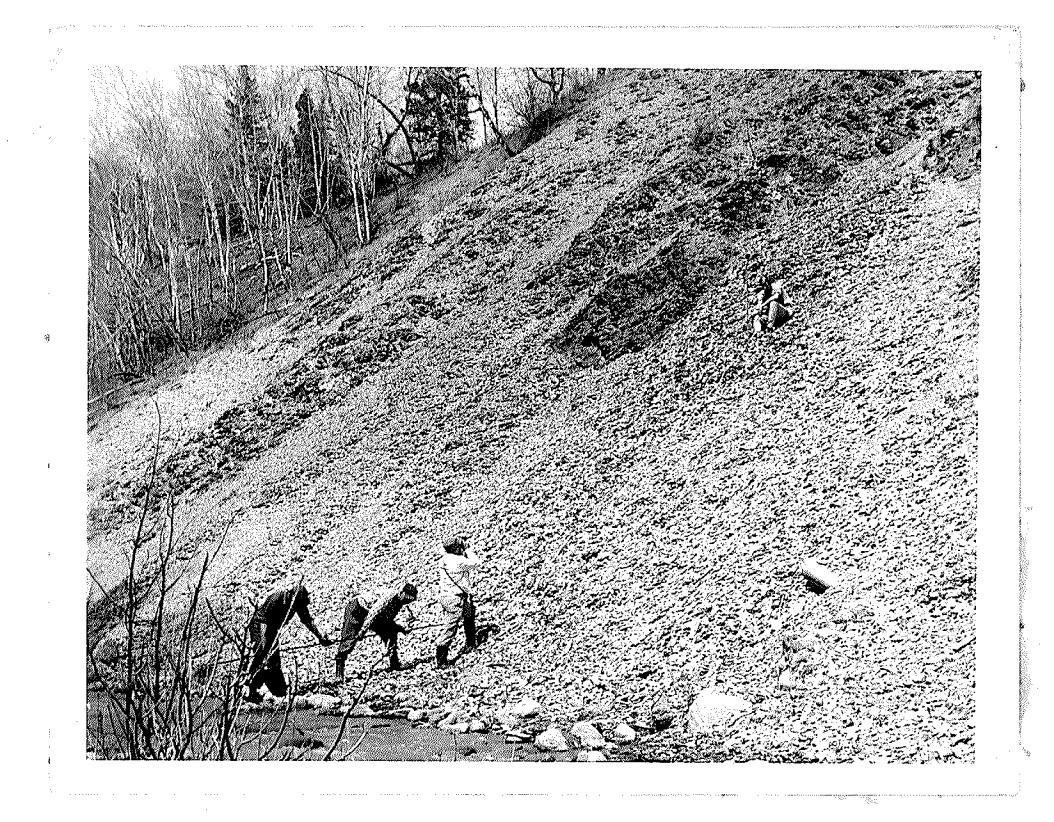
Figure 6. Measurement of Scree Thickness by Probing and Scree Slope Angles by Clinometer.

Measurement of the horizontal thickness of scree deposits at the base of the shale banks was achieved by the method of probing, which involved the use of a steel probe, forced horizontally into the scree material until bedrock was reached (Figure 6). Three scree surface parameters were investigated; slope angle was measured using a clinometer;

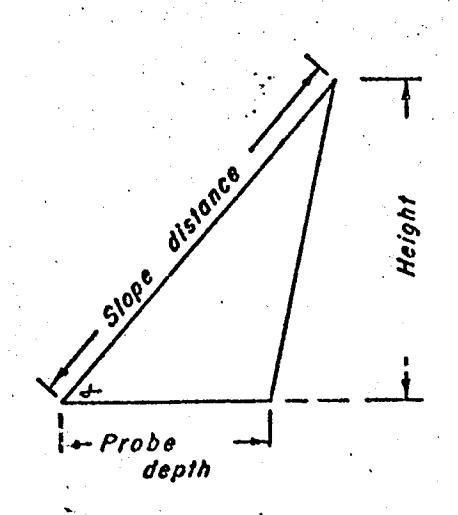
FIG.7 - MEASUREMENT OF VOLUME OF SHALE SCREE.

The following equation is used to calculate the volume of shale scree at the base of the shale banks (Figure 7).

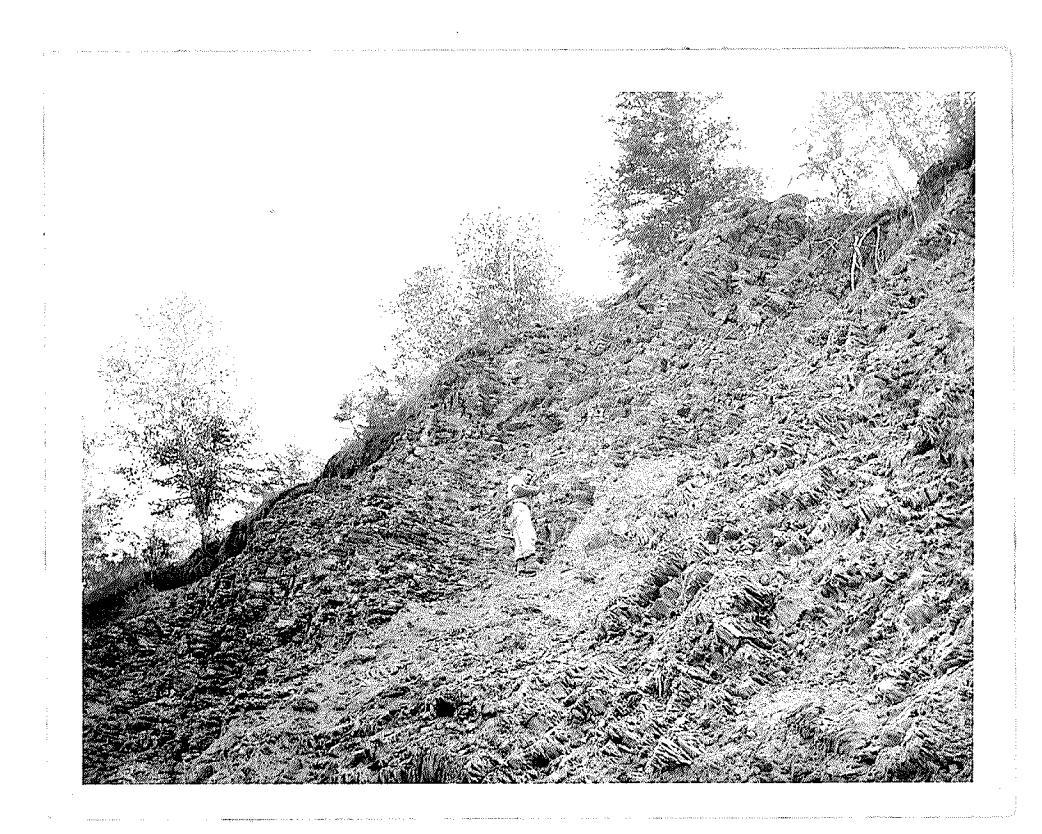
Figure 8. Measurement of Amount of Pin Exposure on Free Face Shale Bank, Packhorse Creek.

Data from May, 1964 to December, 1972, collected at the two free face banks--one on Packhorse and the other on Baldhill--are found in Tables 1 and 2. Measurements of free face retreat were obtained by using "a grid-system of iron pins".³ Twenty-five pins installed in the free face along Packhorse Creek and twenty-two in that on Baldhill Creek were used to monitor the changes. These are four-feet by threequarter-inch iron pins, driven horizontally into the free faces and their specific locations established by survey. The top three inches of each pin were left exposed and painted red for ease of observation. Free face retreat was measured periodically by progressive pin exposure due to mass wasting and erosion. Each year after the amount of exposure

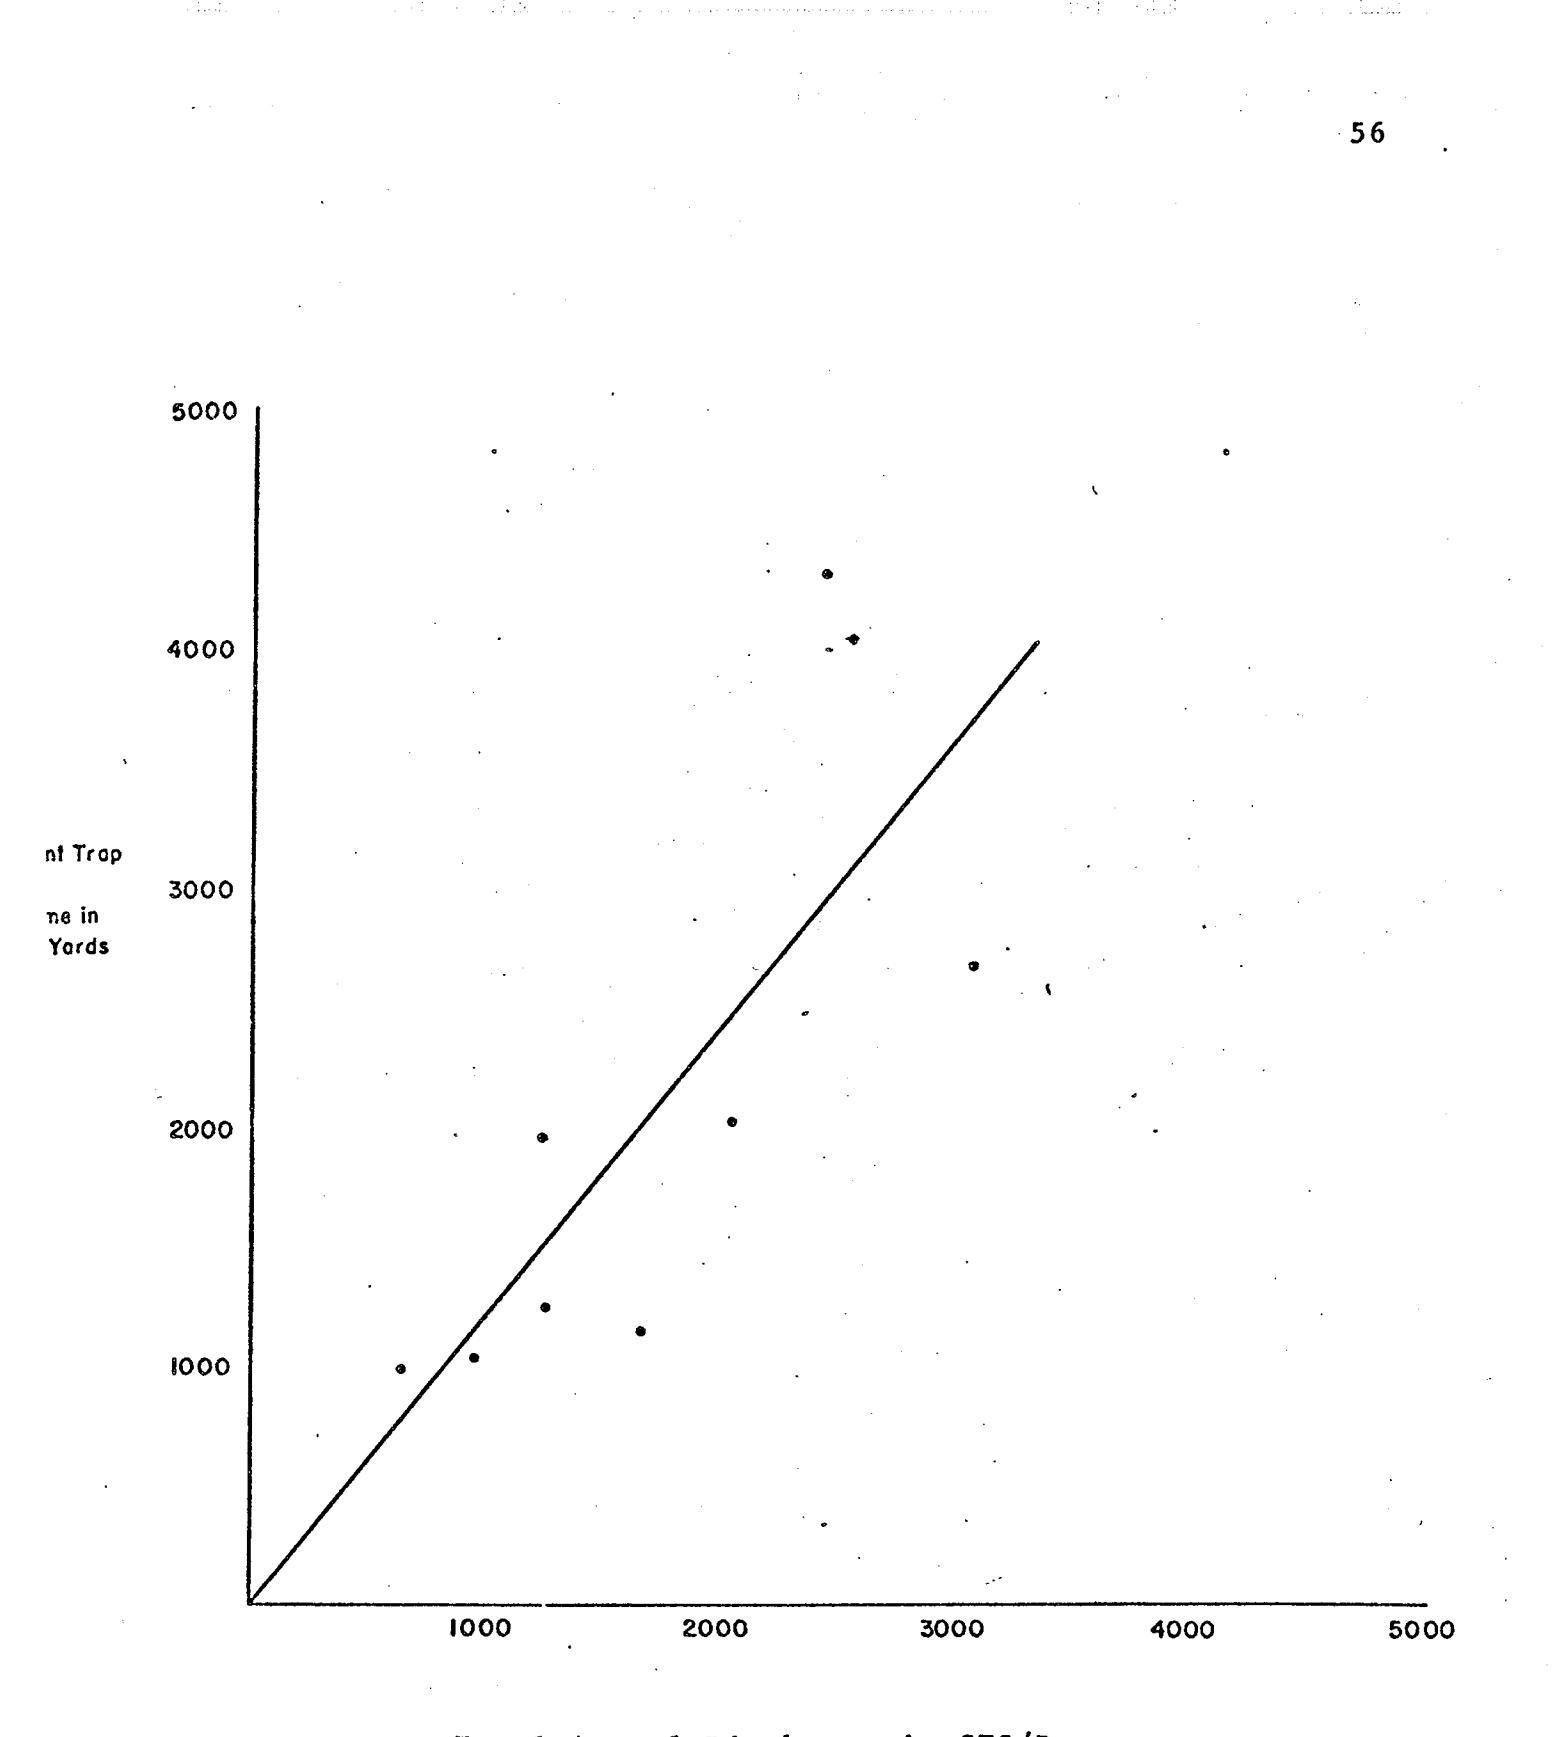
Total Annual Discharge in CFS/Days

a = -10.05 b = 1.23 $R^2 = 0.55$ R = 0.76

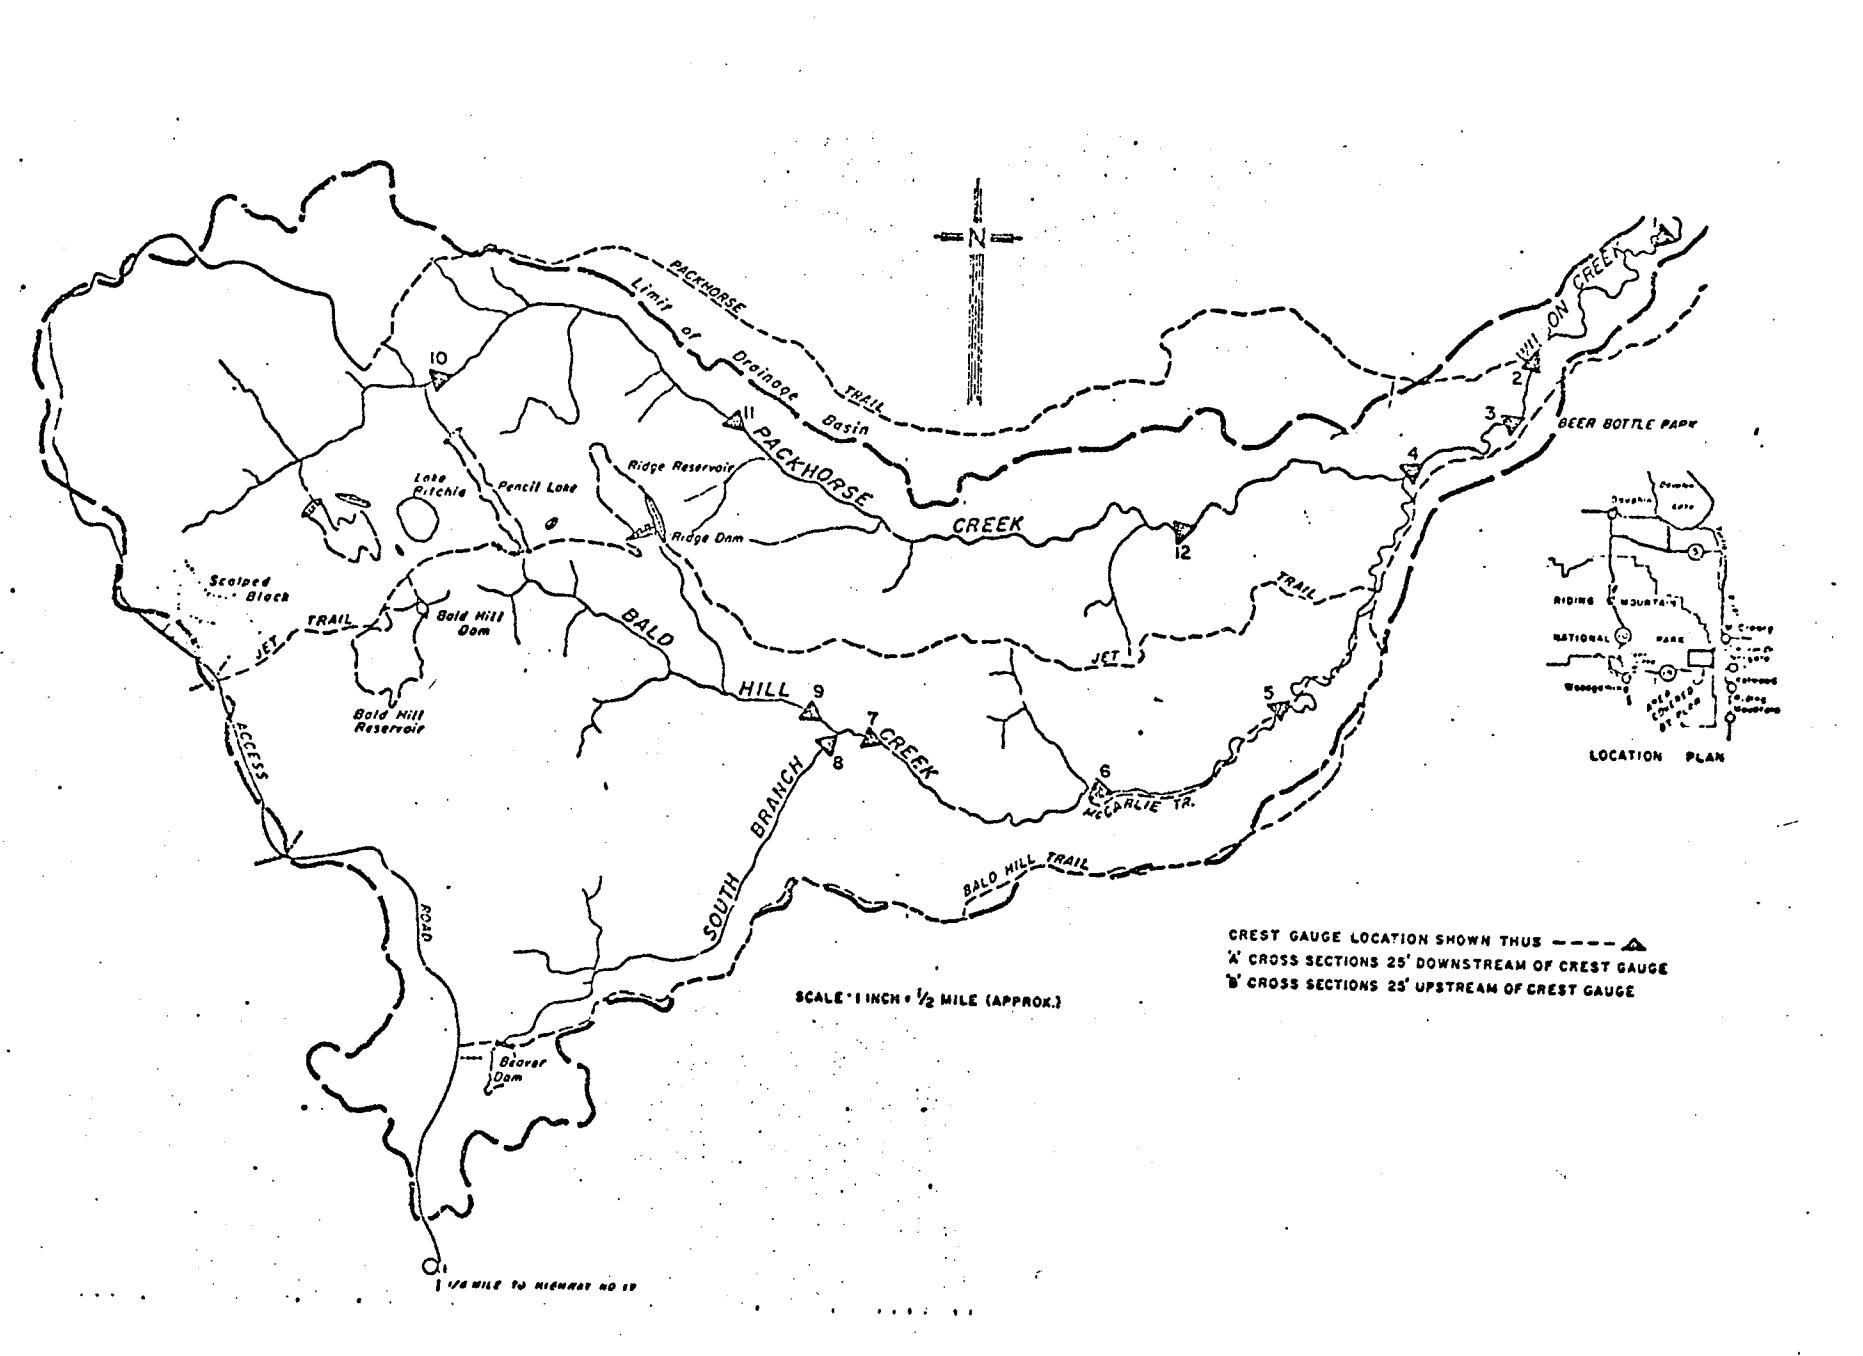
Figure 30 Location of Crest Gauge, Wilson Creek Watershed.

Additional evidence to support the assertion that the rates of lateral erosion exceeds those of vertical erosion and that aggradation exceeds degradation are shown by comparing the cross sections of the streams. Figure 30 shows the location of twelve crest gauges within the Watershed

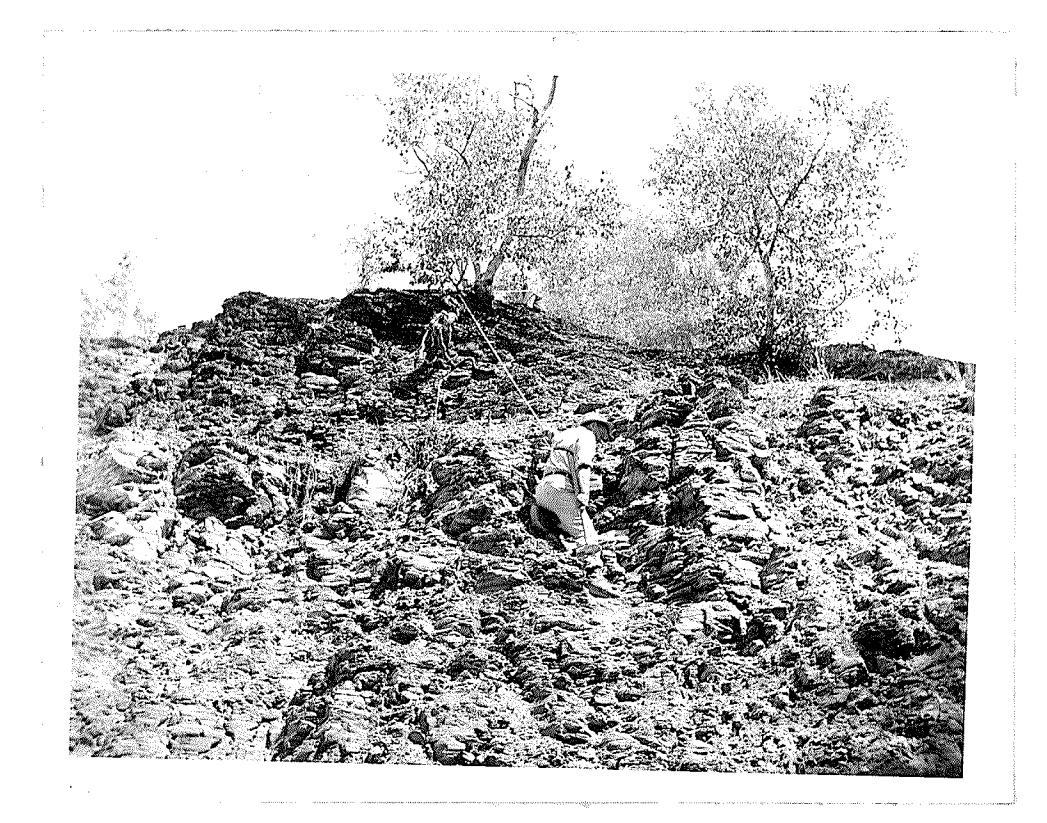
Figure 55. Layered Structure of Exposed Shale.

Alternate wetting and drying of shale is a very important weathering process in Wilson Creek Watershed. Because the shales are thinly bedded (Figure 55), water from spring melt and rainfall percolates along bedding planes, resulting in the expansion of particles of clays such as montmorillonite. During the drier periods the clay minerals in the shale contract and this alternate expansion and contraction causes separation into flakes.

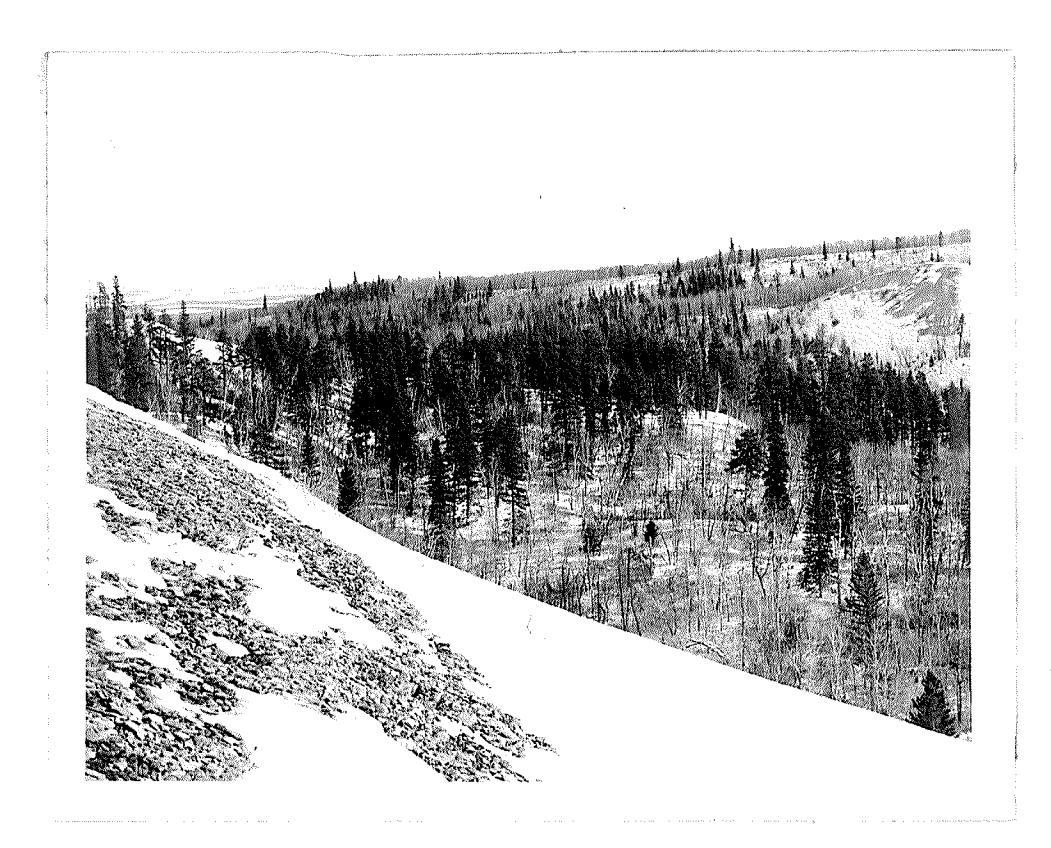
Figure 56. Shale Flakes Resulting from Weathering.

Ollier (1969, p. 21) observed that, "possibly repeated wetting and drying allows the water molecules to become increasingly ordered, assuming a quasi-crystalline nature and exerting expansive force that thrusts against the confining wall." This force causes the shale to separate along zones of weakness to produce shale plates (Figure 56). The

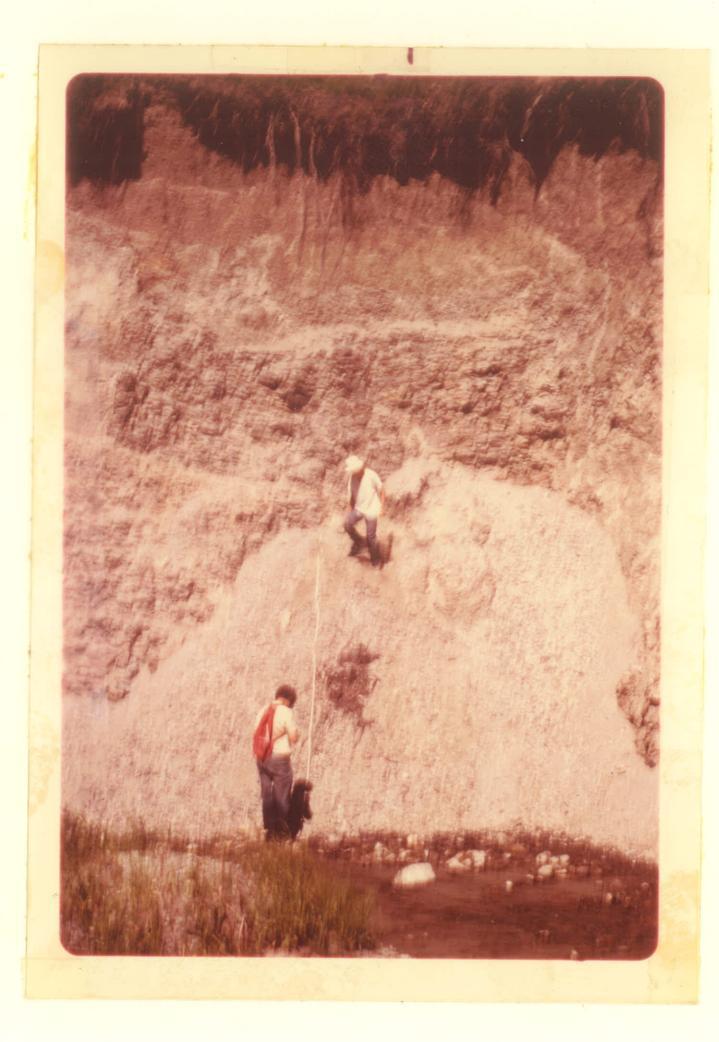
Figure 57. Weathering of Shale Bedrock, Producing Shale Scree.
Other weathering processes in Wilson Creek Watershed are more difficult to identify. Chemical weathering caused by water and gases involves changes in the chemical composition of shales and clays. One visible aspect of chemical weathering in the Watershed is the oxidation of ferrous compounds in the shales, resulting in decomposition and significant loosening of shale bedrock. Bunting (1967) associates this oxidation in shales with the slow movement of water, and where leaching increases the solubility, hence the removal of This removal of iron oxides and hydroxides, or the iron. "iron stained appearance", 6 is typical of the Odanah shales Where concealed bentonite beds in in Wilson Creek Watershed. the shales of Wilson Creek are light grey, the exposed beds have a light yellow colour. Bannantyne (1963) believes that this "discolouration effect of weathering" on the bentonite layers is "caused by oxidation of small amounts of iron in the clay from the ferrous to the ferric state."7

smaller and lighter fragments are either blown down by wind or fall under the influence of gravity to the base of the shale banks to produce shale screes (Figure 57).

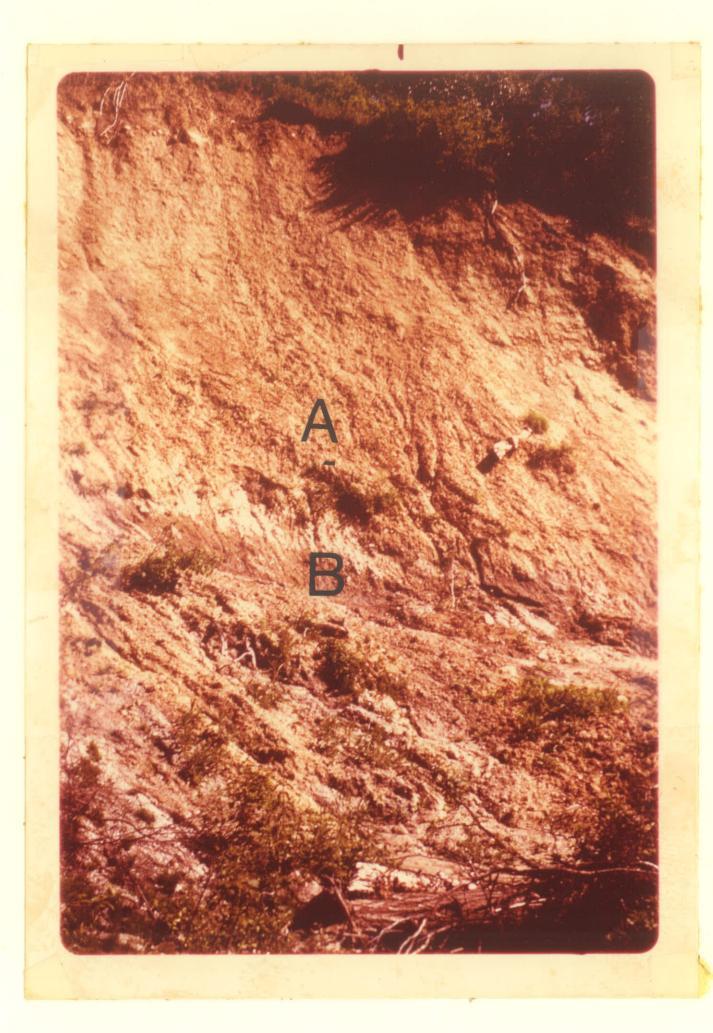
Figure 58. Soil Creep and Debris Slide on Sandy Till.

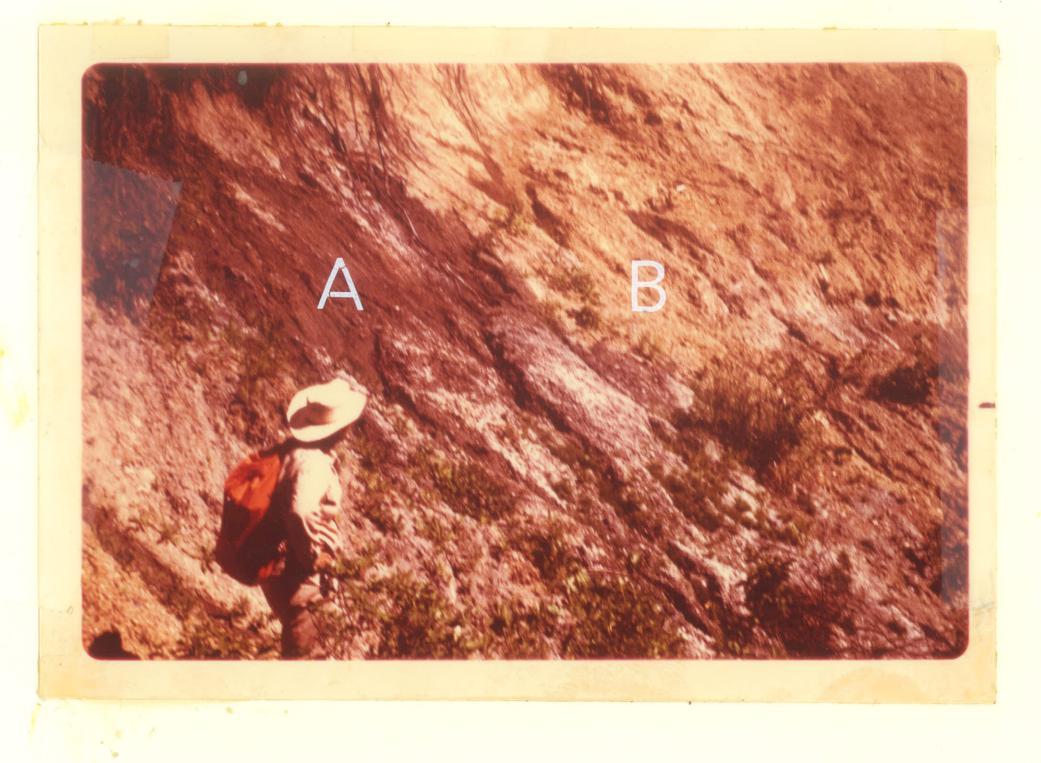
Figure 59. Debris Slide on Clayey Till (A) and Soil Creep on Sandy Till (B).

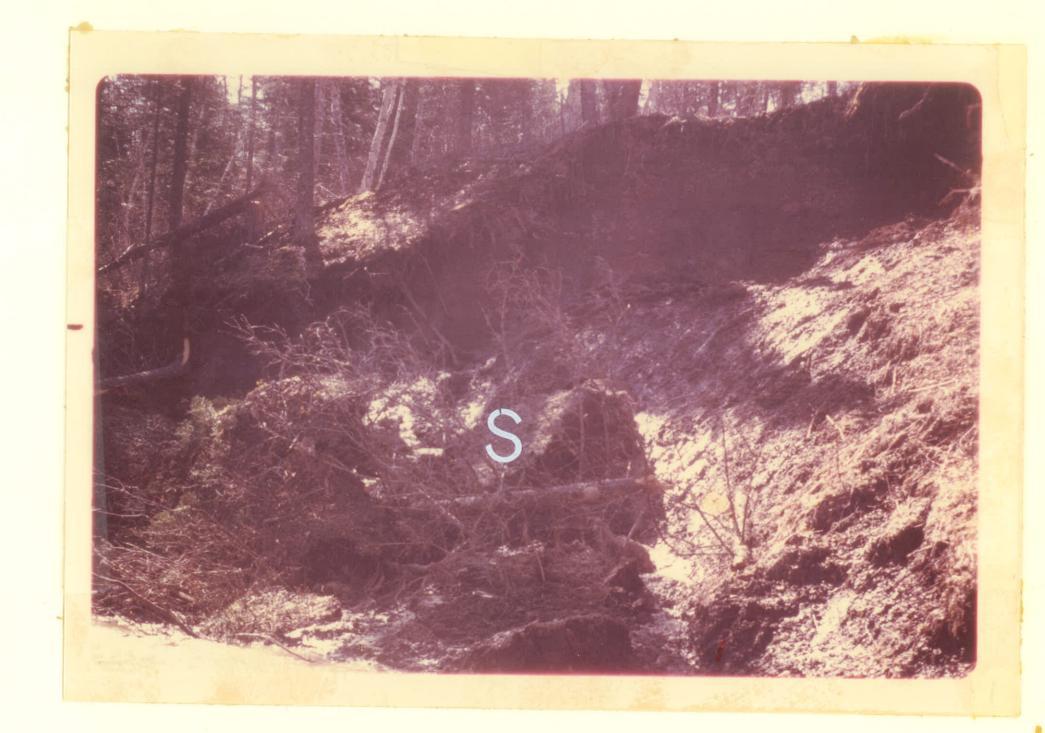
Figure 61. Slumping.

iii) Slumping. Slumping is a mass wasting process that involves "the downward slipping of one or several rock units or rock debris usually with a backward rotation with respect to the slope over which movement takes place" (Thornbury, 1962, p. 46). Slumping is a common phenomenon on the till-covered banks in Wilson Creek Watershed. The main cuase of slumping here is the undercutting of slopes by Baldhill and Packhorse Creeks. This process occurs during the spring on the wet till slopes, in the upper reaches of the Watershed. MacKay and Stanton (1964, p. 8) note that "there are some contributions to the streams in the form of slumping. These slumps are grass covered for the most part and are generally associated with wet areas." Figure 61 shows a "slump face" (MacKay and Stanton, 1964) or scarp on clay till resulting from the creation of rotated masses such as the slump identified by 'S'. Figure 62 shows the effects of slumping on the banks of Packhorse Creek;

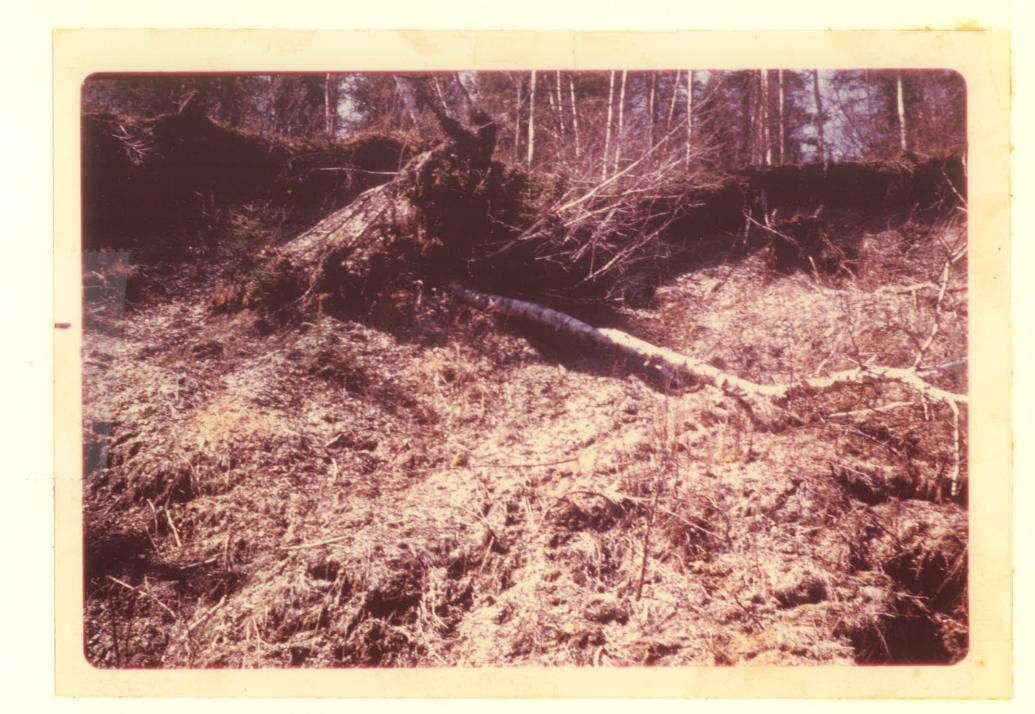
Figure 62. Slumping and Tree Fall.

these are characterized by a matrix of fallen trees and mud resulting from rotational sliding caused by basal stream erosion of the slope. Figure 63 depicts a slump scarp 'S' and a transverse ridge 't' occurring on sandy till debris mantle in the upper reaches of Baldhill Creek; the underlying shale beds are exposed in the scarp.

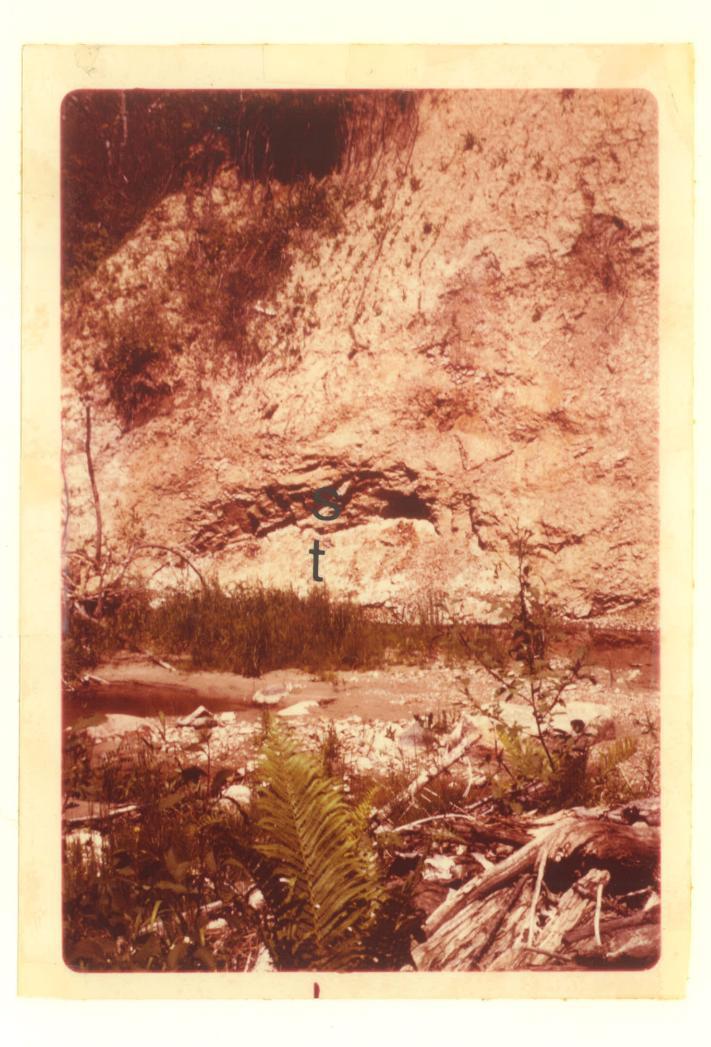
Figure 63. Slumping Due to Basal Erosion.

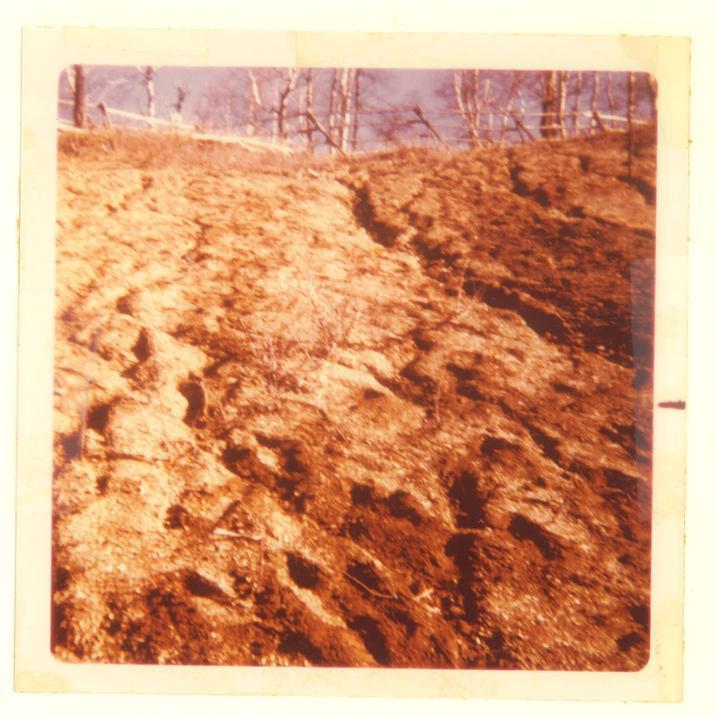
Figure 64. Example of Gullying.

On the whole, C. B. Beaty's following description of the role of gullying on slope retreat adequately applies to the sandy till banks of Packhorse and Baldhill Creeks. "When heavy rain falls, surface runoff again collects in partially filled gullies and again flushes them out, thus intensifying the relief. The cycle is repeated; slice by slice, the slope is literally peeled away" (Beaty, 1959, p. 1481).

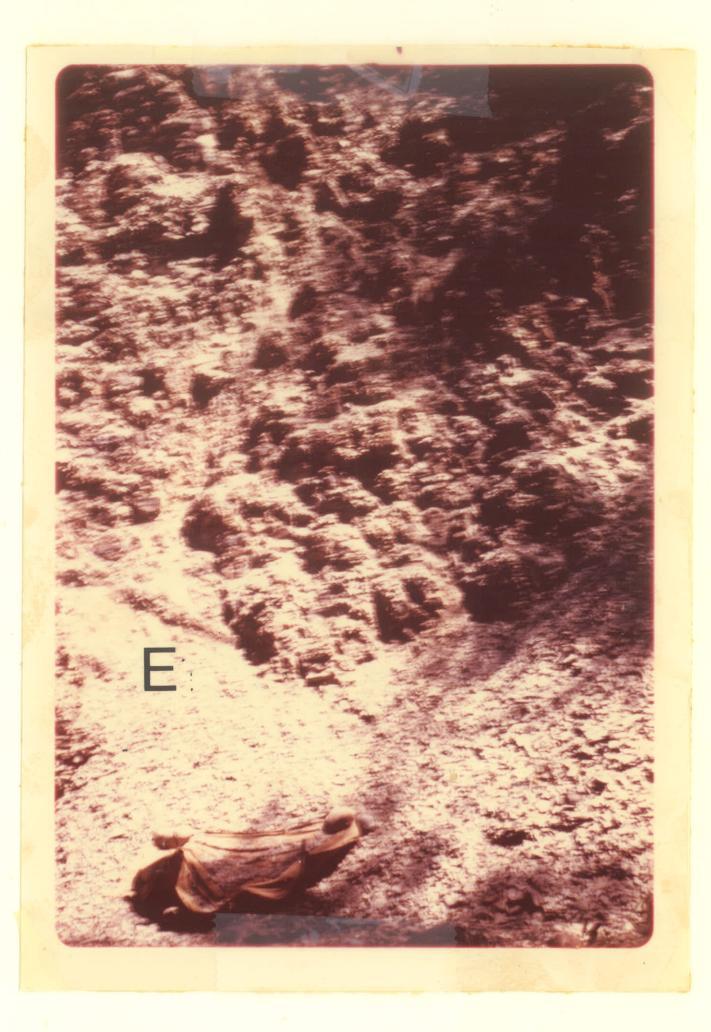
Figure 65. Shale Removal by Wind and Debris Fall.

A simple experiment was carried out by the author to demonstrate the effect of wind and debris fall as a supplier of sediment to the stream channel. In July, 1974, a meshed trough three feet by two feet by one foot was placed at the base of the pin bank on Packhorse Creek. After an hour, with an average wind speed of twelve miles per hour--recorded at the crest of the Watershed--the trough was filled with shale flakes contributed by wind and debris fall. In Figure 66, 'D' identifies the shale fragments at the base of the free face. It is apparent that the trough only captured a small amount of shale flakes blown by wind or falling directly by gravity into the stream below, but this simple experiment

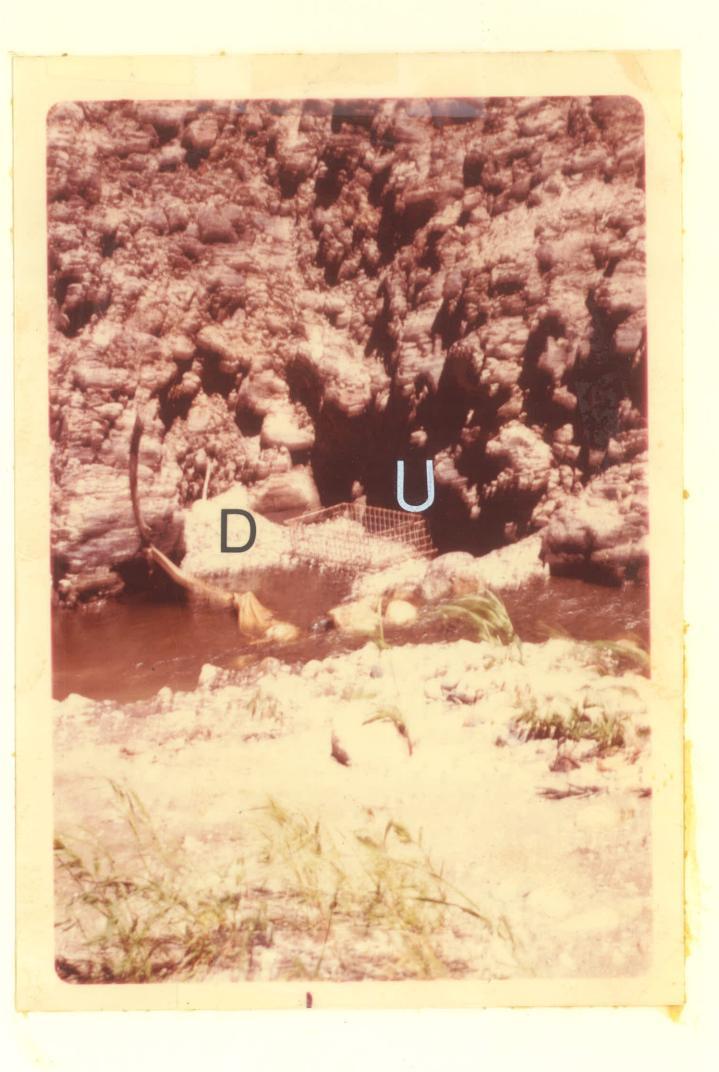
Figure 66. Basal Undercutting and Debris Fall.

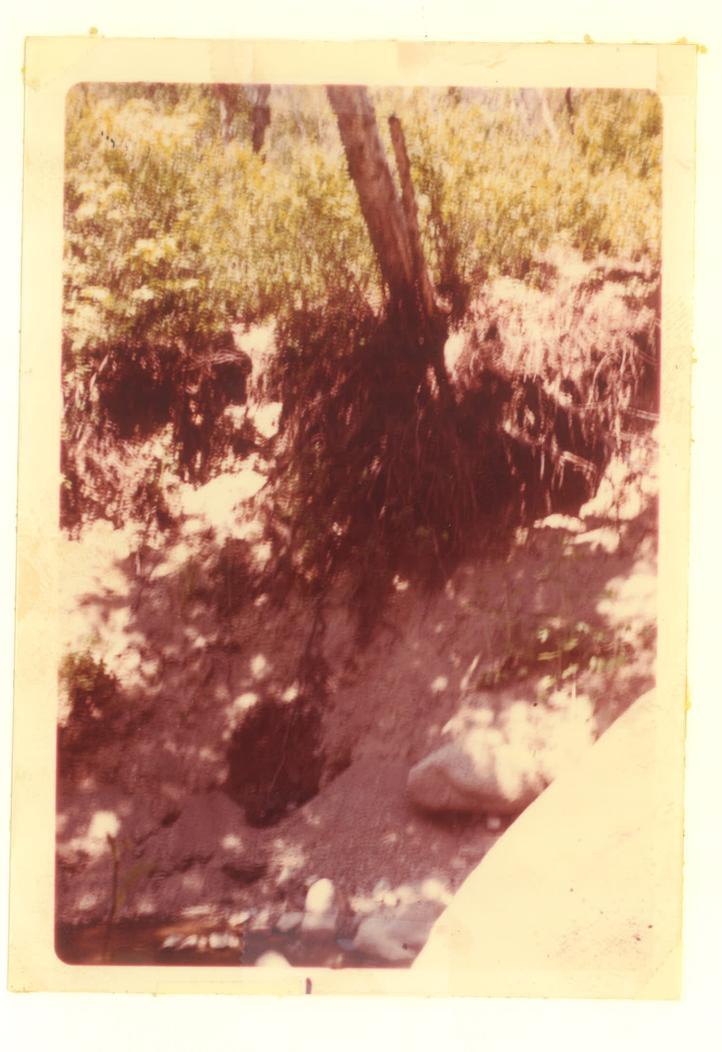
Figure 67. Stage I - Exposure of Soil and Till by Removal of Vegetation.

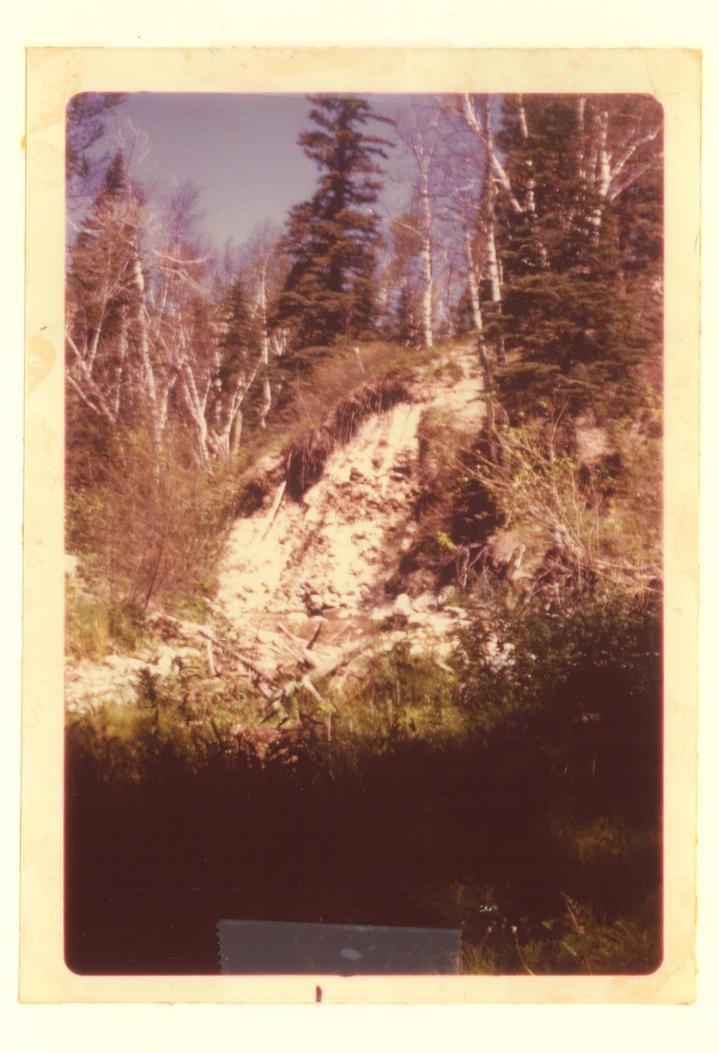
Figure 68. Stage II - Erosion of Surficial Material and Exposure of Shale Bedrock.

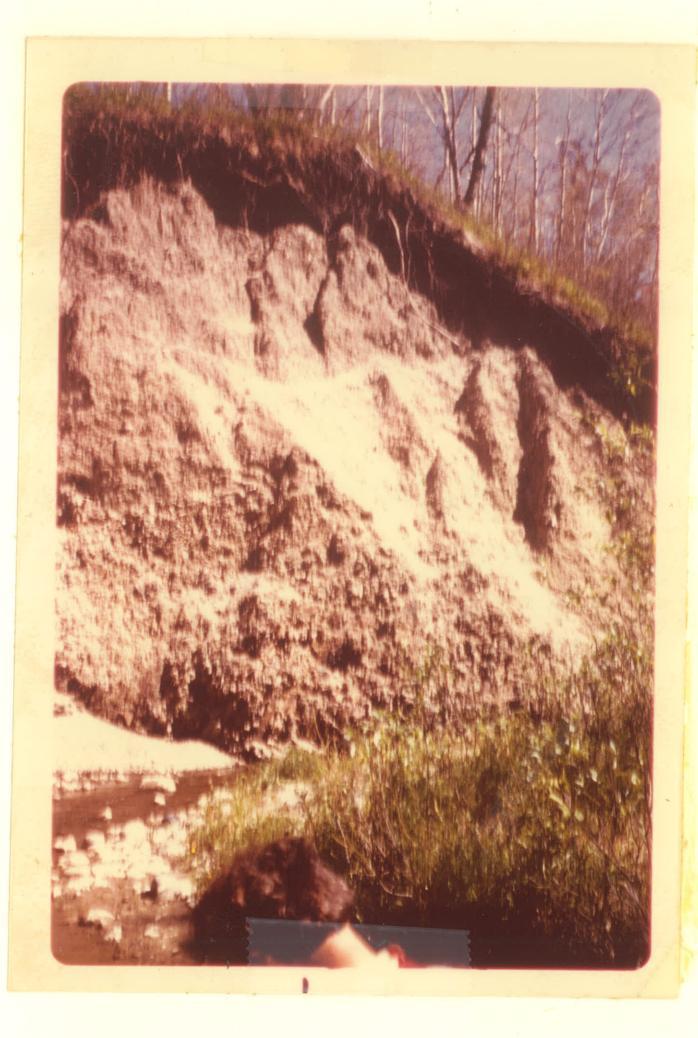
Figure 69. Stage III - Cliffing, Rock Fall and Debris Fall.

Stage III (Figure 69) is typified by cliffing due to continued stream undercutting and a consequent larger exposure of shale bedrock. Rock fall of shale plates and debris fall of overlying material for the first time produce a thin debris cover on narrow ledges or concave facets of the bank. Slope angles vary from 35 to 45 degrees.

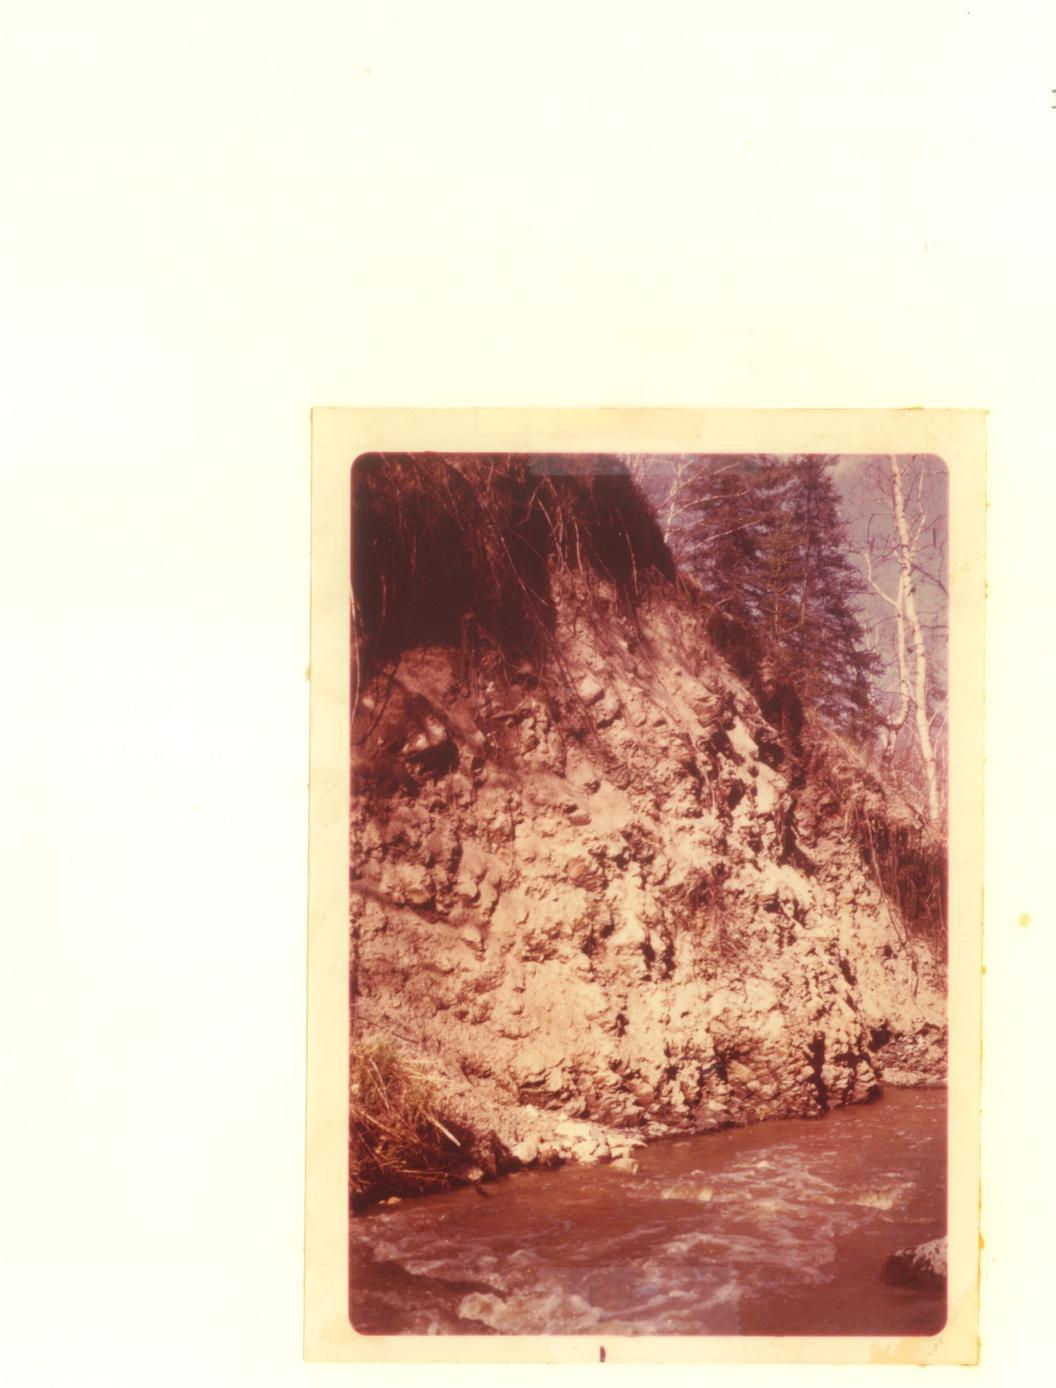
Figure 70. Stage IV - Fully Developed Free Face.

Stage IV may be characterized by a well-developed free face (Figure 70) with precipitously steep gradients (i.e., over 50°) due to pronounced basal undercutting. Alternatively, if undercutting ceases due to lateral stream migration, screes may develop downslope from the free faces (Figure 57).
