A THESIS

SEDIMENTATION AND EROSION STUDIES IN WILSON CREEK WATERSHED, MANITOBA, WITH PARTICULAR REFERENCE TO

SHALE BANK RETREAT

THE UNIVERSITY OF MANITOBA

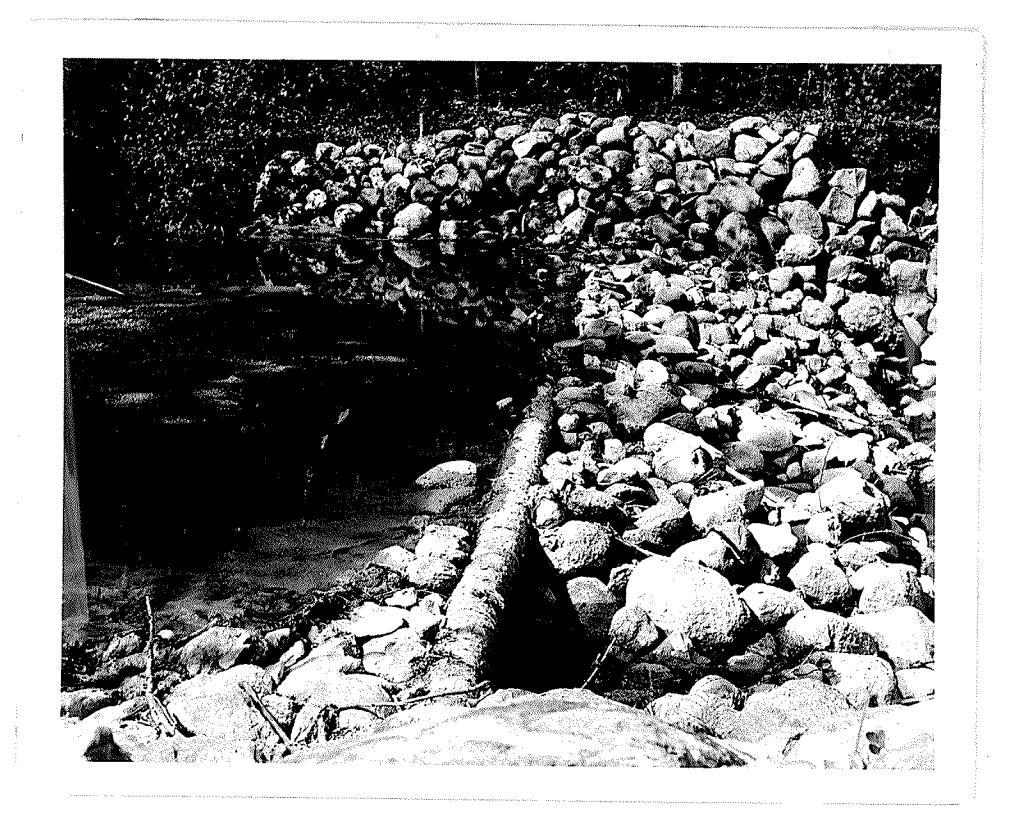
Figure 71. Rip Rap on Concave Bank of Meander.

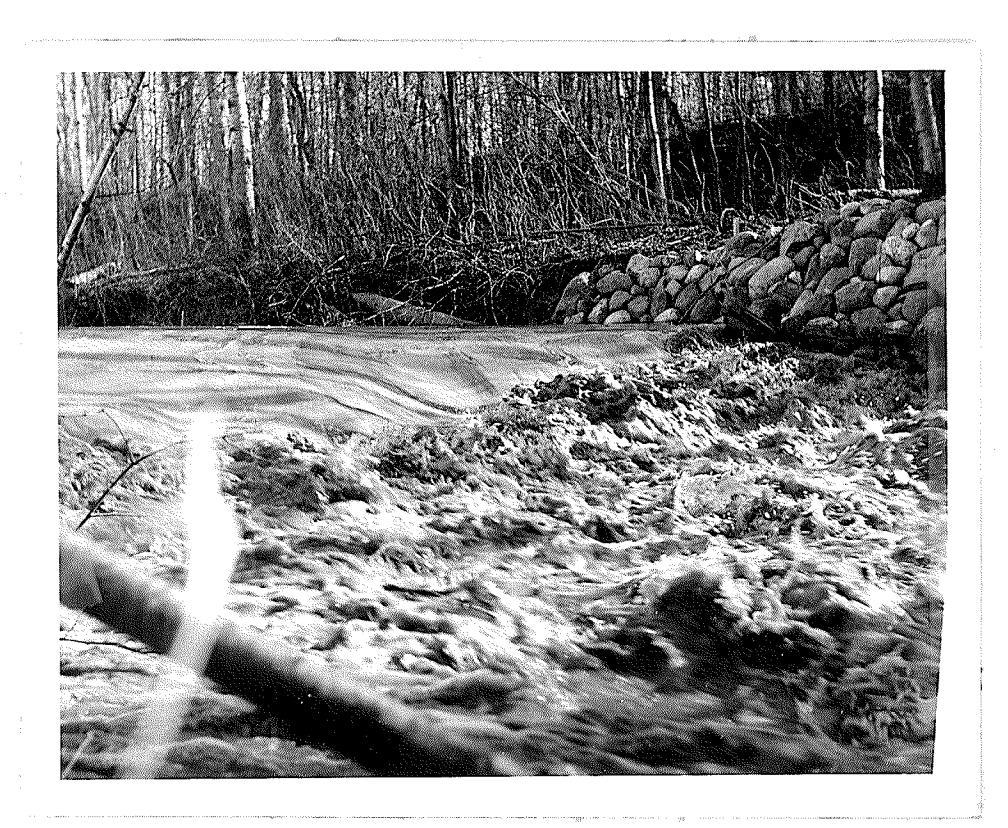
Figure 72. Rip Rap on Straight Channel Bank.

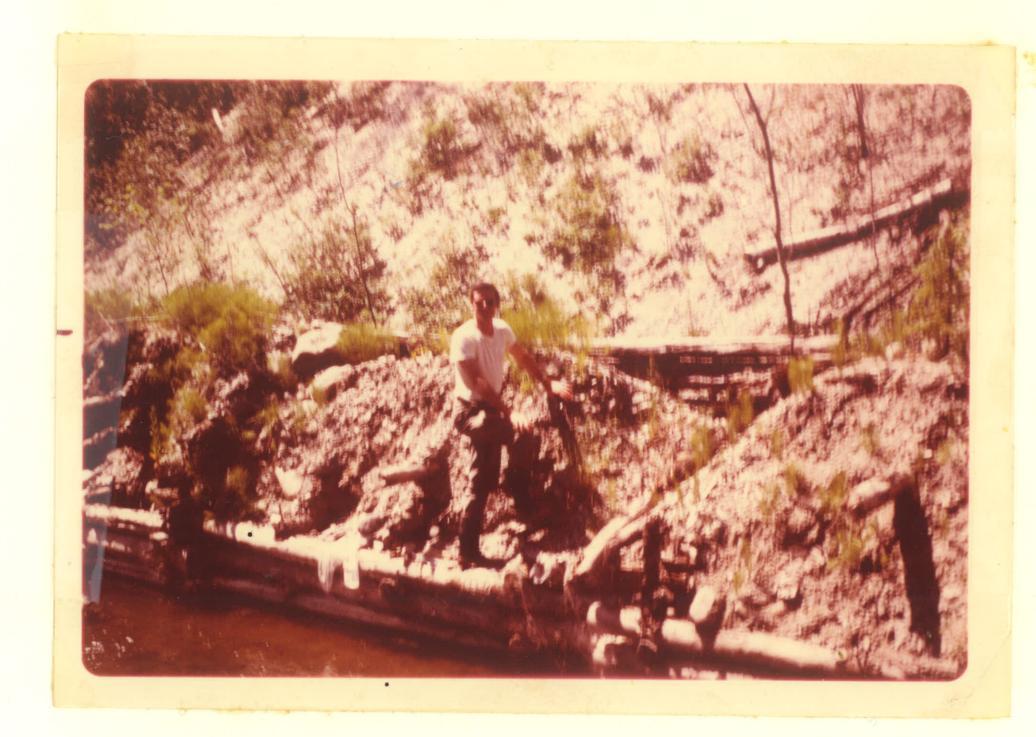
Figure 74. Double-Layer Log Crib.

rip raps is impractical. The main problem with such cribs is that the logs rot in a few years time and consequently, constant checking and repairs are necessary. There are two types of log cribs in Wilson Creek Watershed. These are the single-layer and double-layer log cribs. The single-layer variety (Figure 73) protects the bank from scouring by high velocity currents and from the accompanying caving. The double-layer crib (Figure 74) has an additional layer of logs built away from the stream; the riparian layer has the same function as the single-layer log crib, but the layer farther away from the stream serves to retard the movement of scree material.

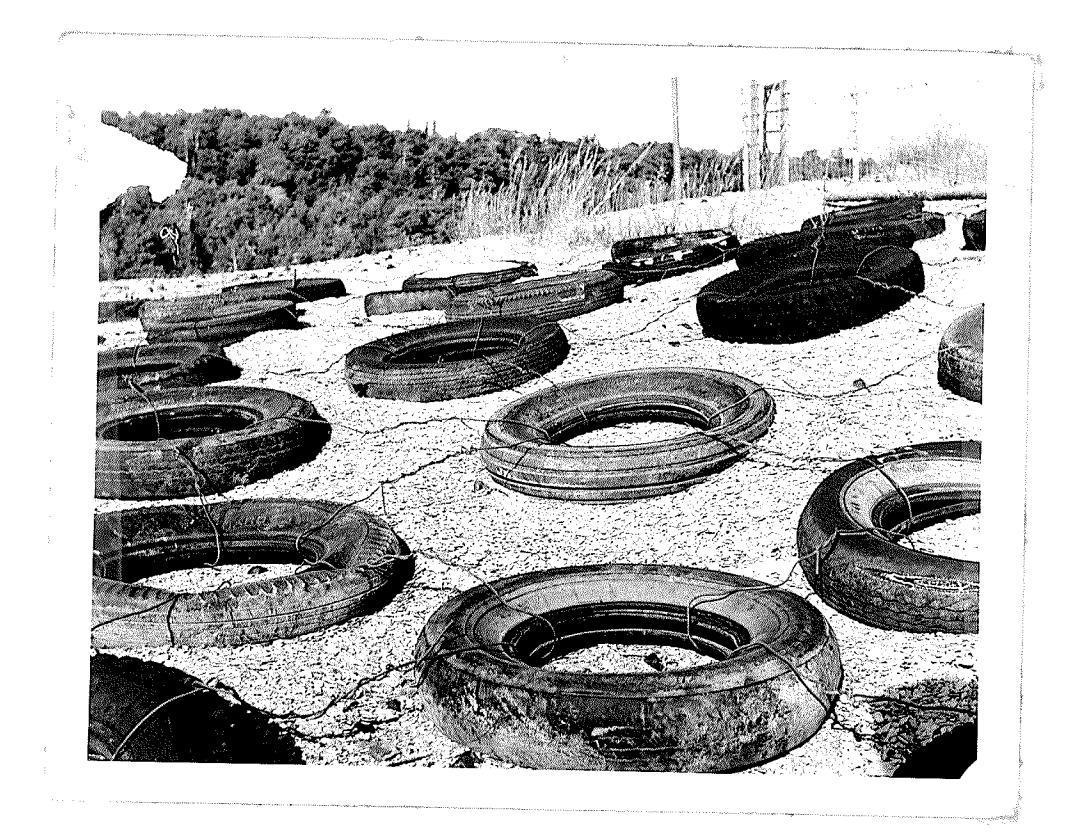
Figure 75. Shale Movement Around Tires, August 1964.

A method used to prevent the movement of shale flakes downslope involves the placing of tires on exposed shale Tires are tied to one another with wires to scree sites. prevent their movement. An experiment carried out to test the effectiveness of this method was initiated in August, 1964, on the slopes of Mount Dunning (Figure 75). The site is unvegetated, steeply sloping and exposed to the wind. The potency of wind action at this site is acknowledged by MacKay and Stanton (1965, p. 19) who note "that during high winds on Mount Dunning it is not possible to face into the wind because of flying shale particles." In the experiment, Juniper trees (Juniperus horizontalis) were planted within the tires. It was expected that the anchoring effect of juniper roots and the blanket effect of tires would stabilize the finely weathered fragments on Mount Dunning slopes.

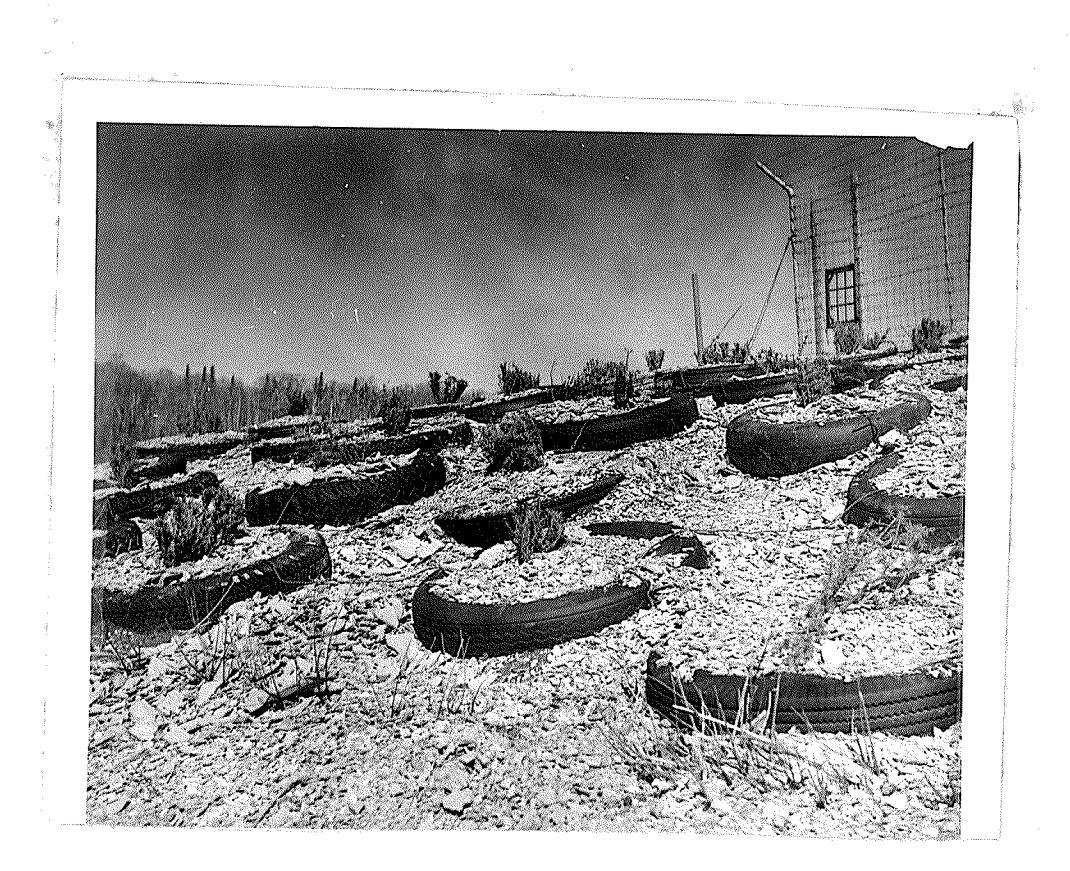
Figure 76. Shale Movement Around Tires, May 1965.

This experiment proved unsuccessful, because by May, 1965, shale flakes had nearly covered the tires (Figure 76) due to wind action.

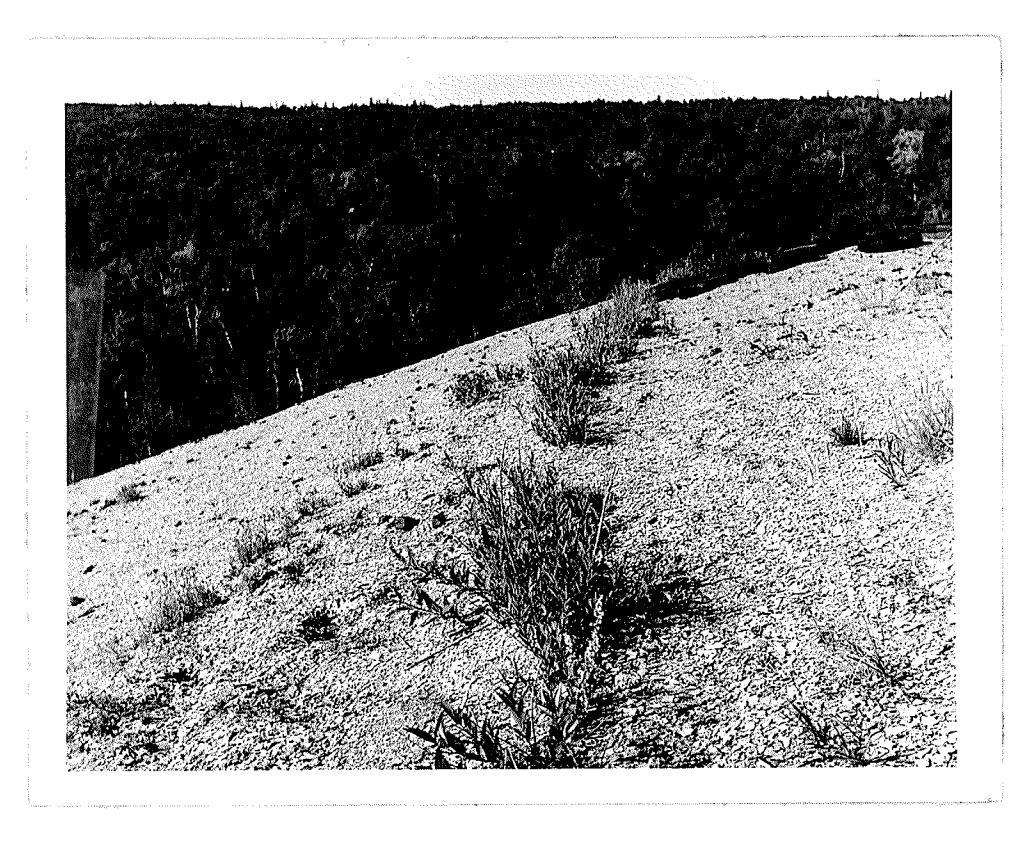
Figure 77. Willow Planted in Contour Trenches.
